WENCHUAN, SICHUAN PROVINCE, CHINA, EARTHQUAKE OF 2008

Lifeline Performance

Technical Council on Lifeline Earthquake Engineering
Monograph No. 39

Earthquake Investigation Committee of the
Technical Council on Lifeline Earthquake Engineering

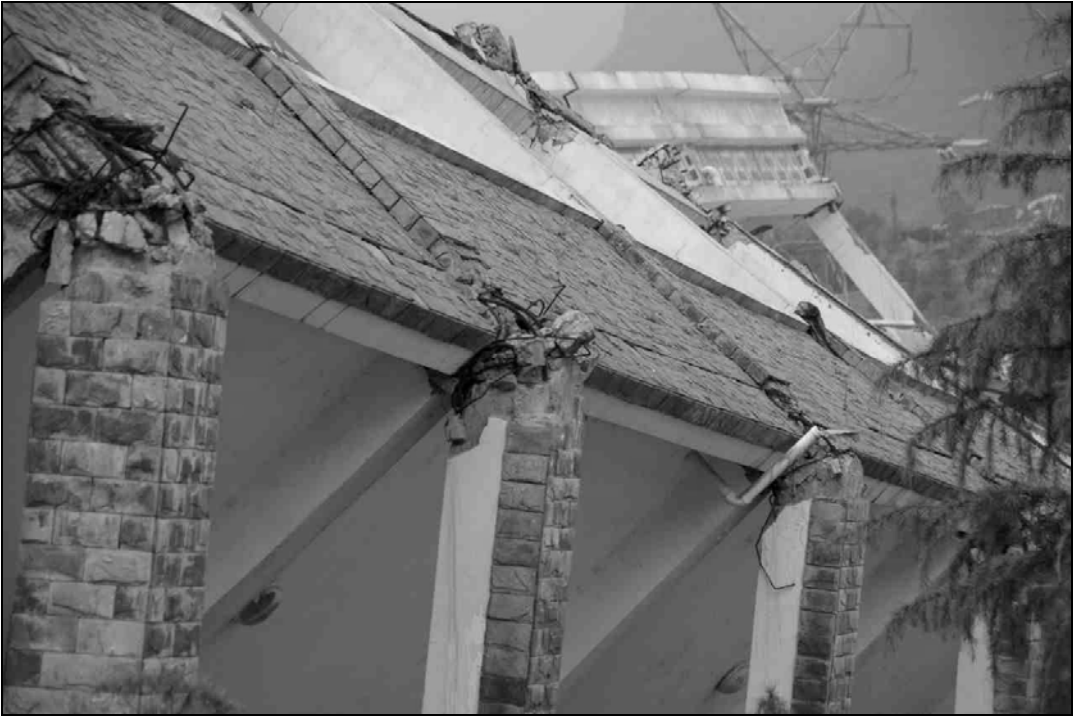
Fig. 9.5. A detailed view of the reinforcement connection to beams and joist.

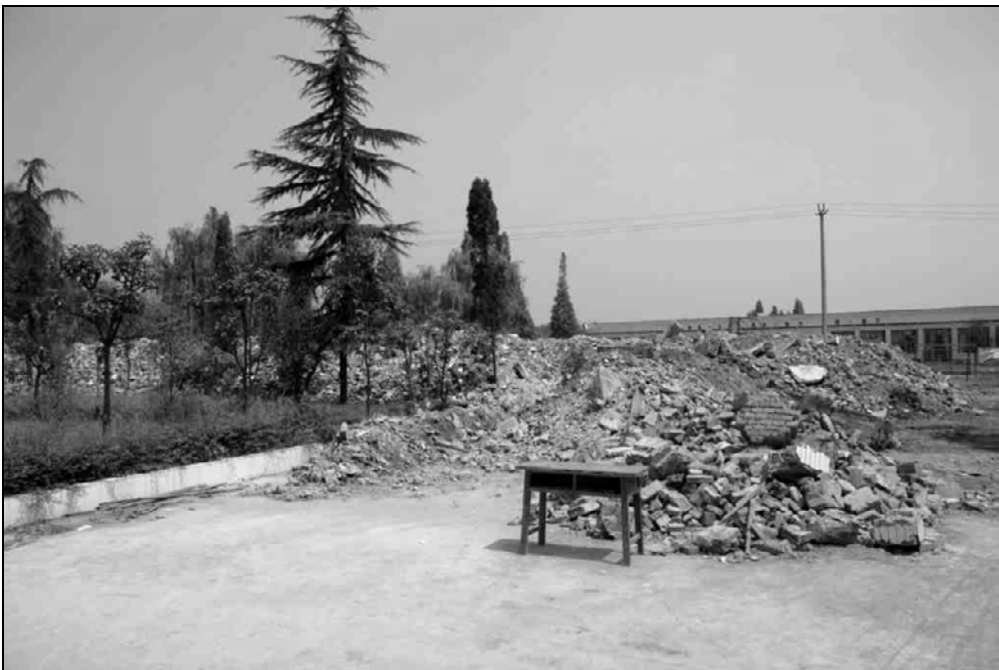
This school is another unreinforced masonry (URM) three-story building. It was impossible to identify its main structural elements from the ruins. We can only conclude from failures of similar structures that this building was not designed and constructed with seismic load bearing capacity. Simply, URM does not have lateral load capacity to resist earthquake force.

Fig. 9.7. Piles of bricks are the only remains of this primary school. Only a classroom desk indicates that this was a school. The one-story building used for student activities in the background did not collapsed; however, there were cracks on outside walls.

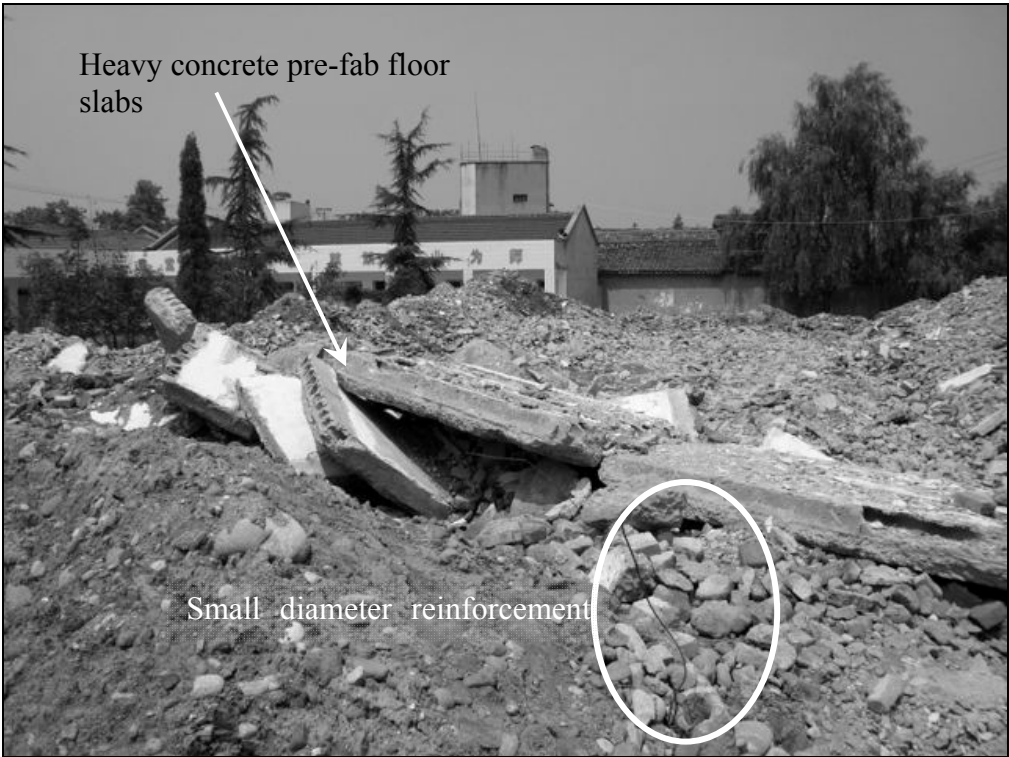
Fig. 9.8. This figure shows the concrete floor slab used. Note the small size reinforcement bar.

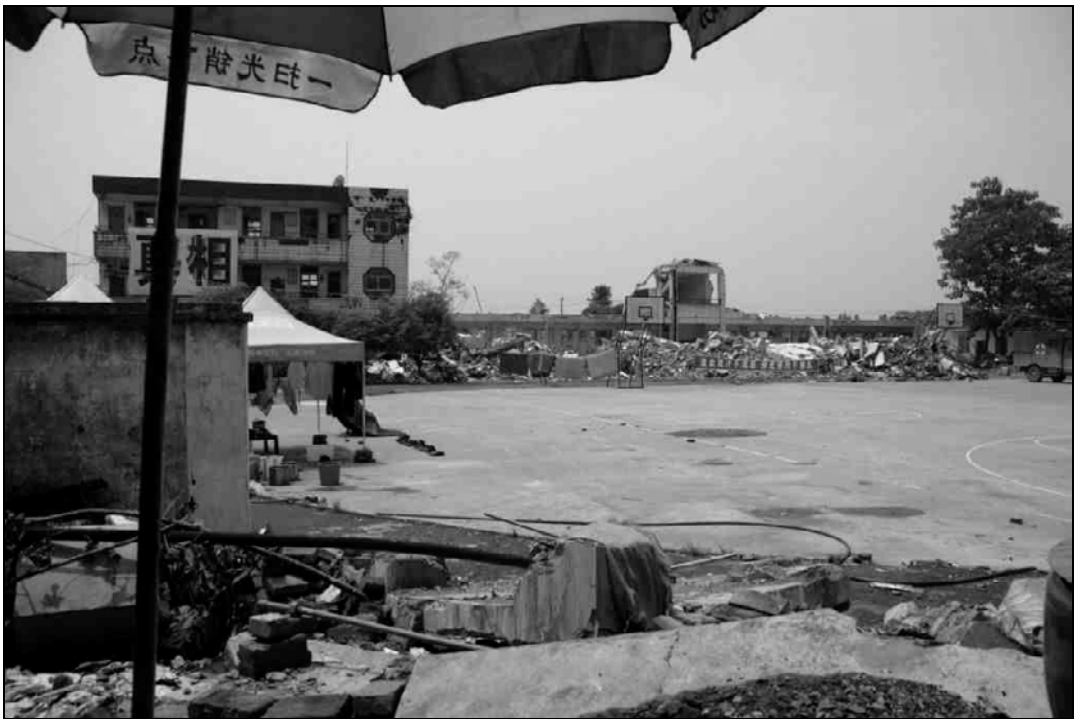
The primary and high school in Longju Zhen sustained extensive damage. The three-story classroom building collapsed while the office building on the left-hand side of the school entrance sustained structural damage but remained standing (Fig. 9.11 to 9.12). The local police did not allow us to enter the campus due to the risk from poor hygienic conditions after the bodies were removed.

The inspection report on the causes of collapse was also posted on a board in the temporary shrine. The report details failed elements, such as sizes and materials. Based on the report it was not difficult to conclude that the failed structures lacked seismic design details.

Fig. 9.12. The collapsed three-story classroom building.

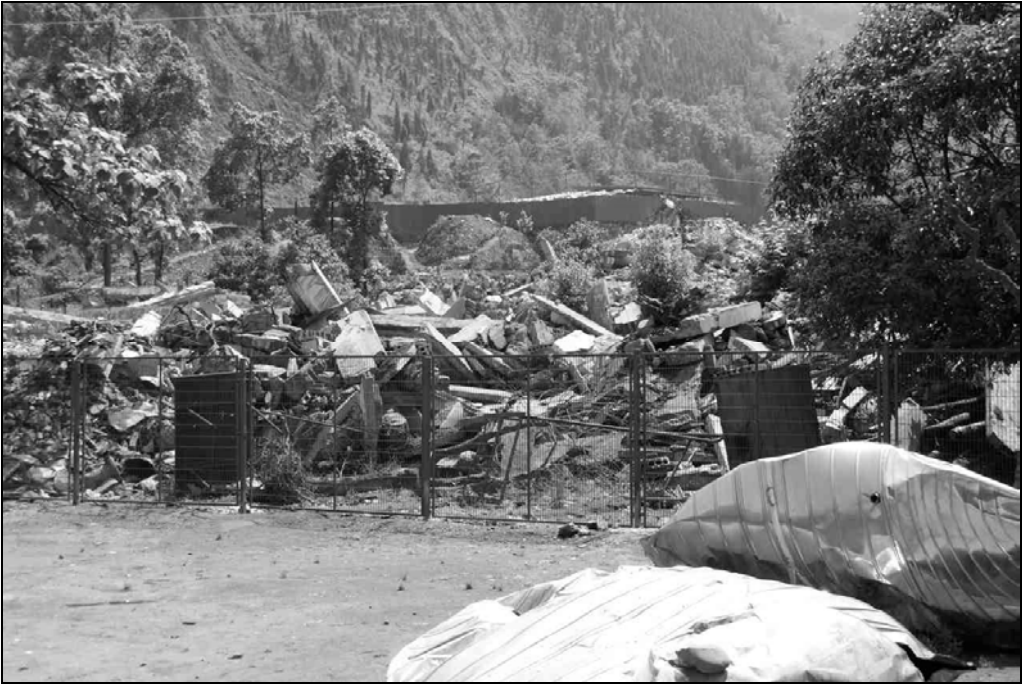
The school we visited in Beichuan was located about 5 km from the city. The ruins were fenced in (Fig. 9.14), as the whole building had collapsed. There was no information about casualties at this school, which had been relocated close by.

Fig. 9.14. This school is located on the main road leading to Beichuan town.

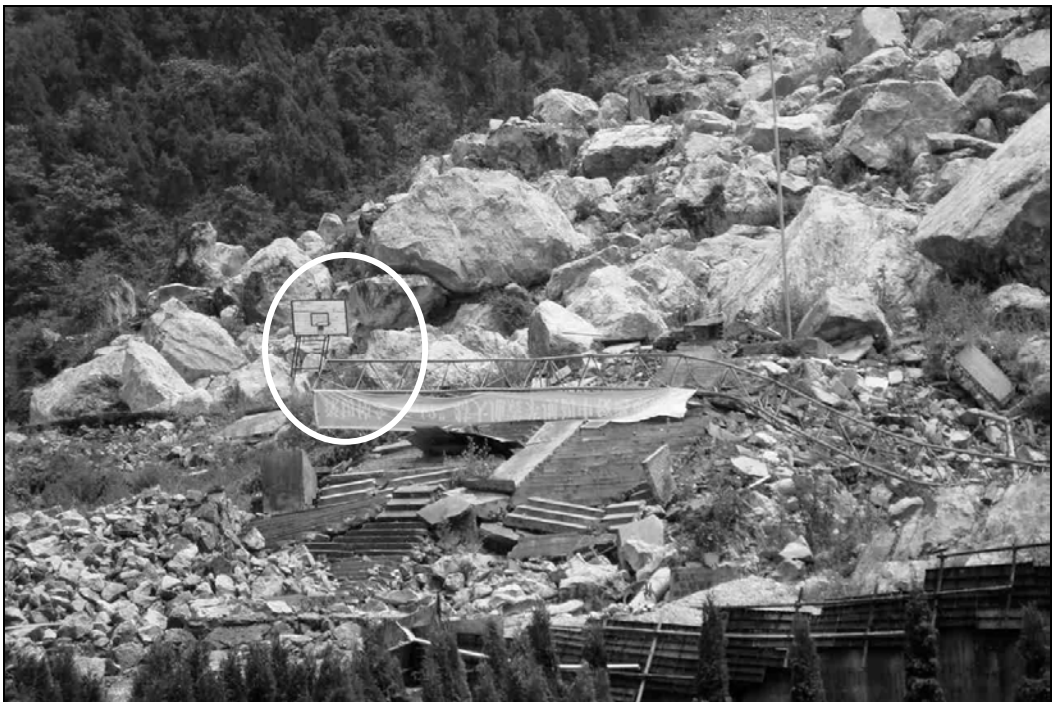
Another school in Beichuan town had been completely demolished by rock fall, leaving only a basketball goal as a sign that a school had existed (Fig. 9.15). This was the worst of all the schools affected by the earthquake. Almost all of its students died.

Fig. 9.15. The remains of this a school in Beichuan town are under the rocks. Note the basketball goal on the left hand side.

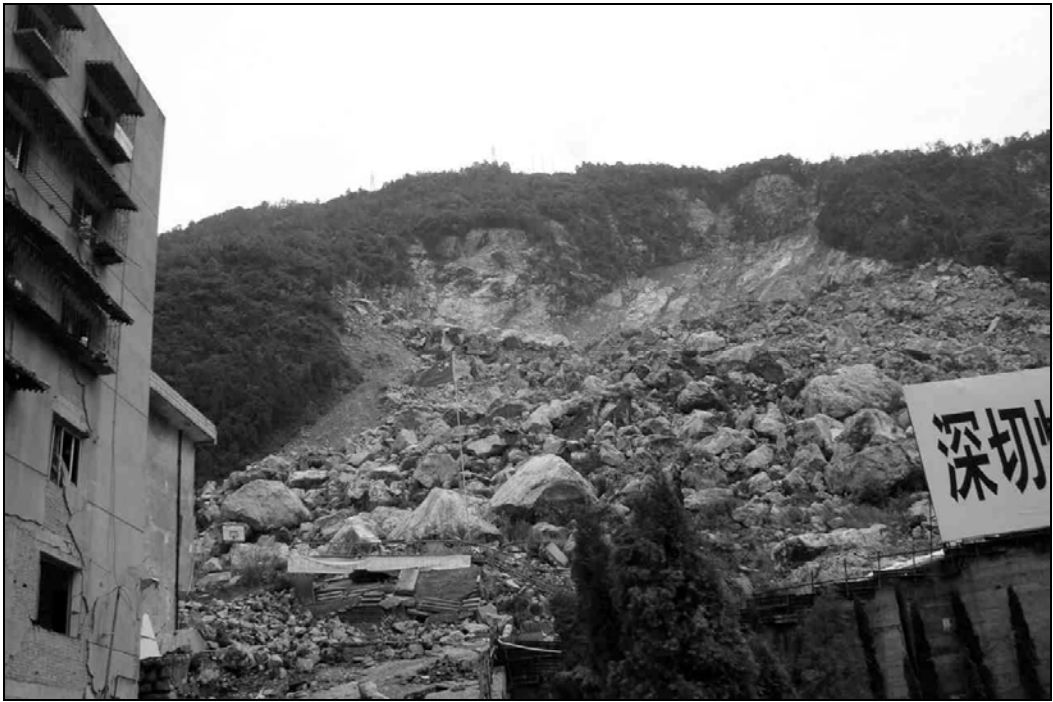
Fig. 9.19. The buildings along this foothill are under the pile of rock that fell from the top of the hill.

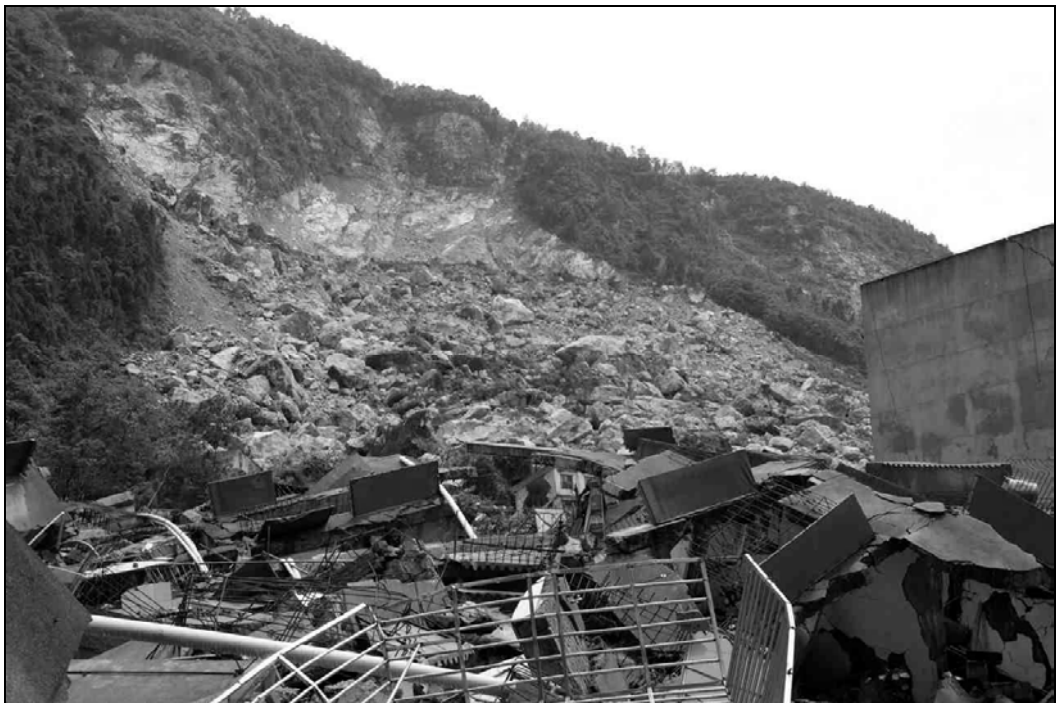
Fig. 9.20. View from a different angle to show the extent of rock fall and the debris of buildings being pushed to the low land

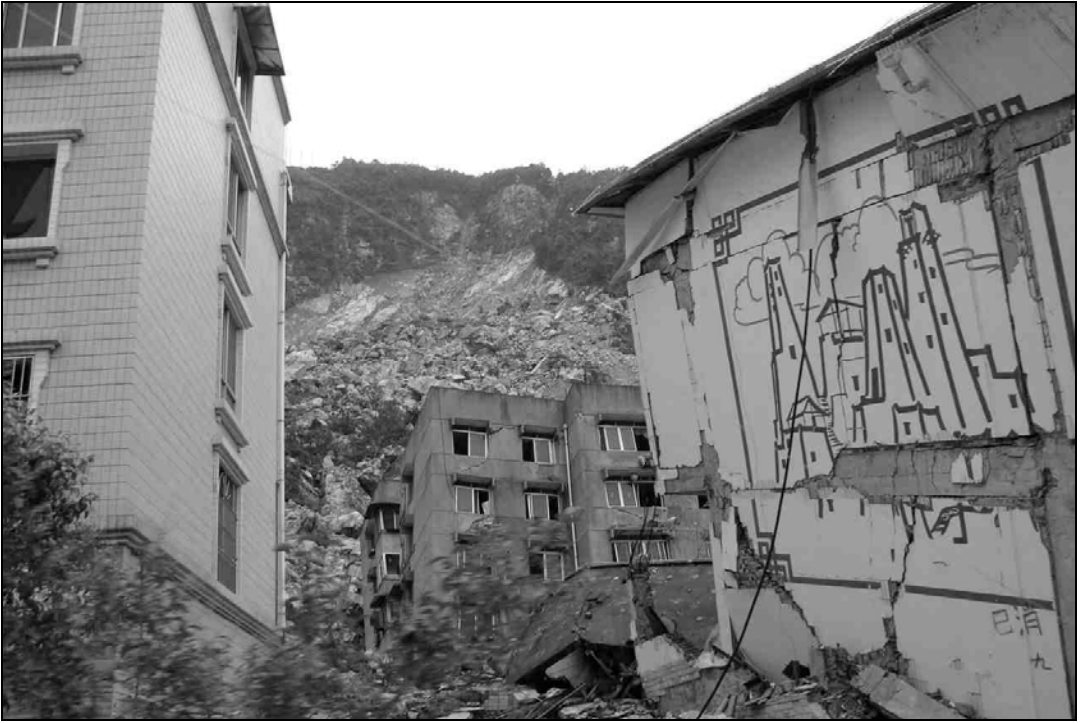
Fig. 9.21 Landslide that damaged and buried a number of buildings along its path.

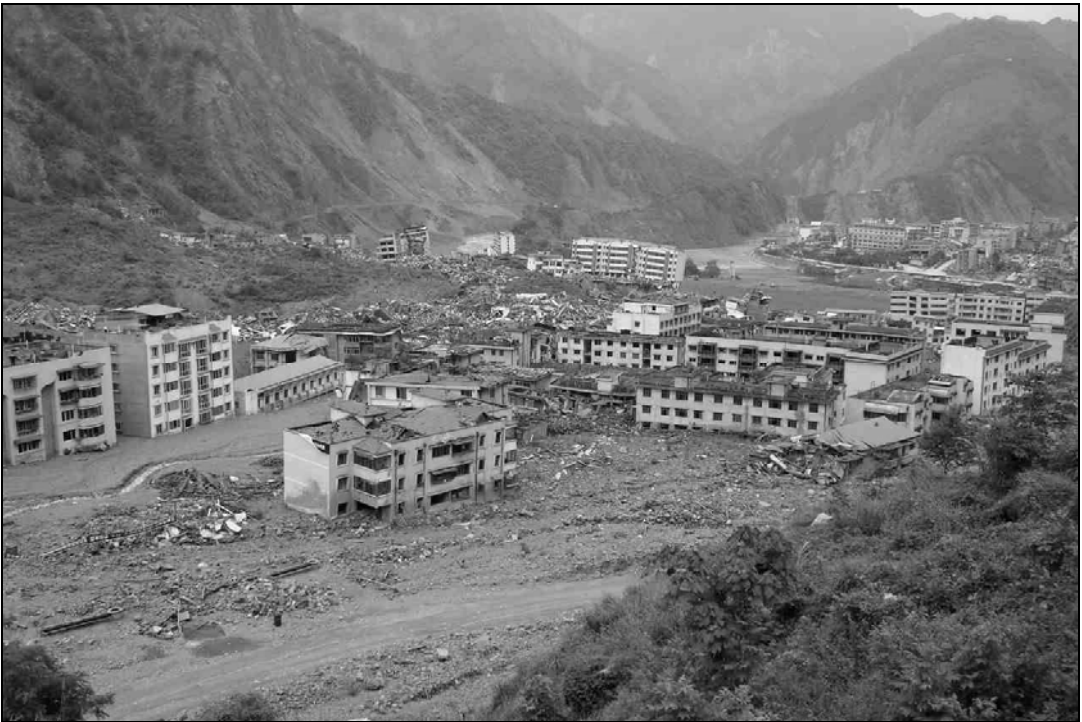
Fig. 9.22. Large part of the town buried by debris flow

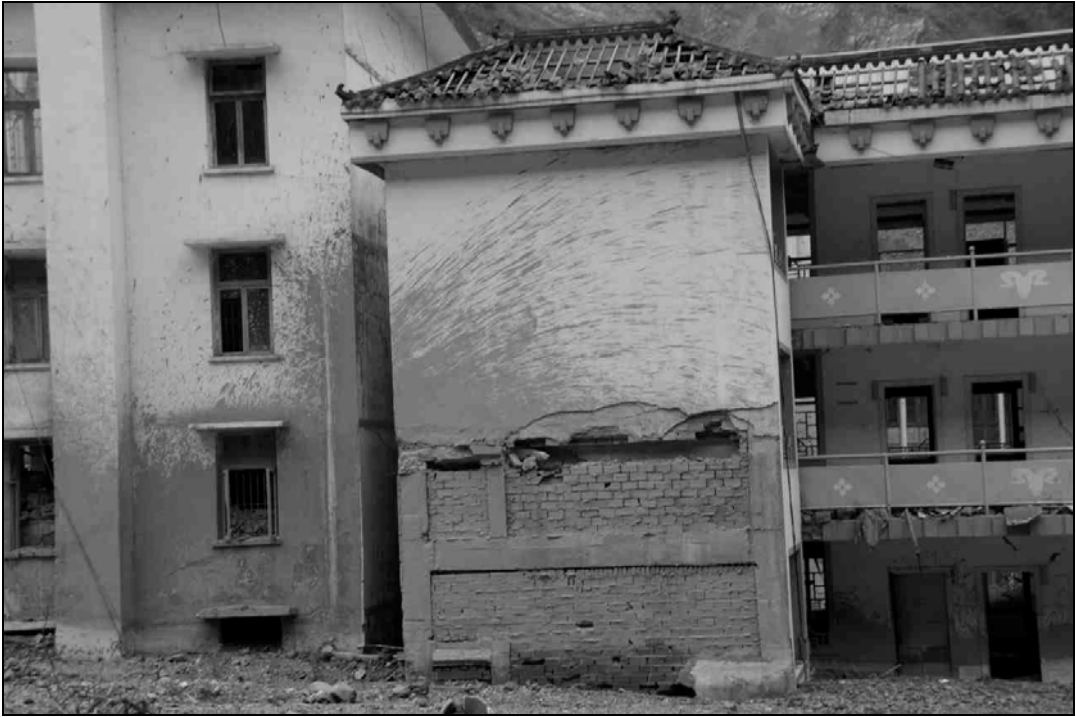
Fig. 9.23. This photo shows the force of the debris flow. The splash shot up two floors.

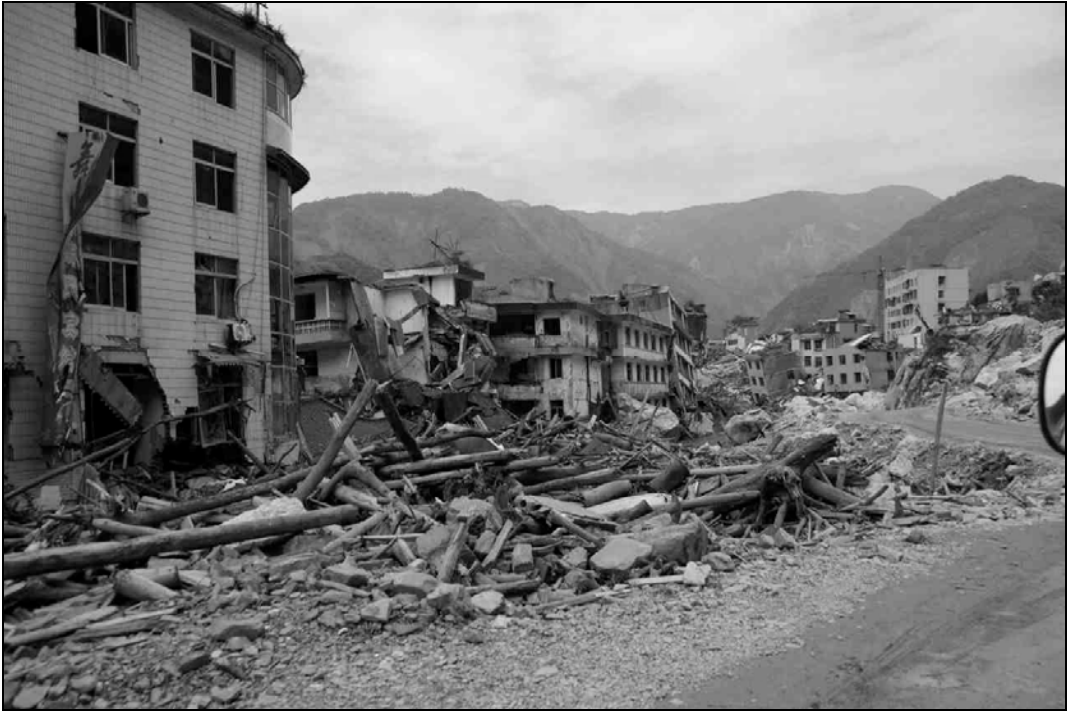
Fig. 9.25. Timber debris flowing from the mountains also caused lots of damage to buildings.

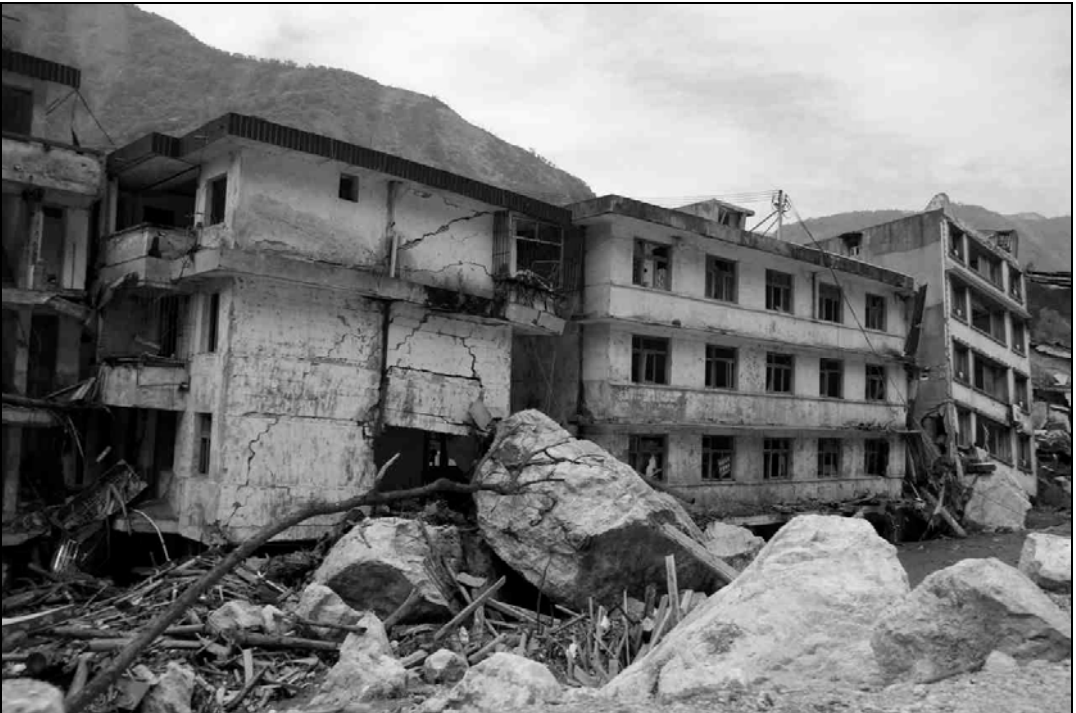
Fig. 9.26. Large boulders from the mountains were also a major cause of building damage.

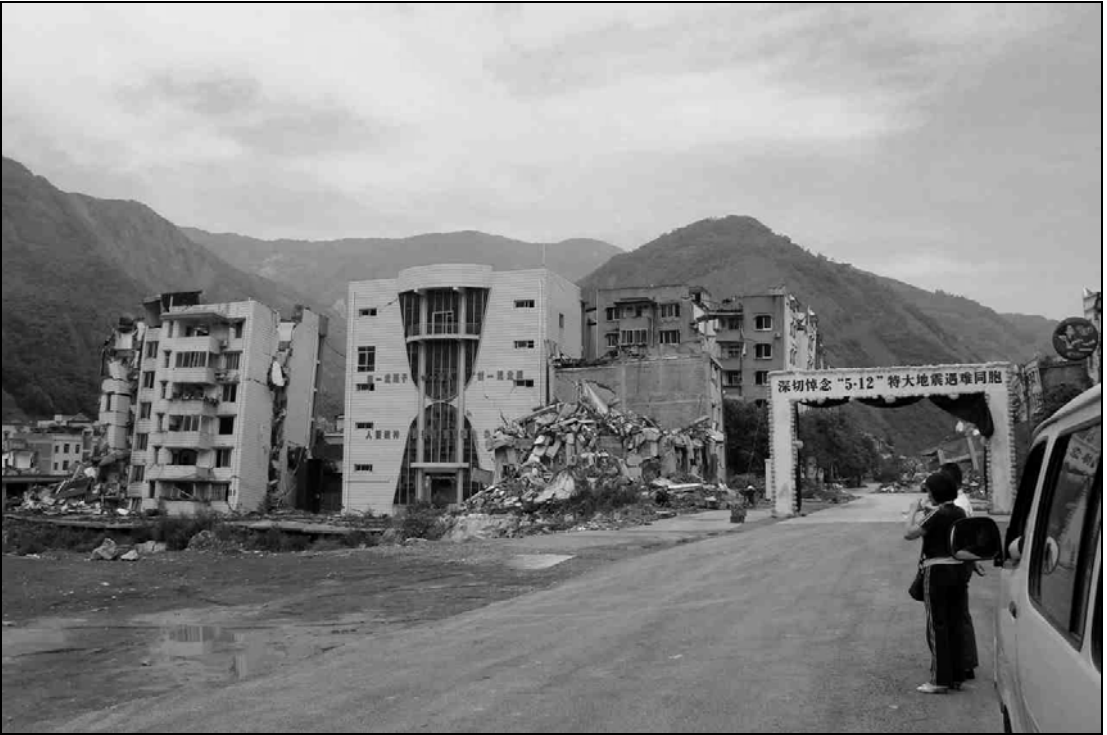
Fig. 9.27. Not all buildings were damaged; here one remained standing while the one next to it collapsed.

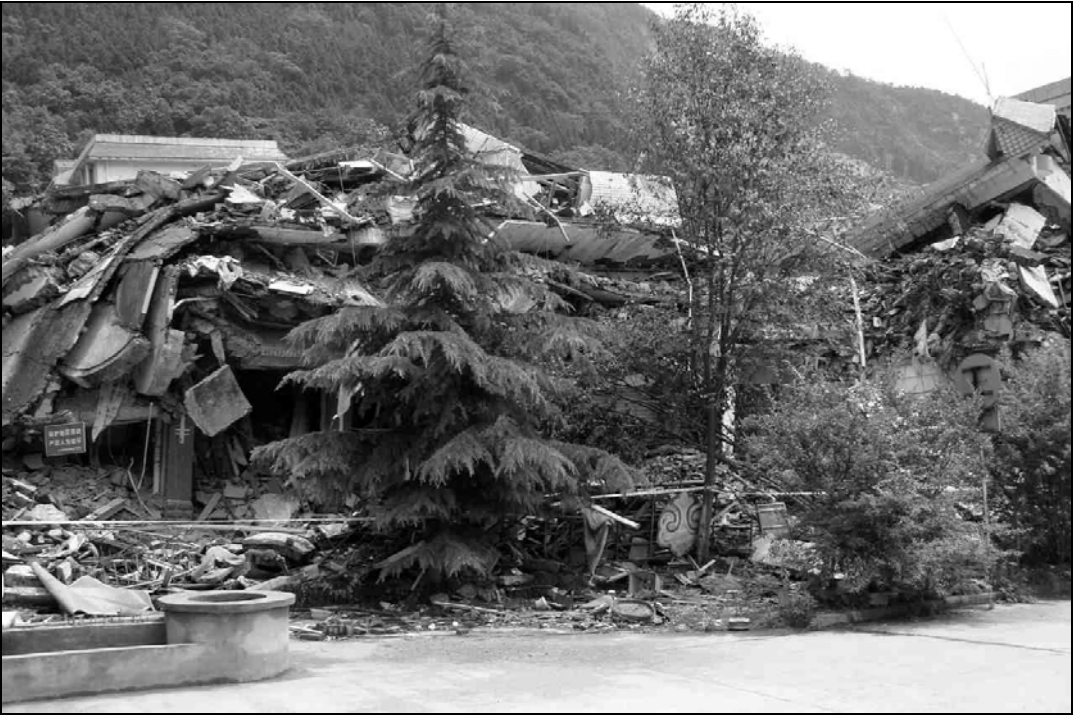
Fig. 9.29. This building pancaked with four floors collapsing to the second floor.

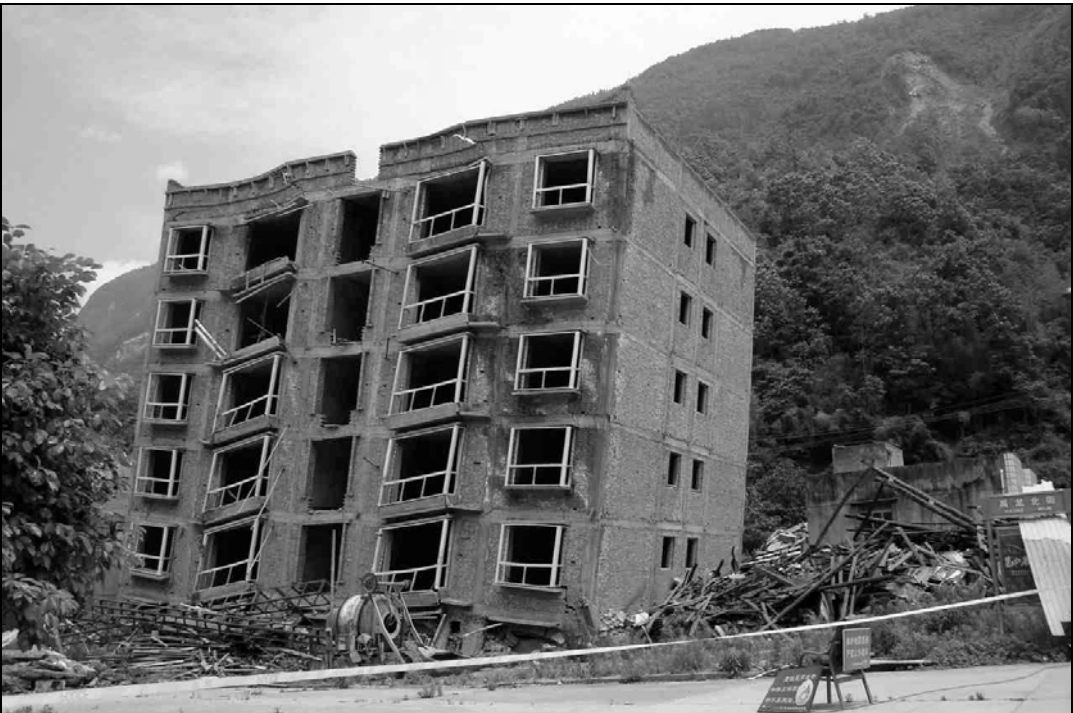
Fig. 9.30. This partially finished building leaned backward along with major structural set back. It was empty with not load on it.

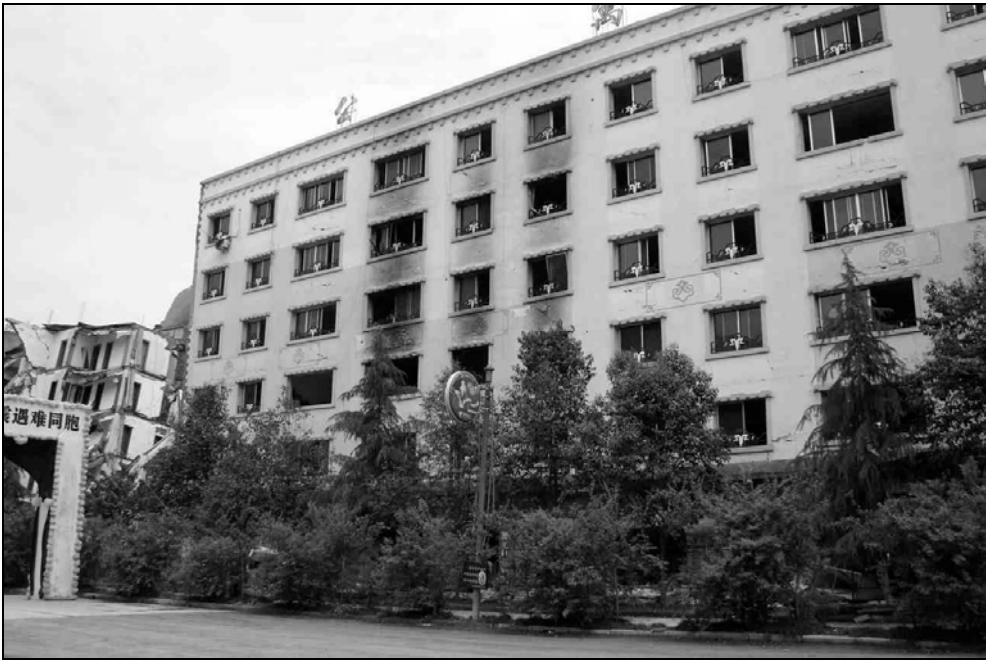
One apartment building had smoke marks around one of its windows indicating that a fire had broken out (Fig. 9.31).

Fig. 9.31. Soot marks the location of a fire, which most likely started on the third floor.

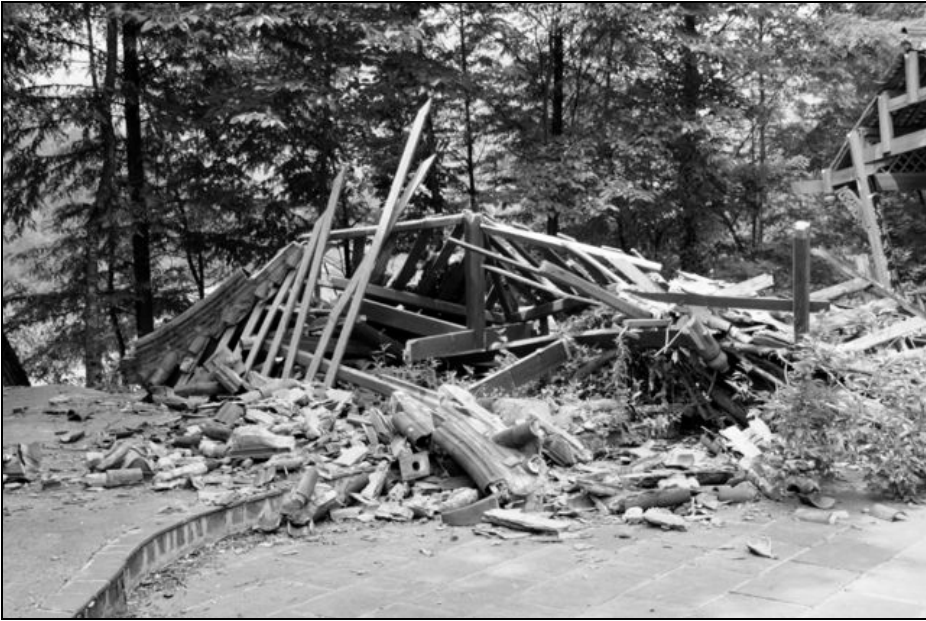
Fig. 9.32. Remains of a rest stop shelter on the road to Hongkou that was demolished by rock fall.

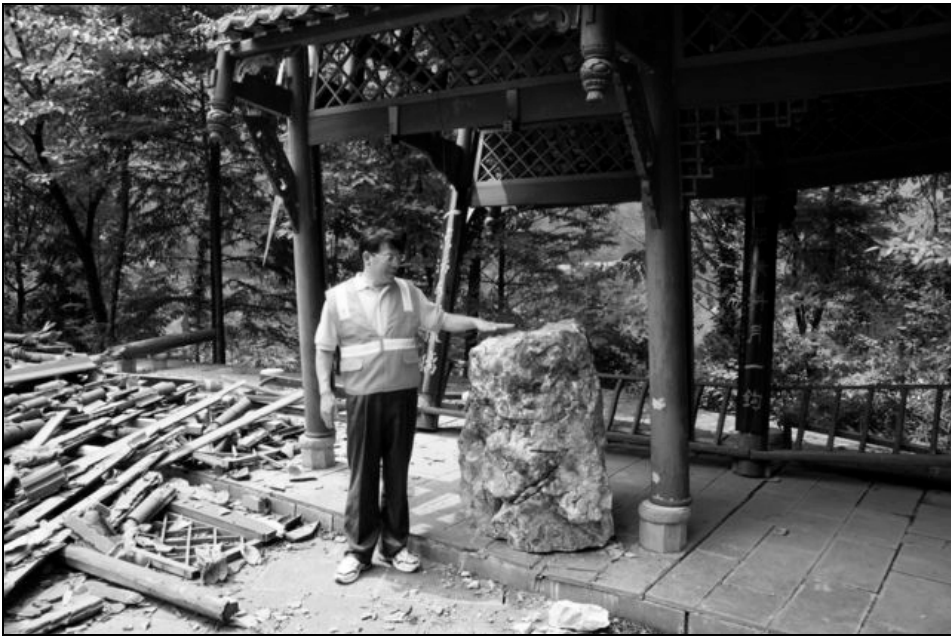
Fig. 9.33. Professor Manchao He and one of the boulders that came through the rest stop.

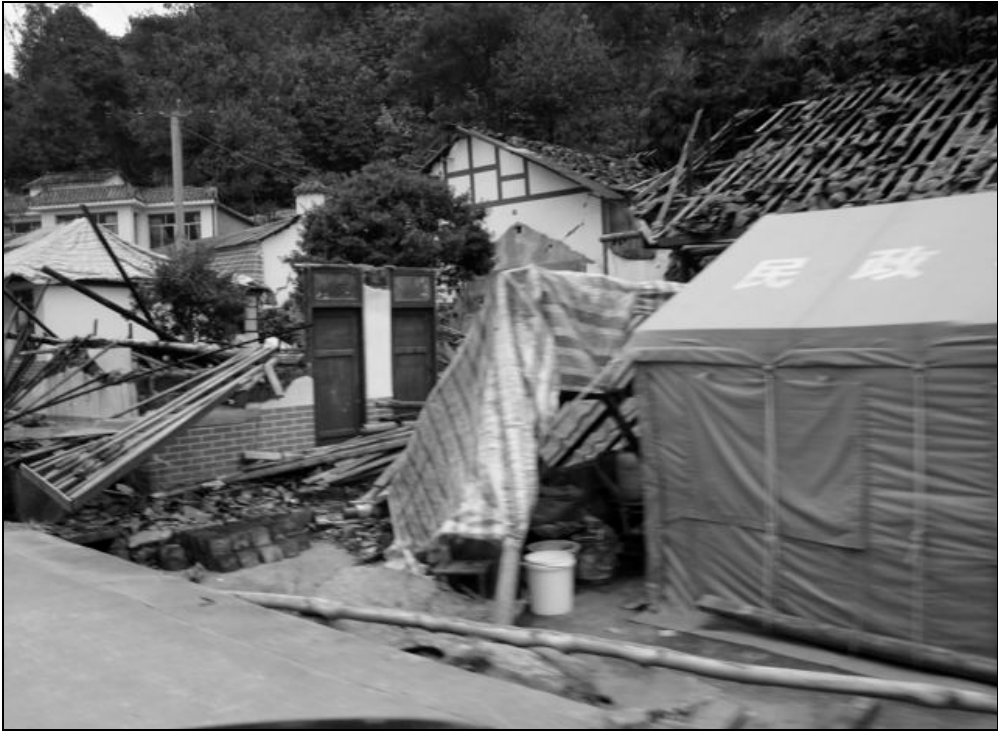
Fig. 9.34. Collapsed timber roofs of the URM houses. The tent was set up by the PLA for the victims and those who did not want to return to their houses due to large number of strong aftershocks.

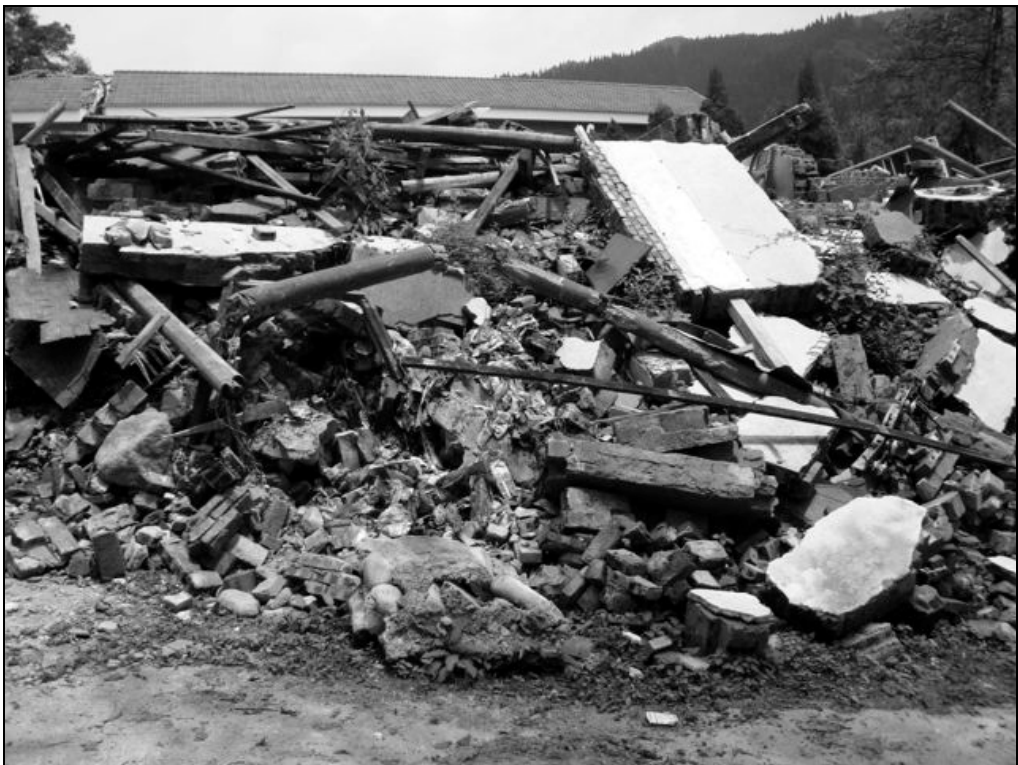
Fig. 9.35. Houses reduced to rubble close to Hongkou town. There were many casualties in this area.

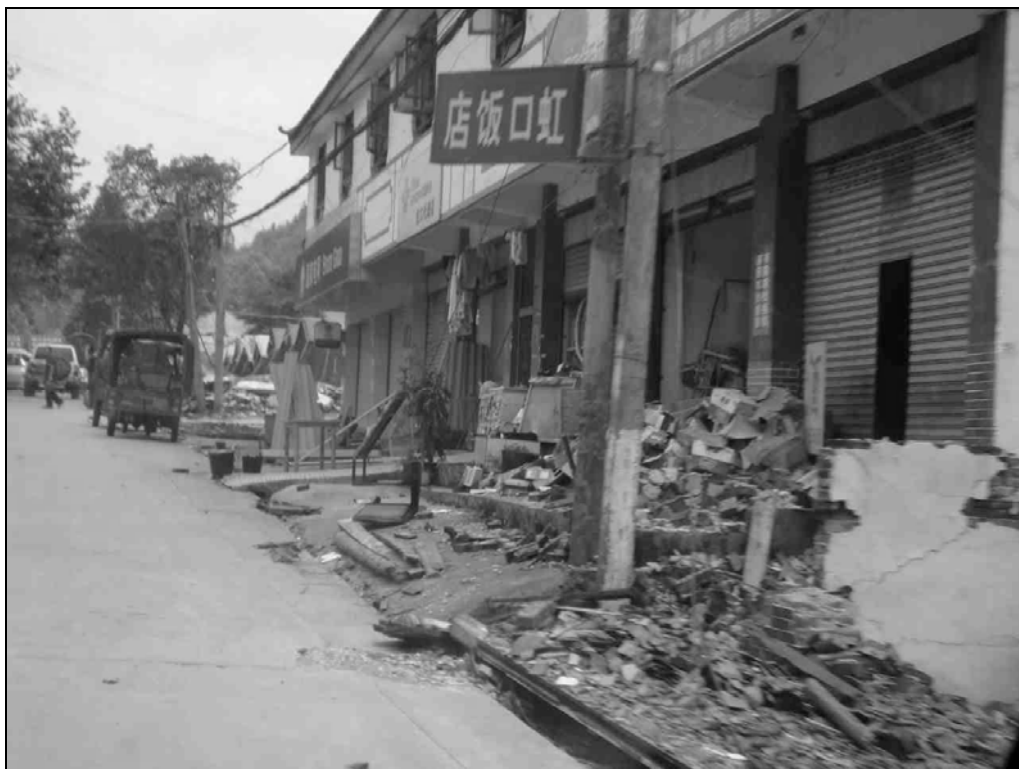
Fig. 9.36. A strip of houses that sustained rather minor damage. Note tents were set up for people whose houses were destroyed.

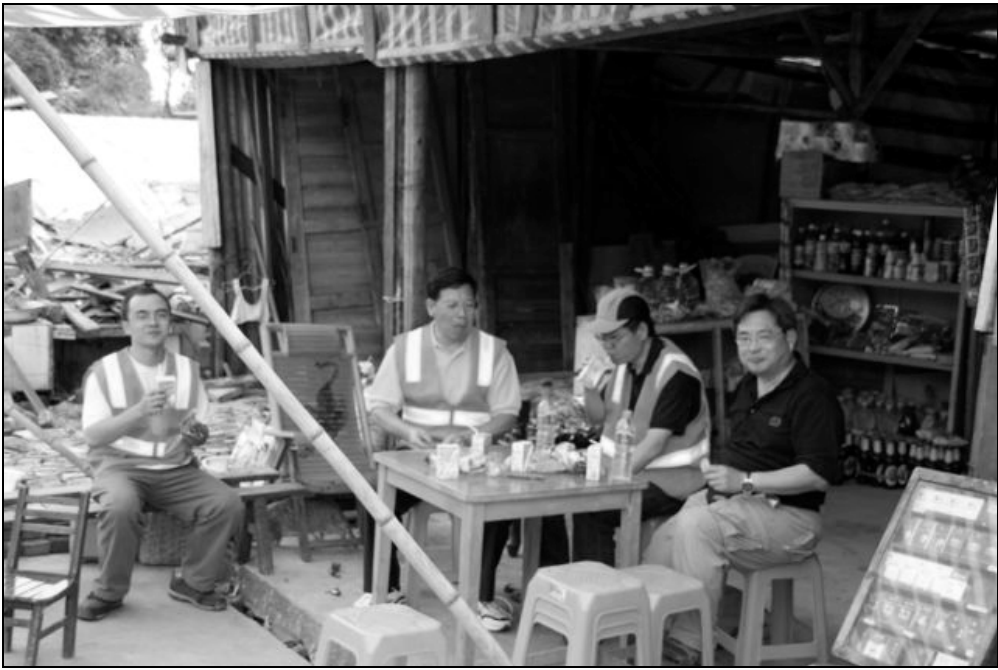
Fig. 9.38 The investigation team taking a short break at this temporarily rebuilt restaurant. Note the pile of rubbles from a collapsed building on the left just behind Jian Wang, a Ph.D. student and our local support from SW Jiaotong University, Chengdu.

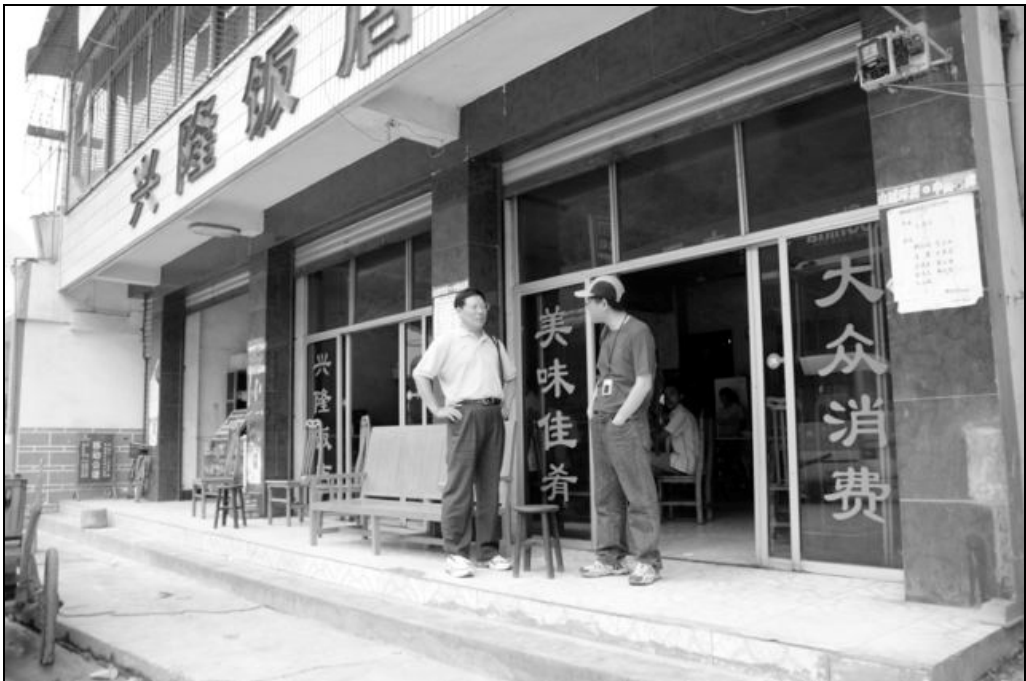
Fig. 9.39. This restaurant in Hongkou, where the team stopped for lunch, performed quite well with very minor superficial damage.

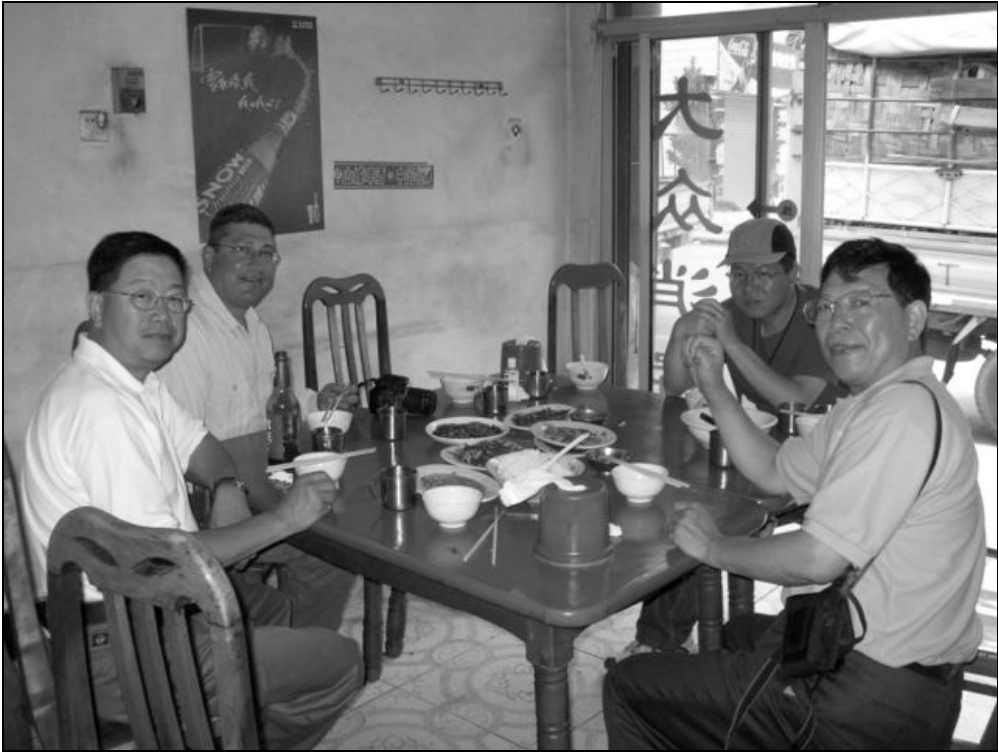
Fig. 9.40 Team members stop for lunch in Hongkou. Note the inside of this restaurant did not show any sign of damage. Some minor cracks were noted.

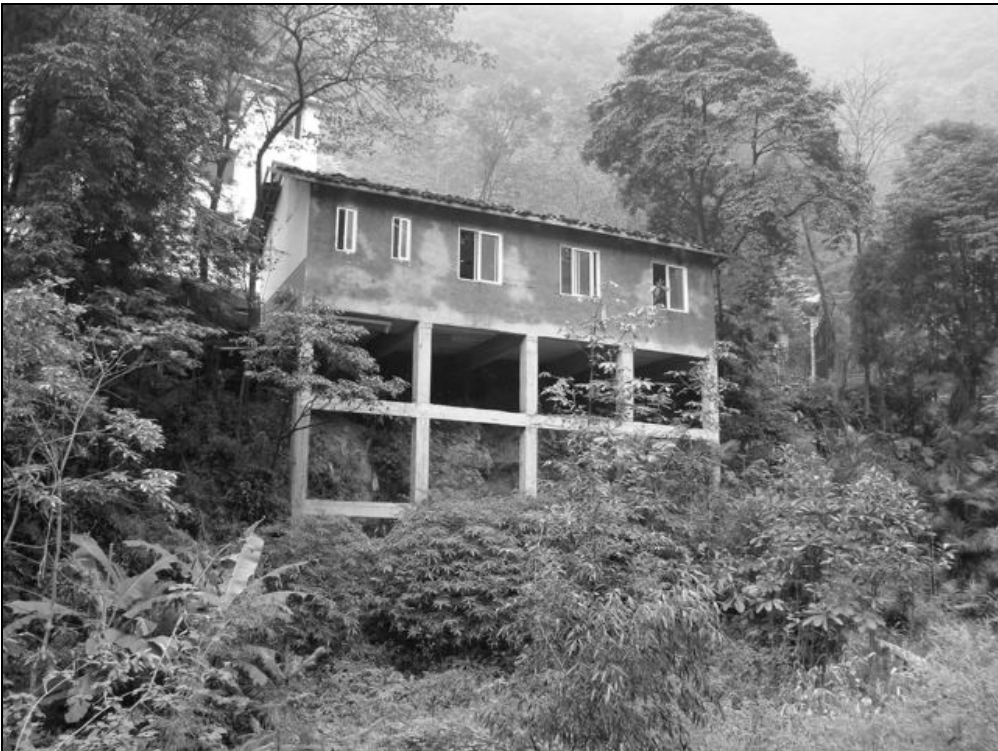
Fig. 9.41 One building in a group of resort-style hotel buildings on a hill side above a creek. See Fig. 9.43 for the front of the building.

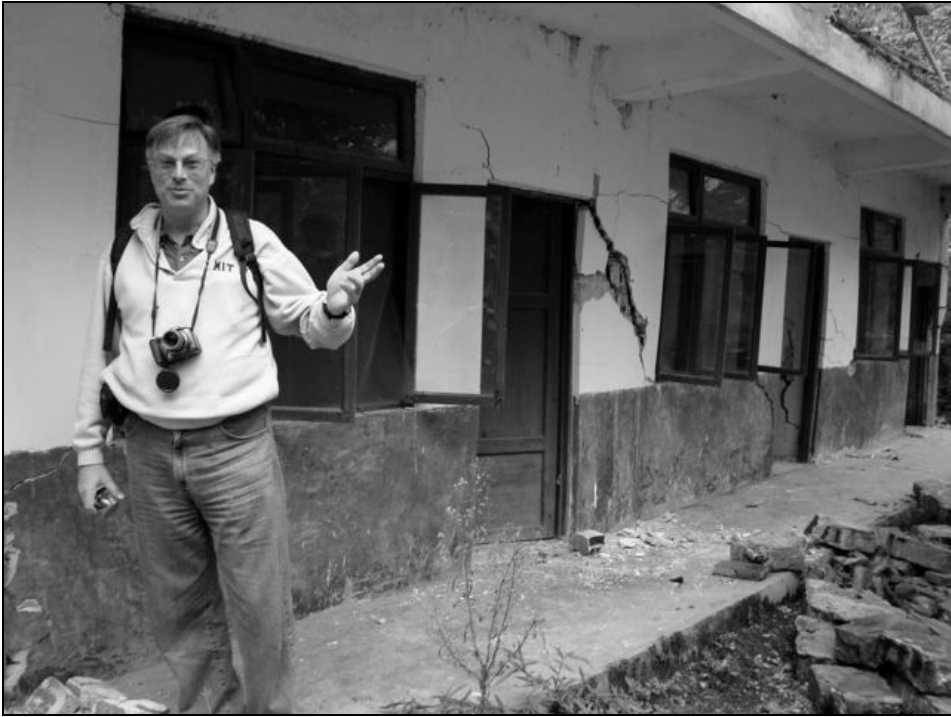
Fig. 9.42 The front of the building in Fig. 9.42 shows significant structural damage; however, it did not collapse.

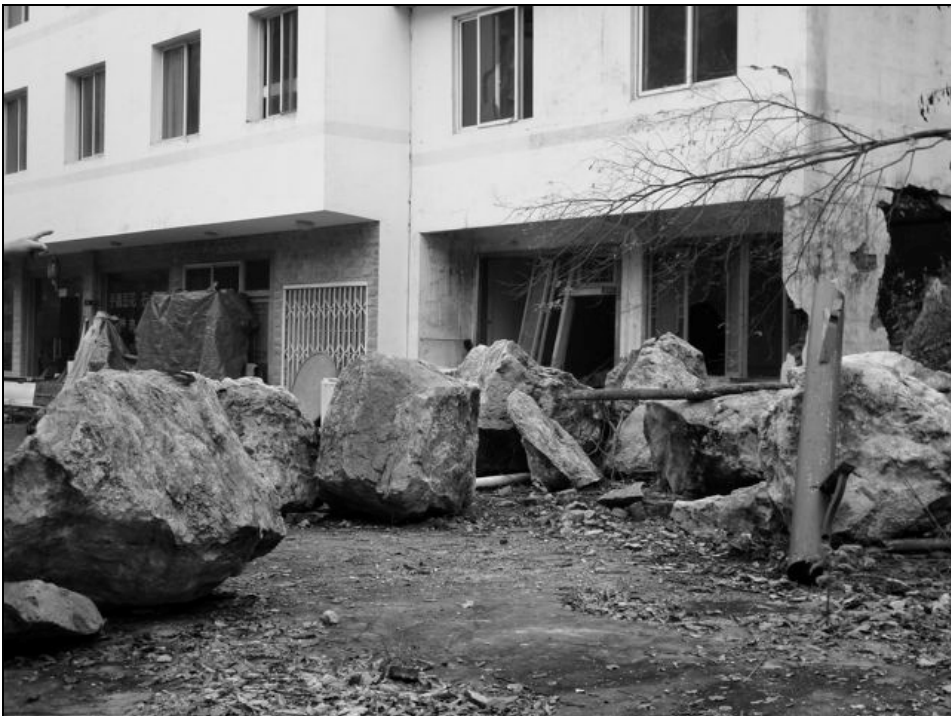
Fig. 9.43. The courtyard the hotel was littered with boulders that rolled down from the mountain above. The house on the right was damaged by the boulders.

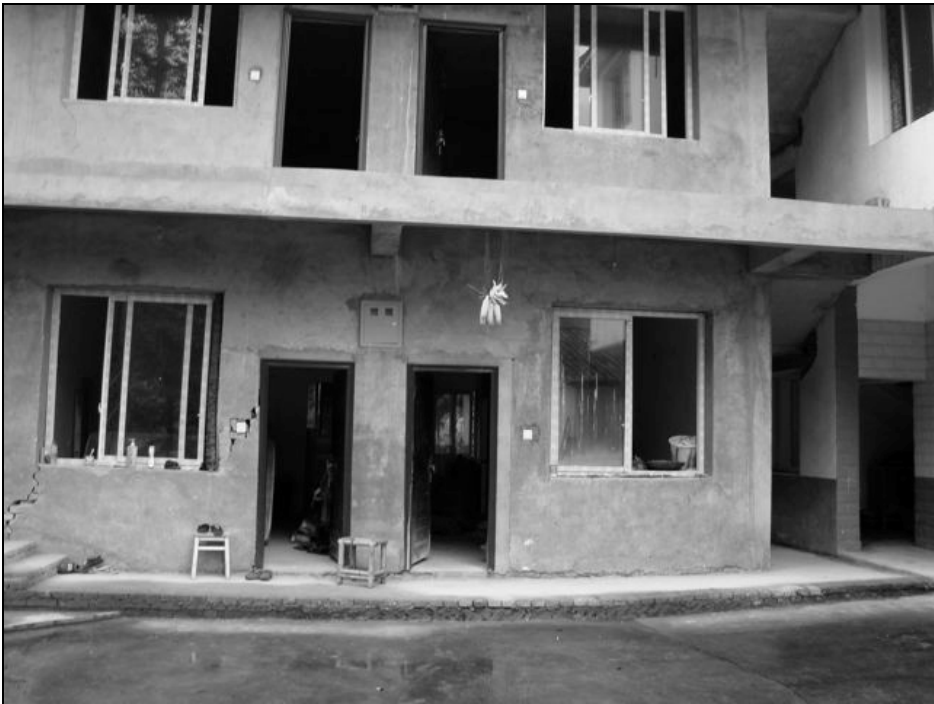
Fig. 9.44. This new building on the north side of the court yard showed some minor cracks. The second floor was not yet occupied, and the railing had not been installed.
