WENCHUAN, SICHUAN PROVINCE, CHINA, EARTHQUAKE OF 2008

Lifeline Performance

Technical Council on Lifeline Earthquake Engineering
Monograph No. 39

Earthquake Investigation Committee of the
Technical Council on Lifeline Earthquake Engineering

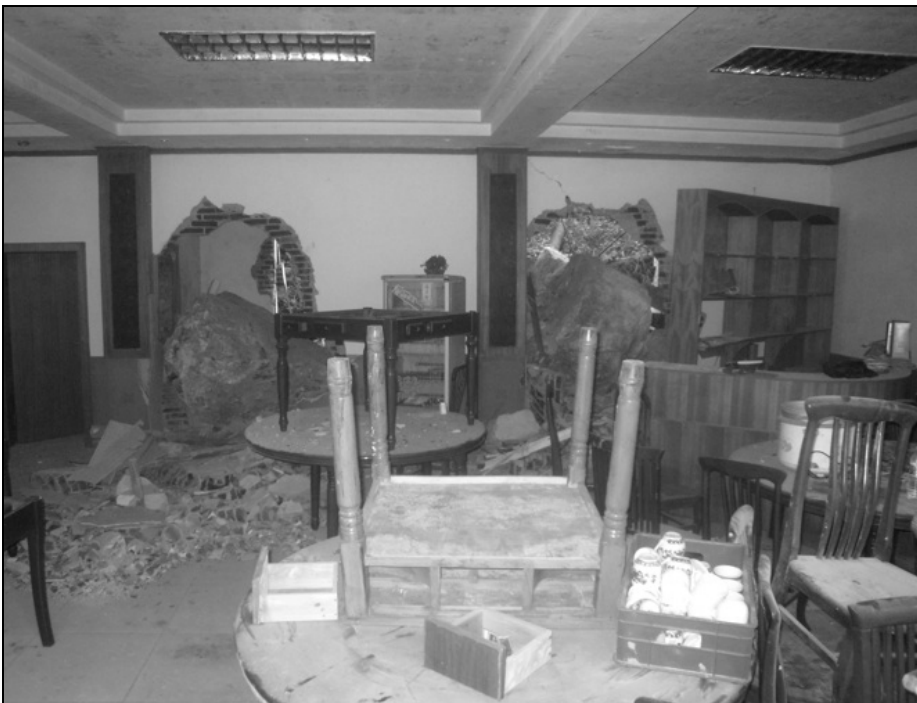
Fig. 9.45. Two boulders entered the hotel dining room through the wall causing lots of damage. Luckily the boulders missed the columns; otherwise, the building would have collapsed.

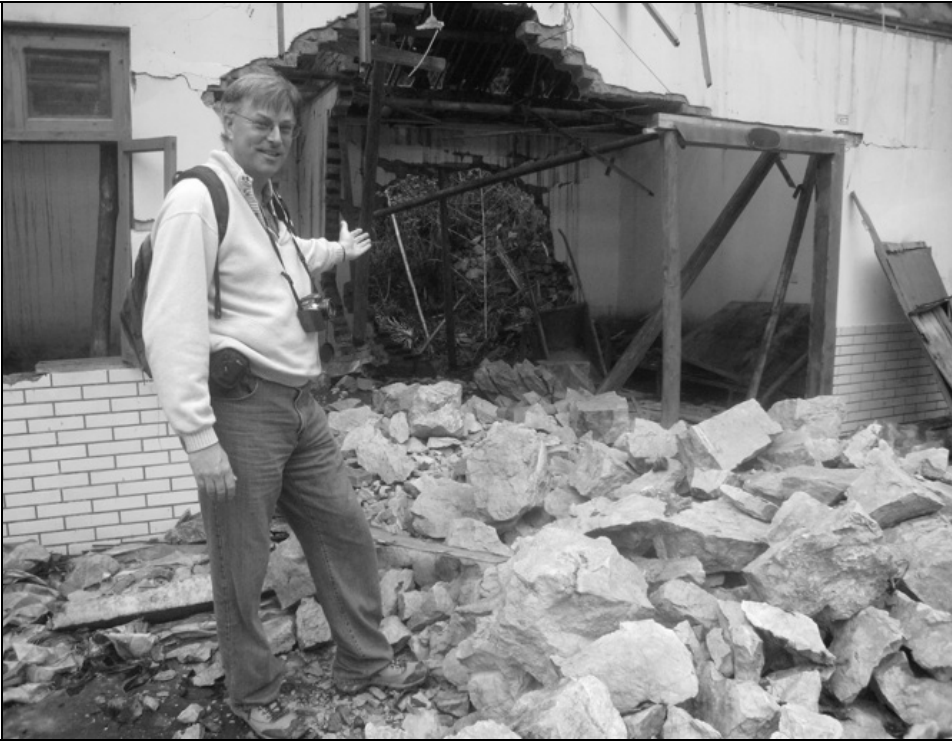
*Fig. 9.46. One boulder broke through the back and front wall.
It was cut into smaller pieces before the team's visit.*

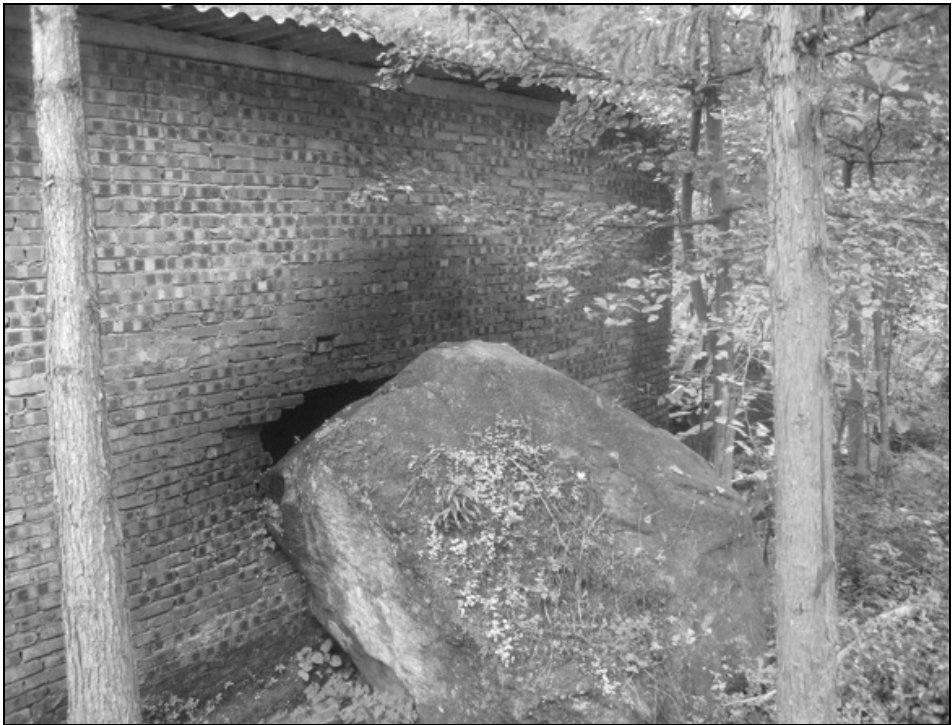
Fig. 9.47. Another boulder impacted one of the building's exterior brick walls.

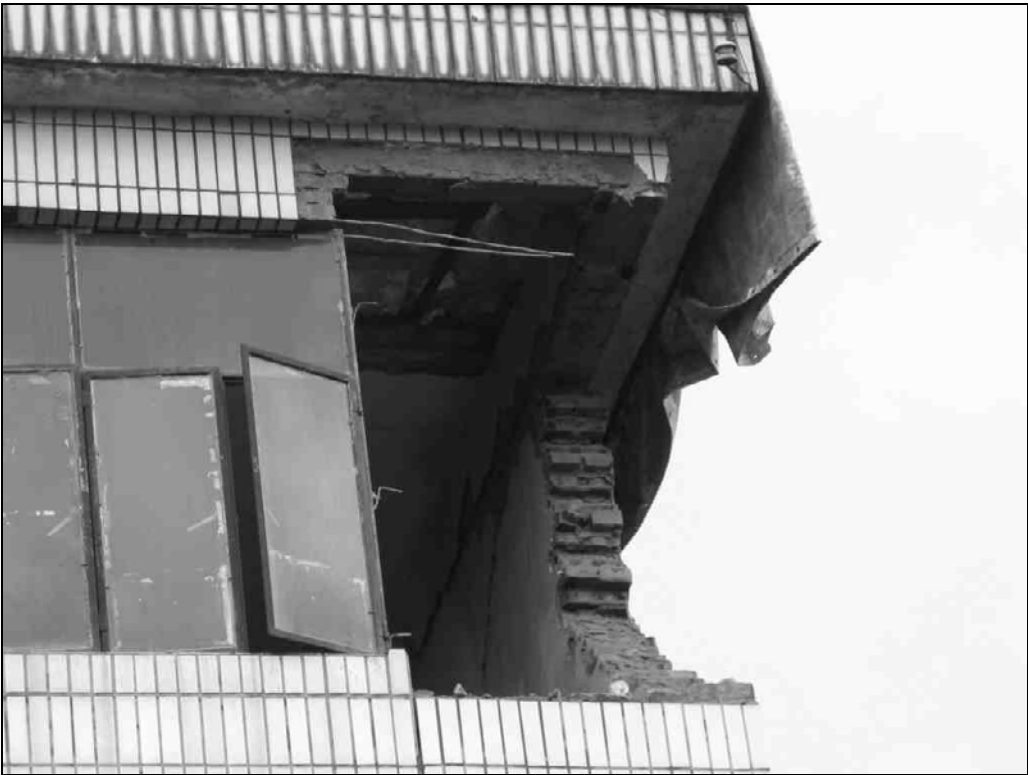
Fig. 9.49. Collapsed brick infill walls, another common scene within Dujiangyan.

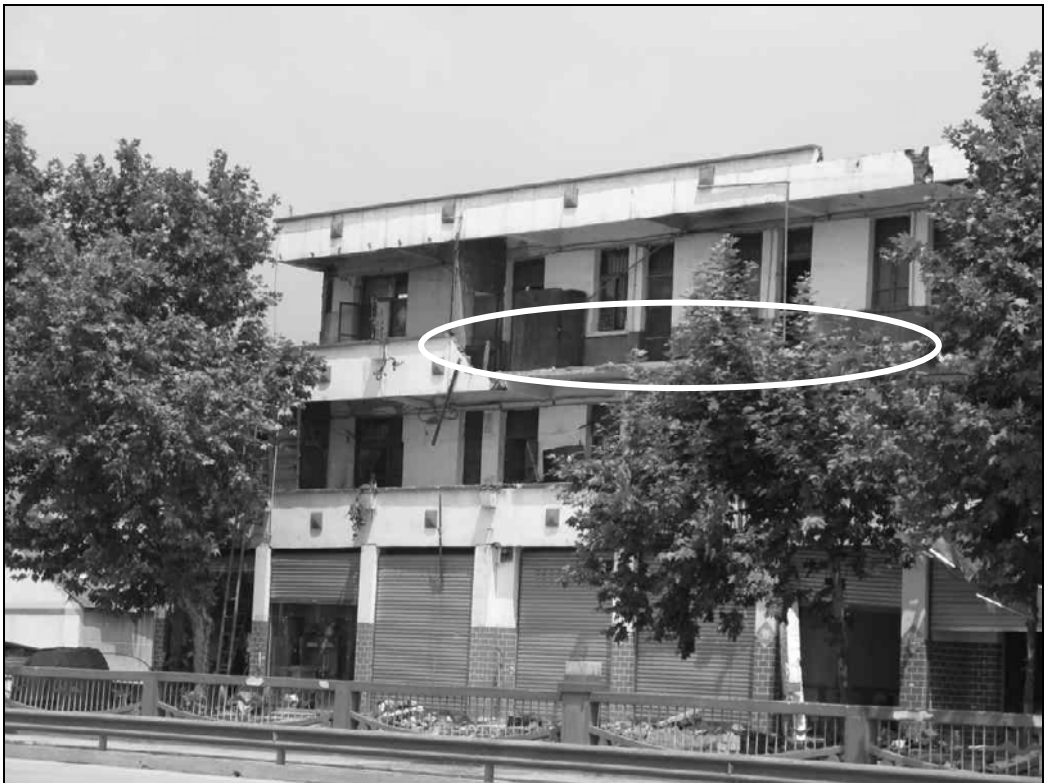
Fig. 9.50. This concrete frame building performed well except for the masonry railing on the third floor.

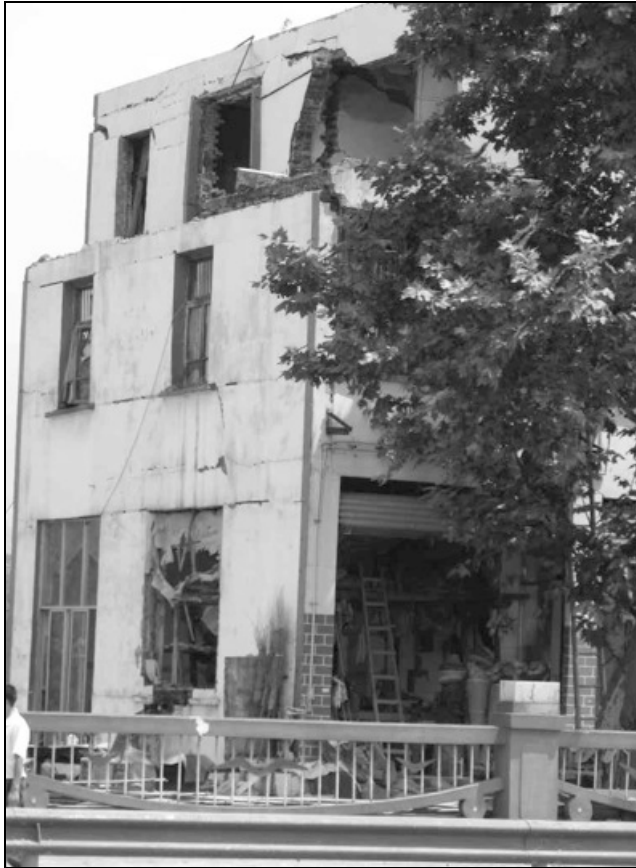
Fig. 9.51. The third floor of this building fell about 1 m to the second floor and shifted to the right.

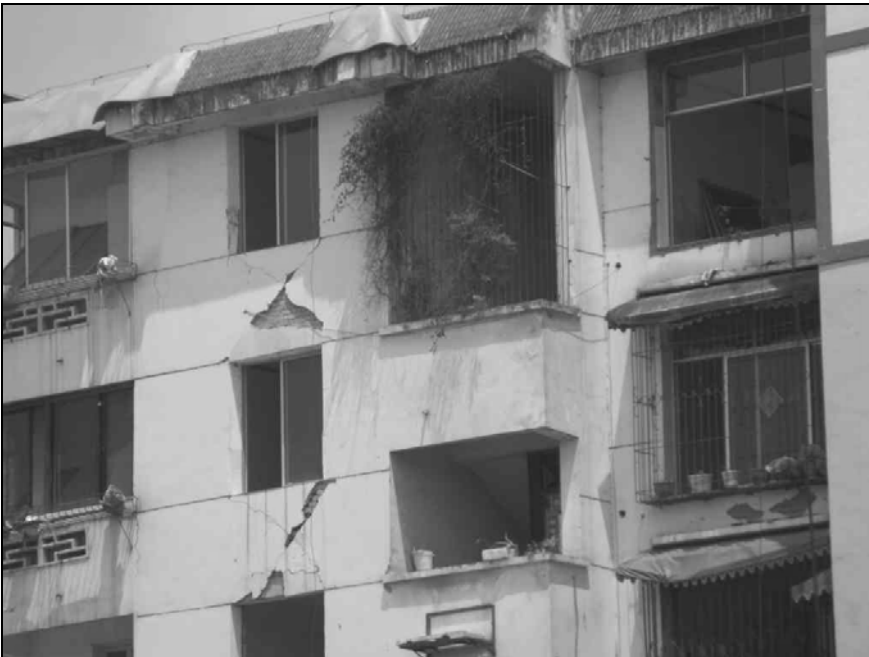
Fig. 9.52. This concrete building performed quite well; only minor stress cracks were observed on the outside. The windows were not broken.

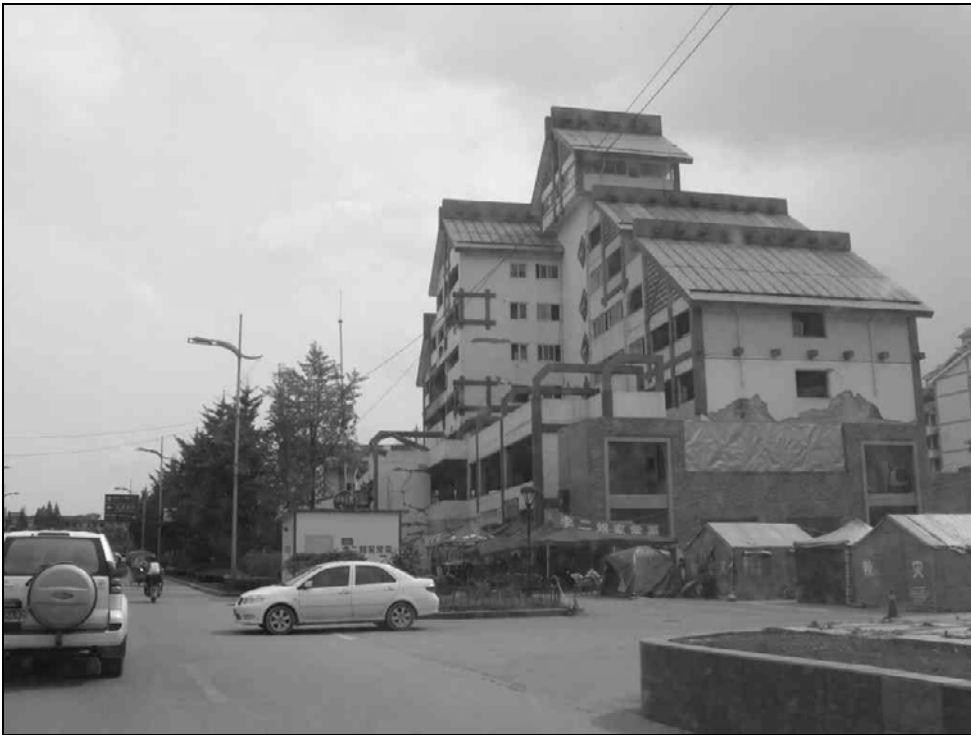
Fig. 9.53. This concrete frame building also performed well. There were stress cracks, and the plaster wall fell off the outside of the building.

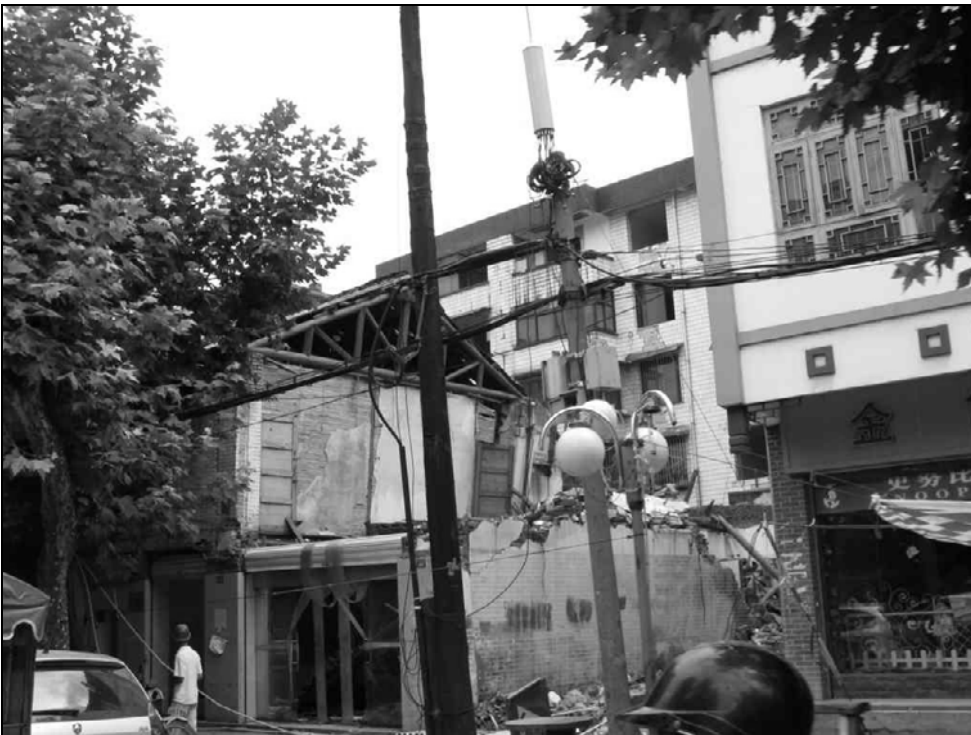
Fig. 9.54. A two-story URM building collapsed. The building behind and next to it sustained minor damage. A window was broken on the top floor the building in the background.

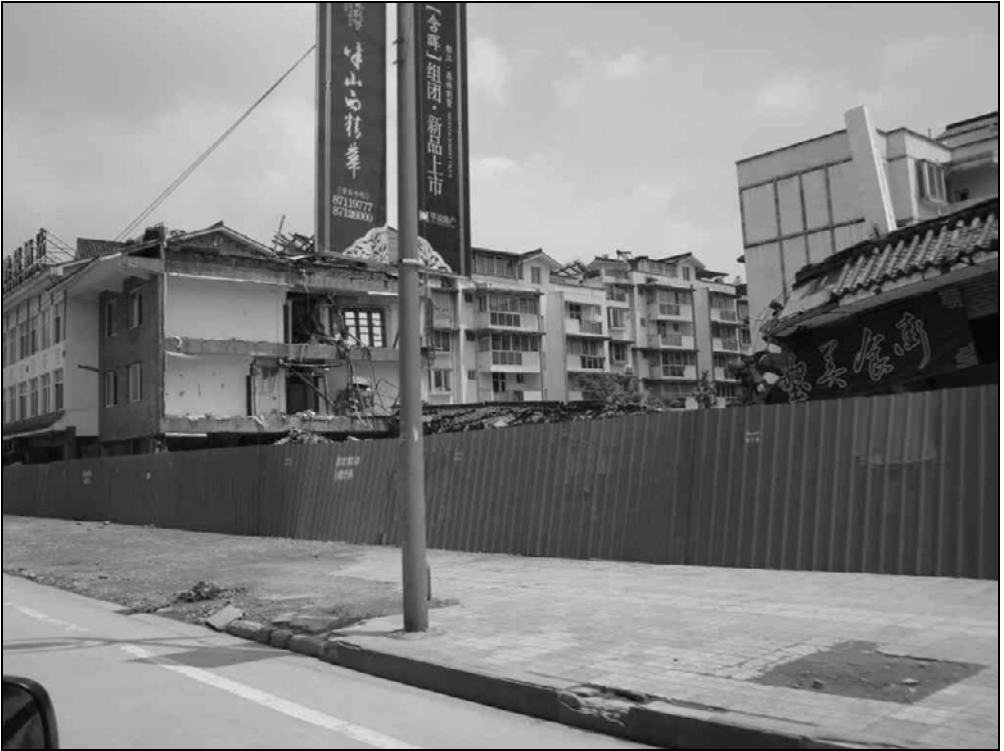
Fig. 9.55. A three-story restaurant building collapsed. Part of the tiled roof shows on the right.

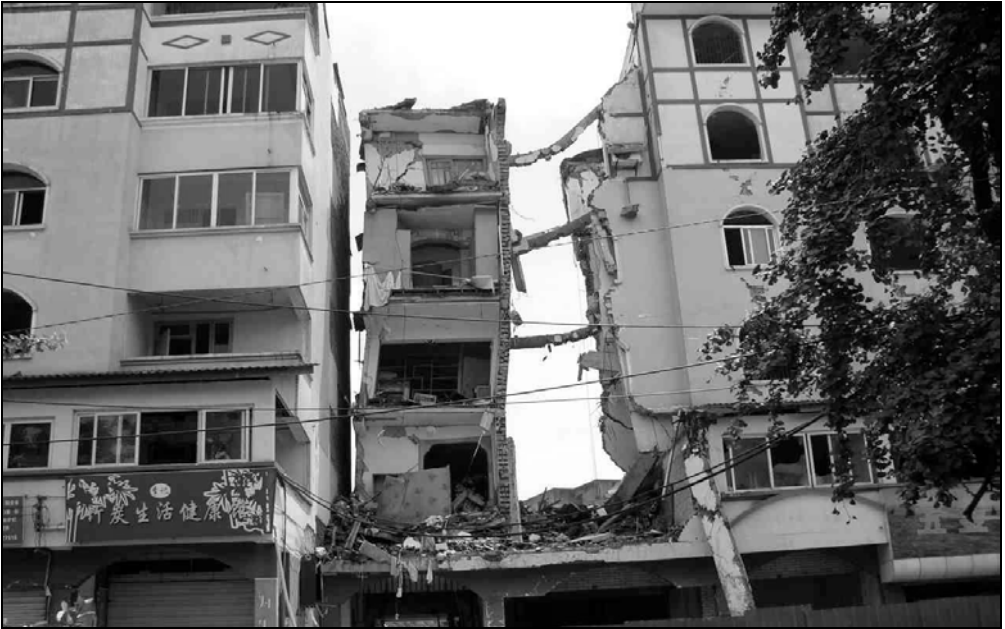
Fig. 9.57. The second floor of the building collapsed with the top four floors resting on it. It appears that the remaining structure is leaning towards the collapsed section.

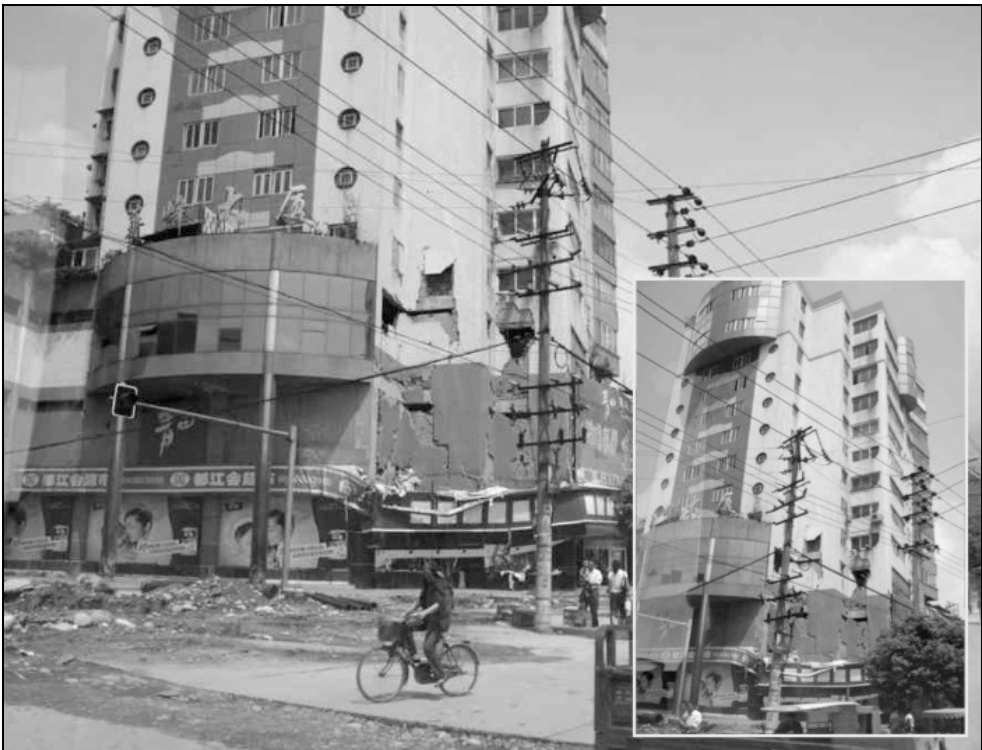
Fig. 9.58. The second and third floor of this apartment building is a shopping mall with a high ceiling, creating a soft-floor effect. Most of the damage is on these two floors. Note the windows above are not damaged.

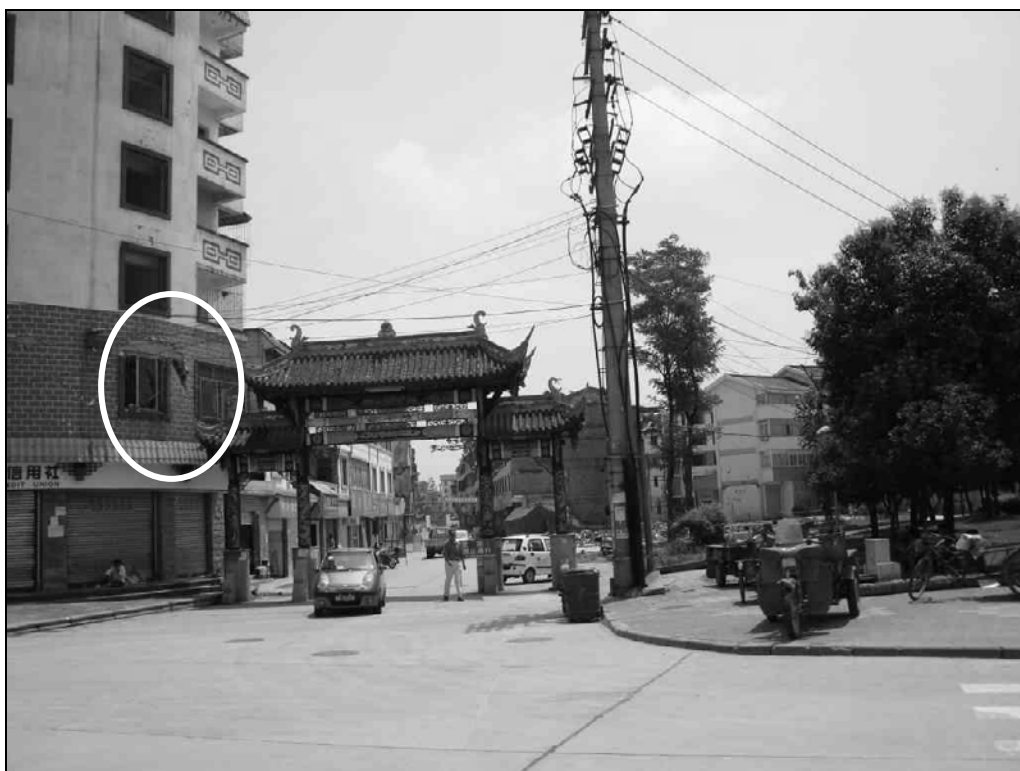
Fig. 9.60. Undamaged gate in Dujiangyan. There were minor cracks on the exterior wall of the building on the left.

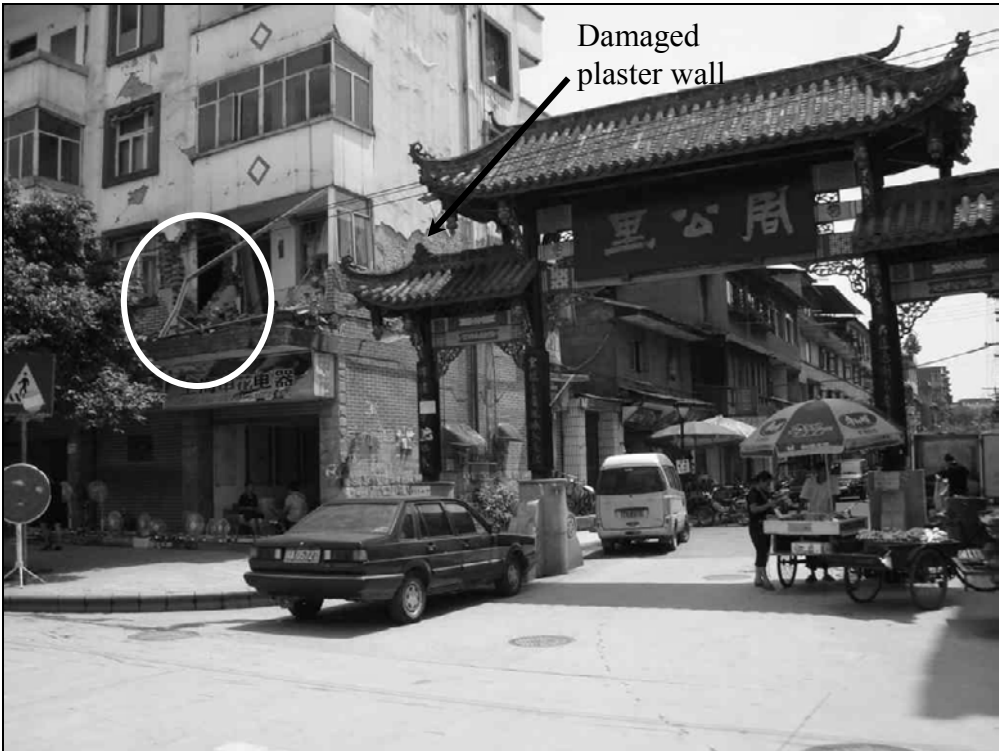
Fig. 9.61. Another old style gate was not damaged. Note the building on the left.

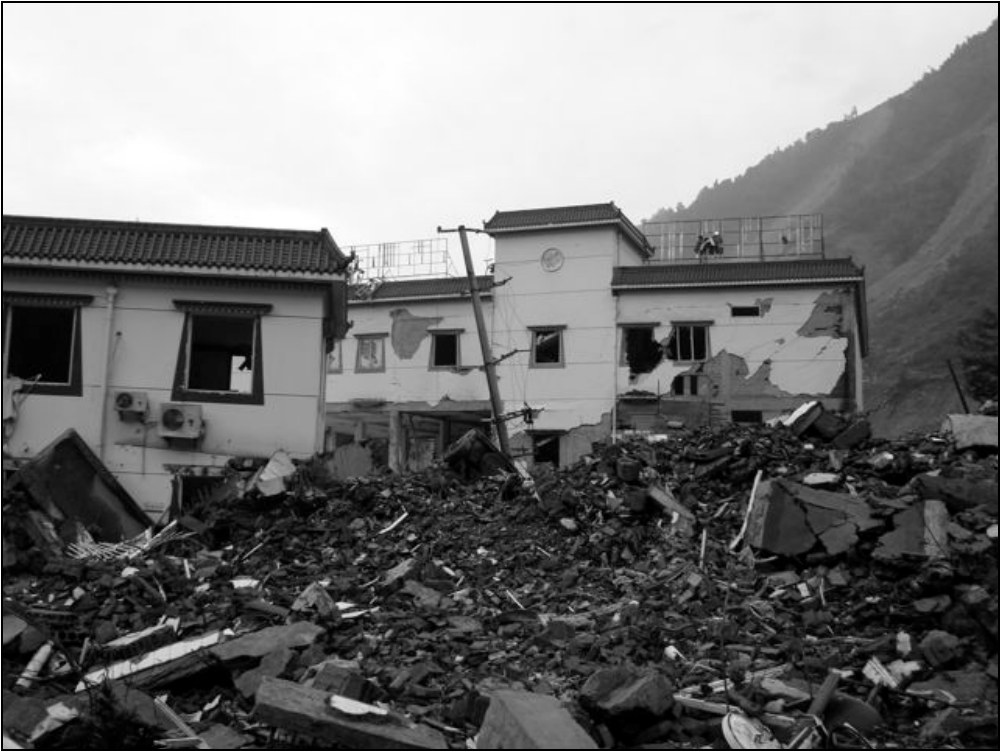
Fig. 9.62. Partially and totally collapsed buildings were seen everywhere in this small town.

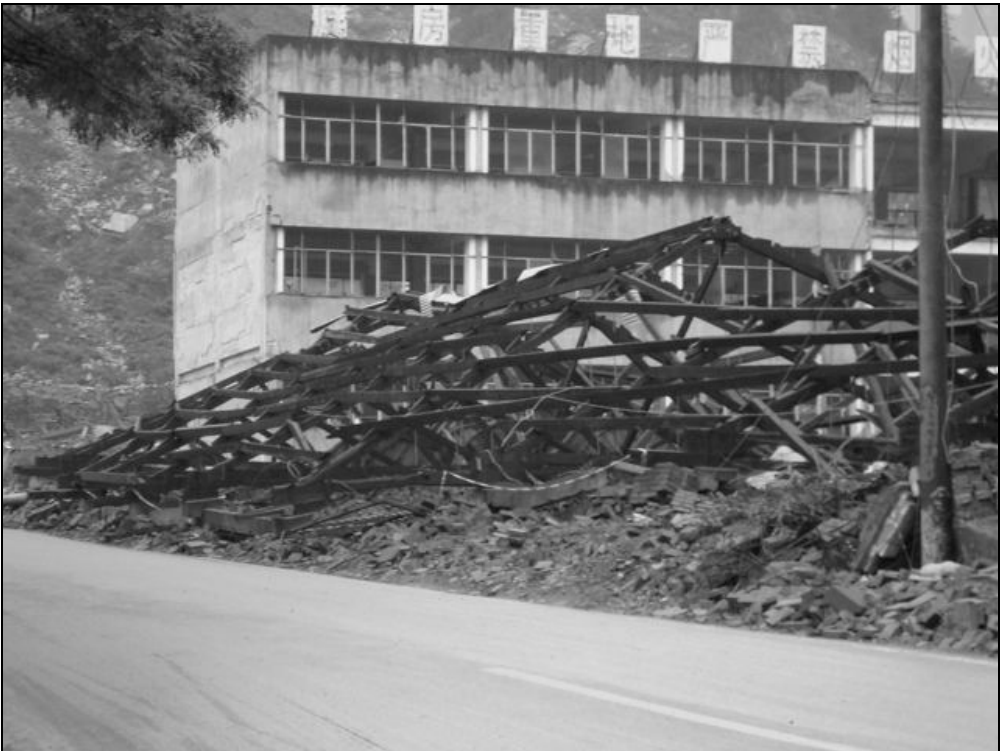
Fig. 9.63. A collapsed manufacturing facility with a standing, but heavily damaged, office building in the background.

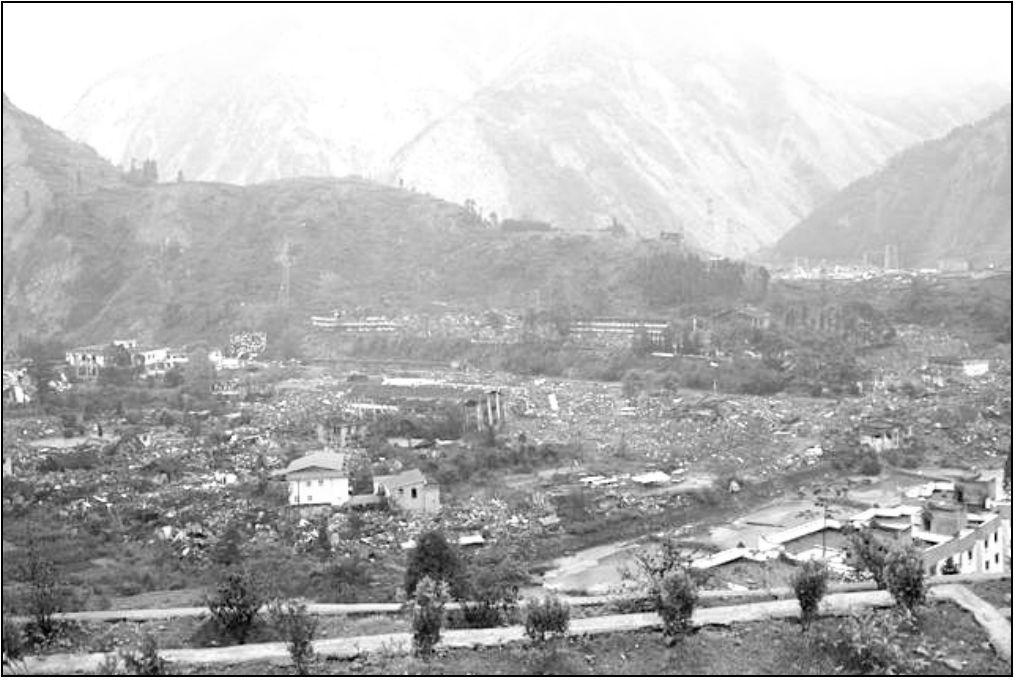
Fig. 9.64. Most of the buildings in Yingxiu were reduced to rubbles.

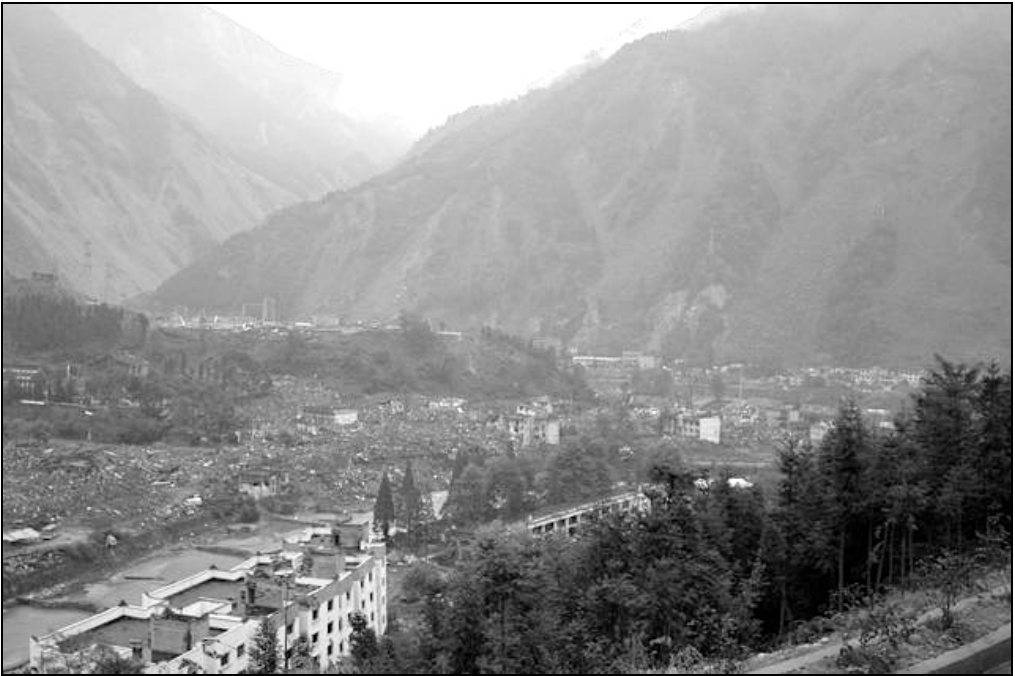
Fig. 9.65. Devastation of another part of Yingxiu

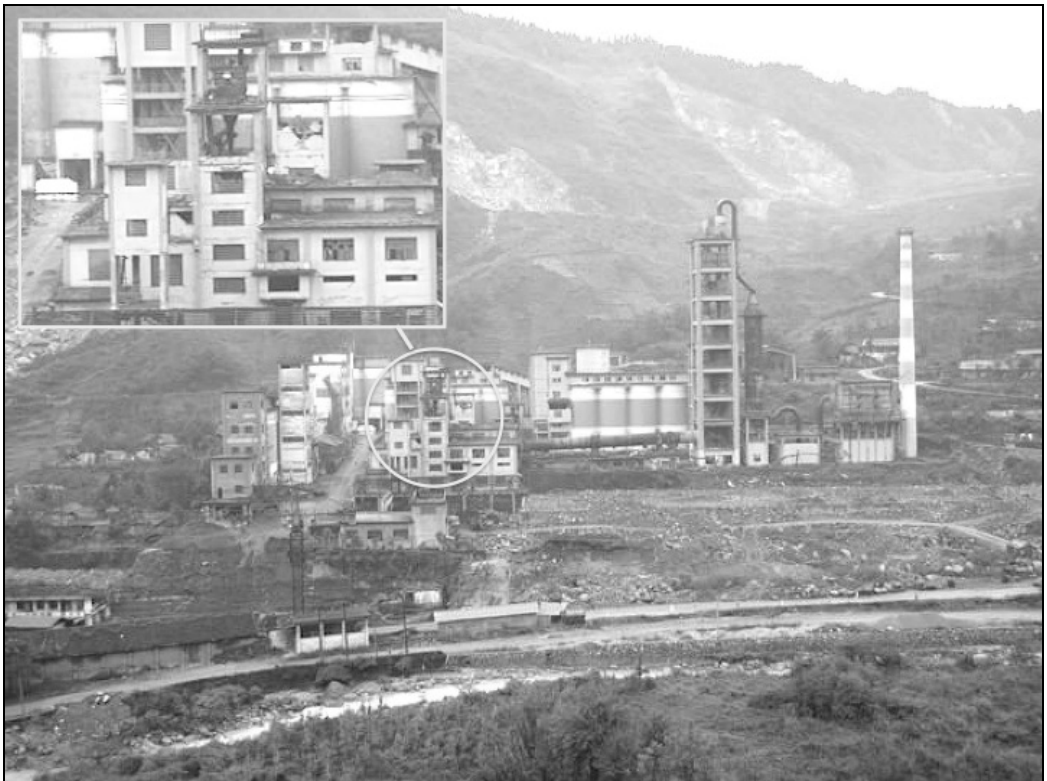
Fig. 9.67. A cement manufacturing facility close to Yingxiu showed very little damage. It was not operating during the team's visit due to road damage.

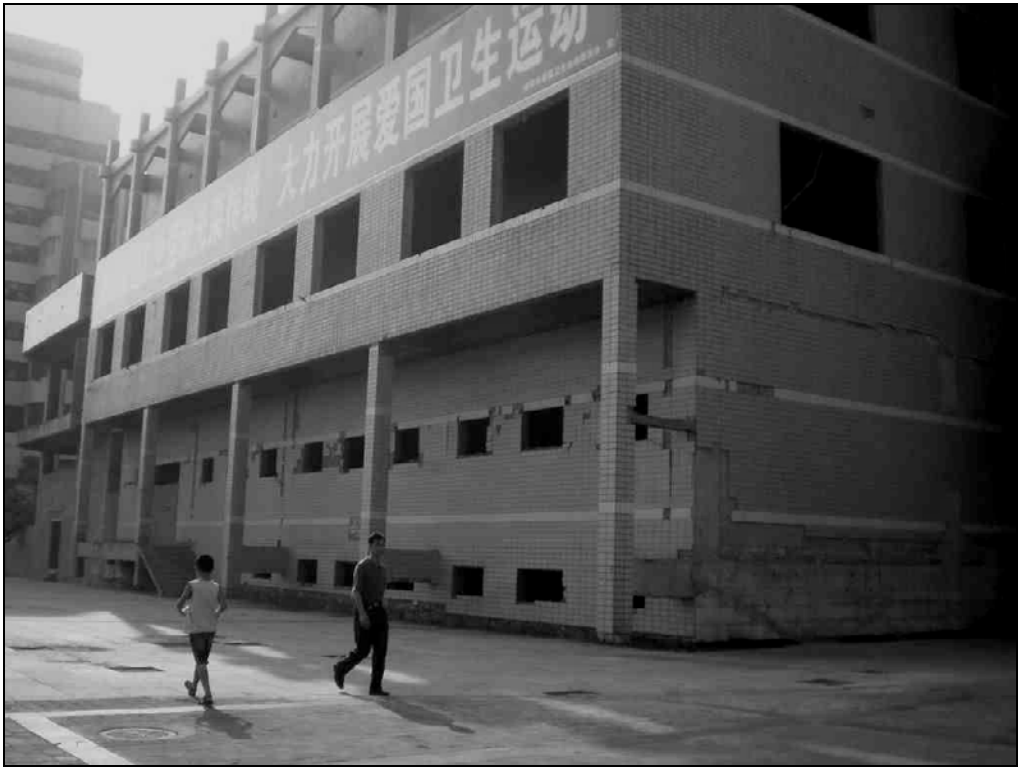
Fig. 9.69. The building next to the hotel ASCE/TCLEE Phase I team members stayed was damaged and closed.

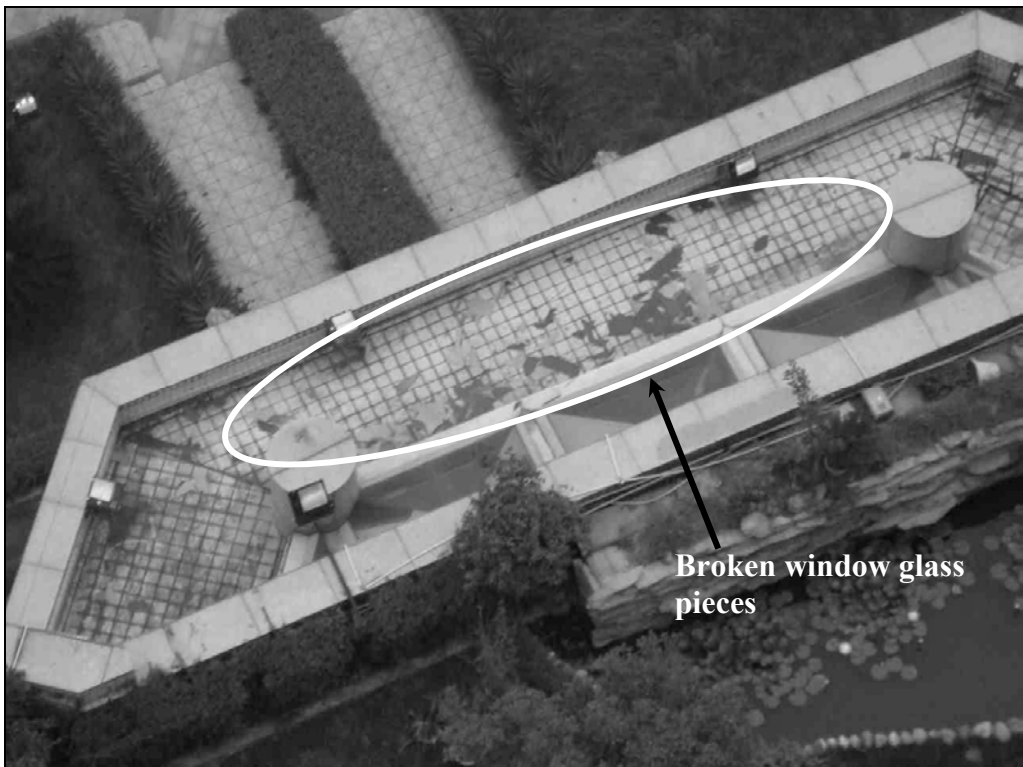
Fig. 9.71. Glass windows from this building fell on the roof of the entrance.

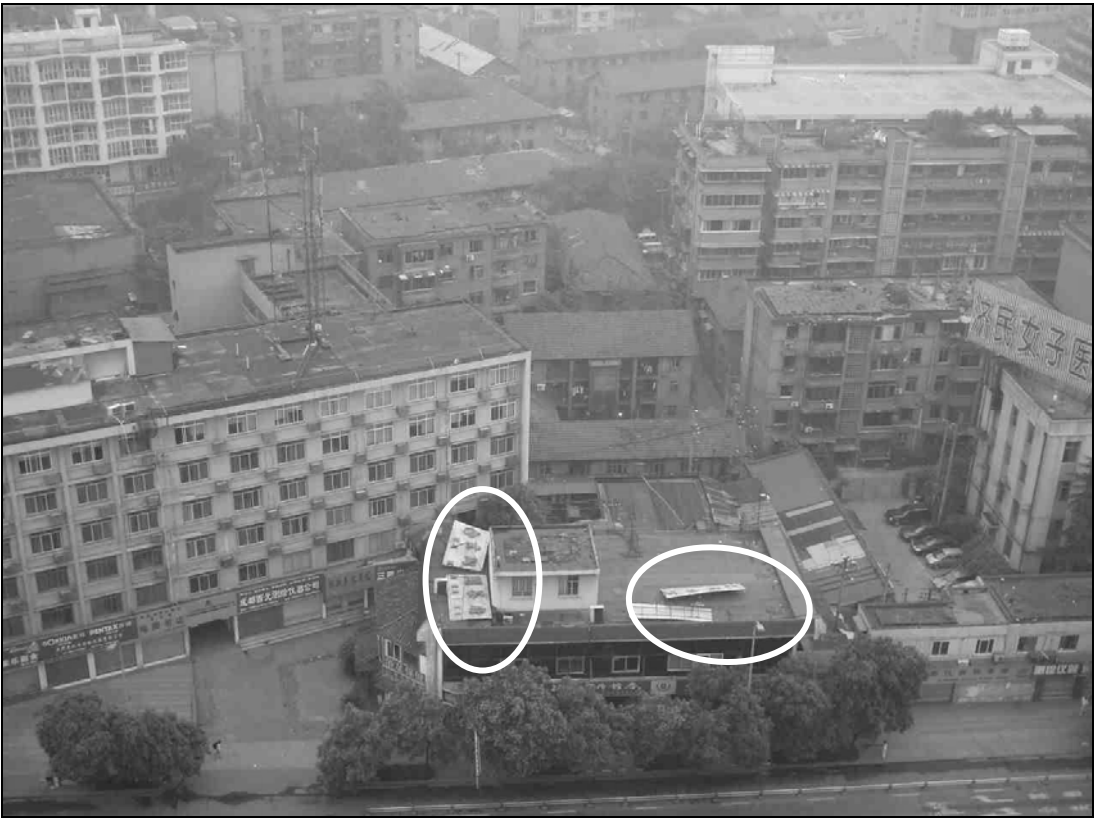
Fig. 9.72. A few large advertisement signs fell on the roof of this building in Chengdu.

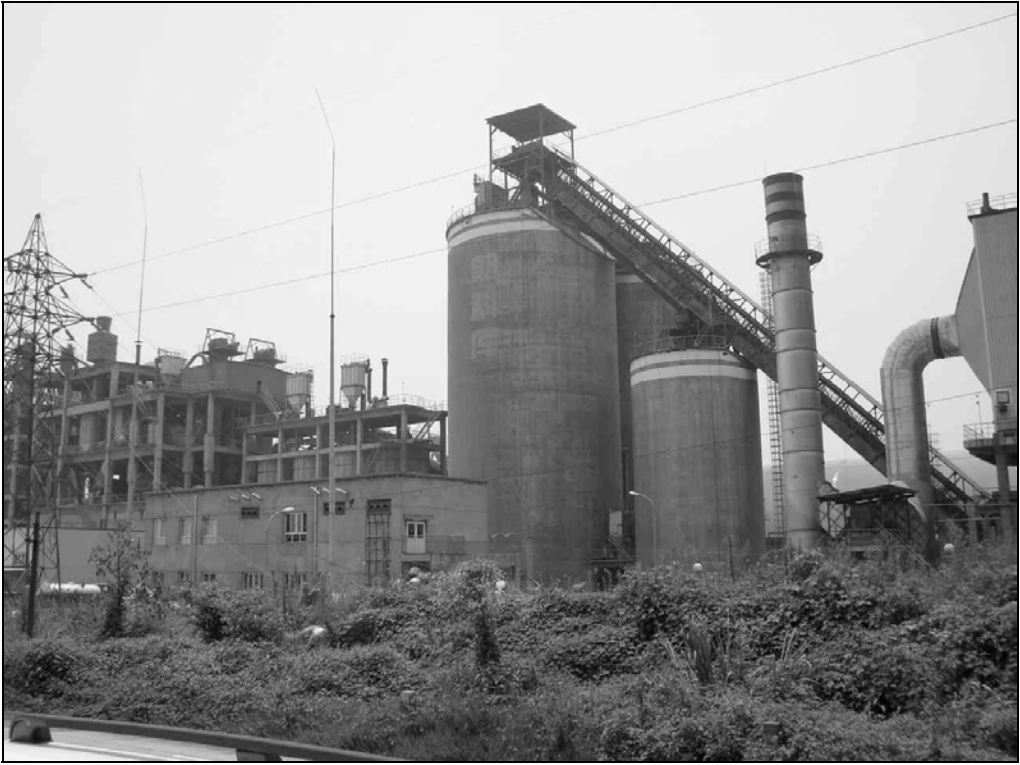
Fig. 9.74. The silos for processed material, located about 200 m apart, showed no signs of damage. The damaged silo is located to the right of this group of silos.

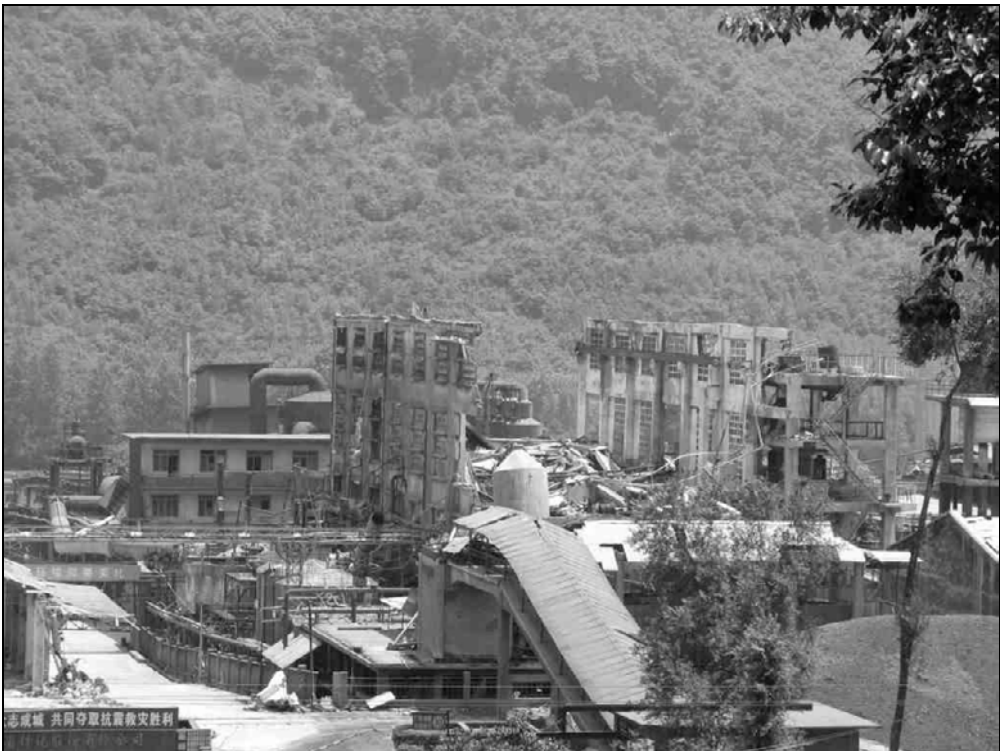
Fig. 9.75. A fertilizer plant in Shifang sustained extensive damage to most of its buildings.

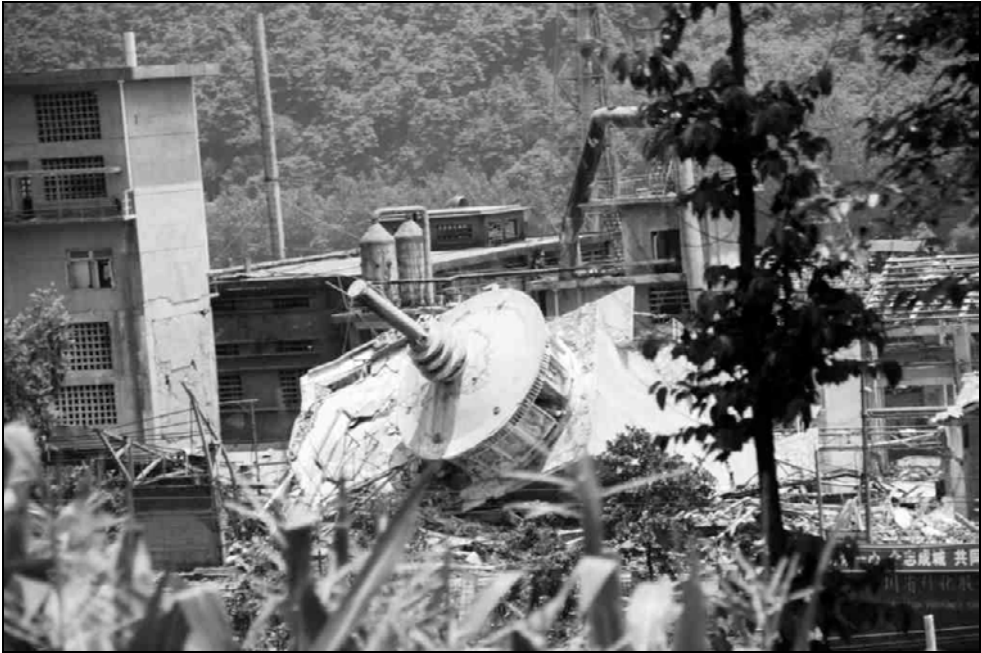
Fig. 9.76. Damage at another building of the fertilizer plant shown in Fig. 9.76.

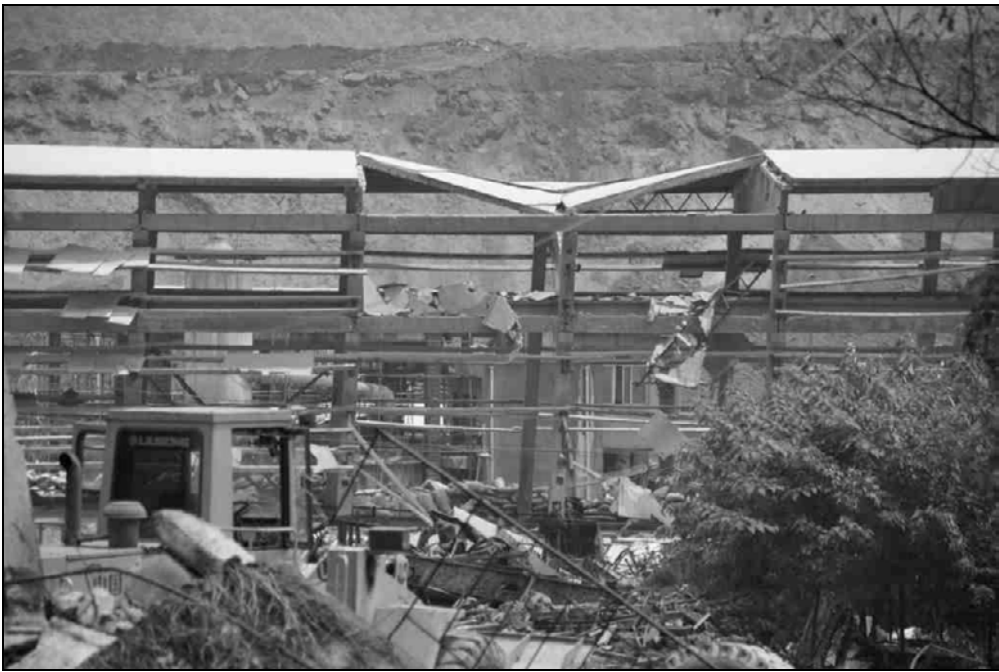
Fig. 9.77. Extensive damage at another chemical processing plant in Shifang.

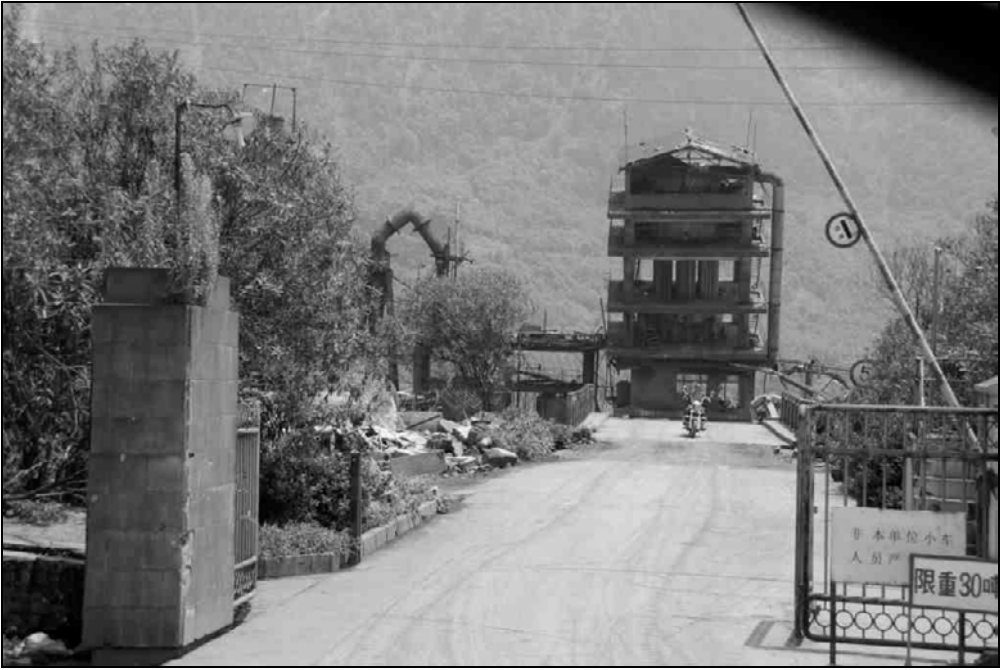
*Fig. 9.78. The building of this chemical plant was leaning towards the front door of the plant.
Note the debris inside the entrance.*

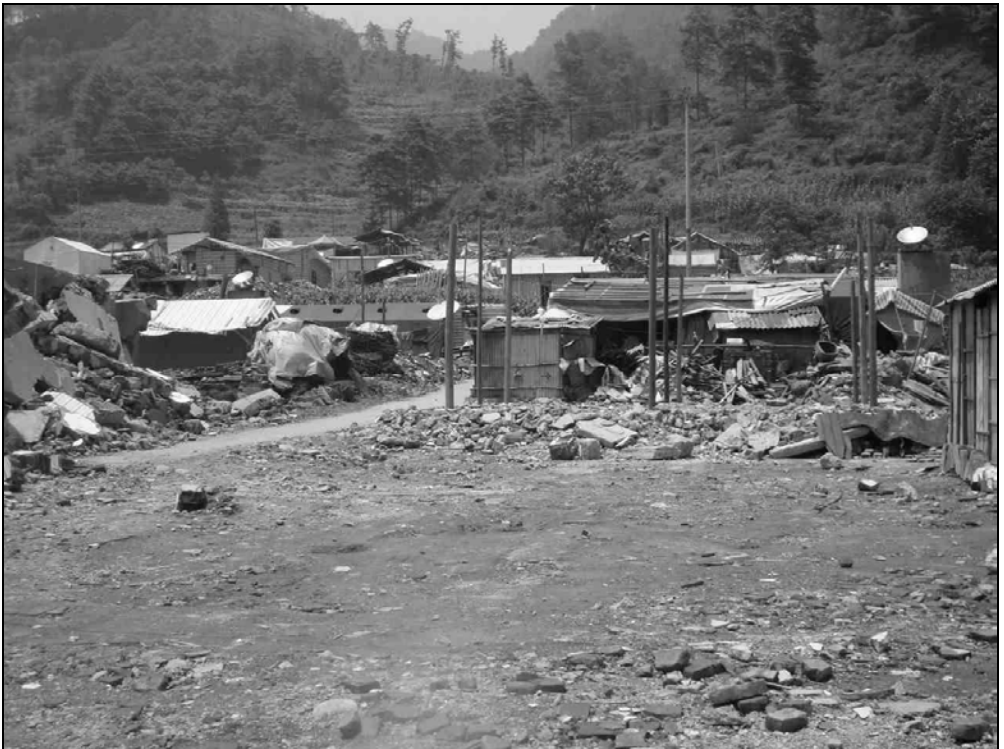
Fig. 9.79. Ruble, a common scene in the Shifang residential area.

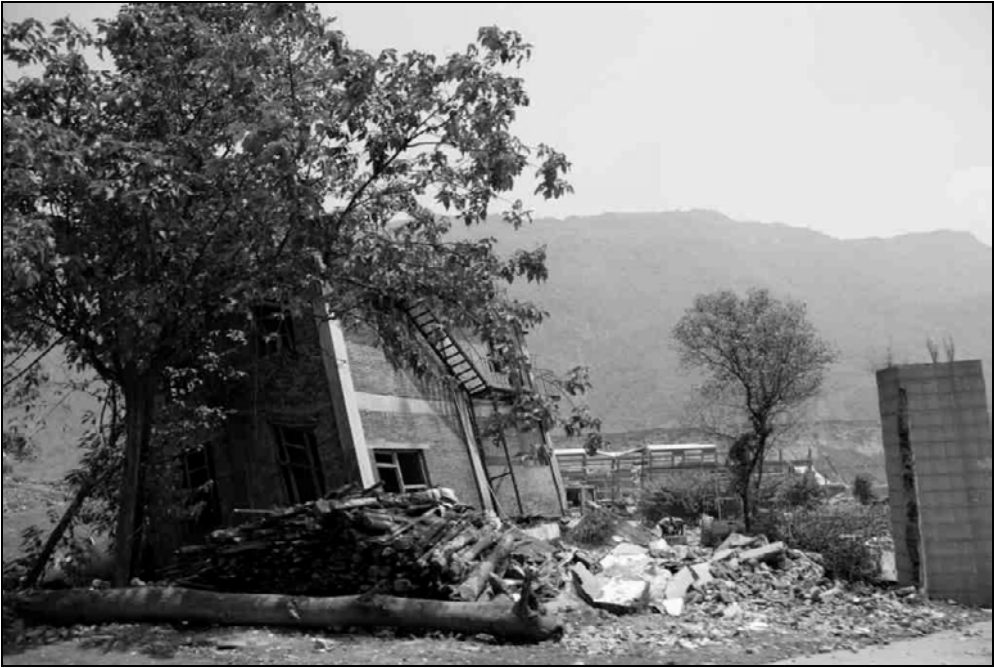
Fig. 9.80. A concrete frame residential building almost tipped over. The structure seems to be in good condition. Most likely the foundation was not properly treated before constructing the building.

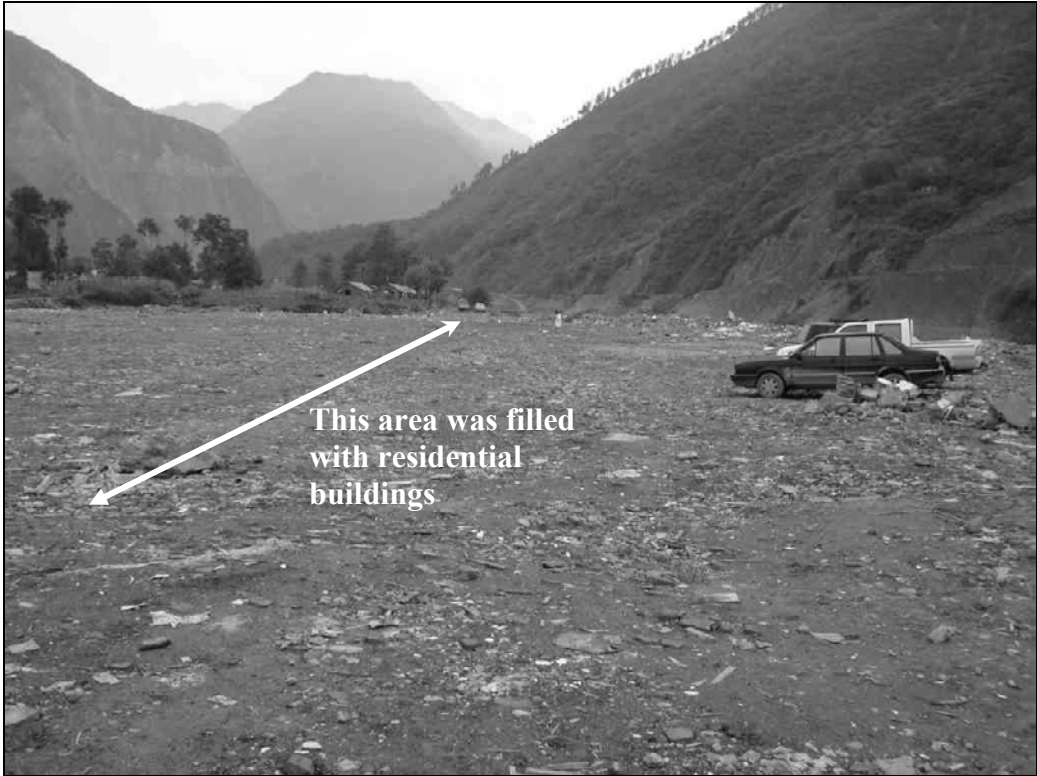
Fig. 9.81. This area in Nanba, located on the south side of the river, was filled with houses before the earthquake.
