WENCHUAN, SICHUAN PROVINCE, CHINA, EARTHQUAKE OF 2008

Lifeline Performance

Technical Council on Lifeline Earthquake Engineering
Monograph No. 39

Earthquake Investigation Committee of the
Technical Council on Lifeline Earthquake Engineering

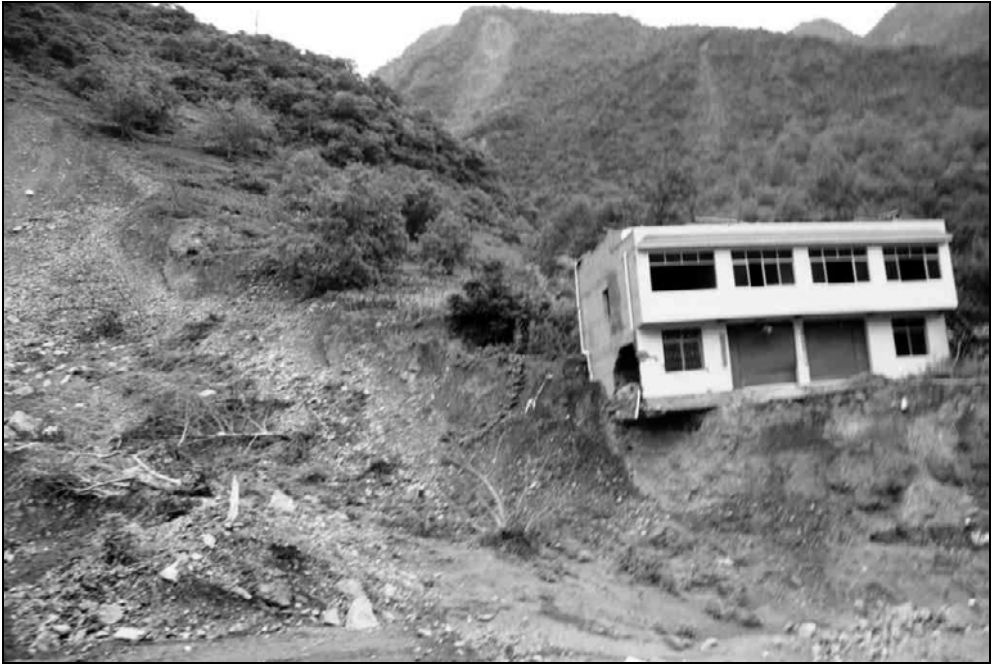
Fig. 9.82. The first house we saw on the road to Nanba was located about 2 km from the center of the town. Note that the foundation is just a concrete pad without footing.

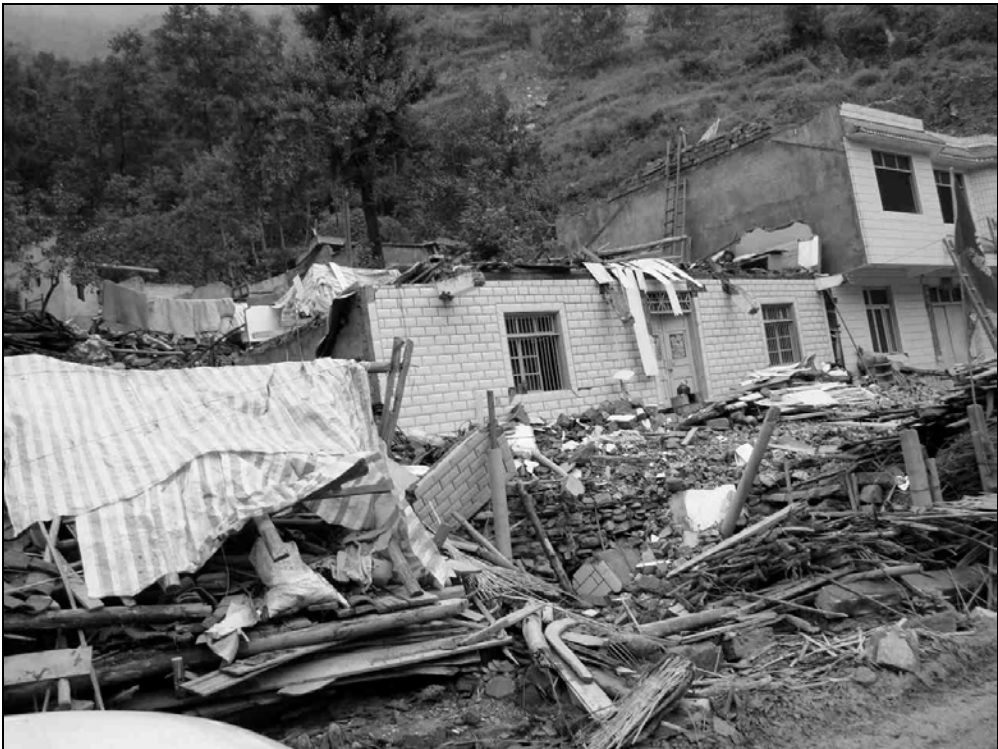
Fig. 9.83. This was a common scene in Nanba. Note the concrete building on the right performed quite well.

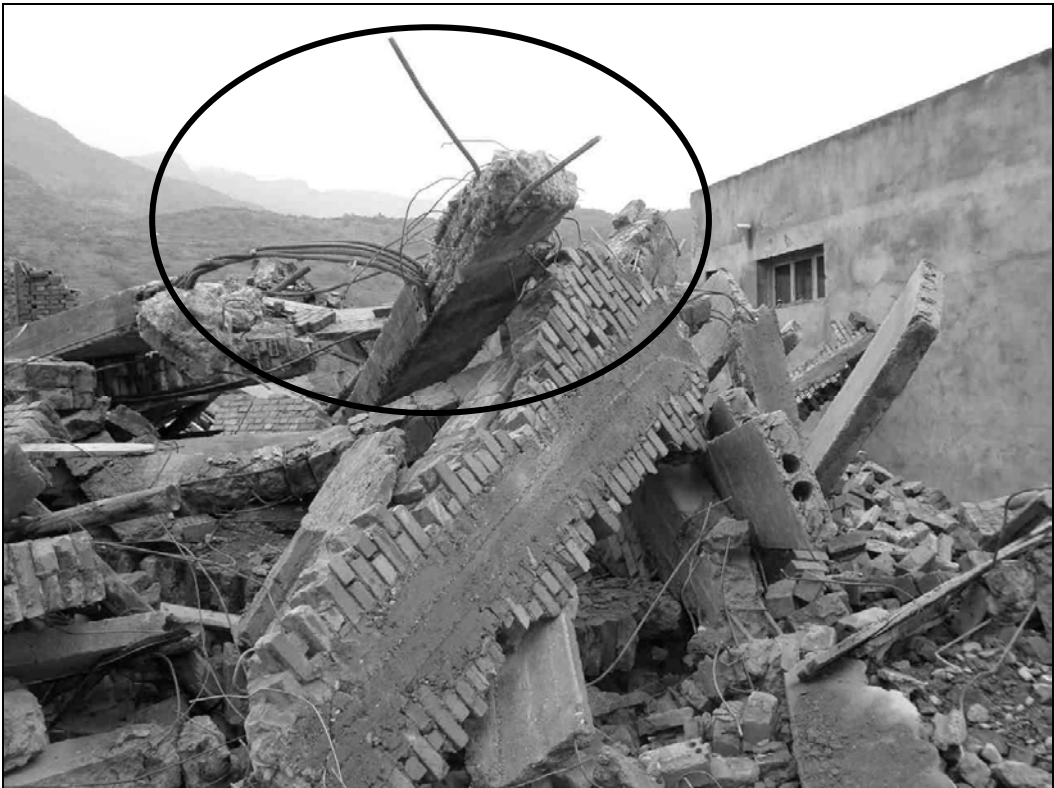
Fig. 9.84. A collapsed concrete frame building showing the reinforcement bar. The pre-cast floor slabs were resting on beams without structural connection to the concrete frame.

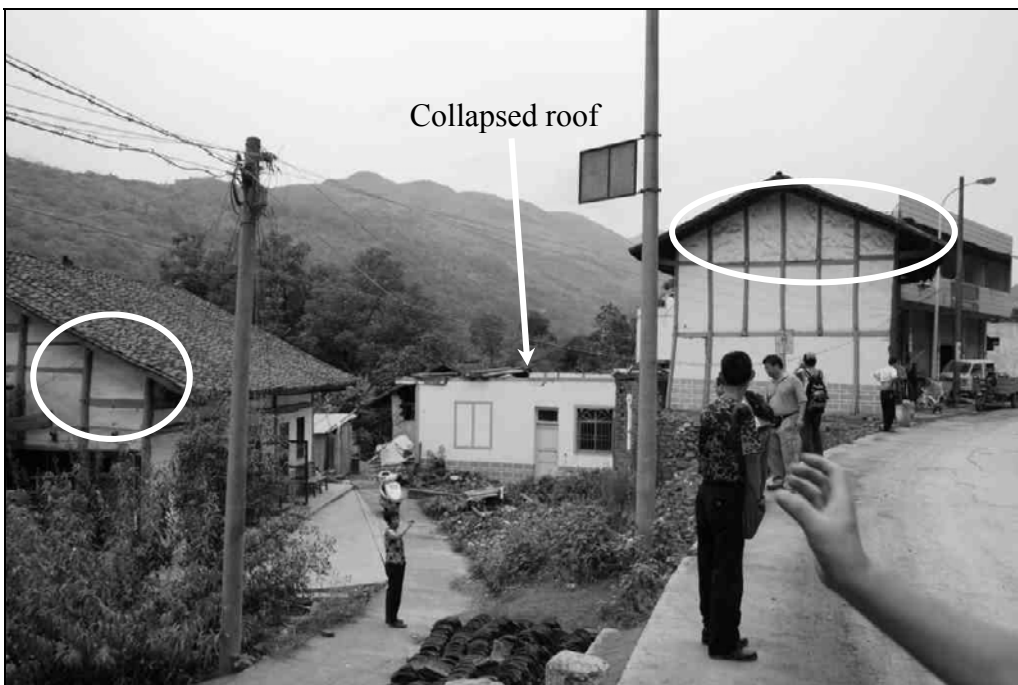
Fig. 9.85. Two timber frame houses (on the right and on the left) had minor damage. The infill exterior walls between the timbers along the roofline failed and were replaced by thin sheet metal to cover the hole. The house in the middle lost its roof.

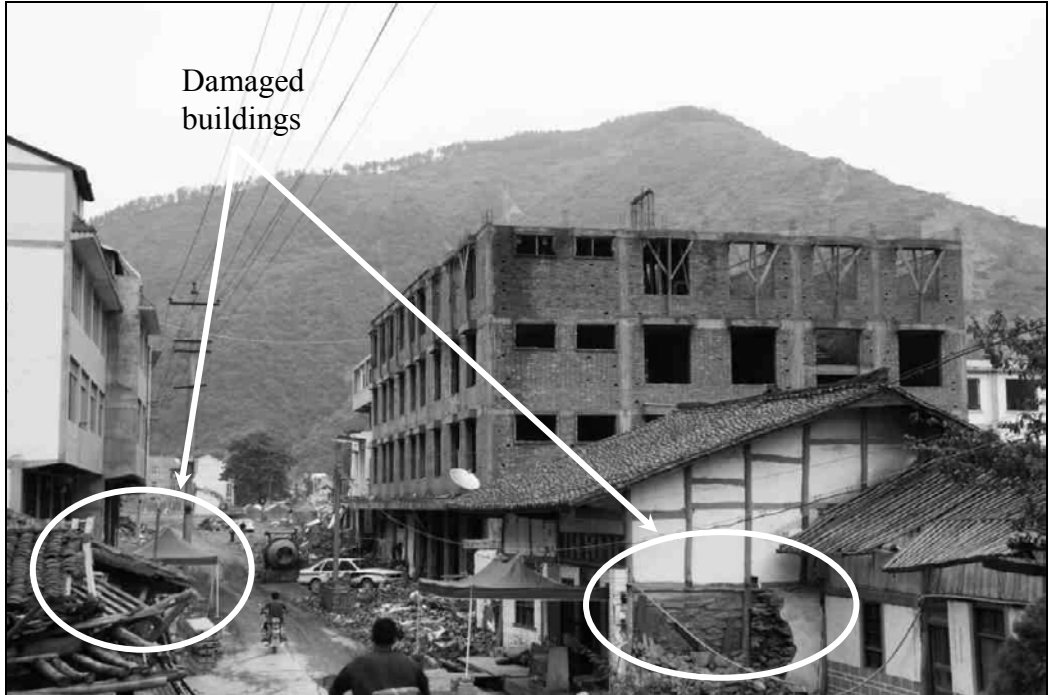
Fig. 9.87. The new building on the right, which was still under construction, and the two building facing it did not show any evidence of damage. However, the URM buildings adjacent to them did sustain damage.

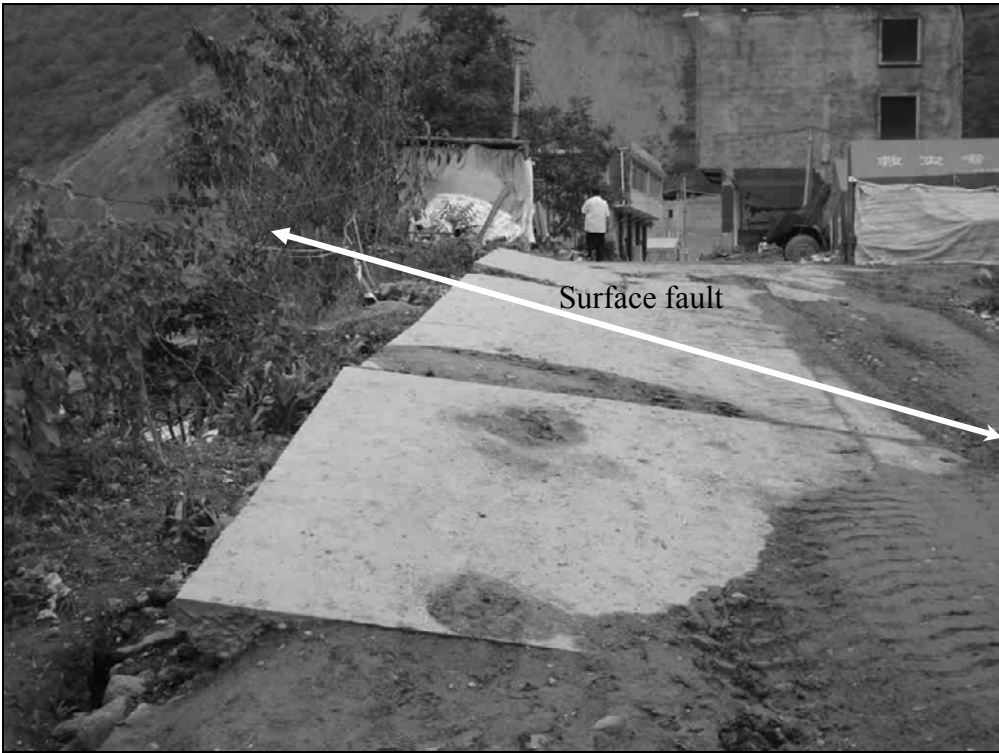
Fig. 9.88. In Hejiaba the surface fault crossed this road in the village. The buildings within 200 m of this surface faulting were damaged and many collapsed.

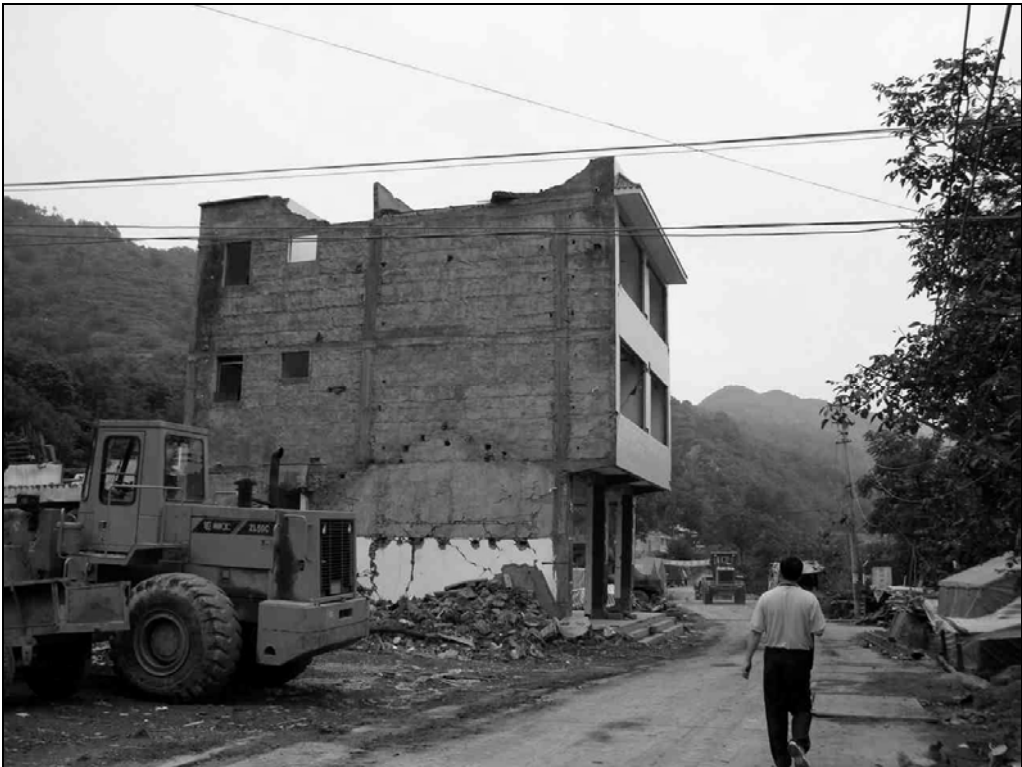
Fig. 9.89. This building is the furthest from the surface rupture, yet it sustained extensive damage and was unsafe to use.

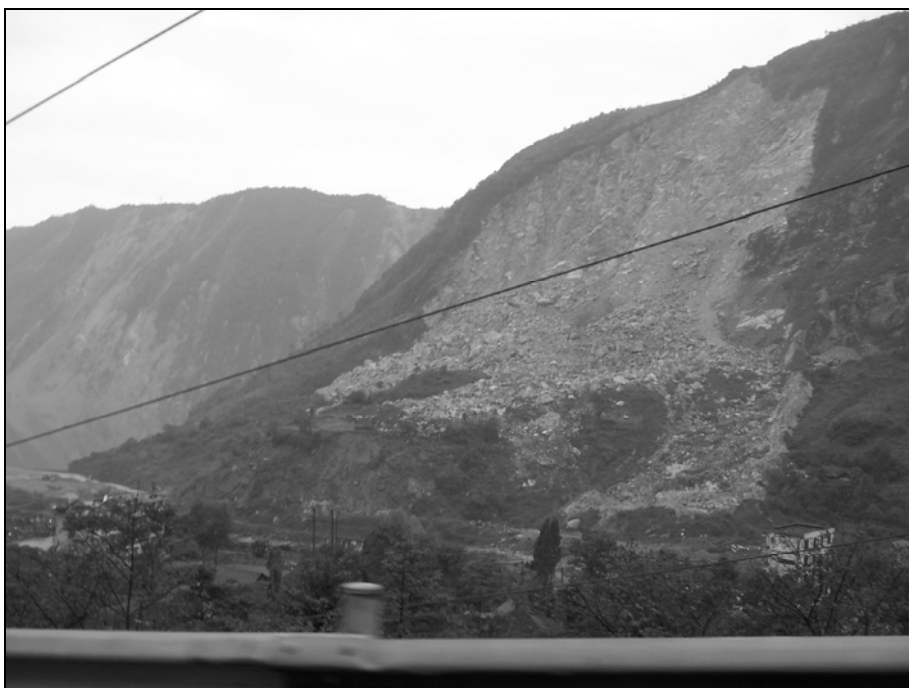
Fig. 10.1. Large landslide blocking road

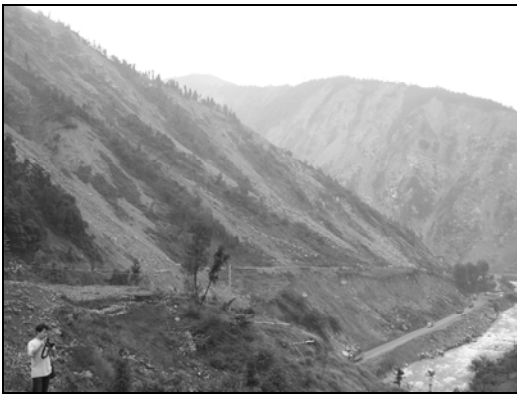
Fig. 10.4. Relocated road below blocked road

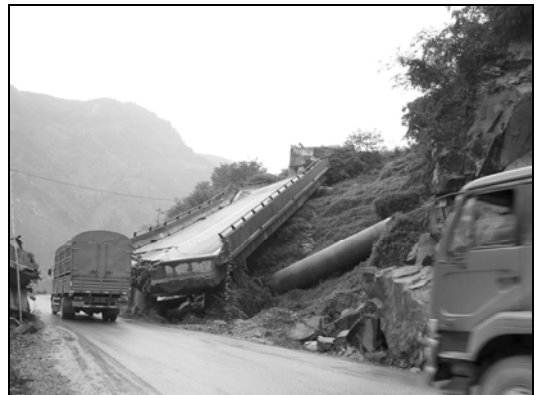
Fig. 10.5. Relocated road at downed bridge

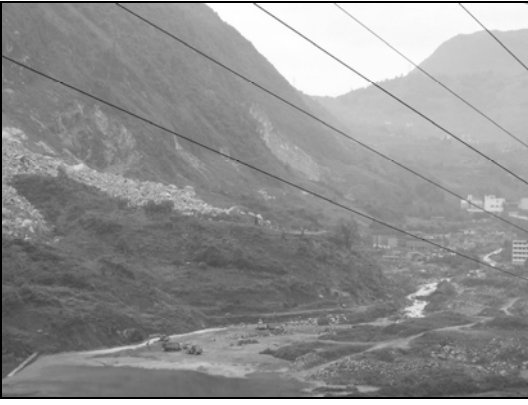
Fig. 10.6. Road clearing below landslide

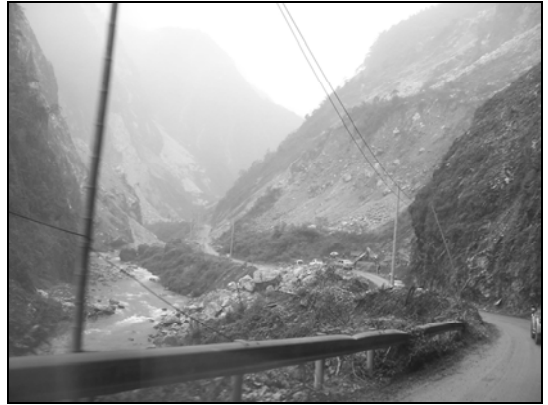
Fig. 10.7. One-way traffic and road clearing

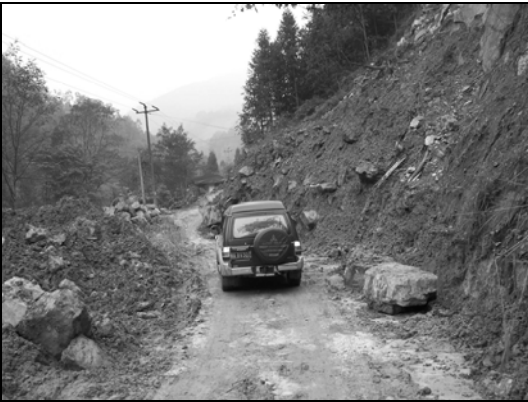
Fig. 10.8. Blocked road

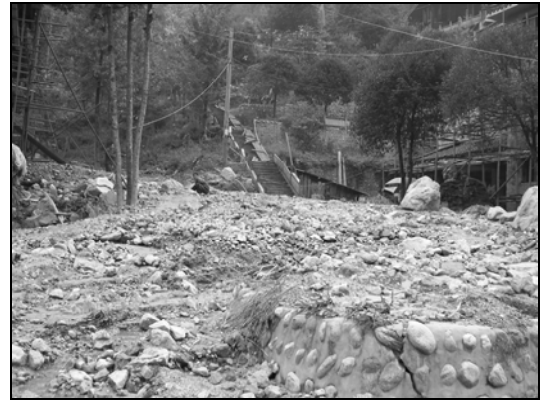
Fig. 10.9. Mud/debris flow blocking road
