Beyond Failure

*Forensic
Case Studies
For Civil Engineers*

Norbert J. Delatte Jr.,
Ph.D., P.E.

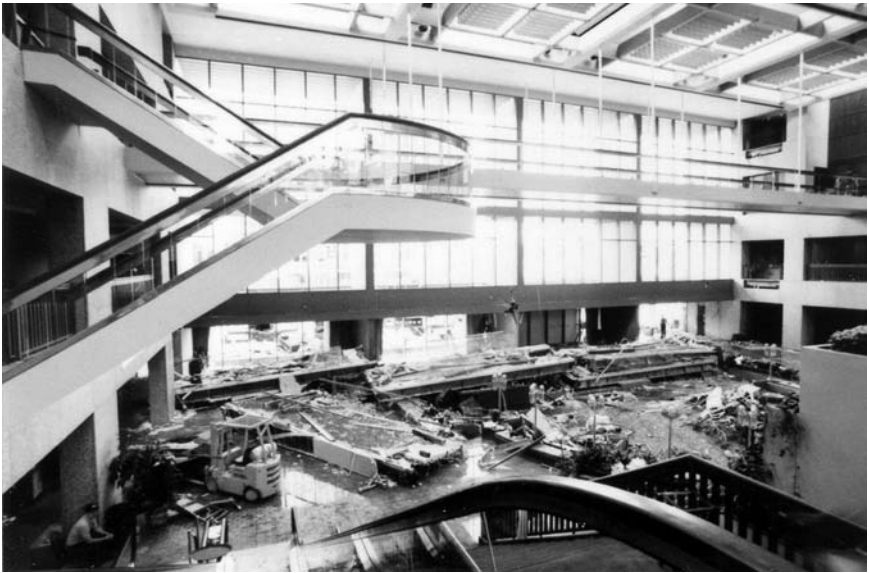
radio station's dance competition (Feld and Carper 1997, pp. 214–215). At 7:05 P.M., a loud crack echoed throughout the building, and the second- and fourth-floor walkways crashed to the ground, killing 114 people and injuring more than 200 others. It was the worst structural failure in the history of the United States (Levy and Salvadori 1992, p. 224). The scene of the collapse is shown in Fig. 2-3.

Figure 2-3. Scene of the Kansas City Hyatt Regency collapse.
Photo provided by Wiss, Janney, Elstner Associates, Inc. (WJE).

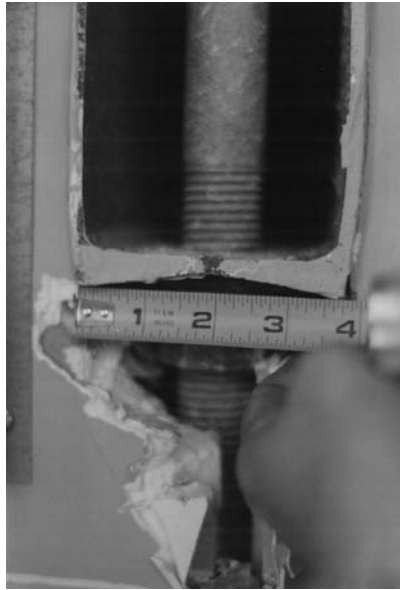
Failure Analysis Associates carried out sophisticated computer modeling (finite element) analysis of the box beam connection. The connection was near failure with dead load only, and an additional live load of 7 people on the upper bridge and 56 on the lower bridge proved to be enough to trigger failure. Plastic deformation of the box beam was estimated at 3–6 mm (0.12–0.24 in.), which was hidden by the finish and fireproofing materials (Moncarz and Taylor 2000, p. 49). The third-floor beam, which did not fail, is shown in Fig. 2-7. This box beam showed substantial permanent deformation.

Figure 2-7. Third-floor beam showing deformation.
Courtesy Lee Lowery, Texas A&M University.

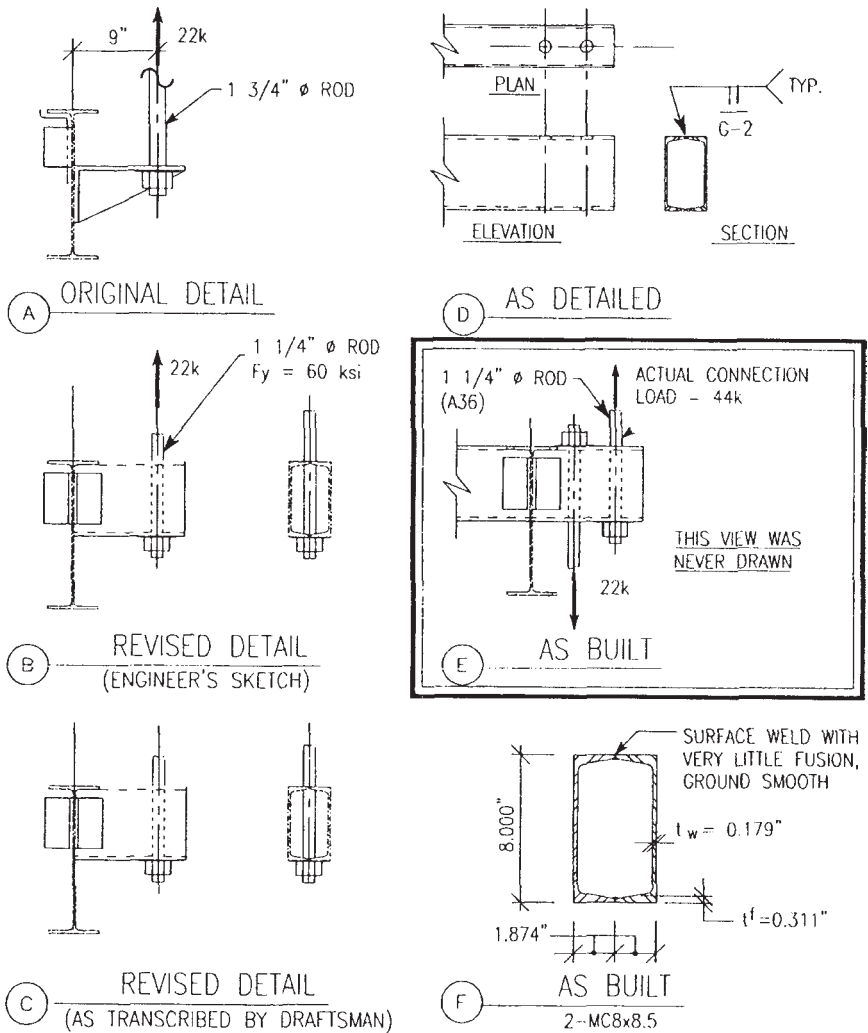
Luth (2000) details the steps in the design and construction process. He makes the important point that the critical connection was never designed and that the view represented by Fig. 2-4 was never drawn until after the failure. Luth's illustration of the various stages in the history of the connection is shown in Fig. 2-8.

Figure 2-8. The evolution of the failed connection.

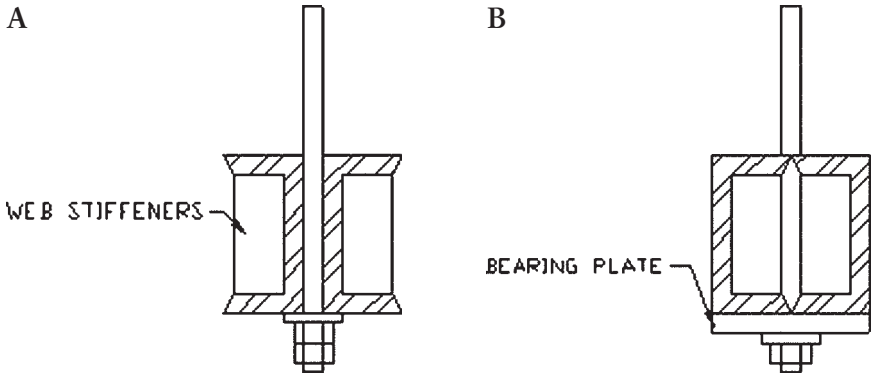
Many articles written referred to the connection as a “designed connection,” and many alternate, satisfactory designs were presented. Two are shown in Fig. 2-9, based on Kaminetzky (1991, pp. 220–221).

Figure 2-9a, b. Proposed alternative connection designs.

The NBS report recommended that concentrated loads never be applied to flanges of steel sections. Load-distributing plates (shown in Fig. 2-9) should be used (Feld and Carper 1997, pp. 222–223).

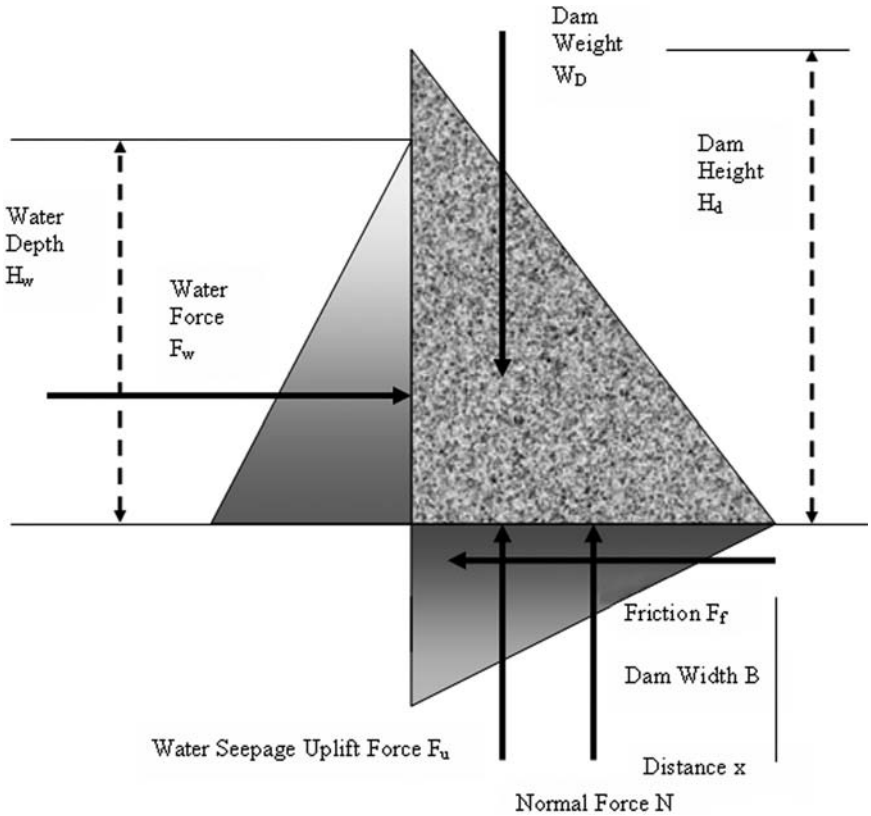
These calculations assume that there is no water seeping under the dam. If, however, there is seepage, then the water pressure provides an uplift force against the base of the dam. The Austin Dam had clear evidence of seepage. The revised free-body diagram of the dam, including seepage, is provided as Fig. 2-15.

Clearly, the uplift force reduces the factor of safety in each case. Determining the uplift force requires knowledge of the properties and permeability of the soils under the dam and is a fairly complicated process.

Figure 2-15. Revised free-body diagram of dam, considering seepage.

Two techniques are used to improve the safety of concrete gravity dams. One technique is cutoff walls or trenches to block water flow and reduce the

hydrostatic pressures. The other is the use of keyways under the dam, which resist sliding. Soil resistance against a buried toe of the dam, or against a keyway, improves the factor of safety against sliding. The revised equation becomes

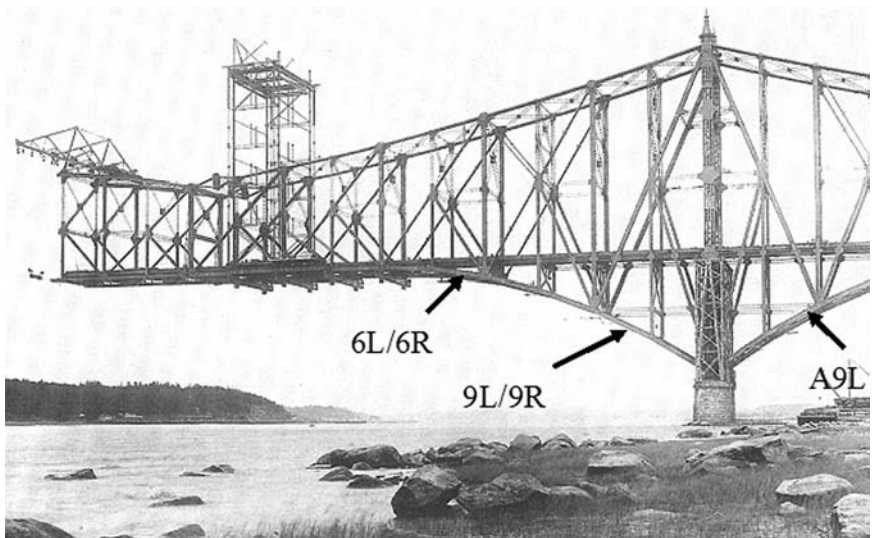
As the bridge was erected, workers and supervisors found noticeable midpoint deflections in some of the chords. When the workers tried to rivet the joints between these chords, the predrilled holes did not line up. In addition, bends (deflections) were observed in some of the most heavily loaded compression members. Over time, some of the member deflections increased.

Figure 3-1. The Quebec Bridge just before the collapse.
Courtesy Archives Canada.

anchor and cantilever arms in the Quebec Bridge were slightly curved, as shown in Fig. 3-1, for aesthetic reasons. This design added difficulty to the fabrication of such unusually large members. The curvature also increased the secondary stresses on the members, reducing their buckling capacity. Secondary stresses are much more dangerous in compression than in tension members.

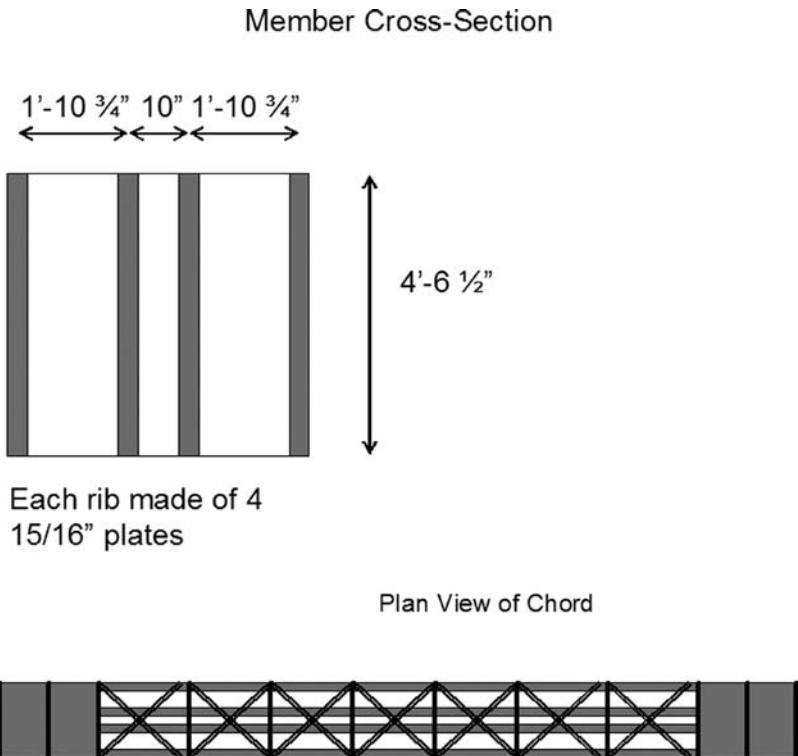
The commission had suspected that the A9L compression chord failed because of improper latticing. Compression tests were performed on one-third scale models of the compression chords in November 1907 and January 1908 to verify this theory. The compression chord members for the Quebec Bridge consisted of four multilayered ribs (Fig. 3-4). They were stiffened by the use of diagonal latticing to make them act as one unit. During testing, the lattice system failed explosively because its rivets sheared, immediately followed by buckling of the chord. This result confirmed the commission's findings that the chords were inadequately designed. In Schneider's opinion,

These members consist of four separate ribs, not particularly well developed as compression members, and their connections to each other are not of sufficient strength to make them act as a unit. (Middleton 2001, p. 97)

Figure 3-4. Built-up compression members.

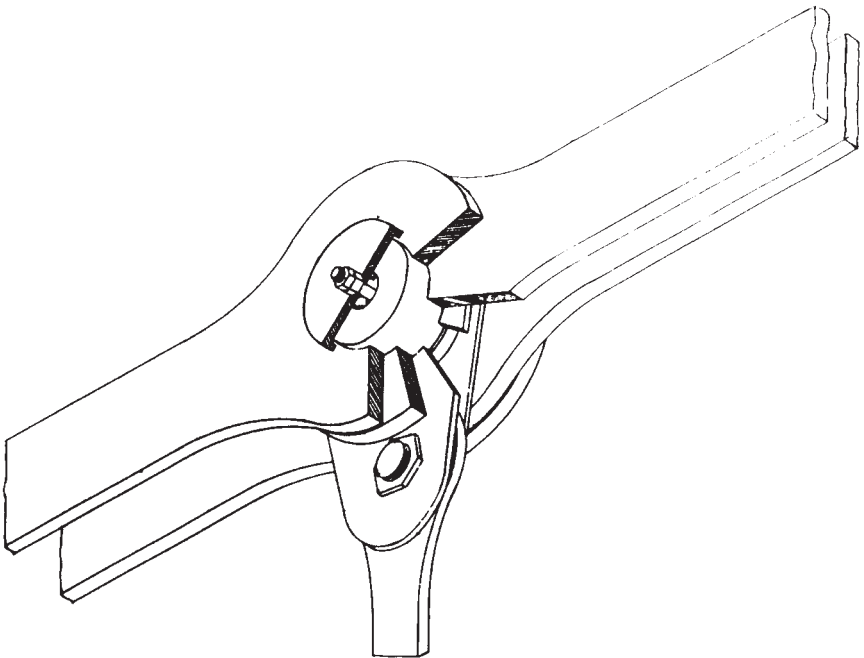
The bridge was completed in 1928. The General Contracting Company of Pittsburgh, constructed the piers. The American Bridge Company of Pittsburgh built the bridge. It was a unique design because it used high-tension eyebar chains, a unique anchorage system, and rocker towers. The eyebars were two force bar members with rounded eyes at each end. Because bedrock was at a great depth, piles were octagons of reinforced concrete. The anchorage consisted of reinforced concrete troughs that were filled with soil and concrete. This substructure supported the bridge towers, which were joined by dowel rods. This connection allowed for a flexible connection that was designed to shift under different loads on the tower, and as the length of the chains changed because of temperature influences. This type of design was only used in one other bridge in the United States: the St. Mary's Bridge in West Virginia, also spanning the Ohio River. Although not integral to the Florianopolis truss design concept, the Point Pleasant and St. Mary's bridges introduced the use of high-strength, heat-treated carbon steel eyebars to the United States. The eyebar connection is shown in Fig. 3-9.

Figure 3-9. Point Pleasant Bridge eyebar connection.
Source: NTSB (1970).

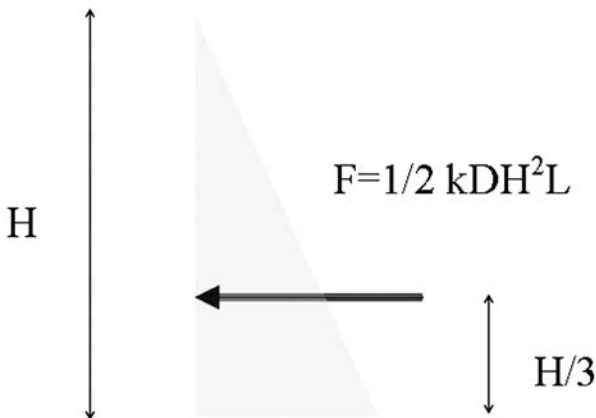
Therefore, along the side walls, each column had an outward resultant force of 63.2 kN (14,200 lb) acting 2.42 m (8 ft) from the base of the wall. On the end walls, the outward resultant forces were as much as 303 kN (68,000 lb).

Because the building was loaded from one end, it was possible to have a full load of cottonseed on the far wall, with no load against the inside of the near wall (door end). This load provided a total force of 1,670 kN (375 kip) acting on the rear wall, at a location 4.66 m (15.3 ft) from the base of the wall. In fact, this condition was not only possible but also unavoidable in the course of operating the warehouses as intended.

Figure 4-4. Resultant force due to cottonseed pressure.

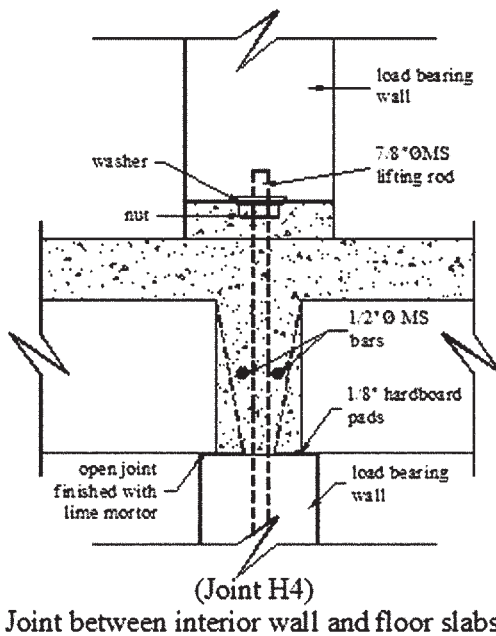
Figure 4-7. Ronan Point connection.
Source: Pearson and Delatte (2005).

Ronan Point was the second of nine identical high-rise, precast, concrete flat plate structures that were erected in London after the war. In this type of structural system, each floor was supported by the load bearing walls directly beneath it. Gravity load transfer occurred only through these load-bearing walls. The wall and floor system panels were fitted together in slots. The joints were then bolted together and filled with dry pack mortar to secure the connections. The connections are shown in Fig. 4-7 and Fig. 4-8.

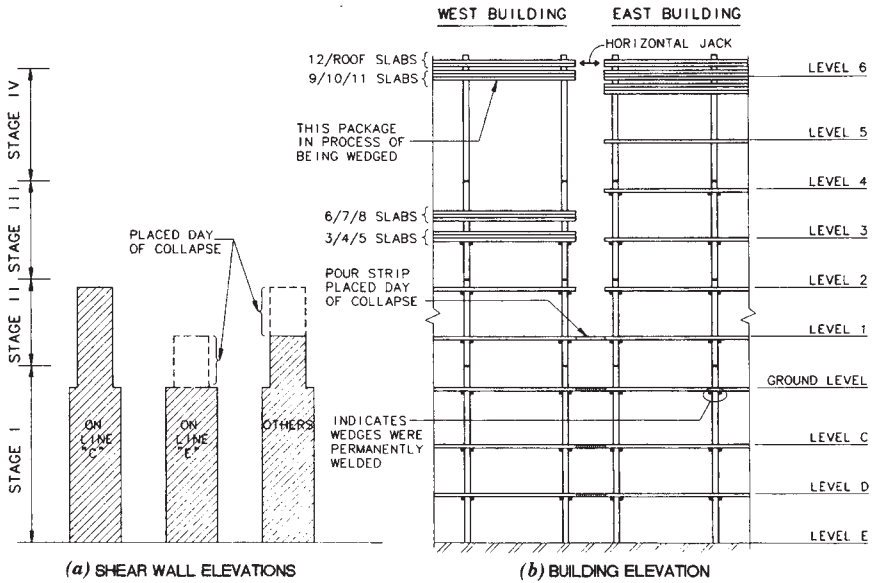
Figure 4-11. Elevation of L'Ambiance Plaza just before collapse.

At the time of the collapse, the building was a little more than halfway completed. In the west tower, the 9th, 10th, and 11th floor slab package was parked in stage IV directly under the 12th floor and roof package (Fig. 4-11). The shear walls were about five levels below the lifted slabs (Cuoco et al. 1992).

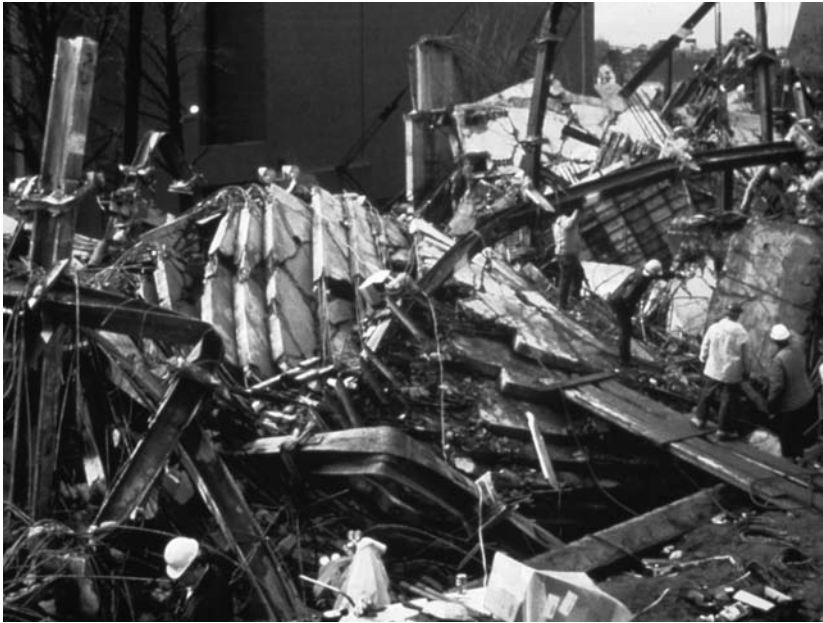
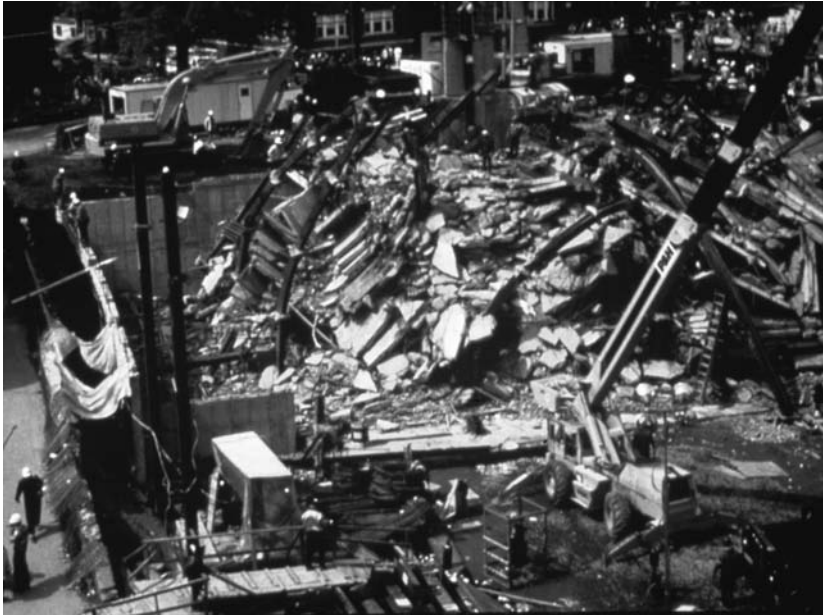
Figure 4-12a, b. The collapsed structure of L'Ambiance Plaza.
Courtesy National Institute of Standards and Technology.

The workers were tack-welding wedges under the 9th-to-11th floor package to temporarily hold them in position, when a loud metallic sound followed by rumbling was heard. Kenneth Shepard, an ironworker who was installing wedges at the time, looked up to see the slab over him “cracking like ice breaking.” Suddenly, the slab fell onto the slab below it, which was unable to support this added weight and fell in turn. The entire structure collapsed, first the west tower and then the east tower, in 5 s, only 2.5 s longer than it would have taken an object to free fall from that height. Ten days of frantic rescue operations revealed that 28 construction workers had died in the collapse, making it the worst lift-slab construction accident ever. Kenneth Shepard was the only one on his crew to survive (Levy and Salvadori 1992). The collapsed structure is shown in Fig. 4-12.

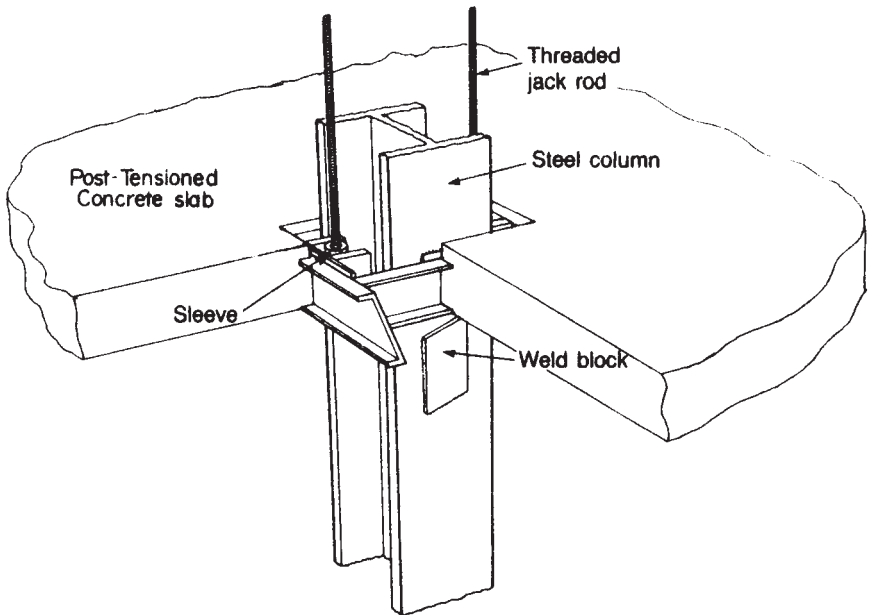
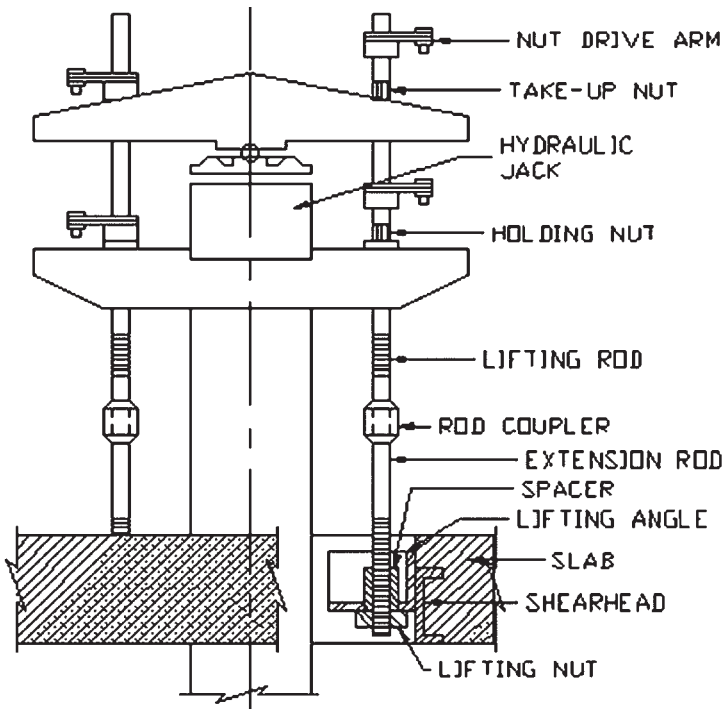
The NBS investigation concluded that the failure occurred at the building's most heavily loaded column, E4.8, or the adjacent column, E3.8, as a result of a lifting assembly failure (Fig. 4-13). The shear head reinforced the concrete slab at each column, transferred vertical loads from the slabs to the columns, and provided a place of attachment for the lifting assembly. It consisted of steel channels cast in the concrete slab, leaving a space for the lifting angle. The lifting angle had holes to pass the lifting rods through. These rods were raised by the hydraulic jacks on the columns above them (Levy and Salvadori 1992).

Figure 4-13a. Lifting assembly.

Shortly before the collapse, the workers lifted the 9th-to-11th floor package to its final position and began tack-welding the steel wedges into place. They used a jack on top of the column E4.8 or E3.8 to slightly adjust the position of the slab, overloading the lifting angles. When the shear heads and lifting angles had lifted the package of three 3.13 MN (320-ton) slabs, they were dangerously close to their maximum capacity, so adding even the smallest of loads could exceed that maximum.

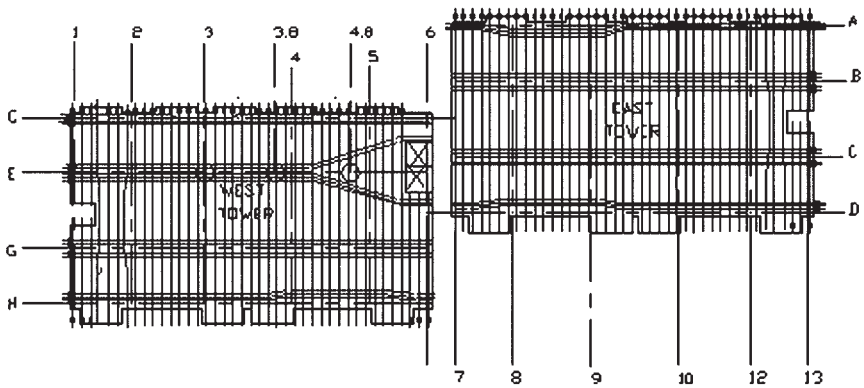
Figure 4-15. Post-tensioning tendon layout.

SSE analyzed the structural behavior of a typical west tower floor slab with respect to the unusual layout of the post-tensioning tendons (Fig. 4-15). The tendons in the east tower followed a typical two-way banded post-tensioning tendon layout. In this layout, the vertical tendons distributed the weight of the slab to the east-west column lines, which in turn distributed

the weight to the columns. The west tower, however, deviated from this pattern. At column 4.8E, the tendons split in two, both diverging from the column line. In the west tower, the vertical tendons still distributed the slab's weight to the column line. Along line E, however, there are no tendons to carry this weight. This setup violated the American Concrete Institute Building Code (ACI 1983). Kaminetsky points out that the code stipulates “a minimum of two tendons shall be provided in each direction through the critical shear section over columns” (1991, p. 84).

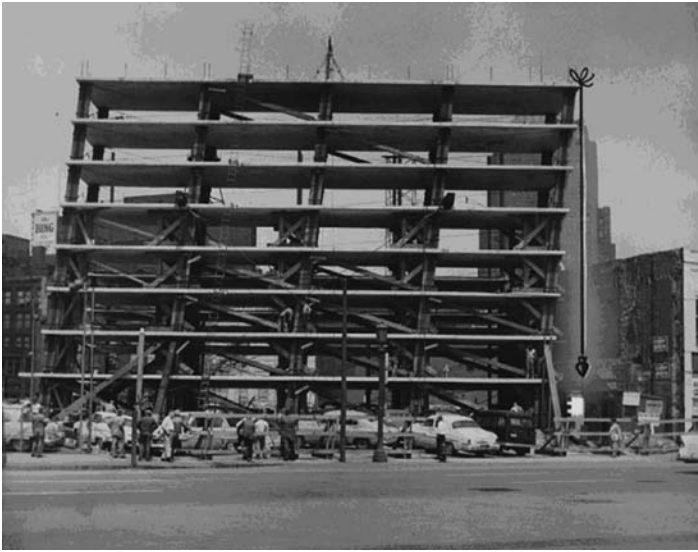
On the evening of April 6, winds gusted 56–80 km/h (35–50 mi/h). The structure shifted 2.1 m (7 ft) out of plumb in the long direction, with the fifth floor close to an adjacent building. The east tower, with only the second and third floors in place, was not affected by the wind. The sidesway displacement of the Cleveland parking garage is shown in Fig. 4-17.

Figure 4-17. Sidesway displacement of Cleveland parking garage.
Courtesy *Cleveland Press* Collection, Cleveland State University Library.

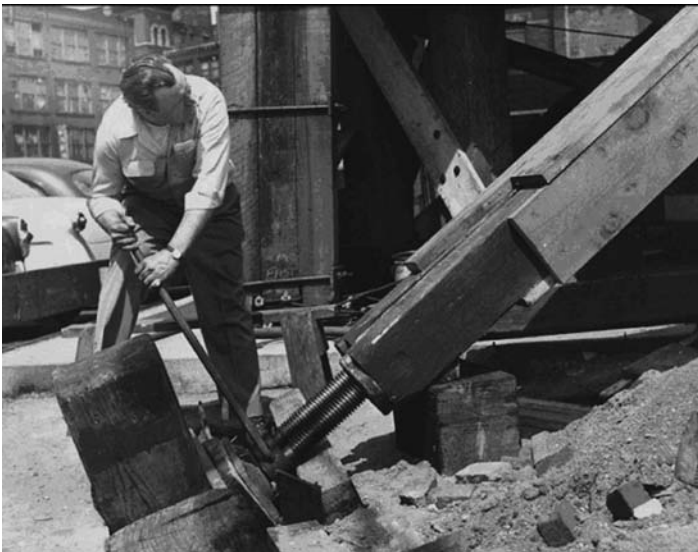
The building was secured with guys and temporary shoring on orders of the Cleveland building commissioner, who remarked, “if they had welded at each floor as they went along the building would have been braced and this would not have happened.” The west tower was eventually jacked back into place (Feld 1964, pp. 93–94). The work to restore the Cleveland parking garage to plumb is shown in Fig. 4-18.

Figure 4-18. Restoring the Cleveland parking garage to plumb.
Courtesy *Cleveland Press* Collection, Cleveland State University Library.

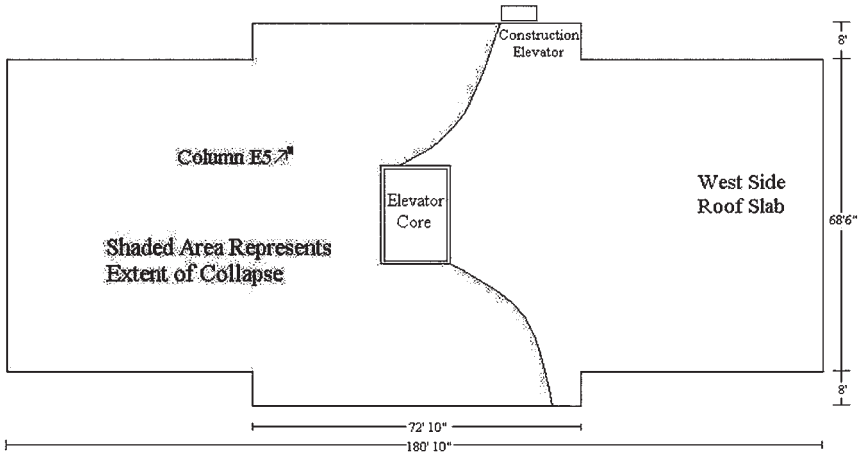
At first, the different floors were distinguishable, but later dust and debris made it difficult to tell them apart. When the dust finally settled, two-thirds of the building had collapsed. The east side and areas on either side of the elevator shaft were gone. Four workers were killed during the collapse, and 30 workers suffered injuries (Granger et al. 1971). The extent of damage is shown in Fig. 5-3. The elevator core probably prevented the collapse from propagating to the other half of the structure.

Figure 5-3. Extent of collapse.

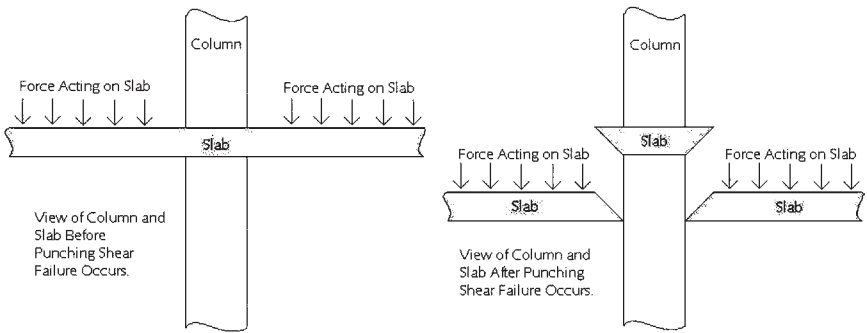
Punching shear is usually the critical failure mechanism for flat-slab reinforced concrete structures. This mechanism is illustrated in Fig. 5-4. With this type of failure, the column and part of the slab punch through the slab as it moves downward.

Figure 5-4. Punching shear.
Source: King and Delatte (2004).

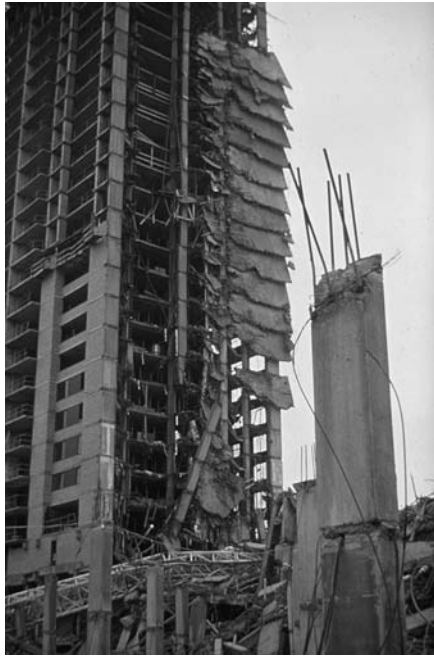
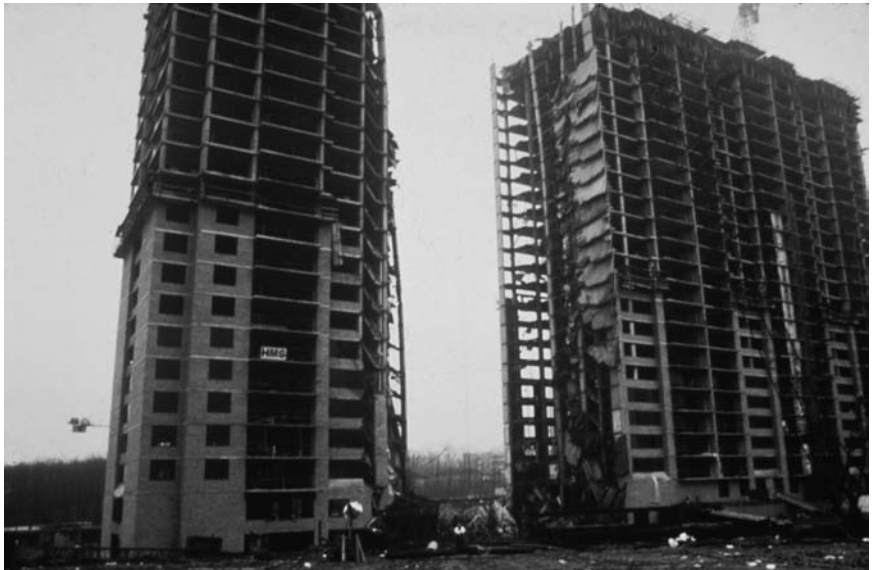
As in the case of 2000 Commonwealth Avenue, premature removal of shoring and insufficient concrete strength were suggested as the causes of failure. The National Bureau of Standards (NBS, now the National Institute of Standards and Technology, NIST) carried out an investigation on behalf of the Occupational Safety and Health Administration (OSHA). The NBS investigation team determined that punching shear failure at the 23rd floor caused a partial collapse that propagated to the ground. Fourteen workers were killed and 34 were injured (Carino et al. 1983).

Figure 5-6a, b. Collapse of Skyline Plaza, Bailey's Crossroads.
Courtesy National Bureau of Standards/National Institute of Standards and Technology.

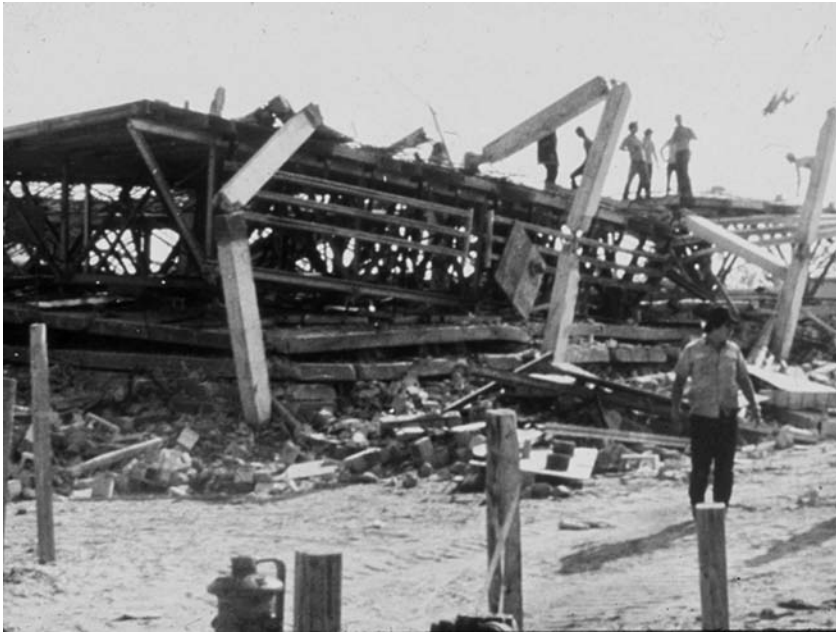
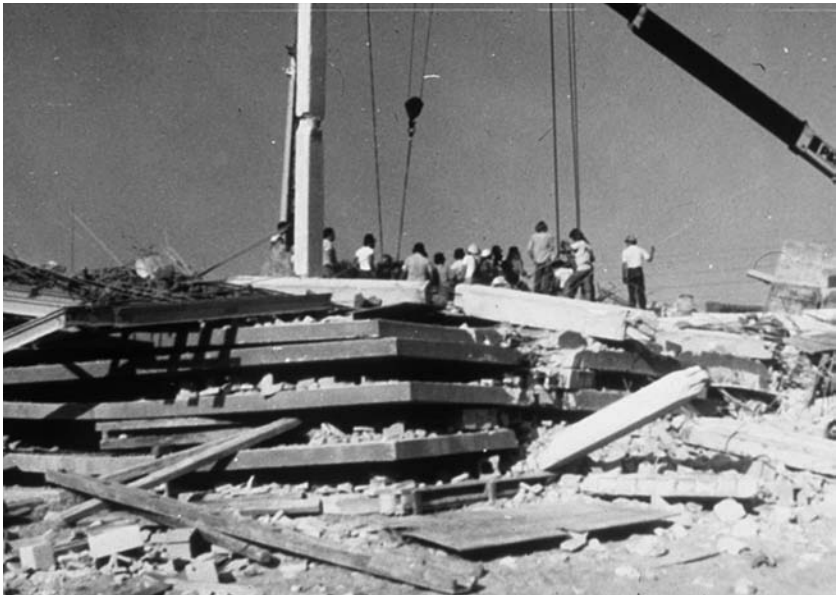
The collapse of the flat-plate Harbour Cay Condominium building in Cocoa Beach, Florida, on March 27, 1981, was caused by a punching shear failure that triggered a progressive collapse, much like those at 2000 Commonwealth Avenue in Boston and Skyline Plaza in Virginia. Eleven workers were killed and 23 were injured. Figure 5-7 shows the building before collapse, and Fig. 5-8 shows the structure afterward. As at Skyline Plaza, OSHA

The NBS team determined that slab thickness of 203 mm (8 in.) did not meet the ACI code minimum of 280 mm (11 in.). Also, the top reinforcing steel was placed too low, reducing the slab effective depth d from 160 mm (6.3 in.) to 135 mm (5.3 in.). As a result, the calculated punching shear stresses exceeded capacity (Lew et al. 1982).

Figure 5-8a, b. Harbour Cay Condominium collapse.
Courtesy National Bureau of Standards/National Institute of Standards and Technology.

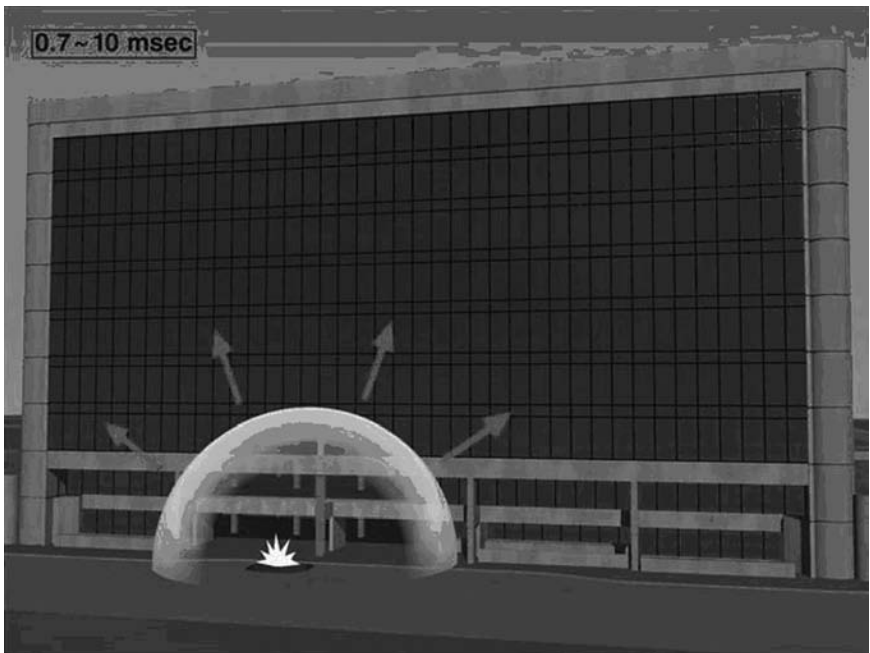
between the second and third floors, at the location of the transfer girders. This failure left the outer bay unsupported (Hinman and Hammond 1997, pp. 6–8). The G row of columns was along the north façade, and the F row was in the middle of the building between the north and south bays. The location of the explosion is shown in Fig. 5-10.

Floor slabs were blasted upward at the second through fourth floors.

Figure 5-10. Location of bomb.

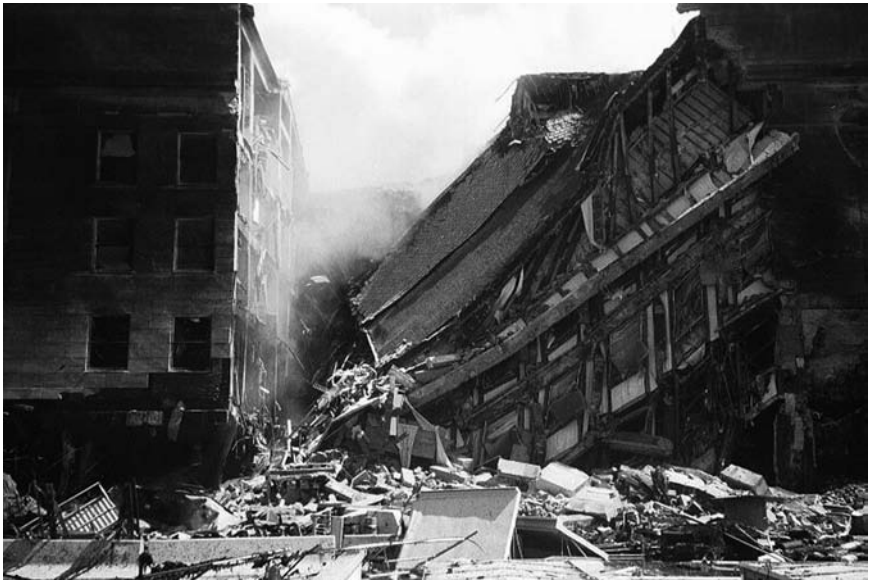
Part of the building in the renovated section to the south of the expansion joint subsequently collapsed about 20 min after the aircraft struck the building. Photos taken between the aircraft impact and the collapse show that this portion of the building was sagging by about 0.45–0.6 m (1½–2 ft). All five floors of the building collapsed. Some of the blast-resistant windows stayed in place even after the collapse. The collapse was confined to the outer E ring (Mlakar et al. 2003, pp. 17–26). Figure 5-13 shows the building after the collapse of the portion adjacent to the expansion joint.

Figure 5-13. The Pentagon following the aircraft impact.

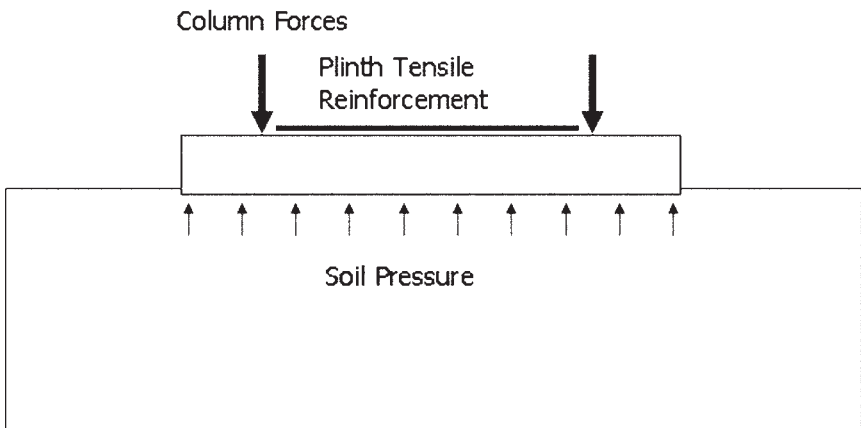
Figure 5-15. Schoharie Creek Bridge plinth reinforcement.

In 1957, plinth reinforcement was added to each of the four piers to correct the problem of vertical cracking. The plinth may be seen as an upside-down, uniformly loaded beam, with the soil-bearing pressure providing the uniform loading and the two columns acting as supports. It becomes obvious that the top of the plinth represents the tension face of the beam and requires reinforcement. The plinth reinforcement is shown in Fig. 5-15.

However, to be properly anchored, the tension reinforcement must be extended past the supports—in this case, into the columns—for the full development length required by the ACI Code. Obviously, this extension was not done, and it would have been difficult to extend the reinforcement through the columns without replacing the columns. Ironically, because the added plinth reinforcement was not adequately anchored, it may have contributed to the brittle and sudden nature of the subsequent collapse by supporting the plinth until most of it had been undermined.

The plinth may be seen as an upside-down uniformly loaded beam, with the soil bearing pressure providing the uniform loading and the two columns acting as supports. It becomes obvious that the top of the plinth represents the tension face of the beam and requires reinforcement. However, to be properly anchored, the tension reinforcement must be extended past the supports—in this case, into the columns (NTSB 1988). This design is illustrated in Chapter 5’s Fig. 5-15.

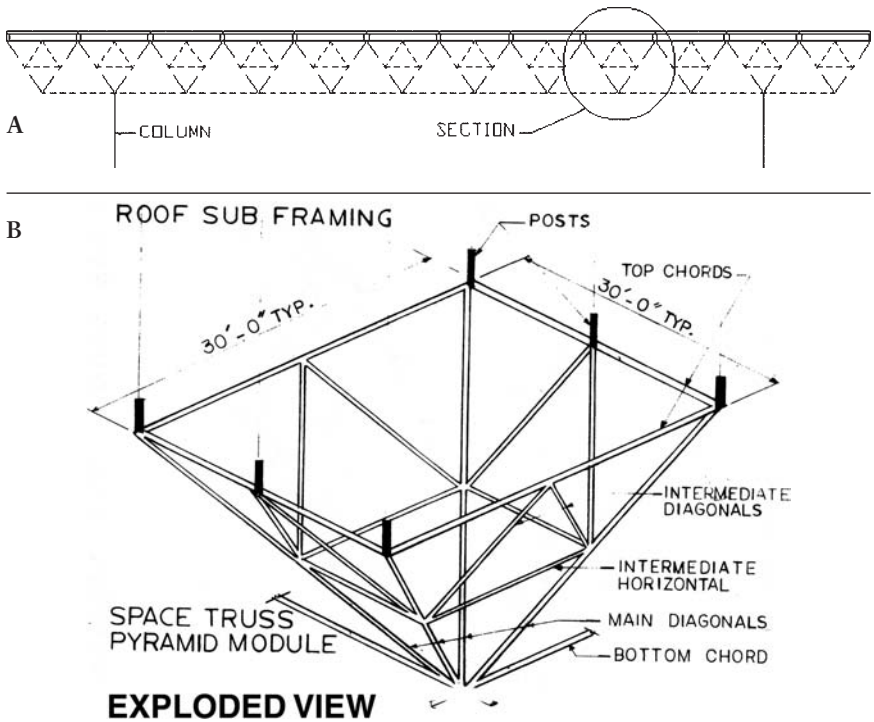
Figure 6-1a, b. Elevation and detail of Hartford Civic Center roof (1 ft = 0.305 m).
Courtesy Lev Zetlin Associates.

To save money, the engineers proposed an innovative design for the 91.4×110 m (300×360 ft) space frame roof 25.3 m (83 ft) over the arena. The proposed roof consisted of two main layers arranged in 9.14×9.14 m (30×30 ft) grids composed of horizontal steel bars 6.4 m (21 ft) apart. Diagonal members 9.14 m (30 ft) long connected the nodes of the upper and lower layers and, in turn, were braced by an intermediate layer of horizontal members. The 9.14-m (30-ft) members in the top layer were also braced at their midpoint by intermediate diagonal members (Fig. 6-1).

1. The cross-sectional configuration of the four steel angles making up each truss member did not provide good resistance to buckling. The cross-shaped built-up section has a much smaller radius of gyration than either an I-section or a tube section configuration of the same structural members (Fig. 6-2). As a result, the buckling load for the cross-shaped section is much lower than that of the other configurations.

2. The top horizontal members intersected at a different point than the diagonal members rather than at the same point, making the roof especially susceptible to buckling because the diagonal members did not brace the top members against buckling.

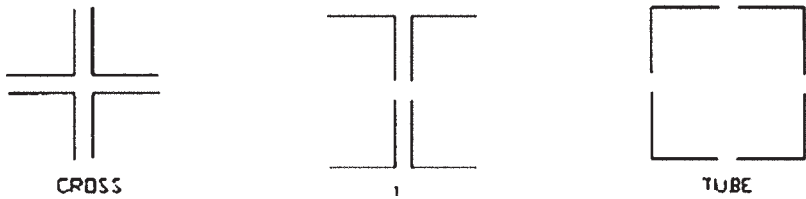
Figure 6-2. Possible truss member configurations.

As a class example or homework problem, students may compare the moment of inertia for the cruciform, I, and tube configurations of four angles, as shown in Fig. 6-2. Angle legs ranged from 89 to 203 mm ($3\frac{1}{2}$ to 8 in.) long and were 8–22 mm ($\frac{5}{16}$ – $\frac{7}{8}$ in.) thick, depending on loads, and the angles were separated by spacers 19–22 mm ($\frac{3}{4}$ – $\frac{7}{8}$ in.) thick (LZA 1978). For numerical examples, $127 \times 127 \times 8$ mm ($5 \times 5 \times \frac{5}{16}$ in.) angles may be used. The torsional stiffness of these configurations may also be calculated and compared.

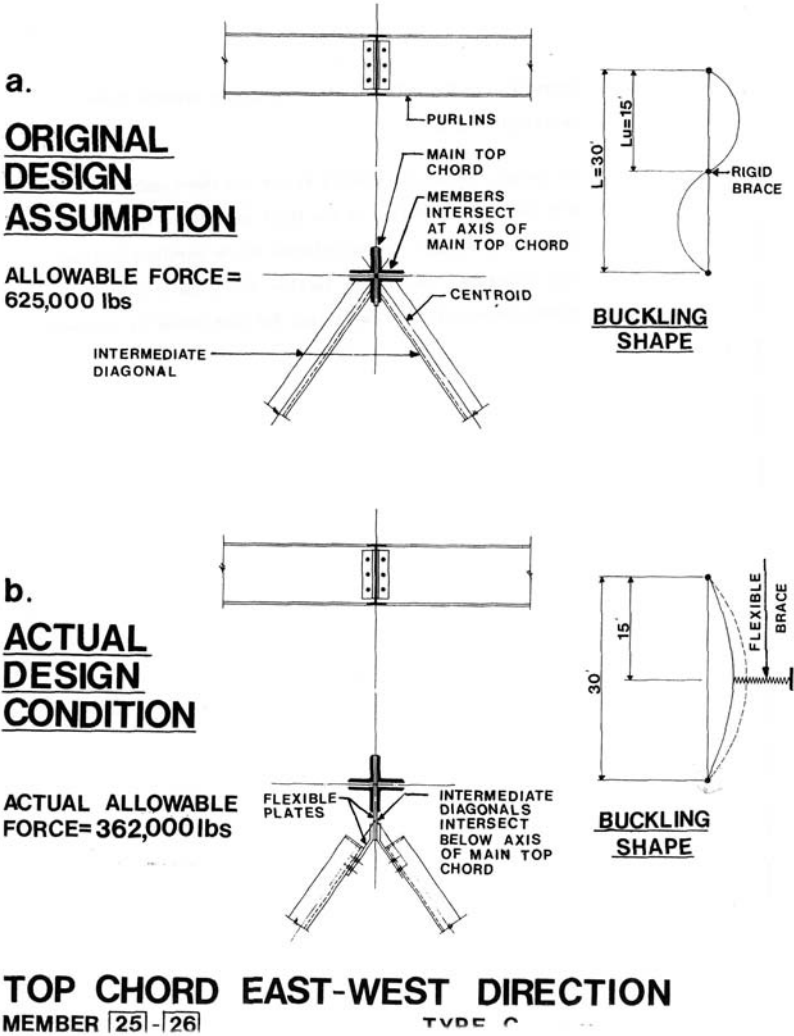
Figure 6-3. Effect of assumed (hard) versus actual (spring) bracing condition. Courtesy Lev Zetlin Associates.

Table 6-1 compares some of the original details to actual designs used in the building, demonstrating the reduction in strength that these changes caused. Connection A was typically used on the east–west edges of the roof, whereas connection B was used on the north–south edges. Most of the interior members used connection C, and a few used connection D. The key difference between the original and the as-built details may be seen by comparing the top and bottom rows of the table. The diagonal members were attached some distance below the horizontal members. Thus, the flexibility of the connection reduced the effectiveness of the bracing by introducing a “spring brace” instead of the hard brace that had been assumed. The effect of a spring brace instead of a hard brace is illustrated in Fig. 6-3.

Using computer analysis, Loomis and Loomis found that the top truss members and the compression diagonal members near the four support pylons were approaching their torsional buckling capacity the day before the collapse. An estimated 0.575–0.718 Pa (12–15 lb/ft²) of live load would cause the roof to fail. The snow from the night before the collapse constituted a live load of 0.670–0.910 Pa (14–19 lb/ft²). Because torsional buck-

ling is uncommon, it is often an overlooked mode of failure (*ENR* 1979a). The cruciform shape is particularly weak against torsional buckling.

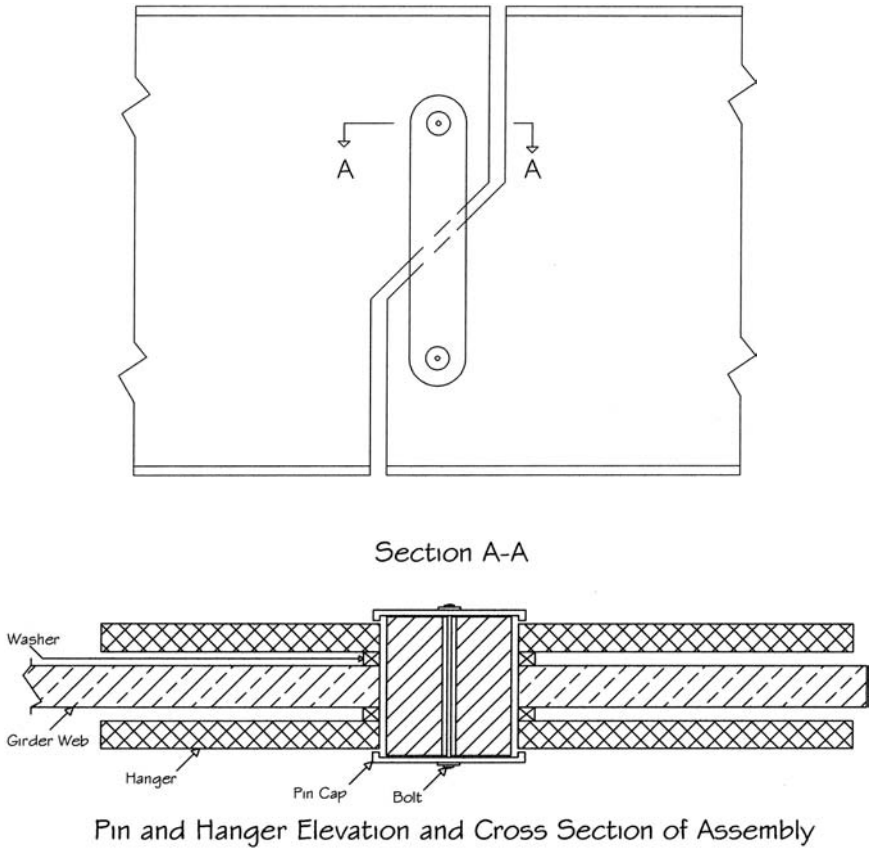
Figure 6-4. Pin and hanger assembly.

Figure 6-4 shows the pin and hanger assembly. Washers were used to separate hangers from the steel girders. Locking caps were used to keep the hanger from slipping off of the pin. According to the experts, the caps were thin and flimsy. "Calculations proved the caps' thickness was less than one half that required by the design regulations in force at the time of construction (1957)" (Levy and Salvadori 1992, p. 139). The thin pin caps could be easily bent.

It was discovered that ten years before the accident the storm drains had been paved over, allowing water, salt, and dirt to flow through the joint between the cantilevered and suspended spans, dropping directly onto the hanger assembly and causing accelerated rusting of its steel. (Levy and Salvadori 1992, p. 140)

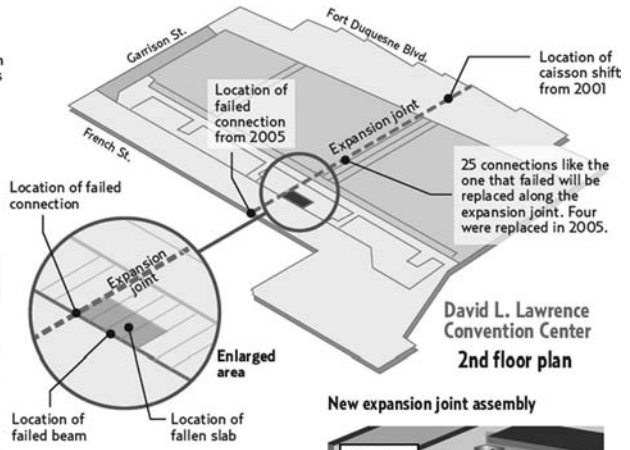
New expansion joint assembly

On Monday, February 5, 2007, an expansion joint at the Pittsburgh Convention Center failed as a tractor-trailer was parked next to it. The cause of the partial collapse was the combination of a cold snap and a poor expansion joint detail. Greg Luth told the *Pittsburgh Tribune-Review* that he had only seen that type of joint once before in almost three decades of structural engineering practice, and that was in the first atrium joint that had failed at the Kansas City Hyatt Regency (Houser and Ritchie 2007). The case study is covered in detail in Chapter 6. The failed expansion joint is shown in Fig. 6-8, along with the retrofit that was installed to fix the problem.

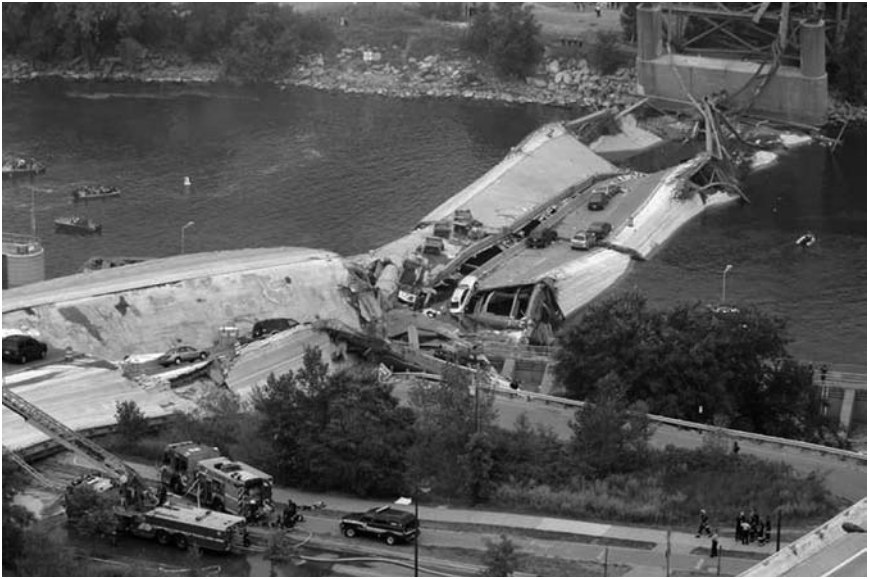
Figure 6-12. Wreckage of the collapsed Minneapolis I-35W Bridge.

Much of the wreckage remained above the water, but about 50 vehicles with their occupants went into the river. At the time, repairs were being made to the bridge deck, guardrails, and lights. Figure 6-12 shows the wreckage of the collapsed bridge.

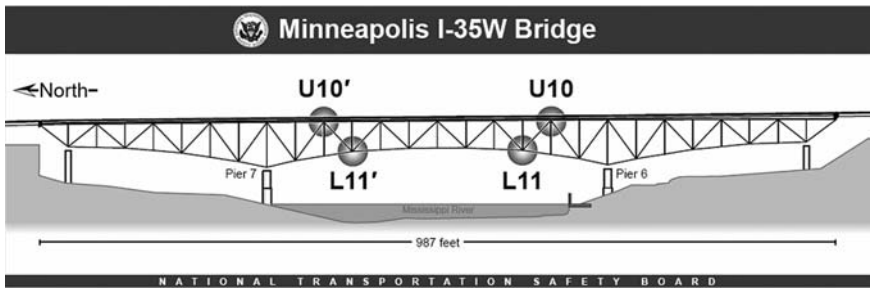
Figure 6-13. Minneapolis I-35W Bridge U10 and L11 gusset plates.
 Source: National Transportation Safety Board.

As of summer 2008, the cause of the I-35W Bridge collapse remains under investigation, and the final reports have yet to be written. However, considerable work has been done, and a critical design flaw that may well have been the cause of the collapse has been identified. The U10 and L11 gusset plates, shown in Fig. 6-13, were only about 13 mm ($\frac{1}{2}$ in.) thick when they should have been 25 mm (1 in.) thick.

This sort of design defect would not be noted during routine bridge inspections because the inspectors would merely note the condition of the gusset plate. They would not have the documents or the time to check its adequacy. In this respect, then, one final similarity to the Point Pleasant Bridge collapse remains: a hidden flaw, not detectable to normal inspection procedures, that can lie dormant for 40 years and then bring a structure crashing down.
