Beyond Failure

*Forensic
Case Studies
For Civil Engineers*

Norbert J. Delatte Jr.,
Ph.D., P.E.

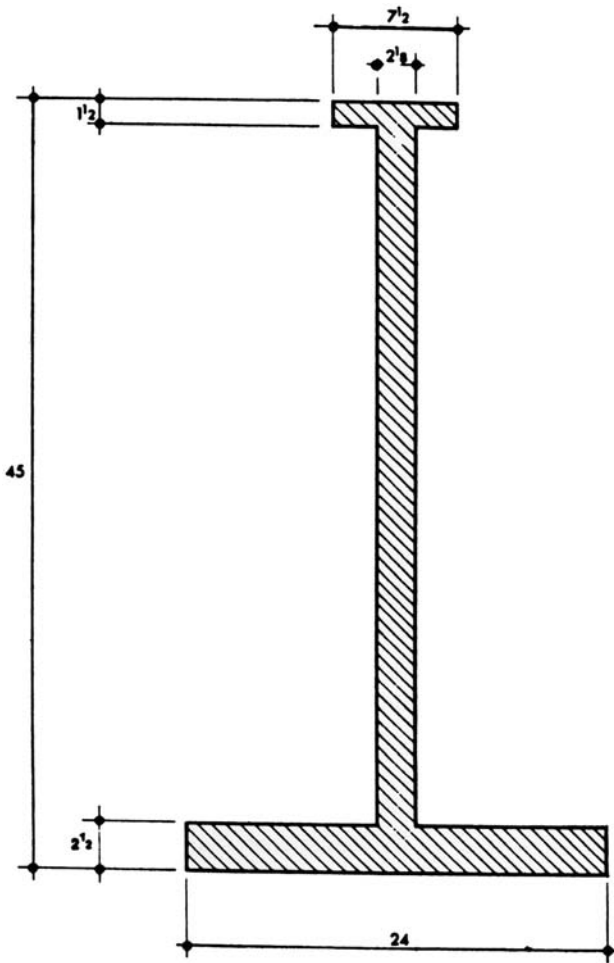
Figure 6-14. The Dee Bridge girders (1 in. = 25.4 mm).

Because cast iron is weaker in tension than in compression, the tension flanges of girders were larger than compression flanges by a ratio of 16:3, following the ratio of material strengths. The Dee Bridge had a relatively long simple span for the day of roughly 29 m (95 ft). The girder cross section is shown in Fig. 6-14. The bridge was also designed with a relatively low factor of safety of 1.5.

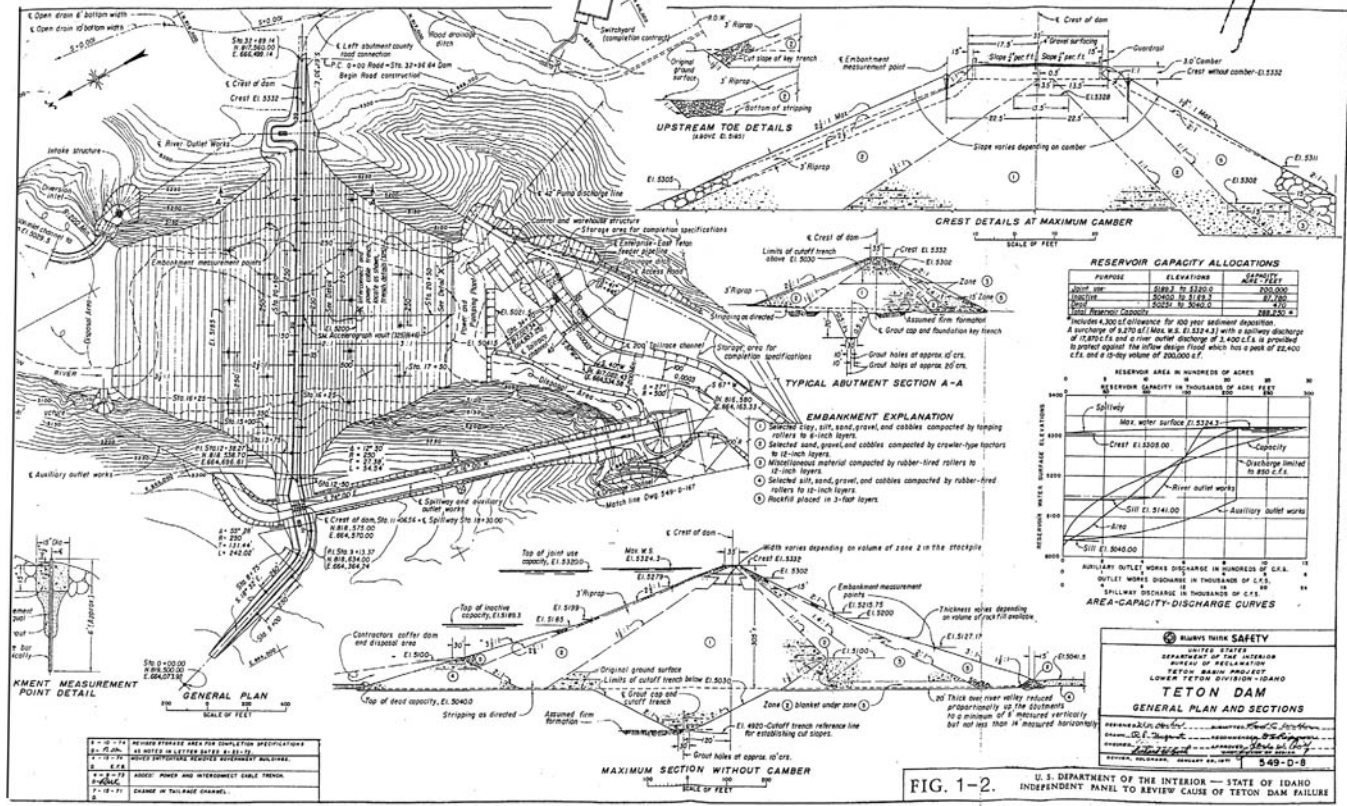
Figure 7-1. Dam construction details, plan view, and cross section.
 Source: Independent Panel (1976).

Conditions favorable for erosion and piping existed in Zone 1 (see Fig. 7-1), where the primary materials were highly erodible silts. Wherever this material was in contact with flowing water, it could be attacked and washed away. This contact could have occurred in three possible ways. First, seepage through the material could have caused backward erosion. This was determined not to play a major role in the failure because this process occurs slowly. Second, erosion by direct contact could have occurred where water was in contact with open joints, and third, where there was direct contact through cracks in the fill itself. It was determined that these last two were possible and were probably occurring simultaneously (Independent Panel 1976).

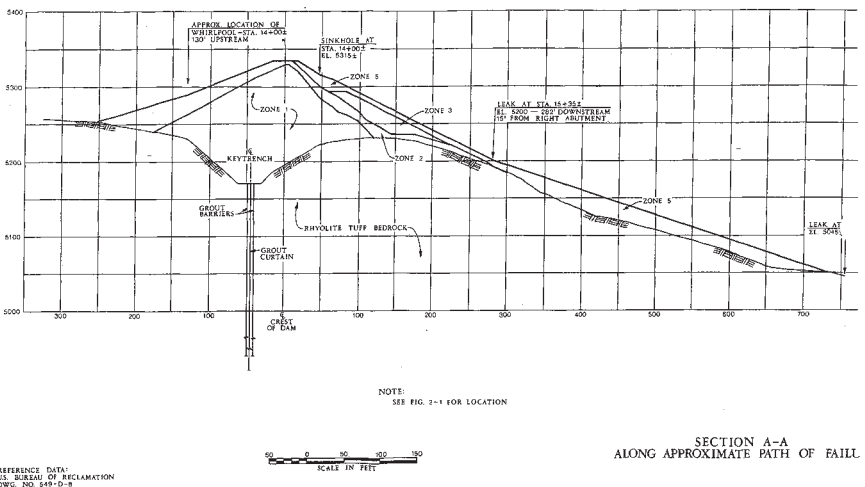
Figure 7-2. Initial failure indications.
Source: Independent Panel (1976).

At 11:00 A.M., a whirlpool was observed in the reservoir directly upstream from the dam, and four bulldozers were sent to try to push riprap into the sinkhole near the dam crest (Independent Panel 1976). Two of the bulldozers were swallowed up by the rapidly expanding hole, and the operators were pulled to safety by ropes tied around their waists. Figure 7-2 shows a cross section of the dam with the approximate locations of the seepage, the sinkhole, and a whirlpool in the reservoir noted.

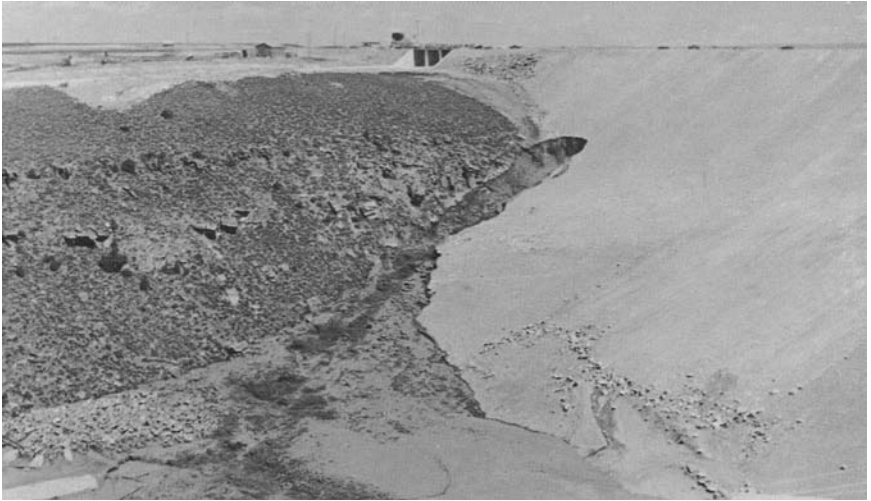
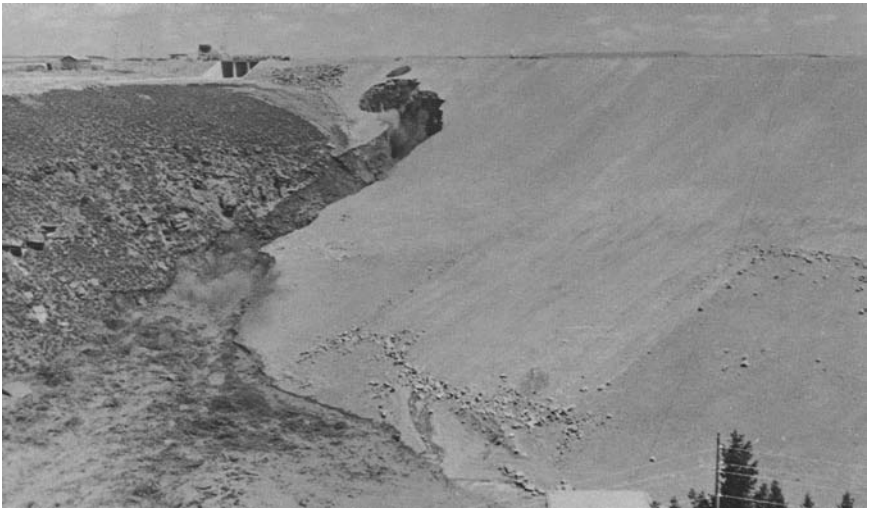
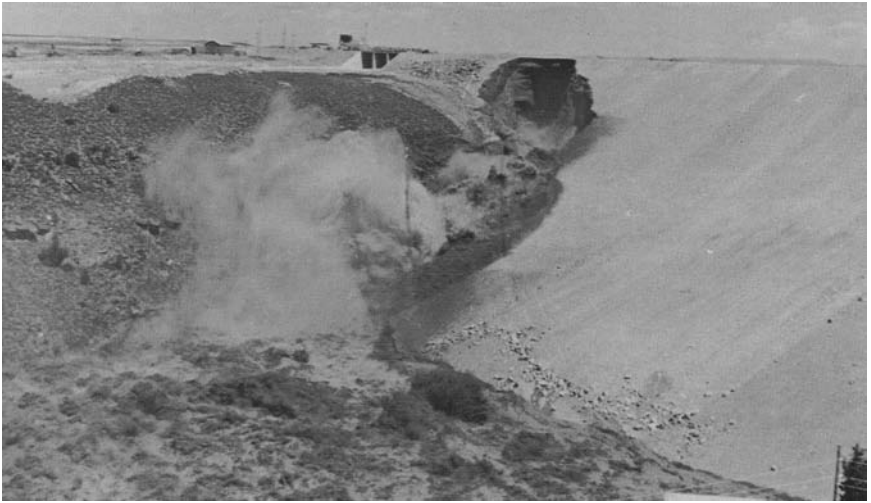
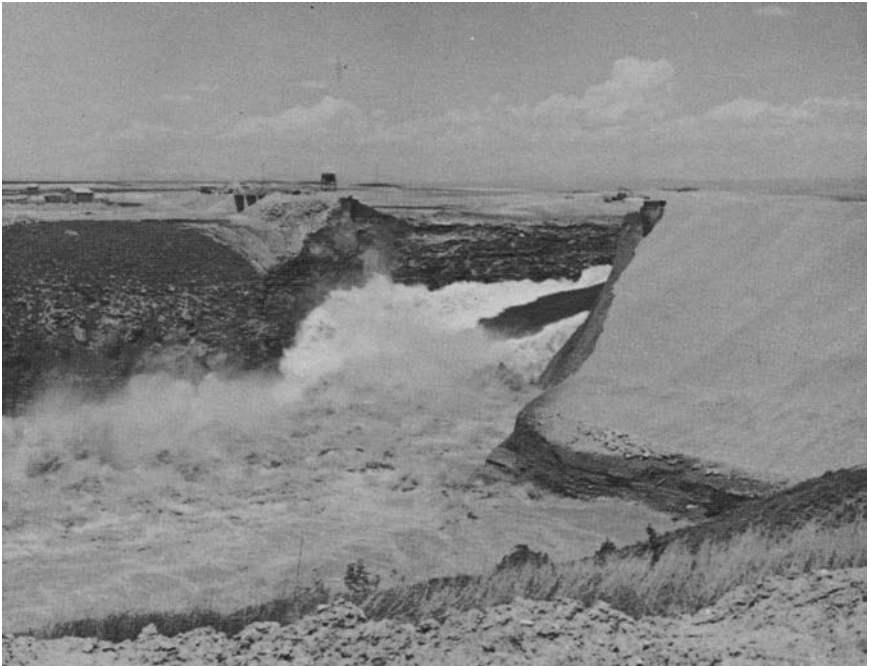
Figure 7-3a shows the location of the initial leak as it expanded up the dam. Between 11:15 and 11:30 A.M., a 6×6 m (20×20 ft) chunk of dam fell into the whirlpool, and within minutes the entire dam collapsed (Independent Panel 1976). The failure sequence is illustrated in Figs. 7-3a through 7-3d.

Figure 7-3a. Failure sequence, initial erosion.
Source: Independent Panel (1976).

Figure 7-3b. Failure sequence, seepage widens.
Source: Independent Panel (1976).

Figure 7-3c. Failure sequence, beginning of final failure.
Source: Independent Panel (1976).

Figure 7-3d. Failure sequence, failure of dam.
Source: Independent Panel (1976).

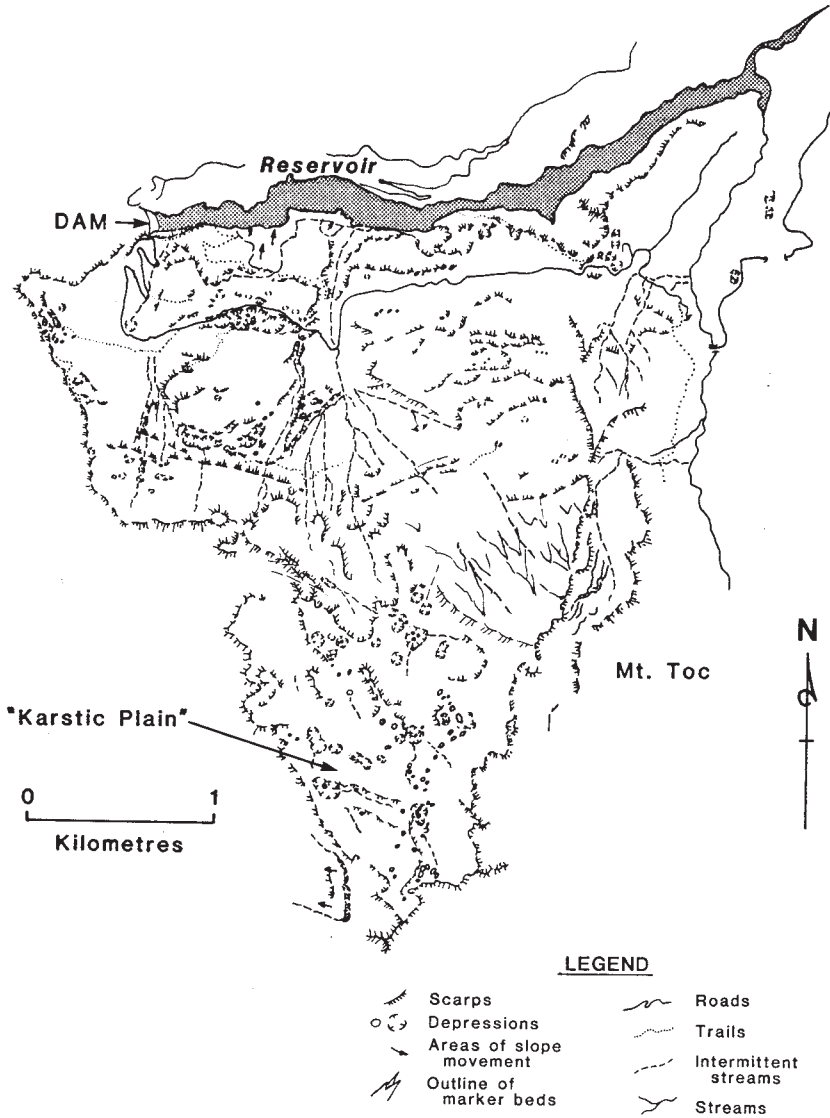
The lower, confined aquifer was fed mostly by precipitation on Mt. Toc (Semenza and Ghirotti 2000). Figure 7-4 shows a plan view of the mass that slid to the north. To observers on the opposite side of the valley, it appeared to be M-shaped.

Figure 7-4. Plan view of mass before slide.
Source: Hendron and Patton (1985).

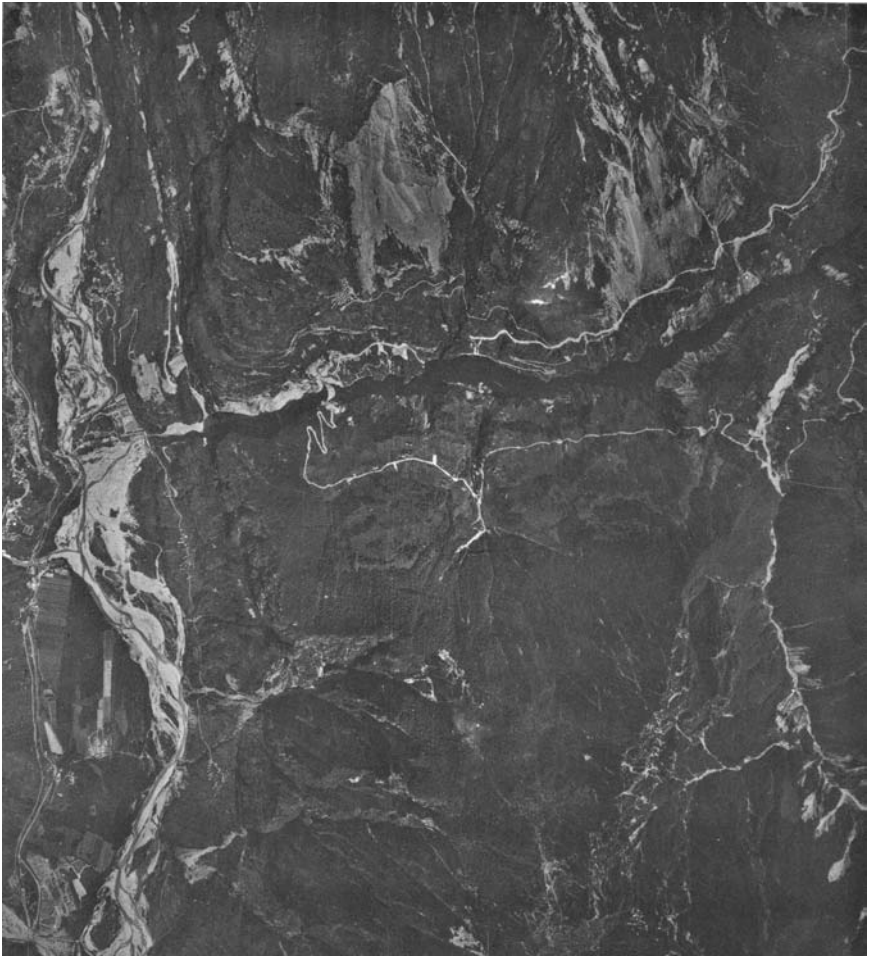
Using aerial photographs available at the time, Hendron and Patton (1985, p. 31) identified a pattern of apparent kettles or sinkholes, along with shallow slide areas. These are shown in Fig. 7-5. These features could have been used to identify a possible landslide area for further ground-based investigation.

Figure 7-5. Aerial photograph of site before slide.

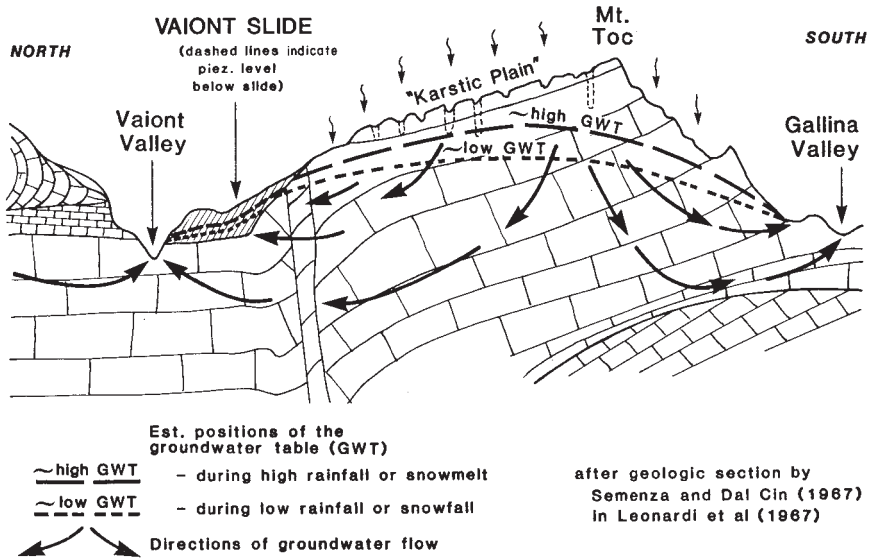
These sinkholes readily allowed rainwater or snowmelt to infiltrate into Mt. Toc, and to reach the base of the slide as shown in Fig. 7-6. With increasing precipitation, pressure would build behind the clay layer. During his surveys in 1959 and 1960, Edoardo Semenza had observed moist areas and springs below the eventual slide plane, which was consistent with the hydrogeology shown in Fig. 7-6 (Hendron and Patton 1985, pp. 34–35).

Figure 7-6. Infiltration of water through the mountain.

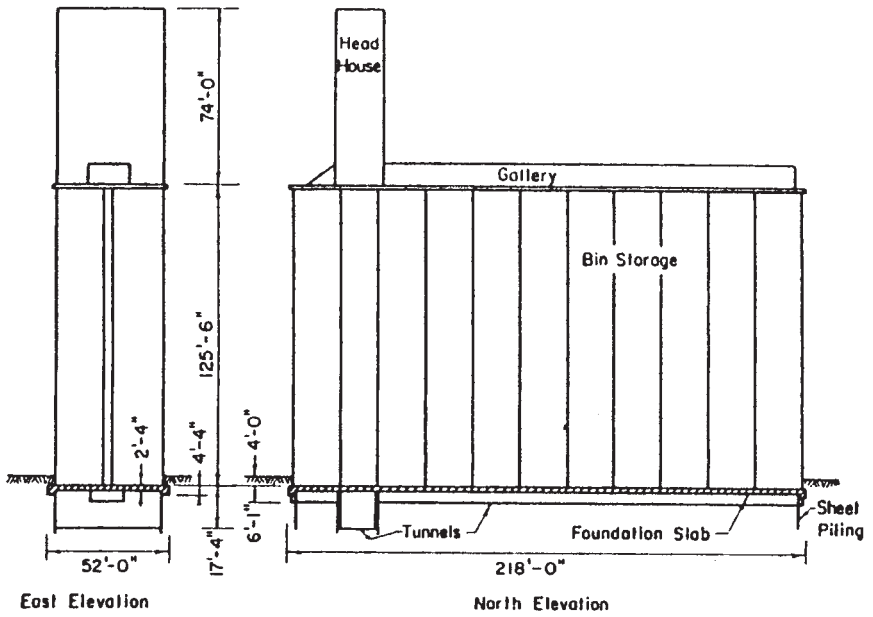
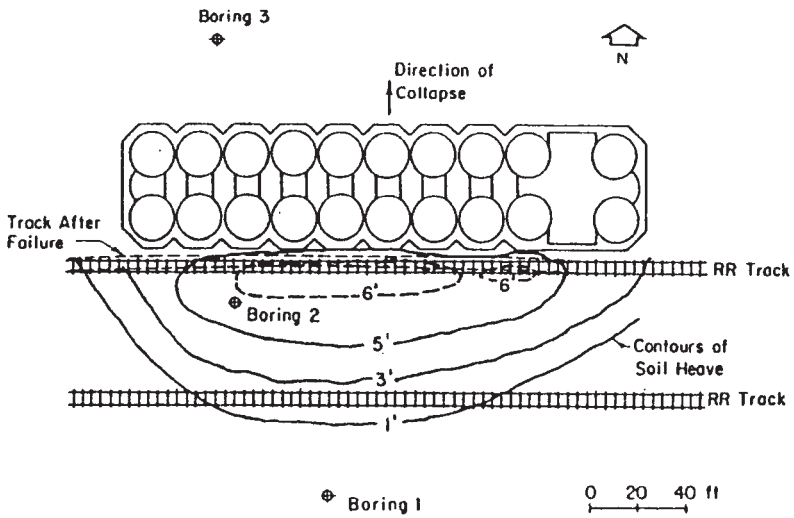
The Fargo Grain Elevator collapsed 42 years after the Transcona Grain Elevator. Major filling began in April 1955, and the collapse occurred on June 12, 1955. The structure broke apart and was completely destroyed in the collapse. It collapsed in the northward direction, forming a mass of concrete rubble and grain with soil heaved up on the south side as much as 1.8 m (6 ft). Like the Transcona Grain Elevator, the Fargo structure was on part of the ancient Lake Agassiz clay deposits that stretch across much of the northern Great Plains of North America (Nordlund and Deere 1970). Figure 7-7 shows the elevation and plan of the failed grain elevator.

Figure 7-7. Fargo Grain Elevator.
Source: Nordlund and Deere (1970).

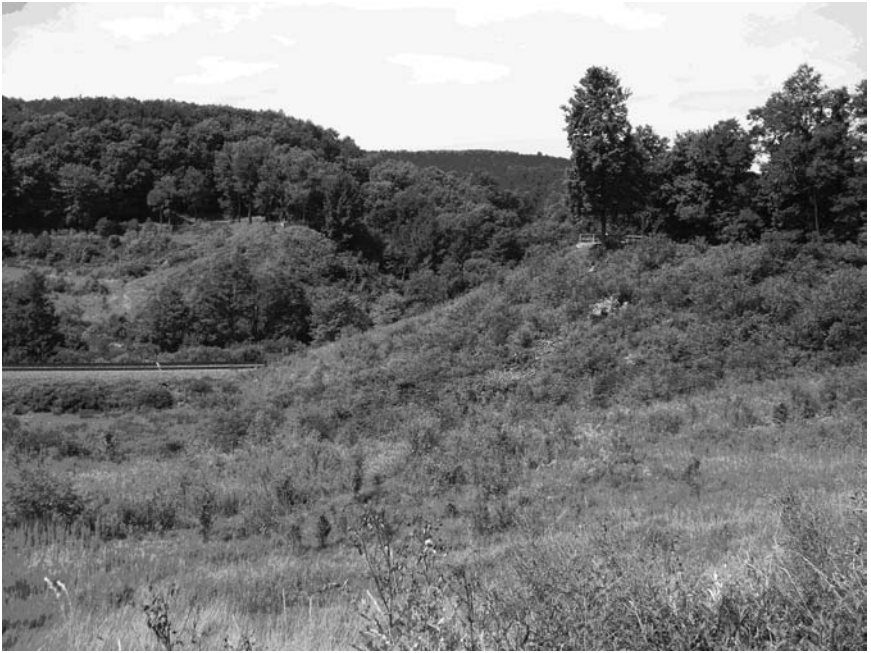
Figure 8-3. Remains of the South Fork Dam.

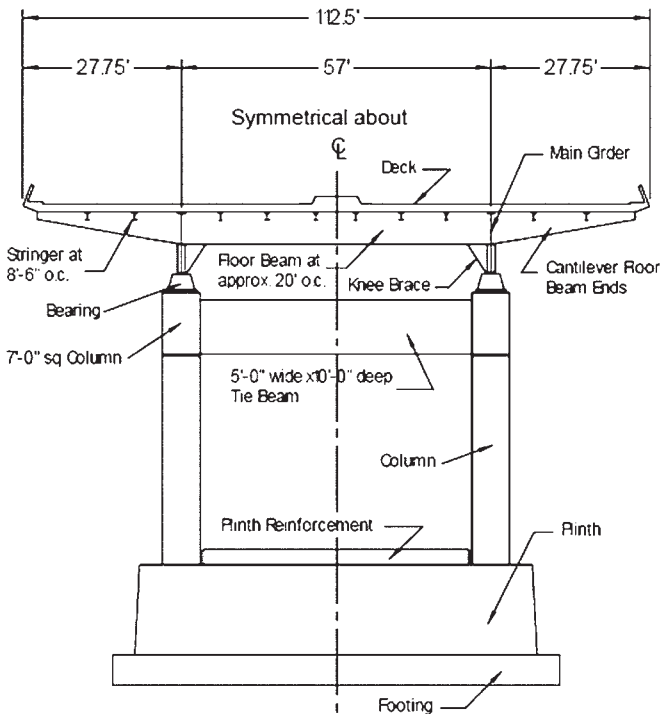
Figure 8-7. Schoharie Creek Bridge pier frames.

Shortly after construction was completed, in the spring and summer of 1955, the Schoharie Creek Bridge pier plinths (shown in Fig. 8-7) began to

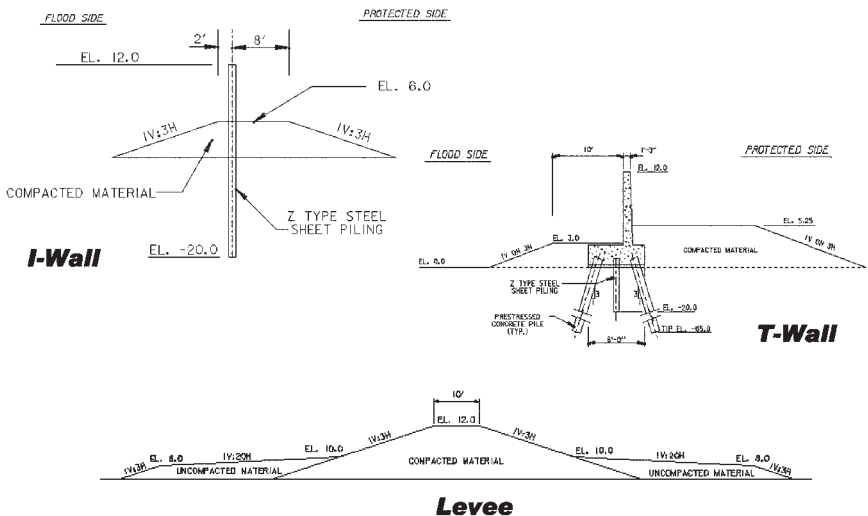
The three types of flood protection structures designed and built by USACE were I-walls, T-walls, and levees. The levees were earthen dams made of compacted material or hydraulic fill, sloped at a rate of 1 vertical to 3 horizontal. As a result, a levee would need to be more than 6 times as wide as it was tall. Raising a levee, then, would require purchasing private property and demolishing buildings. Therefore, I-walls and T-walls were built on top of low existing levees to raise their height without widening them. I-walls were built from Z-type steel sheet piling, and T-walls were reinforced concrete structures shaped like an inverted T, supported by battered pilings. T-walls are much stronger than I-walls but also more expensive (ASCE Review Panel 2007, pp. 20–22). Figure 8-11 shows these flood wall and levee configurations.

One common error in the design and construction of the levees and flood walls was the use of an incorrect datum. The structures were intended to be built referenced to mean sea level (MSL). However, they were actually built to a land-based datum, which was incorrectly assumed to have a constant offset from MSL (ASCE Review Panel 2007, p. 22).

Figure 8-11. New Orleans floodwall and levee configurations. Source: IPET (2007).

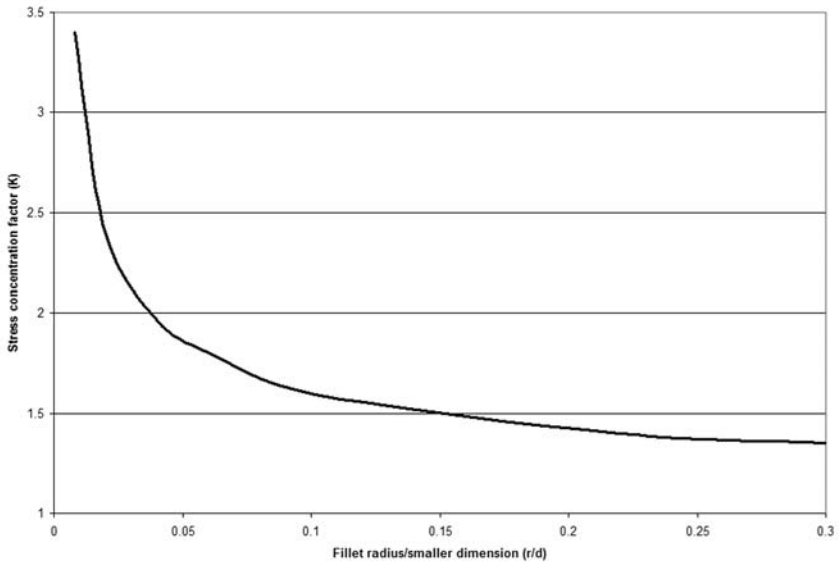
Figure 9-4 shows a typical curve for determining stress concentration factors for fillets. The stress concentration factor K is a function of the radius of the fillet. The nominal average stress is multiplied by K to get the maximum stress:

Note that as the radius approaches zero, for a sharp corner, the stress concentration factor approaches infinity. The solution represented by this curve is based purely on elastic considerations and does not account for material yielding. The stress concentration factor remains the same whether the material is steel, concrete, wood, or silly putty.

Figure 9-4. Stress concentration factors (Wider dimension D 10% larger than smaller dimension d).

With ductile materials, such as mild steel, stress concentrations are relieved as the steel yields. The theoretical maximum stress, shown in Fig. 9-4, does not occur because the steel at the stress concentration yields, and the stresses are redistributed.

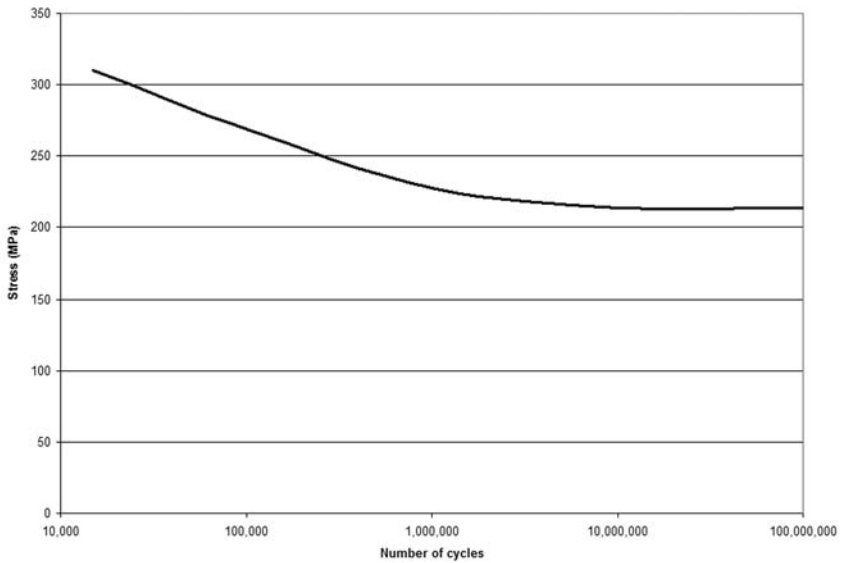
Different materials have different S - N curves describing the relationship between applied stress and number of cycles to failure. Figure 9-5 shows a typical S - N curve for structural steel. S is the stress level, and N is the number of cycles to failure, which increases as S decreases. When $S = 220$ MPa (32 kip/in.²), the material fails immediately with the first loading cycle. If S is sufficiently small, the material may theoretically sustain infinite load applications, and the stress is said to be below the material's endurance limit. If the approximate number of load cycles N can be predicted, the designer needs to merely ensure that all stress ratios are low enough so as to remain below the S - N curve.

When stress concentrations and fatigue are combined, ductile materials, such as mild steel, can fail in a sudden, brittle manner. With the stress concentration, K increases, S increases, and N decreases. The sharp hatch corners of the Liberty ships, coupled with locked-in residual stresses from welding, meant that a few load cycles from wave action or other sources could lead to the brittle fracture.

Figure 9-5. Fatigue S-N diagram (1 MPa = 145 psi).

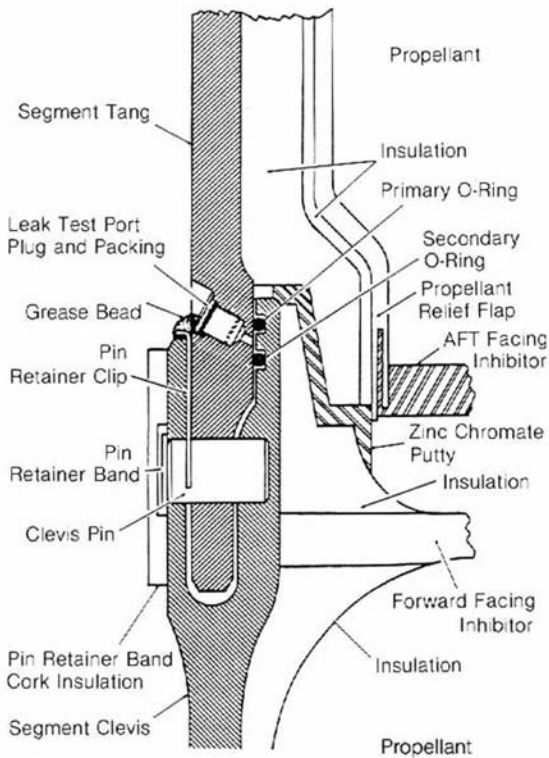
tect the ring itself from the gases. The gap between the tang and the clevis is adjusted with shims to reduce the gap and increase the compression of the O-ring (Space Shuttle *Challenger* Disaster 2007). The O-ring joint is shown in Fig. 10-4.

Several factors affect the size of the gap, including dimensional tolerances of metal cylinders and the tang and clevis assembly, the temperature, the O-ring diameter, the shims, and the loads applied to the joint. When the booster is ignited, internal pressure presses against the putty and forces the O-ring into the gap between the tang and clevis to form a seal (Space Shuttle *Challenger* Disaster 2007).

Figure 14
Solid Rocket Motor cross section shows positions of tang, clevis and O-rings. Putty lines the joint on the side toward the propellant.

Figure 10-4. Space Shuttle *Challenger* O-ring joint.
Courtesy National Aeronautics and Space Administration.

The pressure against the SRB walls also causes the cylinder to increase in diameter or balloon slightly. This, in turn, causes the gap in the tang and clevis joint to open, a phenomenon known as joint rotation. Morton Thiokol discovered the effect during testing in 1977 and implemented three changes to decrease joint rotation. The changes were improved dimensional tolerances of the metal joint and O-ring, an increase in O-ring diameter, and the use of shims. Morton Thiokol's testing also indicated that in some instances, the second O-ring might not seal at all, eliminating the redundancy of the design (Space Shuttle *Challenger* Disaster 2007).
