# ROCKY MOUNTAIN GEO-CONFERENCE 2014

GEOTECHNICAL PRACTICE PUBLICATION NO. 9

PROCEEDINGS OF THE 2014 ROCKY MOUNTAIN GEO-CONFERENCE

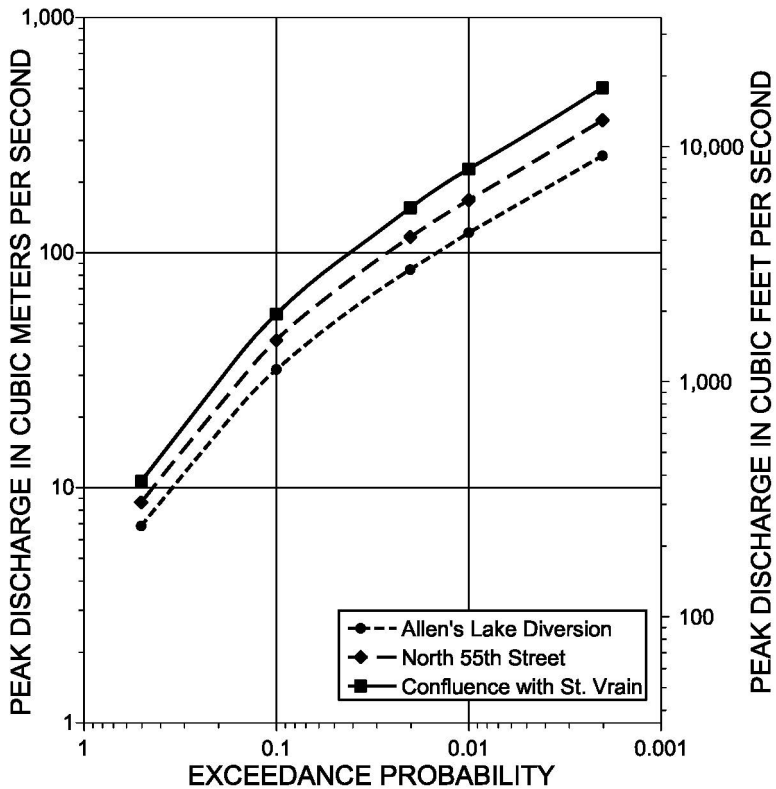
FIG. 3. Flood Recurrence along Left Hand Creek

The U.S. Geological Survey (1988) study of peak flows in the creeks surrounding Left Hand Creek generated a series of empirical correlations for flood levels based on elevation and drainage basin area below an elevation of 2440 m (8000 ft). These correlations were used to calculate exceedance probabilities for Left Hand Creek at the Allen's Lake diversion dam, North 55th Street, and the confluence with the St. Vrain Creek as shown in Fig. 3. The results show a 100-year recurrence flow of 120 m<sup>3</sup>/s (4300 cfs) at the diversion structure. This estimated flow was not able to be verified by field measurements during the flood event.

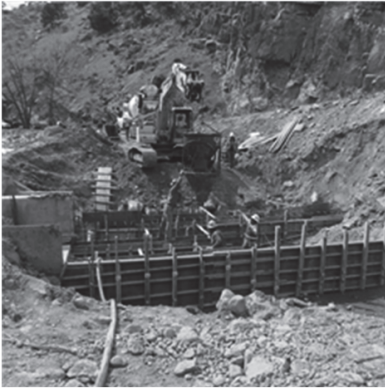
**Photograph 3. Foundation Cutoff for the Dam**

The dam required complete replacement. Colorado water law allows head gates to be moved upstream because of changes in the channel. The remains of the original structure were removed and the new structure placed slightly upstream of the original structure. The water right remained unaffected, since it did not impact another water right. The new structure has a spillway capacity of 130 m<sup>3</sup>/s (4600 cfs) and includes a cutoff extending down 1.8 to 3.6 m (6 to 12 feet) to bedrock across the entire channel. Photographs 3 and 4 show the new diversion dam under construction.

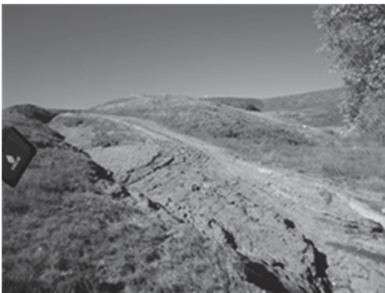
**Photograph 5. Erosion in Service Spillway**

The roller compacted concrete spillway has a capacity of  $351 \text{ m}^3/\text{s}$  (12,400 cfs). The service and emergency spillways are shown in Photographs 5 and 6.

During the flood event both the service right abutment natural channel spillway and the emergency RCC spillway flowed for a combined flow of about  $57 \text{ m}^3/\text{s}$  (2000 cfs). The cut bedrock channel eroded down to competent bedrock and performed well. Minor repairs were required to make the spillway serviceable for the future. The RCC spillway experienced significant damage with 150 mm to 200 mm (6 in to 8 in) of flow depth at the crest of the structure. The damage consisted of wide spread raveling of the RCC surface and rounding of up to 100 mm (4 in) from the edge of the steps. The spillway surface was subsequently found to be satisfactory for continued service.

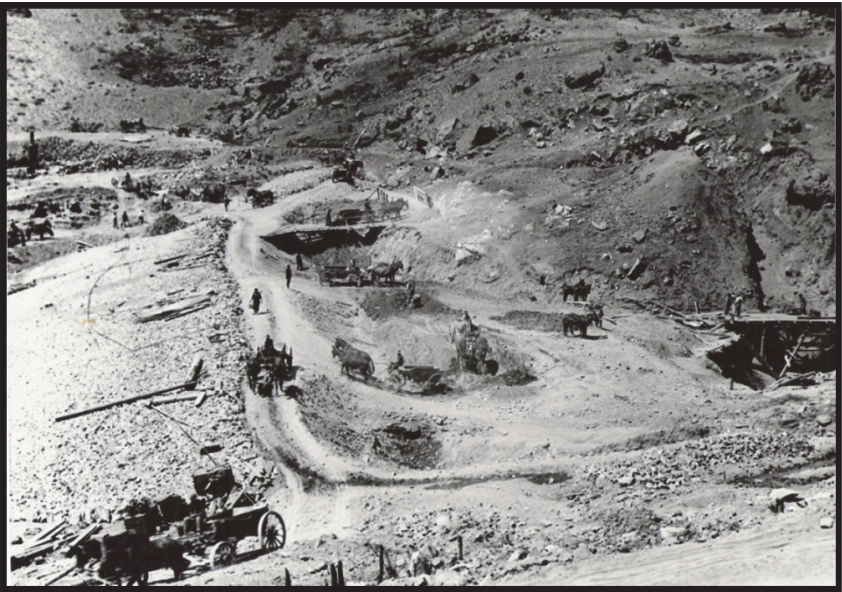
**Photograph 2. Earthfill construction, June 2, 1912**

The earthfill placement was not to exceed two-foot-thick lifts and was compacted by horses and loaded wagons. Over 50 teams of horses or mules were used during the construction. Photograph 2 shows construction of the Rio Grande Dam with horses and loaded wagons. Parallel embankments along the crest line were built up to 1.8 m (6 ft) high with compacted soil and material in between was puddled with water. The puddle trenches or basins were staggered going upward, resulting in a honeycombed pattern. Thus, the puddled sections were allowed to drain and consolidate. Ulrich called this method of construction “the embankment and basin method”.

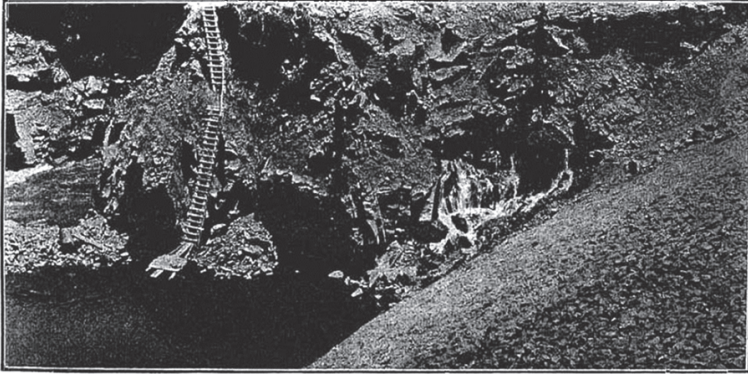
Upon the first filling of the reservoir in 1912, seepage issues were immediately apparent through both the left and right abutments. Seepage exiting the left abutment rock slide deposits is shown in the 1913 photograph, Photograph 3. Seepage in the right abutment bedrock was documented by Atwood (1918) and is shown in the Photograph 4.

C. SOUTH MARGIN OF THE DAM ON THE DOWNSTREAM SIDE, SHOWING LEAKAGE AROUND THE SOUTH END OF THE DAM.

This leakage is through fractured rock. The tunnel opening is near the left margin of the view.

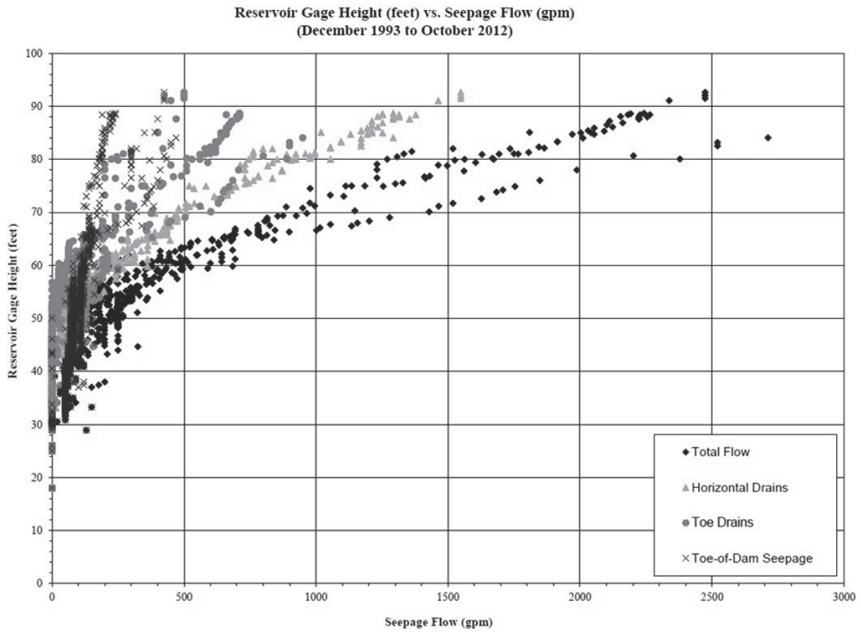
**FIG.4. Reservoir Gage Height Compared to Seepage Source Flows**

The biggest mitigation project for seepage was the 1993 repairs overseen by Harza. Horizontal drains and a rockfill buttress were constructed on the downstream left abutment. Excellent monitoring of seepage flows and piezometer levels have been recorded by the dam caretaker since 1993. The monitoring performed by the dam caretaker consists of water level measurements for 8 standpipe piezometers and water flow measurements of the toe drains, horizontal drain and estimated seepage from the toe of the dam. Monitored seepage rates from 1993 to 2012 through the reservoir are shown in Fig. 4. When the reservoir is full, seepage flows from the horizontal drains exceed 95 L/sec (1,500 gal/min) and an additional 63 L/sec (1,000 gal/min) seeps from the toe of the dam and toe drains for a total of 158 L/sec (2,500 gal/min) total measured flow from all sources.

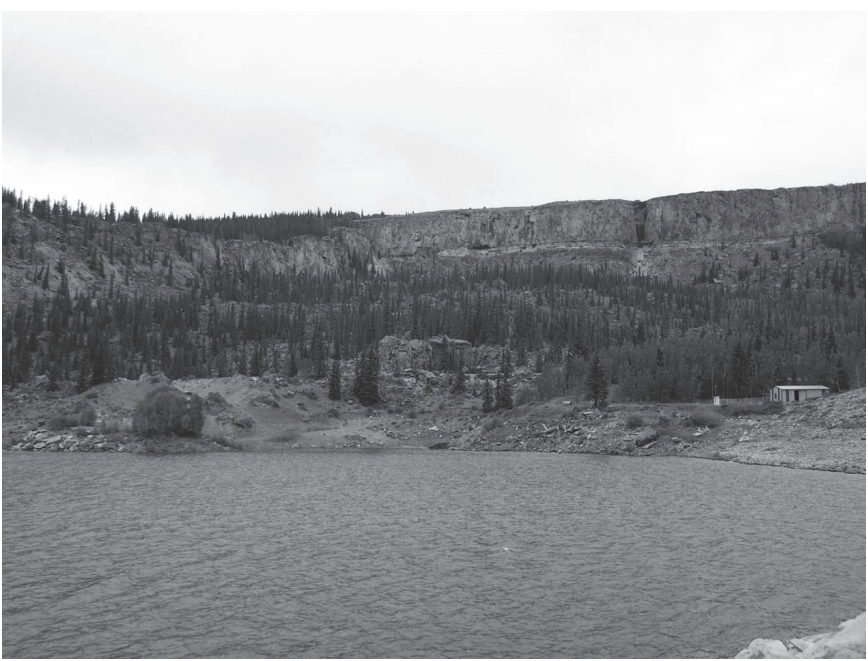
**Photograph 5. Left Abutment Rock Slide Deposits  
(Note tuff cliffs that mark slide scarp)**

This rehabilitation project consisted of the construction of a clay slope liner overlying the upstream left abutment rock slide deposit. The bottom of the slope liner cutoff key was excavated at elevation 2866 m (9404 ft) (Gage Height 12 m (40 ft)). Total measured seepage out of the reservoir below this elevation was determined to be minor compared to the seepage at higher gage heights. The slope liner consisted of two zones of compacted earthfill on the upstream face of the existing left abutment. Zone 1 was constructed as a 6 m (20 ft.) wide zone of clay soils that created an 2.4 m (8 ft) thick core sandwiched between layers of Zone 2. Zone 1 was 3-inch-minus material with a percent passing the No. 200 sieve ranging between 15 and 35 percent, placed in maximum 20.3 cm (8 in) lifts. Zone 2 was 15 cm (6 in) minus material with a percent passing the No. 200 sieve between 5 and 30 percent, placed in maximum 30.5 cm (12 in) lifts. A typical cross-section of the slope liner is shown on Fig. 6. Confirmation Atterberg Limit testing of the Zone 1 material was performed throughout construction of the slope liner. Zone 1 material had an average liquid limit of 48 and plasticity index of 21, classifying the materials as a CL according the USCS.

All materials for the construction of the upstream left abutment slope liner were made on site by screening borrow from the rock slide deposit. As the slope liner zones were constructed from the rock slide deposits with various coarse fractions removed, filter compatibility was naturally achieved. The existing left abutment was prepared by excavation a slope between 2.5:1 and 2:1 on the existing face. Large rafts and boulders were removed by mechanical methods and or dynamite blasting.

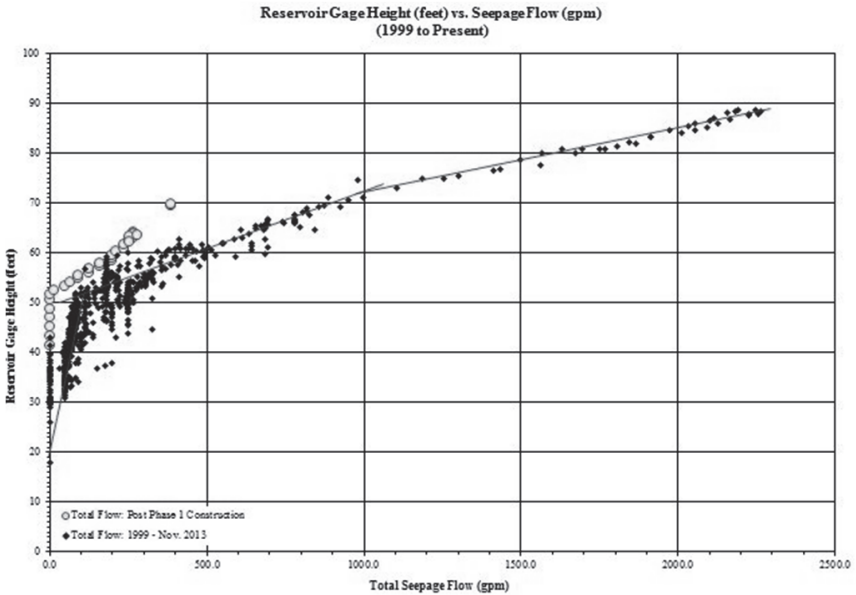
**FIG. 12. Reservoir Gage Height compared to Total Seepage Post-Rehabilitation**

Based on the seepage data collected during re-filling of Rio Grande Reservoir in the first "year" of operation after the completion of the this seepage reduction project (the winter of 2013-2014), it appears that the overall seepage through the left and right abutments and the dam foundation has been reduced by approximately 60 percent from previous seepage measurements recorded at similar reservoir gage height readings. A comparison of historical seepage flows to post-construction seepage results is shown on Fig. 12. Five times since June of 1999, the reservoir has held

water at or near gage height 21 m (70 ft). During those times, the average seepage out of the reservoir was recorded to total between 51 l/s and 63 l/s (806 gal/min and 995 gal/min). The seepage out of the reservoir was recorded to total 24 l/s (385 gal/min) at gage height 21 m (70 ft) this first “year” (the winter of 2013-2014).

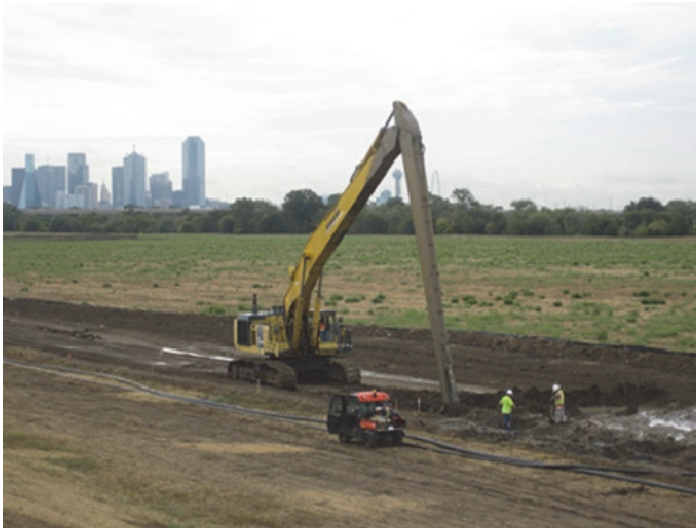
On the East Levee, SB, CB, and Jet-Grout cutoff walls were installed to achieve a maximum specified permeability of  $2.1 \times 10^{-6}$  cm/sec. All three wall types were seamlessly tied together to achieve a continuous wall 4,800 m long at depths of up to 18.9 m below grade keyed into the Eagle Ford Shale, see Photograph 1.

**Photograph 1. East Levee SB cutoff wall construction, heading 1 PC 1250.**

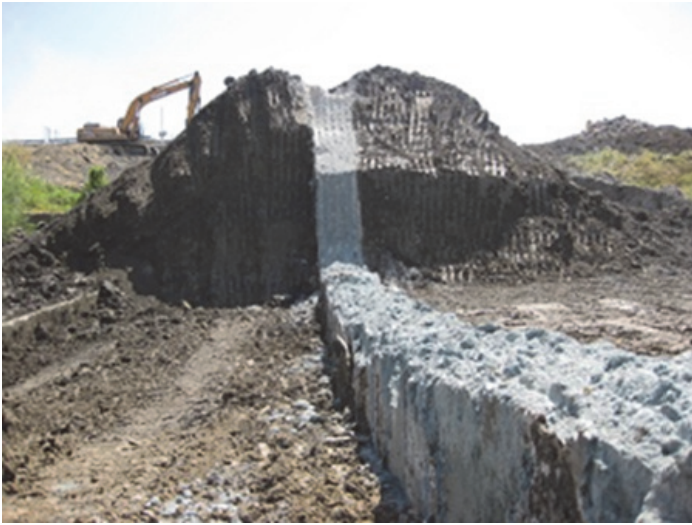
The wall alignment transected two pump station outfall structures. By installing a CB cutoff wall through these outfalls Magnus Pacific was able to avoid shutting down both pump stations at the same time. One pump station was shut down first and a work platform was constructed across the outfall and the CB wall was installed. After sufficient curing and strength gain, the section through the outfall was excavated allowing the pump station to be placed back online before second pump station was shutdown, see Photograph 2.

**Photograph 2. East Levee over-excitation of CB cutoff wall at pump station outfall.**

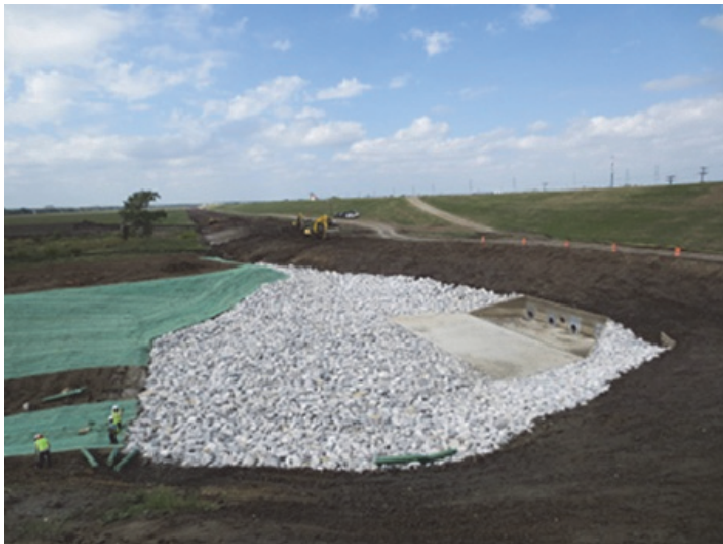
The CB cutoff wall was 200 m long and totaled 2,400 m<sup>2</sup>. After the CB wall was constructed through each outfall structure a clay cap was placed over the wall and on the slope of the outfall. After the clay cap was placed a three layer filter was placed followed by rip rap to protect the slope and outfall from erosion. A completed photo of the Old Hampton Pump Station Outfall prior to being returned to service is shown in Photograph 3.

**Photograph 3. East Levee Old Hampton Outfall.**

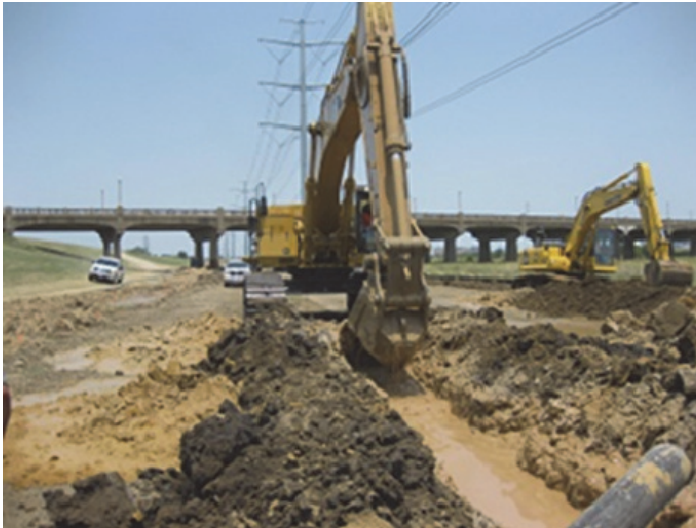
On the West Levee, 800 m of SB and Jet-Grout cutoff walls were installed to depths of 5.8 m below grade. The SB wall was constructed on both sides of a low clearance bridge and keyed into an underlying Austin Chalk, see Photograph 4.

**Photograph 4. West Levee SB cutoff wall construction.**

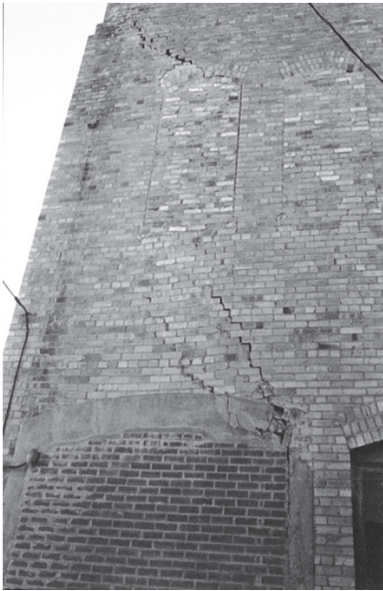
**Photograph 2. Photographs of damaged structures resulting from  
collapsible soils  
(Image Source: White 2008)**

Photograph 1 shows a microscopic photograph of typical collapsible soil. Collapsible soils have caused structural damage to buildings and infrastructure, including damaging differential settlements and pipeline ruptures as shown in Photograph 2.

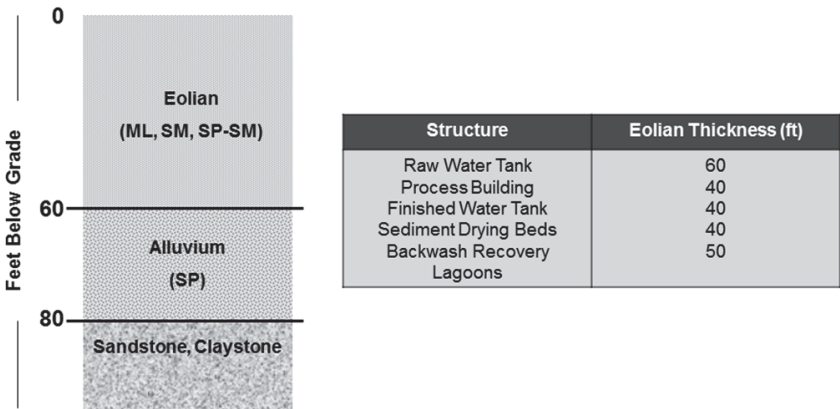
**FIG 4. Generalized soil profile created from geotechnical borings and the anticipated eolian thickness beneath proposed structures**

The borings indicate that subsurface materials generally consist of 8.5 m (28 ft) to 18.3 m (60 ft) of eolian soils. The eolian soils are underlain by dense, coarse alluvium, which was measured to be at least 6.7 m (22 ft) thick in areas. The alluvium is underlain by claystone, siltstone, and sandstone of the Dawson Formation. A generalized soil profile is shown on Fig. 4 and a geologic profile through the treatment train area (not including bedrock) is shown on Fig. 5.

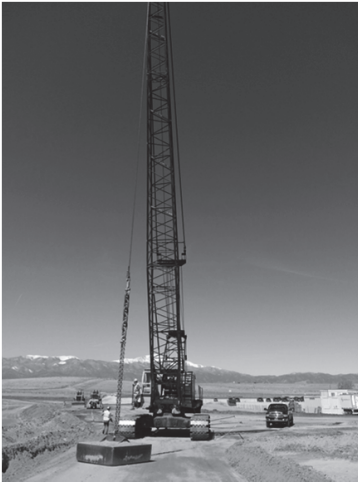
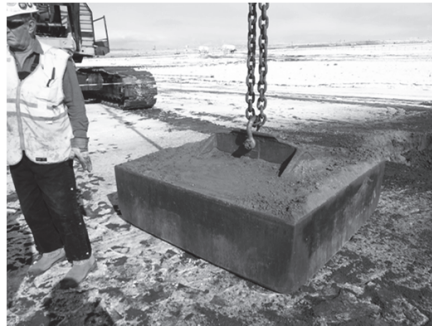
**Photograph 3. Photographs of DDC equipment: (a) Crane with a 21-m height boom; and (b) 14.5-metric ton weight.**

DDC consists of repetitious free-drops of a 88.9 kN (10-ton) to 266.9 kN (30-ton) weight from a height of 15.2 m (50 ft) to 21.3 m (70 ft) (Photograph 3). This puts enormous energy into the ground and in the right soil conditions it can improve soil density for tens of feet in depth. DDC is commonly used for loose, granular soils, for old construction debris fills, and other urban “junk” fills. The application of DDC to collapsible soils is not well documented in the literature; however, a few case histories were identified. Because the eolian soils deposit is essentially loose sand cemented at the grain to grain contacts, it was reasoned that if the compactive energy from the falling weight was enough to break these bonds, then the DDC concept would be effective.

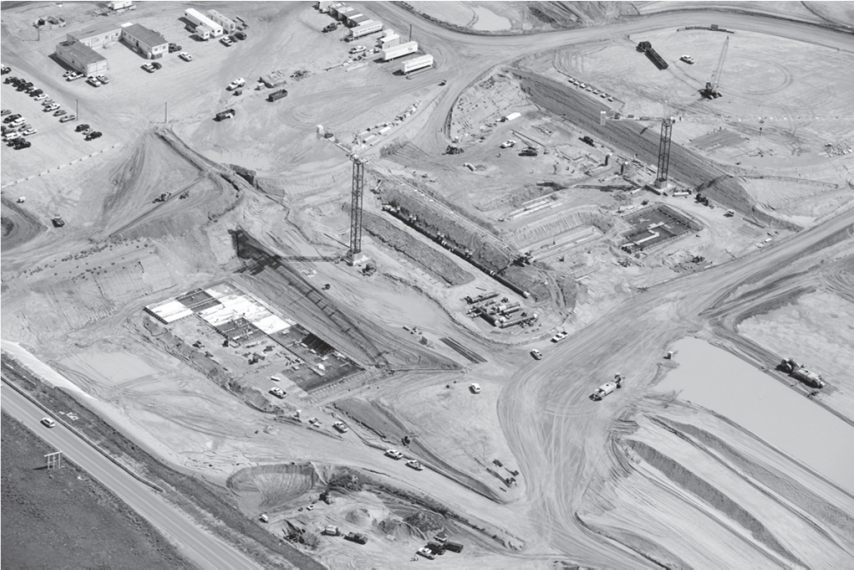
**Photograph 4. Aerial photograph of the main treatment train area (Source: Colorado Springs Utilities, August 2013)**

DDC was considered a viable option for subgrade improvement beneath the concrete-lined lagoon structures (sediment drying beds and backwash recovery lagoons). These structures are not as critical or as sensitive to differential settlement as the main treatment train structures. Therefore, DDC was pursued further for the lagoons and over-excavation, replacement, and recompaction was used for the main treatment train structures (Photograph 4).

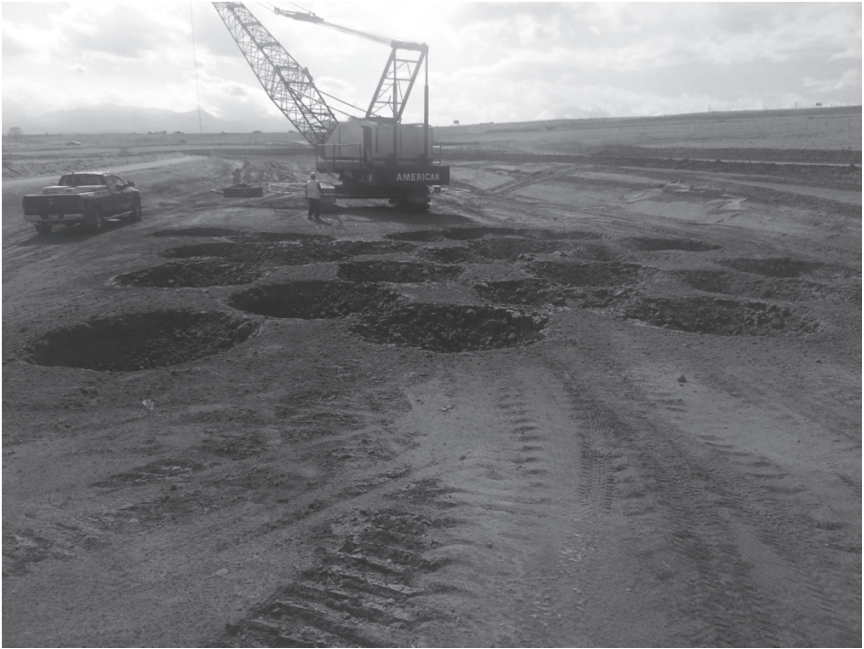
**Photograph 5. Photographs of DDC at the Sediment Drying Beds: (a) Craters formed during the DDC pilot test; and (b) Aerial view of DDC craters formed during production (Source: Colorado Springs Utilities).**

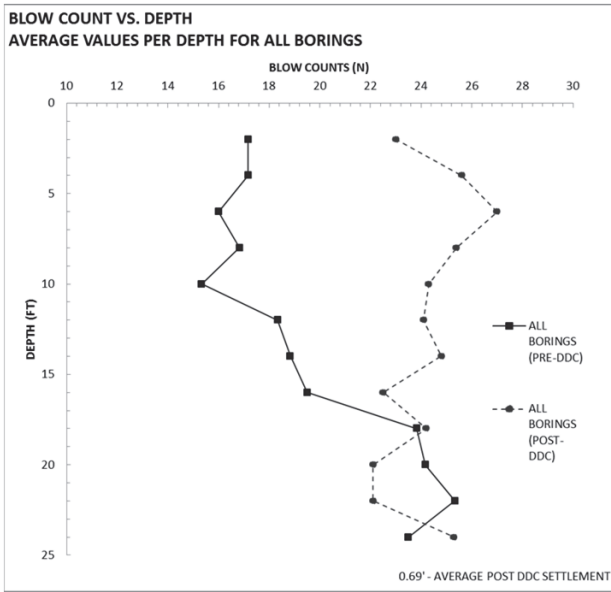
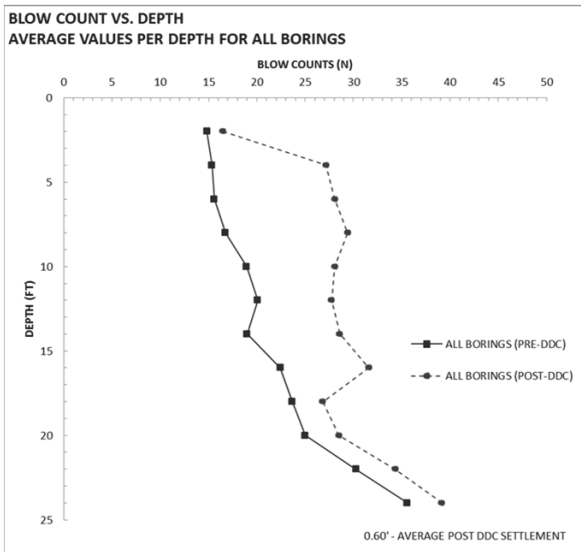
**FIG. 8. Blow count versus depth: (a) Backwash Recovery Lagoon (b) Sediment Drying Beds**

The pilot test was completed in May 2013 and resulted in an average increase in SPT N-value of more than 5 blows per 30.5 cm (1 ft) (N) over roughly the upper 6.1 m (20 ft) of the eolian soils deposit and average surface settlements greater than 6 in, as determined by comparing the before and after ground surface elevations. The pilot test was deemed a success and full production DDC work began in July 2013.

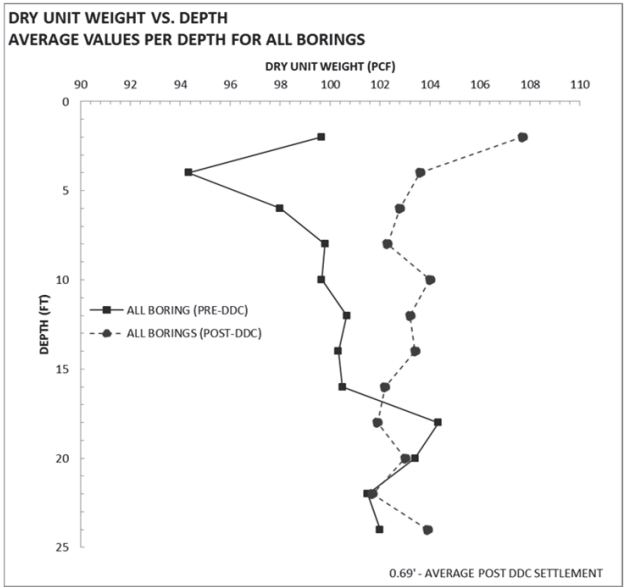
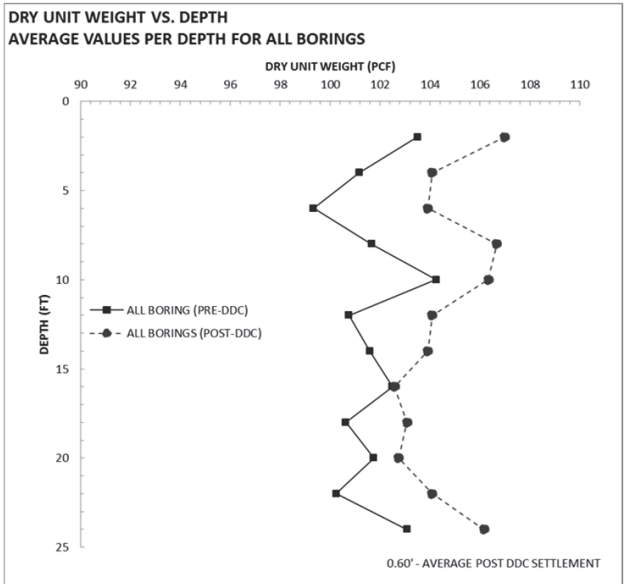
**FIG. 9. Dry unit weight versus depth: (a) Backwash Recovery Lagoon (b) Sediment Drying Beds**

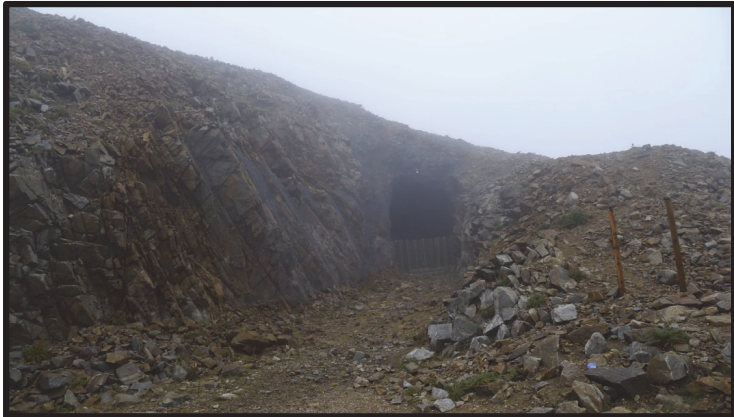
**Photograph 1. Southwest portal overview; note loose rock on left side and low cover over tunnel**

On September 12, 2012, D&A and RPR staff visited the tunnel to observe and photograph the conditions of the rock and the rock support. Aside from its high elevation, two of the striking features of the tunnel are its short length and shallow cover (height of rock above the tunnel). Photograph 1 shows the southwest portal (Rollinsville side). Of note are the steeply dipping joints on the left with accompanying loose rock on the ground. Photograph 2 shows a rock fall from the north crown in the middle of the tunnel. The bolts and mesh are generally in good shape with little corrosion, this is typical for dry, high altitude environments. Photograph 3 shows the shear that forms the north wall and the 1990 rock fall at the northeast portal. Photograph 4 shows the northeast portal looking southwest.

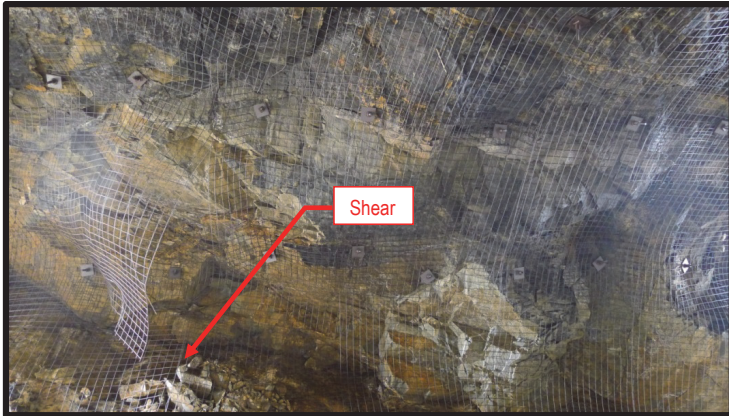
**Photograph 2. Failed mesh and loose rock in mesh near tunnel middle; partial source of rock fall**

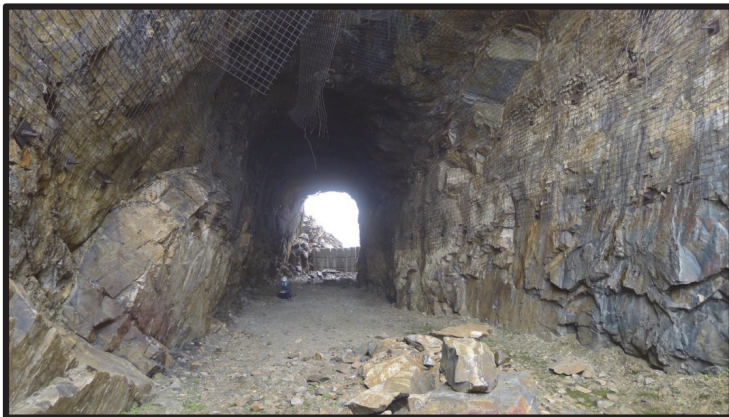
**Photograph 3. Looking southwest with both rock falls visible; note angled tunnel walls**

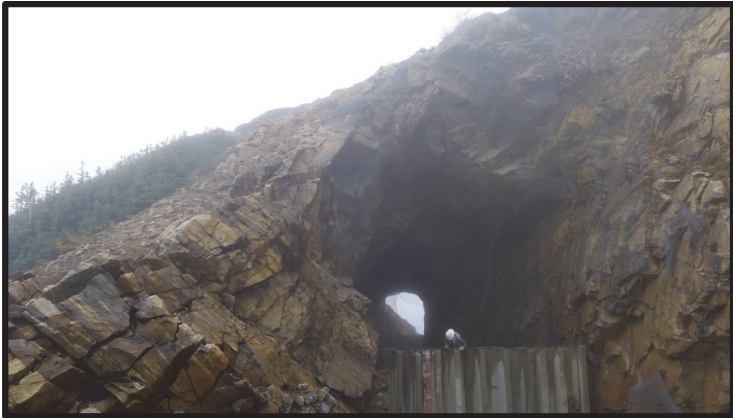
**Photograph 4. Northeast portal overview looking southwest; note the low cover over the tunnel**

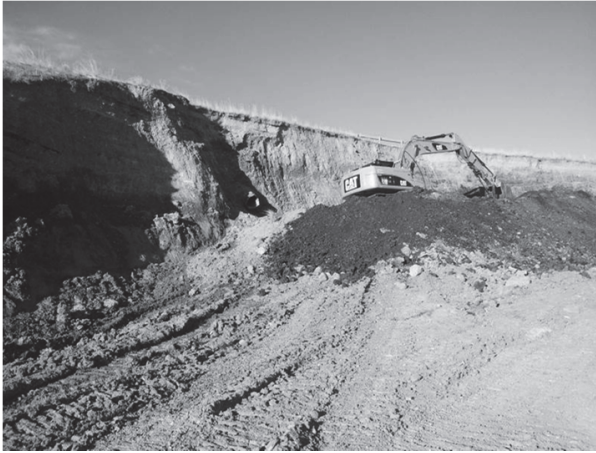
**Photograph 1. Bench Placement**

With WYDOT providing assistance for excavation and traffic control, GSI was able to focus on the head scarp stabilization to prevent further migration into the travel lanes. Benches were initially constructed to provide access to the upper nails. Care

Installation began with top-down construction. Launched nails were installed on a 0.91 m (3 ft) horizontal by 0.91 m (3 ft) vertical pattern at a rate of about 100 nails/work day. Once finished with an area, nails were pressure grouted to provide additional pullout resistance. Near the head scarp area, penetration depths exceeded 4.6 m (15 ft); on areas near the flanks, penetration was less than 3 m (10 ft), in areas. For these cases, GSI performed sensitivity analysis of the slope to ensure acceptable stability. Nails with penetration less than 2.7 m (9 ft) were reinstalled. The variation in the fill material is shown in the fill color difference in Photograph 1 and the nail penetration depth in Photograph 2.

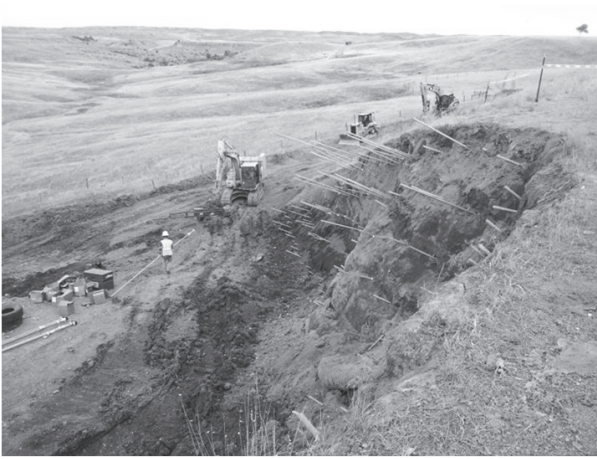
**Photograph 2. Launched Nail Installation**

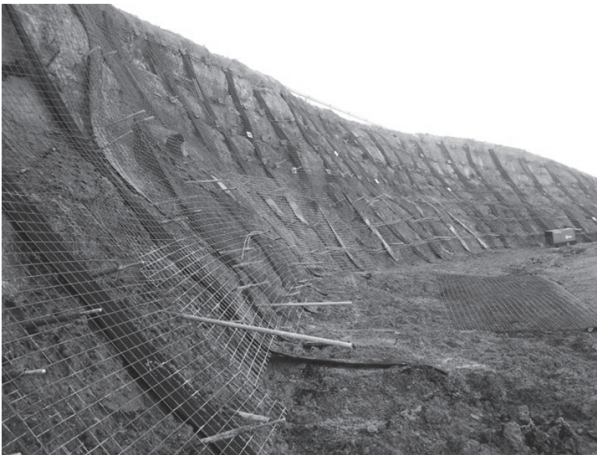
**Photograph 3. Horizontal Drain Placement**

At the bottom of the proposed five rows, significant water and weak soils were encountered. Launched drains (ungrouted perforated launched nail) were installed on a 1.8 m (6 ft) horizontal spacing to reduce hydrostatic pressure in Photograph 3. GSI prepared the slope, installed drain strip and welded wire fabric, and waler bars and was prepared to shoot shotcrete per the original design.

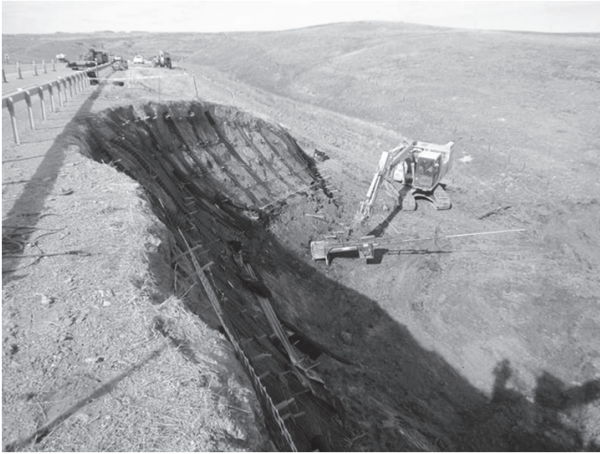
**Photograph 4. Final row installation**

installed below the original five rows. Photograph 4 shows the installation of the last two rows of nails. Bearing plates were welded onto the nails and shotcrete was placed over the majority of the slope, depicted in Photograph 5. Portions of the flanks received only a flexural facing. The amount of water associated with the northern end is also shown Photograph 5. GSI demobilized from the site and WYDOT excavation contractors re-established the slope and constructed the prescribed earthen buttress.

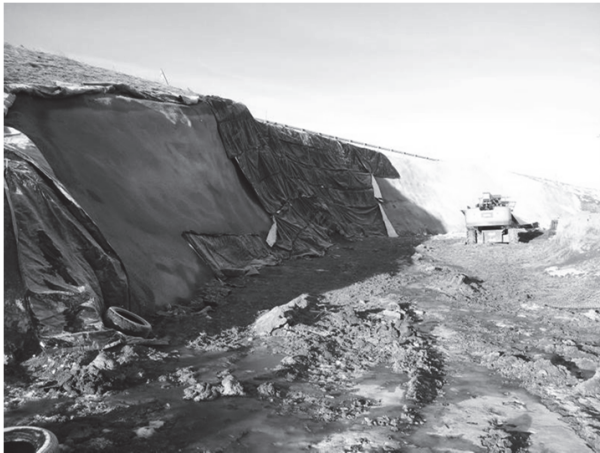
**Photograph 5. Removing Shotcrete Blankets**

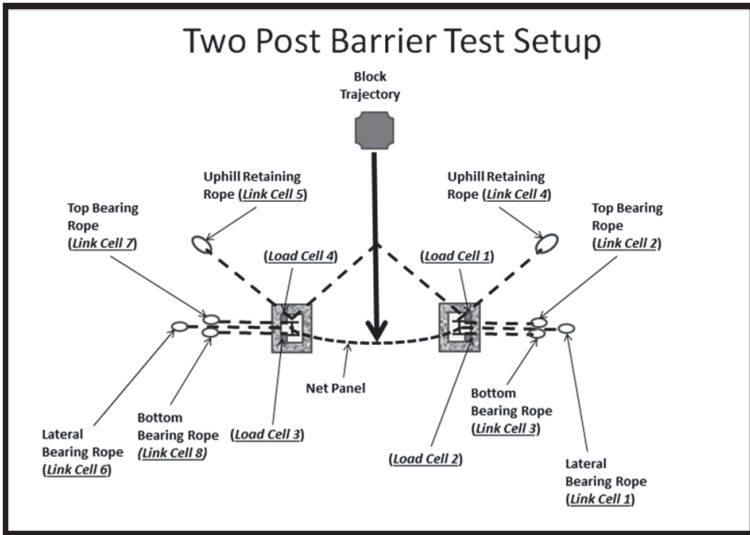
FIG. 5. Elevation View of Typical Setup for Two Post and Barrier System.

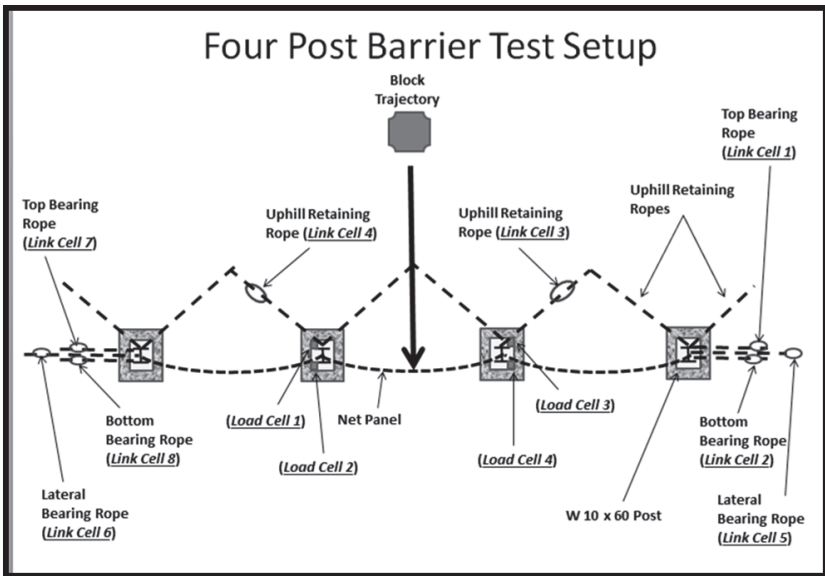
**FIG. 6. Elevation View of Typical Four Post and Barrier Test System.**

Wire Rope Link Cells (depicted in Fig. 6):

- The bottom bearing ropes were subjected to the highest tensile loading conditions.
- The range of loading on the wire rope anchor systems appeared to be more repeatable from test to test when compared to the two post system.
- During Test I, the foundation post broke at the weld in overturning and not in shear at the base (Photograph 5).
- Deflection was limited to 4.2 m for the 911 kJ tested system but it was necessary to use slack braking systems (Photographs 6 and 7).

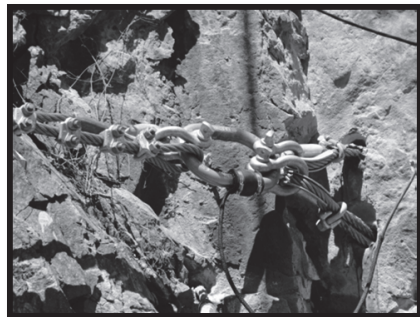
**Photograph 4. Center of Photograph Shows Link Cell for Measuring Tensile Loads in Wire Ropes.**

- Circular link cells were attached to the two upper and two lower bearing ropes and uphill and lateral retaining ropes (Photograph 4).
- Vertically dropping a 1,551 kg block from either 18.3 m or 36.6 m to generate 278 kJ or 578 kJ of energy, respectively.

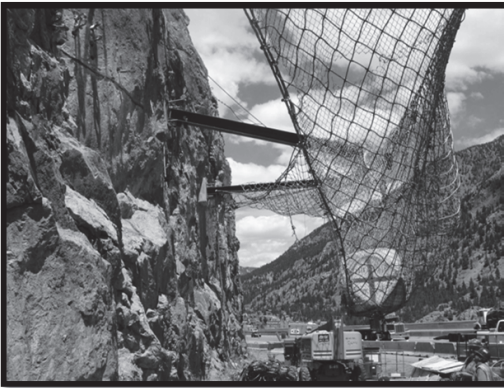
**Photograph 5. Broken Post Resulting from Test I. (Per ETAG 27 this could be considered a Category A test since it stopped the rock and the residual height would be greater than 50 percent).**

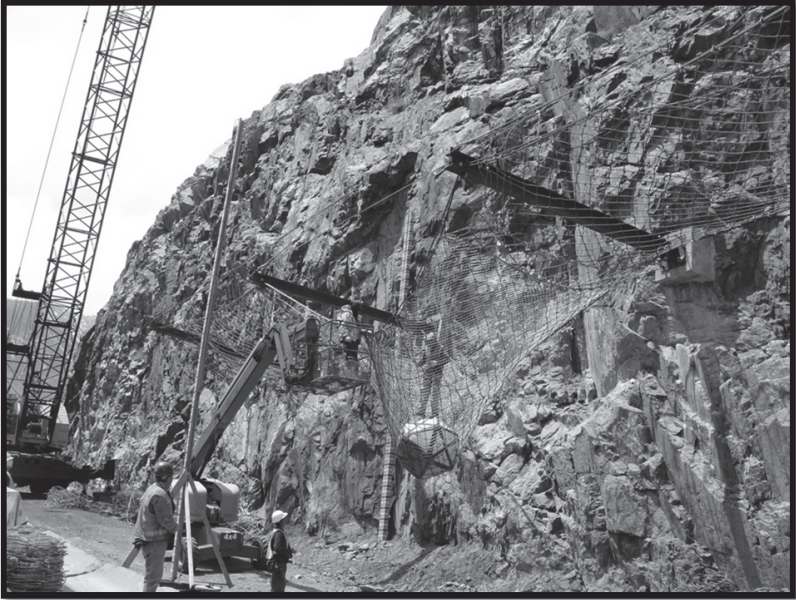
**Photograph 6. Side View of Actual Post and Barrier Test System for Four Posts for Test L – 911 kJ test.**

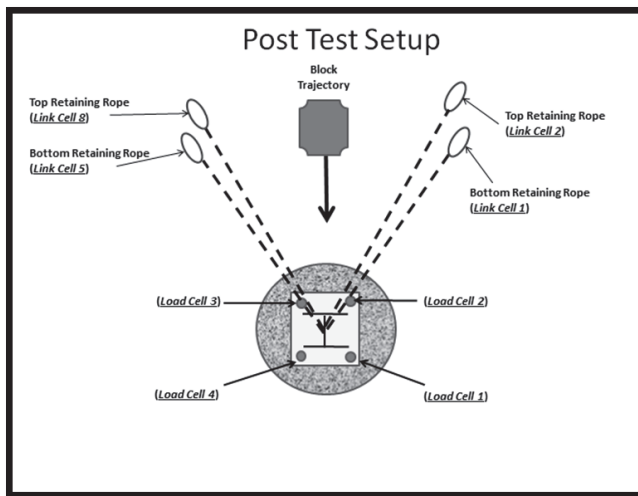
FIG. 7. Anchor test site plan view of set up with load and link cell designations.

Fig. 7 depicts the plan view of the anchor test site setup with the load and link cell designations. Photographs 8 and 9 show a side view and elevation (front) view of the testing setup. Photograph 10 shows the location and tightening of load cells. Photograph 11 shows the link cell anchored to the concrete barrier system.

- As with all testing, the instrumentation data can be evaluated by many different methods that can provide various results within a given framework. The maximum change in loading was evaluated for this publication.
- Load cells were placed to measure the tension in the grouted 25 mm foundation bars (Fig. 7 and Photograph 10). Link cells were placed to measure the tension in the wire rope systems (Fig. 7 and Photograph 11).

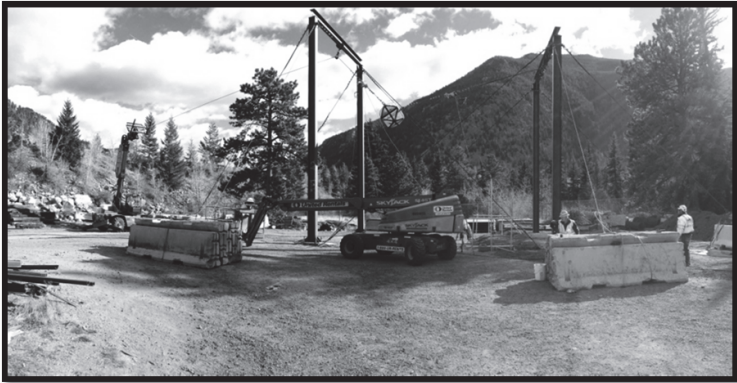
**Photograph 8. Side view of the test site setup. Rock is released and swings to right side of photograph.**

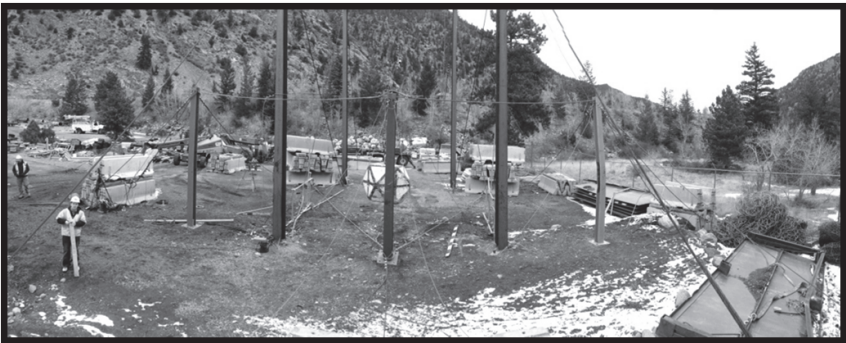
**Photograph 9. Front view of the test site setup. Rock is directly behind test post prior to raising it.**

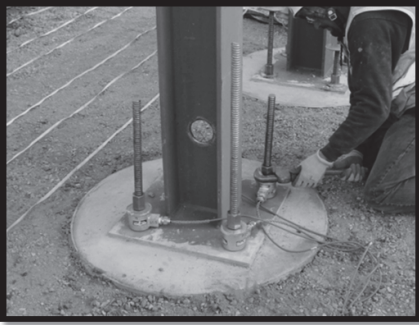
**Photograph 10. Location and tightening of load cells prior to testing.**

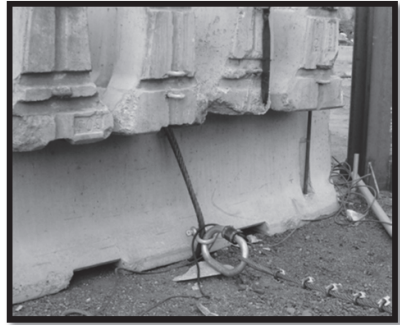
**Photograph 11. Link cell of uphill wire rope anchors attached to the concrete barrier system.**

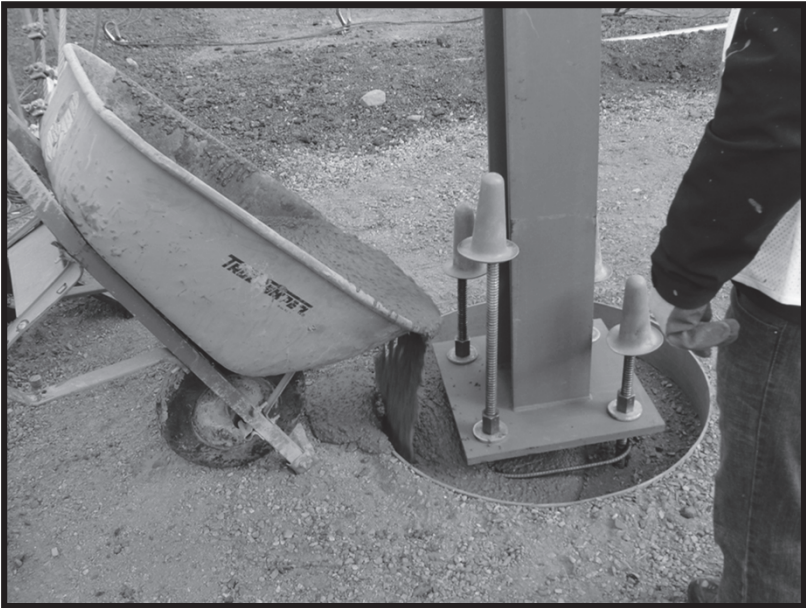
Photograph 12. Pouring the concrete foundation pad around the grouted bar elements.

Photograph 12 shows pouring concrete base pad. Fig. 8 depicts the typical cross section of the system.

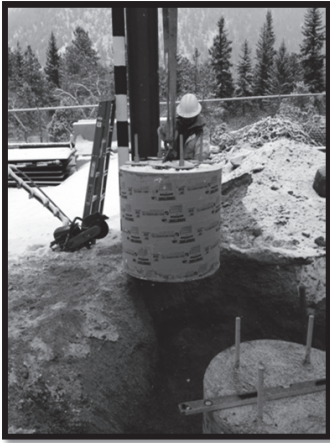
**Photograph 13. Installation of circular concrete shaft post foundation systems with completed system compacted in place.**

Post bases consisting of a circular concrete shaft embedded approximately 0.91 m (B series) and 1.82 m (C series) in ground. Foundations were backfilled with well graded material that was compacted. No uphill wire rope support anchors (Photograph 13 and Fig. 9).

Photograph 13 shows construction of the circular concrete shafts. Fig. 9 depicts the typical cross section of the system.

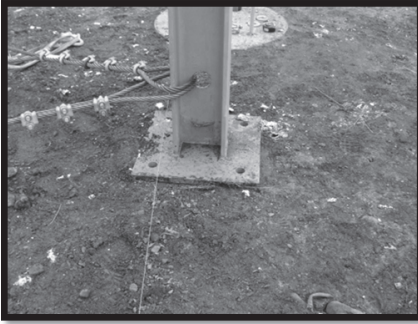
Photograph 14. Typical setup for F series test.

- F-series was W8x48 post that was 4.5 m high with square 508 mm by 508 mm by 25 mm thick base plate in contact with the ground. (Photograph 14)
- G-series was W8x48 post that was 4.5 meters high with circular 457 mm diameter by 25 mm thick base plate in contact with ground. Base had wire rope protective sleeves for bottom wire rope anchor. Post was also set on approximate 20 degree angle to approximate placement on a slope. (Photograph 15). Fig. 12 depicts the typical setup.

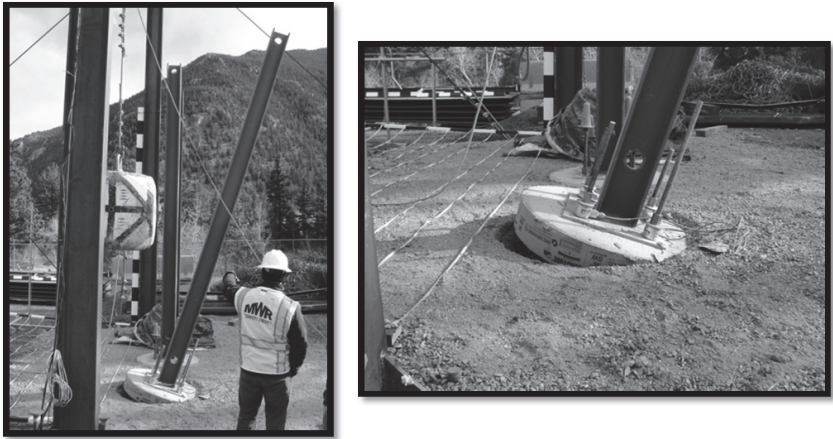
- At 19.7 kJ of energy (50.8 kN of horizontal force), the entire post system rotated in a moment failure.
- Virtually no damage to post, concrete, or foundation elements. Uphill bar elements pulled out of ground.
- Both rear and front foundation bar elements were in tension.

**Photograph 16. Results of 19.7 kJ test for A series test.**

Photograph 16 shows the results of the 19.7 kJ test with no uphill anchors on grouted bar foundation system.

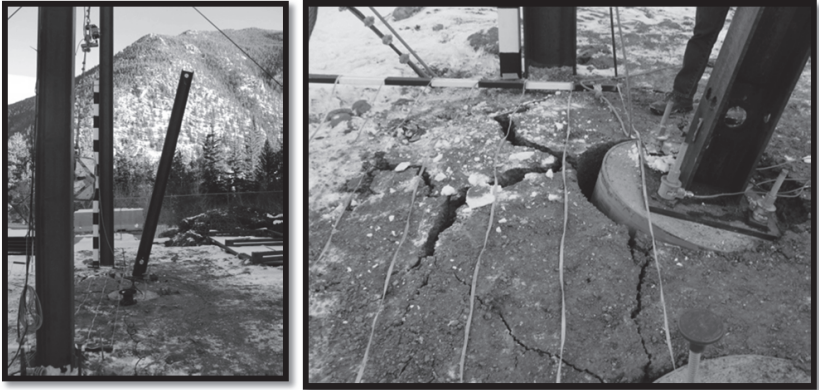
- At 19.7 kJ of energy (50.8 kN of horizontal force), the entire post foundation that was embedded 0.9 m in ground rotated outward in moment failure of confinement of the surrounding soil.
- Virtually no damage to post, concrete, or foundation concrete.
- Both rear and front foundation bar elements were in tension but at approximately 50 percent loads of the A series tests.
- Summing moments around the post base using the horizontal impulse moment versus the passive resistance indicates the 0.9 m embedment is insufficient to withstand the post rotation, which is illustrated in the soil failure condition depicted in the photos.

**Photograph 17. Results of 19.7 kJ test for B series test.**

Photograph 17 shows the results of the 19.7 kJ test with no uphill anchors on 0.9 m deep foundation system.

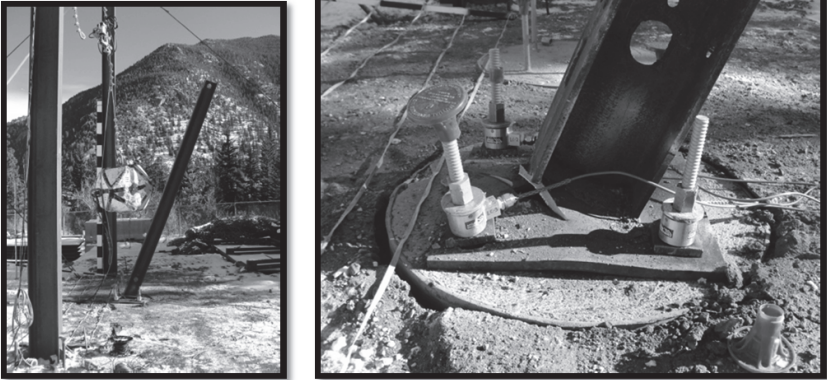
- At 19.7 kJ of energy (50.8 kN of horizontal force), minor damage was observed to post foundation that was embedded 1.8 m (6 feet) in the ground.
- At 67.8 kJ of energy (94.3 kN of horizontal force) significant damage was observed to post foundation plate. No damage to circular shaft foundation embedded 1.8 m (6 feet) in the ground.
- Both rear and front foundation bar elements were in tension at loads similar to A series tests.

- Summing moments around the post base using the horizontal impulse moment versus the passive resistance indicates the 1.8 m embedment is sufficient to withstand the post rotation at impacts up to 19.7 kJ, but is insufficient to withstand the post rotation at impacts up to 67.8 kJ. Since this is a rigid system, the post base was the weakest link and failed.

**Photograph 18. Results of 67.8 kJ test for C series test.**

Photograph 18 shows the results of the 67.8 kJ test with no uphill anchors on a 1.8 m deep foundation system.

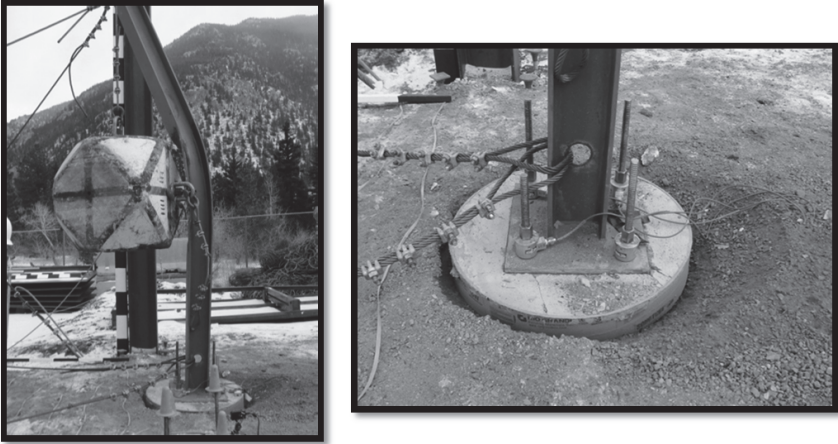
- A series of five successive tests was conducted on this system ranging in energy from 8.9 to 112.8 kJ.
- Post system had both top and bottom uphill wire rope anchors on grouted bar foundation system.
- At 112.8 kJ of energy (144.6 kN of horizontal force), much less damage was observed to post bar and concrete foundation system as compared to D series

- The overall tension to the bar foundation elements was similar to D series tests.

**Photograph 20. Results of 112.8 kJ test for E series test.**

Photograph 20 shows the results of the 112.8 kJ test with both top and bottom uphill anchors on grouted bar foundation system.

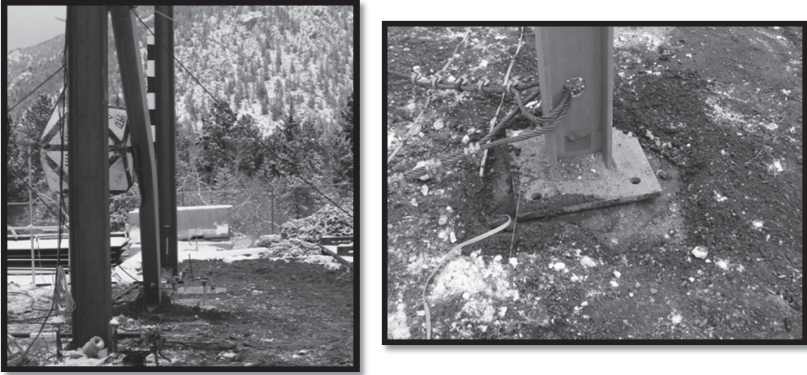
- A series of two successive tests was conducted on this system at 95.8 kJ.
- Post system had both top and bottom uphill wire rope anchors on a floating steel base foundation system.
- At 95.8 kJ of energy (133.3 kN of horizontal force), slight post damage. The post was bent but the system was still functioning overall.
- The overall loads in the wire rope anchors were higher than other tests, but still well within capacities for reasonable anchor pullout and wire rope strength.

**Photograph 21. Results of 95.8 kJ test for F series test.**

Photograph 21 shows the results of the 95.8 kJ test with top and bottom uphill anchors on a floating steel plate foundation.
