# ROCKY MOUNTAIN GEO-CONFERENCE 2014

GEOTECHNICAL PRACTICE PUBLICATION NO. 9

PROCEEDINGS OF THE 2014 ROCKY MOUNTAIN GEO-CONFERENCE

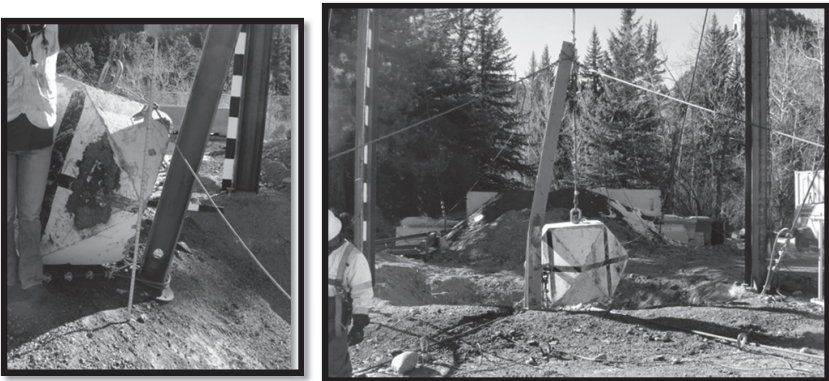
- A series of two successive tests was conducted on this system at 264.9 kJ.
- Post system had both top and bottom uphill wire rope anchors on a circular floating steel base foundation system that was inclined approximately 20 degrees.
- At 217.5 kJ of energy (264.9 kN of horizontal force), the post was bent but the system was still functioning overall.

- The overall loads in the wire rope anchors were higher than other tests, but still well within capacities for reasonable anchor pullout and wire rope strength for 25 mm (1 in) diameter.

**Photograph 22. Results of 217.5 kJ test for G series test.**

Photograph 22 shows the results of the 217.5 kJ test with top and bottom uphill anchors on a circular floating steel plate foundation.
