# **The Nalco Guide to Cooling Water System Failure Analysis**

**Nalco Chemical Company**

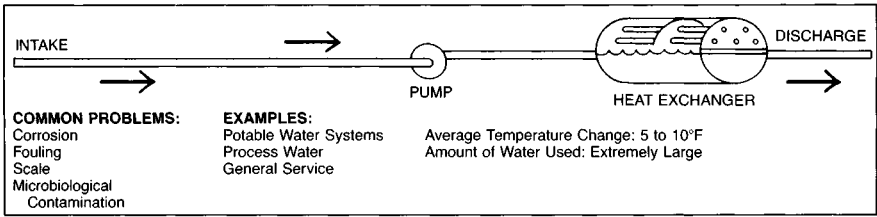
Figure 1.1 Schematic of once-through cooling system.

Cooling water systems are either open or closed, and water flow is either once-through or recirculating. The three basic types of cooling water systems are once-through, closed recirculating (nonevaporative), and open recirculating (evaporative). Each is shown schematically in Figs. 1.1 through 1.3.

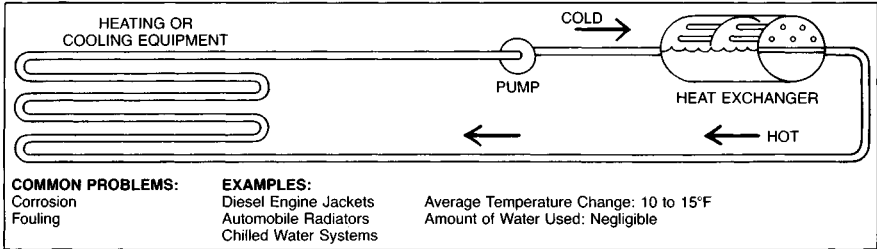
Figure 1.2 Schematic of closed recirculating cooling system.

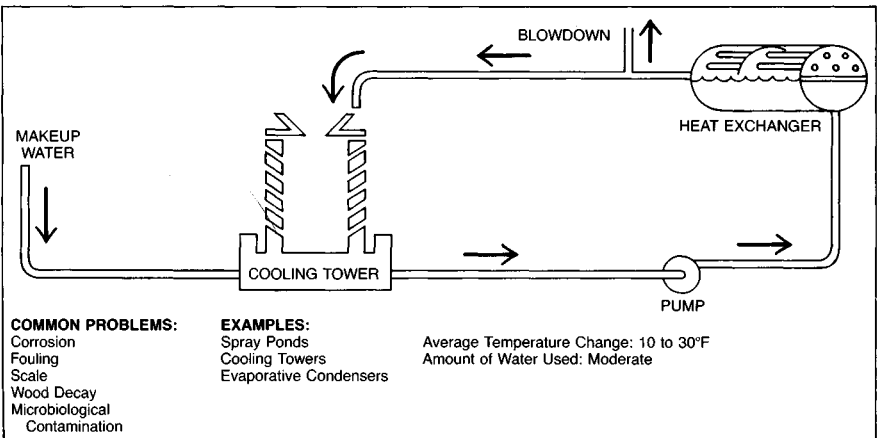
Figure 1.3 Schematic of open recirculating cooling system.

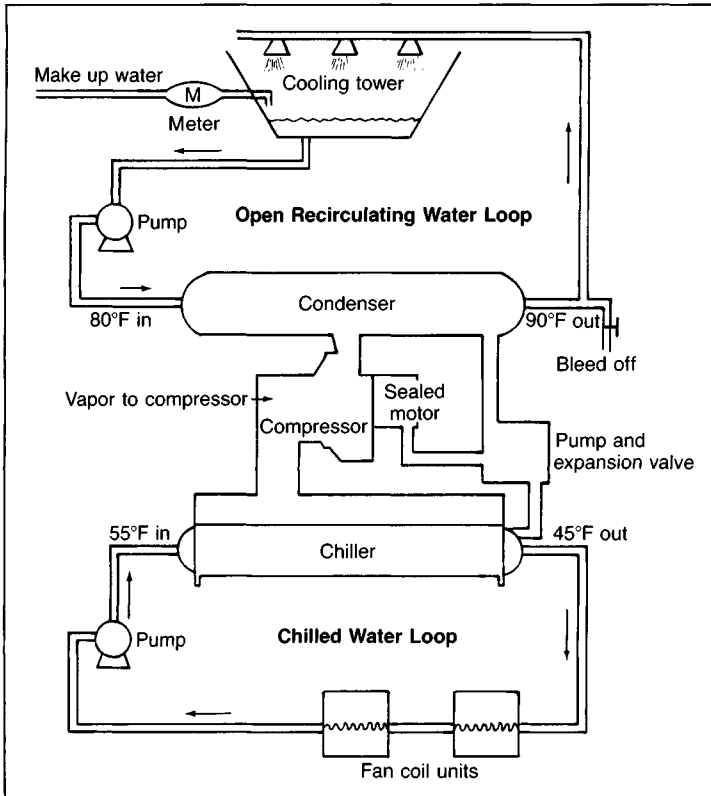
**Figure 1.4** Schematic of all components of a complete air-conditioning system. [Fig. 37.8, *The Nalco Water Handbook*, 1st ed. (1979), reprinted with permission from McGraw-Hill, Inc.]

Open recirculating systems employing cooling towers and spray ponds allow the dissipation of enormous heat loads while limiting the amount of water consumed. An open recirculating water loop joined to a closed loop used in an air-conditioning system is diagrammed in Fig. 1.4. Typical hyperbolic cooling towers in a utility are shown in Fig. 1.5. Once-through cooling takes water from a plant supply, passes it

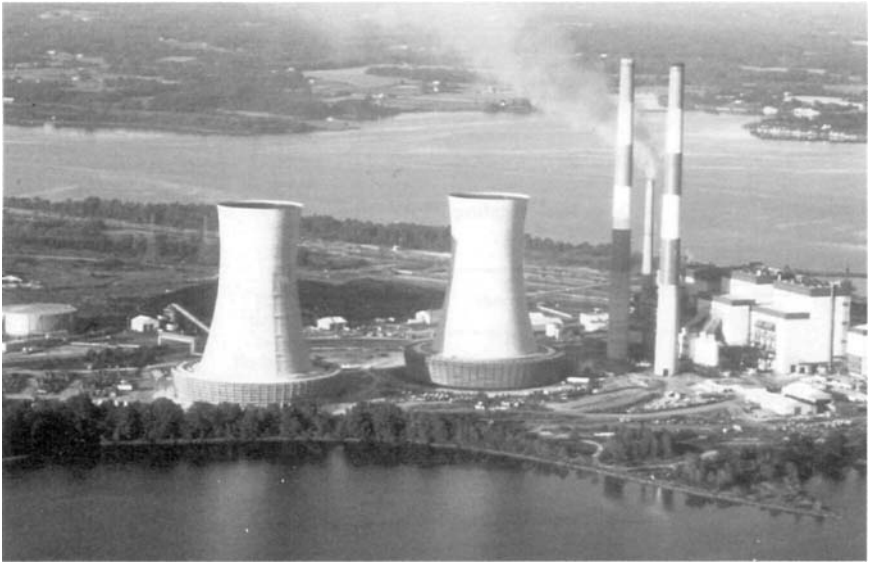
**Figure 1.5** Hyperbolic towers cooling condenser water in a utility station. [Fig. 38.10, *The Nalco Water Handbook, 1st ed. (1979)*, reprinted with permission from McGraw-Hill, Inc., Courtesy of The Marley Company.]

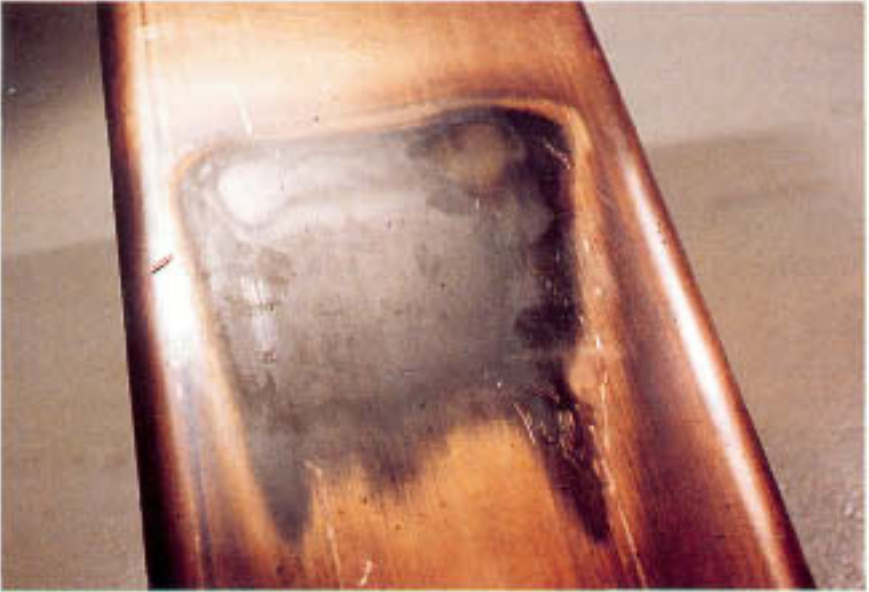
**Figure 1.6** Dark oxide and deposit lobes on a copper continuous caster mold from a steel-making operation. Since heat transfer is high, even small amounts of deposit are unacceptable.

produced, however. Often, closed systems are used in critical cooling operations where even a small amount of deposit cannot be tolerated (Fig. 1.6).

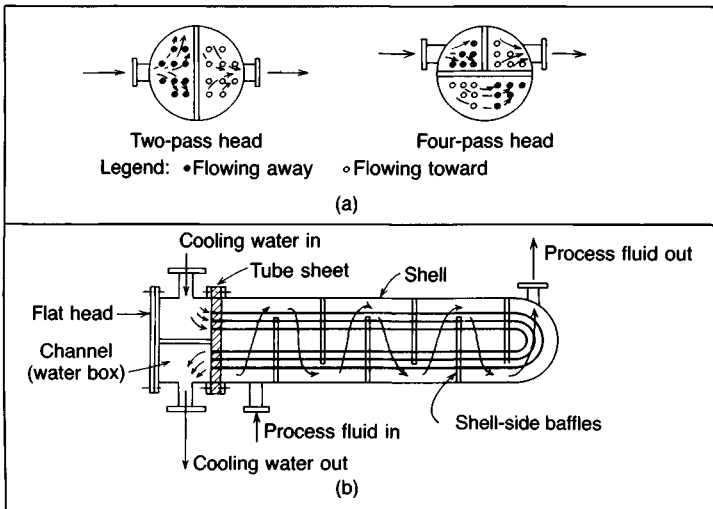
**Figure 1.7** Simple detail of shell-and-tube heat exchanger. The water box may be designed for as many as eight passes, and a variety of configurations of shell-side baffles may be used to improve heat transfer. (a) Several water box arrangements for tube-side cooling. (b) Assembly of simple two-pass exchanger with U-tubes. [Fig. 38.2, *The Nalco Water Handbook*, 1st ed. (1979), reprinted with permission from McGraw-Hill, Inc.]

Heat exchangers have two common designs: shell-and-tube and plate-and-frame designs. Shell-and-tube heat exchangers are very common. A typical shell-and-tube design is shown in Fig. 1.7. The most frequently affected component in the shell-and-tube exchanger is the tubes. Corrosion fatigue, stress-corrosion cracking, erosion-corrosion, underdeposit attack, dealloying, oxygen corrosion, and many other forms of wastage frequently occur. Tube sheets, baffles, and water boxes also may be damaged by any of the aforementioned mechanisms.

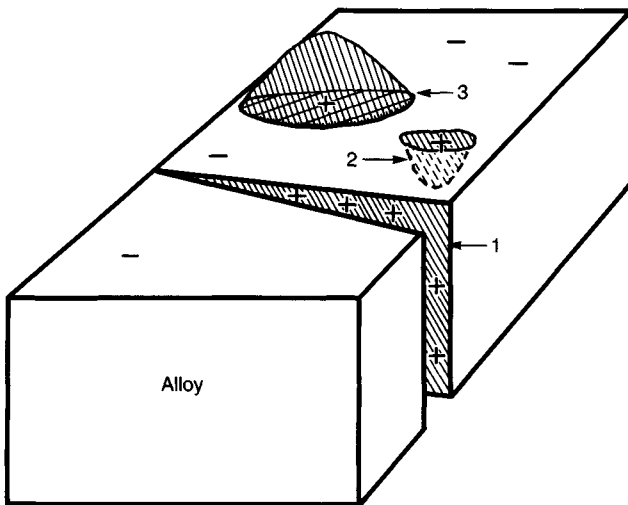
**Figure 2.1** Region of local action cells in an alloy immersed in an electrolyte. 1. Crevice, 2. pit, 3. deposit. Shaded regions are anodic (+) to surrounding metal (-).

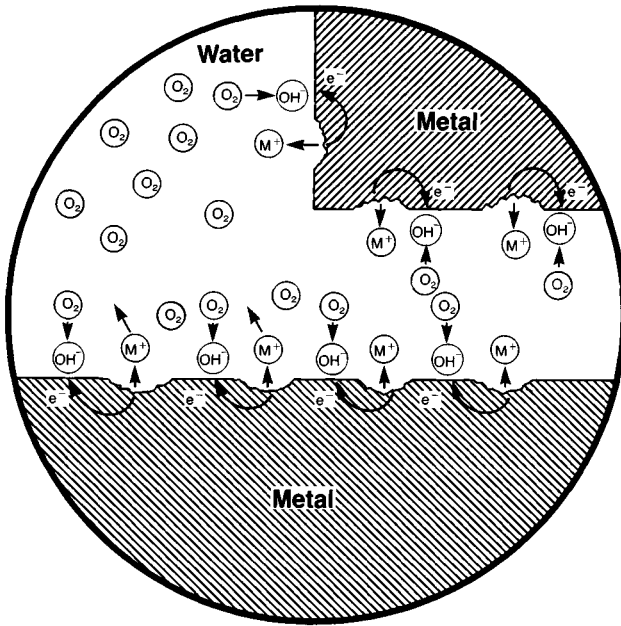
Figure 2.2 Initial stage of corrosion near a crevice.

These reactions are shown schematically near a crevice in Fig. 2.2. Many other reactions may occur at anodes and cathodes, but Reactions 2.1 and 2.2 predominate on carbon steel, for example, in near neutral pH, oxygenated water.

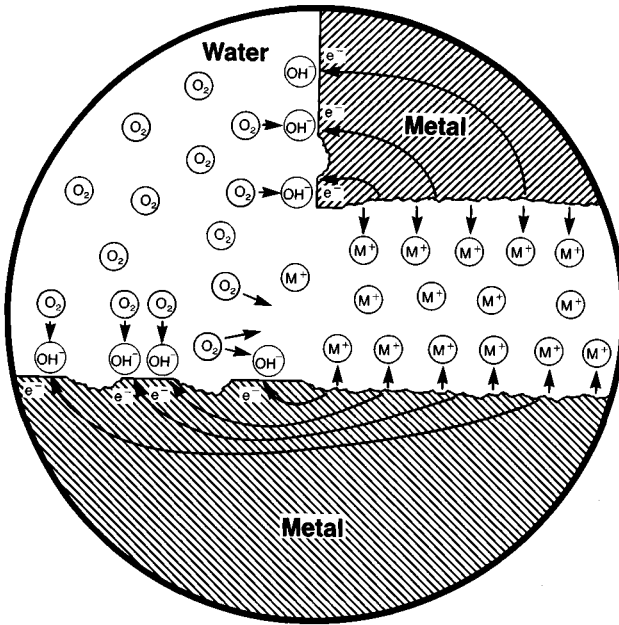
**Figure 2.3** Later stage as in Fig. 2.2 when an oxygen concentration cell is established between regions inside and outside the crevice. Oxygen has been depleted inside the crevice.

Oxygen concentration is held almost constant by water flow outside the crevice. Thus, a differential oxygen concentration cell is created. The oxygenated water allows Reaction 2.2 to continue outside the crevice. Regions outside the crevice become cathodic, and metal dissolution ceases there. Within the crevice, Reaction 2.1 continues (Fig. 2.3). Metal ions migrating out of the crevice react with the dissolved oxygen and water to form metal hydroxides (in the case of steel, rust is formed) as in Reactions 2.3 and 2.4:

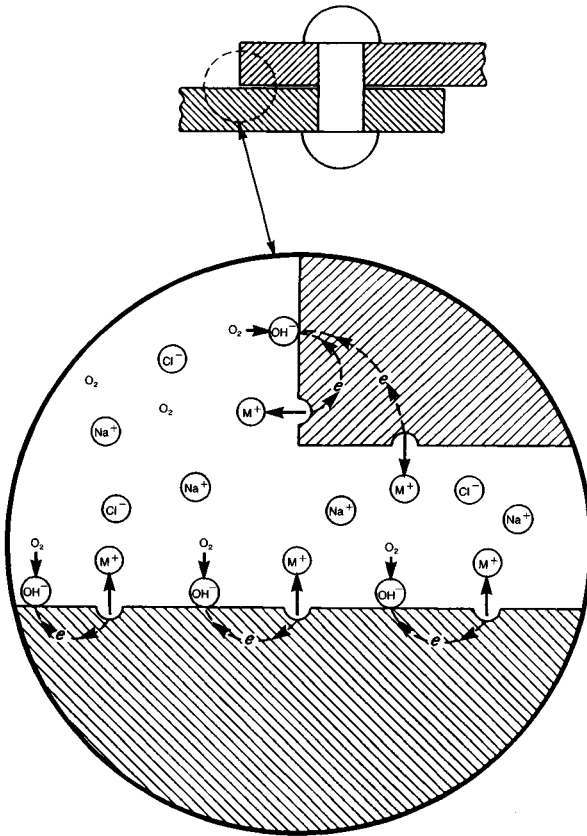
**Figure 2.4** Crevice corrosion—initial stage in oxygenated water containing sodium chloride. (Courtesy of Mars G. Fontana and Norbert D. Greene, *Corrosion Engineering*, McGraw-Hill Book Company, New York City, 1967.)

As metal ion concentration increases in the crevice, a net positive charge accumulates in the crevice electrolyte. This attracts negatively charged ions dissolved in the water. Chloride, sulfate, and other anions spontaneously concentrate in the crevice (Figs. 2.4 and 2.5). Hydrolysis produces acids in the crevice, accelerating attack (Reactions 2.5 and 2.6). Studies have shown that the crevice pH can decrease to 2 or less in salt solutions having a neutral pH.

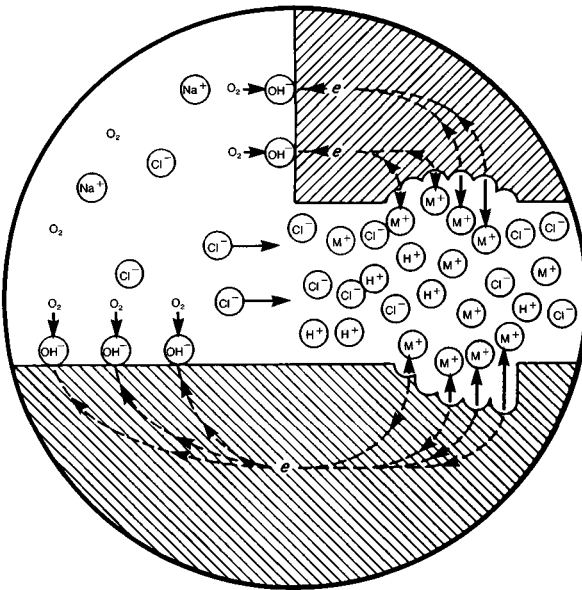
**Figure 2.5** Crevice corrosion—final stage in oxygenated water containing sodium chloride. (Courtesy of Mars G. Fontana and Norbert D. Greene, *Corrosion Engineering*, McGraw-Hill Book Company, New York City, 1967.)

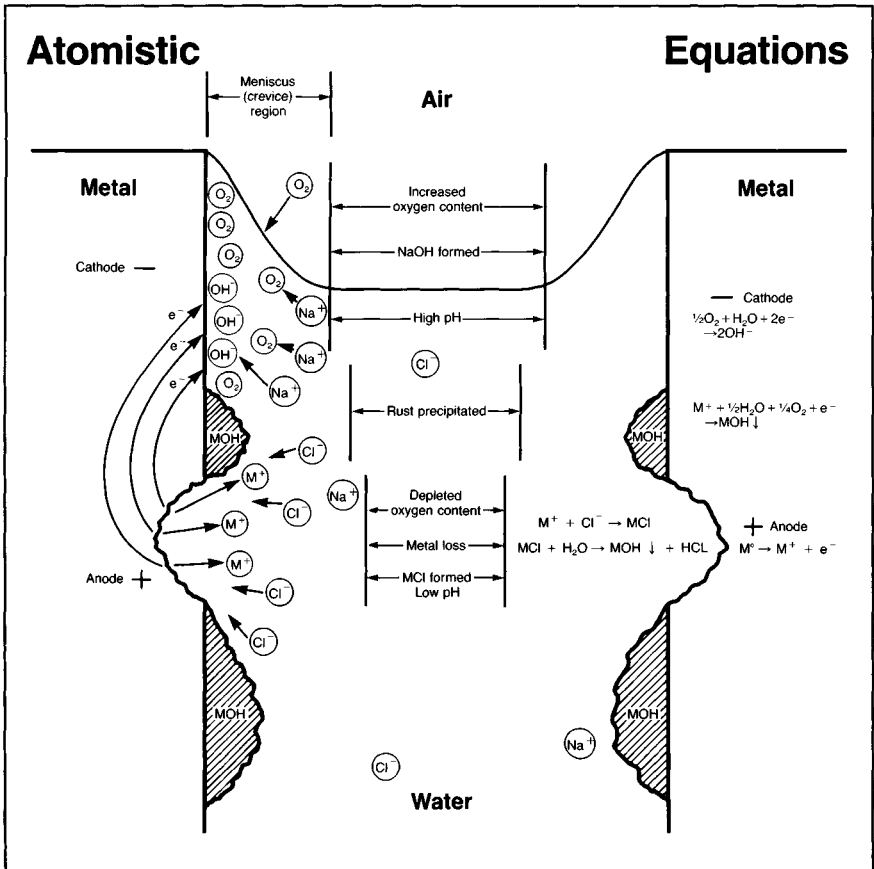
Figure 2.6 Differential aeration cell at a waterline. Water contains sodium chloride.

attracted to the anodic regions. Rust (on steel) or other metal hydroxides usually precipitate nearby. This process is shown in Fig. 2.6.

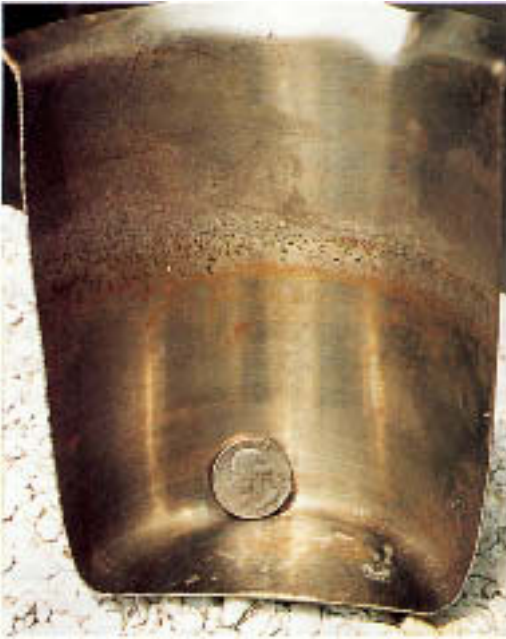
**Figure 2.7** Severe waterline attack in stainless steel beaker. The beaker contained a chlorinated biocide tablet in water over a weekend. Perforations occurred in 40 hours or less, giving a minimum corrosion rate of 4380 mils (11.1 cm) per year at the perforations.

A (316) stainless steel beaker that failed by waterline attack is shown in Fig. 2.7. The beaker contained water into which a chlorinated biocide tablet had been placed. The 0.020-in.-thick (0.051 cm) beaker material perforated near the waterline in less than 40 hours. This corresponds to a minimum localized attack rate of 4.4 in. (11 cm) per year.

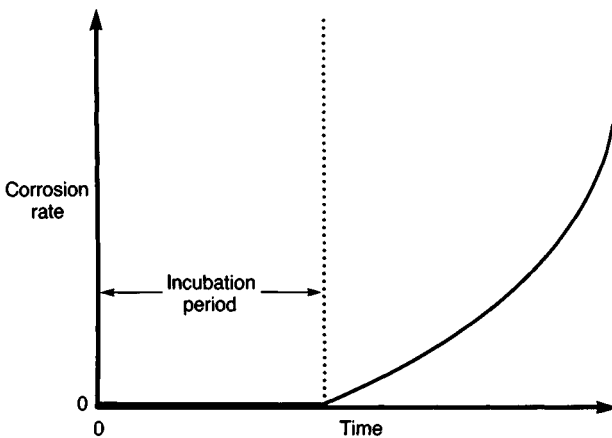
**Figure 2.8** Schematic representation of corrosion rate as a function of time in a crevice in stainless steel exposed to chloride-containing water. The time before corrosion initiation is called the incubation period.

There is often a period before corrosion starts in a crevice in passivating metals. This so-called incubation period corresponds to the time necessary to establish a crevice environment aggressive enough to dissolve the passive oxide layer. The incubation period is well known in stainless steels exposed to waters containing chloride. After a time period in which crevice corrosion is negligible, attack begins, and the rate of metal loss increases (Fig. 2.8).

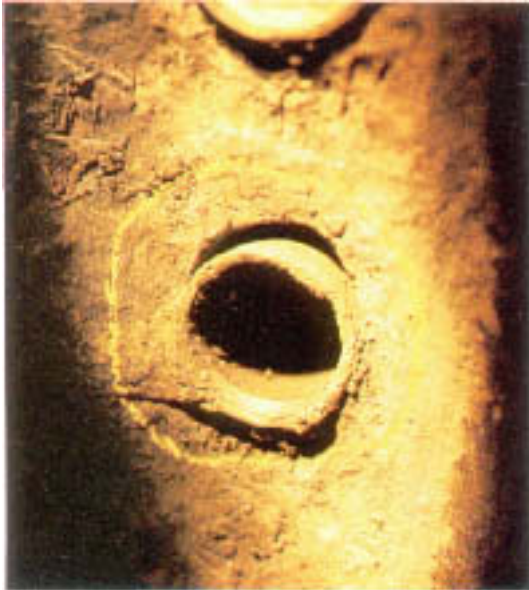
**Figure 2.9** Severely attacked crevice between rolled brass heat exchanger tube and mild steel tube sheet.

Copper alloys often show only weak crevice corrosion. This is especially the case if the copper alloy is coupled to a less noble alloy such as steel. The corrosion of the steel is stimulated by the galvanic effect caused by the coupling of dissimilar metals. Hence, the sacrificial corrosion of the steel protects the copper alloy (Fig. 2.9). See Chap. 16, “Galvanic Corrosion.”

A rolling mill drive motor failed in service. Investigation revealed the motor was short circuited by water in-leakage. This forced a prolonged shutdown, as the motor could not be replaced on site. High humidity was initially assumed to be the problem. Upon close inspection of the motor air coolers, however, it was determined that water leaked from headboxes into the air plenum spaces. Severe corrosion at tube rolls was observed (Fig. 2.9).

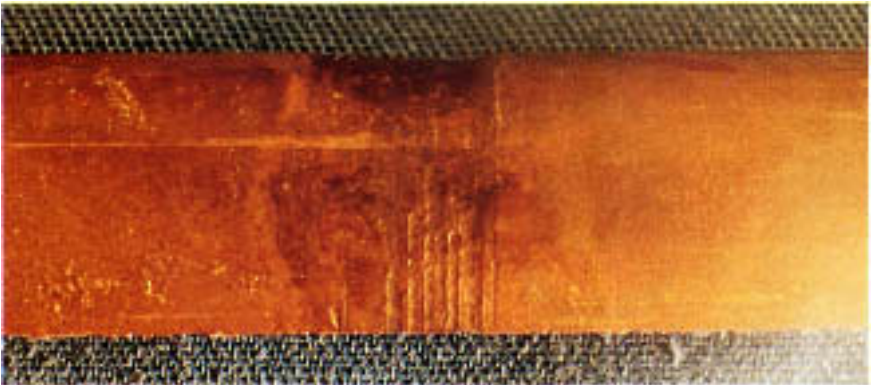
**Figure 2.10** Wastage in a circumferential region where a 90:10 cupronickel main condenser tube passed through a baffle. In places, metal loss was greater than 25% of the nominal wall thickness.

If closely fitting surfaces rub against one another, protective oxides may be dislodged, stimulating attack (Figs. 2.10 and 2.11). This is especially true if temperature variation is great and if differences in thermal expansion of abutting metals are large. Often such attack may resemble fretting (see Glossary).

As part of regular inspection procedures, several sections of tubing were removed. Severe thinning was found on external surfaces near tube supports (Figs. 2.10 and 2.11). Corroded areas had smoothly undulating interiors. Corrosion products and deposits were largely absent, as these sections were mechanically cleaned before inspection. However, visual reports suggested little material was present before cleaning.

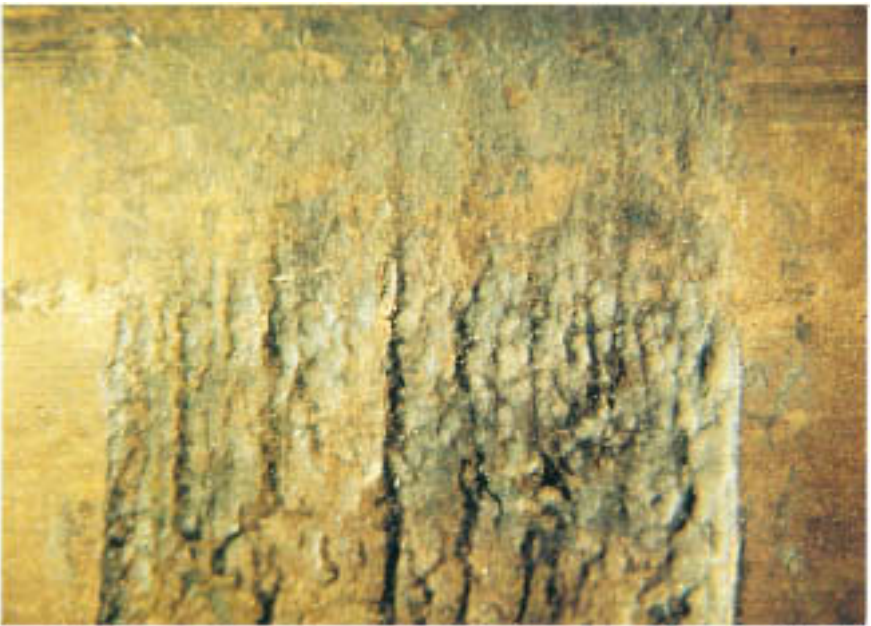
**Figure 2.11** As in Fig. 2.10. Note the more severe attack at the bottom of the tube where the tube rested against its support. (Magnification: 7.5 $\times$ .)

In some areas, up to 25% of the wall thickness was gone at the grooved regions. More metal was lost from the bottoms of the tubes than from the tops (Fig. 2.11).

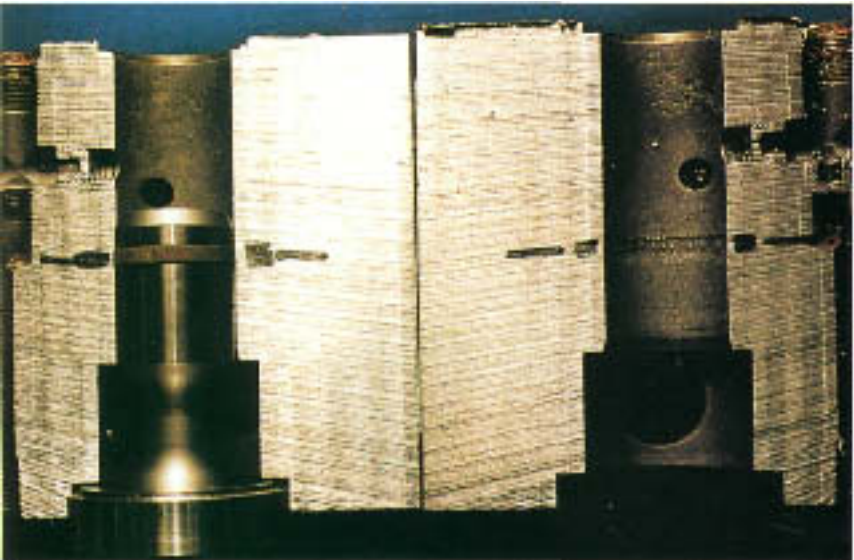
**Figure 2.12** Mild steel valve block split in half with a plunger shaft still in place. Note the ragged ring etched into the shaft throat. See Fig. 2.13.

Coupling of alloys which vary widely in galvanic potential will stimulate attack. Often such coupling is not obvious. A copper-impregnated valve bushing caused severe corrosion of a nodular cast iron fitting (Figs. 2.12 and 2.13). Although a galvanic effect was suspected, crevice corrosion was widespread in this system even when dissimilar alloys were not in contact.

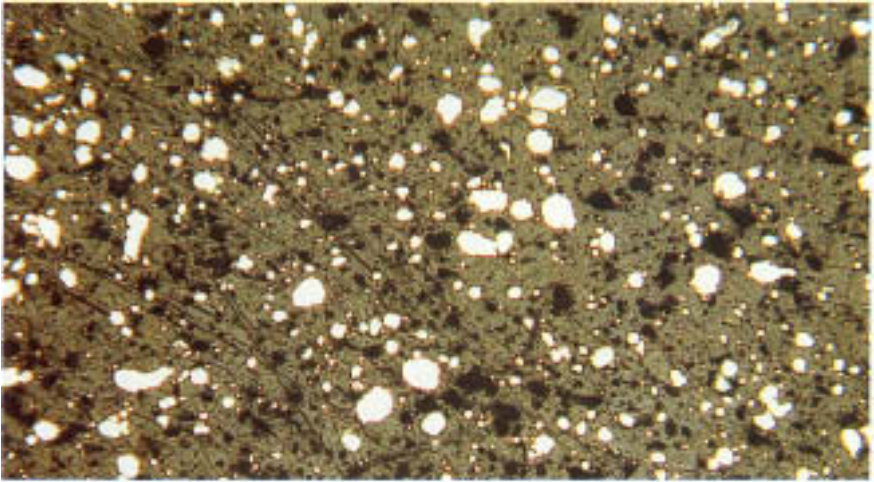
**Figure 2.13** Small particles of copper embedded in shaft bushing material (shown in Fig. 2.12). (Magnification: 55× unetched.)

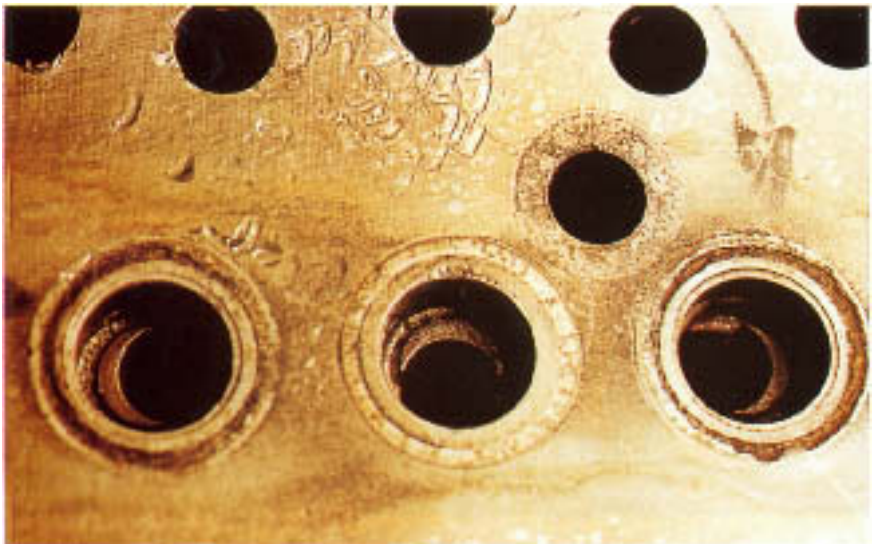
**Figure 2.14** Close-up of annular regions below rubber O-rings on a cast iron valve block. Note how damage varies from hole to hole, probably due to variation in the crevice geometry.

Wastage at the crevice is obvious. Corrosion follows the dimensions of abutting surfaces. Corrosion beneath washers and gaskets produces ghost images of the abutting surfaces (Figs. 2.14 and 2.15). At threaded joints, attack is confined to overlapping areas adjacent to

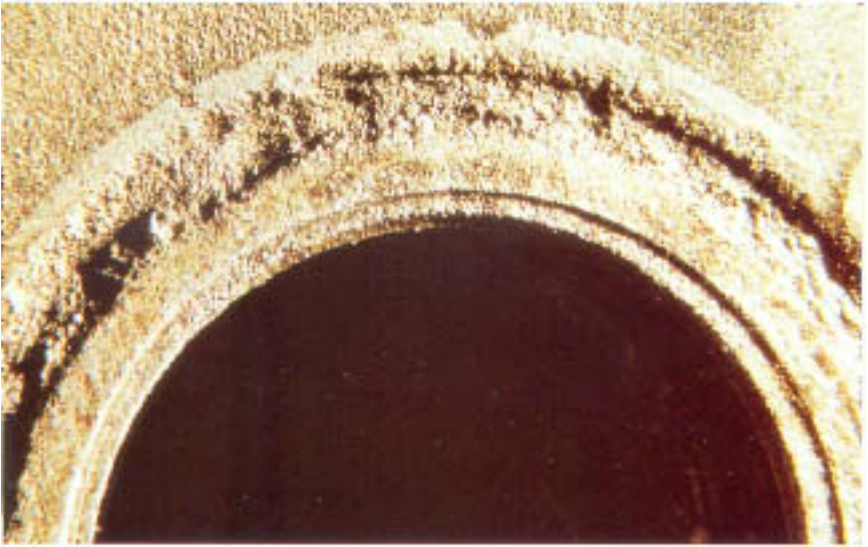
**Figure 2.15** As in Fig. 2.14. (Magnification: 7.5 $\times$ .)

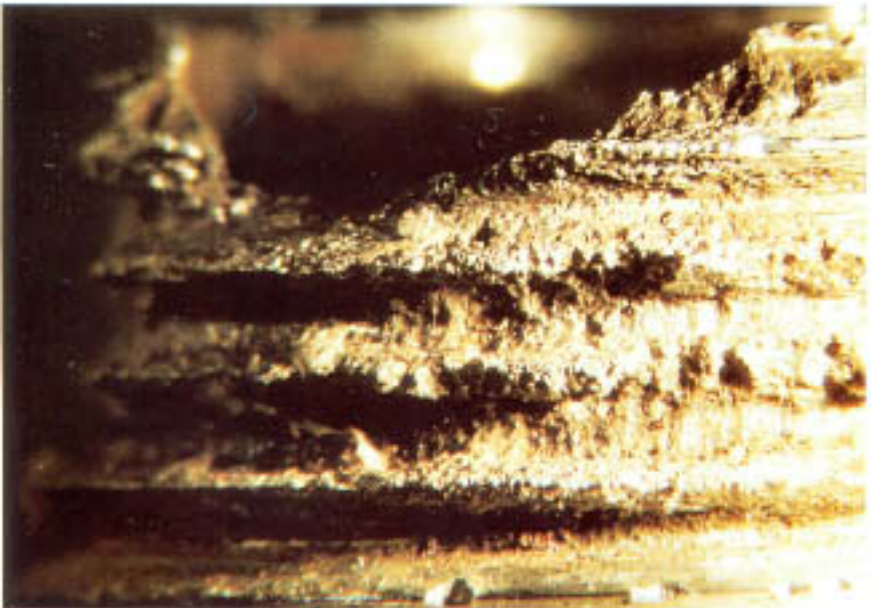
**Figure 2.16** Austenitic stainless steel pipe nipple attacked at threads by acidic chloride-containing solution. (Magnification: 7.5 $\times$ .)

fluids (Fig. 2.16). In stainless steel joints, pitting may be pronounced (Fig. 2.17). General wastage almost always occurs at cast iron and lower alloy steel joints (Figs. 2.18 and 2.19).

Corrosion products are almost always absent in stainless steel crevices. Areas just outside stainless crevices are stained brown and orange with oxides (Figs. 2.20 and 2.21). Metal ions migrate out of the crevice. Precipitation occurs by reactions similar to Reactions 2.3 and 2.4. Crevice interiors remain relatively free of rust (Figs. 2.16 and 2.17).

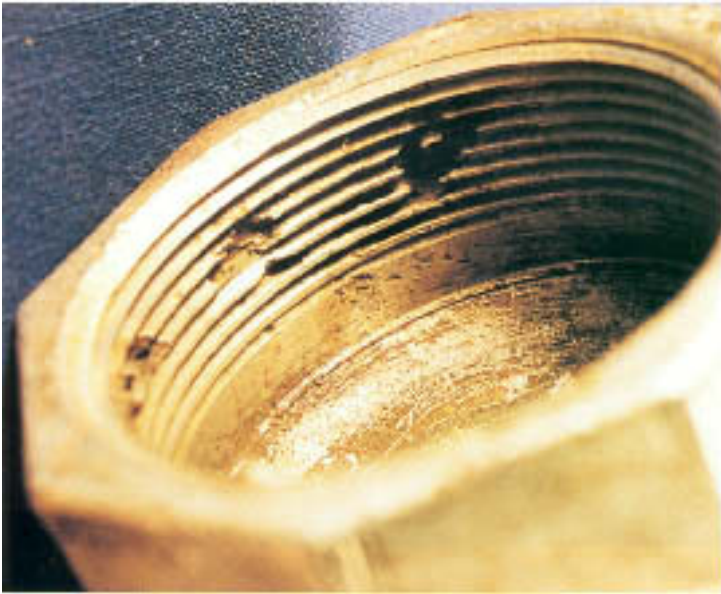
**Figure 2.17** Pitting at a free-machining austenitic stainless steel threaded valve throat. The valve controlled flow of a chlorine-containing, low-pH biocide.

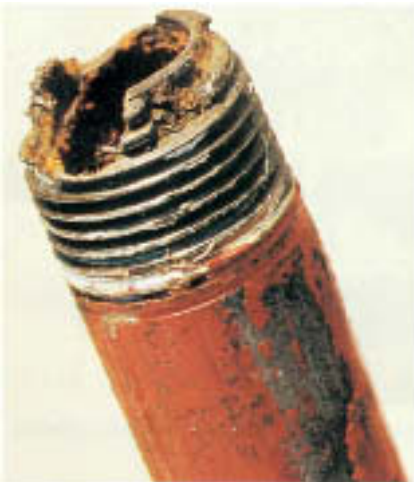
**Figure 2.18** Wasted threads on small-diameter mild steel pipe.

On mild steel and cast irons, rust accumulates at crevice mouths. Darker oxides often are present within crevices (Figs. 2.18 and 2.19).

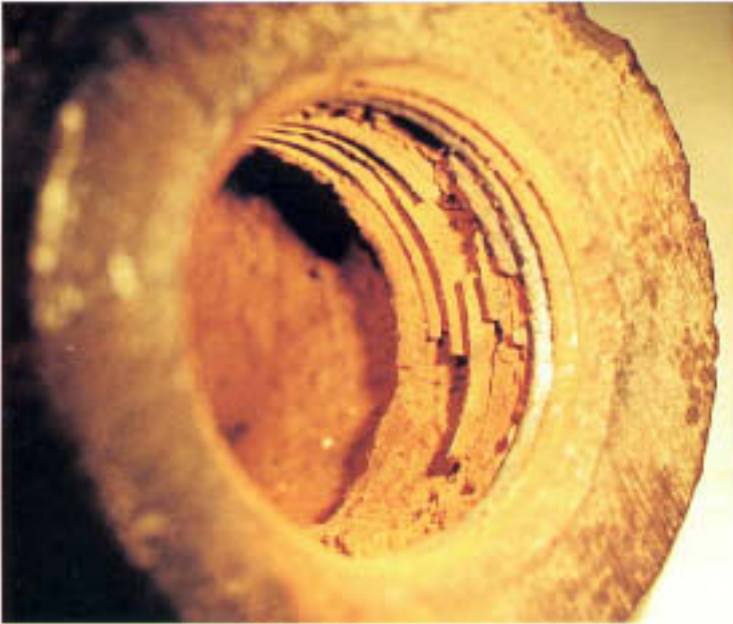
**Figure 2.19** Gray cast iron elbow showing thread wastage.

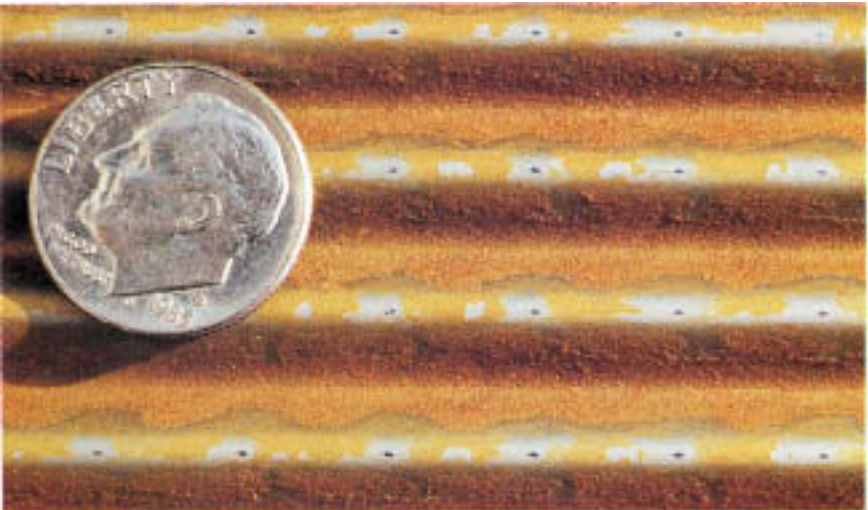
**Figure 2.20** Austenitic stainless steel plate from plate-and-frame heat exchanger. The orange oxide was formed from corrosion product originating at the regularly spaced pits. Pits are present near points of contact between adjacent plates. Corrugations run at right angles on adjacent plates.

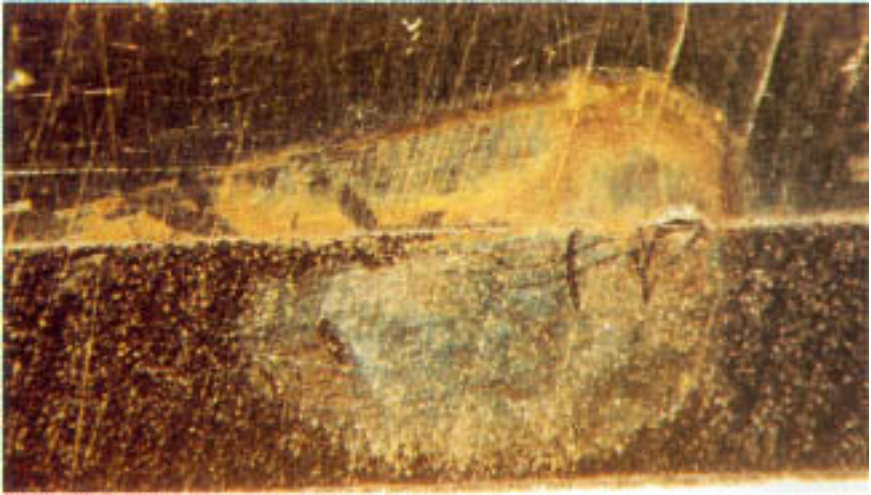
**Figure 2.21** Orange oxides weeping from a tight seam in a martensitic (440) stainless steel surgical scissors. (Magnification: 15 $\times$ .)

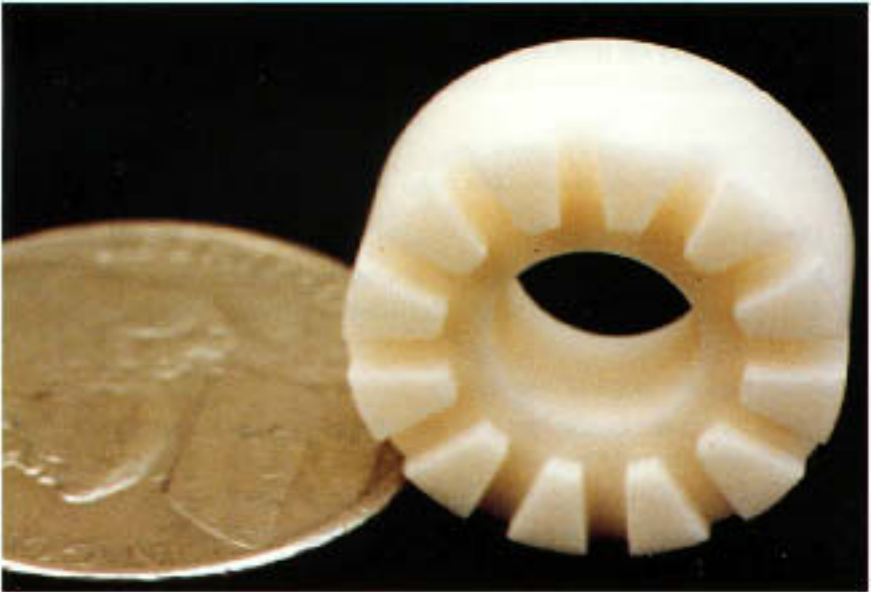
**Figure 2.22** Crevice washer. The radially oriented, wedge-shaped washer teeth provide small areas between which crevices are formed.

Frequently, so-called crevice washers are used in coupon studies to test the environment for its ability to produce crevice corrosion (Fig. 2.22). There are several designs; most consist of a small Teflon\* washer with radially oriented, wedge-shaped teeth. The washer is held to the coupon by a mounting bolt that passes through a central hole. The spaces between teeth form small crevice-shaped areas in which attack may occur (Fig. 2.23). The test is somewhat subjective and is not easily quantified. Using this test, attack in crevices either occurs or does not.

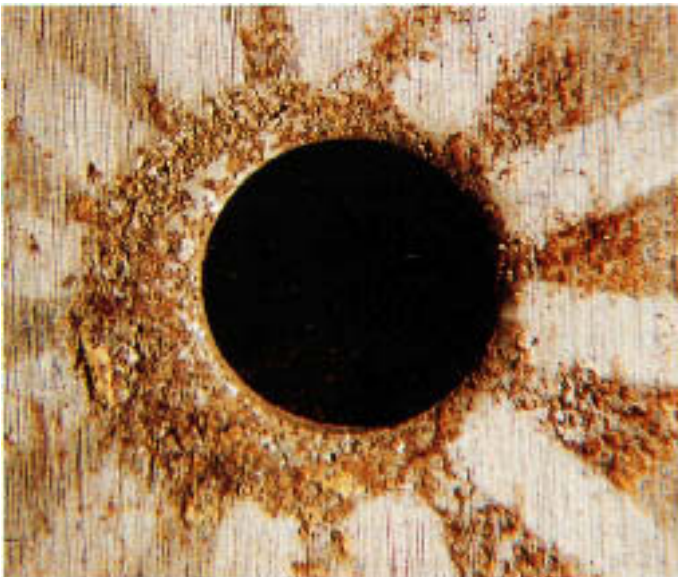
**Figure 2.23** Shallow pitting in crevice areas on a 304 stainless steel coupon exposed to a misting atmosphere. Note the relatively clean areas where the washer teeth contacted the coupon surface. (Magnification: 7.5 $\times$ .)

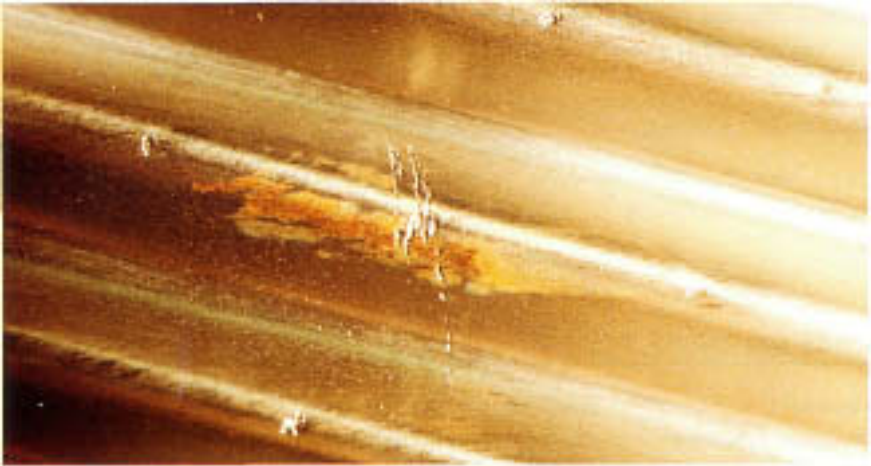
**Figure 2.24** Cracklike corrosion site at apex of corrugation.

Fine, short, cracklike pits run transversely across the apex of many corrugations on the stainless sheets (Figs. 2.24 and 2.25). The corrosion sites originate at the apex of the corrugations at small circular discolorations, spaced apart exactly the peak-to-peak distance between corrugations. All cracklike pits are aligned in the same direction, regardless of their locations on the plate.

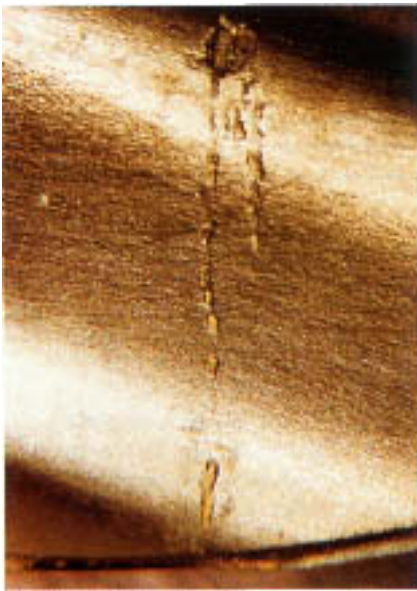
**Figure 2.25** Pit-site and tunnel propagation down the side of the wall. (Magnification: 7.5 $\times$ .)

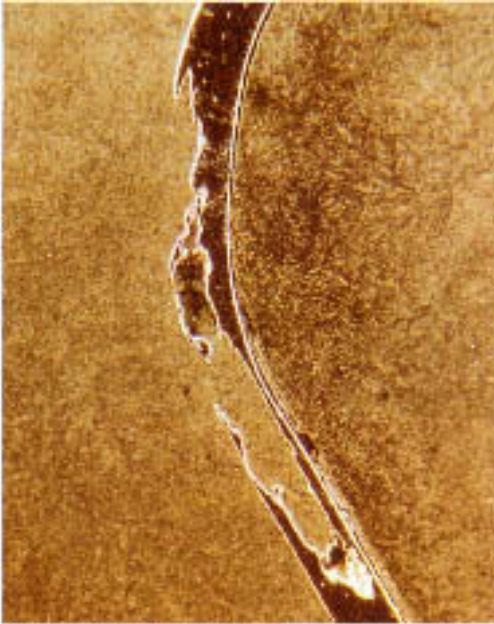
**Figure 2.26** As in Fig. 2.25. Longitudinal cross section through tunnel. (Magnification: 15 $\times$ .)

Close examination of plate surfaces with a low-power stereomicroscope indicates that the attack sites are cracklike in appearance, but they are actually greatly elongated holes or tunnels that originate at pit sites at the apex of corrugations then propagate down through the plate wall (Fig. 2.26).

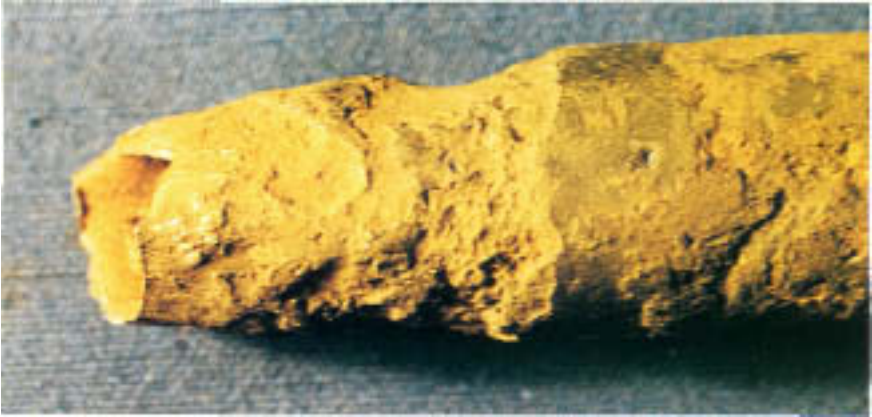
**Figure 2.27** Close-up of severely thinned heat exchanger tube in a baffle.

An ethylene heat exchanger tube failed in service. The tube was severely thinned beneath a baffle and tore in half (Fig. 2.27).

Wastage was caused by long-term crevice corrosion. Attack was much more severe beneath the baffle than elsewhere. Subsequent investigation revealed severe damage at many baffles.

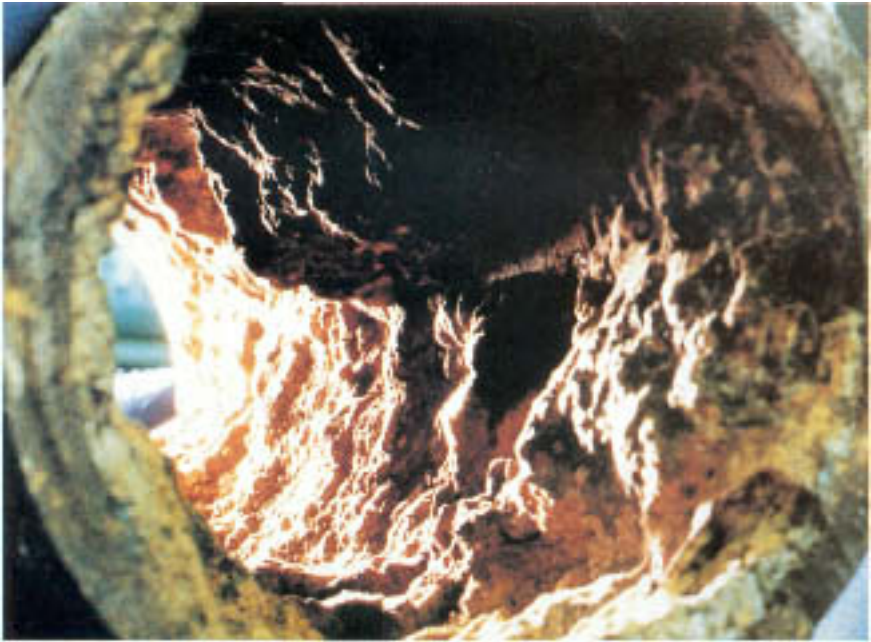
**Figure 3.1** Utility service water system pipe almost plugged by heavy tuberculation.

Tubercles are mounds of corrosion product and deposit that cap localized regions of metal loss. Tubercles can choke pipes, leading to diminished flow and increased pumping costs (Fig. 3.1). Tubercles form on steel and cast iron when surfaces are exposed to oxygenated waters. Soft waters with high bicarbonate alkalinity stimulate tubercle formation, as do high concentrations of sulfate, chloride, and other aggressive anions.

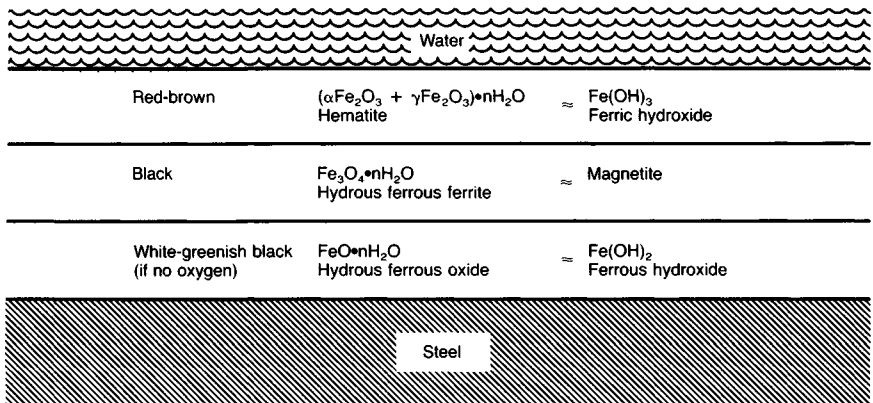
**Figure 3.2** Incipient rust layer on steel in oxygenated water. (Courtesy of National Association of Corrosion Engineers, Corrosion '91 Paper No. 84 by H. M. Herro.)

is next to the metal surface. A black, magnetic hydrous ferrous ferrite layer ( $\text{Fe}_3\text{O}_4 \cdot n\text{H}_2\text{O}$ ) can form between the ferric and ferrous oxides. These layers are shown schematically in Fig. 3.2. The topmost layer is orange and brown, whereas the underlying layers are usually black.

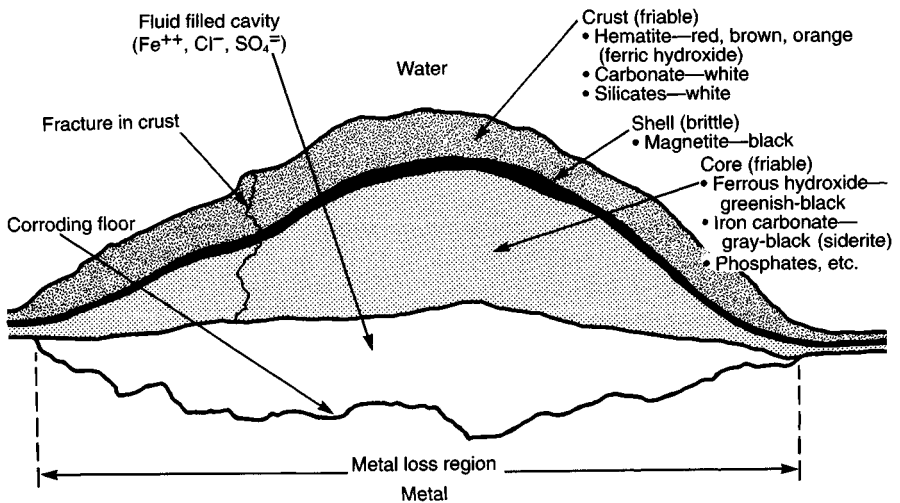
**Figure 3.3** Well-developed tubercle shows chemical compounds and structure. (Courtesy of National Association of Corrosion Engineers, *Corrosion '91* Paper No. 84 by H. M. Herro.)

These features and their associated compounds are shown in Fig. 3.3. Typical reactions and their locations appear in Fig. 3.4.

**Cavity.** A fluid-filled cavity is sometimes present beneath the core (Fig. 3.3). The cavity may be huge as in Fig. 3.8 or small as in Fig. 3.9. The cavity may result, in part, from acidic conditions internally. Acid conditions may prevent precipitation of oxides and hydroxides inside the tubercle.

The presence of tubercles is usually obvious. Friable brown and orange nodular encrustations on mild steel and cast iron cooling water components are almost always tubercles (Figs. 3.12 through 3.14). The presence of a crust, shell, core, cavity, and corroded floor are definitive (Fig. 3.3). Careful analysis can provide considerable information concerning growth, chemical composition, and associated metal loss.

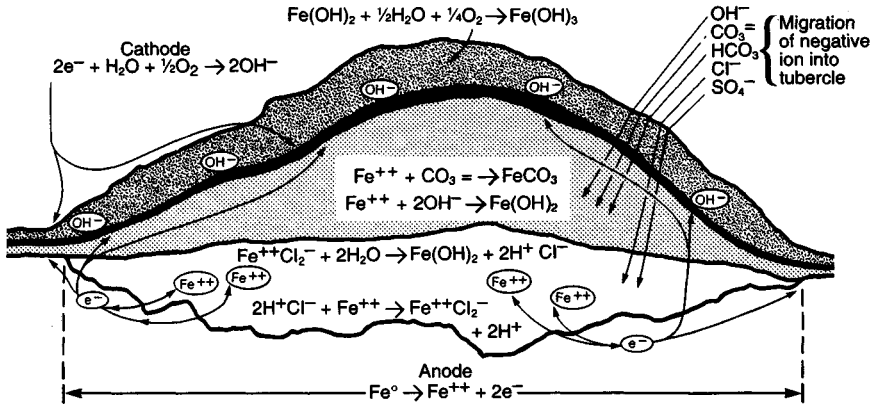
Figure 3.4 As in Fig. 3.3, shows chemical reactions within the tubercle. (Courtesy of National Association of Corrosion Engineers, Corrosion '91 Paper No. 84 by H. M. Herro.)

The hydroxyl ions migrate inward, attracted by the positive charge that is produced by the ferrous ion generated near the corroding surface (Fig. 3.4). Other anions such as carbonate, chloride, and sulfate also concentrate beneath the shell. Carbonate may react with ferrous ions to form siderite ( $\text{FeCO}_3$ ) as in Reaction 3.4 (Fig. 3.7):

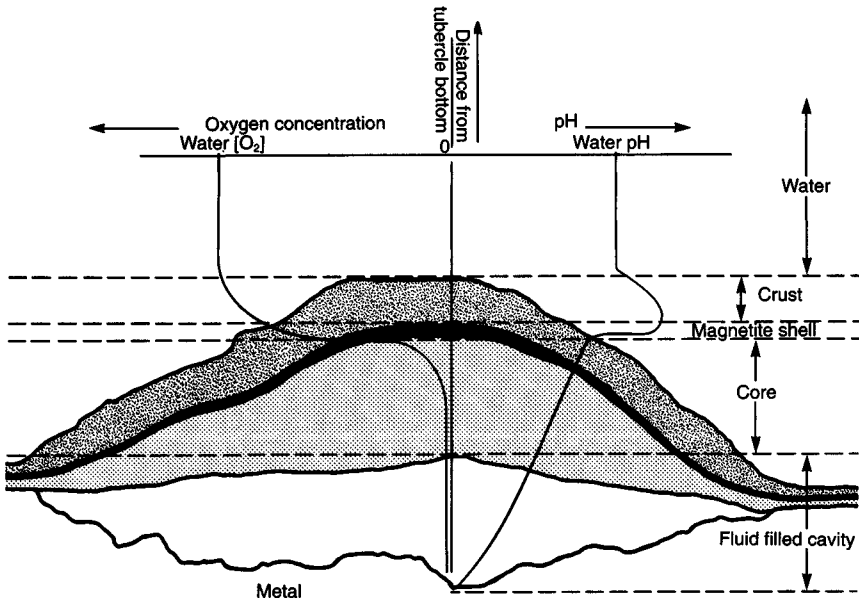
**Figure 3.5** Schematic pH and oxygen concentration profiles in an active tubercle. Below the magnetite shell oxygen concentration decreased sharply. pH rises above the magnetite shell due to cathodic hydroxyl-ion generation and falls below the shell due to concentration of acidic anion. (Courtesy of National Association of Corrosion Engineers, *Corrosion '91 Paper No. 84* by H. M. Herro.)

**Inner shell.** Just beneath the outer crust a brittle, black magnetite shell develops. The shell separates the region of high dissolved-oxygen concentration outside the tubercle from the very low dissolved-oxygen regions in the core and fluid-filled cavity below (Fig. 3.5). The shell is mostly magnetite and thus has high electrical conductivity. Electrons generated at the corroding floor are transferred to regions around the tubercle and to the shell, where cathodic reactions produce hydroxyl ion, locally increasing pH. Dissolved compounds with normal pH solubility, such as carbonate, deposit preferentially atop the shell where pH is elevated as in Reaction 3.2:

A profile of oxygen and pH concentration is shown in Fig. 3.5. A cross section of the outer crust, inner magnetite shell, and core material is shown in Fig. 3.6.

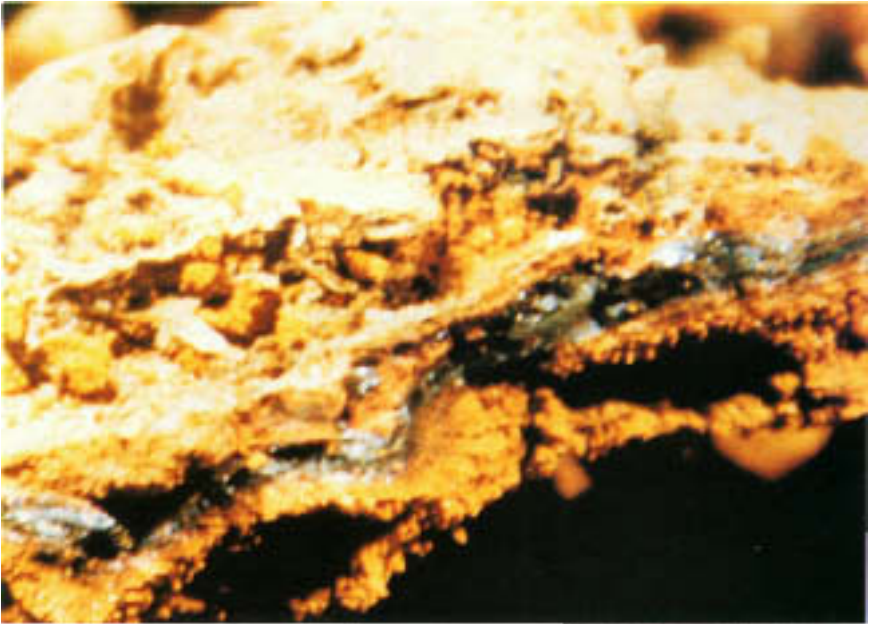
**Figure 3.6** Tubercle cross section shows black magnetite-rich shell beneath deposit and hematite cap. Note the core material below the magnetite shell. (Magnification: 7.5 $\times$ .) (Courtesy of National Association of Corrosion Engineers, *Corrosion '89 Paper No. 197* by H. M. Herro.)

**Core.** Friable core material is present beneath the magnetite shell (Fig. 3.6). The core consists mostly of ferrous hydroxide formed by Reaction 3.3:

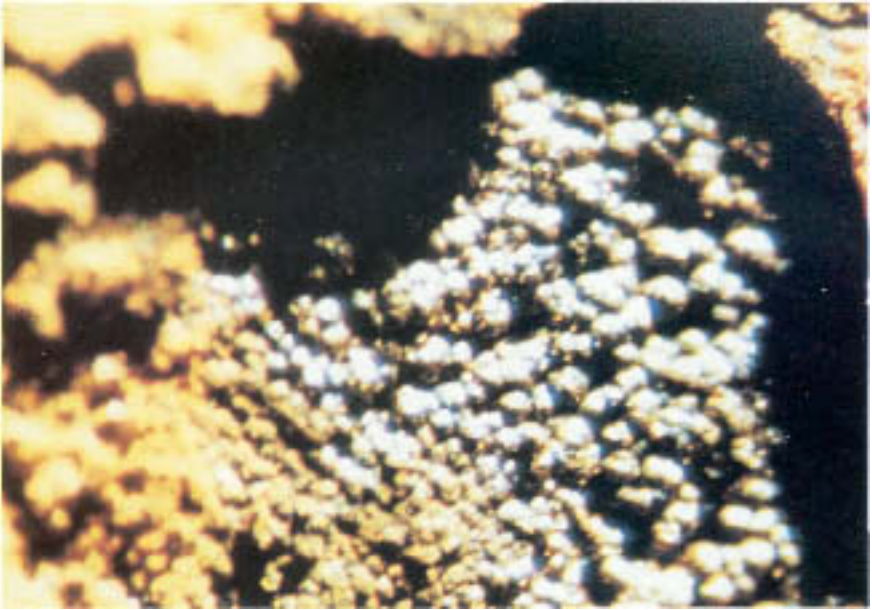
**Figure 3.7** Siderite ( $\text{FeCO}_3$ ) nodules inside a tubercle revealed by breaking open the magnetite shell. (Courtesy of National Association of Corrosion Engineers, *Corrosion '89 Paper No. 197* by H. M. Herro.)

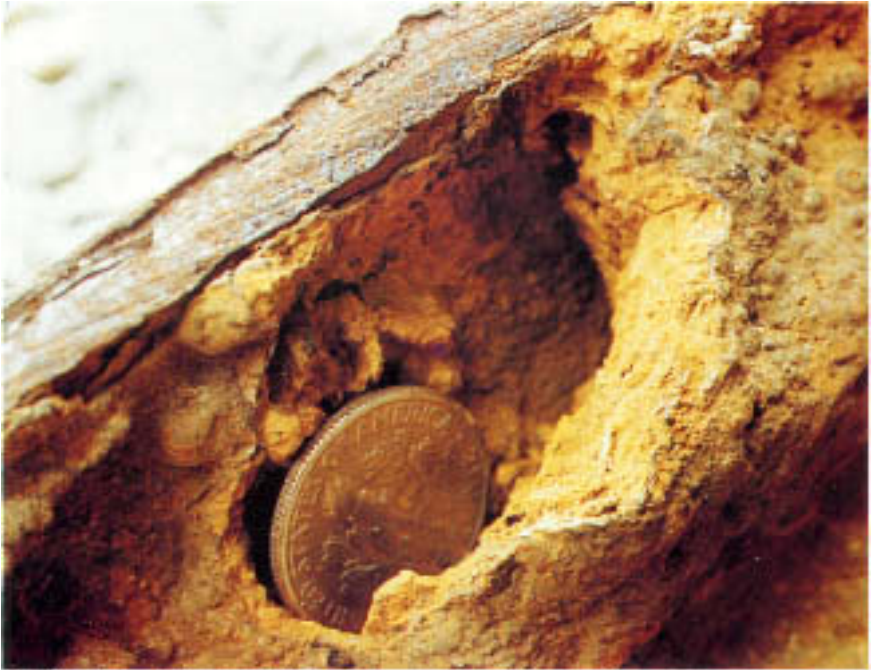
**Figure 3.8** Large tubercle broken open to reveal the internal cavity. The cavity is filled with fluid in service.
