# **The Nalco Guide to Cooling Water System Failure Analysis**

**Nalco Chemical Company**

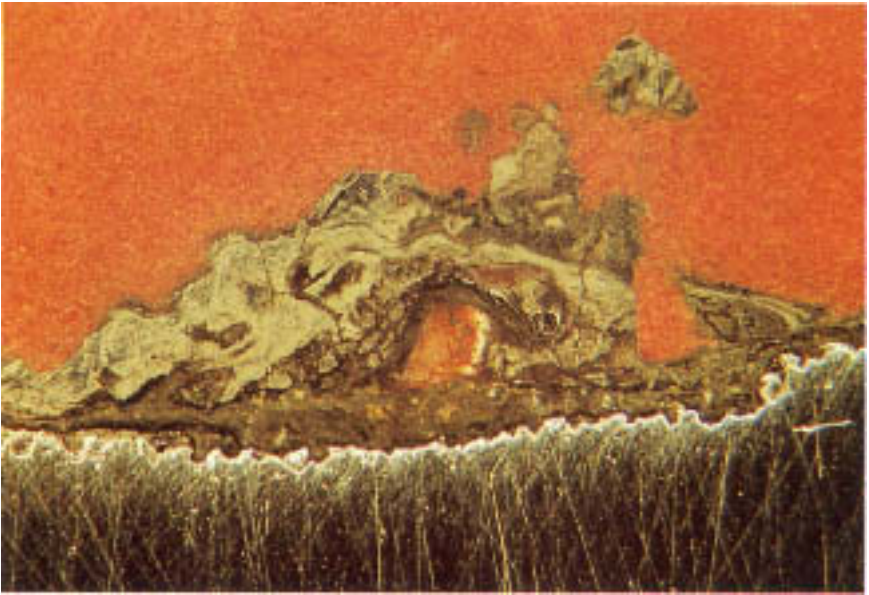
**Figure 3.9** Small tubercle cross section. The steel surface is at the bottom, and the red material is an epoxy mounting medium. Note the small, shallow central cavity. (Magnification: 7.5 $\times$ .)

**Cavity.** A fluid-filled cavity is sometimes present beneath the core (Fig. 3.3). The cavity may be huge as in Fig. 3.8 or small as in Fig. 3.9. The cavity may result, in part, from acidic conditions internally. Acid conditions may prevent precipitation of oxides and hydroxides inside the tubercle.

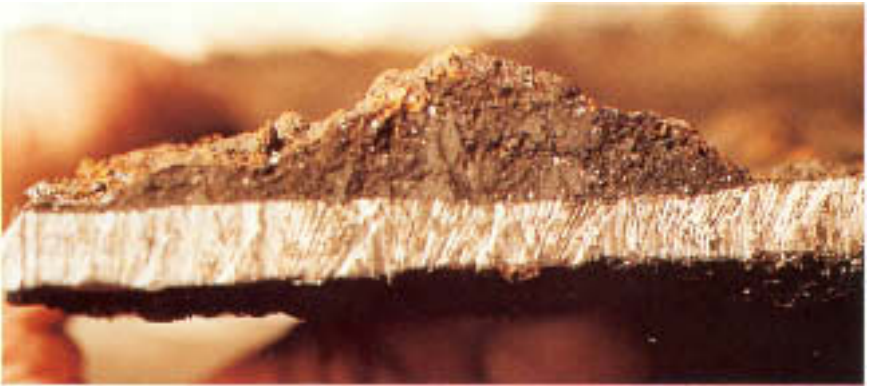
**Figure 3.10** Large-diameter steel pipe wall cross section. Note the very shallow, broad depression beneath the tubercle. (Courtesy of National Association of Corrosion Engineers, Corrosion '91 Paper No. 84 by H. M. Herro.)

deep, forming a shallow dish-shaped bowl (Fig. 3.10). Iron dissolves, forming ferrous ions according to Reaction 3.5:

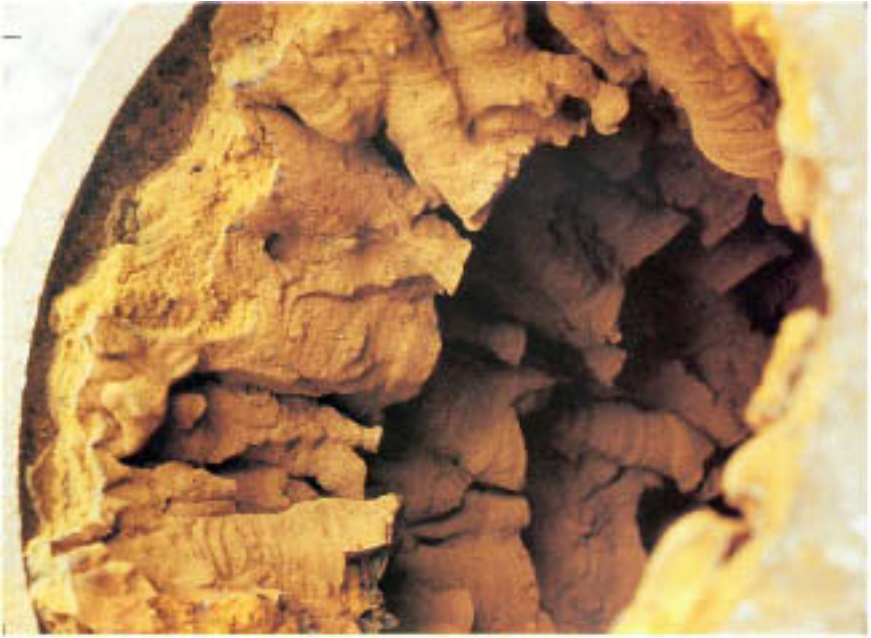
**Figure 3.11** Tubercles elongated by flow in a mill water supply line.

in the direction of the flow (Fig. 3.11). Flow also affects growth by replenishing dissolved oxygen, aggressive anions, chemical inhibitors, and suspended particulate. If flow is very high, turbulence will dislodge tubercular structures.

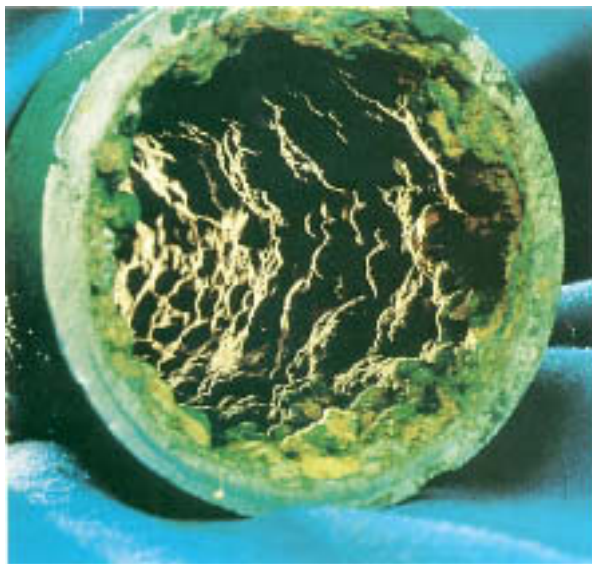
**Figure 3.12** Heavily tuberculated 3-in. (7.6-cm) outer diameter steel mill water supply line.

The presence of tubercles is usually obvious. Friable brown and orange nodular encrustations on mild steel and cast iron cooling water components are almost always tubercles (Figs. 3.12 through 3.14). The presence of a crust, shell, core, cavity, and corroded floor are definitive (Fig. 3.3). Careful analysis can provide considerable information concerning growth, chemical composition, and associated metal loss.

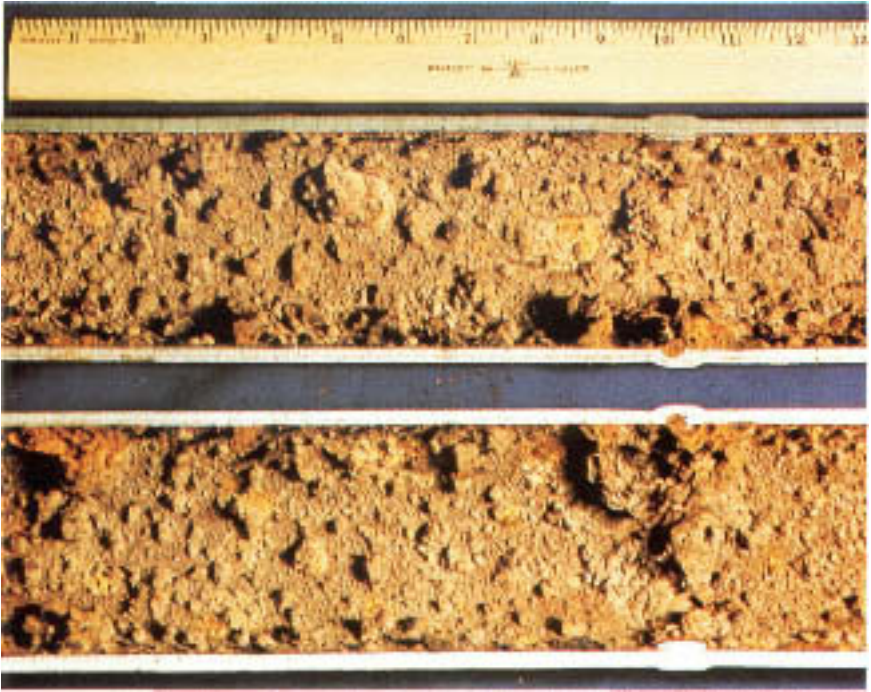
**Figure 3.13** Emergency supply line shows moderate tuberculation.

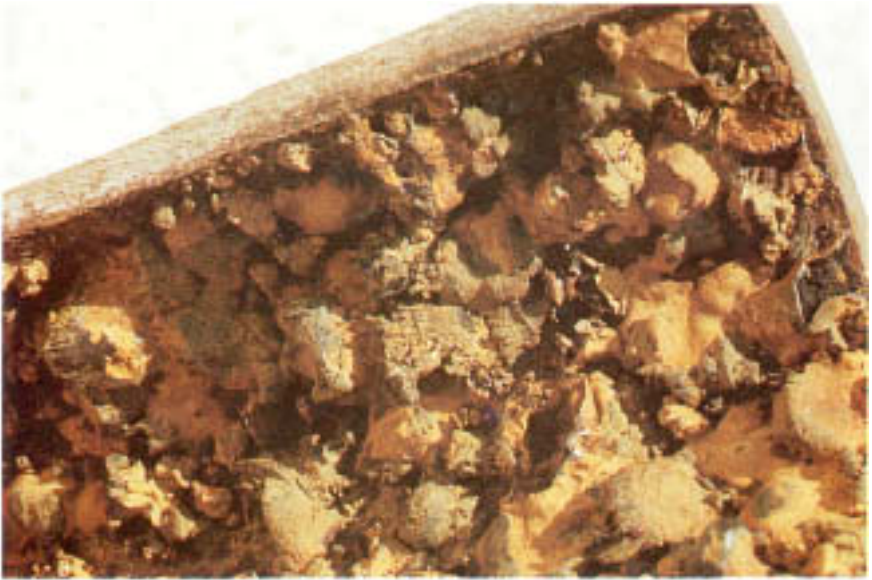
**Figure 3.14** Small, hard tubercles on an essential service water system pipe in a nuclear utility.

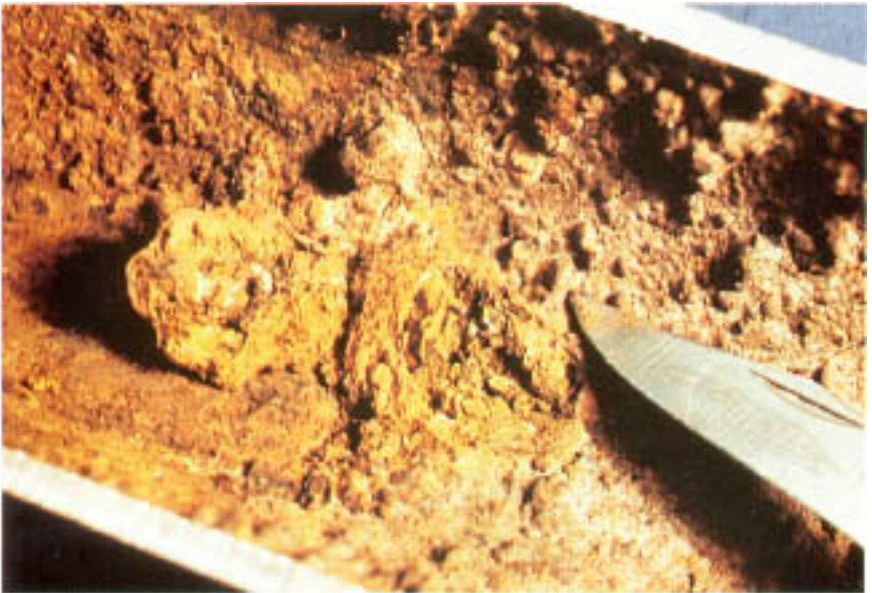
**Figure 3.15** Knife dislodging a dry tubercle from a steel pipe surface.

When dry, tubercles are usually brittle and can be crushed by gentle pressure with a finger. Tubercle caps can be dislodged whole with a hard implement (Figs. 3.15 through 3.17). The physical strength of the tubercle is related to the thickness of the magnetite shell and densities of crust and core material. A typical magnetite shell in cross section is shown in Fig. 3.6. Dense, thick shells harden structures. These harder, denser tubercles have usually grown at a slower rate than lower-density tubercles. Thin magnetite shells are usually indicative of fast growth. Thus, thin magnetite shells are undesirable.

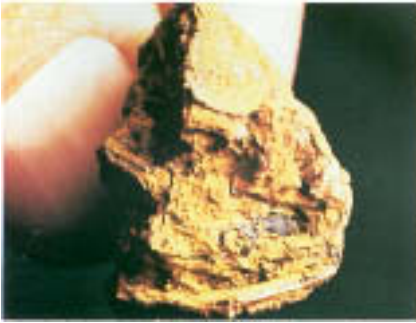
**Figure 3.16** As in Fig. 3.15 but tubercle cap is completely dislodged.

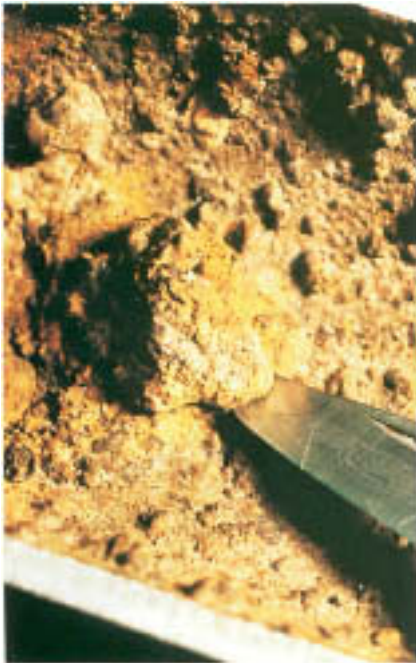
**Figure 3.17** Intact tubercle showing physical integrity after removal from surface in Figs. 3.15 and 3.16.

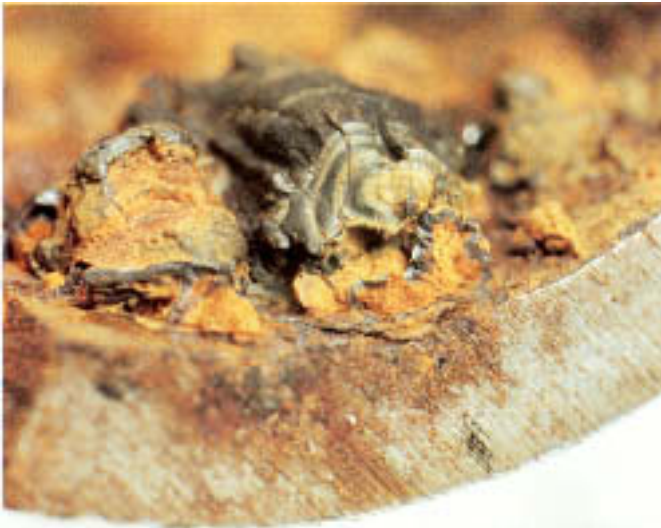
**Figure 3.18** Multiple magnetite shells in a small tubercle. Multiple shells form due to successive fracture during growth. (Magnification: 2 $\times$ .)

Multiple magnetite shells may form by successive fracture. Ferrous species spew out of the fractured shell and are quickly oxidized to form a new ferric hydroxide crust. Beneath the new crust, another mag-

netite shell forms (Fig. 3.18). As tubercles age, their internal structure and outer morphology are altered.

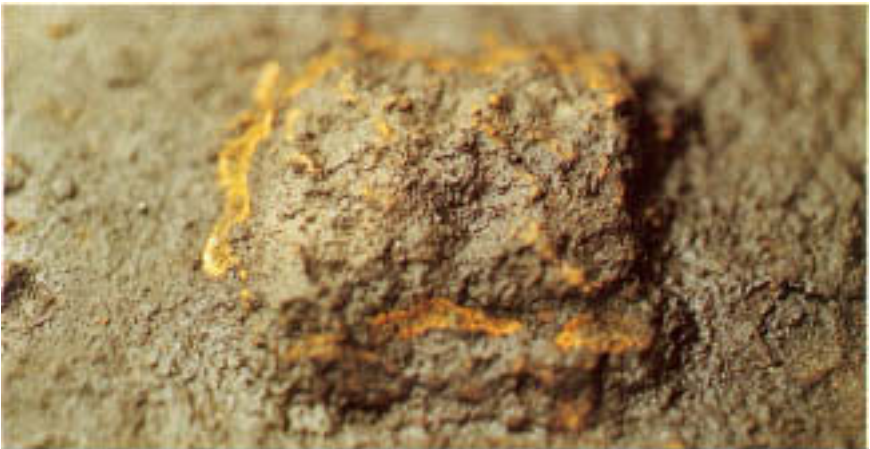
**Figure 3.19** Tubercle only a few minutes after removal from a water-filled pipe.

When first exposed to air, tubercles are often quite dark both externally and internally (Figs. 3.19 and 3.20). After prolonged exposure to air, however, tubercle color changes to red, brown, and orange (Figs. 3.21 and 3.22). The more reduced ferrous hydroxide is converted to ferric hydroxide. A very rapid conversion to lighter colors sometimes signifies high tubercle acidity.

The entire internal surface was covered with a layer of dark greasy deposit and slime intermixed with reddish-brown oxides (oxides were dark immediately upon removal from systems) (Figs. 3.19 and 3.20). Analysis showed tubercular contents were fairly acidic.

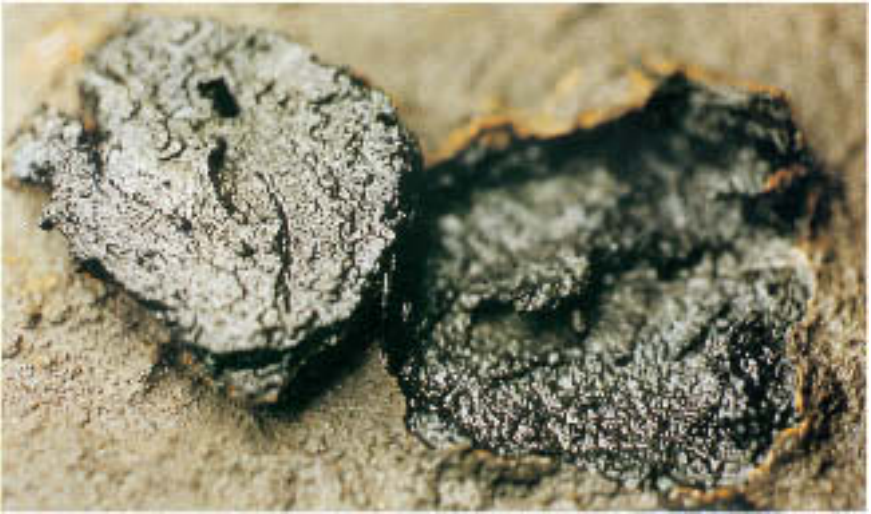
**Figure 3.20** As in Fig. 3.19, with tubercle opened to show the dark interior.

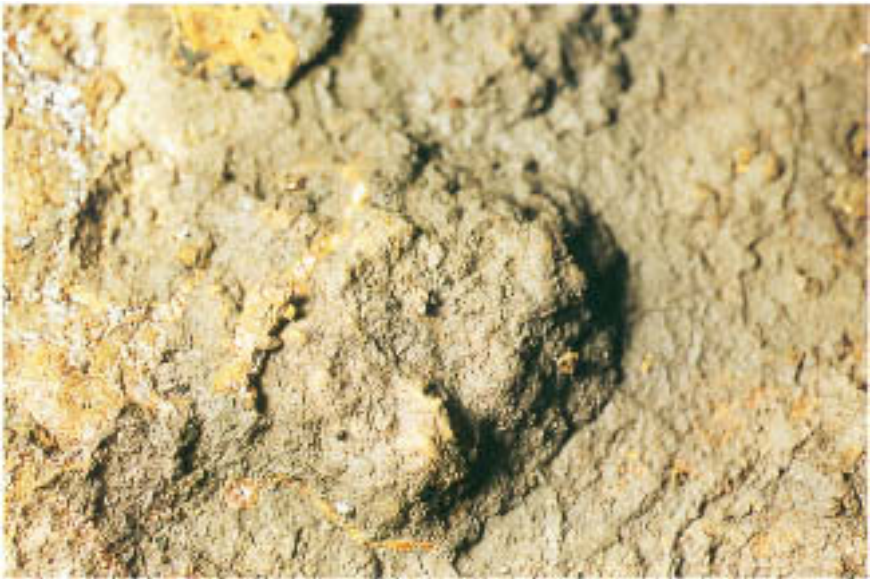
**Figure 3.21** As in Figs. 3.19 and 3.20, after several hours of exposure to air. Note the reddening.

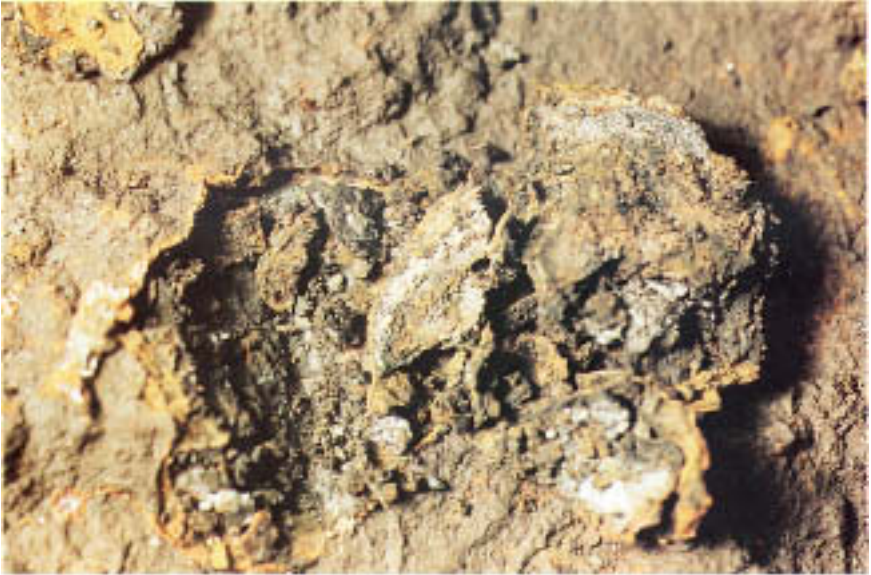
**Figure 3.22** As in Fig. 3.21, but opened to show color change of interior.

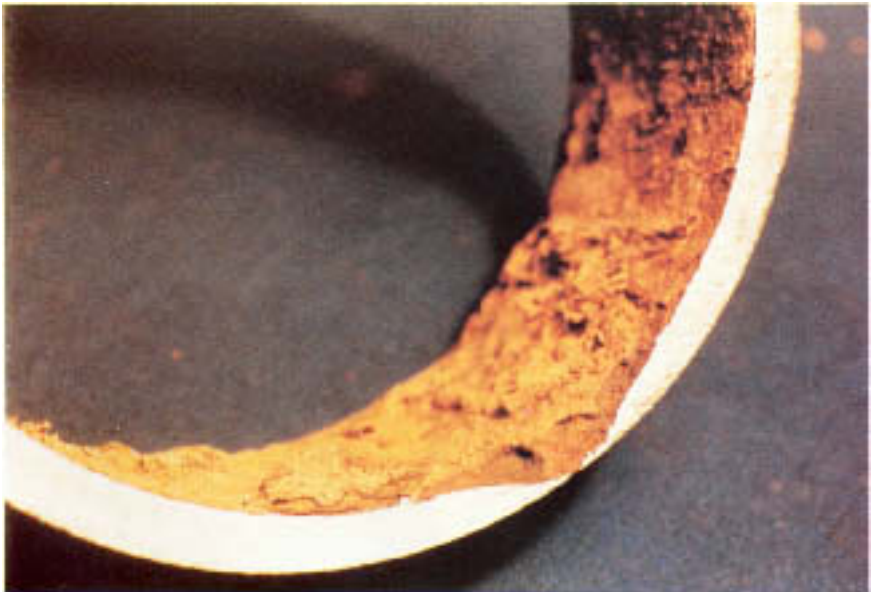
**Figure 3.23** Perforation at a dish-shaped depression on the internal surface of a large-diameter steel pipe. A large tubercle capped the depression but was dislodged during tube sectioning. (Courtesy of National Association of Corrosion Engineers, *Corrosion '89* Paper No. 197 by H. M. Herro.)

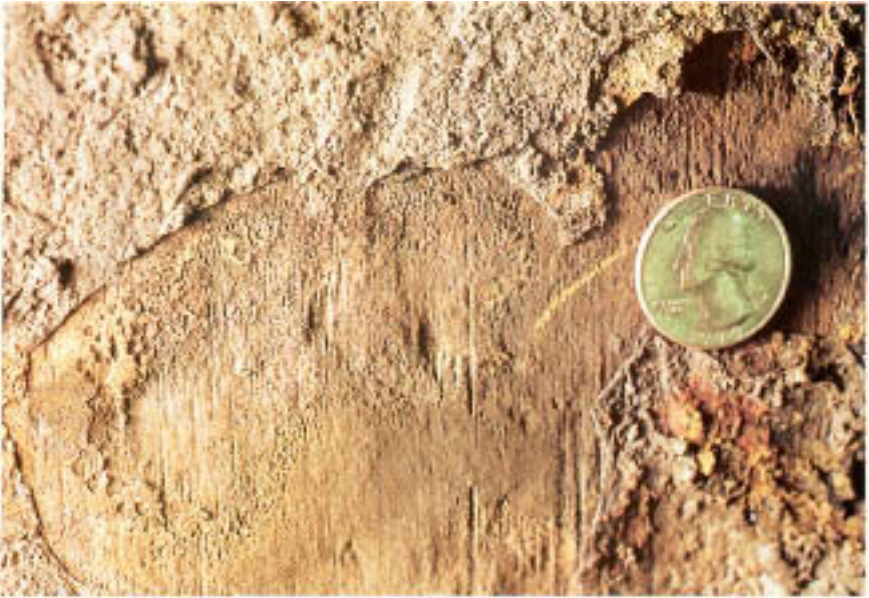
**Figure 3.24** Striated, corroded depressions are revealed on a large-diameter pipe after tubercles were removed. Striated surfaces are caused by preferential corrosion along microstructural irregularities in the steel. Such attack can be caused by low pH conditions.

chemical inhomogeneities, and second-phase material. The defects are elongated and frozen into stringlike artifacts, paralleling the original rolling direction of the steel.

Beneath each tubercle was a dish-shaped depression. Some depressions were as deep as half the intact wall thickness. Many shallow striation-streaked depressions were present on internal surfaces (Fig. 3.24). Circumferential welds were preferentially attacked (Fig. 3.27).

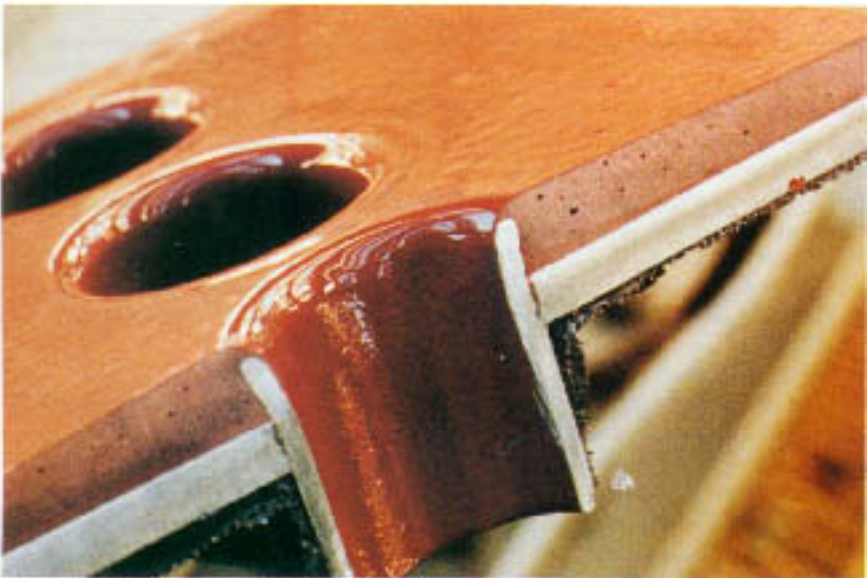
Figure 3.25 Epoxy-coated section of a tube sheet and rolled tube.

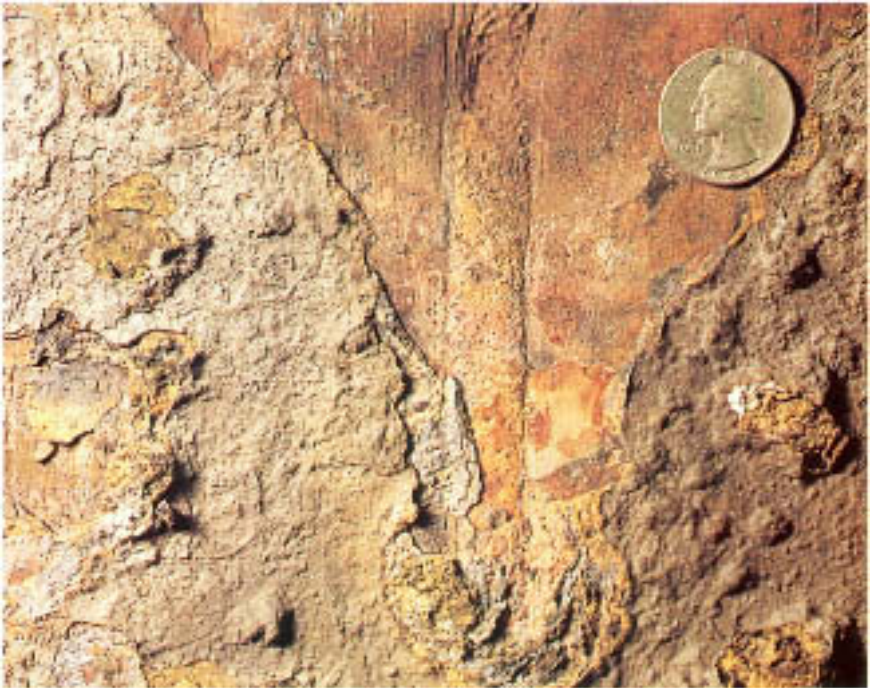
**Figure 3.26** Typical internal surface of heavily tuberculated mill water supply line about 16 hours after removal from system. Surface resembled Figs. 3.19 and 3.20 immediately after removal. Note the weld where corrosion product and deposit were removed.

After 5 more years of service, a few leaks began to develop. Window sections cut from the main contained numerous tubercular encrustations (Fig. 3.26).

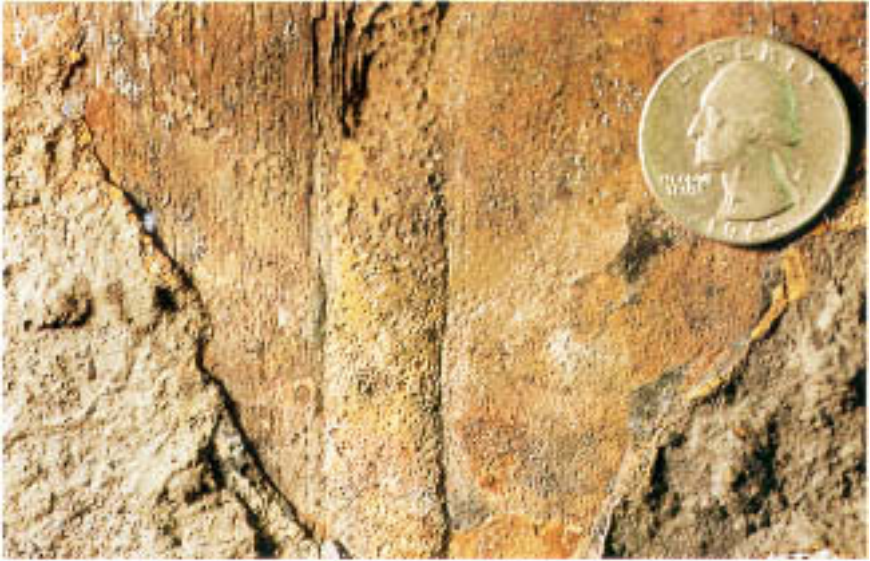
**Figure 3.27** As in Fig. 3.26, showing preferential weld attack.

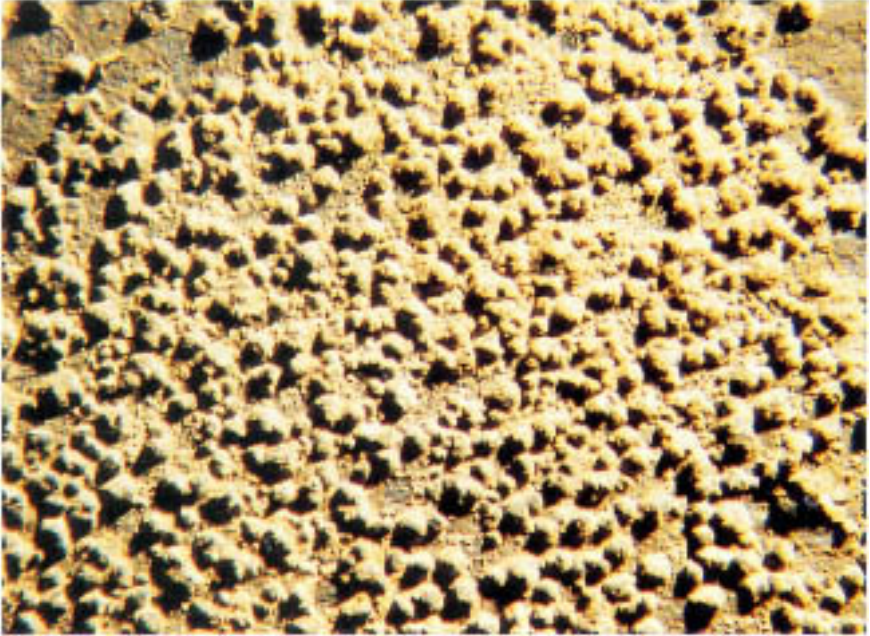
**Figure 3.28** Many incipient tubercles formed on a steel battle plate in 2 weeks. (Magnification: 7.5 $\times$ .) (Courtesy of National Association of Corrosion Engineers, *Corrosion '89 Paper No. 197* by H. M. Herro.)

A test water box was installed during a 2-week trial to monitor corrosion and fouling in a utility cooling water system. A baffle plate from the test box was removed after the test. Small, hollow incipient tubercles dotted surfaces (Fig. 3.28). Small amounts of carbonate were present atop and around each tubercle. Each tubercle capped a small depression no deeper than 0.005 in. (0.013 cm) (Fig. 3.29). This indicated local average corrosion rates were as high as 130 mil/y (3.3 mm/y).

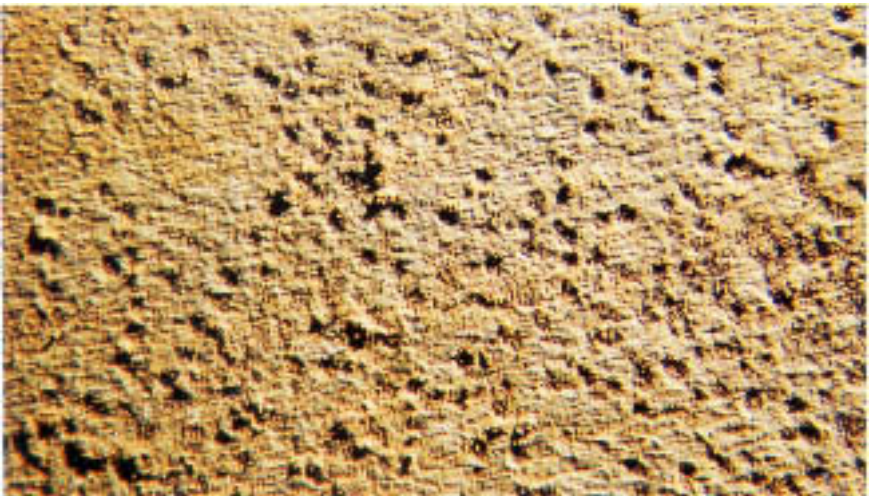
**Figure 3.29** As in Fig. 3.28, but with tubercles removed to show pitlike depressions beneath each mound. (Magnification: 7.5 $\times$ .) (Courtesy of National Association of Corrosion Engineers, *Corrosion '89 Paper No. 197* by H. M. Herro.)

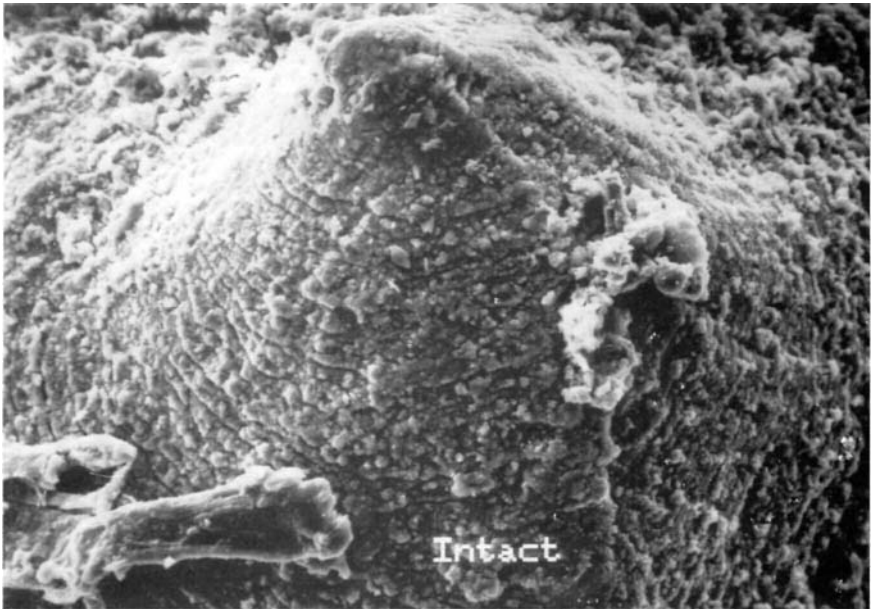
**Figure 3.30** Scanning electron micrograph of tubercles in Fig. 3.28. Note the clam-shell growth steps formed by successive fractures at the tubercle base. Tubercle is about 200  $\mu\text{m}$  in diameter. (Courtesy of National Association of Corrosion Engineers, Corrosion '91 Paper No. 84 by H. M. Herro.)

Each tubercle exhibited small clam-shell marks or growth rings (Fig. 3.30). Each ring was formed by fracture at the tubercle base during growth. Ejected internal contents rapidly deposited when contacting oxygenated waters. Tubercles were hollow (Fig. 3.31). Surfaces below the

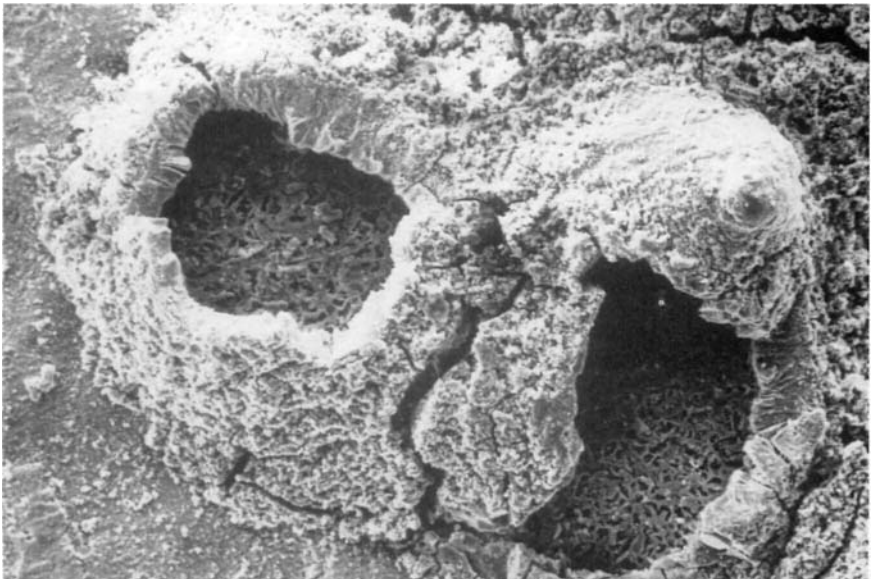
**Figure 3.31** Tubercles in Fig. 3.30 broken open to reveal hollow interiors. (Courtesy of National Association of Corrosion Engineers, Corrosion '91 Paper No. 84 by H. M. Herro.)

cap contained concentrations exceeding 10% of chloride and sulfate, producing severe localized acidic conditions.

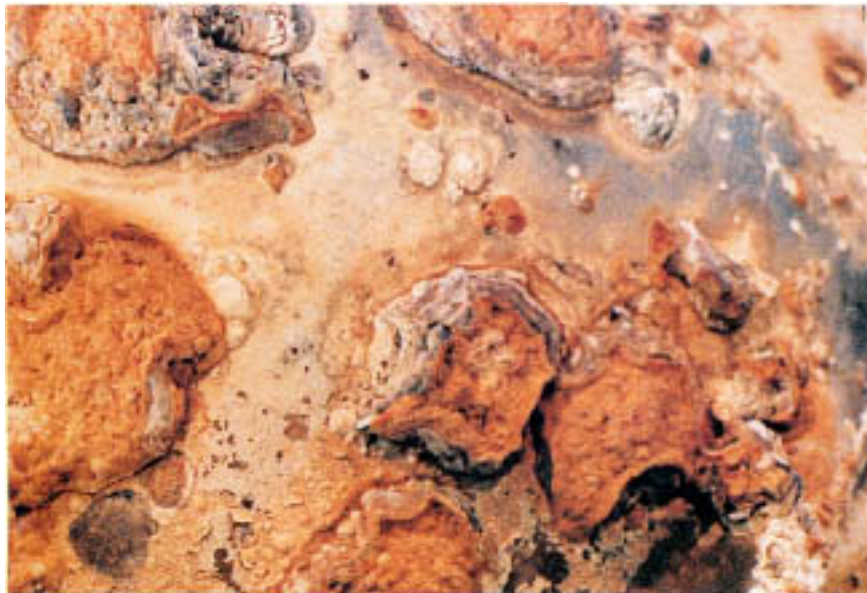
**Figure 3.32** Large tubercles on gray cast iron pump housing.

The external surface of the pump housing was covered with large tubercles up to 2 in. (5 cm) in diameter (Fig. 3.32). Tubercles had hard, black, stratified shells, enveloping reddish-brown internal material. Surfaces beneath tubercles were corroded to a depth of as much as  $\frac{1}{4}$  in. (0.54 cm). Regions below the tubercles were graphitically corroded (see Chap. 17).

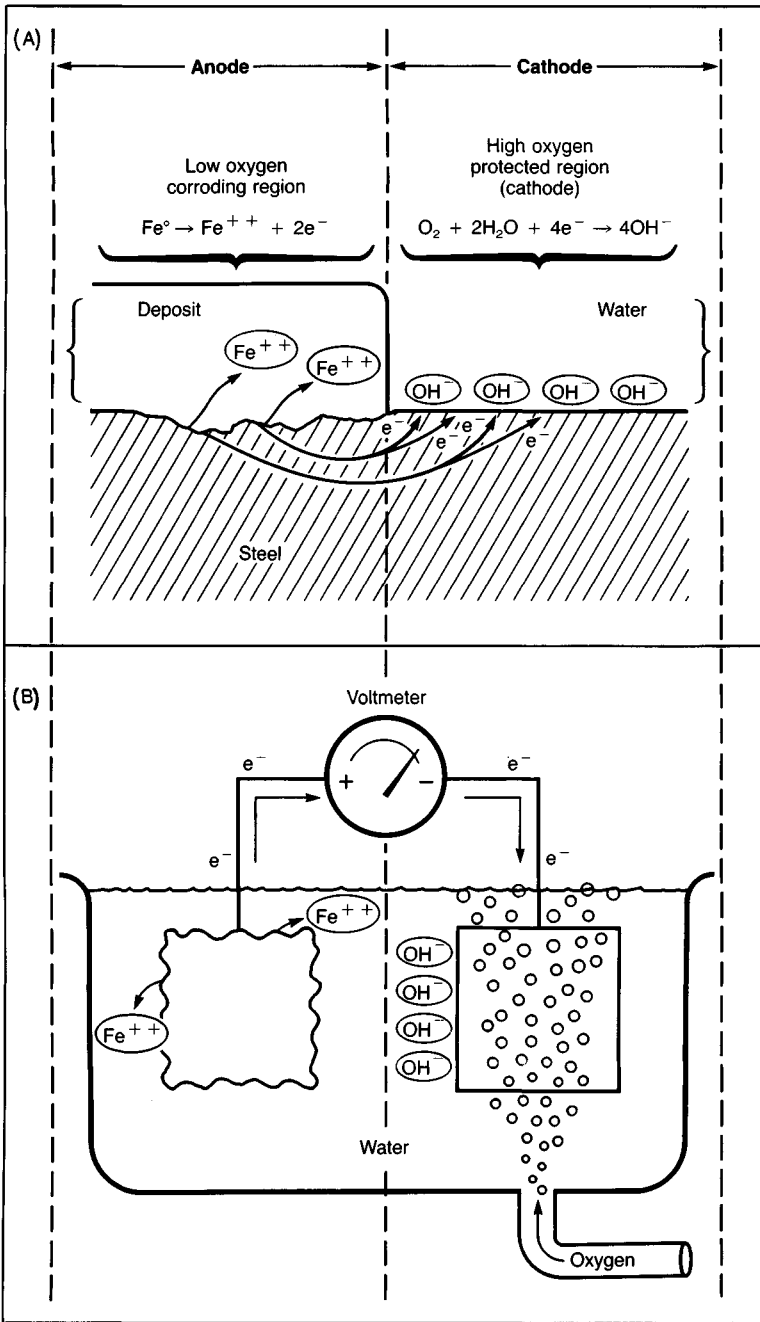
**Figure 4.1** (A) Oxygen concentration cell corrosion beneath a deposit; (B) Oxygen concentration cell corrosion in a beaker containing an aerated piece of steel and an unaerated piece of steel. A potential develops between the aerated and unaerated steel pieces. Steel exposed to the lower dissolved oxygen concentration corrodes. Beneath a deposit (Fig. 4.1A) the oxygen-poor environment causes wastage.

Perhaps the best-known concentration cell, the oxygen concentration cell, involves differential aeration (Fig. 4.1A and B). Dissolved oxygen concentration inevitably decreases beneath deposits near actively corroding steel surfaces; corrosion beneath the deposit consumes oxygen. The deposit retards oxygen diffusion to regions near the corroding surface. Hence, an oxygen cell is established. As general oxygen corrosion proceeds, accumulation of corrosion products may also cause oxygen concentration cell formation. Oxygen concentration cells may also be found at crevices (see Chap. 2, "Crevice Corrosion"), beneath tuber-

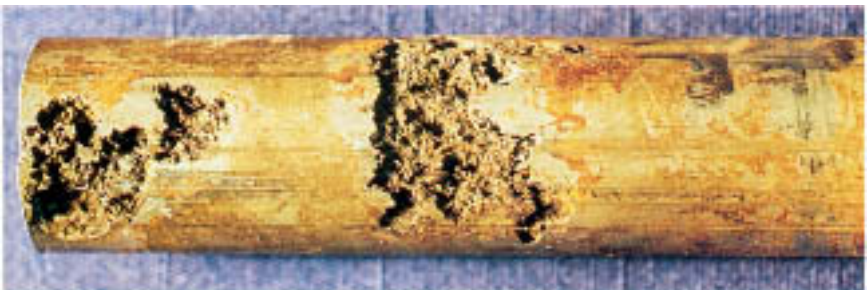
**Figure 4.2** Severe localized wastage on a 316 stainless steel heat exchanger tube. Attack occurred beneath deposits, which were removed to show wastage.

Frequently, differential aeration and the concentration of aggressive ions beneath deposits combine to produce severe localized wastage on stainless steel (Figs. 4.2 and 4.3) and other passivating alloys such as aluminum, titanium, and nickel. However, differential aeration alone is not severe enough in most cases to initiate attack on stainless steels. Yet, in the presence of so-called depassivating agents, such as chloride ions, severe pitting may occur on stainless steels.

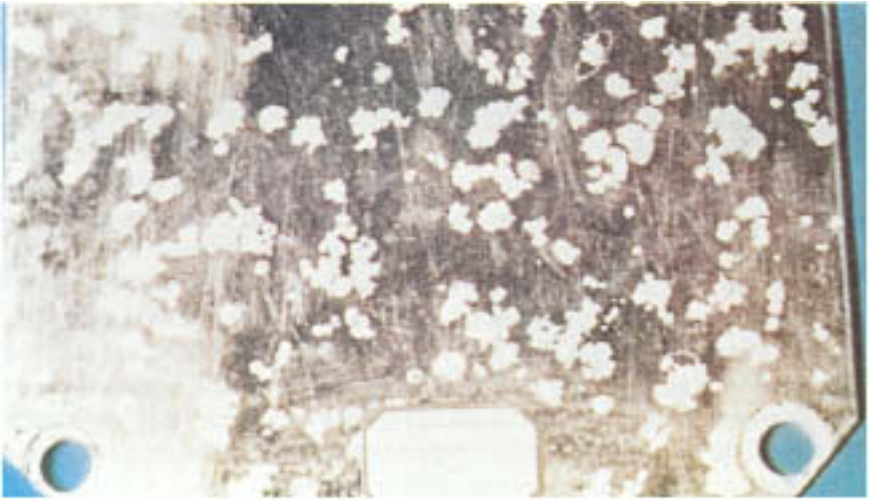
**Figure 4.3** A 304 stainless steel plate from a storage tank floor, which pitted beneath a deposit layer.

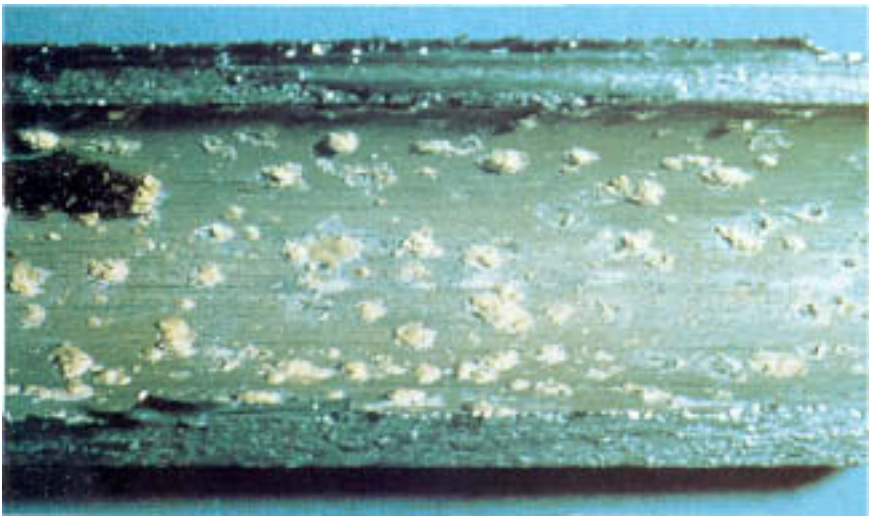
**Figure 4.4** Corrosion product mounds covering localized areas of metal loss on an aluminum heat exchanger tube. Attack initiated beneath a thin deposit layer.

Pitting is also promoted by low pH. Thus, acidic deposits contribute to attack on stainless steels. Amphoteric alloys such as aluminum are harmed by both acidic and alkaline deposits (Fig. 4.4). Other passive metals (those that form protective corrosion product layers spontaneously) are similarly affected.

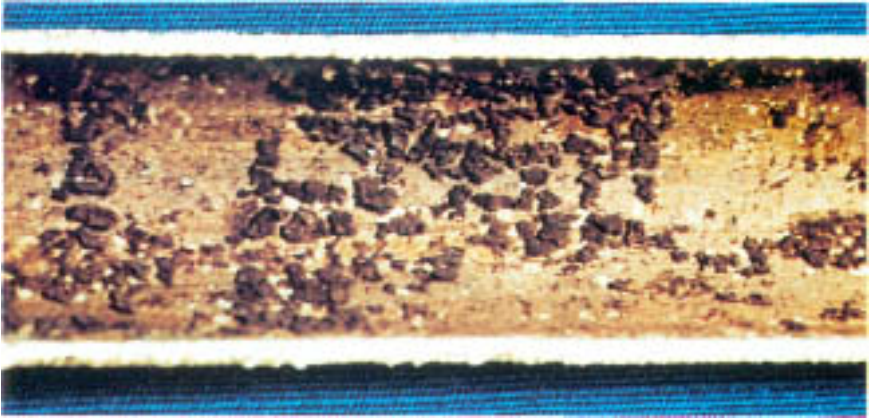
**Figure 4.5** Friable brown deposit patches on a brass condenser tube. The deposit contained more than 30% manganese.

Manganese-rich deposits usually take one of three forms: A loosely adherent, friable, brown, or black deposit may occur (Fig. 4.5). A thin, dark, brittle, glassy manganese layer sometimes forms on heat transfer surfaces (Fig. 4.6). Nodular manganese deposits also occur (Fig. 4.7). Both nodular and glassy layers tend to occur on copper alloys.

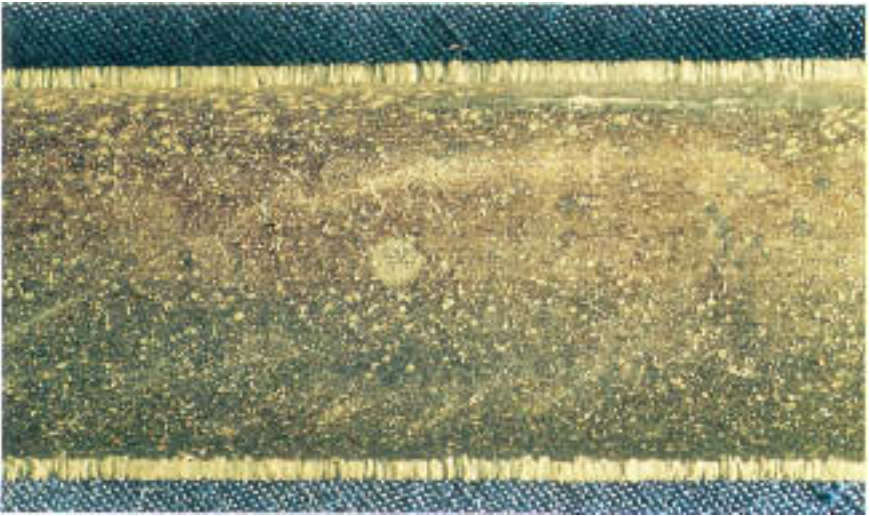
**Figure 4.6** A thin, glassy layer of predominantly manganese oxide on the internal surface of a brass condenser tube. The many white spots are pits at fractures in the manganese layer.

Localized attack is common beneath manganese deposits on copper alloys (Fig. 4.8); it is most common beneath nodular and glassy deposits (Figs. 4.6 and 4.7). The exact corrosion mechanism or mechanisms responsible for pitting beneath manganese deposits on copper alloys are less than clear; no single explanation is consistent with all observed phenomena. Pits are usually filled with friable corrosion products. Pits associated with glassy manganese layers often contain little or no corrosion product and occur at breaks in the glassy layer. General wastage is common beneath porous, voluminous iron and iron-manganese deposits. Surfaces have irregular rolling contours similar to those found on surfaces corroded by oxygen (on steel and cast iron).

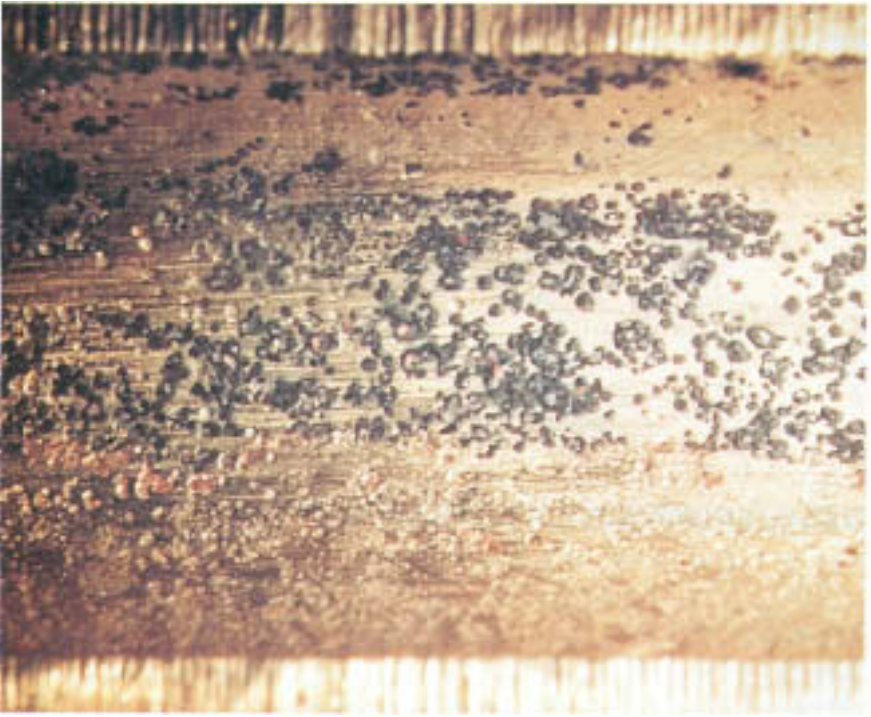
**Figure 4.7** Small, manganese-rich nodules on a 90:10 cupronickel condenser tube. Note the small pits beneath each nodule. (Courtesy of National Association of Corrosion Engineers; Andy Howell Public Service of Colorado, Corrosion '89 Paper No. 197 by H. M. Herro.)

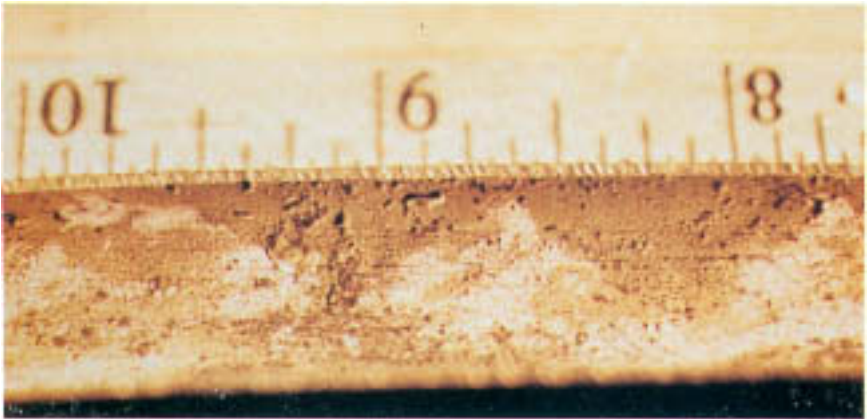
**Figure 4.8** Pitting on internal surface of a brass condenser tube revealed by removal of manganese-rich deposit.

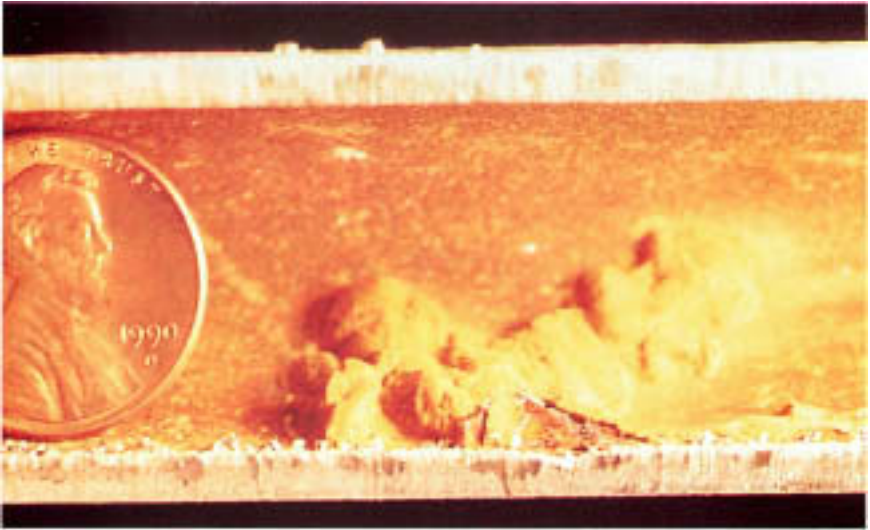
Figure 4.9 Tubercles at breaks in a galvanized layer on steel.

On galvanized steel, tubercles may develop rapidly at breaches in the zinc layer. Attack is frequently highly localized if aggressive ions such as chloride or sulfate concentrate beneath deposits (Fig. 4.9).

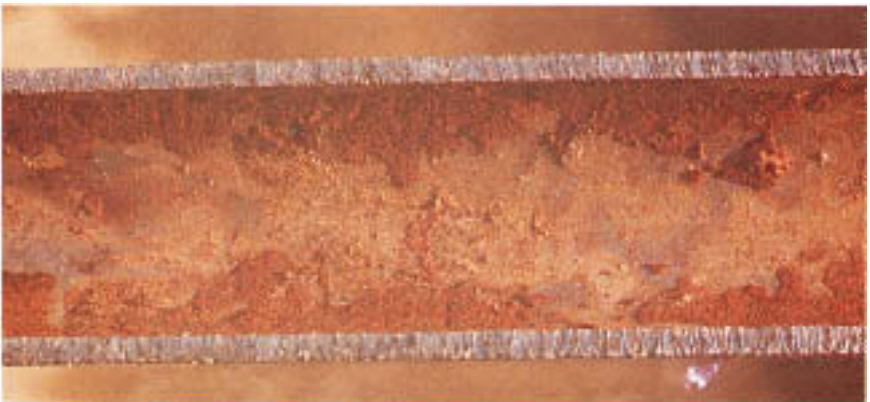
Figure 4.10A Deposits on a 316 stainless steel heat exchanger tube.

Stainless steels may pit or generally corrode beneath deposits (Figs. 4.10A and B through 4.12). Pitting on stainless steels results from a metal surface condition midway between complete passivity and general corrosion. As conditions beneath the deposit become more aggressive due to oxygen depletion, decreasing pH, and/or the concentration of depassivating agents, pits develop (Fig. 4.10A and B). Attack beneath deposits is unlikely unless depassivating agents and/or low pH are present. Attack is intense and localized; pronounced undercutting of pits is present if acid conditions are established below the deposit. Usually corrosion products are reddish brown and may surround the pits (Fig. 4.13). If deposits are sufficiently aggressive, corrosion may become general (Fig. 4.11). Borders separating corroded from unattacked regions are usually sharp, mirroring deposit patterns (Fig. 4.12). Corrosion products resemble rust formed on steel and cast iron surfaces but are considerably less voluminous; tuberculation is rare but can occur (e.g., at sensitized welds).

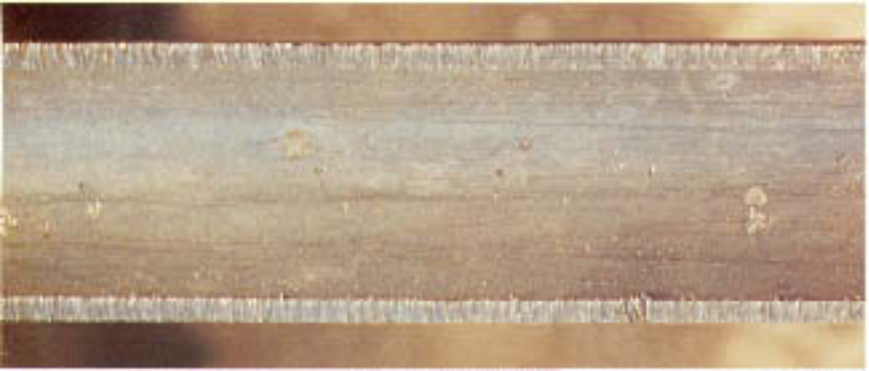
**Figure 4.10B** As in Fig. 4.10A, with deposits removed to show pitting.

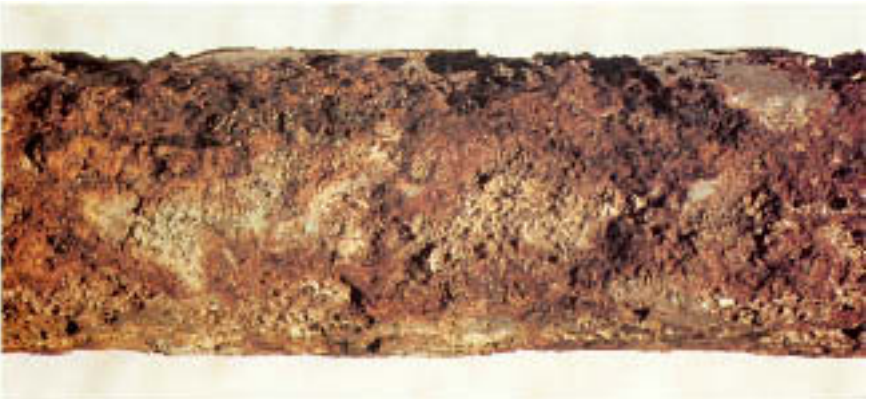
**Figure 4.11** General wastage on a 304 stainless steel heat exchanger tube.

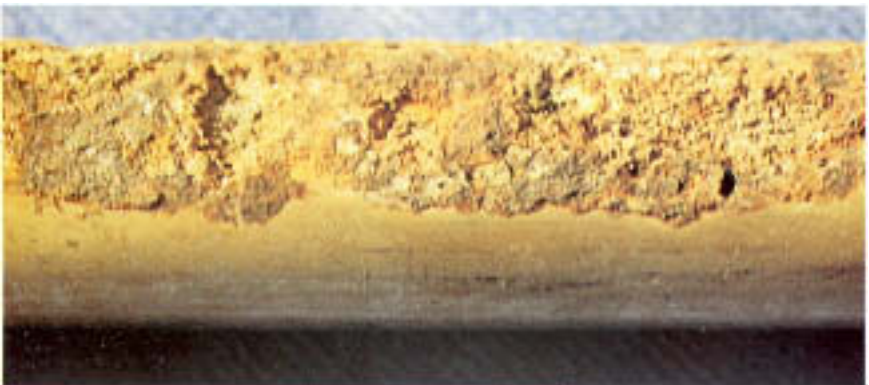
**Figure 4.12** As in Fig. 4.11. Note how abruptly corrosion terminates at deposit edge.

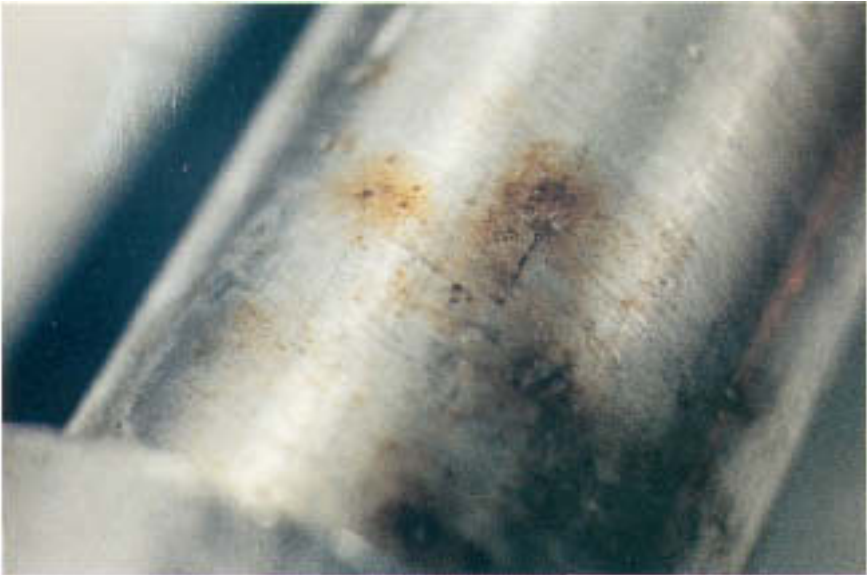
**Figure 4.13** Rust patches surround small pits on a stainless steel shaft. The rust is formed by oxidation of ejected ferrous ion from the tiny pits. Pits were initiated by chloride and sulfate ions concentrated by evaporation.

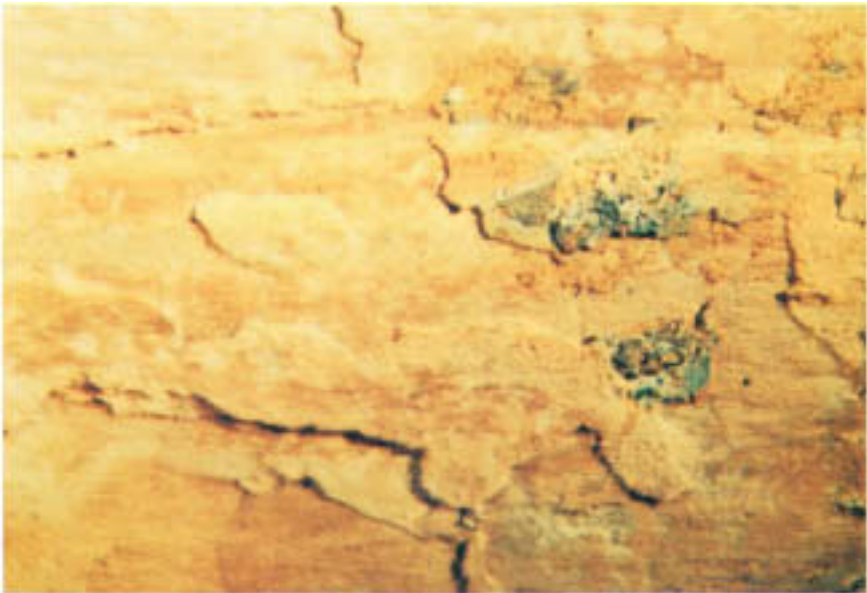
**Figure 4.14** Silt layer on the internal surface of a 90:10 cupronickel condenser tube.

Below silt accumulations on copper, brass, and cupronickel heat exchangers, a layer of bluish-white copper carbonate often forms (Figs. 4.14 and 4.15).

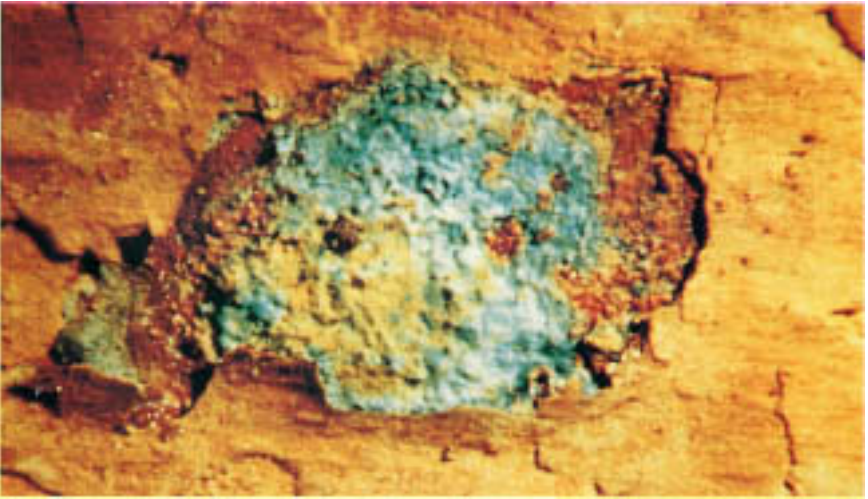
**Figure 4.15** As in Fig. 4.14 but with silt removed to reveal bluish-white copper carbonate corrosion products.

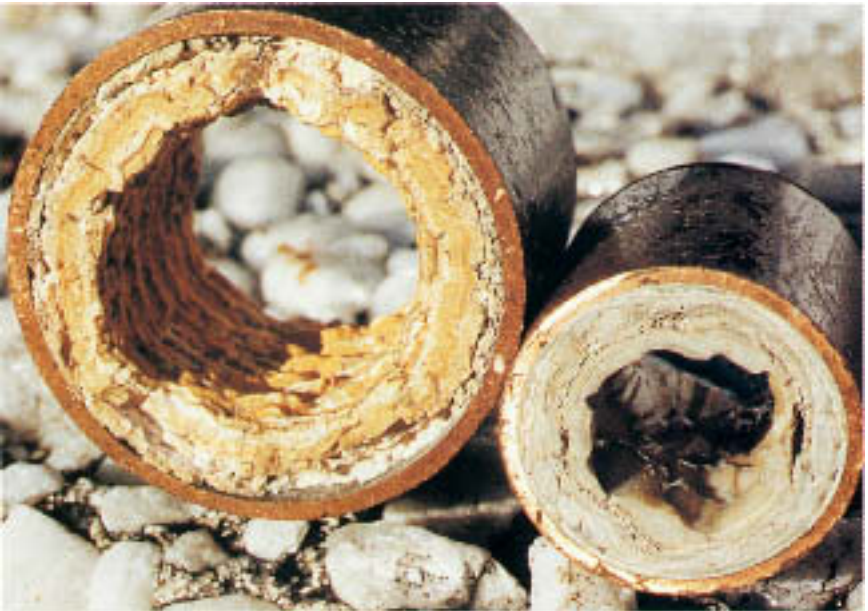
**Figure 4.16** Thick calcium carbonate deposits on condenser tube and copper transfer pipe. Note the stratification.
