# **The Nalco Guide to Cooling Water System Failure Analysis**

**Nalco Chemical Company**

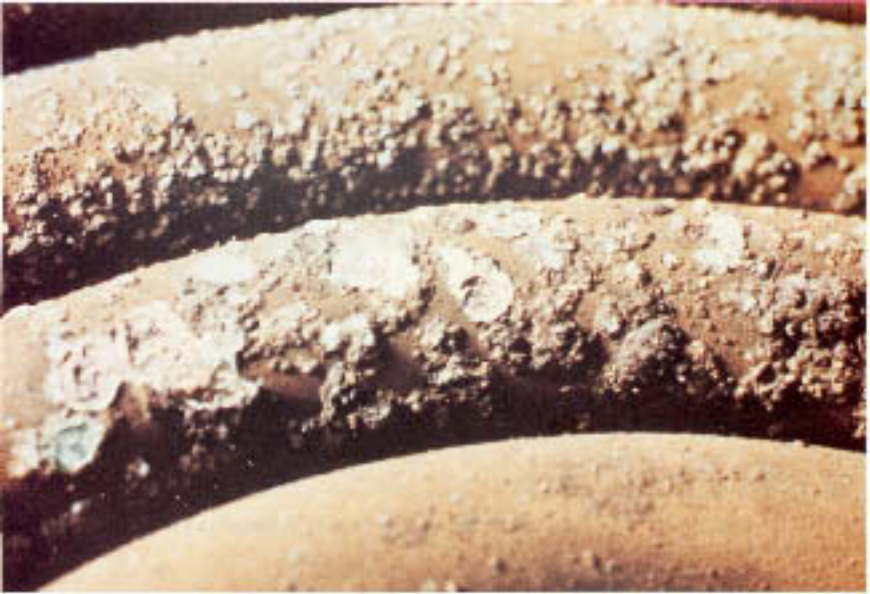
**Figure 4.17** Corroded copper tubes from a heating coil. Cooling water contacted the visible surface. The mounds consist of copper carbonate (see Fig. 4.18).

Calcium carbonate has normal pH and inverse temperature solubilities. Hence, such deposits readily form as pH and water temperature rise. Copper carbonate can form beneath deposit accumulations, producing a friable bluish-white corrosion product (Fig. 4.17). Beneath the carbonate, sparkling, ruby-red cuprous oxide crystals will often be found on copper alloys (Fig. 4.18). The cuprous oxide is friable, as these crystals are small and do not readily cling to one another or other surfaces (Fig. 4.19). If chloride concentrations are high, a white copper chloride corrosion product may be present beneath the cuprous oxide layer. However, experience shows that copper chloride accumulation is usually slight relative to other corrosion product masses in most natural waters.

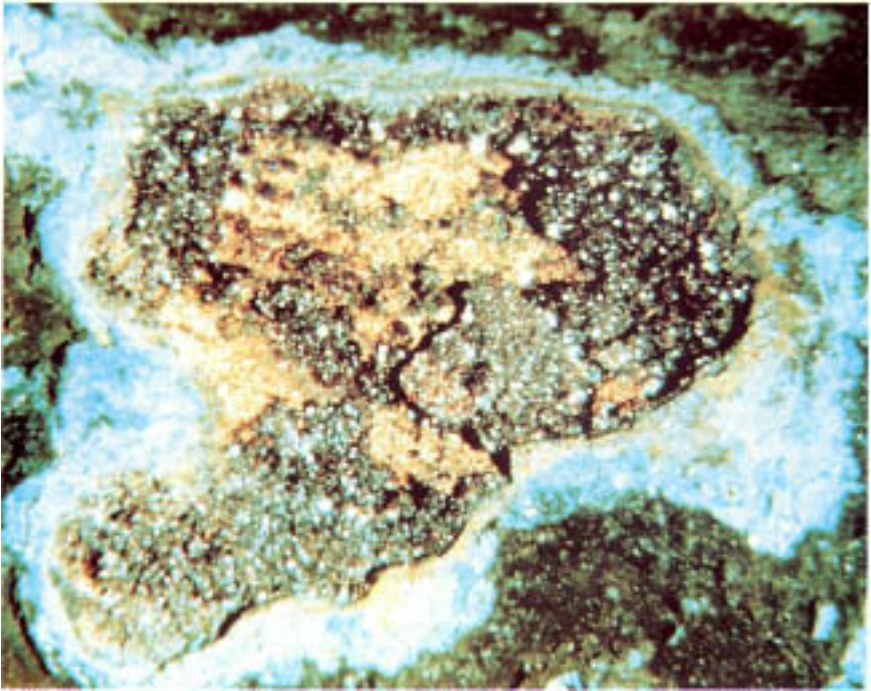
**Figure 4.18** As in Fig. 4.17 but with carbonate mound removed to reveal sparkling lavender cuprous oxide crystals.

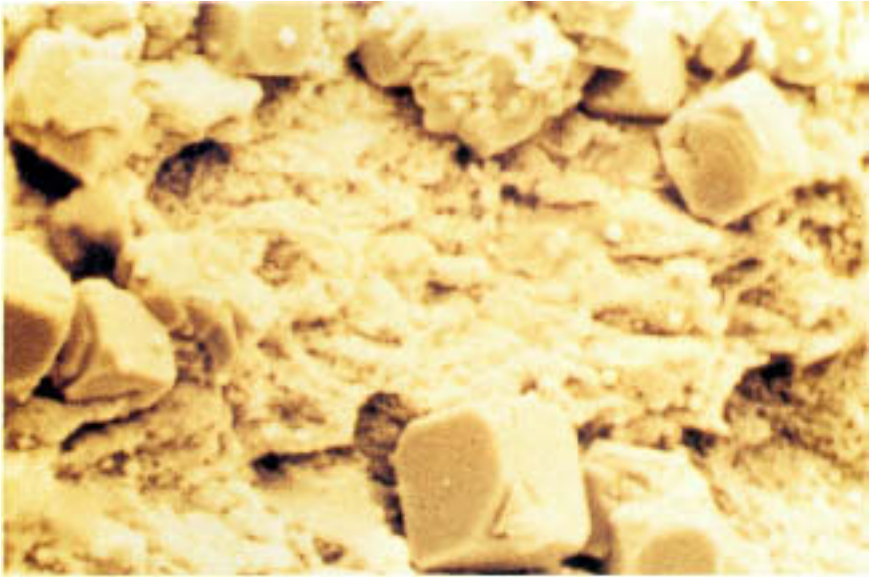
**Figure 4.19** Scanning electron microscope picture of cuprous oxide crystals as shown in Fig. 4.18. Note the partial octahedral symmetry.

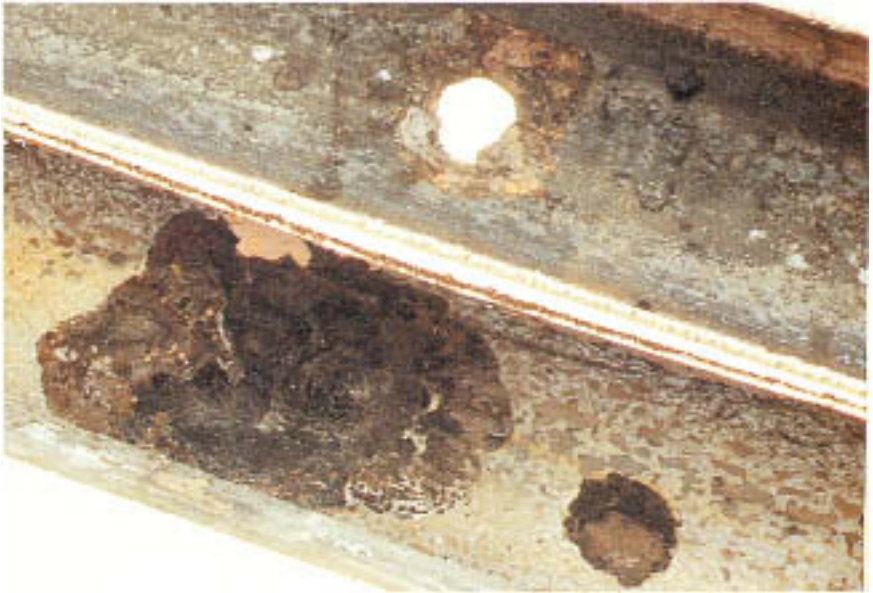
**Figure 4.20** Sulfide deposits (dark patches) on longitudinally split brass heat exchanger tube. Note the perforation where wastage penetrated the tube wall. Sulfide was spalled after perforation by escaping fluids.

Sulfides are directly aggressive to many metals. In particular, copper alloy corrosion is severe (Fig. 4.20). Sulfides are easily detected in the

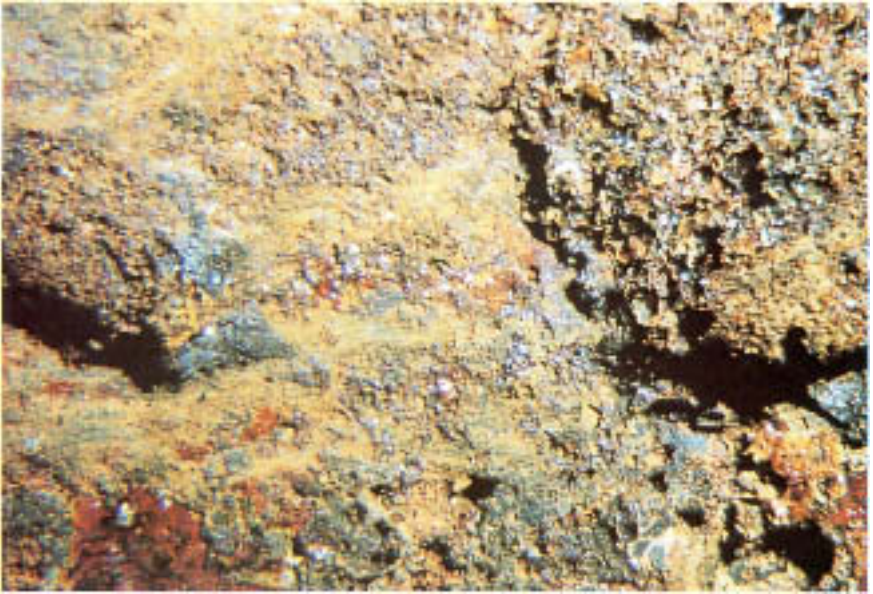
**Figure 4.21** Internal surface (waterside) of alloy steel heat exchanger. Corrosion products and deposits partially cover pits. (Magnification: 7.5 $\times$ .)

Internal surfaces exhibited many rounded, mutually intersecting pits partially buried beneath silt, iron oxide, and sand deposits. Orange and brown corrosion products and deposits overlaid all. Sulfides were present in the deposits and corrosion products. The material was easily removed when acid was applied (Figs. 4.21 and 4.22).

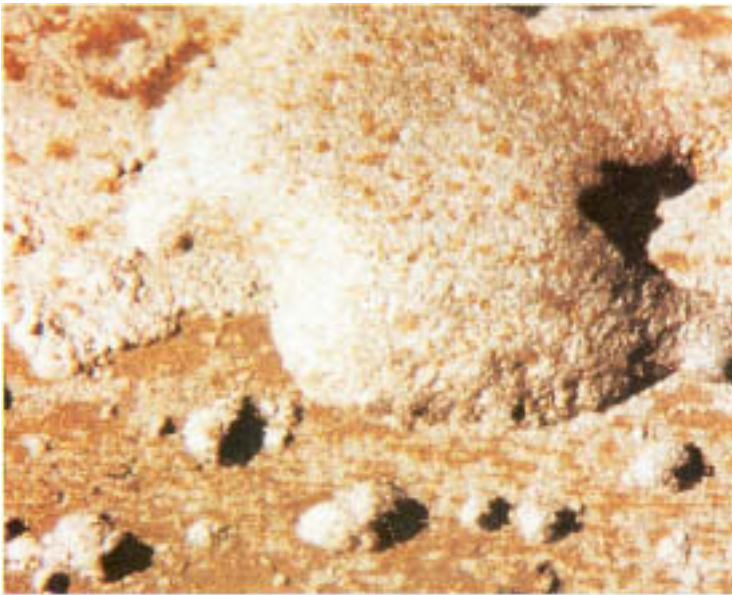
**Figure 4.22** As in Fig. 4.21 but with deposits and corrosion products removed to reveal numerous depressions. (Magnification: 7.5 $\times$ .)

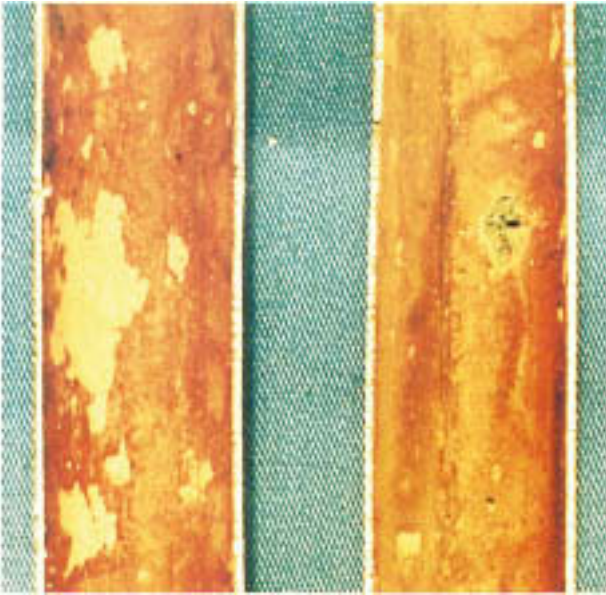
**Figure 4.23** Thick, red cuprous oxide layer covering internal surface of 90:10 cupronickel condenser tube. Note the green mounds marking sites of localized wastage.

The condenser was plagued by rapid attack on waterside surfaces. The entire internal surface was fouled with silt and other deposits, beneath which a cuprous oxide layer was present (Fig. 4.23). Localized areas of metal loss were present beneath mounds of corrosion product. Some of these localized areas were deep enough to threaten tube integrity.

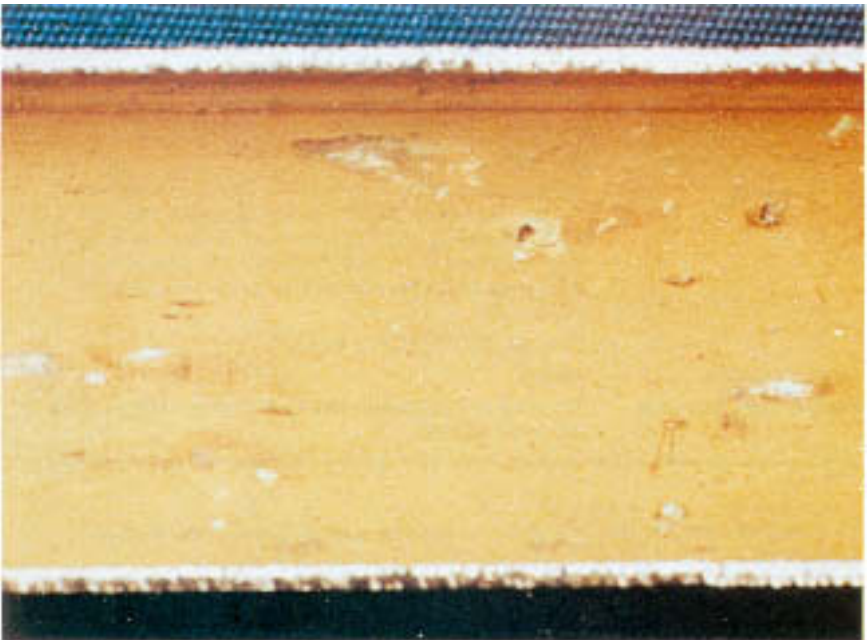
**Figure 4.24** Internal surface of condenser tube as shown in Fig. 4.23.

Ferrous sulfate was added to the condenser in hopes of retarding attack. A thick, tan deposit layer rapidly formed on tubes near inlets (Fig. 4.24). Corrosion continued unabated. Underdeposit corrosion caused localized areas of metal loss (Fig. 4.25). Corrosion product mounds contained up to 10% chloride.

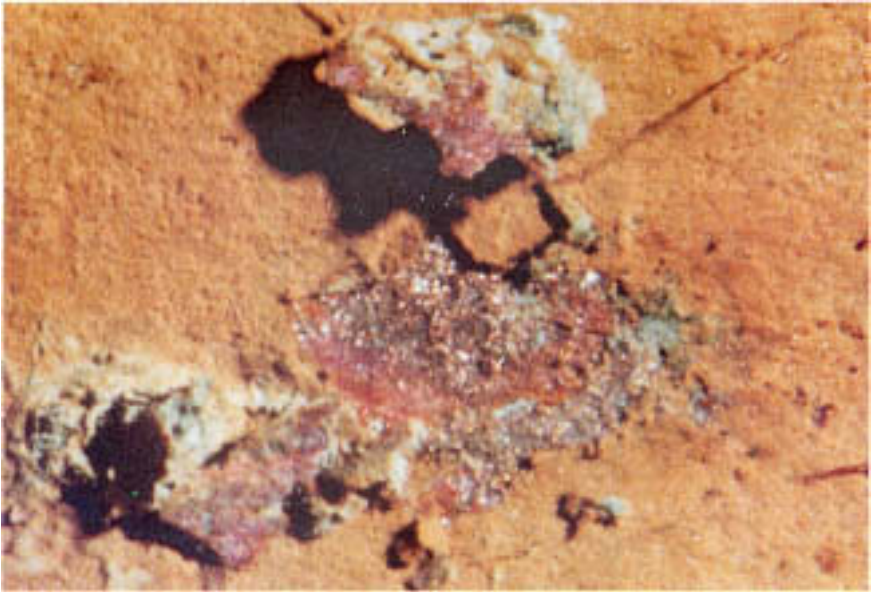
**Figure 4.25** As in Figs. 4.23 and 4.24. Corrosion product mound broken open to reveal sparkling cuprous oxide crystals.

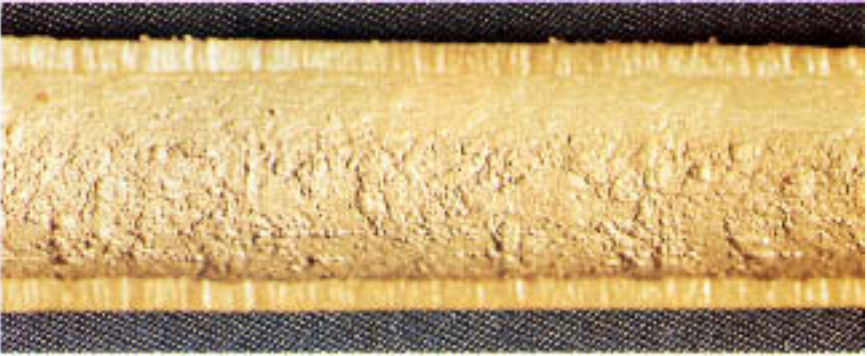
**Figure 4.26** Internal surface of steel heat exchanger tube after removal of deposits. Note the mutually intersecting areas of metal loss.

Tubes were removed for routine inspection. Internal surfaces had rough contours due to mutually intersecting areas of metal loss (Fig. 4.26). Wall thickness varied from 0.080 in. (0.20 cm) to as little as 0.032 in. (0.081 cm).

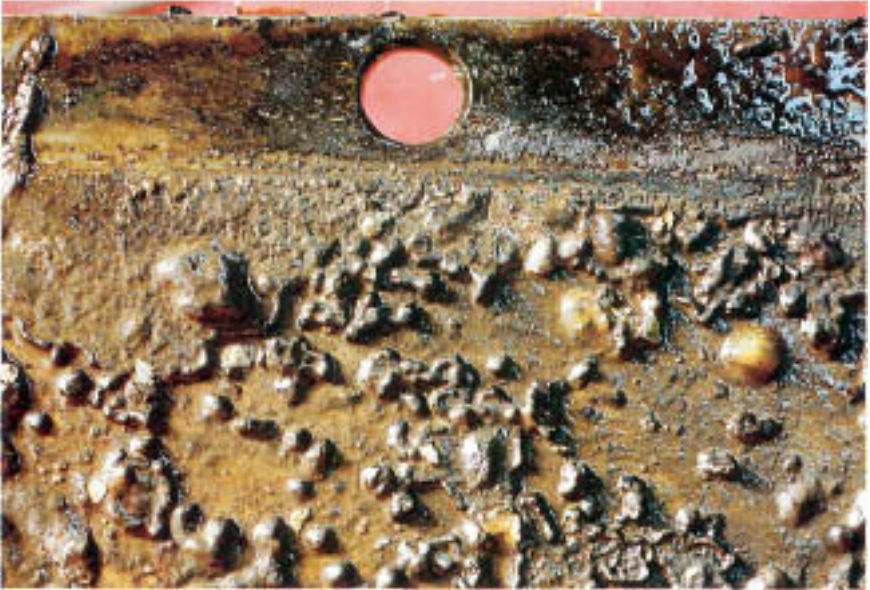
**Figure 4.27A** Mild steel coupon removed from a rolling mill cooling tank. Note the thick greasy deposits.

Carbon steel contacting mill coolant had suffered general corrosion. Stainless steel components were unaffected. Although many factors contributed to wastage in these systems, deposits played an important role (Fig. 4.27A and B). Corrosion exactly mirrored deposition patterns.

Deposits contained organic acids formed by oxidation of rolling oils. Up to 40% by weight of the lumps shown in Fig. 4.27A and B was iron oxides, hydroxides, and organic-acid iron salts. Acidic species concentrated in the deposits.

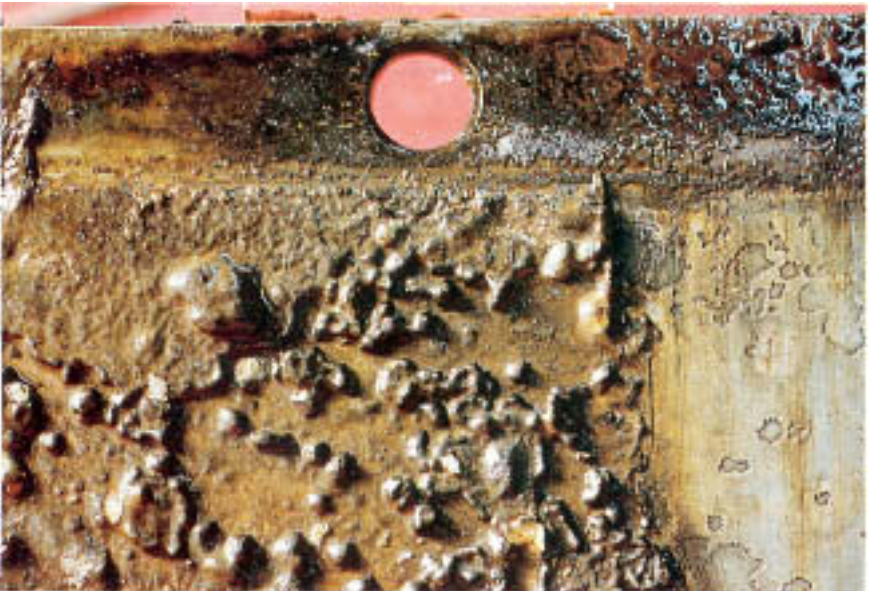
**Figure 4.27B** As in Fig. 4.27A but with deposits removed to show corrosion beneath.

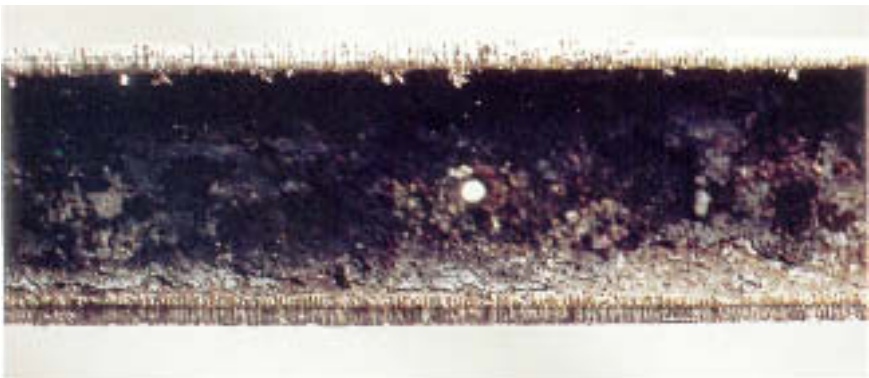
**Figure 4.28** Perforation on a duplex (brass internally, aluminum externally) tube caused by sulfur compounds concentrated on internal surfaces.

A duplex heat exchanger tube containing a single small perforation was examined. Perforation occurred due to internal surface wastage beneath a deposit layer containing large concentrations of sulfur compounds (Fig. 4.28).

Corrosion proceeded generally on internal surfaces during a long period. Eventually, the inner brass tube was penetrated, exposing the aluminum tube to internal cooling waters. The aluminum corroded rapidly at the breach, since coupling of brass and aluminum produced a galvanic cell (see Chap. 16, “Galvanic Corrosion”).

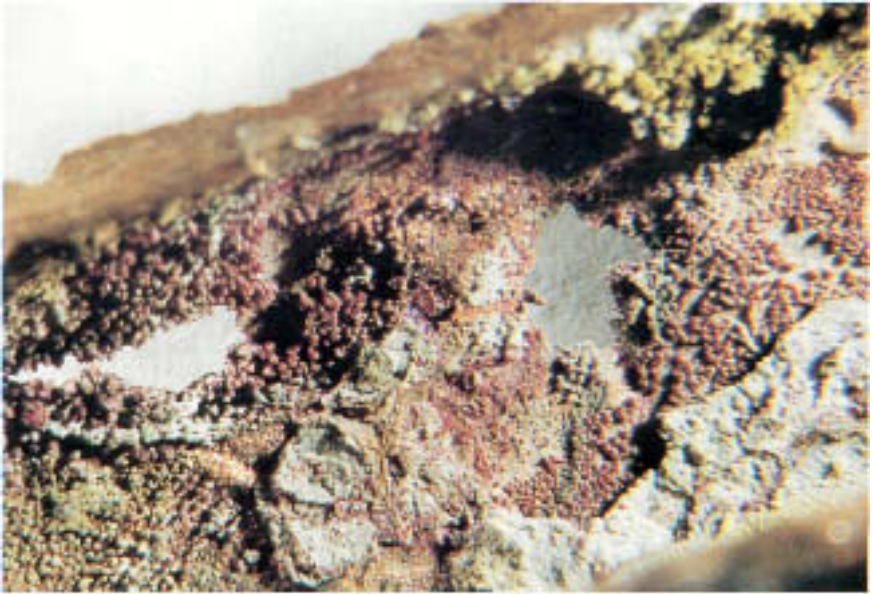
**Figure 4.29** Corroded internal surface of a copper chiller tube. The light-colored deposits are primarily iron oxides and silicates; reddish material is cuprous oxide.

Internal surfaces of all tubes were severely attacked (Fig. 4.29). A brown deposit layer consisting of magnetite, iron oxide hydroxide, and silica covered all surfaces. Deposition was thicker and more tenacious along the bottom of tubes. These deposits had a distinct greenish-blue cast caused by copper corrosion products beneath the deposit. Underlying corrosion products were ruby-red cuprous oxide crystals (Fig. 4.29). Areas not covered with deposits suffered only superficial attack, but below deposits wastage was severe.

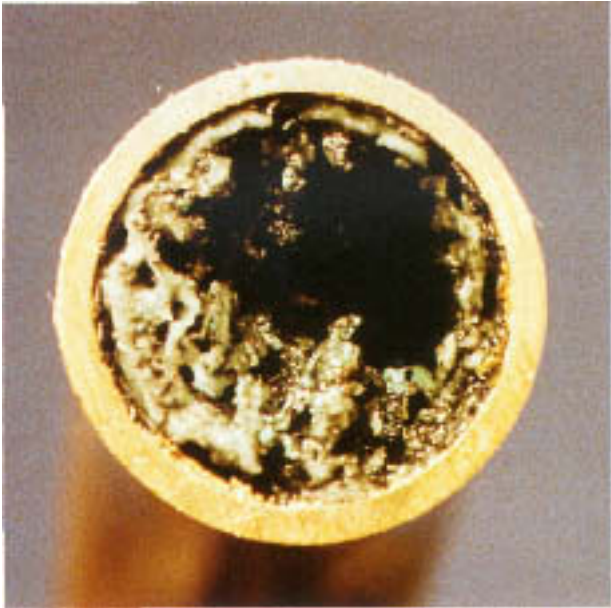
**Figure 4.30A** Brass cooler tube almost plugged by deposits.

Tubes were almost plugged with deposits (Fig. 4.30A and B). The deposits contained almost 40% sulfur by weight. Hydrocarbon in-leakage had occurred through small cracks that originated on internal surfaces beneath deposits.

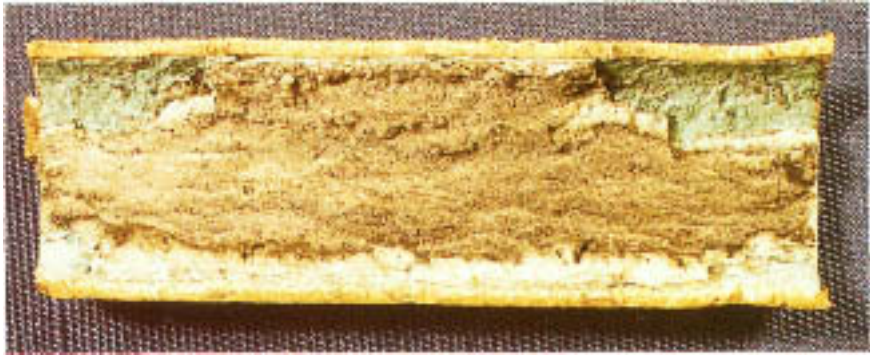
**Figure 4.30B** As in Fig. 4.30A. Note the light-colored deposits intermixed with bluish-green corrosion products.

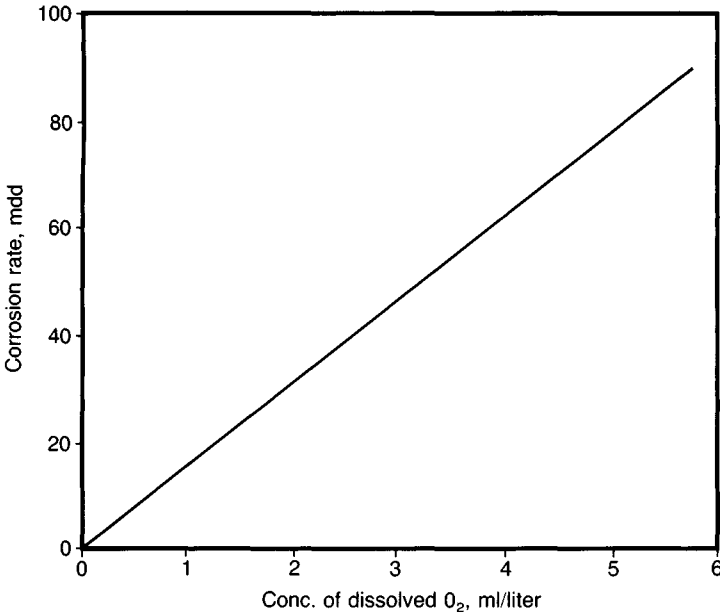
**Figure 5.1** Effect of oxygen concentration on corrosion of mild steel in slowly moving water containing 165 ppm CaCl<sub>2</sub>; 48-hour test, 25°C. [Courtesy of H. H. Uhlig, D. N. Triadis, and M. Stern, "Effect of Oxygen, Chlorides, and Calcium Ion on Corrosion Inhibition of Iron by Polyphosphates," *J. Electrochem. Soc.* 102, p. 60 (1955). Reprinted with permission by The Electrochemical Society, Inc.]

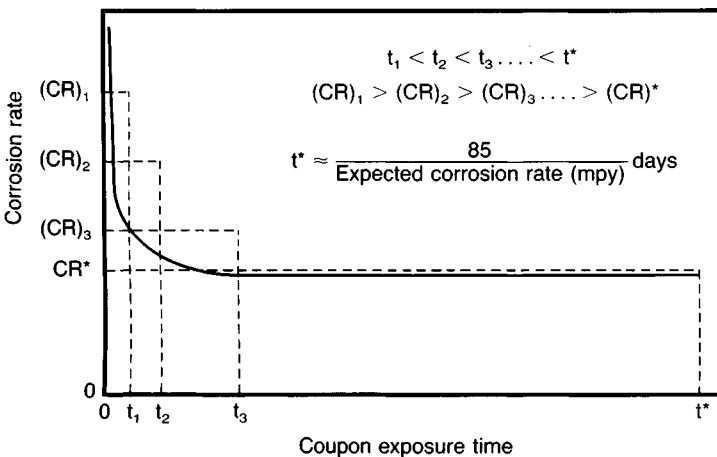
**Figure 5.2** Schematic of carbon steel corrosion rate versus exposure time in a typical oxygenated cooling water. Note how the average corrosion rate decreases with time and converges to  $CR^*$  at  $t^*$  (the minimum exposure time to get reproducible results).

When a clean steel coupon is placed in oxygenated water, a rust layer will form quickly. Corrosion rates are initially high and decrease rapidly while the rust layer is forming. Once the oxide forms, rusting slows and the accumulated oxide retards diffusion. Thus, Reaction 5.2 slows. Eventually, nearly steady-state corrosion is achieved (Fig. 5.2). Hence, a minimum exposure period, empirically determined by the following equation, must be satisfied to obtain consistent corrosion-rate data for coupons exposed in cooling water systems (Figs. 5.2 and 5.3):

$$\text{Minimum exposure time}^* = \frac{85}{\text{corrosion rate}}$$

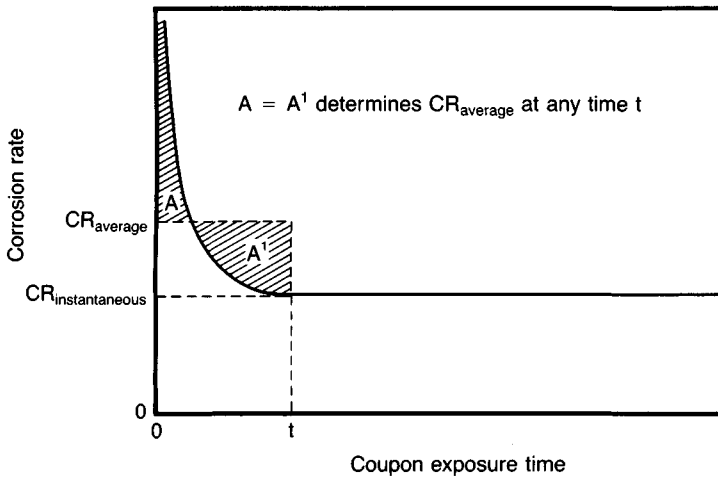
**Figure 5.3** As in Fig. 5.2. Note that the average corrosion rate ( $CR_{\text{average}}$ ) is always larger than the instantaneous corrosion rate ( $CR_{\text{instantaneous}}$ ) and that this difference is largest at small exposure times.

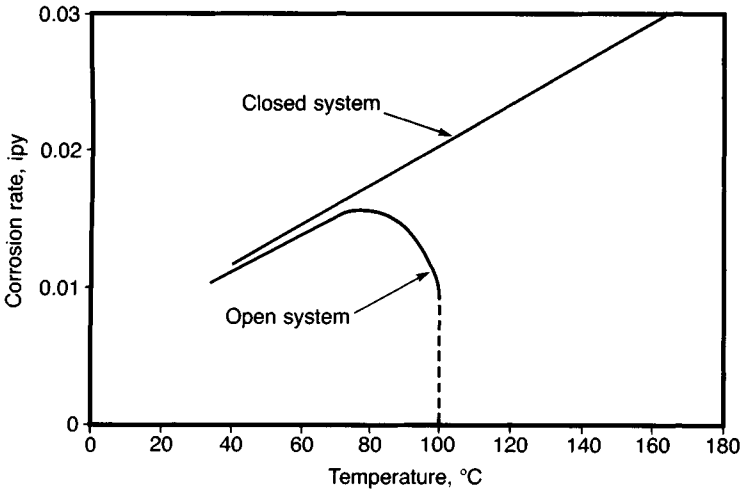
**Figure 5.4** Effect of temperature on corrosion of iron in water containing dissolved oxygen. (Courtesy of McGraw-Hill Inc., *Corrosion, Causes and Prevention*, by F. Speller, p. 168, McGraw-Hill, 1951)

Oxygen corrosion of steel doubles for every 35–55°F (20–30°C) rise in temperature, beginning near room temperature. Corrosion is nearly proportional to temperature up to about 180°F (80°C) in systems open to the air. Although reaction rates increase with temperature, dissolved oxygen is driven from solution as temperatures increase. As temperatures approach boiling, corrosion rates fall to very low values, since dissolved-oxygen concentration also decreases as water temperature rises (Fig. 5.4).

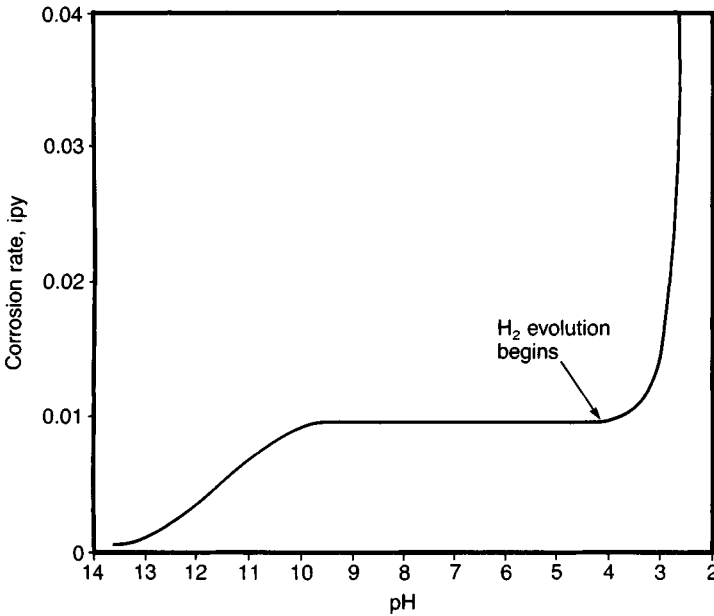
**Figure 5.5** Effect of pH on corrosion of iron in aerated water at room temperature. (Reprinted from *Industrial & Engineering Chemistry* 16, 665, 1924, W. Whitman, R. Russell, and V. Altieri, published by the American Chemical Society.)

When water pH is between about 4 and 10 near room temperature, iron corrosion rates are nearly constant (Fig. 5.5). Below a pH of 4, protective corrosion products are dissolved. A bare iron surface contacts water, and acid can react directly with steel. Hydrogen evolution (Reaction 5.3) becomes pronounced below a pH of 4. In conjunction with oxygen depolarization, the corrosion rate increases sharply (Fig. 5.5).

The corrosion rate of carbon steel (and most cast irons) in pure water is about constant between a pH of 4 and 10 (see Fig. 5.5). In solutions containing strong acids such as hydrochloric and sulfuric, normally pro-

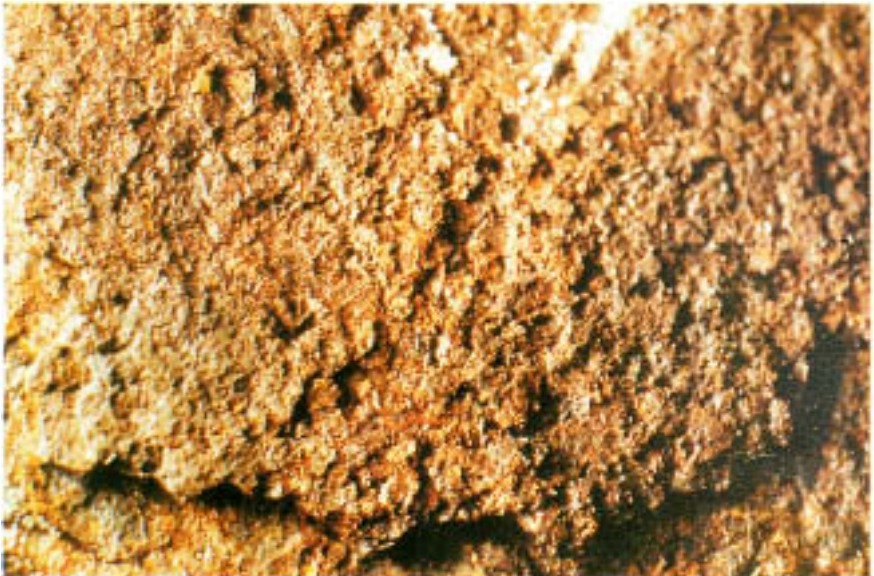
**Figure 5.6** Rust layer on carbon steel mill water supply pipe. Note the partially exfoliated region at the bottom of the photo.

Corrosion in heavily oxygenated waters tends to produce general wastage on many alloys (Figs. 5.6 and 5.7). Localized attack, including pitting, is sometimes favored when a high dissolved-oxygen concentration falls to low values. Localized corrosion can also occur when protective corrosion-product layers, formed under favorable conditions,

Stratified oxide layers form in misted areas (Figs. 5.6 and 5.7). Stratification of corrosion products is common in intermittent wet-dry conditions (Fig. 5.9). Wastage is usually general if oxygen concentrations remain near saturation at room temperature. Surfaces have irregular, undulating contours formed by shallow, intersecting areas of metal loss (Fig. 5.10). As water pH falls, surface contours become rougher.

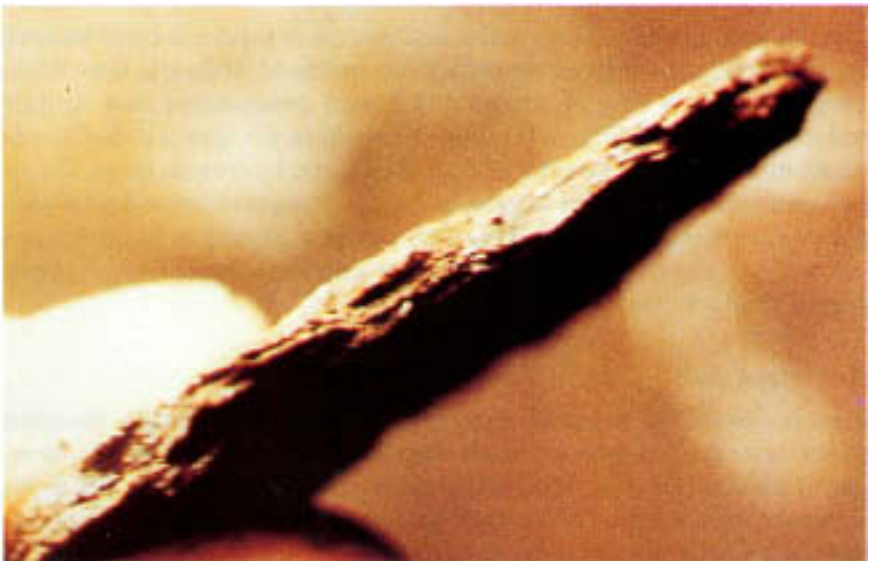
Figure 5.7 Rust chip as in Fig. 5.6.

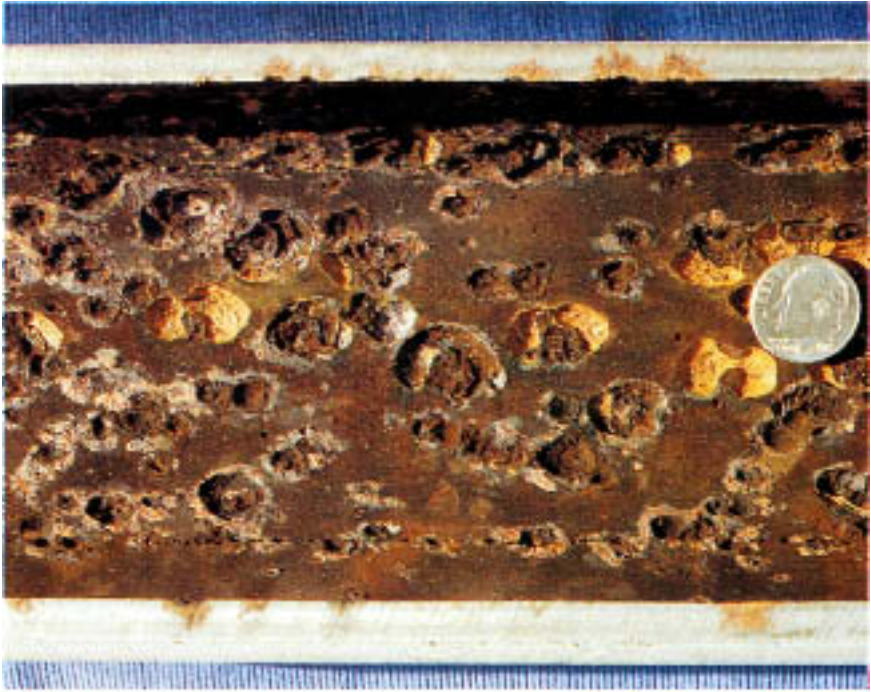
**Figure 5.8** Heavily pitted surface of a mild steel cooling water return line. Note the deep localized metal loss surrounded by aureoles of rust. Pitting is common when oxygen concentration varies greatly over time.

are exposed to elevated oxygen concentrations during upsets or idle periods (Fig. 5.8 and Case History 5.1).

Steel pipe in a cooling water return header contained numerous deep pits on internal surfaces; one pit penetrated the pipe wall (Fig. 5.8). Pits range in size from pinpoint depressions to ½-in. (1.3-cm) pockets. Some pits are filled

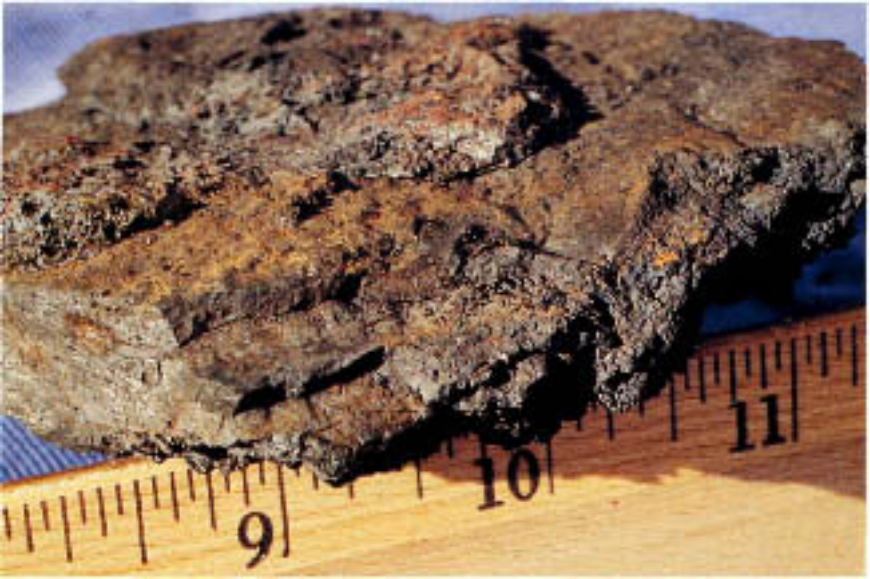
**Figure 5.9** Wall of steel tank, originally  $\frac{1}{2}$  in. (1.3 cm) thick, that was entirely converted to oxide. It was continually exposed to oxygenated water mist at about  $180^{\circ}\text{F}$  ( $82^{\circ}\text{C}$ ).

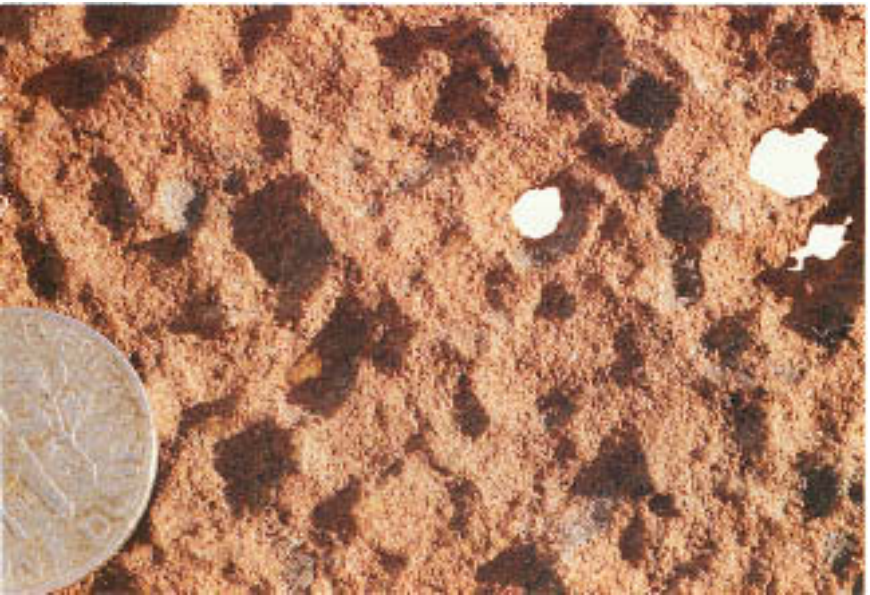
**Figure 5.10** Generally corroded steel surface.

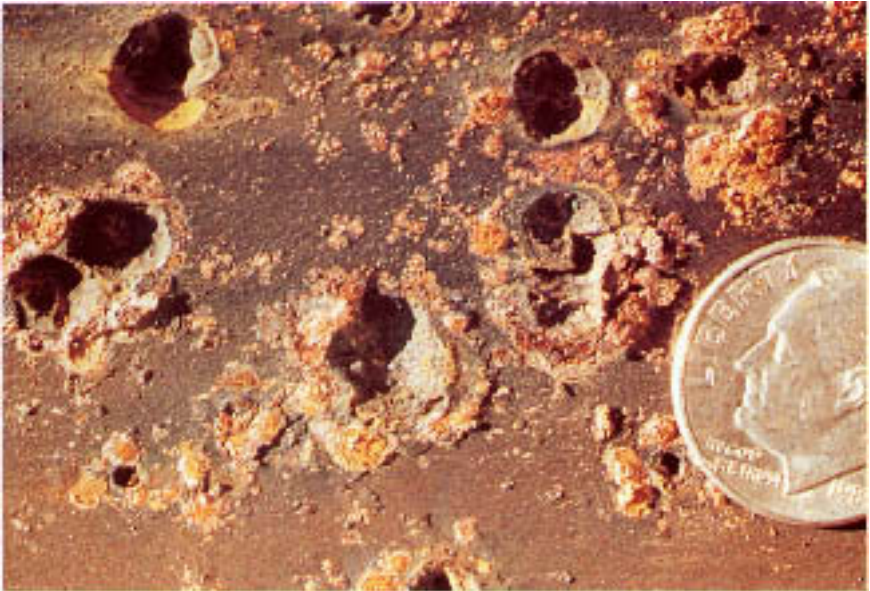
**Figure 5.11** As in Fig. 5.8. Note the rust halos surrounding each pit. Also note how little attack is present between pits.

smooth and unattacked. Deposits and corrosion products cover smooth metal surfaces, except where attack has occurred. If flow is slow when pitting occurs, a ring of orange and brown precipitated rust usually surrounds each pit (Fig. 5.11). Rust forms from the iron ion that is oxidized upon ejection from the pit to form a ferric hydroxide ridge. If flow is significant, these rings may be absent or elongated into ellipses with major axes paralleling flow direction. Uniform rusting is favored when corrosion is slow. Rapid attack tends to produce a more irregular corrosion-product layer.

with friable, dark oxides and are surrounded with orange oxide rings (Fig. 5.11). Pits are more numerous and deeper on the apparent bottom of the pipe. Surfaces between pits are covered with a tenacious, black oxide layer.

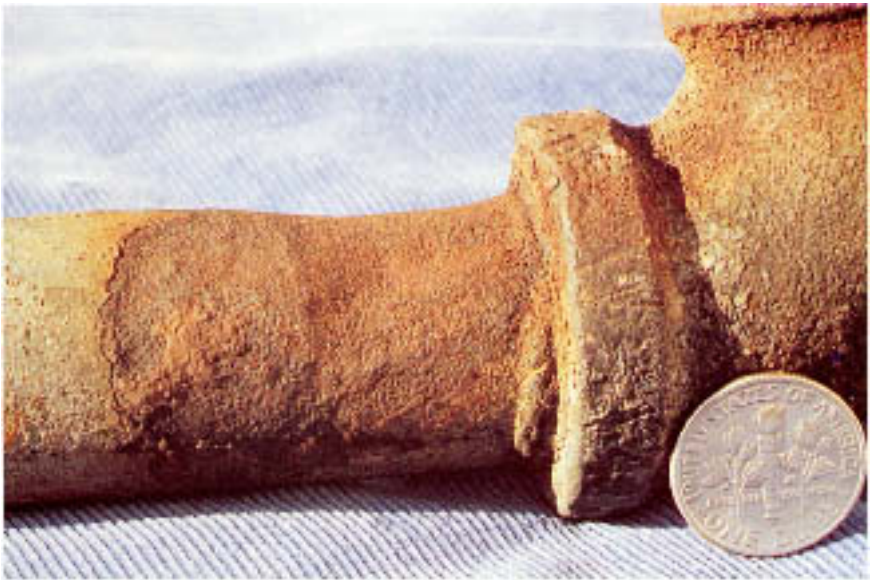
**Figure 5.12** Severely corroded galvanized steel pipe supplying water to a cooling tower fan-bearing system. Where the galvanized metal has been consumed, only a brown rust patch is visible.

Zinc is susceptible to attack from oxygen concentration cells. Shielded areas or areas depleted in oxygen concentration tend to corrode, forming voluminous, white, friable corrosion products. Once the zinc layer is breached, the underlying steel becomes susceptible to attack and is severely wasted locally (Figs. 5.12 and 5.13).

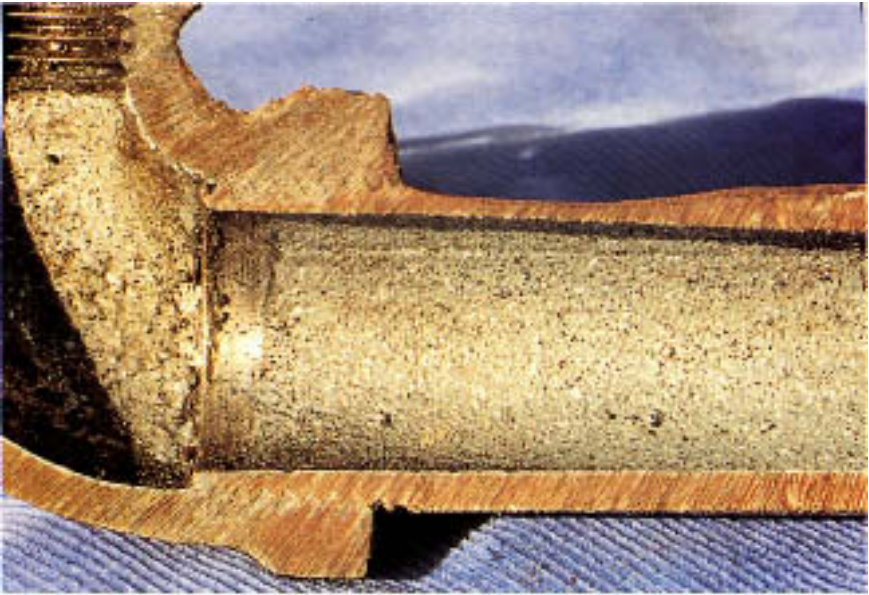
**Figure 5.13** As in Fig. 5.12 but with pipe in cross section, showing severe wastage where the galvanized layer is absent.

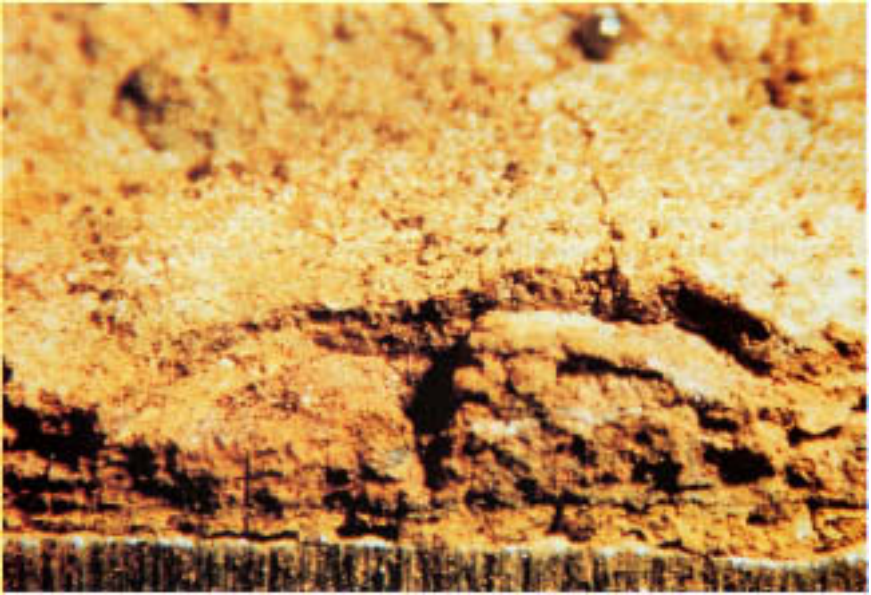
**Figure 5.14** Stratified corrosion products and deposits on the internal surface of a tube. (Magnification: 7.5 $\times$ .)

Two sections of steel condenser tubing experienced considerable metal loss from internal surfaces. An old section contained a perforation; the newer section had not failed. A stratified oxide and deposit layer overlaid all internal surfaces (Fig. 5.14). Corrosion was severe along a longitudinal weld seam in the older section (Fig. 5.15). Differential oxygen concentration cells operated beneath the heavy accumulation of corrosion products and deposits. The older tube perforated along a weld seam.

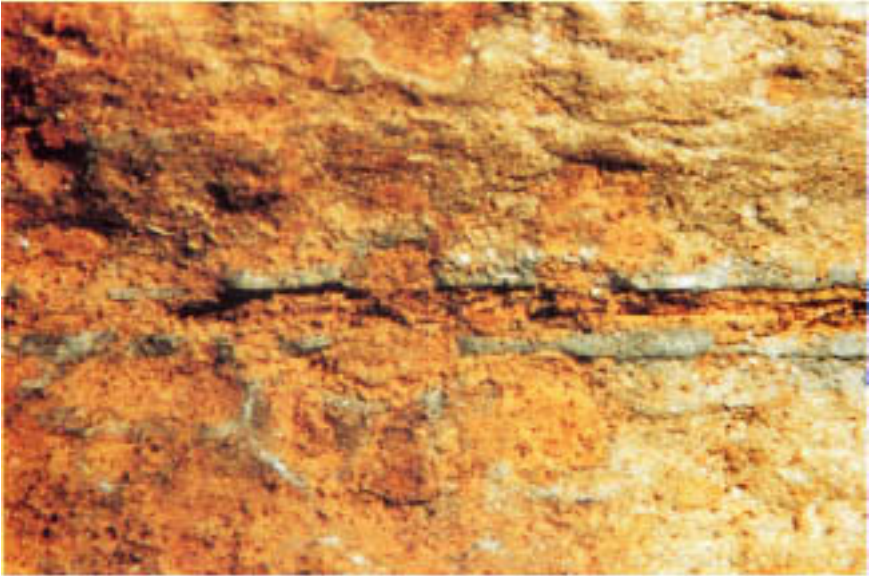
**Figure 5.15** Rough internal surface contour of the tube shown in Fig. 5.14. Note the preferential attack on the weld seam. (Magnification: 7.5 $\times$ .)

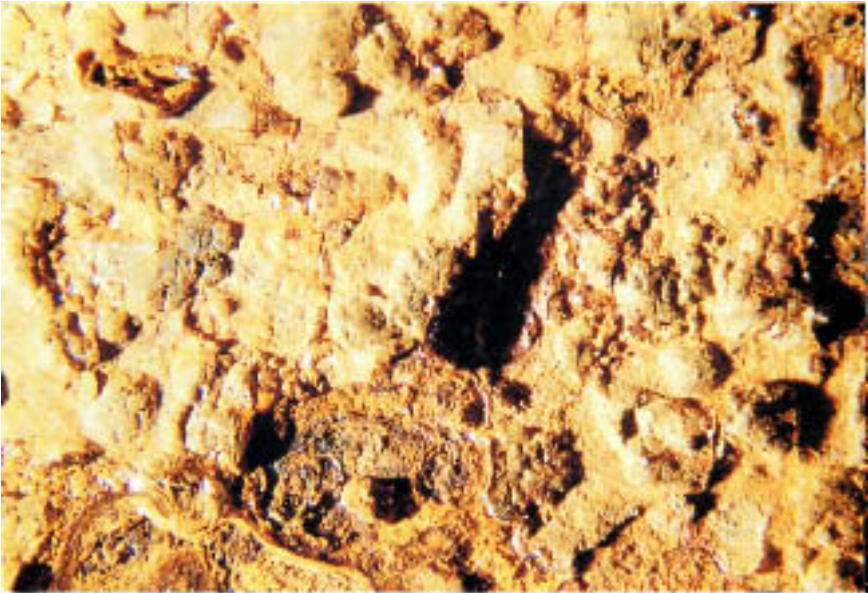
**Figure 5.16** Delaminated, phenolic epoxy resin coating on an internal surface. (Magnification: 7.5 $\times$ .)

Close visual examination of internal surfaces using a low-power stereomicroscope revealed a coating of reddish iron oxides on the internal surface. A population of small, knoblike mounds of corrosion product resembling tubercles was present on the surface (Fig. 5.16).

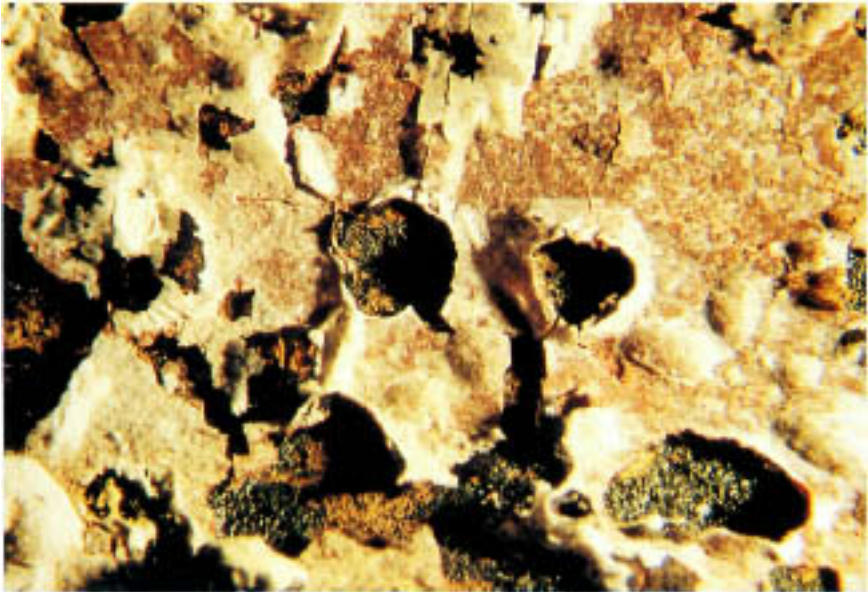
**Figure 5.17** As in Fig. 5.16 but after a brief chemical cleaning. The coating is more easily visible, and small depressions are visible beneath the coating blisters. (Magnification: 7.5 $\times$ .)

Reexamination of the surface after a brief acid cleaning showed that about 90% was still covered by resin, although the resin had been blistered and ruptured at small tubercular sites (Fig. 5.17).

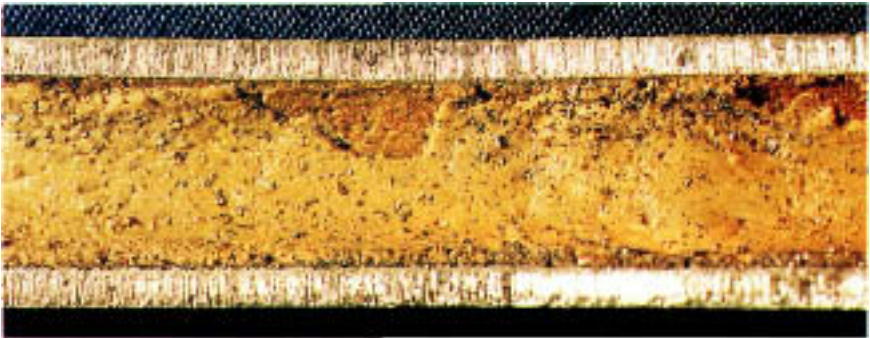
**Figure 5.18** Heavily fouled and corroded internal surface of a galvanized carbon steel pipe.

Pluggage of cooling water return lines had occurred repeatedly. The material removed from internal surfaces contained large amounts of grease, oil, and rust (Fig. 5.18).

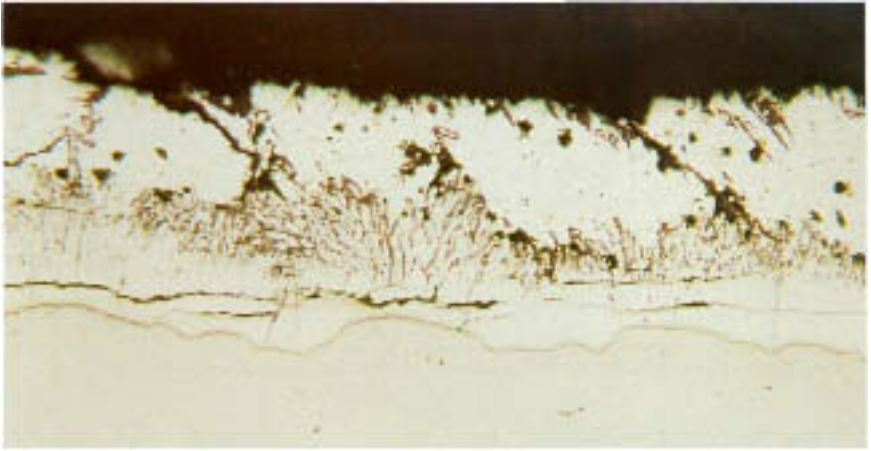
**Figure 5.19** As in Fig. 5.18. Typical galvanizing layer on an internal surface in cross section. Compare with Fig. 5.20. The uniform white area at bottom is the tube steel. (Magnification: 220 $\times$ , unetched.)

In places, the galvanized layer was consumed, exposing the underlying steel (Figs. 5.19 and 5.20). Wastage was caused by exposure of surfaces to high concentrations of dissolved oxygen. The likelihood of concentration cells operating beneath the heavy deposit and corrosion-product accumulation was high.

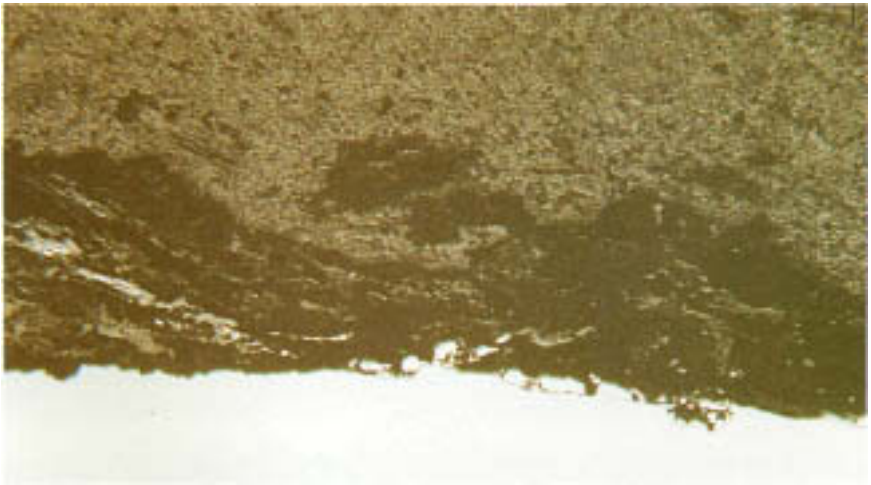
**Figure 5.20** Small area on an internal surface with a breach in the galvanized layer. (Magnification: 110 $\times$ , unetched.)

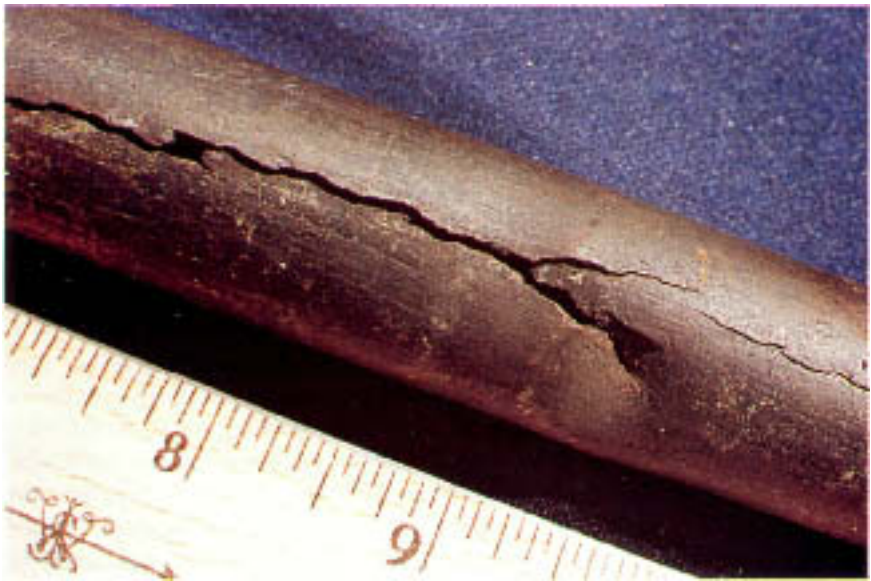
**Figure 6.1** Stress-corrosion cracking of a brass condenser tube caused by ammonia from decomposing slime masses lodged on internal surfaces.

Finally, any living organism dies. Decomposition may generate ammonia at local concentrations high enough to produce stress-corrosion cracking of brass condenser tubes (Fig. 6.1).

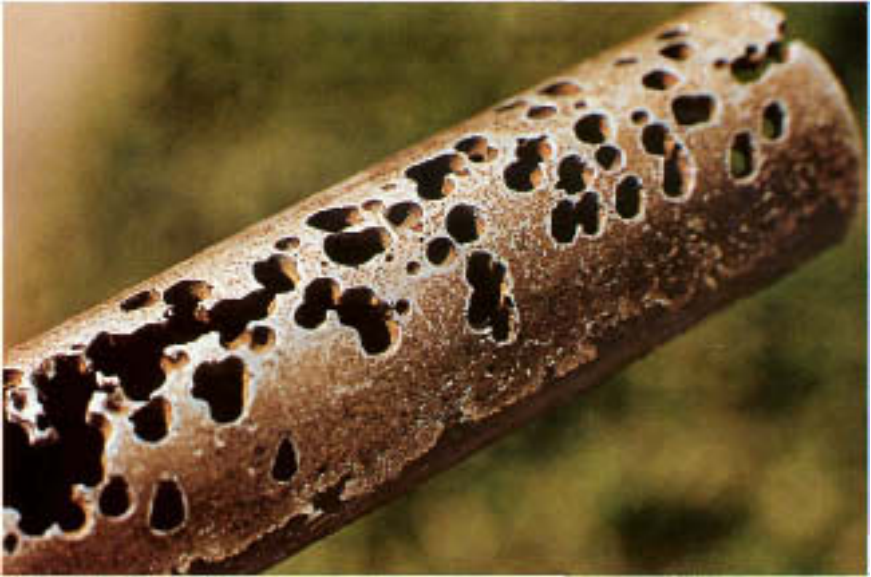
**Figure 6.2** Severely pitted aluminum heat exchanger tube. Pits were caused by sulfate-reducing bacteria beneath a slime layer. The edge of the slime layer is just visible as a ragged border between the light-colored aluminum and the darker, uncoated metal below.

*Corrosion morphologies.* Sulfate-reducing bacteria frequently cause intense localized attack (Figs. 6.2 through 6.7). Discrete hemispherical depressions form on most alloys, including stainless steels, aluminum, Carpenter 20, and carbon steels. Few cases occur on titanium. Copper alloy attack is not well defined.

Passive attack beneath slime is usually general, and rusting on steel may color surfaces brown and red (Fig. 6.14). If sulfate reducers are present, pitting may be superimposed on the generally corroded surface (see Fig. 6.2).

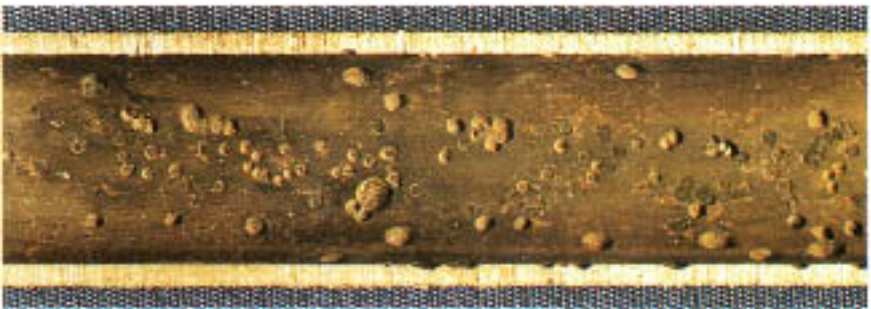
**Figure 6.3** Pitting on the waterside surface of a Carpenter 20 heat exchanger tube caused by sulfate reducers.

Pit interiors are characteristically smooth and distinctly hemispherical, but become rougher on less-noble alloys. Pits tend to cluster together, overlapping to form irregularly dimpled surfaces. Frequently, a lightly etched aureole surrounds the pit clusters. These etched areas are often produced by shallow corrosion beneath deposit and slime masses that covered the sulfate reducers in service (Figs. 6.3 and 6.4A and B).
