# **The Nalco Guide to Cooling Water System Failure Analysis**

**Nalco Chemical Company**

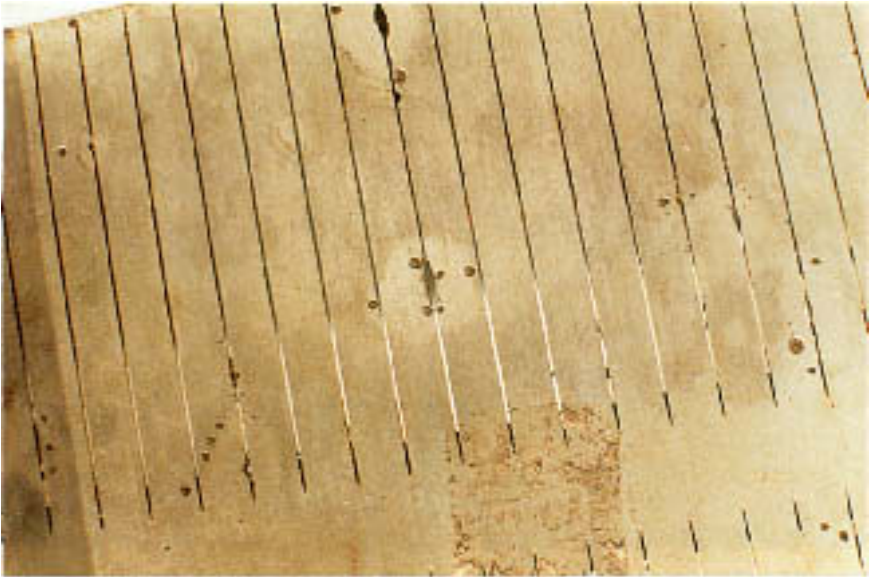
**Figure 6.4A** Small pits on a 316 stainless steel plate. A light area covers the clustered pits, marking ghost images of deposit mounds.

Pit interiors are characteristically smooth and distinctly hemispherical, but become rougher on less-noble alloys. Pits tend to cluster together, overlapping to form irregularly dimpled surfaces. Frequently, a lightly etched aureole surrounds the pit clusters. These etched areas are often produced by shallow corrosion beneath deposit and slime masses that covered the sulfate reducers in service (Figs. 6.3 and 6.4A and B).

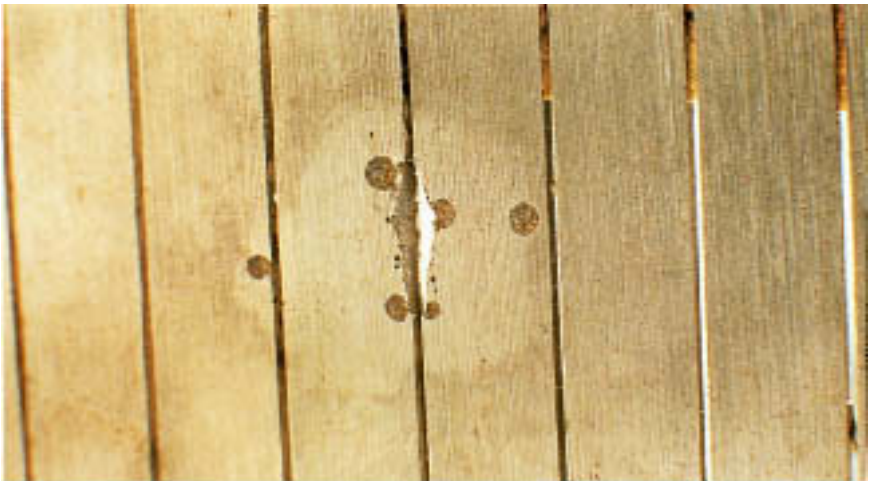
**Figure 6.4B** As in Fig. 6.4A. Note the smooth hemispherical pit contours and the tendency of the pits to cluster together.

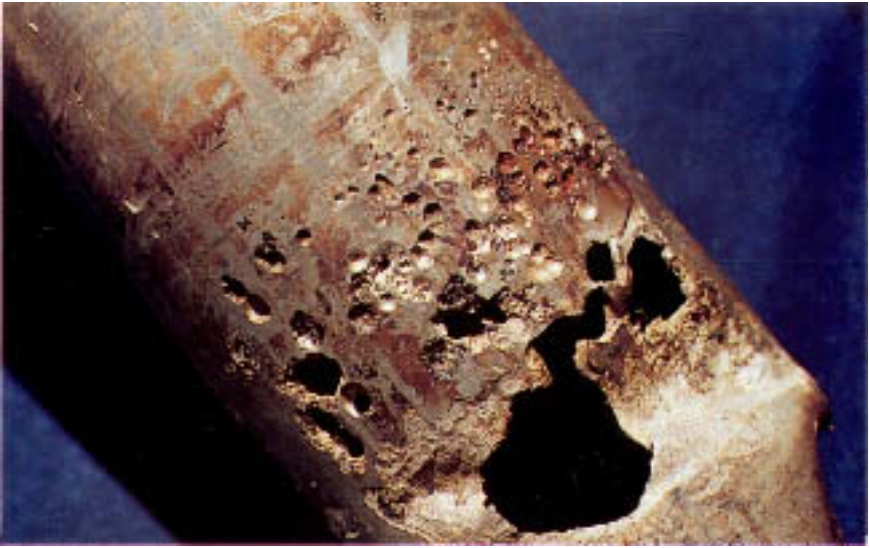
**Figure 6.5** Many small hemispherical pits on a 304 stainless steel heat exchanger tube end. The heat exchanger was removed from service and stored vertically for an extended period. Deposit accumulated at the lower tube ends where sulfate reducers flourished.

*Corrosion morphologies.* Sulfate-reducing bacteria frequently cause intense localized attack (Figs. 6.2 through 6.7). Discrete hemispherical depressions form on most alloys, including stainless steels, aluminum, Carpenter 20, and carbon steels. Few cases occur on titanium. Copper alloy attack is not well defined.

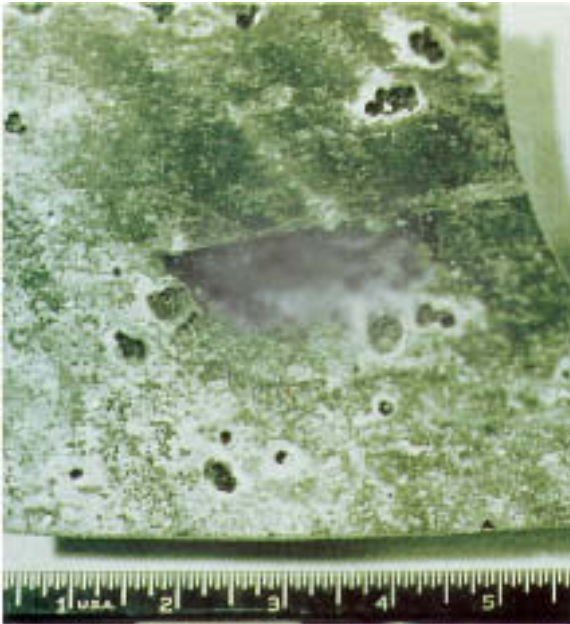
**Figure 6.6** Clustered sulfate-reducer pits on a carbon steel tank bottom.

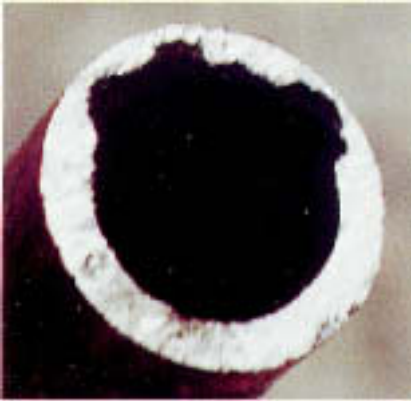
**Figure 6.7** A small-diameter carbon steel service water pipe perforated by sulfate-reducer corrosion.

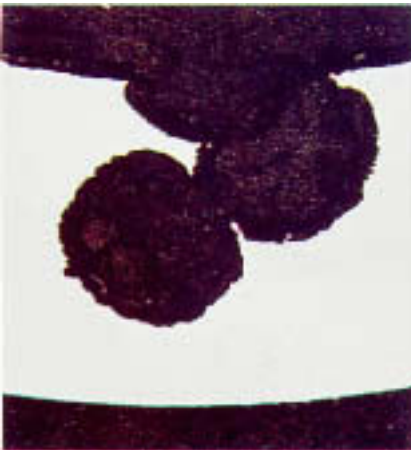
**Figure 6.8** Scalloped, partially undercut pits in a cross section of a 316 stainless steel tube.

In cross section, pits may exhibit scalloping and mild undercutting, especially on stainless steels (Fig. 6.8). On carbon steels, pit interiors are somewhat less regular. Interiors may contain terrace steps, giving the pits a peculiar bulls-eye pattern when viewed from above. It is tempting to speculate that each terrace marks a corrosion-arrest stage in pit development corresponding to changes in biological activity.

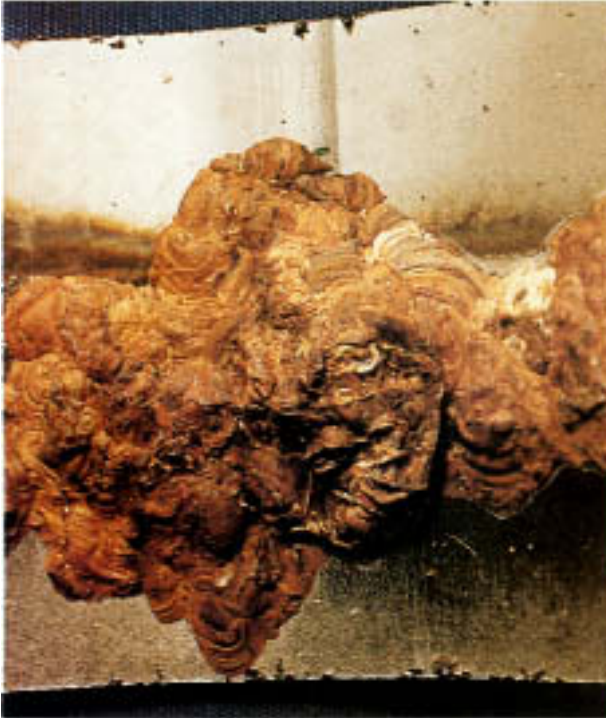
**Figure 6.9A** Irregular deposit and corrosion-product mounds containing concentrations of sulfate-reducing bacteria on the internal surface of a 316 stainless steel transfer line carrying a starch-clay mixture used to coat paper material. Attack only occurred along incompletely closed weld seams, with many perforations. Note the heat tint, partially obscured by the deposit mounds, along the circumferential weld.

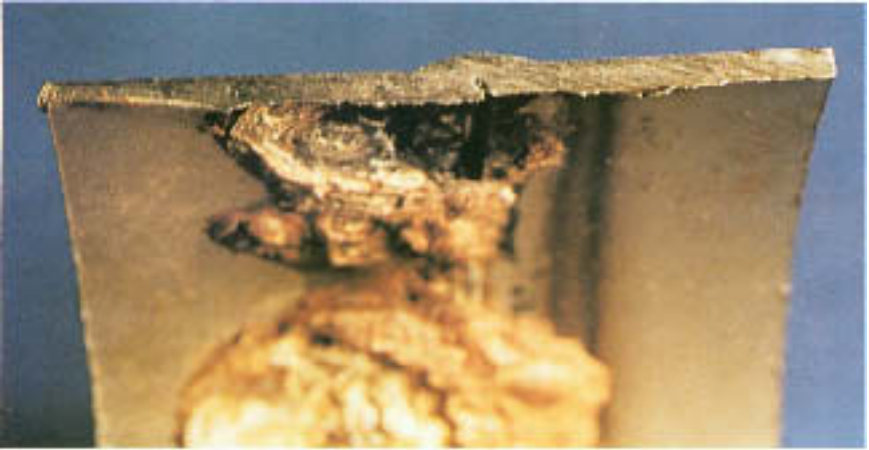
**Figure 6.9B** Longitudinal cross section showing a pit tunneling into an incompletely closed weld seam.

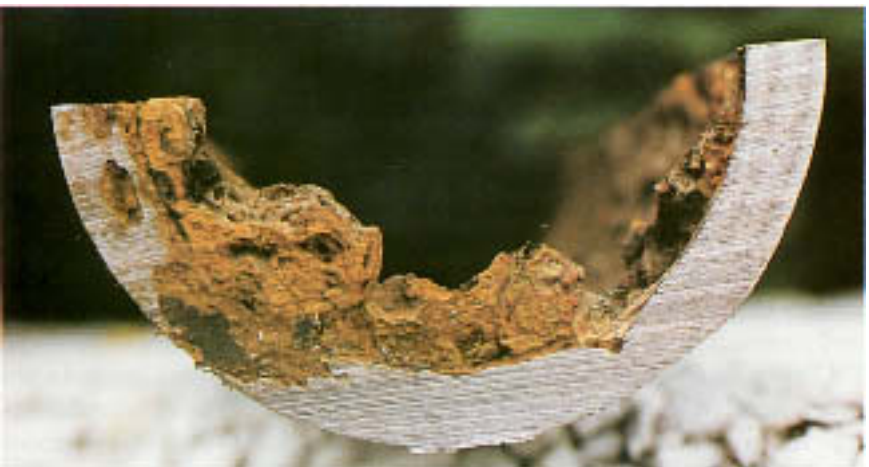
**Figure 6.10** A perforated carbon steel pipe at a weld-backing ring. The gaping pit was caused by sulfate-reducing bacteria (see Case History 6.1).

Attack at welds due to bacteria is possible, but it is not nearly so common as is often supposed. Because of residual stresses, microstructural irregularities, compositional variation, and surface irregularities, welds show a predisposition to corrode preferentially by most corrosion mechanisms. Attack is common along incompletely closed weld seams such as at butt welds in light-gauge stainless steel tubing (Fig. 6.9A and B). Attack at carbon steel welds may occur. Figure 6.10 shows a severely corroded carbon steel pipe from a service water sys-

Stainless steels attacked by sulfate reducers show well-defined pits containing relatively little deposit and corrosion product. On freshly corroded surfaces, however, black metal sulfides are present within pits. Rust stains may surround pits or form streaks running in the direction of gravity or flow from attack sites. Carbon steel pits are usually capped with voluminous, brown friable rust mounds, sometimes containing black iron sulfide plugs (Fig. 6.10).

Internal surfaces were heavily tuberculated. The circumferential weld-backing ring was heavily corroded (Fig. 6.21). The perforation shown in Fig. 6.10 occurred at the ring, which was entirely consumed by corrosion in places. At intact areas the weld was sound, showing adequate penetration and no unusual characteristics.

The weld was riddled with mildly undercut, gaping pits. Attack was confined to fused and heat-affected zones, with a pronounced lateral or circumferential propagation (as in Fig. 6.10). The resulting perforation at the external surface was quite small. Pits were filled with deposits, friable oxides, and other corrosion products. Black plugs embedded in material filling the gaping pit contained high concentrations of iron sulfide. Bulk deposits contained about 90% iron oxide. Carbonaceous material was not detected.

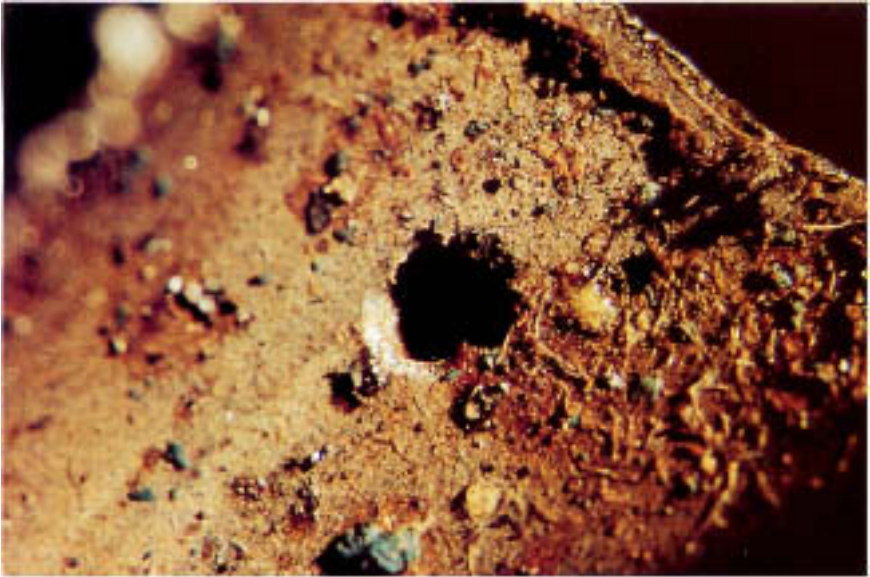
**Figure 6.11** A  $\frac{1}{16}$ -in. (0.16-cm) diameter pit on the internal surface of a 316 stainless steel tube. Note the absence of significant corrosion products or deposits in the pit.

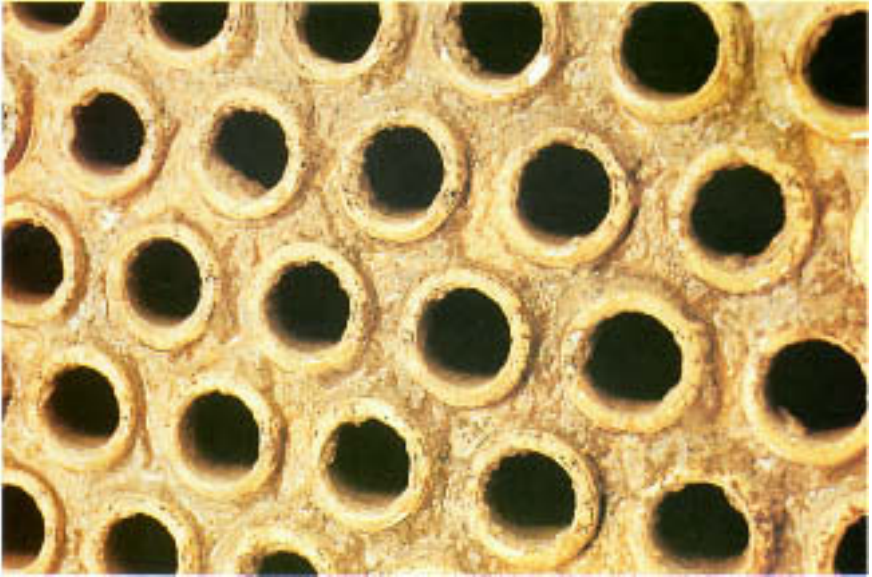
**Figure 6.12A** A gelatinous slime layer on a heat exchanger tube sheet.

**Slime layers.** Sliming is easily recognized by the gelatinous mass that accumulates on surfaces. Heat exchanger tubes feel greasy or slick to the touch. Tube sheets and headboxes are frequently affected (Fig. 6.12A and B). Slime may be colored by dirt and other debris that accumulates in the gooey mass. When dry, slime forms a thin, brittle layer that exfoliates in large patches (Fig. 6.13).

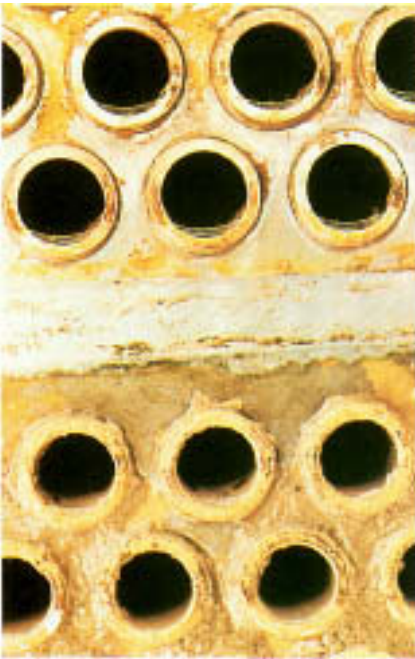
**Figure 6.12B** As in Fig. 6.12A, but split above and below the water box to show the clean outlet sheet (top) and the slimed inlet sheet (bottom).

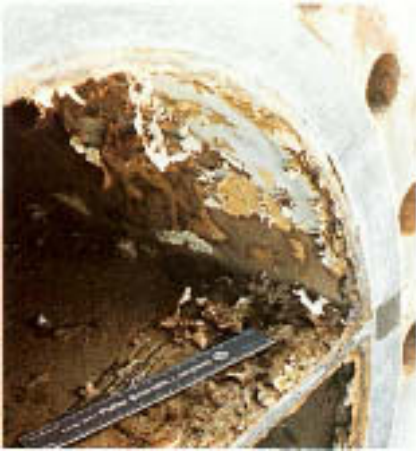
**Figure 6.13** A dried slime layer peeling off water box surfaces on a small heat exchanger.

**TABLE 6.5 Typical Microbiological Evaluation of Slime Layer in Fig. 6.13 and Typical Counts in Cooling Water Contacting Heavily Slimed Surfaces\***

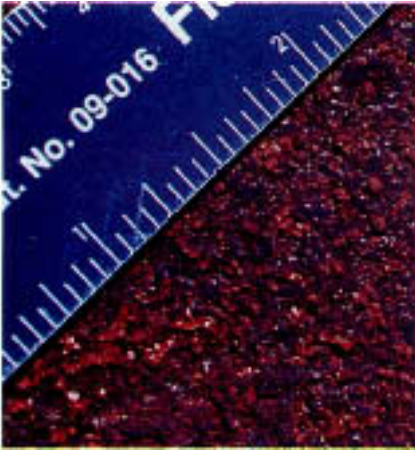
**Figure 6.14** A generally corroded carbon steel surface after the slime layer was removed.

Passive attack beneath slime is usually general, and rusting on steel may color surfaces brown and red (Fig. 6.14). If sulfate reducers are present, pitting may be superimposed on the generally corroded surface (see Fig. 6.2).

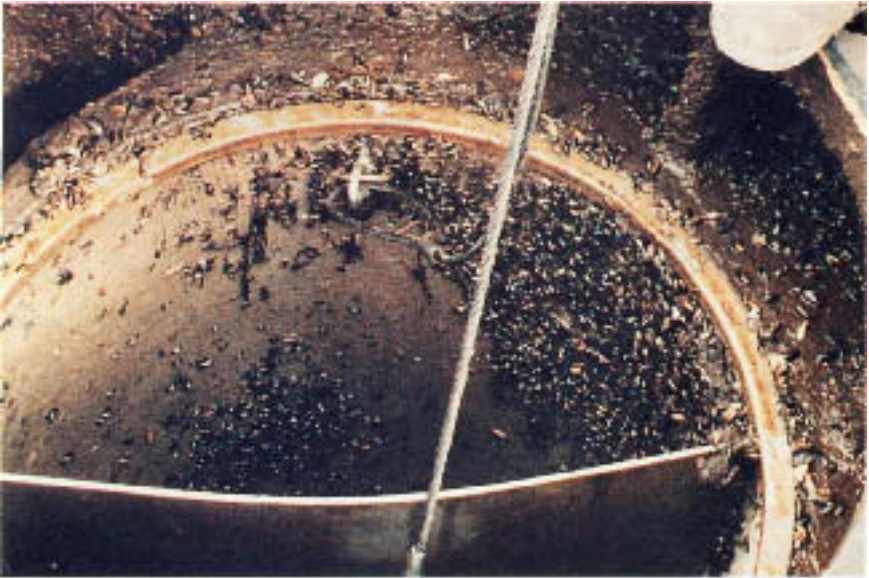
**Figure 6.15** A main mill water-strainer basket caked with clams.

Shells from similar animals have fouled many cooling water systems on seacoasts for some time (Figs. 6.15 and 6.16). Shells tend to lodge near tube inlet ends in shell-and-tube heat exchangers; objects slightly smaller are swept through tubes, and larger ones cannot fit into openings. Brass and cupronickel tubing may suffer severe, localized

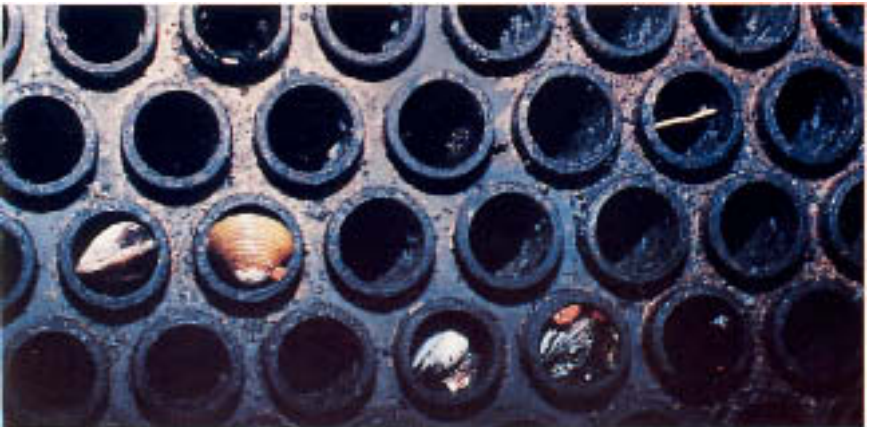
**Figure 6.16** Small clams lodged in heat exchanger tube inlet ends. (Courtesy of Rick Ruckstuhl, Nalco Chemical Company.)

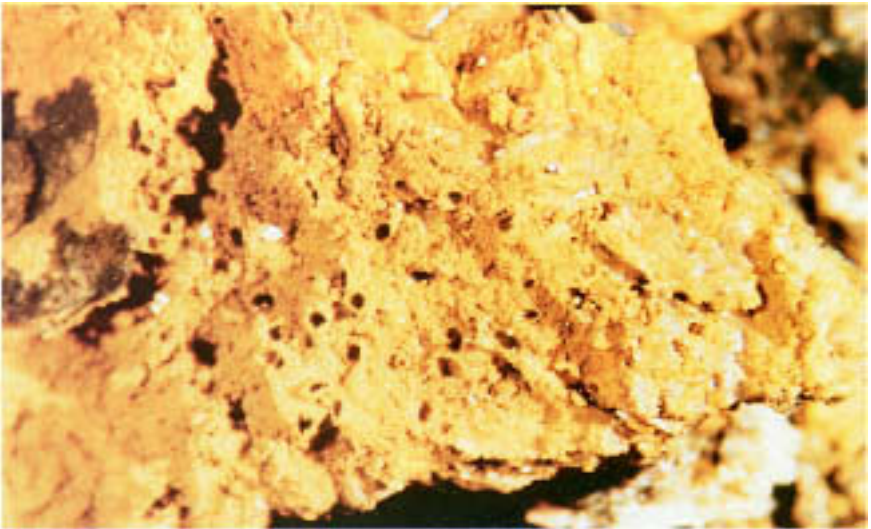
**Figure 6.17A** A corrosion-product and deposit mound on a mild steel service water pipe honeycombed by small tubelike organisms. Each hole is approximately 0.01 in. (0.025 cm) in diameter.

After almost 10 years of service, several pipes were removed because of restricted flow associated with accumulation of corrosion products and macrofouling (Figs. 6.17 and 6.20). The most heavily fouled sections contained unclarified river water and remained stagnant for as long as 30 days at a time. Eighteen months before removal of the pipes, parts of the system had been cleaned using high-pressure water jets. No failure had occurred. Wastage was nowhere deeper than about 0.030 in. (0.076 cm). However, small-diameter tubes were severely obstructed. Up to half the volume of obstructing material consisted of small tubelike organisms (Fig. 6.17).

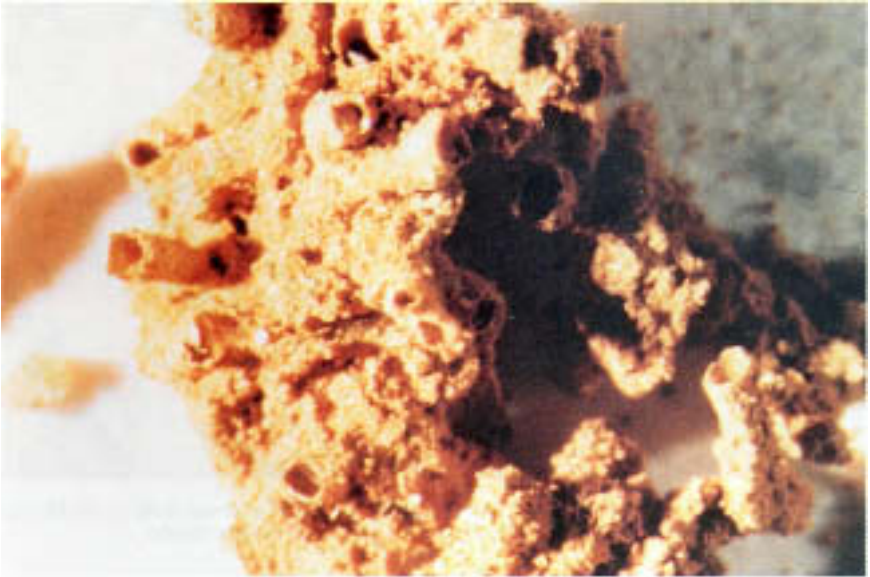
**Figure 6.17B** Close-up of small tubelike “casts.” More than 50% by volume of the surrounding material is composed of these casts.

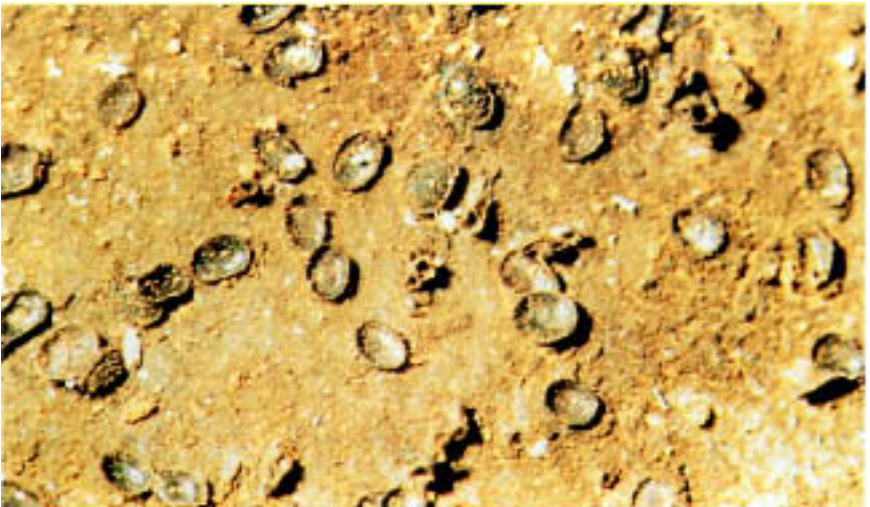
**Figure 6.18** Pinhead-sized, shell-like organisms covering a carbon steel pipe surface.

Many pipes were permitted only a fraction of their normal flow. Close visual inspection of surfaces revealed many small organisms lying atop and beneath tubercles (Figs. 6.18 and 6.19). Surfaces were analyzed using energy-dispersive spectroscopy. Up to 40% of the material covering small, shell-like organisms was manganese. Calcium concentration was as high as 15%, and sulfur concentrations approached 10%.

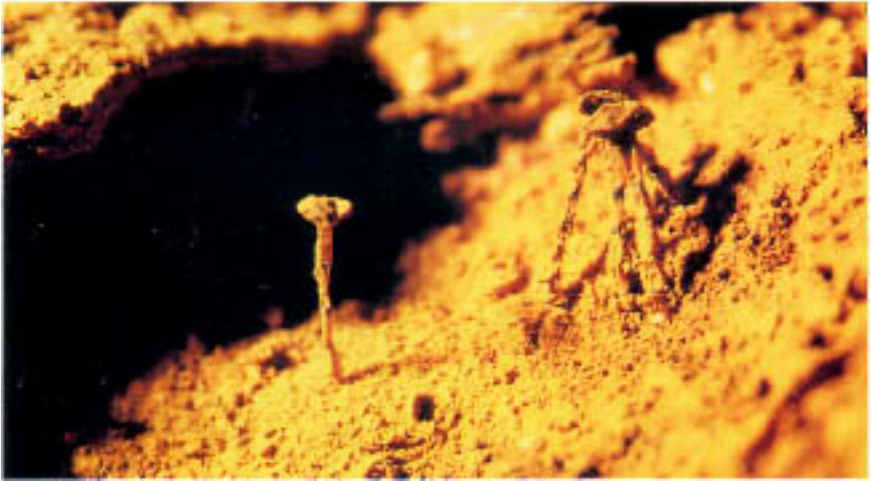
**Figure 6.19** Small organisms found inside a tubercle. Each is about 0.05 in. (0.13 cm) high. The organisms have segmented, fibrous stalks and bivariate heads.

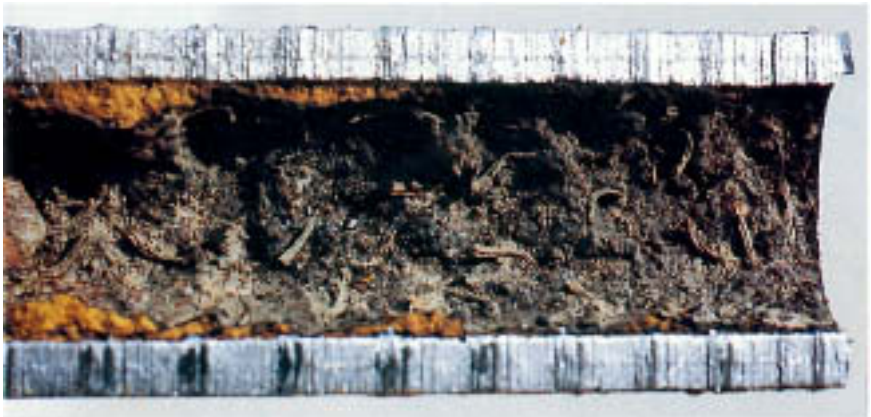
**Figure 6.20A** A 1 in. (2.5 cm) diameter mild steel service water pipe containing many small cone-shaped organisms.

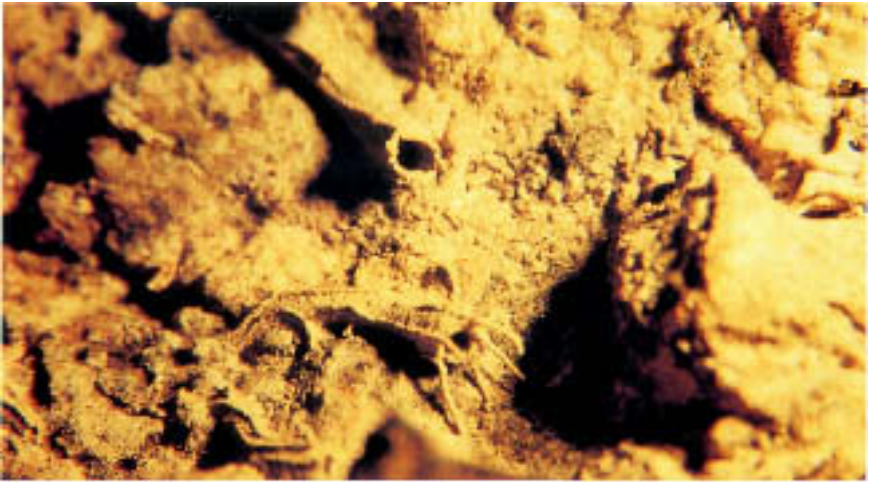
**Figure 6.20B** Close-up of organisms shown in Fig. 6.20A.

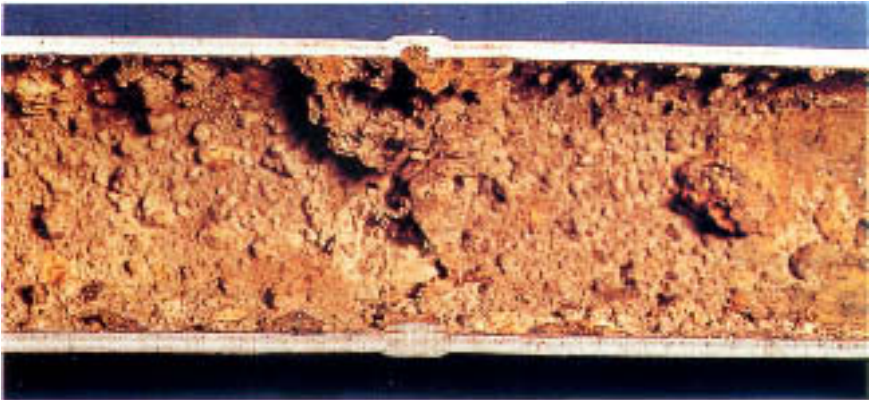
**Figure 6.21** A longitudinally split carbon steel emergency service water pipe, as in Fig. 6.10. Note the circumferential weld-backing ring, which is consumed on one side.

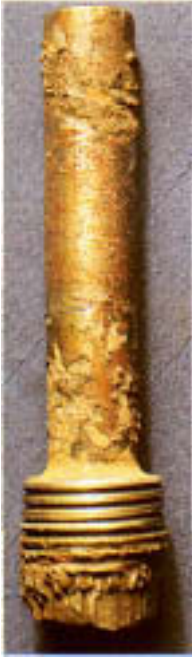
**Figure 6.22** A thermocouple housing showing localized wastage. Small fibers containing high concentrations of salt were found in corroded areas.

Surfaces exposed to water contained many localized areas of wastage (Fig. 6.22). Corroded areas were covered by brittle black or brown caps over irregular metal-loss regions. Many small fibers were embedded in corrosion products, and many more were wrapped around surfaces. Most fibers were about 0.001 in. (0.003 cm) in diameter and were hollow. Surface analysis showed that up to 20% by weight of the fibers was sodium chloride.

The fibers were vegetative in origin, possibly seed hairs. They concentrated salt from the brackish water in which their parent plant grew. These fibers blew into cooling towers and were circulated throughout the cooling water system. Some became attached to rough surfaces. The high concentration of salt in the fibers caused an increased localized corrosion rate at deposit points.

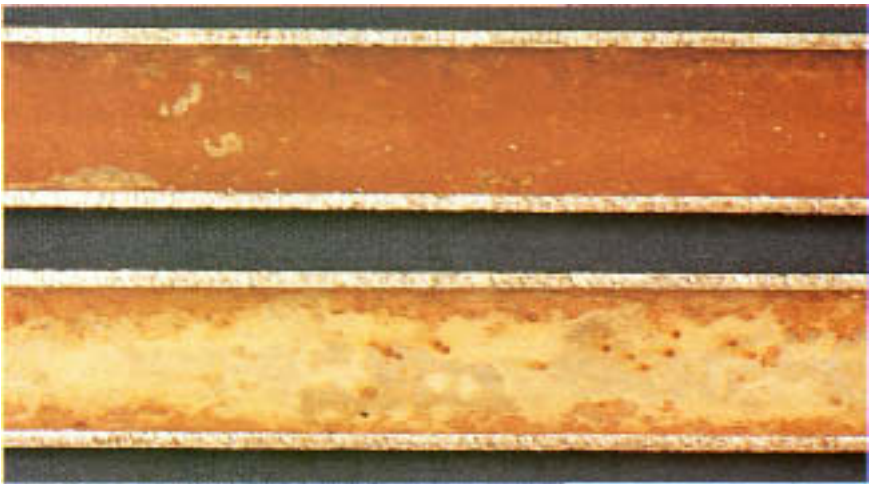
**Figure 6.23A** A longitudinally split 304 stainless steel condenser tube covered with deposits.

The section was perforated in several locations due to severe, localized wastage on internal surfaces (Fig. 6.23A and B). The cooling water had a history of low-pH excursions, with documented depressions to a pH below 5. The system also had been plagued with high sulfate-reducing bacteria counts.

Internal surfaces were covered with brown and tan deposits and corrosion products; pits were present beneath small mounds of reddish-

brown oxide (Fig. 6.23A). When deposits and corrosion products were removed, many pits were revealed (Fig. 6.23B). Most pits were shallow, but some were deep and undercut. The deepest pits had distinctly hemispherical contours (Fig. 6.23C). In places, smaller undercut pits were found growing off the larger hemispherical pits. Chemical spot tests revealed large concentrations of sulfides in pits.

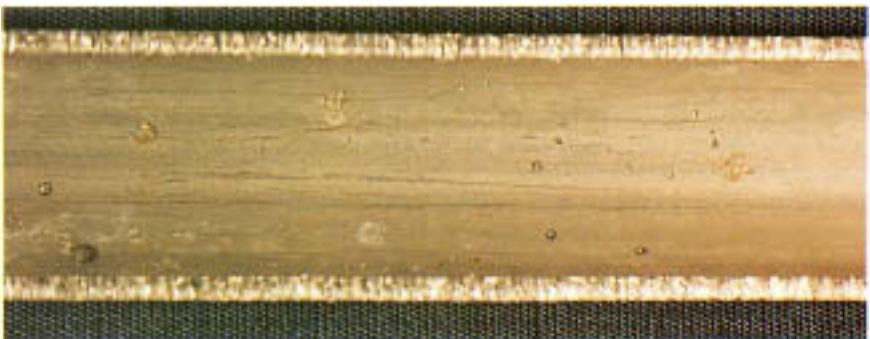
**Figure 6.23B** As in Fig. 6.23A, but with deposits removed to show pits.

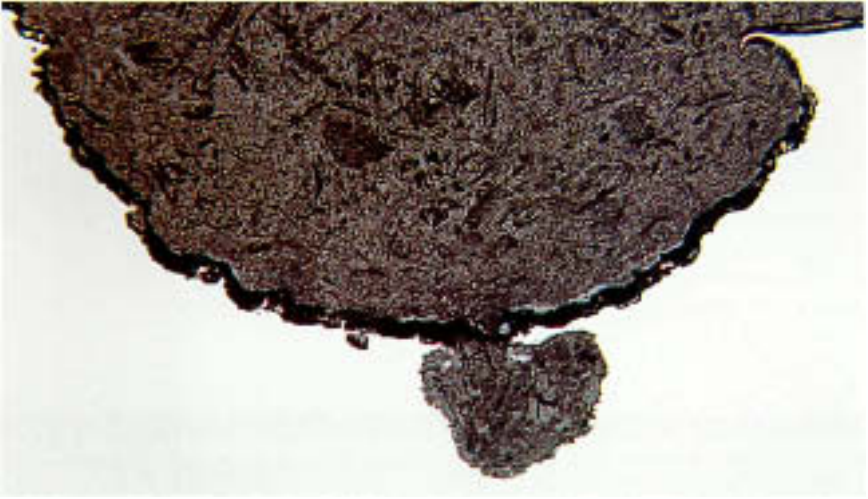
**Figure 6.23C** Pits in profile. Note the smaller pit growing off the large hemispherical pit above.

Pitting had two distinct causes. Sulfate reducers had formed the large hemispherical pits. The more undercut pits were formed during a low-pH excursion involving mineral acid after the sulfate-reducing bacteria became inactive. It is likely the low-pH excursion deepened preexisting sulfate-reducer pits, causing final perforation.

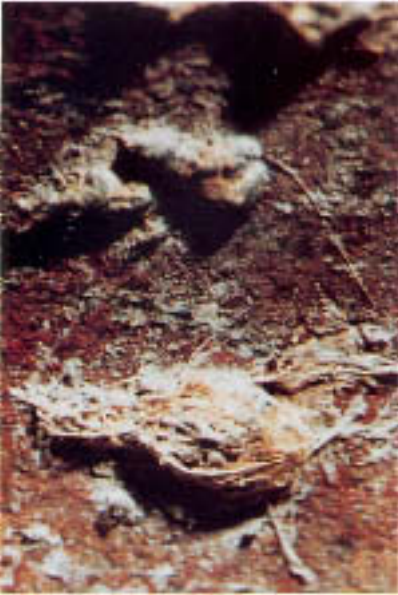
**Figure 6.24A** Small mounds of deposit entrapped by seed hairs that stuck to surfaces.

After only 4 months of service, the main condenser at a large fossil utility began to perforate. Initial perforations were due to erosion-corrosion (see Case History 11.5). Small clumps of seed hairs entering the condenser after being blown into the cooling tower were caught on surfaces. The entrapped seed hairs acted as sieves, filtering out small silt and sand particles to form lumps of deposit (Fig. 6.24A and B). Immediately downstream from each deposit mound, an erosion-corrosion pit was found.

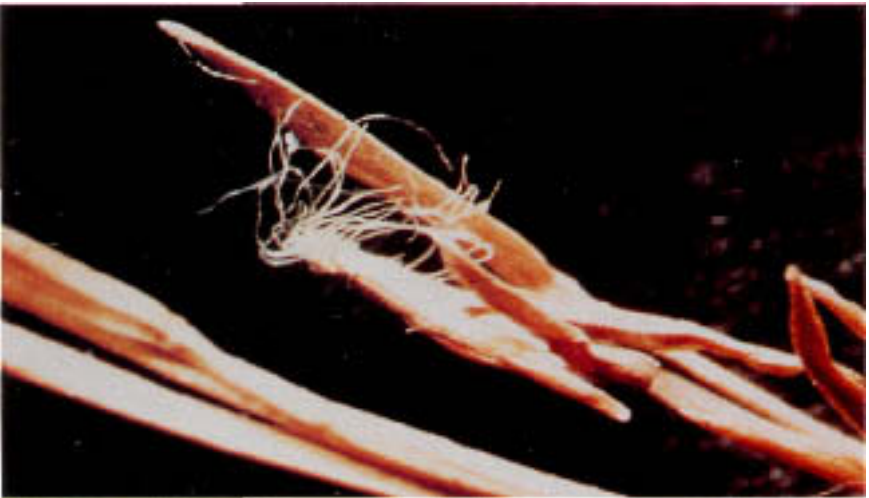
**Figure 6.24B** The source of the seed hairs in Fig. 6.24A. These plants grew immediately around the cooling tower. The white fibers are seed hairs.

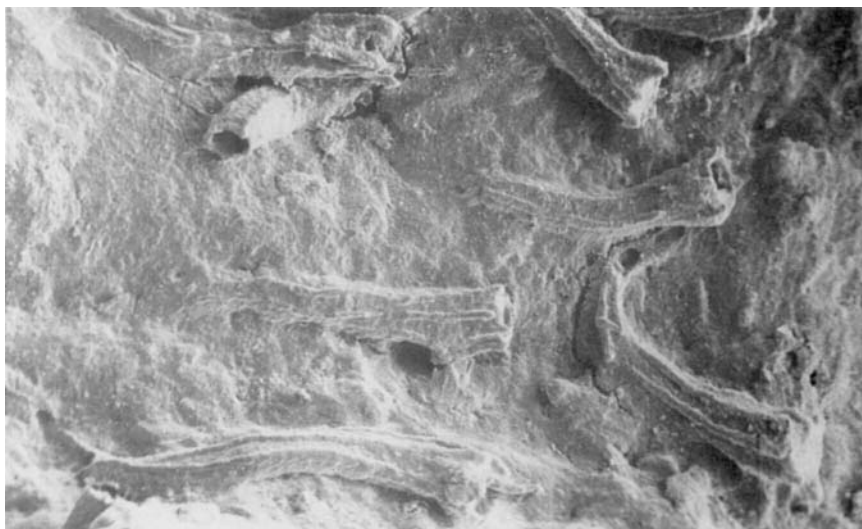
**Figure 6.25** Low-power scanning electron micrograph of small tubelike organisms in Figs. 6.17 and 6.20. Note how all organisms (except one) point into the direction of flow.

From the orientation of the tubelike organisms it was clear that they were flourishing even though the system was periodically chlorinated (Fig. 6.25). Clearly, the biocidal treatment was inadequate.

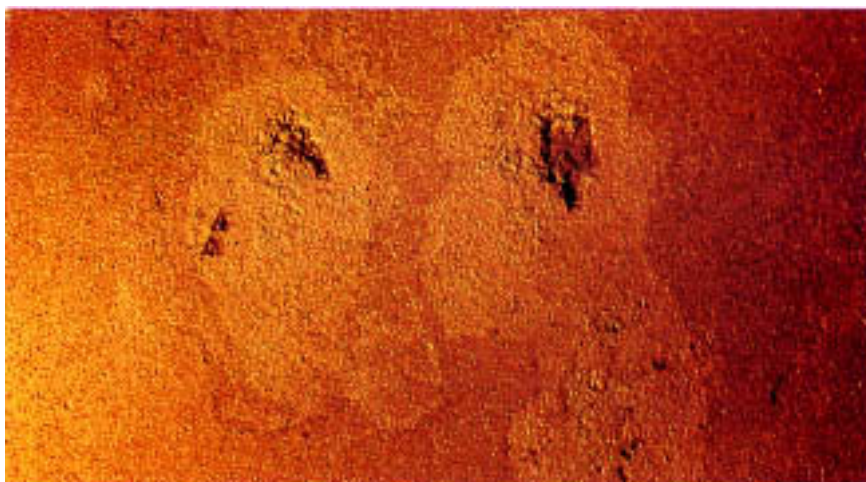
**Figure 6.26** Small, pitlike depressions near the center of lightly etched regions. Each lightly etched region was covered by a gelatinous soap deposit in service. Note how the deeper, more localized metal loss occurred away from the lightly etched border.

Rolling oil tanks were corroded on surfaces contacting the emulsion. Small pitlike depressions were present beneath aluminum soap deposits. Each pit was surrounded by a lightly etched region exactly mirroring deposit patterns (Fig. 6.26).

Organic acids concentrated in deposits and caused most attack. However, the peculiar attack morphology of a deep, localized area of corrosion surrounded by lightly etched areas was not characteristic of acid corrosion.

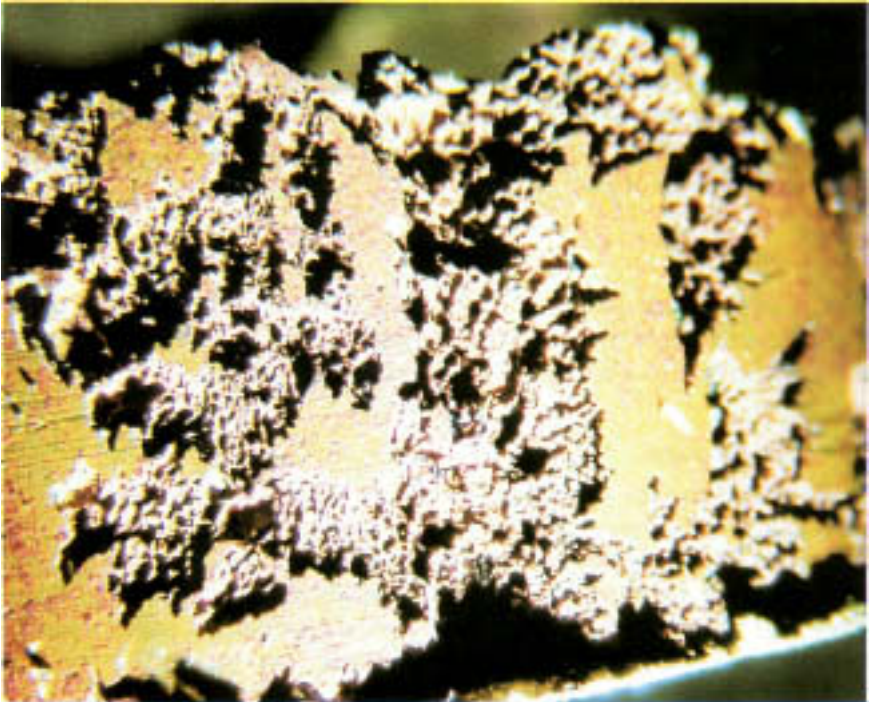
**Figure 7.1** Brass condenser tube inlet end severely corroded by an acid upset involving sulfuric acid.

In general, the higher the residual or applied metal stress, the more severe the corrosion at a given acidic pH. This explains why many heat exchanger tube ends are often attacked so severely (Fig. 7.1). Tube ends that have been rolled or welded often contain high residual stress. Further, crevices are sometimes present in which acidic species may concentrate (see Chap. 2, “Crevice Corrosion”). Screens, rolled sheet metal, and other highly worked metals (not stress relieved) are also prone to attack.

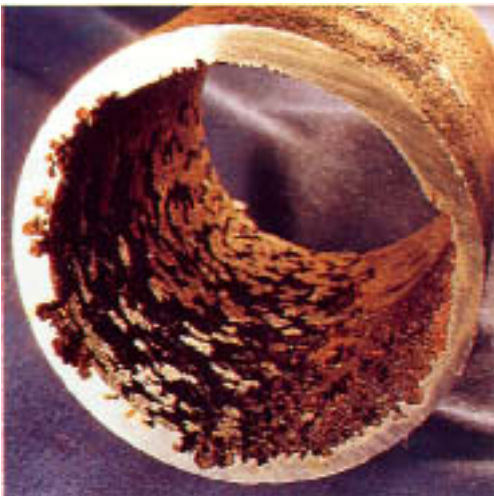
**Figure 7.2** Carbon steel pipe attacked by a strong mineral acid.

**Pit growth.** When most metals are exposed to highly acidic conditions, pitting results (Fig. 7.2). A pit has a depth greater than its width. In strong mineral-acid corrosion, not only is depth greater than width, but undercutting is pronounced (Fig. 7.3). Cavernous chambers form just below the surface (Fig. 7.4) because of segregation of aggressive anions within the pits.

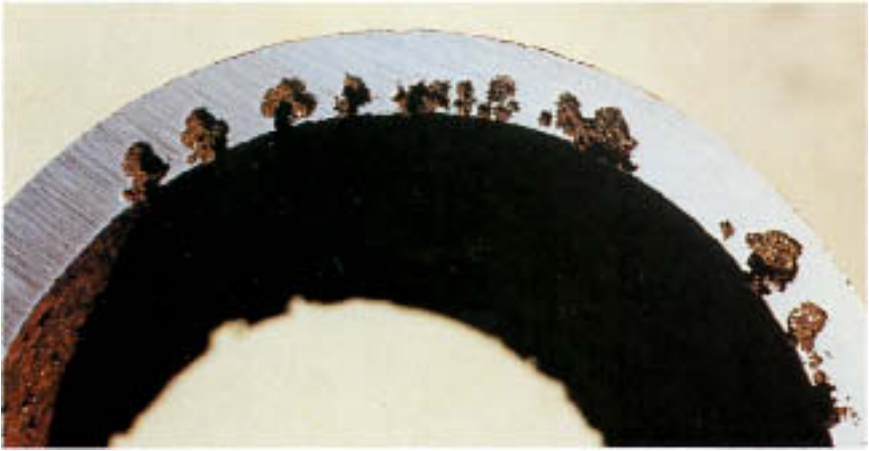
**Figure 7.3** As in Fig. 7.2. Note the narrow pit mouths and the pronounced undercutting.

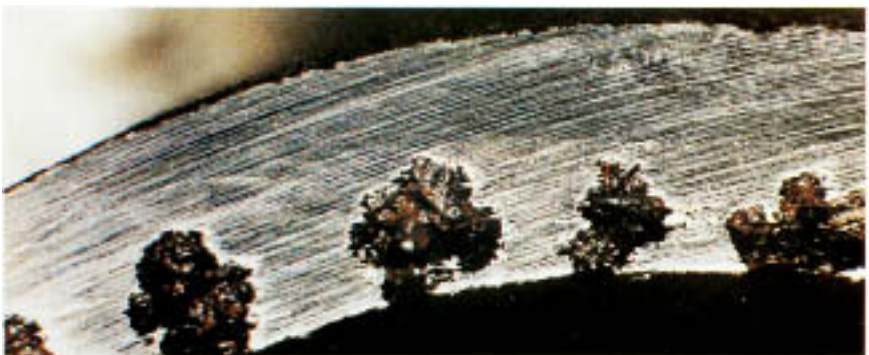
**Figure 7.4** Cross section through a mild steel pipe wall suffering severe acid attack.

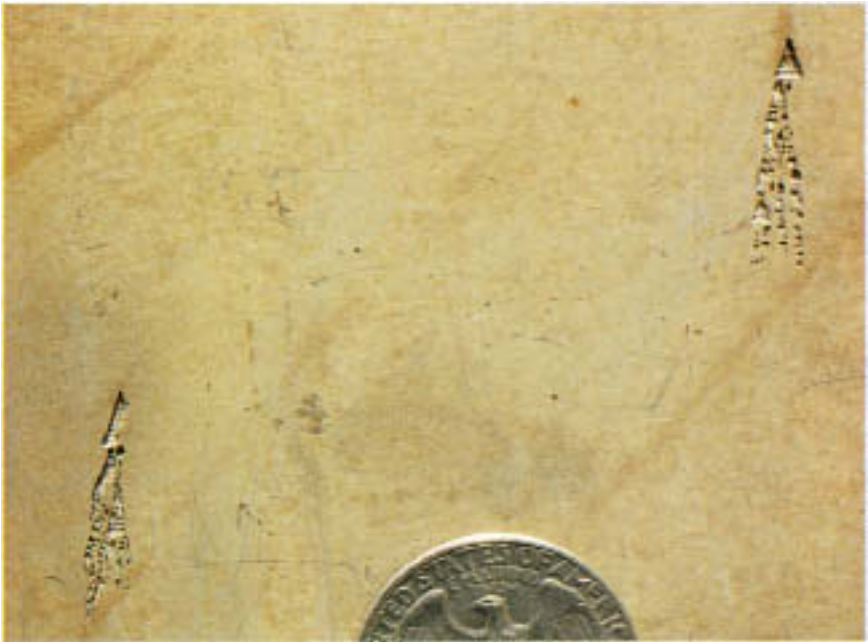
**Figure 7.5** Pits on a large-diameter austenitic stainless steel pipe. Note the grooves formed by leakage of pit contents down the pipe wall in the direction of gravity. (Pipe wall was vertical in service.)

Pits form grooves or furrows on wall surfaces on stainless steels (Figs. 7.5 and 7.6). Contents leak out of pit interiors and depassivate areas immediately below the active corrosion sites. Grooves form, fol-

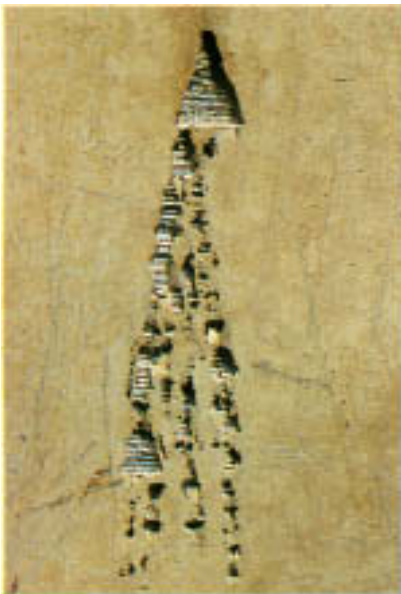
**Figure 7.6** As in Fig. 7.5. Note the multiple parallel striations within the larger grooves following stress lines remaining from the original pipe manufacturing processes.

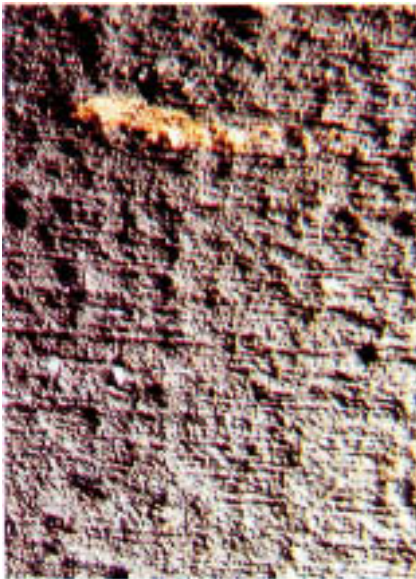
**Figure 7.7** Surface striations and shallow grooves on a carbon steel case coupling. Acid etched the metal along microstructural irregularities producing the grooves. Compare to Fig. 7.8. (Magnification: 7.5 $\times$ .)

**Grooving.** Strong acid corrosion will often highlight microstructural features in steel and other formed and rolled alloys. Striations and grooves appear as the acid attacks microstructural irregularities, such as manganese sulfide inclusion “stringers” elongated by rolling or forming processes (Fig. 7.7) or more highly cold-worked regions (Fig. 7.8). Mutual intersection of pits can lead to a jagged surface contour.

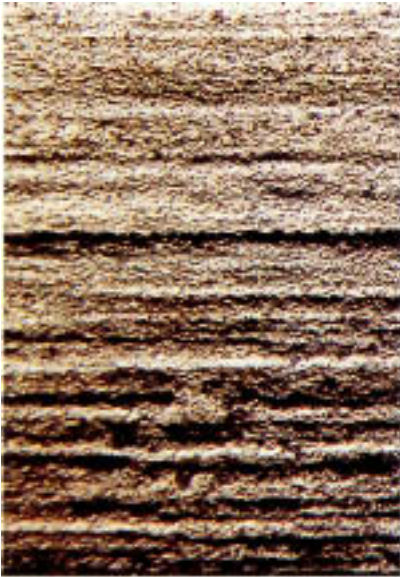
**Figure 7.8** Striations on the internal surface of admiralty brass condenser tube after acid cleaning. (Magnification: 15 $\times$ .)

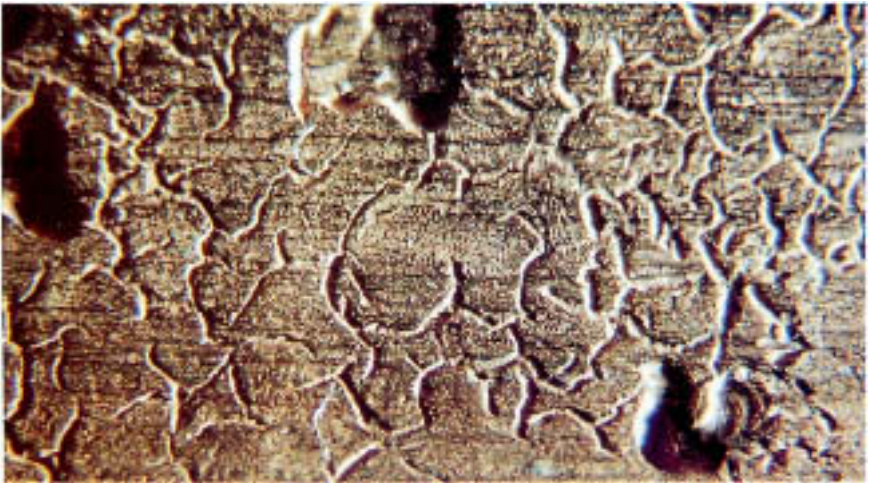
**Figure 7.9** Network of shallow ditches caused by condensation of acidic fluids during acid cleaning of a copper condenser tube.

Irregular grooving can occur, especially on copper alloys after acid cleaning. Tubes can be only partially filled with cleaning solution. Condensation and running of the fluid down the tube interior cuts tortuous channels (Fig. 7.9).

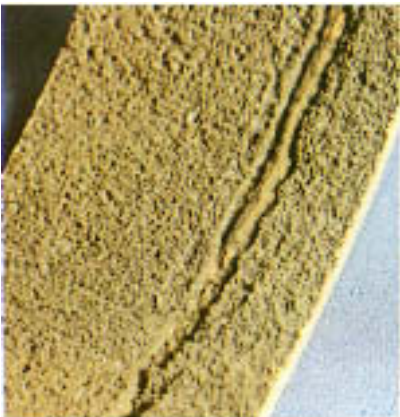
**Figure 7.10** Severely attacked weld on a large-diameter steel pipe by an acid upset.

**Weld attack.** Welds are often more susceptible to corrosion than other areas (see Chap. 15, “Welds Defects”). Welds may contain porosity, crevices, high residual stresses, and other imperfections that favor attack. Carbon steel welds are usually ditched by acid attack (Fig. 7.10).

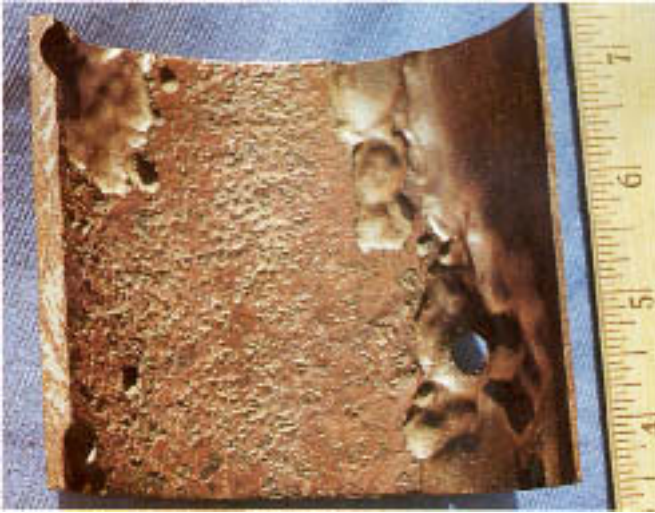
**Figure 7.11** Smooth attack on carbon steel by carbonic acid. Note the vivid red color of hematite, indicating high oxygen concentrations.

**Carbonic acid.** Carbonic acid (as do most weak acids) produces smoother attack than stronger acids. Pitting and surface roughness on carbon steel increase as the amount of dissolved oxygen increases (Figs. 7.11 and 7.12). In regions of condensation, grooving frequently occurs (Figs. 7.13 through 7.15). Grooves are caused by the flow of acidic condensate across surfaces. Friable, light-colored corrosion products containing carbonate are often present and sometimes form during cooling. Similar products may surround leaks and failure sites. Carbonate-containing material effervesces strongly when exposed to mineral acids.

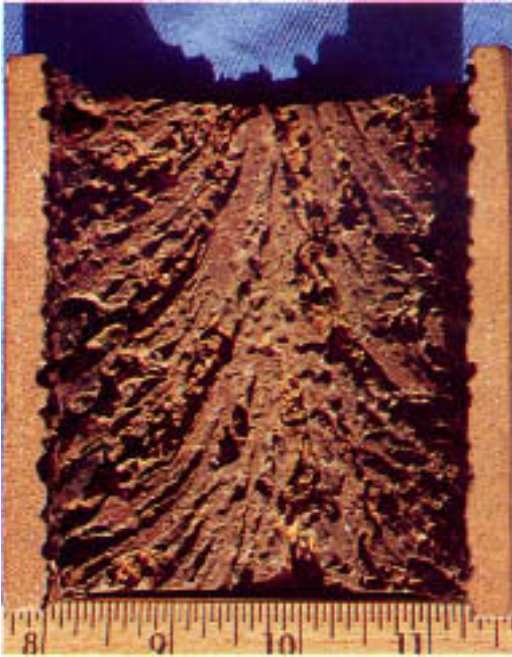
**Figure 7.12** Jagged fir-tree pattern of metal loss caused by condensing steam with high concentrations of carbon dioxide and oxygen.

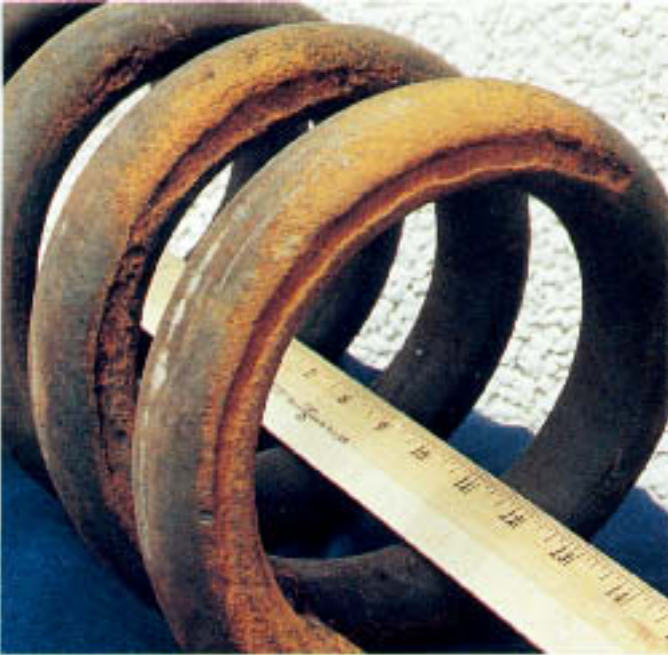
**Figure 7.13** Vertical carbon steel gas cooler with grooving at bottom of the last three coils. Carbonic acid-containing condensate attacked.

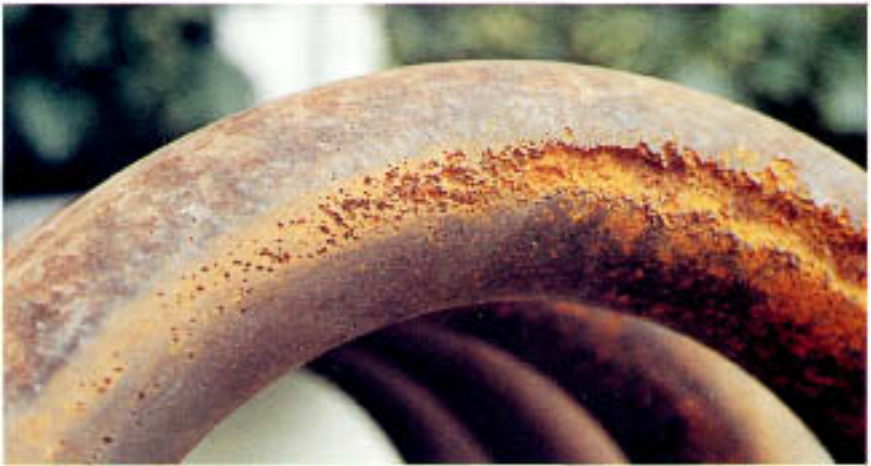
**Figure 7.14** As in Fig. 7.13. Note the presence of orange iron oxides and carbonate. Also note how attack starts as small pits due to dropwise condensation.

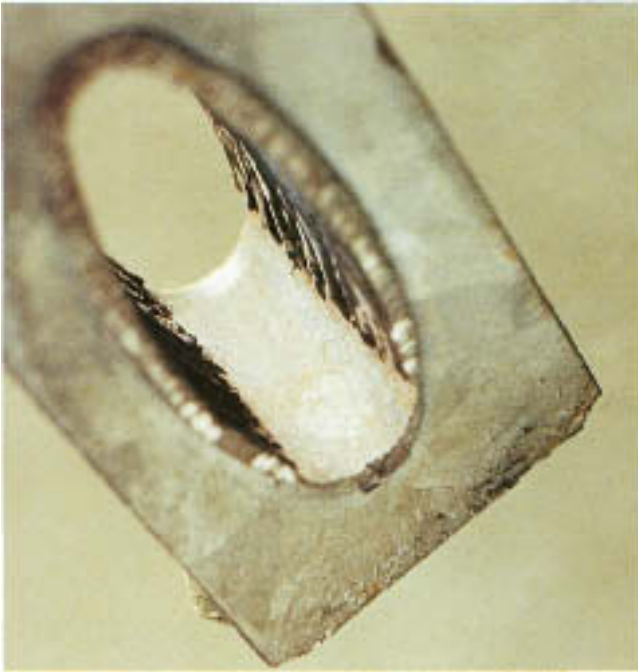
**Figure 7.15** General thinning along the bottom of a steel conduit carrying carbonic acid-laden water.

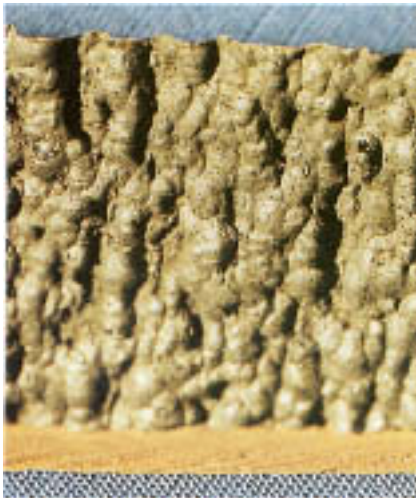
**Figure 7.16** Carbon steel corroded by organic acid on a cast iron pipe elbow.

Pits (if formed) tend to be shallower, rounder, and less severely undercut than surfaces attacked by strong acids (Fig. 7.16). Wasted

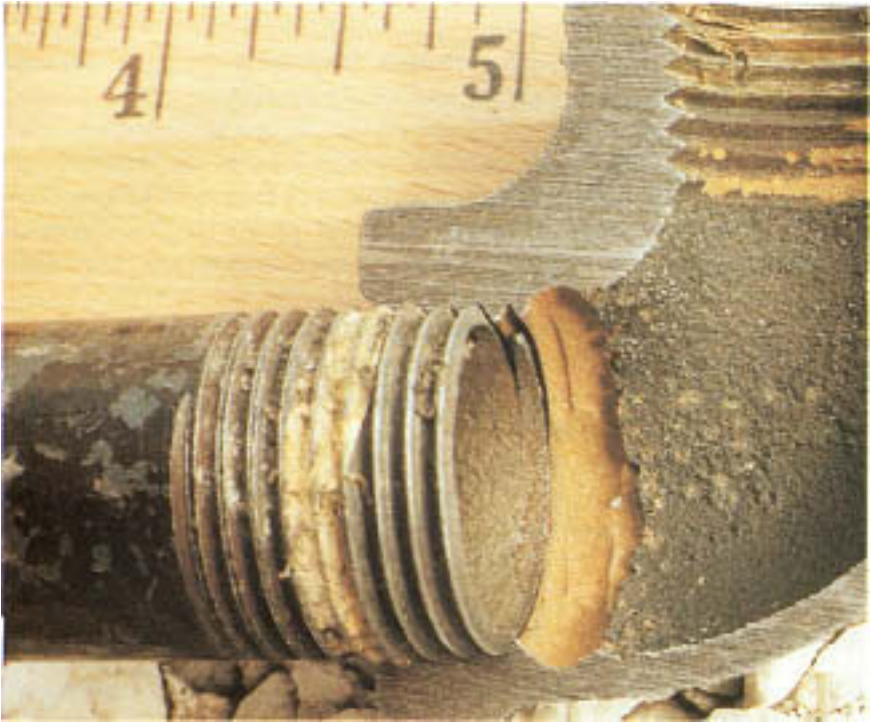
**Figure 7.17** Locally wasted region at an inlet pipe. See Fig. 7.18. Note the severe attack at the discharge end of the straight pipe.

Flow effects may be pronounced. High-turbulence areas can become preferred attack sites (Fig. 7.17). Erosion-corrosion phenomena are important (Fig. 7.18) (see Chap. 11, “Erosion-Corrosion”).
