# **The Nalco Guide to Cooling Water System Failure Analysis**

**Nalco Chemical Company**

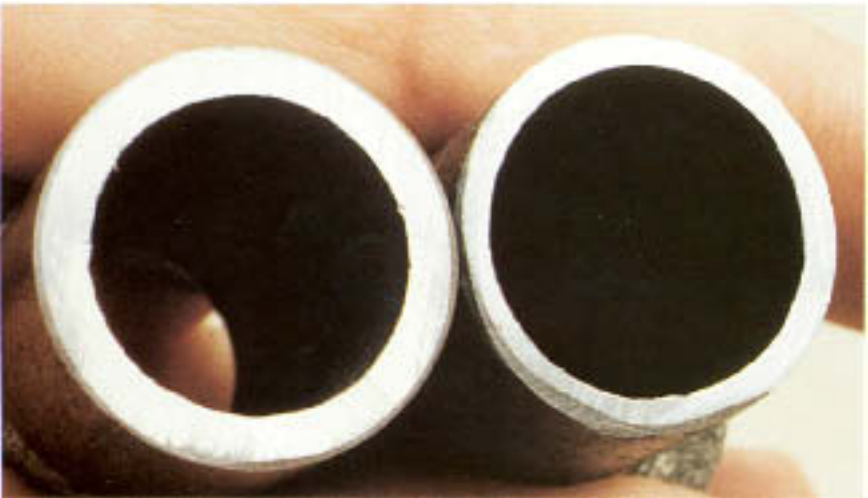
**Figure 7.18** Generally wasted pipe (to the viewer's right) and new pipe. Wastage was general near a pump discharge due to high flow.

Flow effects may be pronounced. High-turbulence areas can become preferred attack sites (Fig. 7.17). Erosion-corrosion phenomena are important (Fig. 7.18) (see Chap. 11, “Erosion-Corrosion”).

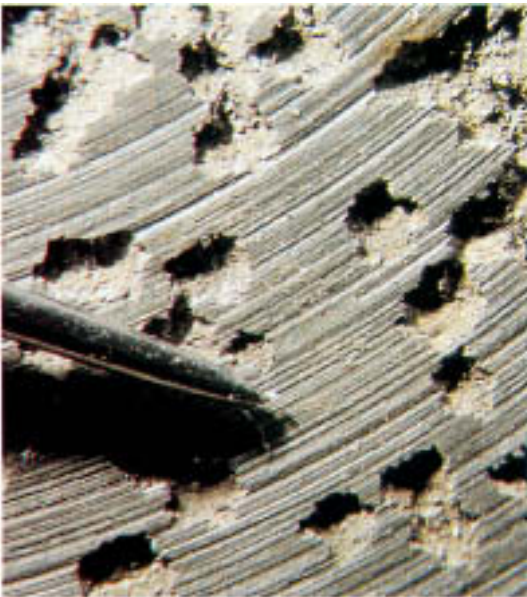
**Figure 7.19** Pits on a carbon steel check valve. Note how pits intersect to form areas of jagged metal loss. A steel probe tip is in the photo. (Magnification: 7.5 $\times$ .)

Valves, nozzles, and regions experiencing high flow were severely attacked (Fig. 7.19). In more quiescent regions, wastage was general with superimposed pitting (Fig. 7.20).

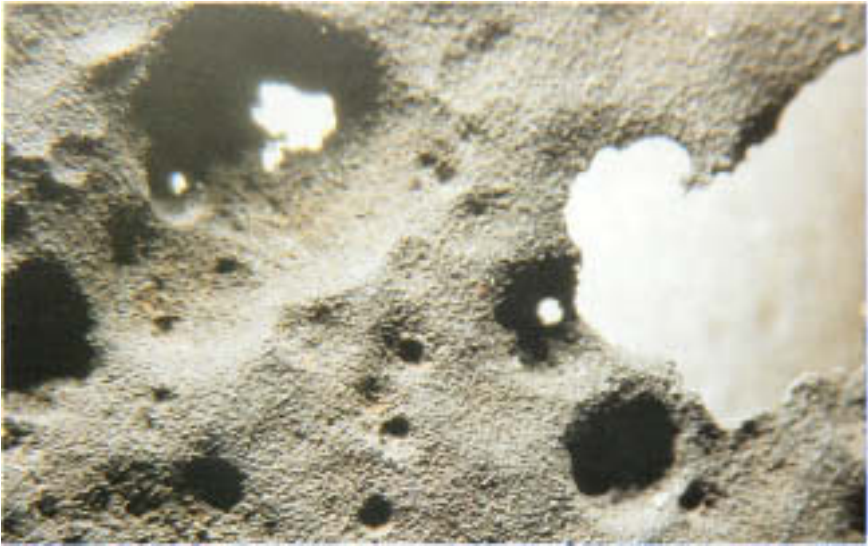
**Figure 7.20** Close-up of general wastage on a carbon steel bracket subjected to low-pH (<2) mill coolant.

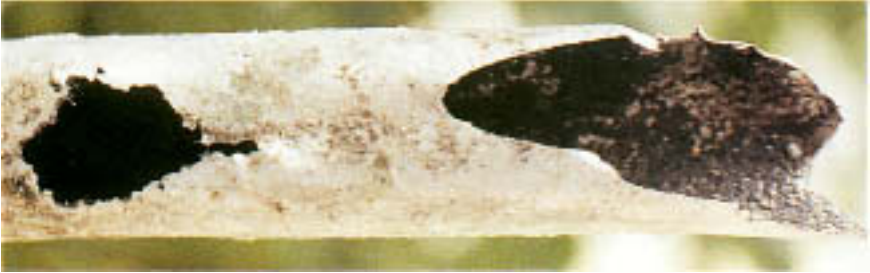
**Figure 7.21** Austenitic stainless steel pipe that carried sulfuric acid. Failure was caused by severe general wastage from internal surfaces.

Feed lines from a concentrated sulfuric acid storage tank failed. Tubing contained large, ragged holes due to severe internal surface wastage (Fig. 7.21).

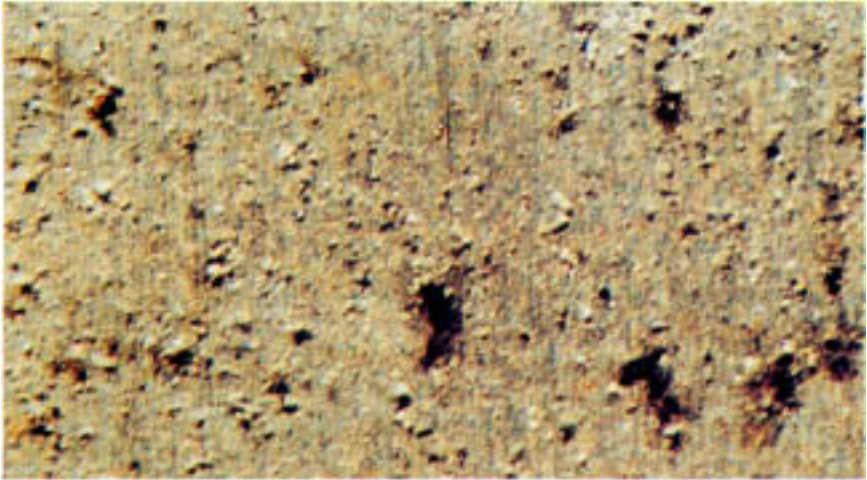
**Figure 7.22** Pitting on a 304 stainless steel coupon caused by acidic, chloride-containing water condensating and evaporating. High chloride concentrations were produced locally.

Small pits, some the size of pinheads, pockmarked surfaces (Fig. 7.22). Each pit was surrounded by a halo of reddish-brown rust. Cyclic wetting and evaporation caused chloride concentration and increased acidity locally.

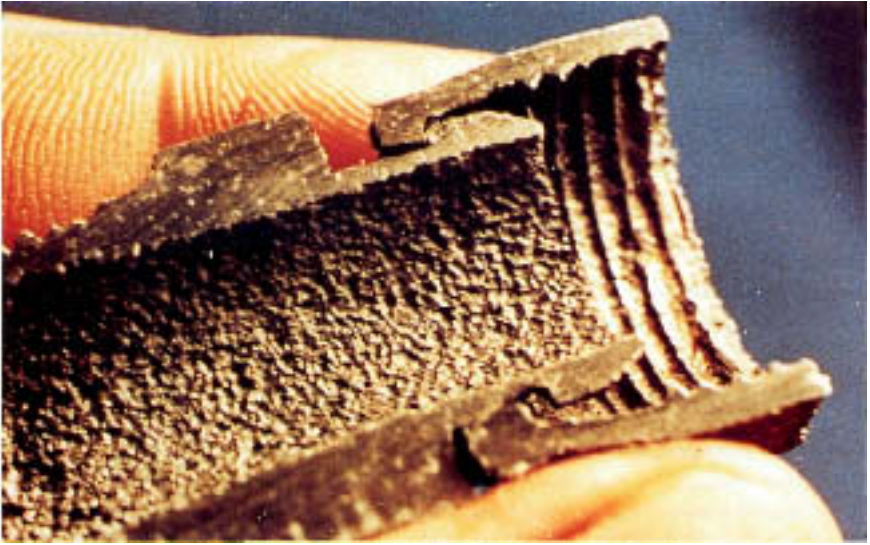
**Figure 7.23A** Free-machining carbon steel hose coupling after 2 months in a solution containing several percent oleic acid.

Severe corrosion by turbulent mill coolant was found generally throughout a rolling-oil system. Hose couplings were severely wasted in as little as 8 weeks (Fig. 7.23A and B). Turbulence caused by high-velocity flow through nozzles accelerated attack. Attack at bends, elbows, intrusive welds, and discharge areas was also severe.

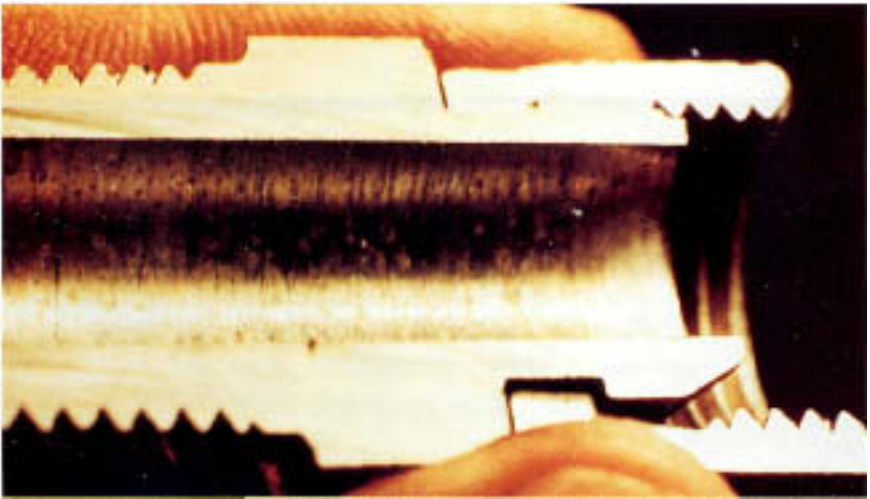
**Figure 7.23B** See Fig. 7.23A; new coupling.

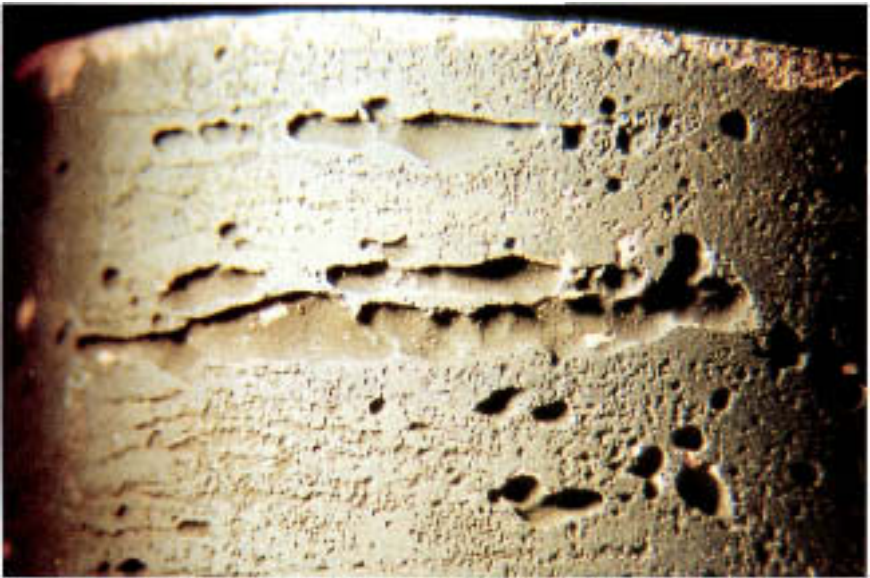
**Figure 7.24** Deep groove in region of localized metal loss on a copper tube. Grooving was caused by carbonic acid containing high concentrations of dissolved oxygen.

Visual examination of external surfaces revealed grooves and general metal loss (Figs. 7.24 and 7.25). Metal loss was caused by erosion-corrosion. However, the corrosive loss was more important than erosive loss, since metal loss was also substantial in low-flow regions.

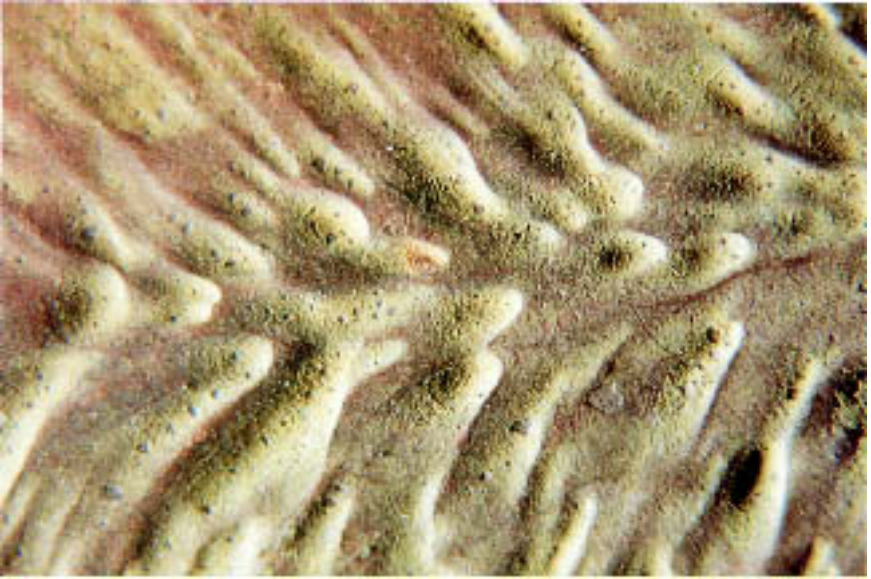
**Figure 7.25** Smooth, wavelike contour in a region of general metal loss on copper due to carbonic acid. The groove patterns indicate channeling of corrosive fluids by flow. (Light is coming from the reader's right.)

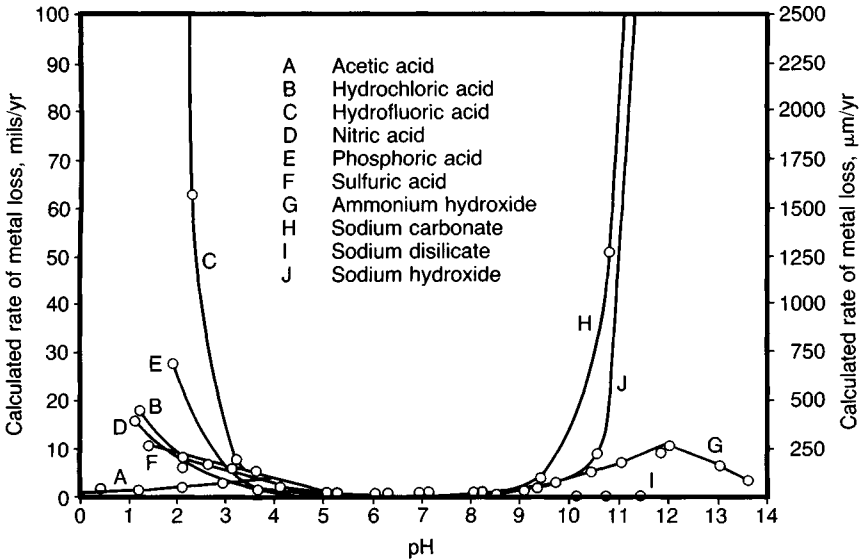
**Figure 8.1** Effect of pH on corrosion of 1100-H14 alloy (aluminum) by various chemical solutions. Observe the minimal corrosion in the pH range of 4–9. The low corrosion rates in acetic acid, nitric acid, and ammonium hydroxide demonstrate that the nature of the individual ions in solution is more important than the degree of acidity or alkalinity. (Courtesy of Alcoa Laboratories; from *Aluminum Properties and Physical Metallurgy*, ed. John E. Hatch, American Society for Metals, Metals Park, Ohio, 1984, Figure 19, page 295.)

Certain alloys frequently used in cooling water environments, notably aluminum and zinc, can be attacked vigorously at high pH. These metals are also significantly corroded at low pH and thus are said to be *amphoteric*. A plot of the corrosion behavior of aluminum as a function of pH when exposed to various compounds is shown in Fig. 8.1. The influence of various ions is often more important than solution pH in determining corrosion on aluminum.

At a pH above about 9, in the presence of sodium carbonate or sodium hydroxide, for example, the protective oxide layer is rapidly dissolved and corrosion becomes severe (Fig. 8.1). Aluminum in the presence of sodium hydroxide corrodes as in Reaction 8.2:

Figure 8.1 shows that aluminum is corroded by alkaline substances, albeit at different rates, when water pH exceeds 9. Corrosion by inorganic salts between a pH of 5 and 9 is very slow near room temperature. Aluminum shows no significant corrosion in most natural waters up to about 350°F (180°C). Of course, natural waters vary widely in composition, and exceptions do occur.

Aluminum alloys are corroded at both high and low pH. Not all compounds that increase pH cause severe attack. Ammonium hydroxide only moderately increases corrosion rates. Wastage actually decreases above a pH of 12 in ammonium hydroxide solutions (see Fig. 8.1). A caustic solution causes corrosion rates to increase substantially as pH rises. The  $\text{Al}^{+3}$  ion reacts vigorously with  $\text{OH}^-$  to produce  $\text{AlO}_2^-$ .

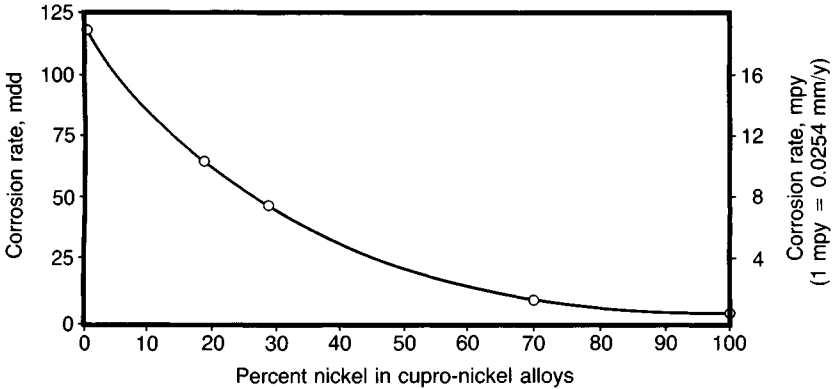
**Figure 8.2** Corrosion rates of copper and copper-nickel alloys in a 50% caustic soda evaporator (Courtesy of F. L. LaQue, *Corrosion* 10:391:1954.)

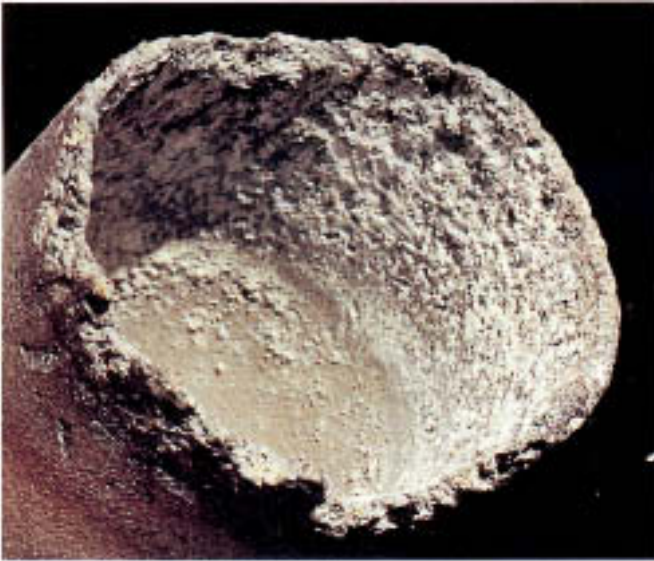
**Figure 8.3** General wastage of an aluminum water manifold from a diesel engine cooling system. Note the generally wasted internal surface due to concentrated caustic and the presence of white deposits and corrosion products.

Wastage morphology is vague. Usually broad areas contacting high-pH fluids are affected (Fig. 8.3). Well-defined pits are rare. Intersecting areas of shallow metal loss produce generally wasted surfaces. More localized attack is found in early stages of corrosion and on castings (Figs. 8.4 and 8.5). Wastage progresses so that individual areas of attack eventually merge.

White, friable corrosion products composed of Bayerite  $\text{Al}_2\text{O}_3 \cdot 3\text{H}_2\text{O}$ , caustic, and  $\text{NaAlO}_2$  cover corroded areas (Fig. 8.3). The white corrosion product and deposit usually test as distinctly alkaline when mixed with distilled water. Corrosion products usually cling tenaciously to the underlying metal and do not form voluminous lumps. Instead, corrosion products line and coat generally wasted surfaces below.

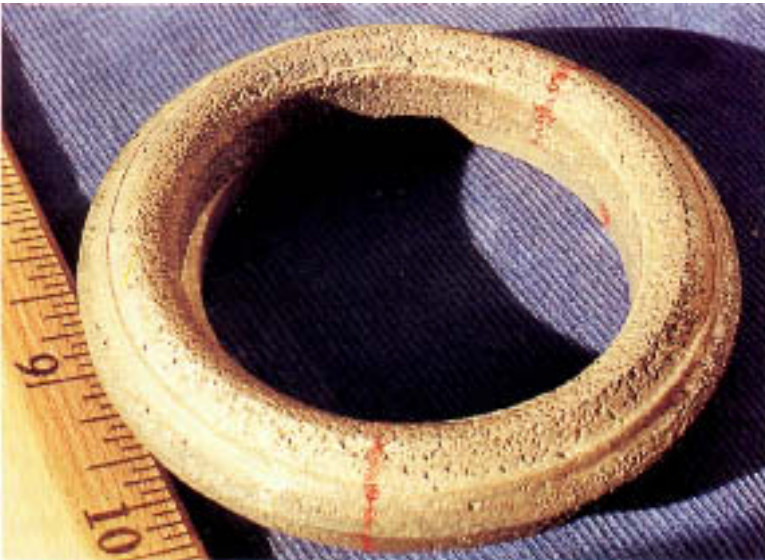
**Figure 8.4** Corroded aluminum-alloy casting valve seat. The seat was in contact with water having a pH between 9 and 10 for 3 months. Red marks were drawn on the surfaces to assist metallographic preparation.

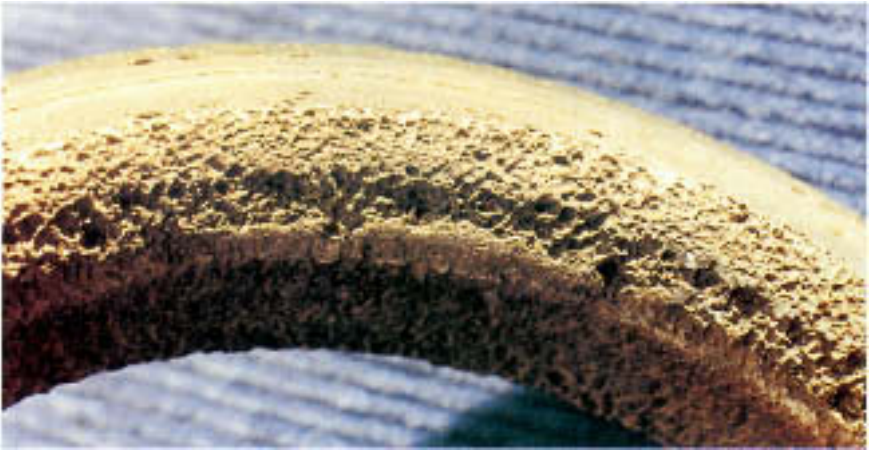
**Figure 8.5** As in Fig. 8.4 but at greater enlargement. Note the intersection of pitlike depressions to form more general metal loss.

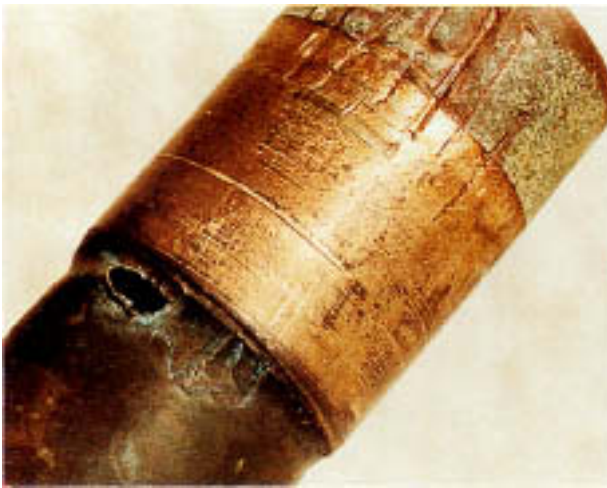
**Figure 8.6** Severe grooving by ammonia-containing condensate on an admiralty brass condenser tube. Condensate flowed down the tube sheet and collected at the tube end, cutting an annular groove. Note the perforation just outside the tube roll.

Grooving becomes broad along the bottom of horizontal piping where ammonia-rich condensate collects. One often finds a zone of severe general thinning along the bottom of pipes carrying condensate (Fig. 8.10). The zone of smooth metal loss will occur on the bottom of pipes and will be bordered on either side by sharp lines marking the steam-water interface. Frequently there is grooving in the direction of gravity immediately above the generally thinned zone. Grooves are formed as rivulets of condensed vapor, laden with ammonia, run down vertical surfaces (Figs. 8.6 through 8.8).

The tube section was one of several that contained a perforation in a region of severe external surface metal loss (Fig. 8.6). Wall thickness was as great as 0.040 in. (0.10 cm) on the rolled end. Just outside the rolled end, wall thickness dropped to a maximum of 0.030 in. (0.076 cm). Most areas were as thin as 0.016 in. (0.042 cm).

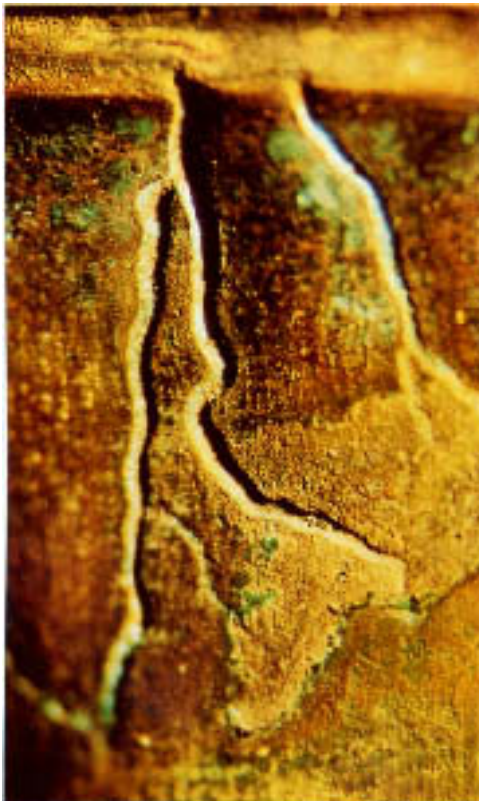
**Figure 8.7** Small grooves on the tube shown in Fig. 8.6. Grooves are condensate rivulet paths cut into the tube surface. (Magnification: 10 $\times$ .)

Close visual inspection of the thinned surface revealed small, longitudinally oriented grooves and gullies running from the rolled tube end across the thinned region (Fig. 8.7). The grooves were deepest at the rolled tube end and branched as they moved away from the tube sheet. The external surface was covered with a thin, dark oxide layer. The layer was replaced in places by a dark green patina. In the thinned region, the surface had an undulating contour.

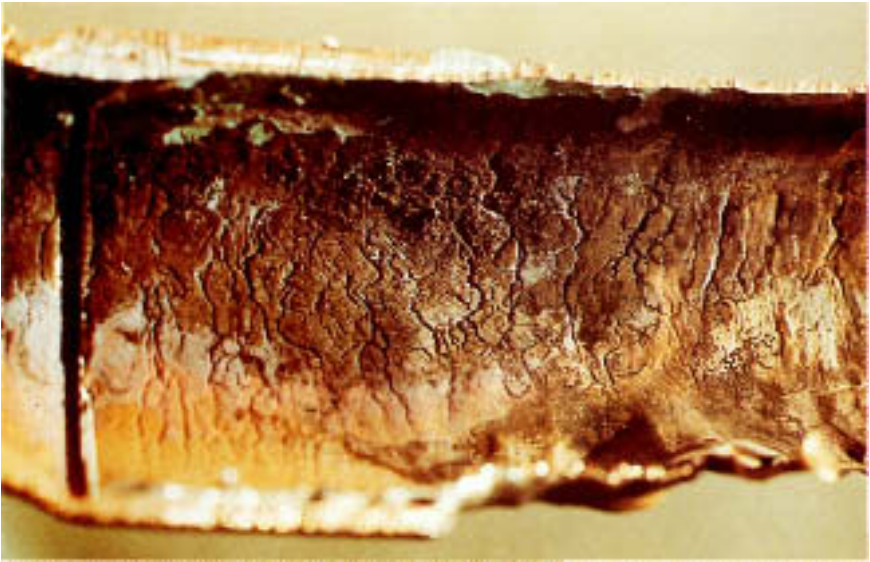
**Figure 8.8** Severe grooving on the internal surface of a copper pipe carrying condensate. Grooves were cut by condensing vapors running down pipe walls. Note the vivid blue corrosion products and deposits near the bottom.

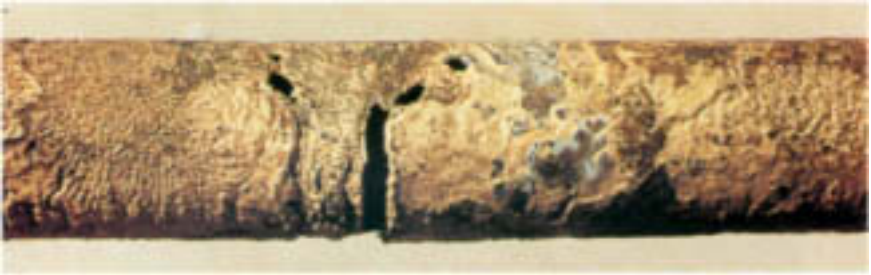
**Figure 8.9A** A brass condenser tube severely wasted by condensing vapors containing ammonia.

In condensers with steam on external tube surfaces, grooving is common on shell sides. Grooving is usually confined to regions near tube sheets and baffles. Condensed vapors containing high concentrations of ammonia collect on and run down the tube sheets and baffles, collecting where tubes are rolled into the sheets or pass through baffles. Broad annular grooves are cut into surfaces abutting the sheets and baffles (Fig. 8.6). Frequently, sinuous grooves run in the direction of gravity (Fig. 8.7). Grooves are produced by rivulets of aggressive condensate and may superficially resemble stress-corrosion cracks (see Chap. 9, "Stress-Corrosion Cracking"). Inside piping where condensation occurs, grooving can be pronounced (Fig. 8.8). In extreme cases, attack can become general, producing undulating surface contours (Figs. 8.9A and B).

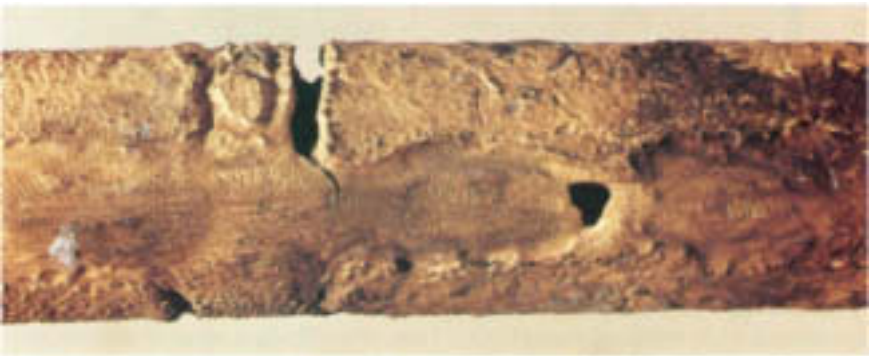
**Figure 8.9B** As in Fig. 8.9A. Note the fine grooves resembling cracks. Compare to Figs. 8.6 through 8.8.

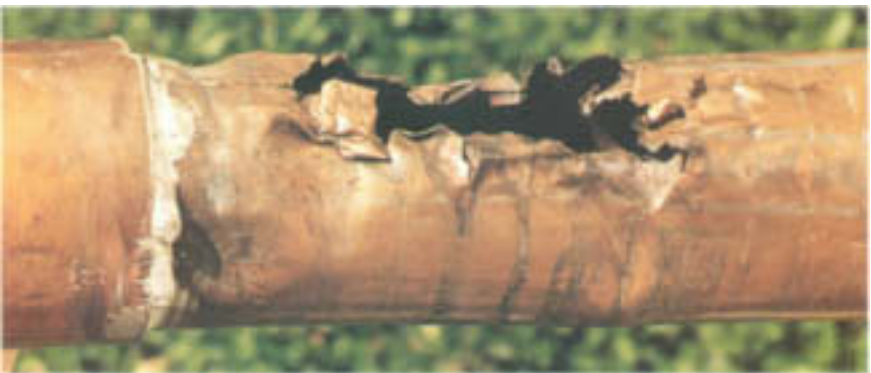
**Figure 8.10** A large, ragged perforation in a region of severe internal wastage on a copper pipe. Corrosion was caused by ammonia-containing condensate.

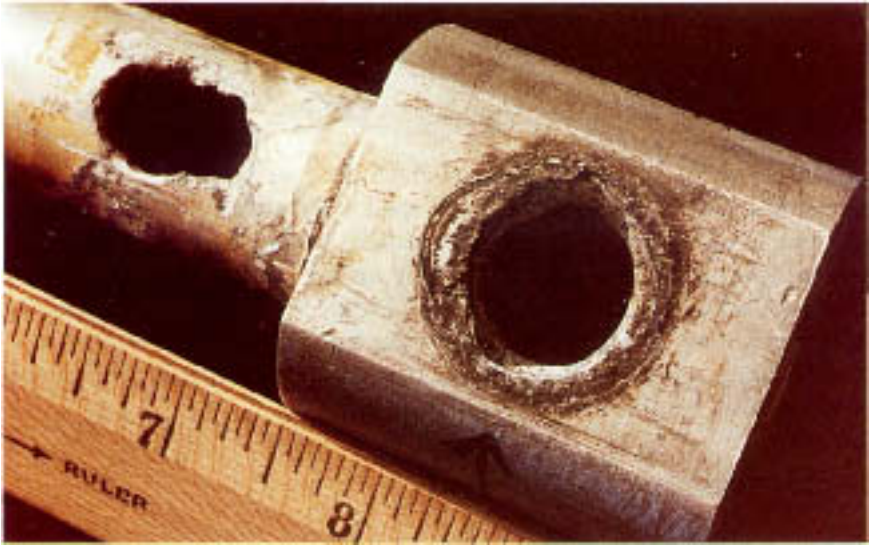
**Figure 8.11** An aluminum cooling water conduit severely attacked by a caustic in service. The large circular hole in the machined face is corroded around its edges. The elliptical hole between the 6- and 7-in. ruler markings was formed by corrosion penetrating the conduit wall.

An aluminum alloy cooling water conduit section was removed from a machine that made polyethylene sheeting. A large hole had formed just below a  $\frac{3}{4}$  in. (1.9 cm) cooling water orifice. The designed orifice is shown in Fig. 8.11, with the elliptically shaped corroded hole just below.

The designed orifice allowed water to exit and move down an annular space between the conduit and a sheathing pipe. Impingement and the relatively high water pH (9.5–10.5) caused corrosion of the designed orifice edges and localized wastage, producing the elliptical perforation.

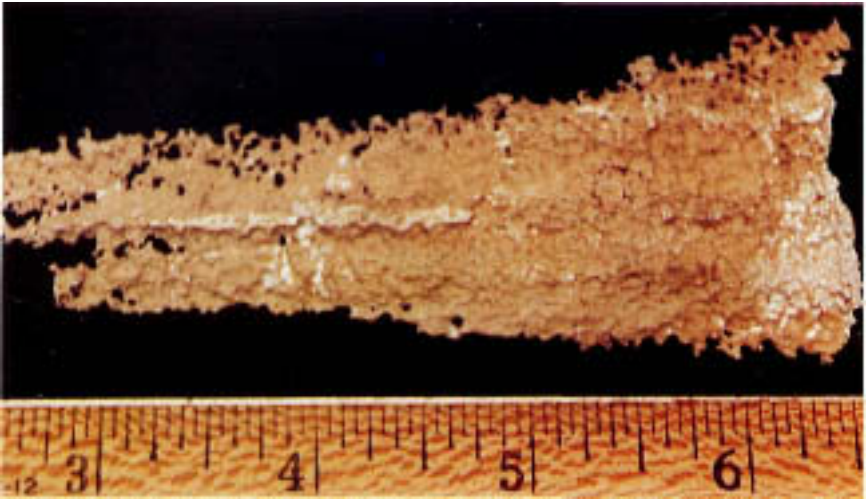
**Figure 8.12** A fragment of a severely corroded aluminum annealing sleeve. Attack was by caustic, which caked the specimen.

Aluminum sleeves used in an annealing machine to heat treat copper rod failed rapidly (Figs. 8.12 and 8.13). Attack was caused by a caustic that concentrated due to evaporation of water in the annealing sleeve.

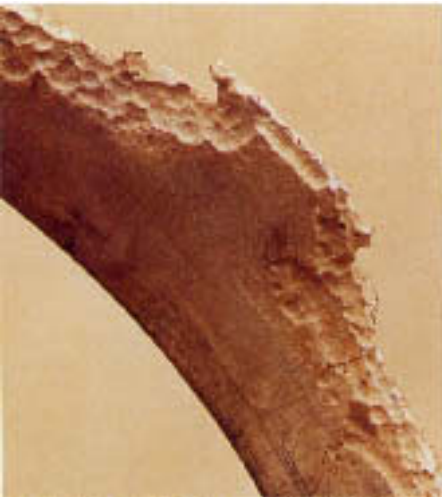
**Figure 8.13** As in Fig. 8.12, but a threaded portion of the annealing sleeve. Note the heavy caustic deposits.

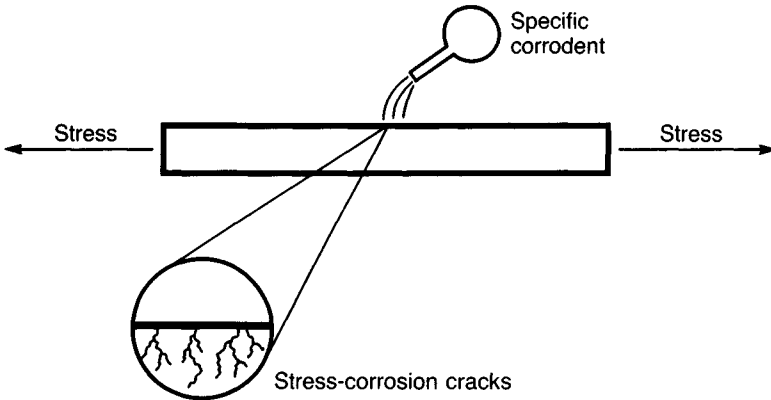
**Figure 9.1** Stress-corrosion cracks result from the synergistic interaction of tensile stress and a specific corrodent.

SCC has been defined as failure by cracking under the combined action of corrosion and stress (Fig. 9.1). The stress and corrosion components interact synergistically to produce cracks, which initiate on the surface exposed to the corrodent and propagate in response to the stress state. They may run in any direction but are always perpendicular to the principal stress. Longitudinal or transverse crack orientations in tubes are common (Figs. 9.2 and 9.3). Occasionally, both longitudinal and transverse cracks are present on the same tube (Fig. 9.4). Less frequently, SCC is a secondary result of another primary corrosion mode. In such cases, the cracking, rather than the primary corrosion, may be the actual cause of failure (Fig. 9.5).

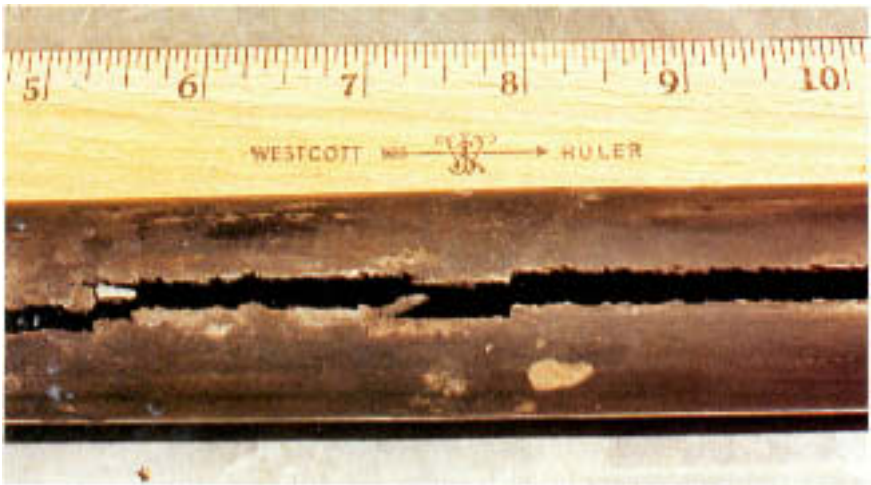
**Figure 9.2** Longitudinal stress-corrosion cracks in a heat exchanger tube; the broad gap between the crack faces reveals that high-level residual hoop (circumferential) stresses from the tube-forming operation provided the stress component required for SCC.

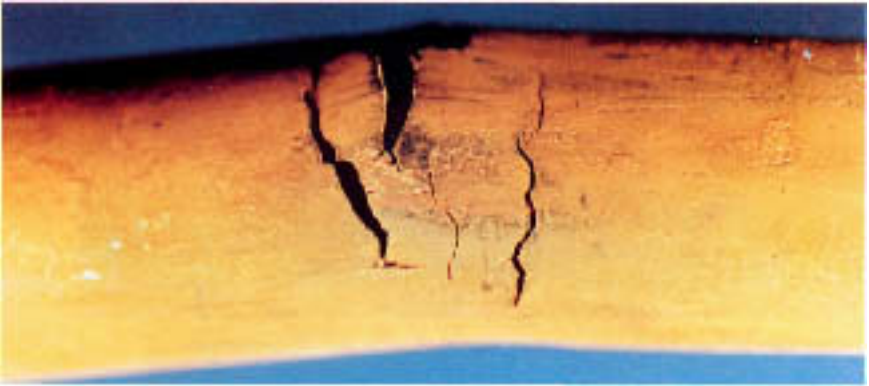
**Figure 9.3** Transverse stress-corrosion cracks in a condenser tube; the presence of the cracks along just one side indicates that a bending moment provided the stress.

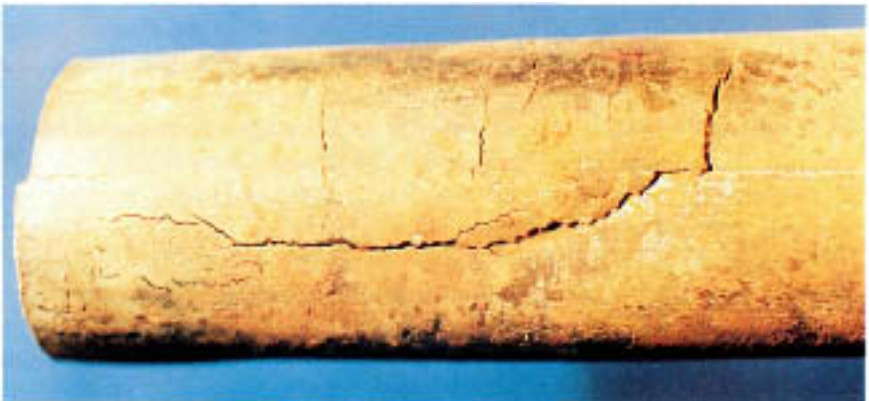
**Figure 9.4** Both longitudinal and transverse stress-corrosion cracks on a brass heat exchanger tube that had been exposed to ammonia. Note the branching of the cracks.

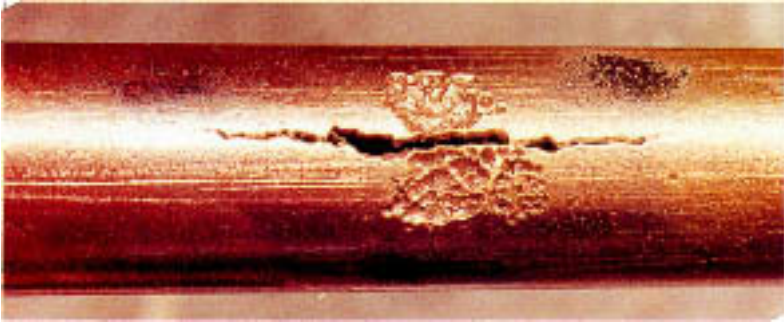
**Figure 9.5** Stress-corrosion cracks associated with simple corrosion.

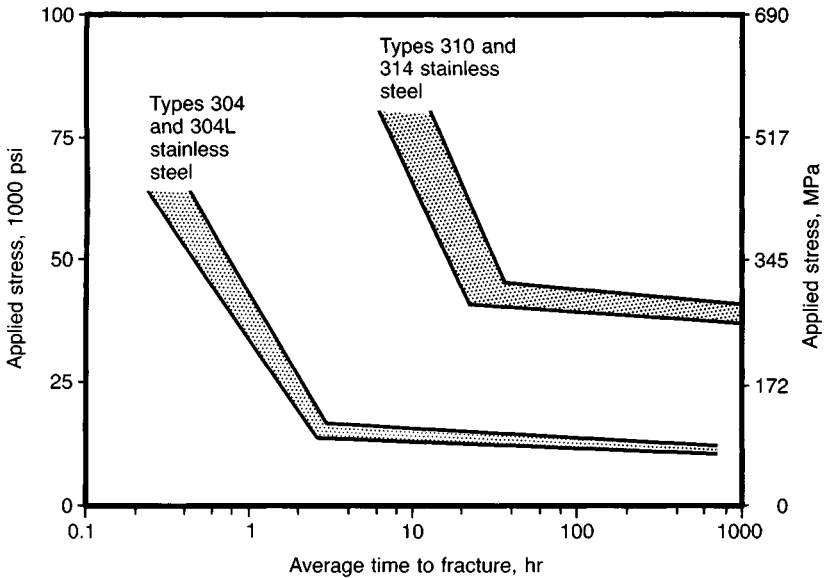
**Figure 9.6** Threshold stresses of two types of stainless steel in boiling 42% magnesium chloride solution. (Reprinted with permission of American Society for Metals from Metals Handbook, vol. 10, 8th ed., Metals Park, Ohio, 1974, p. 210.)

1. *Sufficient tensile stress.* Sufficiency here is difficult to define since it depends on a number of factors such as alloy composition, concentration of corrodent, and temperature. In some cases, stresses near the yield strength of the metal are necessary. In other cases, the stresses can be much lower. However, for each combination of environment and alloy system, there appears to be a threshold stress below which SCC will not occur. Threshold stresses can vary from 10 to 70% of yield strength depending on the alloy and environment combination and temperature (Fig. 9.6).

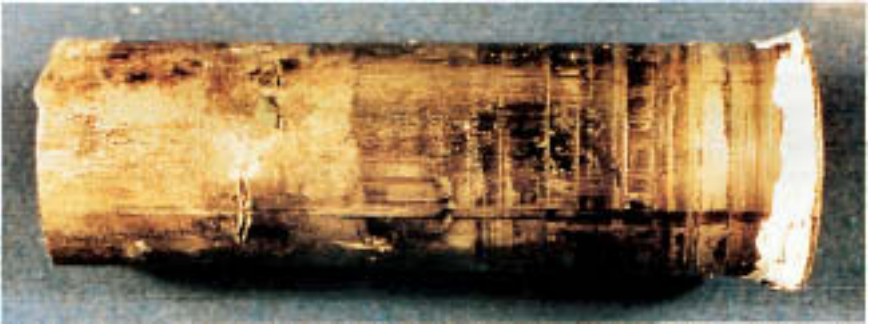
Figure 9.8 Short, transverse fissure adjacent to the rolled end of the tube.

The transverse (circumferential) fissures illustrated in Figs. 9.8 and 9.9 are similar to failures that had occurred in many tubes. All failures occurred near the tube sheet at the hot end of the exchanger (Fig. 9.10). The initial failure had occurred 3 years earlier.

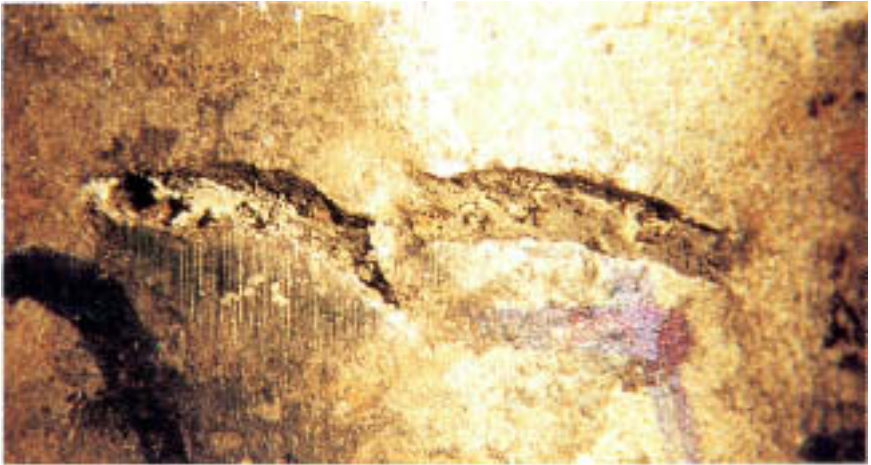
Figure 9.9 Fissures originating on external surface. (Magnification: 7.5 $\times$ .)

Figure 9.9 shows the proximity of the cracks to the rolled end of the tube. The cracks occurred from just one side. The original crack was tight, but distortion of the tube during its removal from the exchanger expanded the cracks, giving them a fissurelike appearance in the photographs.

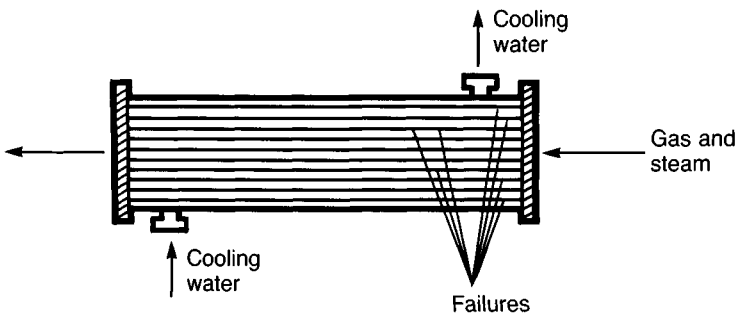
Figure 9.10 Schematic of heat exchanger showing location of cracks.

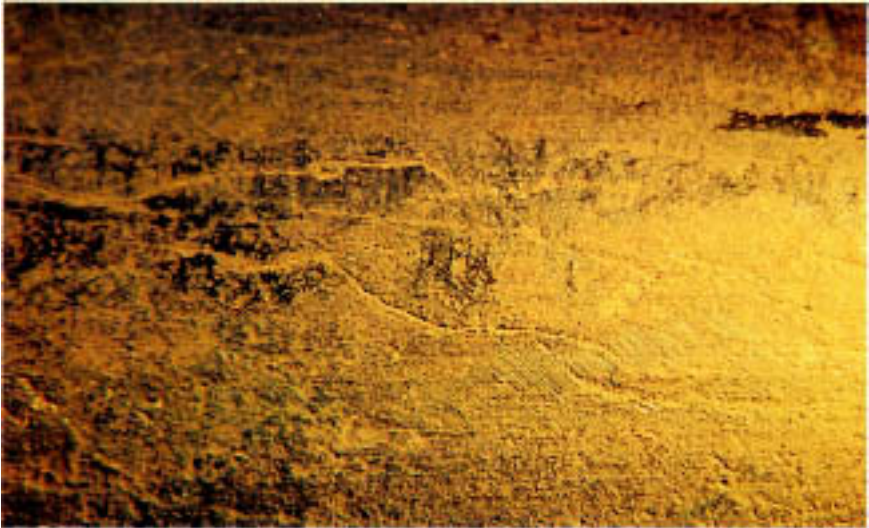
**Figure 9.11** A network of longitudinal cracks along the external surface. (Magnification: 7.5 $\times$ .)

A routine inspection of the tube bundle during a plant outage revealed fine cracks of the type shown in Fig. 9.11. Scattered longitudinal cracks were observed along the lengths of most tubes. The external surface was covered with a thin film of black copper oxide and deposits. The bundle had been exposed to ammonia levels that produced ½ ppm of ammonia in the accumulated condensate.

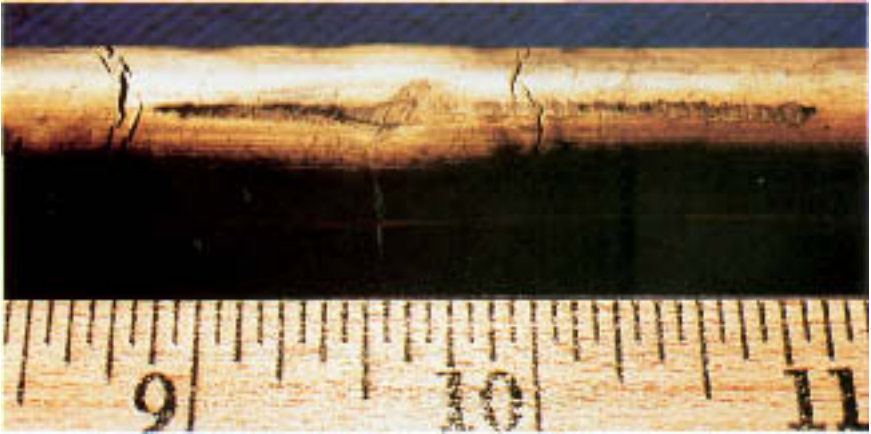
**Figure 9.12** Discontinuous, transverse cracks; close examination of the photograph will disclose at least five tight, secondary cracks.

Cracks of the type illustrated in Fig. 9.12 occurred in many tubes of this new exchanger. All cracks occurred at the air-entry end of the cooler (Fig. 9.13) and had the brittle appearance typical of stress-corrosion cracks.

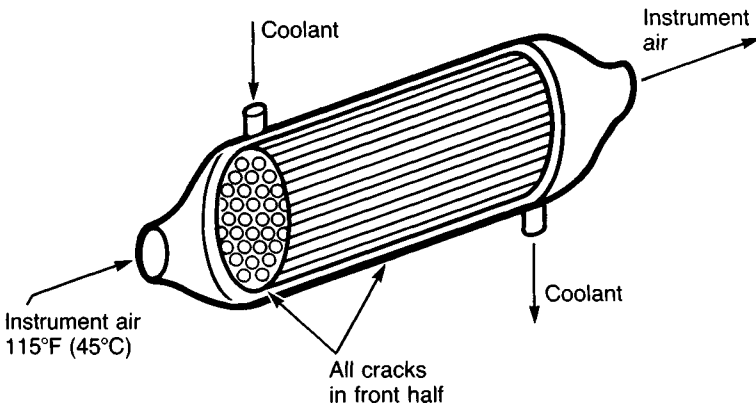
**Figure 9.13** Schematic of air cooler showing location of cracks at the air-entry end.

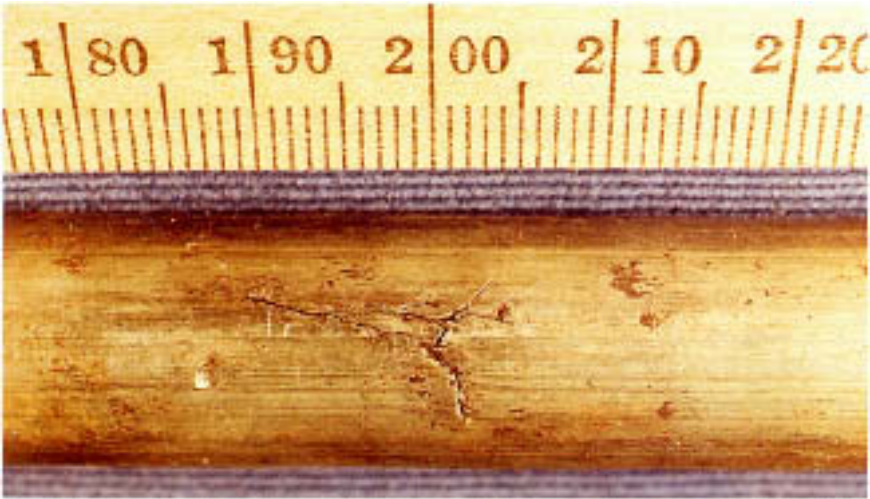
Figure 9.14 Cracks on external surface.

A total of 13 tubes in the exchanger had suffered cracking of the type illustrated in Fig. 9.14. The cracks are predominantly longitudinally oriented.

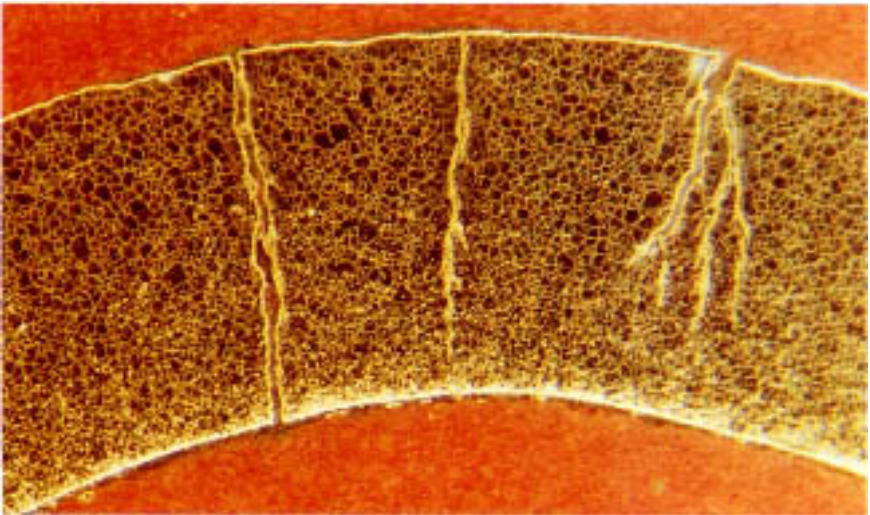
Figure 9.15 Cracks originating on the external surface. Note the branching. (Magnification: 33x.)

Microstructural examinations revealed that the cracks originated on the external surface (Fig. 9.15). The cracks were highly branched and transgranular. The branched, transgranular character of these cracks is typical of stress-corrosion cracking of austenitic stainless steels. The thick-walled fracture faces are also typical of cracking by this mode.

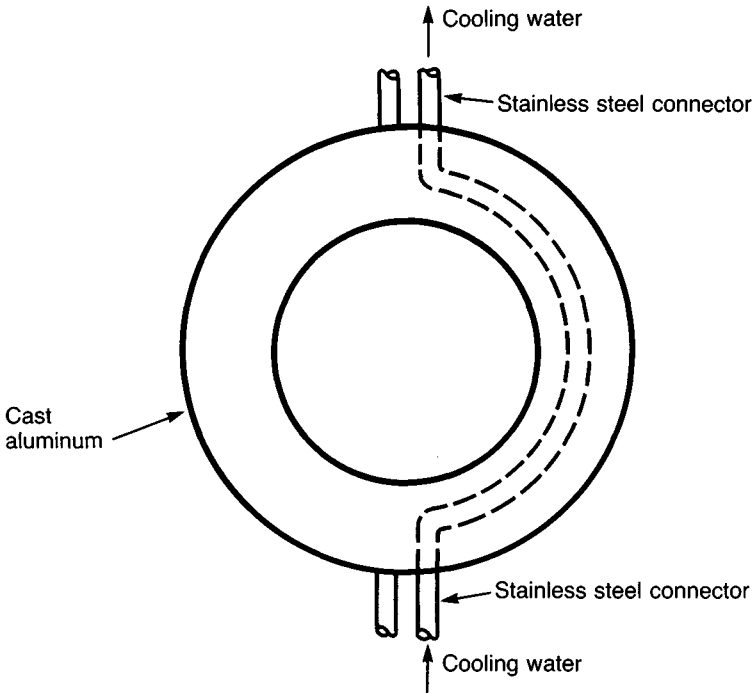
Figure 9.16 End view of plastics extrusion barrel cooling jacket.

Figure 9.16 depicts the arrangement of connections in the extrusion barrel cooling jacket. Embrittlement and cracking of these stainless steel connections (Figs. 9.17 and 9.18) were occurring as frequently as every 4 to 6 weeks.

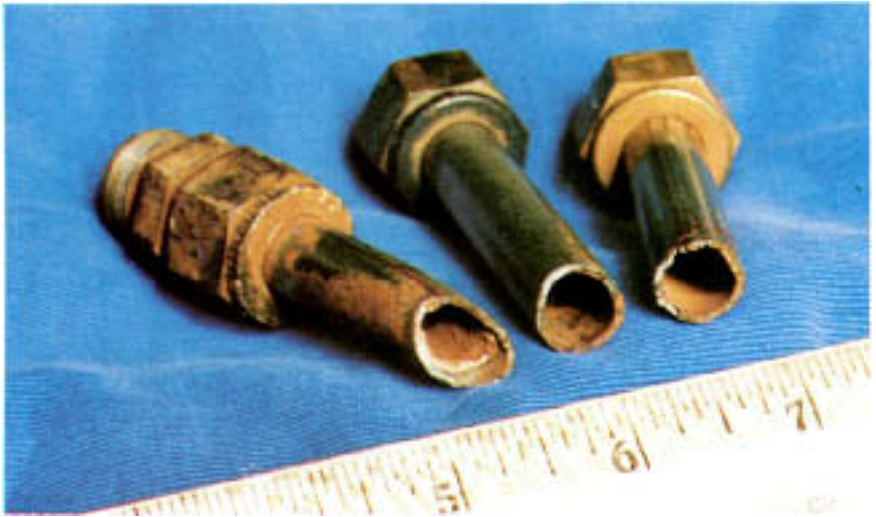
Figure 9.17 Stainless steel connectors showing circumferential fractures.

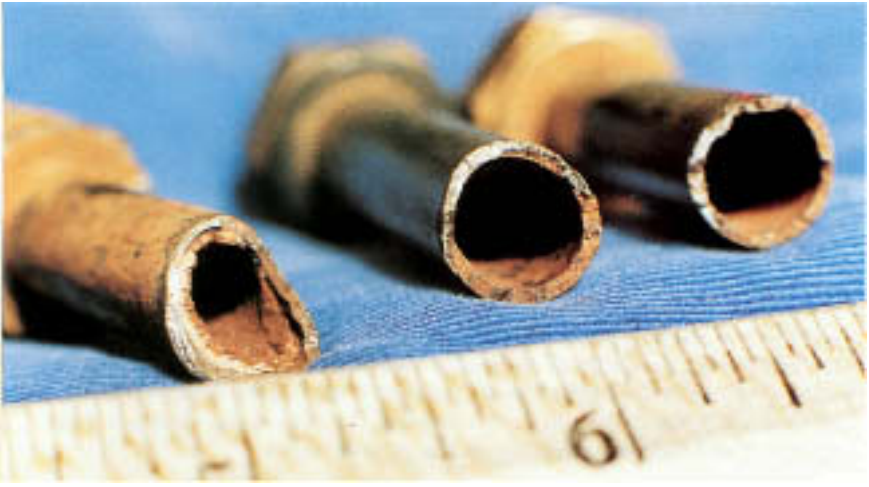
**Figure 9.18** Cracked connectors; note brittle, thick-walled character of the cracked faces and the accumulation of alkaline deposits on the internal surface of the connector on the left.

Close visual inspection of the blunt, fractured ends revealed small secondary cracks along the internal surface. Internal surfaces were covered with a layer of deposit that was highly alkaline (Fig. 9.18).

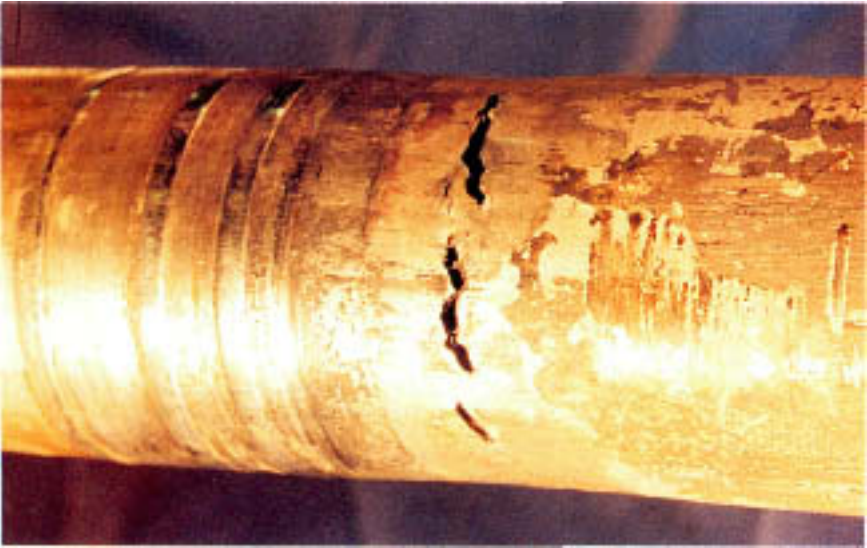
**Figure 9.19** Circumferential cracks along one side of the heat exchanger tube. Note proximity of cracks to the plane of the tube sheet, as indicated by the tube sheet grooves (left). Expansion of the cracks may have occurred during removal of the tube from the exchanger.

Numerous tubes in this new heat exchanger had suffered circumferential cracks of the type illustrated in Fig. 9.19. All cracking had occurred in the top of this vertical condenser, within 1 in. (2.5 cm) of the rolled areas in the vapor space (Fig. 9.20).

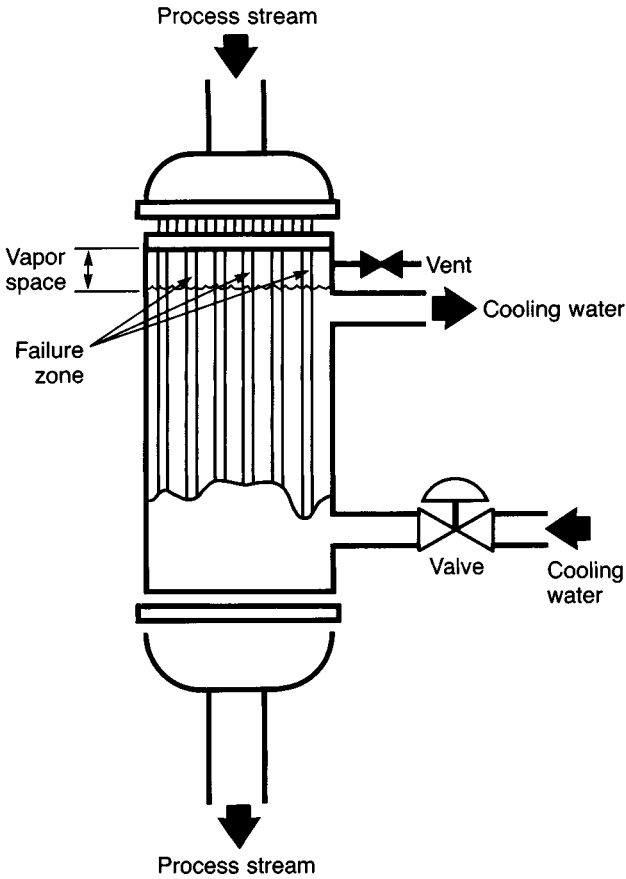
**Figure 9.20** Schematic representation of vertical heat exchanger showing location of cracks in the vapor space.

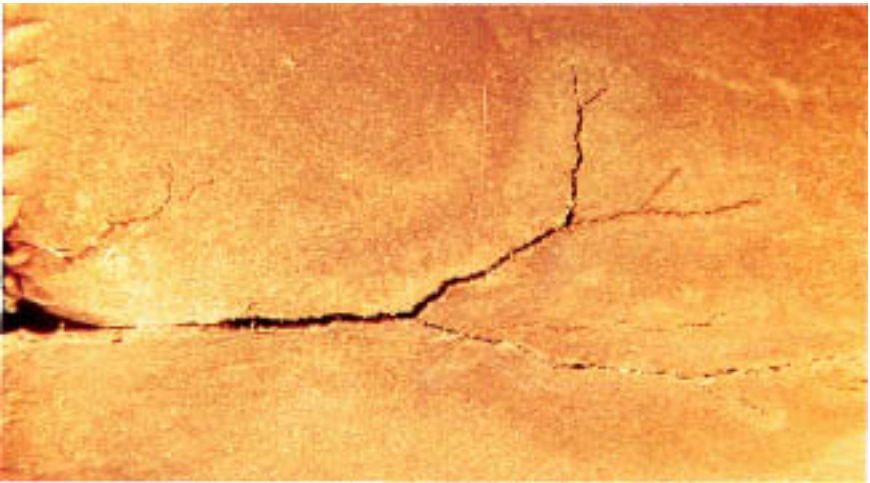
**Figure 9.21** Branched, longitudinal cracks on the external surface. (Magnification: 7.5×.)

As part of a protective maintenance activity, the chiller was examined by eddy current. An eddy current check revealed no failures. However, when the chiller was returned to service, leakage of chill water was detected. The unit was shut down, drained, and visually examined. Numerous branched cracks of the type shown in Fig. 9.21 were observed. Cracks were oriented longitudinally.

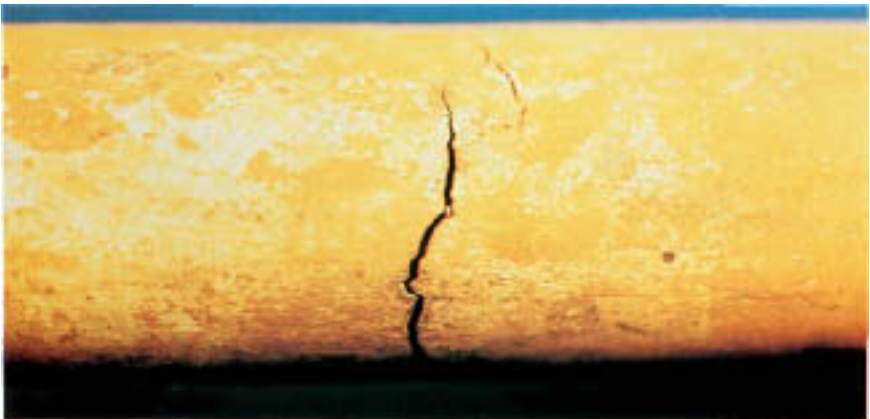
**Figure 9.22** Transverse cracks originating on the external surface.

Numerous failures of the type illustrated in Fig. 9.22 had occurred over a period of months. External surfaces are visually smooth, uncorroded, and covered with a thin layer of deposit. Internal surfaces are covered with a coating of copper carbonate.
