# **The Nalco Guide to Cooling Water System Failure Analysis**

**Nalco Chemical Company**

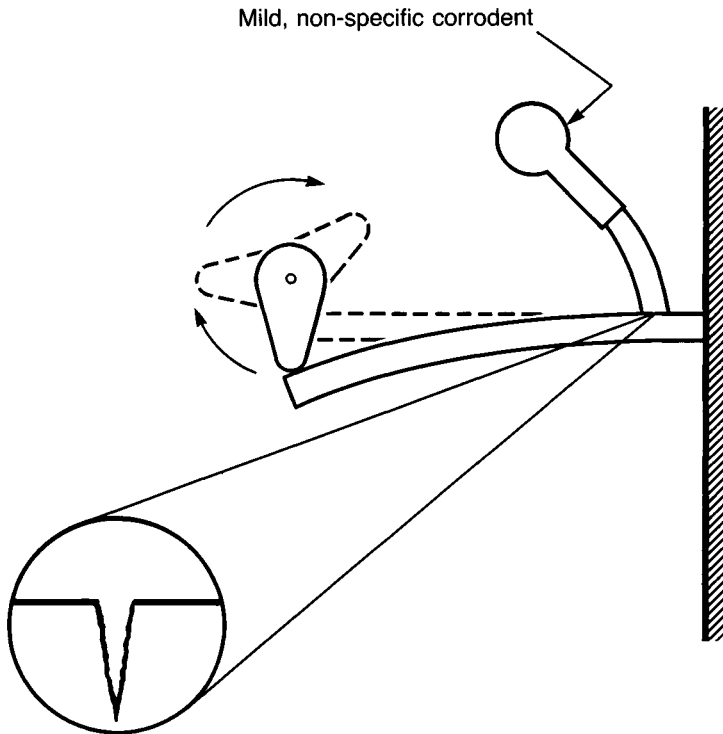
**Figure 10.1** Schematic representation of a corrosion-fatigue crack propagating under the influence of a cyclic bending stress and exposure to a mild, nonspecific corrodent.

Corrosion fatigue, first mentioned in the literature in 1917, refers to the generation of cracks resulting from the combined effects of cyclic stresses and corrosion (Fig. 10.1). A near relative of fatigue, which results simply from cyclic stresses, corrosion fatigue differs from fatigue due to a synergism produced between the stresses and corrosion. Damage produced by the combined effects of the stresses and corrosion is significantly greater than the total damage produced by stresses and corrosion separately.

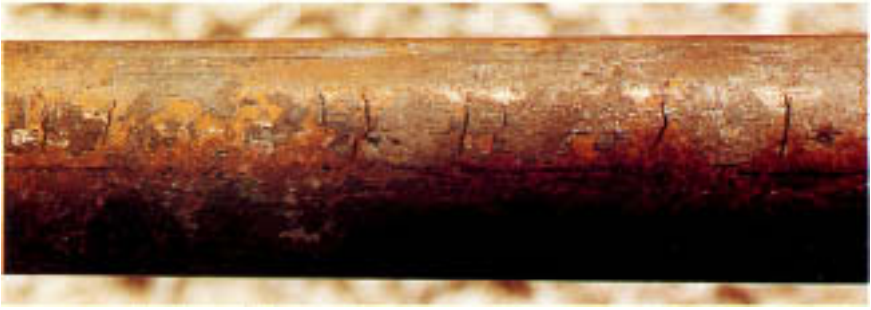
**Figure 10.2** A family of short, transverse corrosion-fatigue cracks originating on the external surface.

Numerous transverse cracks of the type illustrated in Figs. 10.2 and 10.9 were discovered upon inspection. Cracks had not been observed previously.

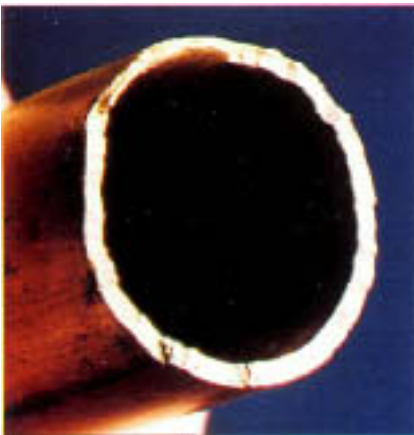
**Figure 10.3** Blunt fracture edges typical of corrosion-fatigue cracks.

environmentally induced cracking, corrosion fatigue produces thick-walled fractures, even in ductile metals (Fig. 10.3).

The short circumferential cracks apparent in Fig. 10.7 are precursors of the complete, brittle fractures shown in Fig. 10.3. Numerous fractures had occurred adjacent to the tube sheet over the past year.

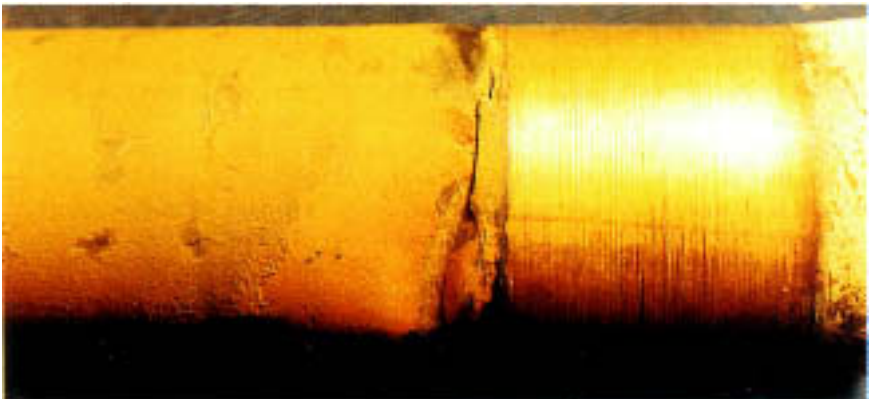
**Figure 10.5** Circumferential corrosion-fatigue crack adjacent to location of tube sheet.

Figure 10.5 shows the appearance of numerous failures that had occurred in a short time in the water box inlet end. Cracking of this type was a recurrent problem in this condenser. Approximately 9% of the tubes in the condenser had been plugged. The condenser was in cyclic service, although the failures had occurred while the boiler itself was out of service.

Note the proximity of the circumferential crack to the rolled section of tube where it had contacted the tube sheet. (Slight distortion of the tube occurred during its removal from the tube sheet.) Figure 10.6 shows the straight, unbranched character of the crack.

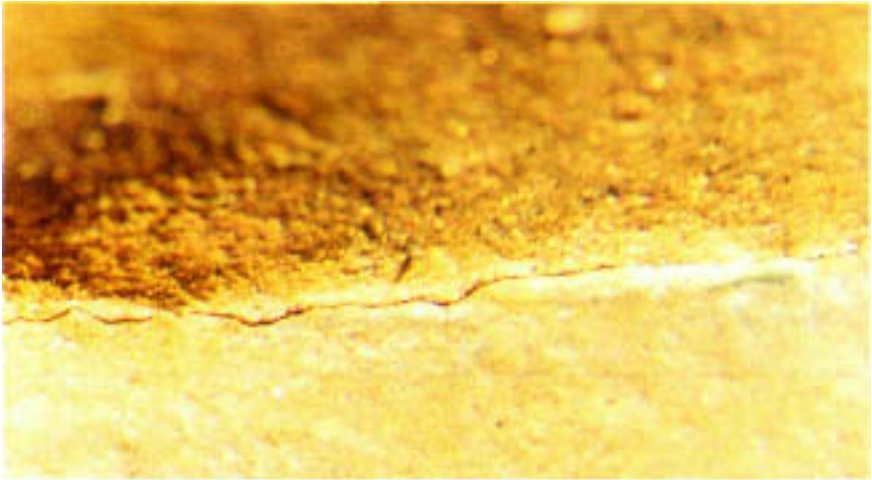
**Figure 10.6** Straight, unbranched crack on the surface. (Magnification: 33 $\times$ .)

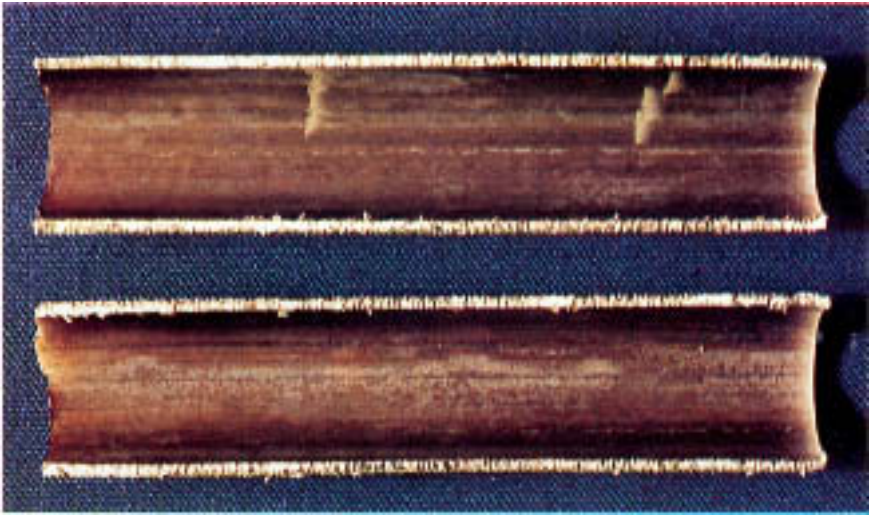
**Figure 10.7** Short, tight, circumferential corrosion-fatigue cracks on the internal surface made apparent by discoloration from “weeping.”

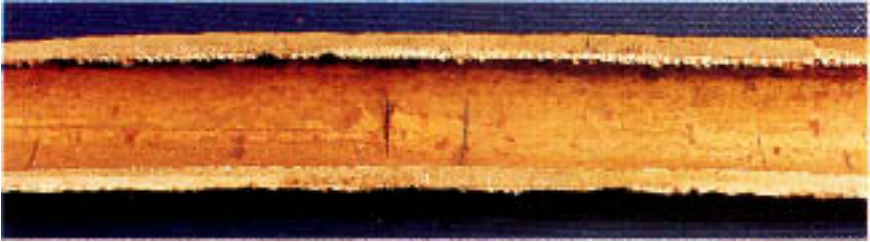
Figure 10.8 Transverse cracks on the internal surface.

Transverse cracks shown in Fig. 10.8 were found in a total of 15 tubes from random areas of the condenser. The equipment had been in continuous service for 2 years. Cracks had not been observed previously.

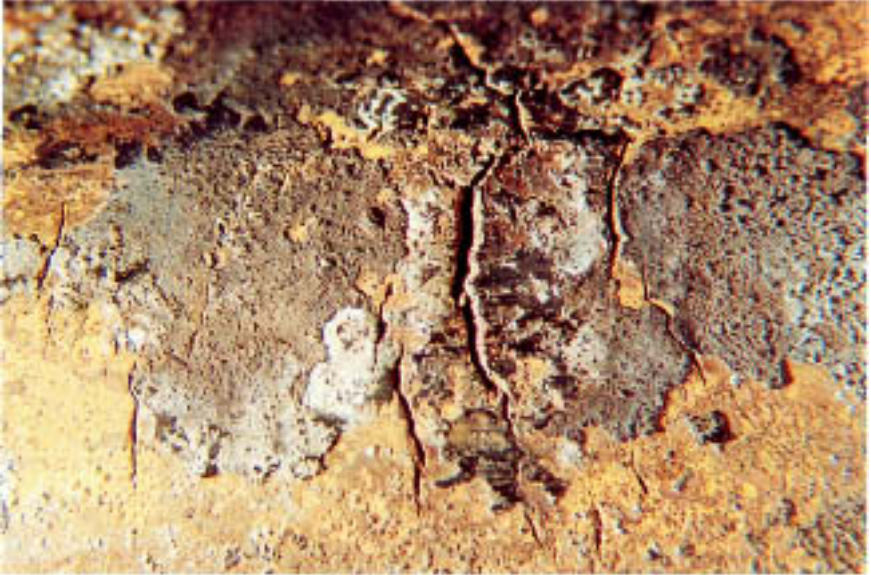
**Figure 10.9** Close-up of cracks. (Magnification: 7.5×.)

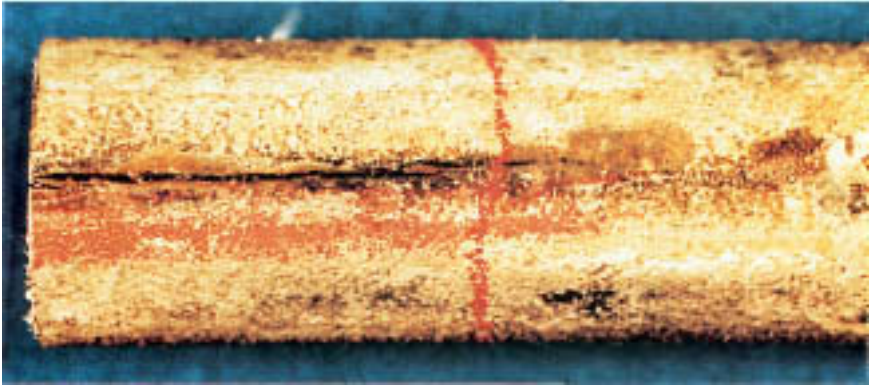
**Figure 10.10** Longitudinal corrosion-fatigue crack originating on the external surface.

Microstructural examinations revealed intergranular, sparsely branched cracks originating on the external surface. Some cracks initiated as transgranular fissures.

Intergranular corrosion-fatigue cracks in copper may be difficult to differentiate from stress-corrosion cracking. The longitudinal orientation of the cracks revealed that the cyclic stresses were induced by fluctuations in internal pressure.

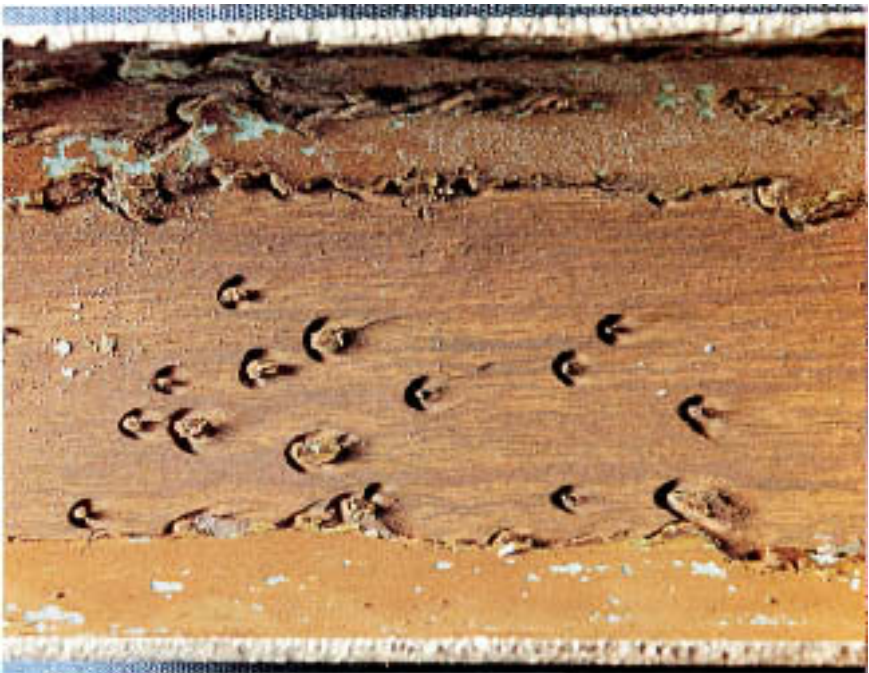
**Figure 11.1** Horseshoe-shaped depressions on the internal surface of a brass heat exchanger tube.

When very high velocities are encountered, metal loss from erosion-corrosion can be general. Typically, however, erosion-corrosion produces localized metal loss in immediate proximity to the disrupted flow. Smooth, rolling, wavelike surface contours are often produced, or distinct, horseshoe-shaped depressions (Fig. 11.1) or comet tails

The classic signature of erosion-corrosion is the formation of horseshoe-shaped depressions, comet tails, grooves, or sand dunelike surface contours oriented along the direction of fluid flow (Figs. 11.1, 11.2, 11.3, 11.5, and 11.8). Occasionally, erosion-corrosion will produce smooth, almost featureless, surface contours (Fig. 11.15), although even in this case oriented metal loss often exists around the perimeter of the affected region. If erosion-corrosion has been recently active, affected surfaces will be free of accumulated deposits and corrosion products.

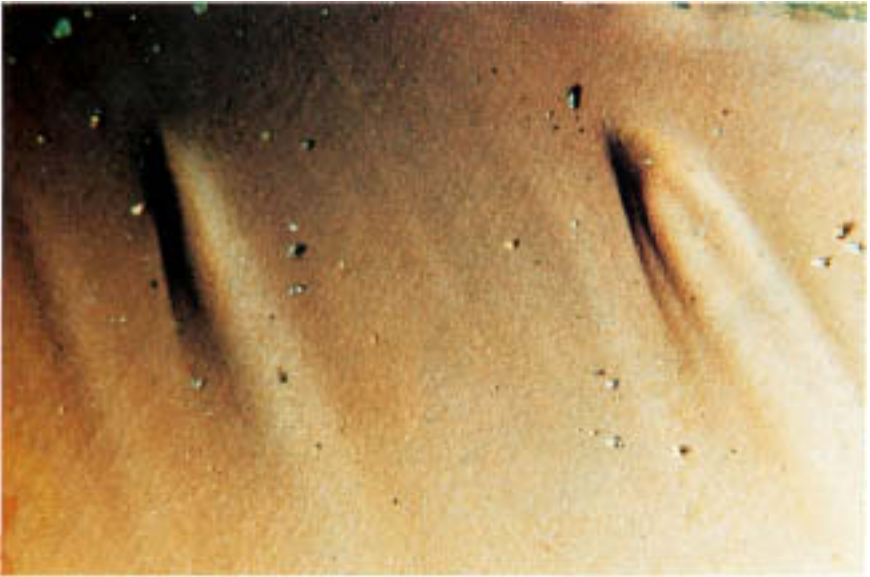
**Figure 11.2** Comet-tail erosion patterns on copper. (Magnification: 15 $\times$ .)

aligned in the flow direction are observed (Fig. 11.2). Sand dunelike contours are sometimes observed (Fig. 11.3).

Figure 11.26 shows a component removed from an air-conditioning compressor. Pinhole perforations in this component had allowed cooling water to leak into the freon. Many failures of this type had occurred previously. Examinations of the internal surfaces of both the canister and the tubes entering it revealed evidence of metal loss. Tiny perforations at the bases of deep grooves were noted in the tubes. Deep, general, smooth metal loss surrounded irregular islands of intact surface (Fig. 11.27). The canister walls displayed a similar metal loss and comet-tail-shaped depressions (Fig. 11.2).

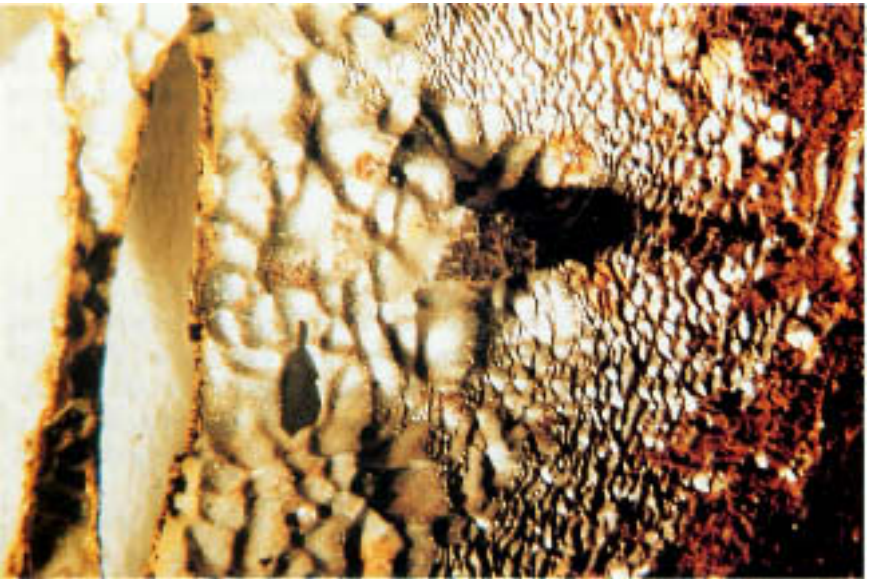
**Figure 11.3** Sand dunelike erosion-corrosion patterns on the inlet end of a steel heat exchanger tube. (Magnification: 7 $\times$ .)

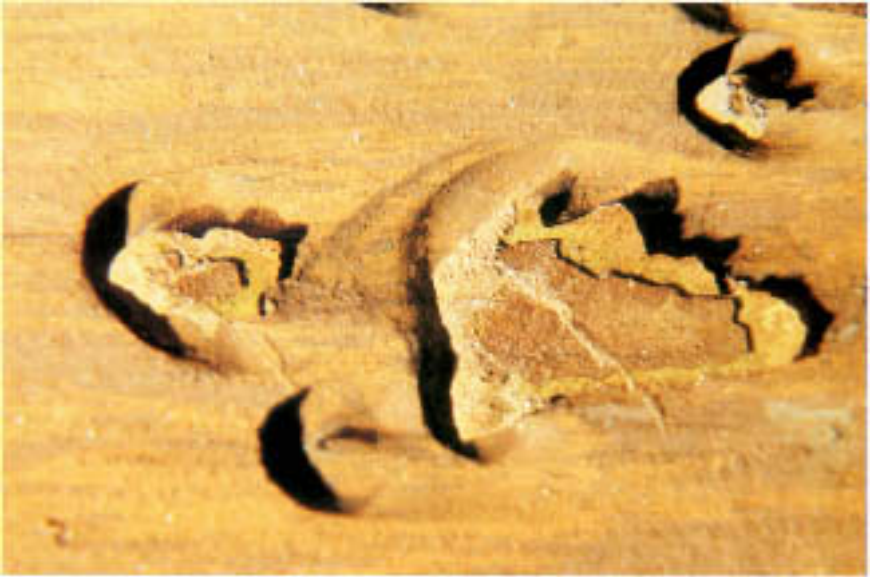
**Figure 11.4** Deposits covering intact metal surfaces at sites of horseshoe-shaped erosion-corrosion depressions. (Magnification: 15 $\times$ .)

Affected areas are essentially free of deposits and corrosion products, although these may be found nearby (Fig. 11.4). Affected areas may be covered with deposits and corrosion products if erosion-corrosion occurs intermittently, and the component is removed following a period in which erosion-corrosion was inactive.

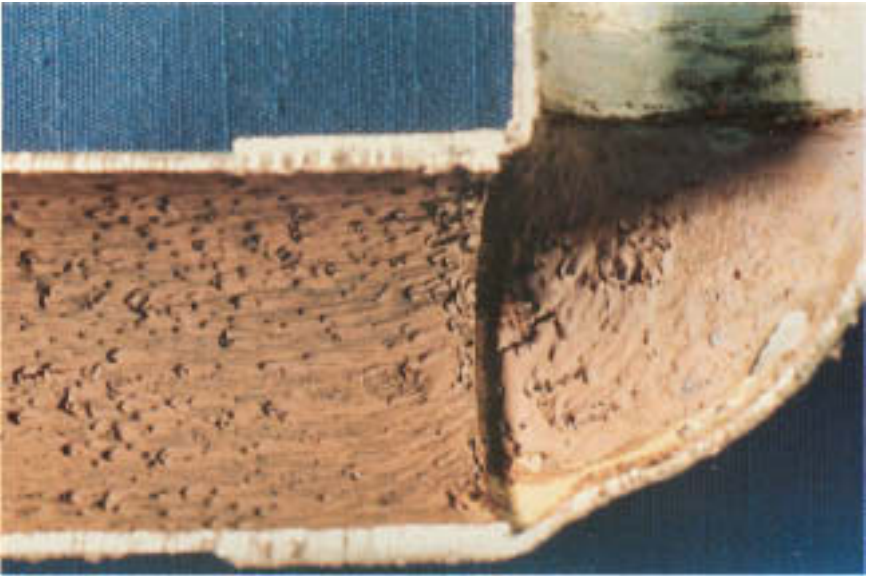
**Figure 11.5** Erosion-corrosion at elbow of a brass tube. Note also the horseshoe-shaped depressions and comet tails aligned with flow direction in the straight section.

Favored locations for erosion-corrosion are areas exposed to high-flow velocities or turbulence. Tees, bends, elbows (Fig. 11.5), pumps, valves (Fig. 11.6), and inlet and outlet tube ends of heat exchangers (Fig. 11.7) can be affected. Turbulence may be created downstream of crevices, ledges (Fig. 11.8), abrupt cross-section changes, deposits, corrosion products, and other obstructions that change laminar flow to turbulent flow.

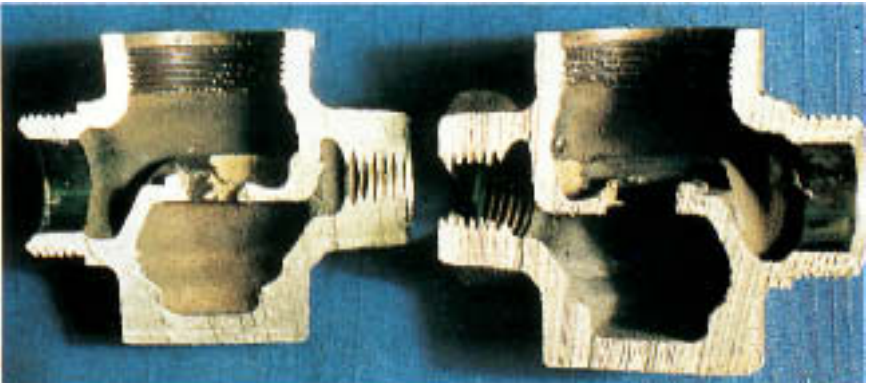
**Figure 11.6** Split valve body showing metal loss at the valve seat.

The cross-sectional schematic of Fig. 11.28 illustrates the spatial relationship between the eroded components shown in Figs. 11.6, 11.29, and 11.30.

Highly localized metal loss at the valve seat is apparent in Fig. 11.6. Figure 11.29 shows the same component close up. Wasted surfaces have a bright, metallic luster free of corrosion products or deposits. Metal loss along the edge of the throttling nut is also apparent (Fig. 11.30).

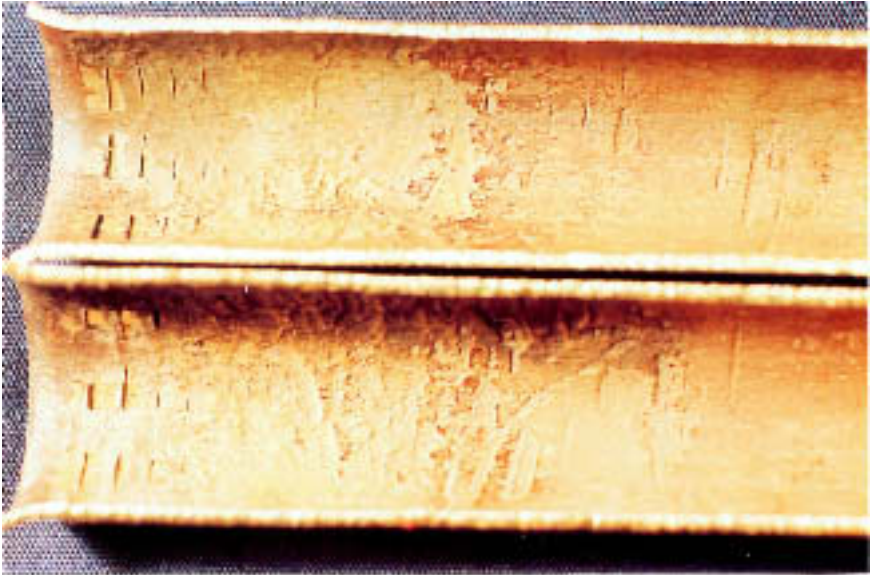
**Figure 11.7** Metal loss on the internal surface at an inlet end (equally spaced circumferential gouges near the tube end were created during tube removal).

Figure 11.7 illustrates the internal surface at the inlet end of the condenser. Approximately 2 in. (5 cm) of the surface is marked by mutually intersecting depressions and grooves. Areas of the internal surface downstream of this zone are smooth and covered with a thin layer of deposits. This typical case of inlet-end erosion can be eliminated by the techniques discussed earlier in this chapter under “Elimination.”

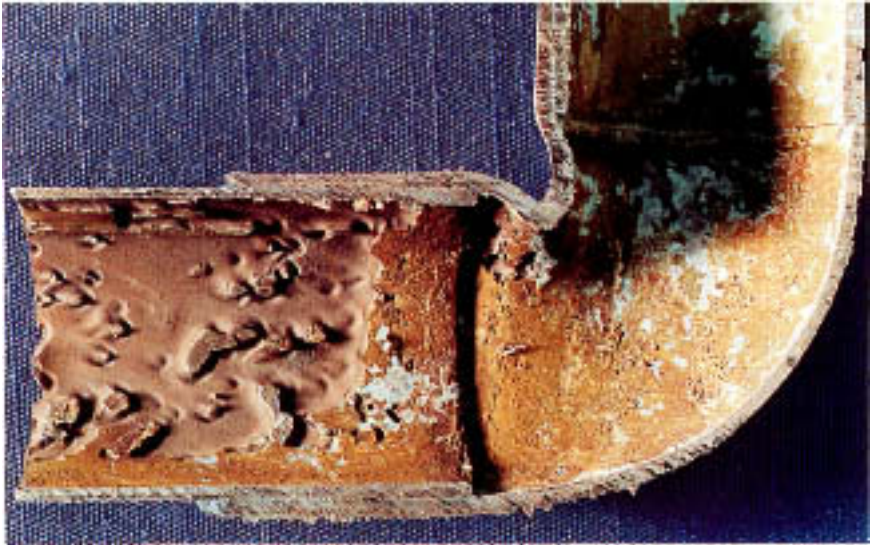
**Figure 11.8** Turbulence created by the ledge at the tube end caused erosion-corrosion immediately downstream.

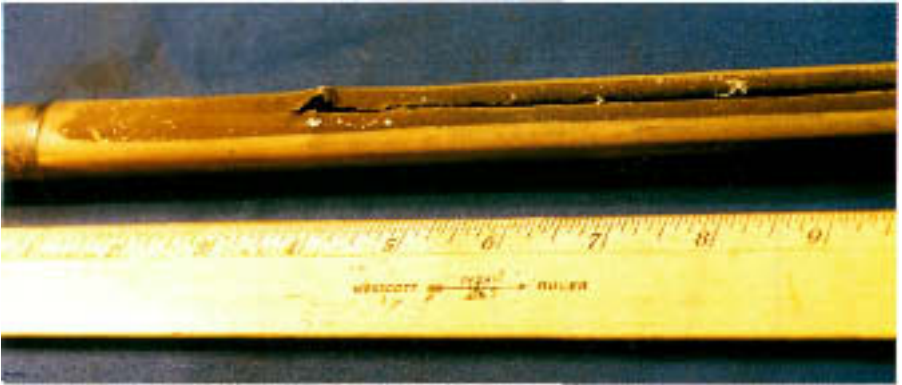
**Figure 11.9** Erosion-corrosion damage on the surface of a brass tube facing the steam inlet nozzle.

Erosion-corrosion problems on the outside of tubes are frequently associated with impingement of wet, high-velocity gases such as steam. This typically involves peripheral tubes at the shell inlet nozzle (Fig. 11.9). Baffle and tube interfaces may also be affected.

The split apparent in Fig. 11.9 was located along the top of the tube facing the steam inlet nozzle. This is one of several tubes in this area having similar longitudinal splits. Leakage of river water from these tubes resulted in feedwater contamination, which turned out to be a major factor in tube failures in the boiler.

The split was centered in a distinct zone of severe wall thinning from the external surface. Close examinations of this surface under a low-power microscope revealed a forest of small, well-formed brass cones pointing straight up from the surface (Fig. 11.16). The external surface on the opposite side retained its smooth, original surface.

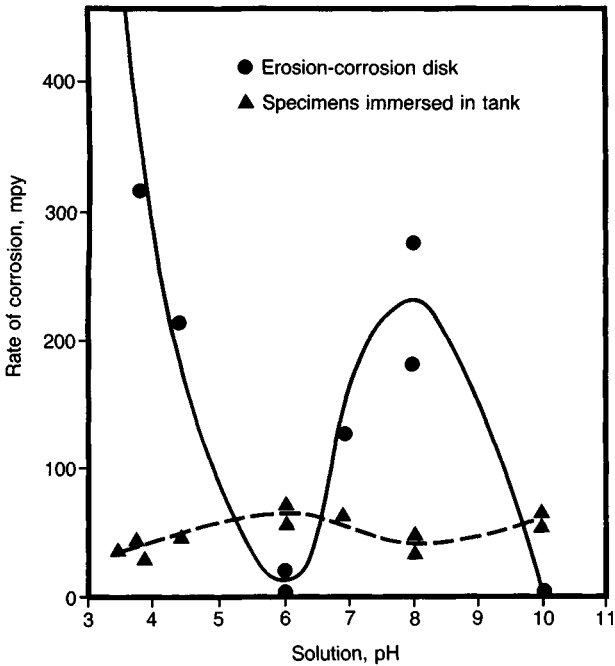
**Figure 11.10** Effect of pH of distilled water on erosion-corrosion of carbon steel at 122°F (50°C) (velocity, 39 ft/s, 12 m/s). (SOURCE: M. G. Fontana and N. D. Greene, *Corrosion Engineering*, 2d ed., 1978, p. 75. Reprinted with permission from McGraw-Hill, Inc.)

is minimized at a pH of 9.6 or higher. Note Fig. 11.10. Copper and copper-base alloys are adversely affected by high pH only if ammonia is present.

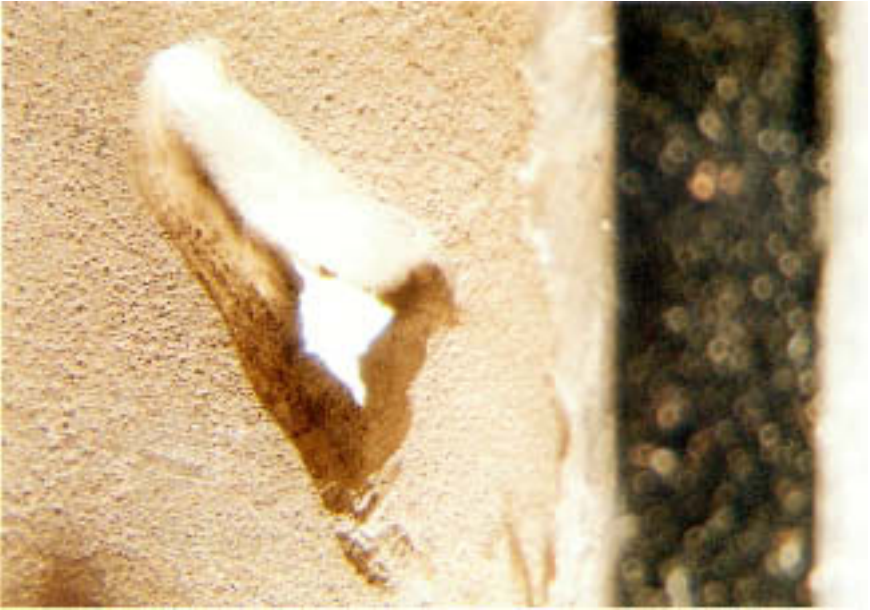
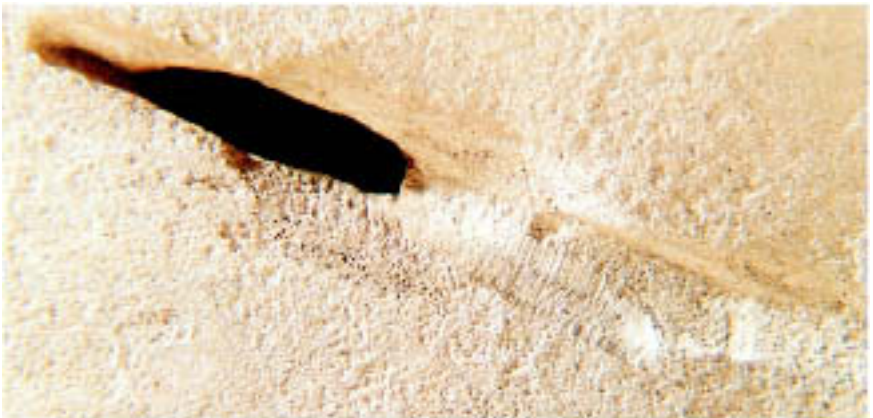
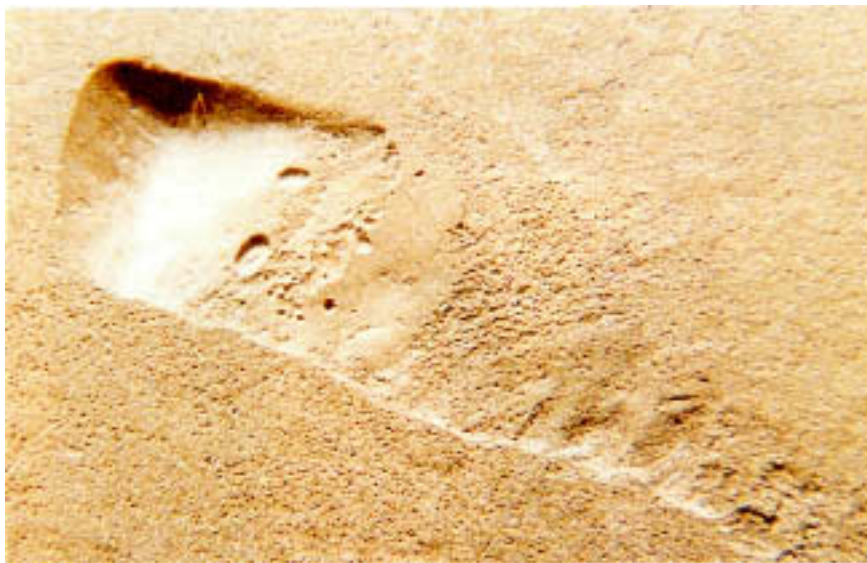
**Figure 11.11** Erosion site resulting from lodgement of a foreign body inside a tube. (Magnification: 8 $\times$ .)

**Figure 11.12** Erosion site resulting from lodgement of a foreign body inside a tube. (Magnification: 8 $\times$ .)

**Figure 11.13** Erosion site resulting from lodgement of a foreign body inside a tube. (Magnification: 8 $\times$ .)

Some debris may enter the tube and then become lodged. Turbulence created at the site of the debris often produces crescent or irregularly shaped erosion-corrosion patterns (Figs. 11.11 through 11.13).

Figures 11.11 through 11.13 illustrate the type of metal loss responsible for a dozen tube leaks over a 3-month period. Note the highly localized character of the metal loss, as well as the unusual shapes and random orientations of the eroded sites. The sites were located at the inlet end and resulted from the lodgment of debris at the mouth of the tube. Highly localized turbulence created by this debris caused the erosion.

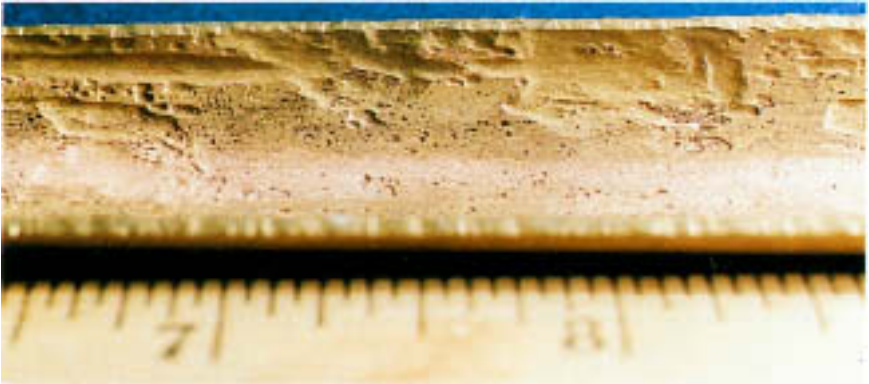
**Figure 11.14** Contour of the internal surface at midspan.

Metal loss of the type illustrated in Fig. 11.14 occurred on the internal surface at the midsection of the tube. Note the erosion grooves oriented in the direction of flow. Metal loss at the inlet end was much more severe and had produced a smooth, relatively featureless contour (Fig. 11.15). Eroded areas were free of corrosion products and deposits.

Generally, maximum flow velocities for brass are between 3 and 5 ft/s (0.9 and 1.5 m/s) depending on environmental conditions. In this case, sand and silt entrained in the river water contributed to the erosiveness of the fluid.

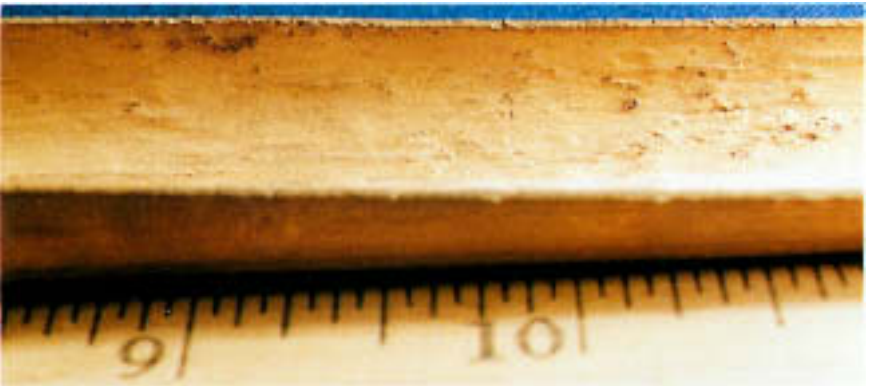
**Figure 11.15** Relatively smooth, lightly rolling contour of the internal surface at the inlet end.

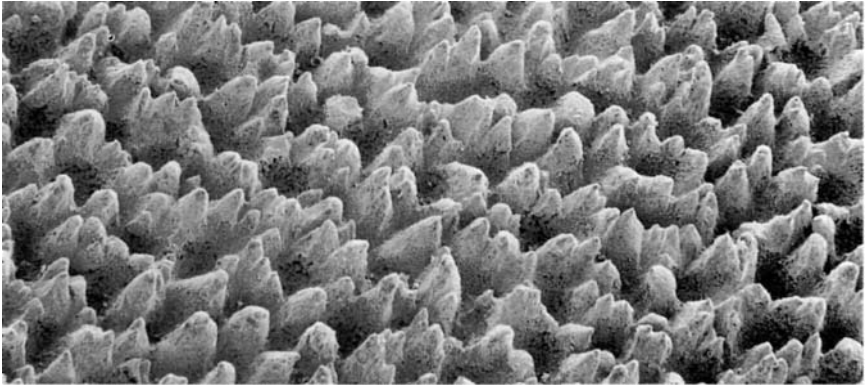
**Figure 11.16** Scanning electron micrograph showing cones of brass created by impingement of high-velocity wet steam. (Magnification: 50 $\times$ .)

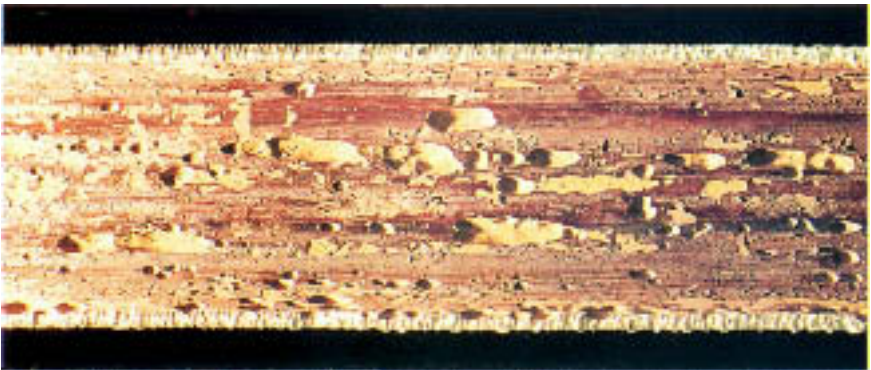
**Figure 11.17** Metal loss from erosion-corrosion in its early stages. Note the elongated depressions aligned with water flow.

Metal loss from the internal surface of the types illustrated in Figs. 11.17 and 11.18 had affected approximately 45 tubes over the previous 4 months. It was noted that metal loss along the bottom half of the tubes was more severe. Significant numbers of failures of this type had not been experienced before, although it was known that entrainment of silt in the cooling water occurred seasonally.

Note the incomplete attack of the surface in Fig. 11.17. This illustrates erosion-corrosion in its early stages. Compare this to the general metal loss illustrated in Fig. 11.18. Note the horseshoe-shaped depressions aligned with water flow. This tube illustrates erosion-corrosion in its mature form.

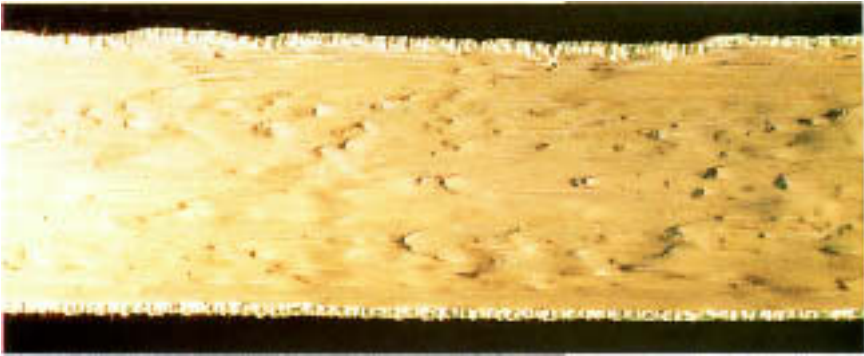
**Figure 11.18** Erosion-corrosion in its mature form. Note the horseshoe-shaped depressions aligned with flow direction.

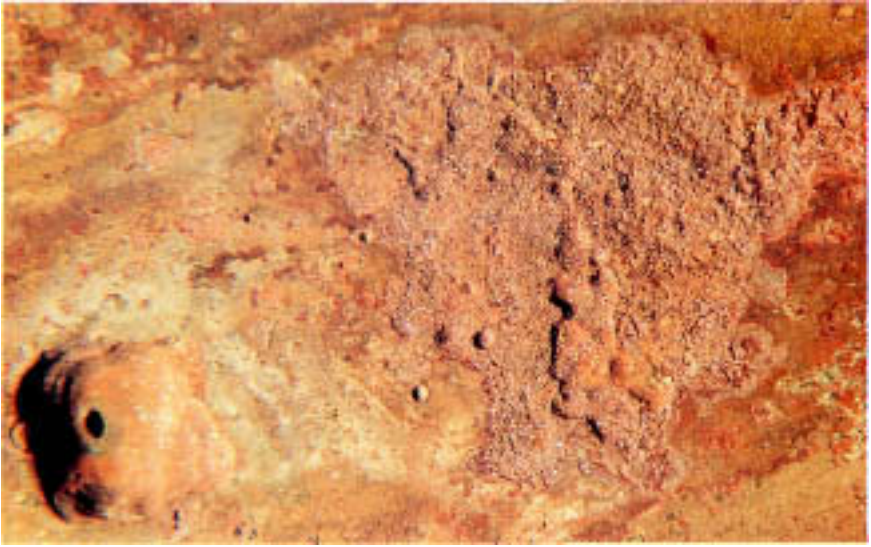
**Figure 11.19** Perforated pit downstream of an arrowhead-shaped area of corrosion. (Magnification: 7.5 $\times$ .)

The first set of tubes received, which had been cleaned before submission for examination, contained randomly distributed, pinhole perforations at the bottom of large pit sites (Fig. 11.19). Associated with these sites was an irregular, arrowhead-shaped region of shallow corrosion. This region was covered with a corrosion product consisting of sparkling cuprous oxide crystals. These regions were immediately upstream of the pit site. Eddy current tests performed earlier in the year indicated that pitting had not occurred at that time.

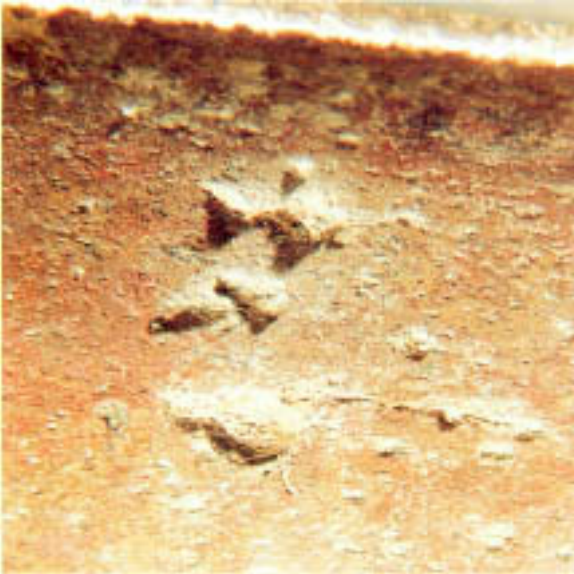
**Figure 11.20** Elongated mounds of fibrous debris attached to the internal surface. (Magnification: 7.5 $\times$ .)

A few months later, a second set of tubes was submitted for examination. These tubes had not been cleaned. Close examination revealed arrowhead-shaped mounds of fibrous debris lodged on the tube wall (Fig. 11.20). Dislodgement of these mounds revealed an arrowhead-shaped region of shallow corrosion containing sparkling crystals of cuprous oxide, essentially identical to that described above.

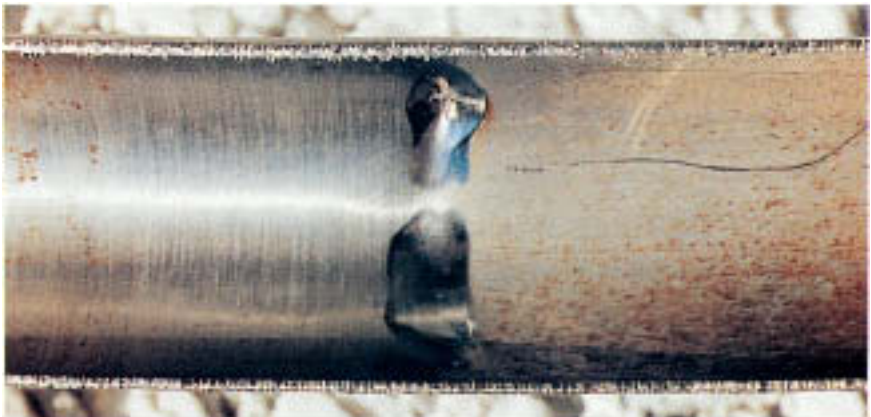
**Figure 11.21** Severe gouging on internal surface.

Severe, highly localized gouging of the internal surface of the type shown in Fig. 11.21 perforated a total of 100 tubes over a 4-year period. Visual inspections disclosed numerous additional gouged but, as yet, unperforated tubes. The gouging was confined to the first 8 in. (20 cm) of the inlet end of the tubes.

Although not illustrated in Figs. 11.21 through 11.23, each erosion site was composed of two or more gouged areas. This is characteristic of erosion due to lodged debris since at least two points of contact with the tube wall are required for a particle to remain in place.

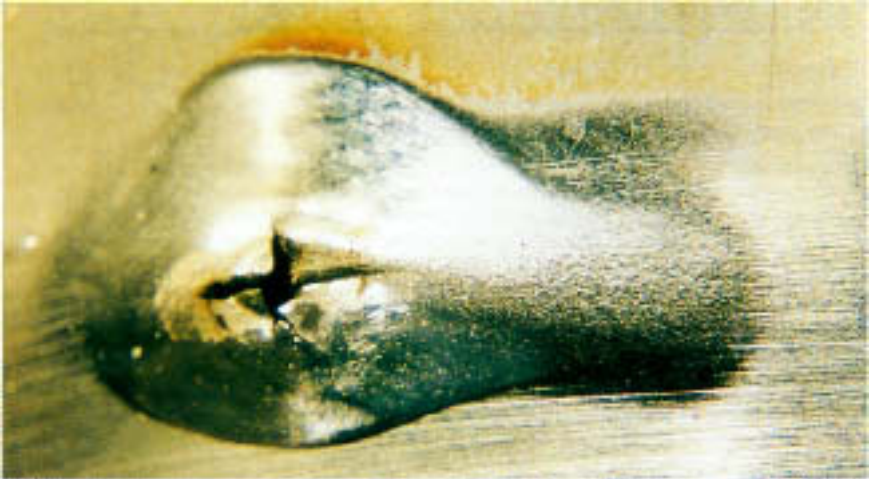
Figure 11.22 Close-up of perforated gouge shown in Fig. 11.21. (Magnification: 7.5×.)

The gouge sites had a bright metallic luster and various shapes (Figs. 11.22 and 11.23). Microstructural examinations of the gouged regions revealed that plastic deformation of the metal had not occurred.

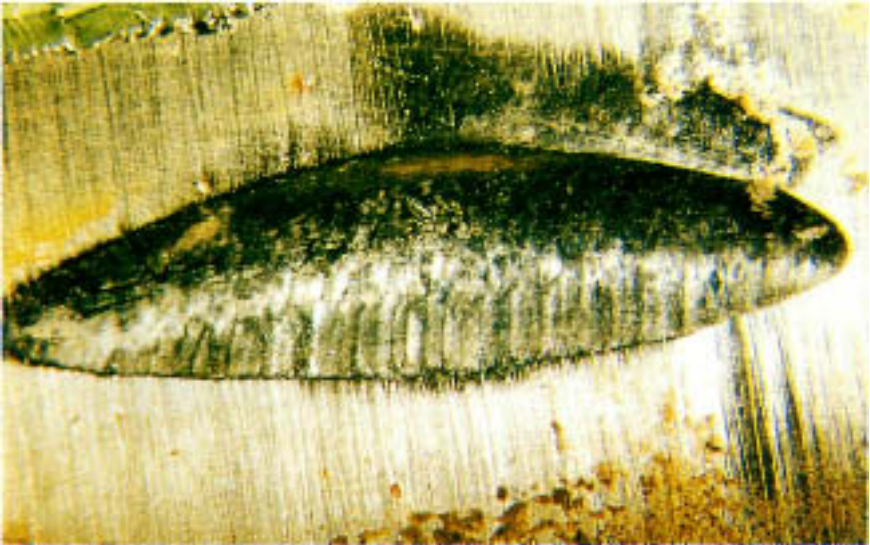
Figure 11.23 Elliptical gouge on internal surface  $\frac{1}{2}$  in. from inlet end. The long axis parallels the longitudinal tube axis. (Magnification: 7.5×.)

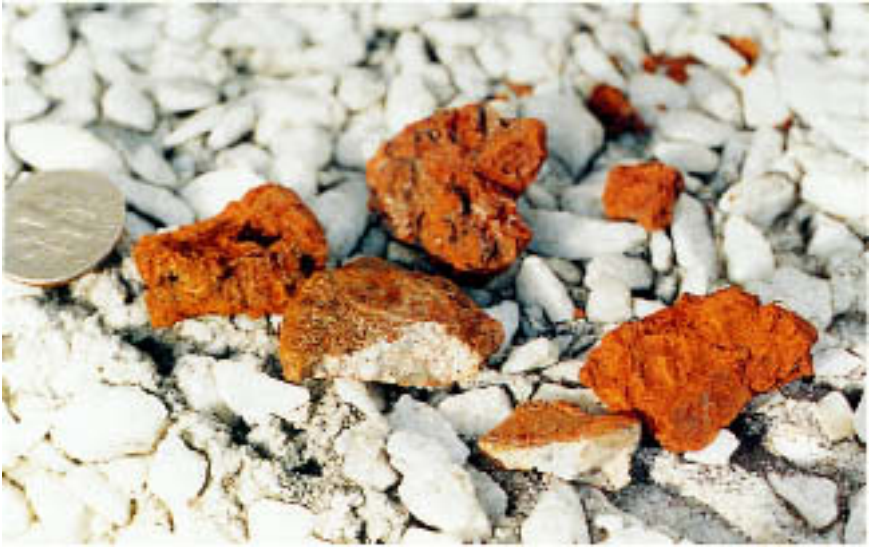
**Figure 11.24** Concrete chips covered with orange iron oxide that were removed from the tube ends.

The rust-colored concrete chips shown in Fig. 11.24 were removed from the tube ends. Inspection of the water box revealed large quantities of debris adhering to the tube sheet. The gouging was caused by the lodgement of this hard debris at the inlet end of the tubes. Intense turbulence by the lodged debris was sufficient to cause highly localized erosion.

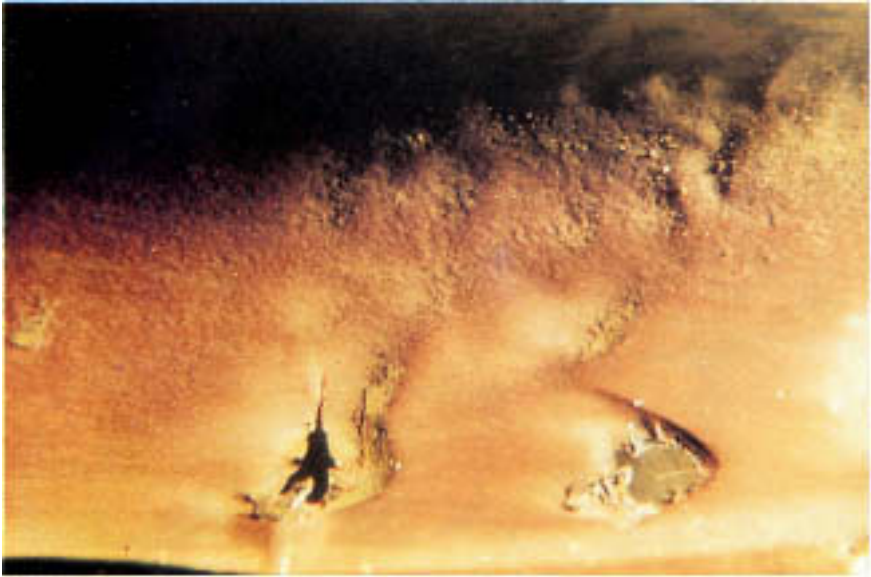
Figure 11.25 Erosion depressions and perforations at inlet ends of a brass tube.

Close examinations revealed that metal loss was confined to  $\frac{1}{2}$  in. (13 mm) of the internal surface at the inlet end (Fig. 11.25). Note the two perforations near the bottom of the photograph. Generally, the metal loss was confined to the region within the tube sheet, but occasionally perforations occurred just beyond the tube sheet, resulting in leakage of cooling water.

Turbulence created at the inlet end resulted in erosion-corrosion. Problems of this type can be remedied by using appropriate inserts or ferrules.

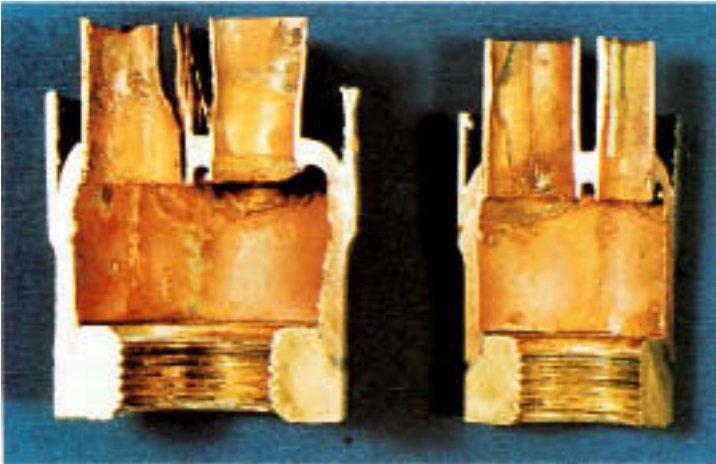
**Figure 11.26** Compressor component after splitting.

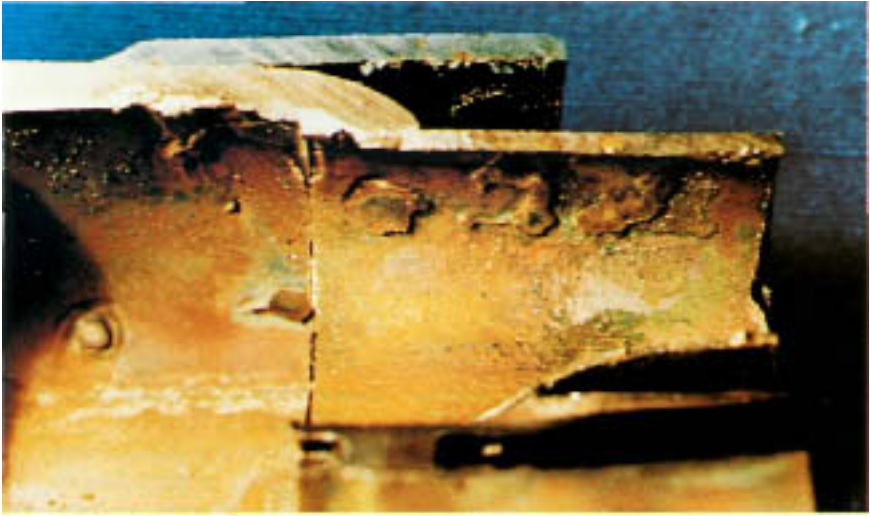
**Figure 11.27** General metal loss surrounding irregular islands of intact metal on the internal surface of the tubes.

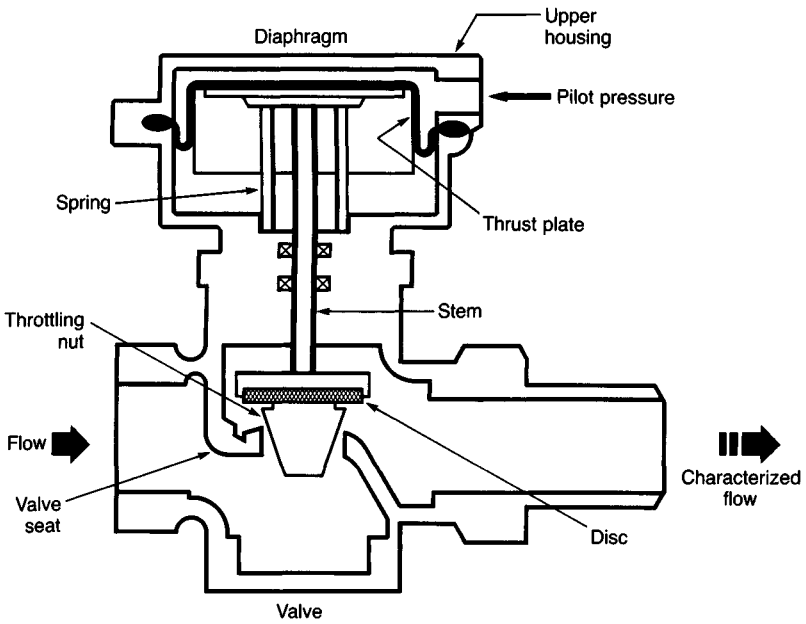
**Figure 11.28** Cross-sectional schematic of chill water control valve. (Reprinted with permission from Landis & Gyr Powers, Inc., Buffalo Grove, Illinois.)

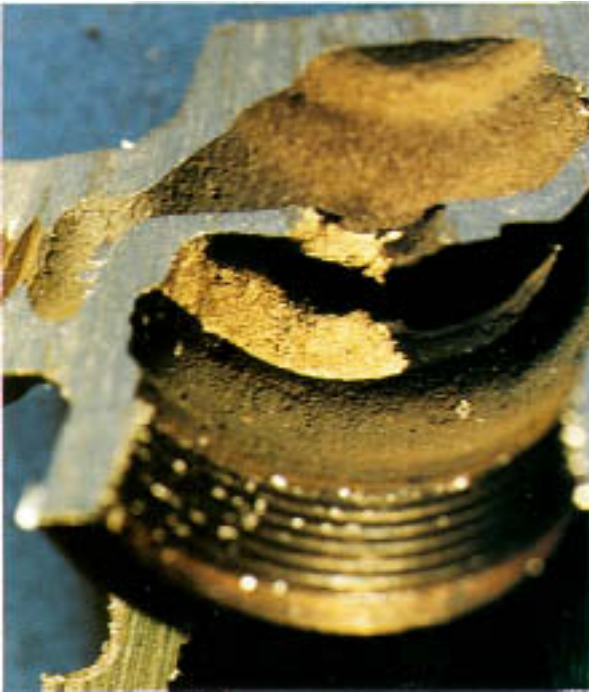
**Figure 11.29** Erosion-corrosion of a valve seat (bright metal in center of photograph).

Erosion-corrosion of these components was caused by high-velocity turbulent flow resulting from incomplete opening of the valve. In this case, erosion is the dominant factor in the metal loss, corrosion being a minor contributing factor.

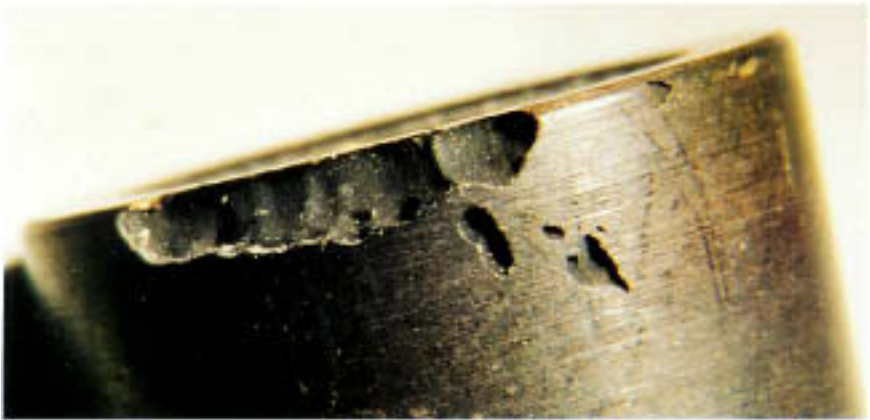
**Figure 11.30** Metal loss by erosion-corrosion at edges of a throttling nut. (Magnification: 7 $\times$ .)

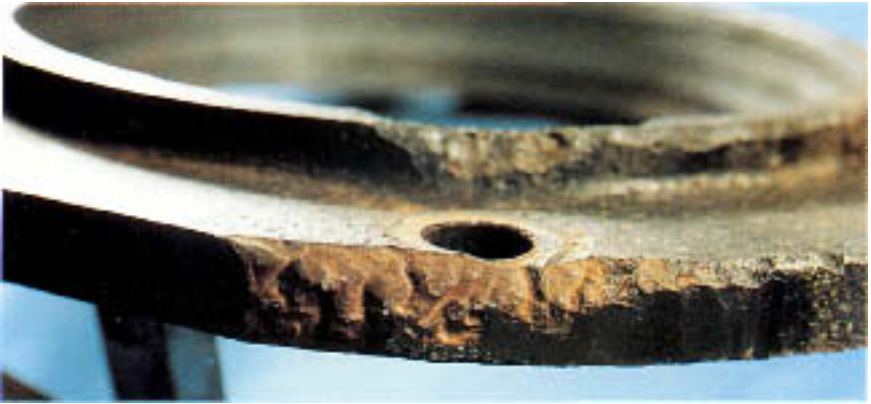
**Figure 11.31** Severe metal loss on the retainer plate at a bolt hole (see Fig. 11.32).

Severe, highly localized metal loss on the roll bearing-retainer plate and associated attachment hardware is illustrated in Figs. 11.31 and 11.32. Figure 11.33 illustrates the arrangement of these components in a continuous caster roll system. Note the smooth surface contours at the edge of the plate. Close examination of these surfaces under a low-power stereoscopic microscope revealed fine, wavelike striations.

Exposed ends of the bolts and nuts have also suffered severe localized deterioration, resulting in smooth surface contours. Adjacent areas of each component show no deterioration. Erosion resulting from the impingement of high-velocity slab-cooling spray is the predominant factor in this metal loss.

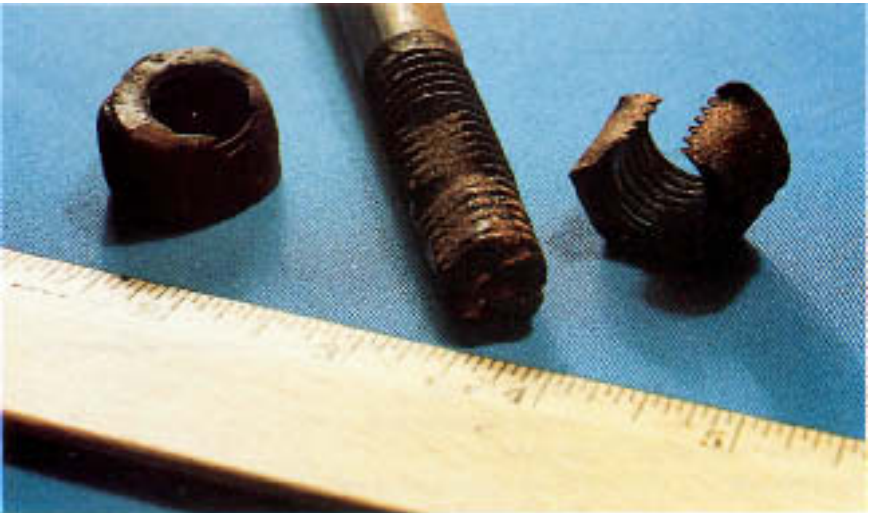
**Figure 11.32** Severe localized metal loss on bolt threads and on nuts.

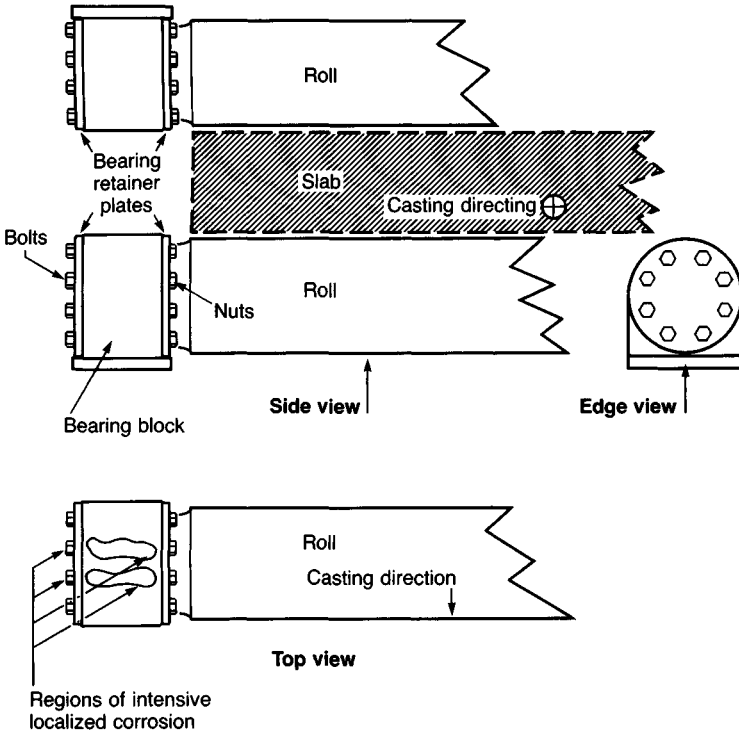
Figure 11.33 Schematic of bearing blocks in a continuous caster.

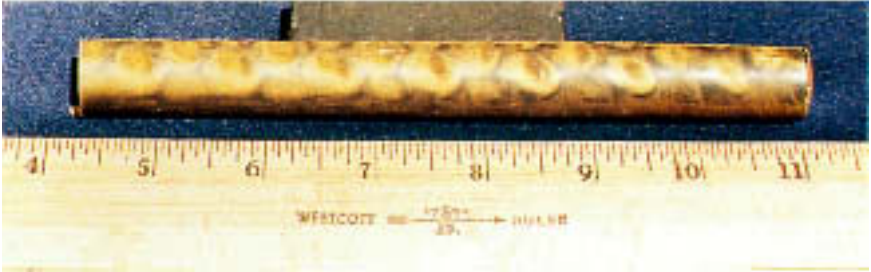
**Figure 11.34** A pattern of erosion spots on the external surface facing the turbine exhaust inlet.

The tube illustrated in Fig. 11.34 was discovered during a routine inspection of the condenser. The tube had been removed from a position directly in line with the turbine exhaust inlet.
