# **The Nalco Guide to Cooling Water System Failure Analysis**

**Nalco Chemical Company**

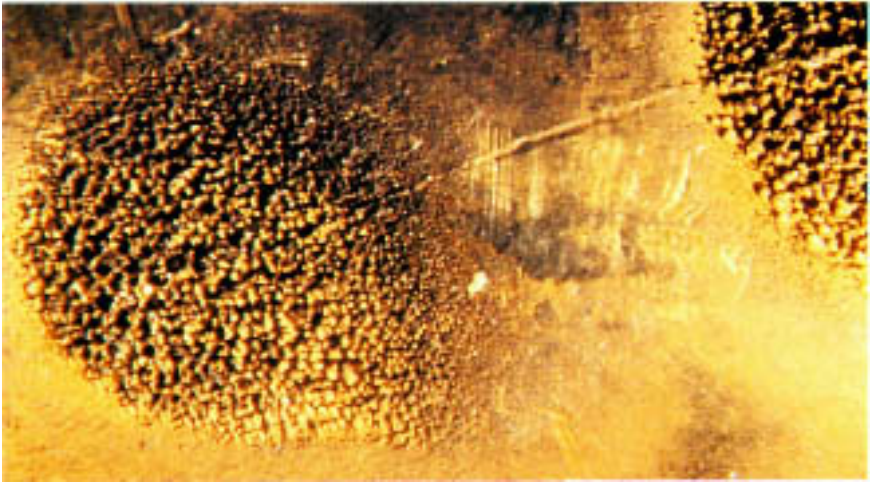
**Figure 11.35** A small forest of erosion cones typical of the appearance of each site. (Magnification: 7.5 $\times$ .)

Close examination of each circular spot revealed a small forest of erosion cones (Fig. 11.35). Erosion was caused by the impingement of high-velocity steam probably mixed with droplets of condensate. The circular, equally spaced erosion sites apparently reproduced corresponding, equally spaced circular openings in the exhaust inlet. Compare Case History 11.3.

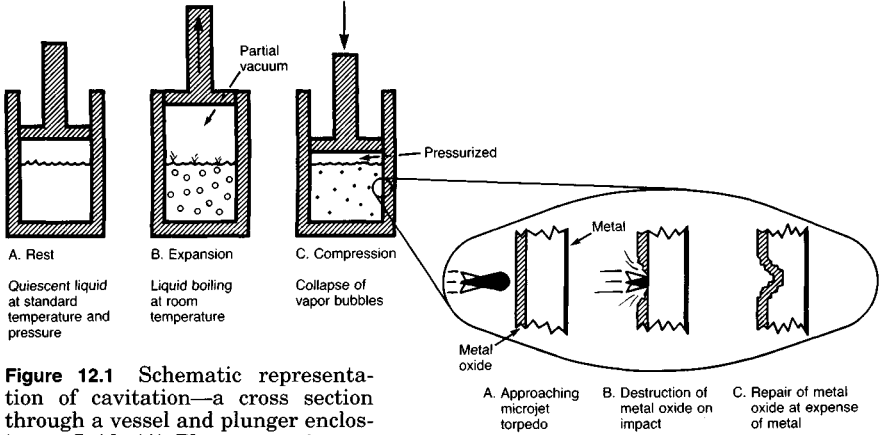
**Figure 12.1** Schematic representation of cavitation—a cross section through a vessel and plunger enclosing a fluid. (A) Plunger stationary, liquid at standard temperature and pressure; (B) plunger withdrawn, liquid boils at room temperature; (C) plunger advanced, bubbles collapse.

Figure 12.1 is a simplified representation of the cavitation process. Figure 12.1A represents a vessel containing a liquid. The vessel is closed by an air-tight plunger. When the plunger is withdrawn (*B*), a partial vacuum is created above the liquid, causing vapor bubbles to form and grow within the liquid. In essence, the liquid boils without a temperature increase. If the plunger is then driven toward the surface of the liquid (*C*), the pressure in the liquid increases and the bubbles

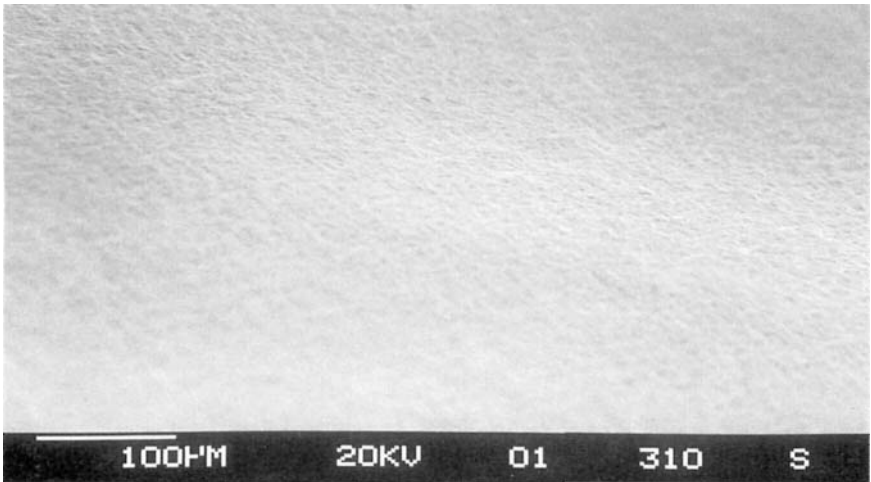
**Figure 12.3A** Progressive deformation in aluminum foil exposed to a cavitating fluid for successively longer periods. (A) No exposure; (B) 5 s; (C) 10 s; (D) 20 s. (350 $\times$  SEM.)

Metal damage due to cavitation can be both rapid (Figs. 12.3A through D) and severe. However, cavitation damage can have a time dependency; see Fig. 12.4. An incubation period may be observed

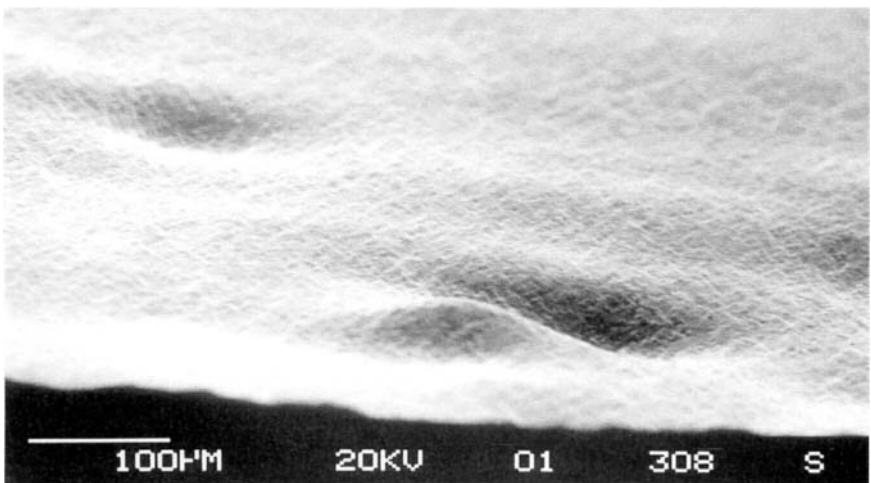
**Figure 12.3B** As in Fig. 12.3A, but exposed for 5 seconds.

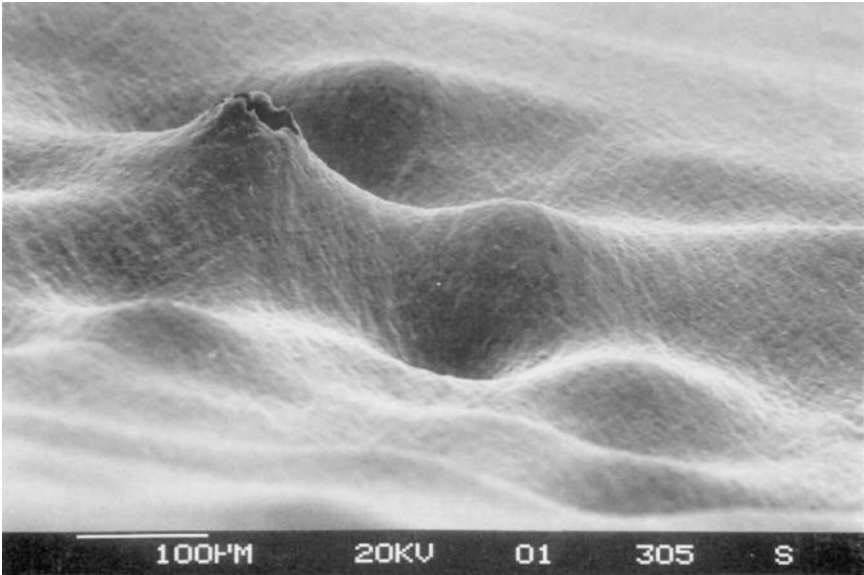
Figure 12.3C As in Fig. 12.3A, but exposed for 10 seconds.

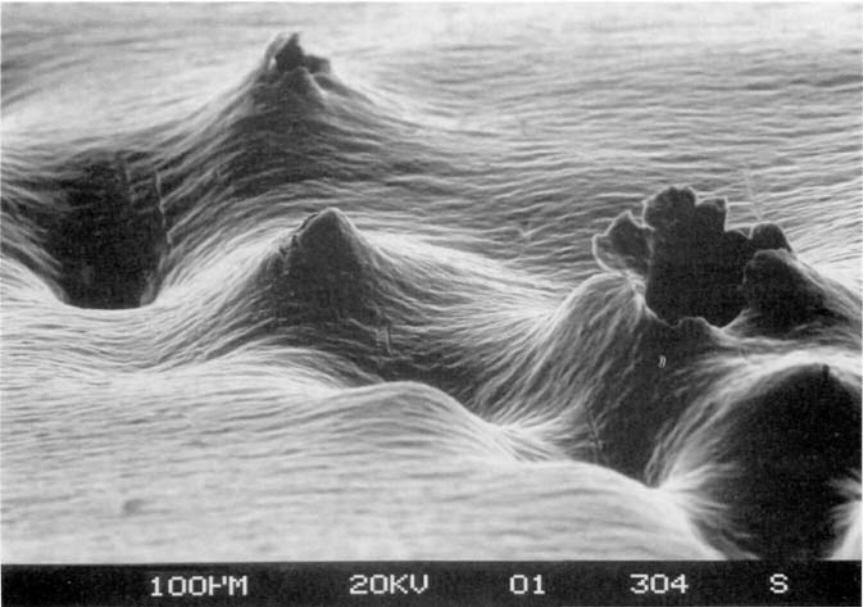
Figure 12.3D As in Fig. 12.3A, but exposed for 20 seconds.

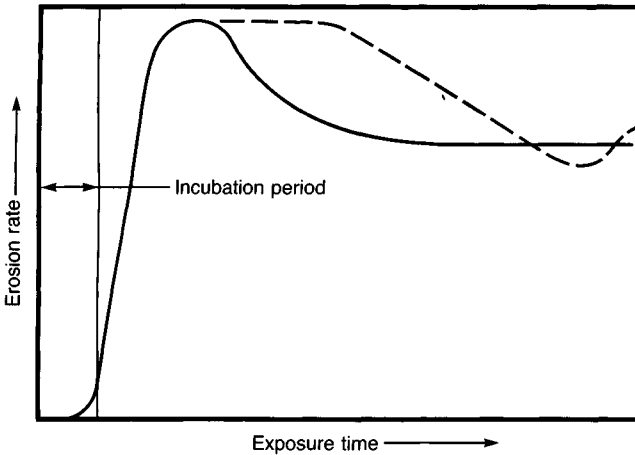
**Figure 12.4** Schematic representation of typical variation of cavitation damage rate with exposure time. (Reprinted with permission of American Society for Metals from *Metals Handbook*, vol. 10, 8th ed., Metals Park, Ohio, 1974, p. 162.)

during which little or no damage is apparent. Following the incubation period, the rate of metal loss may increase sharply. After reaching this maximum value, the rate of damage may then either decline to a lower steady-state value or fluctuate unpredictably.

The actual shape of the curve illustrated in Fig. 12.4 can vary according to factors such as metal properties and cavitation intensity. (Cavitation intensity relates to the number of bubbles created in a unit volume of fluid and the amount of energy transferred during the col-

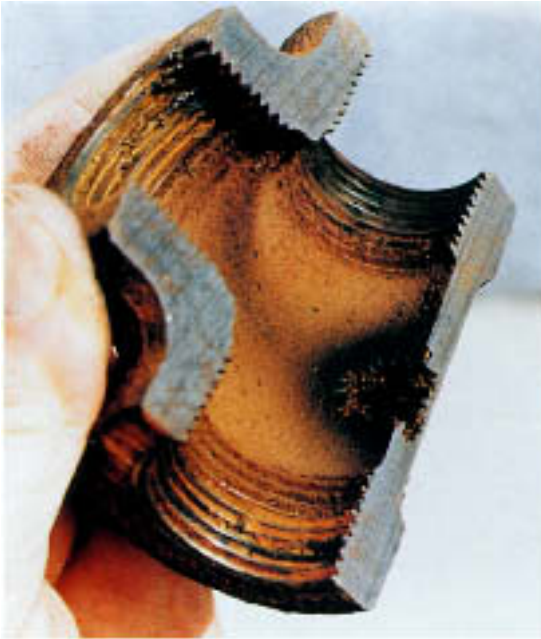
**Figure 12.5** Cavitation damage at bottom of tee at impact site of in-flowing water.

In general, cavitation damage can be anticipated wherever an unstable state of fluid flow exists or where substantial pressure changes are encountered. Susceptible locations include sharp discontinuities on metal surfaces, areas where flow direction is suddenly altered (Fig. 12.5), and regions where the cross-sectional areas of the flow passages are changed.

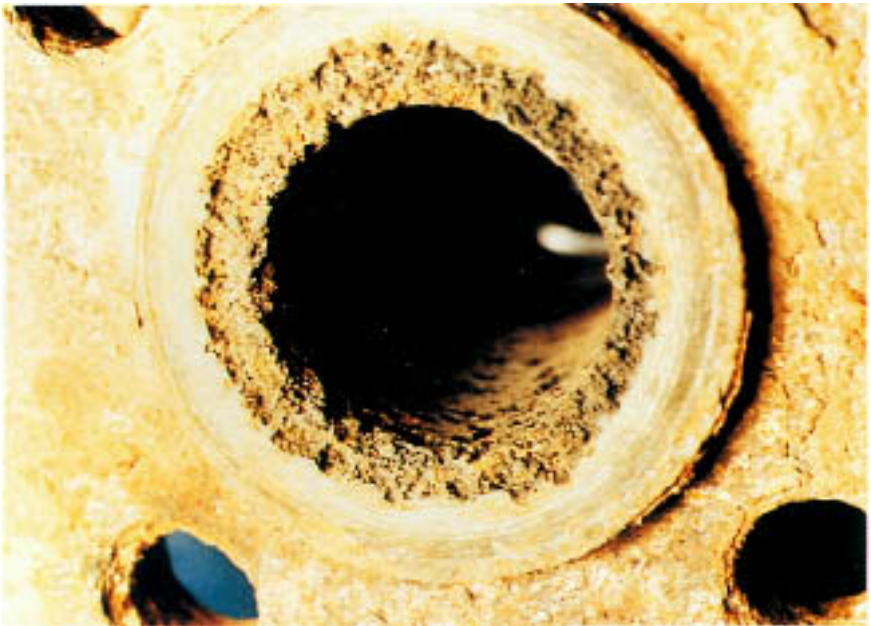
**Figure 12.6** Cavitation damage on the discharge side of a regulating valve.

Damage will be confined to the bubble-collapse region, usually immediately downstream of the low-pressure zone. Components exposed to high velocity or turbulent flow, such as pump impellers and valves, are subject. The suction side of pumps (Case History 12.3) and the discharge side of regulating valves (Fig. 12.6 and Case History 12.4) are frequently affected. Tube ends, tube sheets, and shell outlets in heat exchanger equipment have been affected, as have cylinder liners in diesel engines (Case History 12.1).

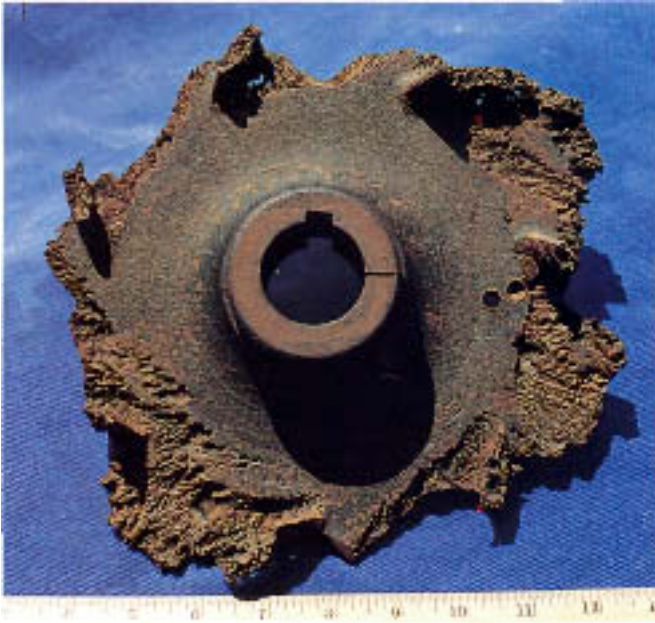
**Figure 12.7** Cast iron pump impeller with severe cavitation damage.

Typically, affected surfaces are highly localized to specific regions, although if cavitation is severe and widespread, the area affected may be extensive (Fig. 12.7). On symmetrical components having repeated elements, the pattern of damage may repeat itself at identical locations on each element (Fig. 12.8).

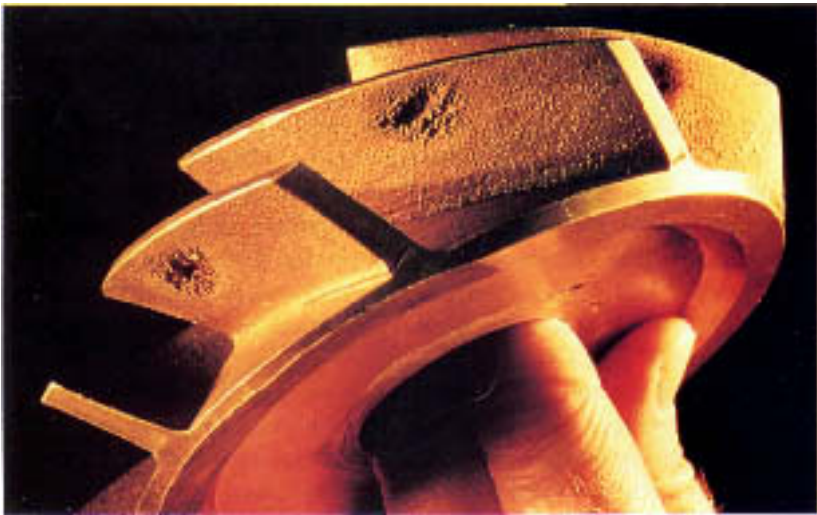
**Figure 12.8** Cavitation damage repeated on successive elements of a bronze impeller.

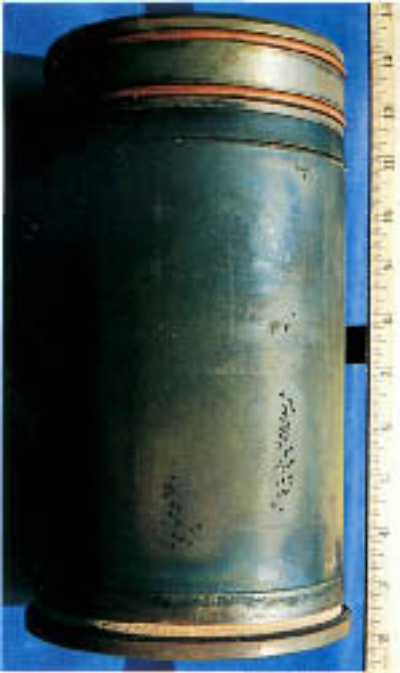
**Figure 12.9** Typical vertical alignment of cavities resulting from cavitation damage in a diesel engine cylinder liner.

Figure 12.9 illustrates the typical appearance of cavitation damage along opposite sides of a diesel engine cylinder liner. The vertical pit alignment, the presence of the pits at opposite sides of the liner, and the comparatively smaller population of pits along one side are typical of cavitation damage of cylinder liners. Note also the jagged, spongelike, highly localized metal loss shown in Fig. 12.10. This is characteristic of cavitation damage in general.

Cavitation occurred on the cooling water side due to vibrations generated during the operation of the engine. (Sources of such vibration include piston slap, loose bearings, and a crank shaft or piston that is out of balance.) Experience has indicated that cavitation intensity in these cases is relatively low. Consequently, cavitation destroys the protective iron oxide covering of the metal. The iron oxide spontaneously reforms over the bare metal but is subsequently removed by impacting microjets from cavitation. Hence, the cavitation damage with respect to the metal is indirect, affecting the iron oxide covering rather than the metal itself.

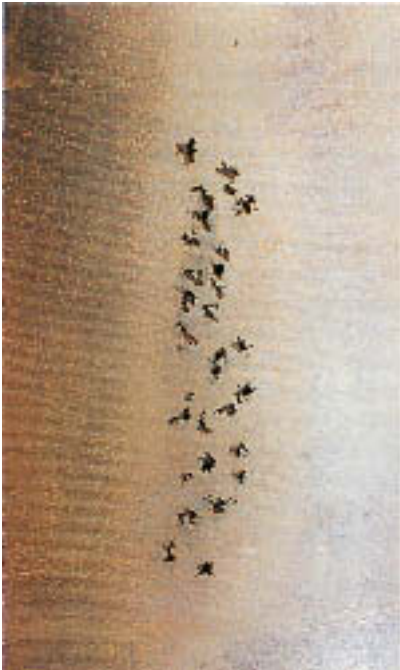
**Figure 12.10** Jagged, cavernous pits typical of cavitation damage.

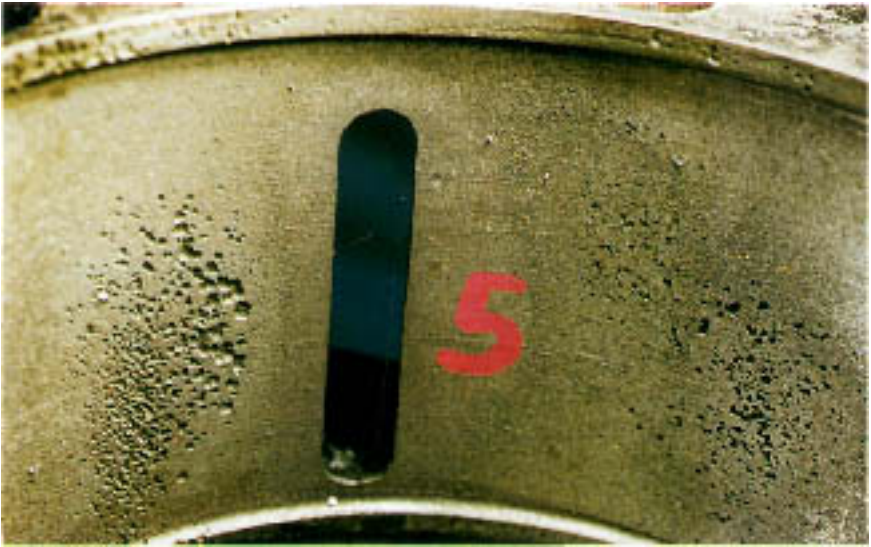
**Figure 12.11** Zones of cavitation damage segregated to both sides of a vertical opening.

Figure 12.11 illustrates the throat of the spacer. Damage is localized to both sides of a  $2\frac{1}{4}$ -in.-long vertical opening.

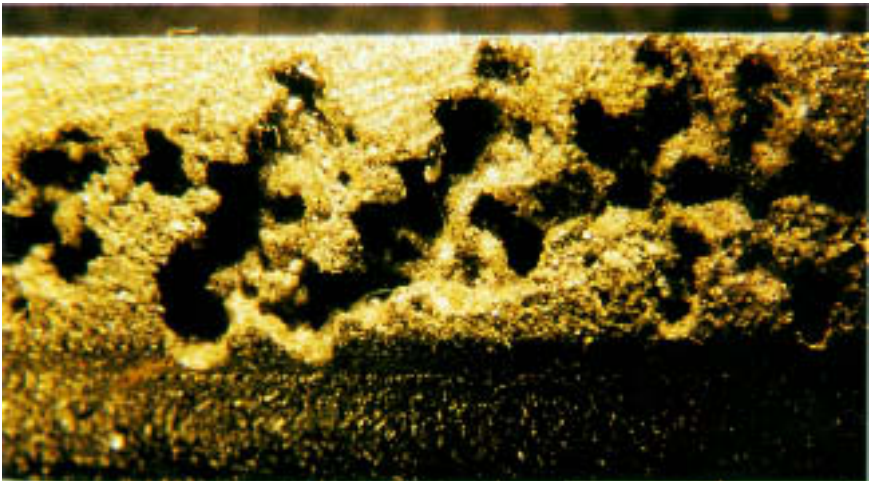
**Figure 12.12** Spongelike surface contour typical of cavitation damage. (Magnification: 8 $\times$ .)

The  $\frac{1}{16}$ -in.-diameter pits are clustered into groups near the center and along the edges of the bore (Fig. 12.12). The interior of the pits is jagged and free of deposits or visually observable corrosion products.

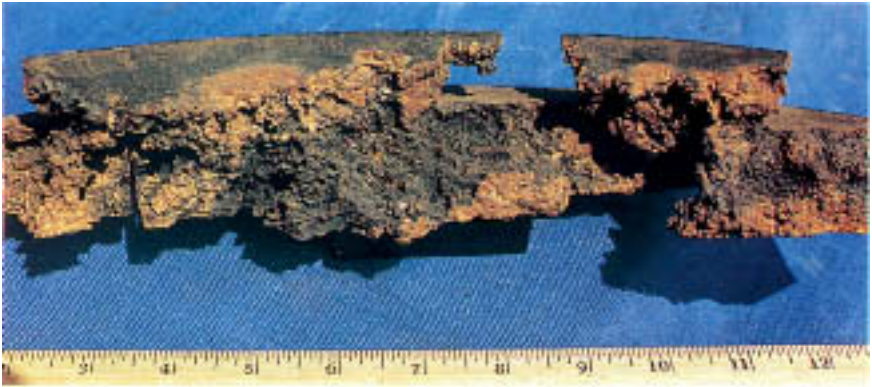
**Figure 12.13** Severe damage to a cast iron pump component.

Figure 12.13 illustrates severe damage suffered by a component of a cooling tower water pump. The jagged, undercut, spongelike metal loss characteristic of cavitation damage is apparent in Fig. 12.14. All damage occurred along the inner curvature of the specimen.

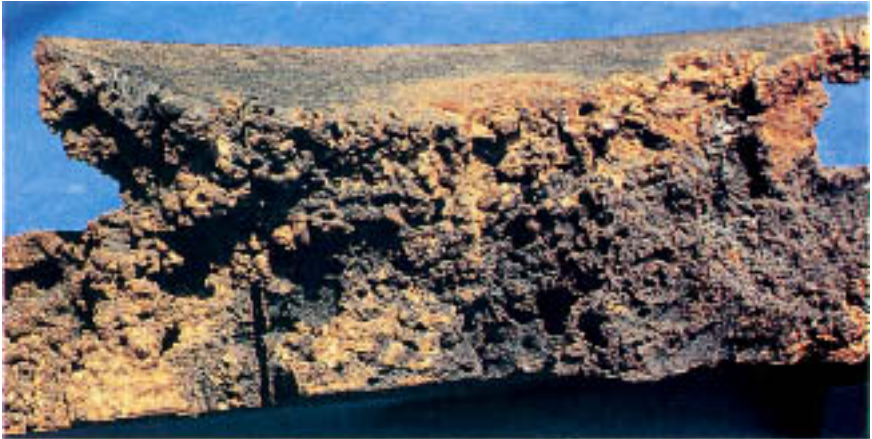
**Figure 12.14** Typical appearance of severe cavitation damage in cast iron.

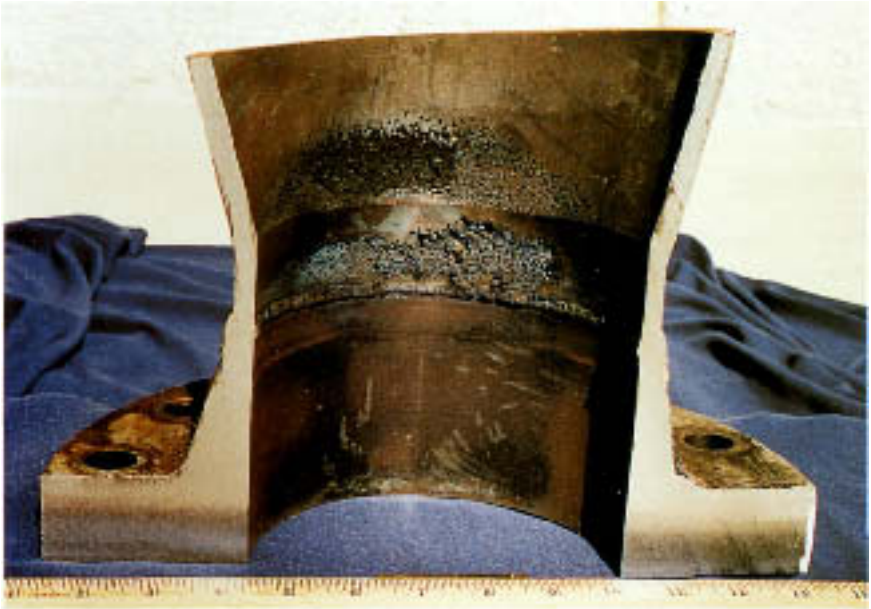
Figure 12.15 Damage to the internal surface of a supply line.

The damage illustrated in Fig. 12.15 occurred in an expansion flange located immediately downstream of a valve. The valve was operated in a partially closed position.

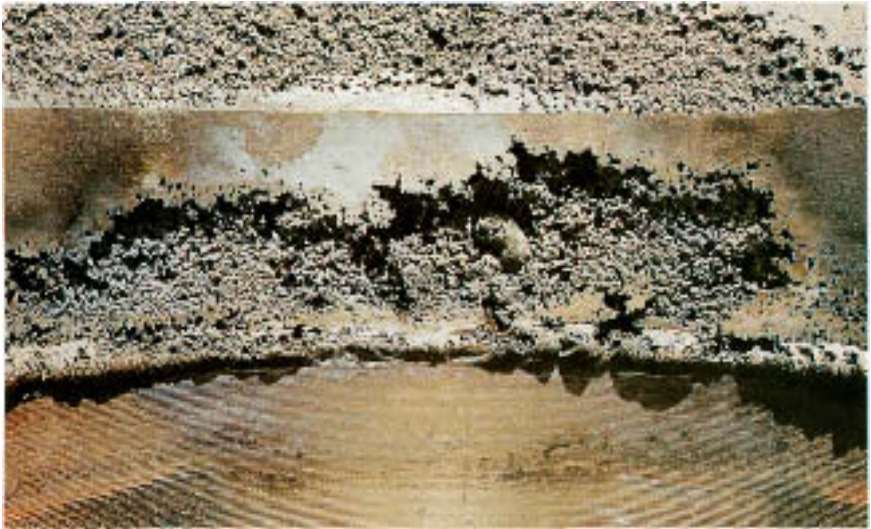
Figure 12.16 Jagged metal loss downstream of protruding weld bead.

Jagged, spongelike metal loss was present downstream of a weld bead (Fig. 12.16), and again in the region of diameter increase (Fig. 12.17). Metal loss was most severe near the weld bead, where weld repairs from the external surface had closed a large perforation.

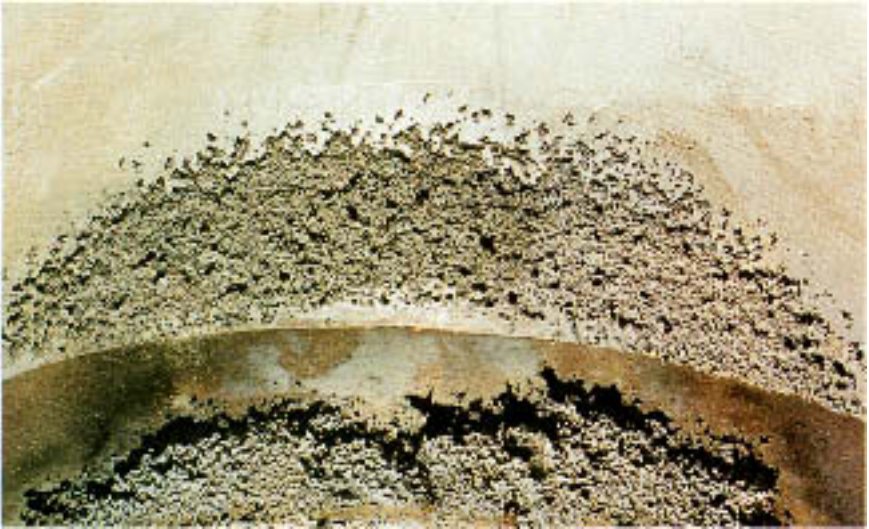
Figure 12.17 Metal loss downstream of flange wall expansion.

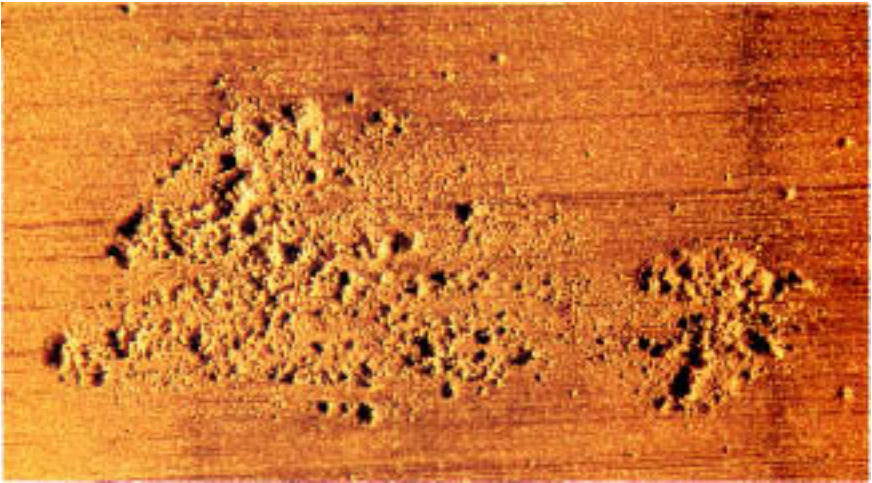
**Figure 12.18** Confined patches of small pits. (Magnification: 15 $\times$ .)

Pinhole perforations were discovered in the walls of chiller condenser tubes of an air-conditioning system. Close laboratory examination of the internal surfaces of affected tubes revealed distinct patches of small pits (Fig. 12.18) and pit sites aligned along longitudinal mandrel marks and fine scratches (Fig. 12.19). In some locations, transversely oriented pit sites that were aligned with the locations of the fins on the external surface branched off the primary longitudinal pit alignment (Fig. 12.20).

This case vividly illustrates the potential effect of surface roughness on the propagation of cavitation bubbles. Figure 12.18 represents a surface

previously roughened by underdeposit corrosion (see Chap. 4, “Underdeposit Corrosion”) that subsequently became a favored site for cavitation because of its roughness. Roughness resulting from mandrel marks and scratches induced the pits of Fig. 12.19. The vertical branching from the primary longitudinal pit alignment in Fig. 12.20 resulted from abrupt contour changes on the internal surface caused by the finning operation performed on the external surface during manufacture of the tubes.

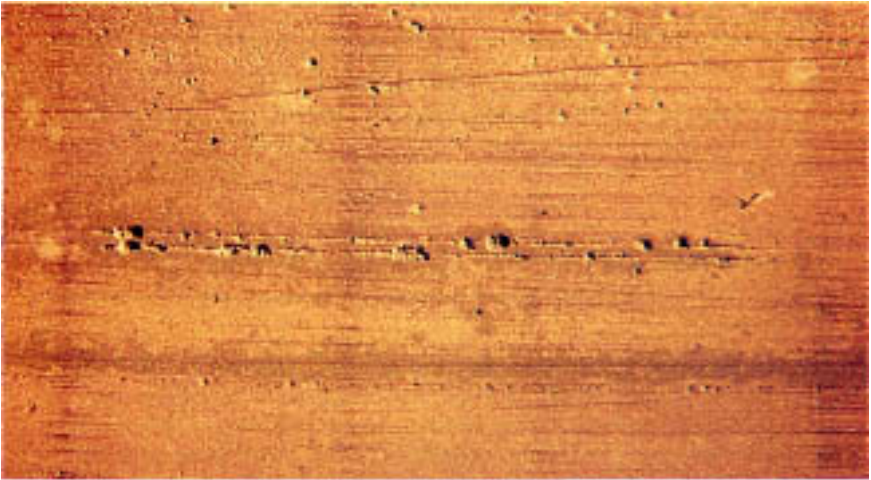
**Figure 12.19** Attack sites aligned along mandrel marks or scratches on the internal surface. (Magnification: 7.5 $\times$ .)

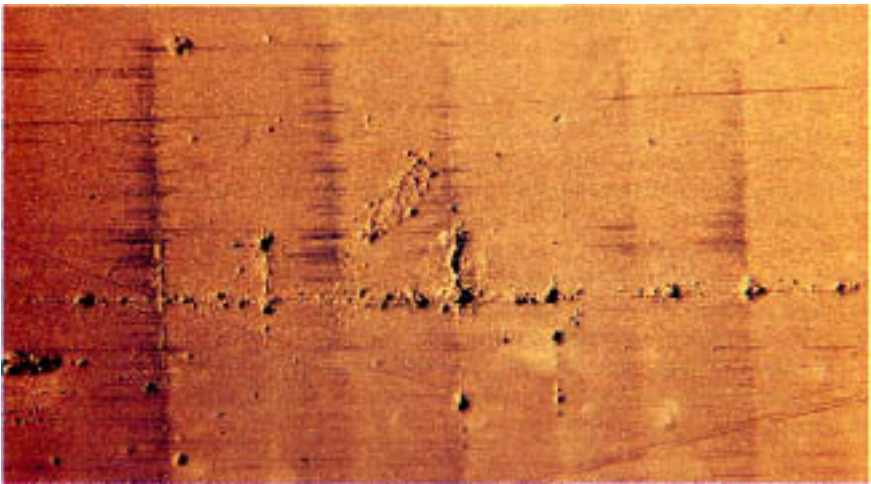
**Figure 12.20** Vertical pit sites aligned with external fins branching from main longitudinal trunk. (Magnification: 7.5 $\times$ .)

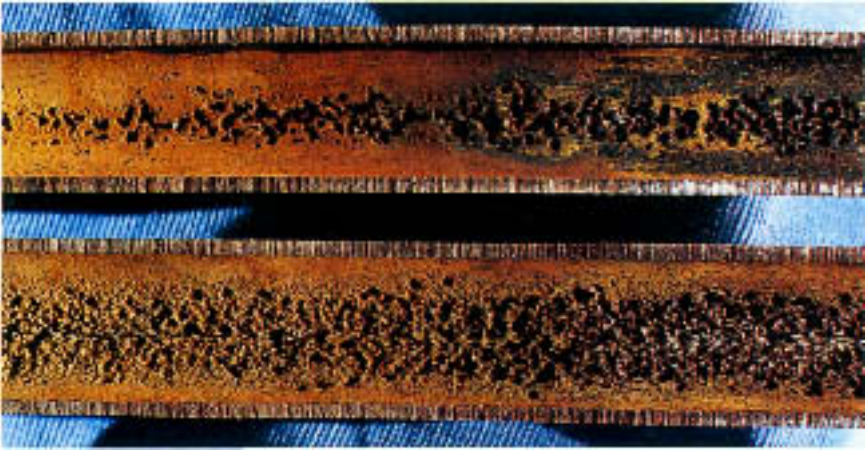
**Figure 12.21** Cavitation damage on the internal surface of the condenser tube. Note longitudinal crack. The surfaces are covered with orange, air-formed iron oxides that formed subsequently to the removal of the condenser tube.

Recent failures of the type illustrated in Fig. 12.21 affected a total of eight tubes in this condenser. Metal loss occurred exclusively on the top and bottom internal surfaces. Affected areas have a rough, jagged contour of deep, overlapping pits that were essentially free of corrosion products. Unaffected areas of the internal surface are smooth and are covered with a layer of black iron oxide.

The longitudinal crack apparent in Fig. 12.21 resulted from stresses from internal pressure that exceeded the tensile strength of the metal in the greatly thinned tube wall.

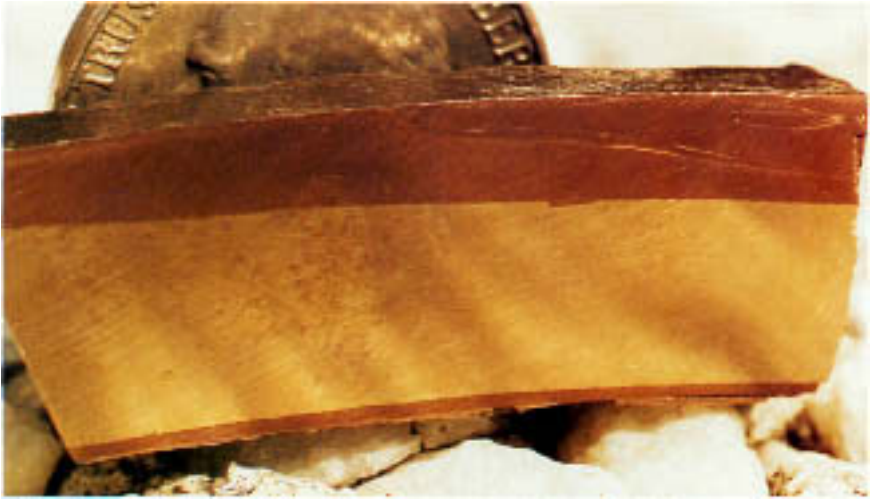
**Figure 13.1** Layer-type dezincification on a brass casting. The red layers are uniformly corroded regions. The original yellow of the brass is visible in between.

The two major forms of dezincification are “layer” and “plug.” The names are taken from characteristic corrosion-product morphologies. In *layer-type dezincification*, the entire component surface is converted to corrosion product to a roughly uniform depth (Figs. 13.1 through 13.3). *Plug-type dezincification* produces small pockets or plugs of almost pure copper (Figs. 13.4 and 13.5). Surfaces may have to be cleaned of deposits

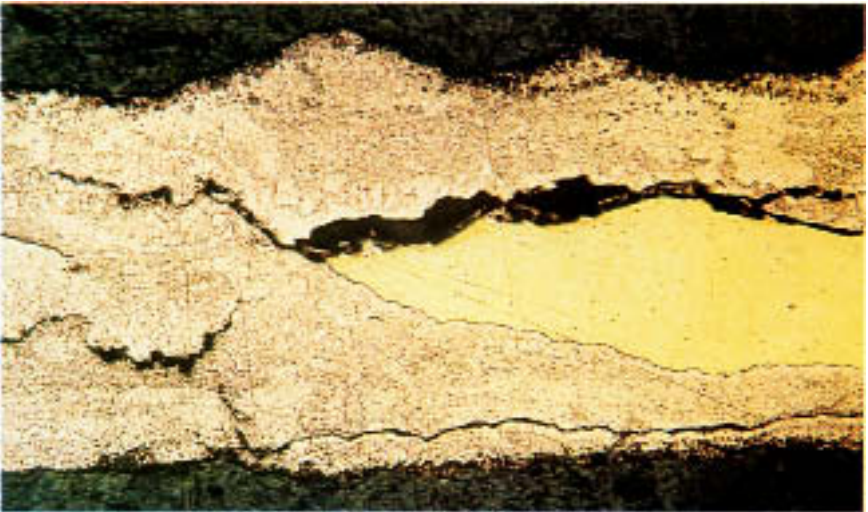
**Figure 13.2** Layer-type dezincification of a thin brass plate. The 0.019-in. (0.048-cm) plate is shown in cross section. The dezincified layers converge toward the plate edge. Note the porosity of the dezincified metal.

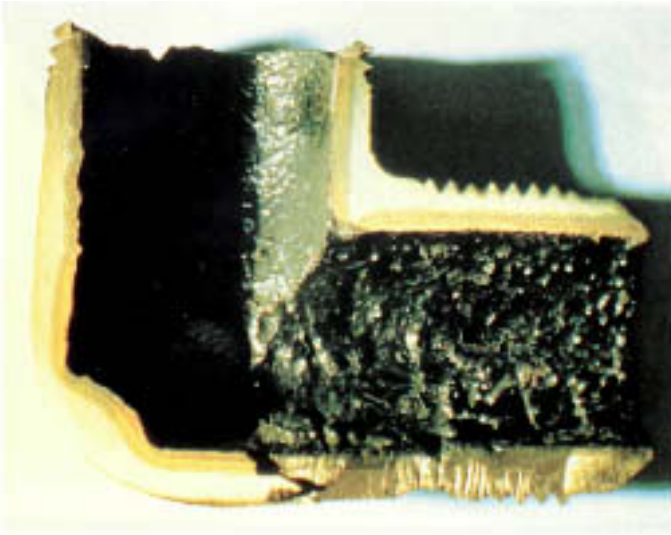
**Figure 13.3** Layer-type dezincification on the internal surface of a cast brass pipe 90° elbow.

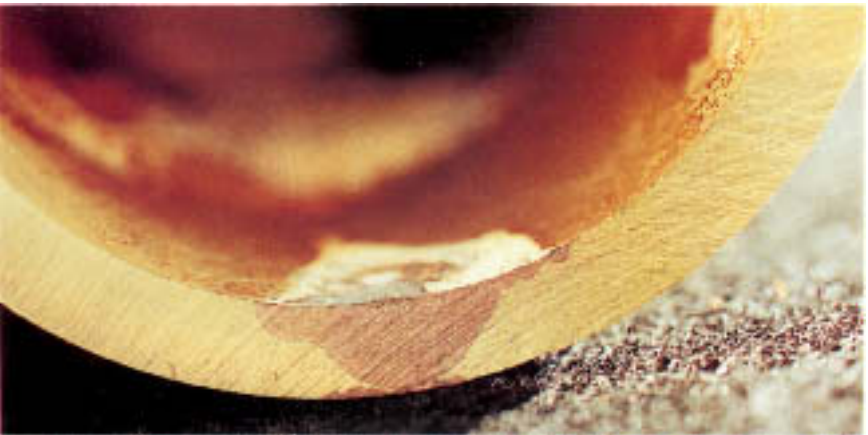
**Figure 13.4** A large plug of dezincified metal beneath a deposit. Plugs often form on the bottom of horizontal pipes, beneath deposits.

Plug-type dezincification is common on horizontal pipe sections. Attack is usually confined to areas beneath deposits lying along tube bottoms (Figs. 13.4 and 13.7). Plugs are sometimes blown out of tube walls due to internal pressure; holes are produced. More often, fluids weep through the porous plugs, leaving stains or mounds of dissolved

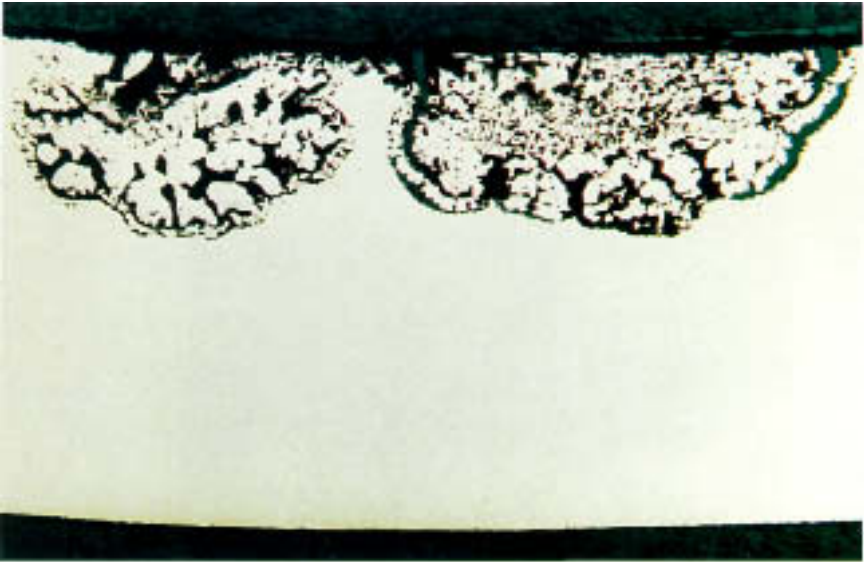
**Figure 13.5** Plug-type dezincification on the internal surface of a brass condenser tube. Note the extreme porosity of the copper plugs. Tube wall thickness was 0.040 in. (0.10 cm). Compare to Fig. 13.13. (Courtesy of National Association of Corrosion Engineers, *Corrosion '89 Paper No. 197* by H. M. Herro.)

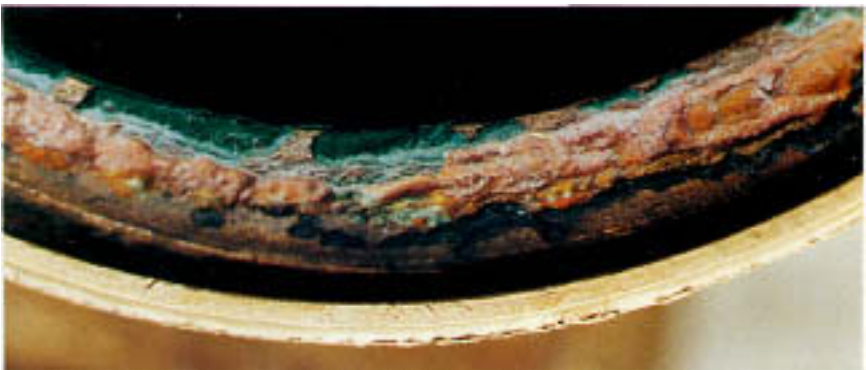
**Figure 13.6A** Red, dezincified gasketed surface of a cast valve throat. Note the partial spalling of the copper corrosion product.

mental copper (Figs. 13.6A and B). The corroded metal has little mechanical strength, and if stressed it fractures easily.

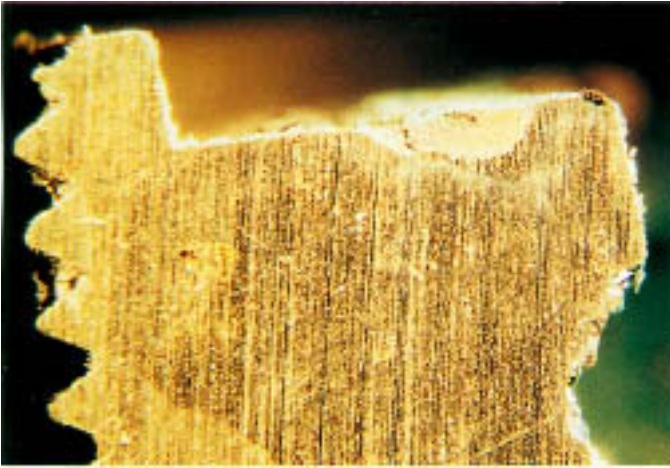
**Figure 13.6B** Cross section through the valve throat in Fig. 13.6A. Note how the dezincification is confined to the gasket region.

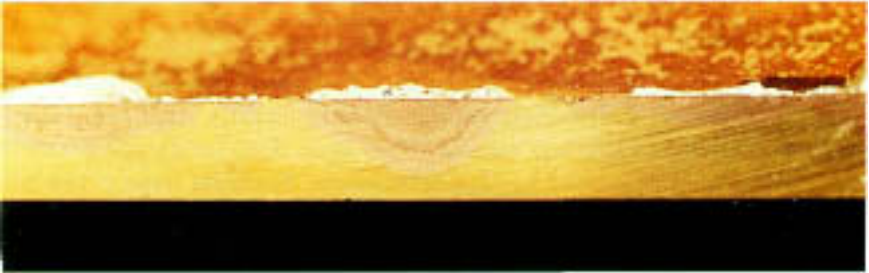
**Figure 13.7** Brass tube wall in longitudinal cross section. Plugs of dezincified metal are present on the bottom of the horizontally oriented tube, beneath deposits. Stratification within the copper plugs is evident.

solids concentrated by evaporation on external surfaces (Fig. 13.8). Unless internal pressures are high, such plugs may remain in place for long periods with no significant water loss. Close visual inspection of both plug- and layer-type corrosion products reveals stratification of corroded metal (Figs. 13.7 and 13.9). These layers probably represent changes in temperature, water chemistry, and/or corrosion processes.

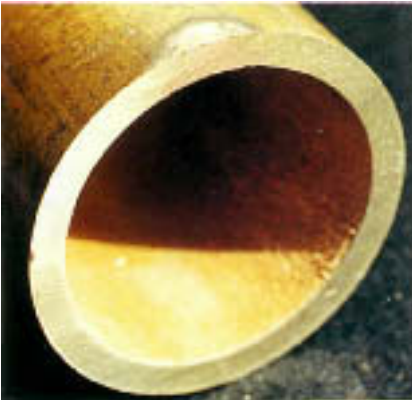
**Figure 13.8** A brass tube showing plug-type dezincification. The white patch above the plug on the external surface was caused by dissolved solids, concentrated by evaporation of water leaking through the porous dezincified plug.

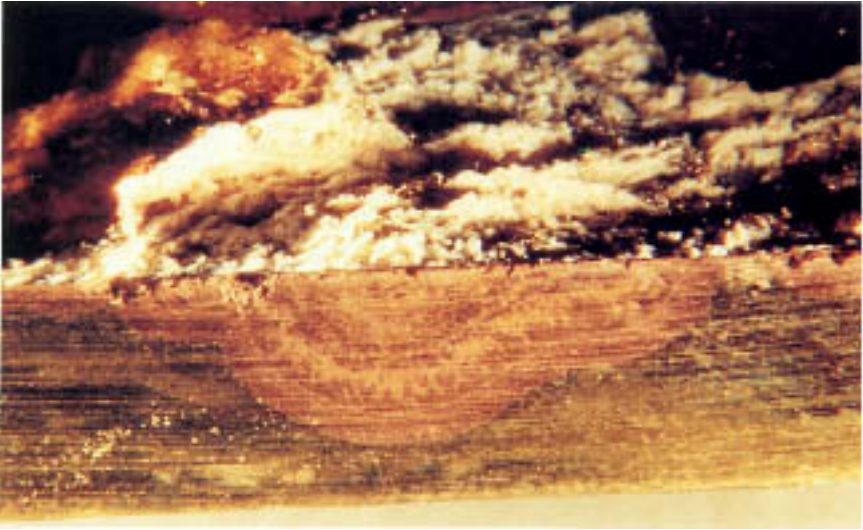
**Figure 13.9** Stratified copper corrosion product in plug-type dezincification.

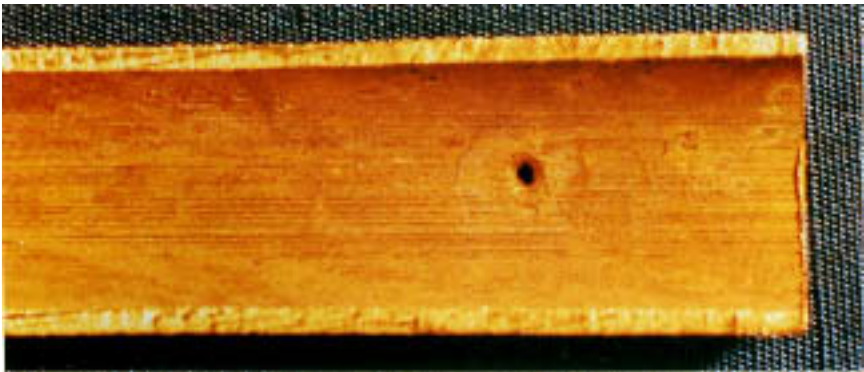
**Figure 13.10A** A hole emanating from the internal surface of a brass condenser tube. The hole was caused by plug-type dezincification (see Fig. 13.11).

A brass condenser tube contained a 1/16-in. (0.16-cm) diameter hole on the apparent bottom side (Fig. 13.10A). Many other shallow depressions pockmarked internal surfaces. Most depressions were filled with red, copper-colored corrosion products.

The depressions and plugs of corroded metal were caused by dezincification. The hole shown in Fig. 13.10A was caused when one such plug blew out of the wall due to the pressure difference between internal and external surfaces.

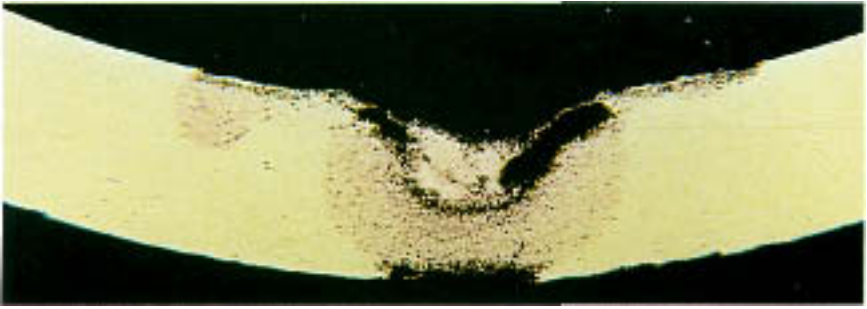
**Figure 13.10B** A transverse cross section through the tube wall in Fig. 13.10A. Note the through-wall plug-type dezincification.

The tube was transversely sectioned, polished, and viewed with various microscopes. Large porous corrosion-product plugs extended entirely through the 0.050-in. (0.13-cm)-thick wall (Fig. 13.10B). The depressions contained 94% copper, 5% zinc, and 1% tin.

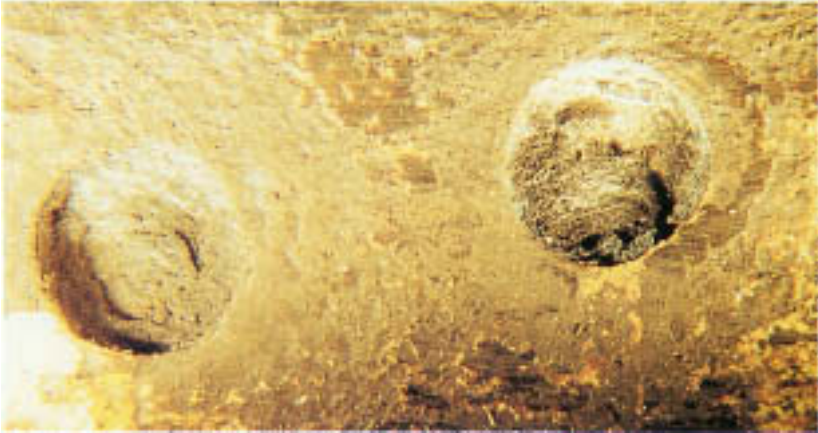
**Figure 13.11A** Deep, hemispherical “depressions” on the external surface of an overhead condenser due to severe dezincification from internal surfaces (see Fig. 13.11B).

Severe wastage was evident on both external and internal surfaces of the tube section. There were two round holes on one side. Deep pockets of internal surface corrosion penetrated to the external surface (Fig. 13.11A). The depressions contained sulfides, mainly concentrated near external surfaces. Below were large amounts of porous elemental copper (Fig. 13.11B).

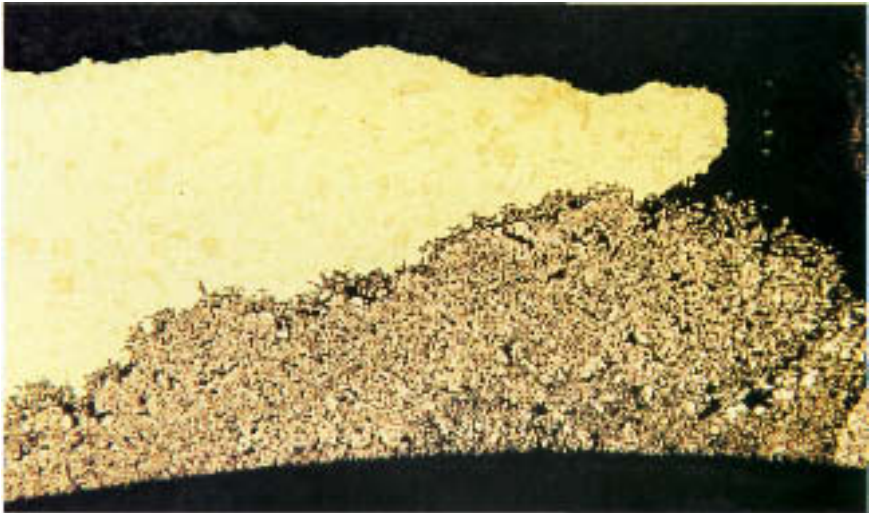
**Figure 13.11B** Porous copper corrosion products filling an internal surface depression. The edge of one crater seen in Fig. 13.11A is to the right.

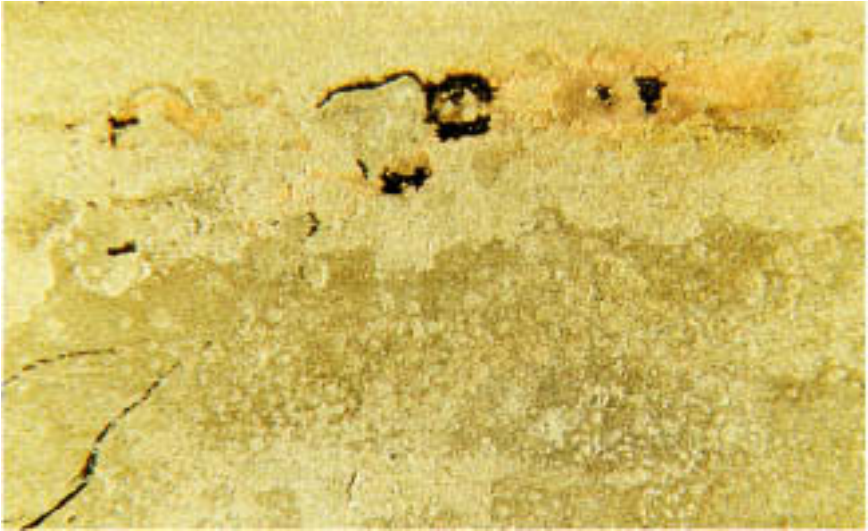
**Figure 13.12** Close-up of a 90:10 cupronickel condenser's internal surface after acid cleaning. Elemental copper stains mark regions of shallow denickelification.

Removal of deposits and corrosion products from internal surfaces revealed irregular metal loss. Additionally, surfaces in wasted areas showed patches of elemental copper (later confirmed by energy-dispersive spectroscopy) (Fig. 13.12). These denickelified areas were confined to regions showing metal loss. Microscopic analysis confirmed that dealloying, not just redeposition of copper onto the cupronickel from the acid bath used during deposit removal, had occurred.

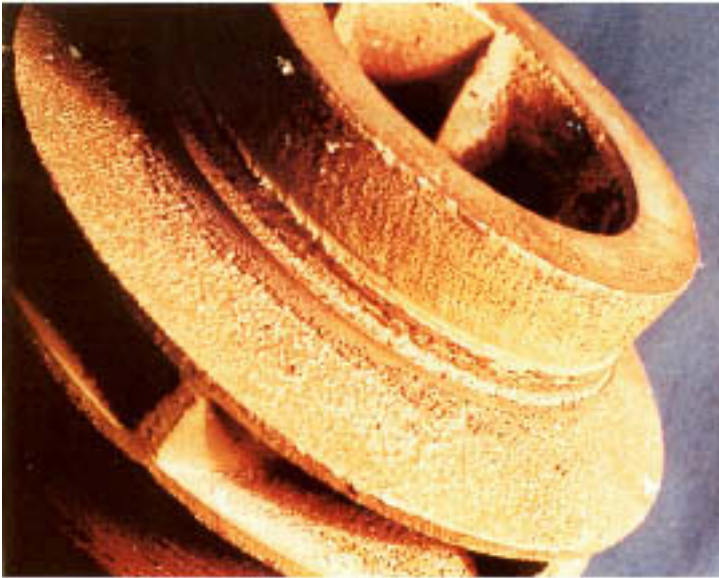
**Figure 13.14** A generally dezincified bronze pump impeller. Surfaces are dealloyed to a depth of about 0.020 in. (0.050 cm).

A pump impeller and a shaft bushing from a small cooling water pump assembly were generally corroded. Reddish surface discoloration revealed layer-type dezincification (Figs. 13.14 and 13.15).

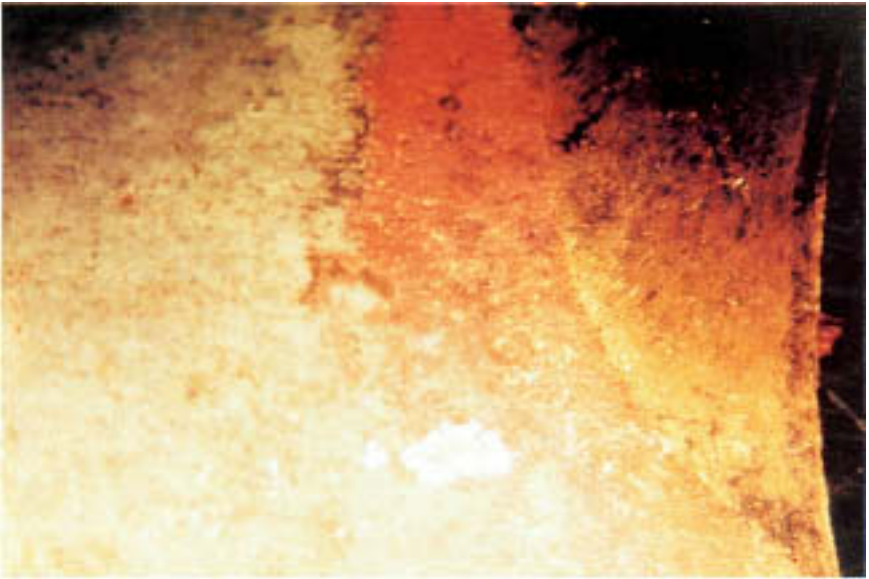
**Figure 13.15** The tricolor internal surface of a leaded-brass bushing. Greenish-blue corrosion product overlies the red of the generally dezincified surface. To the extreme right, only bare metal is visible due to erosion.

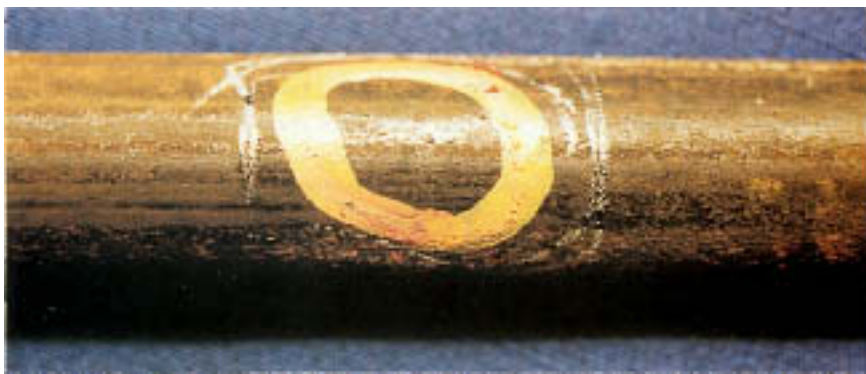
**Figure 14.1** Pinhole perforation in a steel heat exchanger tube, viewed from the external surface.

Figure 14.1 illustrates one of many similar pinhole perforations found in this and other tubes within the exchanger. Figure 14.2 shows the typical appearance of the internal surface immediately after removing the tube from the exchanger. Laboratory acid cleaning of the internal surface revealed a defective weld seam (Fig. 14.3).

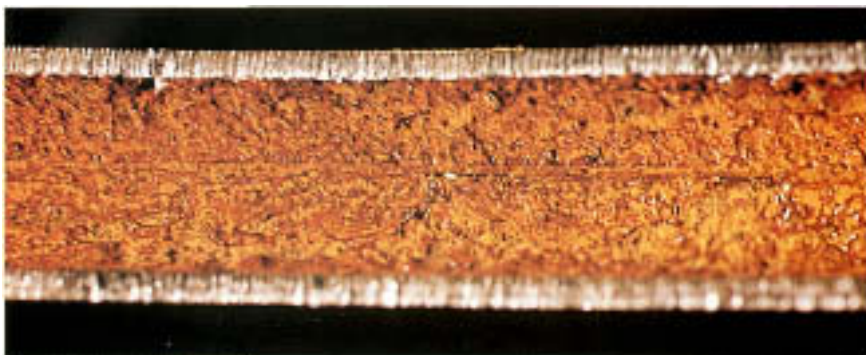
**Figure 14.2** Typical appearance of the internal surface. Note the small pit centered on the longitudinal seam.

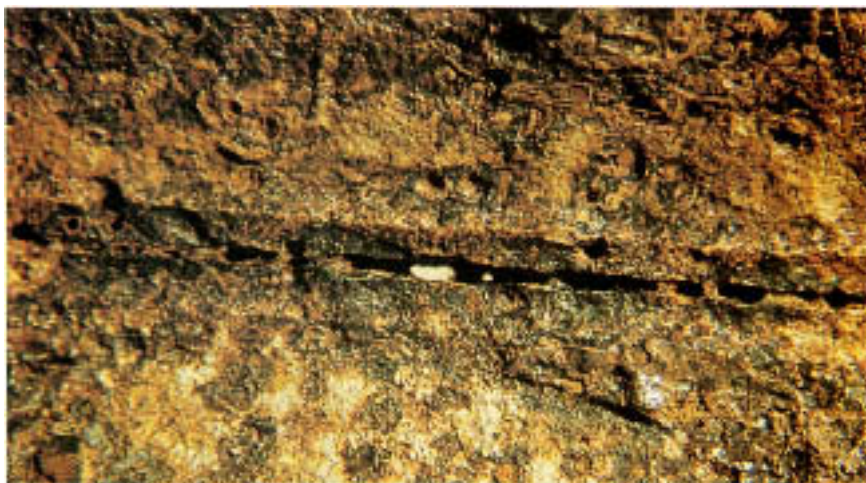
**Figure 14.3** Close-up of the internal surface following acid cleaning. Note the perforation in the tube wall along the weld seam.

Microstructural examinations revealed V-shaped openings along the tube seam, some extending into as much as 50% of the tube wall thickness. The incompletely closed seam provided a crevice in which differential concentration cells developed (see Chap. 2, “Crevice Corrosion”). The resulting localized corrosion caused the observed pits.

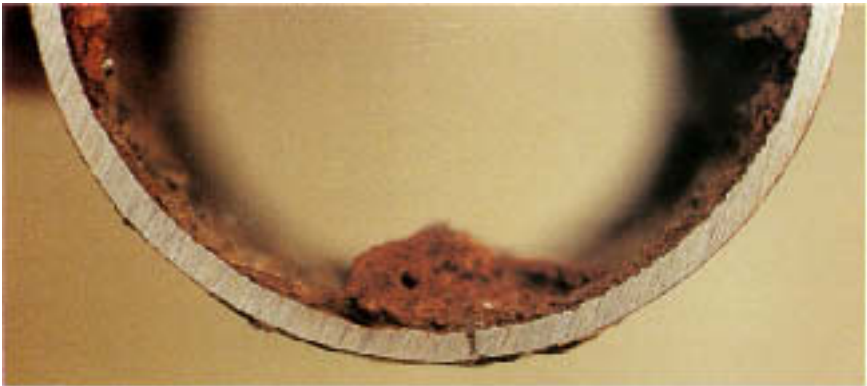
**Figure 14.4** Tubercle capping a pit located in a weld-seam defect.

The tubercle apparent on the internal surface in Fig. 14.4 is located directly above a deep, longitudinal groove that runs the length of the internal surface. The tubercle caps a perforation in the tube wall. The tubercle is soft and easily dislodged. Other, smaller tubercles are aligned along the seam.
