# **The Nalco Guide to Cooling Water System Failure Analysis**

**Nalco Chemical Company**

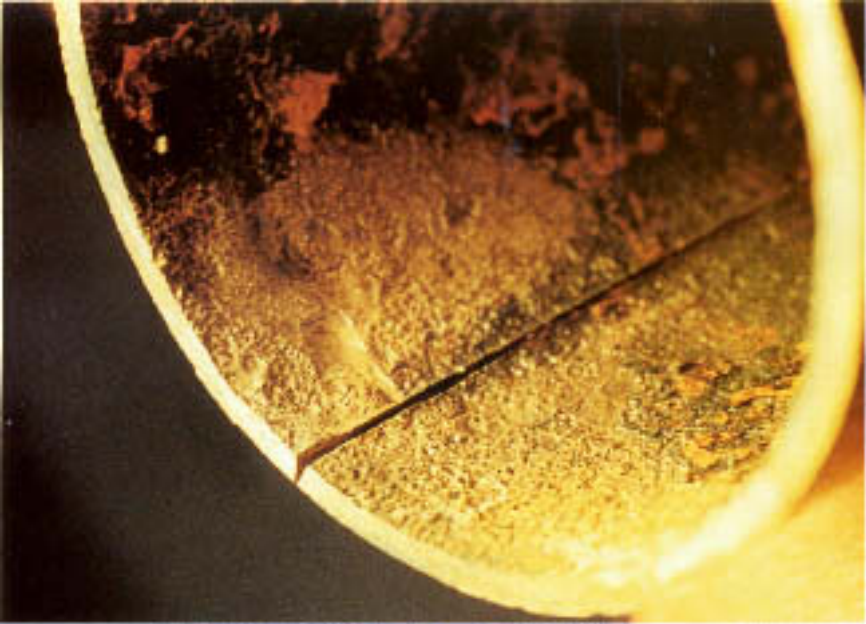
Figure 14.5 Severe seam defect apparent after acid cleaning of the internal surface.

Chemical removal of deposits and corrosion products revealed the appearance of the groove (Fig. 14.5). The crevice formed by the incompletely fused weld seam fostered the establishment of differential concentration cells (see Chap. 2). This resulted in localized corrosion and eventual perforation through the greatly thinned tube wall at the bottom of the crevice. The tubercle, which is composed of corrosion products, is a simple result of the corrosion process occurring locally within the crevice.

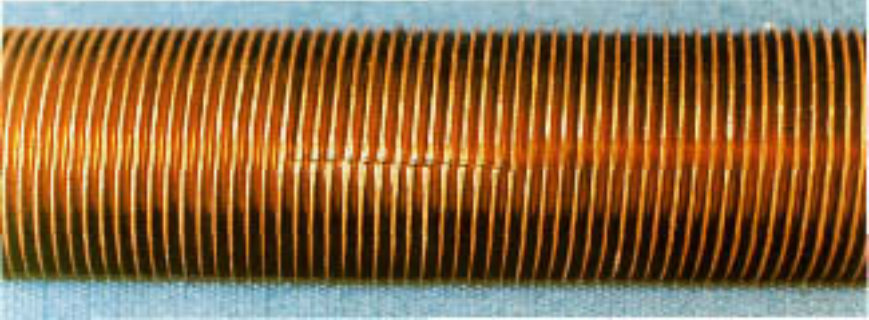
**Figure 14.6** Material defect, perhaps a lap or seam, on the external surface of a finned copper tube.

Figure 14.6 shows the straight, unbranched, longitudinal cracks typical of tubes removed from the unit. The cracked tubes had been located by eddy-current inspection.

Close examination revealed that the cracks originate on the external surface. Exposure of the fracture surface revealed a rough contour covered with dark copper oxide. Close examination of the internal surface revealed fewer, tighter fissures corresponding to the locations of cracks on the external surface.

No other evidence of deterioration, such as corrosion, was apparent on either surface. The cracks are probably material defects. They may be laps or seams that were present on the external surface prior to the fin-rolling operation and were exaggerated during the rolling process.

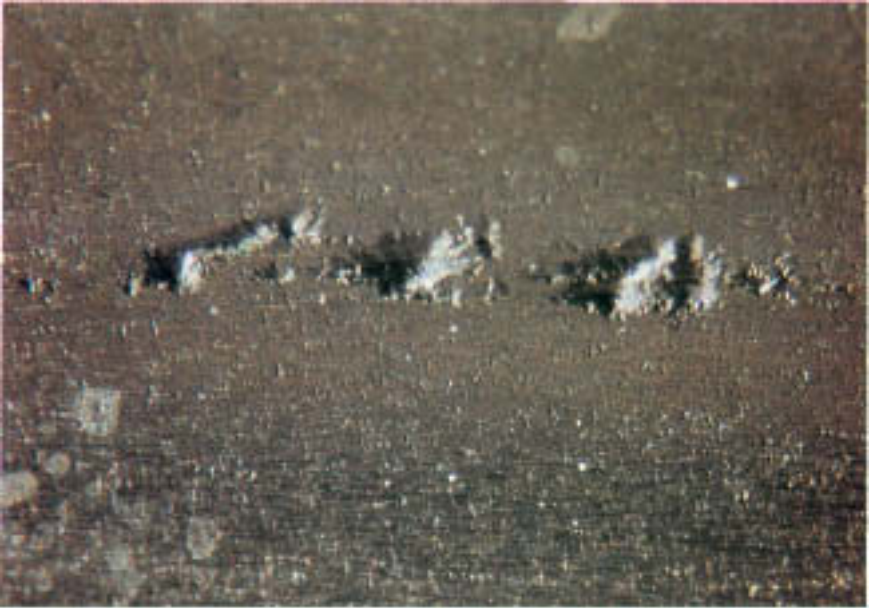
**Figure 14.7** Shallow, aligned gouges on the internal surface. (Magnification: 6.5 $\times$ .)

The various forms of defects on the internal surface of this tube could be overlooked in a casual, visual examination. Closer observation, however, would disclose several forms of discontinuities, such as shallow gouges (Fig. 14.7) and particles of smeared metal (Fig. 14.8). These features are prominent in a distinct longitudinal zone (Fig. 14.9).

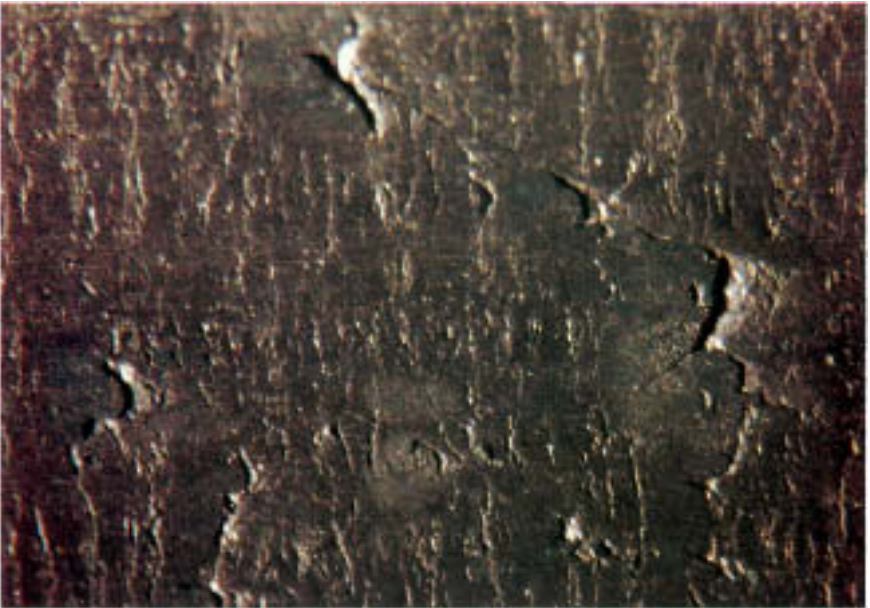
**Figure 14.8** Broad patches of smeared metal aligned longitudinally along the internal surface. (Magnification: 6.5 $\times$ .)

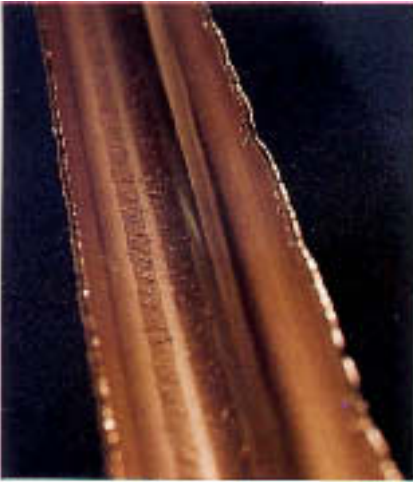
**Figure 14.9** Zone of defects running along the internal surface.

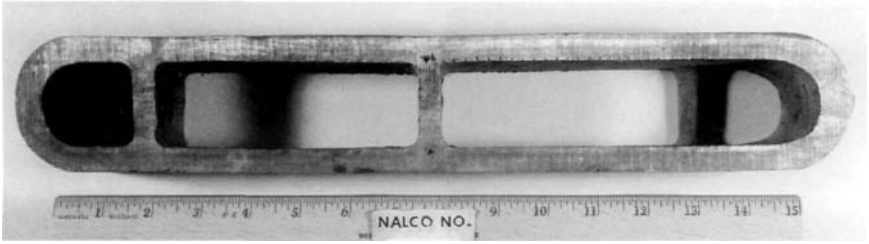
**Figure 14.10** Cross section through a stack plate showing casting voids located at the junction of two walls (black spots at center of photograph).

Figure 14.10 shows the end profile of a sectioned stack plate with deep, irregularly shaped casting voids at the intersection of walls. Sectioning through these void zones revealed deep internal tunnel porosity (Fig. 14.11). When viewed under a low-power microscope, the contours of porous areas showed distinct solidification features (dendrites).

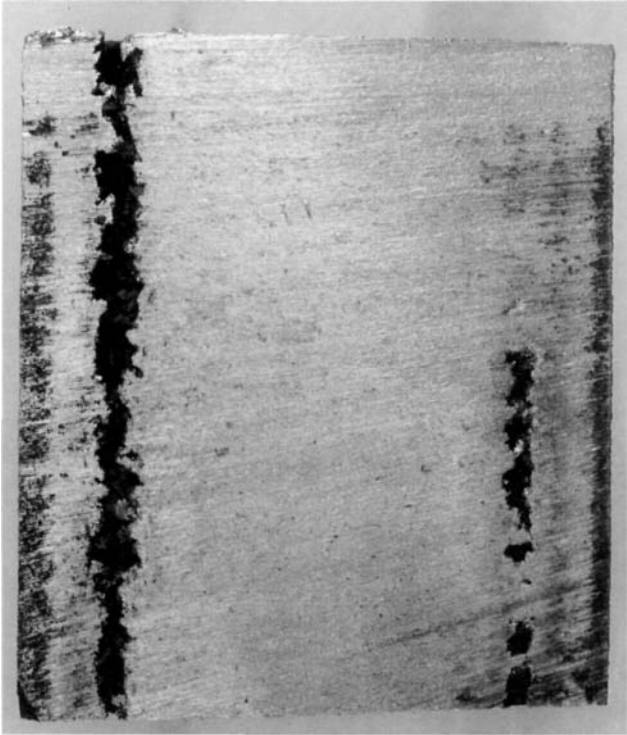
**Figure 14.11** Sectioning along the voids reveals the extent of the defect.

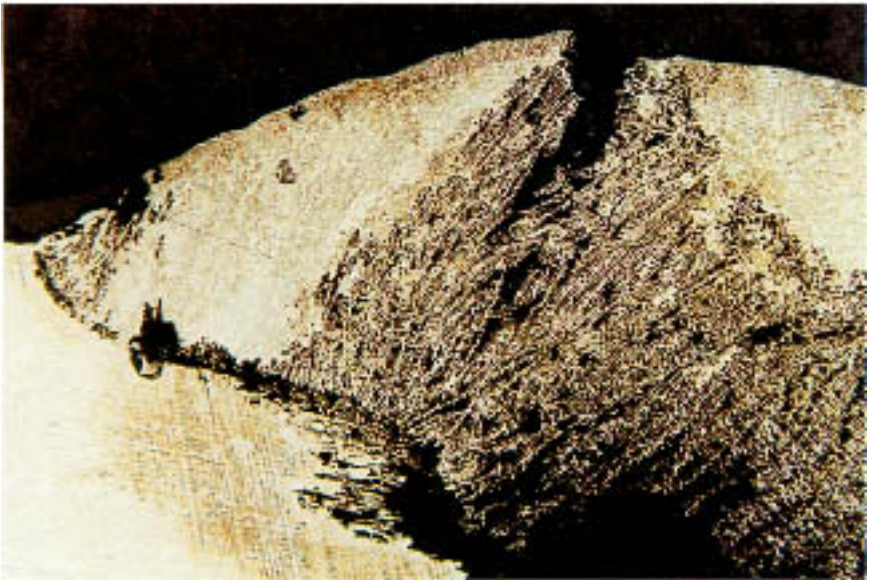
**Figure 15.1** Preferential corrosion of the less noble of two phases in a weld bead (cross section). (Magnification: 50 $\times$ .)

**Locations.** Galvanic corrosion of any type is most severe in immediate proximity to the junction of the coupled metals. Galvanic corrosion of weld metals is frequently microstructurally localized. The less-noble weld material will corrode away, leaving behind the skeletal remnants of the more-noble metal (Figs. 15.1 and 15.2).

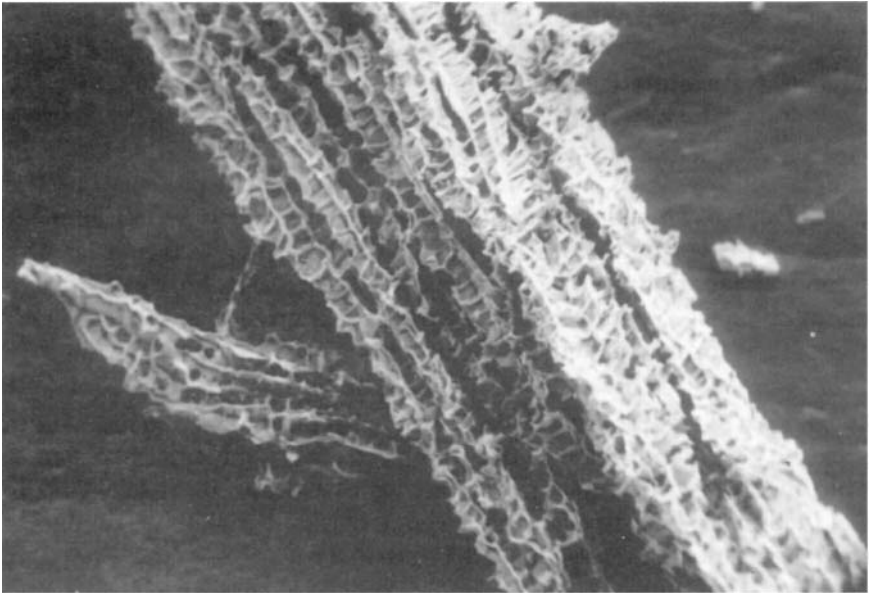
**Figure 15.2** Skeletal remnants of noble phase. (Magnification: 200 $\times$ , scanning electron microscope.)

The triggering mechanism for the corrosion process was localized depassivation of the weld-metal surface. Depassivation (loss of the thin film of chromium oxides that protect stainless steels) can be caused by deposits or by microbial masses that cover the surface (see Chap. 4, “Underdeposit Corrosion” and Chap. 6, “Biologically Influenced Corrosion”). Once depassivation occurred, the critical features in this case were the continuity, size, and orientation of the noble phase. The massive, uninterrupted network of the second phase (Figs. 15.2 and 15.21), coupled

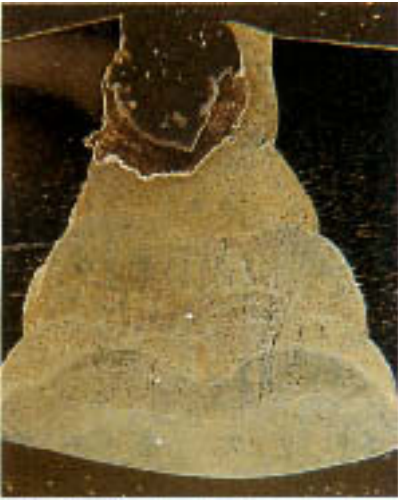
**Figure 15.3** Corrosion confined to weld bead (cross section). (Magnification: 7.5 $\times$ .)

**Identification.** The primary identifying feature is confinement of metal loss to the weld bead (Fig. 15.3), although in advanced stages base metal immediately adjacent to the weld bead may also be affected. Note that this feature seems to distinguish galvanic corrosion of welds from other weld-related corrosion, such as weld decay, which preferentially attacks the immediately adjacent base metal (Fig. 15.4).

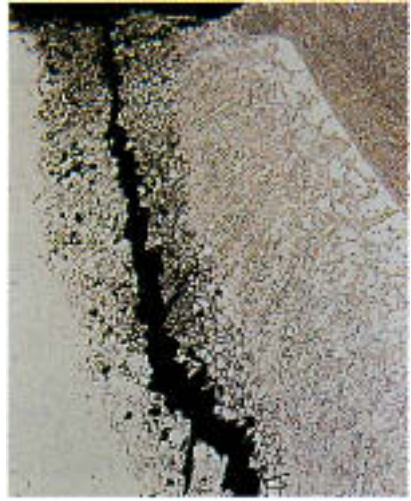
**Figure 15.4** Preferential attack of base metal adjacent to weld bead (top right—cross section). (Magnification: 50 $\times$ .)

**Identification.** Weld decay characteristically produces distinct, narrow zones of disintegration immediately adjacent and parallel to the weldment (Fig. 15.4). Attack will occur on either side of the weld. The weld itself and surrounding metal will be unattacked. The corroded area frequently has a granular or sugary appearance and feel. This is due to corrosion along the boundaries of individual grains that causes them to be released from the metal surface. Affected metal may have lost its metallic ring.

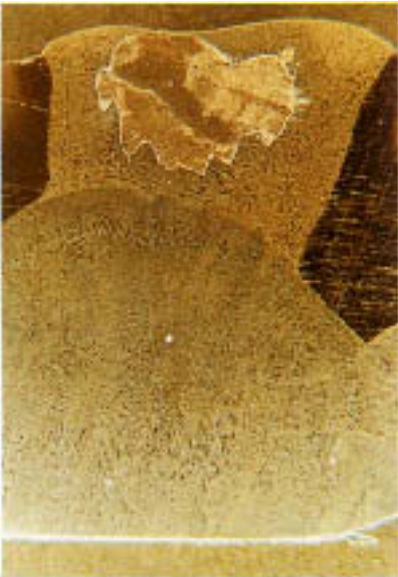
**Figure 15.5** Cavity in weld bead covered by thin skin of weld metal (cross section). (Magnification: 7.5 $\times$ .)

Occasionally, corrosion of this type produces large cavities covered by a thin outer skin of weld metal (Fig. 15.5). Even close examinations of such sites under a low-power microscope may fail to reveal the cavities. Compare Figs. 15.6 and 15.7. Generally, such sites are detected either by fluid leakage or by nondestructive testing techniques such as radiography and ultrasonics.

Figure 15.5 shows a transverse cross section through a pitted weld. Note the cavernous pit below a small opening in the surface skin.

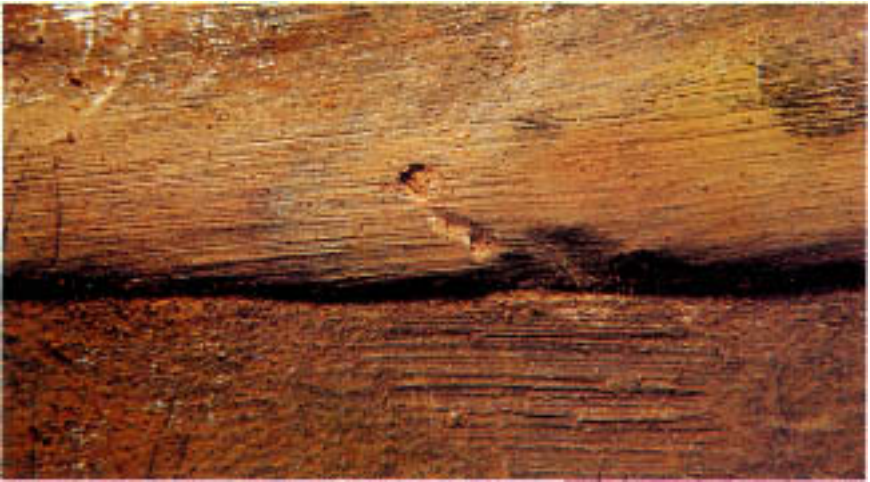
**Figure 15.6** Weld bead site at which radiography indicated a large pit. (Magnification: 7.5 $\times$ .)

Close examination of the weld under a low-power stereoscopic microscope revealed small openings (Fig. 15.6). Probing these sites with a pin revealed a large pit that had been covered by a thin skin of weld metal. These sites contained fibrous, metallic remnants (Fig. 15.7). Examination under a scanning electron microscope further revealed the fibrous character of the material (Fig. 15.2) and also the convoluted shapes of the individual fibers (Fig. 15.21). Energy-dispersive spectrographic analysis of this material revealed the compositions in Table 15.1.

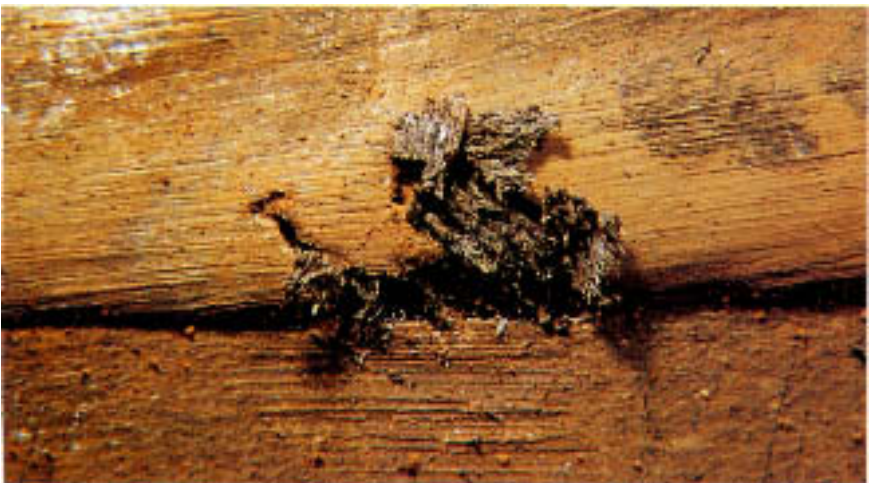
**Figure 15.7** Same site as Fig. 15.6 after probing with a pin. (Magnification: 7.5 $\times$ .)

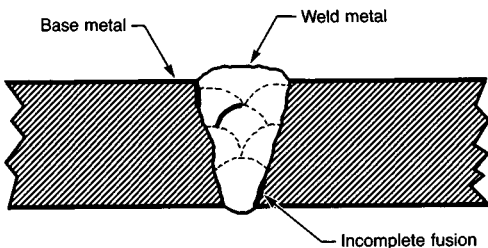
Figure 15.8 Common sites of incomplete fusion.

**General description.** In incomplete fusion, complete melting and fusion between the base metal and the weld metal or between individual weld beads does not occur (Fig. 15.8). Incomplete fusion that produces crevices or notches at surfaces can combine with environmental factors to induce corrosion fatigue (Chap. 10), stress-corrosion cracking (Chap. 9), or crevice corrosion (Chap. 2). See Fig. 15.9.

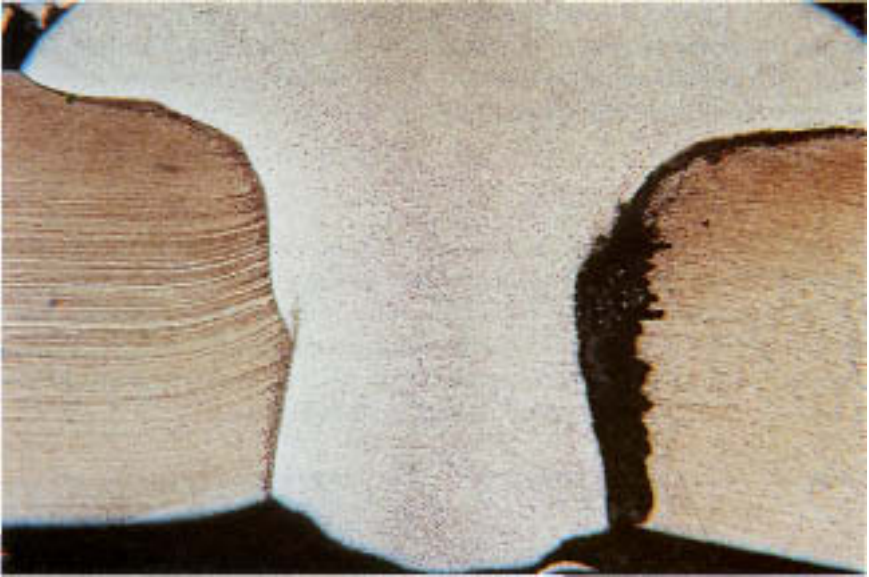
**Figure 15.9** Cross section of stainless steel weld showing crevice corrosion along a site of incomplete fusion. (Magnification: 15 $\times$ .)

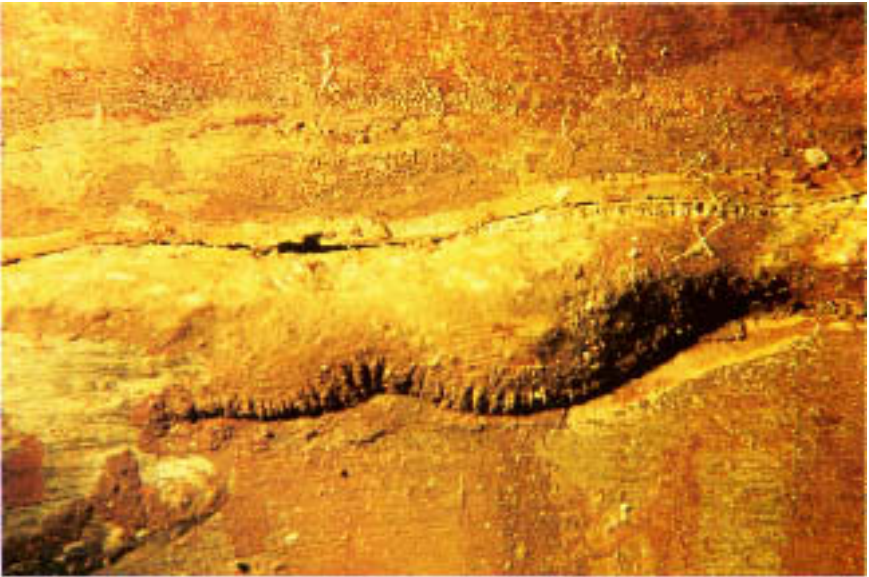
**Figure 15.10** Unfused seam along edge (top) of weld bead. (Magnification: 7.5 $\times$ .)

**Identification.** Incomplete fusion generally results in discontinuities along the side walls of a joint. When these discontinuities emerge at surfaces, they can be observed visually if accessible (Figs. 15.10 and 15.11). Defects of this type may also be detected by ultrasonics, radiography, magnetic particle inspection, and eddy-current testing.

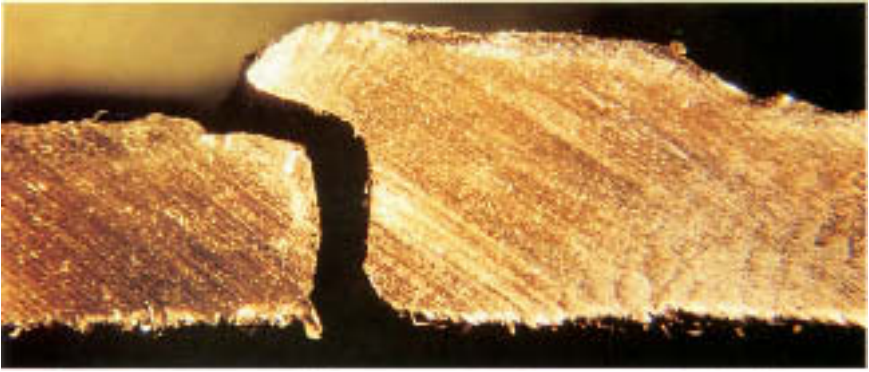
**Figure 15.11** Cross-sectional view of Fig. 15.10. (Magnification: 7.5 $\times$ .)

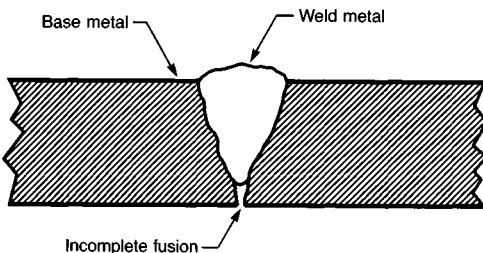
**Figure 15.12** Incomplete penetration.

**General description.** Incomplete penetration describes the condition in which the weld fails to reach the bottom of the weld joint, resulting in a notch located at the root of the weld (Fig. 15.12). This critical defect can substantially reduce the intrinsic mechanical strength of the joint and can combine with environmental factors to produce corrosion fatigue (Chap. 10), stress-corrosion cracking (Chap. 9), or crevice corrosion (Chap. 2).

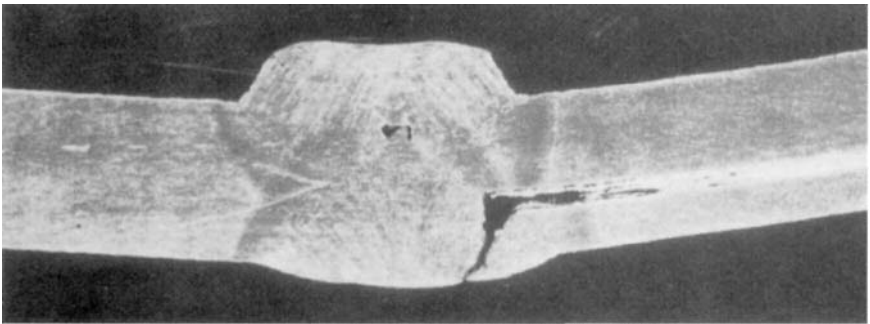
**Figure 15.13** Cracking in weld deposit caused by lamination in steel base metal. (Reprinted with permission from Helmut Thielsch, *Defects and Failures in Pressure Vessels and Piping*, New York, Van Nostrand Reinhold, 1965.)

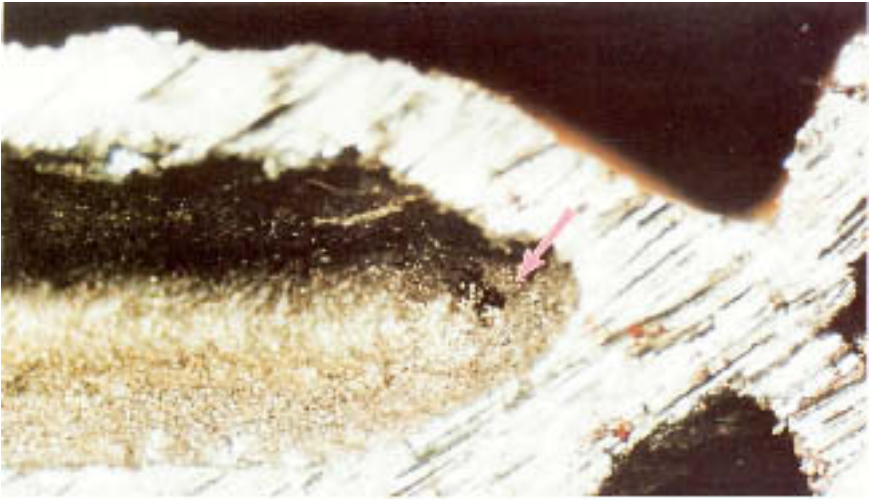
**Figure 15.14** Pore formed by emergence of weld cavity at the surface. (Magnification: 15 $\times$ .)

**Identification.** If accessible, welds having cavities may be visually observed by noting the pore formed where the cavity emerges at the surface (Fig. 15.14). Nondestructive testing techniques include radiography, eddy-current testing, ultrasonics, and possibly magnetic-particle or liquid-penetrant inspections. Note that the last two techniques are useful only if pores emerge at the surface. Leakage from defects of this type may occur soon after start-up of the equipment.

Pressure testing of the finned oil cooler in Fig. 15.29 revealed leaks. Examination of the interior of the cooler after sectioning in the vicinity of the leaks revealed a small cavity in the weld zone in the corner of some fins (Fig. 15.14) and porous areas inside the channel in the welded zone in other fins. Microstructural examinations of specimens cut through the sites revealed interconnected voids resulting from either shrinkage during solidification of the weld or lack of fusion of the base metal and weld metal.

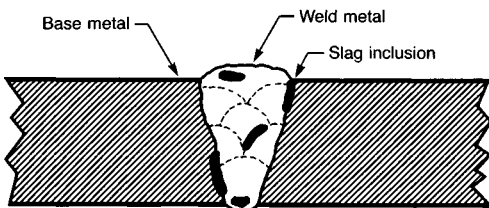
**Figure 15.15** Common slag inclusion sites in a weld.

**General description.** Slag inclusions are various nonmetallic substances that become entrapped in the weld during the welding process. Typically, the inclusions are located near the surface and along the sides of the weld (Fig. 15.15). The inclusions may form from reactions occurring in the weld metal or may be metal oxides present on the metal prior to welding. They may be isolated particles or may form relatively continuous bands.

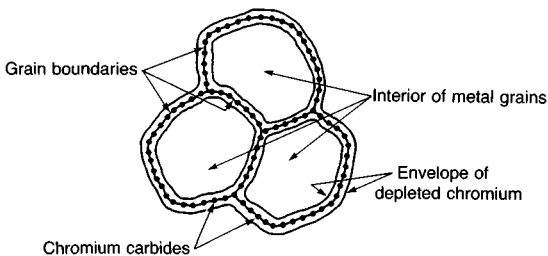
**Figure 15.16** Schematic representation of sensitized stainless steel.

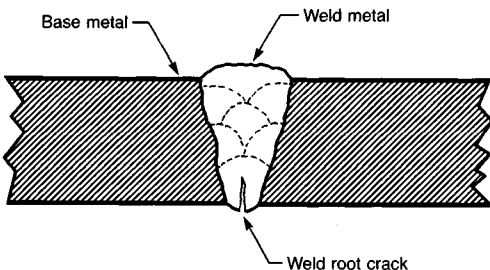
Figure 15.17 Weld-root crack.

**General description.** In weld-root cracking, cracks originate at the root of the weld (Fig. 15.17). Such cracks may propagate into the weld, through the weld, into adjacent components, or through a relatively brittle heat-affected-zone base metal.

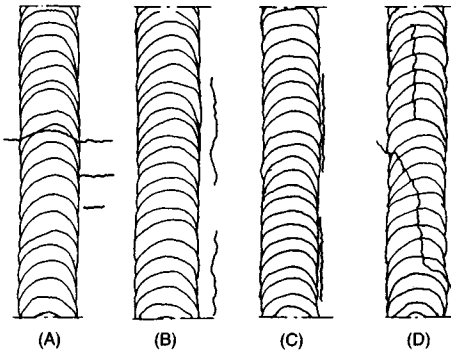
**Figure 15.18** Examples of crack patterns due to stress-corrosion cracking and corrosion fatigue in butt welds. (Reprinted with permission from Helmut Thielsch, *Defects and Failures in Pressure Vessels and Piping*, New York, Van Nostrand Reinhold, 1965.)

Stress-corrosion cracking can result from high-welding stresses in or immediately adjacent to the weld (Figs. 15.18 and 15.19).

The cracks illustrated in Fig. 15.18A resulted from weld metal-shrinkage along the long axis of the weld. The cracks in Fig. 15.18B were caused by shrinkage along the short axis of the weld. The cracking illustrated in Fig. 15.18D may be caused by lack of penetration.

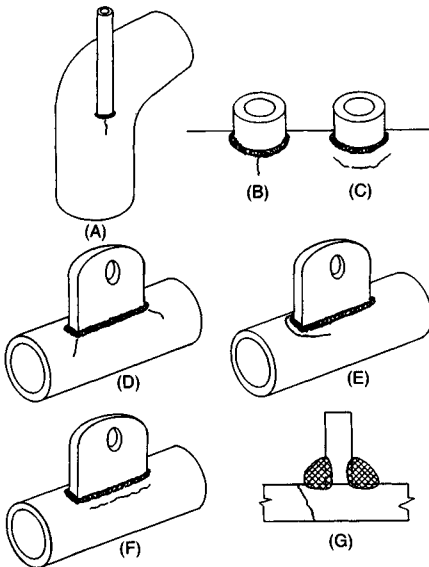
**Figure 15.19** Examples of crack patterns due to stress-corrosion cracking and corrosion fatigue in branch connections and vessel or pipe support attachment welds. (Reprinted with permission from Helmut Thielsch, *Defects and Failures in Pressure Vessels and Piping*, New York, Van Nostrand Reinhold, 1965.)

Figure 15.19 shows various crack orientations that can occur in connection and attachment welds. Applied stresses from external loading of these components can add to the residual weld stresses, producing still higher stress loads. This can increase the susceptibility to stress-corrosion cracking and can affect orientation and location of crack paths.

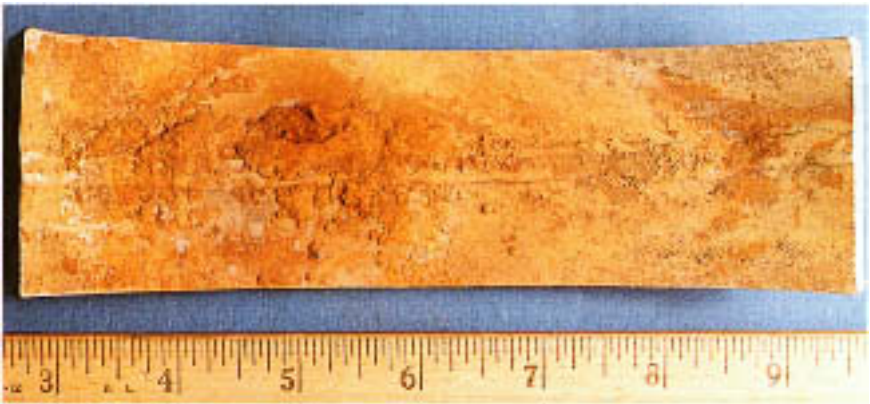
**Figure 15.20** Internal surface of 14-in. diameter stainless steel pipe. The circumferential weld is in the center of the specimen.

Several of the welded junctions were removed from the system for metallographic examination (Fig. 15.20). As can be seen from Fig. 15.20, the internal surface was covered with reddish and tan deposits and corrosion products. The metal surface itself retained a bright, metallic luster.

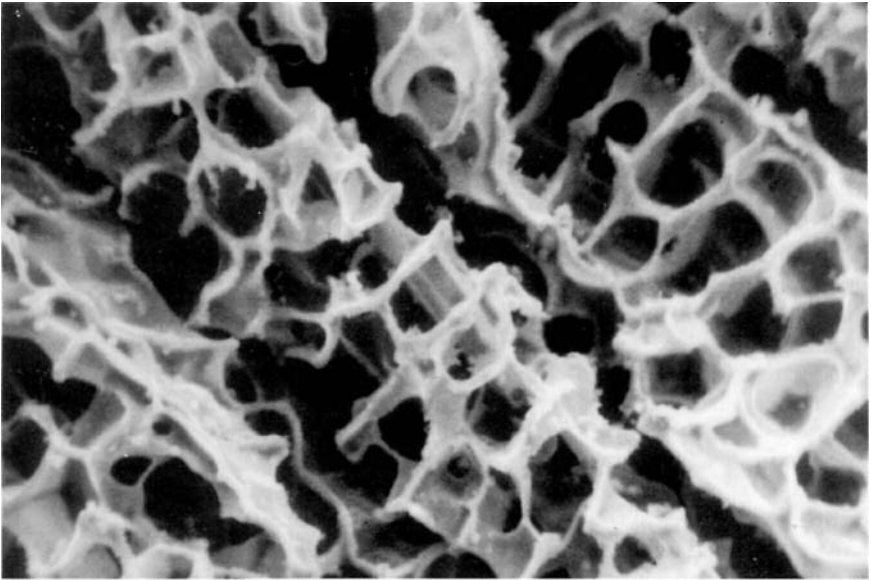
**Figure 15.21** Convoluted contours of individual fibers. (Magnification: 1000×, scanning electron microscope.)

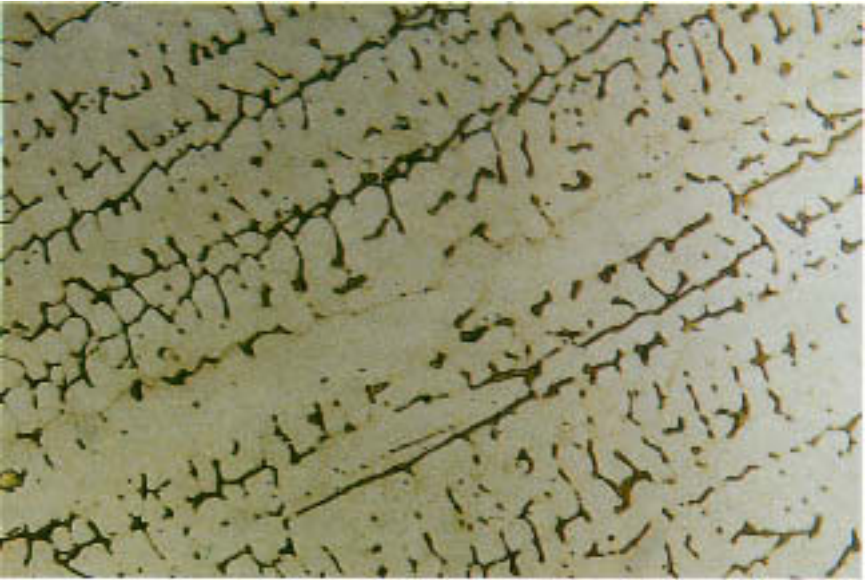
**Figure 15.22** Phase I: (noble) dark script. Phase II: light background. (Magnification: 500 $\times$ , etched nitric acid.)

The only significant corrosion observed in the entire system was confined to the weld beads along the internal surface. Corrosion occurred due to a microstructural galvanic couple formed between two distinct phases in the weld-bead microstructure (Figs. 15.22 and 15.23). The less-noble phase corroded away, leaving behind the skeletal remnants of the more-noble phase.

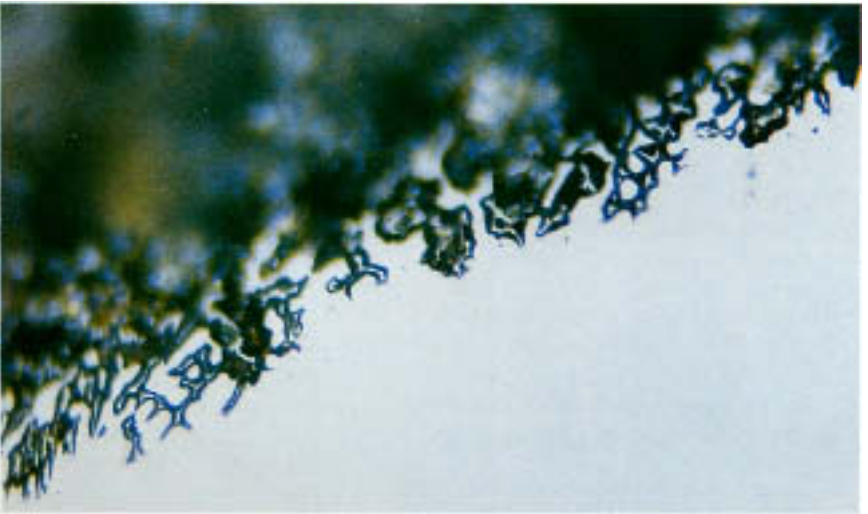
**Figure 15.23** Preferential corrosion of Phase II; Phase I remains unaffected. (Magnification: 500 $\times$ , unetched.)

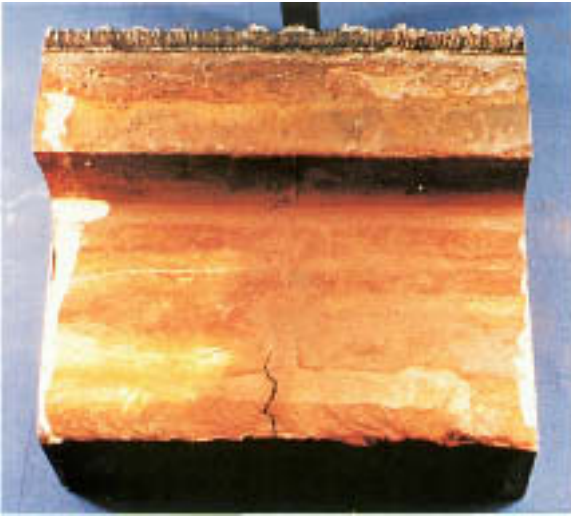
**Figure 15.24** Section of cracked door frame.

The section illustrated in Figs. 15.24 and 15.25 was removed from the door frame that supports the side-loading door to the furnace (Fig. 15.26). Failures of this type had been a chronic problem in the door frame area. The section had been fabricated by welding together three steel plates of ½ to ¾ in. (1.3 to 1.9 cm) thickness.

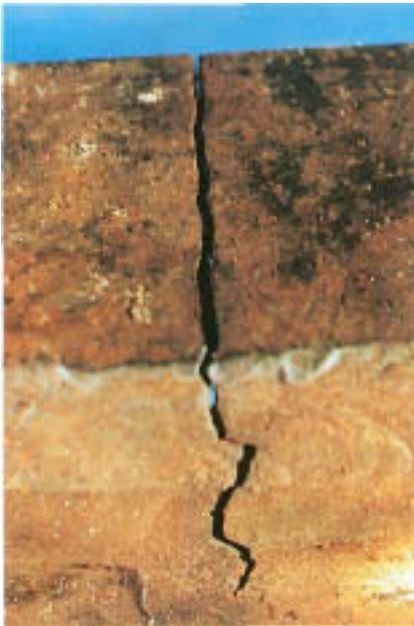
**Figure 15.25** Appearance of fracture along the external surface.

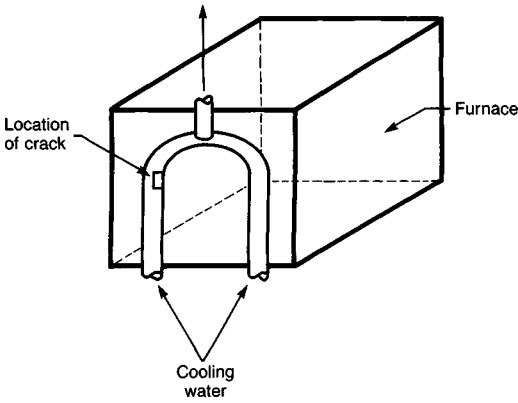
**Figure 15.26** Schematic illustration of remelt furnace showing location of failure.

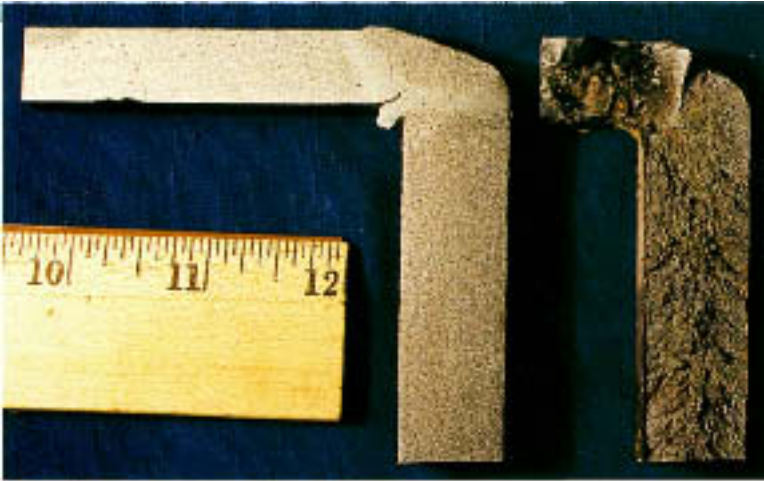
**Figure 15.27** Fracture face (right) contrasted with corresponding, intact weldment. Note that the transition from a rough to a smooth fracture surface occurs abruptly at the junction of the weld metal with the base metal.

Exposure of the fracture surface revealed two distinct regions (Fig. 15.27). A relatively smooth region at the bottom of the J (top of photograph) is weld metal. The relatively rough surface that forms the trunk of the J is a fractured ¾-in. (1.9-cm) plate.

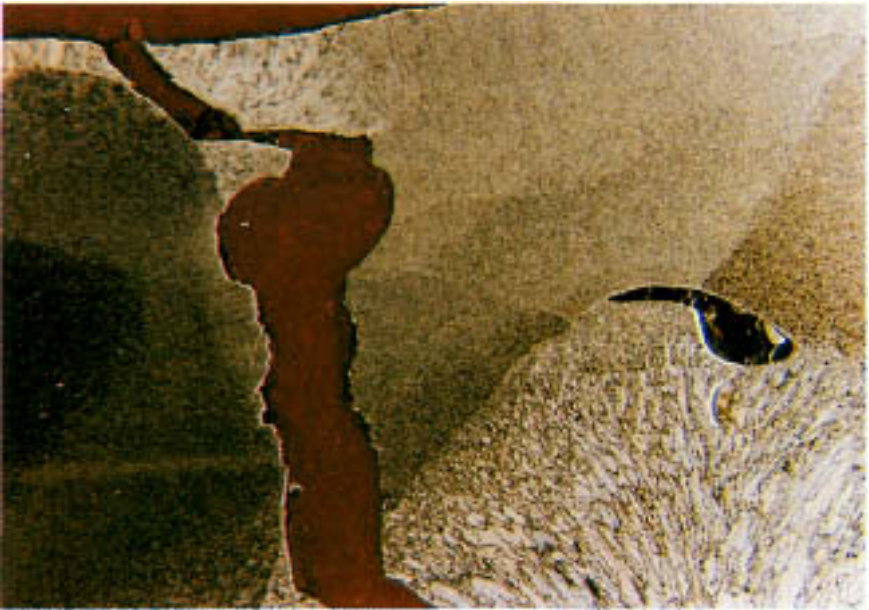
**Figure 15.28** Cross section of fracture along the weldment showing subsurface porosity. Note that the fracture path runs through a large pore. (Magnification: 7 $\times$ .)

Close examination of these areas under a low-power microscope revealed smoothly rippled, spherical surfaces in the weld region and a chevron pattern that pointed back to the weld in the plate. Cross sections cut through the weld revealed substantial subsurface porosity and regions where oxidized surfaces prevented metallurgical bonding of the weld (Fig. 15.28).

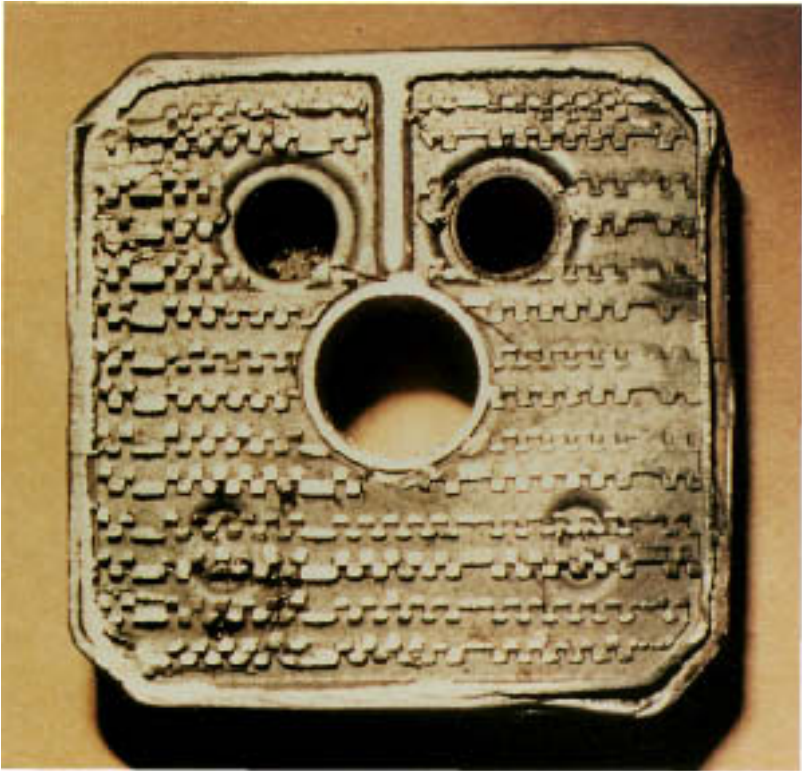
Figure 15.29 Top and side view of oil cooler. Fins at arrows.

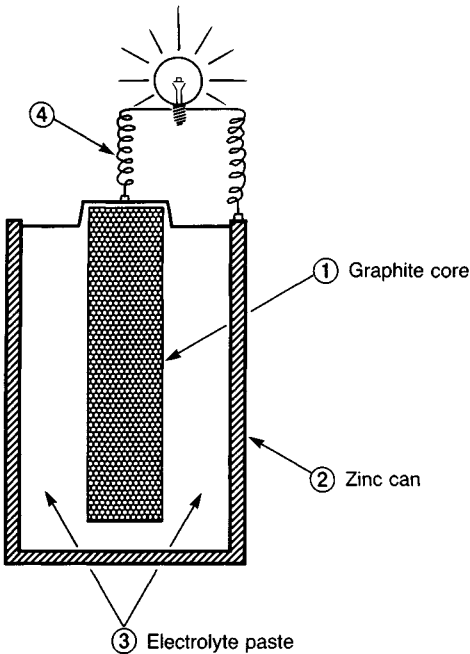
**Figure 16.1** Simple dry cell battery. Electrons are conducted along the external circuit (4), which physically connects the active (2) and noble (1) materials. An equivalent ionic counter-current is conducted through the electrolyte (3), thereby completing the circuit.

The basic features involved in galvanic corrosion can be clearly illustrated by considering a simple dry cell (Fig. 16.1). A dry cell consists of a corrosion-resistant (noble) material and an active material (zinc in the conventional dry cell) embedded in a common, conductive environment (electrolyte). [Note that the noble material in a galvanic corrosion couple can be a conducting nonmetal, such as graphite in the case of a dry cell, or iron oxide (mill scale) or iron sulfide on steel in cooling water systems.] The noble and active materials are linked by an external electrical pathway, which can be opened or closed. When the circuit is closed (such as by switching on a flash light), the active metal begins to corrode and the noble material remains intact. The corrosion of the active metal furnishes electrons that flow to the noble material

- An electrochemical interaction of two or more materials (materials 1 and 2 in Fig. 16.1) having a sufficiently distinct galvanic potential difference
- An electrolyte (3) common to both materials, through which an ionic current flows
- An electrically conductive pathway (4) physically linking the two materials

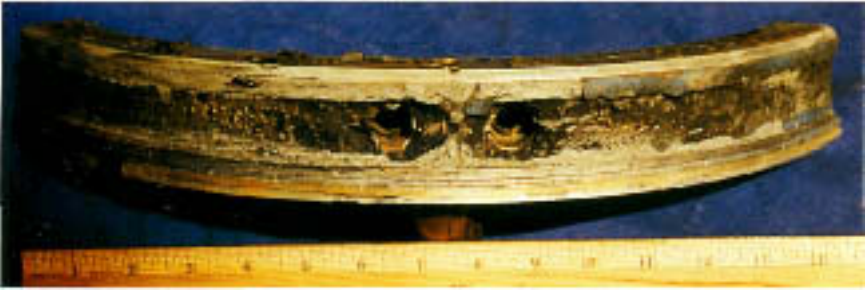
**Figure 16.3** Section of inner ring of extruder cooling system.

A half-section of a ring is shown in Fig. 16.3. The brass nipples have been removed, but two insertion holes are apparent at the center of the ring.

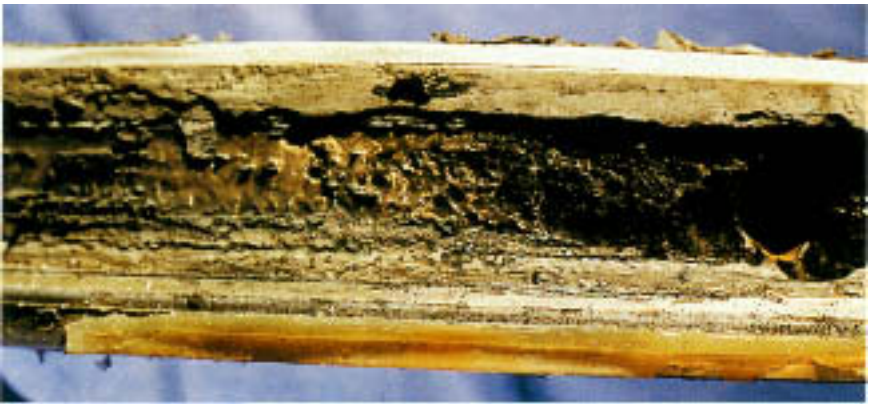
**Figure 16.4** Appearance of corrosion along circumference of ring.

An irregular trough of metal loss is apparent along the circumference of the ring (Fig. 16.4). Metal loss is severe near the nozzle holes (Fig. 16.5). The corroded zone is covered with light and dark corrosion products and deposits. Analysis of these revealed substantial quantities of copper and zinc. Microscopic examinations revealed exfoliation of the aluminum ring in corroded regions.

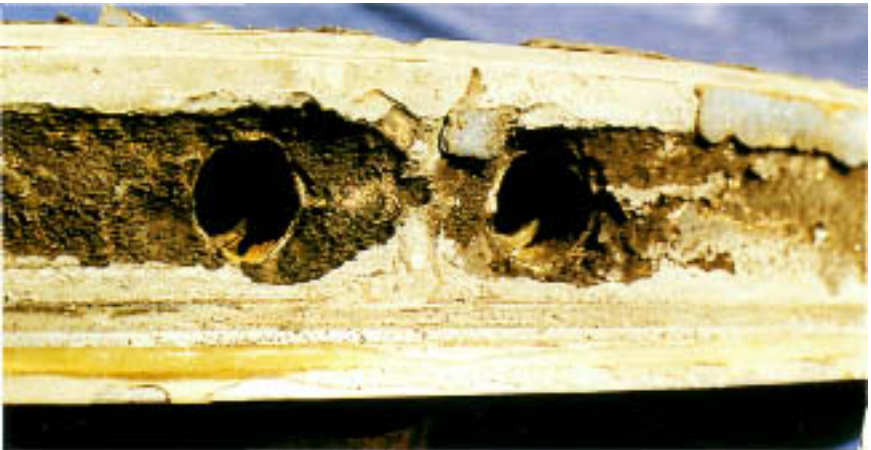
**Figure 16.5** Severe deterioration adjacent to nozzle holes where brass nozzles had been inserted.

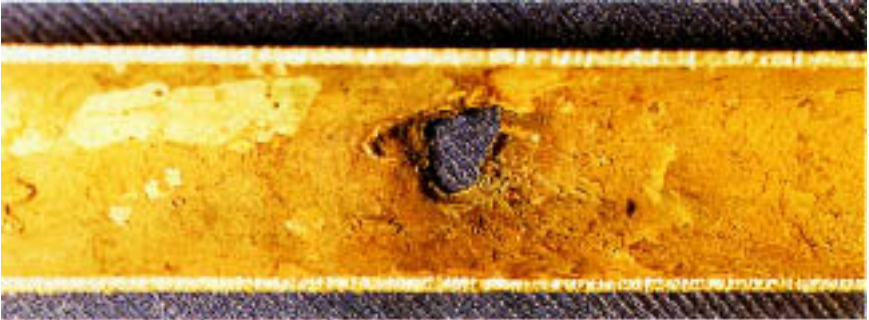
**Figure 16.6** Perforation in tube wall originating on the internal surface.

Figure 16.6 illustrates the internal surface of a section removed from the center of a tube in the second pass. It is apparent from the external surface (Fig. 16.7) that the large, irregular perforation is located along the edge of the contact plane of the tube with a baffle.

Close visual examinations revealed that the perforation originated on the internal surface along the bottom of the tube where it rested on the steel baffle. Apparently, tube metal temperatures were higher in the area of contact with the baffle than at adjacent locations. The hotter tube metal at the baffle established a thermogalvanic cell with the surrounding cooler metal, causing metal wastage in the hotter region.

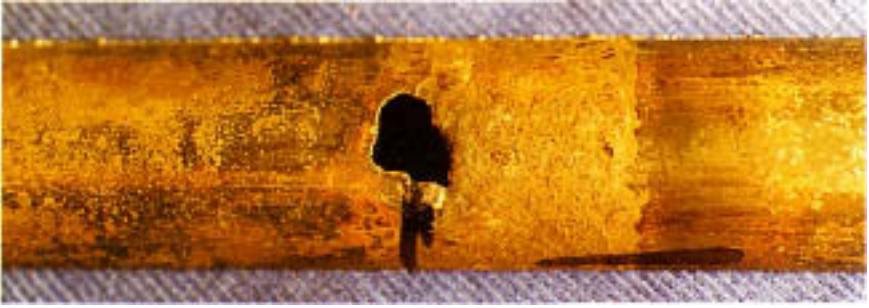
**Figure 16.7** External surface at the same location as Fig. 16.7. Note location of baffle contact surface relative to the perforation.

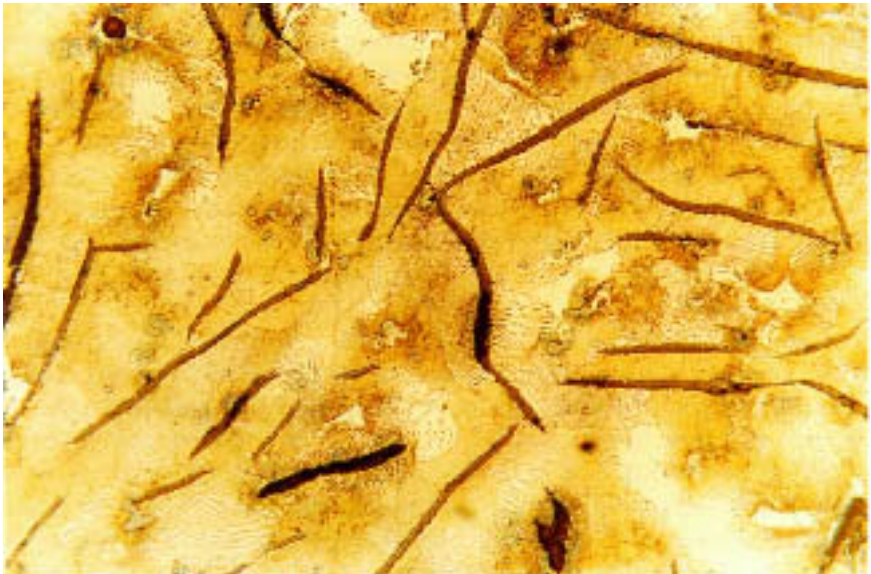
**Figure 17.1** Flakes of graphite embedded in a matrix of iron (gray cast iron).

The basic mechanism causing graphitic corrosion is easily understood, but some information is required on the microstructure of cast iron. The microstructural feature of principal importance is the distribution of flakes (gray cast iron) or spheroids (nodular cast iron) of graphite embedded in a matrix of iron (Fig. 17.1). Since graphite is highly noble from a corrosion standpoint and since it is in intimate physical contact with the relatively innoble iron matrix, it is easy to conceive of the formation of a microstructural galvanic couple between the graphite and iron if both are exposed to the same sufficiently

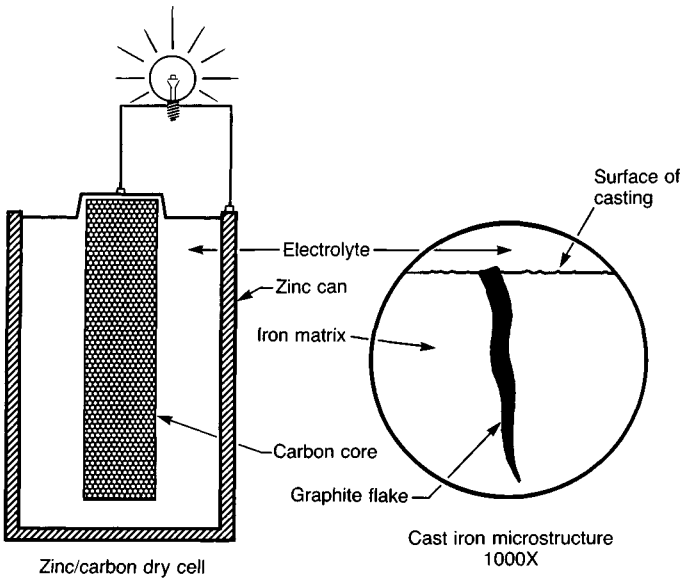
**Figure 17.2** Mechanistic correlation between dry cell and graphitic corrosion.

aggressive environment. Such a situation can occur at exposed surfaces of the casting where graphite flakes emerge. A microminiature battery develops that is mechanistically identical to the old carbon–zinc dry cell (Fig. 17.2). The noble graphite remains intact while the iron corrodes (Fig. 17.3), the corrosion being driven by the potential difference generated by the galvanic couple and the electrolyte environment.

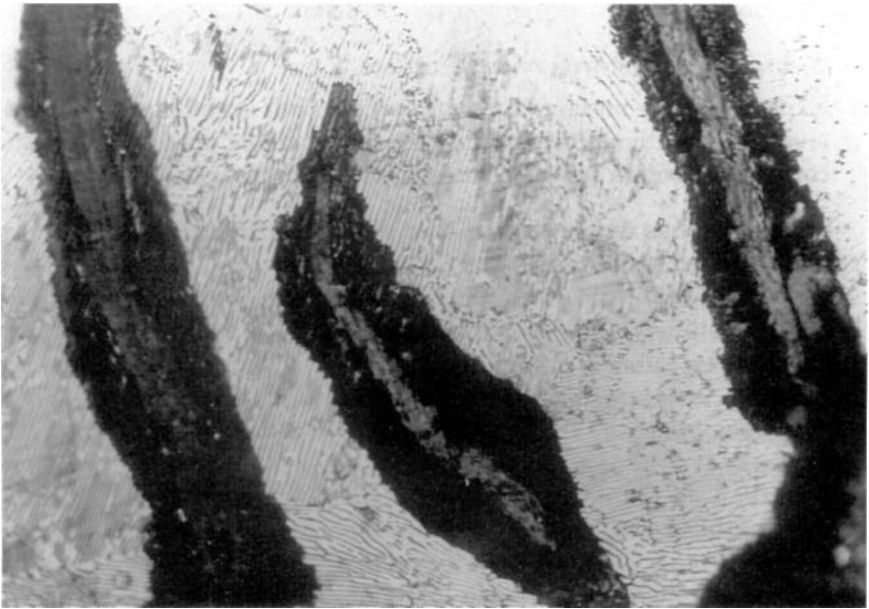
**Figure 17.3** Graphite flakes surrounded by graphitically corroded iron. Bright background is uncorroded metal. (Magnification: 1000x.)

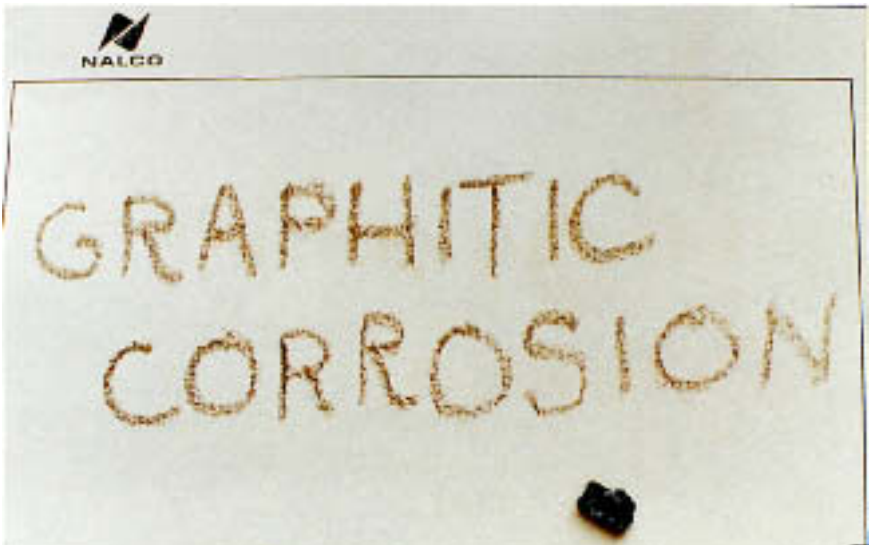
Figure 17.4 Evidence of graphitic corrosion.

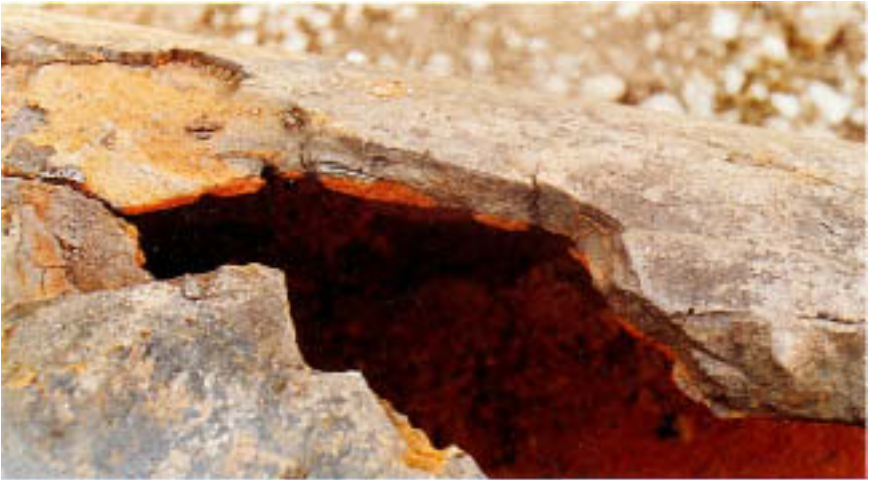
**Figure 17.5** Brittle fracture through pipe. The gray material is graphitically corroded cast iron. Unaffected pipe wall metal is orange from normal rust.

Failure of graphitically corroded cast iron will yield a brittle, thick-walled fracture. Fracture faces through the graphitically corroded region will be black and nonmetallic (Fig. 17.5). Cross sections cut through graphitically corroded regions will readily show bright, intact metal surrounded by a soft, black, corroded area (Fig. 17.6).

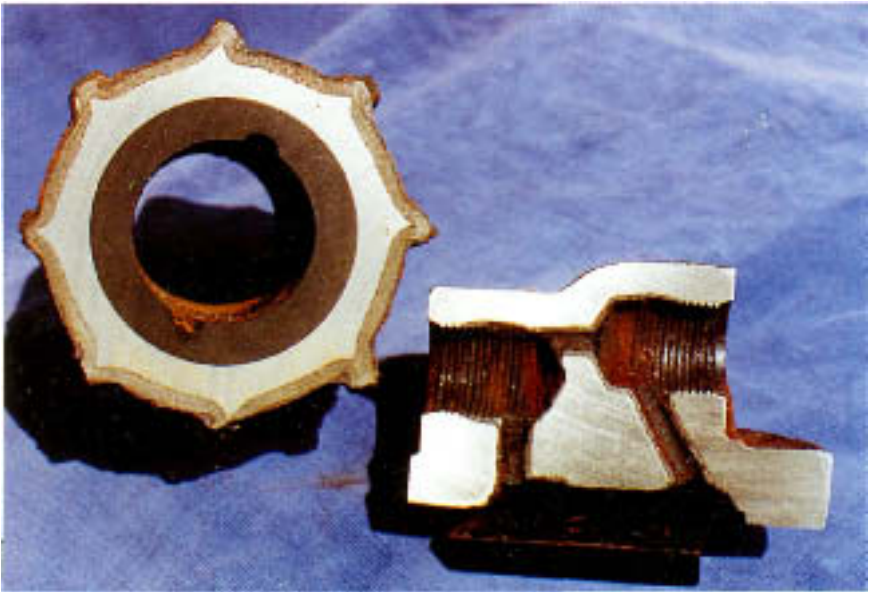
**Figure 17.6** Black, graphitically corroded metal at the surface surrounding bright, unaffected metal.
