# **The Nalco Guide to Cooling Water System Failure Analysis**

**Nalco Chemical Company**

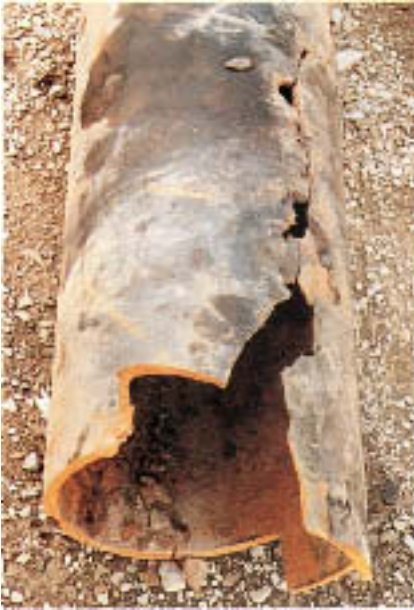
**Figure 17.7** Section of longitudinally fractured subterranean cooling water line. Note that the crack runs the entire length of the line.

Figure 17.7 shows a 10 ft (3 m) section of a main cooling water line that fractured along its bottom. Close examination of this photograph will disclose that this fracture runs the entire length of the section. The pipe wall had been converted from metallic cast iron to a soft, brittle, black corrosion product along a narrow zone that ran the length of the pipe. Note in Figs. 17.8 and 17.5 that the corrosion product has the same contour as the original pipe. Striking the affected zone with a hammer caused the corrosion product to shatter, revealing a thin layer of intact metal below.

Heavy equipment had passed over the site of failure initiation shortly before the rupture was discovered. It is probable that stresses associated with the heavy equipment initiated a fracture in the severely corroded pipe bottom. Once the fracture initiated, it propagated down the length of the line in response to stresses imposed by internal pressure.

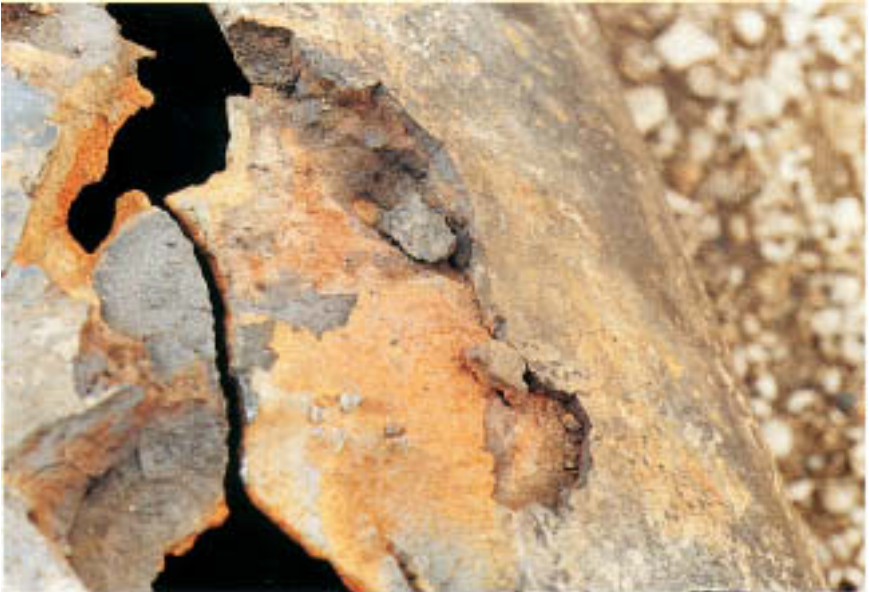
**Figure 17.8** The black outer covering is corrosion product; the reddish-brown surface is coated with air-formed iron oxide.

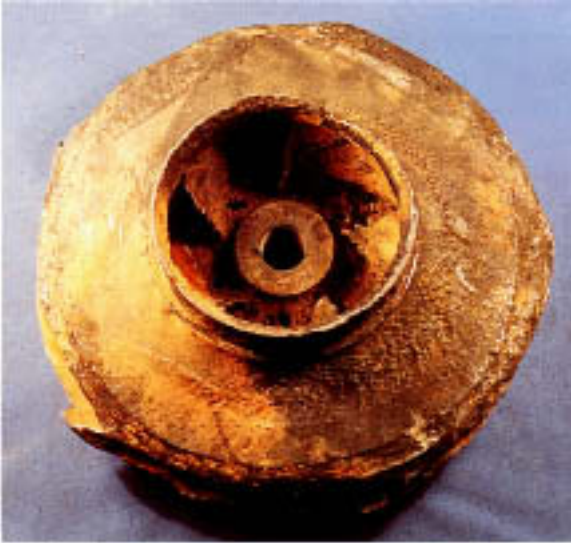
**Figure 17.9** Pump impeller that has suffered erosion associated with graphitic corrosion.

The impeller shown in Fig. 17.9 was removed from a cooling water return line associated with a large press. Failure of these impellers was a chronic problem, requiring impeller replacement every 3 or 4 months.

Most of the surface is covered with a black corrosion product that is thicker in relatively low-flow areas near the hub. This layer of soft corrosion product can be shaved from corroded surfaces. Microstructural examinations revealed flakes of graphite embedded in iron oxide near the surfaces.

Turbulence and high fluid velocities resulting from normal pump operation accelerated metal loss by abrading the soft, graphitically corroded surface (erosion-corrosion). The relatively rapid failure of this impeller is due to the erosive effects of the high-velocity, turbulent water coupled with the aggressiveness of the water. Erosion was aided in this case by solids suspended in the water.

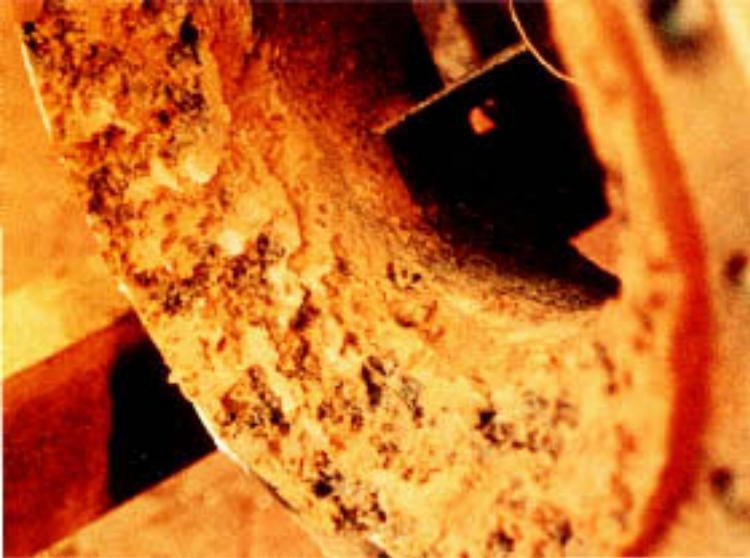
**Figure 17.10** Appearance of the graphitically corroded throat of a pump housing.

Figure 17.10 shows metal loss on the throat of the pump housing. External pump housing surfaces were also affected (Fig. 17.11). Note the large tubercles. (Tubercles are knoblike mounds of corrosion products. They typically have a hard, black outer shell enclosing porous reddish-brown or black iron oxides) (see Chap. 3, “Tuberculation”). The metal surface beneath these tubercles had sustained graphitic corrosion, in some cases to a depth of  $\frac{1}{4}$  in. (0.6 cm) (Fig. 17.12).

The pump has experienced graphitic corrosion. Figures 17.10, 17.12, and 17.14 illustrate typical appearances of graphitically corroded cast iron. In addition, cavitation damage (see Chap. 12) has produced severe metal loss in specific areas (see Fig. 17.13). The soft, friable corrosion products produced by graphitic corrosion are susceptible to cavitation damage at relatively low levels of cavitation intensity.

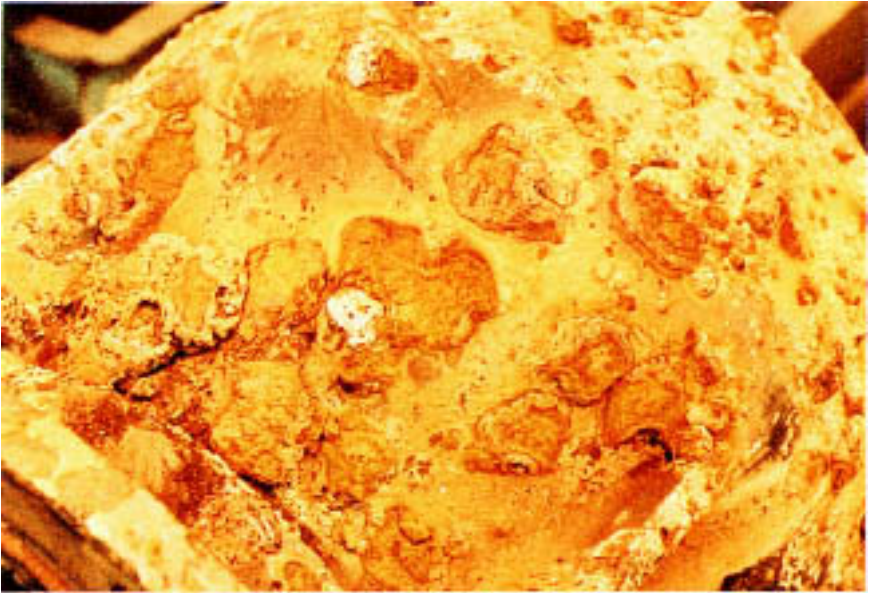
**Figure 17.11** External surface of a pump housing showing tubercles capping sites of graphitic corrosion.

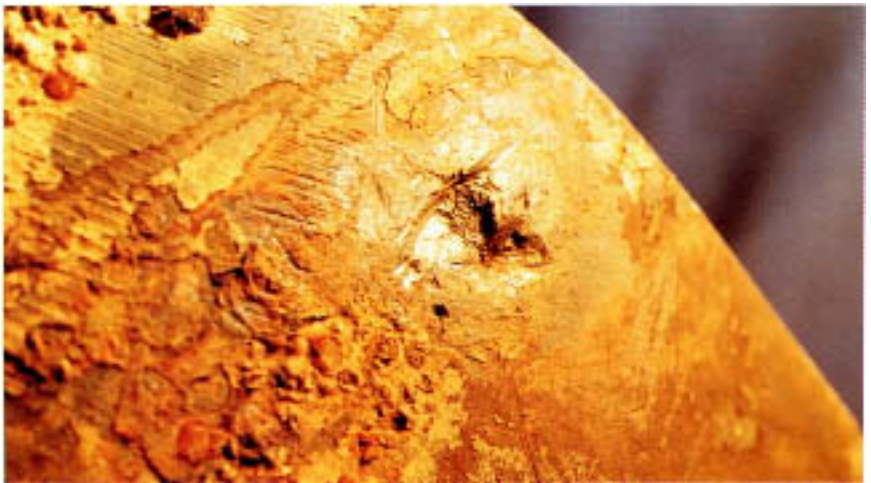
**Figure 17.12** Corroded area beneath a tubercle on the external surface. The shiny black corrosion product has been partially removed to reveal the depth of penetration.

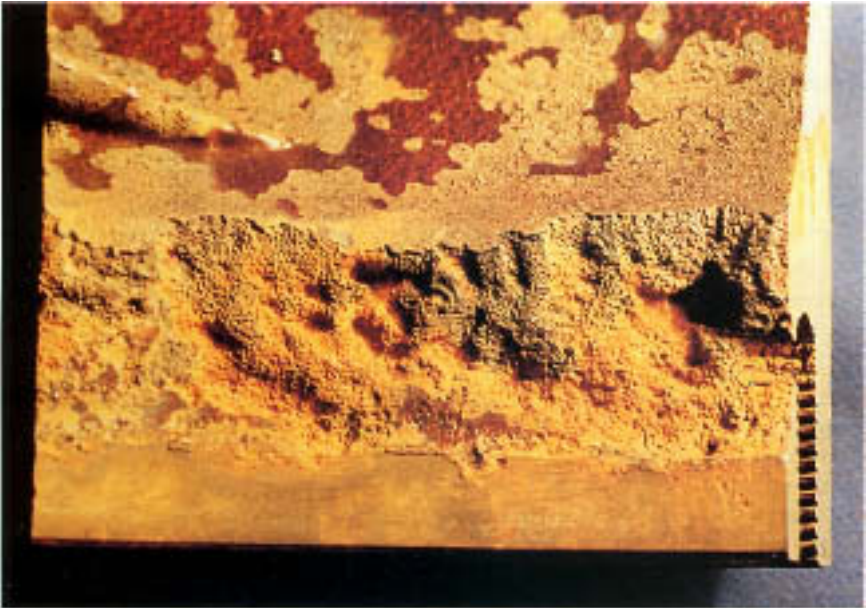
**Figure 17.13** Severe metal loss along an internal surface.

Internal surfaces of the pump show severe wastage (Fig. 17.13). The wasted region is free of corrosion products except for a small amount of soft, black material. Metal loss in this area was as deep as  $\frac{1}{2}$  in. (1.3 cm). The reddish coating partially covering the smooth area above the wasted zone in Fig. 17.13 was applied to mitigate corrosion. Where this coating is

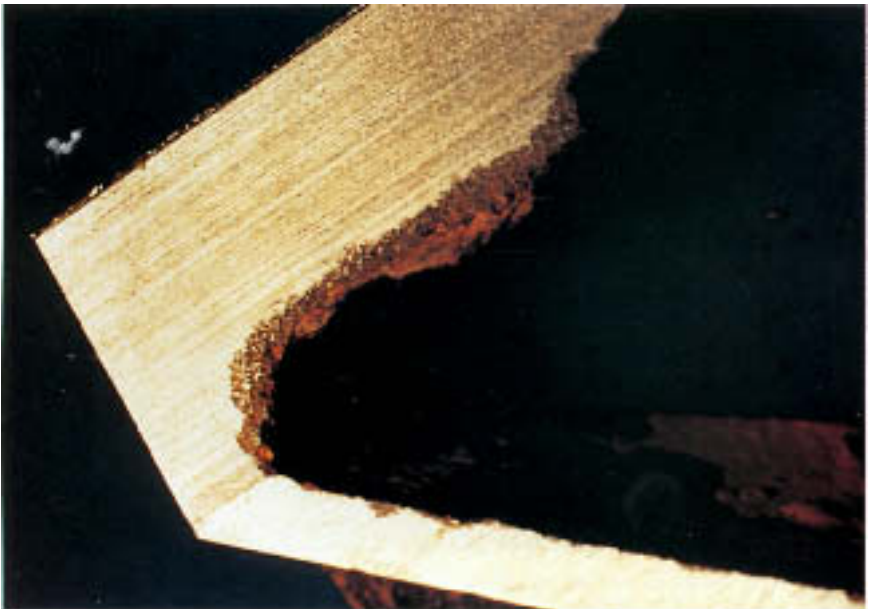
**Figure 17.14** Cross section through the pump housing wall. Note the black and brown graphitic corrosion-product layer near the center of the photo.

intact, corrosion has not occurred. Where it is absent, attack is severe (Fig. 17.14).

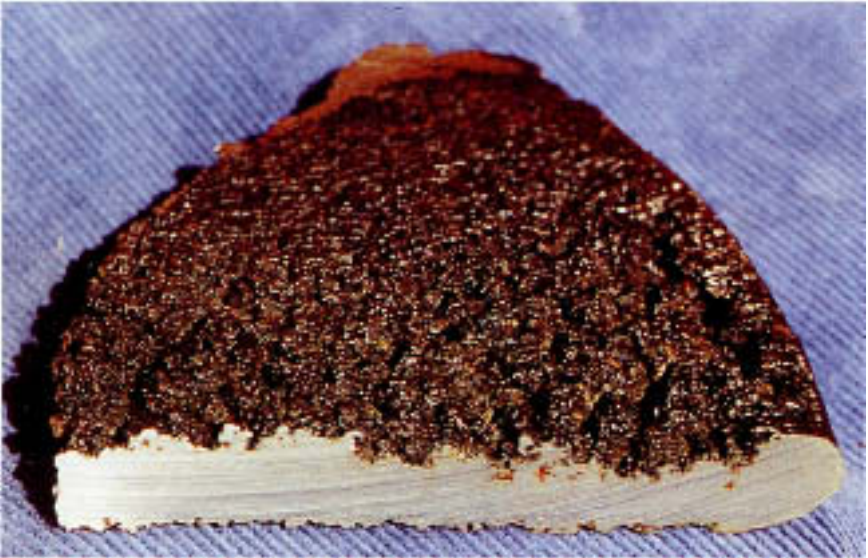
**Figure 17.15** Section of a cast iron pump impeller that has suffered graphitic corrosion followed by cavitation damage.

The specimen in Fig. 17.15 is part of a cast iron pump impeller. The spongelike surface contours are apparent, as is the black coating that covers surfaces exposed to the cooling water. Microstructural examinations revealed preferential deterioration of the iron matrix surrounding the graphite flakes.

Graphitic corrosion of the cast iron produced a soft, mechanically weak corrosion product that is highly susceptible to cavitation damage, even at relatively low cavitation intensities. The black coating on the impeller surface is visual evidence of graphitic corrosion. The spongelike surface contours are typical of cavitation damage (see Chap. 12).

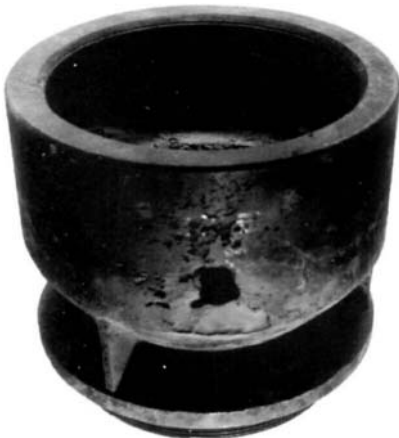
**Figure 17.16** Pump casing as received. Note the large perforation near the center.

Inspection revealed severe metal loss on internal surfaces at the base of the vanes resulting in a large, irregular perforation (Figs. 17.16 through 17.18). In addition, metal loss was observed in a distinct circumferential zone adjacent to internal threads (Fig. 17.17).

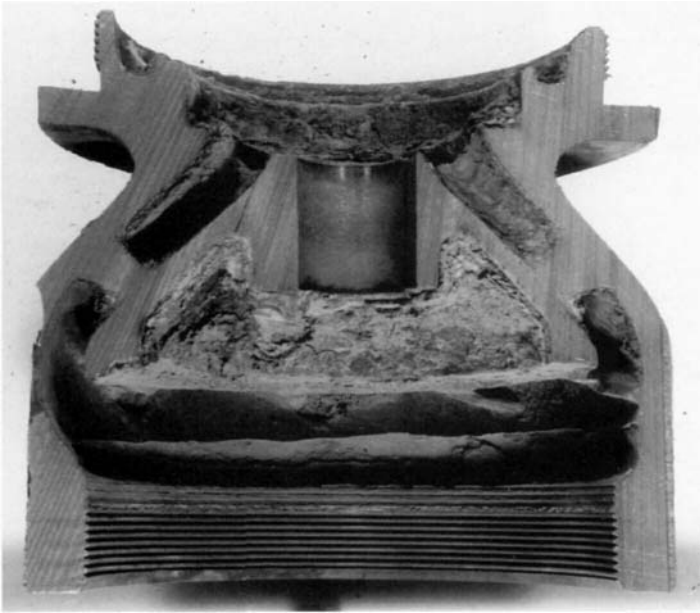
**Figure 17.17** Longitudinally cut half-section. Note the severe wall thinning and the perforation of the wall on the left side. Compare it to the wall thickness on the right side. Also note the circumferential band of irregular metal loss just above the threads, near the bottom of the casing.

Metal loss in these areas had produced a smooth surface, free of deposits and corrosion products. The rest of the internal surface was covered by a thin, uniform layer of soft, black corrosion product. The graphitically corroded surfaces of the pump casing provided soft, friable corrosion products that were relatively easily dislodged by the abrasive effects of high-velocity or turbulent water (erosion-corrosion).

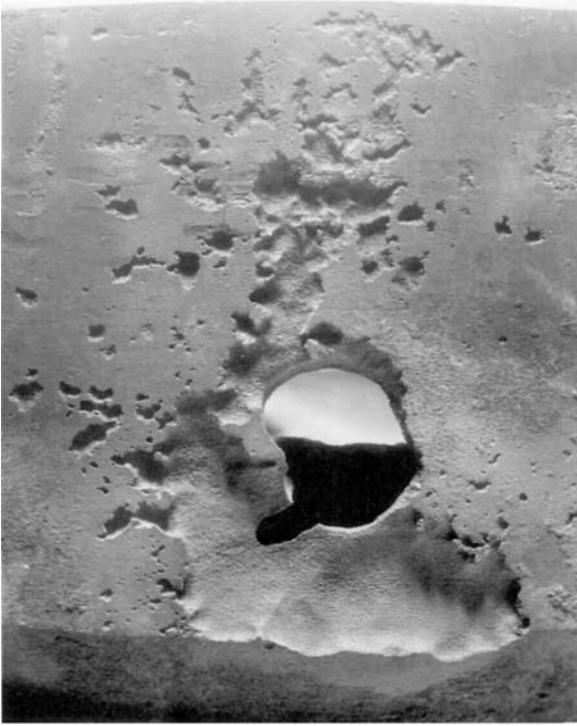
**Figure 17.18** Close-up of the perforation in Fig. 17.16 viewed from the external surface. Graphitic corrosion of the external surface permitted erosion by turbulent water escaping through the perforation.
