failed stone

problems and solutions
with concrete and masonry

Problems and Solutions with Concrete and Masonry

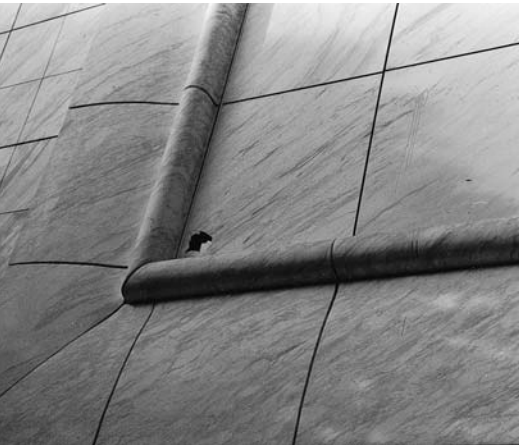
above The translucent marble façade is prone to vandalism and breakage. E.N.S.A.D. – Ecole Nationale Supérieure des Arts Décoratifs, Paris.

The Paris school is composed of a translucent marble curtain wall. A fine layer of marble is laminated to the glass of a traditional curtain wall system. The fabrication of these glass and stone units requires the exterior stone surface to be polished down to a very thin layer in order to improve light transmittance. The building's stone appearance has been challenged by people throwing rocks from the street which penetrated the stone façade. Other stone façades have followed the E.N.S.A.D. project with the hope of resisting much more severe attacks. The Israeli Foreign Ministry Building provides a beautiful stone façade designed to resist bombs. The façade

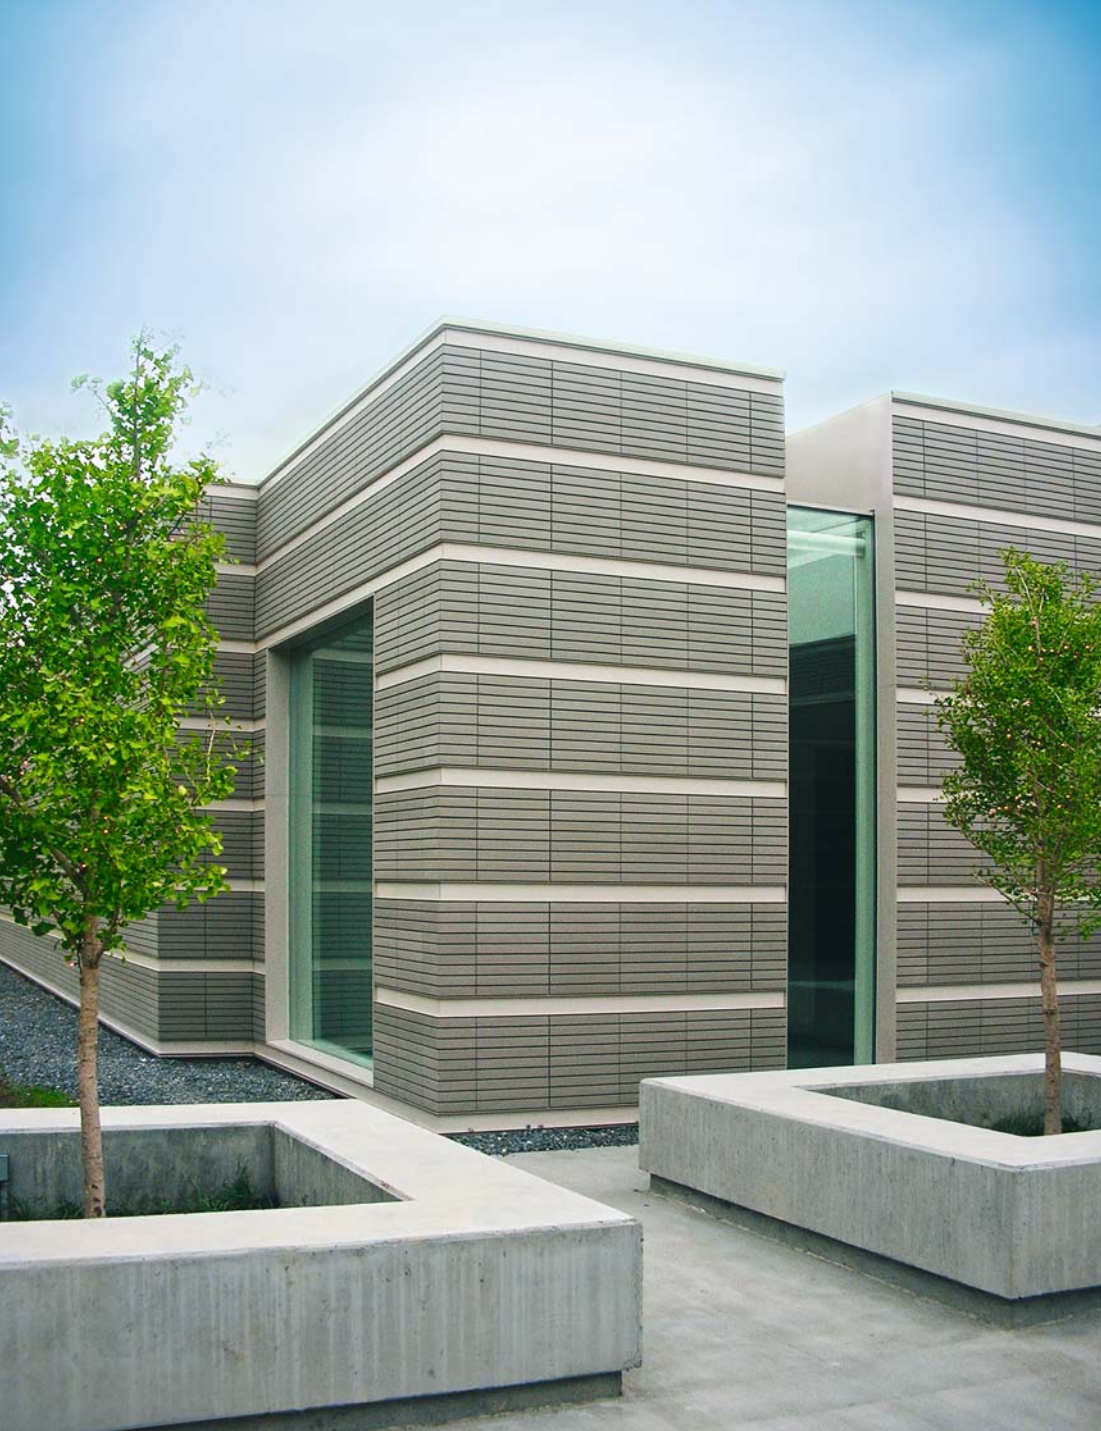
Terra-cotta panel façade, designed by Goettsch Partners, Hessel Museum, CCS Bard College, New York, 2006.

has challenged that perception with masonry structures that are light and fluid. His buildings celebrate the ingenuity of a great designer who was not limited by Uruguay's construction materials or labor force. Similar to brick, the use of terra-cotta is experiencing a re-birth in modern architecture. Many architects had abandoned terra-cotta as an old fashion decorative element prone to corrosion problems in buildings from our past. Architects such as Goettsch Partners have given this traditional material a dynamic new life in modern architecture with terra-cotta panels designed to resist weather and corrosion.

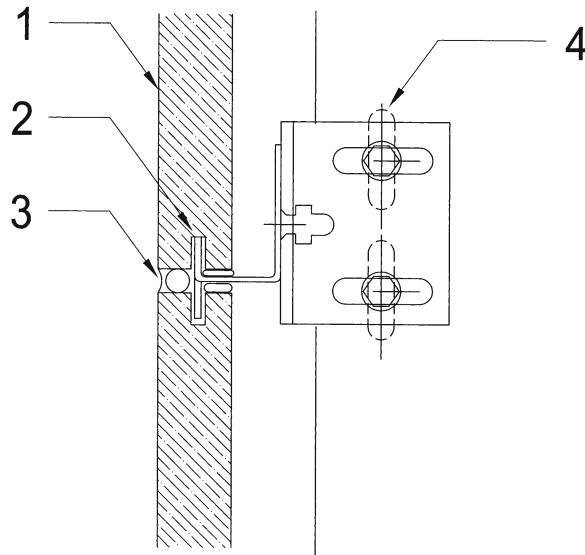
Section through marble connection

- 1 Marble panel 3cm or 4cm (1 1/4–1 1/2 inches)
- 2 Stainless steel bent plate
- 3 Backer rod and sealant
- 4 Galvanized steel angle connection back to chevron shaped steel column

At the conclusion of the design and testing phase of the project, 44,000 pieces of Alpha Gray marble from Carrara, Italy, were used to clad the perimeter columns of the Amoco Building. The work was completed in 1972. The average stone size was 127 x 107 x 32mm (50 inches high by 42 inches wide by 1 1/4 inches thick), except for the reentrant corners where the thickness of the panels was increased to 38mm (1 1/2 inches) from the 42nd floor and above. The increased stone thickness at these locations was to compensate for the higher anticipated wind loads at the upper corners of the building. The marble panels were supported by 152mm long (6 inches) stainless steel bent plates connected to galvanized angles that were stud bolted into the structural steel chevron shaped columns. The marble panels had kerfs cut into them to receive the stainless steel bent plate. The downturned tabs of the bent plate provided lateral support for the stone below and the upturned tab provided lateral/bearing support for the stone above. Each piece of marble was independently supported back to the adjacent steel column. After installation, all of the joints between the marble panels were filled with sealant.

In 1979, inspection of the building indicated crescent shaped cracks in approximately 230 marble panels. The observed crescent shaped cracks occurred in the panels at the 152mm long (6 inches) stainless steel lateral connection points. Between 1979 and 1985, the

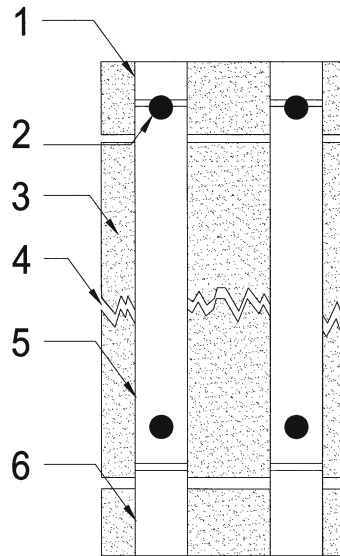
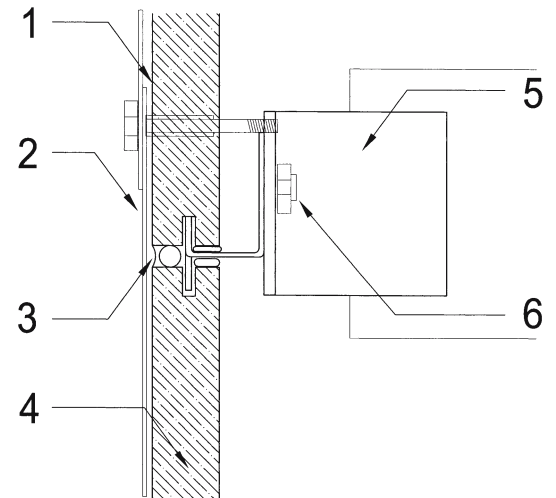
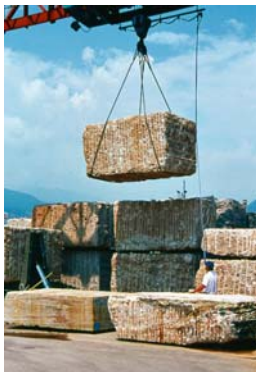
right Temporary strapping detail

- 1 Panel and strap above
- 2 Bolt
- 3 Marble panel
- 4 Theoretical crack location
- 5 Stainless steel straps
- 6 Panel and strap below

- 1 Stainless steel bolt
- 2 Stainless steel straps painted white
- 3 Existing backer rod and sealant
- 4 Existing marble panel
- 5 Existing galvanized angle connected back to structure
- 6 Existing stud weld connection to stainless steel plate

decided to remove the marble panels from the building. Stainless steel straps, color coated white to match the marble color, were bolted through the marble into the supporting angles to prevent any failing stone from coming off.

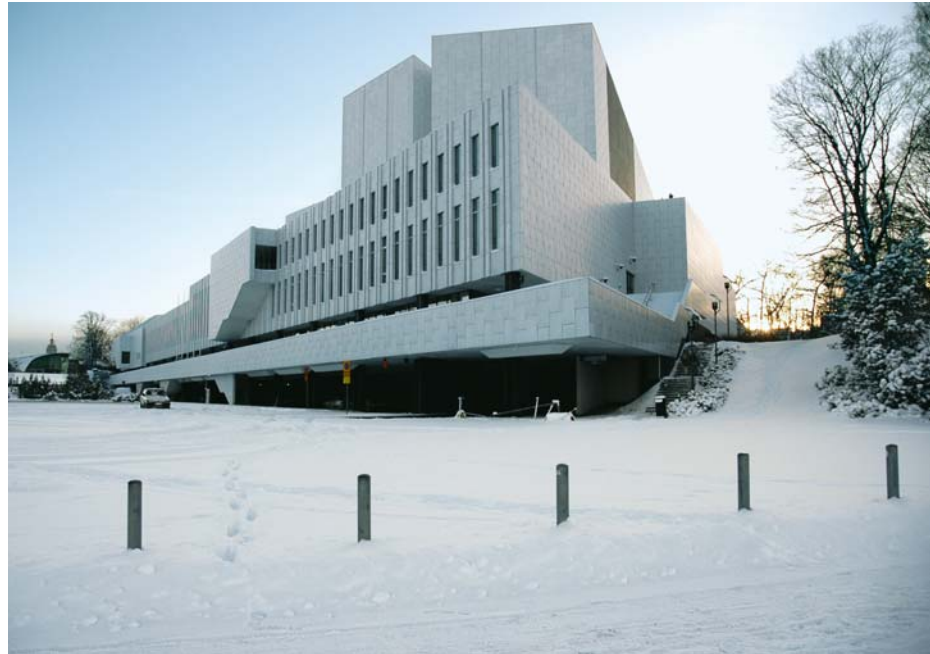
The re-clad Finlandia Hall remains stark white as compared to the neighboring hotel re-clad in white granite.

page 19 above Finlandia Hall was constructed between 1967 and 1971 using white Carrara marble with a distinctive stone veining pattern rising diagonally from the panels.

below Finlandia Hall. Photo of bowing replacement panels taken in the winter of 2006.

In July 1991, safety nets were hung along the length of Finlandia Hall to protect pedestrians from potential cladding failures from above. Similar to other projects, the stone panels on the north face did not suffer from the same dishing as panels on the east, west, and south. What is unique about Finlandia Hall is not the problem, but the solution. The government officially protected Finlandia Hall in 1993, declaring that the exterior should be kept “equivalent to the original”. The appearance of the marble was required to resemble the original stone, even down to the pattern of the stone veins rising diagonally from the left to the right on the panels.

In 1997, re-cladding of Finlandia Hall with white marble was started. Work was completed in May 1999. In total, 7,000m² (75,320 square feet) of panels were replaced at a cost of over 3 million Euros. In autumn 2001, just three years after Finlandia Hall had been re-clad, it was realized that new panels were bending. Measurements have shown that the renovated walls of Finlandia Hall have deteriorated. The reduction in the strength of the marble since the slabs were replaced is 20–30 percent. Panels installed in autumn 1998 are bowed more than those installed the following spring. The reason for this can be attributed to the cold winter in Finland in

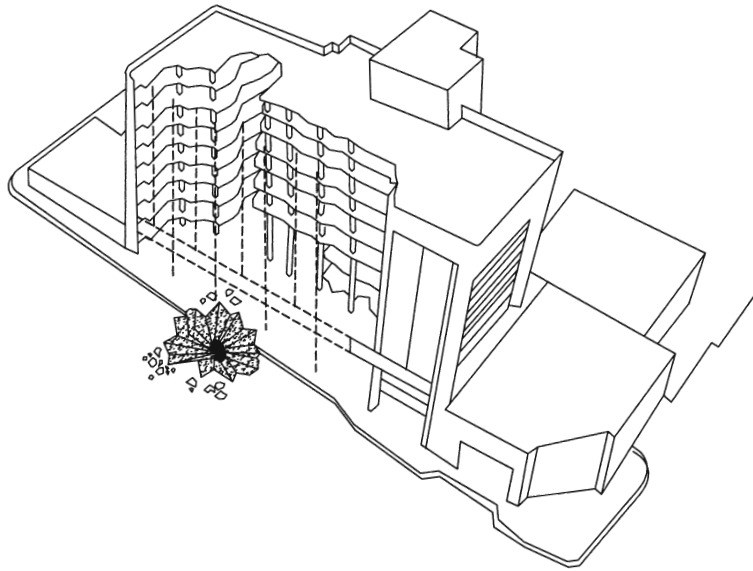
The Murrah Building destruction came from a truck filled with 4,000 pounds of explosives parked less than 3m (10 feet) from the face of the building.

On April 19, 1995, the Alfred P. Murrah Federal Building was destroyed by a truck bomb. The truck, which carried thousands of pounds of explosives, was located less than 3m (10 feet) from the front of the building. The Murrah Building and site proved to be ill prepared for this type of impact. The bombing forced the United States Government and America to rethink how its government buildings should be designed against acts of terrorism, and concrete and stone were part of the solution. Following the Murrah Federal Building collapse, three major design considerations have been developed for buildings of higher-level security: maintaining stand-off distance to a building, preventing progressive collapse to a building structure, and minimizing debris mitigation.

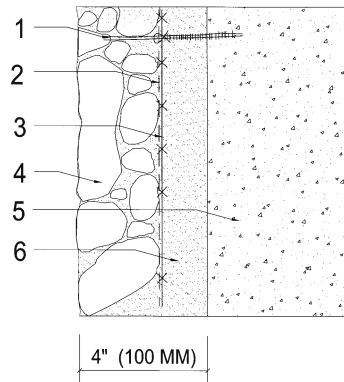
right The stone barrier wall at the main entrance

- 1 Form tie voids to be grouted solid
- 2 25 x 25mm (1 x 1 inch) steel mesh
- 3 15.2 x 15.2cm (6 x 6 inch) welded wire fabric (wwf) secured to form ties
- 4 Stone
- 5 Structural cast in place concrete wall
- 6 Grout

A new stone-setting technique, eliminating the voids in the wall, had to be developed for this project. In order to minimize debris in the event of a blast, 27.58 MPa (4,000 psi) grout was required to secure the veneer stone to the concrete wall. The problem was how to achieve a monolithic pour. How could the contractor ensure that the high-strength grout would flow around the voids in the stone? Learning from several mock-ups, the solution was a new method for constructing a stone wall. The process involved attaching 3.8cm (1 1/2 inch) thick furring strips to the face of a

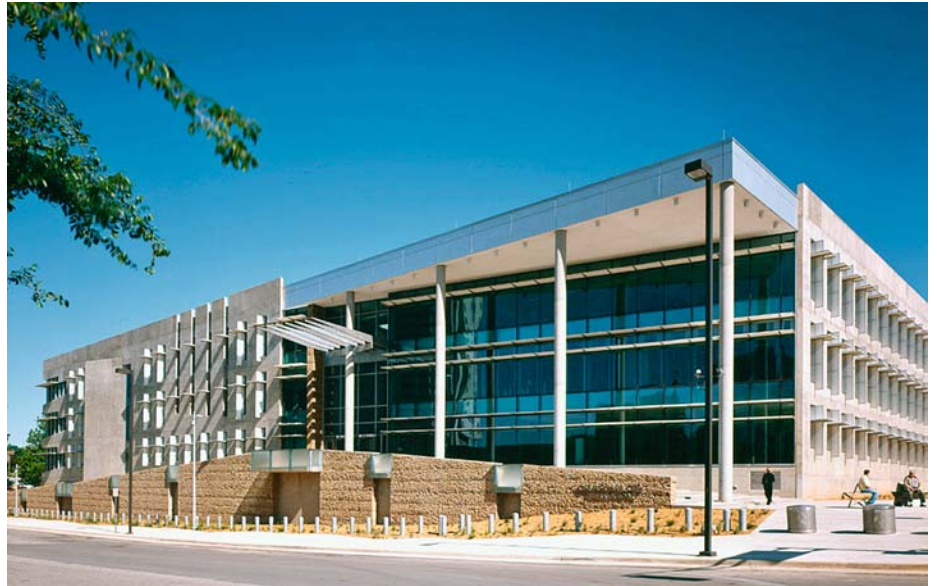
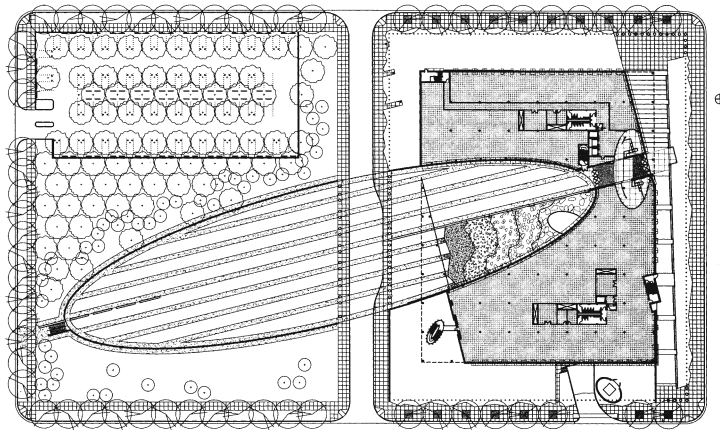
Front entrance to the Oklahoma Federal Campus Building, 2004.

The ground floor plan of the Oklahoma Federal Campus Building provides a perimeter of bollards and a stone wall at the main entrance to protect the face of the building.

The building structure would be one of the first new federal office buildings requiring blast protection. Designed by the architectural firm of Ross Barney + Jankowski, the Federal Campus Building in Oklahoma City is a 16,815m² (181,000 square foot) office building occupying the southern block of a two-block site. The site topography influenced the design of the building in such a way that the east wing of the building is three stories in height while the west side is four. To allow as much daylight as possible into the heart of this large floor plan, a large elliptical courtyard was incorporated into the design. A large window,

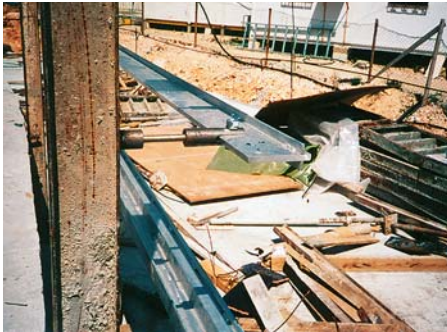
Israeli Foreign Ministry, Jerusalem, 2002. Exterior view of onyx blast-resistant wall.

below Detail of stone connection back to metal framing during construction.

The public building complex at the Israeli Foreign Ministry is configured to accommodate elements appropriate to the State of Israel and its ceremonial functions. In ceremonial fashion there is an atrium and reception hall for heads of state and dignitaries. This was a structure that had to be both beautiful and safe. The innovative design of the wall assembly for the reception building consists of a structure that permits light penetration while maintaining heightened security requirements. The stone wall system has been designed specifically to resist the horizontal thrust that would result from an exterior bomb blast. The central structure of the atrium consists of 12 concrete columns that support a skylight roof above. A steel frame is bracketed off of these columns to provide a secondary outer structure. This second structure consists of 20 x 10cm (7 4/5 x 3 9/16 inch) elliptical steel columns that support the barrier wall. This barrier wall is enclosed by 30 horizontal aluminum channels, which carry 3cm (1 1/4 inch) onyx panels.

Directly behind the stone panels are a series of vertical airplane-gauge stainless steel wires that are suspended from a flexible 5cm (2 inch) diameter steel pipe. The wall system has been designed to resist an exterior blast, which would be absorbed by the stone and secondary aluminum structure. Wooden screens located along the walkways in the atrium provide additional protection for occu-

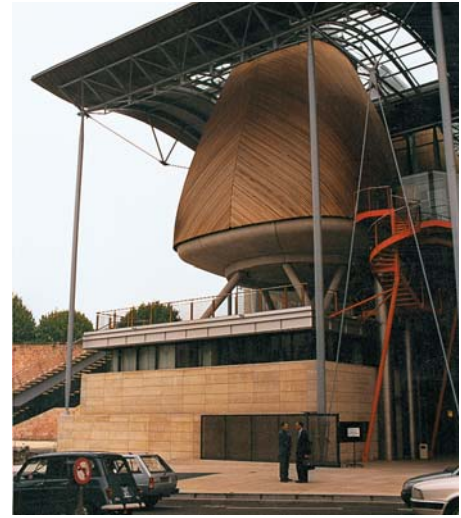
below The new Palace of Justice building, completed in 1999, was constructed with a stone base composed of panels that were cut too thin and broke easily under contact.

below right The original Palace of Justice building was constructed of large stone blocks that have weathered with time.

The base of the building consists of a limestone wall. Using the same stone as the original Palace of Justice building, the designers tried to make a connection between the two very different buildings. In an effort to match the stone of the old Palace of Justice, the new stone was sandblasted. This gave the stone a weathered appearance and texture similar to the original weathered building. However, the new stone cladding was made of thin stone panels and smaller stone blocks than were used with the old Palace of Justice. It is believed that the loss of thickness due to

sandblasting contributed to a design that could not resist the impact loads often found at the street level of a building. The stone at the base of the new building underwent regular breakage and had to be replaced with thicker stone.

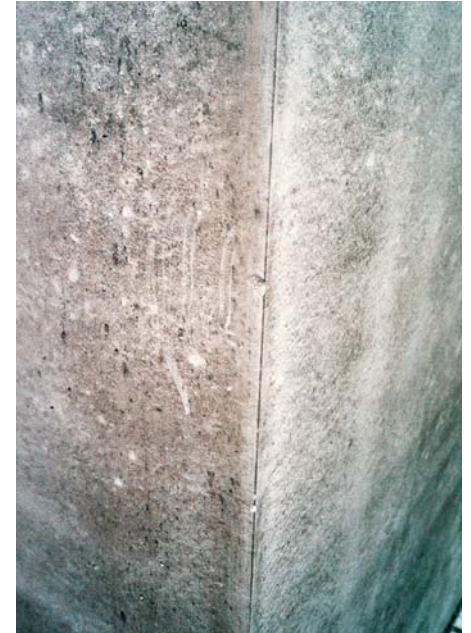
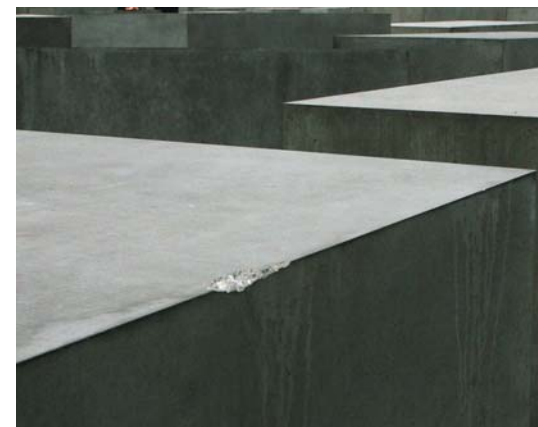
right In contrast to the Holocaust Memorial concrete blocks, beveled edges reduce the risk of chipping at a garden sculpture west of Munich.

Typically sharp corners are hard to maintain with a brittle material like concrete. Traditional cast-in-place corners can be weaker because water leaks out of formwork corners, reducing the water available for full concrete hydration. Chamfered corners are typically used to improve seals and provide a less vulnerable edge to impact forces. Chamfered edges are made with triangular strips. They make strip-

ping the form easier and prevent corners from leaking cement paste. The finished product is also less vulnerable to abrasion. Sharp corners are best achieved with watertight, precisely fabricated corners. If the joints are not tight and concrete mix water escapes from the form, color variation and material strength loss can occur. For this reason sharp corners are more susceptible to breakage. The corners at the Holocaust Memorial are in very good condition; however, chipped edges are fairly frequent.

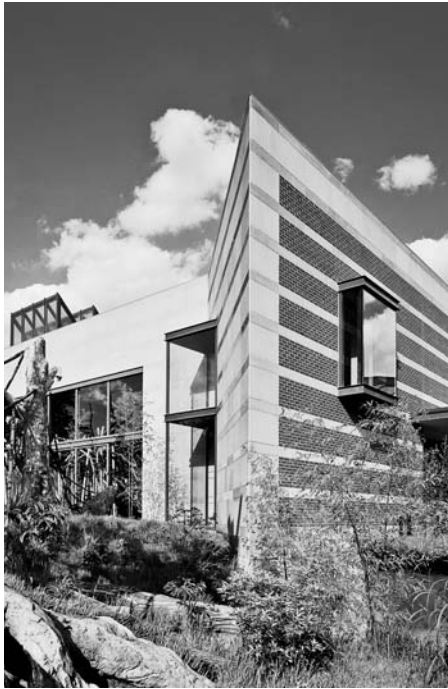
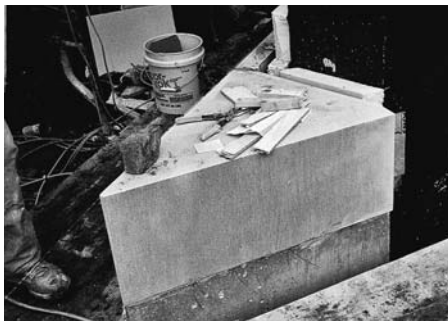
The Lincoln Park Zoo, Regenstein Center for African Apes, designed by Goettsch Partners, has a sharp corner to the exterior gorilla habitat.

Because the corner is exposed to the gorillas and keepers at grade level, the durable corner was fabricated as a solid unit and beveled to resist chipping. Regenstein Center for African Apes, 2004, Chicago.

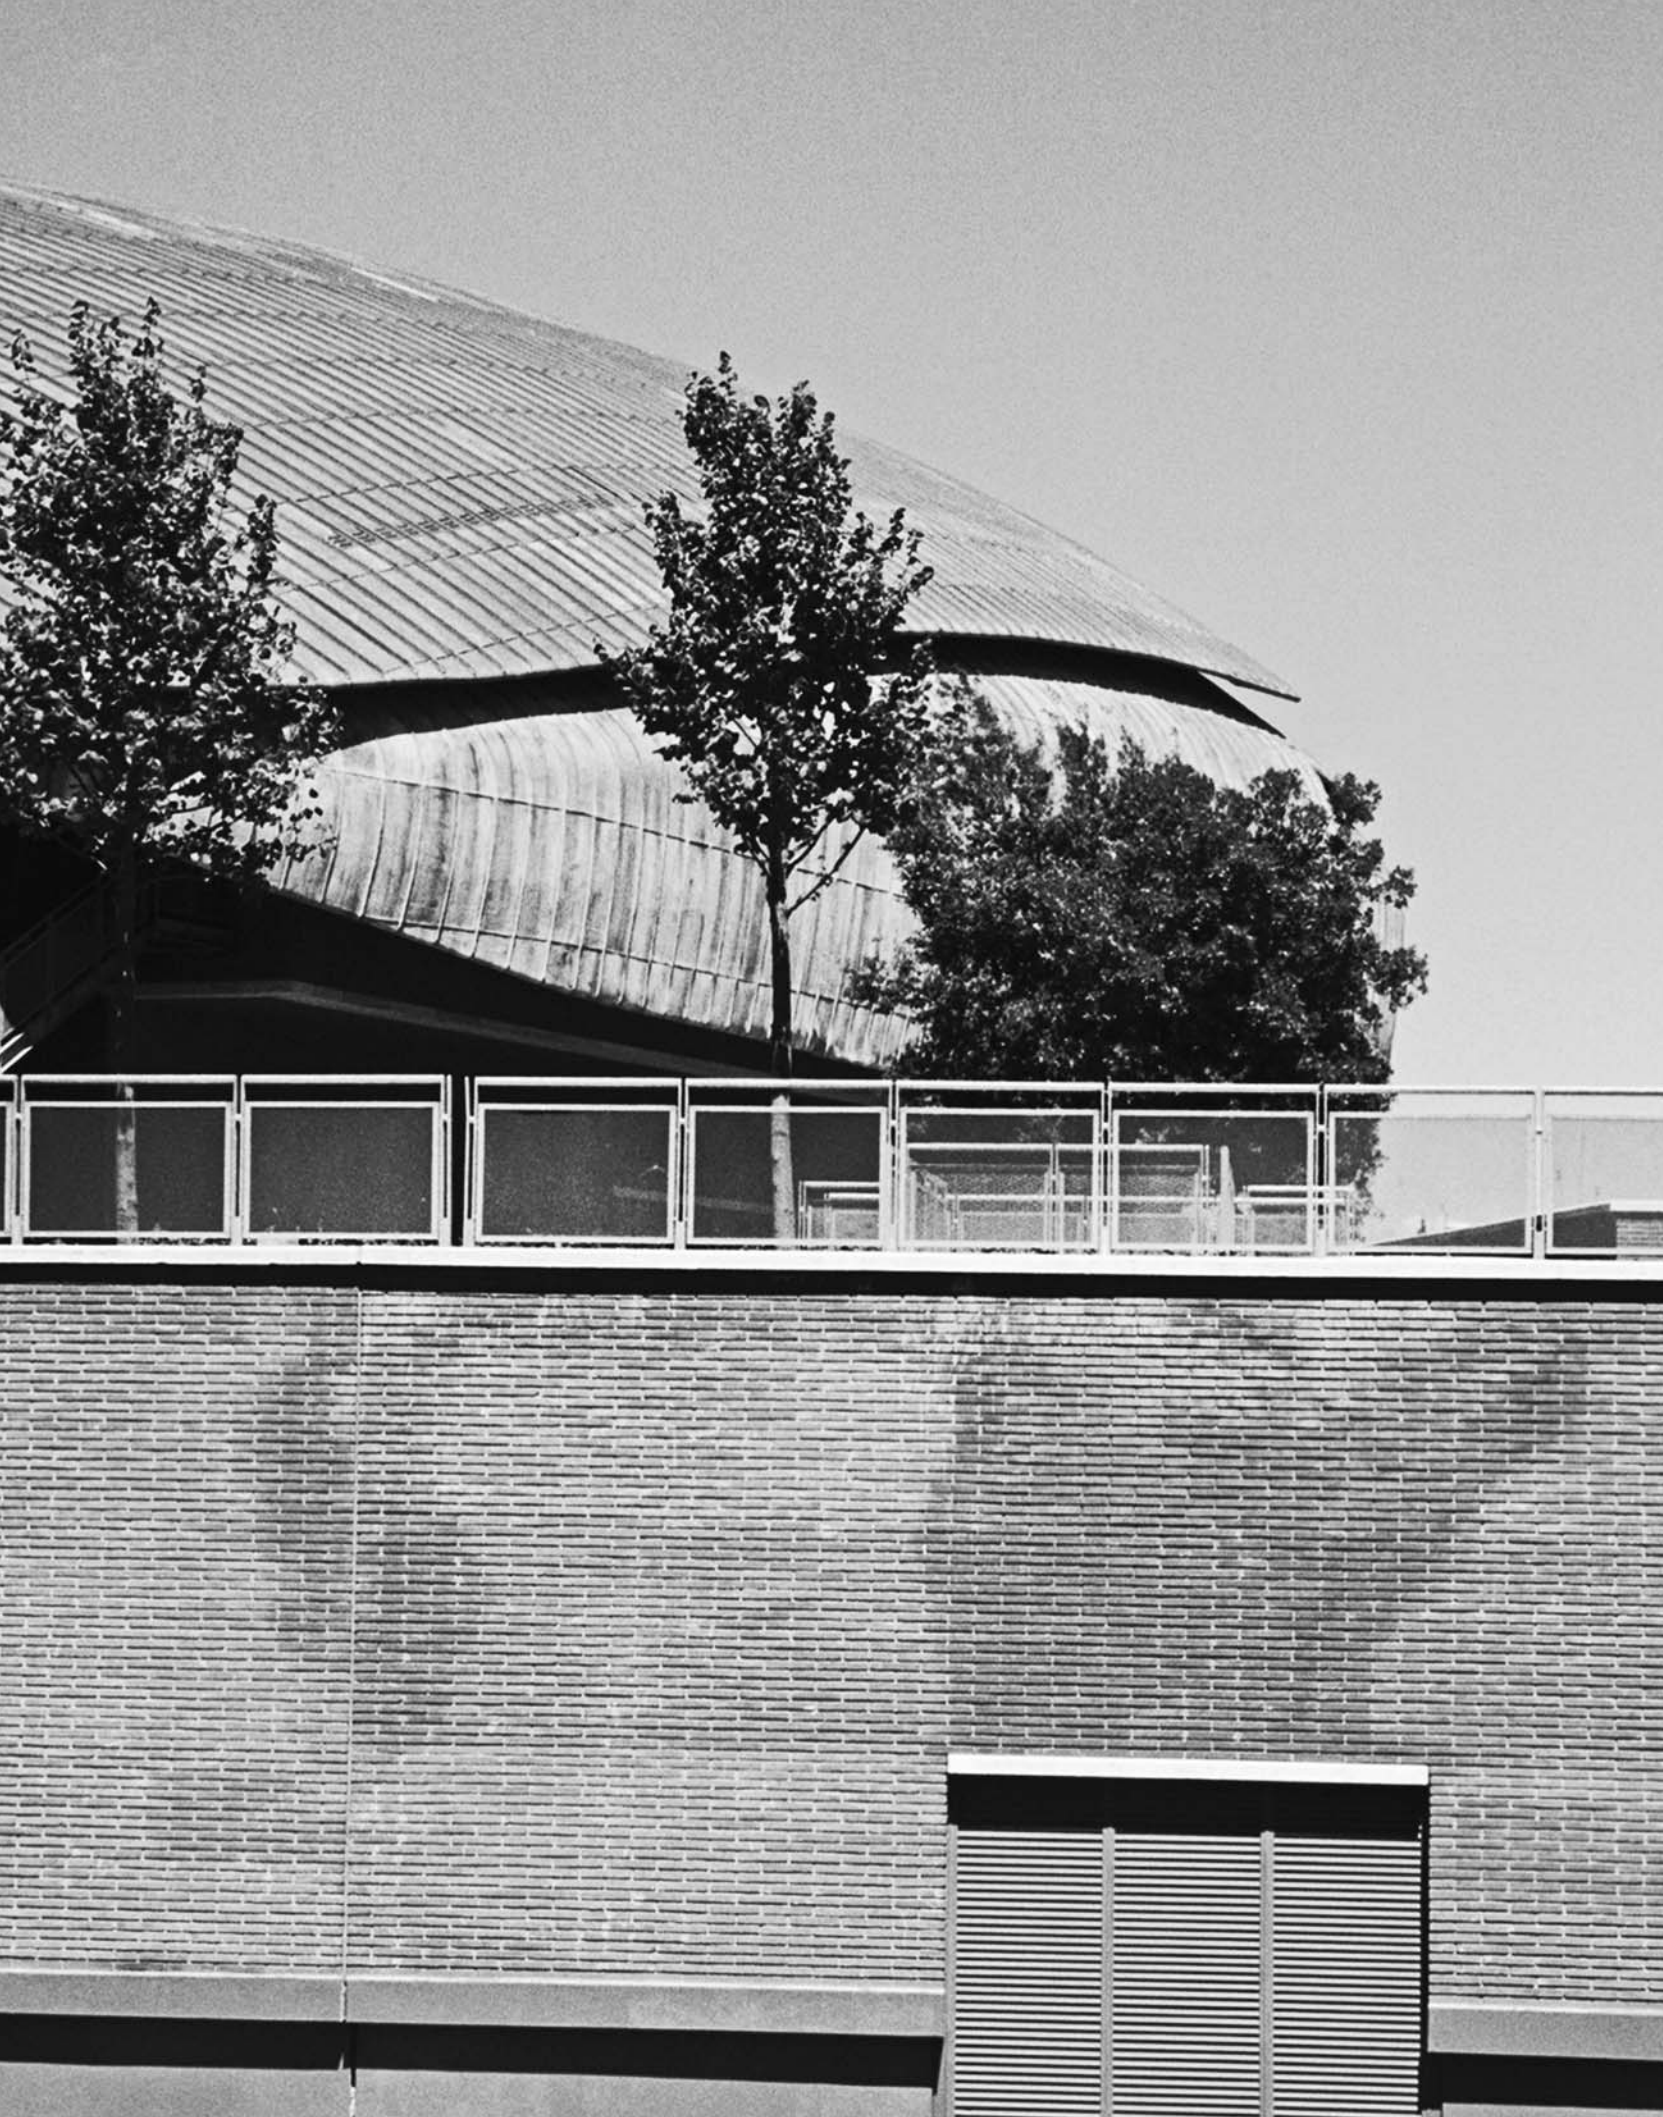
right Large amounts of efflorescence appear on the unprotected exterior walls. Covered walls show no sign of efflorescence. Auditorium Parco della Musica.

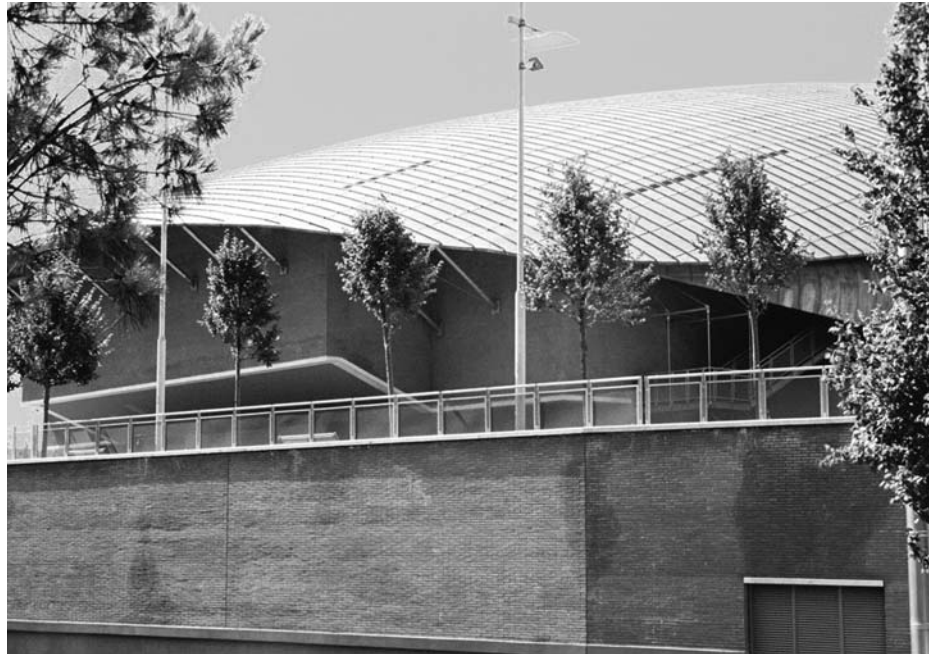
below Raked mortar joints provide poor weatherability as compared to concave or flush joints. Auditorium Parco della Musica.

properties of the travertine cap material, the stone coping mortar joints on a regular interval allow for a second path for water to penetrate the top horizontal surface. On the face of the wall the masonry joints have been raked back for aesthetic reasons. Although this helps create a richer wall texture, the raked joints provide an easy path for water to infiltrate the wall. The ability of water to move through the wall is facilitated by the lack of flashing below the coping and the absence of effective weep holes at the base of the wall. Thus penetrating water can be trapped in the wall cavity and will evaporate through the body of the brick and mortar joints to the exterior. This moving water carries soluble components and eventually evaporates on the face of the building, leaving patches of white powder in its wake. It should be noted that the masonry exterior walls of the building that are protected from rainwater by large overhangs do not show signs of efflorescence. In order to better understand efflorescence and the potentially serious nature of the defect, one needs to examine the chemical composition of the problem.

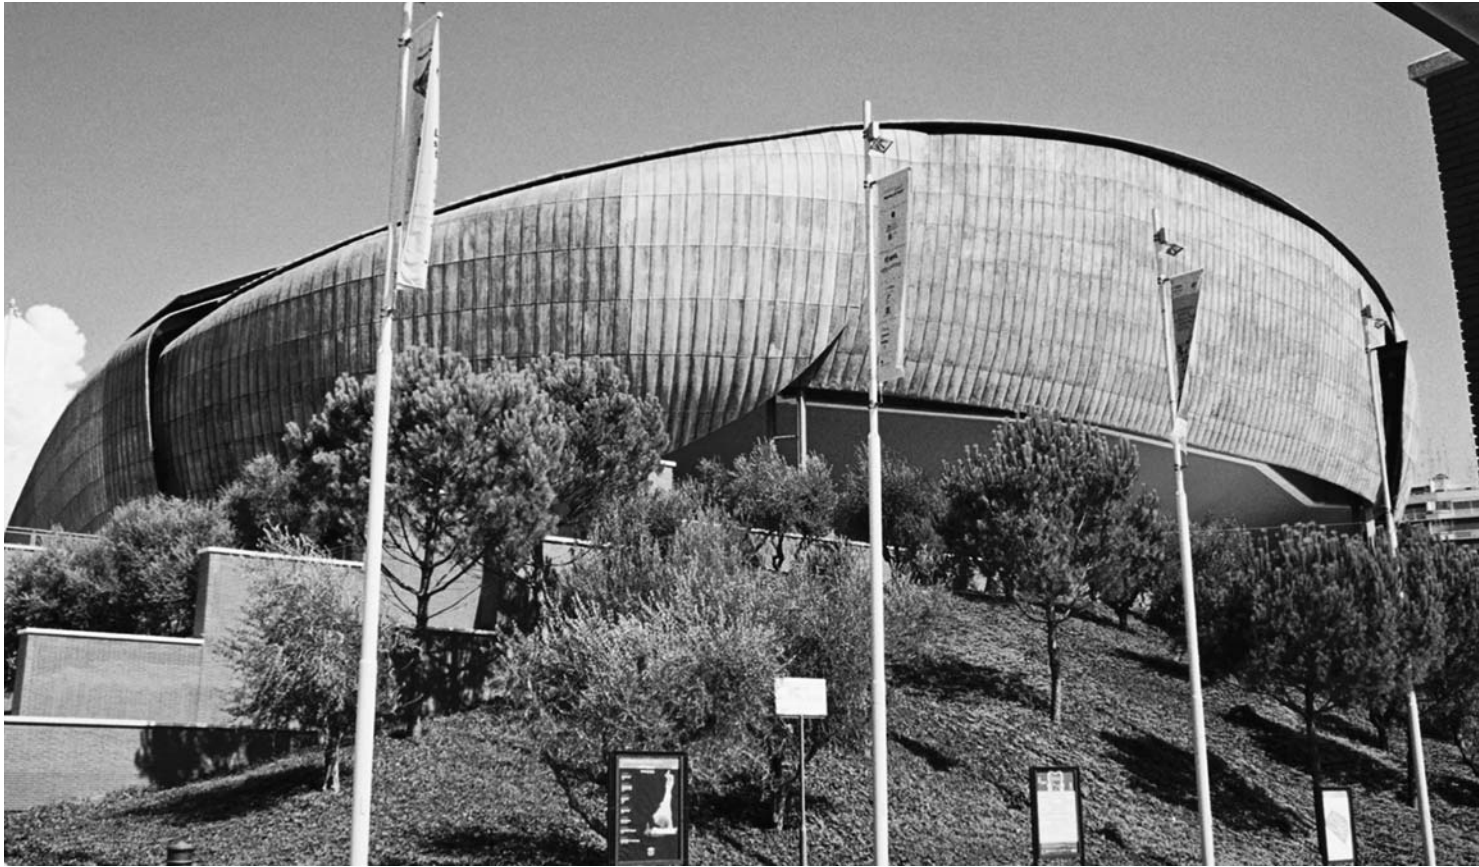
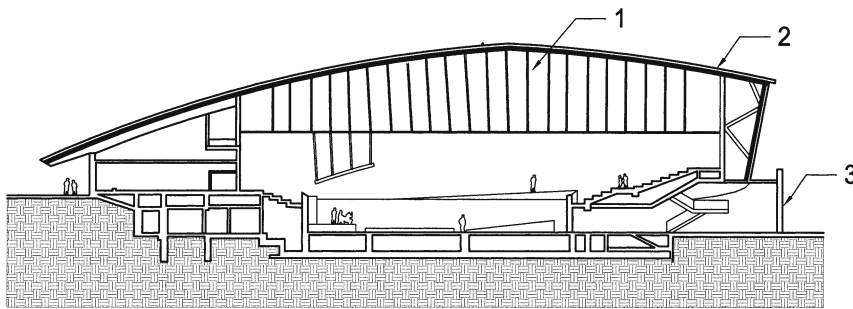
above Large wood-framed structure wrapped in metal rests on masonry walls. Auditorium Parco della Musica.

below Building section of music hall. Auditorium Parco della Musica.

The Auditorium Parco della Musica in Rome was designed to serve as a multifunction complex dedicated to music. Constructed over the remains of a Roman villa dating to the 4th century, the site consists of three concert halls and one large amphitheater. The scale of these "music box" structures is enormous. Each of the building elements resembles a large beetle resting on a masonry plinth surrounded by luxurious vegetation. The goal of these brick and metal enclosures was to acoustically separate each of the concert halls. All three of the buildings share similar details. The roofs are composed of metal-standing seam roofing, covering a wood structure, with a concrete foundation surrounded

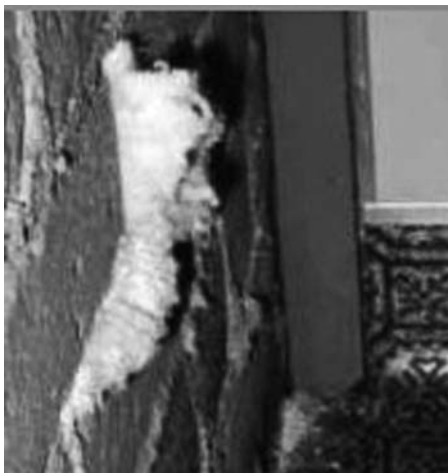
Crystallized efflorescence in a masonry wall.

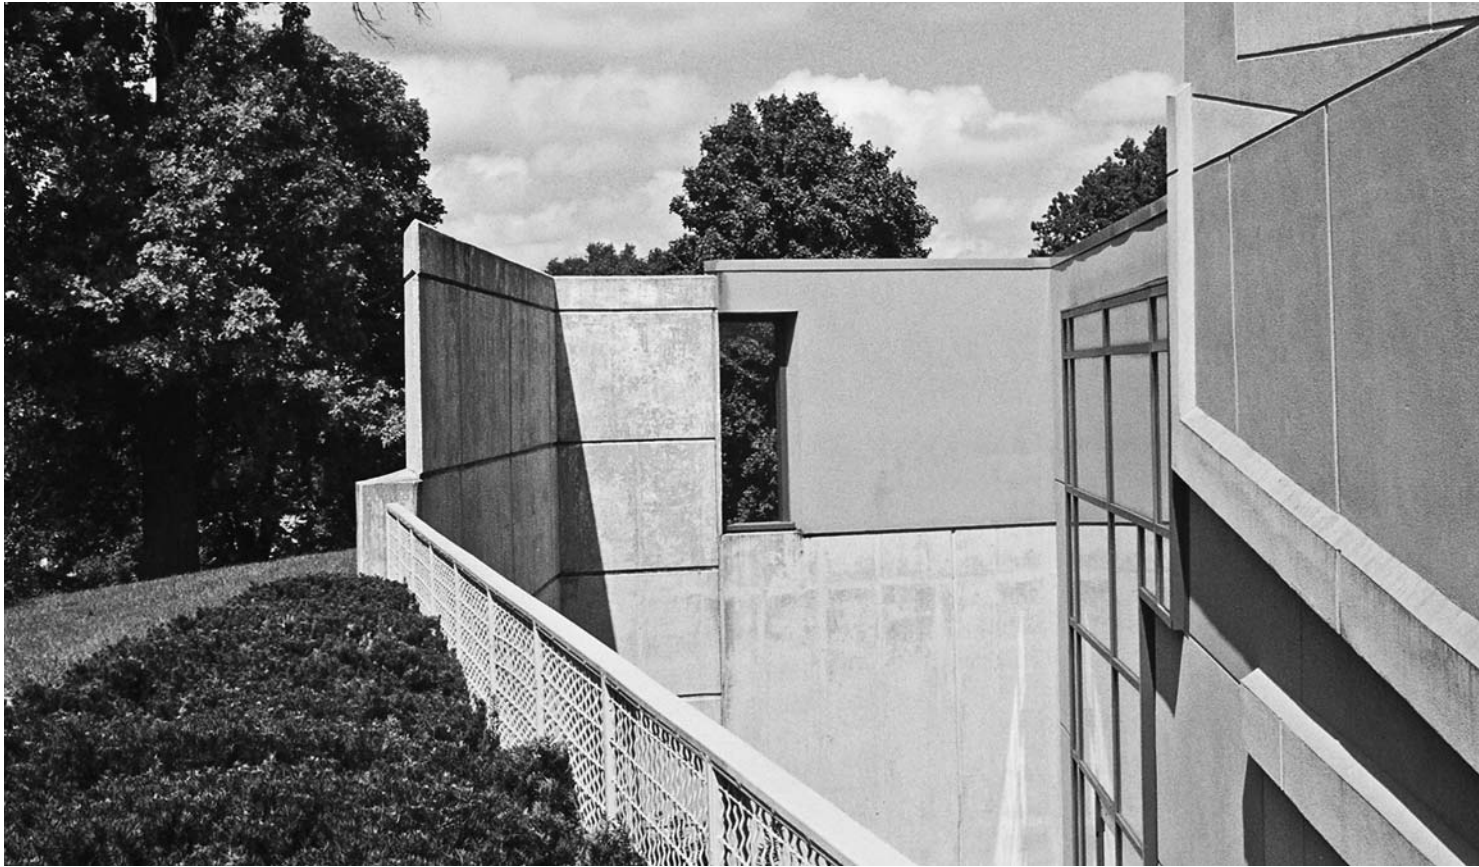
Exposed concrete wall shows evidence of slight efflorescence. Expansion of University of Cincinnati School of Architecture and Interior Design.

The University of Cincinnati School of Architecture and Interior Design expansion contains exterior concrete walls that are exposed to rain on all sides. These walls exhibit a mild film of efflorescence on the exterior surface noticeable as a white powder substance. However, because the concrete substrate resembles the color and texture of efflorescence, it is not perceived as a problem.

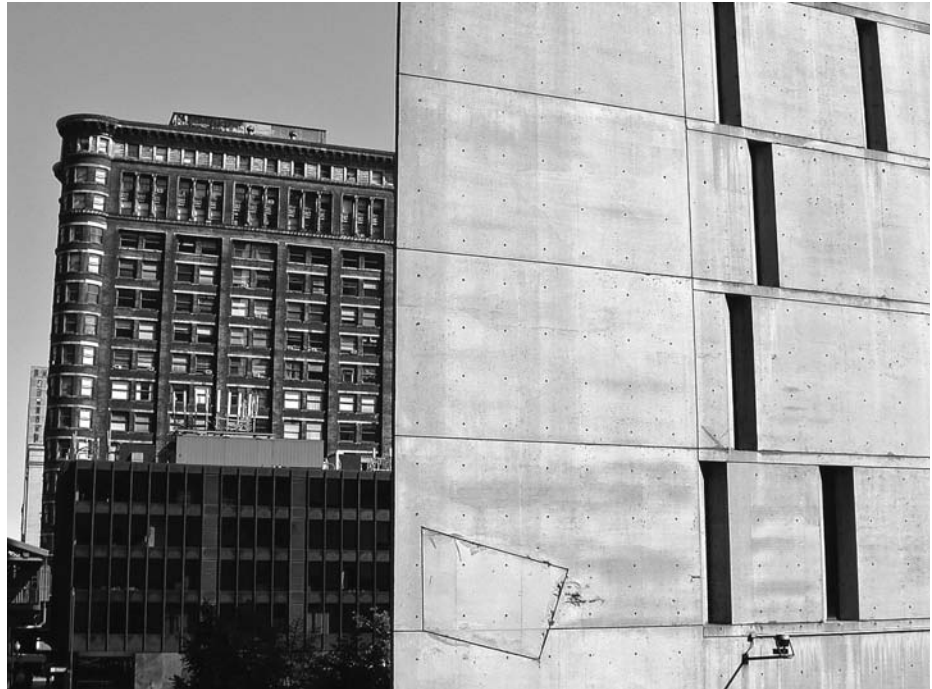
right Spalled concrete at window detail. Metropolitan Correctional Center.

The Metropolitan Correctional Center in Chicago was constructed with sleek concrete walls and narrow windows to prevent the escape of inmates. The building is nestled in the heart of Chicago's downtown business district. Although the walls may prevent the escape of inmates, the passage of water has not been stopped in all areas of the exterior wall. Spalling concrete can be seen as a side effect of moving water and of salt deposits. The white efflorescence film shown near an exterior window provides the smoking gun to a problem of water migration through the wall.

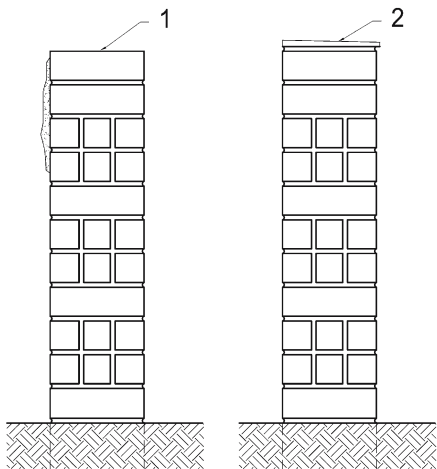
- 1 Existing brick coping allows water to infiltrate the wall
- 2 A solution to the water problem would be to install a metal coping

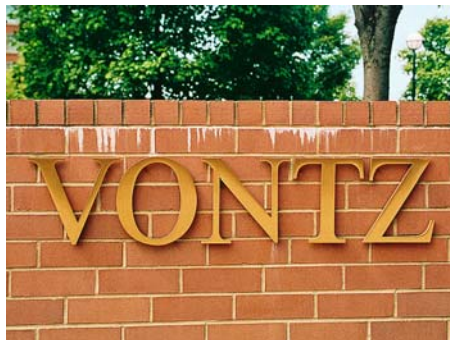
A brick cap above the building sign allows water to infiltrate the wall.

Vontz Center for Molecular Studies.

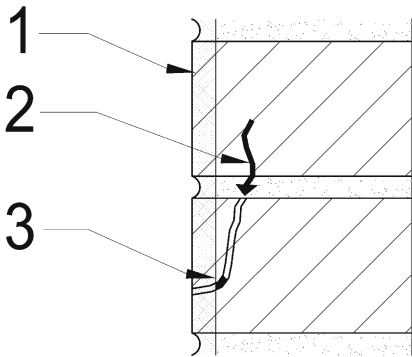
Some water repellants can cause more harm than good.
1 Silicone sealers penetrate the face of the wall.
2 Water penetrates wall through defects, evaporates out as vapor, but leaves salts at line of sealer.
3 Crystallization of salts can cause spalling of surface material from internal pressures.

It can be hazardous to apply seals to walls that contain both moisture and salts. The moisture may evaporate through the treated surface, but salt deposits can accumulate behind the sealer near the surface. Localized accumulation of salts and their crystallization may cause the surface of the material to spall or flake off. The use of a silicone treatment to suppress efflorescence may be dangerous in cases where excessive water migration produces hydrostatic pressure buildup from entrapped salts below the surface. This is particularly true when there are large amounts of salts in the masonry and the units are soft and porous.

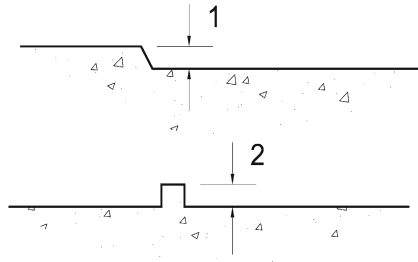
Surface defects in cast-in-place concrete from form joints.

- 1 Offset
- 2 Fin

Cast-in-place concrete forms have size limitations and therefore require joints between units. If these joints are not sealed properly, a surface defect can result. Fins are narrow linear projections on a formed concrete surface, resulting from mortar flowing into the space between the forms. An offset is a step in the concrete surface due to an abrupt change in alignment of adjacent forms. It can occur either horizontally or vertically. Similar to a fin, an offset interrupts the smooth appearance of a surface. For smooth-formed concrete surfaces the maximum allowable offset or fin would be 3mm (1/8 inch).

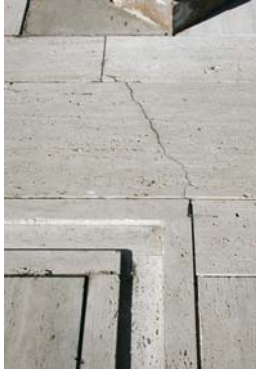
below Small crack in travertine paving, Salk Institute.

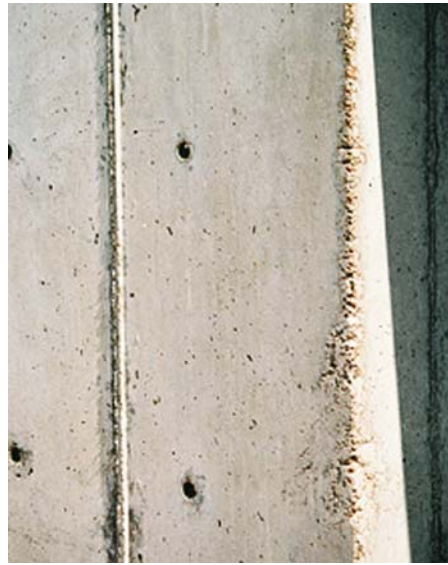
below right Finish, form lines, and tie holes on the original Salk Institute were never intended to be perfect.

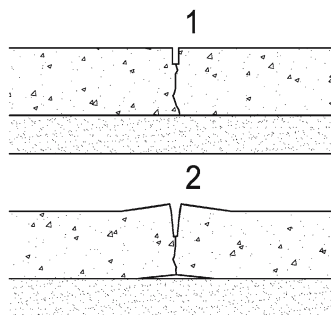
Curling at a saw-cut joint in slab.
 1 Saw-cut joint prior to curling of concrete
 2 Saw-cut joint after curling of concrete

Concrete slabs on grade can curl up at joints and around the perimeter of the slab. In topping slab conditions the top slab can lose contact with the subbase material, curling up at the ends. Curling is most noticeable at construction control joints, but it can also occur at cracks and saw-cut joints. The cause of curling is differential shrinkage that occurs in a slab as the exposed top surface shrinks and

the core does not. Although it is possible to repair curling in most slabs, prevention by controlling shrinkage is preferred. Good mix proportioning, proper curing, and placement of saw-cut joints can help to reduce the effects of curling.

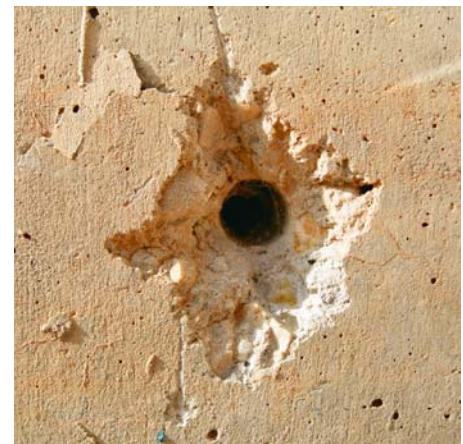
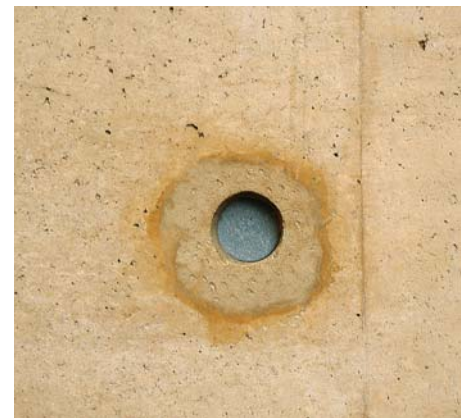
right Colored concrete poses a challenge to repair as seen by tie hole fix at Our Lady of the Angels.

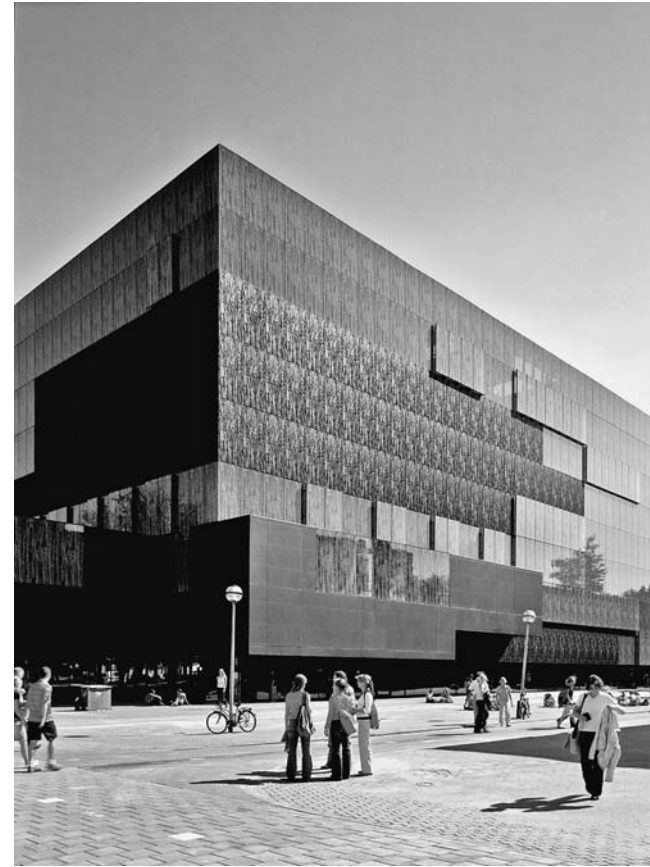
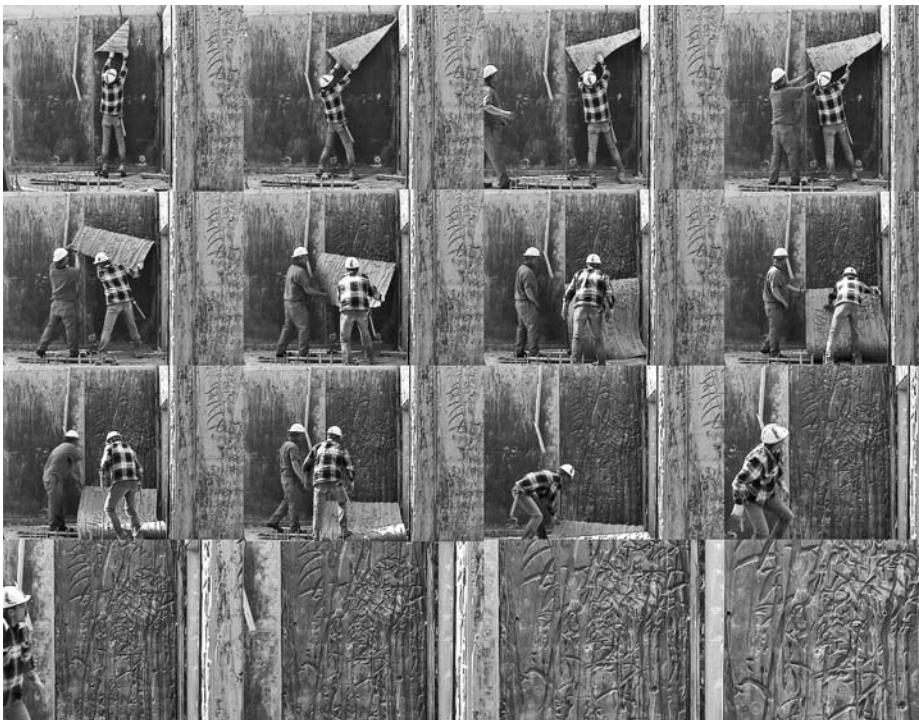
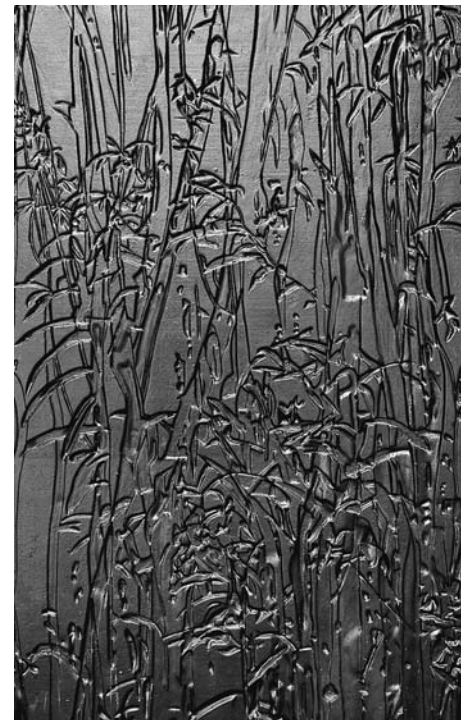
right and below University Library in Utrecht, 2004. Fabrication of rubber mold for precast concrete panels and façade detail.

By this method, the concrete panels provide a three-dimensional surface quality. The concrete has a smooth black-painted surface. The panels were stylized using four gray tones. The relief for the form was manually cut to a maximum depth of 25mm (1 inch) in a sheet of polyurethane. Each gray tone was allotted its own separate plane.

The concrete surface was colored. However, colored pigments in the concrete mix were not used because of cost and potential variations in surface tone. The concrete surface was painted after it had set. Two coats of paint were applied to the interior panels and three coats to the exposed panels of the building.
