failed stone

problems and solutions
with concrete and masonry

Problems and Solutions with Concrete and Masonry

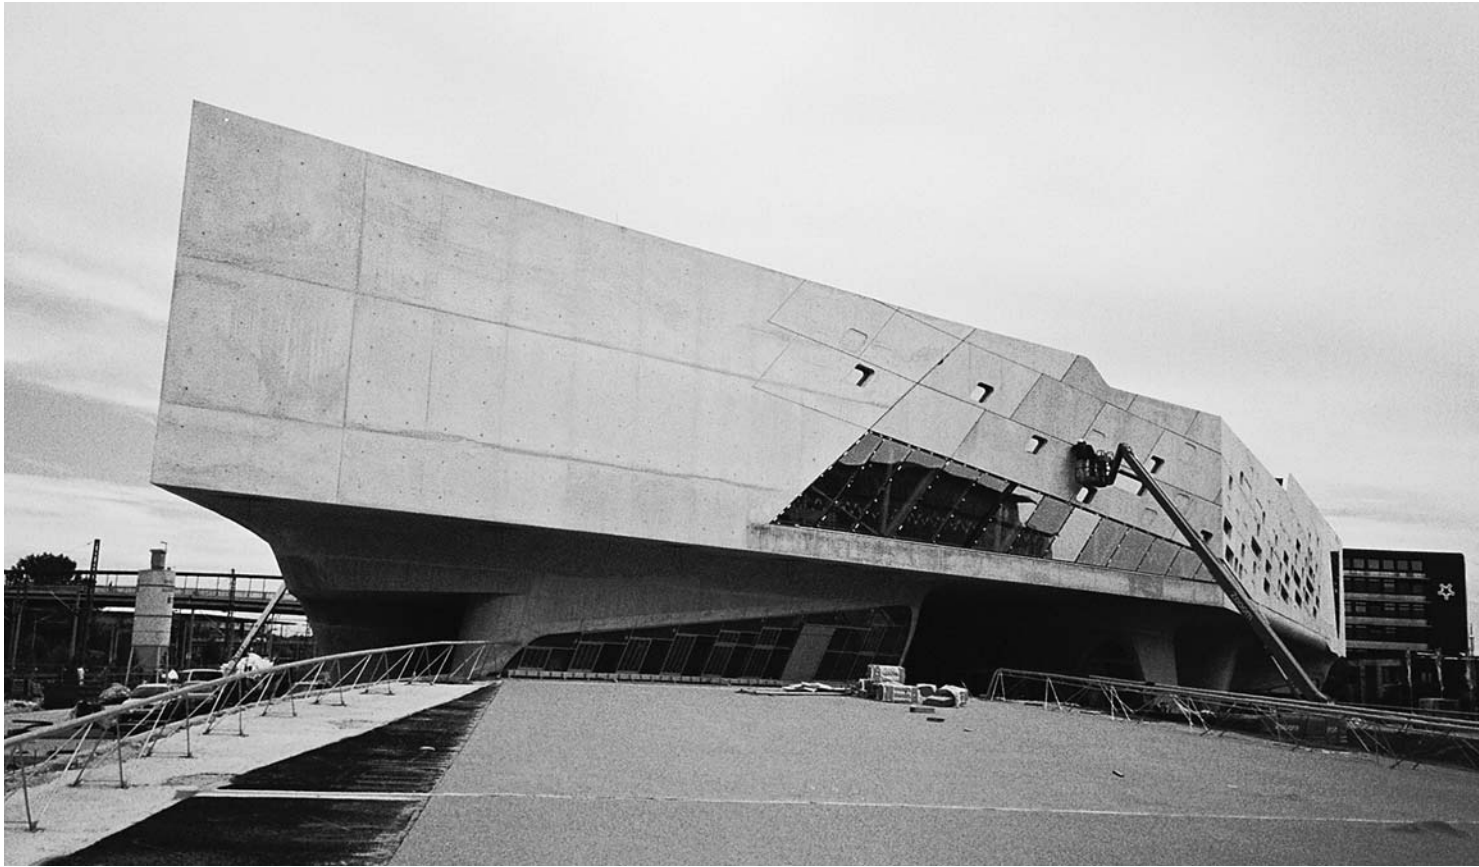
above The Phaeno Science Center, Wolfsburg, Germany, 2005, was constructed with cast-in-place concrete (left side of photo) as well as precast concrete panels. With time the color variation is expected to go away.

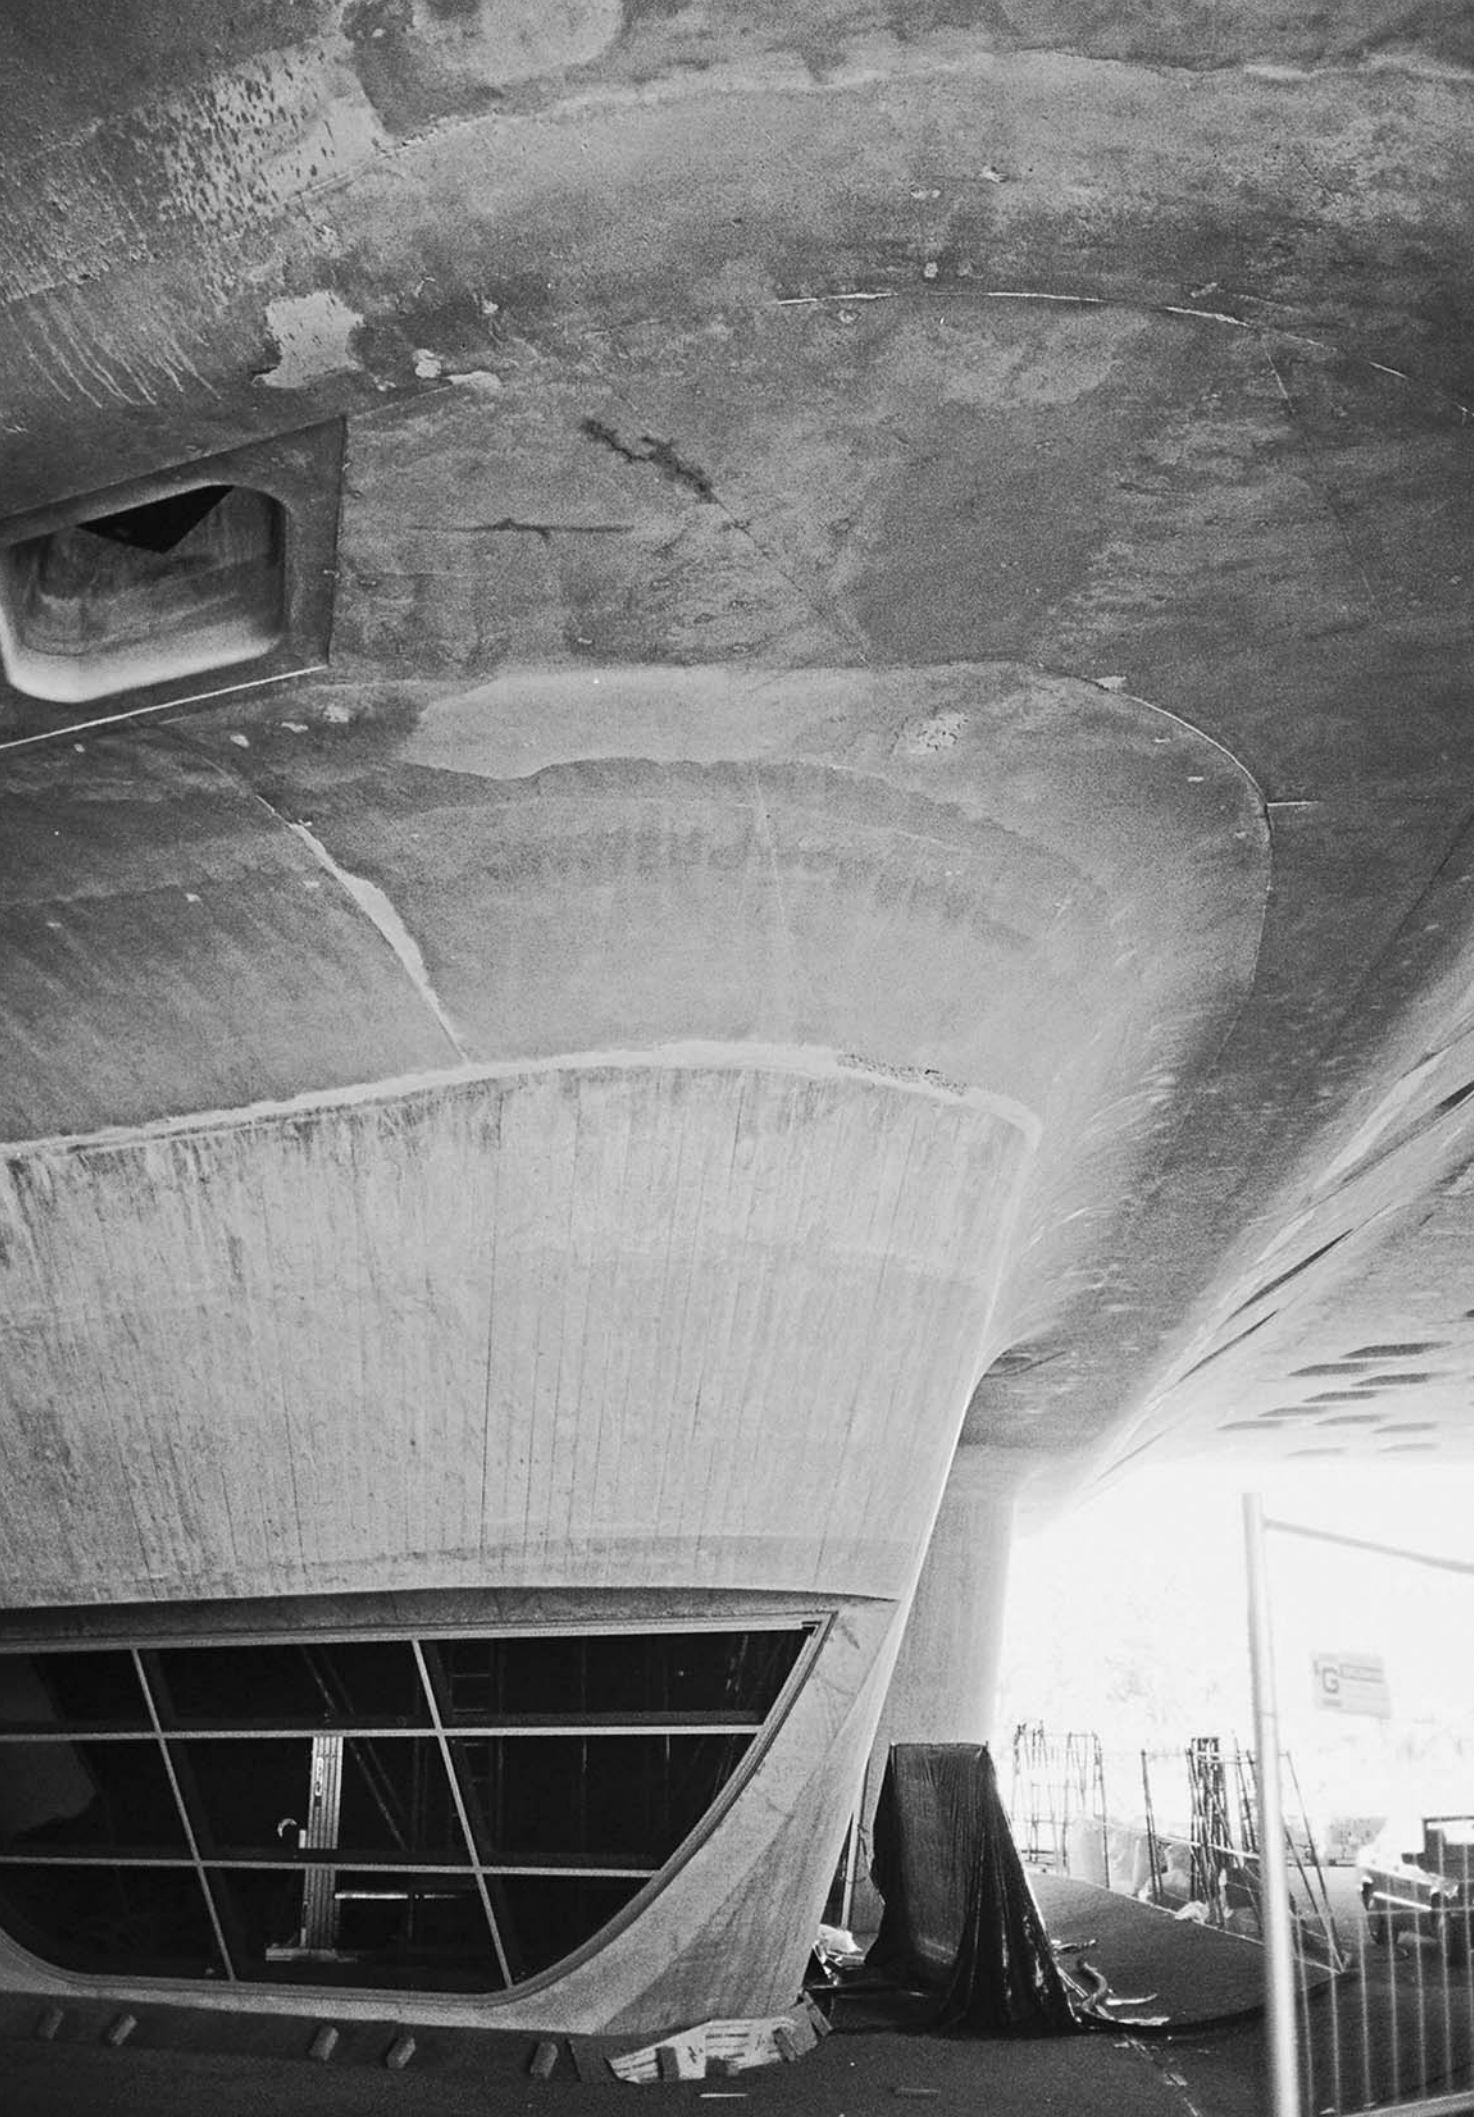
page 60 The self-compacting concrete elements at the Phaeno Science Center, Wolfsburg, which were constructed on site have a fair amount of surface defects at some difficult transitions.

Curing is particularly important to the finish of self-compacting concrete. The Phaeno Science Center battled with trying to provide uniform color and texture for an incredibly complicated building form. The goal was to have everything in the same high-quality surface finish. The cement mix was closely monitored to obtain consistency in color and texture. The surface finish can resemble an elephant skin if the concrete mixture is not kept in constant motion during pouring. For this reason, the mix was pumped into the forms.

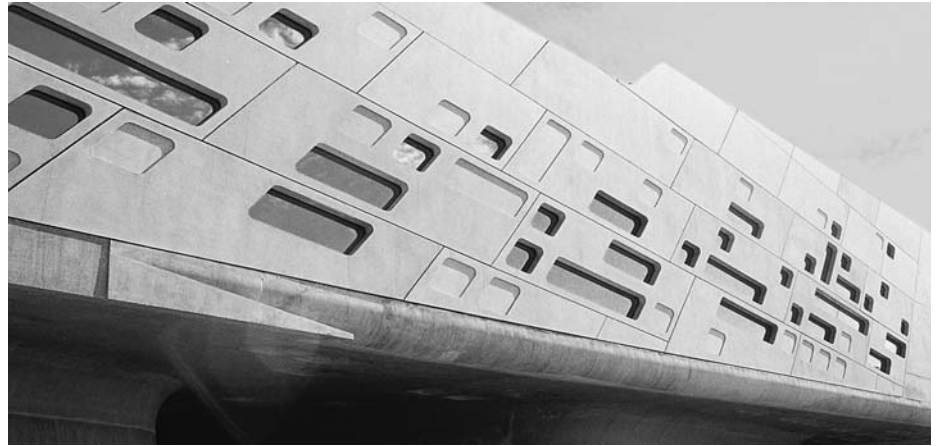
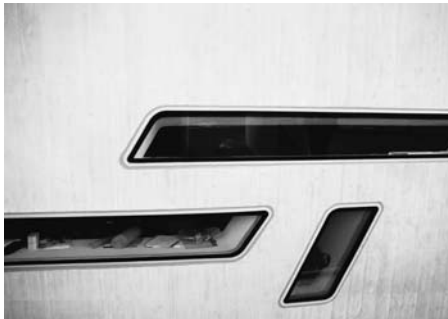
right and below The factory constructed precast concrete panels at the Phaeno Science Center are close to perfect.

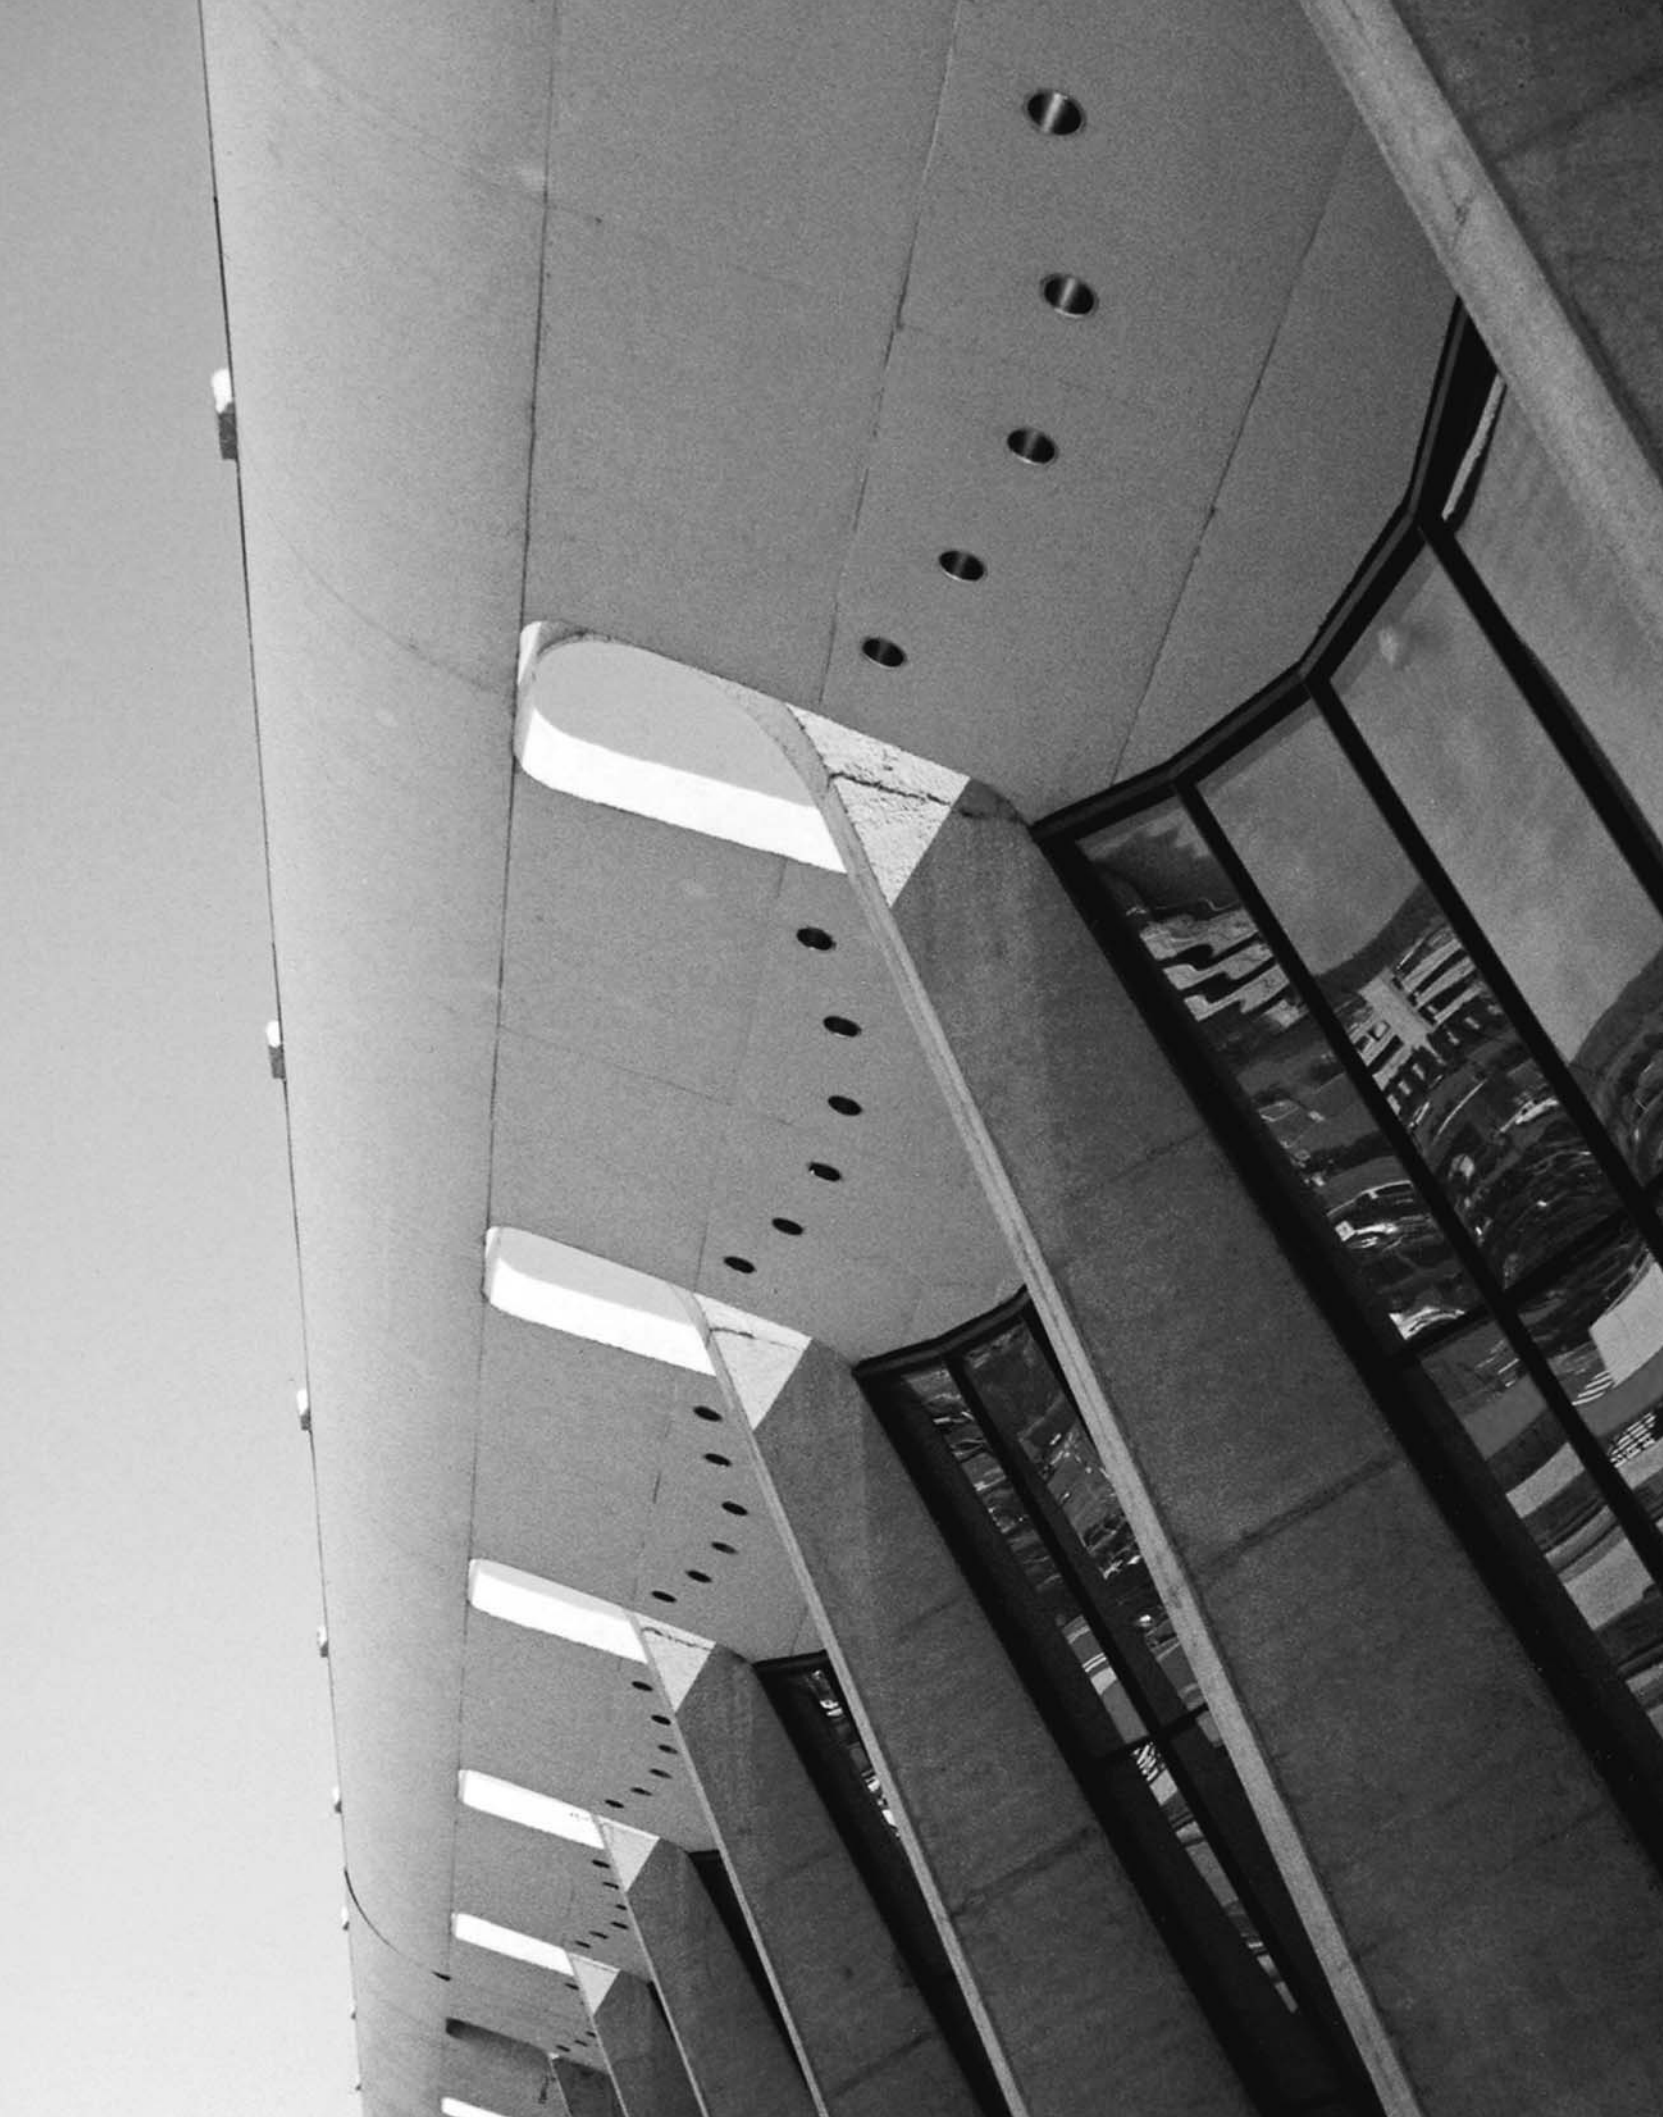
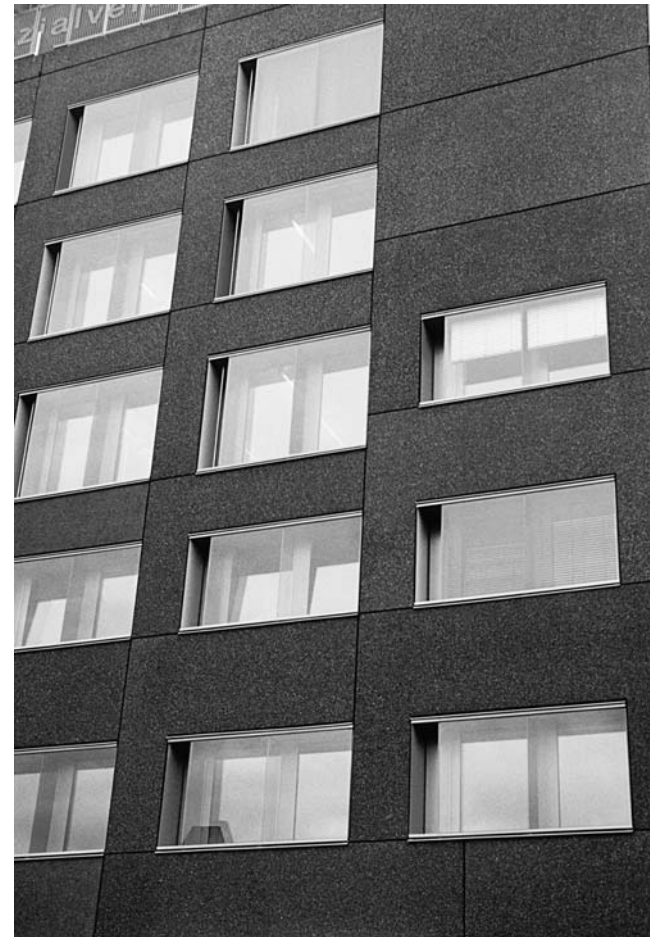
above and right Exposed aggregate in precast concrete panels, Headquarters of Sozialverband Deutschland, Léon Wohlhage Wernik Architekten, Berlin, 2003.

example of the uniform appearance of an exposed aggregate concrete finish. The building's colorful shiny windows stand out in a background of textured black concrete. The precast concrete panel finish was achieved by washing out the paste of the precast panels, exposing the crushed fine black basalt aggregate. The design provides precast corner panels that wrap the edges of the building with large thick returns. The corner edge is a sharp crisp line. The edges of the panels were protected during transportation and installation. Because the panels are elevated above the ground floor of the building, they are not vulnerable to chipping.

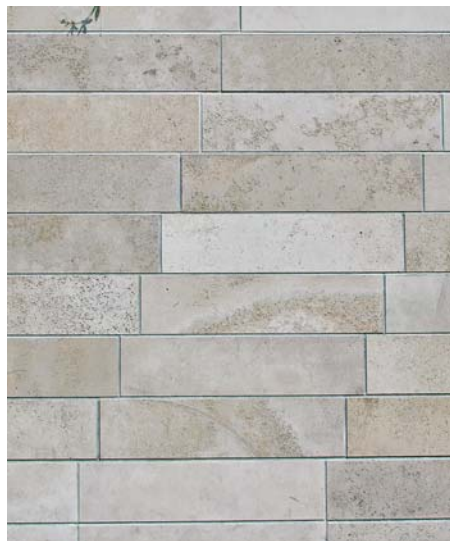
below One out-of-place stone can distract from the uniform veining pattern of a stone wall.

The veining in stone is caused by the presence of trace elements at the time of its formation. Iron oxide makes the pinks, yellows, browns and reds. Most gray, blue-gray and black lines are from bituminous substances. These veins are a distinctive part of a stone's appearance and must be considered in the design and installation of the stone. The natural folds and veins found in marble and some granite create distinctive markings throughout the stone. The quarried blocks are cut and finished for particular patterns. Uncontrolled use of natural stone finishes on a building can appear as a visual defect, making it necessary to commit to a pattern when installing the stone. Understanding the veining patterns

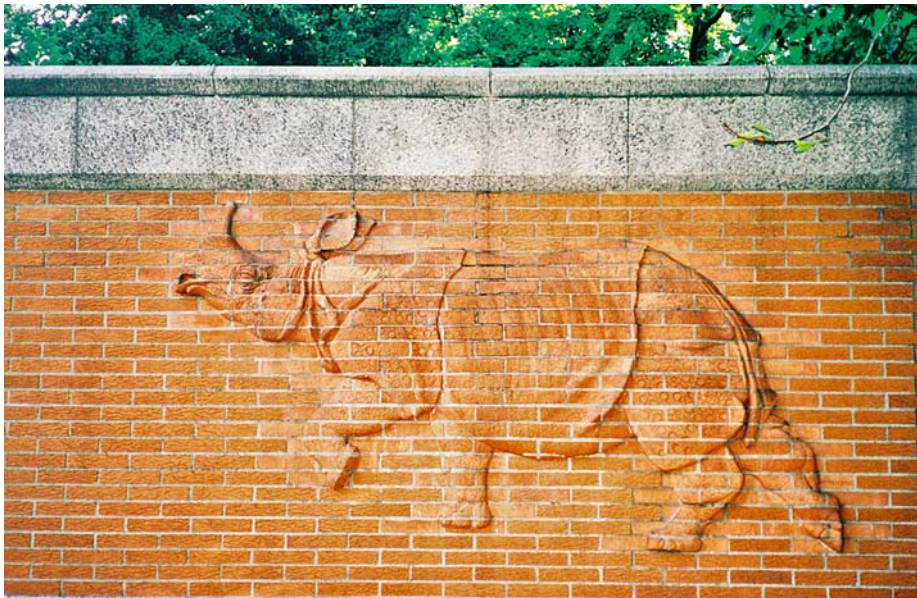
Sculptured brick free of defects, exterior wall of Zoo Berlin.

One of the most demanding brick finishes to keep defect-free is sculptured brick. Sculptured brick panels are the most unusual example of customized masonry. The forms are sculptured pieces handcrafted from the green clayware before firing. The unburned units are firm enough to allow the artist to work freely without damage to the brick body, but sufficiently soft for carving, scraping and cutting. After firing, the sculptured surface is permanently set in the brick face. The brick surface can be selected from a variety of textures, including: smooth, wire-cut, stippled, bark and brushed. Defects like chippage, warpage, and cracks in brick are common in

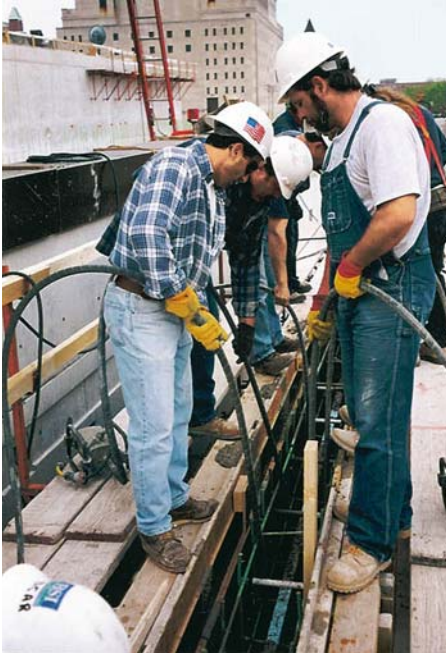
Extensive vibration is required during pours to remove air pockets that can lead to surface defects. Pulitzer Foundation, St. Louis.

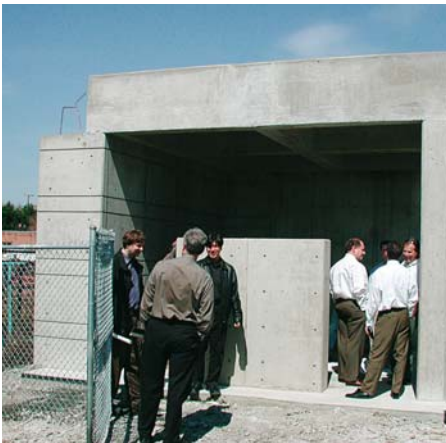
Concrete mock-up for Lincoln Park Zoo, Regenstein Center for African Apes, Chicago, 2004.

Concrete, masonry and stone have surface quality limitations that must be understood by all parties involved in a project. The best way to avoid disappointment with finished components is to specify a representative mock-up for the project. The mock-up should exactly reproduce all details that will be executed on the project, from corner details to wall to ceiling transitions. Stone panels should show all representative veining, color and inclusions that are expected from the selected stone. It is important for designers to specify a repair sample for all finished concrete, together with the repair procedure. Damage is inevitable on a construction site, and repairs will invariably be required. A completed mock-up, accepted by all parties as the representative quality expected on the project, will prevent arguments during construction.

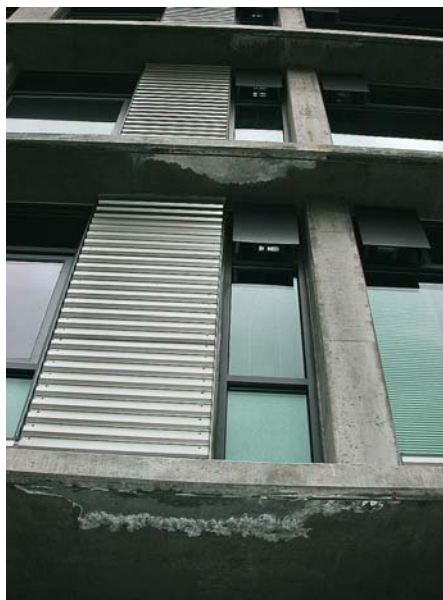
right Met Lofts, Los Angeles, completed in 2006 by the firm Johnson Fain. Surface discoloration on exterior concrete walls is intentionally left untouched to provide an urban feel to the façade. Stains resulting from the form release agent and efflorescence have not been removed.

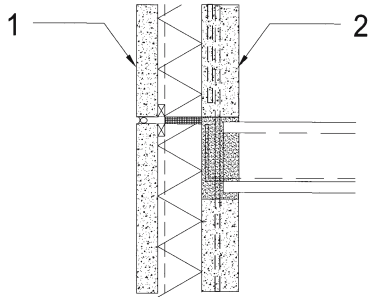
The Mustakivi School and Community Center in Helsinki, 1998, designed by ArkHouse, uses chemically stained precast concrete panels for non-uniform earthy tones.

- 1 Exterior wythe panel is chemically stained
- 2 Interior wythe provides for building structure

Concrete surfaces can be chemically stained to give variations in color and texture. The Mustakivi School and Community Center in Helsinki uses chemically stained precast concrete panels to break up the uniformity of a complex of buildings clad with precast concrete sandwich panels. The exterior panels of the school block form a load-bearing structure, which supports precast floor planks at the first floor and roof level. The precast sandwich panels consist of two internally connected concrete wythes separated by an insulated core. The colors on the external panel surface represent a canvas of abstract art, of neutral tones and regular shapes arranged in an asymmetric design. Not all of the surface colors are even; some panels are rusty gold in appearance, some look green with wood stain, and some are yellow in color. The basic earth colors of iron oxides and copper sulphides are particularly interesting. This project refutes the notion that concrete sandwich panels have to be boring. The chemical stain is a very thin layer on the surface of the concrete panel. The stain is durable under exposure to rain or snow, but cannot withstand heavy abrasion. A surface treatment of commercial sealant was used to avoid dirt and unwanted graffiti penetrating the concrete micro-pores of the panel surface. The appearance of chemical staining

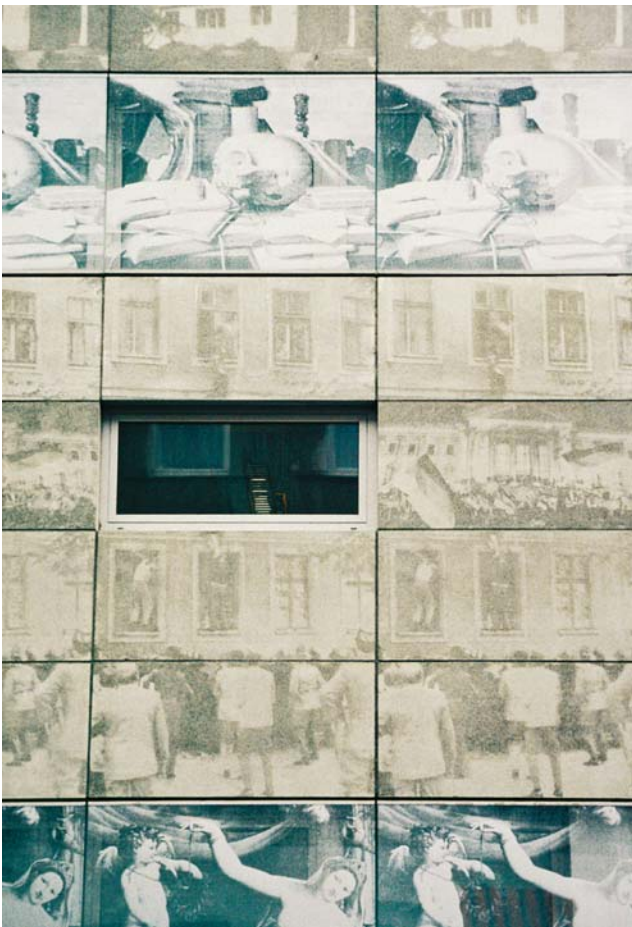
Concrete can be photoengraved through a process similar to silk-screening. Eberswalde Technical School.

Concrete can be photoengraved through a process similar to silk-screening. A photo is screen-printed as a layer of tiny dots onto a polystyrene sheet, but instead of using paint or ink, the image is printed with a cure retarder liquid. A cure retarder is a chemical that slows the cure rate of concrete. The prepared sheet is then placed into the concrete mold and the concrete poured on top of it. When the concrete has set, it is removed from the mold and pressure-washed, revealing a half-tone image on the finished concrete surface. Eberswalde Technical School, designed by Herzog and de Meuron, used photoengraved concrete to provide detail to what would otherwise be a flat concrete box. The photoengraved pattern was also applied to the glass using a silkscreen coating technique. The concrete impression process has proven to be very successful, retaining its color and detail many years after completion. Like many finished surfaces, a regular pattern of color variation can hide any slight discoloration of the surface. The discoloration of materials is not limited to concrete. Natural stone can also have shifts in color that are not anticipated.

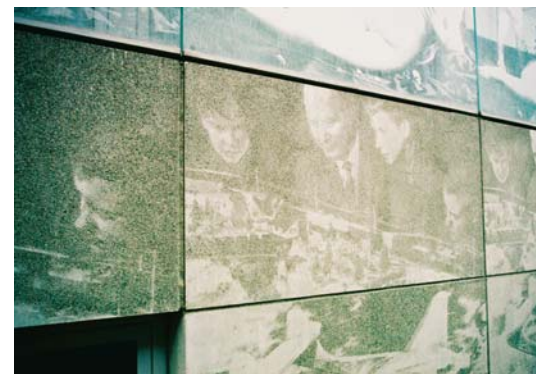
The concrete impression process has proven to be very successful, retaining its color and detail many years after completion.

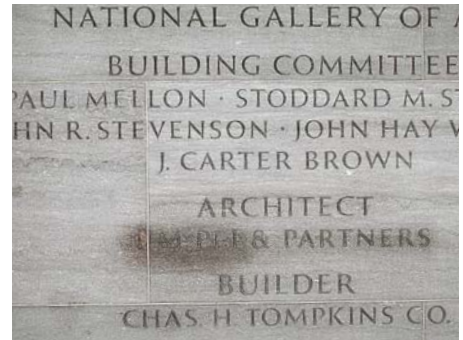
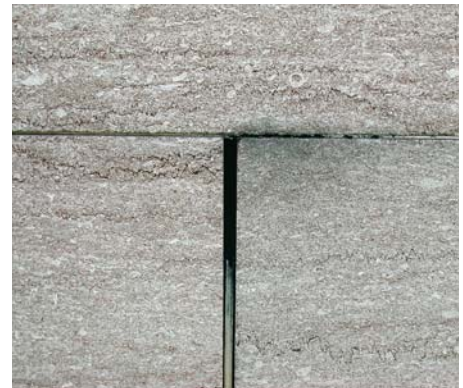
page 82 above Neoprene strips between stone blocks open up at locations where the stone blocks have shifted. The East Wing of the National Gallery of Art.

marble to enclose their walls; both, however, take on completely different forms. In 1986, The American Institute of Architects, College of Fellows, designated the East Wing for the National Gallery of Art as one of the ten most successful examples of architectural design in the United States. The famous solid corner pieces have provided the architectural community with an icon. Visitors touch the corner both in tradition and genuine curiosity leaving one famous stain. A similar stain occurs inside the building on a sign carved in stone that bears the building architect's name. The East Wing walls consist of exterior blocks of stone supported by stainless steel connections from concrete and brick core walls averaging 30cm (12 inches) in thickness. Neoprene strips between blocks allow for expansion and contraction while eliminating the

need for sealant or mortar joints. This design detail reduces the need for maintenance through failed sealant joints or tuckpointing. The typical stone joints for this project are not in contact with any sealant.

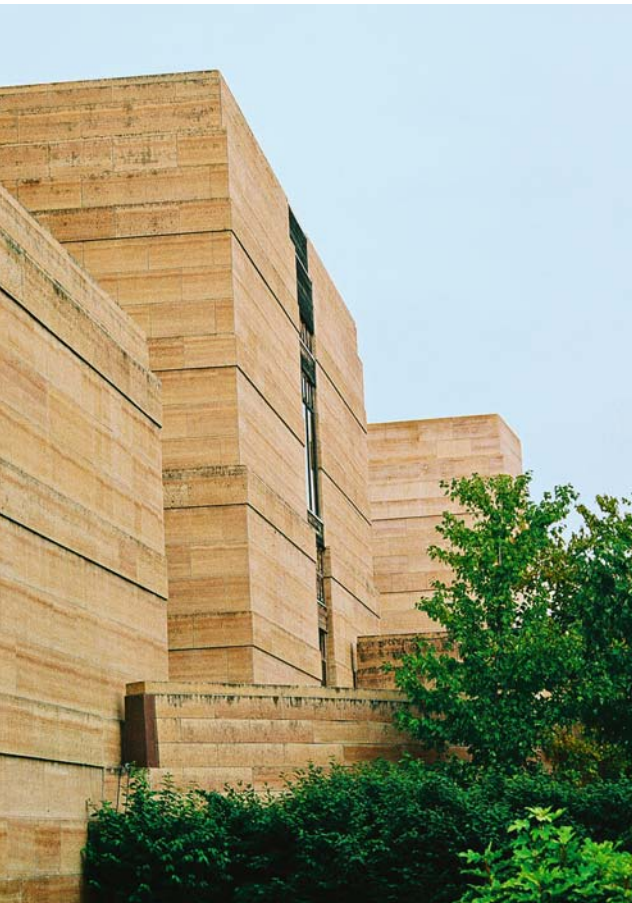
above The finish of the stone changed between completion of the original building and the time it was expanded. The difference comes partly from the algae growth. Eiteljorg Museum of American Indians and Western Art, Indianapolis.

Indiana and Indianapolis were named after their first human inhabitants. Completed in 1989, the Eiteljorg Museum of American Indians and Western Art, pays tribute to this group. The 10,960m² (118,000 square feet) honey-colored museum is composed of nearly 12,000 pieces of hand-cut Minnesota dolomite, a stone creating the feel of the Southwestern Pueblo. Plum-colored German sandstone serves as the building's base. It was decided to allow algae to decorate the museum walls. In 2005, construction of the Mel and Joan Perelman Wing doubled the size of the institution. The new north end of the museum faces the Indianapolis Center Canal. The finish of the stone changed between completion of the original building and the time it was expanded. The difference comes partly from the algae growth. If algae discoloration is not wanted in heavily planted wetted areas, application of a water repellent coating should be considered. These coatings form a hydrophobic layer that requires renewal every two to three years as its effect reduces with time. If an alga is to be allowed to build up on concrete surfaces, the cover to steel reinforcement must be thicker. Other forms of natural discoloration are less desirable than growth of algae on the Eiteljorg Museum of American Indians and Western Art.

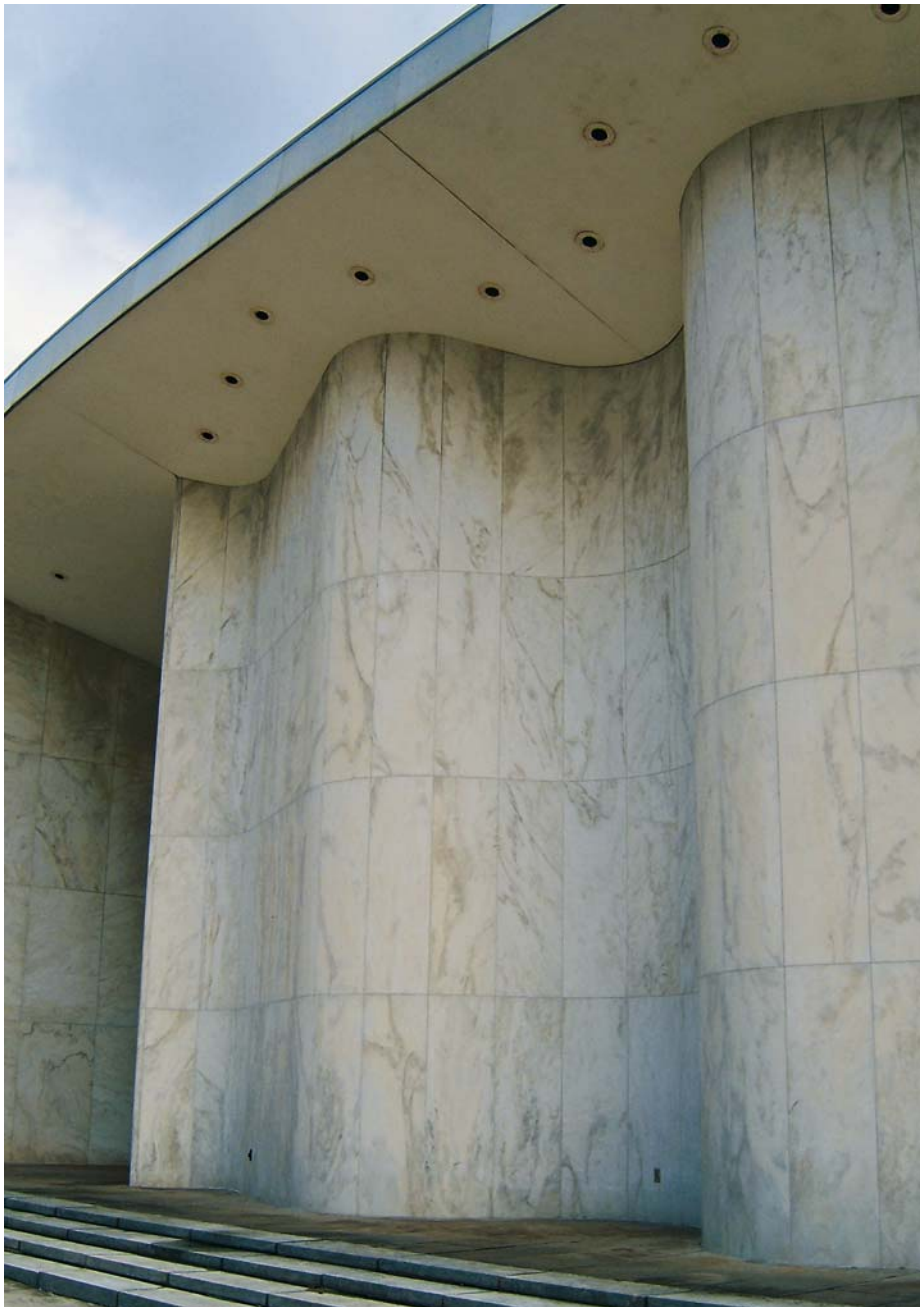
The top portion of the undulating stone façade has marks from a soffit that does not drip water away from the façade. Hall Auditorium at Oberlin College.

Uncontrolled water runoff on a building can leave hideous stains on a façade. Examples of water-runoff stains can be found in every major city in the world. Completed in 1953, Hall Auditorium, at Oberlin College, Ohio, provides a good example of how white marble can be permanently stained from run-off water. The top portion of the undulating stone façade has marks from a soffit that does not drip water away from the façade. Water runoff can be attributed to poor design or poor building maintenance.

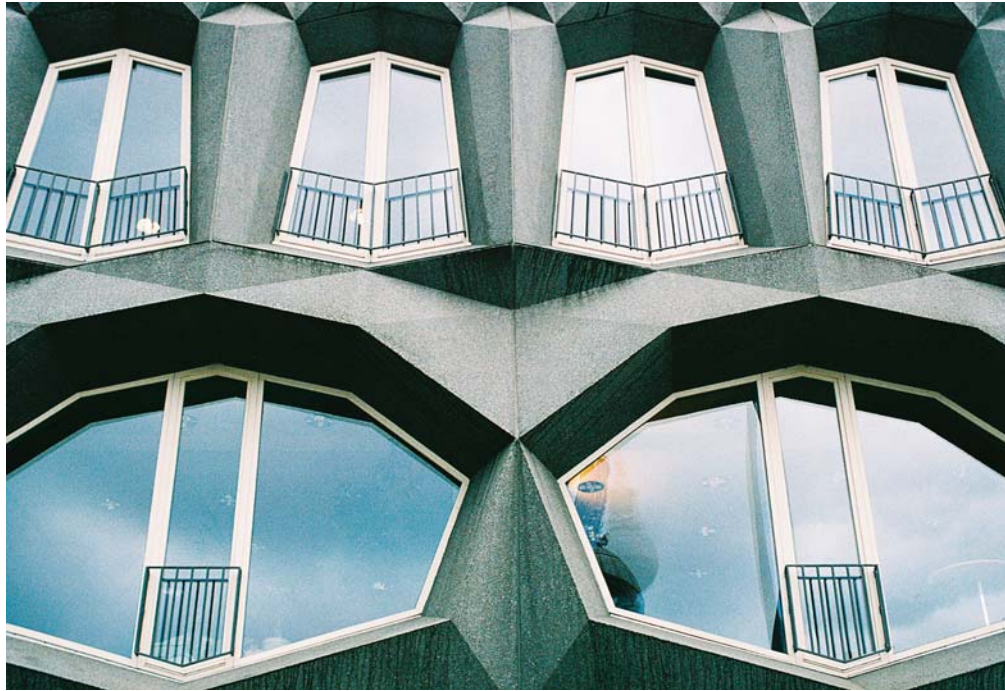
Water stains can be seen at the changes of the planes of the façade. The headquarters of the Berlin Water Works, House III Close up.

Properly detailed drip edges can direct water away from wall surfaces, protecting them from discoloration. If no drips are provided, water marks will be present on dark surfaces as well as light ones. The headquarters of the Berlin Water Works, House III was constructed in 2000, in strong contrast to the neighboring Baroque buildings of Berlin. The five-story façade is composed of broken, prism-like forms the color of granite and is based on the styles of Cubism. Water stains can be seen at the changes of the planes of the façade.

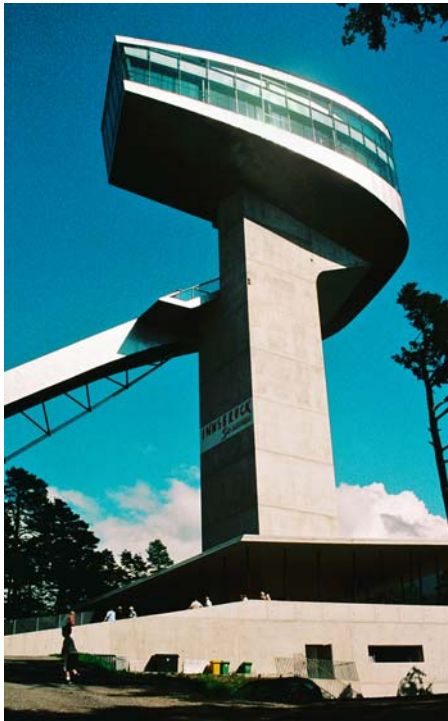
The new Innsbruck Ski Jump, designed by Zaha Hadid and completed in 2002, provides an excellent drip edge at the window sill.

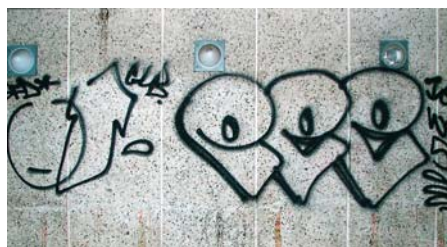
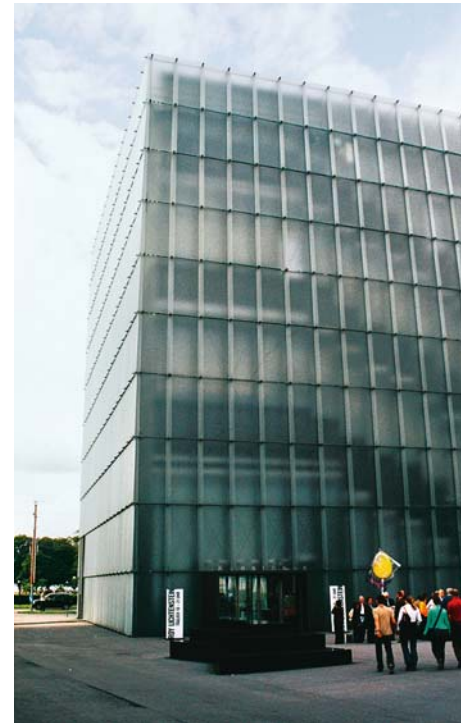
above Bregenz Art Museum, Bregenz, Austria, 1997. All-glass walls are less susceptible to graffiti than a porous stone or concrete wall.

In an urban environment, graffiti and other acts of vandalism can discolor exterior walls wherever they are accessible; however, there are ways of protecting the appearance of façades. One method is to make the surface impervious to the markings of vandals. The four exterior walls of the Bregenz Art Museum by Peter Zumthor are composed of shingled, frameless translucent glass covering the entire concrete structure. These details make it difficult to permanently paint or mark the exterior walls of the museum. Paint markings can be scraped off the glass easily. Concrete, stone and masonry surfaces are more porous than glass and require a different strategy.

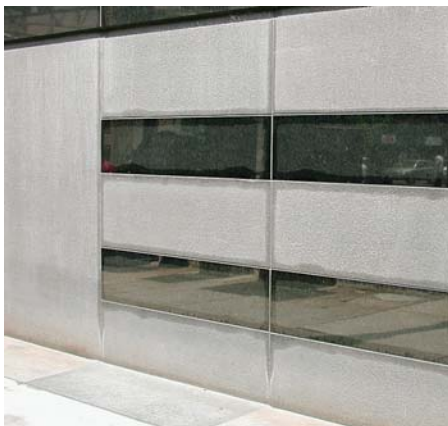
right Stone replacement is the only method for removing the picture-frame effect of sealant joint stains.

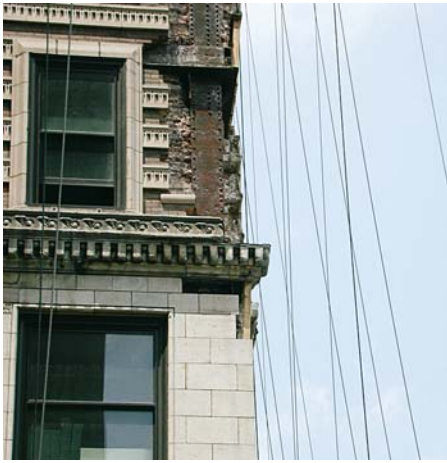
above Removal of the stone cladding reveals the corroded steel structure.

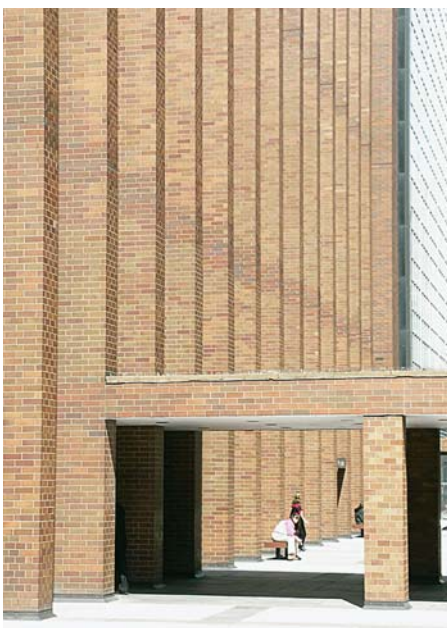
right and below Central National Bank, Cleveland, Ohio, 1970. Corrosion of wall reinforcement caused brick walls to fall to the street just seven years after the project was completed.

The masonry industry experienced a corrosion catastrophe in the mid 1970s. A high-tensile-strength mortar additive was developed and marketed under the name Sarabond. Many thought it was a breakthrough in mortar technology. Sarabond was first introduced to the construction market in 1965 as a mortar additive that increased masonry's flexural strength fourfold and its tensile strength threefold over conventional mortar. It was intended to revolutionize the use of brick in high-rise construction. A laboratory cousin of Saran Wrap, Sarabond was intended to make mortar as strong as the bricks it joined. Made of saran latex, it was intended to render mortar less permeable to air and water infiltration, thus protecting any embedded steel from corrosion. The hope was that this new technology would expand the creative possibilities of masonry for architects and engineers. The product was used throughout North America, from the Giraffe House at the Denver Zoo to a United Auto Workers building in Detroit. Sarabond had become a commonplace additive in masonry construction. In 1977, disaster struck as many of the projects that used Sarabond began to have problems. In one case, bricks from the 23-story façade of the Central National Bank in Cleveland, Ohio, came crashing to the street just a few years after the building had been completed. The bank façade was completed in 1970, using over 1.8 million bricks, bonded together with a mortar mix that contained Sarabond. Investigation of the façade and others like it uncovered a problem with Sarabond, and the issue related to corrosion.

In traditional masonry walls, when steel reinforcement is embedded in conventional cementitious mortar, a stable oxide coating is formed over the steel surface, thereby protecting the steel from damaging corrosion. Investigation revealed that the Sarabond additive creates a corrosive environment for embedded steel. Sarabond was a latex modifier containing polyvinyl chloride (PVC). When Sarabond was added to fresh cement, it released chloride into the cement pores. In sufficient concentration, chloride ions destroy the normally protective steel oxide coating that develops naturally over the surface reinforcement in contact with cementitious mortars and concretes; the oxide coating becomes unstable, giving rise to damaging corrosion at the steel surface. As steel corrodes, it gains in volume. In a cementitious mortar, the expansion due to uncontrolled corrosion at the metal surface generates tension forces. Cement mortars have little capacity to resist these tension forces, even with the increased strength characteristics of Sarabond, and cracks develop in the mortar. The combination

of uncontrolled steel corrosion and cracking of the supporting mortar leads eventually to failure of the steel. Where steel fasteners or ties are used, this type of failure can result in buckling of an entire wall of bricks. Sarabond was blamed for weakening the reinforcement system and for causing façades to peel away from the building and bricks to plunge to the street below. In the case of the Central National Bank in Cleveland, the solution was replacement of the brick façade.

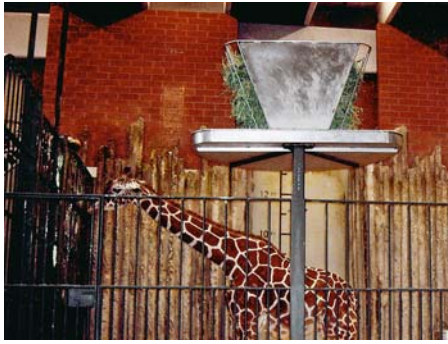
right Corrosion of masonry joint. Giraffe House, Denver Zoo.

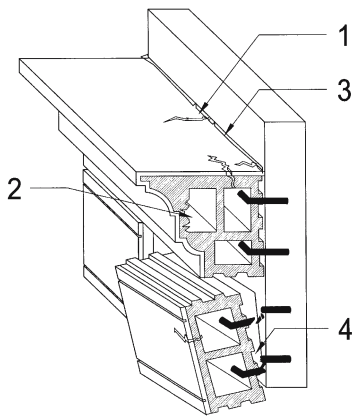
above Failure of terra-cotta panels.

1 Cracking – Fine cracking of the glaze finish due to thermal expansion and contraction of terra cotta. Moisture can enter through the cracks.

2 Spalling – The partial loss of masonry caused by water trapped within the terra-cotta unit.

3 Mortar deterioration – Deteriorated mortar joints are a source of water infiltration.

4 Deterioration of metal anchoring – Deteriorated anchoring system due to water infiltration and rusting of carbon steel anchor can be severe before it is noticed. As a result, terra-cotta blocks can fall from the building with little warning.

Terra-cotta failures occur with time, following a progressive deterioration. Initially, fine cracking, called crazing, occurs in the glaze finish of the terra-cotta element. This can occur as a result of thermal expansion and contraction of the piece. Moisture penetrates through the cracks, entering the porous baked clay. The presence of moisture and oxygen at the surface of the internal steel anchor connecting the terra-cotta block to the building structure allows the onset of corrosion. Deterioration of the mortar used for filling between terra-cotta elements also provides a path for water to migrate to the steel supports. With time, corrosion weakens the metal until the anchor finally breaks. Terra cotta deterioration can ultimately lead to large sections of façade falling to the ground. Terra cotta restoration can be difficult and expensive to complete. There are a handful of companies that make classic architectural terra-cotta pieces. Repair methods of terra cotta include the use of stainless steel replacement anchors. This technique insures that corrosion will not be a factor in years to come.

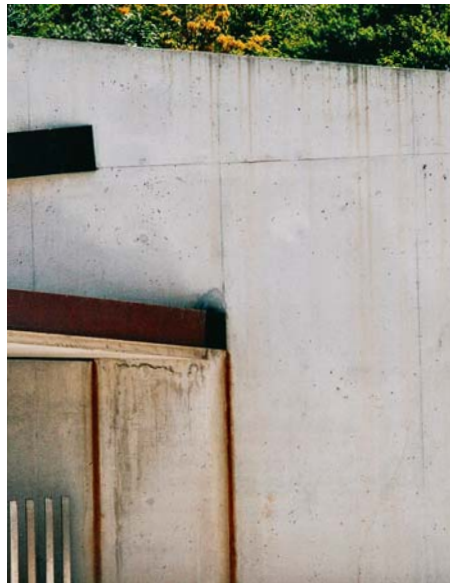
above and right Botanical Gardens in Barcelona, designed by Carlos Ferrater and completed in 1999. Elements of the park are constructed with Cor-Ten steel. The staining that occurs at the entrance almost looks deliberate.

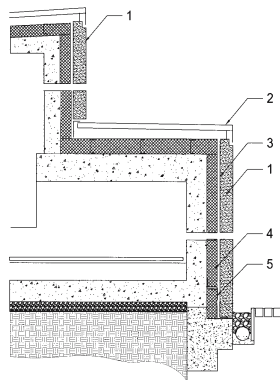
Oskar Reinhart Collection.
 1 Precast concrete panel with jurassic limestone and copper
 2 Copper roofing material
 3 Air space
 4 Insulation
 5 Through-wall base flashing

The exterior wall comprises a cast-in-place 20cm (7¾ inch) thick reinforced concrete wall, an external attached 10cm (4 inch) thick layer of insulation (rock wool), a 3cm (1¼ inch) air gap, and a precast concrete panel (10 and 12cm [4 and 4¾ inch] thick). The concrete panels have a rich surface derived from the unusual concrete mix. Trial panels comprising a variety of materials were made and observed. Two materials used in the construction of the original villa, Jurassic limestone and copper, were found to give the best results. Both of these materials were ground down and added as fine aggregate to the concrete mix. The new walls have undergone an accelerated aging process, acquiring a patina that gives the walls a discreet green color. The wall details allow runoff water from the copper roof to deliberately streak the walls with copper ions to provide the desired effect.
