failed stone

problems and solutions
with concrete and masonry

Problems and Solutions with Concrete and Masonry

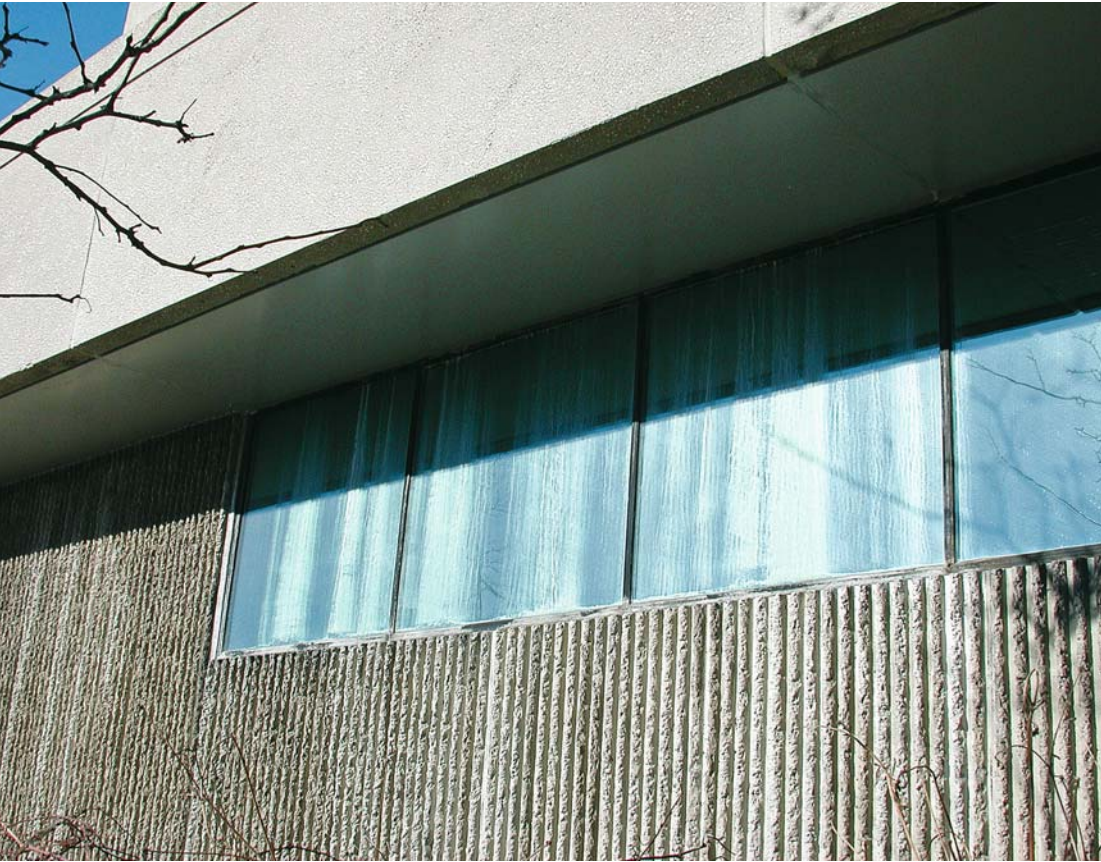
right Image of white corrosion marks on glass from concrete runoff.

When water reaches a building, it is either reflected, or absorbed, or allowed to run down the building's façade. When water runoff occurs across a masonry or concrete wall, the water can carry minerals from these surfaces to the glass below. Water runoff containing contaminants can damage glass. To understand the chemistry involved with this process, one must review some basic concepts. An aqueous solution can be described on a pH scale from one to 14, with neutral solutions having a pH of seven. Materials measured below seven are considered acids, and materials above seven are considered basic or alkaline. If the alkalinity of a solution reaches a pH greater than nine, a destructive stage of glass corrosion can begin to occur. Fresh concrete can have a pH of 12; however, as the concrete ages the alkalinity of the surface decreases. Damage to the surface of glass can be caused by alkalis that leach out of precast concrete panels by rain, or the fluorides in the wash-off from concrete floors that have been treated for hardening with solutions of zinc or magnesium fluorosilicates. These materials can stain or etch the surface of the glass if allowed to remain for an extended period of time.

The contaminating effects from runoff water may lead to white streaks on the glass, which is difficult to remove. The transparency of glass can be permanently lost once the glass surface has been severely etched. Although concrete and stone have taken most of the blame for unsightly glass stains and etching, it is important to remember that many structures built of materials other than concrete and masonry have experienced glass staining. This staining can be explained by natural corrosion of the glass.

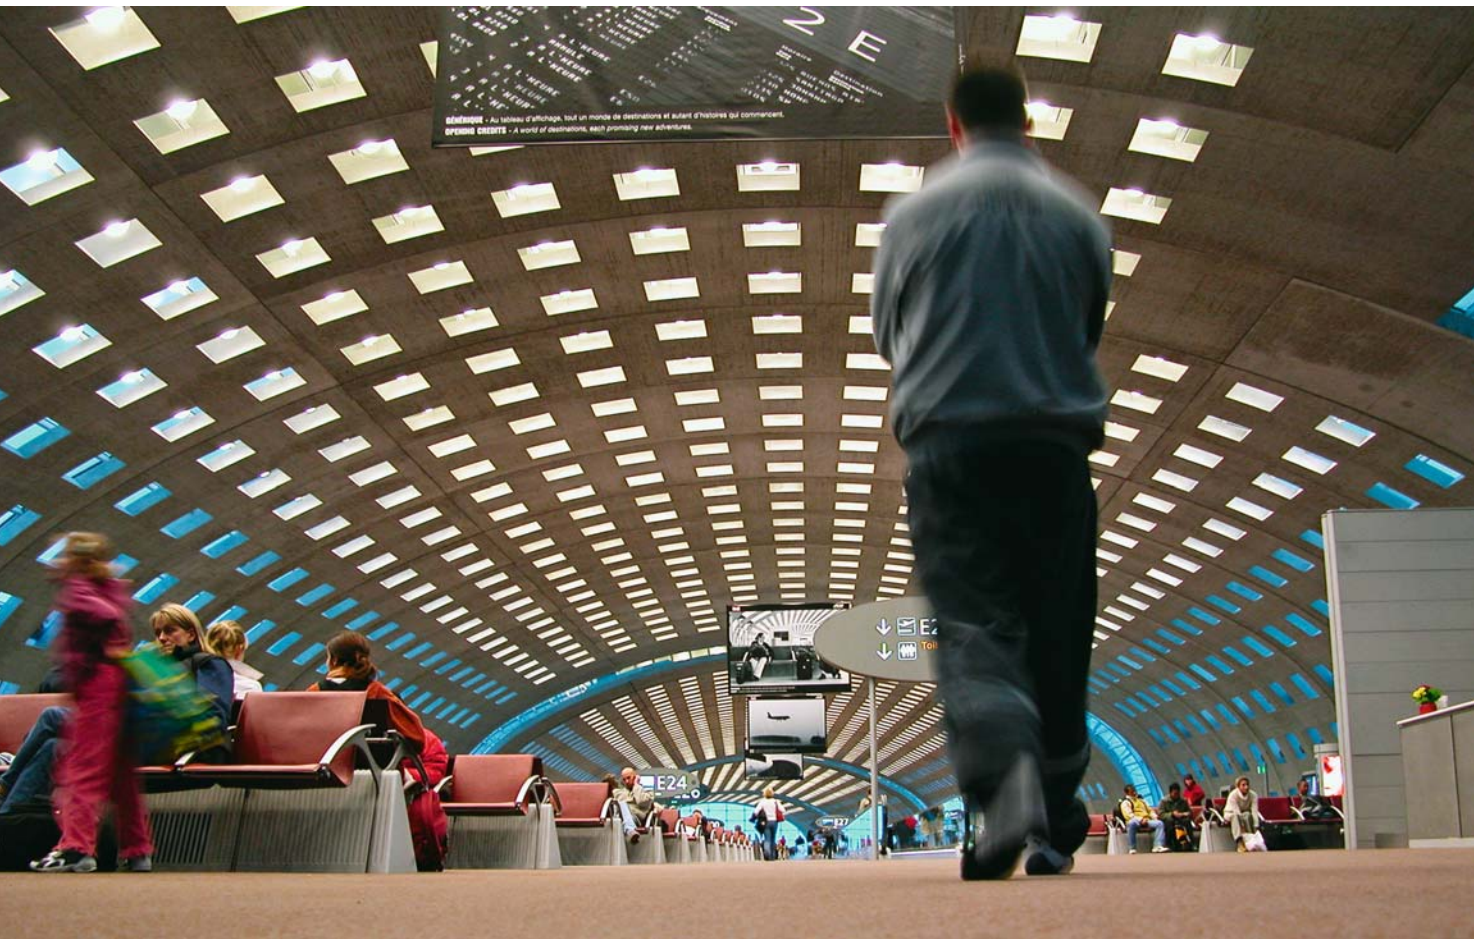
above Interior view of Terminal 2E, Charles de Gaulle International Airport, completed in 2003.

Terminal 2E at the Charles de Gaulle International Airport, completed in 2003 at a cost of 750 million dollars, features a stunning, airy elliptical concrete tube structure approximately 33.5m (110 feet) wide and 305m (1,000 feet) long. The new terminal was intended to transform Paris into the most powerful air transport hub in Europe. The building's skin consists of a double shell assembly with an outer layer of glass and aluminum and an inner shell structure of reinforced concrete. The shape of the building stemmed from the Parisian airport authority's requirement that there be no intermediate interior supports to restrict the flow of passengers through the terminal. The outer skin consisted of a glass supported by metal framing, preventing air and water from entering the terminal. The elegant inner shell was built with prefabricated 3.66m (12 foot) reinforced concrete ring sections. Each 54.4 tonne (60 ton) ring section rested

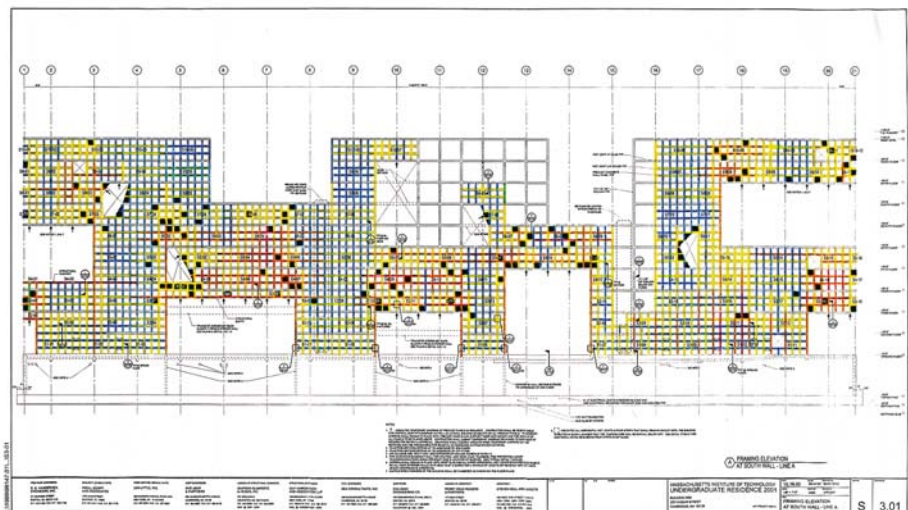
right Simmons Hall at MIT. Like a Vierendeel truss, the precast concrete panels interconnect with steel reinforcement to span large and small openings.

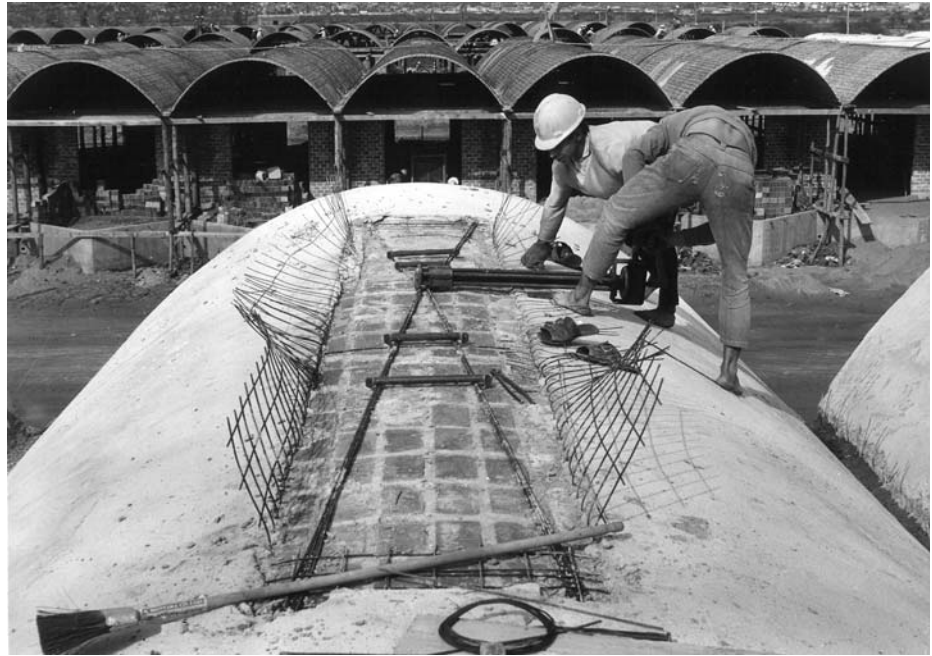
below Prestressing of a self-supporting arch.

- 1 Lightweight concrete
- 2 Unbraced lightweight concrete
- 3 Prestress cable
- 4 Reinforcement anchor
- f Force of jack
- F Force of prestress

A large looped prestressed steel cable is then installed to absorb the negative bending moment on the vault. With the vault still supported by formwork, the ends of the loop are cast into the vault. After the lightweight con-

crete has hardened, the prestressing cable is mechanically pinched at the mid-point of the vault. The mid-section of the vault is then covered with mesh and filled with lightweight concrete to complete the roof. Although complicated by contemporary developments, prestressing has been used for thousands of years. A good example of prestressing can be seen in the fabrication of an old cart wheel. The heating of the iron outer band of the wheel prior to placing it around the cart wheel provides a form of prestressing. As the steel band cools, it contracts, clamping the wood parts together. In a similar manner, Eladio Dieste developed a method of prestressing with the same inherent simplicity, requiring no heavy equipment. Prestressing creates much larger forces in a building element than the element would normally experience through normal use. What happens if the natural forces are much greater than expected?

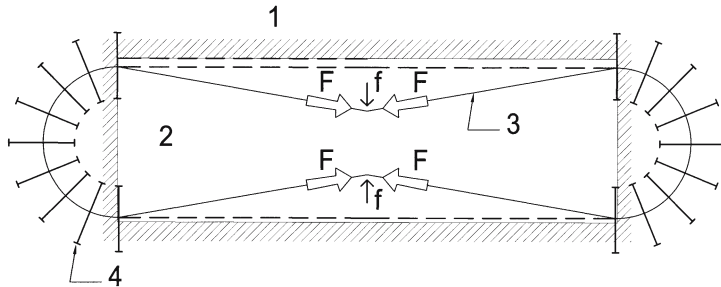
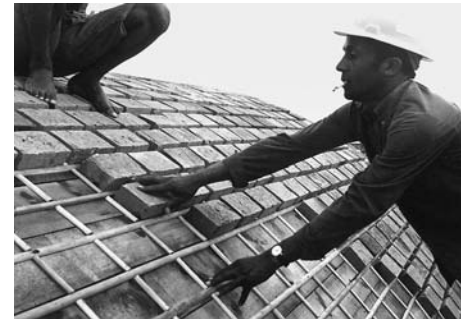
right and below The Municipal Bus Terminal in Salto.

The Municipal Bus Terminal in Salto, Uruguay, completed in 1974, provides a classic example of how daring structural forms were developed prior to the advent of sophisticated computer analysis. A single row of columns is all that supports the long self-carrying vaults with equal cantilevers of 12.2m (40 feet). These cantilevered vaults are ideal for sheltering travelers coming in and out of the buses at the station. The self-carrying vault is achieved using innovative prestressing techniques that could be simply executed by local laborers. Timber trusses provide the formwork for posi-

tioning the bricks on the vault. The bricks are evenly separated by small wood strips. Steel-reinforcing bars are placed between the bricks, and the joints are filled with mortar.

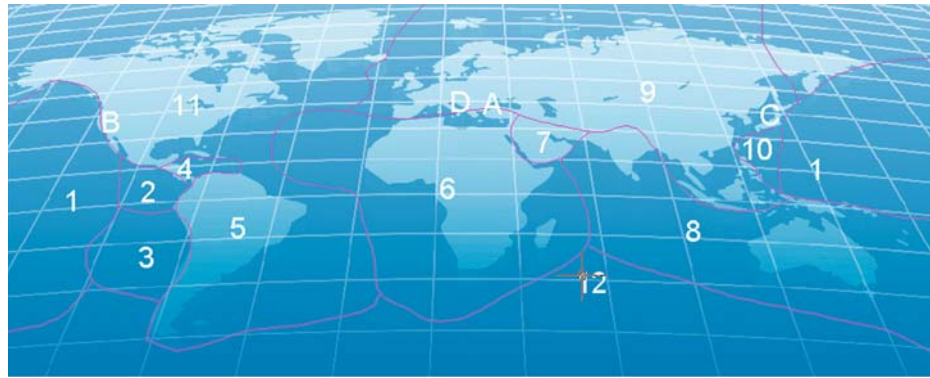
World tectonic plates

- 1 Pacific Plate
- 2 Cocos Plate
- 3 Nazca Plate
- 4 Caribbean Plate
- 5 South American Plate
- 6 African Plate
- 7 Arabian Plate
- 8 Indo-Australian Plate
- 9 Eurasian Plate
- 10 Philippine Plate
- 11 North American Plate
- 12 Antarctic Plate

Referenced buildings

- A Hagia Sophia
- B Ennis-Brown House
- C Imperial Hotel
- D Church of Padre Pio

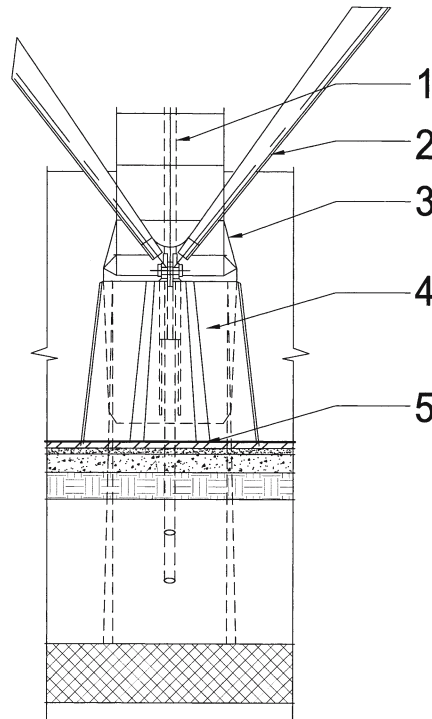
Interior base detail, the Church of Padre Pio

- 1 Posttension cable threaded through stone arch
- 2 Limestone block with sealable joints
- 3 Stainless steel V-strut
- 4 Concrete arch footing clad with limestone 10cm (4 inches) thick
- 5 Honed limestone flooring

The arches are posttensioned to precompress the stone and reduce the subsequent risks of failure under tensional stresses. The stone was drilled to take sleeves for steel cables. The stone pieces were then stacked and bonded with two-part epoxy resin and a 2mm ($\frac{1}{16}$ inch) stainless steel space plate to ensure a consistent junction between stones. With all of the blocks in place, the tension cables were mechanically inserted. The steel scaffolds were lowered and the cables were tensioned. The flexibility of a great structure is critical to a building in a seismic zone; however, too

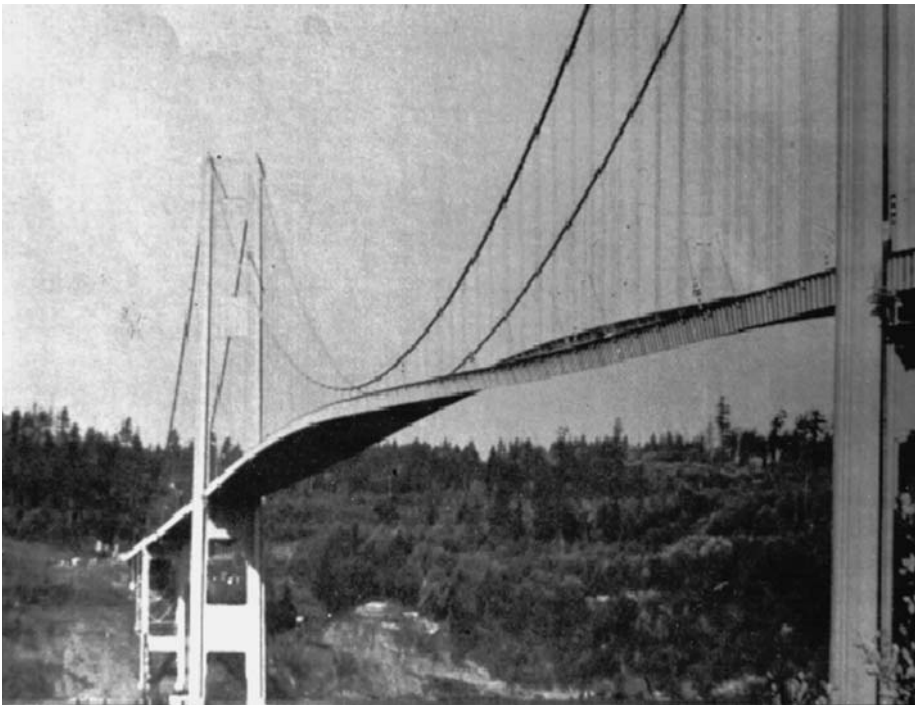
above The replacement bridge for the Tacoma Narrows was redesigned with deep open truss members that allow wind to pass through them. The construction of the second design was completed in 1950.

below The Tacoma Narrows Suspension Bridge, built in 1940 across Puget Sound in Washington, was the first of its type to use plate girders to support the concrete roadbed. With this new thin design, wind was diverted above and below the structure.

The Tacoma Narrows Suspension Bridge, constructed in 1940, was a graceful structure of enormous proportions. It consisted of two towers that supported main cables hung in a parabolic configuration from which slender steel deck girders were suspended by further vertical cables. The concrete deck on which cars drove was constructed between the two slender girders. The girders had a depth of 2.4m (8 feet) with a span of 853m (2,800 feet)

from tower to tower. The slender nature of this deck was part of its elegance as well as its demise. Uncontrolled oscillation was a problem from the time the bridge was completed in July 1940. The flexible nature of the bridge caused travelers to become motion-sick with its movements and the bridge quickly acquired the nickname, Galloping Gertie. On November 7, just four months after its completion, the Tacoma Bridge was destroyed by aerodynamic wind oscillations. The concrete deck was said to have broken up like popcorn. Huge chunks of concrete broke from the deck as oscillation of the bridge reached its peak. Tearing itself apart, the twisting undulations of the bridge reached an ampli-

tude of 7.5m (25 feet) before a 183m (600 foot) length of the bridge deck tore away from the suspension cables and plunged into the water below. The collapse of the Tacoma Narrows Bridge became even more infamous as its destruction was caught on film. How could such a bridge deck twist and jump like a rubber band under relatively normal winds, and how could it have been avoided? The principal cause of the failure was later understood to stem from the aerodynamic behavior of the bridge deck; essentially, the slender deck section caused it to behave like an aircraft wing, inducing the destructive undulating motion. Bridge designers of today carry out routine wind tunnel testing during the design phase of a project to avoid such disasters. There was a device that could have saved Galloping Gertie, after it had been constructed with the faulty design. Unfortunately, it was developed 40 years after its steel frame collapsed into the Tacoma Narrows.

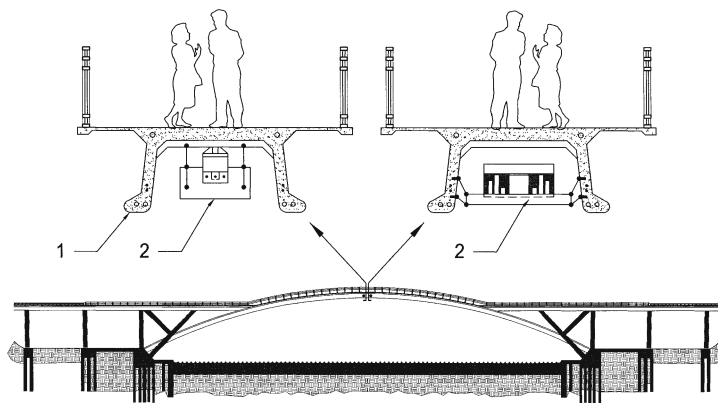
Seonyu Footbridge, Seoul, 2002.

1 Ultrahigh-performance precast concrete structure
2 Tuned mass damper concealed below bridge deck to reduce lateral motion of bridge

The Seonyu Footbridge, completed in 2002, provides a recent example of a tuned mass damper used in a very slender bridge structure. The design of the footbridge provides a pedestrian link from the city of Seoul, to

Sunyudo Island in the Han River. Potential vibration of such a slender arch had to be considered. In order to maintain comfort for pedestrians crossing over the bridge, the design included shock-absorbing tuned mass dampers at the top of the arch. These limited the horizontal acceleration to 0.2m/sec (0.66 feet/sec) and the vertical acceleration to 0.5m/sec (1.64 feet/sec). In addition to the use of new structural technology, the foot-bridge uses a relatively new type of building material: ultrahigh-performance concrete.

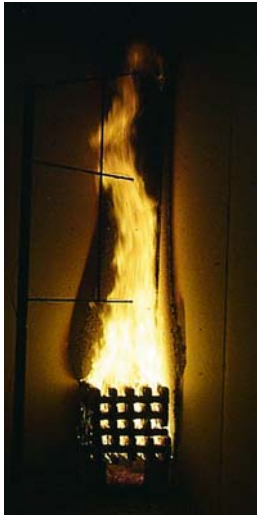
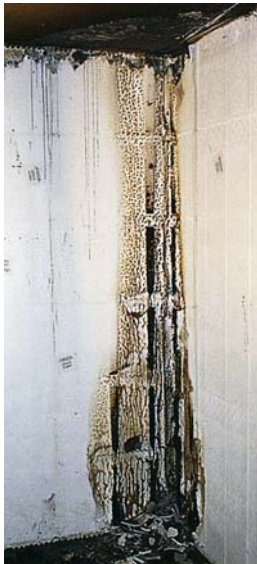
above ICF wall construction during and after fire testing

right Insulated Concrete Form (ICF)

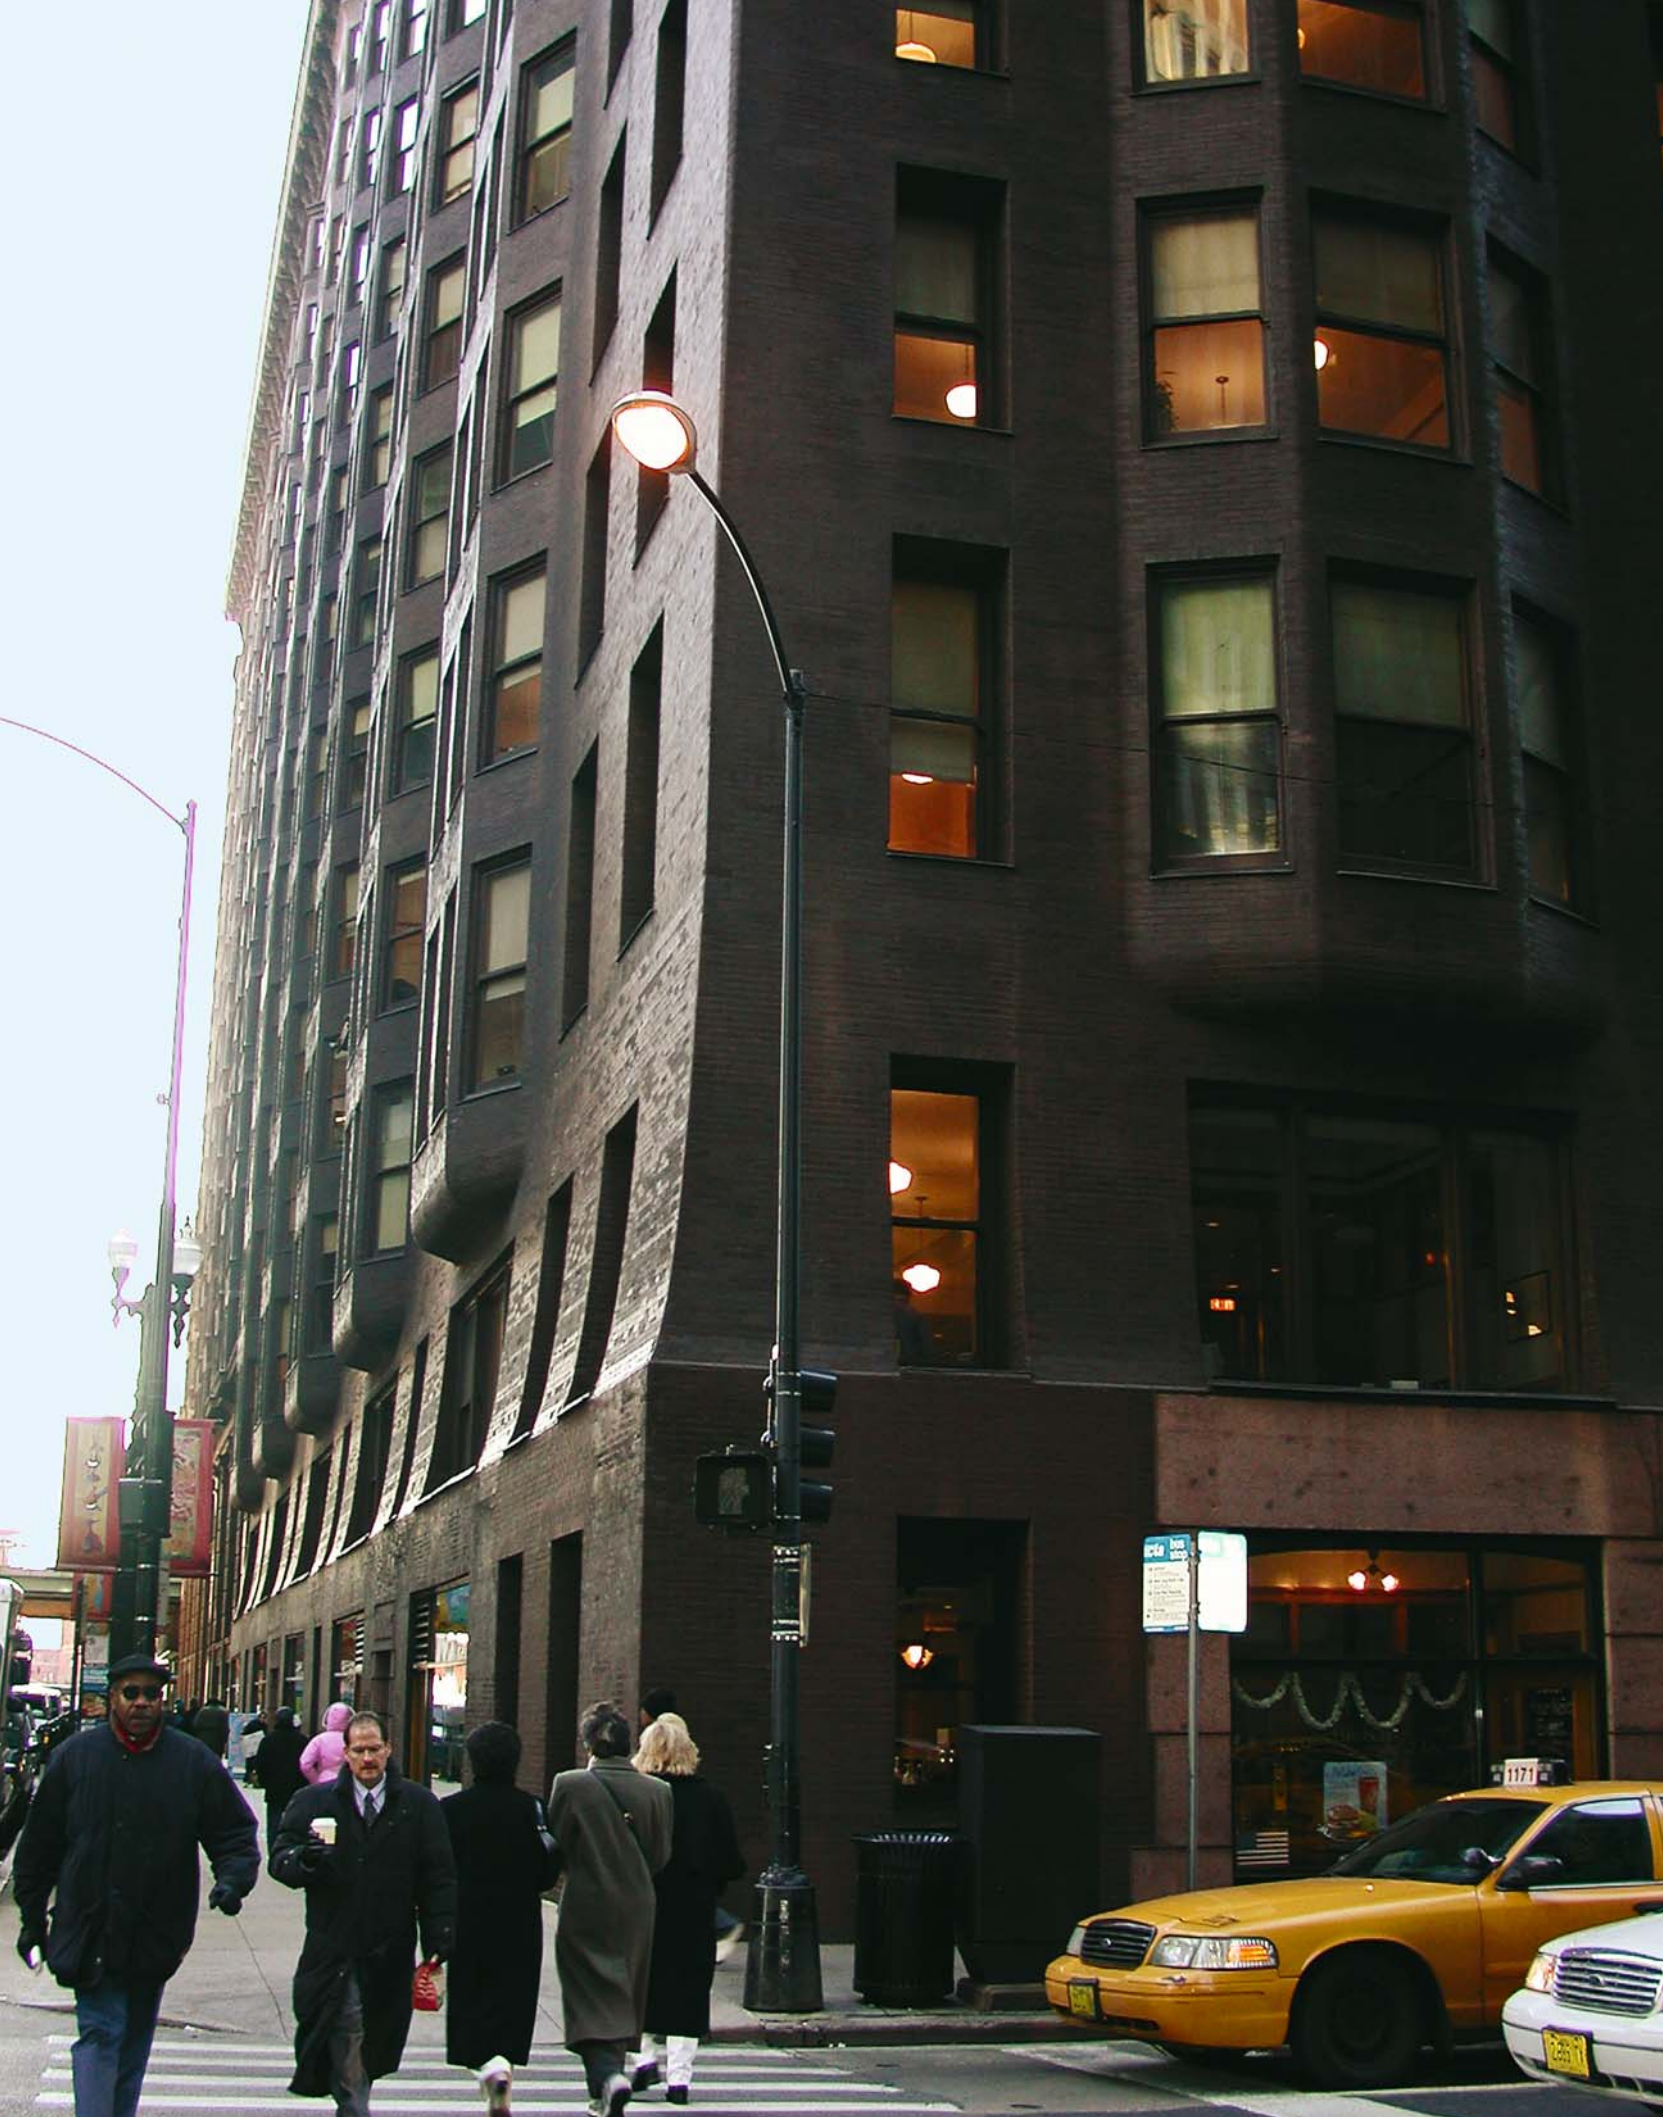
right Complicated building geometry has contributed to water infiltration issues at the Vontz Center for Molecular Studies at the University of Cincinnati, Ohio, 1999.

below White efflorescence on interior masonry walls is an indication that the building may have water infiltration problems. Vontz Center for Molecular Studies.

The Vontz Center for Molecular Studies at the University of Cincinnati was completed in 1999. The Center consists of three occupied floors containing a variety of offices and laboratories. Easily distinguished from other masonry buildings on campus, the Vontz Center has multi-story windows that protrude the exterior façade in irregular shapes around the building. The building appears as if it has been overinflated and the brick exterior walls

appear to pillow outward. The brick walls are non-load-bearing walls, with weeps at the heads and sills of the panels. The bowing of the walls is not a defect, but the preconceived sculptural form of an exterior assembly constructed of prefabricated masonry panels.

Because of the Vontz Center's irregular shape, the wall, window, and skylight transitions were very difficult to execute. In addition, the majority of the precast panels were prefabricated, making through-wall flashing difficult to integrate with sloped skylights and window head conditions. In an effort to simplify these transitions, it appears that some of the flashings were applied to the surface of the masonry in lieu of penetrating through the wall assembly. For example, the skylight transition to the masonry wall appears to be a surface-mounted flashing connected to the outside wythe of brick. If the flashing does not extend all the way through the cavity, infiltrating water can-

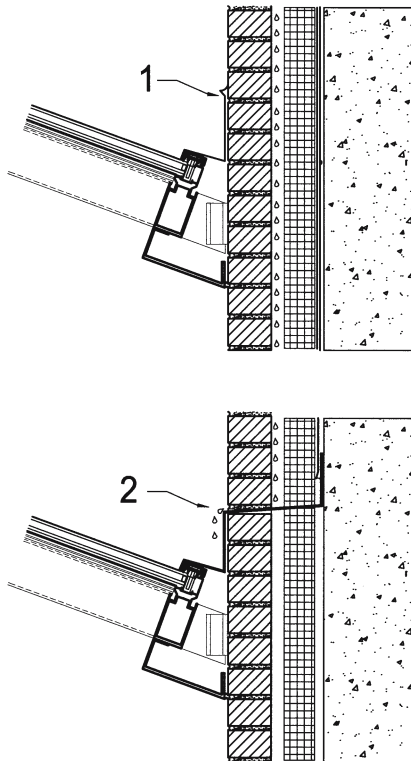
Flashing details

1 Surface-applied flashings do not allow weeping water to be shed to the exterior.

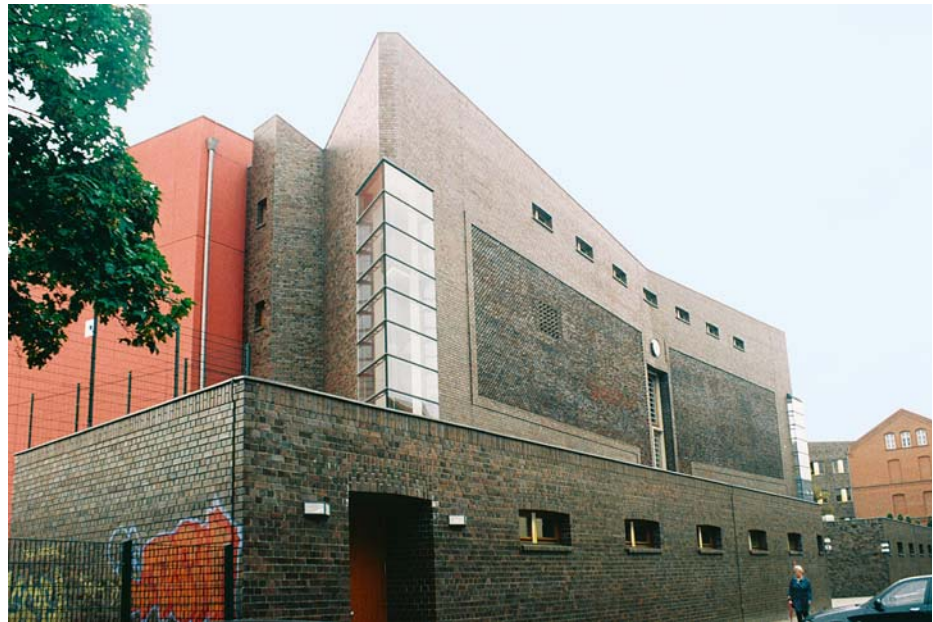
right and page 135
Lévi-Strauss School.
The construction photograph
shows the solid masonry
walls.

The Lévi-Strauss School in Köpenick, Berlin, has made a return to modern construction with solid masonry walls. Completed in 2000, the exterior of the building is constructed with a complex, beautifully detailed masonry wall, filled with interweaving layers of brick. In order to meet German code requirements for thermal protection, the exterior and interior masonry are different. The outer masonry work must be resistant to weathering and frost, while the inner must be distinguished by higher compressive strength coinciding with a greater proportion of perforations. Poroton bricks used on the interior provide the necessary thermal requirements. In order to prevent water damage, the bricks must be set into the mortar without air pockets. Expansion joints are not required, because the outer wall is load-bearing and monolithic.

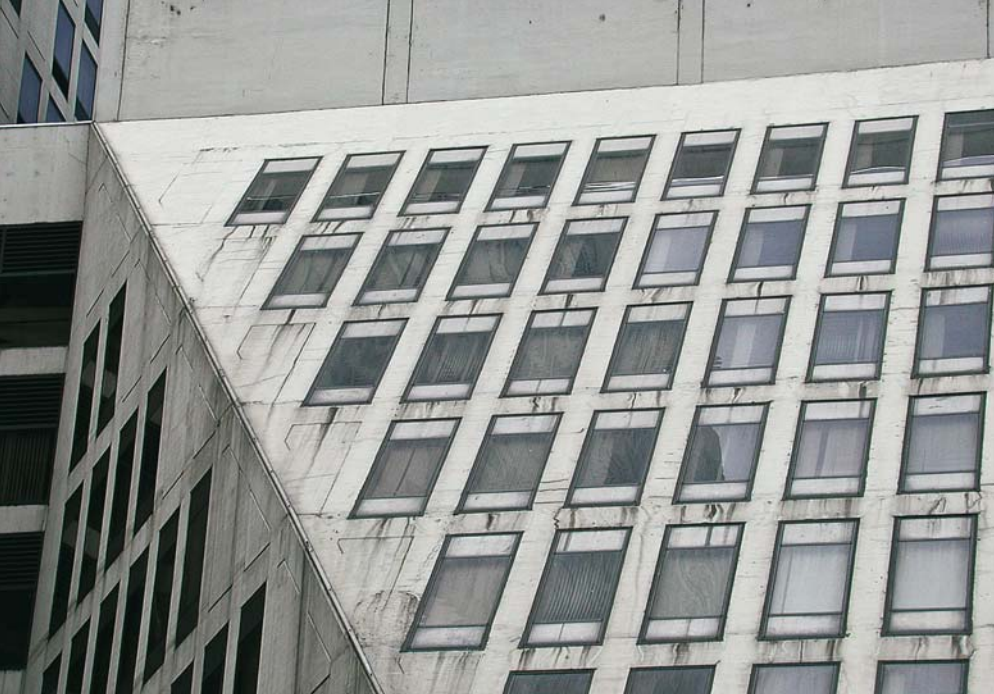
above Onterie Center, Chicago, 1986. Cracks in concrete can allow water infiltration.

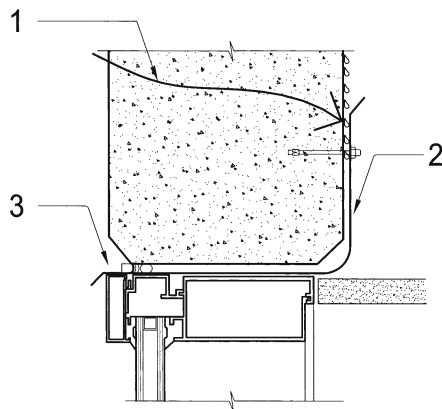
right Second line of defense for concrete façade

- 1 Water can infiltrate a concrete enclosure through crack in the wall.
- 2 Water is captured by through-wall flashing at head of windows.
- 3 Water is directed to exterior through weeps.

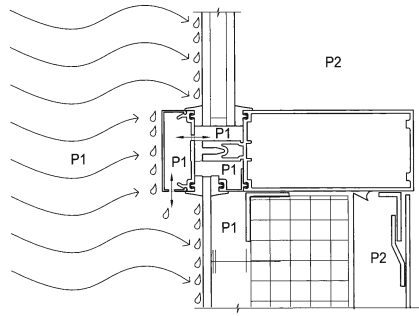
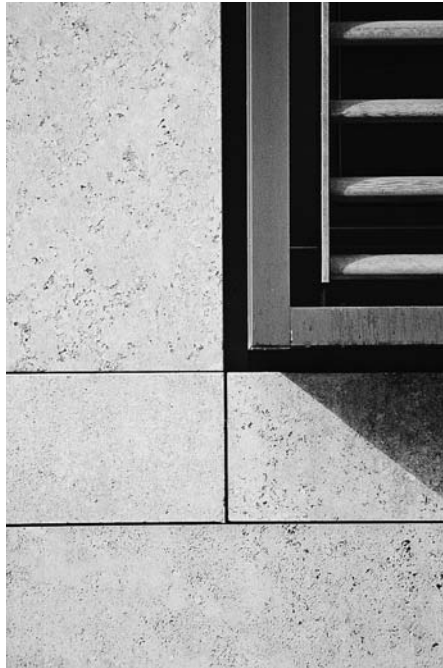
Pressure equalization prevents driving rain from infiltrating.
P1 Exterior pressure
P2 Interior pressure

right and below In rainscreen design, open stone joints will not allow water into the building.

Pressure-equalized wall construction attempts to reduce water penetration by eliminating the air pressure differential across the outer barrier, with a “rainscreen design.” A rainscreen consists of an outer layer of material separated by a minimum 19mm (³/₄ inch) drainage cavity followed by an airtight moisture barrier at the back of the cavity. The rainscreen drainage cavity is wide enough to break the capillary action and surface tension of water such that gravity will pull the water that gets behind the exterior, cladding down-and-out through weep holes at the base. The outer barrier contains openings to ensure that the internal cavity of the enclosure will have the same pressure as the exterior. Weepage at the base of these systems is critical to draining incidental water that can penetrate any of the pressure equalization holes. For a stone wall with a rainscreen design, joints can be left completely open on the outer face of the wall. For a masonry wall, pressure equalization holes can be achieved with small vents in the head joints at the top of a wall with weep holes at the base of the wall. These holes at the top serve to vent out the cavity. This type of system prevents water from being sucked into a building by an internal pressure differential. Pressure-equalized design is particularly important in high-rise

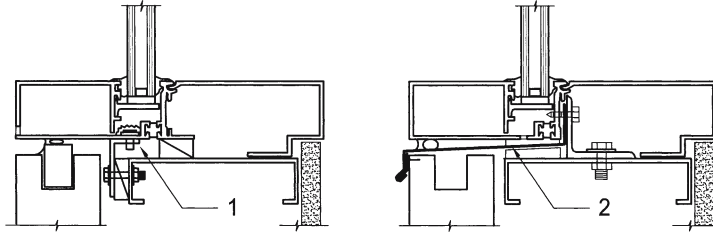
Base flashing

- 1 Window sill without base flashing
- 2 Window sill with base flashing to direct water to the exterior

ty of window systems to water infiltration can be greatly improved by providing a weeped through-wall flashing under them. This added detail will prevent infiltrating water from the window system from finding its way into the building. An upturned leg of the flashing will keep driving rain from leaking back into the interior. If properly detailed and executed, flashing details can provide a path for the inevitable leakage to exit a building enclosure. If flashing details are not executed properly, they will trap water, which can cause damage to the masonry and lead to further moisture penetration into the building.

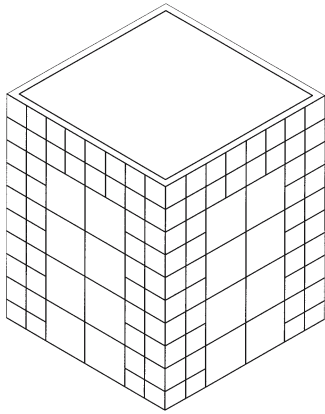
above Compartmentalization: The corners and the tops of a building are exposed to greater wind pressure and hence more rain. These areas should be compartmentalized at more frequent intervals to reduce the risk of overloading the internal weepage system.

A key component of any weepage system is compartmentalization. The system's ability to weep water out of the building is dependent on limiting the enclosure area above the weeps. For example, weeps at the base of a 30-story office building should not be expected to accommodate all 30 floors. Compartmentalization is not just based on a building skin's surface area. The direction of the wind can influence the amount of rain that will cover a façade. Because wind pressure is inconsistent over the entire building surface,

building exteriors should be compartmentalized at more frequent intervals in high wind areas – for example, near the corners and the top. Enclosure systems that cover large areas (e.g. high-rise buildings) require compartmentalization in order to ensure that internal drainage systems will not overload the design and allow water to back up into the building.

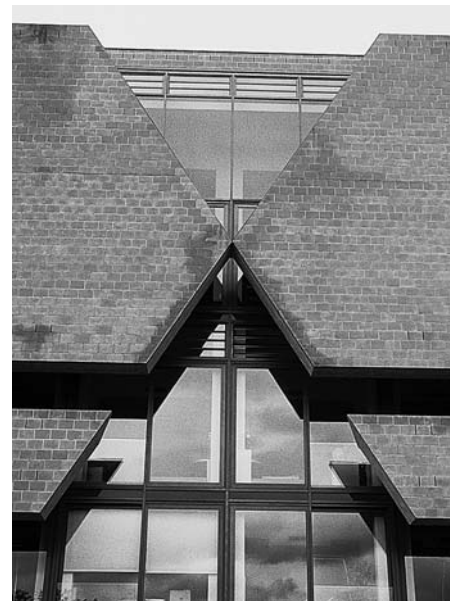
right Kulturzentrum Gasteig, Munich, 1985. Library building with weeps in header joints of diagonal masonry wall.

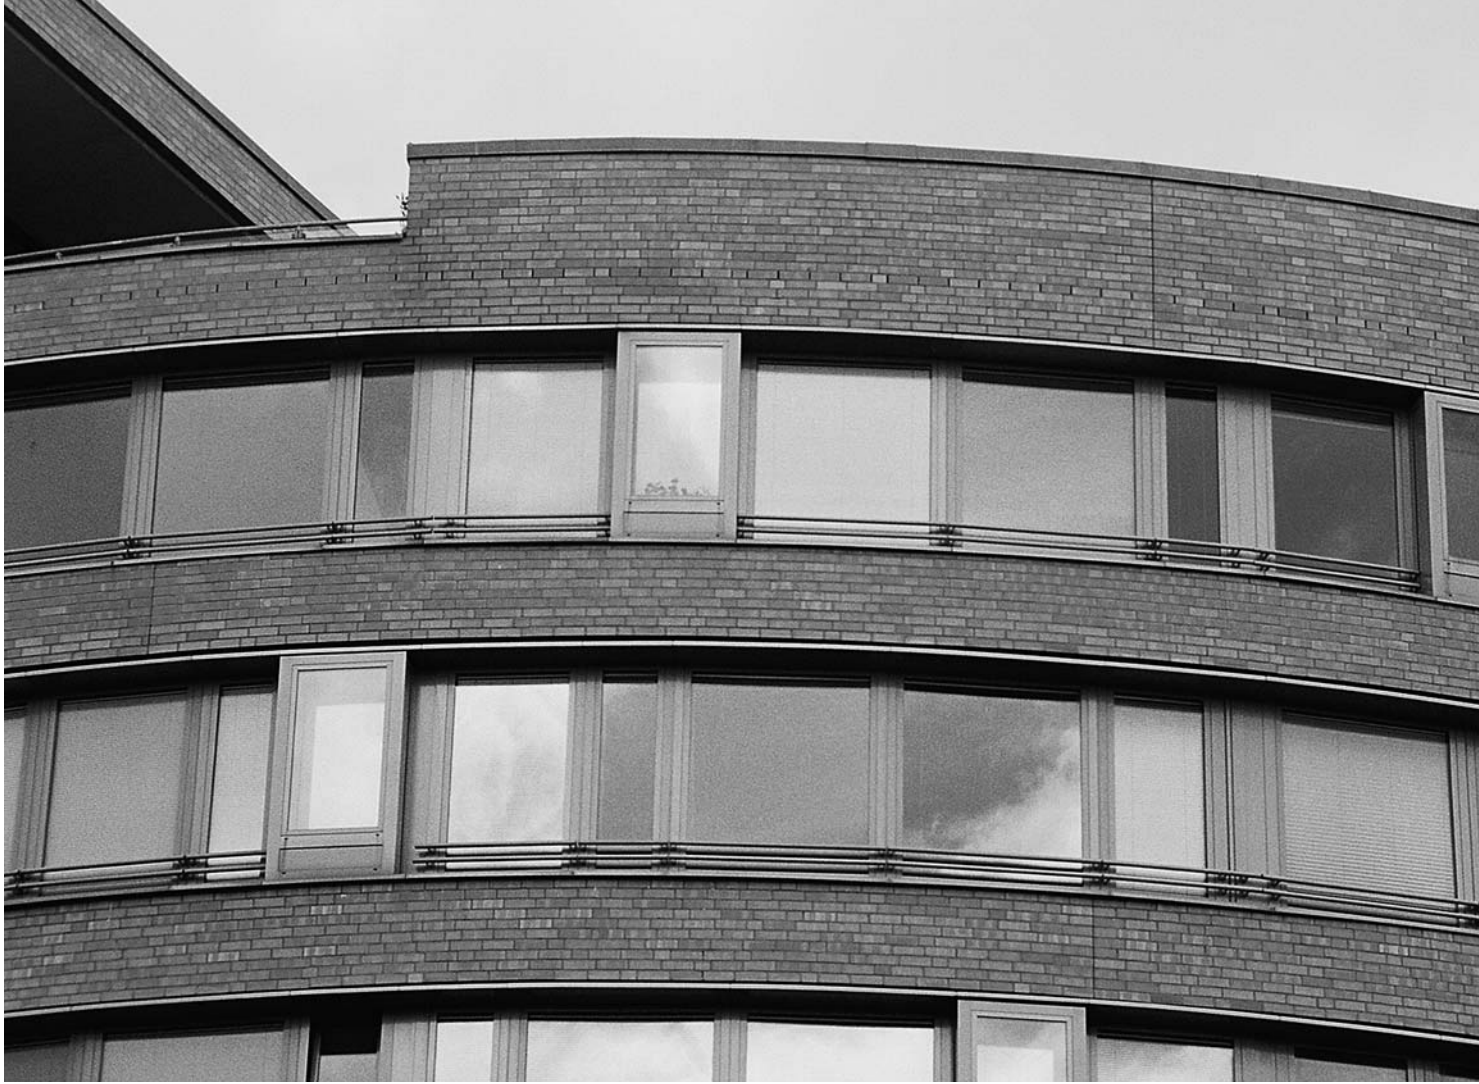
Residential complex for government employees, Berlin, completed in 1999. The apartments have masonry weeps and vents to allow moisture out of the wall.

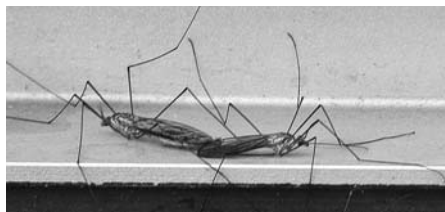
Baffled weeps are often used to prevent insect infestation into the wall.

Drainage holes are required to leak infiltrating water out of the system. Baffles are used to prevent water infiltration through the weeps by driving rain. Baffles can be made of a foam material but must be dense and secure to prevent insects from infiltrating the system and nesting. Spiders are notorious for spinning their webs across elegant façades on high-rise buildings. Pressurized cavities within the enclosure system provide insects with shelter from harsh natural elements like rain, sun, high winds, and snow. Baffles can prevent insects from entering weep holes. If the enclosure system cavity has loose construction debris or corroded metals, weep holes can be marked by stains. The design of any enclosure cavities must anticipate the entry of water and provide a clean method of draining through weeps.

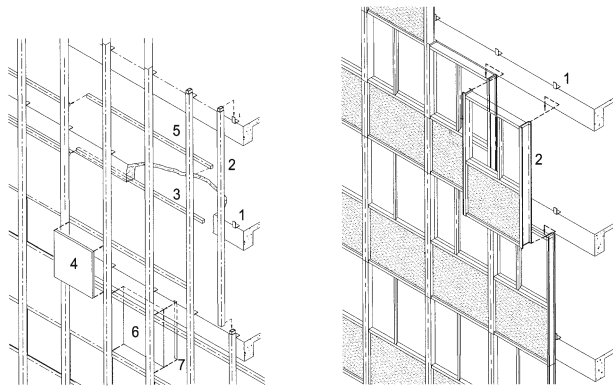
left Stick system:

- 1 Anchor
- 2 Mullion
- 3 Horizontal rail (gutter section at window head)
- 4 Spandrel panel
- 5 Horizontal rail (window sill section)
- 6 Vision glass
- 7 Interior mullion trim

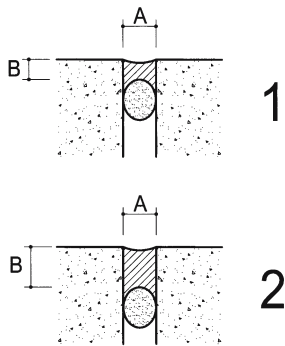
Sealant joint width-to-depth ratio

- 1 Effective sealant joint
- 2 Ineffective sealant joint

Sealant failure can be cohesive or adhesive. Cohesive failure occurs when the movement capacity of the joints surpasses the designed movement capacity of the sealant. Cohesive failures can be avoided by using durable sealants and by detailing joints to accommodate anticipated movements. The joint width-to-depth ratio is critical. Typically, the width-to-depth ratio should be 2:1. Sealant manufacturers provide guidelines about how their product is to be installed, and should be consulted regarding atypical conditions. Properly installed sealant joints should only have adhesion to two sides of the joint. Three-sided adhesion will prevent the joint from expanding properly. Backer rod or bond breaker material is used to ensure a joint can accommodate movements.

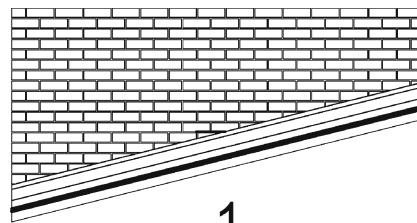
right Roof flashing, Imperial Polk County Courthouse in Bartow, Florida
 1 Initial design of flashing at roof transition was surface-applied to masonry wall
 2 Revised detail of flashing was stepped to provide through-wall flashing to effectively weep water

Water leakage through the brick veneer wall occurred primarily at window openings and at roof-to-wall intersections. The transition details at the courthouse had four major problems. First, the flashing material proved to have poor durability. Composed of PVC, the flashing material became brittle within three years of installation – particularly in areas where it had been folded or manipulated, the flashing began to split. Second, many of the window flashings failed to shed water to the exterior. In most cases, they did not extend all the way to the face of the veneer. Third, end dams were not provided at terminal edges, and the flashings did not turn up behind the window sill to prevent water from tracking back into the building. Finally, the flashing at the intersection of the brick veneer and the side (rake edge) of the sloped roof did not provide a through-wall flashing. Similar to the Vontz Center in Ohio, flashing of the sloped roof consisted of a metal termination bar surface-mounted to the face of the masonry wall. With no through-wall flashing to collect water flowing down the inside face of the cavity wall, water infiltration was inevitable.

In order to stop the air and water infiltration that riddled this building, the entire brick veneer with its windows was removed. A rubberized asphalt membrane was applied to the exterior face of the CMU back-up wall, and new copper flashings were installed around the entire perimeter of the window openings. The flashing system with an upturned leg was sealed to the window frames and the rubberized asphalt membrane was adhered to the flashings. In order to be effective, the flashing at the roof was installed in a step manner to follow the slope of the roof and the masonry mortar joints. The flashing was integrated into the mortar bed and head joints of the brick veneer. All the vinyl wall covering was removed from the interior face of the dry wall and replaced with a breathable latex paint. It was important to establish a vapor barrier on the warm side of the insulation (in this case, the outside was the warm side), and removal of the wall paper was necessary to prevent a double vapor barrier from trapping moisture within the wall system. After three years of work, remedial construction costs

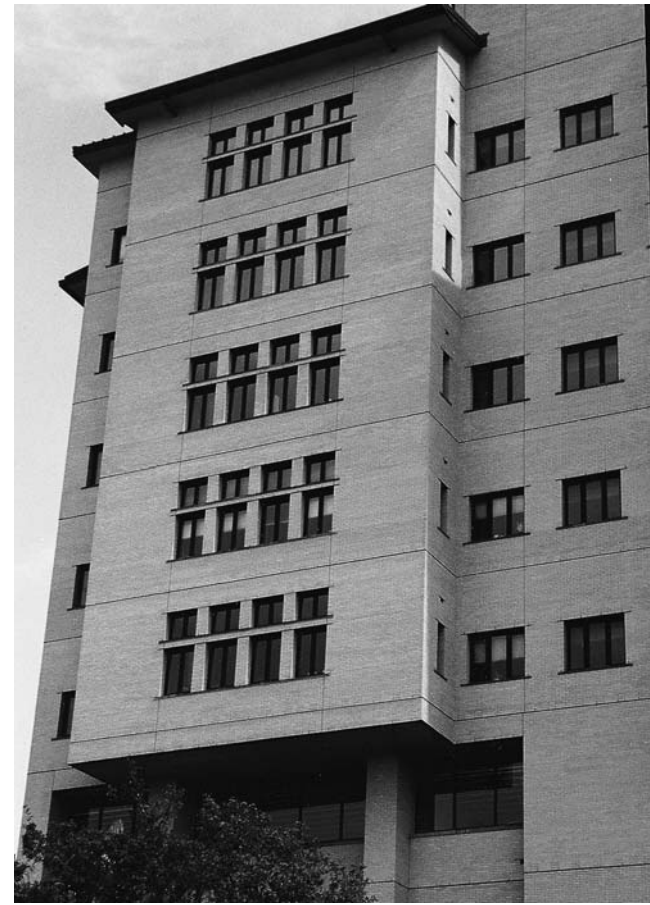
right Imperial Polk County Courthouse, Bartow, Florida, 1986. Relieving angles with soft joints below each relieving angle and vertical control joints at approximately 6–9m (20–30 feet) on center were installed with the replacement veneer wall.

below Imperial Polk County Courthouse showing revised stepped flashing completed with replacement veneer wall.

The cracking and bulging of the brick veneer at the courthouse was the result of ineffective and missing relieving joints in the brick façade. These cracks were the entry point for much of the water problems at the building. The original veneer lacked vertical control joints and horizontal expansion soft joints. These were installed in the replacement veneer. In order to better understand the origin of the cracks at the Imperial Polk County Courthouse, one needs to understand the modes of differential movements in a veneer façade.
