failed stone

problems and solutions
with concrete and masonry

Problems and Solutions with Concrete and Masonry

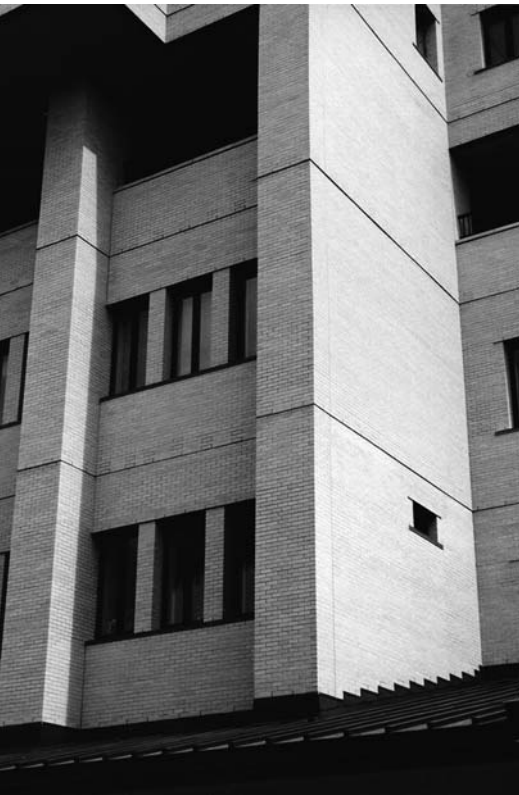
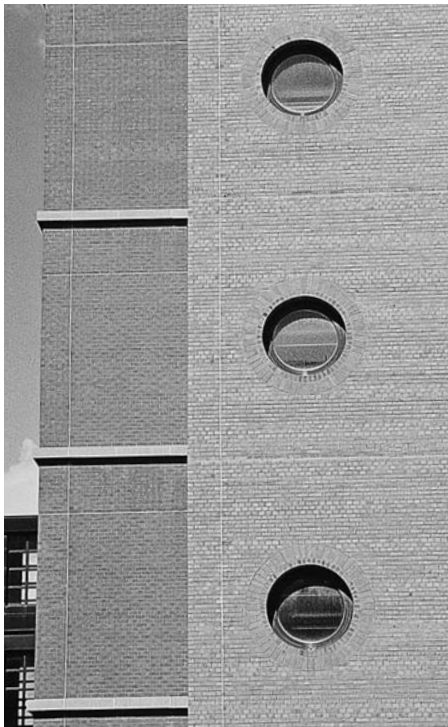
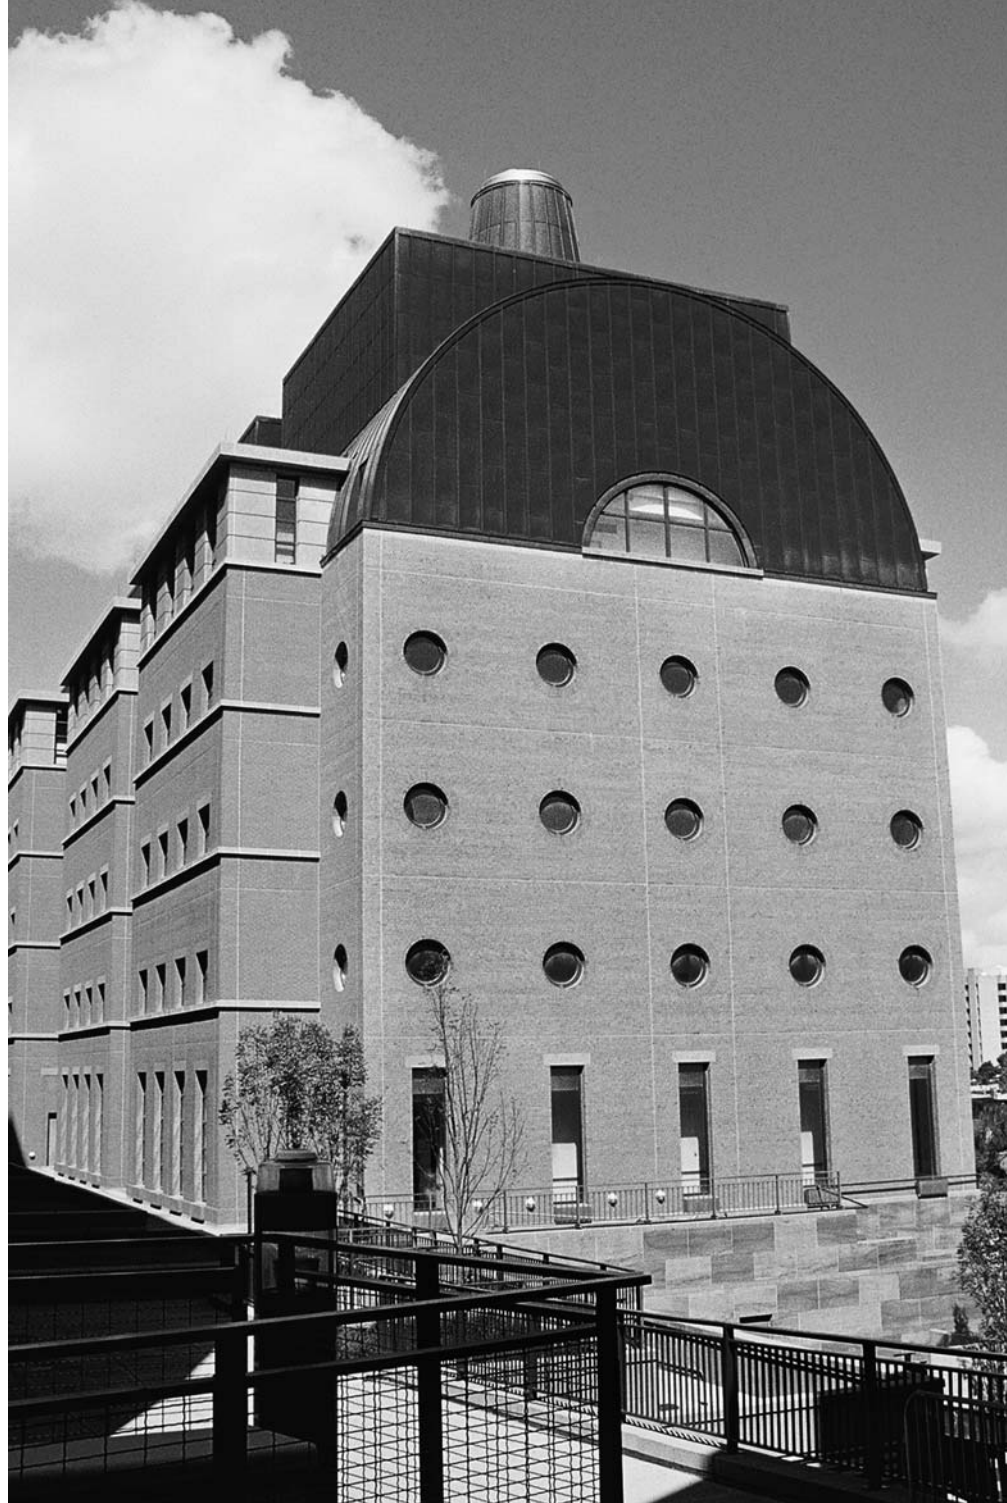
right and below Masonry expansion joints can be an integral part of the façade design. Engineering Research Center (ERC) at the University of Cincinnati, Ohio, 1995.

a building façade in an unattractive fashion. They can be an integral part of the façade design. The Engineering Research Center (ERC), University of Cincinnati, Ohio, designed by Michael Graves and completed in 1995, provides an excellent display of crack-free expansion joints and supplies a grand entrance to the historic section of the campus. The stone and brick building is the east addition to the Schneider Engineering Quadrangle. Sculptural smokestacks top each

section of the ERC and the barrel roof is clad in copper. “Portholes” and elegant masonry designs add variety to the façade. Masonry expansion joints are not hidden but extenuated with color and provide a grid pattern for the exterior.

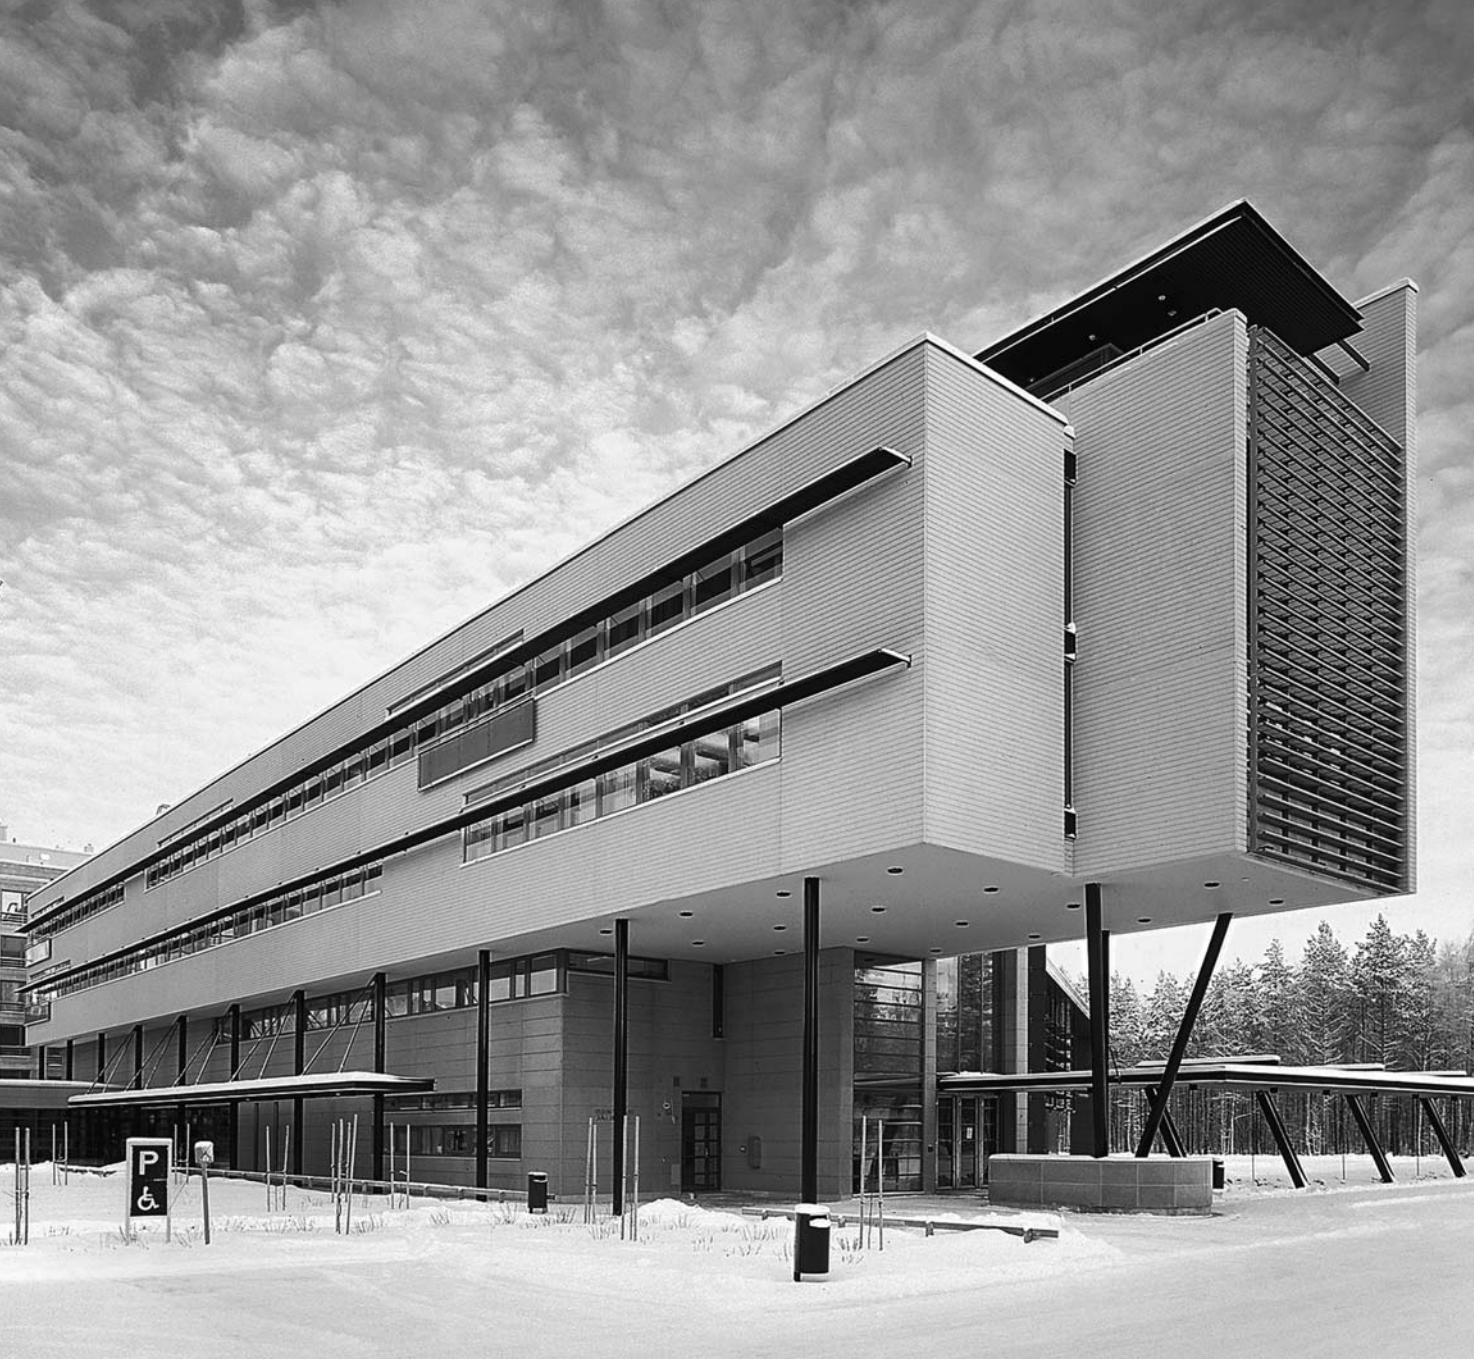
For the new main building of the University of Oulu, Finland, designed by Virta Palaste Leinonen and completed in 1989, the concrete panel joint design had to consider extreme thermal cycling.

Designing in extreme temperatures can be tricky. The University of Oulu in the Linnannmaa District, north of Oulu, Finland, is a concrete structure covered in precast concrete panels. The main building required a pale, gray precast concrete panel with white exposed aggregate finish. A critical feature in the design was the joint detail. The designers wanted the joints to be as narrow as possible and also wanted the panels to be as long as possible so the façade would appear monolithic. Larger panels would also reduce cost and installation time. These desires were in conflict with the extreme temperature range found in Finland, from -40°C to $+40^{\circ}\text{C}$. Joint design must consider the full thermal movement of adjacent materials. A compromise in panel size and joint width was determined. Each panel is one story tall and up to 6m (20 feet) wide, and panel joints are 15mm ($\frac{5}{16}$ inch) in width. When panel joints are not well considered, the result can be disastrous.

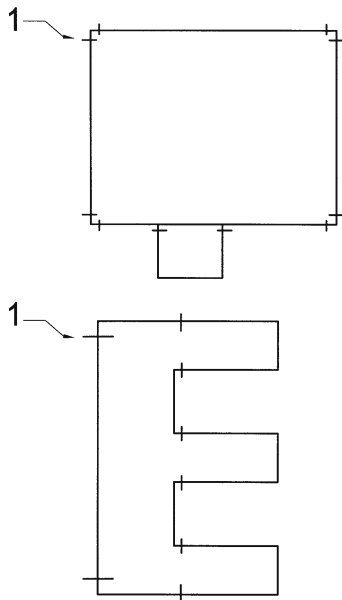
right Vertical cracks in masonry: the symptoms of masonry façade stress are often readily recognizable. High vertical stress may result in specific bulging or cracking patterns, usually at building corners where reduced lateral masonry confinement leads to compression buckling or vertical shear cracks. Often vertical cracks occur about 30cm (12 inches) from the corner.

expanding at the same rate and the massive walls could sustain the force in the wall. In the late 1950s, masonry wall design changed from barrier walls to cavity walls. This new design created a thinner masonry wall with an air gap separating it from the back-up wythe. The resulting thermal isolation exposed the façade to greater cyclic temperature extremes and differential movement. As a result, greater thermal expansion and contraction occurred. The façade’s resistance to compressive forces was lessened due to the reduced thickness and lateral restraint, especially at narrow piers and building corners.

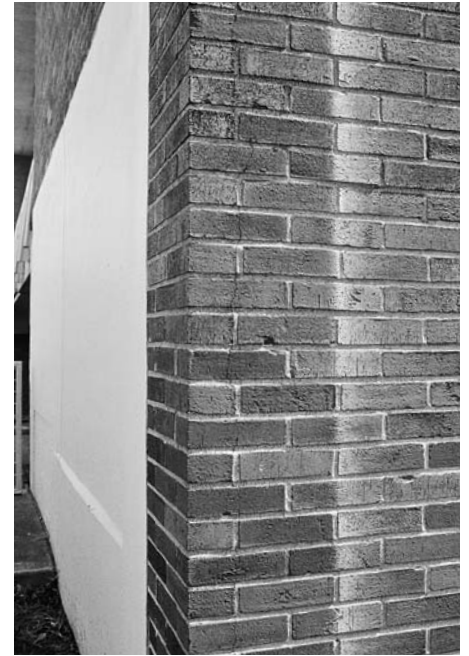
Brick expansion joint locations for various building plan shapes.

1 Vertical joint in veneer wall.

Expansion joints prevent cracks that can lead to water infiltration. Their execution is critical to maintaining a leak-free building. The joints are essentially continuous gaps in the masonry to accommodate accumulated vertical or horizontal planar expansion and contraction of the building façade.

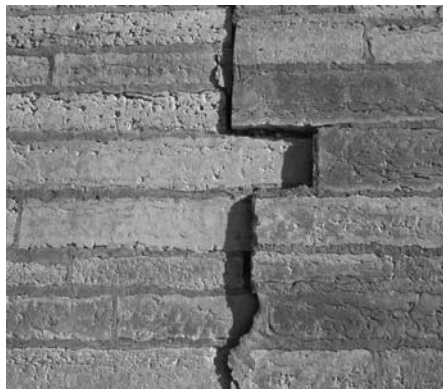
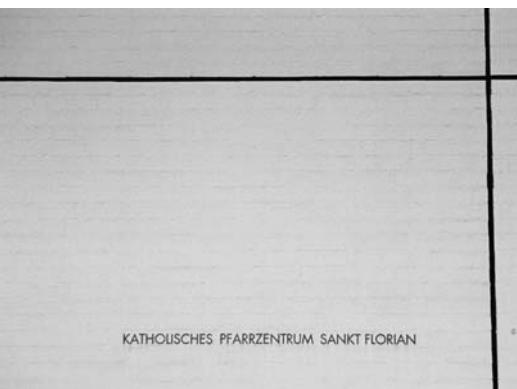
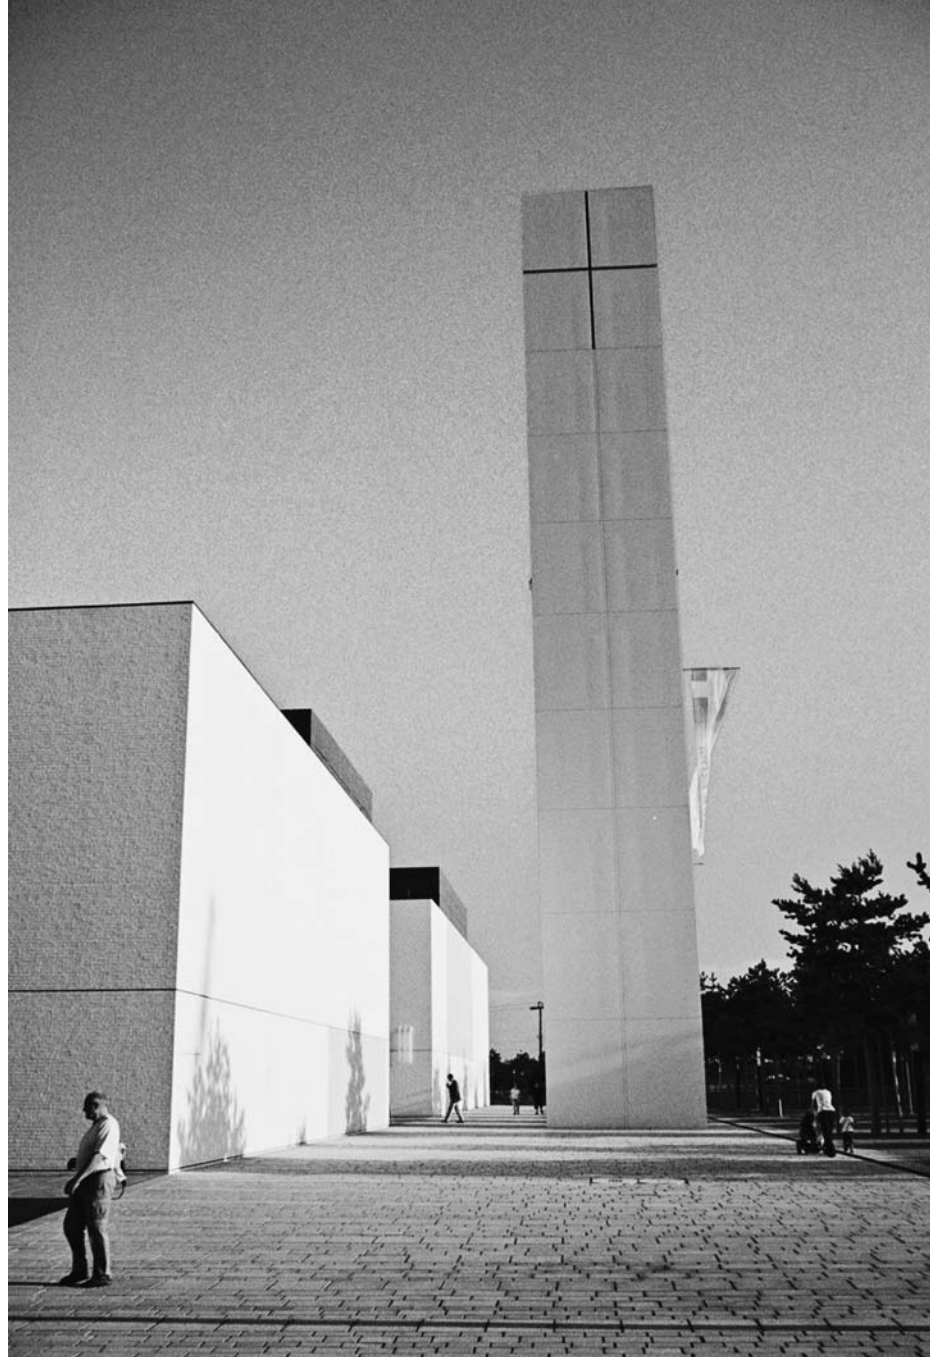
Sankt Florian Church Center in Riem, Munich, 2004. The expansion joints and control joints for the building are an integral part of the design and provide a method for articulating the sign of the cross on the church tower.

Control joints for concrete and concrete masonry walls are designed to relieve stress in a regular pattern in a wall. Designers can use control joints to predetermine where the cracks in a concrete wall will occur. The joints can become part of the façade design. A new church in Riem just outside of Munich used control joints in the façade design. Completed in 2004, the Roman Catholic and the Protestant Lutheran Churches came together to construct a church center east of Munich central. Church rooms and official areas can be accessed directly from the mutual church square. The individual structures of varying heights and the incisive steeple are shielded from the outside by a 10m high (33 feet) wall which hides a microstructure of multipurpose rooms. The expansion joints and control joints for the building are an integral part of the design and articulate the sign of the cross on the church tower.

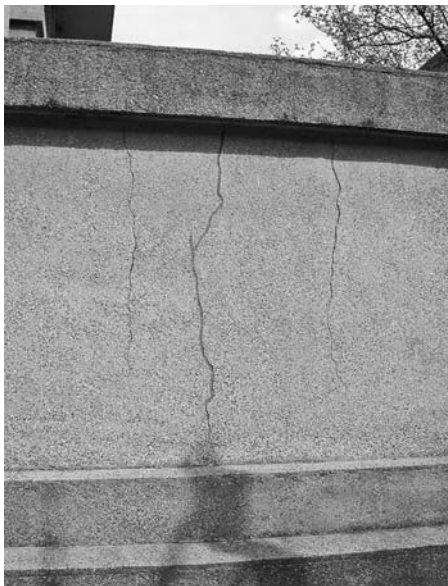
right and below Unity Temple, Oak Park, Illinois, 1905, shows isolated cracks in the exterior walls even after extensive restoration work in 2002.

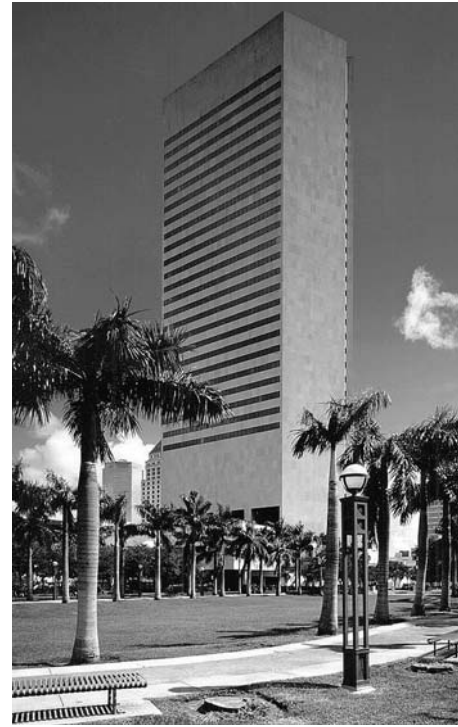
right Metro Dade Center in Miami, Florida, 1985.

When exterior stone wall panel expansion joints are missing or filled solid, the results can be disastrous. The 152.4m (500 foot) tall Metro Dade Center in Miami, Florida, was constructed in 1985 to house county offices. It is clad with approximately 8,700 limestone panels that are 10cm (4 inches) in thickness. The panels are attached to the building's reinforced concrete frame with stainless steel anchor supports. They range in size from 1.5m (5 feet) high and 0.61m (2 feet) wide and weighing 255kg (600 pounds), to 3m (10 feet) high and 1.5m (5 feet) wide, weighing 977.5kg (2,300 pounds). In 1987, cracks were detected in the building's limestone façade after a piece of stone fell to the ground. The cause of the cracked panels was linked to the system's inability to accommodate vertical and horizontal movement between the panels and the concrete frame. The differential movement was created primarily from the building structure's concrete shrinkage and creep, and thermal expansion/contraction of the limestone relative to the concrete frame.

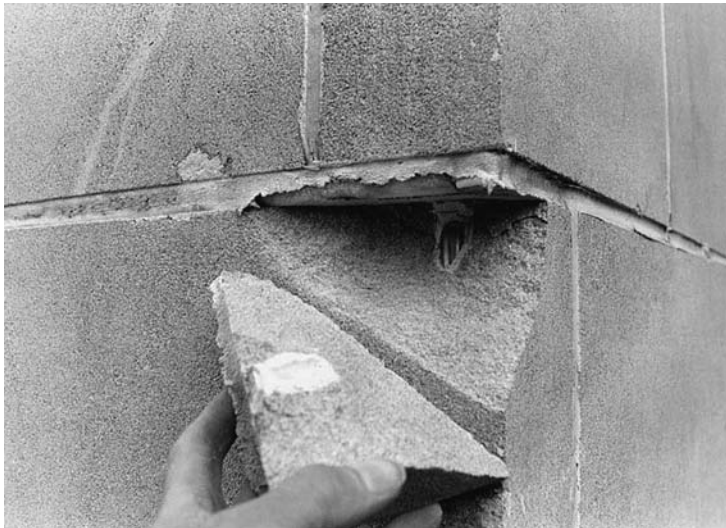
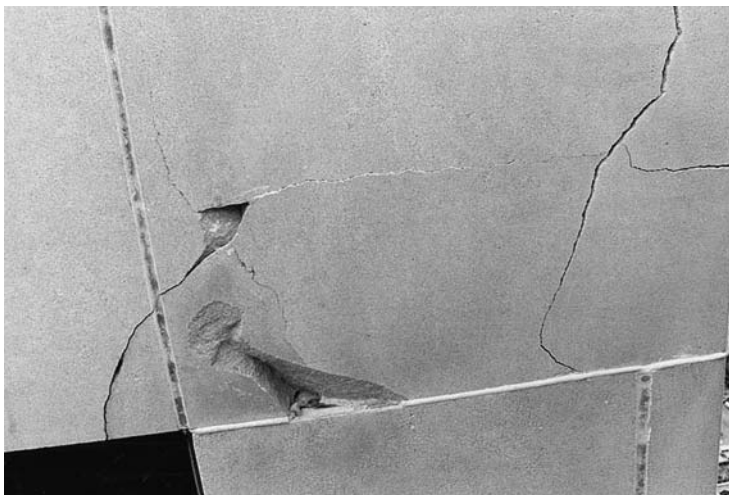
below Metro Dade Center. Corner cracks in stone.

cases, the stone panels on one face of the building were pushed out beyond those of the adjacent façade, and anchors were peeling off triangular pieces of stone. In order to solve the problem, corner panels were replaced and a continuous expansion joint was installed.

The engineering firm of Simpson Gumpertz & Heger was hired to solve the problem. To resolve the vertical expansion problem, horizontal joints between stone panels were cut to provide a gap of a minimum 3mm ($\frac{1}{8}$ inch) and filled with sealant. Approximately 15,000 new anchors were installed. All of the original limestone panels were retained, except for 44 panels which were significantly cracked. These panels were replaced with new stone.

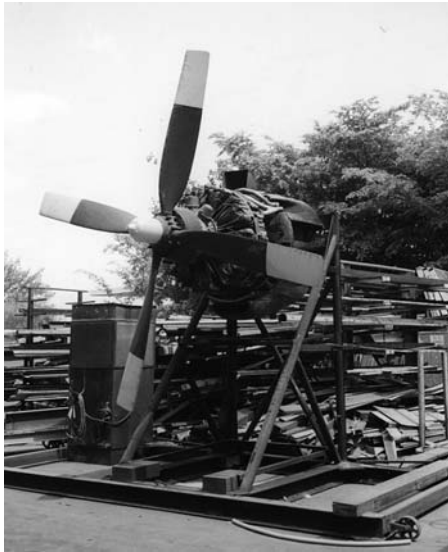
An airplane engine is used with a sprat rack for dynamic water infiltration mock-up testing.

To verify the effectiveness in controlling water penetration. Resistance to air and water infiltration can only be determined through testing. The test intends to simulate an enclosure subjected to high winds combined with heavy rainfall. The assembly is subjected to a predetermined internal pressure to simulate the force of wind on the enclosure. Water is sprayed on the assembly at a specified rate for a given time period. Failure of the test occurs when water appears on the inside surface of the enclosure during the course of the test. Controlled water inside the system that weeps to the exterior is allowed. A second method of testing for water penetration into a building is the dynamic pressure test. Dynamic testing is used to determine if water will infiltrate an assembly when exposed to a pulsating pressure. The in-and-out turbulent flow of air occurring during a storm is typically

simulated by using an airplane propeller engine in conjunction with water spray racks. Because of the turbulent nature of the pressure, water may penetrate a system, which would not show up in the uniform static air pressure test. It is recommended that the water infiltration test should be repeated after structural loading to confirm that minor deflections in the system will not trigger leakage into the building.

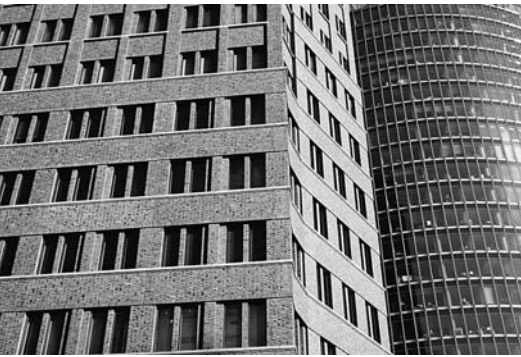
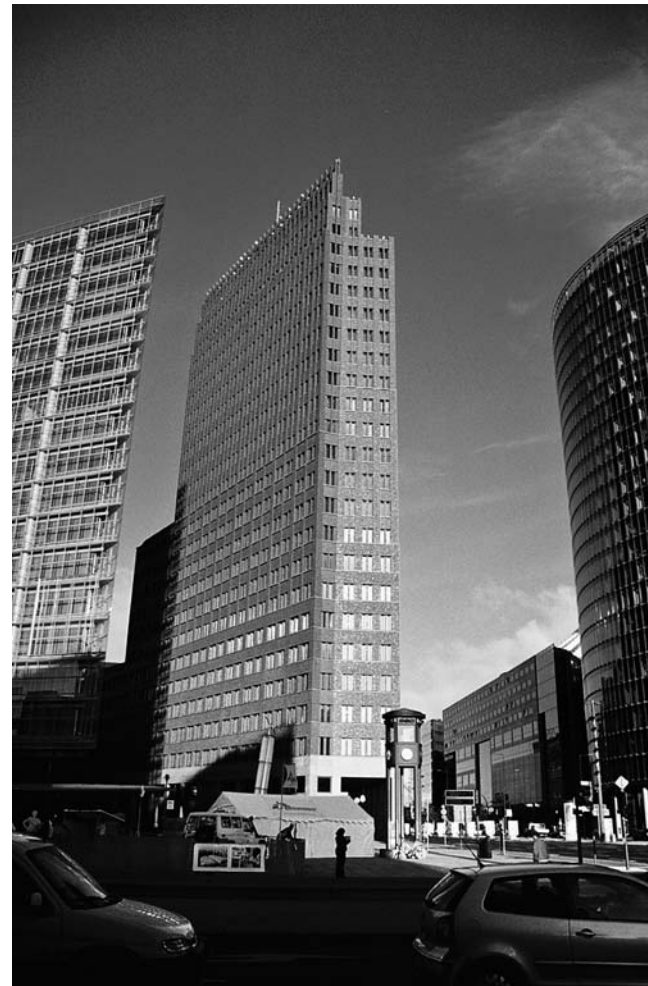
above and right Masonry tower at Potsdamer Platz, Berlin, 2000.

building completed in 2000 at Potsdamer Platz, Berlin, continues the tradition. The masonry spire mirrored by the Sony Tower form an ironic gateway to Potsdamer Straße.

The dark red brick façade with small window openings is in strong contrast to the all-glass façade of the Sony Tower. The facing and relief structure as well as the staggered design is modeled on the skyscrapers of the 1930s and 1940s in North America; however, the building shows all of the standard joints requirements of a contemporary masonry façade. With properly installed through-wall flashings, weeps and expansion joints, concrete, masonry, and stone can be leak-free.

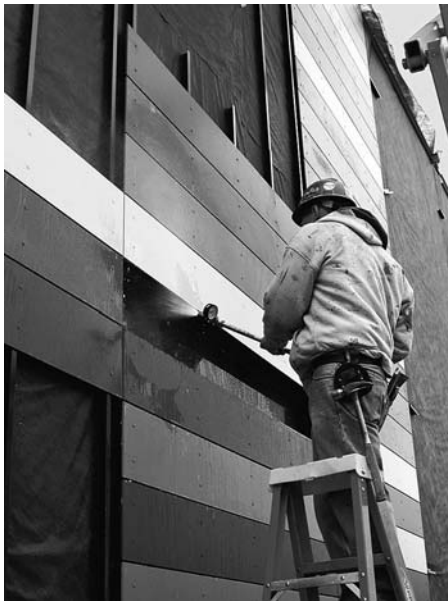
Field water test of cement fiber panel and window system transition. Gary Corner Youth Center, Chicago, 2006.

The most critical time to complete field testing is at the beginning of a project. Early testing can eliminate these faults before the remainder of the installation is completed. Field testing when the first units of an enclosure are installed can uncover any faults with the assembly of the system. Random field testing of the system as the project progresses will help verify that quality control has been maintained throughout the process. Atypical conditions not part of laboratory testing can be reviewed for air and water infiltration. Field testing is also important to ensure that transitions to adjacent systems have been properly executed. Random sealant adhesion field testing is important to verify that substrates are being prepared properly. These tests confirm that the seals are being installed as designed and that the sealant material is curing properly.
