failed stone

problems and solutions
with concrete and masonry

Failed Stone

Problems and Solutions with Concrete and Masonry

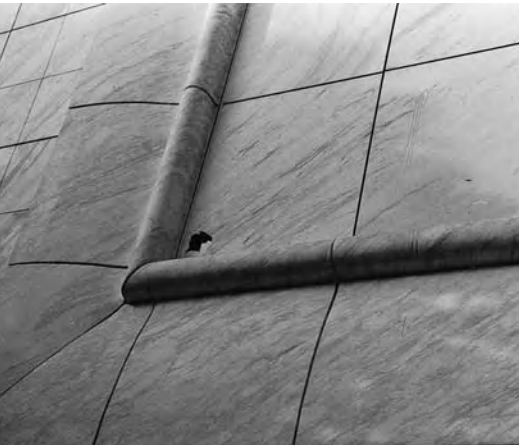
above The translucent
marble façade is prone to
vandalism and breakage.
E.N.S.A.D. – Ecole Nationale
Supérieure des Arts Décora-
tifs, Paris.

right Translucent stone
façade allows light into the
building. E.N.S.A.D., Paris,
1997

The Paris school is composed of a translucent marble curtain wall. A fine layer of marble is laminated to the glass of a traditional curtain wall system. The fabrication of these glass and stone units requires the exterior stone surface to be polished down to a very thin layer in order to improve light transmittance. The building's stone appearance has been challenged by people throwing rocks from the street which penetrated the stone façade. Other stone façades have followed the E.N.S.A.D. project with the hope of resisting much more severe attacks. The Israeli Foreign Ministry Building provides a beautiful stone façade designed to resist bombs. The façade

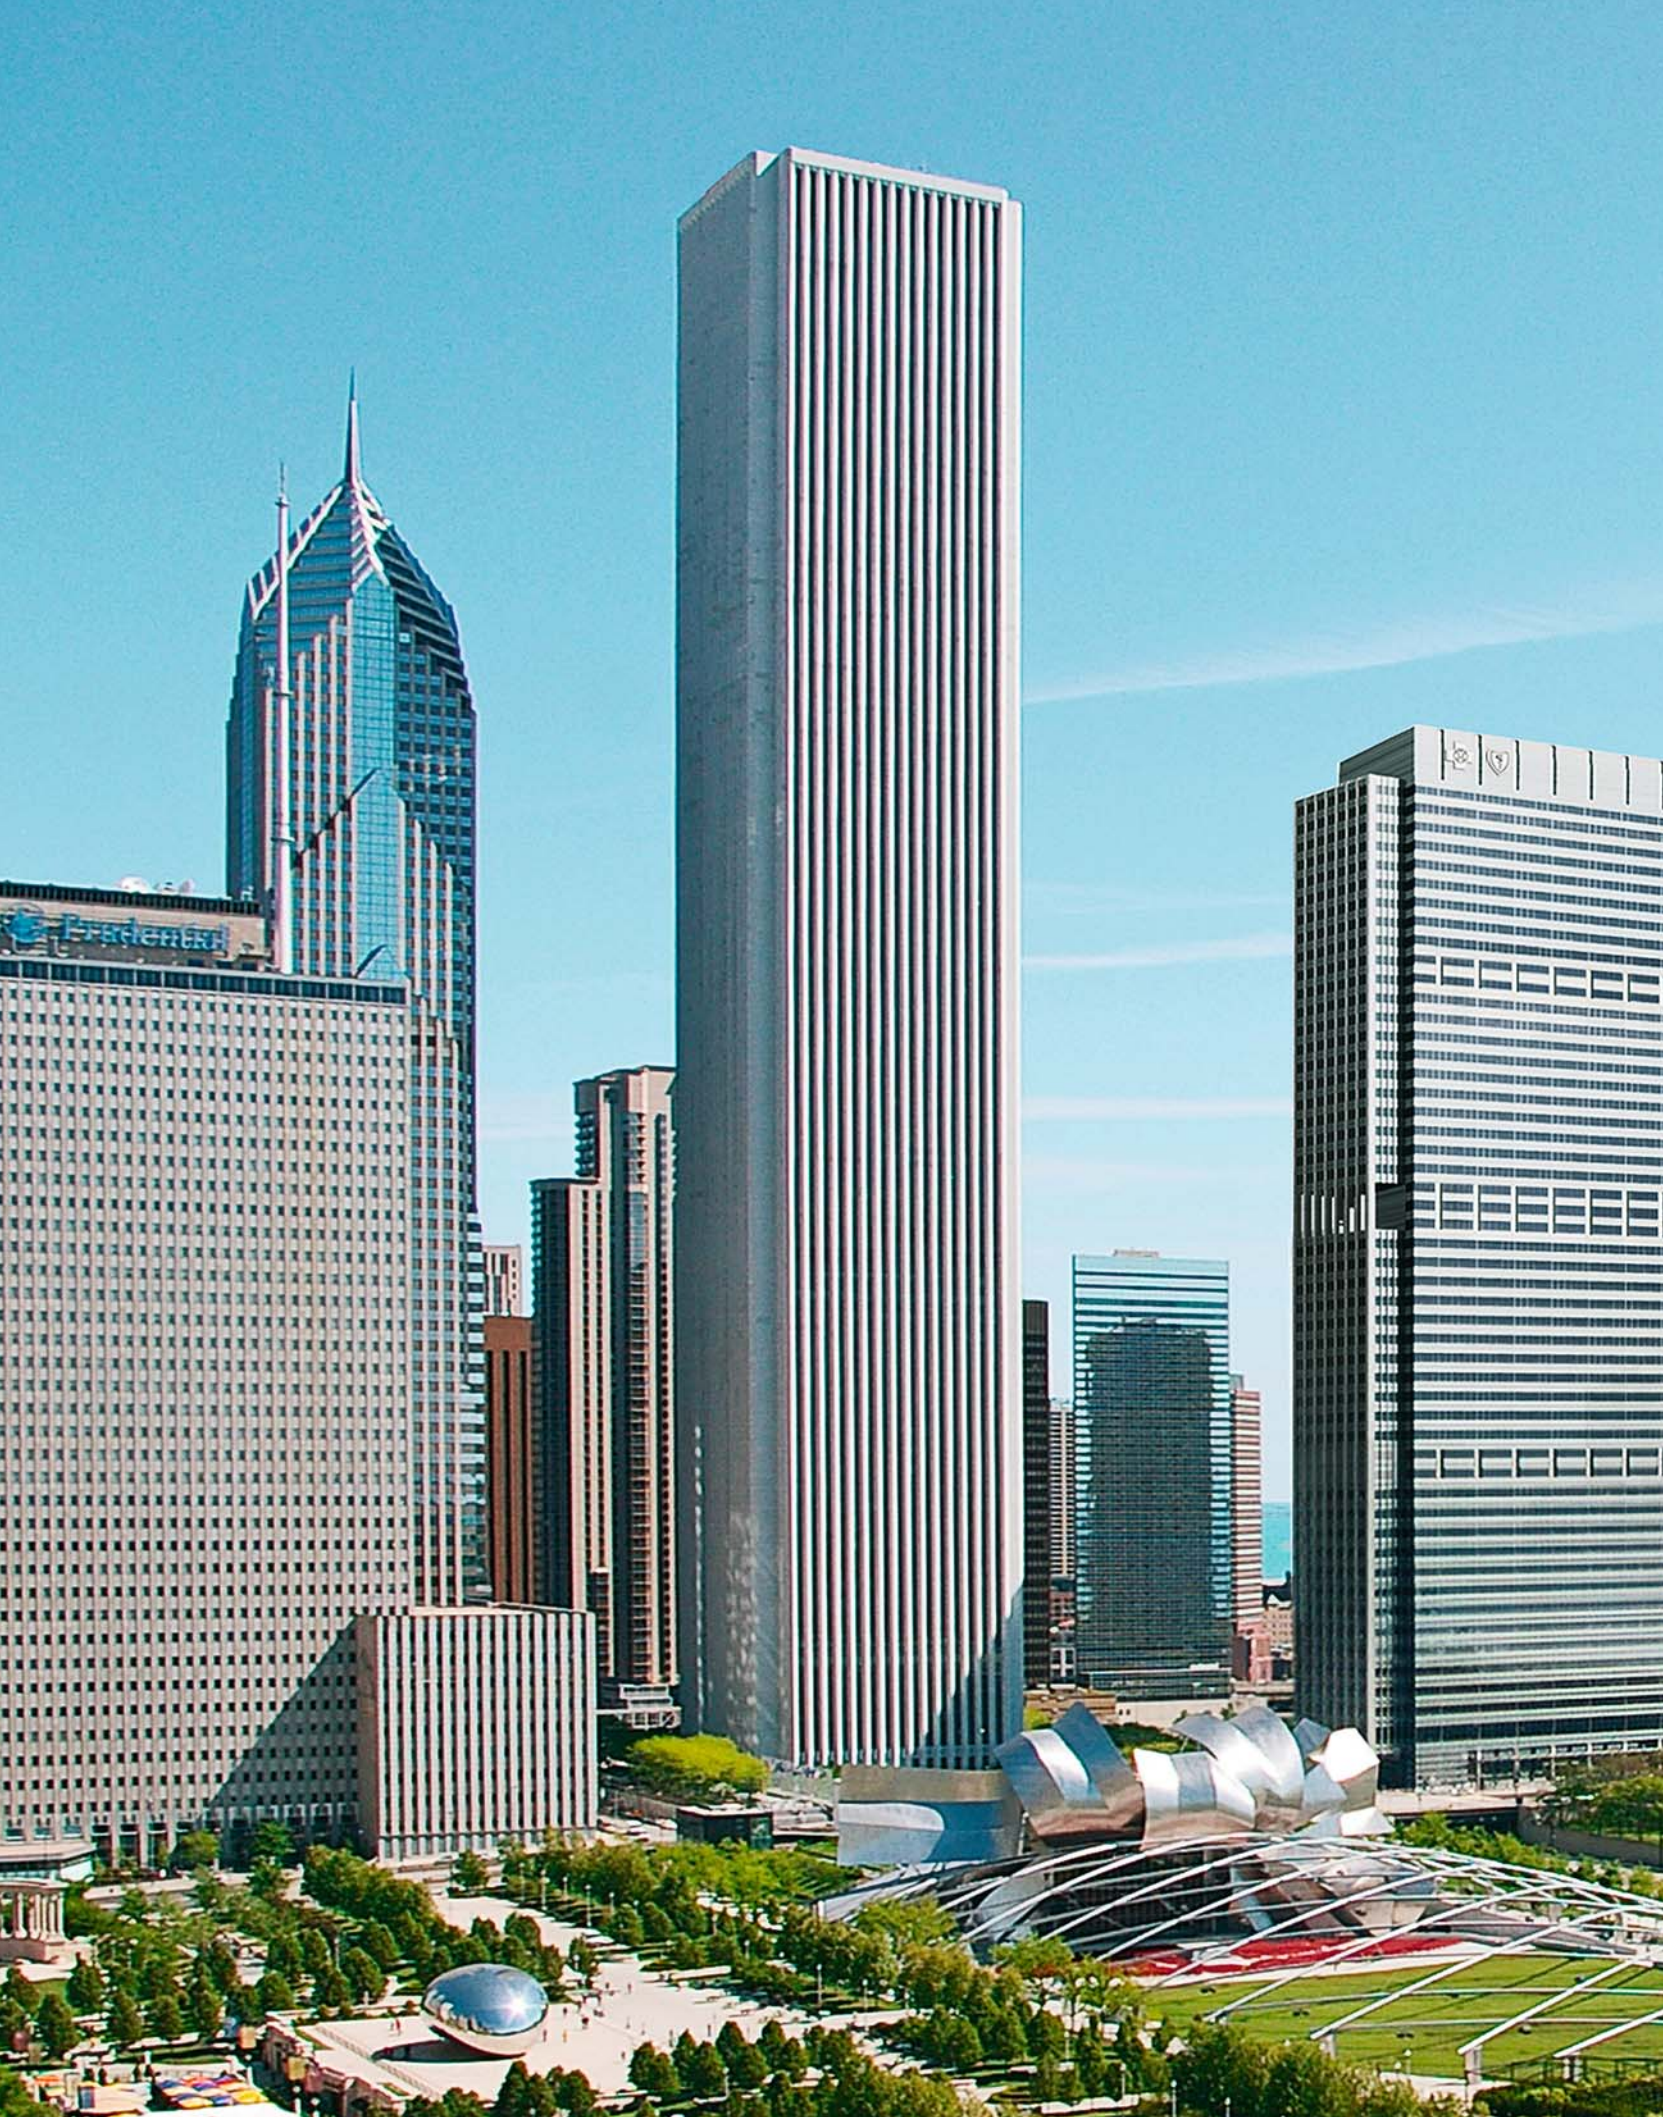
Mock-up of original Amoco Building façade at Construction Research Laboratory in Miami, Florida.

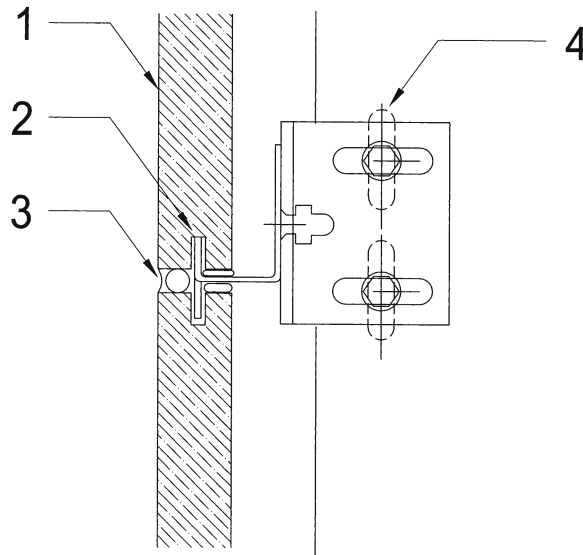
Section through marble connection

- 1 Marble panel 3cm or 4cm (1 1/4 - 1 1/2 inches)
- 2 Stainless steel bent plate
- 3 Backer rod and sealant
- 4 Galvanized steel angle connection back to chevron shaped steel column

At the conclusion of the design and testing phase of the project, 44,000 pieces of Alpha Gray marble from Carrara, Italy, were used to clad the perimeter columns of the Amoco Building. The work was completed in 1972. The average stone size was 127 x 107 x 32mm (50 inches high by 42 inches wide by 1 1/4 inches thick), except for the reentrant corners where the thickness of the panels was increased to 38mm (1 1/2 inches) from the 42nd floor and above. The increased stone thickness at these locations was to compensate for the higher anticipated wind loads at the upper corners of the building. The marble panels were supported by 152mm long (6 inches) stainless steel bent plates connected to galvanized angles that were stud bolted into the structural steel chevron shaped columns. The marble panels had kerfs cut into them to receive the stainless steel bent plate. The downturned tabs of the bent plate provided lateral support for the stone below and the upturned tab provided lateral/bearing support for the stone above. Each piece of marble was independently supported back to the adjacent steel column. After installation, all of the joints between the marble panels were filled with sealant.

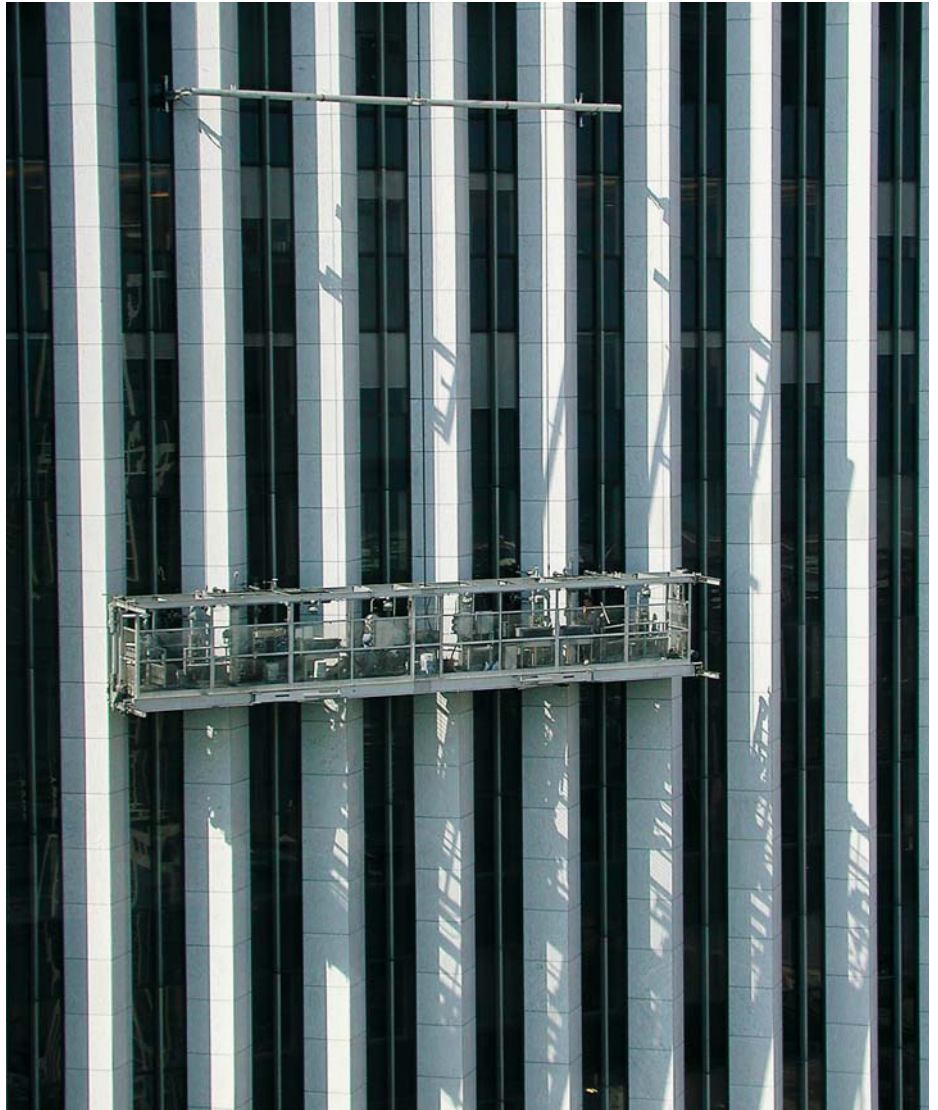
Inspection of the building indicated crescent shaped cracks were visible on the stone panels that clad the chevron shaped steel columns. Amoco Building.

In 1979, inspection of the building indicated crescent shaped cracks in approximately 230 marble panels. The observed crescent shaped cracks occurred in the panels at the 152mm long (6 inches) stainless steel lateral connection points. Between 1979 and 1985, the

building owner observed additional cracking and bowing of the marble panels. Outward displacement of the marble panels was found to be as much as 28.6mm (1 1/8 inch). The outward bowing of the panels was actually an outward dishing of the stone, because the bow occurred along the vertical and horizontal axis of the panels. The effects were linked to thermal cycling, because approximately 80 percent of the significantly bowed panels were located on the south and east elevations of the building, which unlike the west elevations had no adjacent structures to block direct exposure of the sun. The marble panels on the north elevation of the building, which received the least amount of direct sunlight, had the least amount of outward bowing. As a result of these observations, a more thorough investigation of the building cladding began.

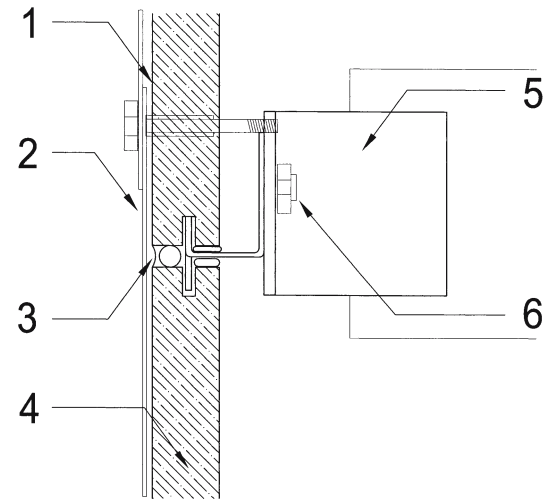
right Temporary strapping detail

- 1 Panel and strap above
- 2 Bolt
- 3 Marble panel
- 4 Theoretical crack location
- 5 Stainless steel straps
- 6 Panel and strap below

- 1 Stainless steel bolt
- 2 Stainless steel straps painted white
- 3 Existing backer rod and sealant
- 4 Existing marble panel
- 5 Existing galvanized angle connected back to structure
- 6 Existing stud weld connection to stainless steel plate

decided to remove the marble panels from the building. Stainless steel straps, color coated white to match the marble color, were bolted through the marble into the supporting angles to prevent any failing stone from coming off.

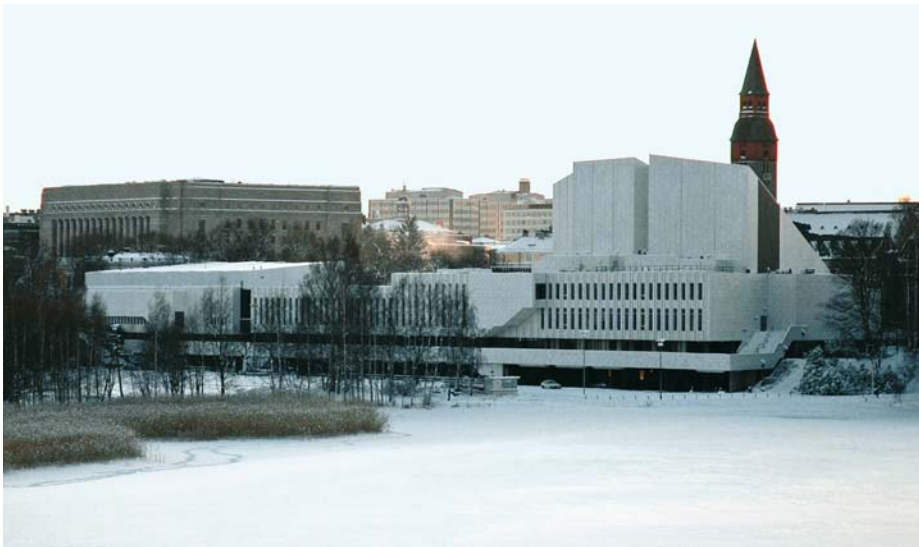
below Finlandia Hall. Photo of bowing replacement panels taken in the winter of 2006.

In 1997, re-cladding of Finlandia Hall with white marble was started. Work was completed in May 1999. In total, 7,000m² (75,320 square feet) of panels were replaced at a cost of over 3 million Euros. In autumn 2001, just three years after Finlandia Hall had been re-clad, it was realized that new panels were bending. Measurements have shown that the renovated walls of Finlandia Hall have deteriorated. The reduction in the strength of the marble since the slabs were replaced is 20–30 percent. Panels installed in autumn 1998 are bowed more than those installed the following spring. The reason for this can be attributed to the cold winter in Finland in

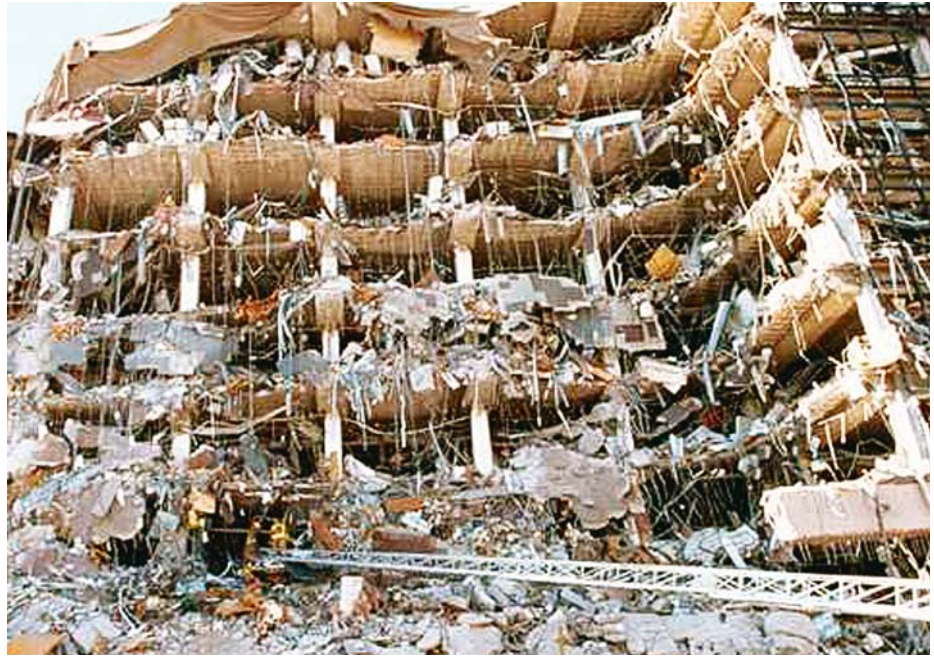
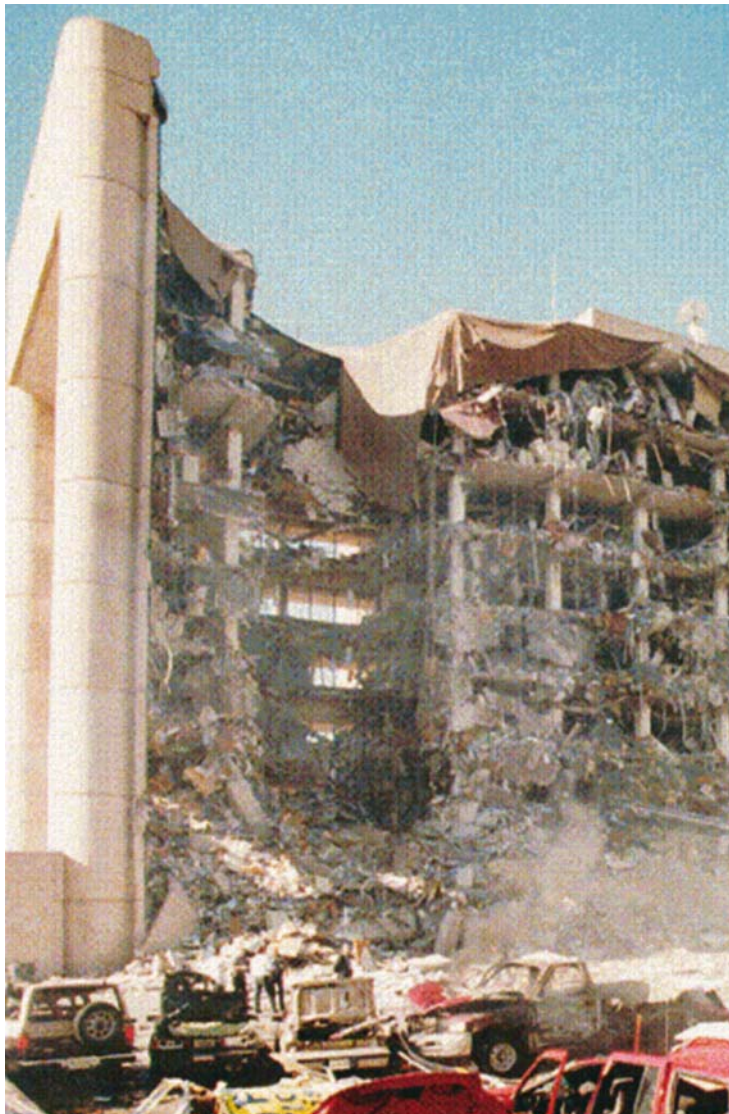
right and below Murrah Building, Oklahoma City. Façade destruction due to impact.

On April 19, 1995, the Alfred P. Murrah Federal Building was destroyed by a truck bomb. The truck, which carried thousands of pounds of explosives, was located less than 3m (10 feet) from the front of the building. The Murrah Building and site proved to be ill prepared for this type of impact. The bombing forced the United States Government and America to rethink how its government buildings should be designed against acts of terrorism, and concrete and stone were part of the solution. Following the Murrah Federal Building collapse, three major design considerations have been developed for buildings of higher-level security: maintaining stand-off distance to a building, preventing progressive collapse to a building structure, and minimizing debris mitigation.

The Murrah Building had a transfer girder running across the face of the structure at the second floor, which transferred the weight of ten building columns to five columns down to the ground. The failure of one column meant three failed; with the failure of two, as many as seven could fall. Localized damage is expected in a bomb blast; however, by preventing progressive collapse, designers hope to limit damage and save lives. In blast design sufficient redundancy must be available in all major structural elements, including beams, girders, columns, and slabs. All are to assume the loads carried by adjacent damaged or removed elements. Post-damage resistance is typically provided by the cantilever or catenary action to hold the damaged zone in place to facilitate rescue efforts. Transfer girders are less likely to be used in this type of design because they increase the potential for a catastrophic failure.

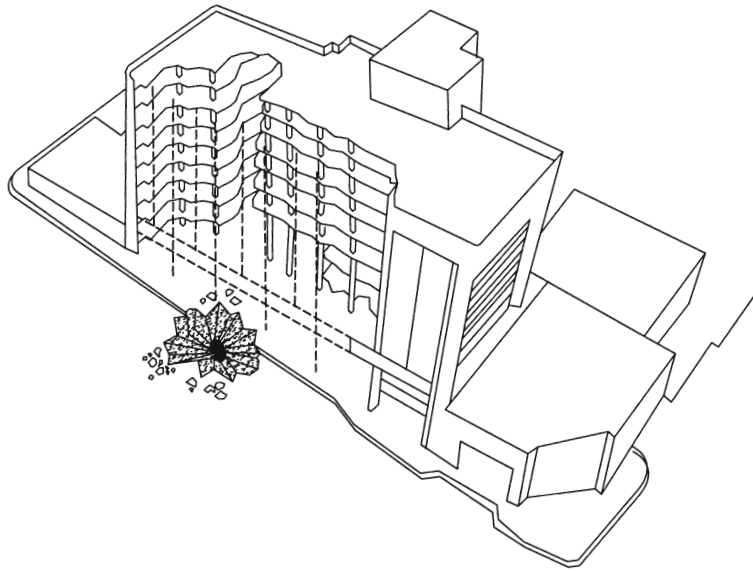
The Murrah Building destruction came from a truck filled with 4,000 pounds of explosives parked less than 3m (10 feet) from the face of the building.

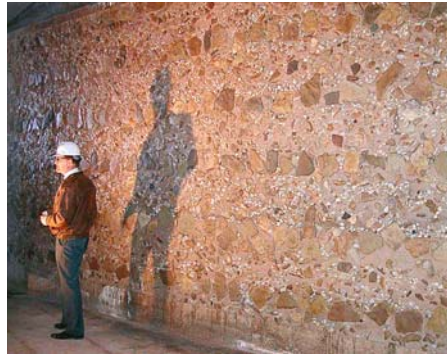
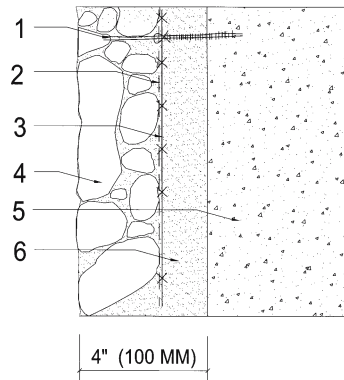
right The stone barrier wall at the main entrance

- 1 Form tie voids to be grouted solid
- 2 25 x 25mm (1 x 1 inch) steel mesh
- 3 15.2 x 15.2cm (6 x 6 inch) welded wire fabric (wwf) secured to form ties
- 4 Stone
- 5 Structural cast in place concrete wall
- 6 Grout

A new stone-setting technique, eliminating the voids in the wall, had to be developed for this project. In order to minimize debris in the event of a blast, 27.58 MPa (4,000 psi) grout was required to secure the veneer stone to the concrete wall. The problem was how to achieve a monolithic pour. How could the contractor ensure that the high-strength grout would flow around the voids in the stone? Learning from several mock-ups, the solution was a new method for constructing a stone wall. The process involved attaching 3.8cm (1 1/2 inch) thick furring strips to the face of a

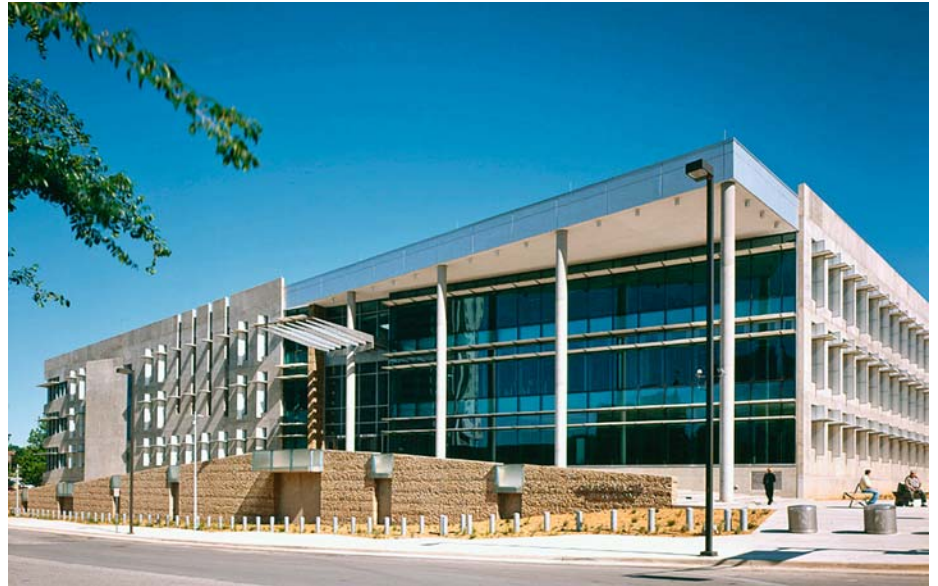
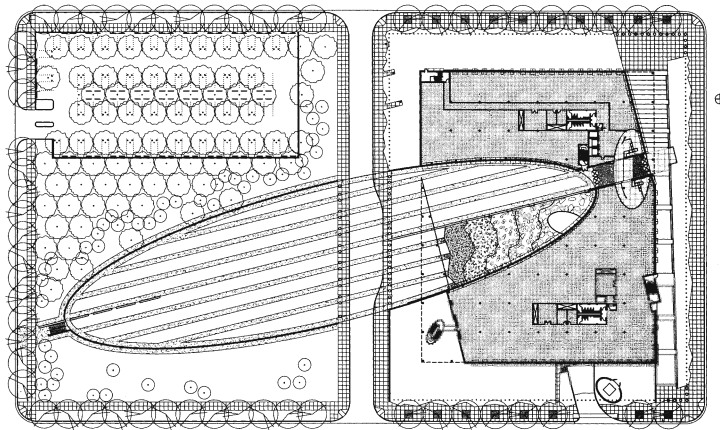
Front entrance to the Oklahoma Federal Campus Building, 2004.

The ground floor plan of the Oklahoma Federal Campus Building provides a perimeter of bollards and a stone wall at the main entrance to protect the face of the building.

The building structure would be one of the first new federal office buildings requiring blast protection. Designed by the architectural firm of Ross Barney + Jankowski, the Federal Campus Building in Oklahoma City is a 16,815m² (181,000 square foot) office building occupying the southern block of a two-block site. The site topography influenced the design of the building in such a way that the east wing of the building is three stories in height while the west side is four. To allow as much daylight as possible into the heart of this large floor plan, a large elliptical courtyard was incorporated into the design. A large window,

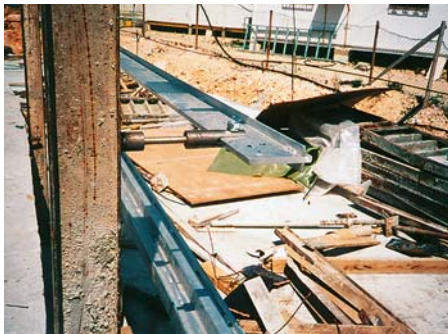
Israeli Foreign Ministry, Jerusalem, 2002. Exterior view of onyx blast-resistant wall.

below Detail of stone connection back to metal framing during construction.

The public building complex at the Israeli Foreign Ministry is configured to accommodate elements appropriate to the State of Israel and its ceremonial functions. In ceremonial fashion there is an atrium and reception hall for heads of state and dignitaries. This was a structure that had to be both beautiful and safe. The innovative design of the wall assembly for the reception building consists of a structure that permits light penetration while maintaining heightened security requirements. The stone wall system has been designed specifically to resist the horizontal thrust that would result from an exterior bomb blast. The central structure of the atrium consists of 12 concrete columns that support a skylight roof above. A steel frame is bracketed off of these columns to provide a secondary outer structure. This second structure consists of 20 x 10cm (7 7/8 x 3 9/16 inch) elliptical steel columns that support the barrier wall. This barrier wall is enclosed by 30 horizontal aluminum channels, which carry 3cm (1 1/4 inch) onyx panels.

Directly behind the stone panels are a series of vertical airplane-gauge stainless steel wires that are suspended from a flexible 5cm (2 inch) diameter steel pipe. The wall system has been designed to resist an exterior blast, which would be absorbed by the stone and secondary aluminum structure. Wooden screens located along the walkways in the atrium provide additional protection for occu-

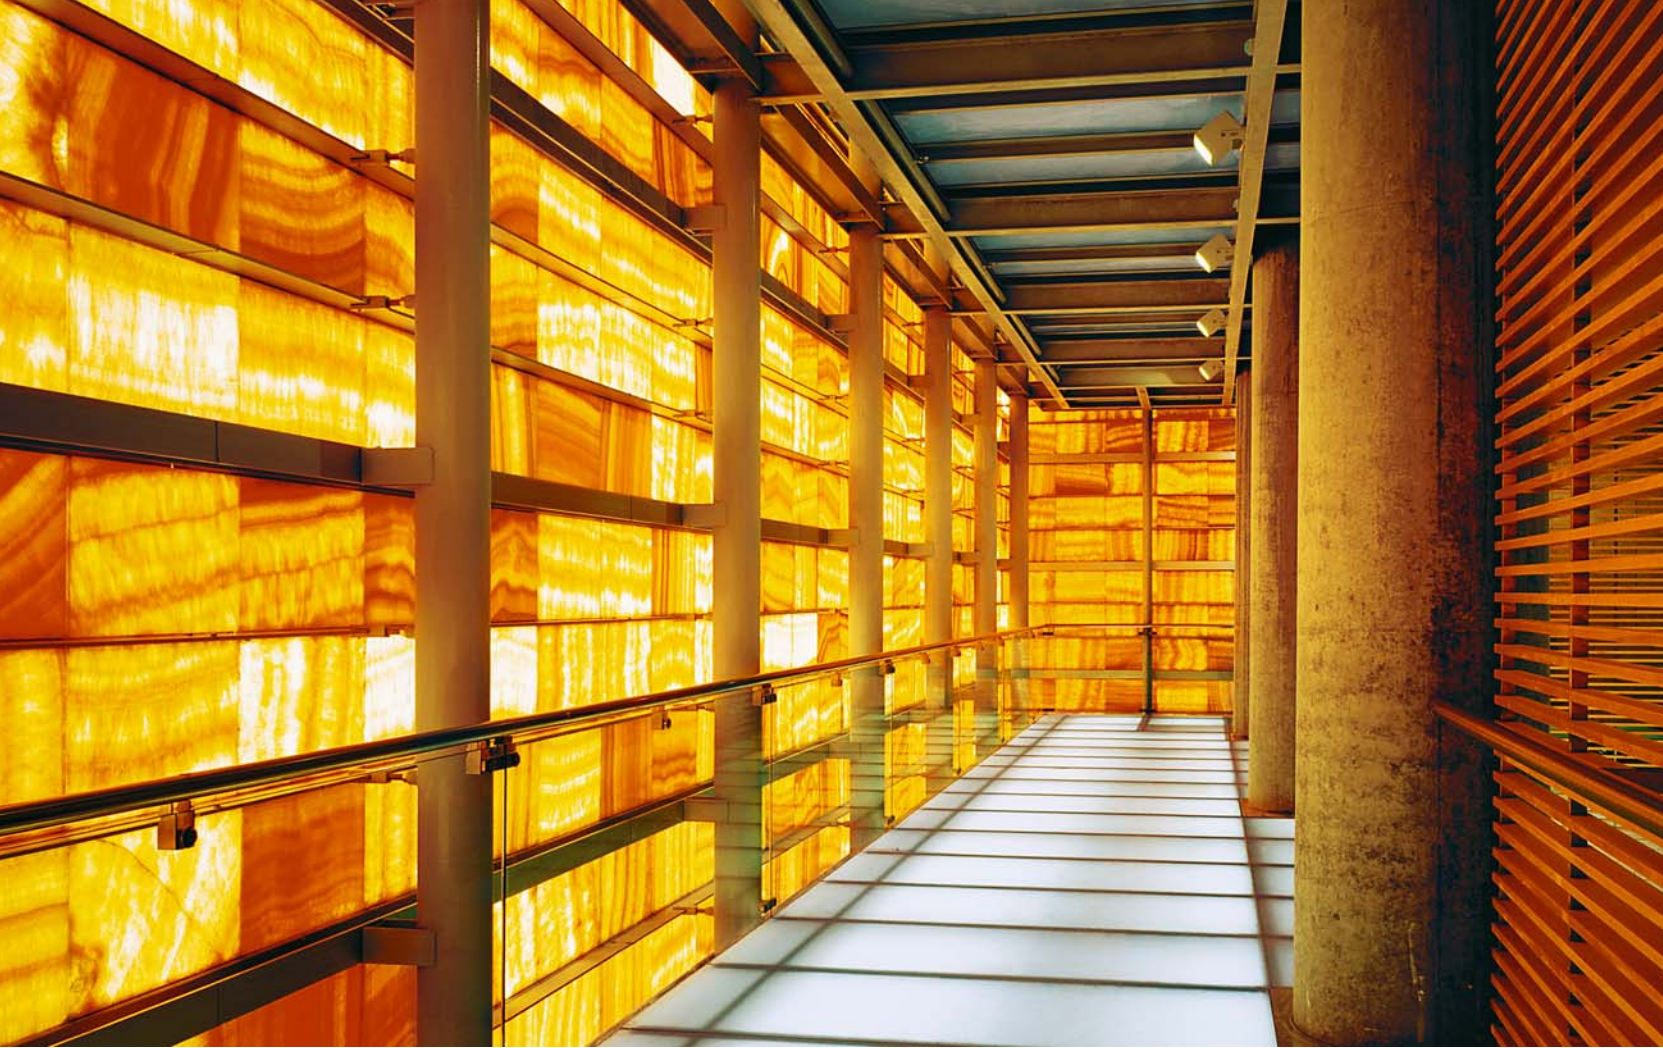
Israel Foreign Ministry, interior view of onyx wall.

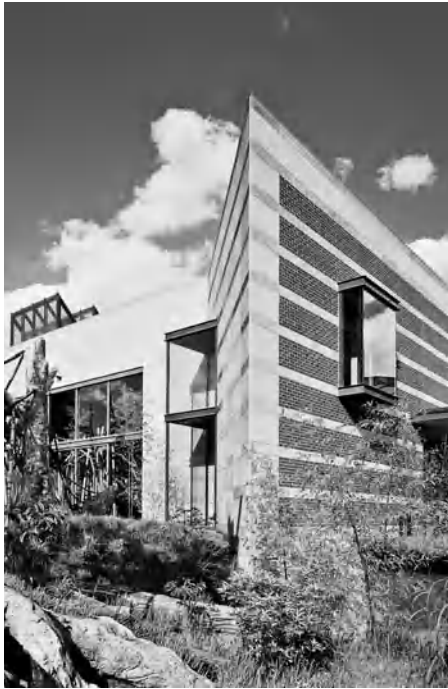
The Lincoln Park Zoo, Regenstein Center for African Apes, designed by Goettsch Partners, has a sharp corner to the exterior gorilla habitat.

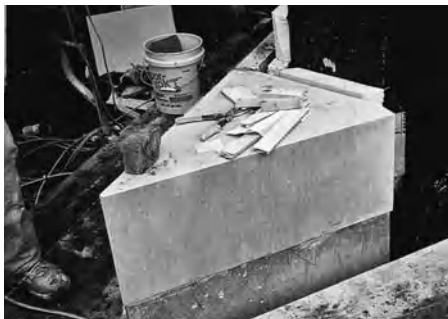
Because the corner is exposed to the gorillas and keepers at grade level, the durable corner was fabricated as a solid unit and beveled to resist chipping. Regenstein Center for African Apes, 2004, Chicago.

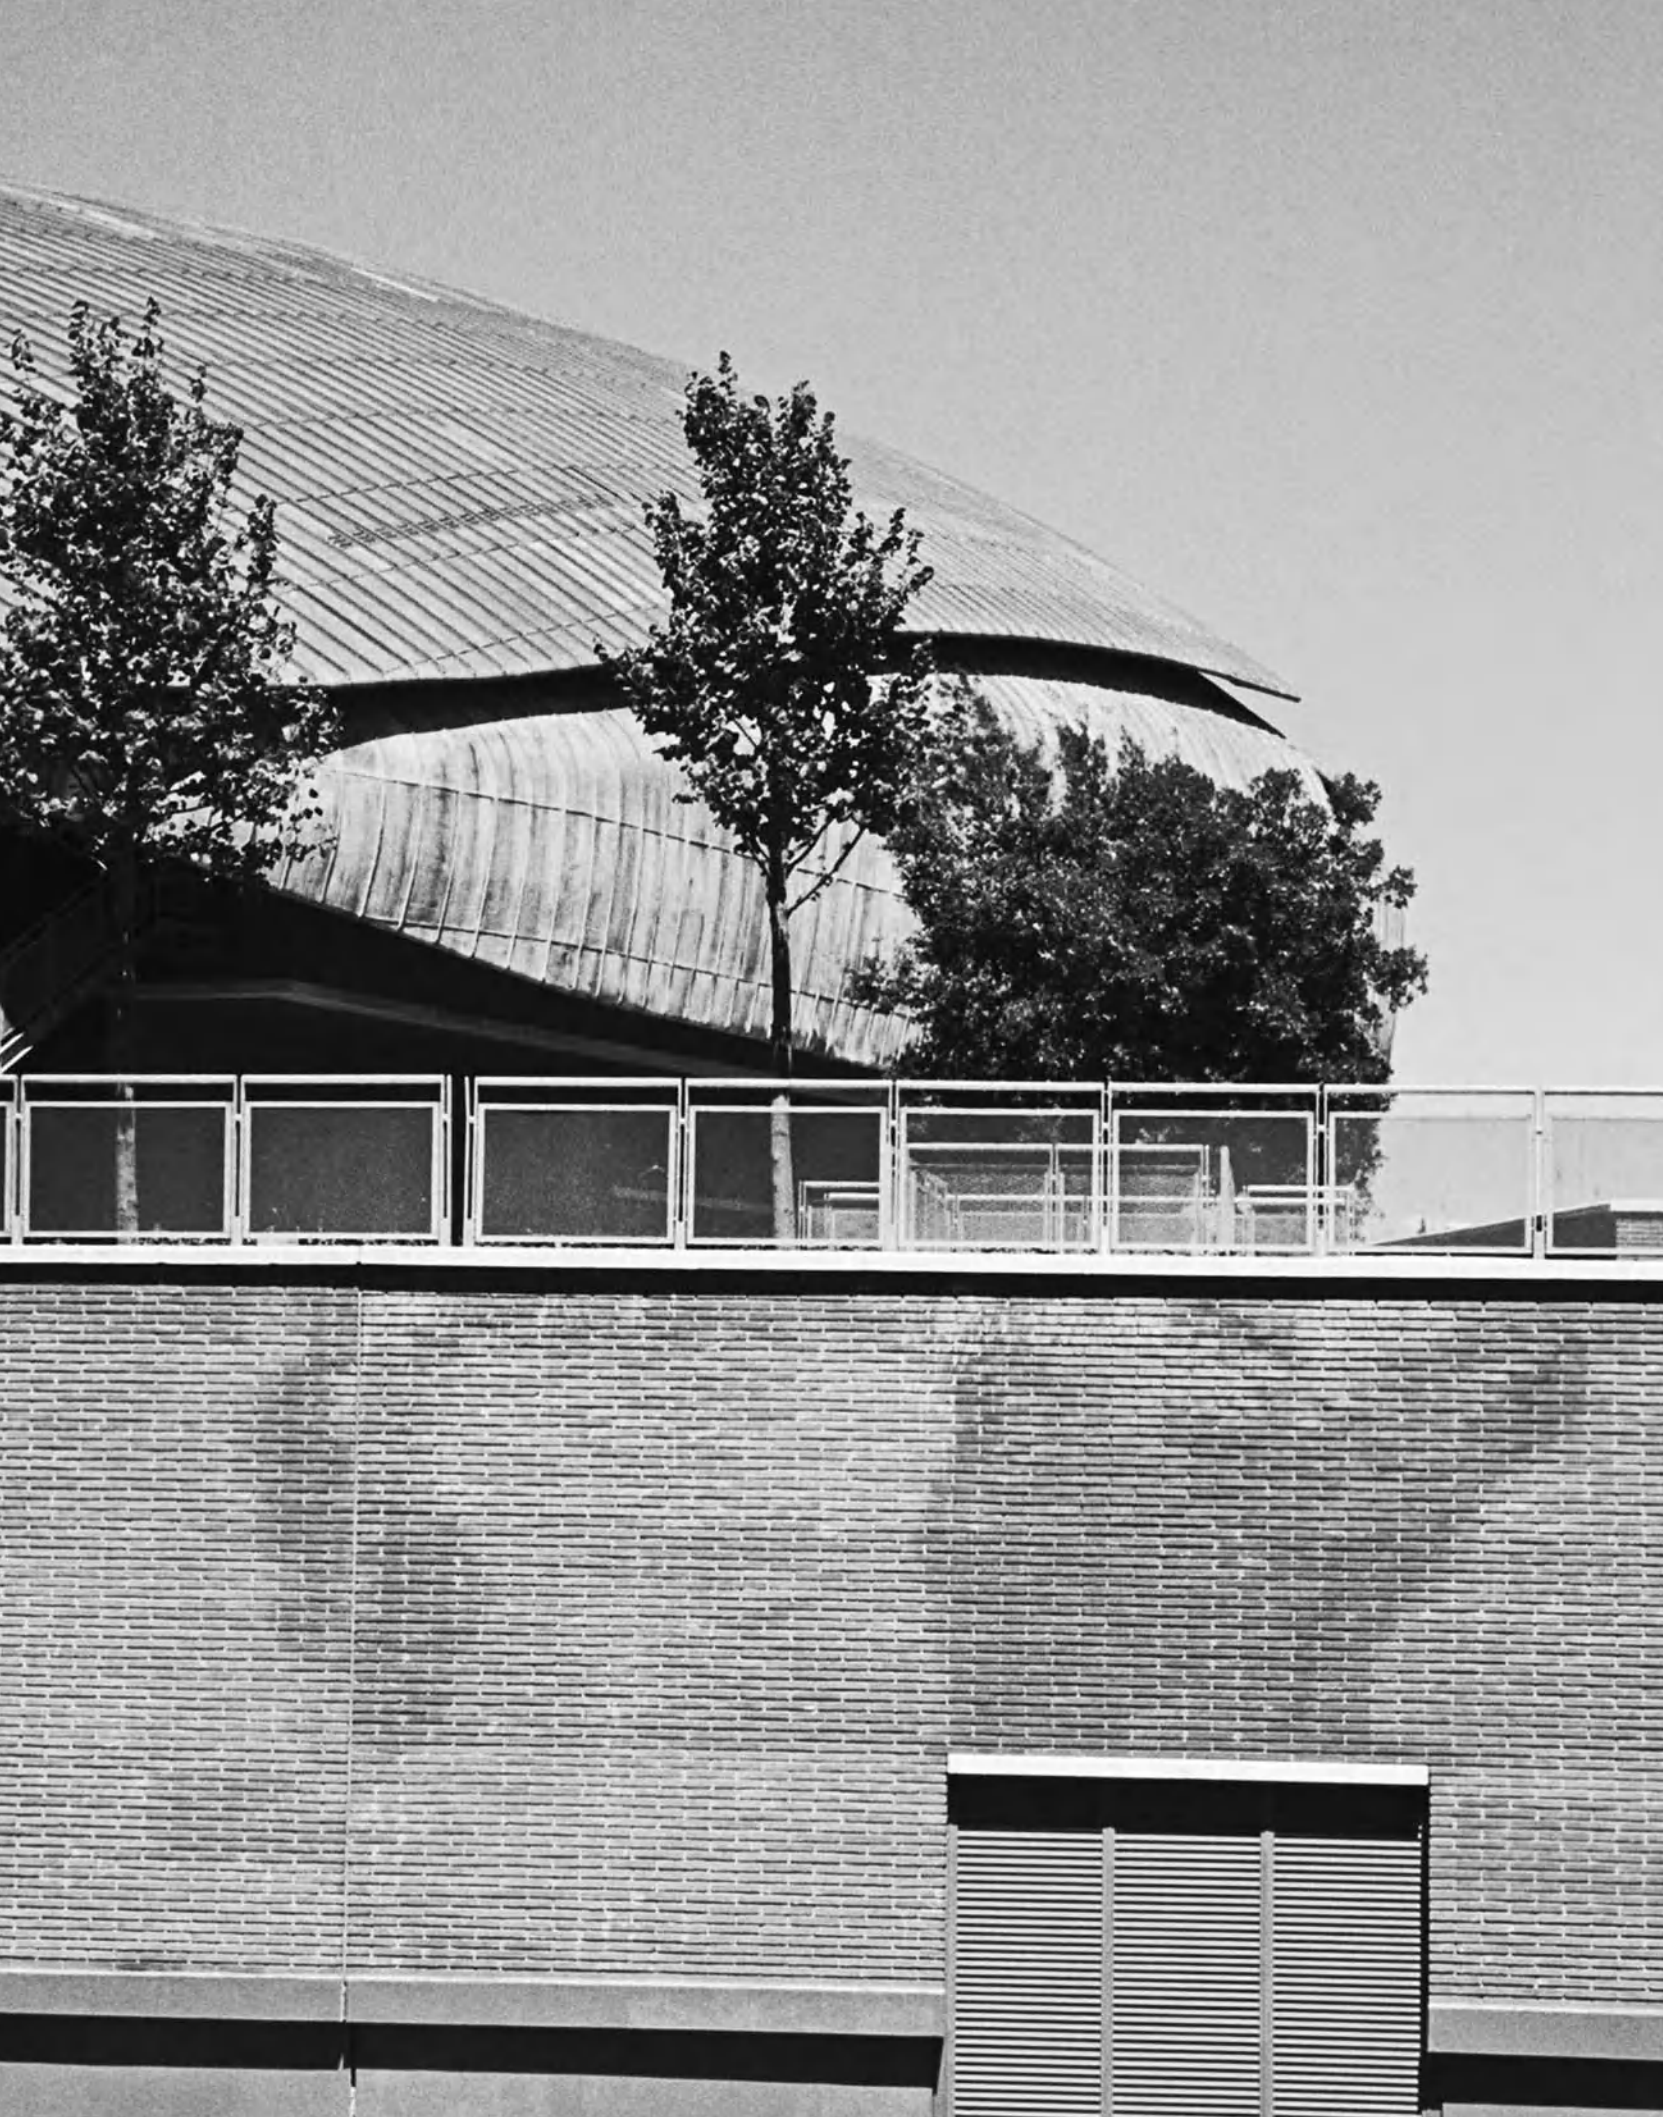
right Large amounts of efflorescence appear on the unprotected exterior walls. Covered walls show no sign of efflorescence. Auditorium Parco della Musica.

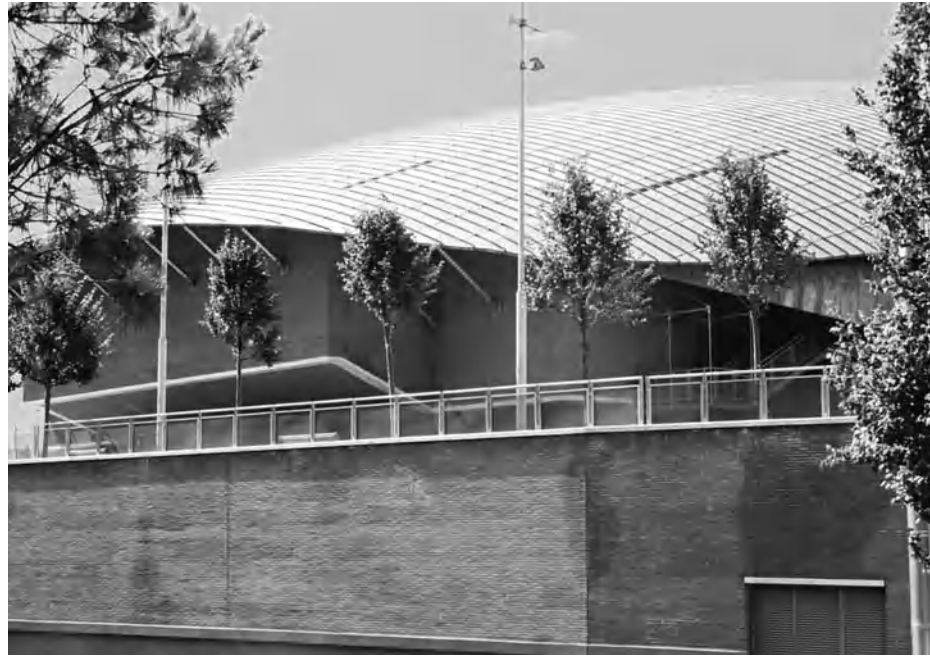
below Raked mortar joints provide poor weatherability as compared to concave or flush joints. Auditorium Parco della Musica.

properties of the travertine cap material, the stone coping mortar joints on a regular interval allow for a second path for water to penetrate the top horizontal surface. On the face of the wall the masonry joints have been raked back for aesthetic reasons. Although this helps create a richer wall texture, the raked joints provide an easy path for water to infiltrate the wall. The ability of water to move through the wall is facilitated by the lack of flashing below the coping and the absence of effective weep holes at the base of the wall. Thus penetrating water can be trapped in the wall cavity and will evaporate through the body of the brick and mortar joints to the exterior. This moving water carries soluble components and eventually evaporates on the face of the building, leaving patches of white powder in its wake. It should be noted that the masonry exterior walls of the building that are protected from rainwater by large overhangs do not show signs of efflorescence. In order to better understand efflorescence and the potentially serious nature of the defect, one needs to examine the chemical composition of the problem.

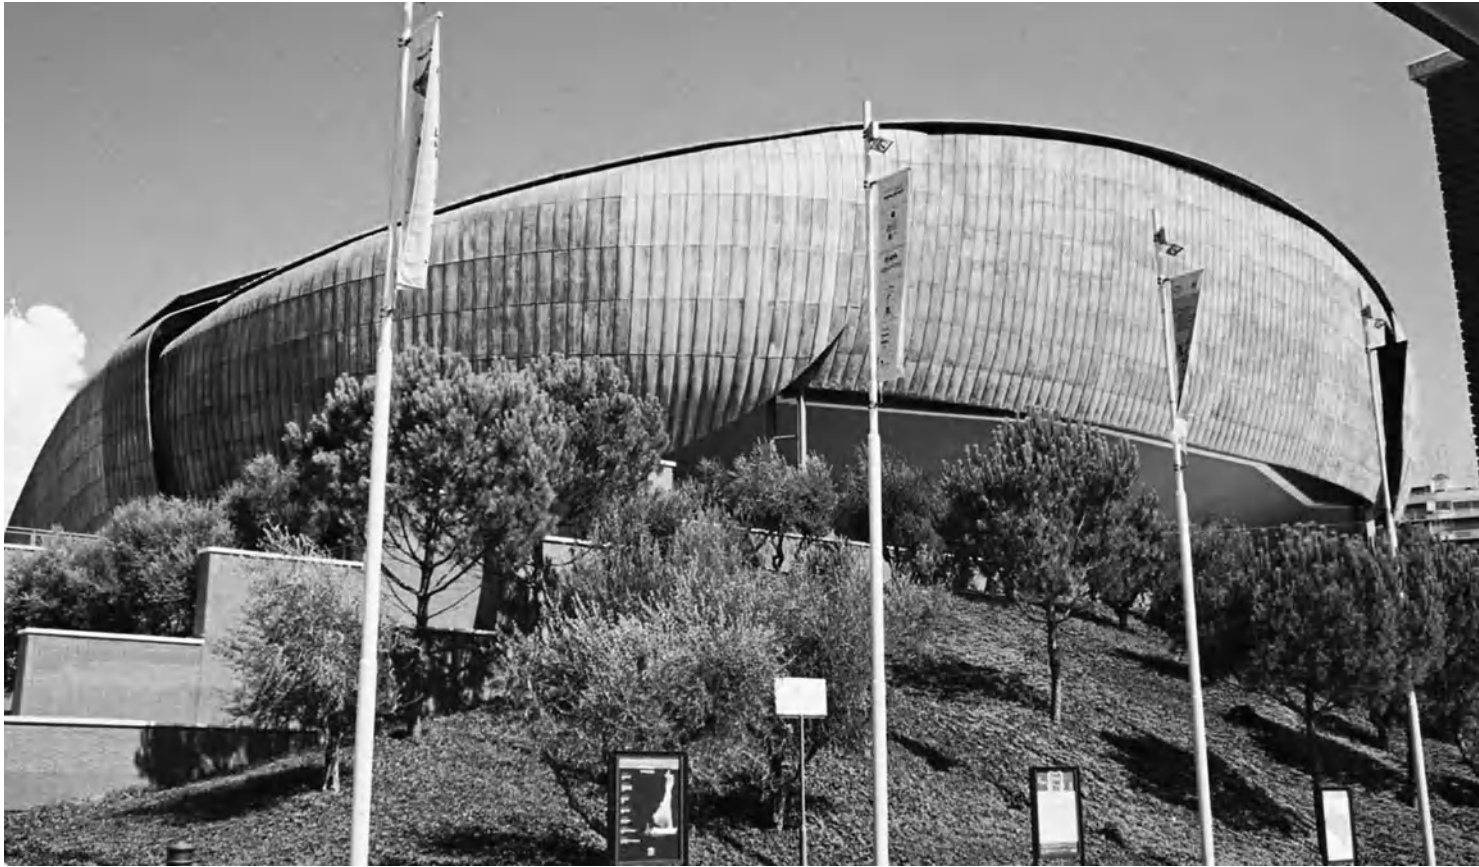
above Large wood-framed structure wrapped in metal rests on masonry walls. Auditorium Parco della Musica.

The Auditorium Parco della Musica in Rome was designed to serve as a multifunction complex dedicated to music. Constructed over the remains of a Roman villa dating to the 4th century, the site consists of three concert halls and one large amphitheater. The scale of these "music box" structures is enormous. Each of the building elements resembles a large beetle resting on a masonry plinth surrounded by luxurious vegetation. The goal of these brick and metal enclosures was to acoustically separate each of the concert halls. All three of the buildings share similar details. The roofs are composed of metal-standing seam roofing, covering a wood structure, with a concrete foundation surrounded

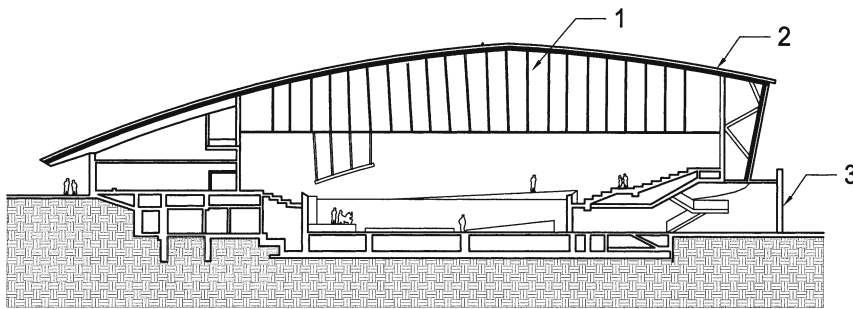
below Building section of music hall. Auditorium Parco della Musica.

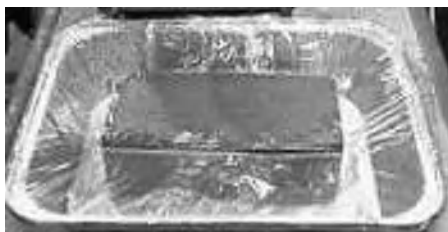
Testing of brick for efflorescence.

Although mortar is a governing source of the salts found in efflorescence, it is not the only source. Bricks may contain appreciable amounts of salts which are dissolved by moisture and brought to the surface through time. Bricks can be tested to determine the amount of salts present. The test consists of placing a brick on end in a pan of distilled water for seven days. With time the water is drawn upwards through the brick and evaporates on the surface of the brick. If soluble salts are present in the brick, they will be deposited on its surface.

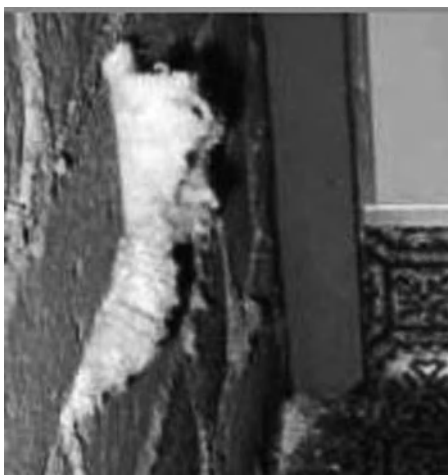
Crystallized efflorescence in a masonry wall.

If left untreated the powdery efflorescence that can blemish a wall will continue through many cycles of depositing salts to the surface, re-dissolving when new water occurs, drying out afterwards. Finally the deposits can form crystals on the wall which become tightly bonded to the surface material. Crystallized efflorescence is more difficult to remove than the powdery type and can lead to serious structural damage to brick and mortar cavity walls.

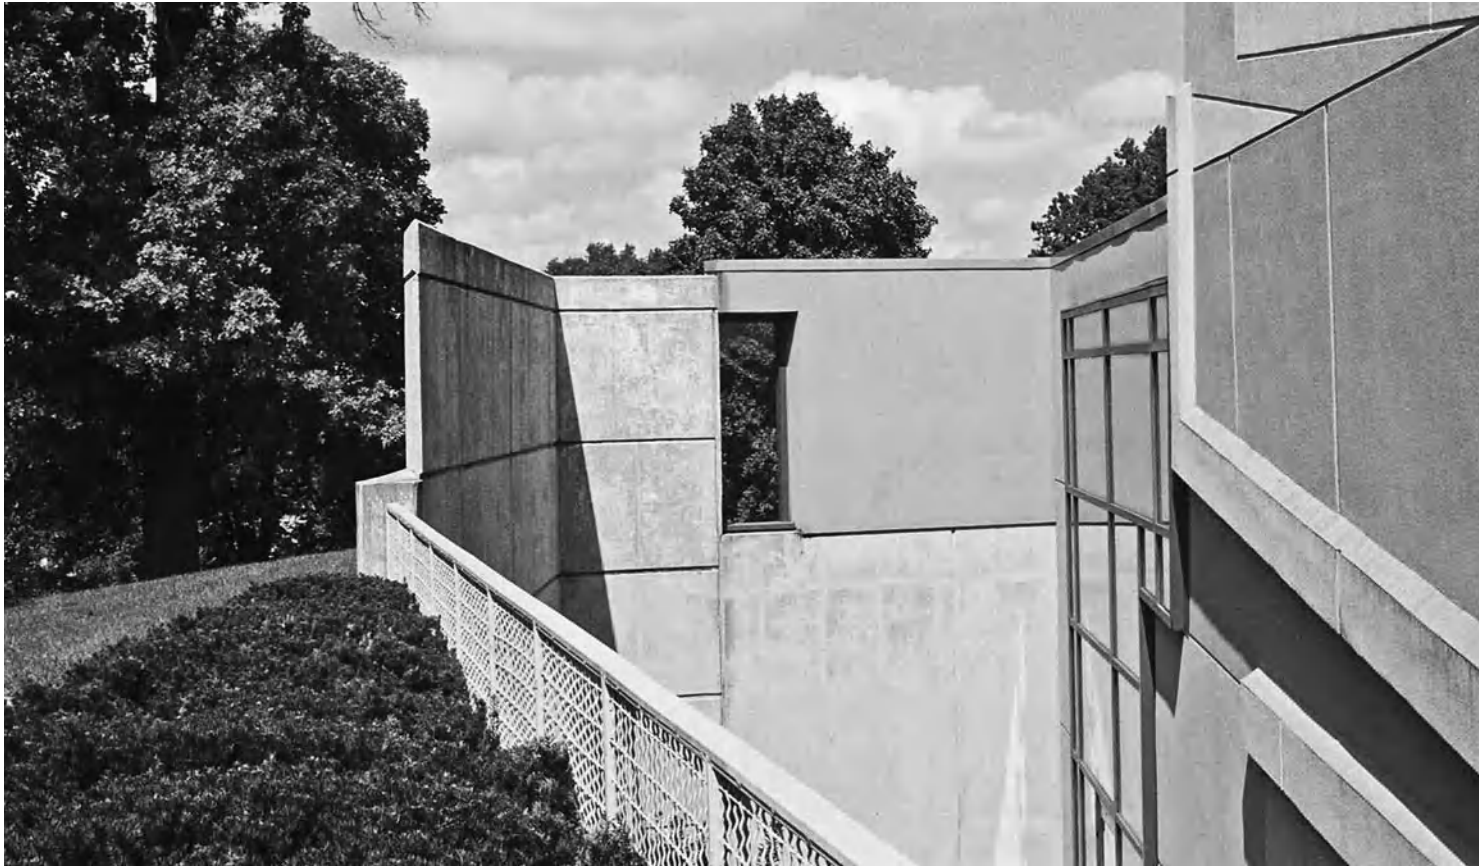
Exposed concrete wall shows evidence of slight efflorescence. Expansion of University of Cincinnati School of Architecture and Interior Design.

The University of Cincinnati School of Architecture and Interior Design expansion contains exterior concrete walls that are exposed to rain on all sides. These walls exhibit a mild film of efflorescence on the exterior surface noticeable as a white powder substance. However, because the concrete substrate resembles the color and texture of efflorescence, it is not perceived as a problem.
