failed stone

problems and solutions
with concrete and masonry

Failed Stone

Problems and Solutions with Concrete and Masonry

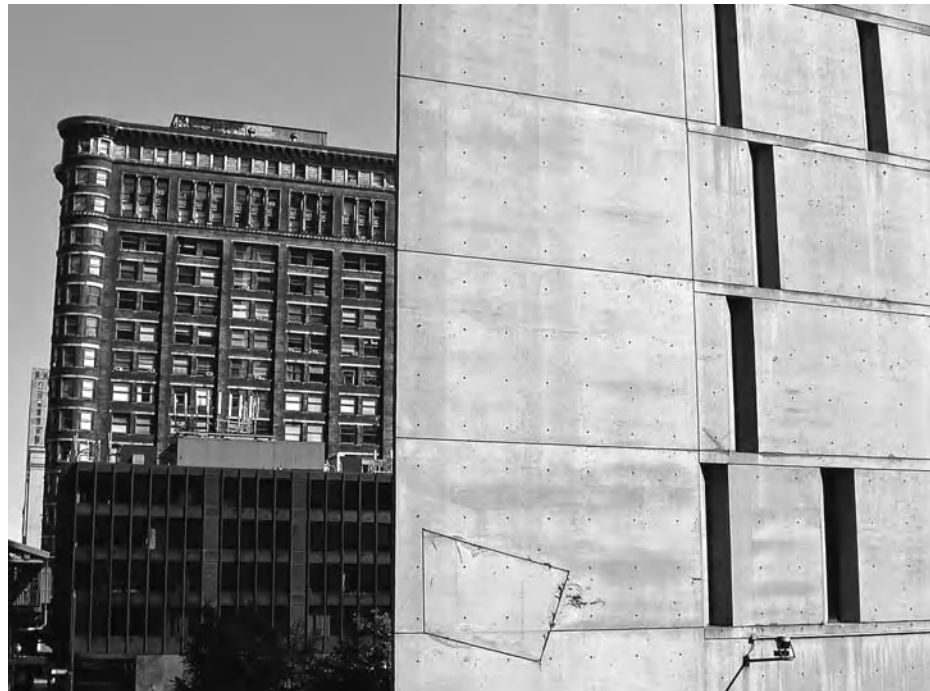
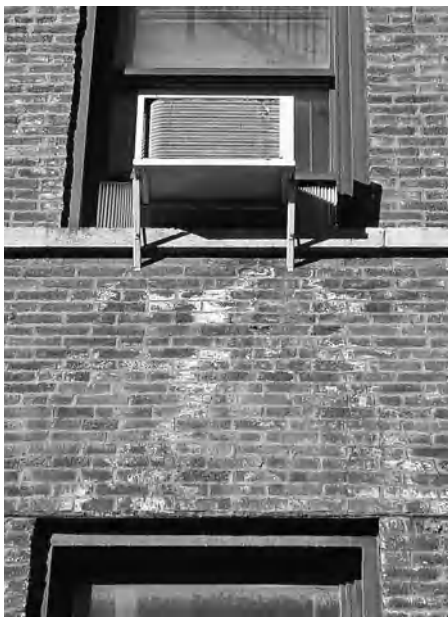
right Spalled concrete at window detail. Metropolitan Correctional Center.

page 41 Exterior cast in place concrete walls. Metropolitan Correctional Center.

The Metropolitan Correctional Center in Chicago was constructed with sleek concrete walls and narrow windows to prevent the escape of inmates. The building is nestled in the heart of Chicago's downtown business district. Although the walls may prevent the escape of inmates, the passage of water has not been stopped in all areas of the exterior wall. Spalling concrete can be seen as a side effect of moving water and of salt deposits. The white efflorescence film shown near an exterior window provides the smoking gun to a problem of water migration through the wall.

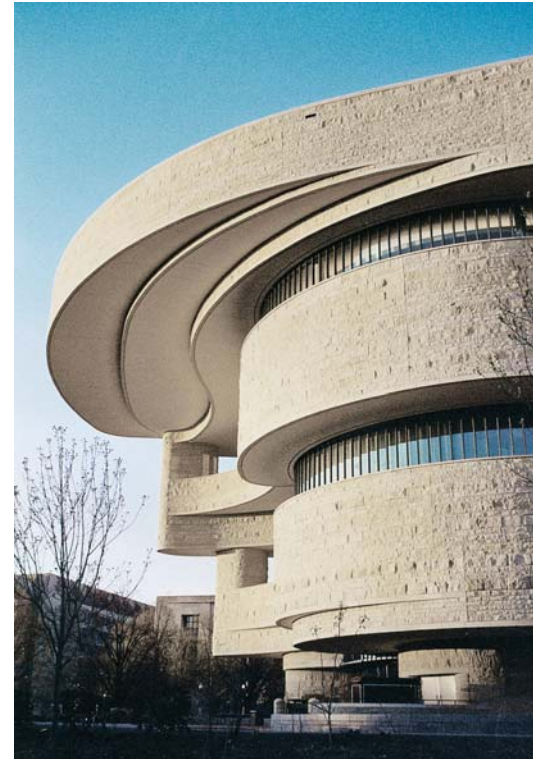
right Efflorescence marks at roof transition.

National Museum of the American Indian.

The undulating walls of the Museum required extensive flashing details and transitions. It is at these locations where water has the potential to infiltrate the wall. Marks of efflorescence can be seen below a northern roof transition. It should be noted that all of the efflorescence markings visible on the wall were on the north side of the building. Because of the newness of the building, some of these marks could be attributed to “new building bloom.”

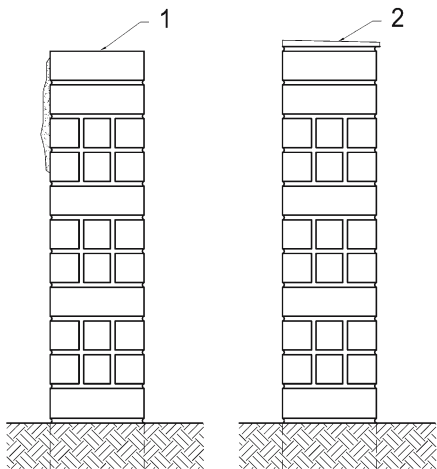
- 1 Existing brick coping allows water to infiltrate the wall
- 2 A solution to the water problem would be to install a metal coping

Water is the vehicle used for the salt deposits. Stopping the path of water will stop efflorescence. Failure to repair cracked or broken mortar joints can contribute to the problem. When efflorescence is linked to abnormal wetting of the wall, as from a roof leak or sprinkler head, it is critical to correct these problems prior to removing the efflorescence. In a similar manner, when the cause of efflorescence is water penetration of a coping, the solution is installing a damp-proof course or metal coping to interrupt the movement of water into the brickwork.

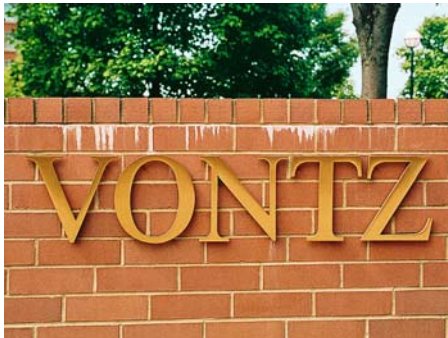
A brick cap above the building sign allows water to infiltrate the wall.

Vontz Center for Molecular Studies.

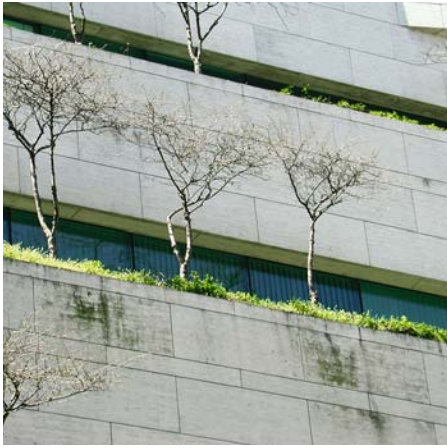
Green stains indicate moisture from the planters.
Canadian Embassy, Washington, D.C., 1989.

Washington, D.C., has a series of balconies at the interior courtyard which show signs of migrating water. The green stains that mark the outside face of these walls are a signal that moisture from the soil is evaporating through the wall. Constant moisture present on building materials can provide conditions of growing algae and mold.

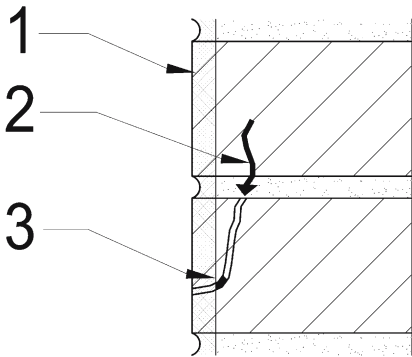
Some water repellants can cause more harm than good.

- 1 Silicone sealers penetrate the face of the wall.
- 2 Water penetrates wall through defects, evaporates out as vapor, but leaves salts at line of sealer.
- 3 Crystallization of salts can cause spalling of surface material from internal pressures.

It can be hazardous to apply seals to walls that contain both moisture and salts. The moisture may evaporate through the treated surface, but salt deposits can accumulate behind the sealer near the surface. Localized accumulation of salts and their crystallization may cause the surface of the material to spall or flake off. The use of a silicone treatment to suppress efflorescence may be dangerous in cases where excessive water migration produces hydrostatic pressure buildup from entrapped salts below the surface. This is particularly true when there are large amounts of salts in the masonry and the units are soft and porous.

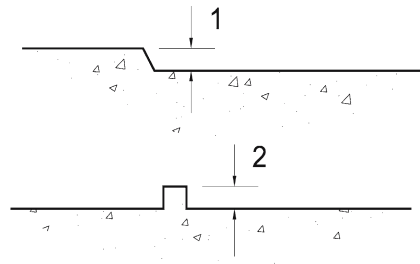
Surface defects in cast-in-place concrete from form joints.

- 1 Offset
- 2 Fin

Cast-in-place concrete forms have size limitations and therefore require joints between units. If these joints are not sealed properly, a surface defect can result. Fins are narrow linear projections on a formed concrete surface, resulting from mortar flowing into the space between the forms. An offset is a step in the concrete surface due to an abrupt change in alignment of adjacent forms. It can occur either horizontally or vertically. Similar to a fin, an offset interrupts the smooth appearance of a surface. For smooth-formed concrete surfaces the maximum allowable offset or fin would be 3mm (1/8 inch).

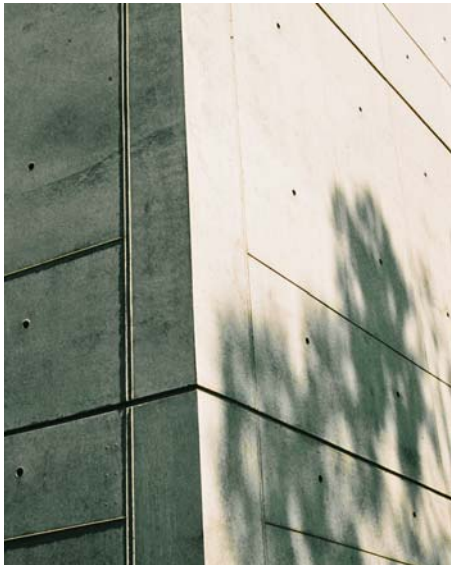
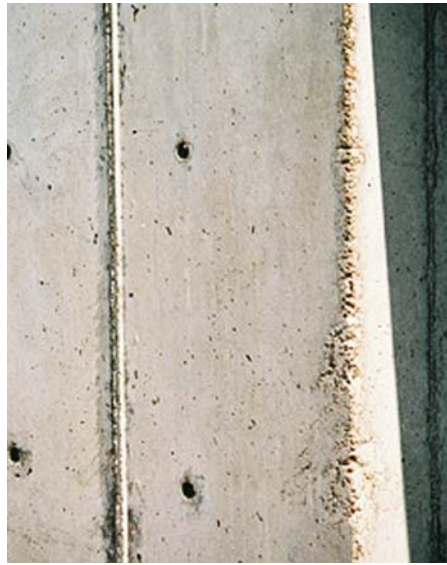
below left Finish, form lines, and tie holes on the Salk Institute expansion are virtually flawless.

below right Finish, form lines, and tie holes on the original Salk Institute were never intended to be perfect.

Tie bars connect in the gang form frames and prevent the forms from bulging out under the hydrostatic pressure of the liquid concrete. Tie holes are the void in a concrete surface left when a tie end is snapped off, broken back, or removed. Ties that are broken back or snapped off frequently leave irregular holes, whereas threaded internal disconnecting ties leave more uniform holes. Where spreader cones are used on the ties, the holes are uniform. Tie holes are normally filled; however, in exposed locations where they are spaced in a regular pattern, they have become an important architectural detail in contemporary design. Tie bar spacing must consider the strength of the panels. If the spacing between tie bars becomes too great, the formwork will bow out and create an uneven finished surface.

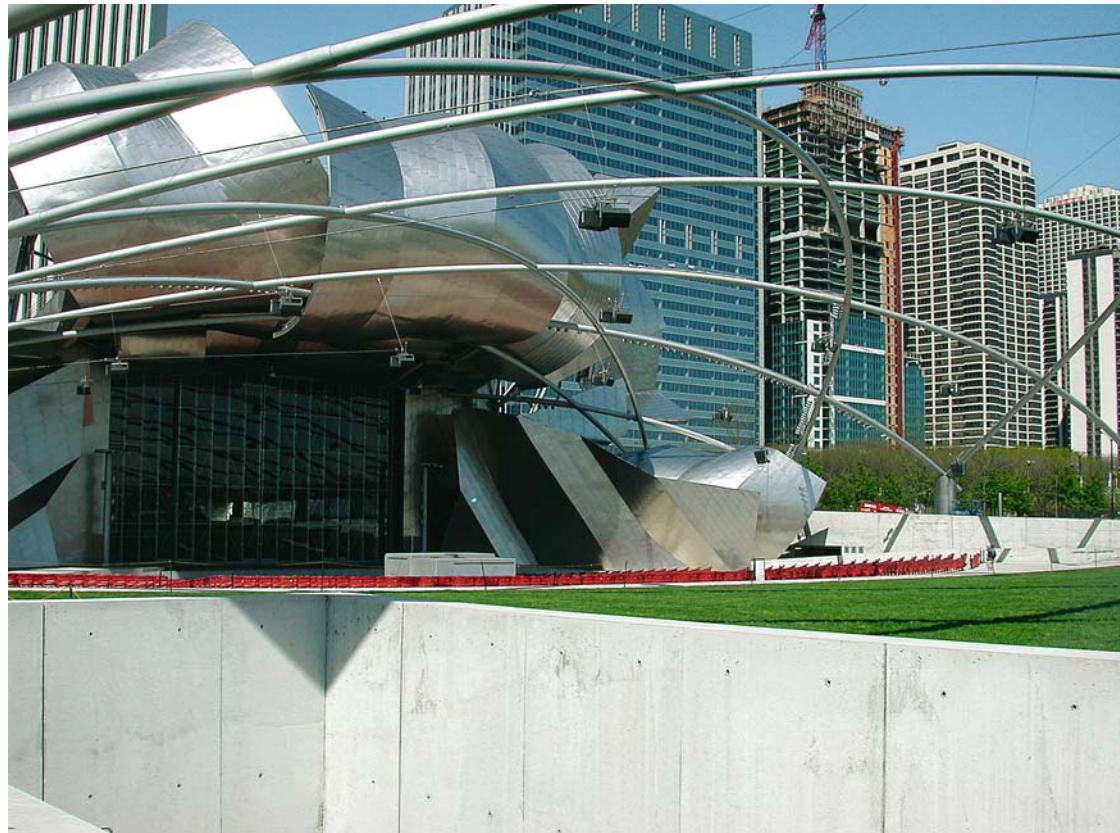
Retaining walls display layer marks in the concrete. The Jay Pritzker Pavilion.

Prominent layer marks can occur as a result of inadequate compaction and long-time intervals between placing the layers. Layer marks can also result from a change in the composition of the concrete mix.

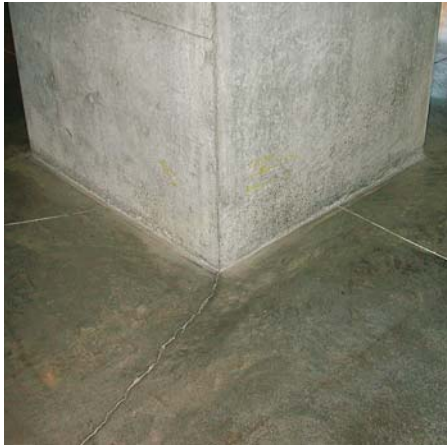
Cracks in the floor slab around an interior column oppose the anticipated crack direction. Cracking can be caused by improper isolation-joint design that does not provide relief at reentrant corners.

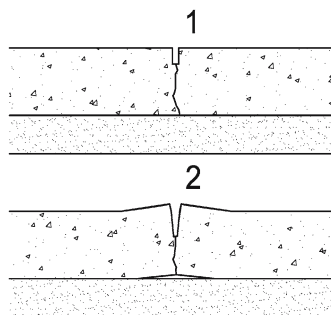
Curling at a saw-cut joint in slab.
 1 Saw-cut joint prior to curling of concrete
 2 Saw-cut joint after curling of concrete

Concrete slabs on grade can curl up at joints and around the perimeter of the slab. In topping slab conditions the top slab can lose contact with the subbase material, curling up at the ends. Curling is most noticeable at construction control joints, but it can also occur at cracks and saw-cut joints. The cause of curling is differential shrinkage that occurs in a slab as the exposed top surface shrinks and

the core does not. Although it is possible to repair curling in most slabs, prevention by controlling shrinkage is preferred. Good mix proportioning, proper curing, and placement of saw-cut joints can help to reduce the effects of curling.

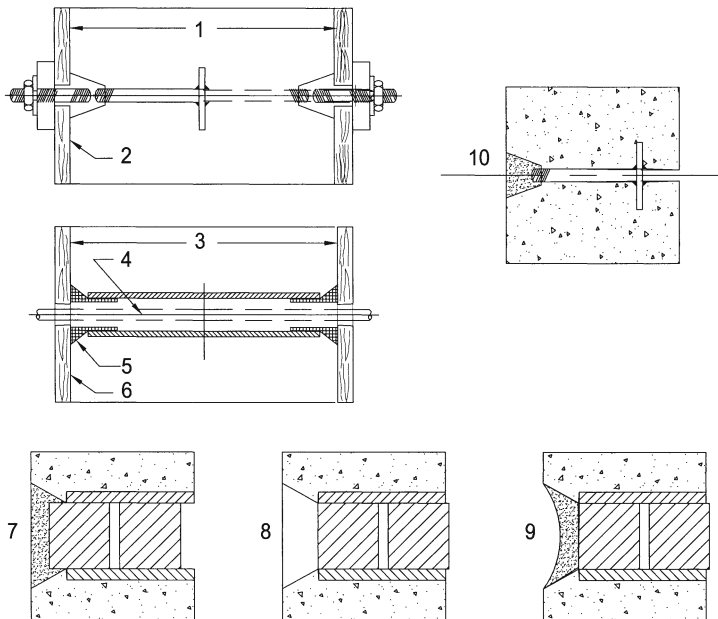
below Tie holes in cast-in-place concrete can be covered with a variety of techniques.

- 1 Welded water stop plate
- 2 Metal or plastic cone
- 3 Wall thickness
- 4 Formwork anchor (threaded rod)
- 5 Plastic cone
- 6 Formwork
- 7 Filled with mortar
- 8 Plugged (e.g. with lead)
- 9 Filled and shaped with mortar
- 10 Filled with mortar

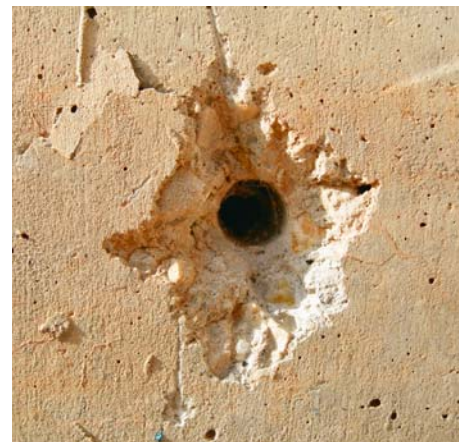
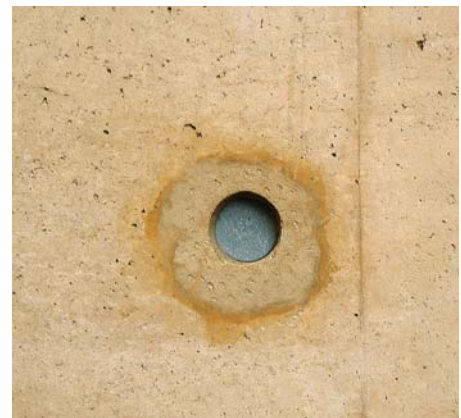
right Colored concrete poses a challenge to repair as seen by tie hole fix at Our Lady of the Angels.

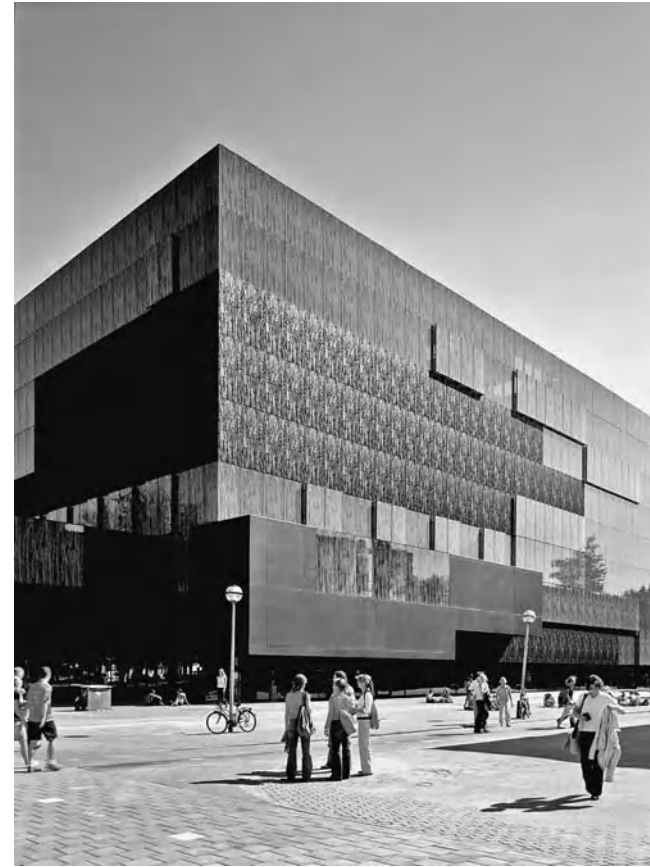
right and below University Library in Utrecht, 2004. Fabrication of rubber mold for precast concrete panels and façade detail.

By this method, the concrete panels provide a three-dimensional surface quality. The concrete has a smooth black-painted surface. The panels were stylized using four gray tones. The relief for the form was manually cut to a maximum depth of 25mm (1 inch) in a sheet of polyurethane. Each gray tone was allotted its own separate plane.

The concrete surface was colored. However, colored pigments in the concrete mix were not used because of cost and potential variations in surface tone. The concrete surface was painted after it had set. Two coats of paint were applied to the interior panels and three coats to the exposed panels of the building.

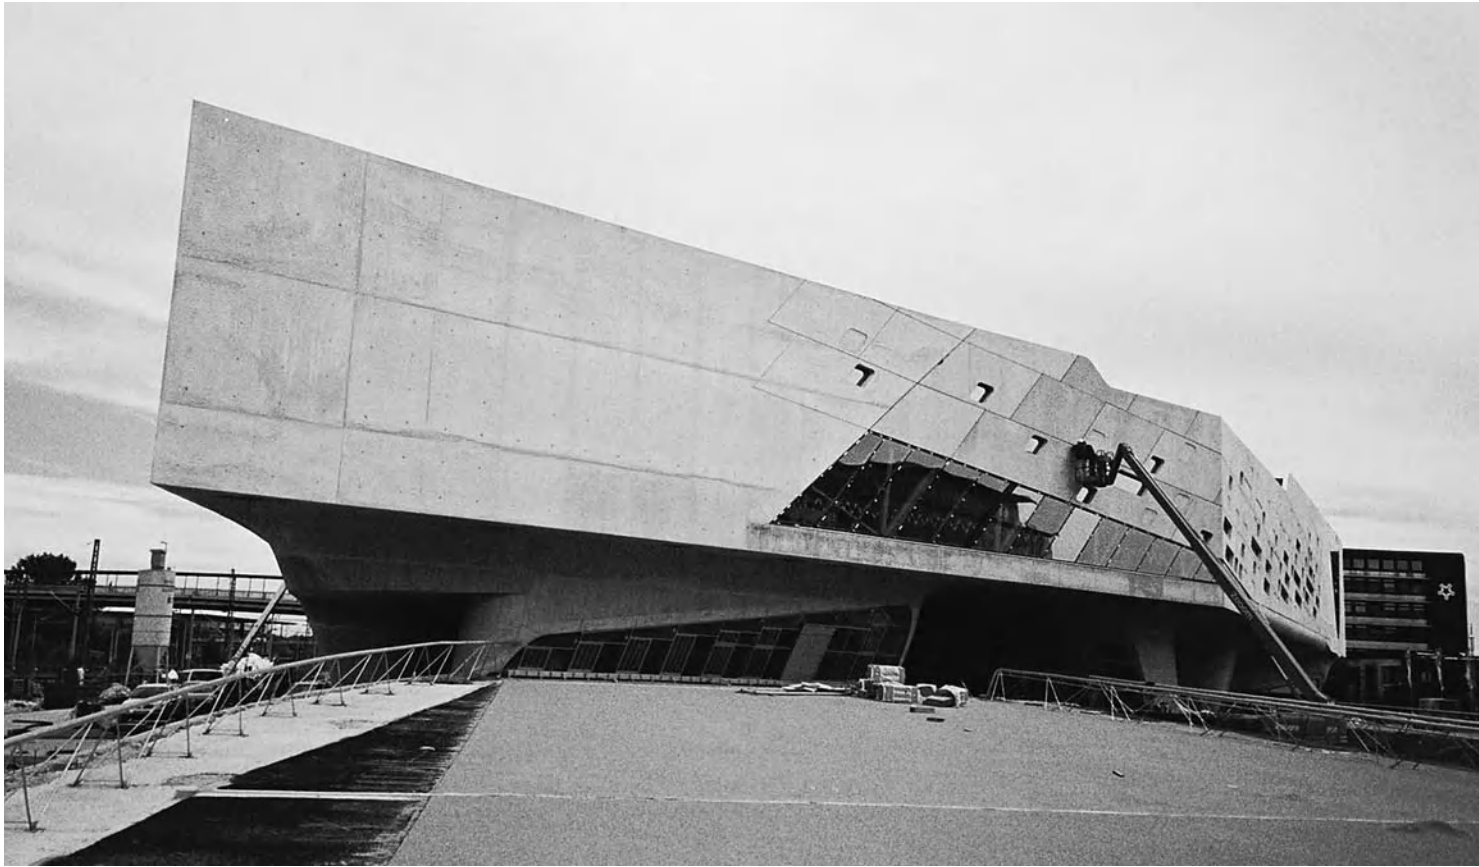
above The Phaeno Science Center, Wolfsburg, Germany, 2005, was constructed with cast-in-place concrete (left side of photo) as well as precast concrete panels. With time the color variation is expected to go away.

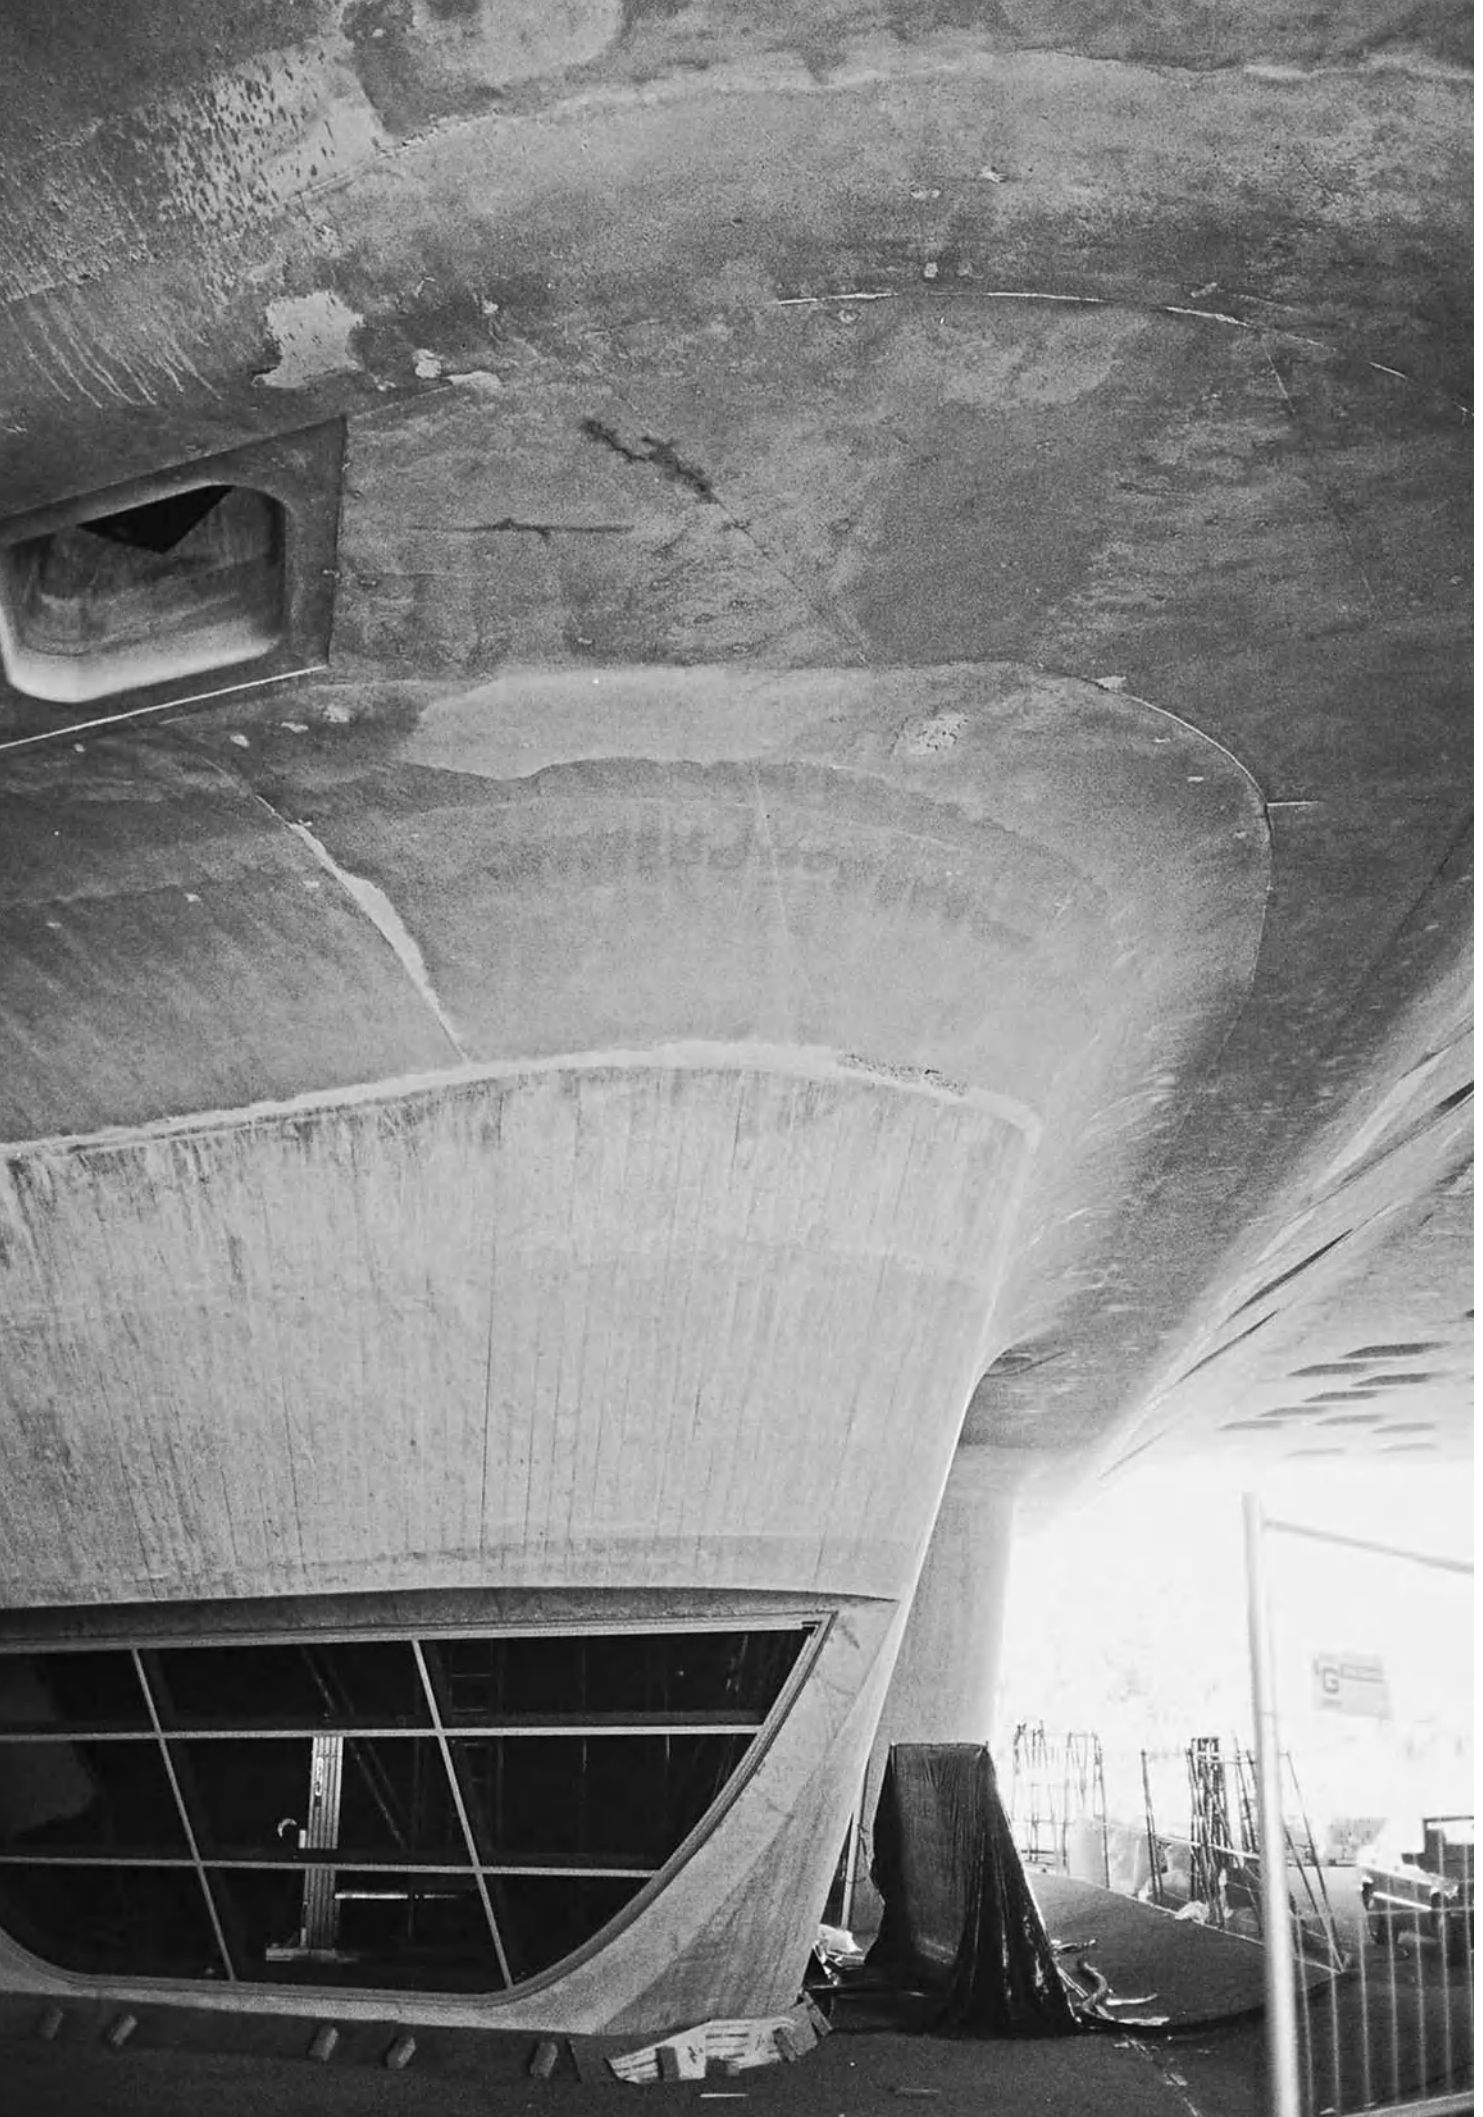
page 60 The self-compacting concrete elements at the Phaeno Science Center, Wolfsburg, which were constructed on site have a fair amount of surface defects at some difficult transitions.

Curing is particularly important to the finish of self-compacting concrete. The Phaeno Science Center battled with trying to provide uniform color and texture for an incredibly complicated building form. The goal was to have everything in the same high-quality surface finish. The cement mix was closely monitored to obtain consistency in color and texture. The surface finish can resemble an elephant skin if the concrete mixture is not kept in constant motion during pouring. For this reason, the mix was pumped into the forms.

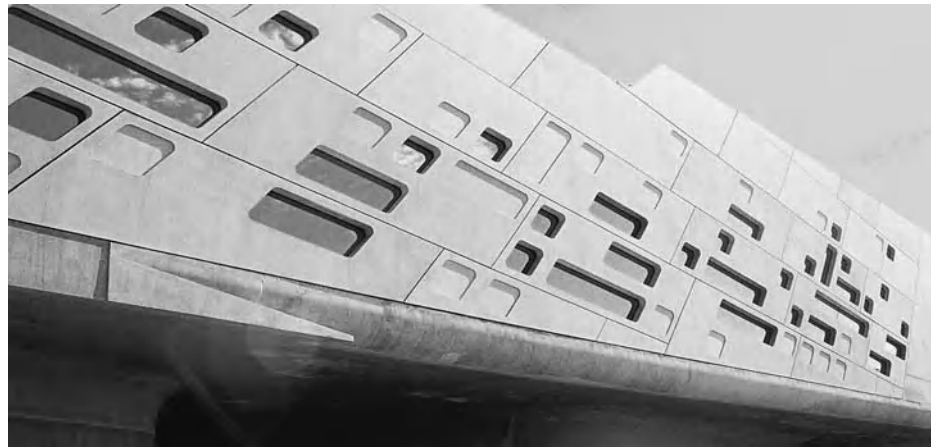
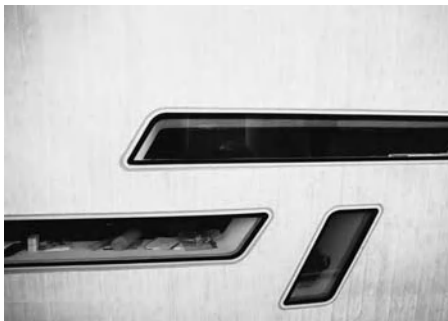
right and below The factory constructed precast concrete panels at the Phaeno Science Center are close to perfect.

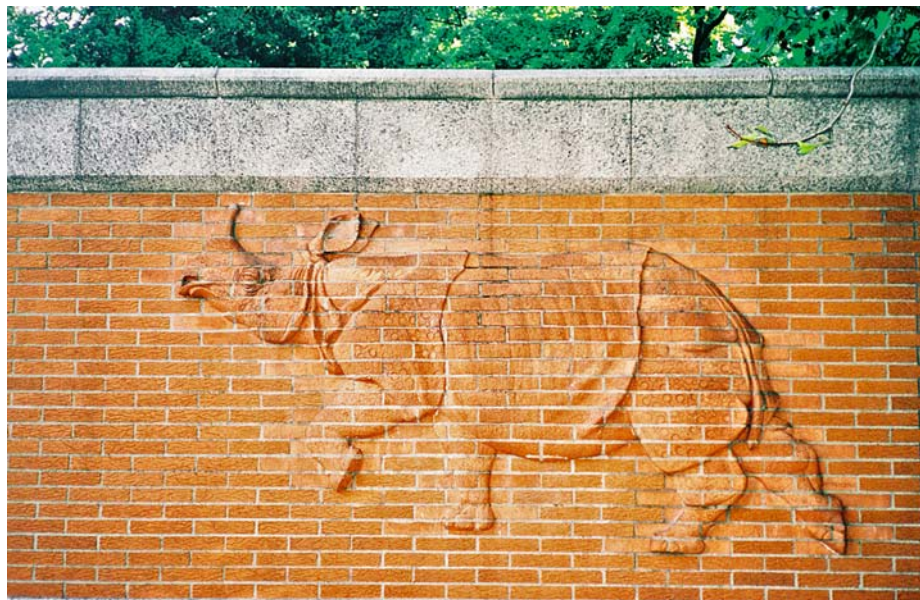
Sculptured brick free of defects, exterior wall of Zoo Berlin.

One of the most demanding brick finishes to keep defect-free is sculptured brick. Sculptured brick panels are the most unusual example of customized masonry. The forms are sculptured pieces handcrafted from the green clayware before firing. The unburned units are firm enough to allow the artist to work freely without damage to the brick body, but sufficiently soft for carving, scraping and cutting. After firing, the sculptured surface is permanently set in the brick face. The brick surface can be selected from a variety of textures, including: smooth, wire-cut, stippled, bark and brushed. Defects like chippage, warpage, and cracks in brick are common in

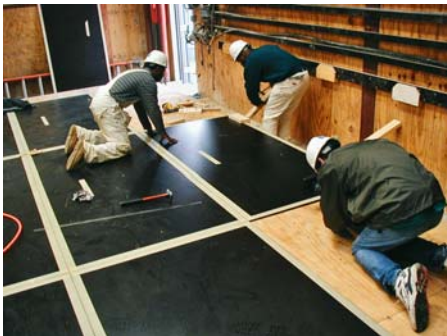
Fabrication of wood forms at Pulitzer Foundation, St. Louis.

With the architect’s desire to create the “perfect concrete,” construction crews spent years forming the walls of this single building. The structure had 150 wall pours, which took place over a two-and-a-half-year time period. In order to maintain a uniform appearance the concrete mix was designed with great care. In order to maintain a consistent color on all walls, the raw materials were closely monitored and water levels controlled to obtain a uniform mix for all concrete pours. Higher water levels in concrete can darken the color of the finished material. Merrimac stone was used in the aggregate at the Pulitzer Foundation because it has a very low absorption rate, and is abundant in the region. The mixture went through several trials. The maximum aggregate size was reduced to 19mm ($\frac{3}{4}$ inch) in order to improve the strength of the mix at the top of the tall forms.

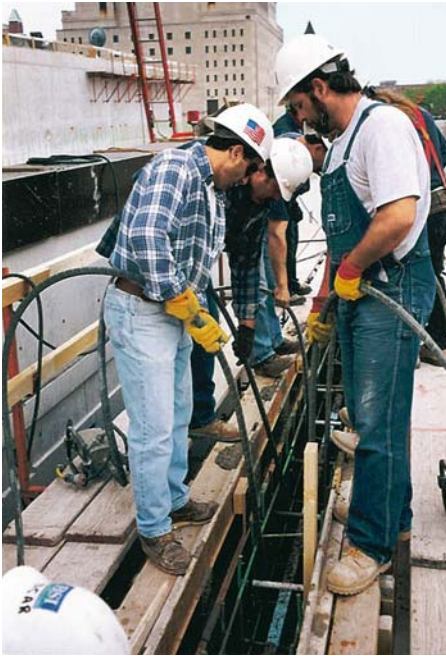
Extensive vibration is required during pours to remove air pockets that can lead to surface defects. Pulitzer Foundation, St. Louis.

Timing was critical during concrete placement. The concrete mix used for the project was extremely dense and set quickly, taking approximately two hours to stiffen after being mixed. In order to maintain the quality of color and finish, the time from mixing the material to removing the last vibrator could take no more than two hours. This criterion put enormous pressure on concrete suppliers because the material was mixed off-site at the supplier’s plant and delivered by truck. Concrete skips were positioned using cranes and provided just enough material to fill to the top of the formwork. Many men were required to vibrate the concrete in order to ensure compaction. The architect has said that the shine on the surface of the concrete was a reflection of the skill of the people that put it there. Even with the highest quality control during construction, defects occurred. At the Pulitzer Foundation, a total of three walls were replaced after curing because of imperfections. This attention to detail produced finished monolithic planes that deserve the description “Ando concrete.”

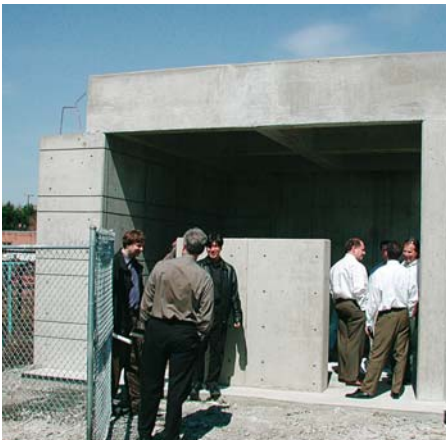
Concrete mock-up for Lincoln Park Zoo, Regenstein Center for African Apes, Chicago, 2004.

Concrete, masonry and stone have surface quality limitations that must be understood by all parties involved in a project. The best way to avoid disappointment with finished components is to specify a representative mock-up for the project. The mock-up should exactly reproduce all details that will be executed on the project, from corner details to wall to ceiling transitions. Stone panels should show all representative veining, color and inclusions that are expected from the selected stone. It is important for designers to specify a repair sample for all finished concrete, together with the repair procedure. Damage is inevitable on a construction site, and repairs will invariably be required. A completed mock-up, accepted by all parties as the representative quality expected on the project, will prevent arguments during construction.

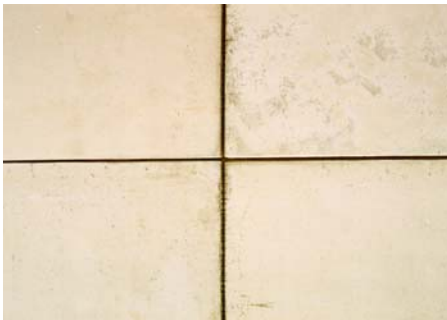
above What was once an even white concrete shell has turned into a quilt pattern of different shades of white.

shells, symbolizing the Holy Trinity of the Roman Catholic Church, are the focal point of the exterior façade. Soaring from a travertine stone plaza, the concrete walls, formed as segments of a sphere, range in height from 17.4m to 27.4m (57 to 90 feet). The sail-like forms were actually constructed as 10.9 tonne (US short 12 ton) precast concrete elements that were lifted into place. The curved panels provide shelter from direct sun shining into the church. To prevent the panels from discoloring, brilliantly white cement incorporating photocatalytic particles was used in the concrete mix. This special mixture of concrete

was intended to neutralize atmospheric pollutants, keeping the panels brilliantly white.

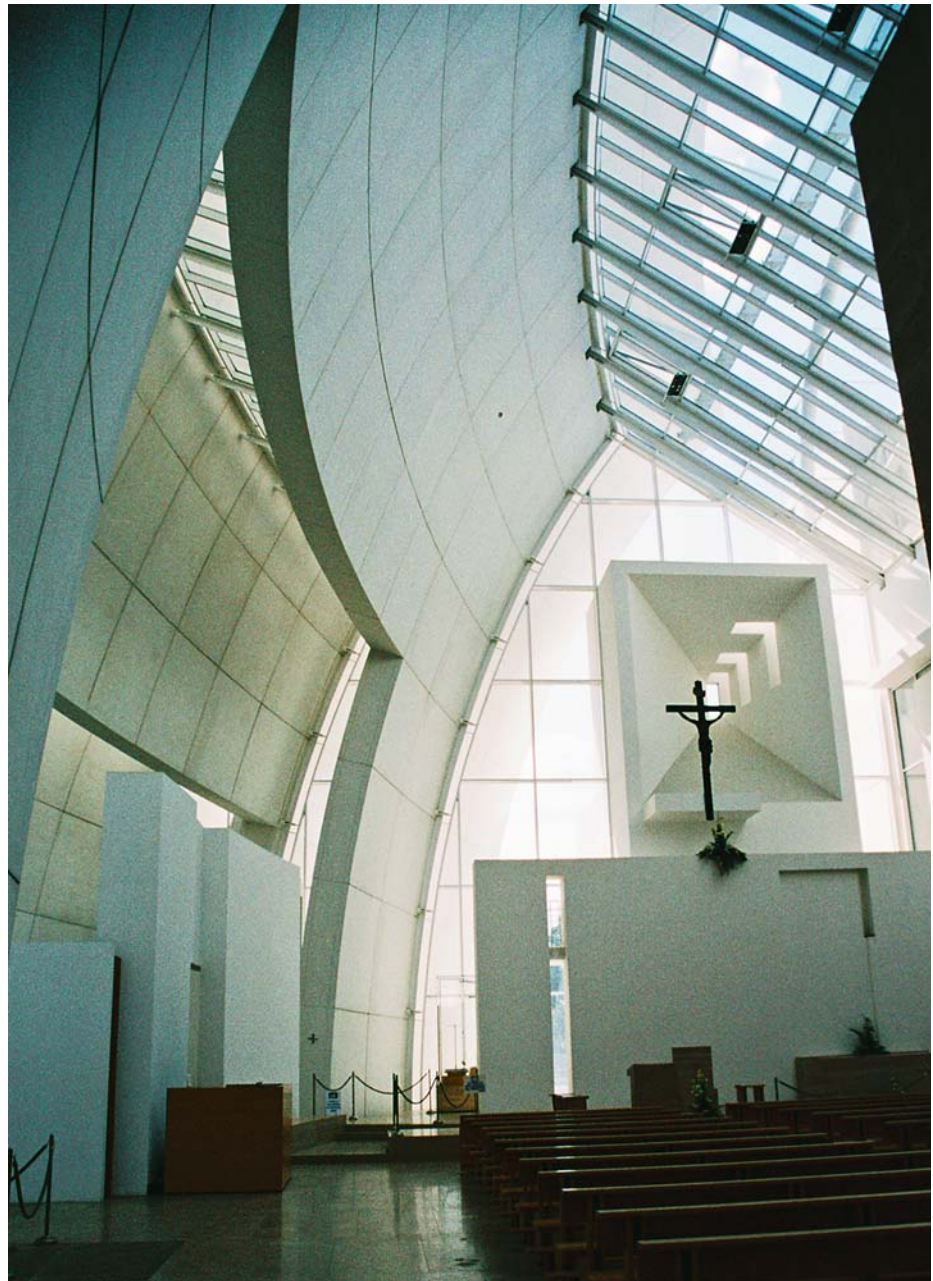
right In strong contrast, the interior side of the shells has maintained its original brilliant white color and finish. Jubilee Church.

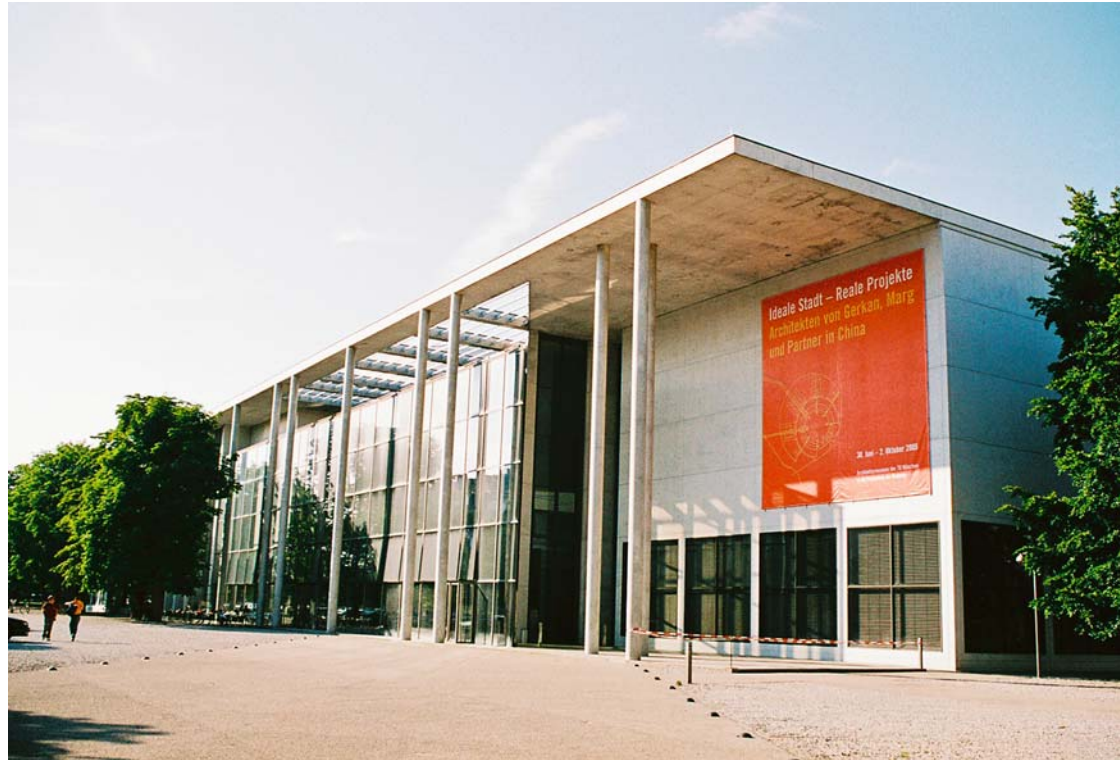
The Pinakothek der Moderne.

The Pinakothek der Moderne, an art museum in Munich, completed in 2002, appears to have discoloration caused by concrete consolidation issues. The underside of the roof slab is exposed to view at the main entrance.

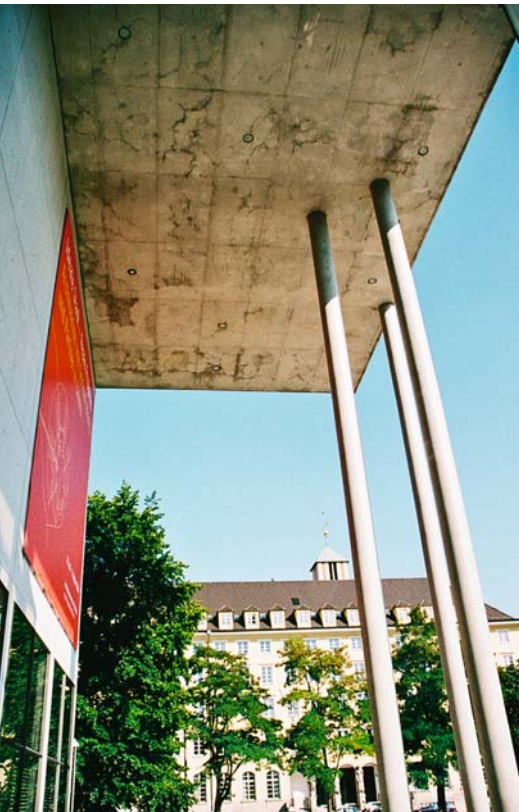
right Concrete Discoloration. A change in cement type or the percentage of water in a mix can create a shift in the color.

The change to the water-cement ratio of a concrete mix can dramatically affect the color of the concrete. A high water-cement ratio will produce a lighter-colored concrete as compared to a darker color of the same mix with a low water-cement ratio. Although the mix may have the same water-cement ratio in the delivery truck, variations can occur after the concrete is poured. For example, if the grade is not uniformly moistened prior to pouring a concrete slab on grade, localized dry spots can reduce the water-cement ratio in the mix and cause localized discoloration.

Individual brands and types of cement may differ in color depending on the source of the raw material. A change in the type of cement used during a project can cause a noticeable color change in the concrete. If consistent color is desired for a large project, a uniform source of cement should be obtained prior to starting the work.

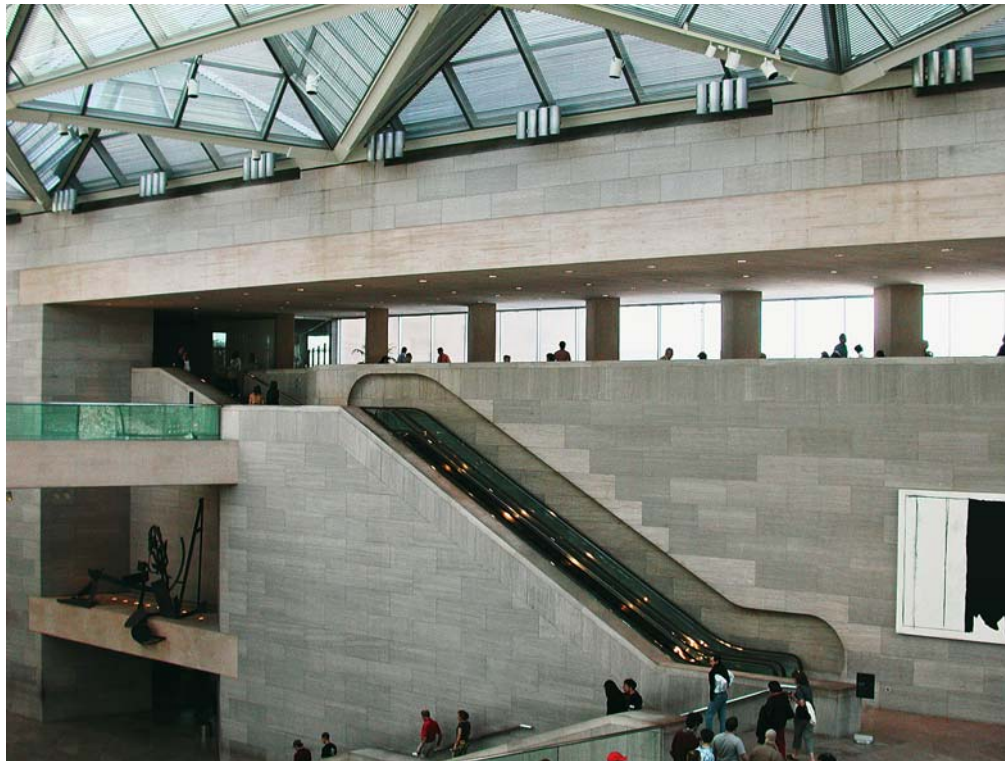
The East Wing of the National Gallery of Art.

The East Wing of the National Gallery of Art in Washington, D.C., completed 1978. The architectural concrete is composed of white cement, a coarse pink aggregate, a fine white aggregate and marble dust from the same Tennessee quarries that provided stone for the exterior cladding.

The choice of aggregates will affect the color of the finished concrete. For example, white sand can produce uniform white-colored concrete. Dark areas can occur over coarse aggregate particles near the surface. Aggregates containing contaminants such as iron oxides and sulfides can cause unsightly rust stains if they are located near the surface of concrete. The formed concrete ceiling and large concrete lintels of the East Wing of the National Gallery of Art in Washington, D.C., have a similar color to the Tennessee marble used to clad the building.

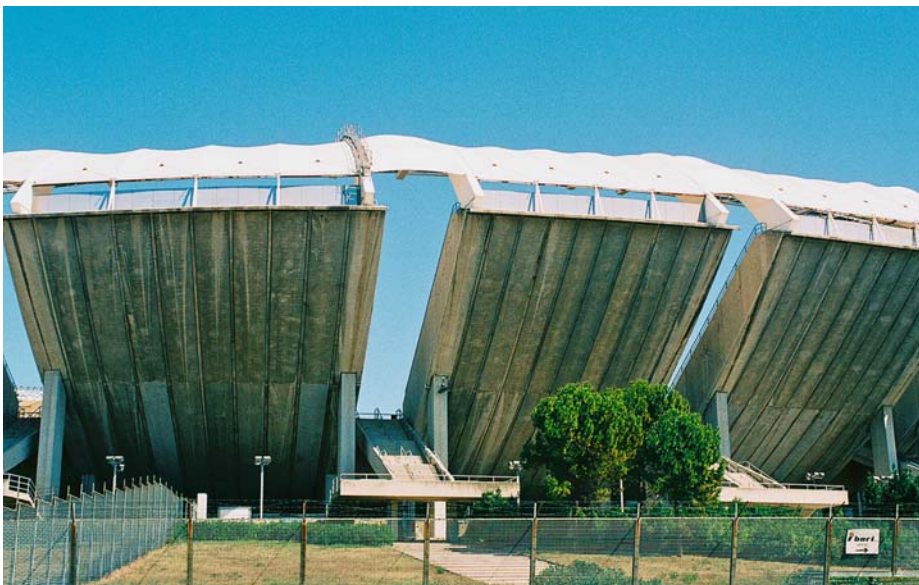
The San Nicola Stadium in Bari in the South of Italy, 1990, shows color differentiation across the concrete surface. Variation in the absorption of forms or inconsistent application of the form release agent can cause this type of discoloration.

In a cast-in-place wall, the forms used to hold the concrete during hardening can greatly influence the color and texture of the concrete. Forms with different rates of absorption produce different shades of color. For example, unsealed wood forms will absorb moisture from the concrete, which causes dark-colored surfaces due to the reduced water-cement ratio. Sealed, non-absorbing forms will lighten surfaces of concrete, as water levels remain high during the curing process. Discoloration caused by varying absorption rates can also be triggered by non-uniform application of release agents to the forms, as can a change in the type or brand of form release agent during a project. Forms that separate or pull away from the concrete surface, allowing air to come in contact with the surface, can cause a drying discoloration of the exposed area.

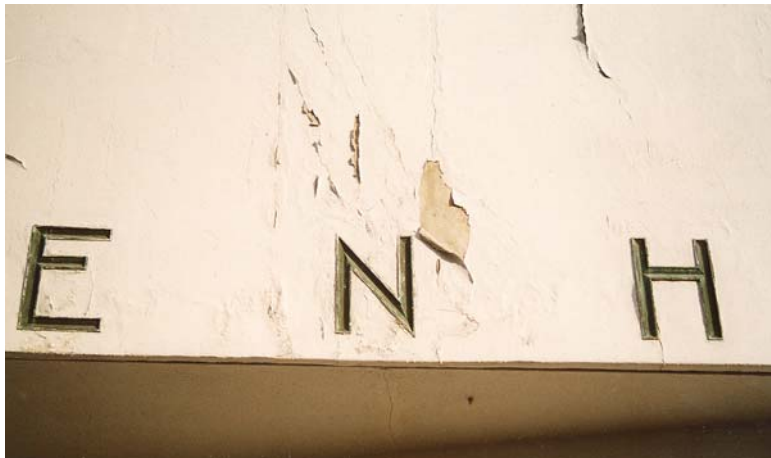
Guggenheim Museum, New York. The façade is frequently in disrepair and needs to be painted every four years.

toric works have often struggled with painted concrete. The Guggenheim Museum, New York, was completed shortly after Frank Lloyd Wright died, in 1959. This building has had a continual problem with the exterior paint. The façade is frequently in disrepair and needs to be painted every four years. These problems could be related to the surface preparation of the concrete or to the coating used to cover it. New painting products have been developed which provide a longer-lasting elastomeric solution for buildings. The painting industry today has a variety of products to provide a uniform appearance to concrete. Some paint products can be classified as stains because they penetrate the surface of the material. A stain is thus integral to the concrete and does not peel off. Light-tinted stains will maintain a certain amount of color variation that may be desired in the finished product.

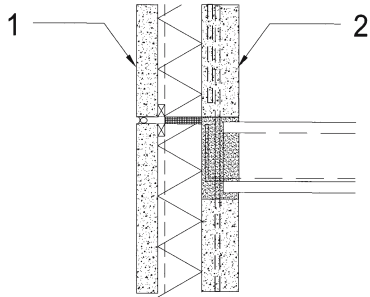
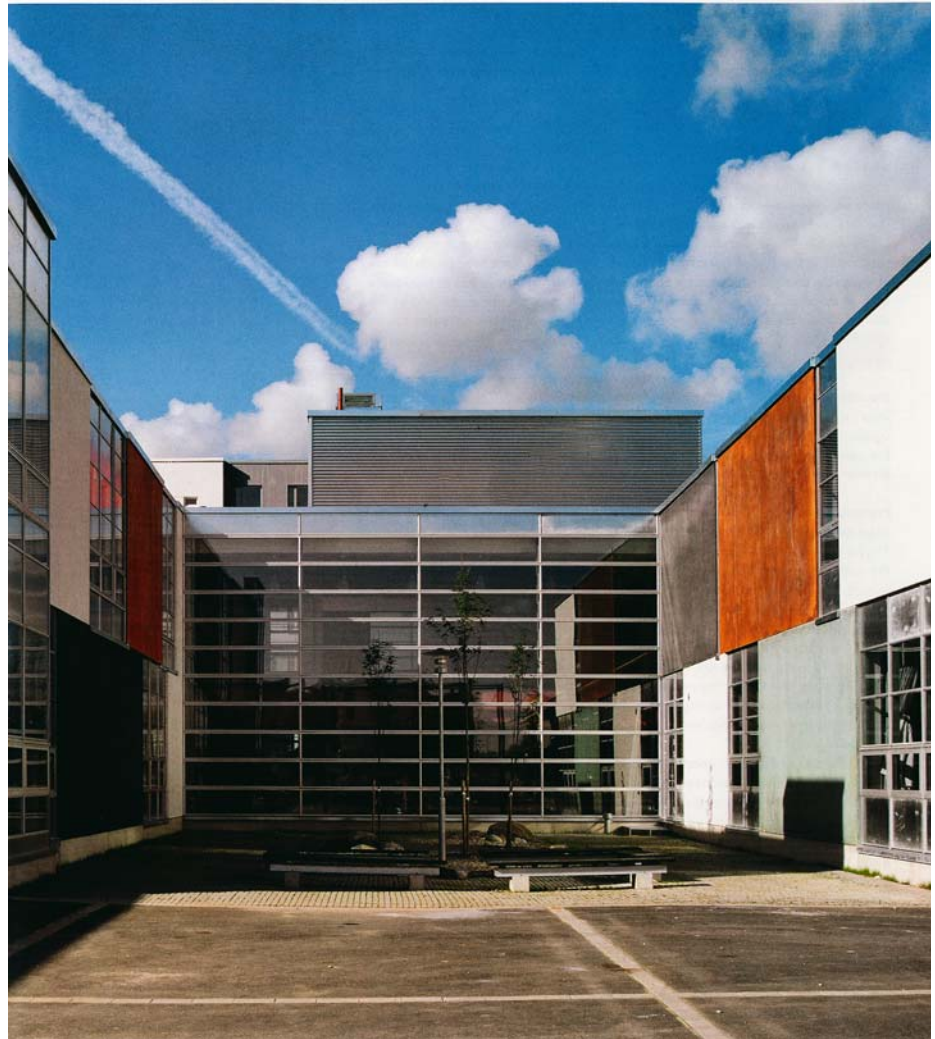
below Precast concrete sandwich panels, Mustakivi School and Community Center.

The Mustakivi School and Community Center in Helsinki, 1998, designed by ArkHouse, uses chemically stained precast concrete panels for non-uniform earthy tones.

- 1 Exterior wythe panel is chemically stained
- 2 Interior wythe provides for building structure

Concrete surfaces can be chemically stained to give variations in color and texture. The Mustakivi School and Community Center in Helsinki uses chemically stained precast concrete panels to break up the uniformity of a complex of buildings clad with precast concrete sandwich panels. The exterior panels of the school block form a load-bearing structure, which supports precast floor planks at the first floor and roof level. The precast sandwich panels consist of two internally connected concrete wythes separated by an insulated core. The colors on the external panel surface represent a canvas of abstract art, of neutral tones and regular shapes arranged in an asymmetric design. Not all of the surface colors are even; some panels are rusty gold in appearance, some look green with wood stain, and some are yellow in color. The basic earth colors of iron oxides and copper sulphides are particularly interesting. This project refutes the notion that concrete sandwich panels have to be boring. The chemical stain is a very thin layer on the surface of the concrete panel. The stain is durable under exposure to rain or snow, but cannot withstand heavy abrasion. A surface treatment of commercial sealant was used to avoid dirt and unwanted graffiti penetrating the concrete micro-pores of the panel surface. The appearance of chemical staining
