failed stone

problems and solutions
with concrete and masonry

Failed Stone

Problems and Solutions with Concrete and Masonry

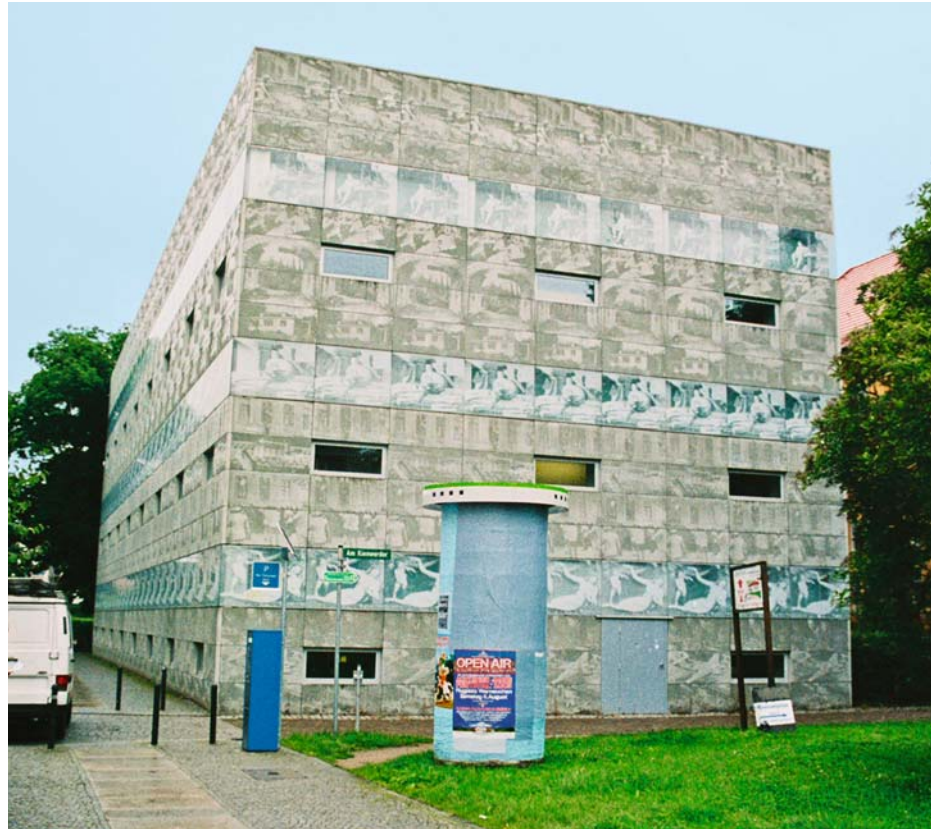
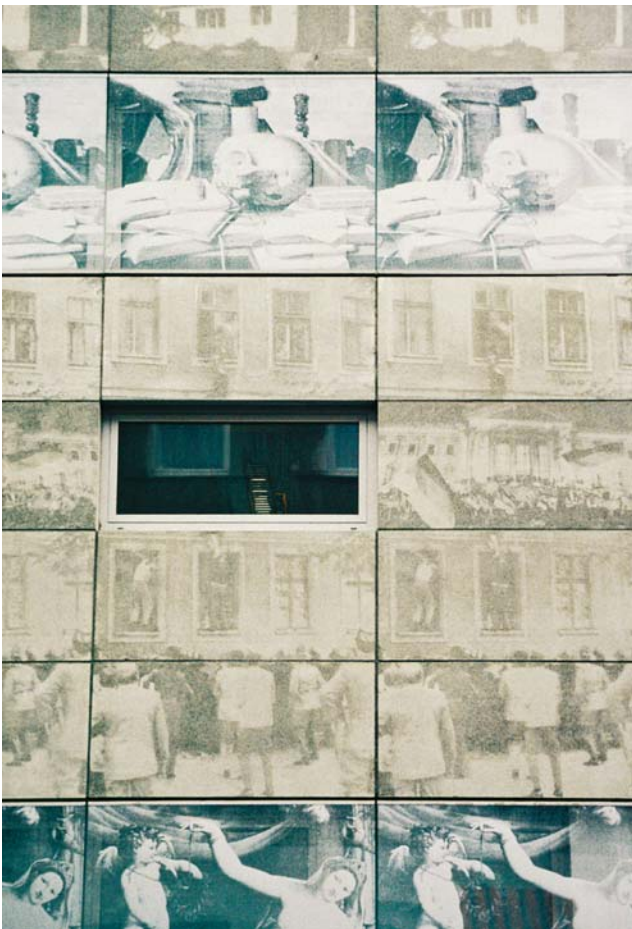
Eberswalde Technical School, built in Eberswalde near Berlin, in 1999.

Concrete can be photoengraved through a process similar to silk-screening. Eberswalde Technical School.

Concrete can be photoengraved through a process similar to silk-screening. A photo is screen-printed as a layer of tiny dots onto a polystyrene sheet, but instead of using paint or ink, the image is printed with a cure retarder liquid. A cure retarder is a chemical that slows the cure rate of concrete. The prepared sheet is then placed into the concrete mold and the concrete poured on top of it. When the concrete has set, it is removed from the mold and pressure-washed, revealing a half-tone image on the finished concrete surface. Eberswalde Technical School, designed by Herzog and de Meuron, used photoengraved concrete to provide detail to what would otherwise be a flat concrete box. The photoengraved pattern was also applied to the glass using a silkscreen coating technique. The concrete impression process has proven to be very successful, retaining its color and detail many years after completion. Like many finished surfaces, a regular pattern of color variation can hide any slight discoloration of the surface. The discoloration of materials is not limited to concrete. Natural stone can also have shifts in color that are not anticipated.

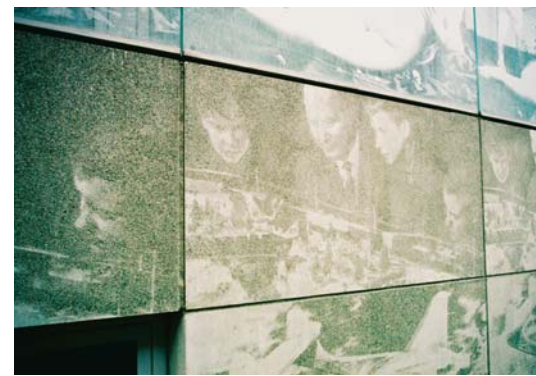
The concrete impression process has proven to be very successful, retaining its color and detail many years after completion.

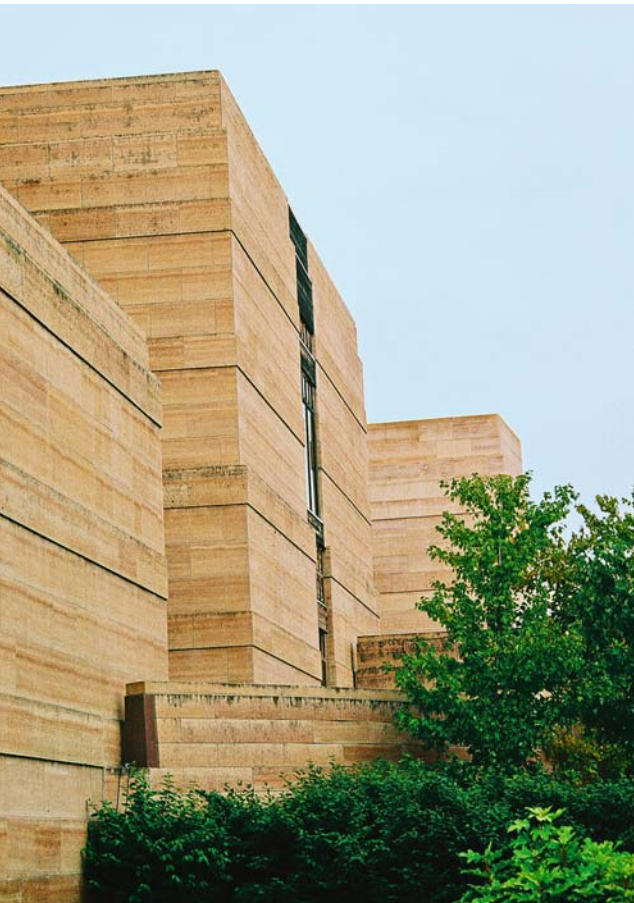
above The finish of the stone changed between completion of the original building and the time it was expanded. The difference comes partly from the algae growth. Eiteljorg Museum of American Indians and Western Art, Indianapolis.

Indiana and Indianapolis were named after their first human inhabitants. Completed in 1989, the Eiteljorg Museum of American Indians and Western Art, pays tribute to this group. The 10,960m² (118,000 square feet) honey-colored museum is composed of nearly 12,000 pieces of hand-cut Minnesota dolomite, a stone creating the feel of the Southwestern Pueblo. Plum-colored German sandstone serves as the building's base. It was decided to allow algae to decorate the museum walls. In 2005, construction of the Mel and Joan Perelman Wing doubled the size of the institution. The new north end of the museum faces the Indianapolis Center Canal. The finish of the stone changed between completion of the original building and the time it was expanded. The difference comes partly from the algae growth. If algae discoloration is not wanted in heavily planted wetted areas, application of a water repellent coating should be considered. These coatings form a hydrophobic layer that requires renewal every two to three years as its effect reduces with time. If an alga is to be allowed to build up on concrete surfaces, the cover to steel reinforcement must be thicker. Other forms of natural discoloration are less desirable than growth of algae on the Eiteljorg Museum of American Indians and Western Art.

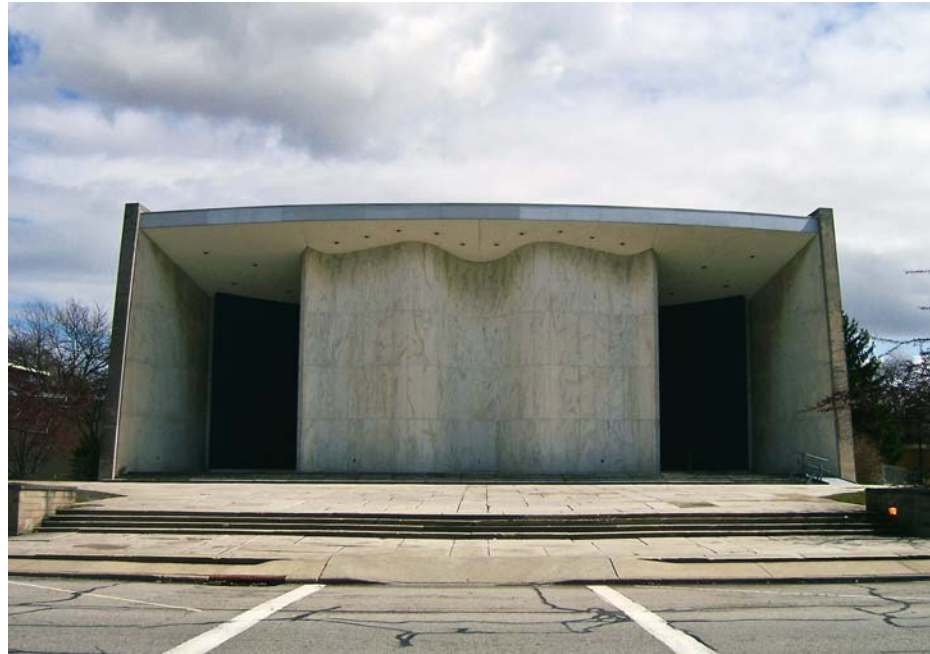
The top portion of the undulating stone façade has marks from a soffit that does not drip water away from the façade. Hall Auditorium at Oberlin College.

Uncontrolled water runoff on a building can leave hideous stains on a façade. Examples of water-runoff stains can be found in every major city in the world. Completed in 1953, Hall Auditorium, at Oberlin College, Ohio, provides a good example of how white marble can be permanently stained from run-off water. The top portion of the undulating stone façade has marks from a soffit that does not drip water away from the façade. Water runoff can be attributed to poor design or poor building maintenance.

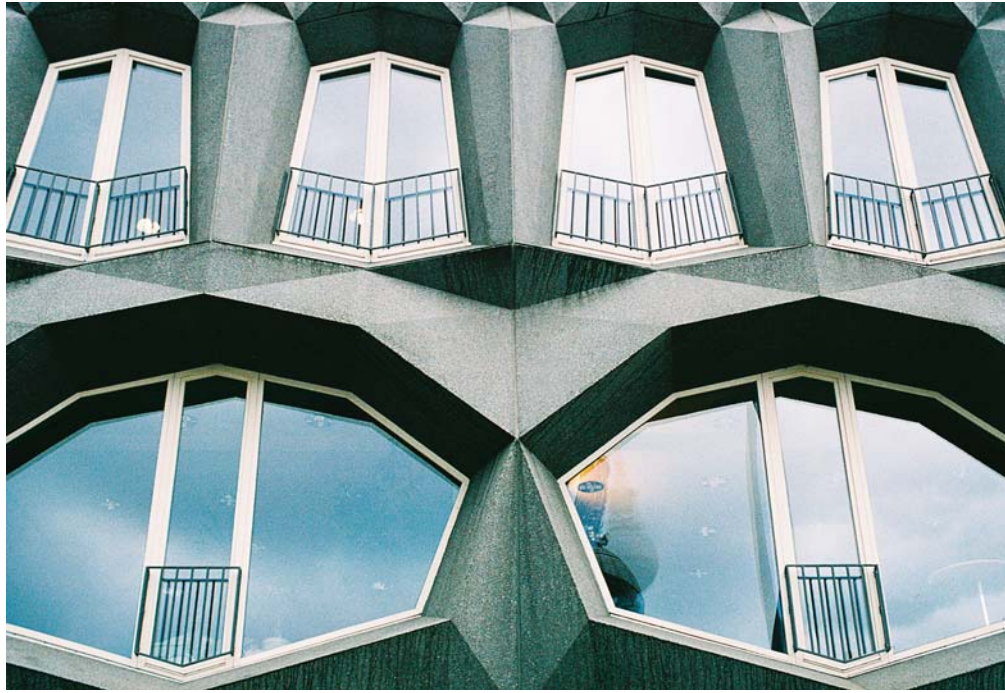
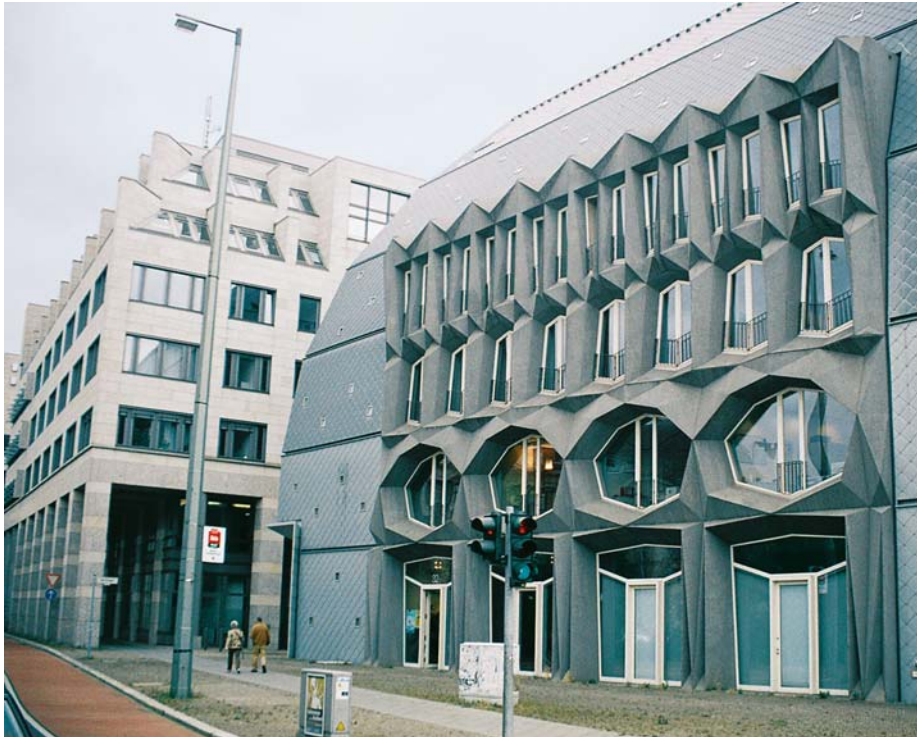
Water stains can be seen at the changes of the planes of the façade. The headquarters of the Berlin Water Works, House III Close up.

The headquarters of the Berlin Water Works, House III, 2003.

Properly detailed drip edges can direct water away from wall surfaces, protecting them from discoloration. If no drips are provided, water marks will be present on dark surfaces as well as light ones. The headquarters of the Berlin Water Works, House III was constructed in 2000, in strong contrast to the neighboring Baroque buildings of Berlin. The five-story façade is composed of broken, prism-like forms the color of granite and is based on the styles of Cubism. Water stains can be seen at the changes of the planes of the façade.

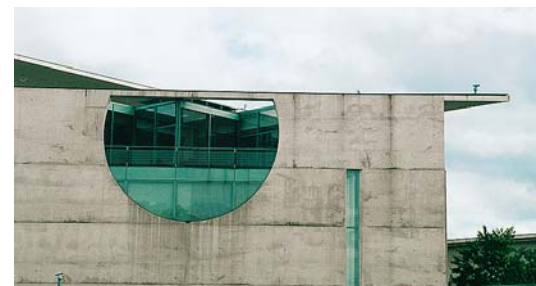
right After rainfall, the water runs off the sill, takes the dirt with it and streaks down the face of the building, discoloring the façade. The Federal Chancellery building, Berlin, 2001.

Light-colored concrete shows the worst stains. Water runoff from large horizontal surfaces can carry extensive amounts of dirt down the face of a building. The Federal Chancellery building, completed in Berlin in 2001, was part of a “ribbon” of government buildings running along the River Spree, uniting East and West Berlin. This series of buildings is architecturally linked by formal blocks with

large circular cut-outs. One façade that faces the River Spree is badly stained from rainwater. The circular cut-out in the façade has a large projecting ledge that collects dirt and other air-borne debris. After rainfall, the water runs off the sill, takes the dirt with it and streaks down the face of the building, discoloring the façade. The forces of nature can permanently stain our buildings; however, the most troublesome marks on a building façade in an urban environment come from human intervention.

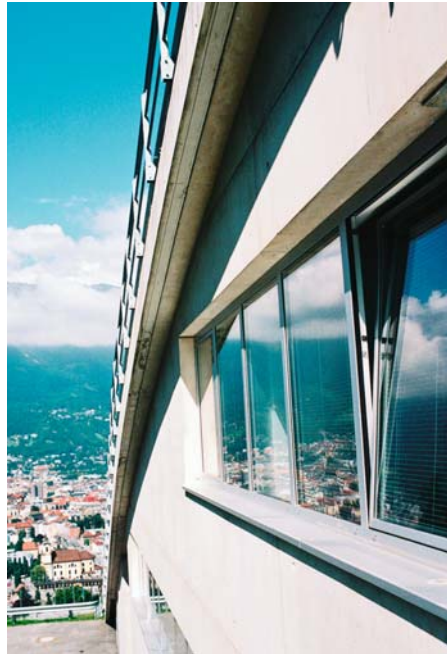
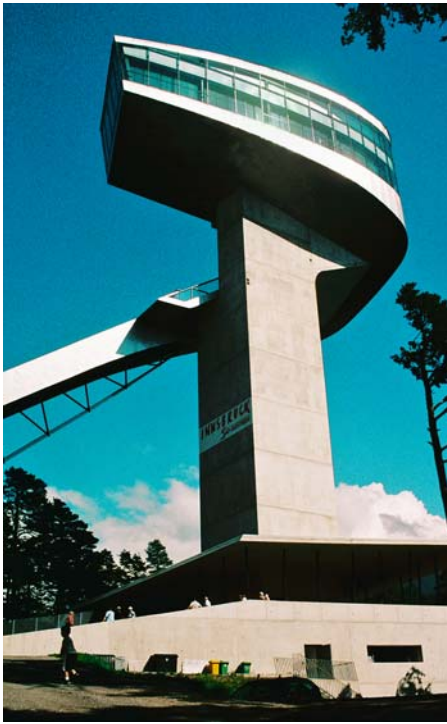
Innsbruck Ski Jump.

The new Innsbruck Ski Jump, designed by Zaha Hadid and completed in 2002, provides an excellent drip edge at the window sill.

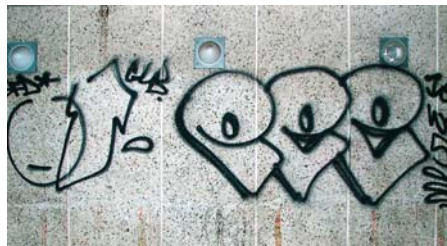
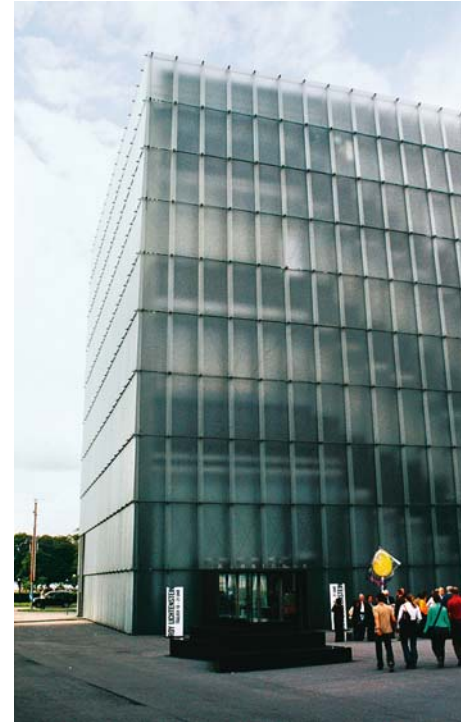
above Bregenz Art Museum, Bregenz, Austria, 1997. All-glass walls are less susceptible to graffiti than a porous stone or concrete wall.

page 87 These glass details make it difficult to permanently paint or mark the exterior walls of the museum. Bregenz Art Museum, Bregenz, Austria, 1997.

In an urban environment, graffiti and other acts of vandalism can discolor exterior walls wherever they are accessible; however, there are ways of protecting the appearance of façades. One method is to make the surface impervious to the markings of vandals. The four exterior walls of the Bregenz Art Museum by Peter Zumthor are composed of shingled, frameless translucent glass covering the entire concrete structure. These details make it difficult to permanently paint or mark the exterior walls of the museum. Paint markings can be scraped off the glass easily. Concrete, stone and masonry surfaces are more porous than glass and require a different strategy.

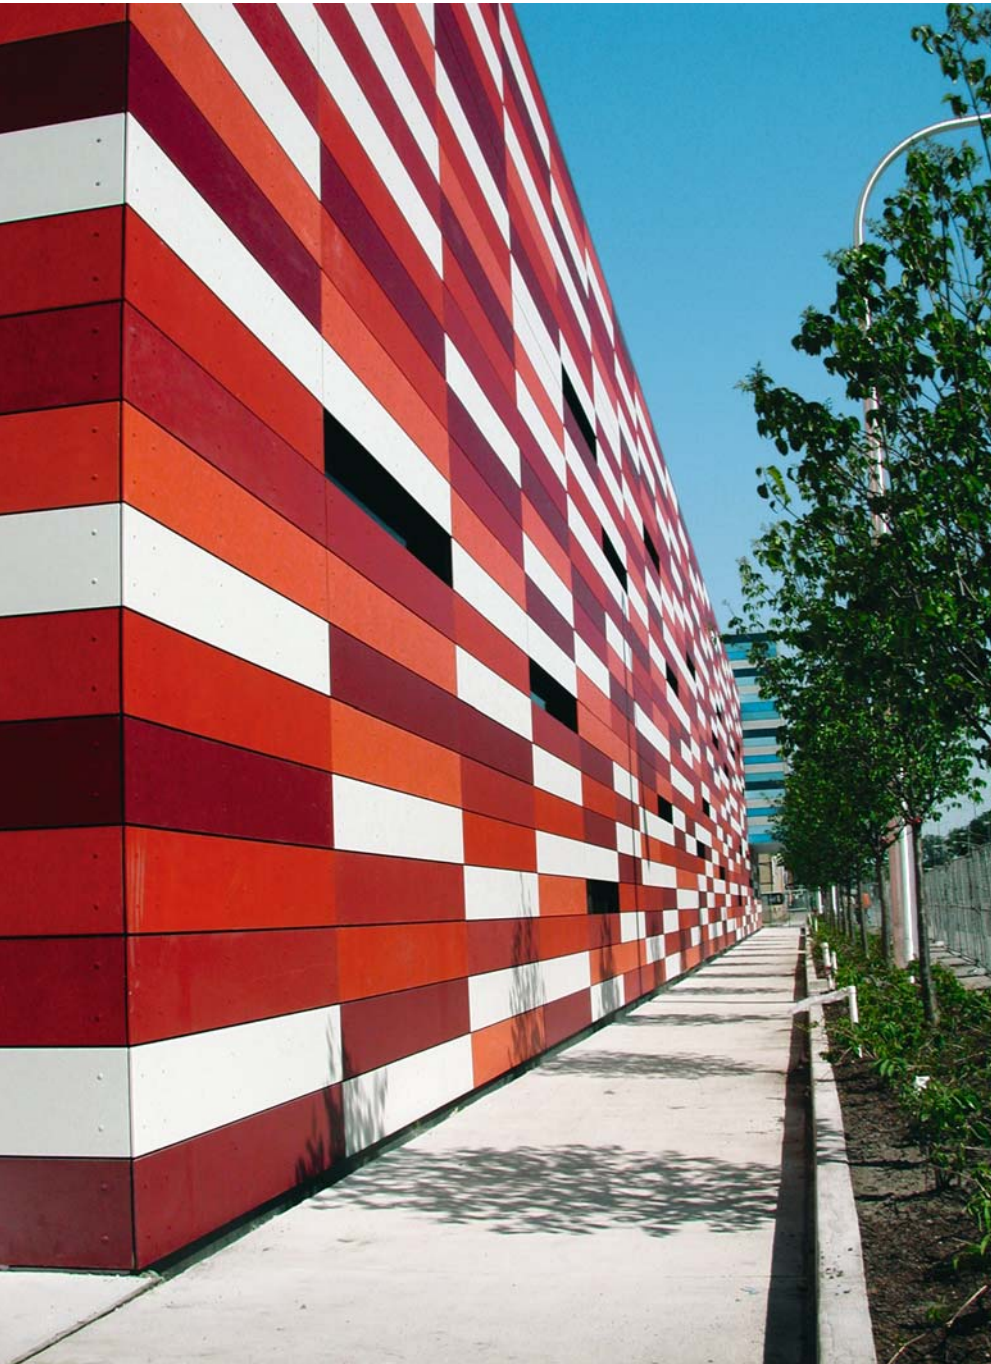
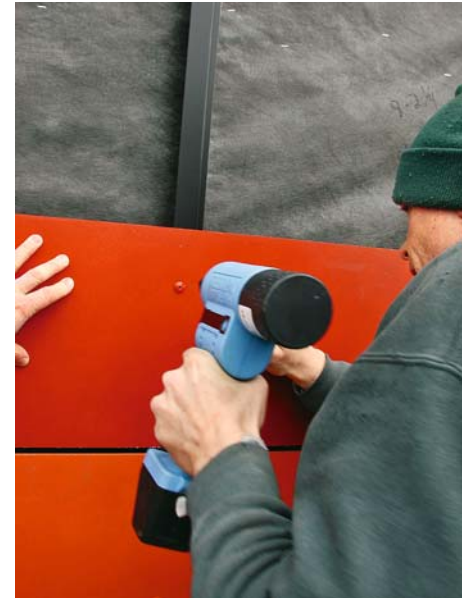
The Gary Comer Youth Center, Chicago, 2006.

The building is clad with a colorful array of architectural fiber cement façade panels. The Gary Comer Youth Center.

The fiber cement façade panels can easily be replaced if damaged from vandalism. The Gary Comer Youth Center.

A second strategy to combat vandalism is to make the enclosure panels easily replaceable. The Gary Comer Youth Center was designed by John Ronan Architects to provide practice and performance space for the South Shore Drill Team and Performing Arts Ensemble in Chicago. Completed in 2006, the building is clad with a colorful array of architectural fiber cement façade panels. The panels are approximately 6.25mm (1/4 inch) thick and riveted to a metal framing with stainless steel fasteners. Because the building is located in an active urban environment, the design for the building envelope at the street level had to consider the possibility of graffiti on the walls. If panels are discolored beyond repair, they can easily be replaced with panels from stock.

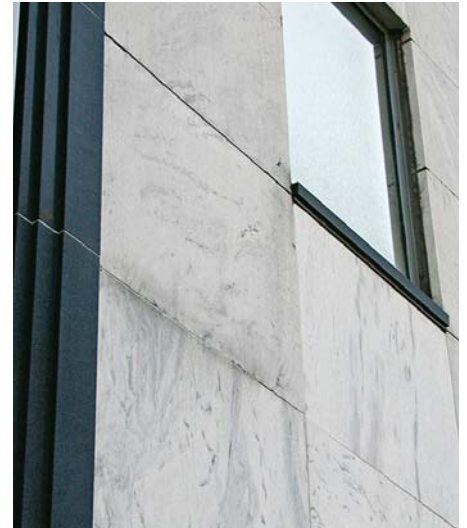
Silicone sealant can stain white marble.

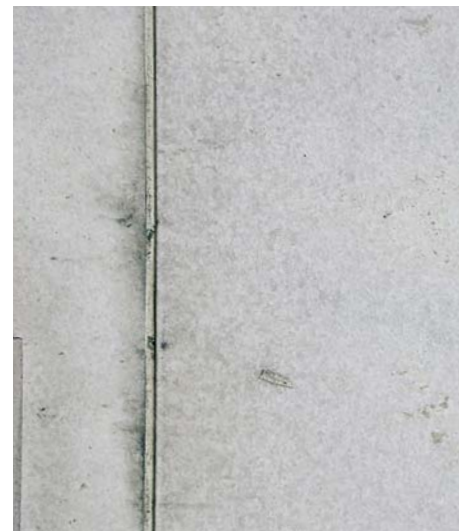
Stone replacement is the only method for removing the picture-frame effect of sealant joint stains.

right Stone replacement is the only method for removing the picture-frame effect of sealant joint stains.

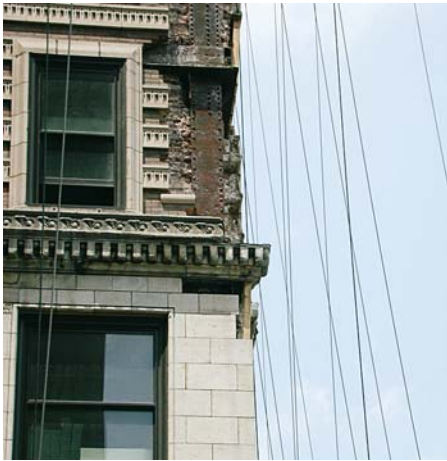
above Removal of the stone cladding reveals the corroded steel structure.

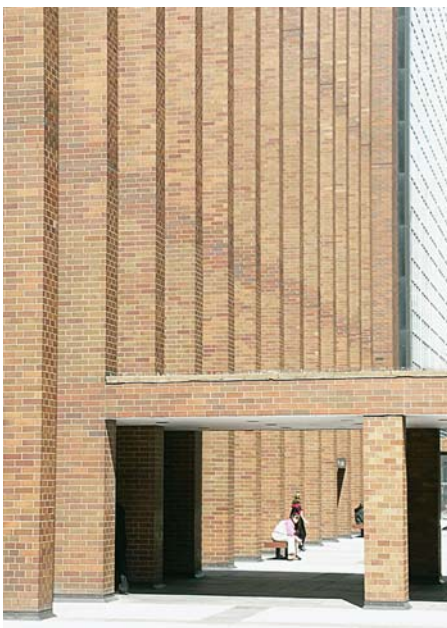
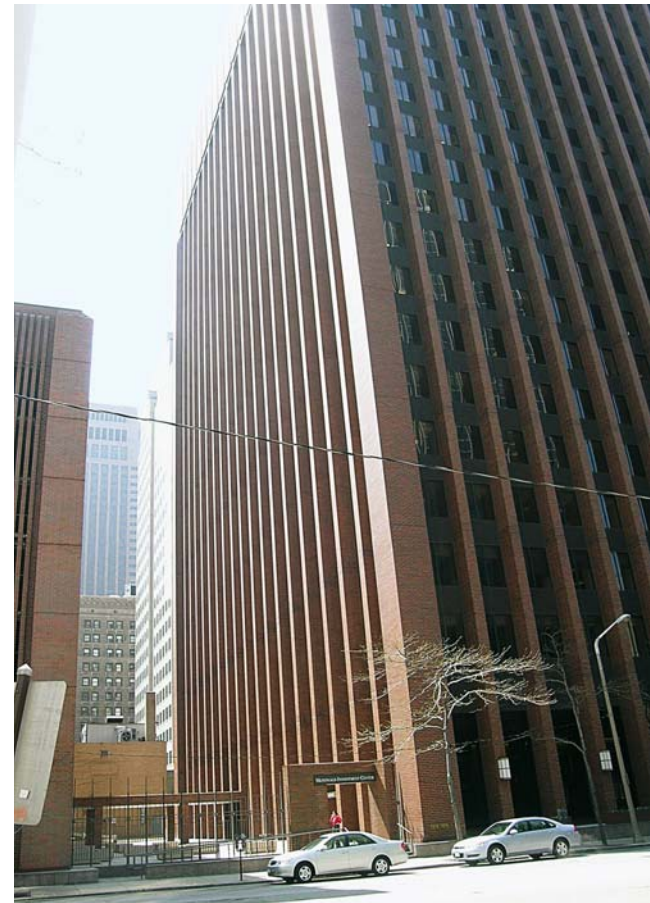
right and below Central National Bank, Cleveland, Ohio, 1970. Corrosion of wall reinforcement caused brick walls to fall to the street just seven years after the project was completed.

In traditional masonry walls, when steel reinforcement is embedded in conventional cementitious mortar, a stable oxide coating is formed over the steel surface, thereby protecting the steel from damaging corrosion. Investigation revealed that the Sarabond additive creates a corrosive environment for embedded steel. Sarabond was a latex modifier containing polyvinyl chloride (PVC). When Sarabond was added to fresh cement, it released chloride into the cement pores. In sufficient concentration, chloride ions destroy the normally protective steel oxide coating that develops naturally over the surface reinforcement in contact with cementitious mortars and concretes; the oxide coating becomes unstable, giving rise to damaging corrosion at the steel surface. As steel corrodes, it gains in volume. In a cementitious mortar, the expansion due to uncontrolled corrosion at the metal surface generates tension forces. Cement mortars have little capacity to resist these tension forces, even with the increased strength characteristics of Sarabond, and cracks develop in the mortar. The combination

of uncontrolled steel corrosion and cracking of the supporting mortar leads eventually to failure of the steel. Where steel fasteners or ties are used, this type of failure can result in buckling of an entire wall of bricks. Sarabond was blamed for weakening the reinforcement system and for causing façades to peel away from the building and bricks to plunge to the street below. In the case of the Central National Bank in Cleveland, the solution was replacement of the brick façade.

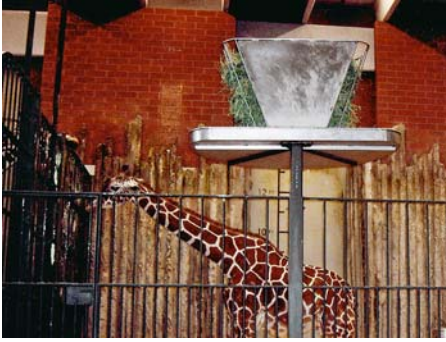
above Giraffe House, Denver Zoo, detail.

right Corrosion of masonry joint. Giraffe House, Denver Zoo.

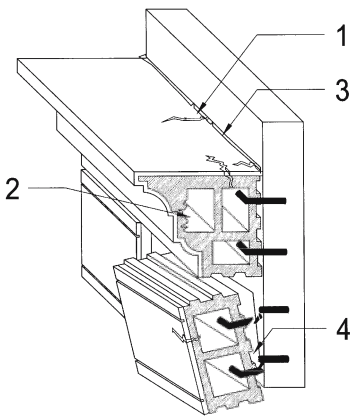
above Failure of terra-cotta panels.

- 1 Crazeing – Fine cracking of the glaze finish due to thermal expansion and contraction of terra cotta. Moisture can enter through the cracks.
- 2 Spalling – The partial loss of masonry caused by water trapped within the terra-cotta unit.
- 3 Mortar deterioration – Deteriorated mortar joints are a source of water infiltration.
- 4 Deterioration of metal anchoring – Deteriorated anchoring system due to water infiltration and rusting of carbon steel anchor can be severe before it is noticed. As a result, terra-cotta blocks can fall from the building with little warning.

Terra-cotta failures occur with time, following a progressive deterioration. Initially, fine cracking, called crazing, occurs in the glaze finish of the terra-cotta element. This can occur as a result of thermal expansion and contraction of the piece. Moisture penetrates through the cracks, entering the porous baked clay. The presence of moisture and oxygen at the surface of the internal steel anchor connecting the terra-cotta block to the building structure allows the onset of corrosion. Deterioration of the mortar used for filling between terra-cotta elements also provides a path for water to migrate to the steel supports. With time, corrosion weakens the metal until the anchor finally breaks. Terra cotta deterioration can ultimately lead to large sections of façade falling to the ground. Terra cotta restoration can be difficult and expensive to complete. There are a handful of companies that make classic architectural terra-cotta pieces. Repair methods of terra cotta include the use of stainless steel replacement anchors. This technique insures that corrosion will not be a factor in years to come.

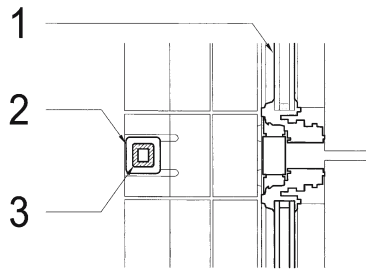
New terra-cotta panels.
 1 Glass curtainwall system
 2 Terra-cotta tube, "baguette"
 3 Aluminum support

its design. Unlike the traditional glazed terra cotta, this unglazed material is made of carefully selected clay of higher density and greater strength than the traditional material. The rod-like sunshade elements, referred to as "baguettes," fasten into receptors cast into the vertical mullions. Aluminum and galvanized-steel fittings attach the cladding to the substructure. In the case of the thin terra-cotta "baguettes," an aluminum support tube threads through the terra cotta, preventing their displacement if the terra cotta breaks. By using nonferrous connections in contemporary designs, terra-cotta elements will stay on the building and not fall to the street below.

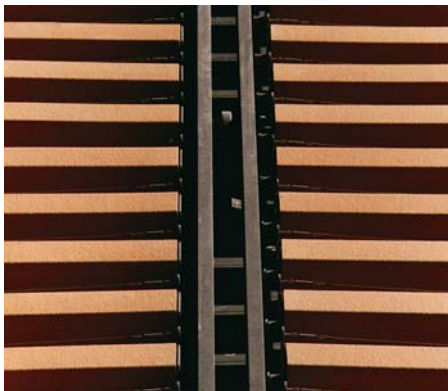
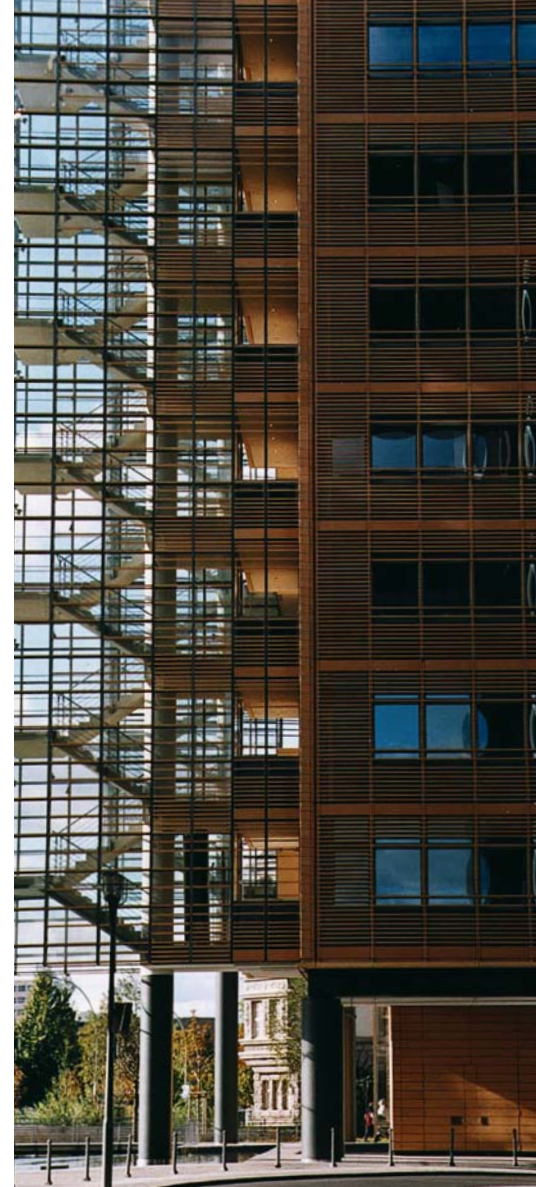
right Debis Headquarters, Potsdamer Platz, Berlin, 1998.

below Terra-cotta "baguette" at Debis Headquarters.

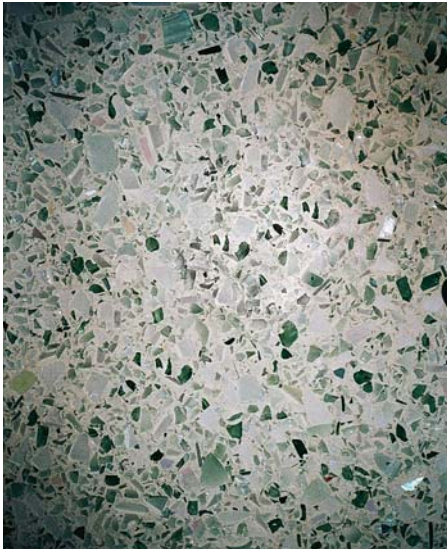
Precast concrete panels using recycled glass as an aggregate can show alkali silica reaction.

Throughout the world today, cladding panels are being made of concrete mixes incorporating a variety of materials. The San Jose State Museum is proposing polished, precast concrete panels using recycled glass as an aggregate. There is much interest in this potentially sustainable application for recycling glass. However, there are technical difficulties to be aware of, principally due to the reaction that occurs when high silica aggregates come into contact with cement. A reaction occurs between reactive silica in the aggregate and the soluble alkali products in the cement paste forming a hygroscopic alkali-silica gel, which swells on contact with water. This form of corrosion is a well-known problem where reactive aggregates have been used in concrete; because glass is principally reactive silica, its use as an aggregate carries the same risk. When wet, the glass aggregate produces alkali-silica gel when in contact with the high alkali concrete paste. The reaction produces a swelling of the gel that breaks the concrete, causing a readily identifiable crazing pattern at the surface.

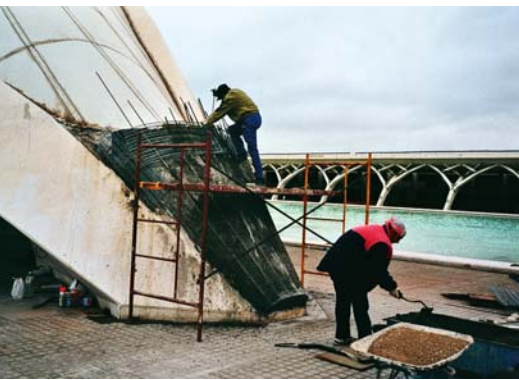
Concrete cover: The concrete base at the "City of Arts and Sciences" in Valencia, Spain, a complex of buildings is composed of steel reinforcement covered in concrete.

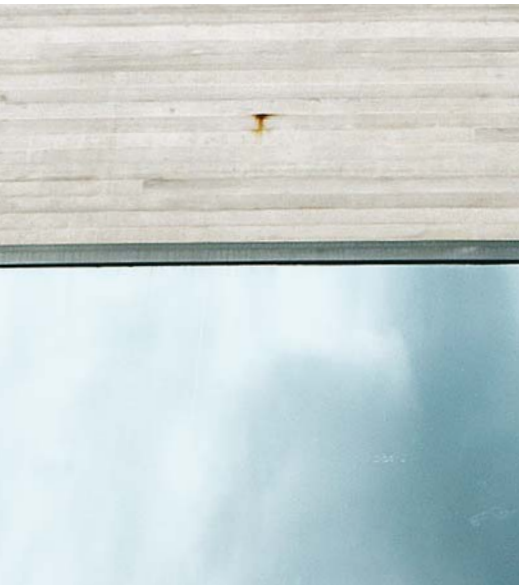
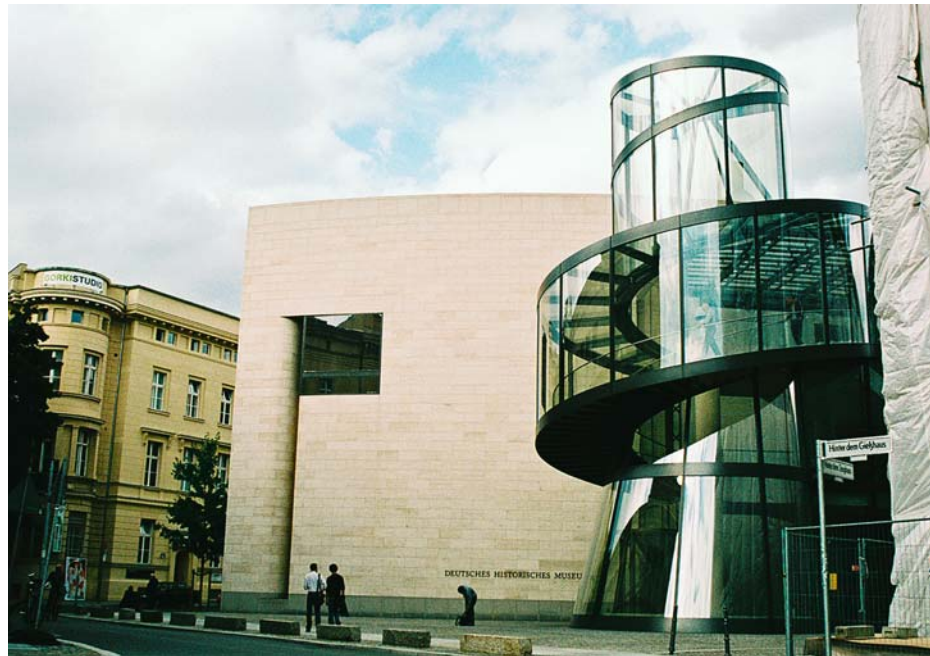
above and right Extension of the Deutsches Historisches Museum, Berlin, 2004. Signs of carbon steel corrosion are visible above the window.

Completed in 2004, the extension of the Deutsches Historisches Museum in Berlin has several differently shaped halls on four levels where the exhibitions take place. The south façade is composed of an all-glass volume and a large stonewall. There is only one window on the extension structure, above which lies a concrete lintel. The concrete lintel includes steel reinforcement; however, it appears that the amount of coverage is insufficient over one of the bars. In strong contrast to the light-colored stone façade, rust marks have started to streak down the face of the lintel as the steel reinforcement corrodes.

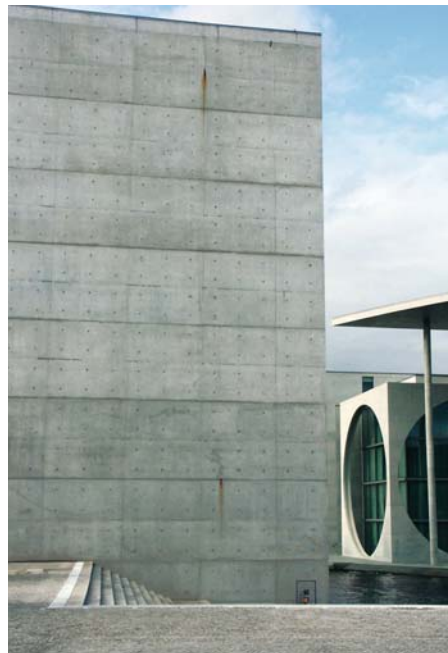
right Paul-Löbe-Haus, Berlin, 2001. Unwanted stains from carbon steel appeared on concrete walls shortly after the project was completed.

The extension of the Deutsches Historisches Museum is not alone. Less than a mile away, a new Parliament office building, the Paul-Löbe-Haus, designed by Stephan Braunfels and completed in 2001, has several locations on the concrete façade with rust marks from unprotected carbon steel inadvertently exposed to the environment. These nuisance defects are typically aesthetic only; however, continued corrosion in certain environments can lead to serious, even catastrophic, structural problems.

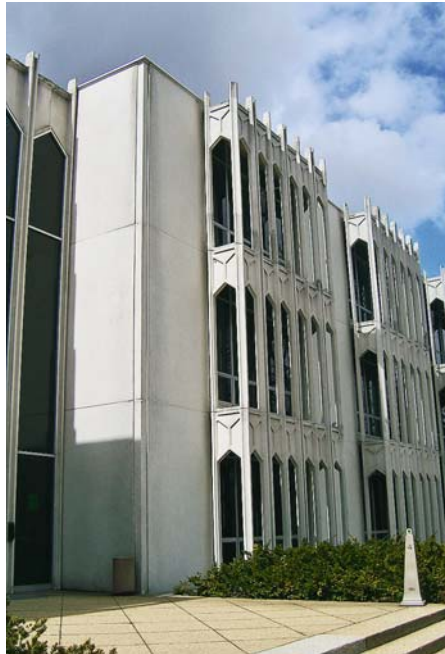
above and right King Building, Oberlin College, Ohio, 1966.

The King Building at Oberlin College, Ohio, was constructed in 1966, with similar precast concrete details to the Pan Am hanger in Miami. Corrosion of the concrete panels at the King Building is not caused by the ocean air, but by salts applied near the entrance to melt snow and ice in the winter.

Special care must be taken when concrete with carbon steel reinforcement is going to be exposed to de-icing salts. Advances in materials and mix design enable the specification of reinforced concrete that will resist even the most aggressive environments. The key lies in understanding the environment and the requirements that it places on the structure.

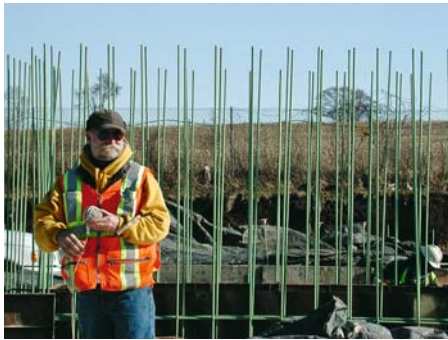
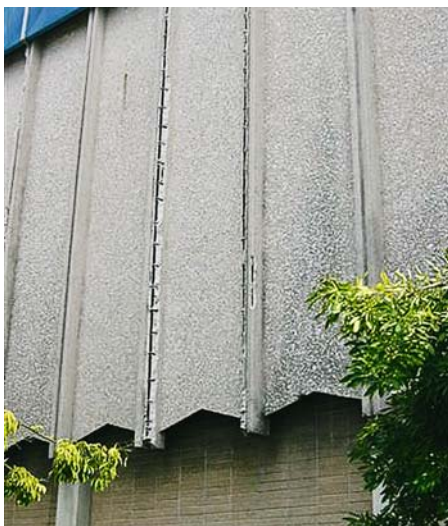
below and right Corrosion of steel reinforcement can be unsightly and can compromise the structural integrity of a concrete structure.

A former Pan Am aircraft hanger, constructed in Miami, Florida, during the 1980s, has a corrosion problem that is out of control. Corroding steel reinforcement is visible at the fins of precast concrete elements over a large percentage of the façade. Heightened corrosion from the salts in the ocean air may have added to the severe corrosion exhibited on the precast concrete panels. Over many years, a building envelope can develop serious structural problems due to the deterioration of concrete due to corrosion. Salts are a corrosive element found in coastal regions of the world and in cities away from the ocean.

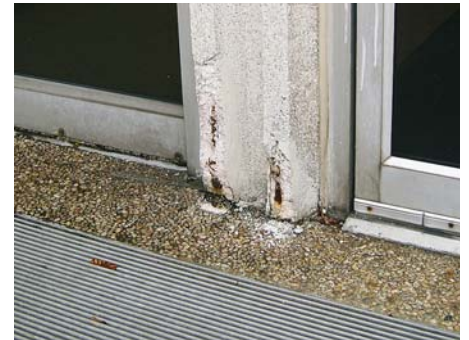
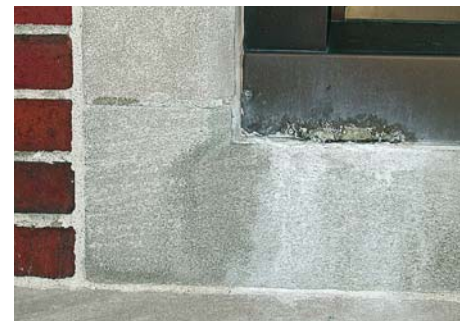
above Aluminum will corrode if in contact with wet concrete.

Metal deterioration can occur in any environment when metals come in contact with chemically active materials. Typically, this process can be accelerated when moisture is present. For example, aluminum in direct contact with concrete or mortar will corrode. Steel in contact with certain types of treated wood will corrode. An example of an unwanted

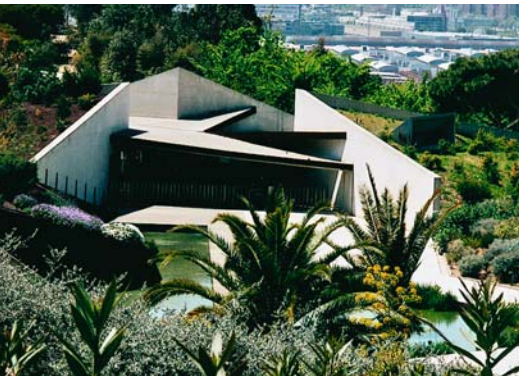
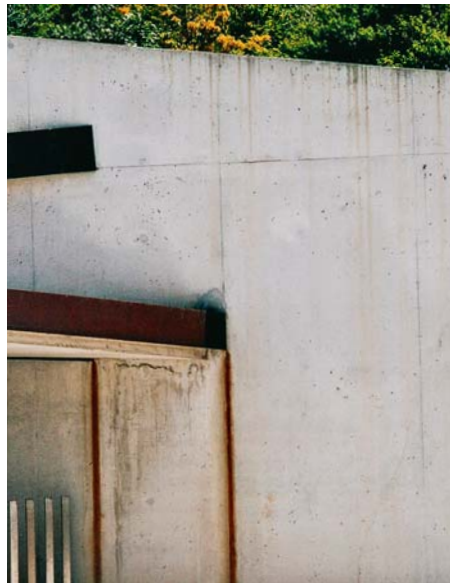
above and right Botanical Gardens in Barcelona, designed by Carlos Ferrater and completed in 1999. Elements of the park are constructed with Cor-Ten steel. The staining that occurs at the entrance almost looks deliberate.

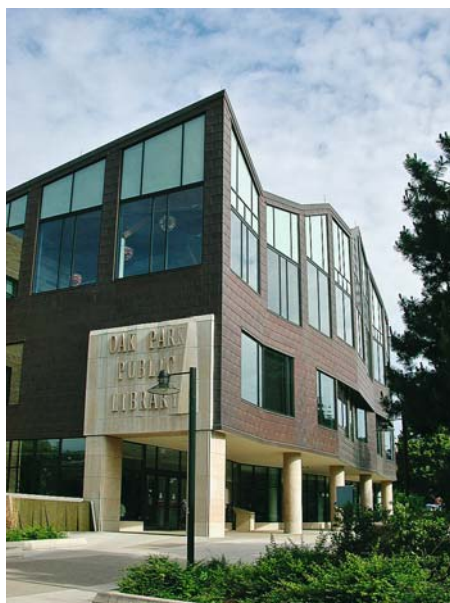
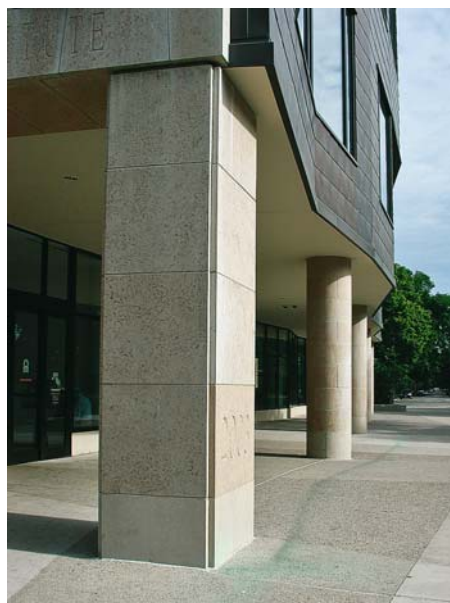
below Staining of concrete walkway was an inevitable consequence of installing copper cladding on Oak Park Public Library, Chicago completed in 2003 and designed by Nagle Hartray and Associates.

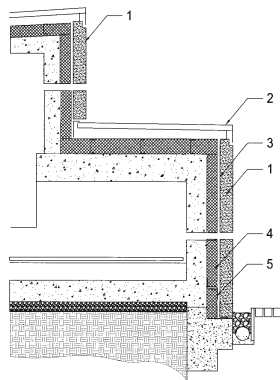
Oskar Reinhart Collection.
 1 Precast concrete panel with jurassic limestone and copper
 2 Copper roofing material
 3 Air space
 4 Insulation
 5 Through-wall base flashing

The exterior wall comprises a cast-in-place 20cm (7¾ inch) thick reinforced concrete wall, an external attached 10cm (4 inch) thick layer of insulation (rock wool), a 3cm (1¼ inch) air gap, and a precast concrete panel (10 and 12cm [4 and 4¾ inch] thick). The concrete panels have a rich surface derived from the unusual concrete mix. Trial panels comprising a variety of materials were made and observed. Two materials used in the construction of the original villa, Jurassic limestone and copper, were found to give the best results. Both of these materials were ground down and added as fine aggregate to the concrete mix. The new walls have undergone an accelerated aging process, acquiring a patina that gives the walls a discreet green color. The wall details allow runoff water from the copper roof to deliberately streak the walls with copper ions to provide the desired effect.

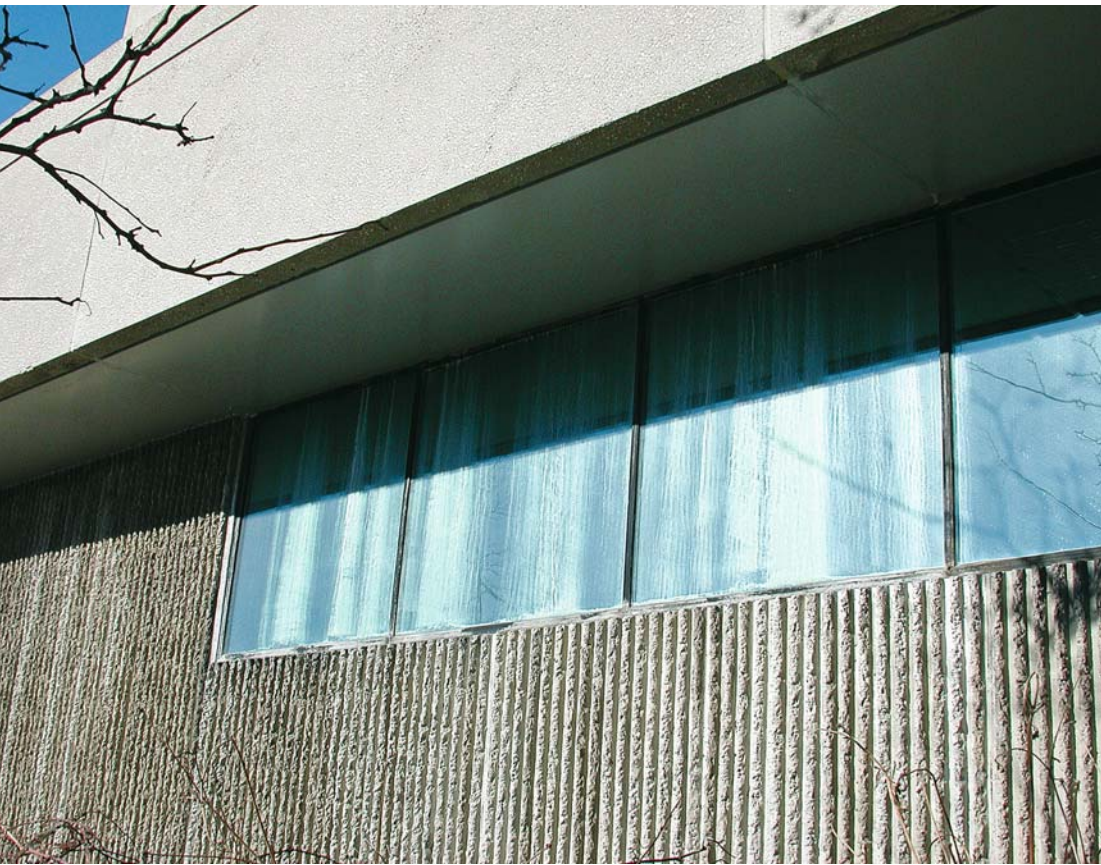
right Image of white corrosion marks on glass from concrete runoff.

When water reaches a building, it is either reflected, or absorbed, or allowed to run down the building's façade. When water runoff occurs across a masonry or concrete wall, the water can carry minerals from these surfaces to the glass below. Water runoff containing contaminants can damage glass. To understand the chemistry involved with this process, one must review some basic concepts. An aqueous solution can be described on a pH scale from one to 14, with neutral solutions having a pH of seven. Materials measured below seven are considered acids, and materials above seven are considered basic or alkaline. If the alkalinity of a solution reaches a pH greater than nine, a destructive stage of glass corrosion can begin to occur. Fresh concrete can have a pH of 12; however, as the concrete ages the alkalinity of the surface decreases. Damage to the surface of glass can be caused by alkalis that leach out of precast concrete panels by rain, or the fluorides in the wash-off from concrete floors that have been treated for hardening with solutions of zinc or magnesium fluorosilicates. These materials can stain or etch the surface of the glass if allowed to remain for an extended period of time.

The contaminating effects from runoff water may lead to white streaks on the glass, which is difficult to remove. The transparency of glass can be permanently lost once the glass surface has been severely etched. Although concrete and stone have taken most of the blame for unsightly glass stains and etching, it is important to remember that many structures built of materials other than concrete and masonry have experienced glass staining. This staining can be explained by natural corrosion of the glass.

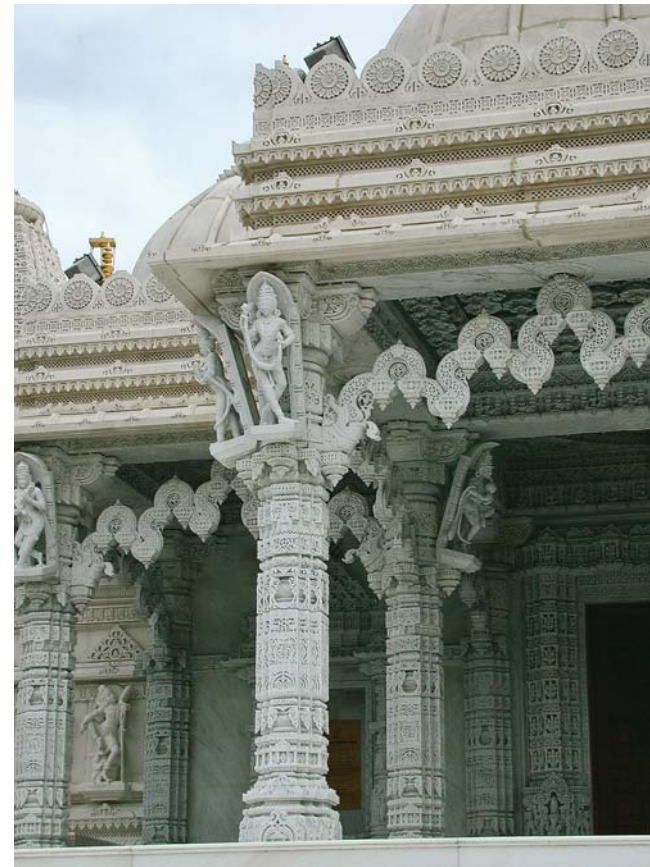
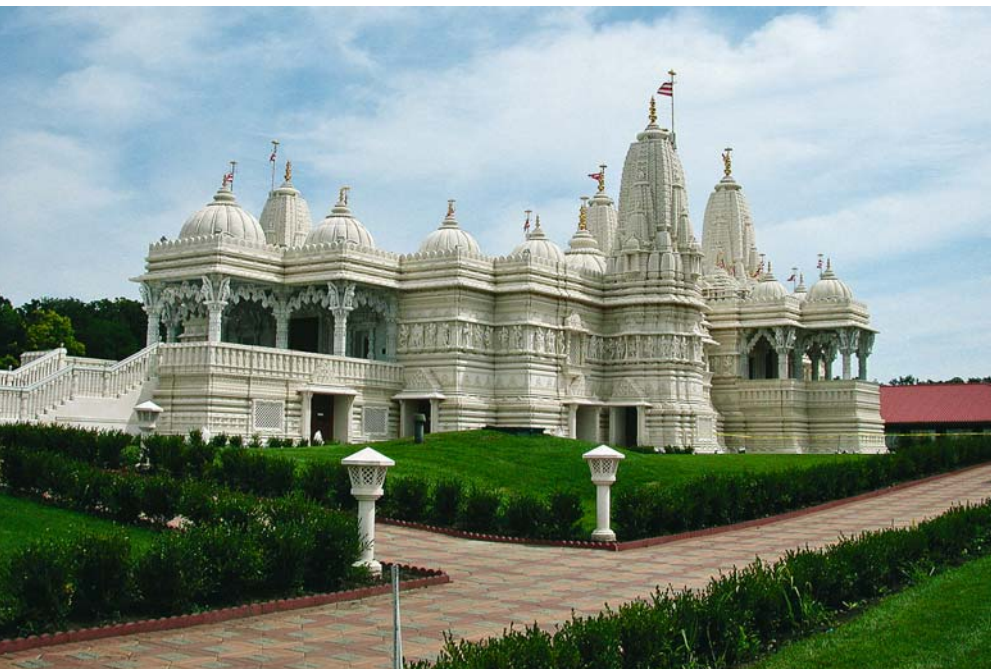
right and below BAPS Temple, Bartlett, Illinois, 2004. The only metal used on the building structure were copper rods used to connect the carved marble blocks together.

The concrete industry has even developed structural concrete that does not use any metal. The new Hindu Temple in Bartlett, Illinois, was constructed with no metal in the concrete at all. This was a requirement of the Hindu monks, related to their practical knowledge and spiritual beliefs.

Bartlett is free of ferrous metals that could corrode with time. In addition to creating a building that would last for thousands of years, the temple space was to be free from metal to create a space for the highest level of concentration. It is believed that steel and the magnetic flux associated with it can be a minor distraction to the focused mind. The massive concrete foundation for the temple used a high-strength mix free of steel with a mix of 33 percent cement and 67 percent flyash.
