failed stone

problems and solutions
with concrete and masonry

Failed Stone

Problems and Solutions with Concrete and Masonry

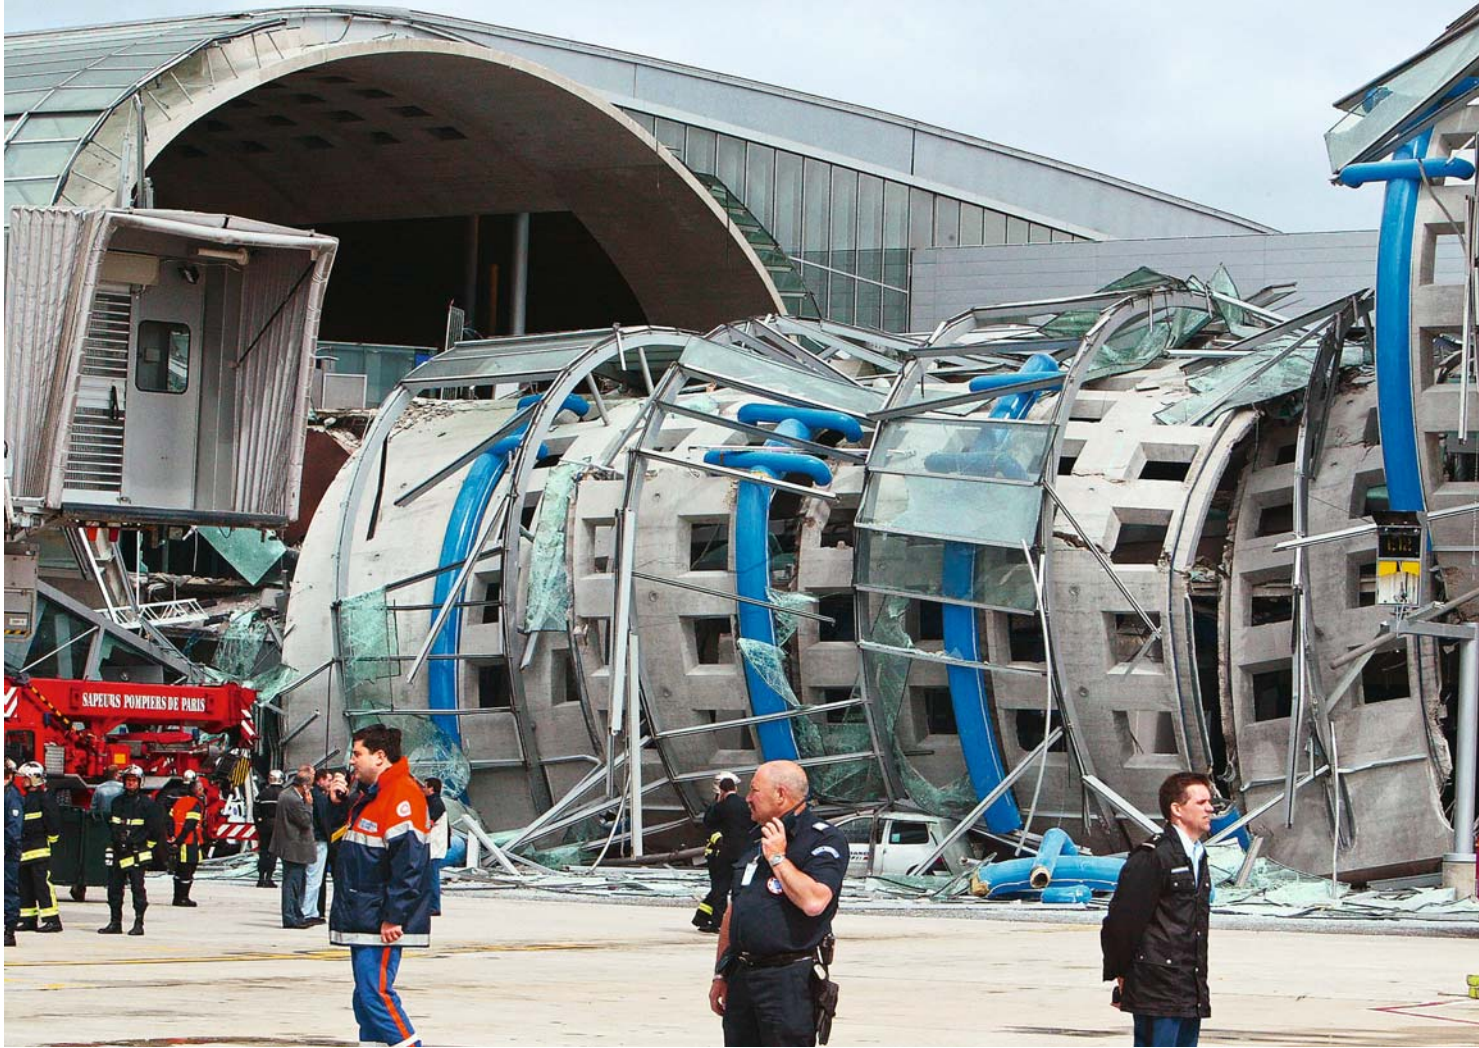
right and below Terminal 2E, Charles de Gaulle International Airport, Paris. The collapsed structure cleanly sheared away from adjacent sections of the double shell enclosure.

Terminal 2E at the Charles de Gaulle International Airport, completed in 2003 at a cost of 750 million dollars, features a stunning, airy elliptical concrete tube structure approximately 33.5m (110 feet) wide and 305m (1,000 feet) long. The new terminal was intended to transform Paris into the most powerful air transport hub in Europe. The building's skin consists of a double shell assembly with an outer layer of glass and aluminum and an inner shell structure of reinforced concrete. The shape of the building stemmed from the Parisian airport authority's requirement that there be no intermediate interior supports to restrict the flow of passengers through the terminal. The outer skin consisted of a glass supported by metal framing, preventing air and water from entering the terminal. The elegant inner shell was built with prefabricated 3.66m (12 foot) reinforced concrete ring sections. Each 54.4 tonne (60 ton) ring section rested

on four cast-in-place reinforced concrete pylons. The long elliptical tube was formed by interlocking concrete sections. Each vault ring is made up of three pieces. The top piece is nearly horizontal, straddled by the two-side pieces. The 30cm (12 inch) thick concrete walls allow light into the structure with a repetitive series of rectangular holes that pierce through the shell. The contractor erected each of the sections on mobile falsework and struc-

turally tied them together. To stiffen the shallow vault and provide support for the outer glass enclosure, curved steel girders embrace the concrete shell. The tensile girders are held away from the vault by regularly spaced, 10cm (4 inch) diameter steel struts on 20cm (8 inch) diameter plates embedded in roughly 10cm (4 inch) deep concrete shell recesses. Air ducts and artificial lighting for the terminal are located between the two skins. The build-

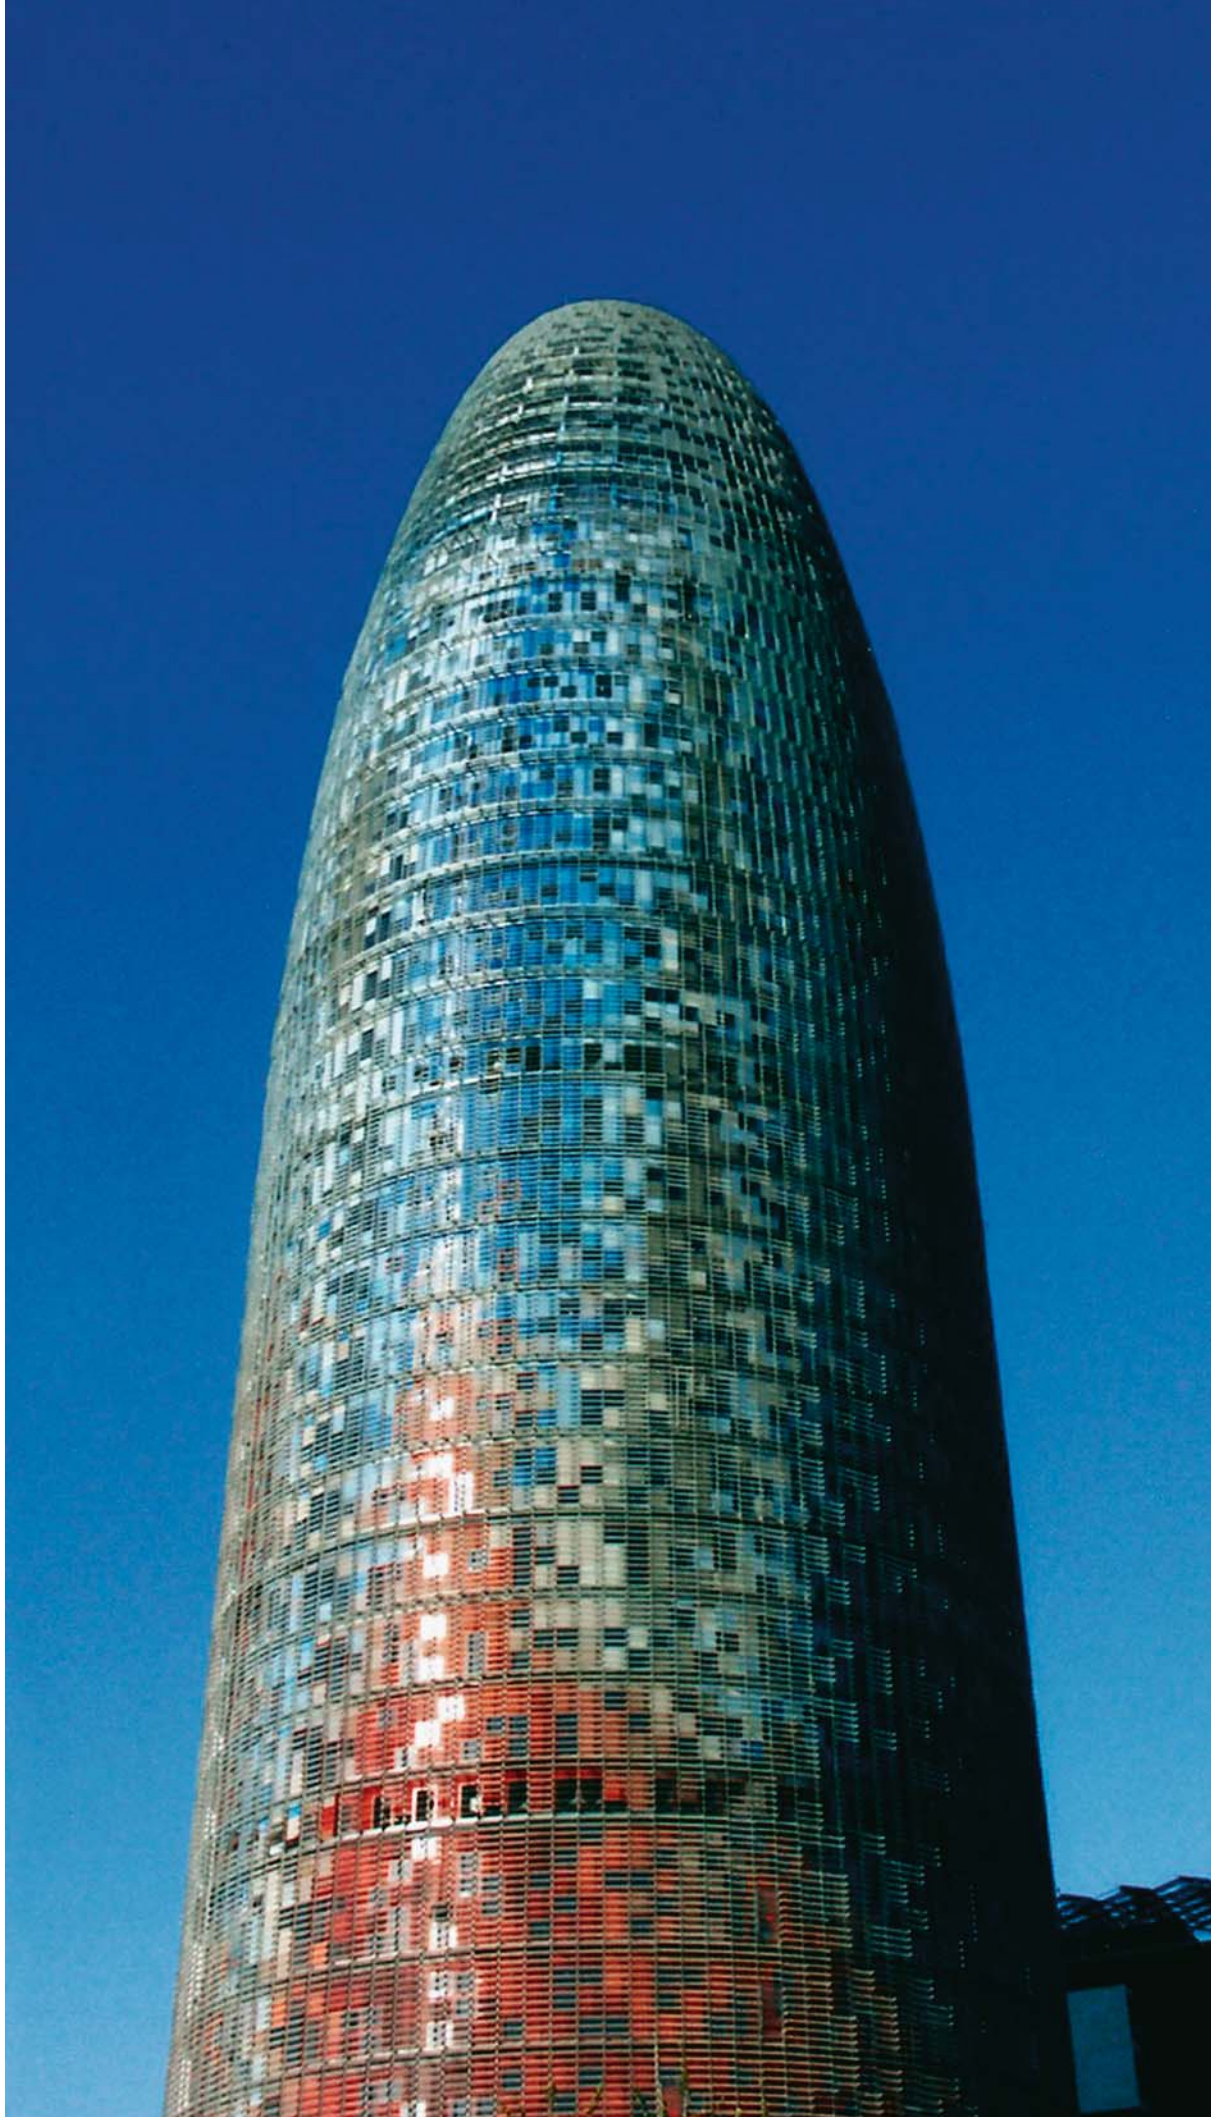
page 113 Penetrations in the concrete structure allow for natural light to enter into the terminal.
Terminal 2E, Charles de Gaulle International Airport.

In the early morning, approximately 7 a.m. on Sunday May 23, 2004, just 12 months after the terminal's opening, a large section of the airport terminal collapsed. The 30m (98.5 foot) long by 20m (65.6 foot) wide reinforced concrete section of the terminal enclosure fell, taking with it the glass and metal tube of the outer shell. The collapsed section cleanly sheared away from adjacent sections of the double shell, which remained intact. There was some warning before the accident. At 5:30 a.m. it is reported that a large spalled section of concrete fell from an overhead arch, passengers reported seeing cracks appear in the roof elements and dust falling from the ceiling. Ninety minutes later, the roof caved in. The area that collapsed was a section of the terminal containing access points for three boarding walkways. The lower sections of three alternating concrete rings were omitted in order to provide access for these walkways into the departure lounge. Steel connections transferred loads from the shortened rings to the full ones on either side. This is a different condition when compared to the rest of the terminal structure.

lems with the base of the building for explanations. Before the concourse opened, supporting pillars were repaired and reinforced with carbon fibers after fissures appeared in the concrete. This, however, was in an area away from the collapsed section of the terminal. Others look to the construction of the vault itself. The elliptical arch pushed the limits of conventional vault design, the curvature continuing beyond the vertical without conventional abutments other than the reinforcing steel hoops to stop it from spreading. Some believe the structural design of the building was insufficiently analyzed for all conditions of the project. Analysts believe additional computer modeling and computations should have been completed prior to constructing the terminal. The official report following the accident indicated simultaneous and interlinked failure of two elements giving rise to the catastrophic collapse of the terminal element. At the footbridge opening, on the north side, several external struts appear to have punctured the shell. Retrospective calculations showed some struts would have been overstressed. It is probable that this perforation was made possible by the prior gradual deterioration of the concrete. The second failure was immediately opposite, on the south side of the terminal. The shell edge beam appears to have fractured, falling off its bearing to the ground. Either mechanism could have been the trigger to cause the collapse of the terminal. The report also cited the extreme thermal cycling of the reinforced concrete that could have exacerbated initial cracking, and the lack of redundancy in the structure.

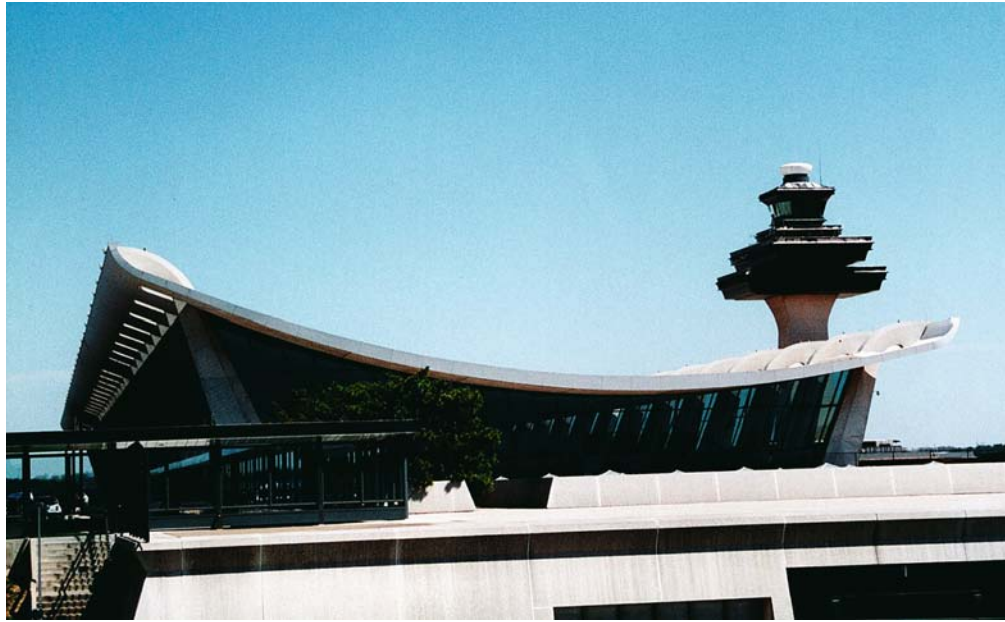
right Dulles International Airport, Washington, D.C., 1962.

Completed in 1962, the Dulles International Terminal provides an excellent example of a structure that is true to its form. A huge concrete sheet is slung between two asymmetric rows of concrete columns. Like a large hammock suspended between leaning concrete trees, the terminal's structural design can easily be understood and analyzed. Invisible within the concrete ceiling of the terminal are steel suspension-bridge cables that support the weight of the concrete roof. Since the load from the suspension cables is quite large, it was necessary to both heavily reinforce the concrete columns with steel and also cantilever them outward to counteract the inward acting force from the roof. The connections at the "horse head" tops of the columns are the most critical in the structure. Here two different systems come together where the load transfer is the greatest. The connection consists of steel tension cables connected to a site cast concrete beam. The concrete beam

The building design requirements at Dulles are similar to those of the Terminal 2E in Paris. In its current form, the ground floor slab is 305m (1000 feet) by 50m (164 feet) by 21m (68 feet) high. The tarmac façade piers are 15m (50 feet) high. The piers are spaced 12.2m (40 feet) apart. Similar to Terminal 2E, the Dulles Terminal has no intermediate interior supports that would restrict the flow of passengers through the terminal. The load path of forces is more easily understood at the Dulles Terminal than at Terminal 2E. Forces acting on the roof are transferred in tension to the ends of the leaning concrete columns. The load is transferred downward to the ground through the massive reinforced concrete columns. The columns are kept in equilibrium due to the slab between the piers, keeping them from pulling inward. This simple yet unique structural system allows for an extremely open and lengthy span.

Each pier is independently supported, like a flagpole, in all four directions giving it individual stability and structural independence. Very deep foundations were cast into the ground in order to make this system work. The two glass end walls and the infill walls between the concrete piers are structurally independent of the main system. The great scale of the building is a factor in the overall stability of the structure. The building is kept in equilibrium by the massive weight of the roof structure. Wind and snow loads are minimal in comparison with

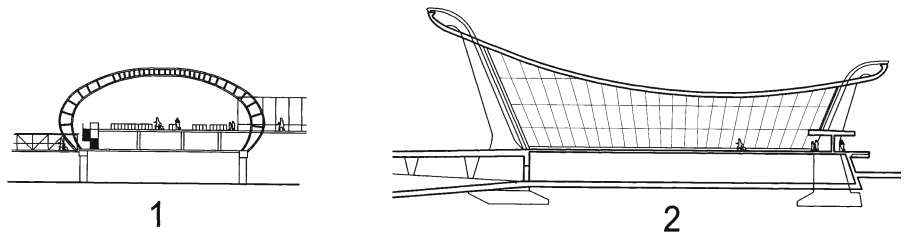
right Different structural solutions for the same objective: column-free space

- 1 Terminal 2E, Charles de Gaulle International Airport
- 2 Main Concourse, Dulles International Airport

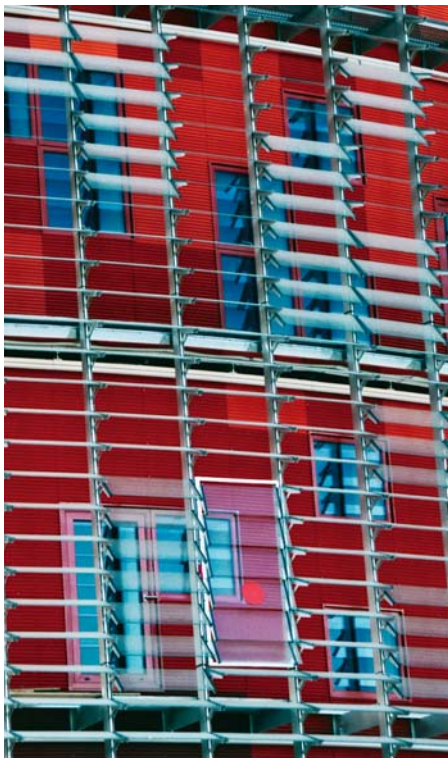
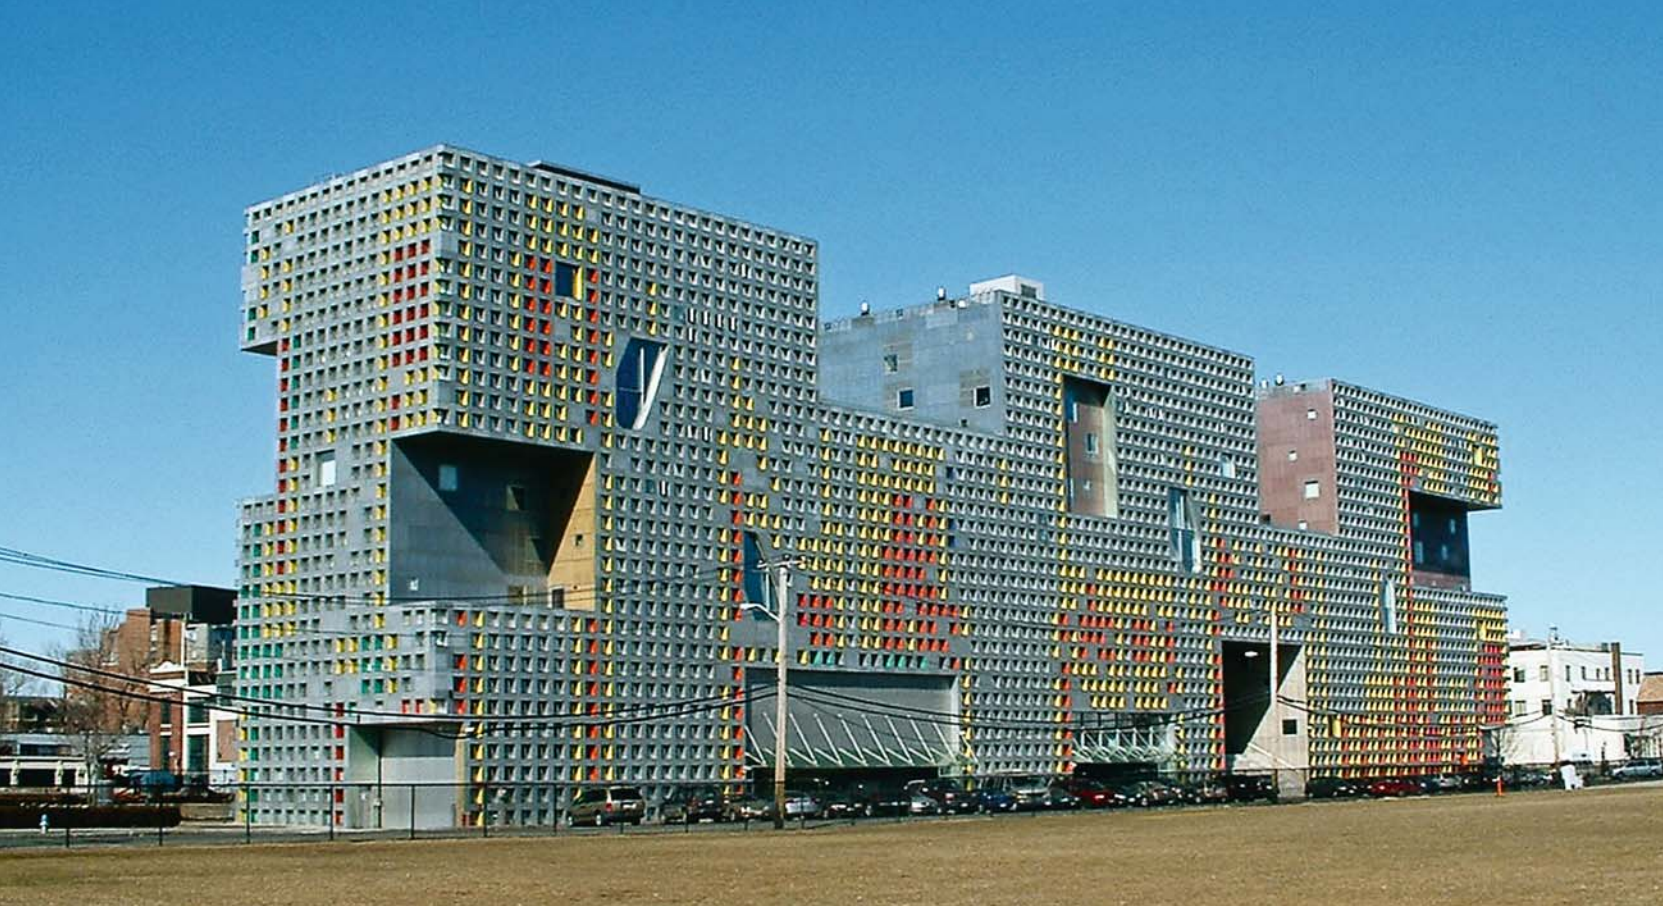
Simmons Hall at MIT, Cambridge, Massachusetts, 2002. Color coated red precast concrete panels identify units that span large openings, acting like a Vierendeel truss.

MIT campus, the designers offer assistance. Completed in 2002, this large dormitory at the edge of MIT's campus is of overwhelming scale. The designers sought to diminish the appearance of the building by making it visually "porous." A second goal was to keep the interior as flexible and open as possible in order to maximize social interaction among residents. The solution was to place the primary structure at the perimeter of the building, using a gridded, precast system dubbed "PerCon" for "perforated concrete." The architect, Steven Holl, had always intended

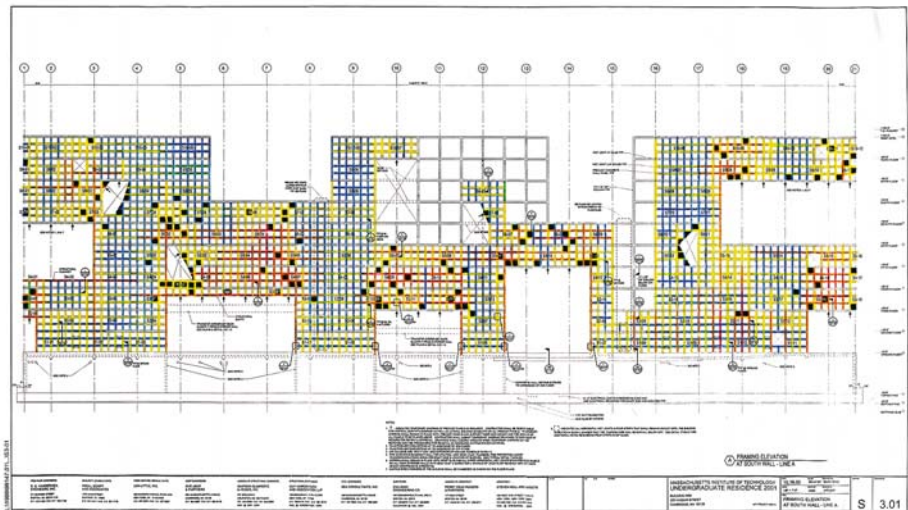
Simmons Hall at MIT. A drawing using colored pencil created to check steel reinforcement became the inspiration for the final design.

to include color on the outer concrete façade. Initially, the thought was to have outside colors reflect inside function in the building; however, during the design process a drawing created to check steel reinforcement by Amy Schreiber, an engineer from Simpson Gumpertz & Heger Inc. Structural Engineers (in collaboration with Guy Nordenson and Associates), became the inspiration for the final design. Amy's drawing used color pencils to identify the amount of steel reinforcement in each respective concrete panel.

This graphical diagram was translated into the aluminum cladding on the precast concrete façade panels. The load path of forces at the building perimeter is literally identified with colors on the façade.

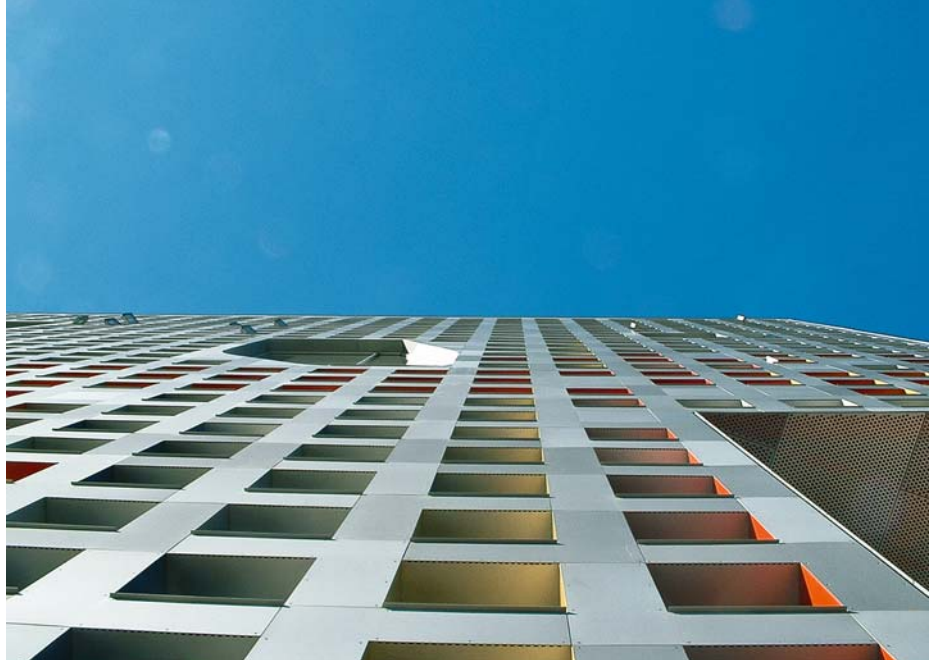
right Simmons Hall at MIT. Like a Vierendeel truss, the precast concrete panels interconnect with steel reinforcement to span large and small openings.

above and right Simmons Hall at MIT. Precast concrete panels lifted into place and assembled.

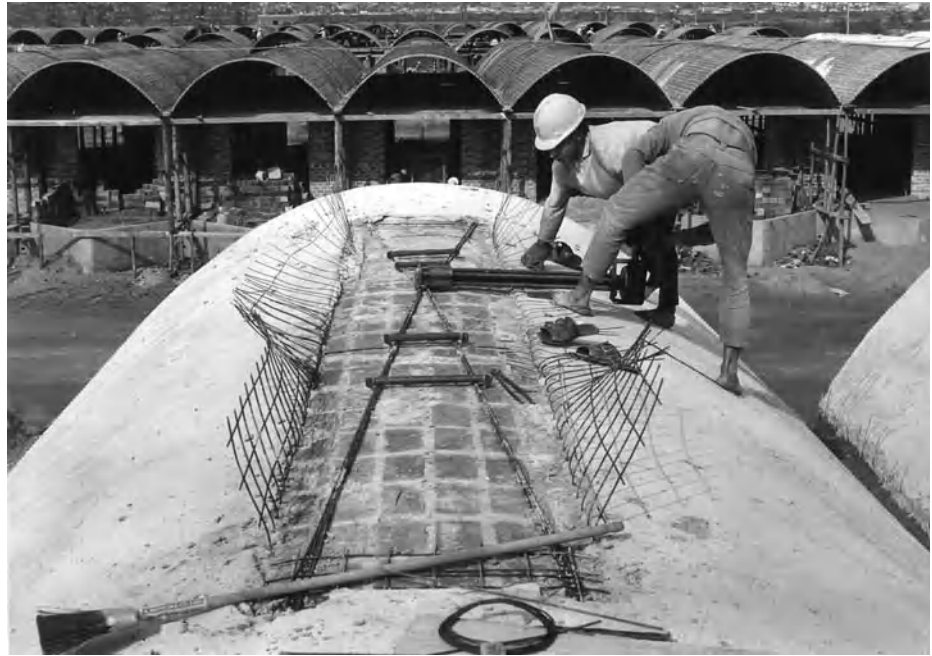
below Prestressing of a self-supporting arch.

- 1 Lightweight concrete
- 2 Unbraced lightweight concrete
- 3 Prestress cable
- 4 Reinforcement anchor
- f Force of jack
- F Force of prestress

A large looped prestressed steel cable is then installed to absorb the negative bending moment on the vault. With the vault still supported by formwork, the ends of the loop are cast into the vault. After the lightweight con-

crete has hardened, the prestressing cable is mechanically pinched at the mid-point of the vault. The mid-section of the vault is then covered with mesh and filled with lightweight concrete to complete the roof. Although complicated by contemporary developments, prestressing has been used for thousands of years. A good example of prestressing can be seen in the fabrication of an old cart wheel. The heating of the iron outer band of the wheel prior to placing it around the cart wheel provides a form of prestressing. As the steel band cools, it contracts, clamping the wood parts together. In a similar manner, Eladio Dieste developed a method of prestressing with the same inherent simplicity, requiring no heavy equipment. Prestressing creates much larger forces in a building element than the element would normally experience through normal use. What happens if the natural forces are much greater than expected?

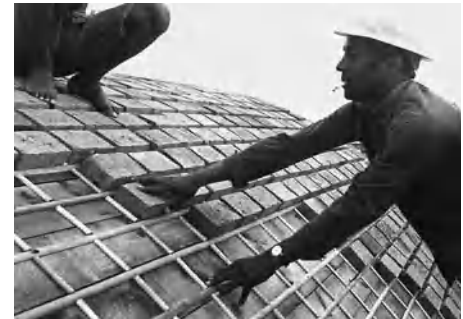
right and below The Municipal Bus Terminal in Salto.

The Municipal Bus Terminal in Salto, Uruguay, completed in 1974, provides a classic example of how daring structural forms were developed prior to the advent of sophisticated computer analysis. A single row of columns is all that supports the long self-carrying vaults with equal cantilevers of 12.2m (40 feet). These cantilevered vaults are ideal for sheltering travelers coming in and out of the buses at the station. The self-carrying vault is achieved using innovative prestressing techniques that could be simply executed by local laborers. Timber trusses provide the formwork for posi-

tioning the bricks on the vault. The bricks are evenly separated by small wood strips. Steel-reinforcing bars are placed between the bricks, and the joints are filled with mortar.

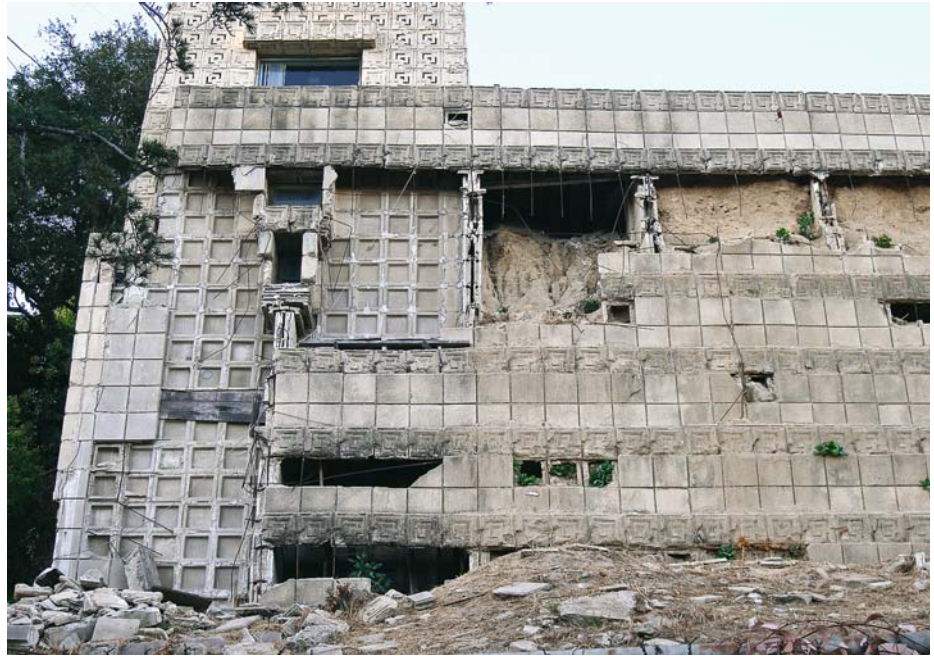
The Ennis-Brown House, Los Angeles, 1924. Exterior concrete block retaining walls crumbled after an earthquake and subsequent mud slides.

Built in 1924, the Ennis-Brown House in Los Angeles was named for its original owners, Mabel and Charles Ennis. The home is famous for a luxurious pool, artistic glass doors, ironwork, and intricate concrete block cladding. The monumental scale of the house is softened by the human scale of the concrete forms, and the combination of plain and patterned blocks. Wright believed that steel combined with concrete could be the great liberating element that would produce an entirely new architecture for the 20th century. The main part of the building is constructed on bedrock; however, a large portion of the house is surrounded by large concrete-block retaining walls that support the outside perimeter of the complex. The design of the perimeter retaining walls has proven to be less than adequate for the moving earth of southern California. Plagued by a 1994 Northridge earthquake and a devastating series of

storms in 2005, the earth below the retaining walls has washed away, taking the concrete block walls with it. More contemporary buildings composed of stone blocks have been designed to resist the forces that the Ennis-Brown House could not.

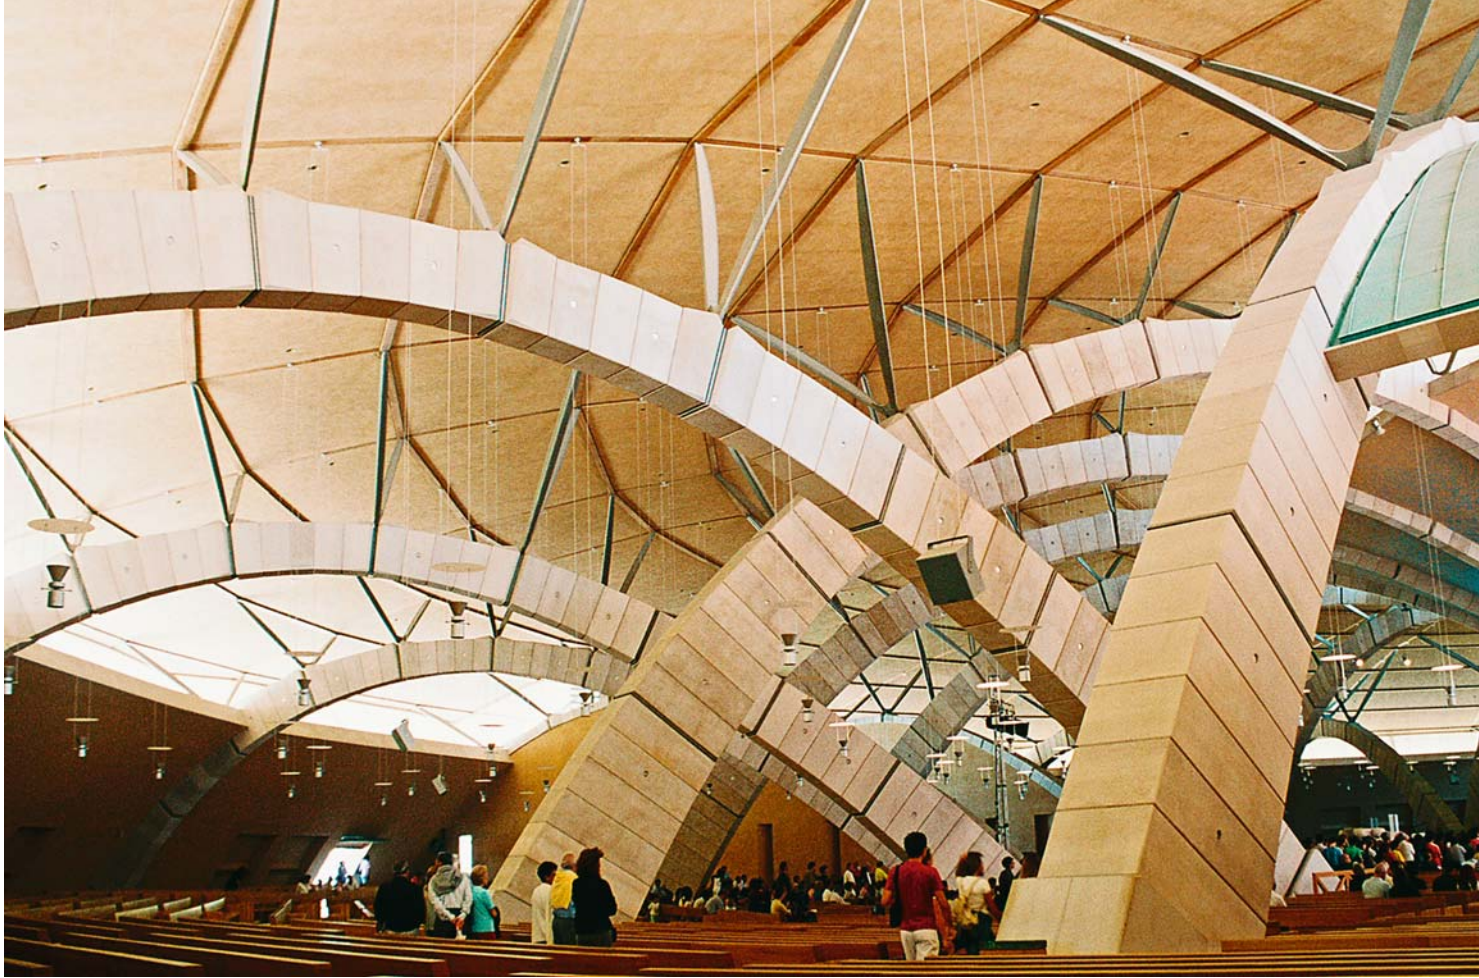
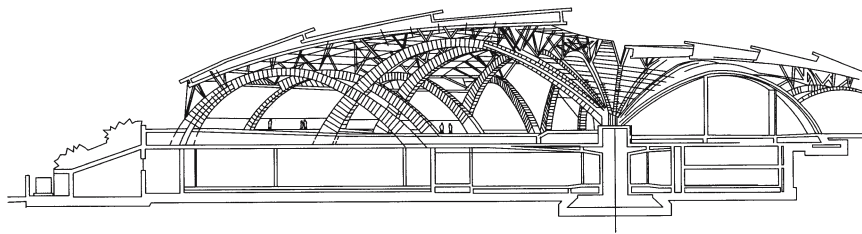
Section through the Church of Padre Pio showing the great stone arches with inherent flexibility.

The structure is composed of two intersecting rows of segmental arches, laid out in radial plan. The larger arches converge in a funnel-like form behind the pulpit. Steel struts rising from the arches support the laminated wood roof with its stuccoed underside and its green, segmented outer shell of preoxidized copper roofing. The V-shaped stainless steel struts separate and articulate structural components, allowing clerestory illumination of the curved ceiling above the arches.

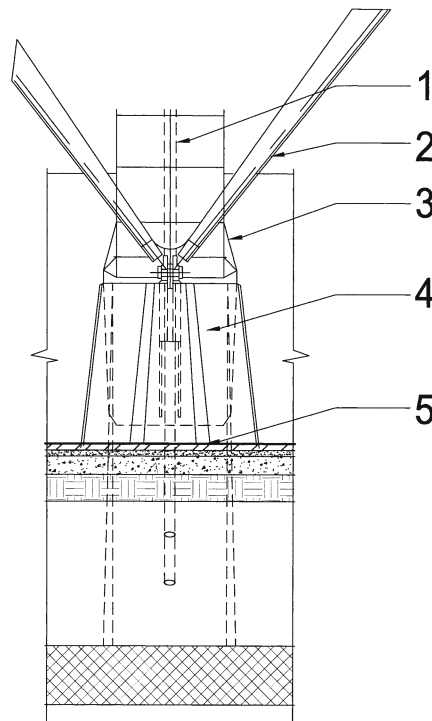
Interior base detail, the Church of Padre Pio

- 1 Posttension cable threaded through stone arch
- 2 Limestone block with sealable joints
- 3 Stainless steel V-strut
- 4 Concrete arch footing clad with limestone 10cm (4 inches) thick
- 5 Honed limestone flooring

The arches are posttensioned to precompress the stone and reduce the subsequent risks of failure under tensional stresses. The stone was drilled to take sleeves for steel cables. The stone pieces were then stacked and bonded with two-part epoxy resin and a 2mm ($\frac{1}{16}$ inch) stainless steel space plate to ensure a consistent junction between stones. With all of the blocks in place, the tension cables were mechanically inserted. The steel scaffolds were lowered and the cables were tensioned. The flexibility of a great structure is critical to a building in a seismic zone; however, too

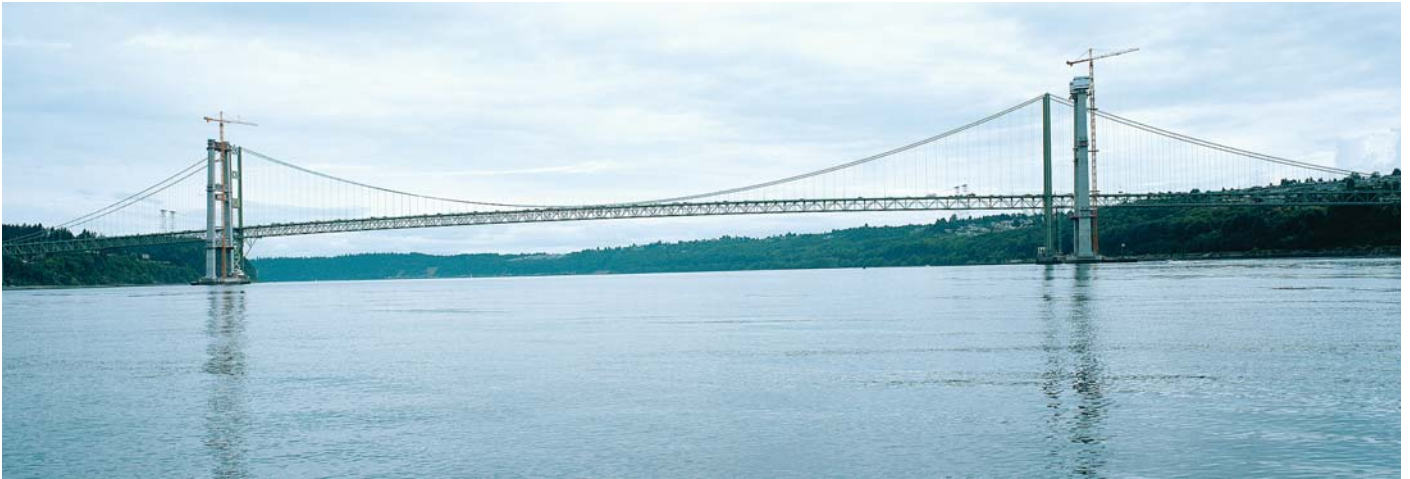
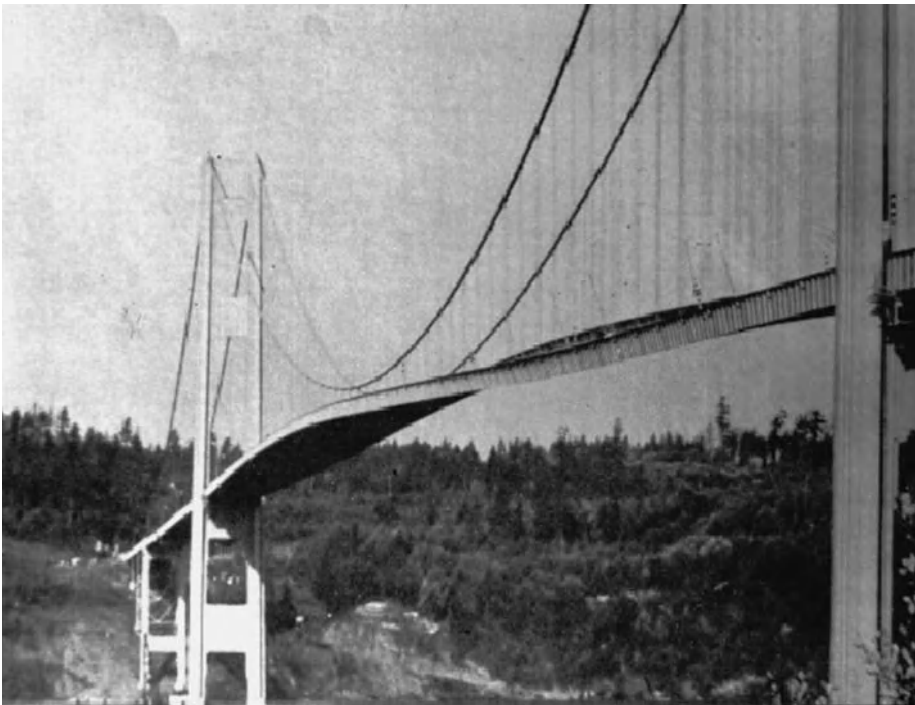
above The replacement bridge for the Tacoma Narrows was redesigned with deep open truss members that allow wind to pass through them. The construction of the second design was completed in 1950.

below The Tacoma Narrows Suspension Bridge, built in 1940 across Puget Sound in Washington, was the first of its type to use plate girders to support the concrete roadbed. With this new thin design, wind was diverted above and below the structure.

The Tacoma Narrows Suspension Bridge, constructed in 1940, was a graceful structure of enormous proportions. It consisted of two towers that supported main cables hung in a parabolic configuration from which slender steel deck girders were suspended by further vertical cables. The concrete deck on which cars drove was constructed between the two slender girders. The girders had a depth of 2.4m (8 feet) with a span of 853m (2,800 feet)

from tower to tower. The slender nature of this deck was part of its elegance as well as its demise. Uncontrolled oscillation was a problem from the time the bridge was completed in July 1940. The flexible nature of the bridge caused travelers to become motion-sick with its movements and the bridge quickly acquired the nickname, Galloping Gertie. On November 7, just four months after its completion, the Tacoma Bridge was destroyed by aerodynamic wind oscillations. The concrete deck was said to have broken up like popcorn. Huge chunks of concrete broke from the deck as oscillation of the bridge reached its peak. Tearing itself apart, the twisting undulations of the bridge reached an ampli-

tude of 7.5m (25 feet) before a 183m (600 foot) length of the bridge deck tore away from the suspension cables and plunged into the water below. The collapse of the Tacoma Narrows Bridge became even more infamous as its destruction was caught on film. How could such a bridge deck twist and jump like a rubber band under relatively normal winds, and how could it have been avoided? The principal cause of the failure was later understood to stem from the aerodynamic behavior of the bridge deck; essentially, the slender deck section caused it to behave like an aircraft wing, inducing the destructive undulating motion. Bridge designers of today carry out routine wind tunnel testing during the design phase of a project to avoid such disasters. There was a device that could have saved Galloping Gertie, after it had been constructed with the faulty design. Unfortunately, it was developed 40 years after its steel frame collapsed into the Tacoma Narrows.

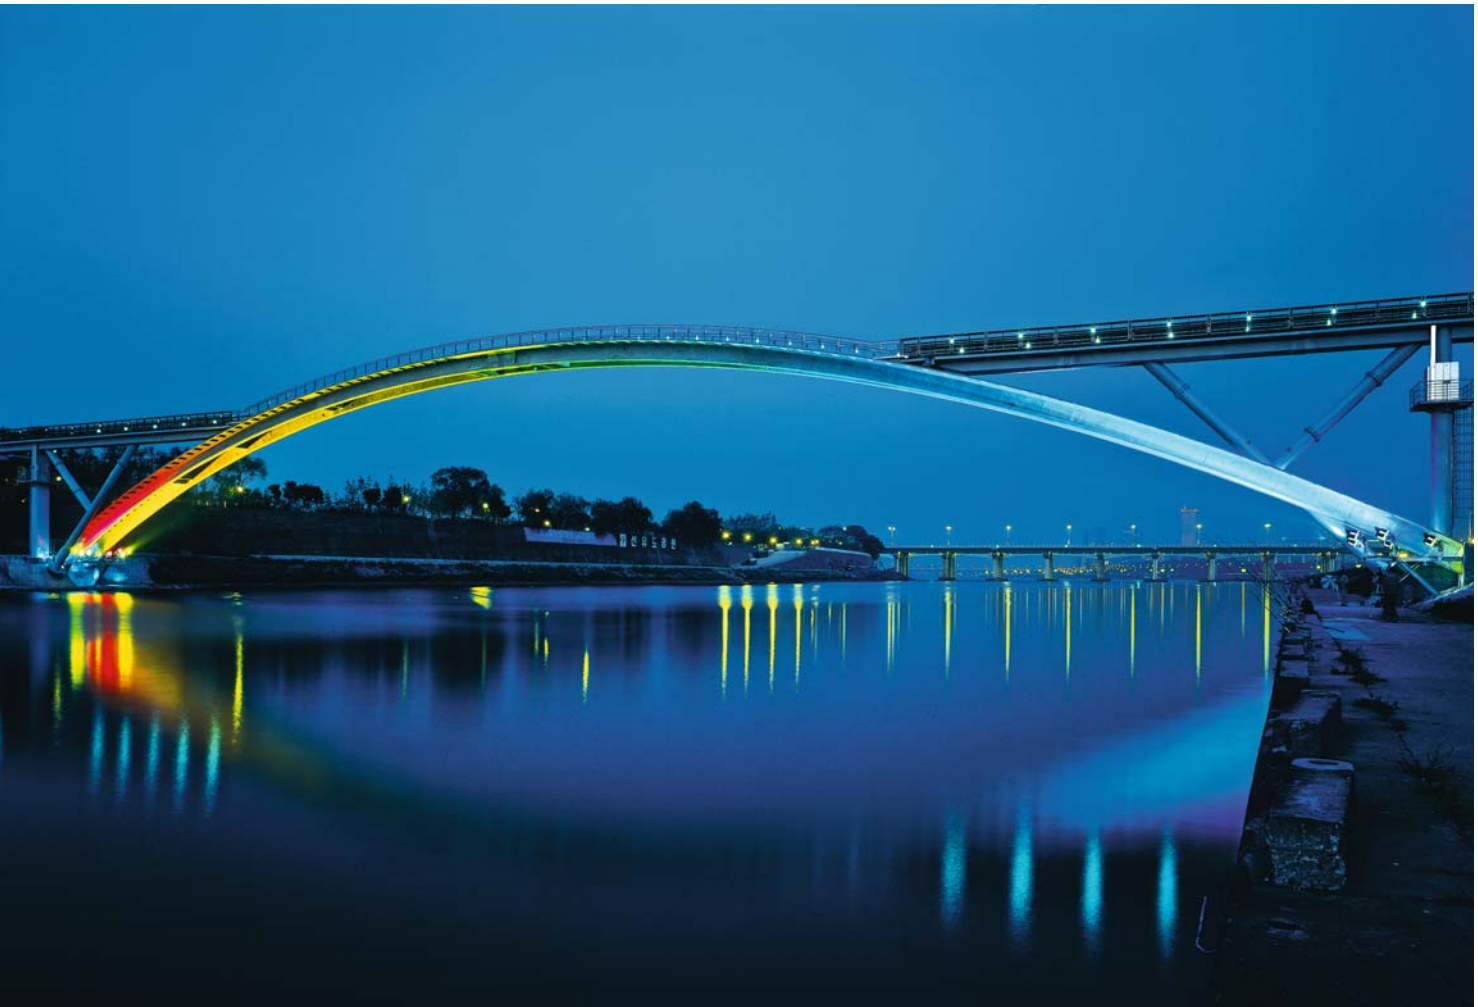
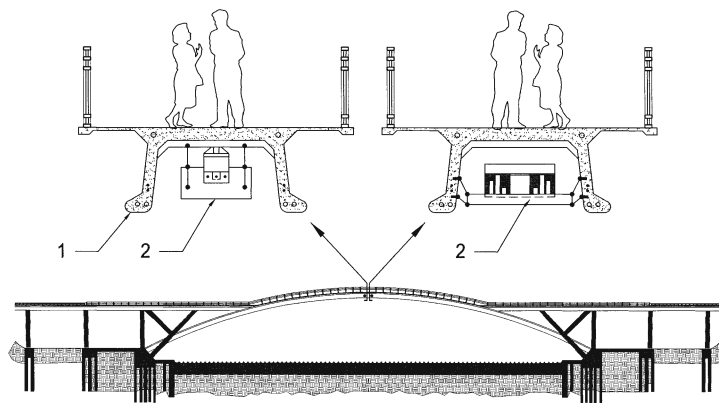
Seonyu Footbridge, Seoul, 2002.

1 Ultrahigh-performance precast concrete structure
2 Tuned mass damper concealed below bridge deck to reduce later motion of bridge

The Seonyu Footbridge, completed in 2002, provides a recent example of a tuned mass damper used in a very slender bridge structure. The design of the footbridge provides a pedestrian link from the city of Seoul, to

Sunyudo Island in the Han River. Potential vibration of such a slender arch had to be considered. In order to maintain comfort for pedestrians crossing over the bridge, the design included shock-absorbing tuned mass dampers at the top of the arch. These limited the horizontal acceleration to 0.2m/sec (0.66 feet/sec) and the vertical acceleration to 0.5m/sec (1.64 feet/sec). In addition to the use of new structural technology, the foot-bridge uses a relatively new type of building material: ultrahigh-performance concrete.

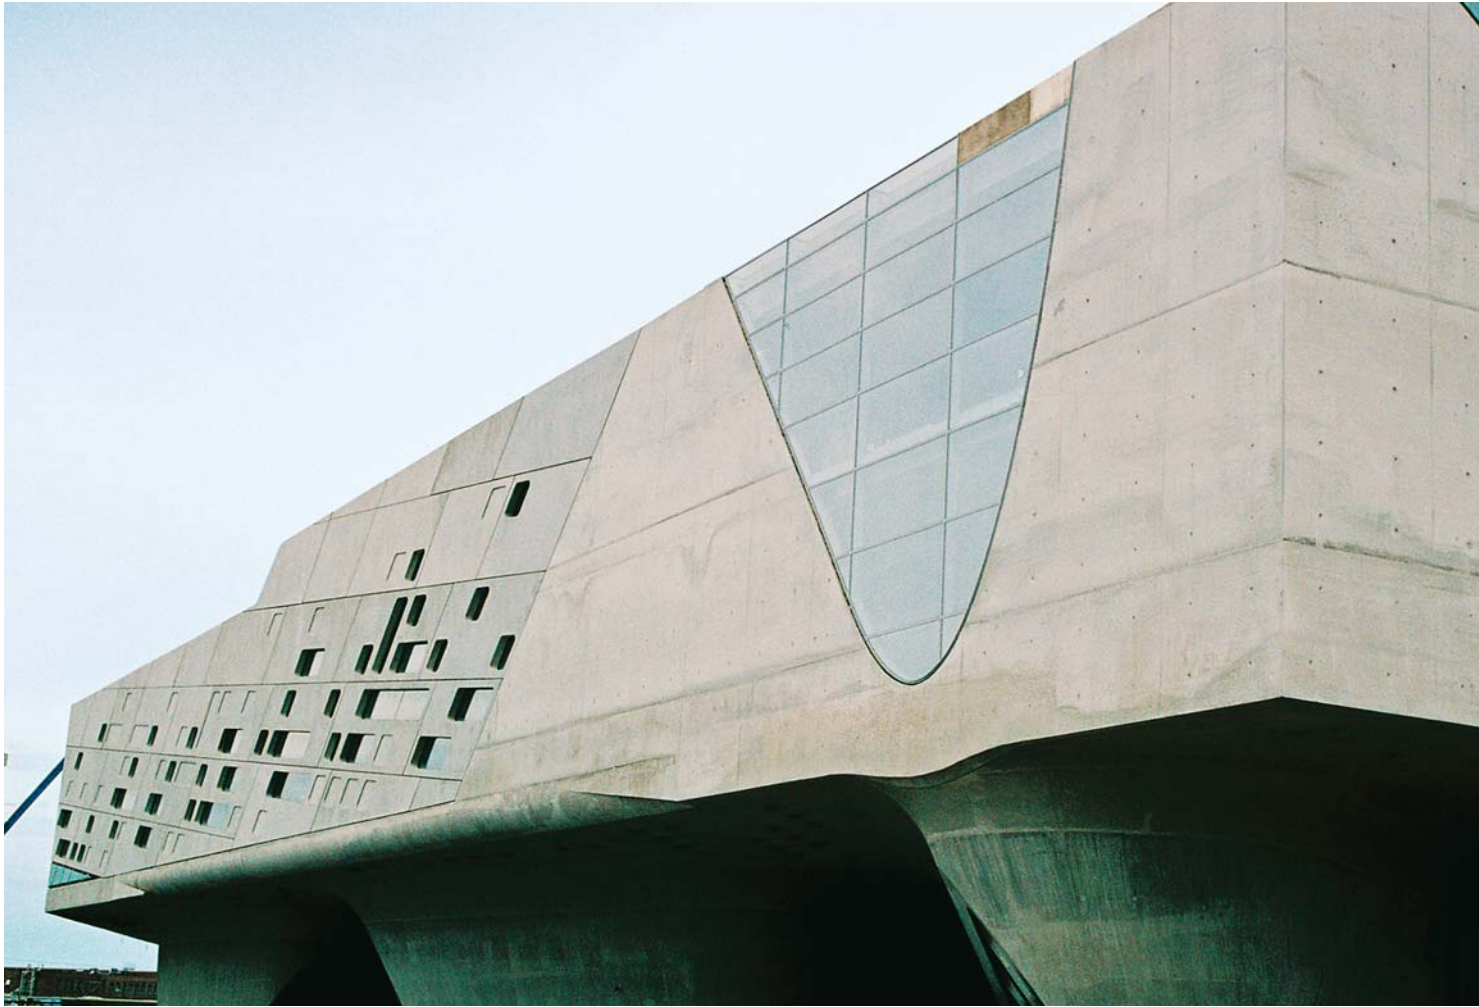
Phaeno Science Center,
Wolfsburg, Germany, 2005.
Self-compacting concrete was
used to construct ten cone-
shaped support elements.

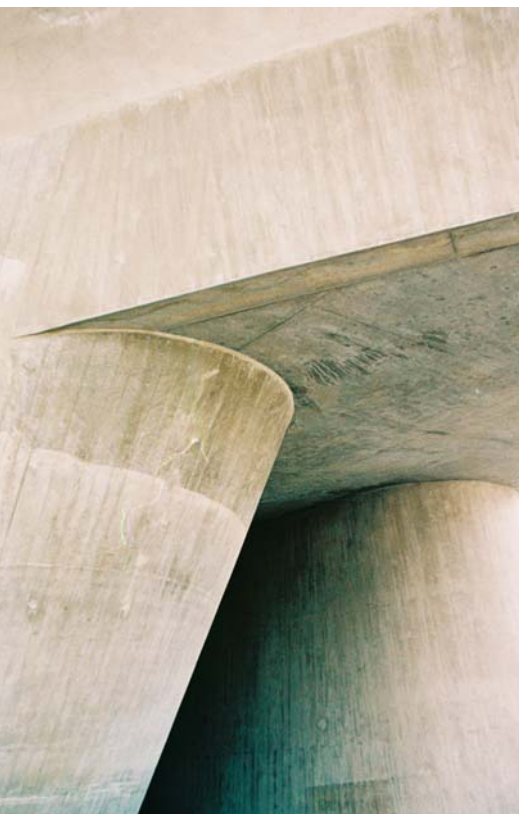
Phaeno Science Center.
Self-compacting concrete
support elements.

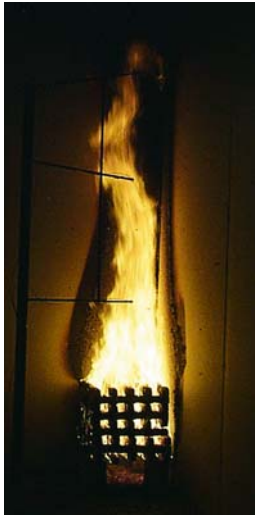
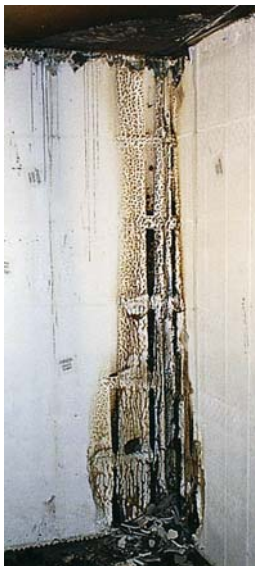
above ICF wall construction during and after fire testing

right Insulated Concrete Form (ICF)
