failed stone

problems and solutions
with concrete and masonry

Failed Stone

Problems and Solutions with Concrete and Masonry

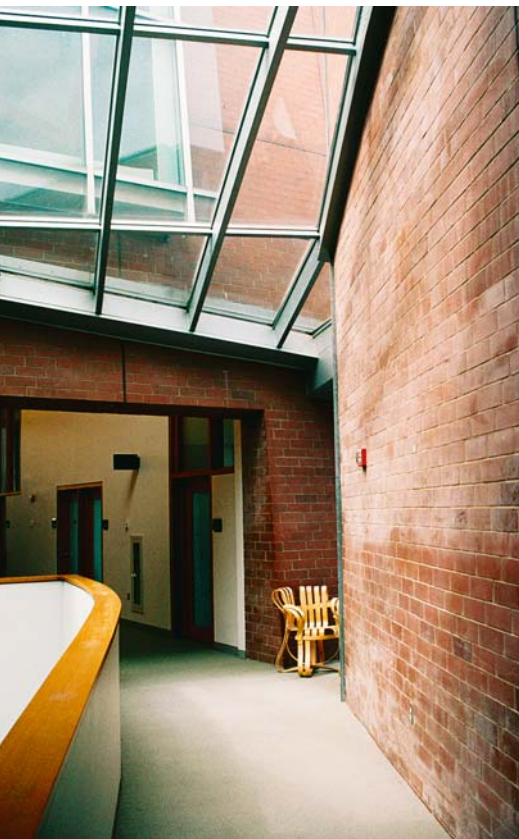
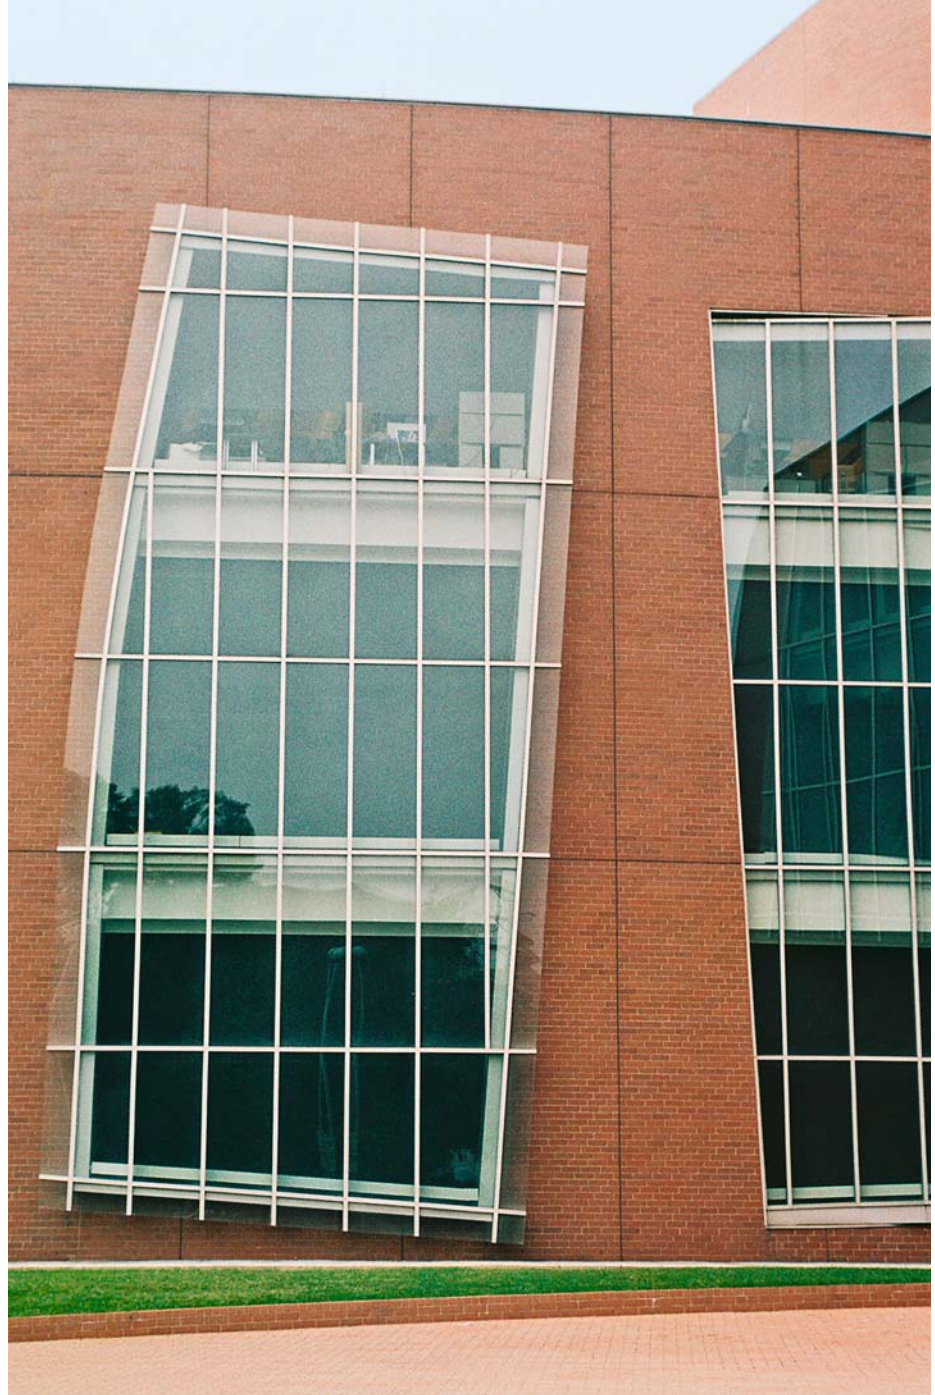
right Complicated building geometry has contributed to water infiltration issues at the Vontz Center for Molecular Studies at the University of Cincinnati, Ohio, 1999.

below White efflorescence on interior masonry walls is an indication that the building may have water infiltration problems. Vontz Center for Molecular Studies.

Because of the Vontz Center's irregular shape, the wall, window, and skylight transitions were very difficult to execute. In addition, the majority of the precast panels were prefabricated, making through-wall flashing difficult to integrate with sloped skylights and window head conditions. In an effort to simplify these transitions, it appears that some of the flashings were applied to the surface of the masonry in lieu of penetrating through the wall assembly. For example, the skylight transition to the masonry wall appears to be a surface-mounted flashing connected to the outside wythe of brick. If the flashing does not extend all the way through the cavity, infiltrating water can-

not be directed to the exterior. Evidence of water migration can be seen on the interior masonry walls which are covered with a white efflorescence powder. Brick veneer systems typically provide a weepage path to the outside of the building. Weep vents are installed at the base of an exterior wall to weep water out of the cavity. The Vontz Center actually has an installation of a masonry weep on the interior face of the masonry wall. For any building envelope, it is critical to provide clear weepage paths to the exterior for infiltrating water. For concrete, masonry, and stone veneer walls, understanding the basic concepts of exterior wall construction is essential for creating a leak-free building.

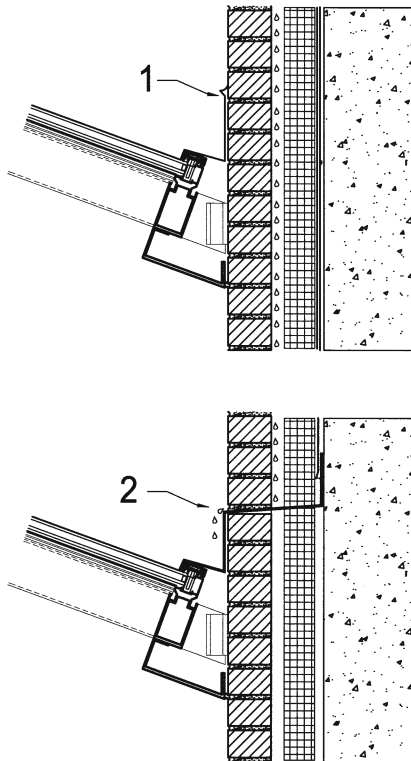
Flashing details

1 Surface-applied flashings do not allow weeping water to be shed to the exterior.

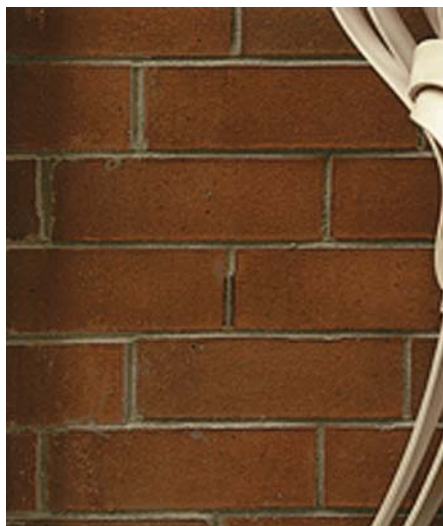
right and above Skylight flashing detail appears to be surface-applied to masonry in lieu of penetrating through masonry wall. Vontz Center for Molecular Studies.

right Masonry weep vents can be found on the interior face of the brick wall. Vontz Center for Molecular Studies.

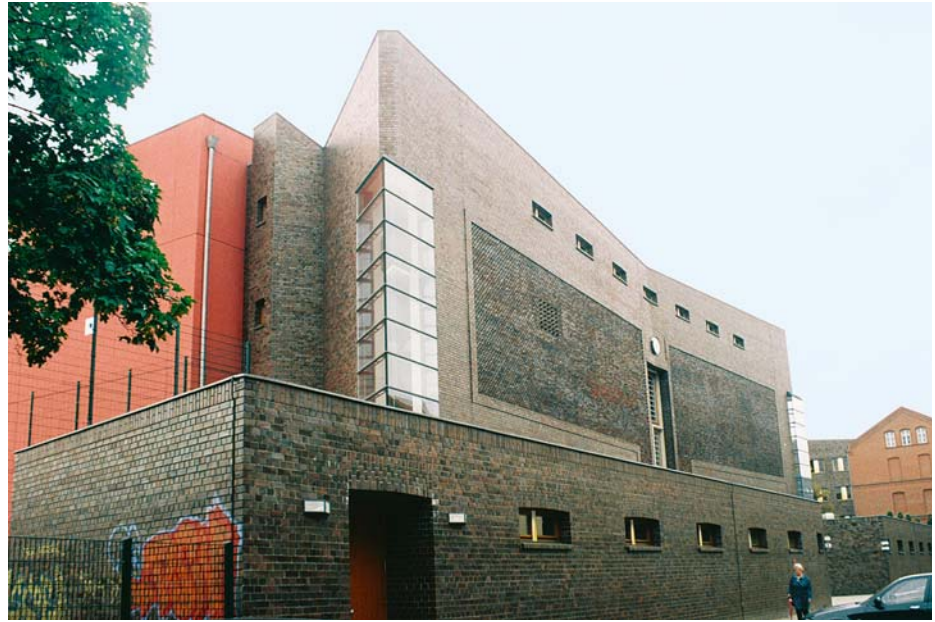
Masonry wall construction
1 Solid masonry wall
2 Cavity masonry wall

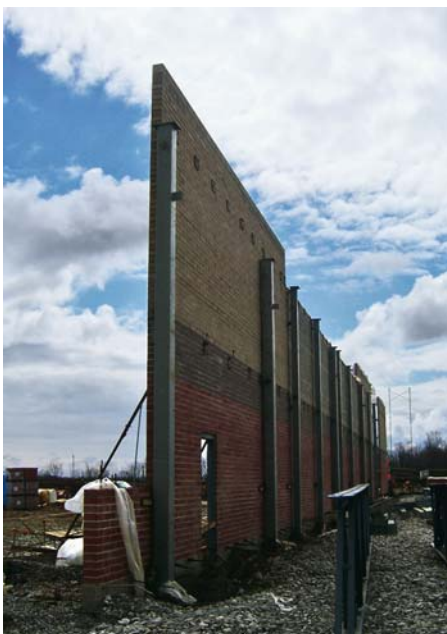
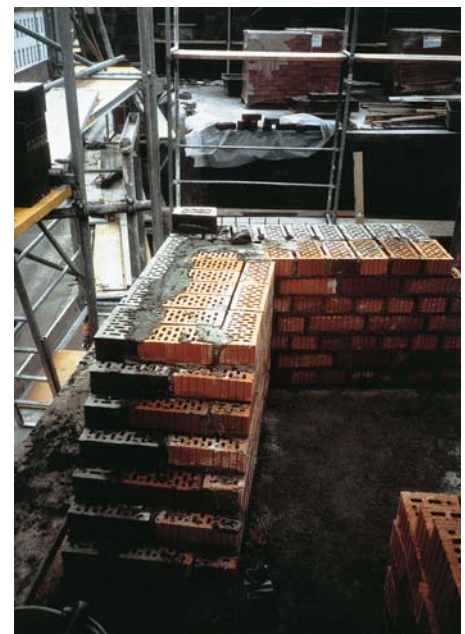
right and page 135
Lévi-Strauss School.
The construction photograph
shows the solid masonry
walls.

below Single wythe construc-
tion in a warehouse applica-
tion.

The Lévi-Strauss School in Köpenick, Berlin, has made a return to modern construction with solid masonry walls. Completed in 2000, the exterior of the building is constructed with a complex, beautifully detailed masonry wall, filled with interweaving layers of brick. In order to meet German code requirements for thermal protection, the exterior and interior masonry are different. The outer masonry work must be resistant to weathering and frost, while the inner must be distinguished by higher compressive strength coinciding with a greater proportion of perforations. Poroton bricks used on the interior provide the necessary thermal requirements. In order to prevent water damage, the bricks must be set into the mortar without air pockets. Expansion joints are not required, because the outer wall is load-bearing and monolithic.

enclosure with or without the water repellent agent. Water can track its way to the interior because there is no cavity separation. Single wythe construction is common in warehouse applications, where large areas need to be enclosed with few openings at low cost. These types of systems provide a minimal barrier for water infiltration unless they incorporate an internal drainage system that weeps water to the exterior. In the case of precast concrete panels, a dual seal with an internal gutter system can be used to provide a second line of defense for preventing air and water infiltration. Precast panels can include a layer of insulation in the middle of the panel. These so-called “sandwich” panels try to achieve an effect similar to cavity wall construction in a unitized element.

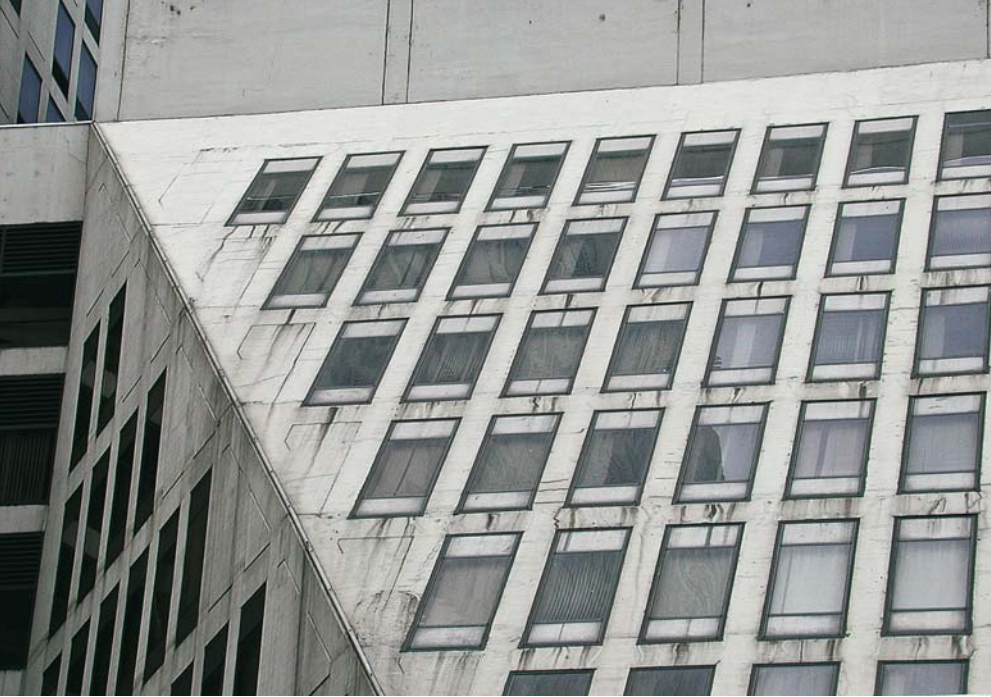
above Onterie Center, Chicago, 1986. Cracks in concrete can allow water infiltration.

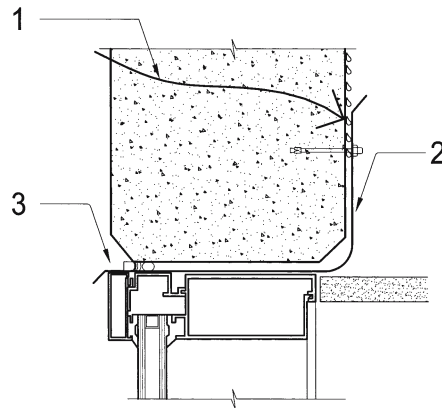
right Second line of defense for concrete façade

- 1 Water can infiltrate a concrete enclosure through crack in the wall.
- 2 Water is captured by through-wall flashing at head of windows.
- 3 Water is directed to exterior through weeps.

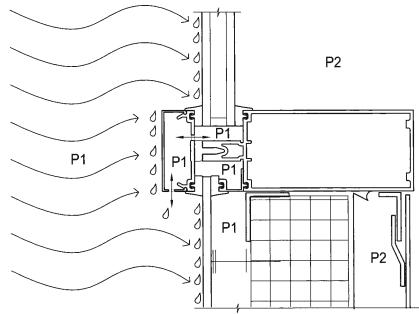
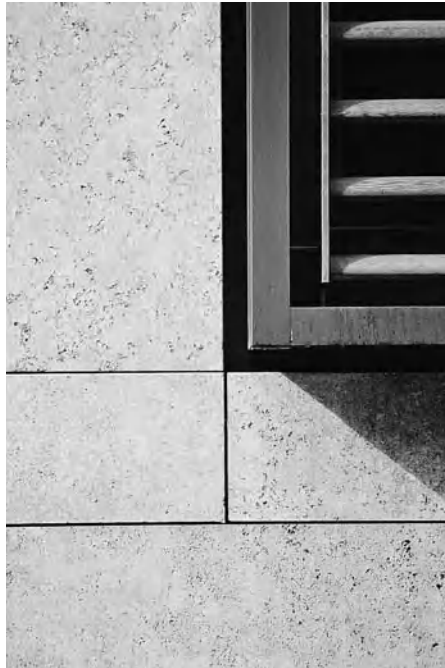
Pressure equalization prevents driving rain from infiltrating.
 P1 Exterior pressure
 P2 Interior pressure

right and below In rainscreen design, open stone joints will not allow water into the building.

Pressure-equalized wall construction attempts to reduce water penetration by eliminating the air pressure differential across the outer barrier, with a “rainscreen design.” A rainscreen consists of an outer layer of material separated by a minimum 19mm (3/4 inch) drainage cavity followed by an airtight moisture barrier at the back of the cavity. The rainscreen drainage cavity is wide enough to break the capillary action and surface tension of water such that gravity will pull the water that gets behind the exterior, cladding down-and-out through weep holes at the base. The outer barrier contains openings to ensure that the internal cavity of the enclosure will have the same pressure as the exterior. Weepage at the base of these systems is critical to draining incidental water that can penetrate any of the pressure equalization holes. For a stone wall with a rainscreen design, joints can be left completely open on the outer face of the wall. For a masonry wall, pressure equalization holes can be achieved with small vents in the head joints at the top of a wall with weep holes at the base of the wall. These holes at the top serve to vent out the cavity. This type of system prevents water from being sucked into a building by an internal pressure differential. Pressure-equalized design is particularly important in high-rise

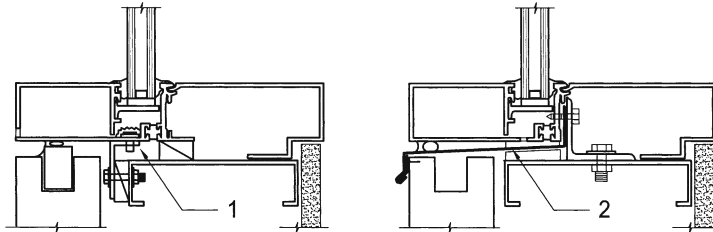
Base flashing

- 1 Window sill without base flashing
- 2 Window sill with base flashing to direct water to the exterior

ty of window systems to water infiltration can be greatly improved by providing a weeped through-wall flashing under them. This added detail will prevent infiltrating water from the window system from finding its way into the building. An upturned leg of the flashing will keep driving rain from leaking back into the interior. If properly detailed and executed, flashing details can provide a path for the inevitable leakage to exit a building enclosure. If flashing details are not executed properly, they will trap water, which can cause damage to the masonry and lead to further moisture penetration into the building.

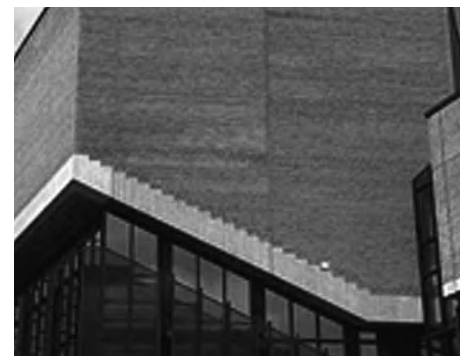
right Kulturzentrum Gasteig, Munich, 1985. Library building with weeps in header joints of diagonal masonry wall.

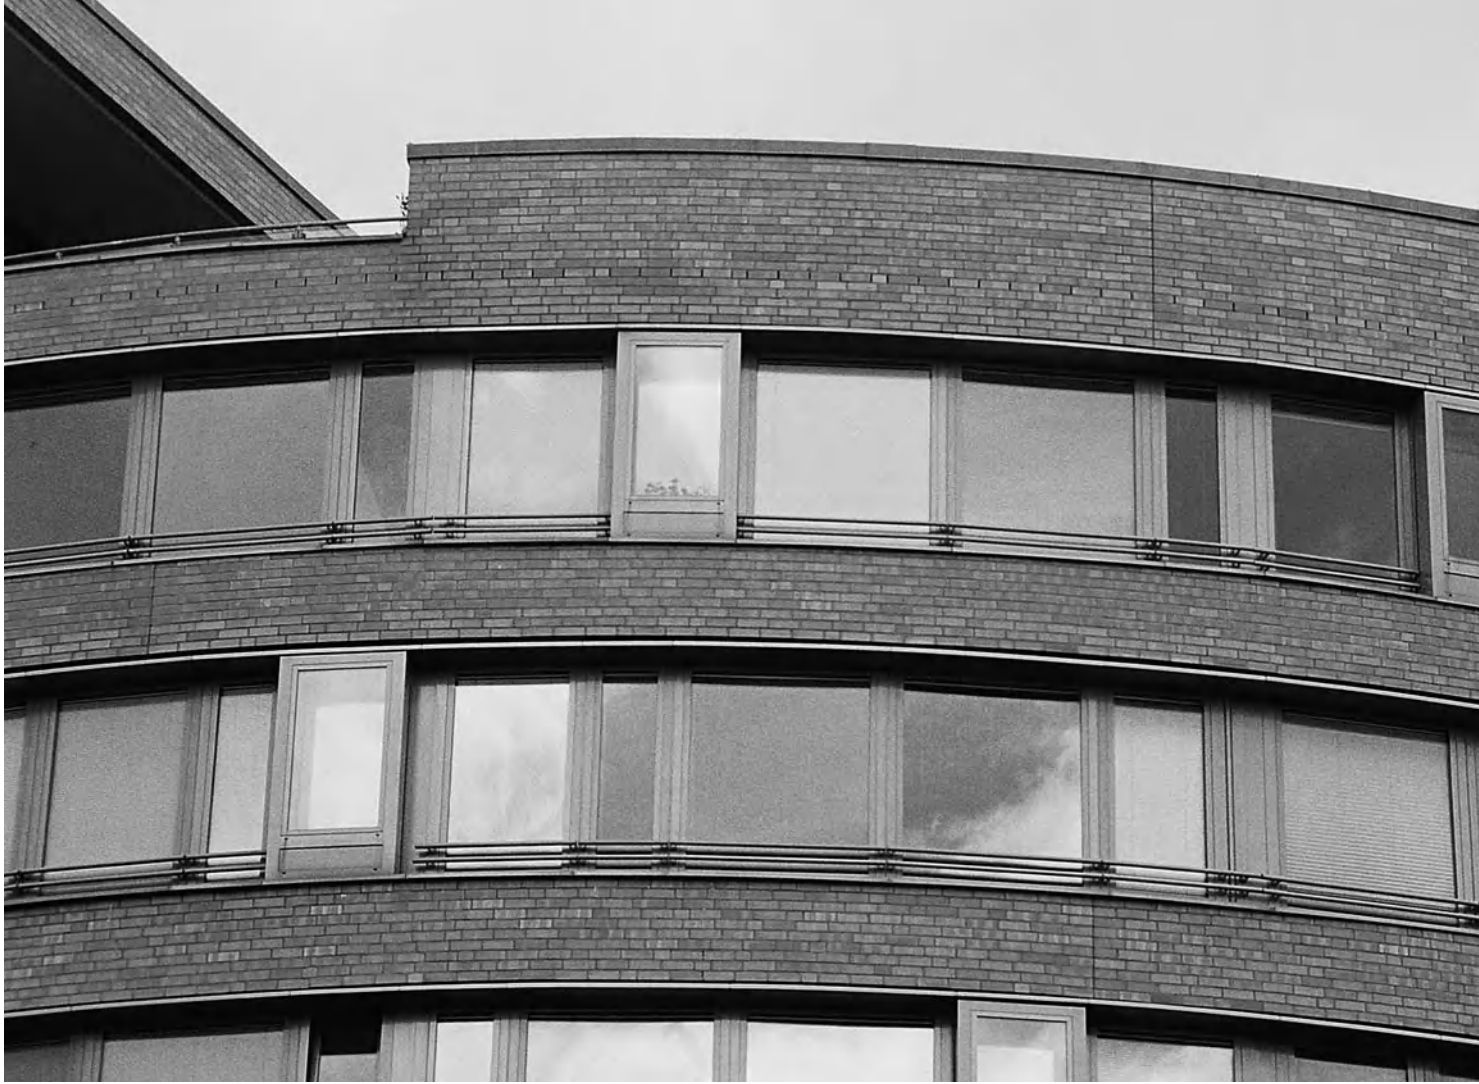
Residential complex for government employees, Berlin, completed in 1999. The apartments have masonry weeps and vents to allow moisture out of the wall.

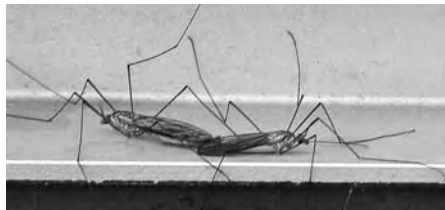
Baffled weeps are often used to prevent insect infestation into the wall.

Drainage holes are required to leak infiltrating water out of the system. Baffles are used to prevent water infiltration through the weeps by driving rain. Baffles can be made of a foam material but must be dense and secure to prevent insects from infiltrating the system and nesting. Spiders are notorious for spinning their webs across elegant façades on high-rise buildings. Pressurized cavities within the enclosure system provide insects with shelter from harsh natural elements like rain, sun, high winds, and snow. Baffles can prevent insects from entering weep holes. If the enclosure system cavity has loose construction debris or corroded metals, weep holes can be marked by stains. The design of any enclosure cavities must anticipate the entry of water and provide a clean method of draining through weeps.

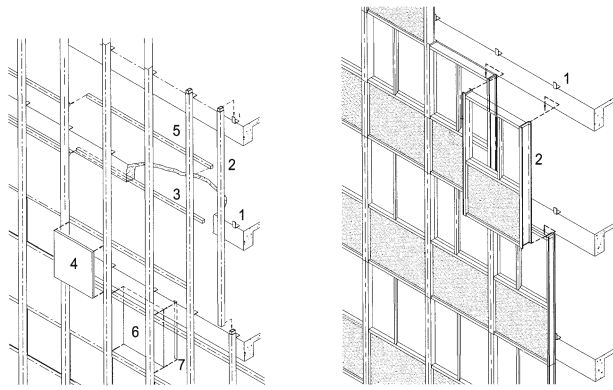
left Stick system:

- 1 Anchor
- 2 Mullion
- 3 Horizontal rail (gutter section at window head)
- 4 Spandrel panel
- 5 Horizontal rail (window sill section)
- 6 Vision glass
- 7 Interior mullion trim

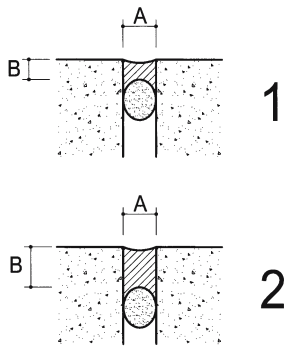
Sealant joint width-to-depth ratio

- 1 Effective sealant joint
- 2 Ineffective sealant joint

Sealant failure can be cohesive or adhesive. Cohesive failure occurs when the movement capacity of the joints surpasses the designed movement capacity of the sealant. Cohesive failures can be avoided by using durable sealants and by detailing joints to accommodate anticipated movements. The joint width-to-depth ratio is critical. Typically, the width-to-depth ratio should be 2:1. Sealant manufacturers provide guidelines about how their product is to be installed, and should be consulted regarding atypical conditions. Properly installed sealant joints should only have adhesion to two sides of the joint. Three-sided adhesion will prevent the joint from expanding properly. Backer rod or bond breaker material is used to ensure a joint can accommodate movements.

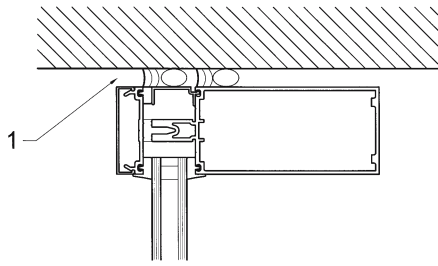
Window perimeter calking
 1 Dual seals provide a second line of defense against water infiltration

Dual Seals

Reliance on an exposed single barrier of sealant to prevent water penetration into an enclosure is the single most common source of contemporary building enclosure problems. Despite improved sealant technology and installation techniques, a single sealant barrier is only effective if it maintains its original seals. There are many problems that can lead to sealant failure – including weathering, poor workmanship during installation, incompatibility, improper mix design, preparation of substrates, ultraviolet radiation. An enclosure design that relies on single seals for protection lacks the level of redundancy required for a leak-free building. A dual seal design provides

a continuous outer and inner seal at all transition details. The outer seal can fail, and the system will still resist water and air infiltration. A dual seal system allows the primary seal (the one on the inboard side of the system) to be sheltered from rain, sun, and birds. All of the elements could adversely affect its performance. The outer seal can be seen as a sacrificial element.

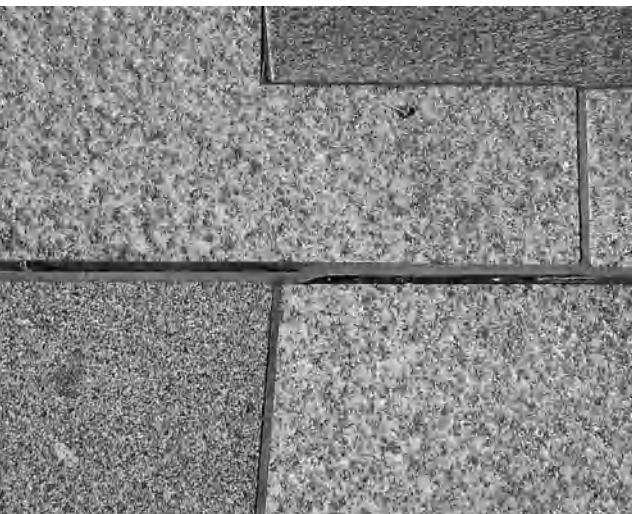
Adhesion failure of sealant on stone.

Adhesive failures occur when the bond between the sealant and substrate releases. This is displayed when sealant peels off of stone, leaving no remnant of the sealant on the stone. Adhesion failures can be prevented on a building by testing the sealant's adhesive quality to anticipated substrates. It is not uncommon to use primers in order to allow sealant to bond to some substrates. Clean dry substrates are also important to achieving good adhesion. The surface preparation of the substrate is critical to providing an effective seal. Primers are typically employed on substrates that require mechanical cleaning, such as brick, stone, and concrete. Most sealants should not be installed at temperatures below freezing or in damp weather. Sealant substrate contamination and subsequent loss of sealant adhesion are difficult to avoid entirely, since invisible films of airborne debris can accumulate between cleaning, priming, and sealant application. Even wiping a surface with solvent to clean it prior to applying the sealant can lower its surface temperature, thus causing a film of moisture condensation that will impair or prevent sealant adhesion.

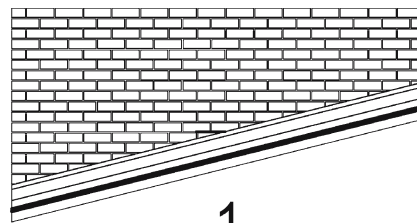
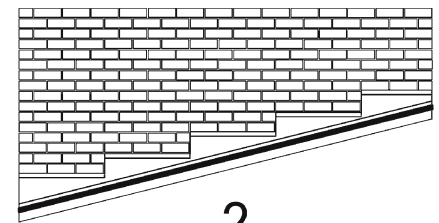
right Roof flashing, Imperial Polk County Courthouse in Bartow, Florida
 1 Initial design of flashing at roof transition was surface-applied to masonry wall
 2 Revised detail of flashing was stepped to provide through-wall flashing to effectively weep water

Water leakage through the brick veneer wall occurred primarily at window openings and at roof-to-wall intersections. The transition details at the courthouse had four major problems. First, the flashing material proved to have poor durability. Composed of PVC, the flashing material became brittle within three years of installation – particularly in areas where it had been folded or manipulated, the flashing began to split. Second, many of the window flashings failed to shed water to the exterior. In most cases, they did not extend all the way to the face of the veneer. Third, end dams were not provided at terminal edges, and the flashings did not turn up behind the window sill to prevent water from tracking back into the building. Finally, the flashing at the intersection of the brick veneer and the side (rake edge) of the sloped roof did not provide a through-wall flashing. Similar to the Vontz Center in Ohio, flashing of the sloped roof consisted of a metal termination bar surface-mounted to the face of the masonry wall. With no through-wall flashing to collect water flowing down the inside face of the cavity wall, water infiltration was inevitable.

In order to stop the air and water infiltration that riddled this building, the entire brick veneer with its windows was removed. A rubberized asphalt membrane was applied to the exterior face of the CMU back-up wall, and new copper flashings were installed around the entire perimeter of the window openings. The flashing system with an upturned leg was sealed to the window frames and the rubberized asphalt membrane was adhered to the flashings. In order to be effective, the flashing at the roof was installed in a step manner to follow the slope of the roof and the masonry mortar joints. The flashing was integrated into the mortar bed and head joints of the brick veneer. All the vinyl wall covering was removed from the interior face of the dry wall and replaced with a breathable latex paint. It was important to establish a vapor barrier on the warm side of the insulation (in this case, the outside was the warm side), and removal of the wall paper was necessary to prevent a double vapor barrier from trapping moisture within the wall system. After three years of work, remedial construction costs

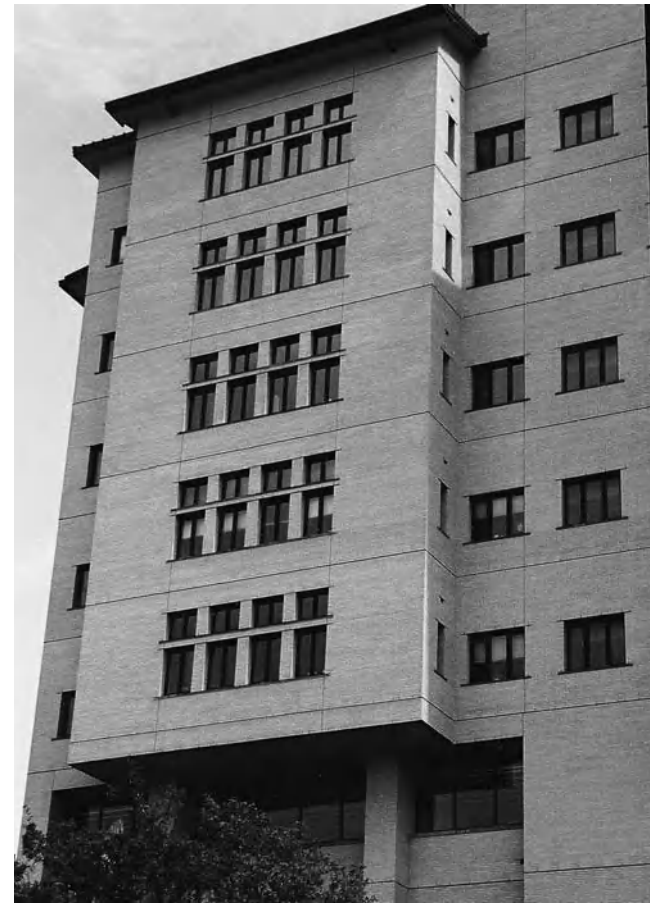
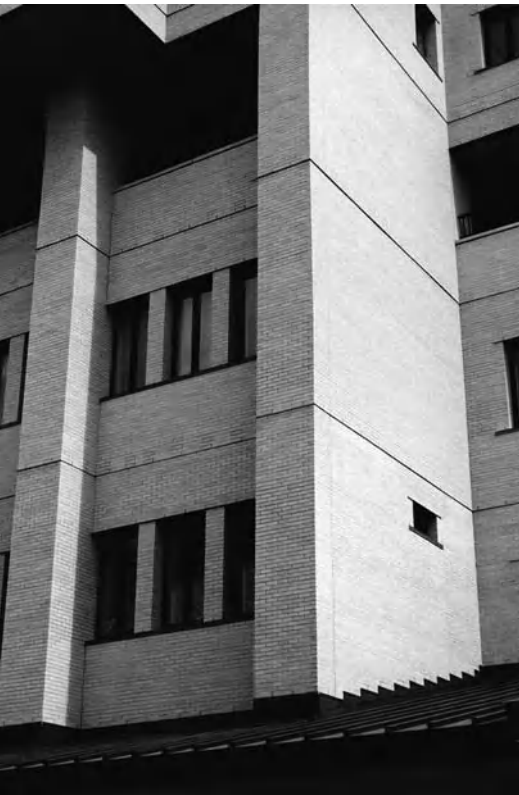
right Imperial Polk County Courthouse, Bartow, Florida, 1986. Relieving angles with soft joints below each relieving angle and vertical control joints at approximately 6–9m (20–30 feet) on center were installed with the replacement veneer wall.

below Imperial Polk County Courthouse showing revised stepped flashing completed with replacement veneer wall.

The cracking and bulging of the brick veneer at the courthouse was the result of ineffective and missing relieving joints in the brick façade. These cracks were the entry point for much of the water problems at the building. The original veneer lacked vertical control joints and horizontal expansion soft joints. These were installed in the replacement veneer. In order to better understand the origin of the cracks at the Imperial Polk County Courthouse, one needs to understand the modes of differential movements in a veneer façade.

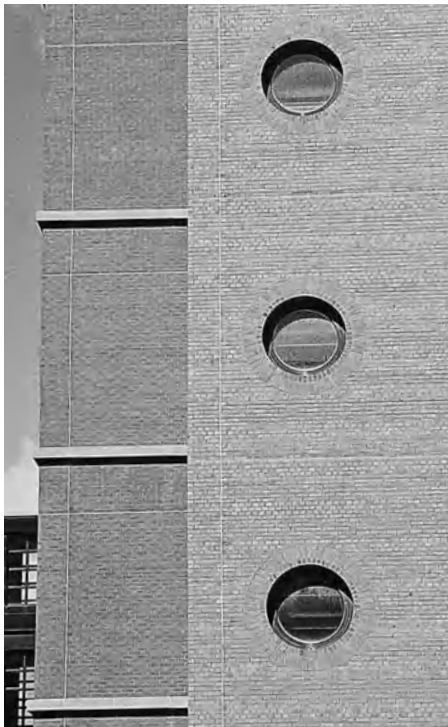
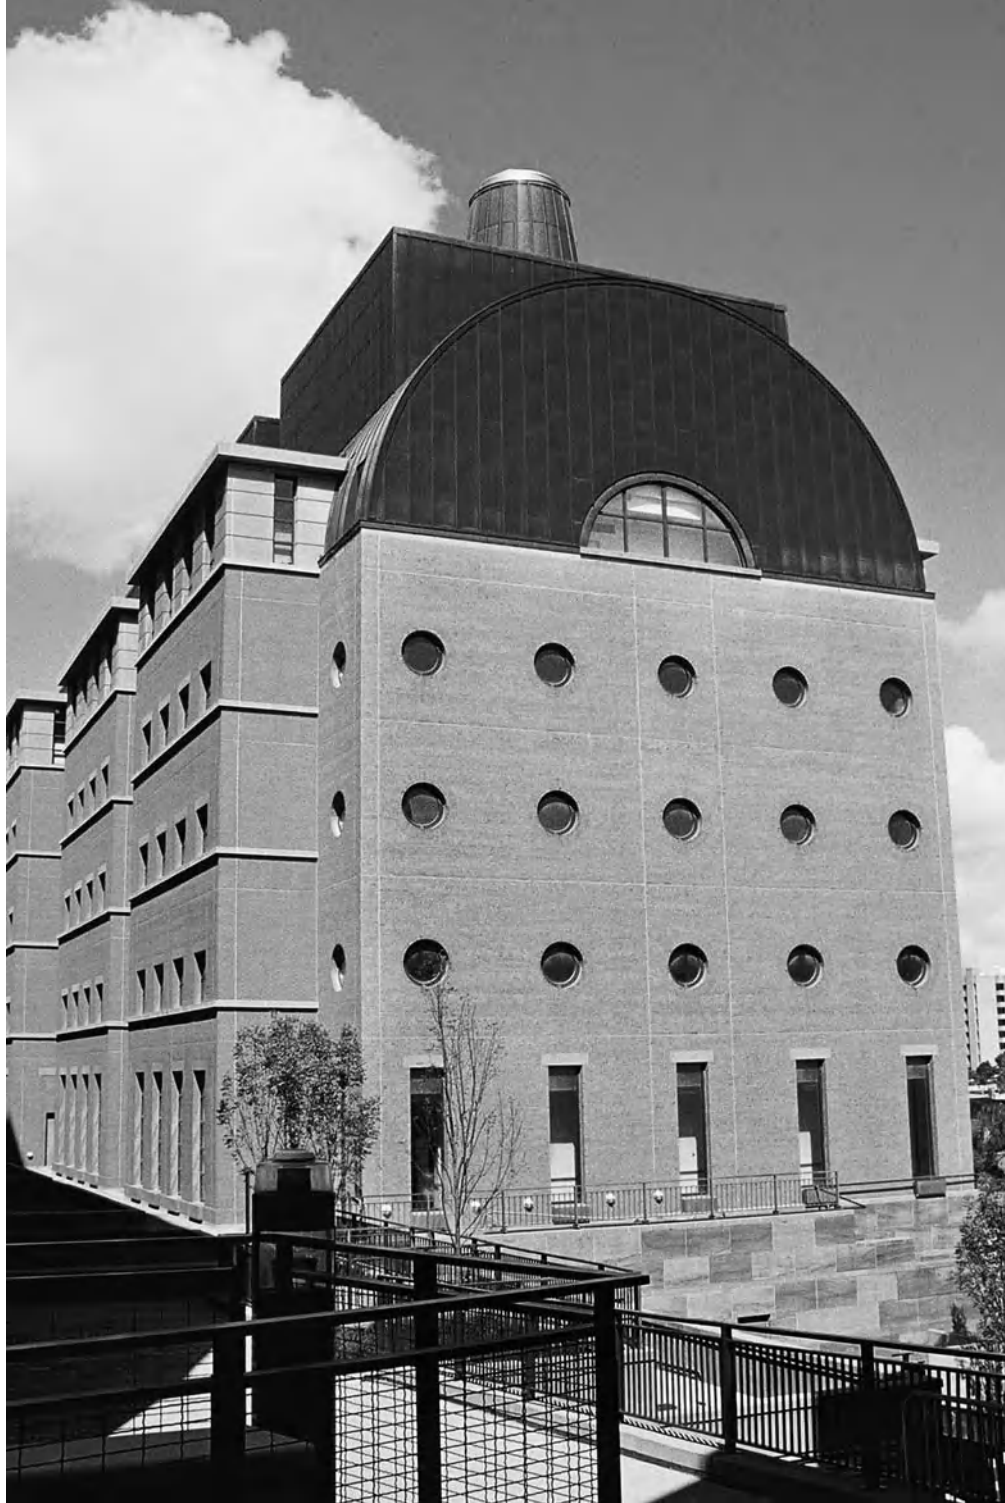
right and below Masonry expansion joints can be an integral part of the façade design. Engineering Research Center (ERC) at the University of Cincinnati, Ohio, 1995.

a building façade in an unattractive fashion. They can be an integral part of the façade design. The Engineering Research Center (ERC), University of Cincinnati, Ohio, designed by Michael Graves and completed in 1995, provides an excellent display of crack-free expansion joints and supplies a grand entrance to the historic section of the campus. The stone and brick building is the east addition to the Schneider Engineering Quadrangle. Sculptural smokestacks top each

section of the ERC and the barrel roof is clad in copper. “Portholes” and elegant masonry designs add variety to the façade. Masonry expansion joints are not hidden but extenuated with color and provide a grid pattern for the exterior.

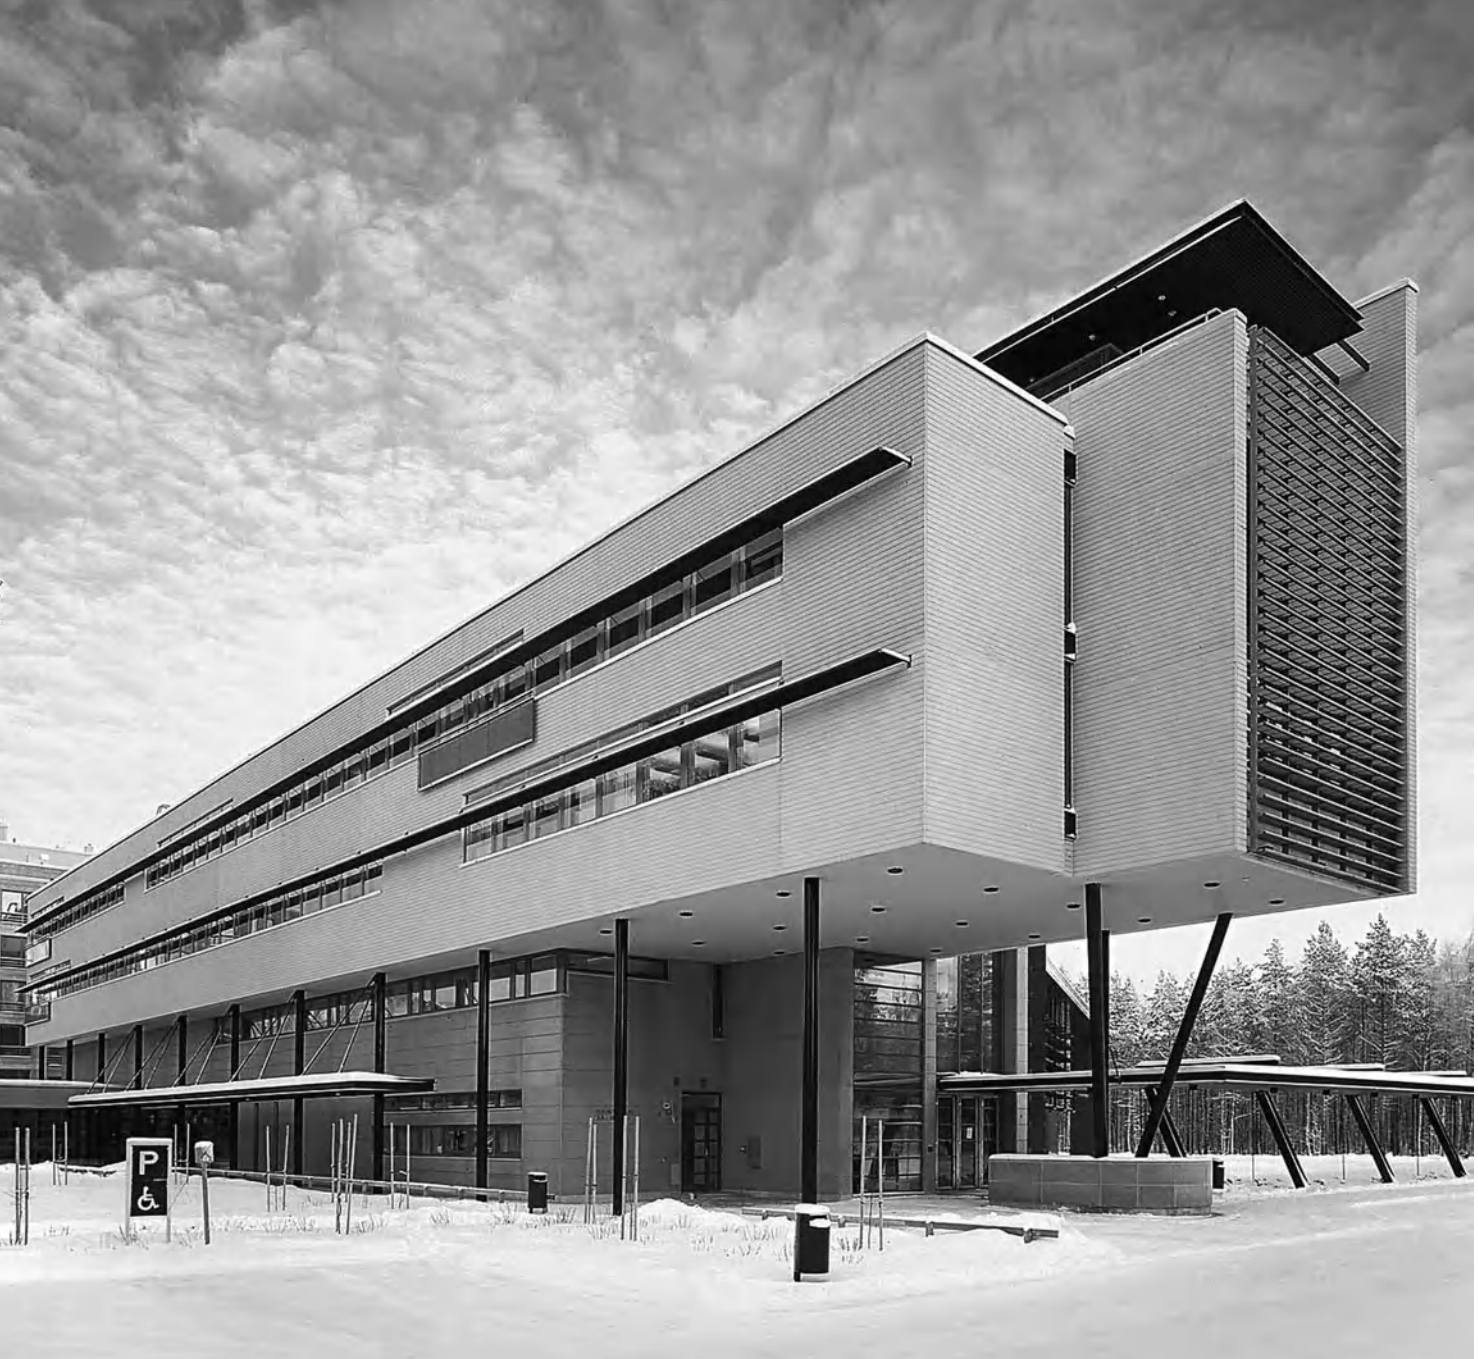
For the new main building of the University of Oulu, Finland, designed by Virta Palaste Leinonen and completed in 1989, the concrete panel joint design had to consider extreme thermal cycling.

Designing in extreme temperatures can be tricky. The University of Oulu in the Linnannmaa District, north of Oulu, Finland, is a concrete structure covered in precast concrete panels. The main building required a pale, gray precast concrete panel with white exposed aggregate finish. A critical feature in the design was the joint detail. The designers wanted the joints to be as narrow as possible and also wanted the panels to be as long as possible so the façade would appear monolithic. Larger panels would also reduce cost and installation time. These desires were in conflict with the extreme temperature range found in Finland, from -40°C to $+40^{\circ}\text{C}$. Joint design must consider the full thermal movement of adjacent materials. A compromise in panel size and joint width was determined. Each panel is one story tall and up to 6m (20 feet) wide, and panel joints are 15mm ($\frac{9}{16}$ inch) in width. When panel joints are not well considered, the result can be disastrous.

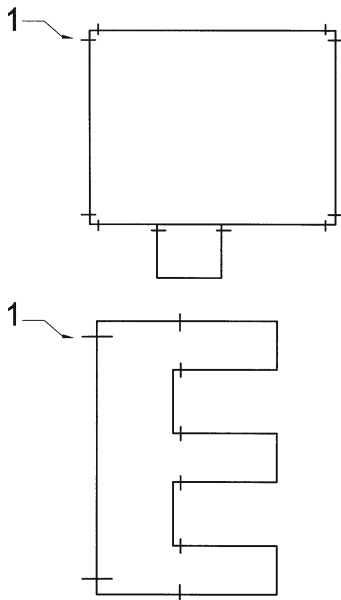
Brick expansion joint locations for various building plan shapes.

1 Vertical joint in veneer wall.

right Vertical cracks in masonry: the symptoms of masonry façade stress are often readily recognizable. High vertical stress may result in specific bulging or cracking patterns, usually at building corners where reduced lateral masonry confinement leads to compression buckling or vertical shear cracks. Often vertical cracks occur about 30cm (12 inches) from the corner.

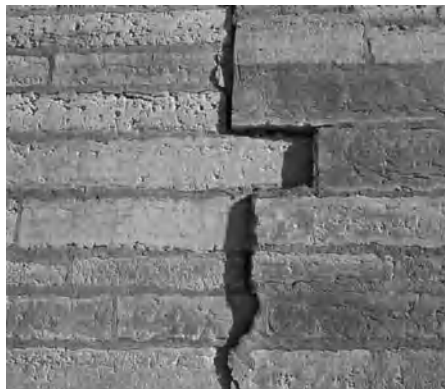
Sankt Florian Church Center in Riem, Munich, 2004. The expansion joints and control joints for the building are an integral part of the design and provide a method for articulating the sign of the cross on the church tower.

Control joints for concrete and concrete masonry walls are designed to relieve stress in a regular pattern in a wall. Designers can use control joints to predetermine where the cracks in a concrete wall will occur. The joints can become part of the façade design. A new church in Riem just outside of Munich used control joints in the façade design. Completed in 2004, the Roman Catholic and the Protestant Lutheran Churches came together to construct a church center east of Munich central. Church rooms and official areas can be accessed directly from the mutual church square. The individual structures of varying heights and the incisive steeple are shielded from the outside by a 10m high (33 feet) wall which hides a microstructure of multipurpose rooms. The expansion joints and control joints for the building are an integral part of the design and articulate the sign of the cross on the church tower.

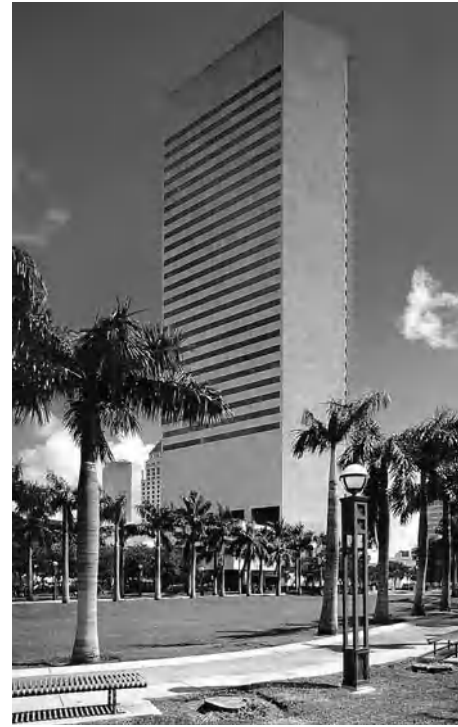
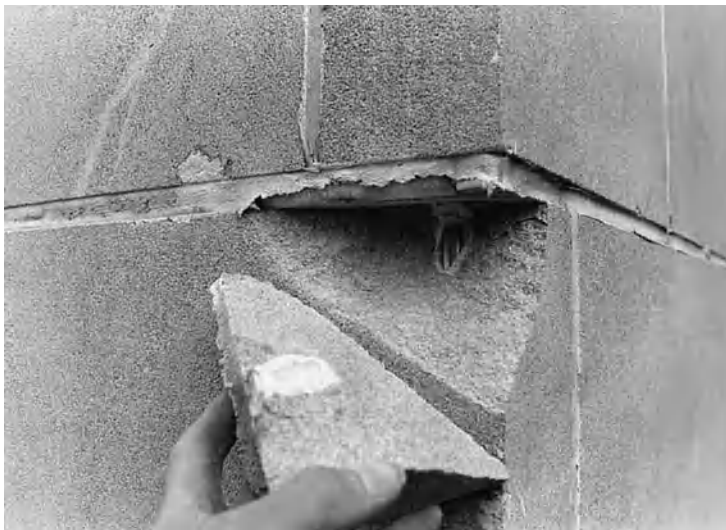
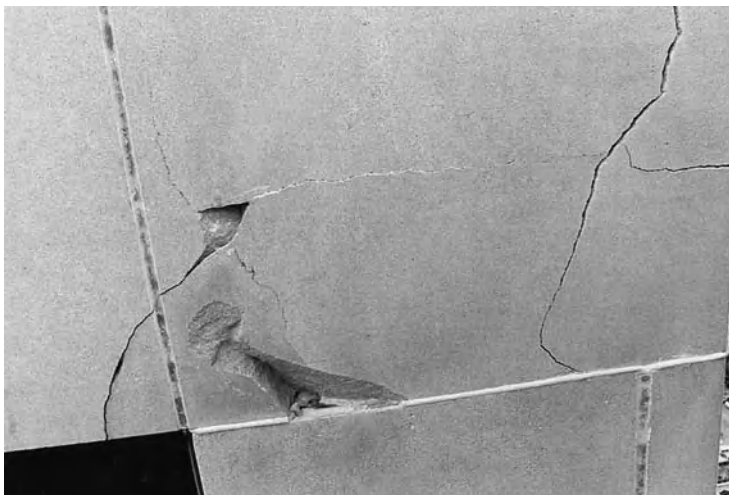
right Metro Dade Center in Miami, Florida, 1985.

below Metro Dade Center. Corner cracks in stone.

When exterior stone wall panel expansion joints are missing or filled solid, the results can be disastrous. The 152.4m (500 foot) tall Metro Dade Center in Miami, Florida, was constructed in 1985 to house county offices. It is clad with approximately 8,700 limestone panels that are 10cm (4 inches) in thickness. The panels are attached to the building's reinforced concrete frame with stainless steel anchor supports. They range in size from 1.5m (5 feet) high and 0.61m (2 feet) wide and weighing 255kg (600 pounds), to 3m (10 feet) high and 1.5m (5 feet) wide, weighing 977.5kg (2,300 pounds). In 1987, cracks were detected in the building's limestone façade after a piece of stone fell to the ground. The cause of the cracked panels was linked to the system's inability to accommodate vertical and horizontal movement between the panels and the concrete frame. The differential movement was created primarily from the building structure's concrete shrinkage and creep, and thermal expansion/contraction of the limestone relative to the concrete frame.

cases, the stone panels on one face of the building were pushed out beyond those of the adjacent façade, and anchors were peeling off triangular pieces of stone. In order to solve the problem, corner panels were replaced and a continuous expansion joint was installed.

The engineering firm of Simpson Gumpertz & Heger was hired to solve the problem. To resolve the vertical expansion problem, horizontal joints between stone panels were cut to provide a gap of a minimum 3mm ($\frac{1}{8}$ inch) and filled with sealant. Approximately 15,000 new anchors were installed. All of the original limestone panels were retained, except for 44 panels which were significantly cracked. These panels were replaced with new stone.

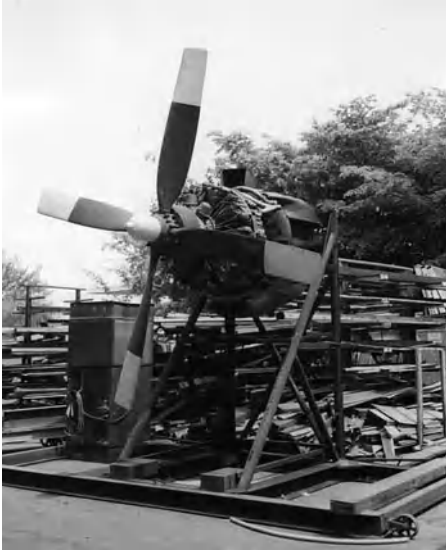
An airplane engine is used with a sprat rack for dynamic water infiltration mock-up testing.

2
To verify the effectiveness in controlling water penetration. Resistance to air and water infiltration can only be determined through testing. The test intends to simulate an enclosure subjected to high winds combined with heavy rainfall. The assembly is subjected to a predetermined internal pressure to simulate the force of wind on the enclosure. Water is sprayed on the assembly at a specified rate for a given time period. Failure of the test occurs when water appears on the inside surface of the enclosure during the course of the test. Controlled water inside the system that weeps to the exterior is allowed. A second method of testing for water penetration into a building is the dynamic pressure test. Dynamic testing is used to determine if water will infiltrate an assembly when exposed to a pulsating pressure. The in-and-out turbulent flow of air occurring during a storm is typically

simulated by using an airplane propeller engine in conjunction with water spray racks. Because of the turbulent nature of the pressure, water may penetrate a system, which would not show up in the uniform static air pressure test. It is recommended that the water infiltration test should be repeated after structural loading to confirm that minor deflections in the system will not trigger leakage into the building.

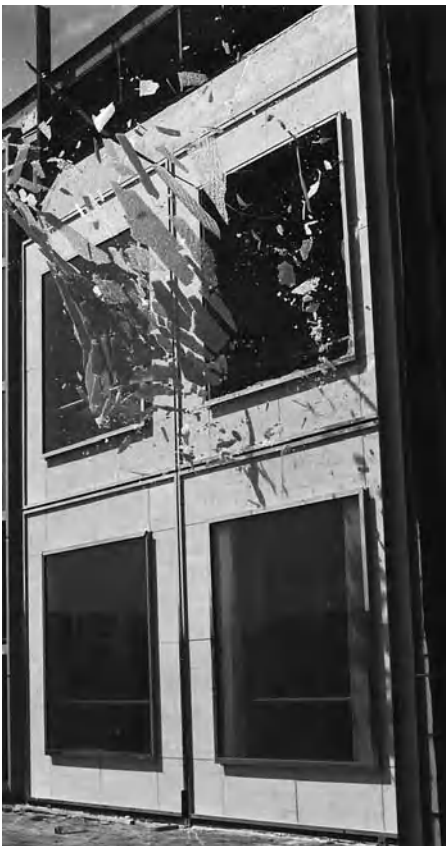
Glass failure at 4.3 MPa (90psf) pressure test on windows in façade mock-up.

To verify the structural adequacy of the enclosure under wind loads. The strength and stiffness of framing members may be determined by engineering analyses and calculations. However, the structural performance test is the final check to find out if the composite assembly meets the design loads. Pressurizing a test chamber encased by the enclosure system being tested simulates wind loads. Inward and outward forces are achieved by drawing air in or out of the chamber. Failure of this test consists of fracture of any individual element or deflection beyond the established maximum under loads equal to or less than the design loads.

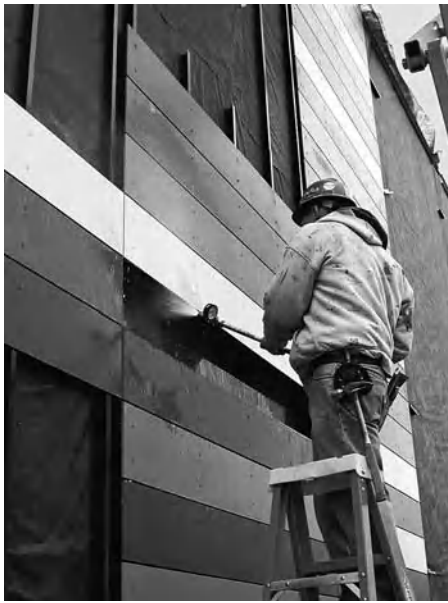
Field water test of cement fiber panel and window system transition. Gary Corner Youth Center, Chicago, 2006.

The most critical time to complete field testing is at the beginning of a project. Early testing can eliminate these faults before the remainder of the installation is completed. Field testing when the first units of an enclosure are installed can uncover any faults with the assembly of the system. Random field testing of the system as the project progresses will help verify that quality control has been maintained throughout the process. Atypical conditions not part of laboratory testing can be reviewed for air and water infiltration. Field testing is also important to ensure that transitions to adjacent systems have been properly executed. Random sealant adhesion field testing is important to verify that substrates are being prepared properly. These tests confirm that the seals are being installed as designed and that the sealant material is curing properly.
