SEVENTH EDITION

# BUILDING SURVEYS

PETER GLOVER

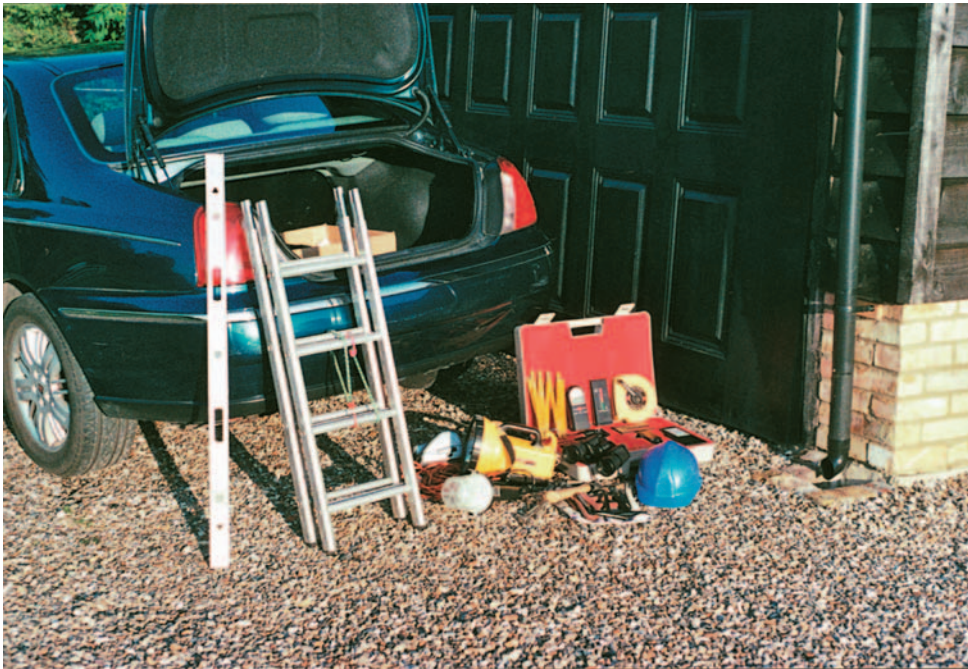
**FIG 1.1** Equipment for a Building Survey of a simple low rise structure.

1. A4 clipboard with pro forma site notes, field sheets and checklists.
2. Folding or sectional 'surveyors' ladder.
3. Laser measuring device, linen and steel tapes and wooden rule.
4. Mains powered light and extension lead plus rechargeable torch.
5. Moisture meters.
6. Binoculars.
7. Spirit level and plumb line.
8. Selection of manhole keys, claw hammer and bolster.
9. Mirrors.
10. Identity documents.
11. Selection of tools including meter box keys, screwdrivers and wood probes.
12. Protective gloves and face masks.
13. Digital camera.
14. Magnetic compass.
15. Endoscope.
16. Drain plugs and drain testing equipment.
17. Metal detector.

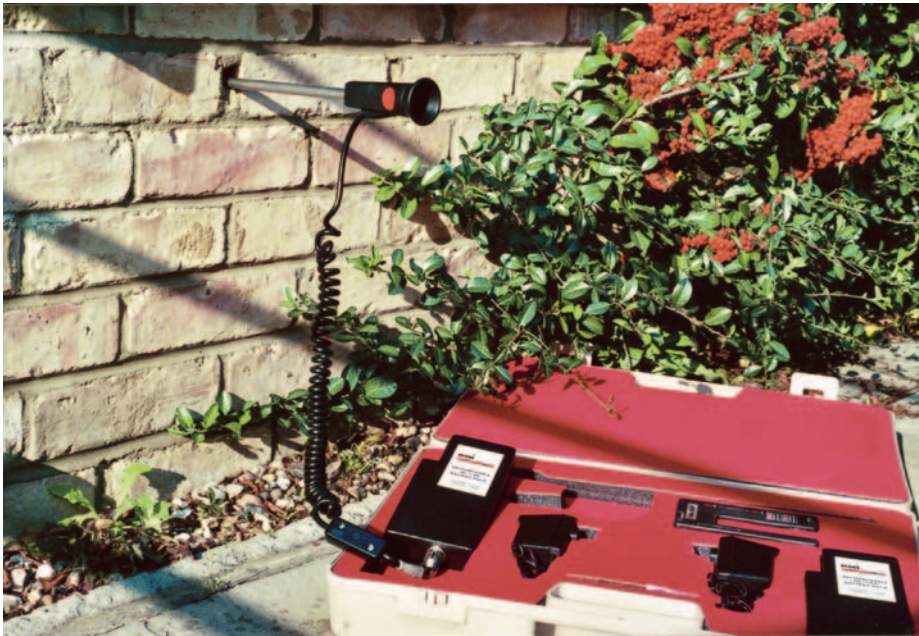
**FIG 1.2** Borescope for inspecting inside wall cavities, sub-floor voids and other areas. The wide-angle lens provides good depth of field.

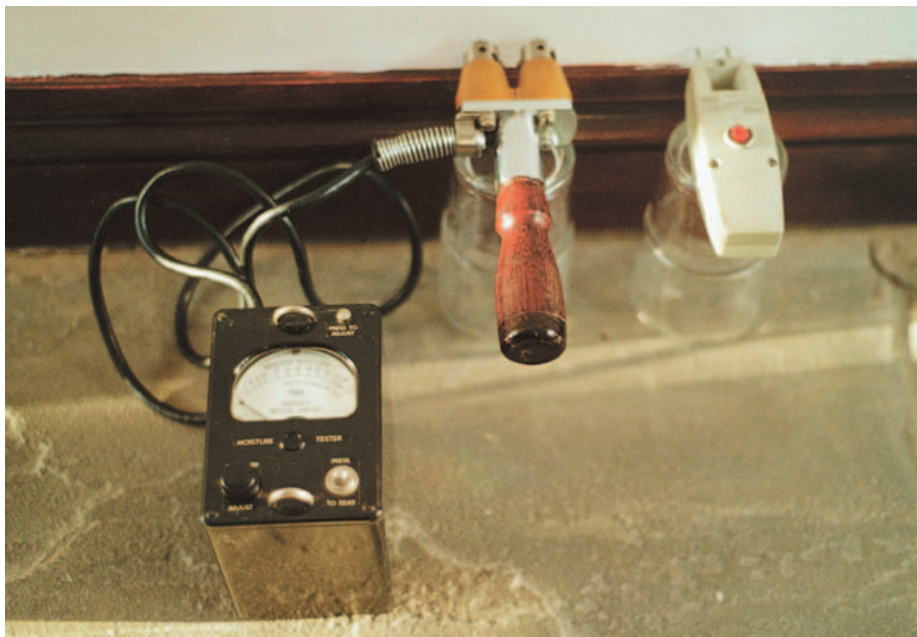
**FIG 1.4** Moisture meters are not a new invention. On the left a Weston Moisture Meter manufactured by the Weston Electrical Instrument Corp in the USA in the 1930s. Principally designed to check moisture levels in timber but also having a scale to measure dampness in plaster. On the right an Aquatrace made in England in the 1960s – you press the red button and a flashing light indicates damp. The faster it flashes the damper the wall.

- 1.3 Environmental issues should be covered in the report but the client must decide whether a problem such as aircraft noise is acceptable or not.
- 1.4 Moisture meters are not a new invention. On the left a Weston Moisture Meter manufactured by the Weston Electrical Instrument Corp in the USA in the 1930s. Principally designed to check moisture levels in timber but also having a scale to measure dampness in plaster. On the right an Aquatrace made in England in the 1960s – you press the red button and a flashing light indicates damp. The faster it flashes the damper the wall.

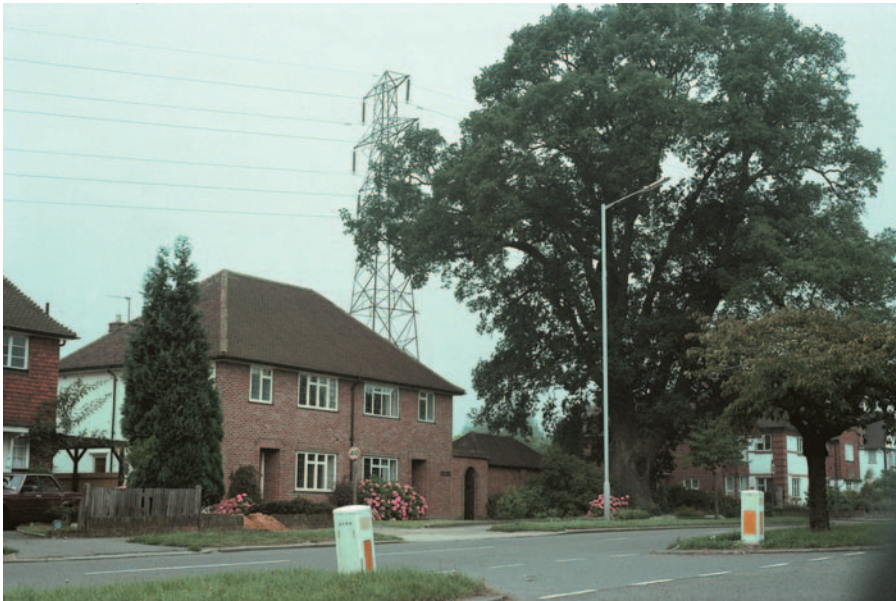
**FIG 2.2** The huge oak tree almost touches the garage wing to this house and there are a pylon and overhead power lines close by, both matters to be reflected in the report.

- 2.1 This house is built directly on the riverbank. Issues arising include foundations, potential riparian liabilities and flood risk.
- 2.2 The huge oak tree almost touches the garage wing to this house and there are a pylon and overhead power lines close by, both matters to be reflected in the report.

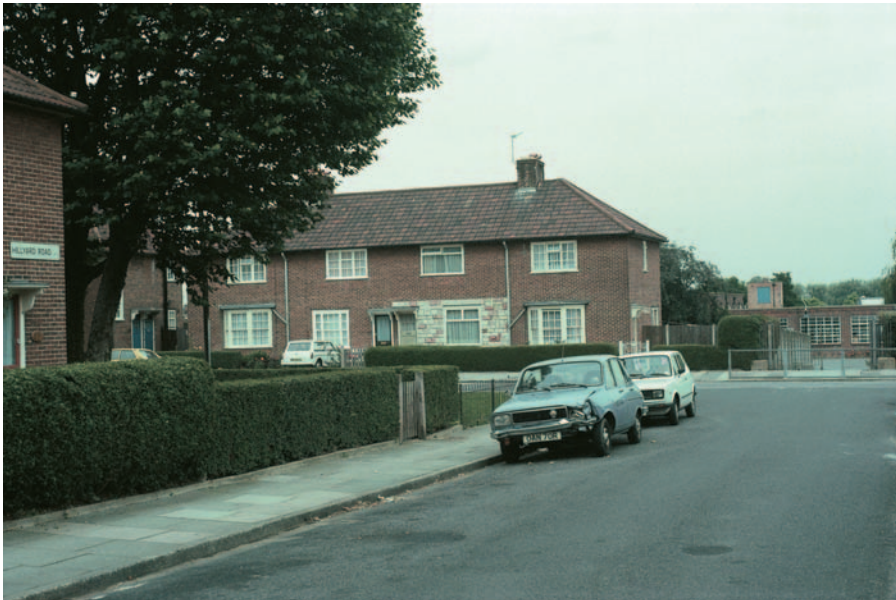
**FIG 2.3** Artificial stone cladding generally reduces the value of the property to which it is applied, and in this case by cladding only at ground floor level the owner has left a ledge for driving rain to penetrate behind the cladding resulting in a damp problem inside.

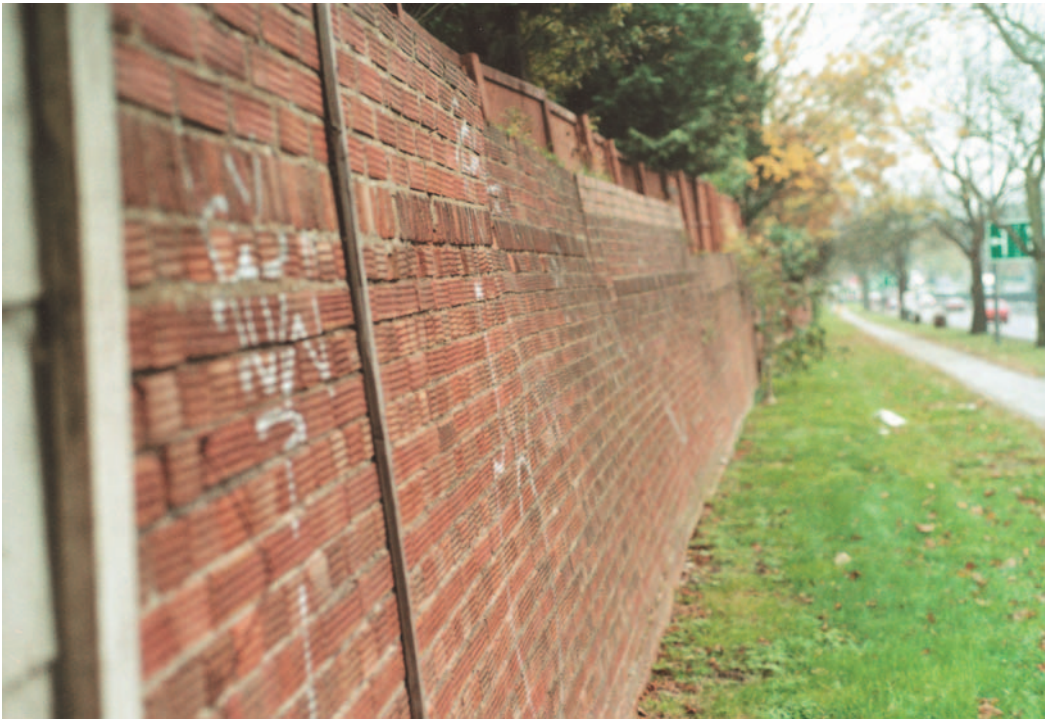
**FIG 2.4** If leaning boundary walls have to be rebuilt this can be very expensive.

- 2.4 If leaning boundary walls have to be rebuilt this can be very expensive.
- 2.5 Condensation between the glass in double-glazed sealed units generally arises when the windows are between 10 and 20 years old, often (and conveniently for the manufacturers), just after the 10-year guarantee period has run out. The sealed units then have to be replaced. The cost/benefit and payback calculations for double glazing need to reflect the fact that these windows are not maintenance free. During a Building Survey, it is necessary to check any condensation on the glass to see if it is inside, outside or between the panes. If it is between the panes, there is likely to be a developing problem with the windows which could be expensive for the client.

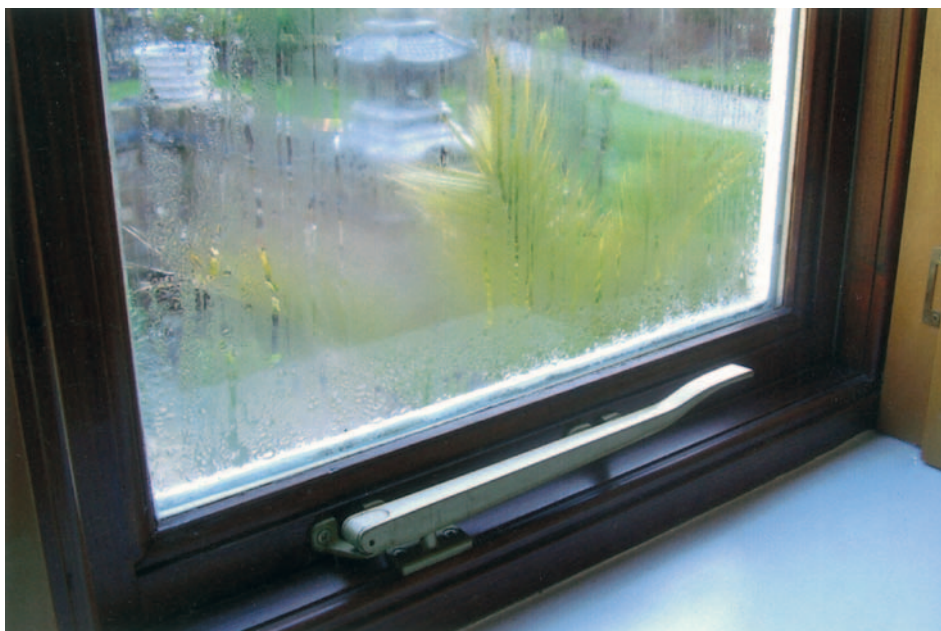
**FIG 2.5** Condensation between the glass in double-glazed sealed units generally arises when the windows are between 10 and 20 years old, often (and conveniently for the manufacturers), just after the 10-year guarantee period has run out. The sealed units then have to be replaced. The cost/benefit and payback calculations for double glazing need to reflect the fact that these windows are not maintenance free. During a Building Survey, it is necessary to check any condensation on the glass to see if it is inside, outside or between the panes. If it is between the panes, there is likely to be a developing problem with the windows which could be expensive for the client.

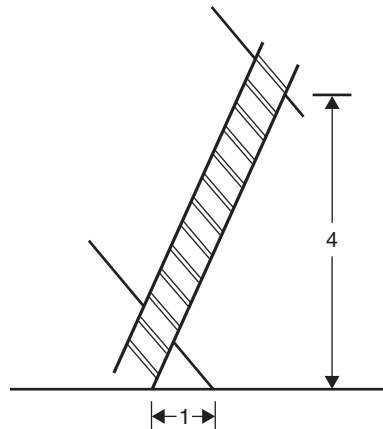
**FIG 2.6** During the survey any ladders used must be properly angled and grounded. A 4 to 1 ratio of height to distance is best. Steeper and the user may topple backwards; shallower and the ladder may slide from beneath.

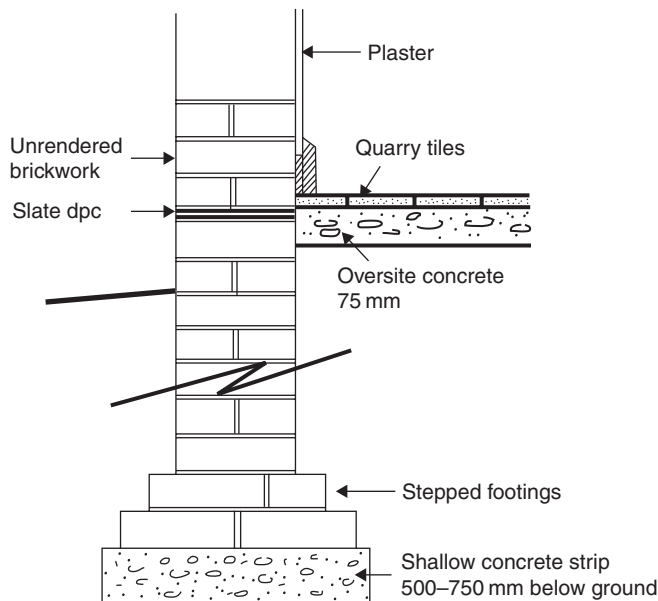
FIG 3.1 Late Victorian foundation, circa 1900.

- 3.1 Late Victorian foundation, circa 1900.
- 3.2 Typical 1930 domestic foundation.
- 3.3 Modern short-bored pile foundation for domestic and other buildings. Common 1990 foundation.

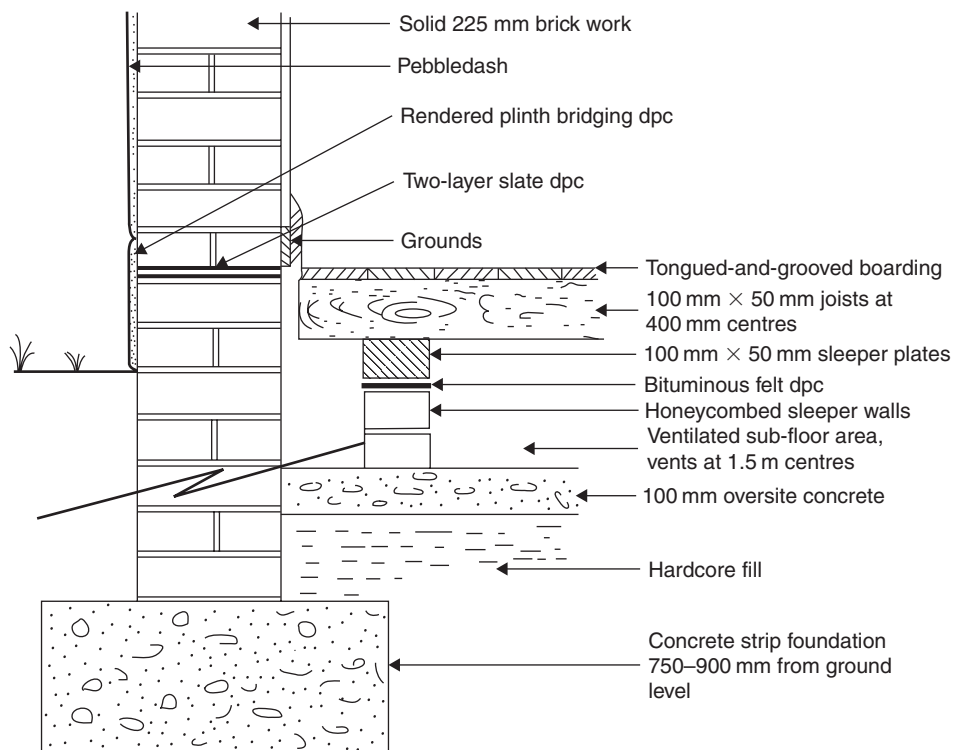
FIG 3.2 Typical 1930 domestic foundation.

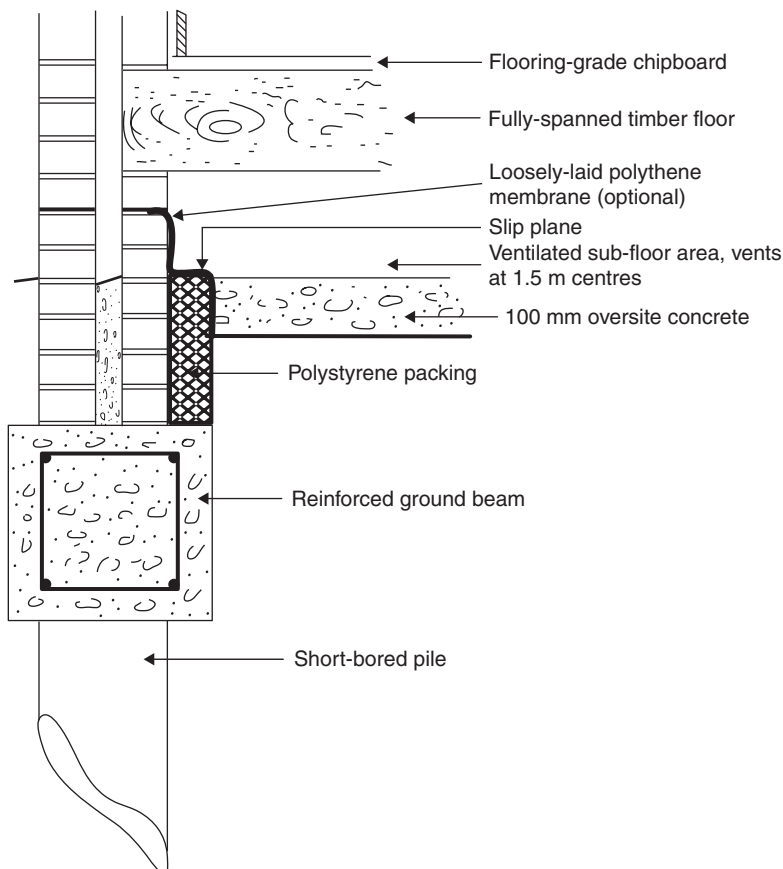
**FIG 3.3** Modern short-bored pile foundation for domestic and other buildings. Common 1990 foundation.

One should pause for a moment to consider the full implications of BS 5837. In most cases the property being inspected, whether residential, commercial or industrial in character, is unlikely to have special foundations of the type anticipated, unless it is quite modern. Generally a short-bored pile-and-beam foundation, or pad-and-beam, or occasionally a raft design, would be used to accommodate the seasonal ground movements induced on clay sites by tree roots. (A sketch section through a pile-and-beam foundation is shown in [Figure 3.3](#).) It follows that for most older structures on clay sites a traditional shallow foundation design may be assumed, and that if trees are present whose height at maturity will exceed their distance from the walls of the structure,

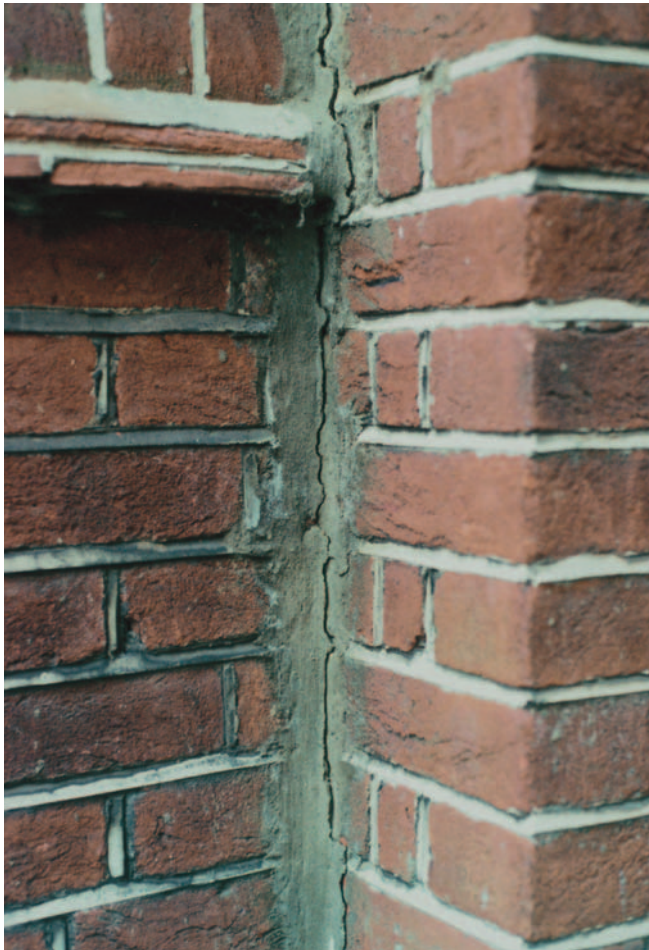
**FIG 3.4** This settlement fracture has been poorly repaired and opened up again indicating continuing movement.

- 3.4 This settlement fracture has been poorly repaired and opened up again indicating continuing movement.
- 3.5 A bulge fracture due to compression not related to foundations.

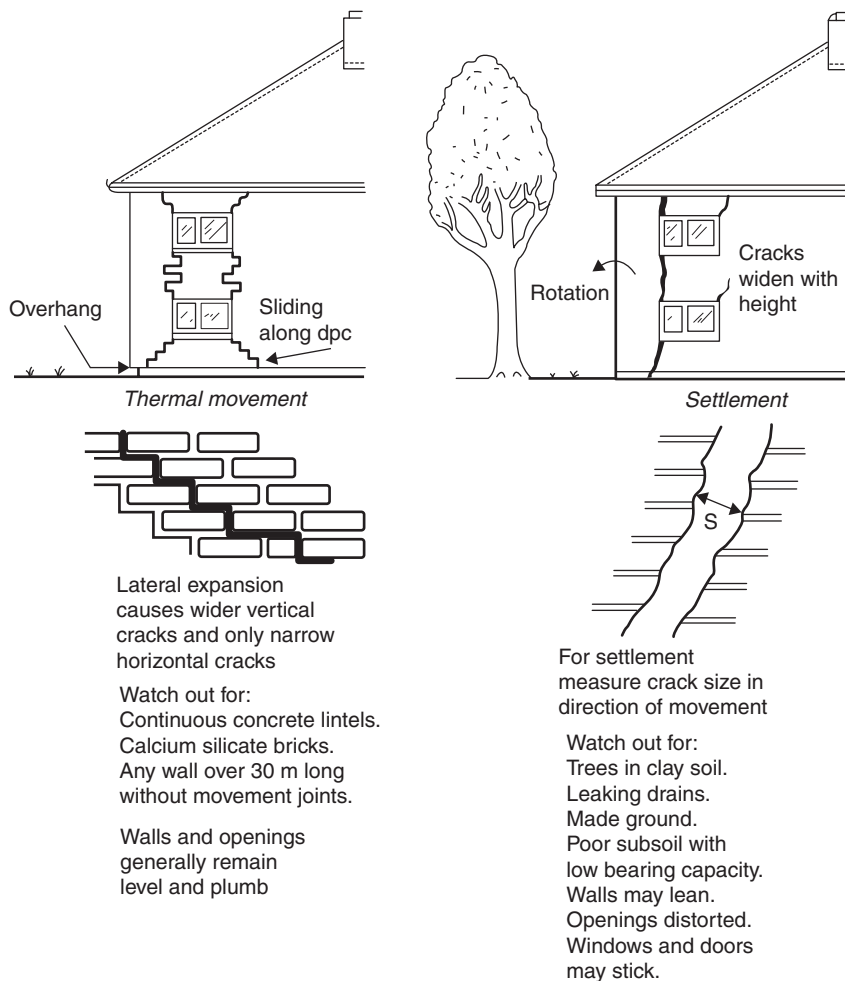
FIG 3.6 Assessing crack damage – 1.

- 3.6 Assessing crack damage – 1.
- 3.7 Assessing crack damage – 2.

Damage of Categories 1 and 2 proportions would not generally of itself justify any specific remedy, and a cosmetic repair should be sufficient. Categories 1 and 2 damage in circumstances where other adverse features of the structure or site exist may, however, be a foretaste of more serious problems to come. Most major structural fractures start with a hairline crack.

Category 3 damage could require a specific remedy depending upon the circumstances. Certainly such damage would require periodic monitoring in order to confirm whether or not the structural movement is continuous and worsening.

Categories 4 and 5 damage will probably require a specific remedy in addition to above-ground repairs. There is a likely need for some type of underpinning in these cases.

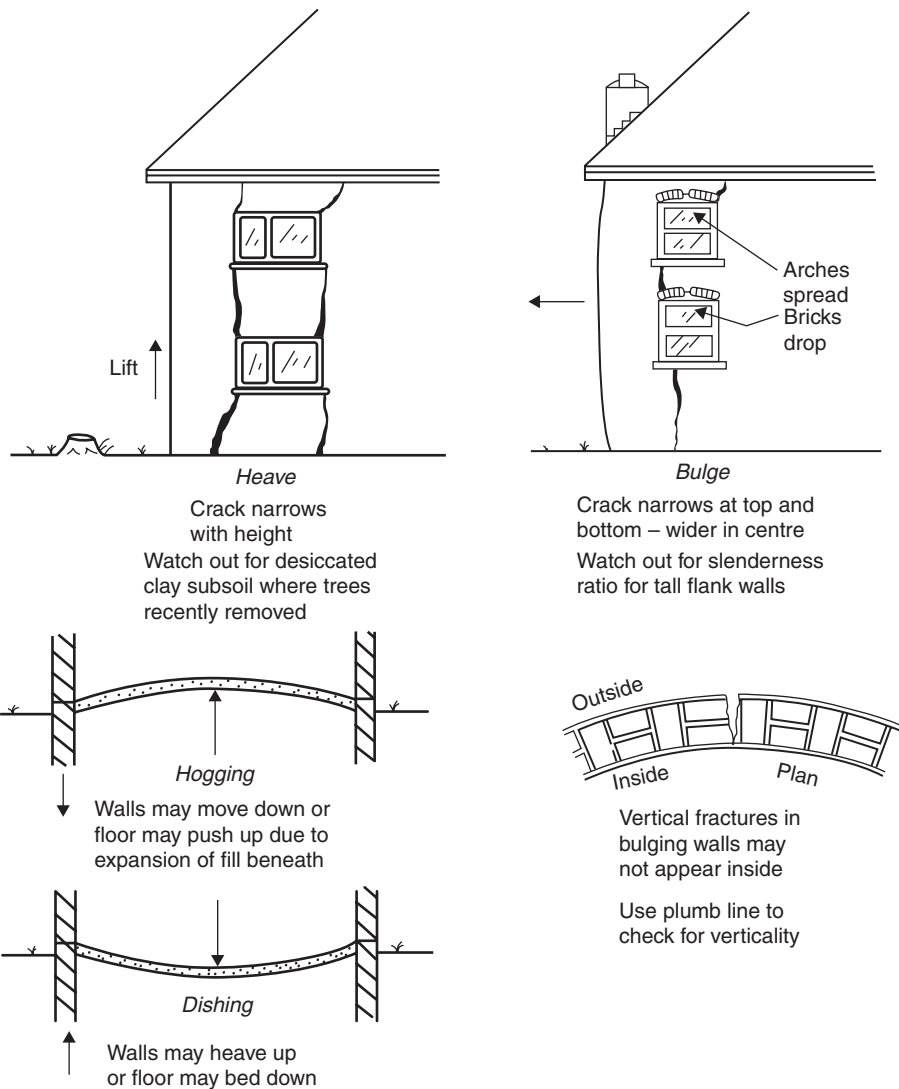
FIG 3.7 Assessing crack damage – 2.

The question of which category in which to place a specific observed area of damage is very much a matter of judgement. A large number of narrow cracks may, in some cases, be more significant than a few larger ones. The recommendations for categorising damage can be no more than a guide, and each property and area of damage has to be

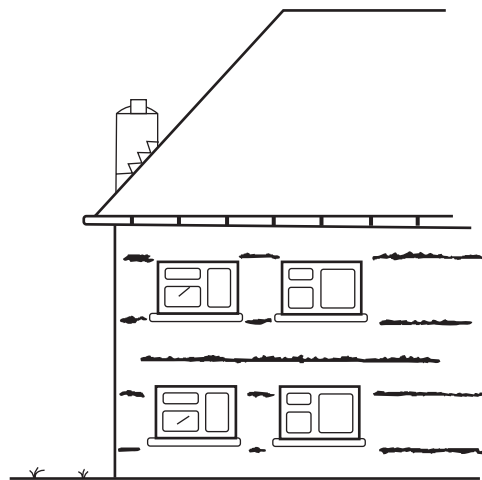
*Rusting wall ties*

Pattern of horizontal cracking to mortar joints in cavity wall. There may be bulging and separation of two skins of brickwork.

Watch out for:  
Any pre-war cavity walls.  
Black ash mortar.  
High exposure for driving rain.  
1950s Finlock gutters with leaking joints.

Cracks tend to appear every six courses, this being typical wall tie spacing.

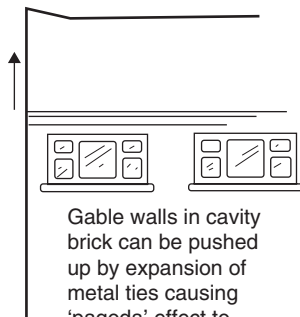
Gable walls in cavity brick can be pushed up by expansion of metal ties causing 'pagoda' effect to verge tiles.

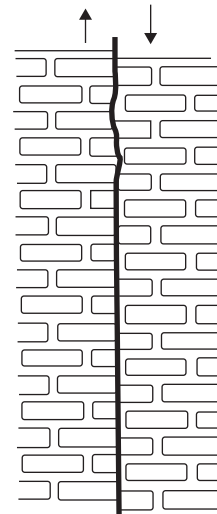
*Shear failure*

Often to bonding between new and pre-existing construction.

FIG 3.8 Assessing crack damage – 3.

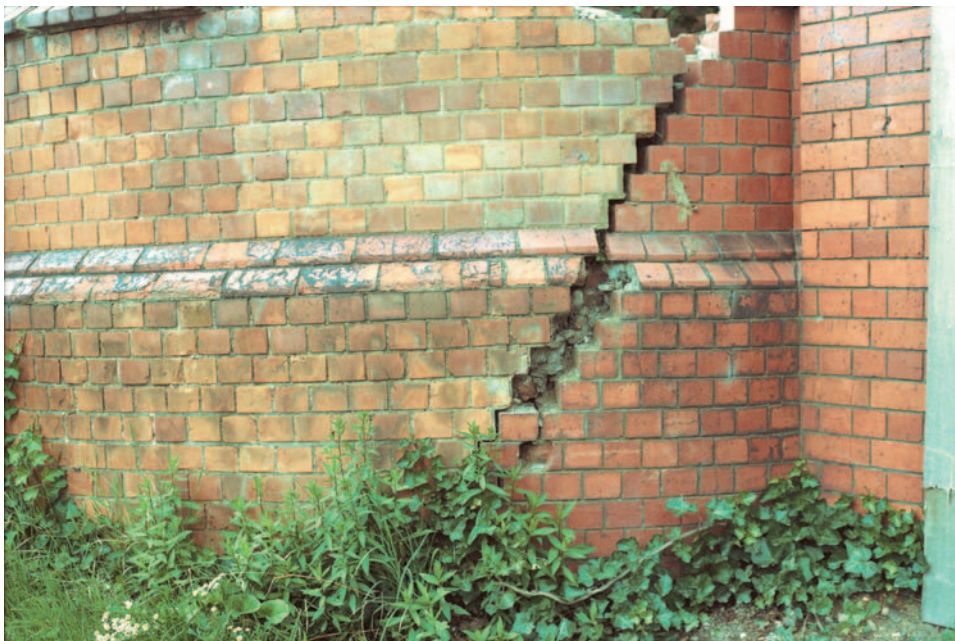
**FIG 3.11** Settlement or subsidence. The crack widens with height.

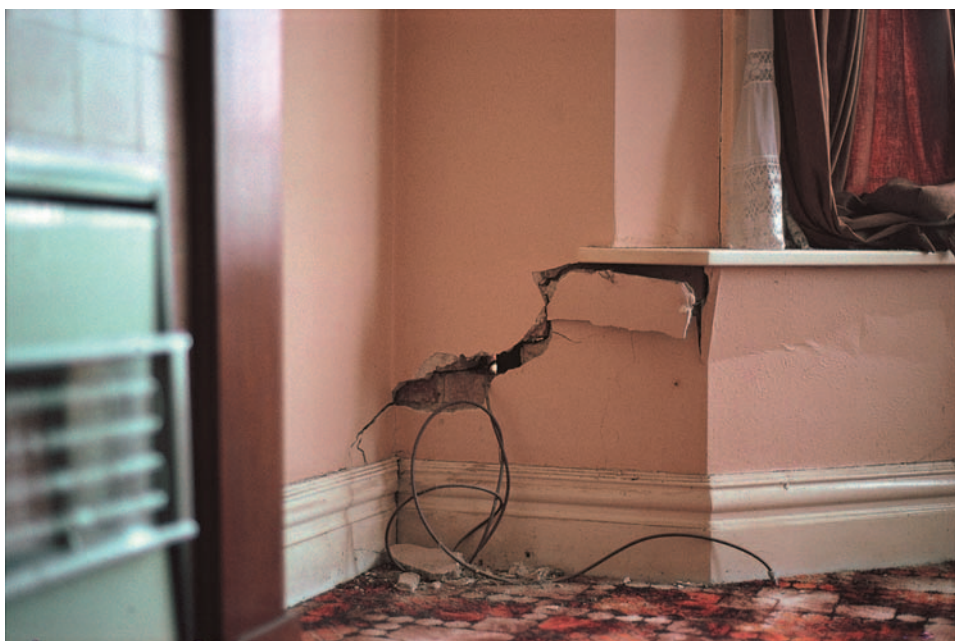
**FIG 3.12** Subsidence damage inside house.

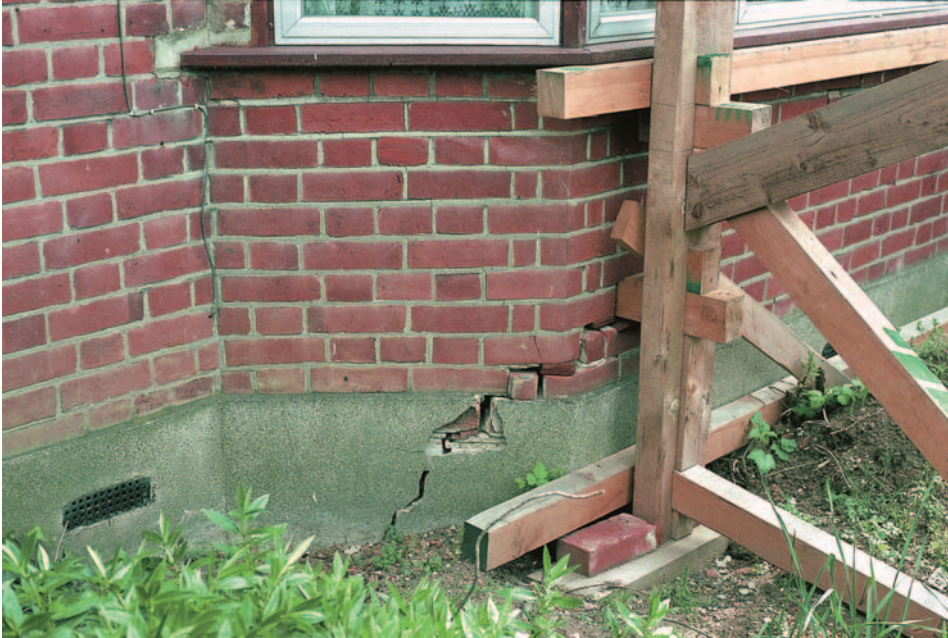
FIG 3.13 Subsidence damage outside house.

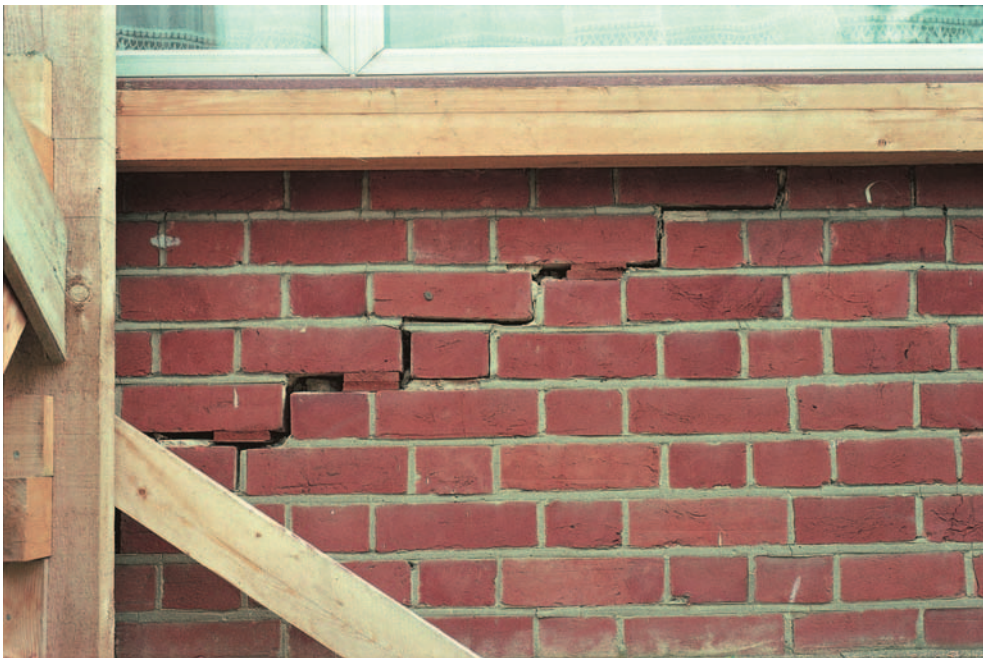
**FIG 3.15** Subsidence has affected the lower part of this wall. As a temporary measure raking shores have been placed against the wall and hardwood wedges driven into the open bed joints to prevent further movement of the construction above.

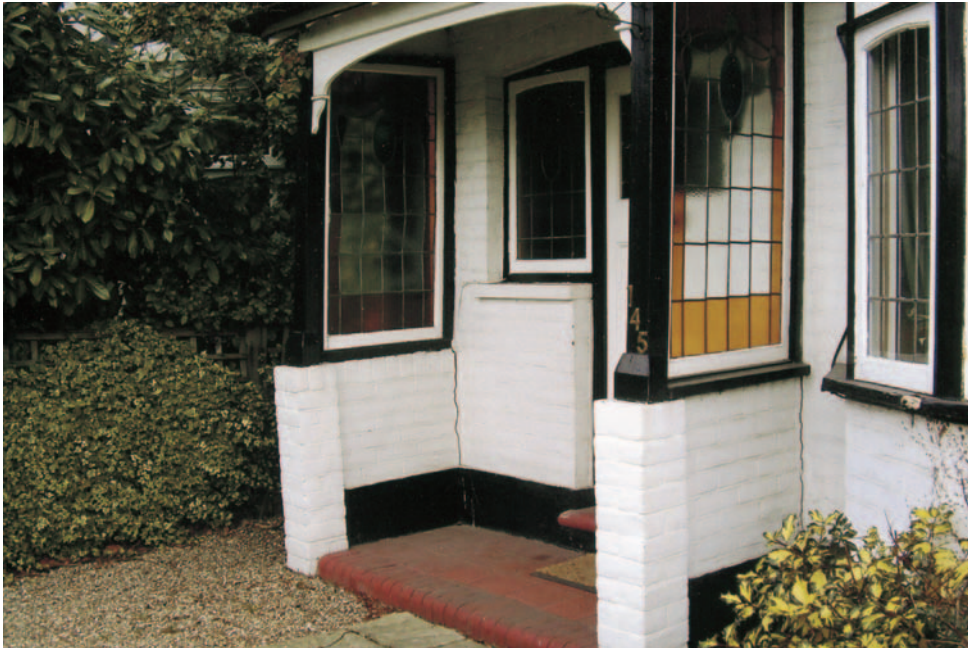
**FIG 3.17** Builders will often use a very shallow foundation for a porch thinking that because the weight is low they do not need to excavate as deeply as for the main house; this is not so and the porch in this case will need to be rebuilt on deeper footings.

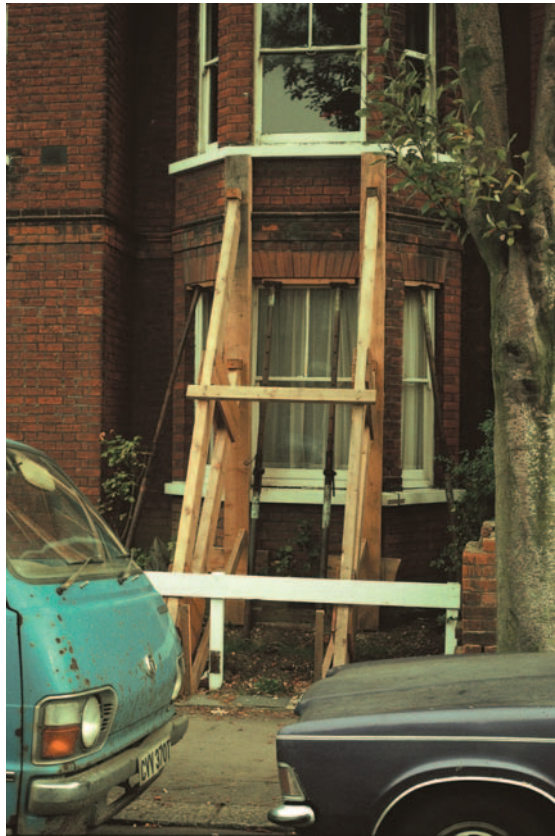
**FIG 4.2** Raking shores used to support bay suffering from subsidence pending repair. Note the tree.

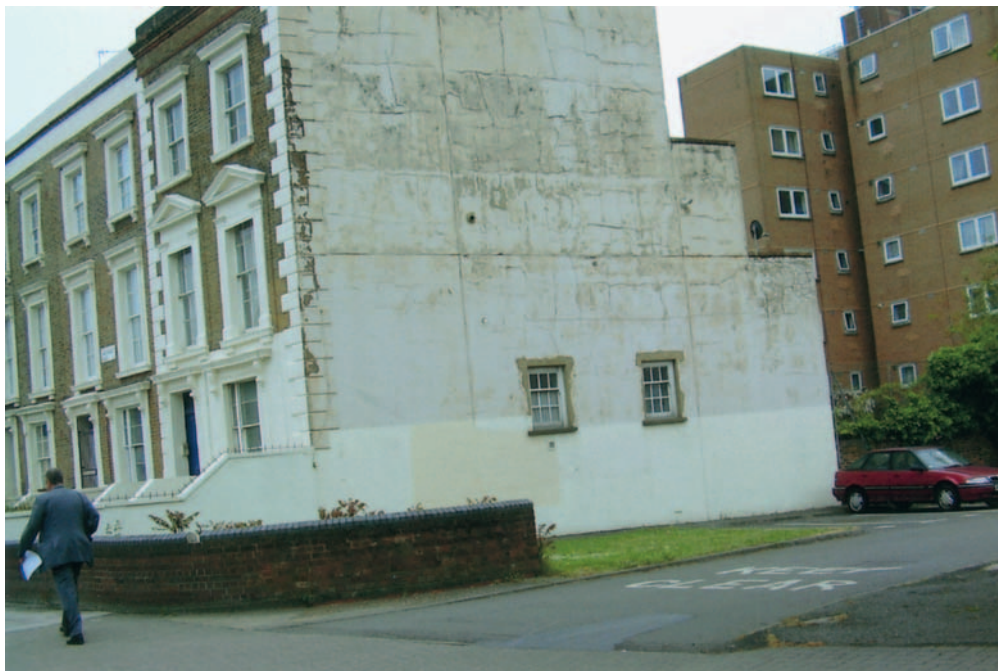
**FIG 4.3** Stucco render has been applied to the flank wall of this London terrace. Poor preparation of the wall behind with inadequate keying, trapped moisture and the wrong mix, badly applied, combine to produce this unfortunate result. The builders need to hack it all off back to the brickwork and then start again. Many of these flank walls in London have resulted from Second World War bomb damage, so that part of a terrace has been demolished and something has to be done to weather-proof the exposed wall.

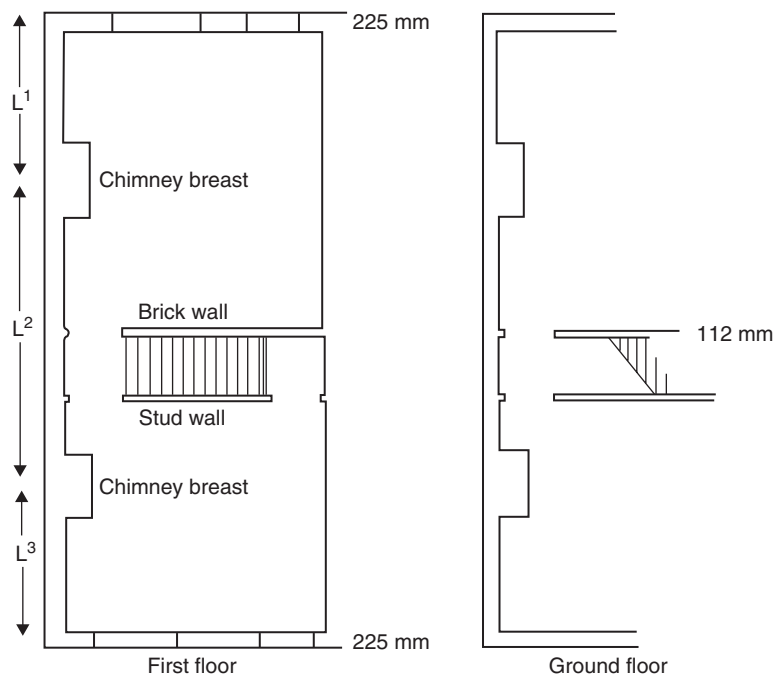
FIG 4.4 Ground and first floor plans of end-of-terrace Victorian cottage.

Figure 4.4 shows part of an end-of-terrace Victorian cottage. Note that the brick cross-wall construction is separated from the flank wall on both levels by door openings so that little or no effective cross-wall bonding exists. The stud cross-wall is of no benefit to the stiffness of the flank wall either. The flank wall is 225 mm thick and divided into three lengths, these being 3, 5 and 3 m, respectively, this flank wall being carried up to form a gable-end with an effective height exceeding 3.6 m.

If the chimney breasts are removed a single length of 11 m of wall exceeding 3.6 m high results which should be a minimum of 300 mm thick at ground floor level. Since this

is not so, the removal of the chimney breasts is not recommended; they add essential stiffness to the flank wall construction. If soft lime mortars are used, the removal of buttressing from the flank wall may still be ill-advised, even if a check by reference to Rule 7 raises no technical objection, because the SR by reference to CP 111 is excessive.

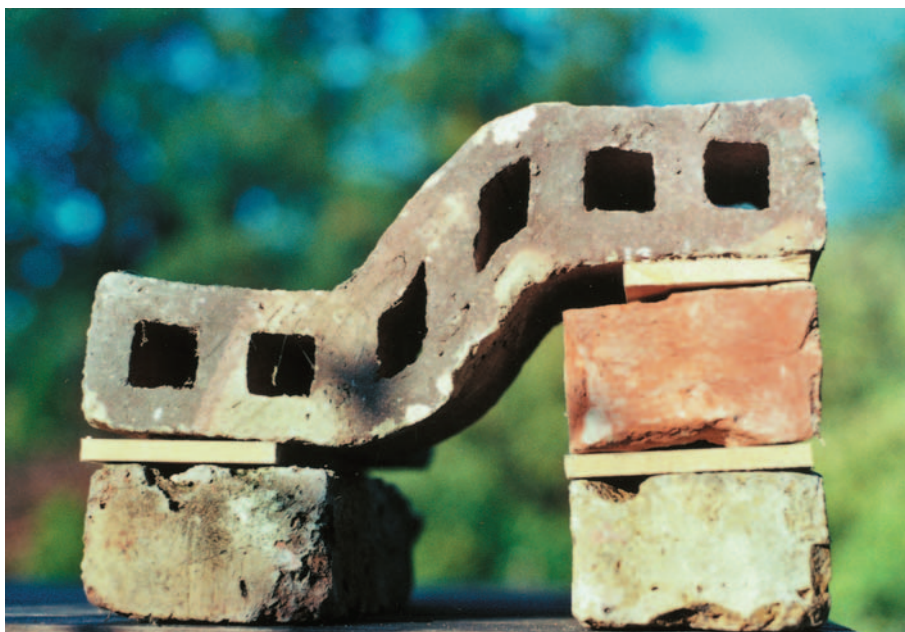
**FIG 4.6** The Victorians used special-shaped bricks as wall ties in their cavity walls.

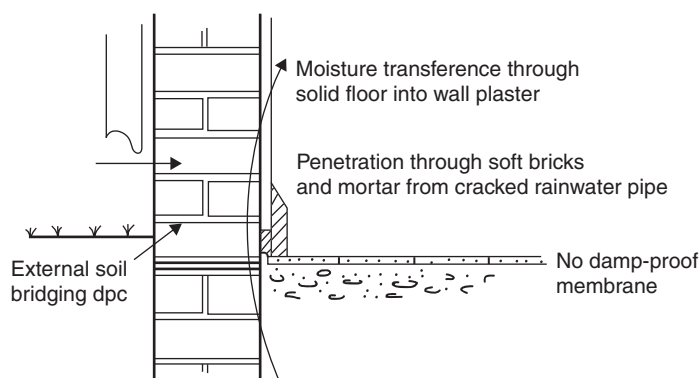
FIG 4.7 Bridging of slate damp-proof course in unrendered, solid brick wall.

Figure 4.7 shows a sketch section through an unrendered solid brick wall of a type commonly encountered in Victorian and Edwardian construction having a solid internal floor covered with quarry tiles and no effective damp-proof membrane. A risk of damp penetration through the wall and dampness rising by capillary action via bridging arises with this type of construction. Wet- or dry-rot to grounds and skirting boards in such a location is likely if dampness is present. Simple remedies such as dealing with defective rainwater equipment and lowering ground levels may suffice but it will not be possible to confirm whether the slate damp-proof courses are effective or not since they cannot function properly anyway until the obvious problems are dealt with. Floors may be re-surfaced with a new covering of two good coats of 'Synthaprufe' or similar bituminous coating, taking care to cut back old tiles, to expose the damp-proof courses and to finish the bituminous backing against the slates to ensure a continuous damp-proof course and membrane. Pointing and soft brickwork should also be attended to as required.

The standard of thermal insulation of such a wall will be poor and heat loss is excessive by modern standards.

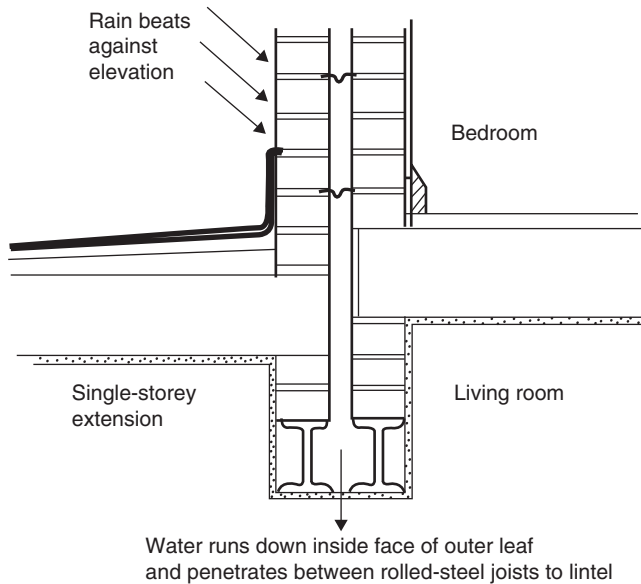
**FIG 4.8** Lack of damp-proof cavity tray to cavity wall over opening for living-room extension.

Figure 4.8 shows a sketch section through a cavity wall where a living room has been extended and two small rolled-steel joists inserted. In such a location, especially in conditions of high exposure or normal exposure facing the prevailing weather (usually south west), a damp-proof cavity tray should be provided, lapped over the exterior roof flashing and a few open perpend or weepholes allowed for so that any water running down the inside face of the outer skin is picked up and taken to the outside over the roof line. Similar provision is required in a cavity wall where a subsidiary pitched roof joins the outer skin using a conventional flashing and where the cavity continues downwards to terminate at lintels over rooms below.

The provision of rolled-steel joists and other lintel work in residential extensions of this type is often badly done but the detail can rarely be checked. Apart from the provision of proper damp-proof cavity trays and weeping perpend joints as necessary, it is essential that proper bearings for joists are provided and that for all but the very short

spans, the rolled-steel sections should be bolted together with spacers to provide improved stiffness and resistance to torsion.

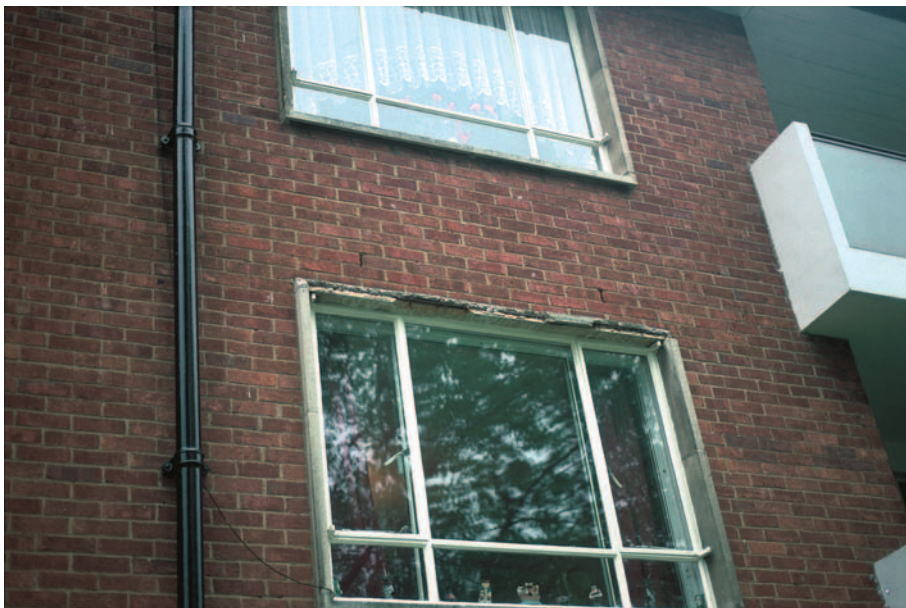
**FIG 4.9** Inadequate cover for steel reinforcement in concrete lintel. Rust can take up to seven times the space of the steel it replaces causing bursting to the concrete surface.

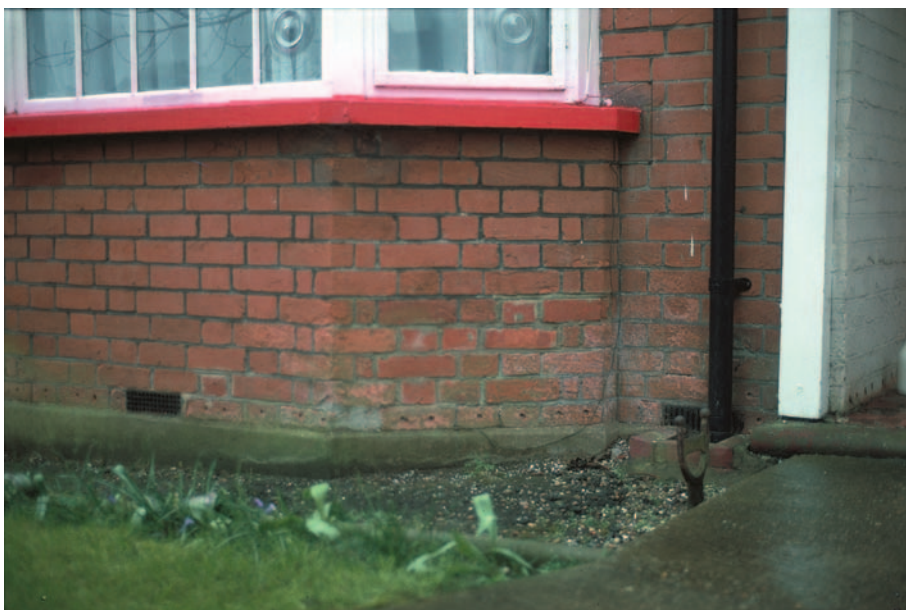
**FIG 4.10** Drill holes at the base of the wall indicate that a chemical injection damp-proof course has been added.

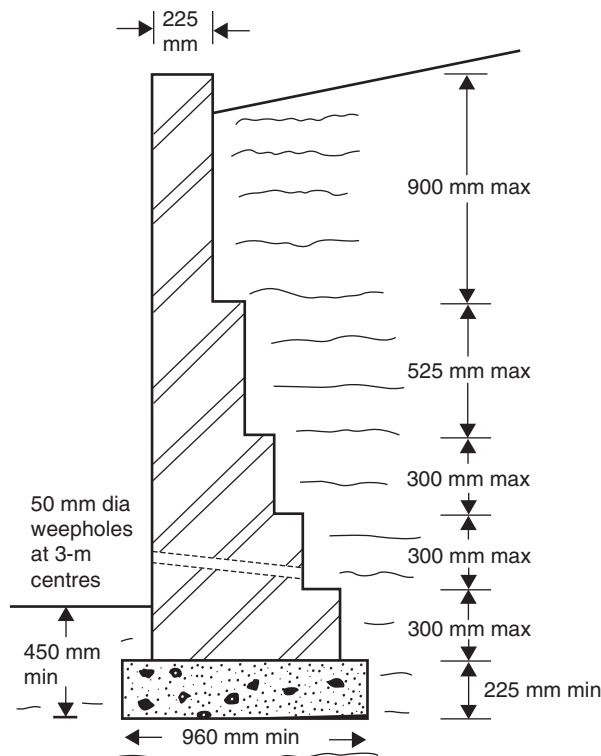
**FIG 4.13** Typical design for all-brick retaining wall, using special-quality brickwork which does not require tanking or weathering. The wall is stepped back in half-brick increments. Backward-sloping drain-holes prevent staining down the face of the wall from very small quantities of groundwater discharging over a long period. Note that ordinary-quality brickwork requires special tanking, damp-proof courses and weathering, otherwise frost damage will result.

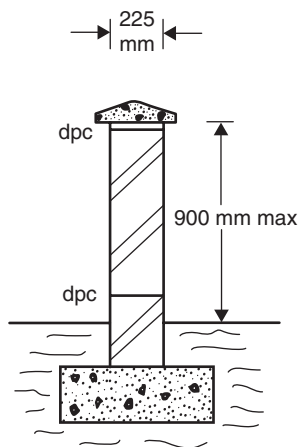
**FIG 4.14** Freestanding wall construction. Throated weathering projecting at least 45 mm, plus damp-proof courses at top and bottom, allow ordinary-quality brickwork to be used for normal exposure conditions, but special-quality bricks are necessary for footings below damp-proof course, (dpc).

shown. Below damp-proof course at the base a special-quality brick footing is necessary. In [Figures 4.14](#) and [4.15](#) the damp-proof course is shown as a line. For most situations however a simple bituminous felt or plastic damp-proof course should not be used due to the weak bonding line which results and the risk of overturning failure of the wall – a better solution is to use two courses of engineering brick to provide a damp-proof course with uninterrupted mortar joints within the construction.

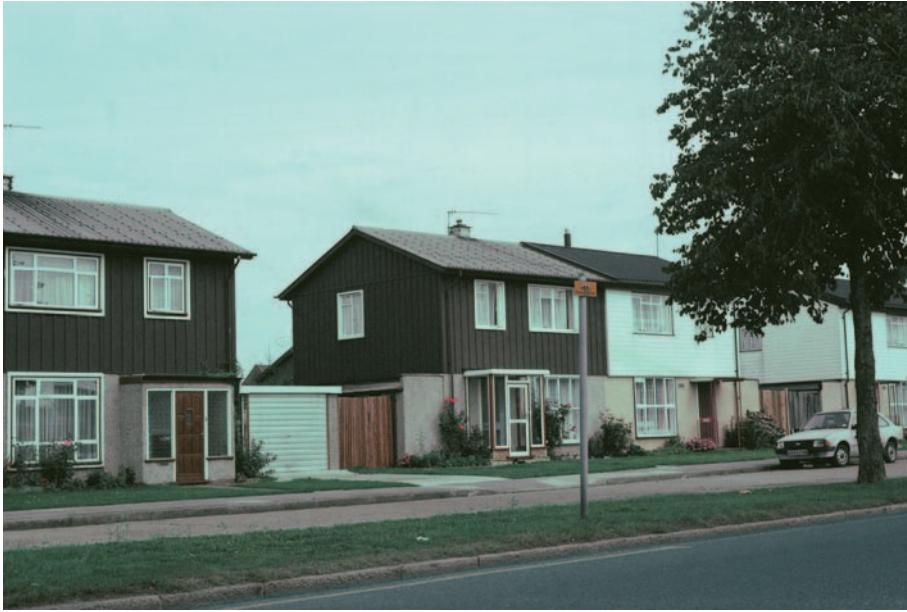
**FIG 4.16** BISF (British Iron and Steel Federation) Houses.

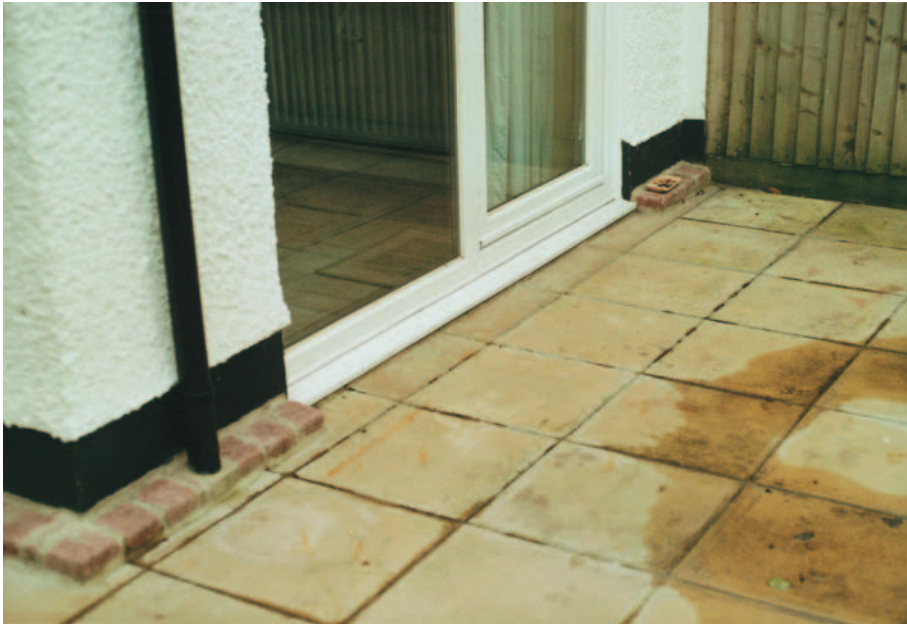
**FIG 4.17** The paving is too high. It should be lowered to at least 150 mm (2 brick courses) below the damp-proof course or internal floor level whichever is the lower, with a slope away from the wall.

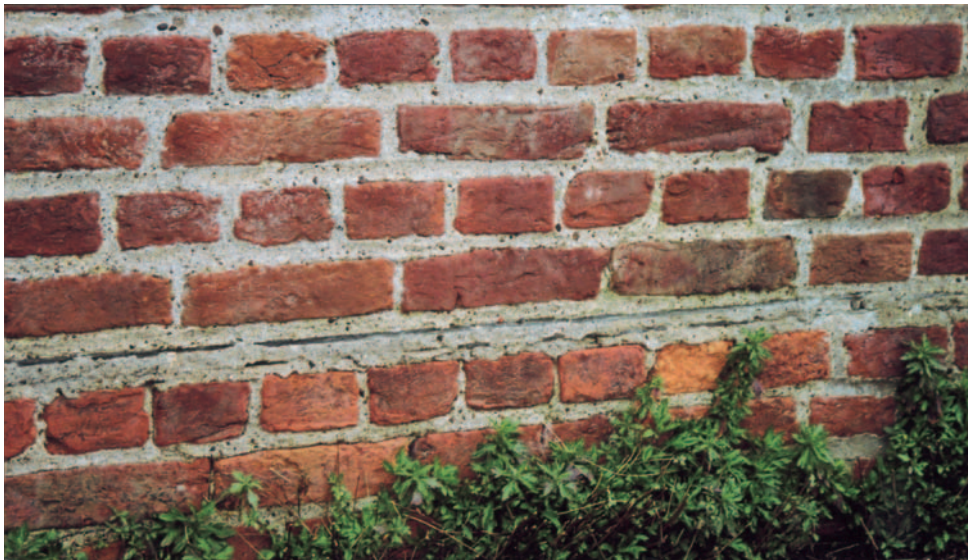
**FIG 4.18** Hand-made red facing bricks set in lime mortar to English Bond with a two-course slate damp-proof course. Good ground clearance below the damp-proof course.
