SEVENTH EDITION

# BUILDING SURVEYS

PETER GLOVER

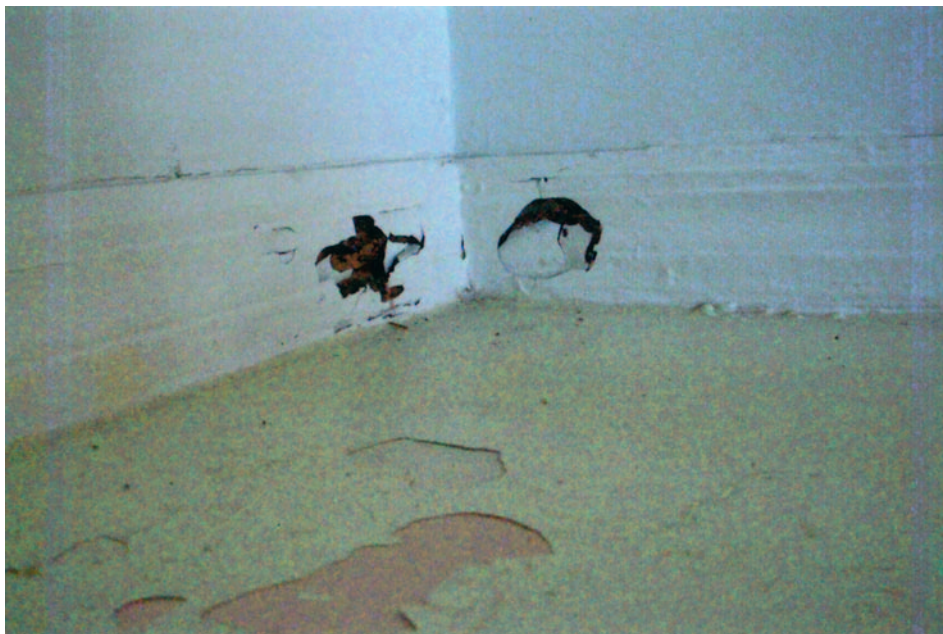
**FIG 5.1** A solid concrete floor and masonry walls. The damp-proof membrane in the floor is not contiguous with the damp-proof course in the walls, allowing dampness to rise up behind the skirting boards resulting in rot. Look out for rusting nail heads showing through skirting board paintwork – a sure sign of dampness behind. Fortunately, in this case there is no adjacent timberwork, so the remedy is to deal with the damp and replace the skirtings. If this were a timber floor then more extensive investigation would be needed to establish how far the rot had travelled beneath and whether the true dry rot fungus – *Serpula lacrymans* – may be active.

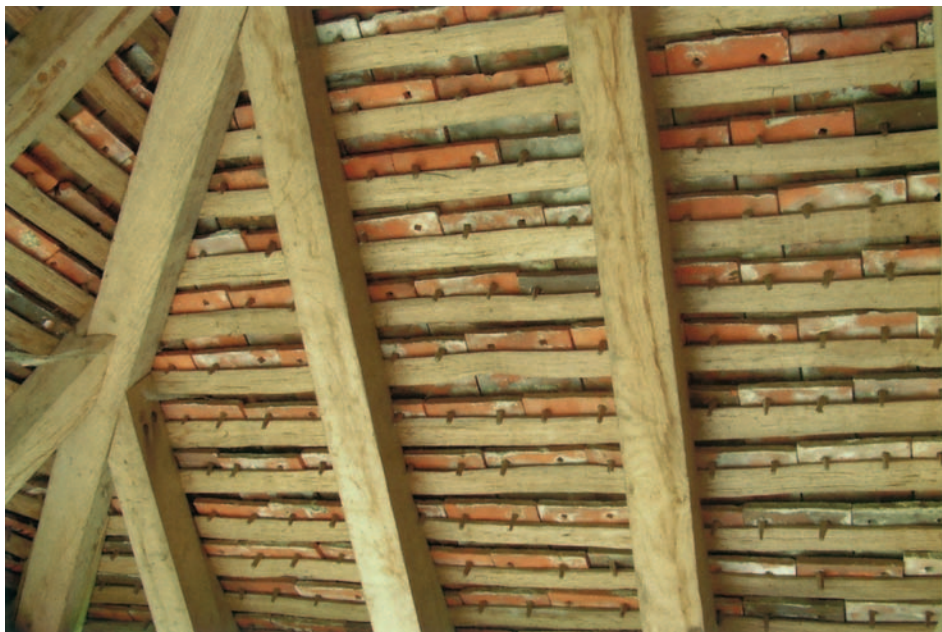
**FIG 6.1** Double lap plain clay tiles held in place using traditional wooden pegs on battens with no underfelt. Pegs may rot or shrink causing them to fall out – as has happened to some here – then tiles slip. Tiles can be replaced and, if there is no underfelt, new pegs inserted from beneath, although then the pegs will taper the wrong way and need to be pinned to the battens. This type of tile was gradually superseded in the 19th century by plain tiles with nibs to hold the tiles on the battens. These plain tiles with nibs remain very popular today in both traditional clay and modern concrete form and incorporate nail holes just below the nibs so that they can also be nailed to the battens for an even more secure fixing.

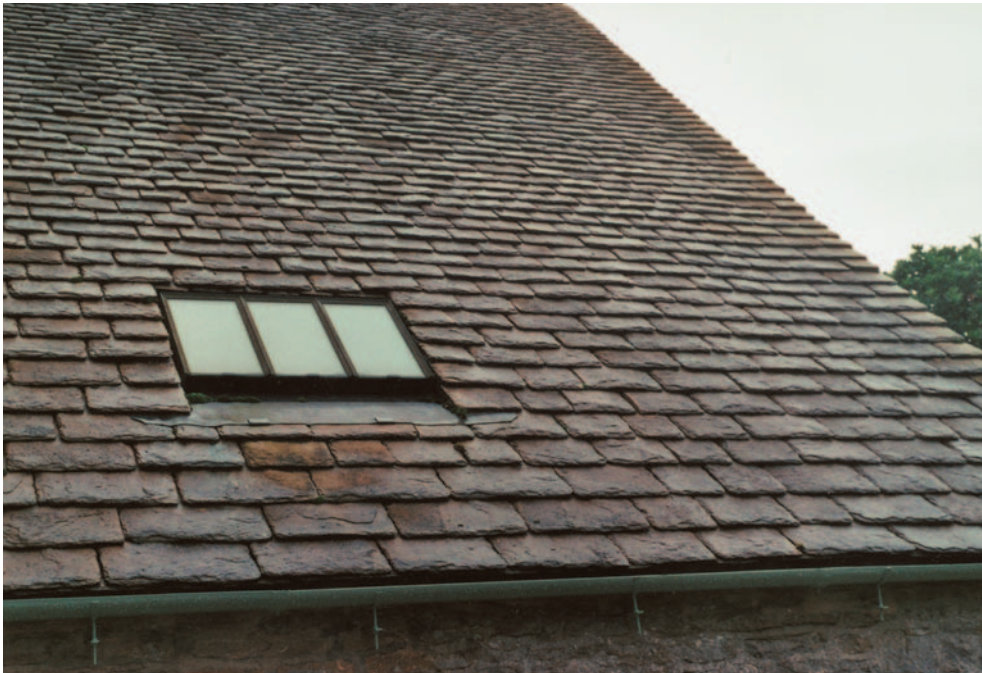
**FIG 6.2** Cotswold stone roof with skylight and lead apron. Careful attention to detail is needed if leakage around skylights is to be avoided.

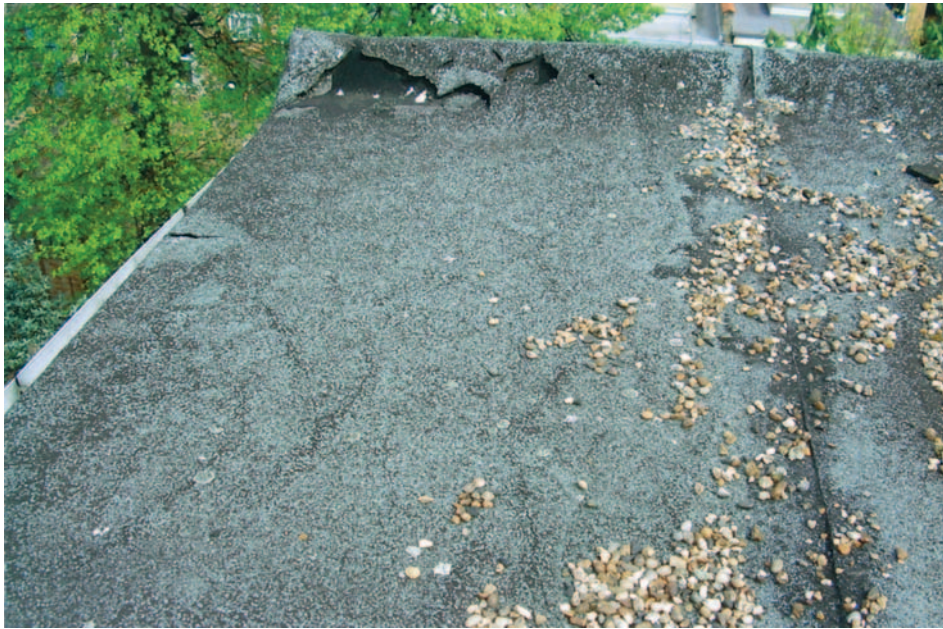
**FIG 6.3** A flat roof surfaced in three layers of built-up mineral felt to British Standard 747. Typical life expectancy is less than 10 years. A number of important matters cannot be confirmed without exposure including the condition of timbers, insulation, ventilation under the decking and the presence or otherwise of a vapour barrier. Take care when walking on one of these roofs – the decking may be rotten, and collapse is possible. Watch out for holes cut in the ceiling beneath for downlights, or similar; these can provide a mechanism for warm damp air from the interior to pass into the roof void condensing on timbers and causing premature flat roof failure.

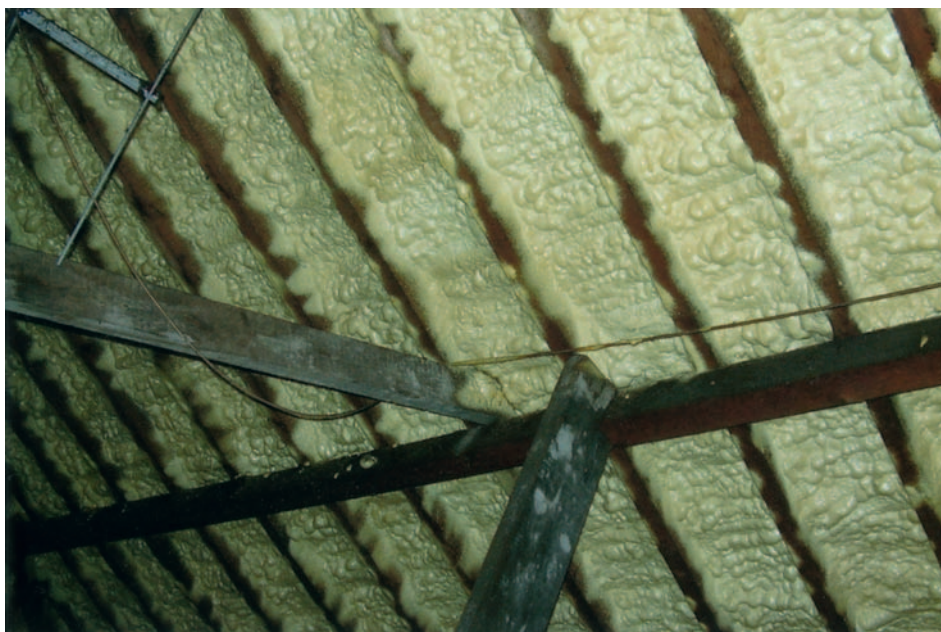
**FIG 6.4** Homeowners will sometimes be encouraged by a salesman to have sprayed foam insulation applied from within the roofspace under the tiles and battens between the rafters. I do not recommend this as the timbers cannot breathe, and if they become damp, rotten battens and rafters may result. A roof needing this type of treatment is probably due for recovering with tiles, battens and sarking felt, incorporating ventilation. The best place for insulation is directly over the ceilings between the joists.

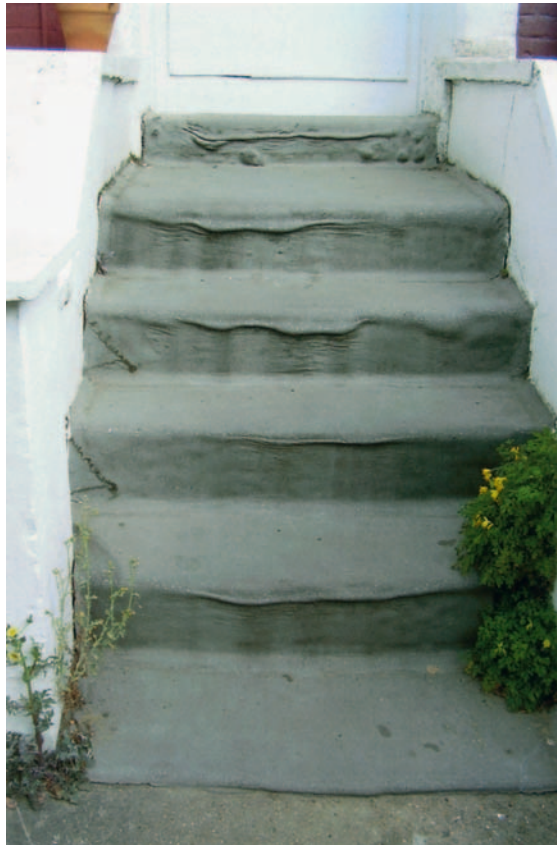
**FIG 6.5** Asphalt is used for flat roof covering, basement tanking and as a waterproof surface coating to steps if there are vaults or other accommodation beneath. Vapour blowing and creep can be a problem. Creep to the asphalt on these south-facing steps results from poor preparation and application of the asphalt exacerbated by trapped moisture and exposure to the full heat of the sun.

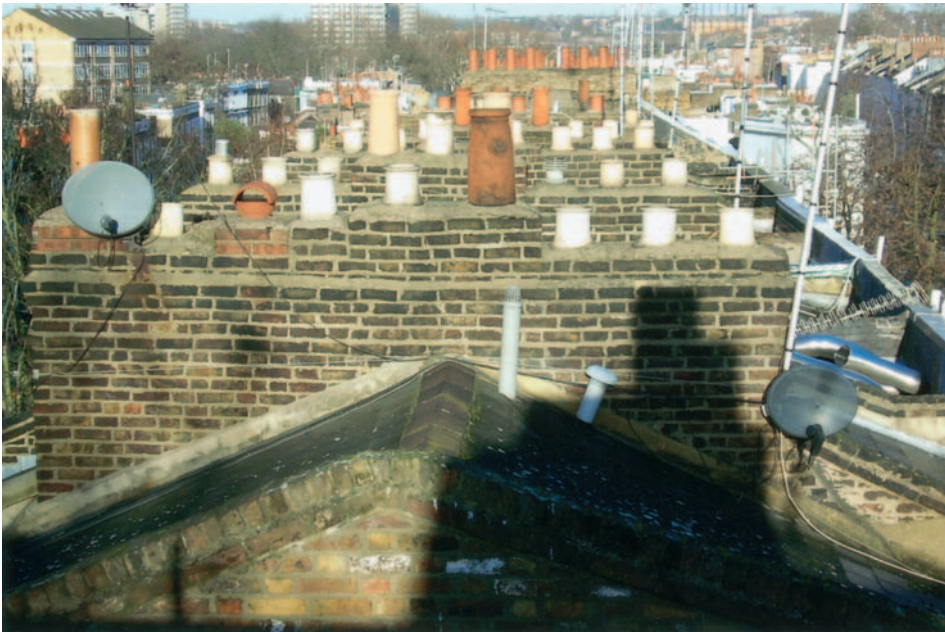
**FIG 6.7** In Victorian London almost every room had a fireplace with the flues gathered together in shared chimney stacks over the party walls. Lots of scope here for downward damp penetration. Redundant flues should be vented at the base with hooded pots on top to keep them dry. Often only a limited view will be available from ground level even with the use of binoculars but many of these roofs have external trapdoors from the roofspace, especially the centre-valley or “butterfly” London roofs, so the surveyor can climb out onto the roof to view the construction at close quarters.

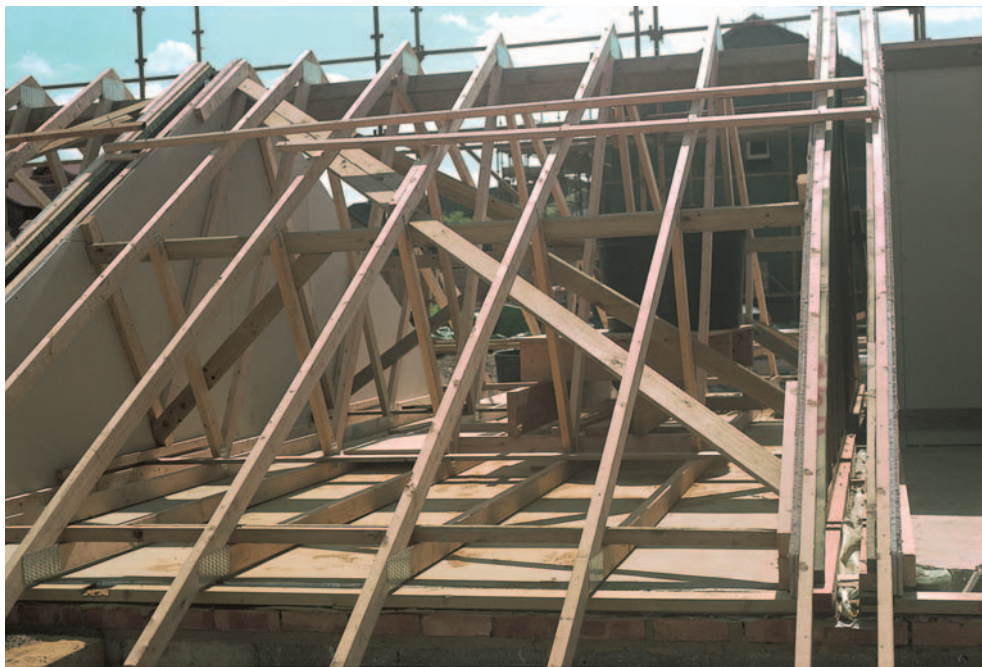
**FIG 6.8** Modern gang-nailed trussed rafter roofs require diagonal bracing and gable-end strapping to prevent racking.

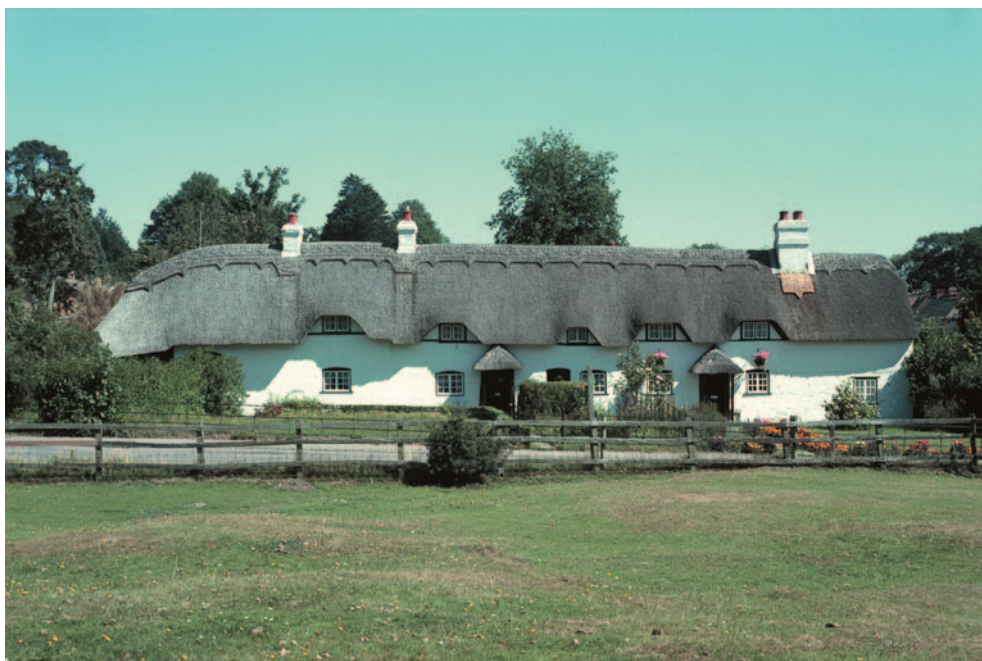
**FIG 6.9** Hampshire thatch with eyebrow window details.

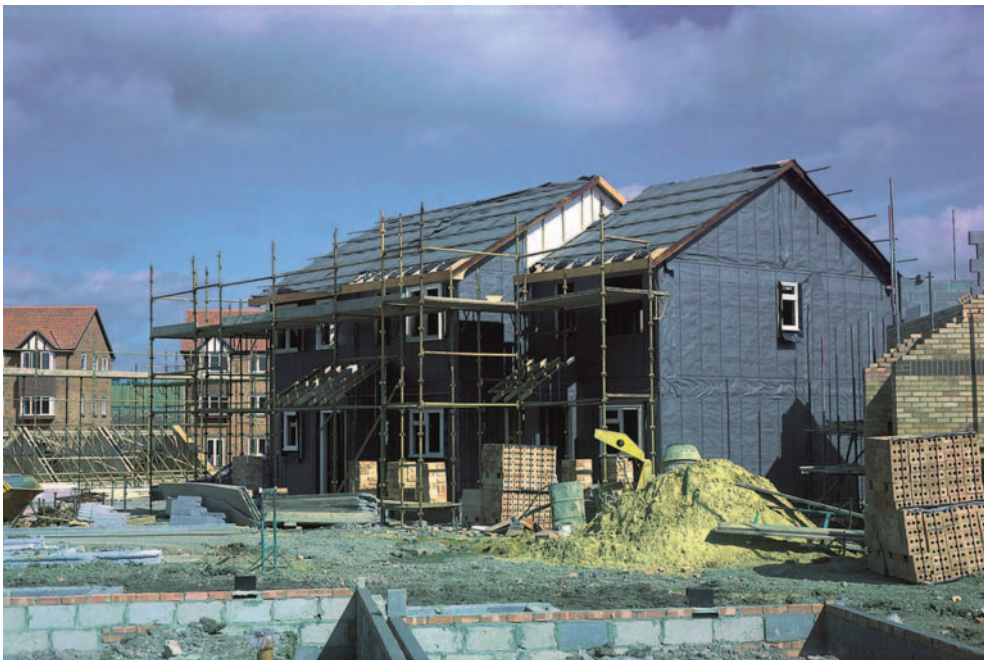
**FIG 7.1** Timber frame house under construction in an estate. Note the breather membrane over the timber frame inner skin to the prefabricated timber frame construction.

**FIG 7.2** A traditional brick and block house under construction in the same estate as the house in Fig. 7.1.

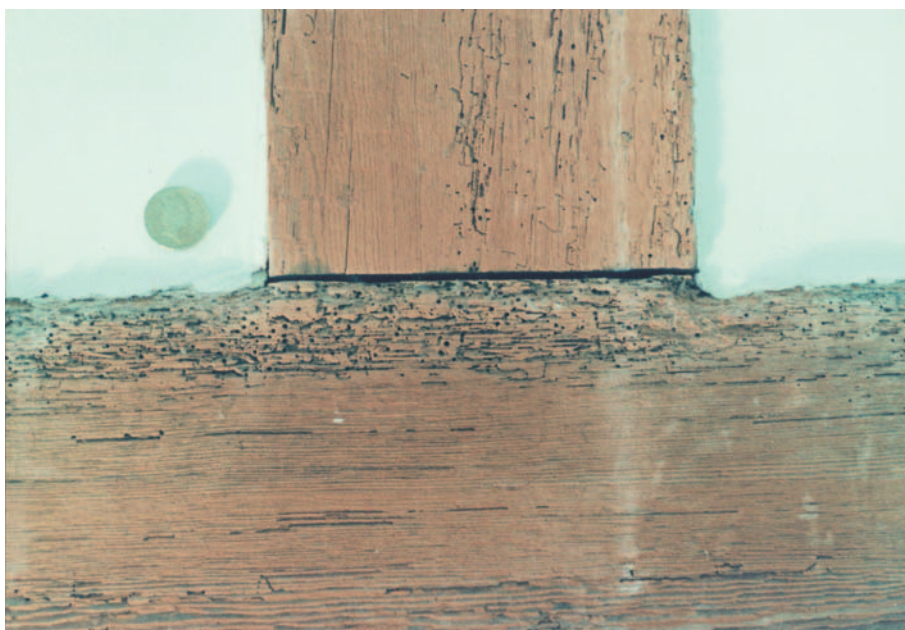
FIG 7.3 Flight holes of the common furniture beetle (*Anobium punctatum*) in relation to a £1 coin.

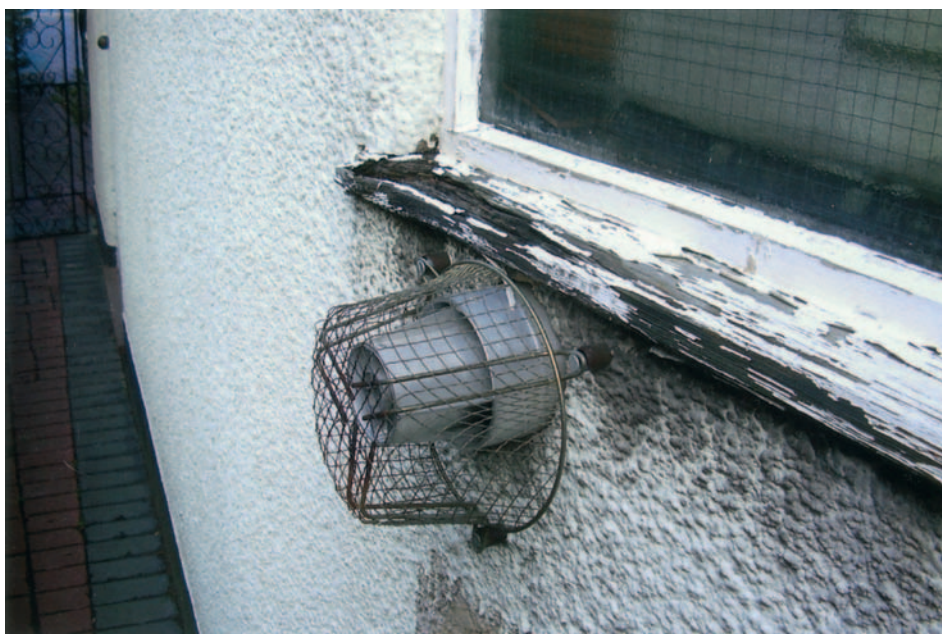
**FIG 9.2** The location of this balanced flue directly under the window sill would not comply with current regulations. The discharge of flue gases – mostly water vapour – has had a predictable consequence in the form of wet rot to the window woodwork.

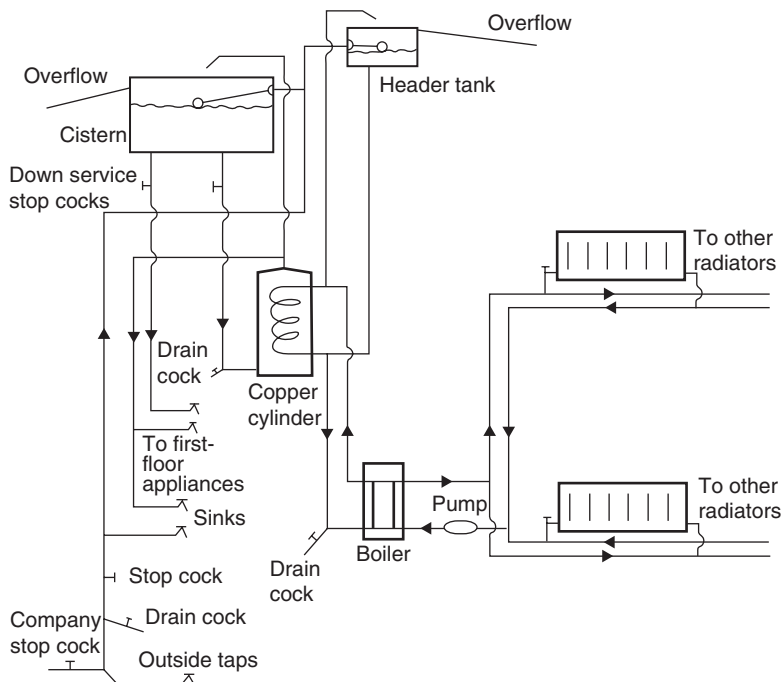
**FIG 9.3** Diagrammatic layout of a simple domestic water and heating system using copper piping in 15-, 22- and 28-mm diameters. Indirect gravity primary circulation is provided to the cylinder. A pumped heating system is provided in small-bore, two-pipe layout to pressed-steel panel radiators.

Figure 9.3 illustrates diagrammatically the layout of a typical water- and central-heating system likely to be installed in a small residential or commercial property dating from the nineteen-sixties or nineteen-seventies. Such a system is simple with only a single pump on the heating circulation and very little to go wrong. Provided that the system is correctly installed and the radiators and pipework are protected from chemical corrosion by an inhibitor, such a system should prove reliable and serviceable for 20–30 years before major renewals or repairs are needed. Occasional servicing and attention

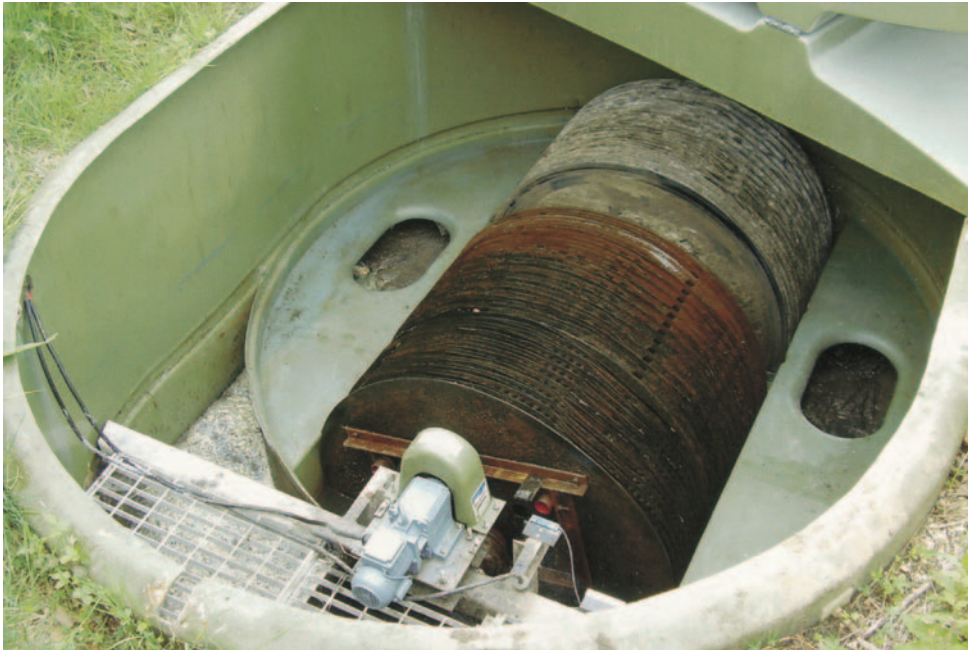
**FIG 9.4** When mains drainage is not available a modern alternative is the Klargester Biodisk septic tank drainage system. Effluent enters the system and is rapidly broken down by bacteria with the process hastened by the electric motor and rotating disks which increase the exposure to oxygen in the air. The treated effluent emerging from the system is clear water suitable for draining into soakaways or an adjoining water course. Consent to discharge effluent is required from the Environment Agency. Periodic de-sludging is necessary.

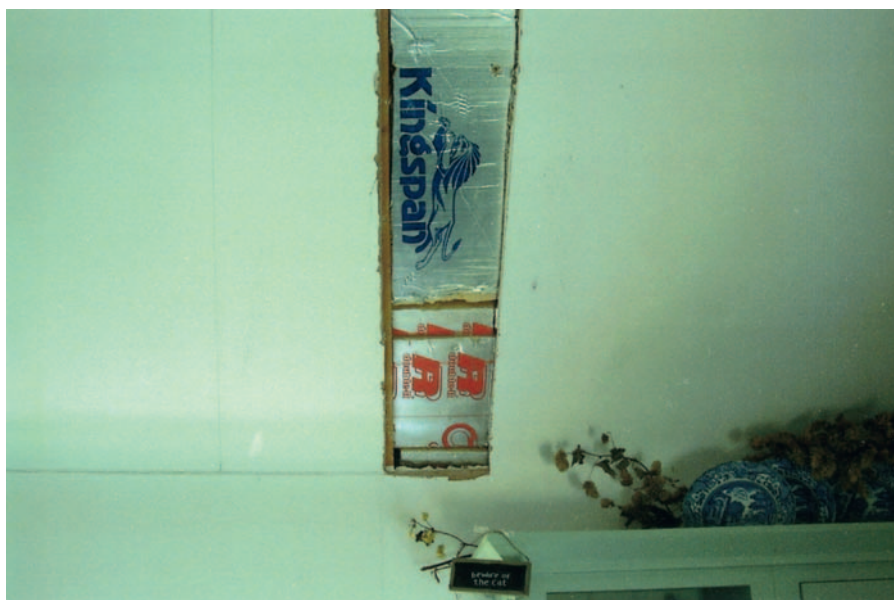
**FIG 11.2** A section of plasterboard to a sloping ceiling is removed revealing Kingspan foam insulation panels. Normally, the actual level of insulation above a ceiling cannot be confirmed in these circumstances because there is no access behind. So, the computer program used to provide an energy rating makes certain assumptions based upon the age of the property and the Building Regulations applicable at the time it was built. This presupposes, of course, that the property is correctly dated and that the builders complied with the Regulations.

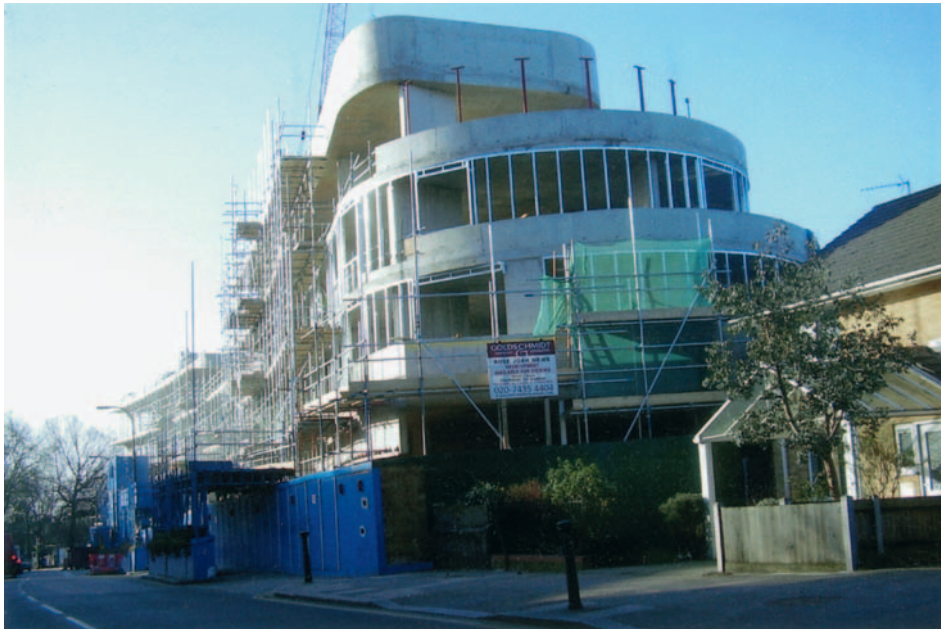
**FIG 12.1** Concrete is artificial stone and ferrous reinforced cast-in-situ concrete construction makes use of some fortuitous chemistry. Steel reinforcement encased in Portland cement concrete does not normally rust, being protected by the alkali cement so provided that the depth of concrete covering the steel bars is satisfactory and so long as deleterious chemicals such as chlorides, sulphates or high alumina cement are not present, this type of construction is very durable. It also presents architects with the facility to incorporate slender columns and curved cantilerved elevations as in this building under construction in north London.

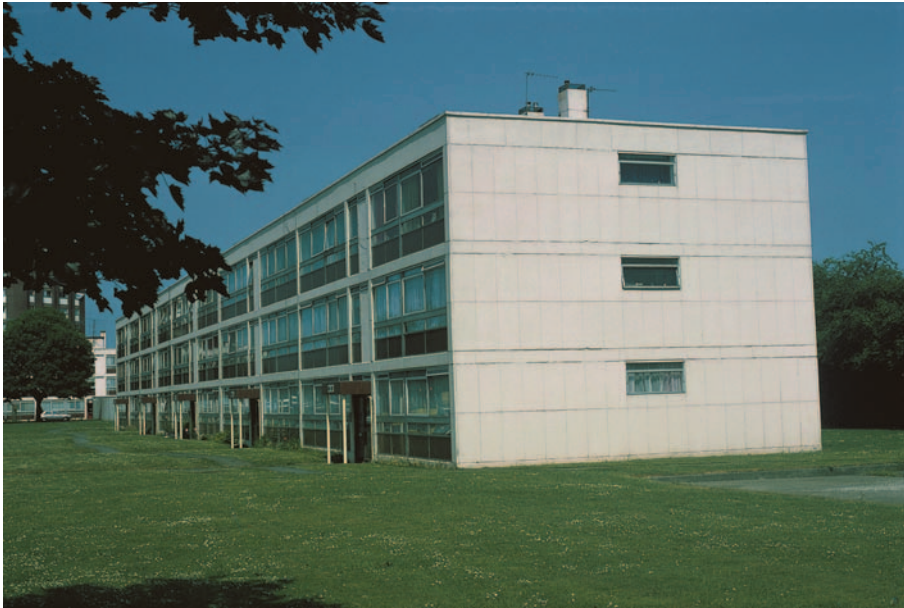
**FIG 13.1** Flats system built in the 1960s using pre-cast concrete panel construction. This construction may be unacceptable as mortgage security for most mainstream mortgage lenders.

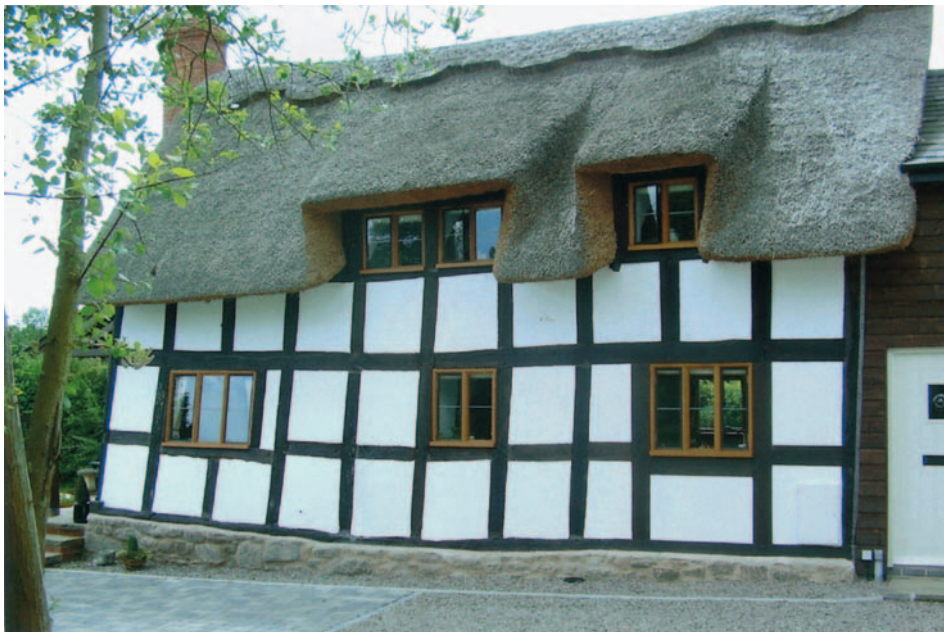
**FIG 15.1** A “black and white” house in Herefordshire. A framework of oak wallplates, studs and beams provides the strength with an infilling of single skin brick, cob or wattle and daub. Timbers are morticed and tenoned using oak pegs. Walls are finished off inside and out with a lime render and lime wash. The structure sits on a stone pinning. Similar building methods were used throughout the middle ages. In Lincolnshire these houses are referred to as “Stud-and-mud” with a cob infilling generally used, and this type of construction crossed the Atlantic and was used by the first English settlers in Jamestown, Virginia.

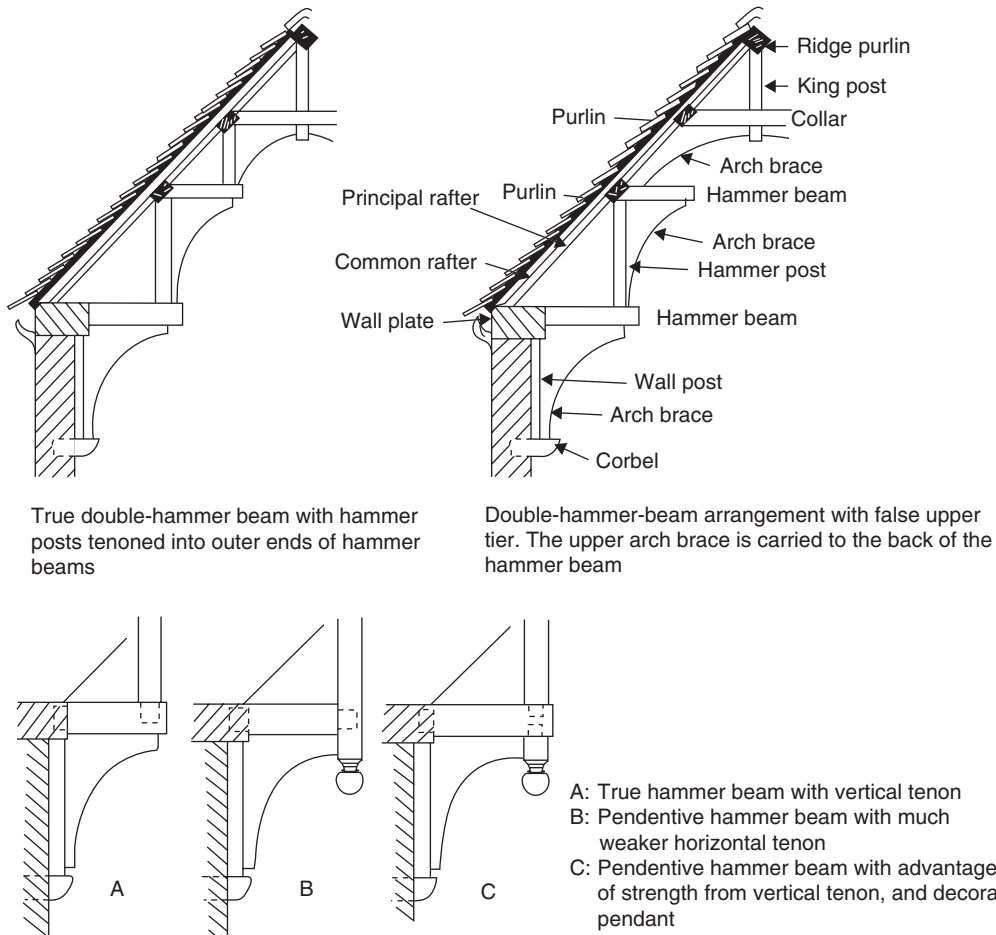
**FIG 15.2** Typical hammer-beam construction used mainly in churches and cathedrals. Detailed knowledge of this type of construction is essential before an accurate assessment of strength may be made.

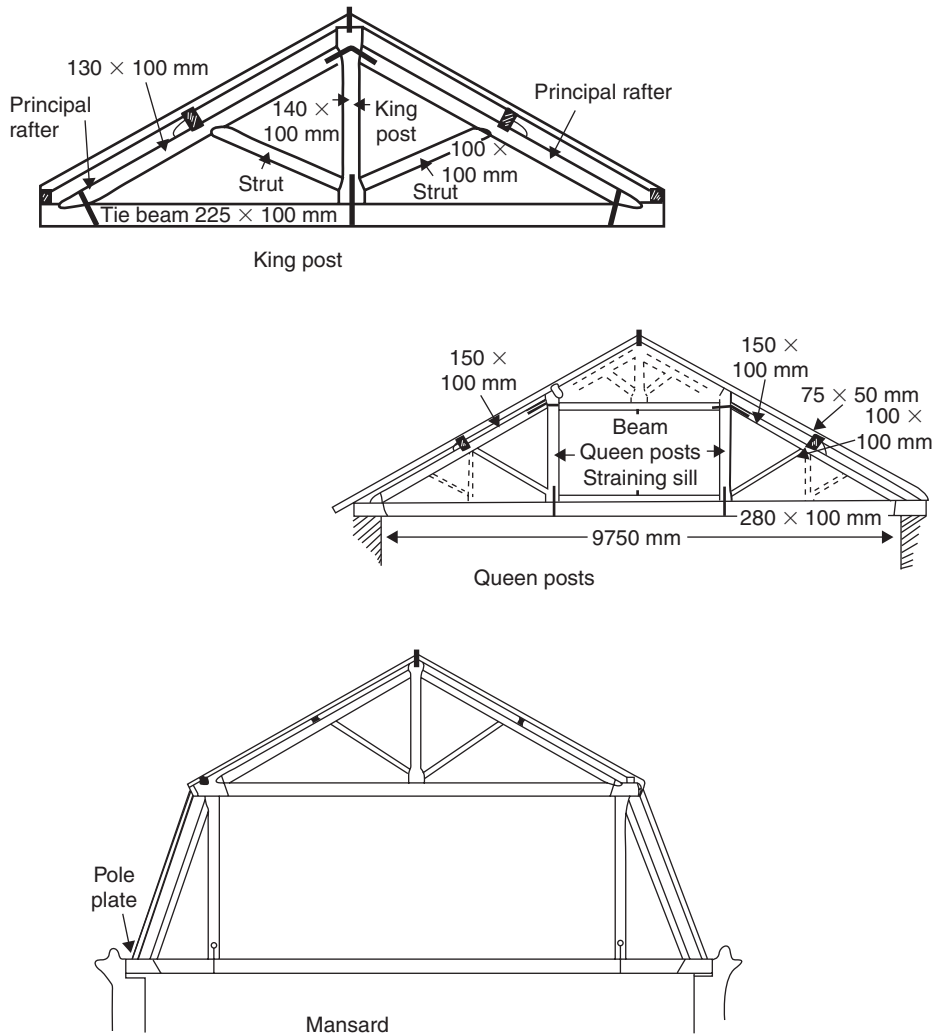
FIG 15.3 Early timber trusses, variations of which will be commonly encountered in older buildings.

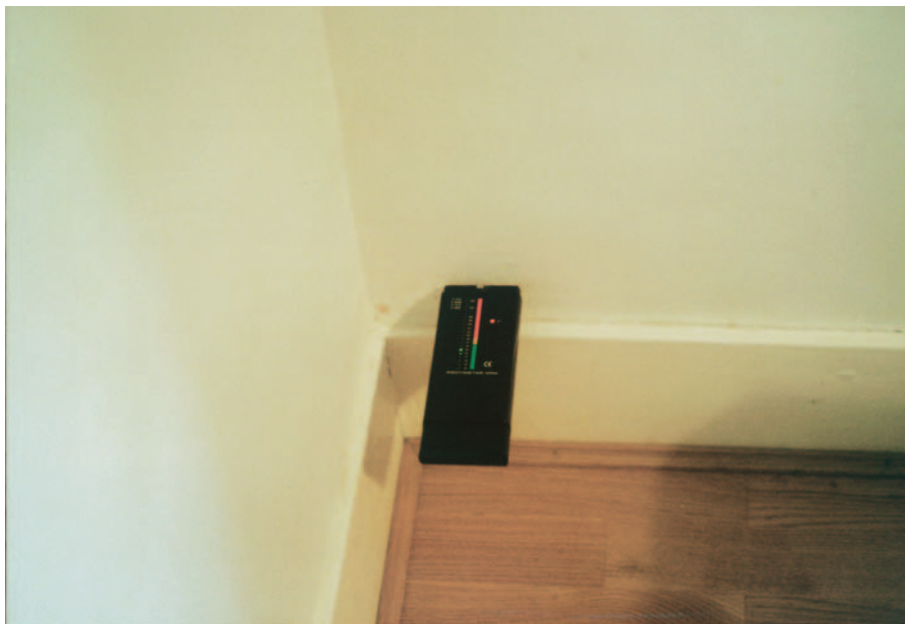
**FIG 18.2** Testing No. 1 Suburban Road for damp. The green light on the left indicates that the wall is dry. If the light moves up into the red sector it would indicate increasing levels of moisture in the wall plaster. This would not necessarily indicate rising damp due to failure of damp-proof courses however; there are many other reasons why wall plaster could be damp.

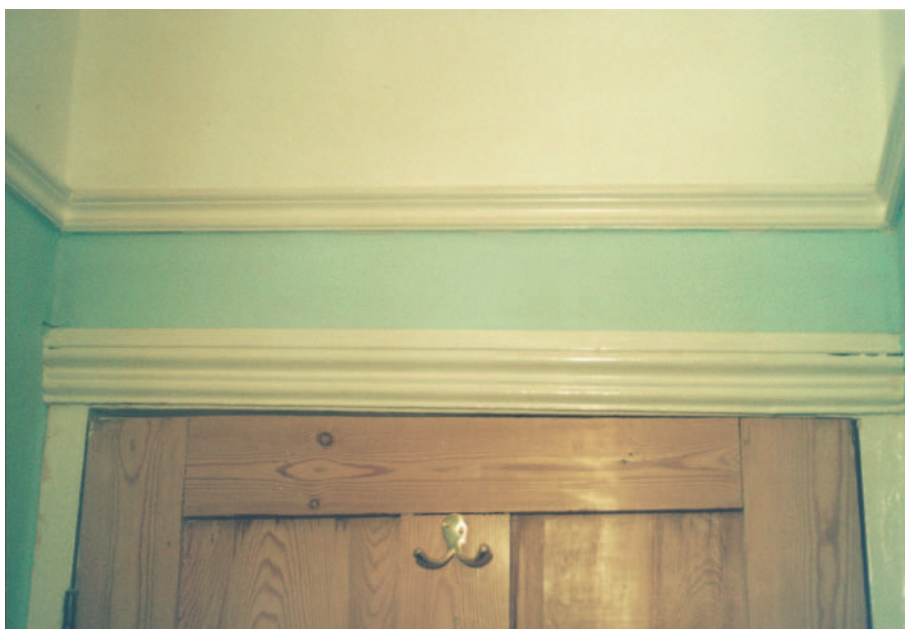
**FIG 18.3** Sloping door head due to downward settlement of partition walls.

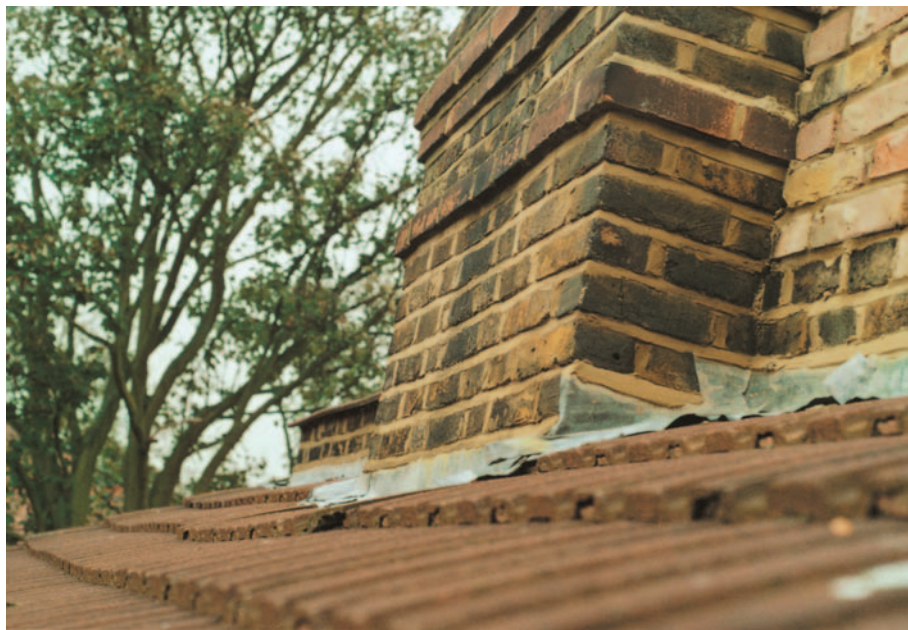
**FIG 18.4** Loose and lifting lead flashings will allow driving rain to penetrate.

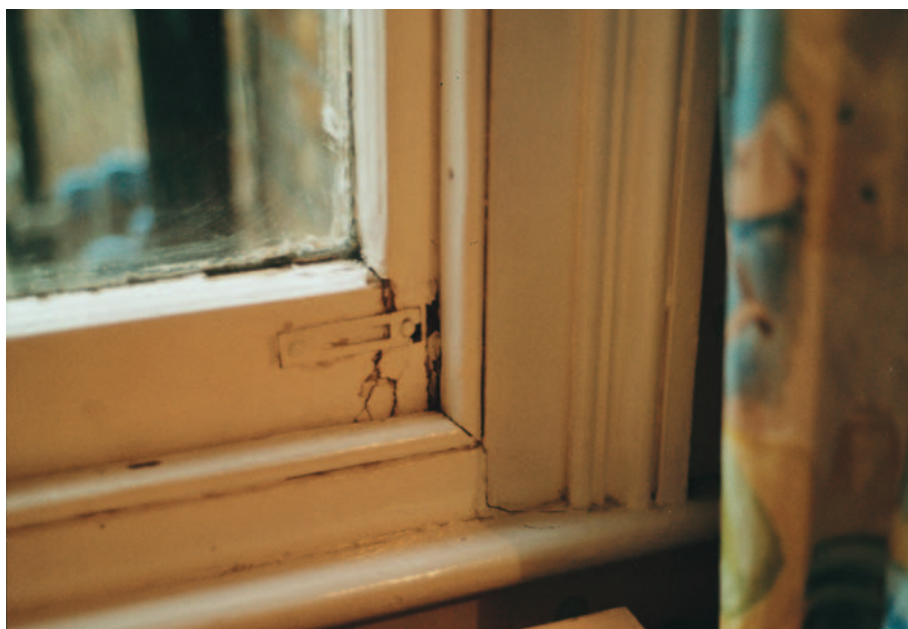
**FIG 18.5** Significant expenditure on repairs or replacements of window frames will be needed prior to the next redecoration.

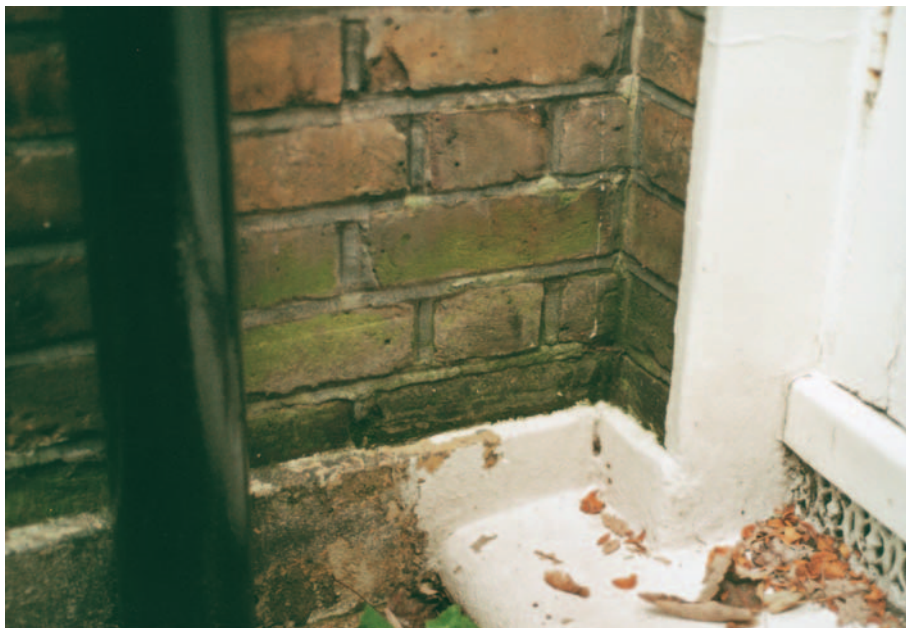
**FIG 18.6** Green algae and moss growing at the base of a wall due to gutter splash.

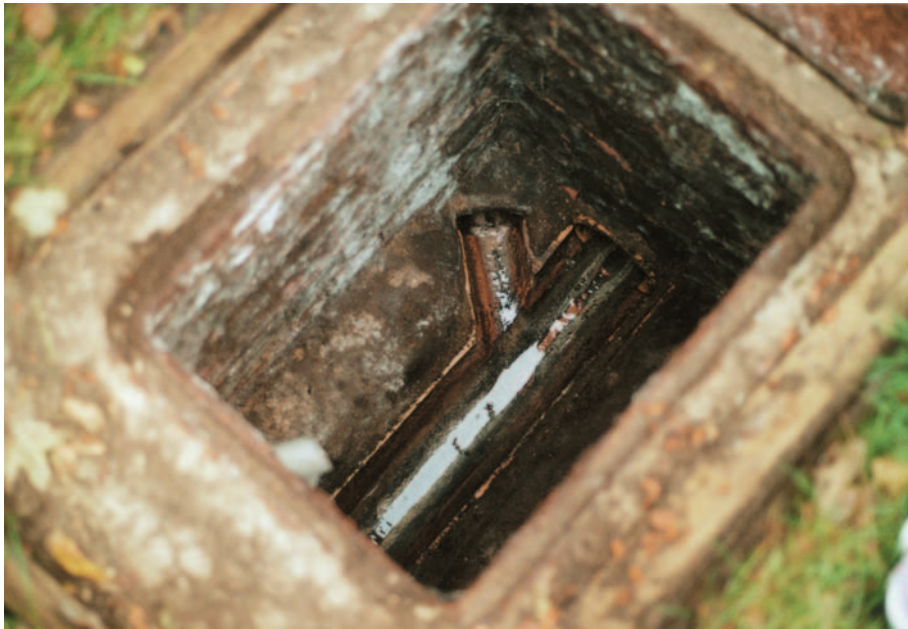
**FIG 18.8** One hundred year old drains. Drain flow satisfactory.

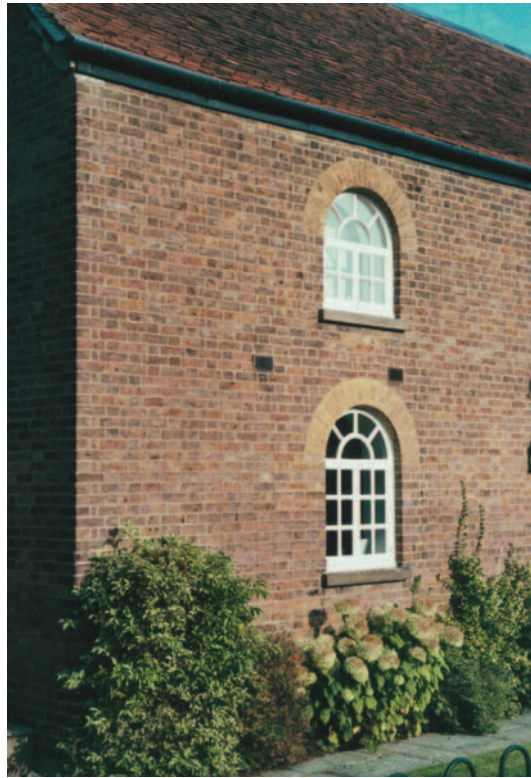
**FIG 21.3** London Stock brick set in lime mortar to Flemish bond. Properly formed arches are self-supporting and do not need lintels. Bricklayers who set out the corners are known as 'corner men' whilst those who infill with the main runs of brickwork are known as 'line men'. Corner men are the most experienced and the final appearance of the wall depends very much on their skill.

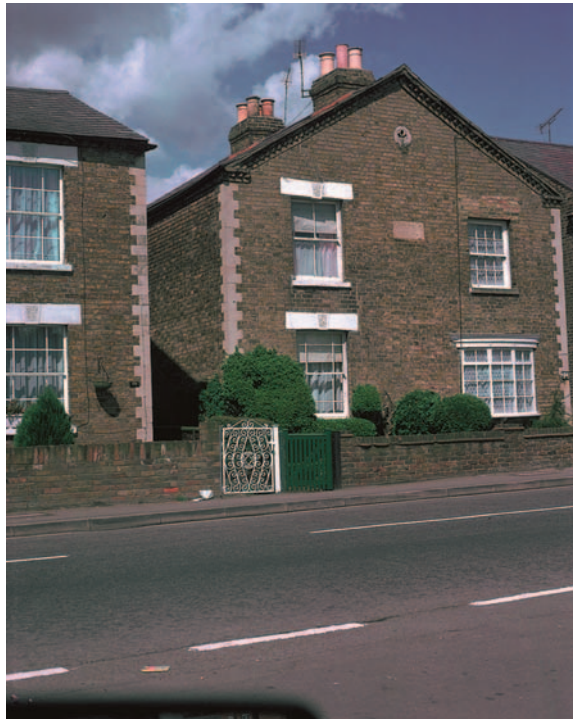
**FIG 21.4** The arch over first floor window has spread and the lintel has dropped. This section of wall will need to be rebuilt.

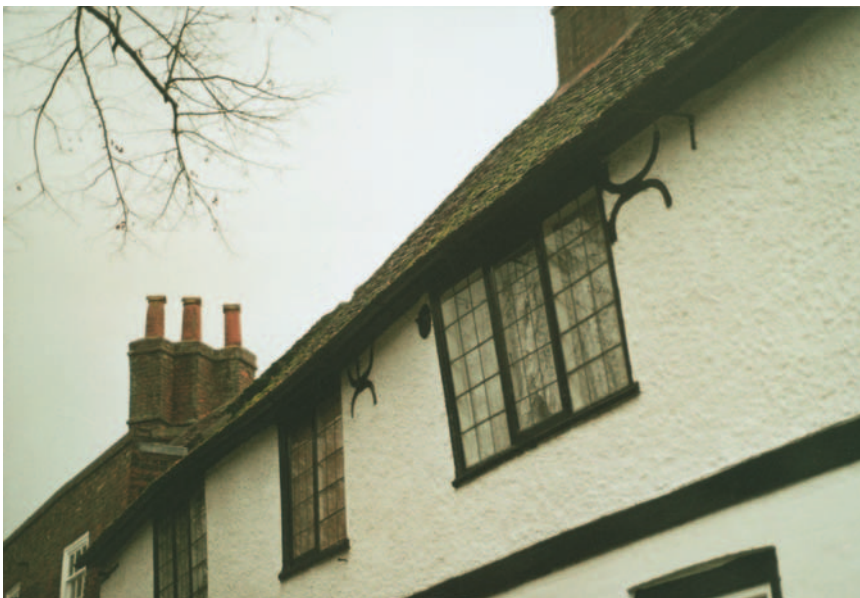
**FIG 21.5** The wall around this window leans out and has been restrained by the use of tie bars with the painted tie bar plates used as an added decorative feature. The tie bars will only work if the steel rods are in good order and very firmly secured at the other end.

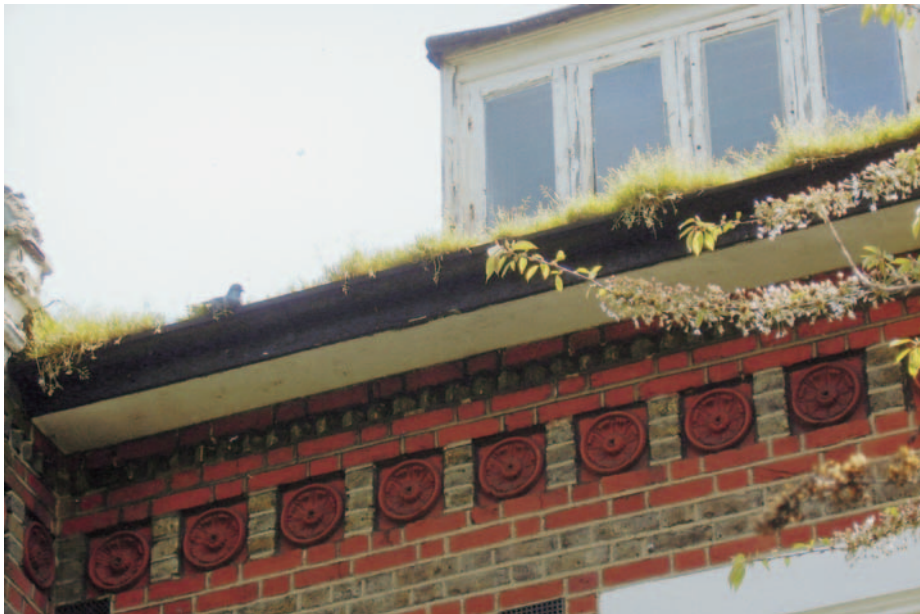
**FIG 21.6** The grass growing in this gutter results from years of neglect. Sometimes conservation is just a matter of common sense.
