Forensic Engineering

Proceedings of the
Fourth Congress

FORENSIC ENGINEERING

October 6–9, 2006
Cleveland, Ohio

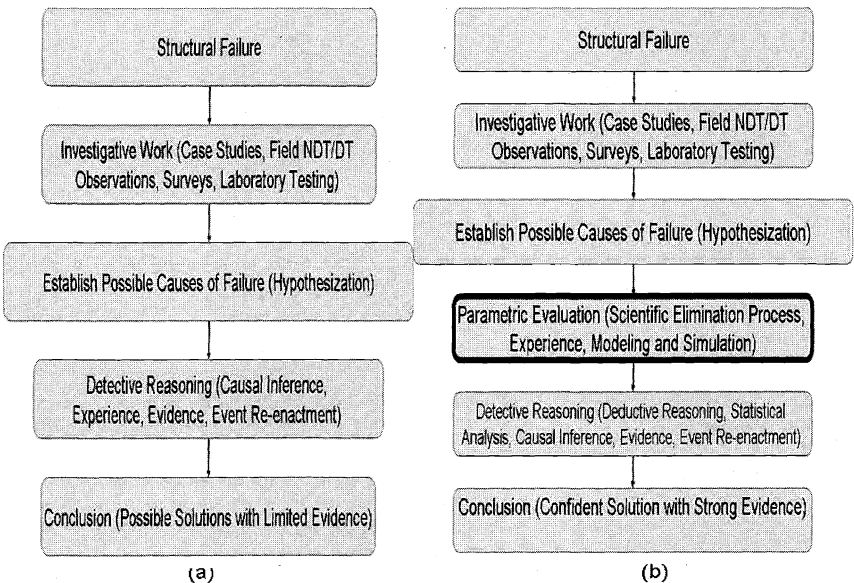
Figure 1 Forensic Investigation Processes: a) Current and b) Experiment-Based

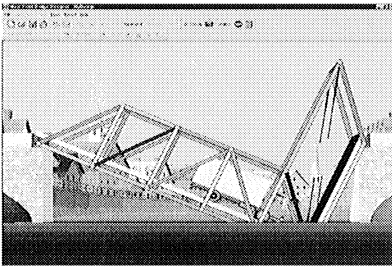
Figure 2 WPBD showing failed bridge during truck crossing

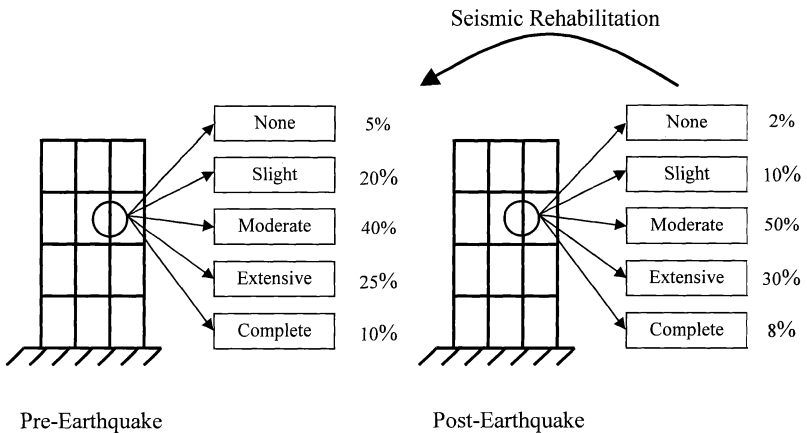
Figure 1. Seismic rehabilitation to prior condition damage state probability equivalence.

is calculated (e.g. it could be 2%, 10%, 50%, 30%, and 8% probability of being in the None, Slight, Moderate, Extensive and Complete Damage States, respectively, for a 10% in 50-year earthquake). To bring the building back to its pre-earthquake condition these probabilities must be brought back to their pre-earthquake values. Figure 1 illustrates this approach, where the damage state probabilities are the equivalency parameters.

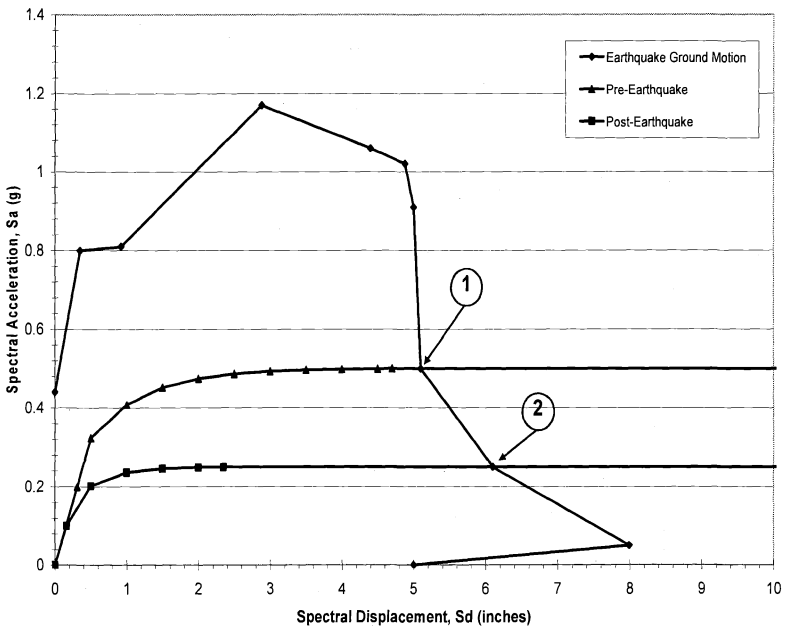
Figure 2. HAZUS earthquake ground motion and building capacity curves.

The structural engineer first obtains, for the earthquake that occurred, an estimate of the earthquake ground motion at the building site. Either by direct measurement or the use of earthquake ground simulation methods, the earthquake ground motion can be estimated. Figure 2 shows one form of such an estimate which is a plot of the Spectral Acceleration (S_a) versus Spectral Displacement (S_d) – essentially the capacity curve used in the HAZUS methodology, denoted as the Earthquake Ground Motion in Figure 2.

The next step in the method is to develop the building capacity curve for the pre-earthquake and the post-earthquake conditions. Figure 2 shows these two capacity curves. For this specific example ground motion and capacity curve, the value of the spectral displacement at the building roof for the pre-earthquake condition, Point 1 in Figure 2, is 5.1 inches and for the post-earthquake condition, Point 2 in Figure 2, is 6.1 inches.

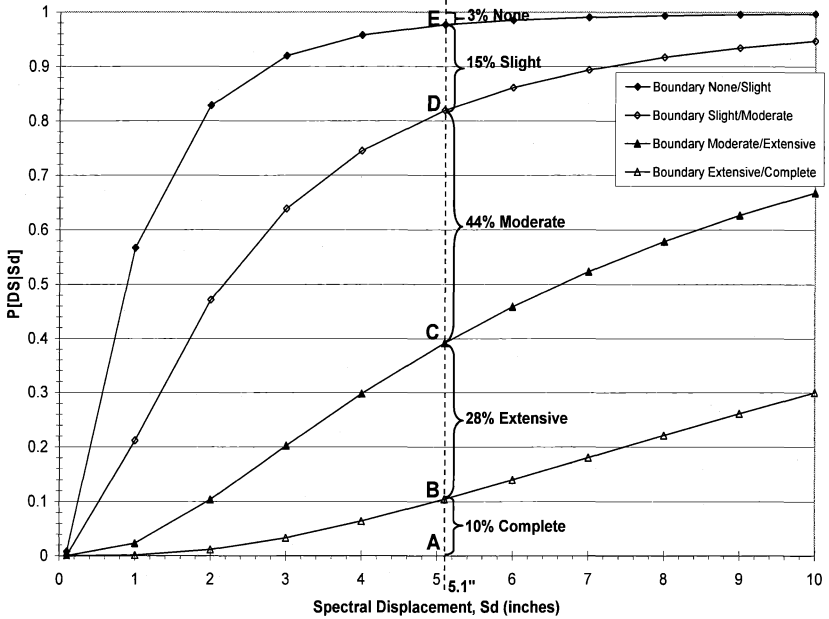
Figure 3. Pre-earthquake HAZUS damage states.

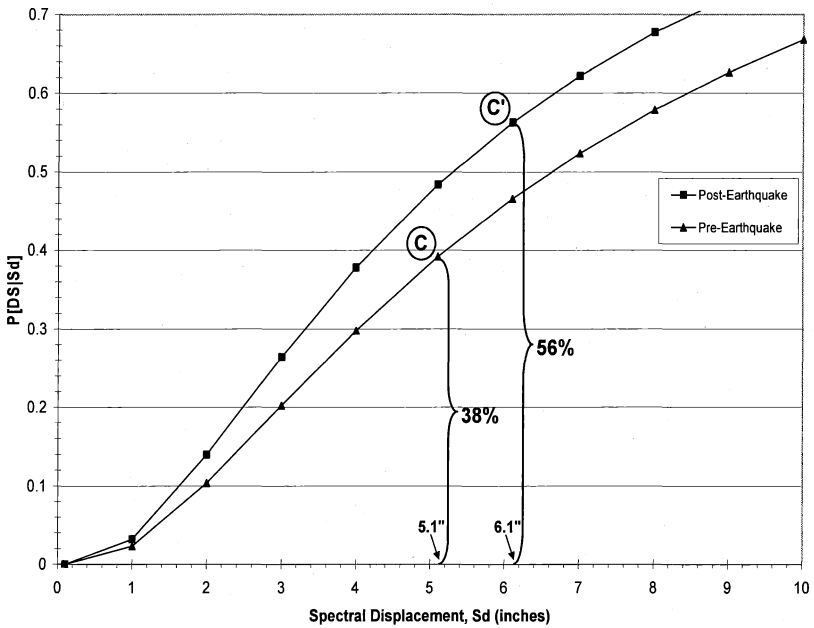
Figure 4. Pre- and Post-earthquake boundary curves between Moderate and Extensive HAZUS damage states.

Figure 4 shows how the boundary between the Extensive and Moderate damage states changes when the building is damaged. The pre-earthquake Point C has now moved to location C^1 for the roof displacement value of 6.1 inches for the damaged building. It then follows from this figure that the probability that the building experienced either Extensive or Complete damage has increased from 38% for the pre-earthquake condition to 56% for the post-earthquake condition. Figure 5 shows all of the fragility curves for this example pre- and post-earthquake building.

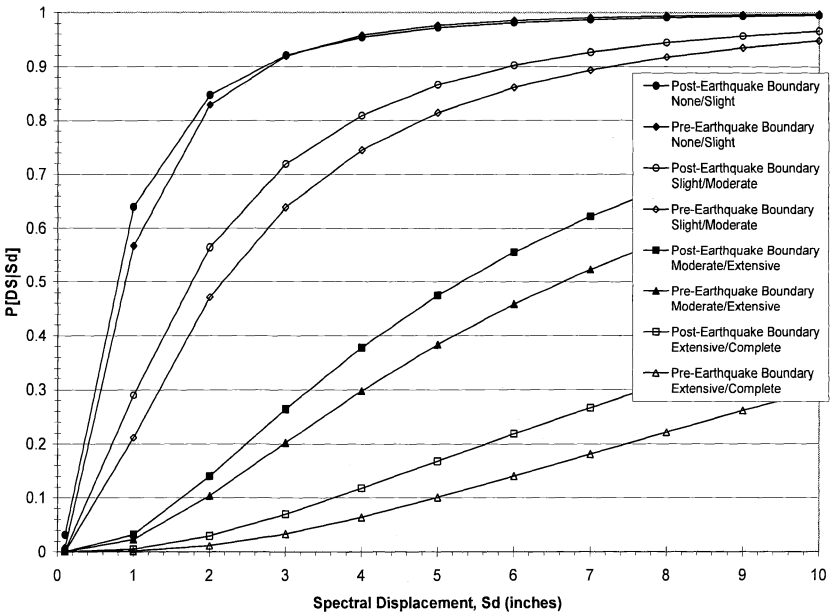
Figure 5. Pre- and Post-earthquake HAZUS fragility curves.

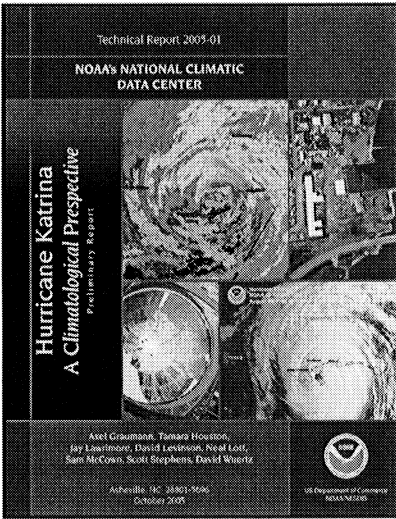
Figure 1: NOAA preliminary report⁴ issued 10/05

National Oceanographic Atmospheric Administration (NOAA), many of the key weather stations failed during the hurricane making it difficult to quantify information on the storm. NOAA and other forensic meteorologists published their findings and analyses several weeks after the hurricane event [see Figure 1]. In some cases, computer modeling was performed to estimate the hurricane characteristics as it struck the coastline.

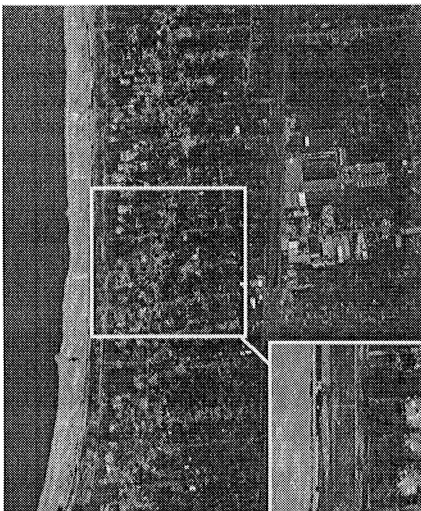
Figure 4: Aerial photographs of damages near Gulfport, Mississippi after Hurricane Katrina [provided by NOAA]. Note the difference in damages in buildings on either side of the debris field. The debris field was created by the storm surge, and those structures impacted by the storm surge were essentially destroyed, whereas buildings inland from the storm surge remained intact.

A tremendous amount of information became available for those assessing Hurricane Katrina damage. Of particular value were aerial photographs of the hurricane damaged areas published by NOAA³ [see Figure 4]. Other valuable resources included weather data from a variety of sources, United States Geological Survey (USGS) topographic maps⁵, and aerial photographs taken prior to the hurricane. The use of these resources to supplement on-site observations provided structural engineers with the means to determine damages caused by high winds versus the storm surge. These resources were available free of charge on the internet. Forensic meteorologists were also available to provide weather information and opinions on the chronology of the wind and surge components of the hurricane.

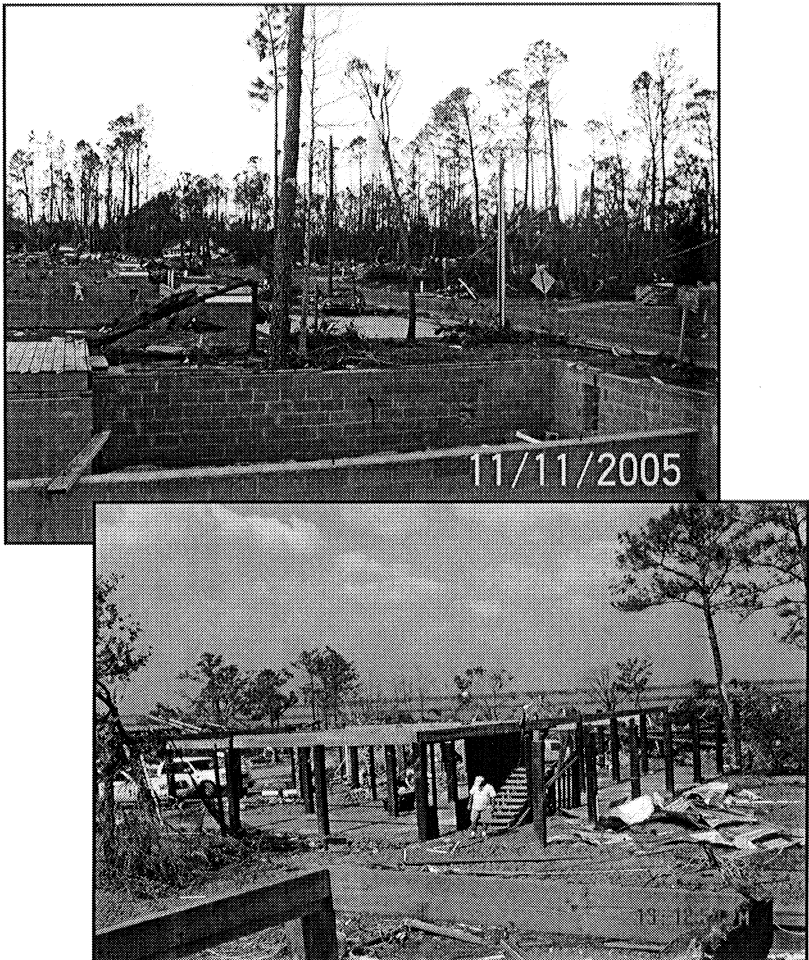
Figure 6: Typical views of devastation along the Mississippi coast caused by Hurricane Katrina. Determining the extent of wind damages prior to the storm surge sweeping through these sites was a daunting task for the structural engineer.

In some coastal neighborhoods, all of the visible building superstructures were destroyed. A structural engineer assessing a distinction of damages caused by high winds before the storm surge swept through the site had a very daunting task. Without the aid of the aforementioned resources, an opinion regarding the extent of the likely wind damages was difficult (if not impossible) to substantiate. Figure 6 shows some of the typical views along the areas with the most severe damage.

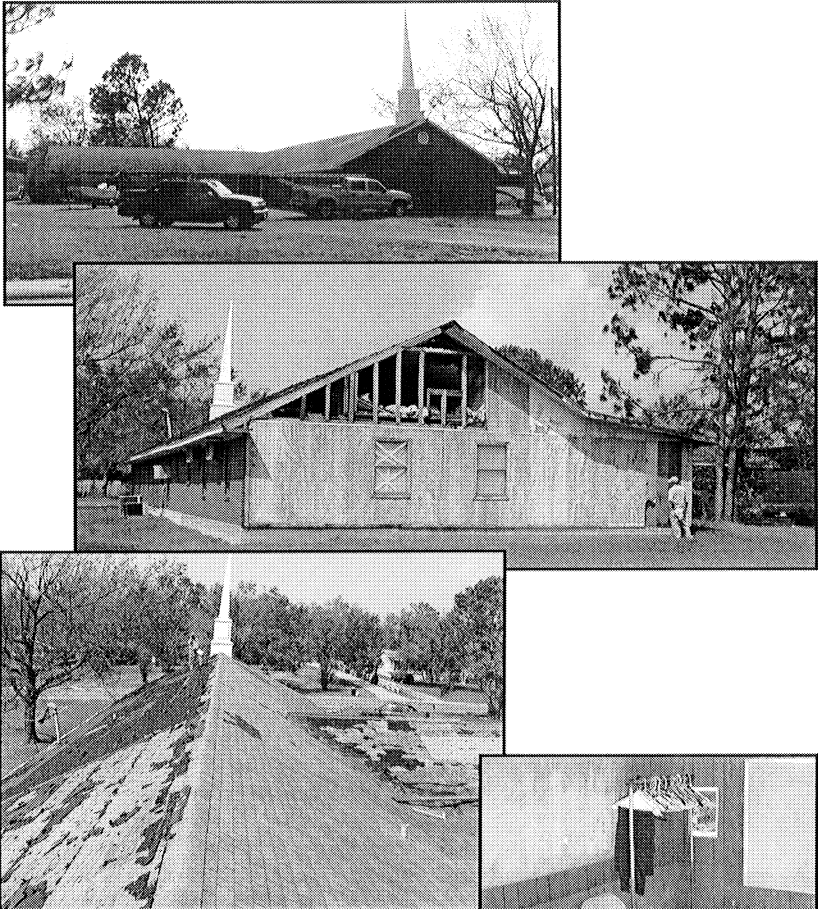
Figure 7: Series of photographs that documented damages to the church structure. In this example, the forces from wind caused the majority of structural damages, while the surge caused extensive water damages to the interior. This is a good example of typical wind damages caused by Hurricane Katrina.

Slow-rising flood waters from the storm surge reached a height of 30-inches above the first floor, causing extensive water damage to interior floor and wall coverings. High winds damaged the roof covering, caused wind-blown debris to penetrate the roof sheathing, and removed roof and wall sheathing panels from the windward gable end. Wind-driven rain entered breaches in the roof covering and gable wall openings causing water damages to the ceilings and partial second story.

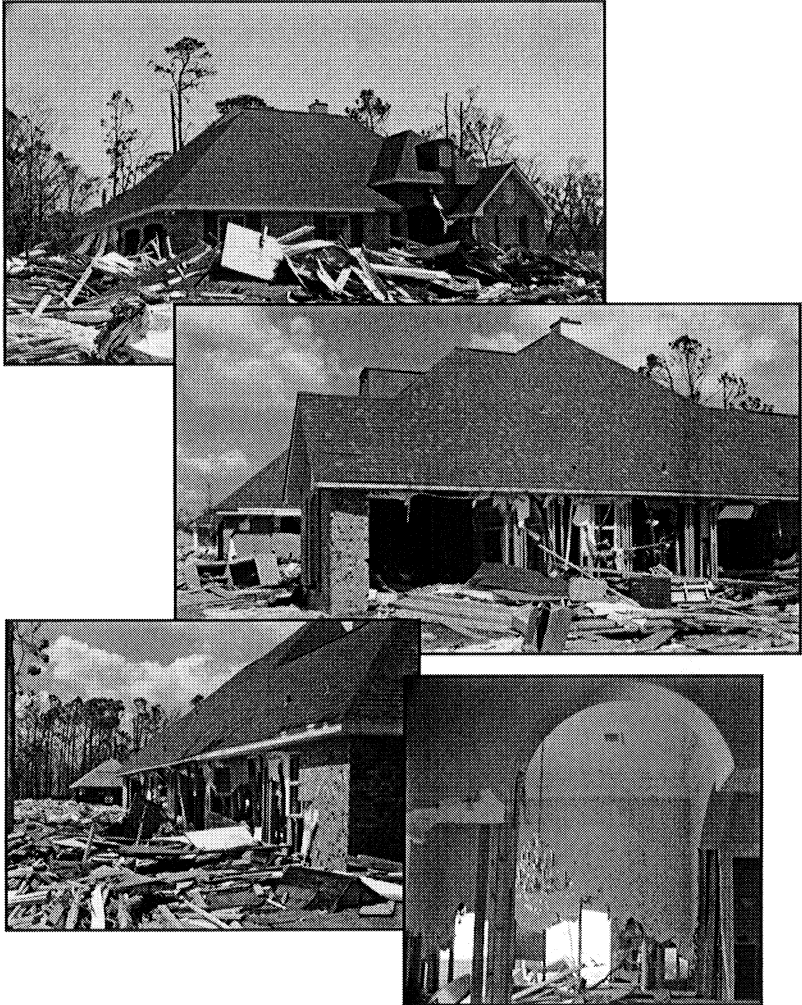
Figure 8: Series of photographs that documented damages to the house. Note that minimal damage was present to the roof covering, while severe damages were on the lower part of the structure. This was a good example of typical damages caused by the storm surge from

The storm surge reached a height of about 10-feet at this site, and caused the destruction of the south exterior wall (facing the beach). The severity of damage was greatest at the first story, consistent with the destructive forces of the storm surge. Relatively minor damage to the roof covering was the extent of wind damages found at this structure.

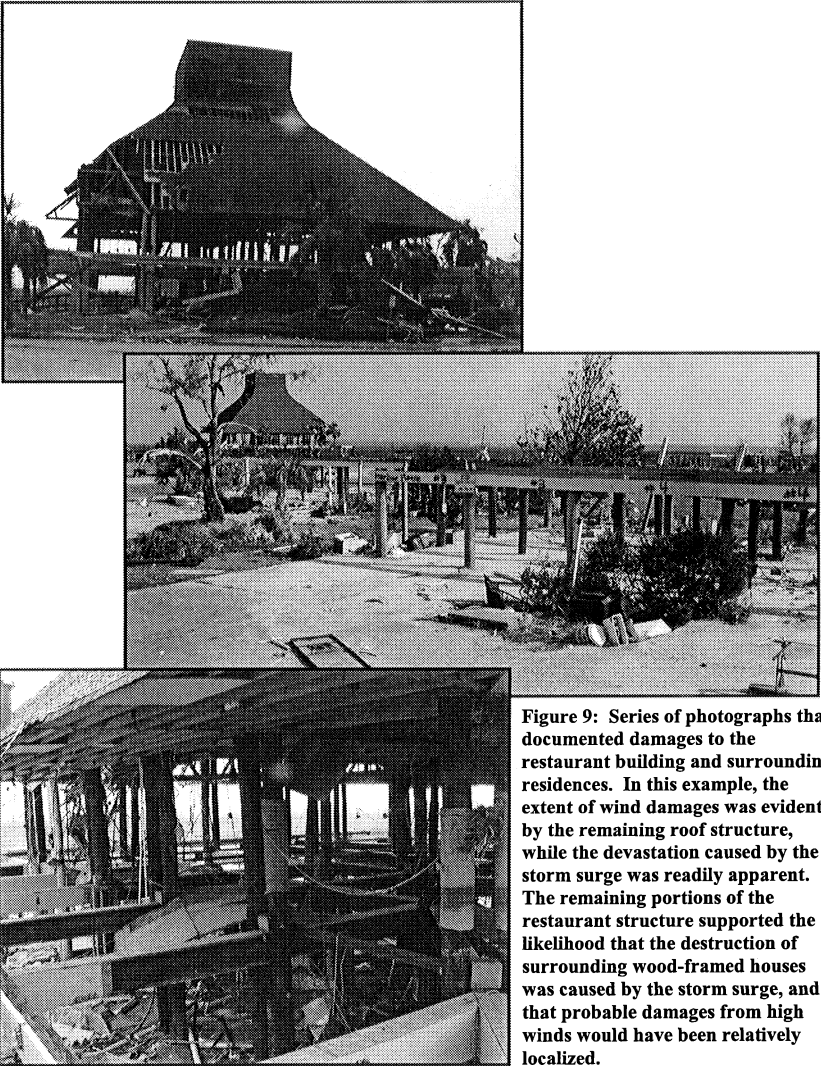
Figure 9: Series of photographs that documented damages to the restaurant building and surrounding residences. In this example, the extent of wind damages was evident by the remaining roof structure, while the devastation caused by the storm surge was readily apparent. The remaining portions of the restaurant structure supported the likelihood that the destruction of surrounding wood-framed houses was caused by the storm surge, and that probable damages from high winds would have been relatively localized.

The storm surge reached a height of about 20-feet at this site (near the roof eave), and caused extensive damage to the first two stories. High wind forces caused localized damages to the roof structure. All surrounding wood-framed residences were demolished by the hurricane such that only some of the piers and beams remained.

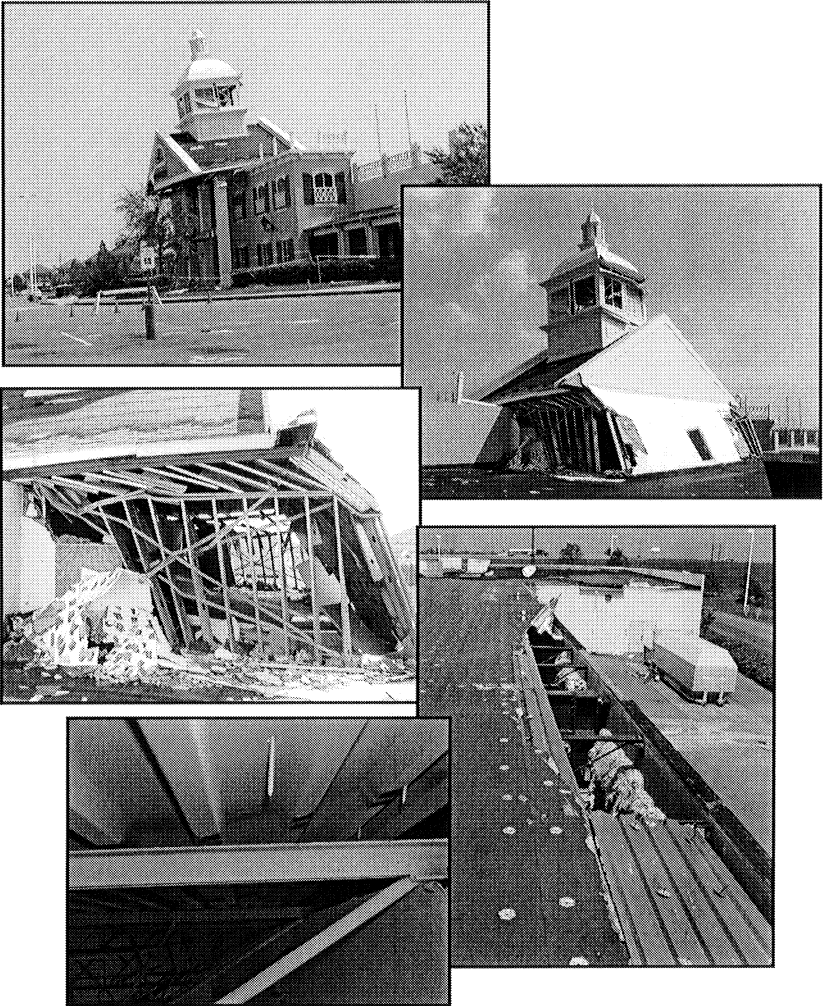
Figure 10: Series of photographs that documented damages to the shopping mall. The partial collapse of the elevated roof structure was attributed to construction defects (inadequate bracing / unstable construction) whereas the removal of localized portions of roof deck occurred at the perimeter due to the failure of puddle welds.

The storm surge did not reach this site, thus the storm damage was caused by high winds. Wind gusts of 132 mph were estimated in Gulfport. Damages to these buildings included localized portions of missing metal roof deck, removal of about half of the membrane roof covering, and the collapse of an elevated roof structure.

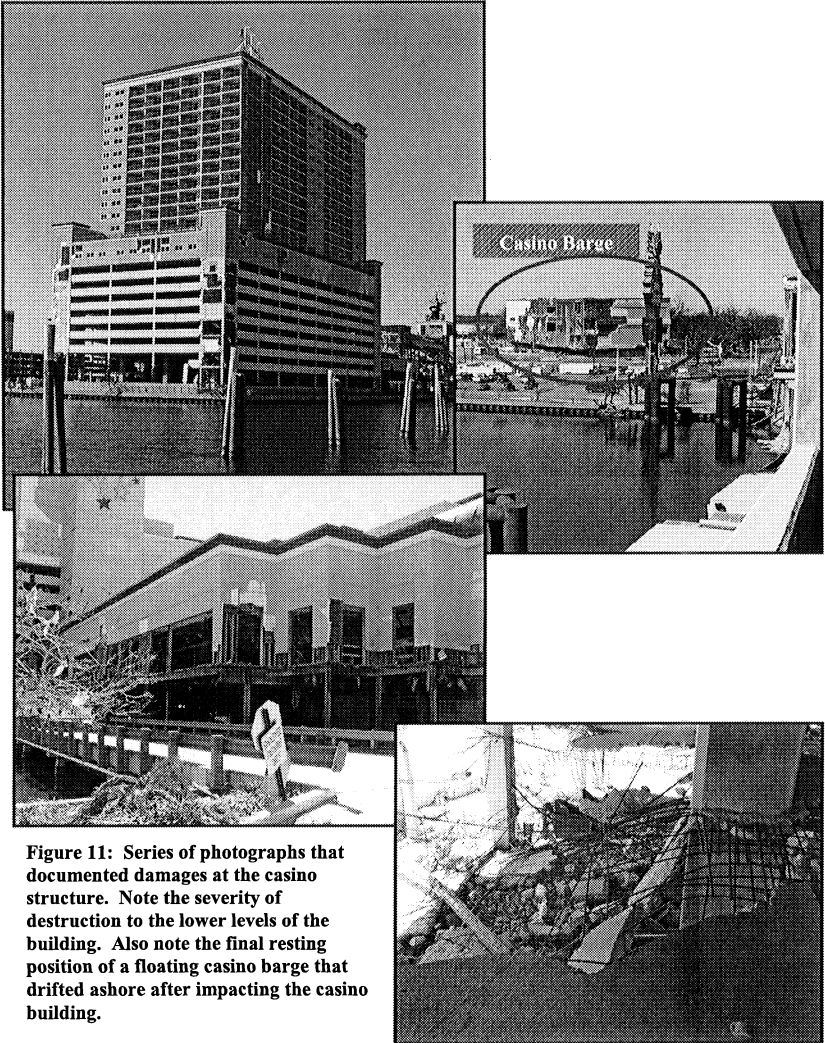
Figure 11: Series of photographs that documented damages at the casino structure. Note the severity of destruction to the lower levels of the building. Also note the final resting position of a floating casino barge that drifted ashore after impacting the casino building.

The storm surge reached a height of about 25-feet at the site, and caused severe damages to all of the first and second story walls and finishes. Waves from the storm surge caused a floating casino structure to break from its moorings and batter the building as it drifted ashore. There was finish damage caused by the wind to the portions of the structure above the second floor.

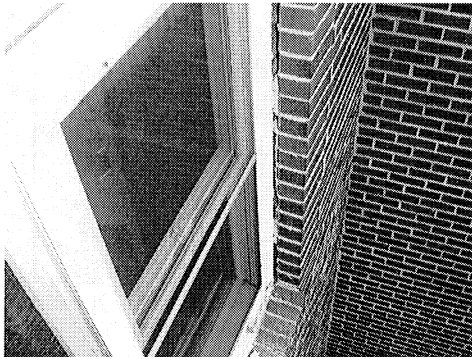
Fig. 2: Gap between window frame and brick veneer

Similar horizontal and vertical gaps were observed between the brick veneer at the front entry door and at the curved-head window above the door. The location of maximum movement appeared to be near the top of the curved window head, and the width of the gap diminished toward the base of the front door. A four-foot-long carpenter's level was placed vertically on the outside face of the window frame above the front entry door. The window frame appeared to be plumb.

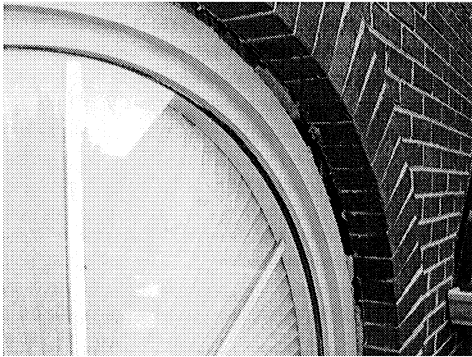
Fig. 3: Gap between curved-head window frame and brick veneer

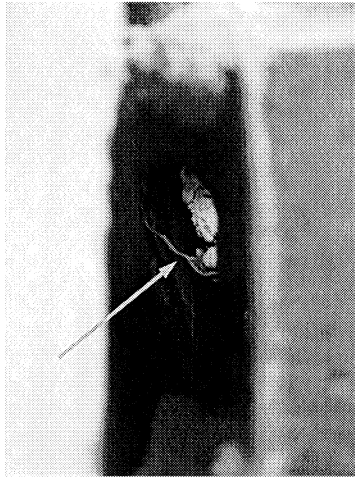
At the north jamb of the master bedroom window, it was possible to view between the brick veneer and the oriented stand board (OSB) sheathing. A corrugated galvanized steel brick tie was visible (Fig. 4). The vertical leg of the corrugated brick tie appeared to have pulled out away from the wall. No building wrap was observed over the OSB sheathing, which appeared water damaged.

Fig. 4: Corrugated steel brick tie

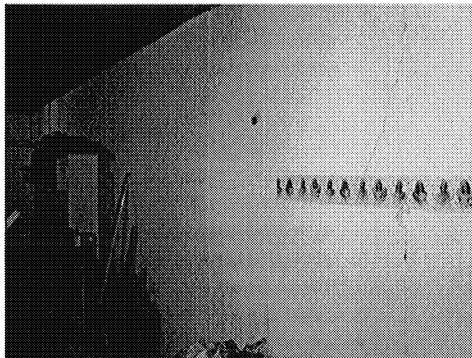
A horizontal crack was located in the east foundation wall approximately five feet above the floor and extended horizontally for approximately 25 ft. (Fig. 5). The crack extended up and down on both ends and had a maximum crack width of approximately 1/16 in.

Fig. 5: Cracked east foundation wall

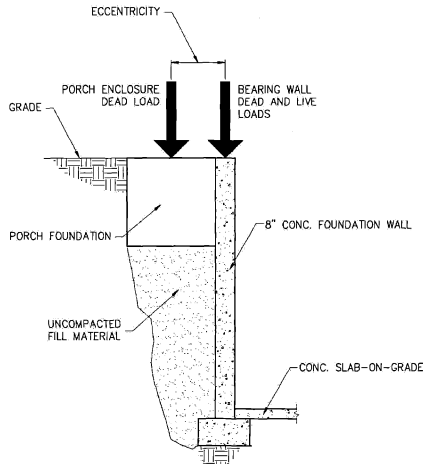
eccentricity would create a moment at the top portion of the wall developing increased tensile stress on the inside face of the foundation wall. The fact that the horizontal crack terminates with vertical cracks rather than diagonal cracks that extend to the corners of the foundation wall also indicates that the eccentricity of the porch structure contributed to the formation of the crack.

Fig. 7: Foundation wall cross-section

The depth of the concrete foundation for the brick porch enclosure was determined to be approximately 32 in. below grade by others during previous work on the property. The depth of the east foundation wall was most likely approximately 9.5 ft. below grade, and the porch foundation appears to have been anchored to the east foundation wall. Therefore, any settlement of the porch foundation would impose an eccentric force at the top of the east foundation wall (Fig 7). Since it is likely that the porch foundation was constructed on backfill material placed against the east foundation wall, it is likely the porch foundation has experienced some settlement. This

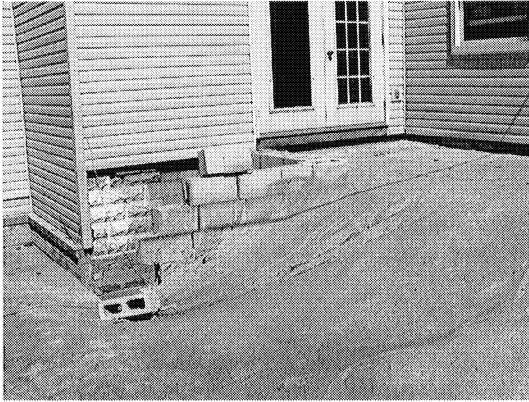
During the last pour of flowable fill, the structure fails catastrophically, destroying most of the walls and causing the interior of the patio to cement together into one solid mass of concrete (Figure 1).

Figure 1. Failed patio.

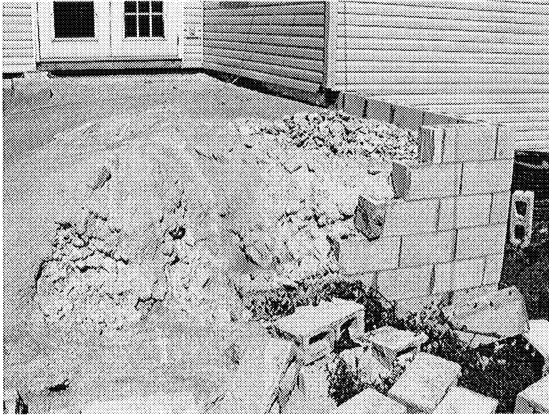
Figure 2. Fill flowed in between pieces of rubble.

When the flowable fill was placed on top of the loose fill material, it began to fill in the gaps between pieces of rubble (Figure 2). More importantly, it also began to do exactly what the contractor envisioned: accumulate on top of the rubble and form a pond. It acted as a fluid in that it flowed to the edges of the patio and formed a liquid layer on the top, which began to increase in thickness. Conventional substrates for concrete slabs require measuring, working, and compacting to achieve a level, substantial surface suitable for pouring over. Flowable fill would seem to bypass all of these steps and consolidate the base by infiltrating the voids beneath and, being a fluid, leveling itself.

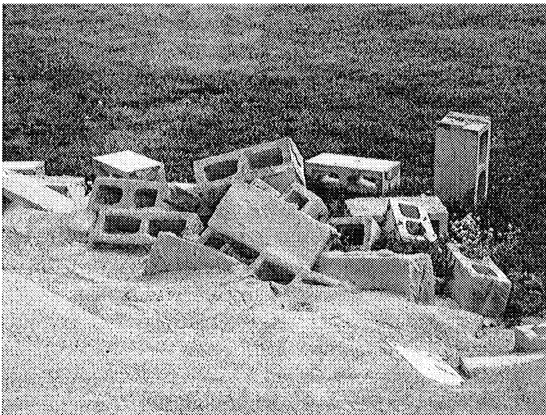
Figure 3. Fill and blocks in yard.

The one factor that the contractor overlooked was that a fluid will exert great lateral pressures on the surfaces it contacts. With a weight of about 2000 kg/m^3 , the flowable fill is twice as heavy as water. The concrete masonry units which made up the patio perimeter, which were never intended to function as a formwork, unintentionally became a formwork. Even though the fluid formed a relatively thin layer, and the lateral stresses themselves were within the range of what the blocks could withstand, the height of the walls allowed the resultant force to generate a large moment at the base of the wall. The wall was overwhelmed and toppled outward, resulting in a yard full of concrete blocks (Figure 3) and thousands of pounds of rubble fused together with sand and cement.

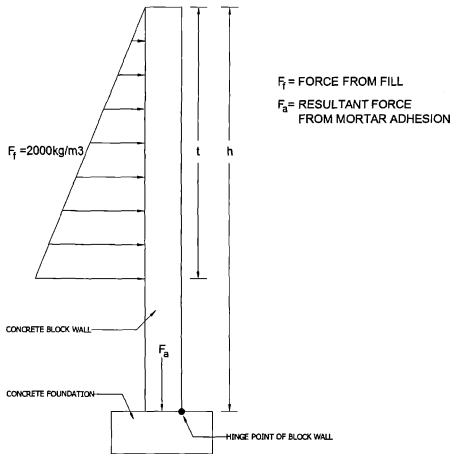
To find the moment at the base (hinge) of the wall caused by the flowable fill, I integrated from the bottom of the flowable fill to the top of the pour

$$M_B = \sum M_B = \int_{h-t}^h f x dx = \frac{1}{2} \gamma h x^2 - \frac{1}{3} \gamma x^3 \Big|_{h-t}^h$$

where f is the forcing function of the fluid pressure at the elevation x such that $f = \gamma(h - x)$ where γ is the unit weight of the flowable fill. h, t are the height of the wall and the thickness of the pour, respectively. The distance x assumes that the wall has no thickness, for conservative simplification.

Figure 4. FBD for masonry wall.

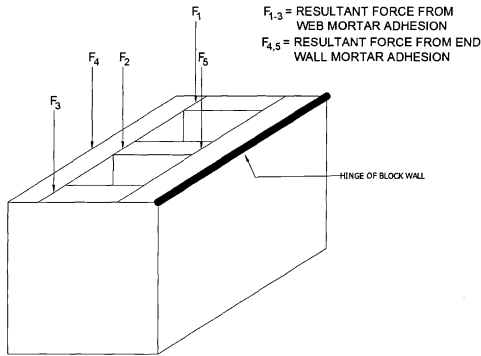
To find the moment at the base (hinge) of the wall caused by the adhesion of the mortar to the block, I summed the contributing moments from each element of the block where mortar is in contact

$$M_B = \sum Fx = 3F_1x_1 + F_4x_4 + F_5x_5$$

where F is found by multiplying the area of the element by a , which is the adhesion of the mortar to the brick. The average adhesive force of type N mortar on masonry prisms was assumed to be about .72MPa at a 90-day cure (Tahal and Shrive). The distance x is the farthest point from the hinge on the individual element being analyzed, for conservative simplification. The width, length, and web thickness of the brick is assumed to be 9.2cm, 39.7cm, and 2cm respectively.

Figure 5. FBD for mortar adhesion to masonry.

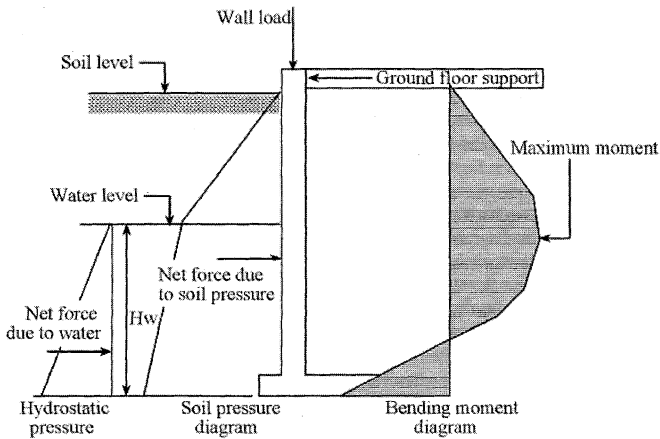
Figure 1. Cross Section to Show Basement Wall and Primary Imposed Loads (not to scale)

concrete structures including basement walls (Goodchild, 1999). The generalized loading conditions are shown in Figure 1.

Input data based on field measurements of the geometry of the structure, laboratory strength testing of a concrete core recovered when forming a penetration for new HVAC duct-work, and estimates of soil properties based on field observation were input to the spread-sheet based model. The results of interest are the maximum bending moment creating tension on the inside face of the wall, and the moment resistance of the concrete section.

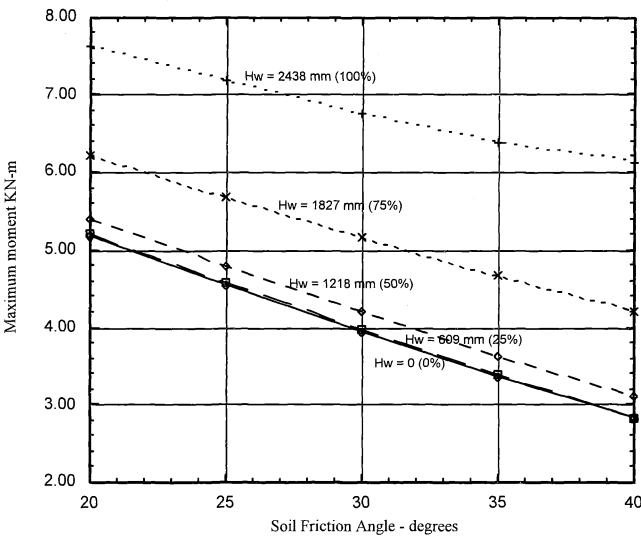
Figure 2. Bending Moment Imposed on Basement Wall Due to Soil Pressure and Hydrostatic Loading

The impact of a rising water table is clear. At low water levels, (up to about 50% of the height of the wall) the presence of the water does not significantly increase the maximum moment. However, as the water level rises beyond this, it increases quite dramatically. For a 25-degree friction angle soil, the initial 'dry conditions' moment (4.55 KN-m) increases by about 5% for the first 4 feet (1209 mm) of the water level increase and by 50% to 7.18 KN-m for the next 4 feet (1209 mm).

The retained soil is silty clay and, in the absence of strength test results, a range of possible friction angles were examined. The graph below (Figure 2) shows the maximum moment in the wall for soil friction angles between 20 and 40 degrees and a range of ground water levels (Hw) from full depth (water at the ground surface) to no water. The soil at the site is assumed to have a friction angle towards the bottom of the range; say 20 – 30 degrees.

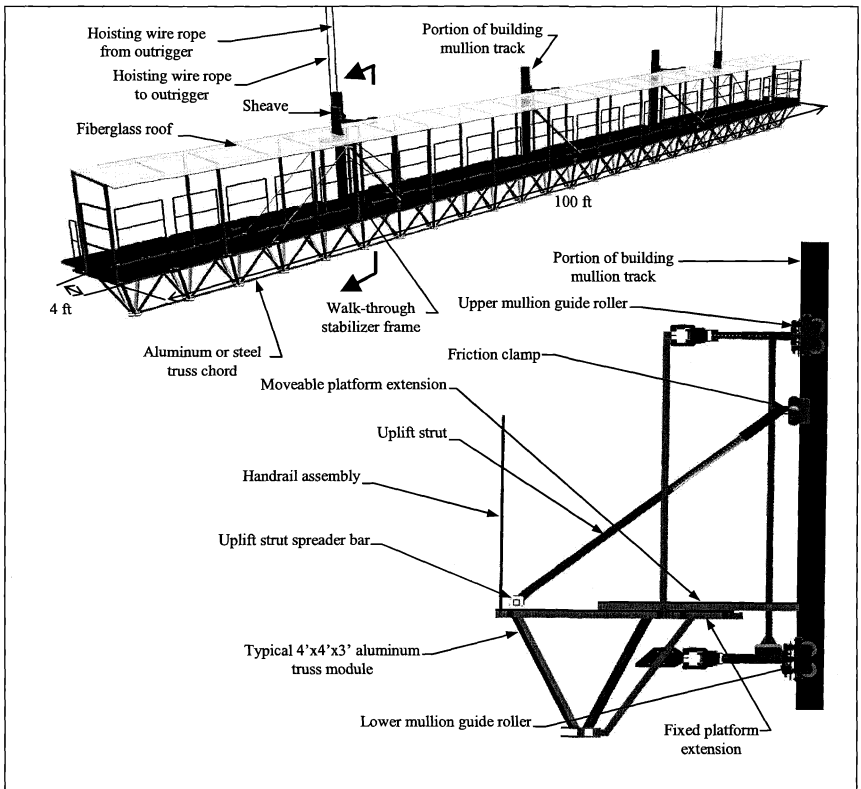
Figure 2. Scaffold Platform

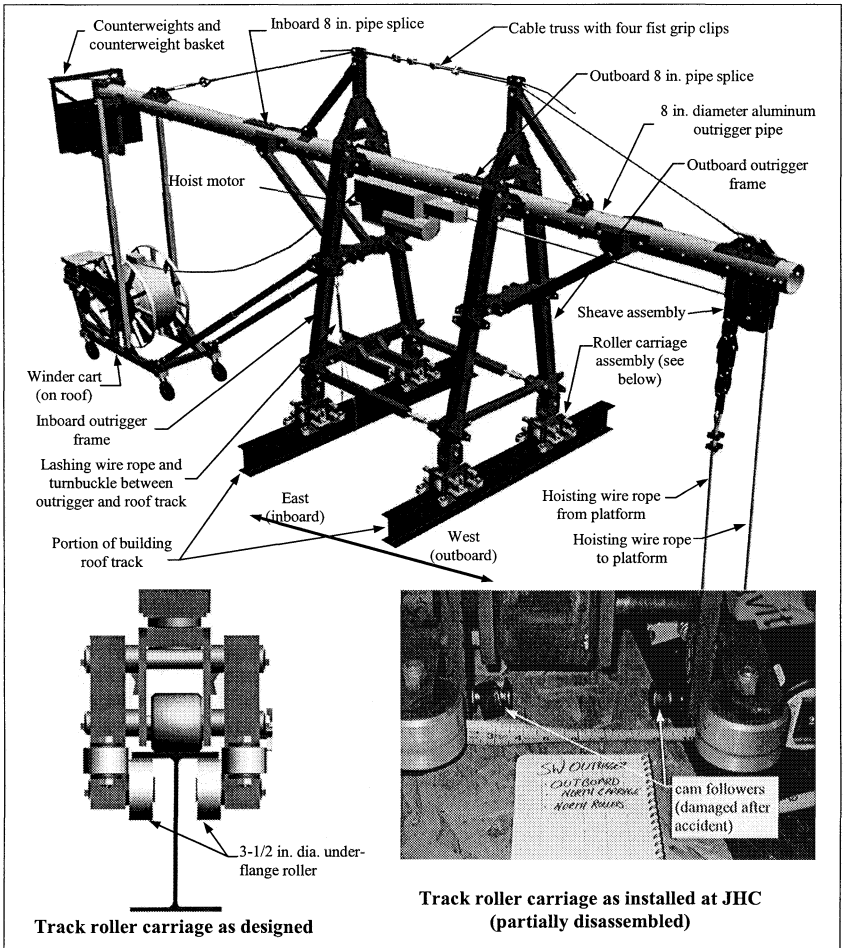
Figure 3. Scaffold Outrigger

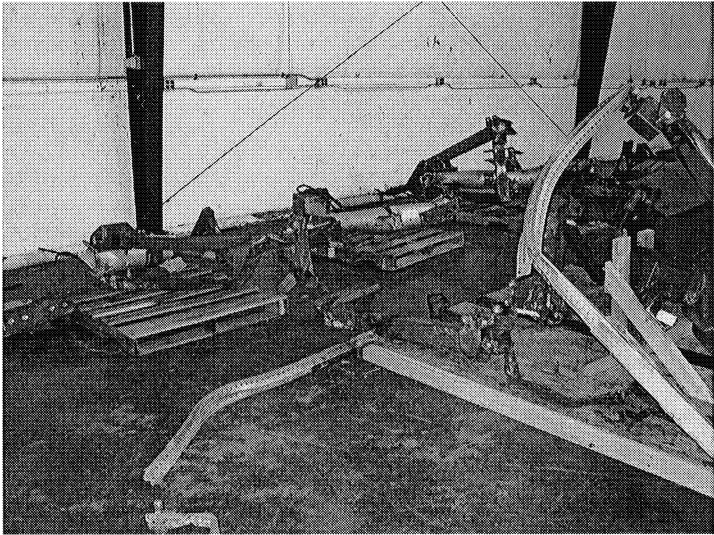
Figure 4. Layout of North Outrigger Components

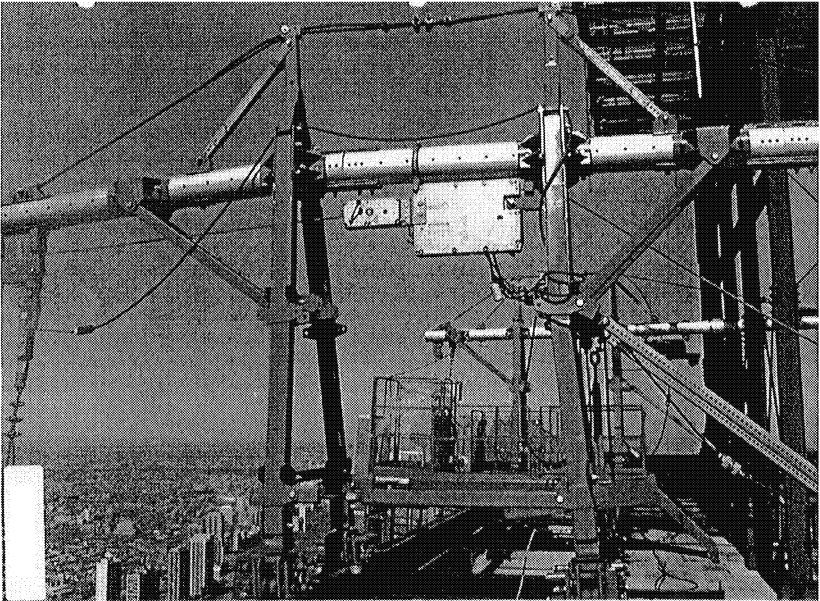
Figure 6. South Outrigger Following Collapse

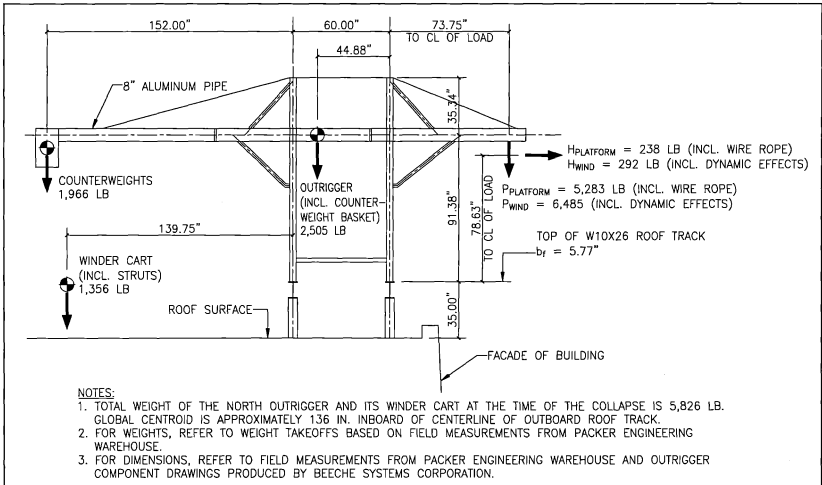
Figure 7. Forces Acting on North Outrigger at Time of Collapse

The scaffold collapsed under the forces of dead load and down-draft wind loads on the scaffold platform. The failure initiated when the splice in the outrigger's cable truss slipped, the cam followers on the inboard (uplift) track roller carriages fractured, and the wire rope lashing the outrigger to the roof track failed. Without its anchorage to the building, the north outrigger overturned. On loss of its north suspension lines, the scaffold platform swung down and around the southwest corner of the building where it collided with the south face of the building, raining debris and broken window glass onto the street below.

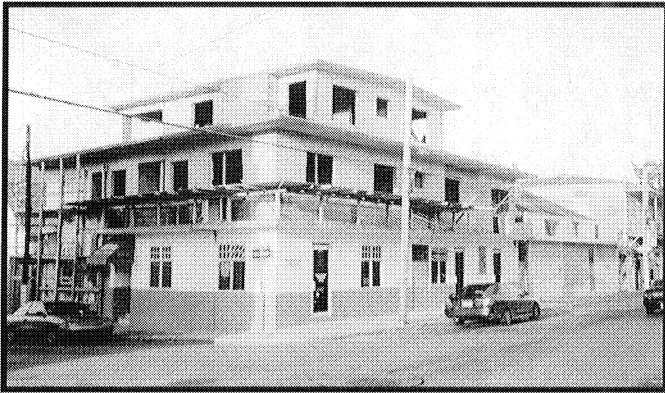
Figure 1. New second and third floor over an existing structure

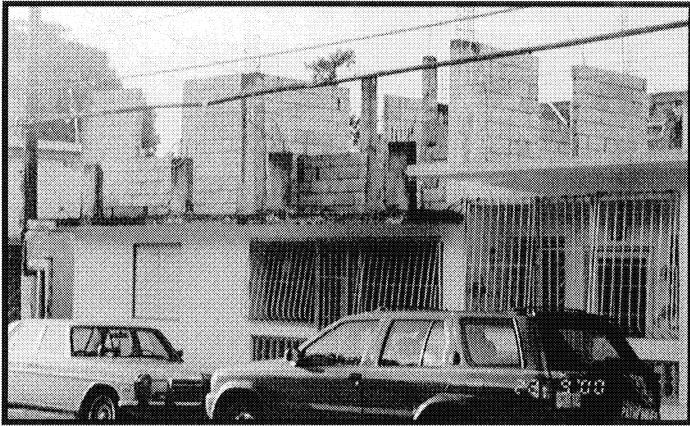
Figure 2. Inadequate anchorage length for columns

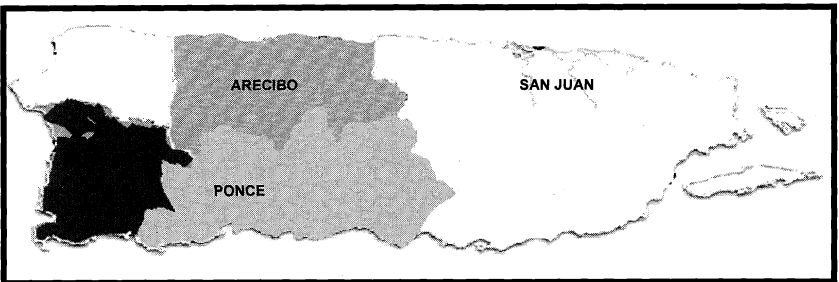
Figure 3. Regions covered in the field survey

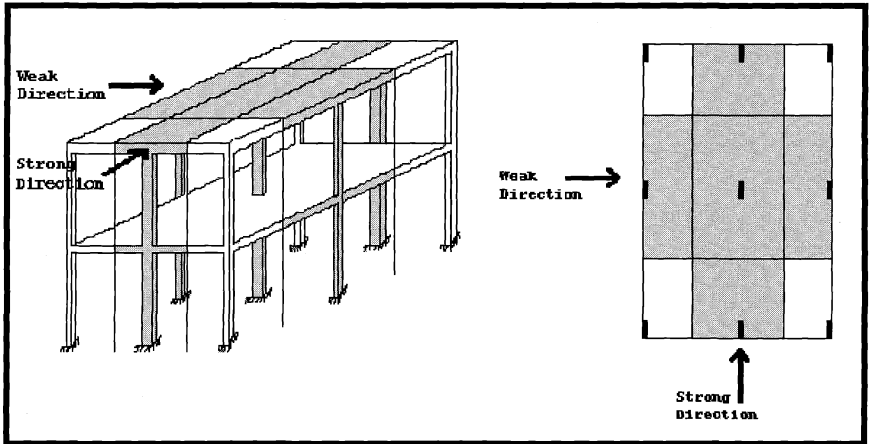
Figure 4. Preliminary systems for vulnerability analysis

stories height and with the cross sections mentioned before were defined and modeled. A typical structural system used in the analysis is shown in Figure 4.

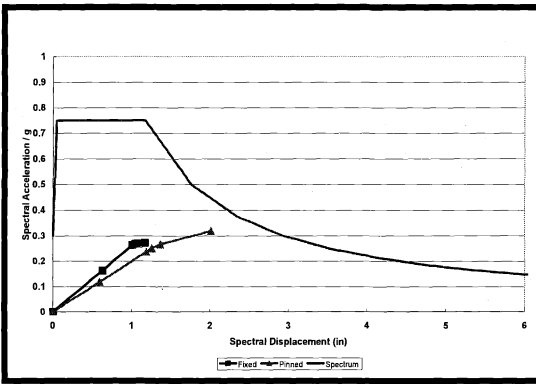
Figure 5. Capacity Spectrum Methodology for Case F21 (1 in = 25.4 mm)

All of the results produced by these analyses are presented from Figures 5 to 16. Examining the capacity demand curve of residences, it can be observed that there is no intersection or Performance Point in Cases F21, F22, F23, K22, K23, F31, F32, F33, K31, and K32 (10 out of 12) which means that the frames of these residences are not capable of withstand the ground motion in the nonlinear range. It is important to recall that the spectrum was based on rock (UBC S_b Soil Type) and the effect of soft soils was not included in the analyses. Including the soft soil condition will increase the demand spectrum and the Performance point will not be reached. Furthermore, notice that the two models that resist the demand imposed are the K21 and K33 which are the same residences as F21 and F33 but loaded in the weak direction. This means that these models that resist the demand in one direction are not capable of resisting the same earthquake in the other direction. In summary none of the models would resist the earthquake demand because the main frames could collapse in one or the other direction.

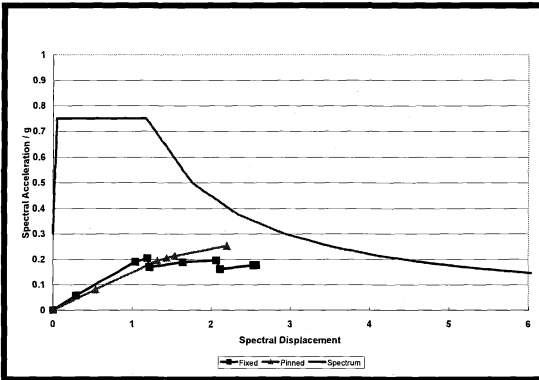
Figure 6. Capacity Spectrum Methodology for Case F22 (1 in = 25.4 mm)

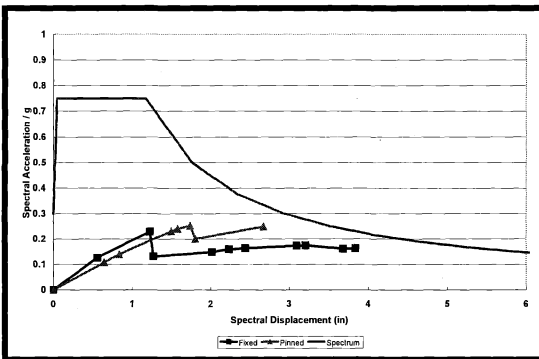
Figure 7. Capacity Spectrum Methodology for Case F23 (1 in = 25.4 mm)

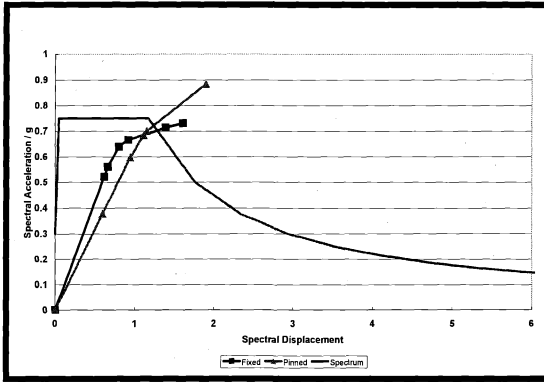
Figure 8. Capacity Spectrum Methodology for Case K21 (1 in = 25.4 mm)

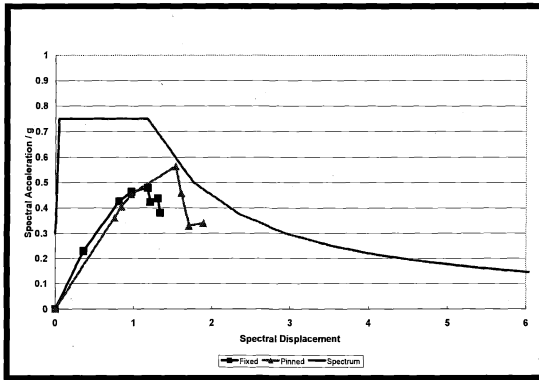
Figure 9. Capacity Spectrum Methodology for Case K22 (1 in = 25.4 mm)

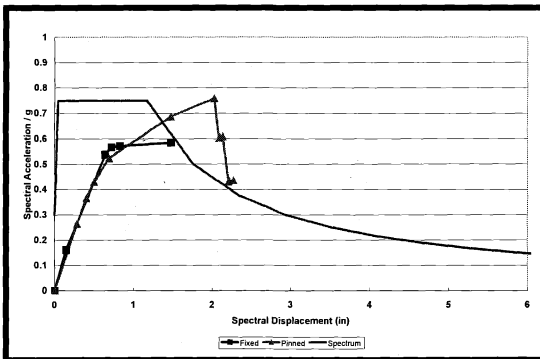
Figure 10. Capacity Spectrum Methodology for Case K23 (1 in = 25.4 mm)

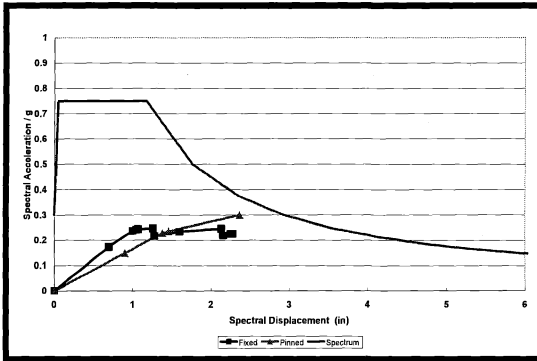
Figure 11. Capacity Spectrum Methodology for Case F31 (1 in = 25.4 mm)

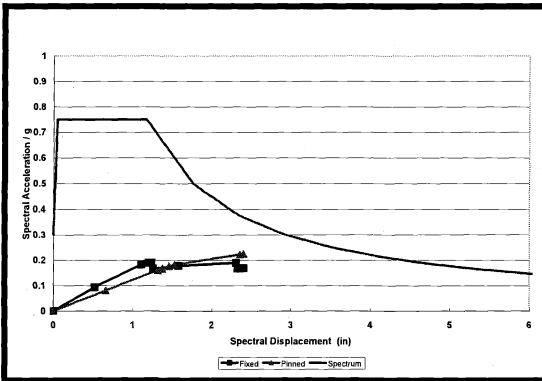
Figure 12. Capacity Spectrum Methodology for Case F32 (1 in = 25.4 mm)

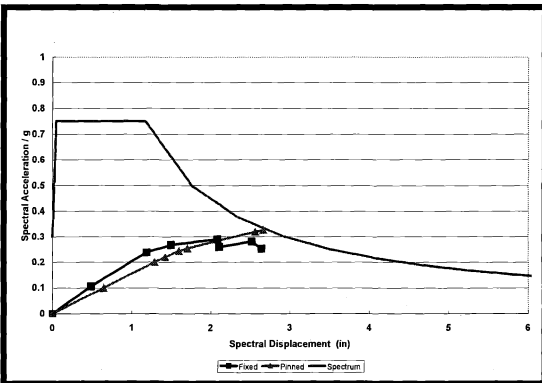
Figure 13. Capacity Spectrum Methodology for Case F33 (1 in = 25.4 mm)

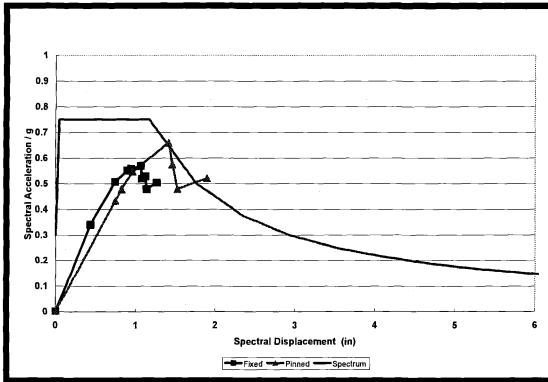
Figure 14. Capacity Spectrum Methodology for Case K31 (1 in = 25.4 mm)

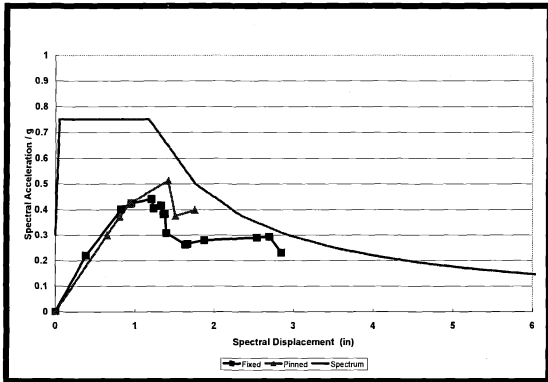
Figure 15. Capacity Spectrum Methodology for Case K32 (1 in = 25.4 mm)
