Forensic Engineering

Proceedings of the
Fourth Congress

FORENSIC ENGINEERING

October 6–9, 2006
Cleveland, Ohio

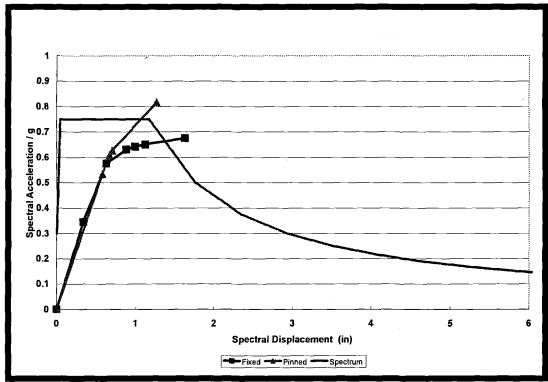
Figure 16. Capacity Spectrum Methodology for Case K33 (1 in = 25.4 mm)

All of the results produced by these analyses are presented from Figures 5 to 16. Examining the capacity demand curve of residences, it can be observed that there is no intersection or Performance Point in Cases F21, F22, F23, K22, K23, F31, F32, F33, K31, and K32 (10 out of 12) which means that the frames of these residences are not capable of withstand the ground motion in the nonlinear range. It is important to recall that the spectrum was based on rock (UBC S_b Soil Type) and the effect of soft soils was not included in the analyses. Including the soft soil condition will increase the demand spectrum and the Performance point will not be reached. Furthermore, notice that the two models that resist the demand imposed are the K21 and K33 which are the same residences as F21 and F33 but loaded in the weak direction. This means that these models that resist the demand in one direction are not capable of resisting the same earthquake in the other direction. In summary none of the models would resist the earthquake demand because the main frames could collapse in one or the other direction.

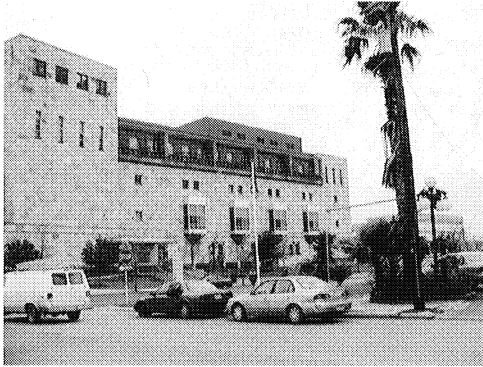
Figure 1. General view of Building A exterior.

The authors performed an investigation of the cause of failure of the veneer. The structures were approximately six years old at the time of investigation (they were built in the late 1990's); however, stone veneer failure had been ongoing for some time prior. Both Buildings A and B are five-story buildings with conventional reinforced concrete framing. Refer to Figures 1 and 2 for representative views of each building exterior.

at the fourth and fifth floors. The lighter veneer in Figures 1 and 2 is indicative of the limestone, and the darker-colored veneer is indicative of the sandstone (also, the porcelain tile is visible and is darker in appearance than the sandstone).

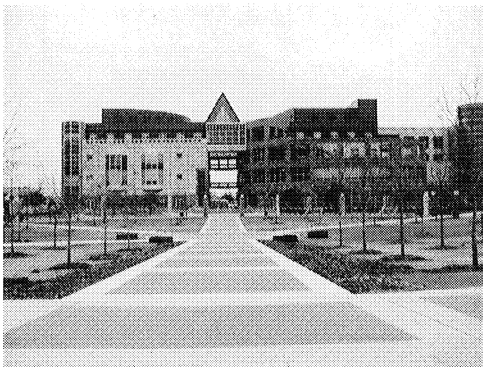
Figure 2. General view of Building B exterior.

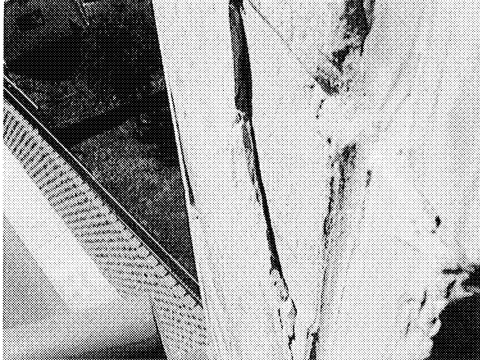
Figure 3. View of stone veneer – note vertical orientation of the grain.

forces from the stones' self-weight are in-line with the direction of the layering within the stone (refer to Figure 3). The specifications indicate a dimensional stone depth of 2 1/2"-3" for the veneer system; and Type N mortar with Type S lime for the mortar in the dimension stone veneer system. A typical dimension stone in the veneer system measures 24" wide x 20" high and has an estimated weight of 115 lbs. The specifications indicate stainless steel anchors, spaced at 18" on-center, for the stone veneer anchors. The design documents indicate a steel lintel support for the veneer at each floor level.

although some of the compressive strength results were below the 12,000 psi limit of the project specifications. ASTM C 568 also states that, "*Limestone shall be sound, durable, and free of spalls, cracks, open seams, pits, or other defects that are likely to impair its structural integrity in its intended use.*" The limestone observed at the buildings does not comply with this requirement, as several stones were observed to have separations and spalls at the bedding planes (Figures 3-6).

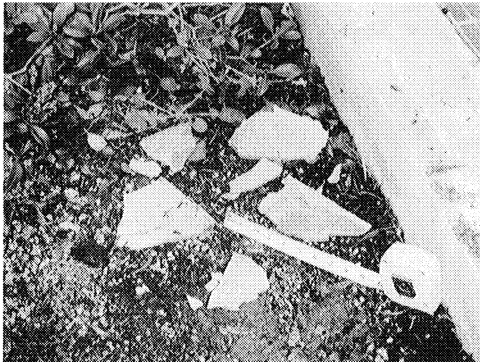
Figure 4. Pieces of delaminated limestone veneer on the ground.

Delamination of Stone. Pieces of delaminated stone were noted all along the perimeter of the building (Figures 4 and 5). The stone debris at the surrounding ground was of various sizes, although it should be noted that the size of debris is misleading, as the stone shatters when it falls from the wall above and impacts the ground. The largest debris pieces observed were up to 7" in length (Figure 5) and were generally about 1/4" thick. All of the limestone veneer on the buildings has been observed to have the rift (or grain) in a vertical orientation.

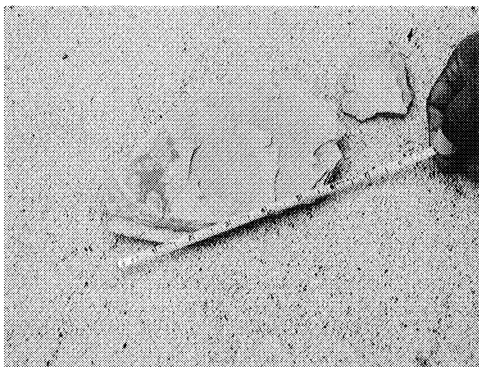
Figure 5. Piece of delaminated limestone measures 7" in length.

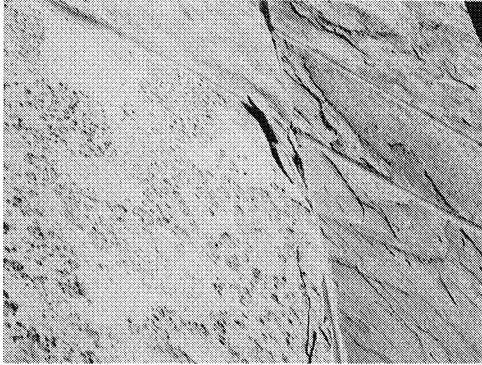
Figure 6. Delaminated limestone veneer at Building A.

Active delamination was observed at the limestone veneer for the buildings. Figure 6 indicates a piece of limestone which has delaminated from the surface of a veneer stone, but has not yet fallen. This condition exists throughout the exterior veneer walls of both buildings.

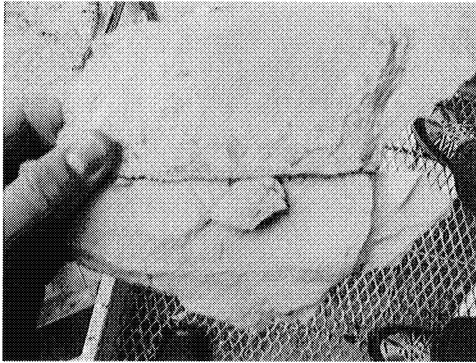
Figure 7. Delaminated stone pieces with no expansion joint.

direct contact (Figure 7). Also, expansion joint sealant material appeared compressed and was observed to be bulging at many joints. Delamination of the stones was observed at the corners of the joints where the stones were in contact.

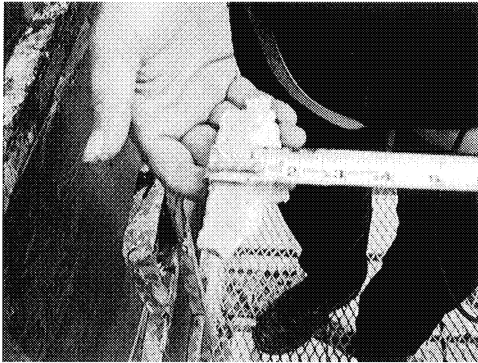
Figure 8. Depth only 1" at extracted mortar.

Based on measurements from mortar samples taken from the site, the bed depth of the samples ranged from 1" to 3", and averaged 2" on one building and 1 5/8" on the other. Of the samples from both buildings, 64% had measured mortar depths of 2" or less. Figure 8 indicates a typical piece of mortar extracted from the joints, measuring only 1" in depth.

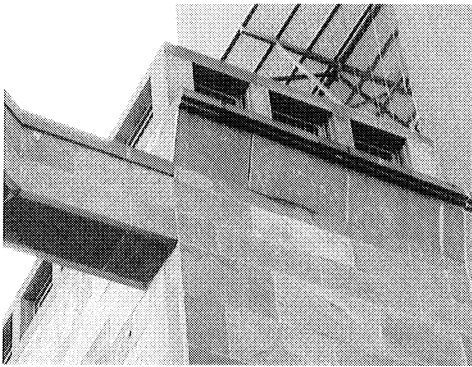
Figure 9. Angled stone veneer at fourth floor. There is no mechanical horizontal anchorage to the concrete structure.

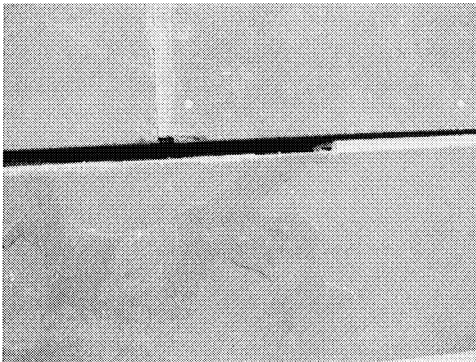
Figure 10. Veneer displacement and loose mortar above entry.

- At the main ground level entry to one of the structures, separated and displaced dimension stone veneer was observed. The mortar joints in the stone veneer above the center opening were separated, and a downward movement of the veneer was observed in the approximate shape of an arch starting from the header course above the opening. Figure 10 below shows the displacement of the veneer above the entry and the loose mortar. The separations were measured, as 15/16" at horizontal joints and the mortar was loose and easily removed by hand. Some repairs had been done previously; however, the separations re-opened and the stone continued to displace. Although the support could not be seen from the wall cavity due to excessive mortar, similar details at other openings had a lack of full support for the stone. At one location above another entry door, a gap between the stone and the steel support lintel was observed.

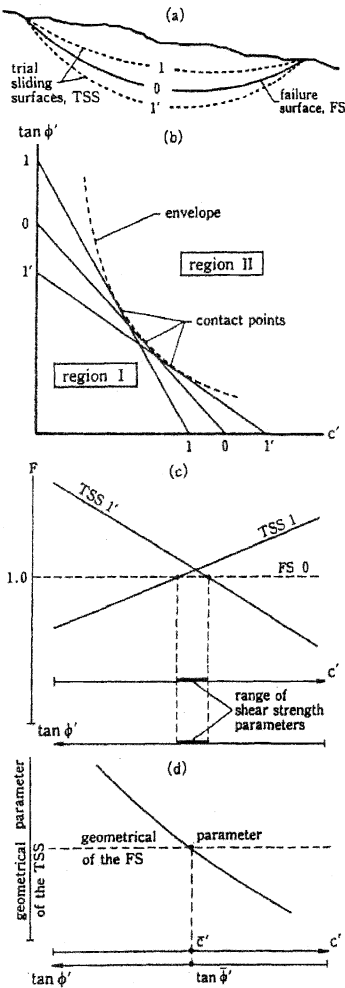
Figure 2. Shear strength back analysis methods

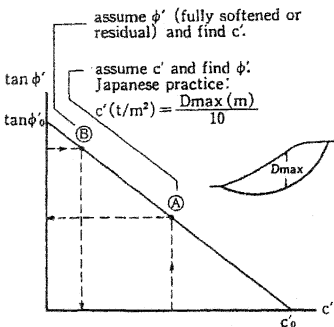
Figure 3. Assume one of the shear strength parameters and determine the other one

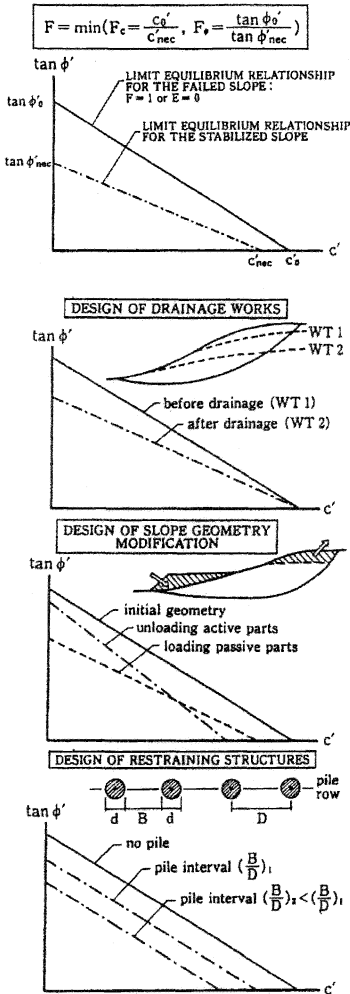
Figure 4. Limit equilibrium relationship and design of slope remedial works

The method principle is shown in Fig.4. It is considered that a slope failure provides a single piece of information which results in a linear limit equilibrium relationship between shear strength parameters. That piece of information is that the factor of safety is equal to unity ($F=1$) or the horizontal force at the slope toe is equal to zero ($E=0$) for the conditions prevailing at failure. Each of the two conditions ($F=1$ or $E=0$) results in the same relationship $c' - \tan \phi'$ which for any practical purpose might be considered linear.

Using the concept of limit equilibrium linear relationship c' - $\tan \phi'$, the effect of any remedial measure (drainage, modification of slope geometry, restraining structures) can easily be evaluated by considering the intercepts of the c' - $\tan \phi'$ lines for the failed slope (c_0' , $\tan \phi_0'$) and for the same slope after installing some remedial works (c'_{nec} , $\tan \phi'_{nec}$), respectively (Fig. 4). The safety factor of the stabilized slope is:

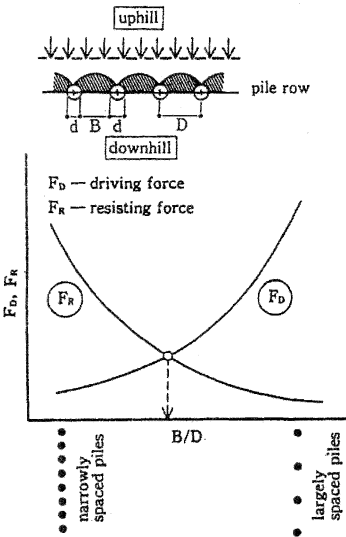
Figure 5. Driving vs. resisting force for stabilizing piles

The above outlined procedure was used to design piles to stabilize landslides (Popescu, 1991) taking into account both driving and resisting force. The principle of the proposed approach is illustrated in Fig.5 which gives the driving and resisting force acting on each pile in a row as a function of the non-dimensional pile interval ratio B/D . The driving force, F_D , is the total horizontal force exerted by the sliding mass corresponding to a prescribed increase in the safety factor along the given failure surface. The resisting force, F_R , is the lateral force corresponding to soil yield, adjacent to piles, in the hatched area shown in Fig.5. F_D increases with the pile interval while F_R decreases with the same interval. The intersection point of the two curves which represent the two forces gives the pile interval ratio satisfying the equality between driving and resisting force.

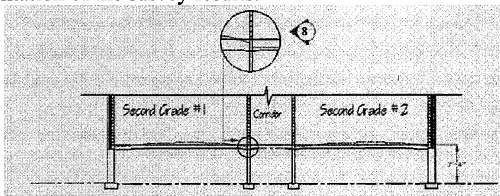
Figure 2 - Cross-Section of Elementary School

In January of 2003 a survey of the school was completed to establish a baseline of elevation. There was no 'as-built' survey performed in 1999 at the time of construction completion. It was measured that the slab within the building was higher in the center of the classrooms than at the edge, and the survey established that the edge of the slab was higher than the top of the exterior foundation wall. The cross-section in Figure 2 provides a graphical presentation of the survey results.

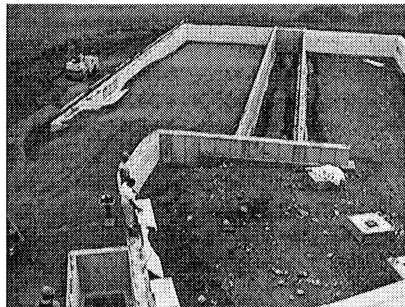
Figure 4 - Elementary School Foundation with Initial Lift of Substitute Material

The substituted fill at the elementary school ranged in depth from approximately 1-foot to over 6-feet. The fill had been specified to be an engineered structural fill, yet the contractor requested to use stone dust as a substitute for this material. Figure 4 shows the first lift of the substitute stone dust installation.

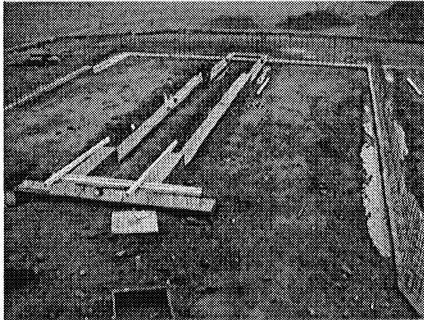
Figure 6 - Water Trapped Adjacent to Footing

continue downward into the native soil mantle. With this underlying soil quite dense, the ability of the water to penetrate into the native soil is limited; therefore it will be captured at the base of the foundation wall. The footing, once in place, and without a footing drain, has created a moat around the building that allows water to be captured and to stand in place without the opportunity to freely drain away. This is shown in Figure 6.

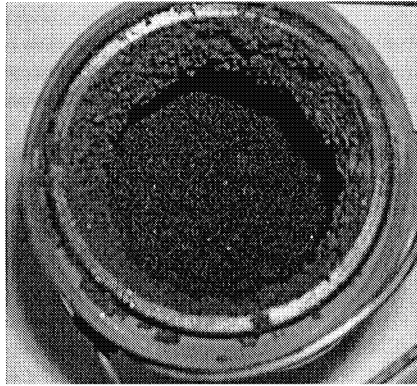
Figure 7 Fill material collected from below the floor slab

The footing drain installation in the summer of 2005 allowed us to observe and collect additional material for analysis. The footer drain was installed at the bottom of the footing elevation, and the foundation wall was exposed for the drain installation. Core drilling of the concrete foundation wall allowed us to collect additional samples of the structural fill under the slab-on-grade. The material collected had the same "wet sand" appearance as the samples collected in 2003. This is shown in Figure 7.

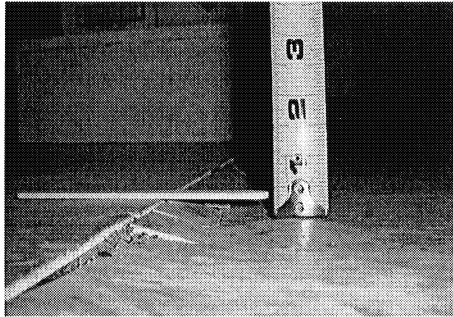
Figure 8 - The Effect of Pyrite Expansion

Figure 8 is a photo of the differential movement of the floor at the classroom / corridor interface in 2003.

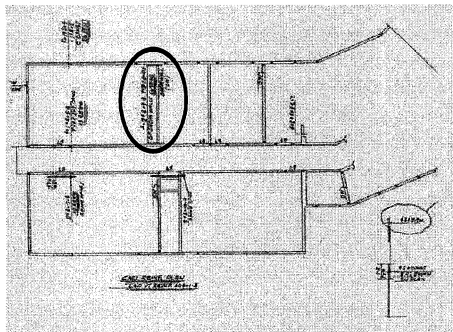
Figure 9 - Floor Plan

In addition to the conditions above, the lifting of the slab has in 2005 resulted in the structural impact to the building. The interior wall adjacent to the end classroom is a shear wall. This is a wall that transfers the horizontal wind load on the building from the walls to the foundation. The location of shear walls is shown in the Figure 9.

One such location, where the wind forces are transferred into the shear wall is at the location depicted in the circle. Without this connection, the forces imposed by the wind would have to be resisted by the exterior wall alone, and from our earlier investigation of the building's super-structure we know these walls alone are incapable of resisting these forces.

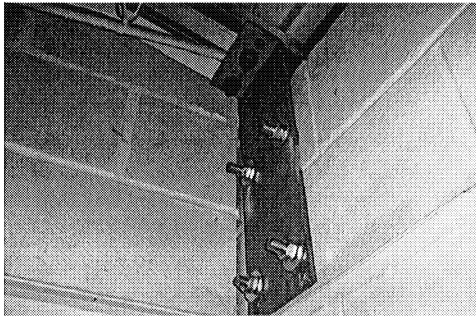
Figure 10 - Remediation Measure

The wall, which rests on the upward moving floor slab, was now lifting the structural joist. The August 2005 discovery that the joists adjacent to the two shear walls had been loaded upward to a point where it had broken free of the exterior wall. It was also noted that the joist located approximately four-feet on either side of the shear wall were also disconnected from the exterior wall. The joist's functioning as a load-transmitting member to resist the forces of wind load on the building was in serious question. Remediation was essential, and the attachment shown in Figure 10 was effected.

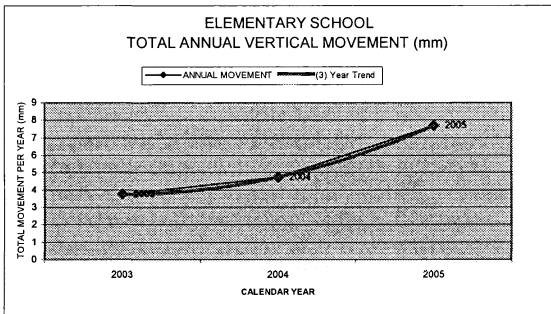
Figure 11 – Movement over Time

Once the oxidation process has begun, the ability to halt its action is essentially non-existent. The rate of movement, and building failure may be expected to increase with time. This is supported by the tracking of building rate of movement over time as presented in Figure 11.

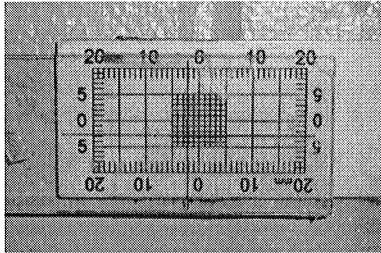
Figure 12 - Movement Gage installed July 2005 - Observed November 10, 2005

The photo of the movement gage installed on February 23, 2005 is shown in Figure 12. This picture shows that the movement in eight month's time has now been in the vertical and the horizontal direction.

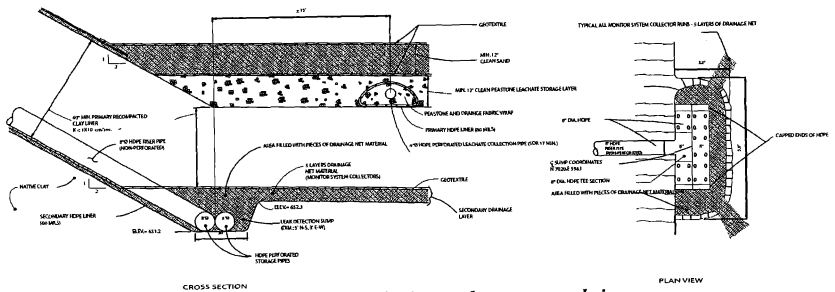
Figure 1. - Typical secondary sump and riser

The secondary leak detection system for subcell D includes a sump and an SDR 17 HDPE riser pipe that extends along, and is fully supported by, the sideslope of the cell to ground surface. Each of the remaining subcells incorporates a secondary sump and an SDR 17 HDPE riser pipe (Fig. 1) that extends approximately 10 vertical feet along a 2 vertical to 1 horizontal slope, then turns within the primary compacted clay layer and

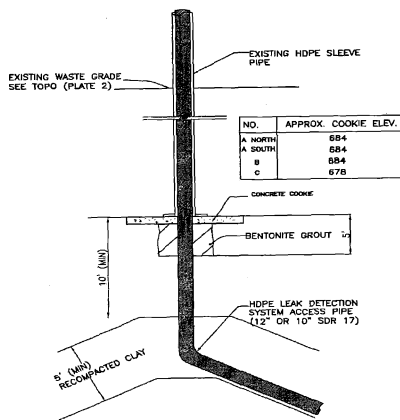
Figure 2. - Protective outer sleeve for riser pipe

extends vertically through approximately 120 feet of waste. The vertical portion of the riser pipe is sleeved with a second pipe at a point approximately 10-feet above the primary liner (Fig. 2). The sleeve was designed to reduce dowdrag forces imposed upon the riser pipe as waste settlement occurred.

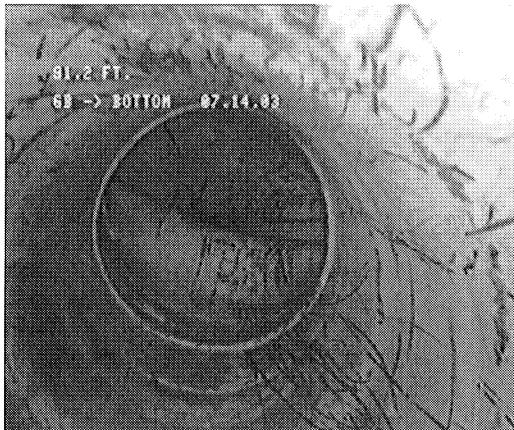
Figure 3. - Distressed elbow in Subcell B riser

Camera inspection of the riser at subcell B was initiated to locate and determine means of retrieving the outer pump shield. A 4-inch diameter pan-and-tilt camera was lowered into the riser pipe and revealed significant deformation of the pipe wall in the field fabricated elbow within the primary compacted clay liner (Fig. 3). The magnitude of the deformations prevented camera inspection past the elbow.

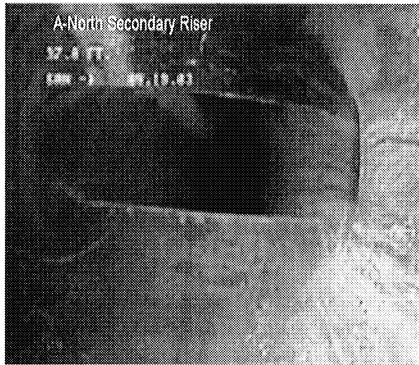
Fig. 4 – Vertical riser at A-North

Because difficulty was encountered during extraction of the pump from the riser at A-North, this pipe was also inspected using the 4-inch camera. At a depth of approximately 57 feet below the waste surface, the vertical portion of the riser pipe was severely buckled (Fig. 4). Again, this condition prevented camera inspection below the buckled section.

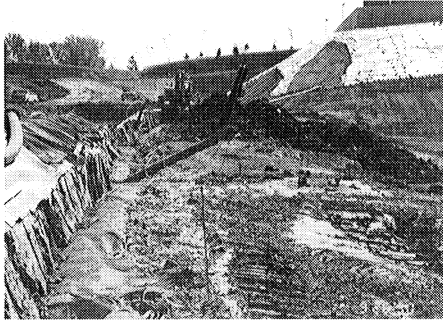
Figure 5. – A-North riser at subcell D tie-in

Historical photographs from the project records revealed a construction sequence that included fabrication of the HDPE riser pipe from the sloped section of the intra-cell berm, through the elbow, and the first vertical section of pipe, before the compacted clay layer had been constructed. This sequence made adequate backfilling and structural support below the elbow very difficult, if not impossible. Figure 5 shows this sequence at the tie-in between subcell A-North and subcell D. Figure 6 shows the loose condition of the bedding soil at the reducer and elbow sections.

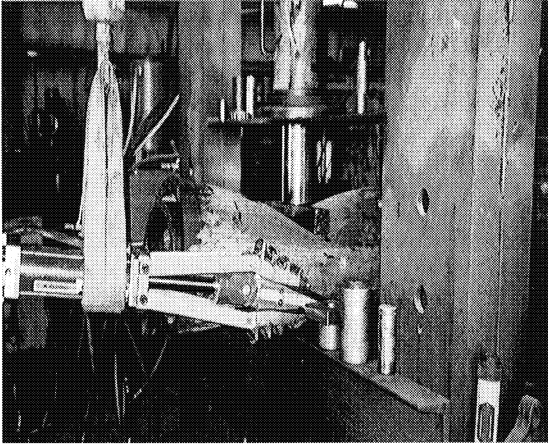
Figure 7. - Bench scale trials of rerounder

Trials of the modified rerounder equipment were conducted at the contractor's facility (Figure 7) to determine optimum configurations and operating pressures to prevent damage to the pipe. After several months of research, bench scale trials and equipment modifications, field trials were begun in early 2004 (Figure 8).

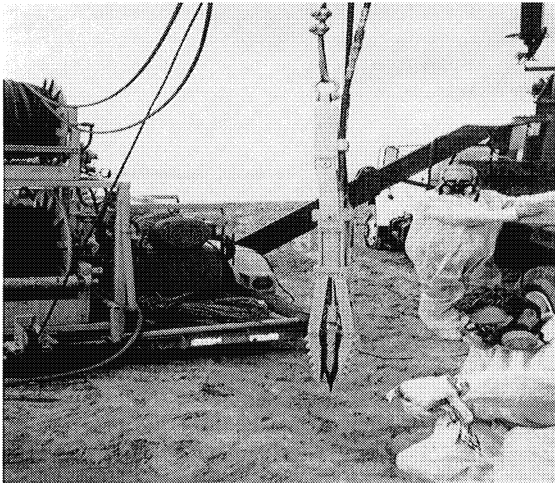
Figure 8. - Field trials of rerounder

Field trials successfully rerounded one of the upper deformations of the riser pipe, but failed to make the turn through the deformed elbow section. Several modifications to the equipment were made, and after numerous unsuccessful attempts at rerounding, the technology was ultimately abandoned.

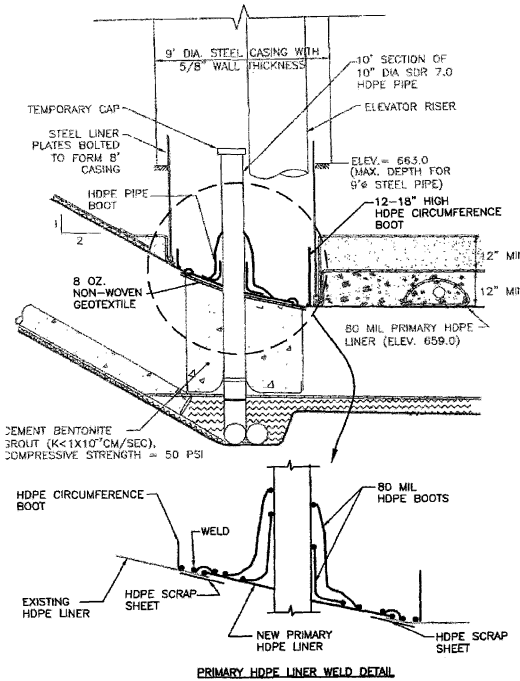
Figure 10. – Restoration of liner system

After sufficient set of the cement-bentonite backfill, the primary geomembrane liner must be restored. This step in the process is the most critical to the success of the project. The primary geomembrane repair must be made leak-proof under less than ideal welding conditions. Therefore, multiple redundant measures were incorporated. For the repair of the liner itself, the extrusion weld will be capped with an additional layer of geomembrane. In the area where the pipe penetrates the liner, an extrusion-welded boot will be installed with a second boot completely covering the first (Fig 10.)

All liner welds will then be covered with a layer of bentonite paste. The entire area within the HDPE cylinder, trimmed to leave approximately 12 to 18-inches in place, will be filled with low shrinkage cement based grout. In this manner, the HDPE cylinder filled with grout will serve to direct leachate away from the repair welds. Each of the primary repair welds are also backed up with a second redundant welded repair.

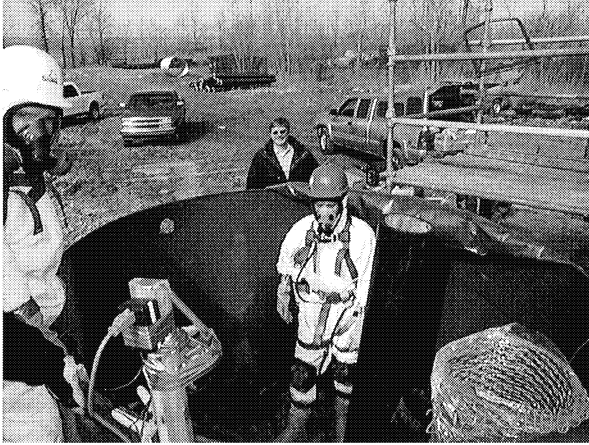
Figure 11. – Full scale mockup

The critical nature of this project, both to the owner and potentially to the environment, has required that every aspect of the design be scrutinized with regard to constructability, contingencies and safety. One major effort completed to assure constructability, involves construction of a full-scale mock-up. There was concern that personnel in full Level B PPE and with all required tools and support equipment may not be physically able to complete the required welds within the confines of the 7-foot diameter shaft with the new 10-inch diameter riser pipe in place. A full scale mock-up would demonstrate the ability to make high quality welds within the confined space anticipated (Fig 11.)

The owner constructed a test pad area with similar slope and configuration anticipated within the landfill. The surface was lined with 80-mil HDPE geomembrane that intentionally included a wrinkle.

A section of 7-foot diameter steel casing was placed over the geomembrane liner and a 10-inch diameter pipe was installed near the center. Anticipated equipment such as air supply lines, lighting, air monitors, video cameras, simulated air exchange equipment

and electrical lines were included within the confines of the casing. The contractor then completed all welding described on the drawings and work plan, including repair of the intentionally placed wrinkles, while fully dressed in Level B PPE. Although several problems needed to be addressed, the mock-up successfully demonstrated that quality welds could be made within the confines of the shaft. The contractor also learned that the maximum amount of time a person could work under the anticipated conditions was slightly more than one hour.

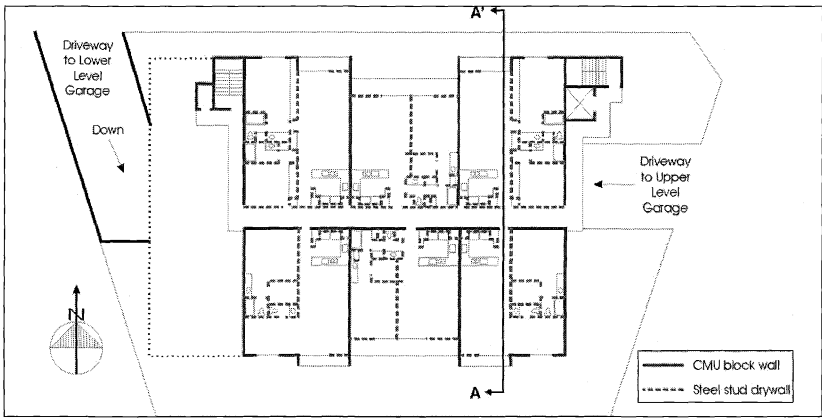
Figure 1. Building plot plan.

A plot plan of the building with the layout of units on a typical floor is presented in Figure 1 and a cross-section through the building is shown in Figure 2. The building has plan dimensions of approximately 25 m by 27.4 m (82 ft by 90 ft), and a height of approximately 19 m (62 ft) from the ground surface (first floor level in Figure 2). Vertical loads are transferred from the roof, 7th through 1st floors to the interior and exterior concrete masonry block walls, the transfer beams and columns in the parking levels, and then down to the foundation. The roof and the floor diaphragms, the interior and exterior concrete masonry block walls resist lateral loads. The building's properties were determined from on site observations and available building plans.

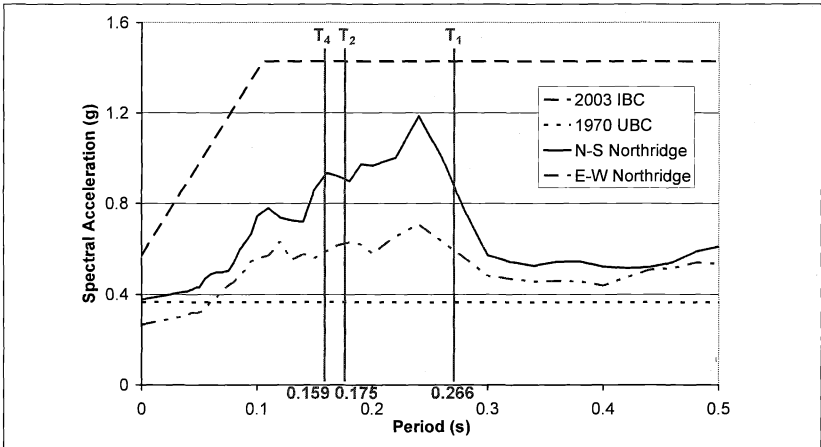
Figure 3. Comparison of estimated site response spectra with design response spectra and the building's 1st, 2nd, and 4th mode periods of vibration.

The effective peak acceleration (EPA) values of the estimated earthquake ground motion at the site are 0.296 g in the North-South direction, 0.125 g in the vertical direction, and 0.221 g in the East-West direction. Figure 3 shows a comparison of the 5% damped horizontal acceleration response spectra from the estimate of the ground motion experienced at the site during the 1994 Northridge Earthquake with the code-specified values from 1970 UBC (ICBO 1970) when the building was designed and the current 2003 IBC (ICC 2003). The 1970 UBC did not define a response spectra; the constant value of acceleration for 1970 UBC in Figure 3 is equivalent to the design base shear divided by the weight of the building. The 2003 IBC spectrum is for the design level earthquake.

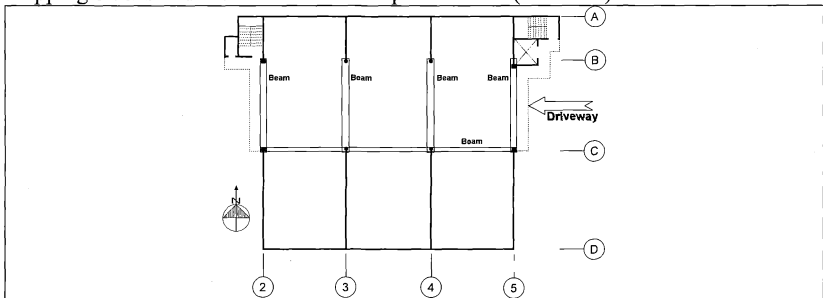
Figure 4. Second floor level plan with gridlines showing transfer beam and column locations.

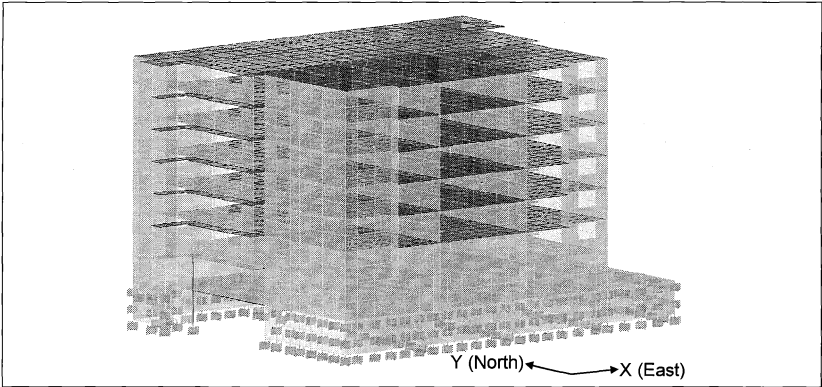
Figure 6. The three-dimensional structural model of the building.

A detailed three-dimensional computer model of the entire building was developed using the structural engineering software SAP2000 (CSI 2001) as shown in Figure 6. Columns, beams and lintels were modeled with frame elements, floor slabs and walls were modeled with shell elements. Fixed boundary conditions were assigned to the foundation and the walls of the lower parking level in contact with the ground. The material strength values used in the model were as specified in the structural drawings used for the construction of the building. The model utilized cracked section properties as recommended by the FEMA 356 (2000) document for the effective stiffness of reinforced concrete beams and columns and reinforced masonry shear walls. Thus, the shear stiffness was reduced by 60% for these members; the flexural stiffness was reduced by 50% for beams and columns and by 20% for walls. A uniform thickness was used for the uncracked hollow-core pre-cast concrete slabs which were modeled as orthotropic shell elements. The equivalent thickness was obtained by performing an analysis to calculate plank properties in bending and shear in each orthogonal direction.

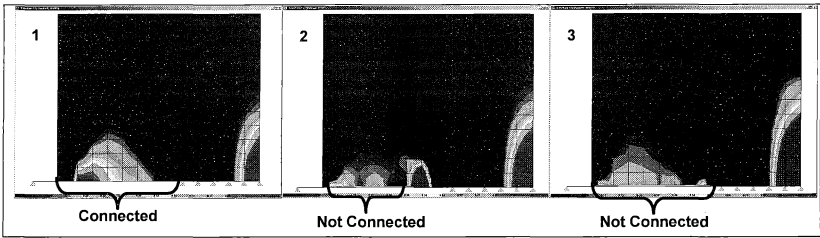
Figure 7. Vertical force diagrams for the CMU shear wall above the transfer beam on gridline 4 in three stages of gravity load analysis.

The structural design drawings indicated that the second floor transfer beams were to be shored until the construction reached up to the fifth floor. A SAP2000 (CSI 2001) finite element model of the second floor beam along gridline 4 and the wall above it in the North-South direction was created. Only the dead load from the walls and floor slabs was applied to this computer model. As determined from the dead load study of the model, the vertical stresses in portions of the second floor walls had exceeded the yield strength of the vertical reinforcing bars ($\text{Ø}16@1200\text{mm}$ (#5@48") on center) in the walls, assuming no real capacity in tension for the mortar bedjoint between the wall and planks. Therefore, the transfer beam was separated from the wall in these regions of large stress resulting in even larger stresses in the neighboring nodes of the beam due to load distribution. In the final stage, all wall nodes with stress values exceeding the yield capacity of the $\text{Ø}16$ (#5) reinforcing bar were released from the beam. Figure 7 illustrates the staged gravity load analysis. While releasing the wall from the beam, the vertical loads from the wall were still kept on the beam. Otherwise, the CMU wall would have acted as a very deep cantilever beam carrying its own load without transferring anything to the beam.

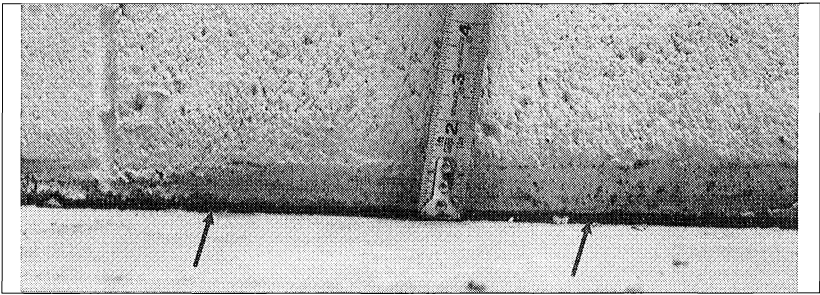
Figure 8. Separation between CMU shear wall and the concrete topping at the second floor.

The outcome of the gravity load analysis was incorporated into the detailed three-dimensional model in which the transfer beams on gridlines 2, 3, 4 and 5 at the second floor level were released from the second floor CMU walls in the mid-span region of the beams. This was consistent with the observations at the site of a significant separation along the beam-wall interface at the second floor (Figure 8).

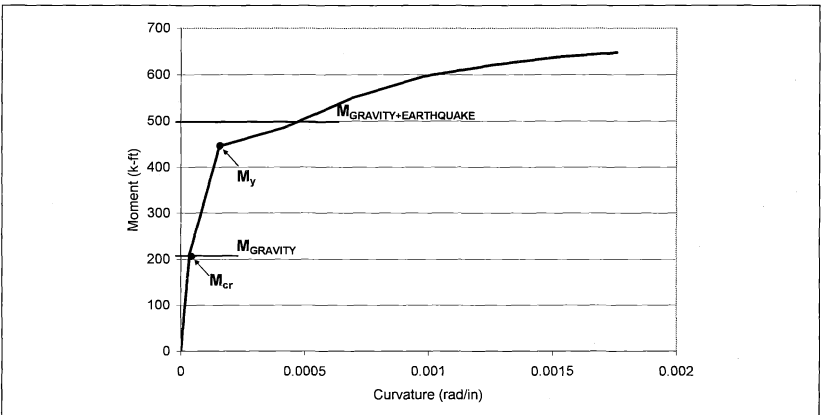
Figure 10. Moment-Curvature diagram for second floor beam section at 3/16" crack location.

gravity loads, and gravity and Northridge earthquake loads combined. The maximum moment demand values are compared in Figure 10 with the capacity curve obtained from a moment-curvature analysis of the beam. The beam has 12Ø36 (12#11) longitudinal steel bars at the bottom for the first 3.7 m (12 feet) from its South end to support the termination point of the CMU wall above, but only 2Ø36 (2#11) bars for top reinforcement for the entire span. All longitudinal steel is Grade 420 (60). At 3.7 m (12 feet) from the South end of the beam where the beam is lightly reinforced, the moment demand from the combined gravity and Northridge earthquake loads was computed as 677.0 kN-m (499.3 kip-ft), 12% larger than the beam's yield moment capacity of 603.6 kN-m (445.2 kip-ft). The locations of the observed beam cracks (Figure 5) and their sizes correspond well with the locations of the moment demand in the beams beyond their capacity.

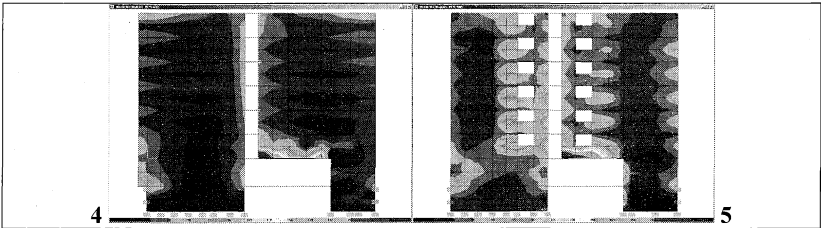
Figure 11. Gridlines 4 and 5 horizontal stress (S11) diagrams (Units: Kips, in).

Figure 11 illustrates the horizontal stresses in the plane of the reinforced masonry walls on gridlines 4 and 5. The stresses are plotted for the combination of gravity and Northridge earthquake loads. Cracking in the walls is expected for the red (dark) colored areas in Figure 11 where the tensile stress demands exceed the tensile strength capacity of the masonry mortar joints just above the 2nd floor transfer beams. Stress plots for other gridlines are similar to that of Figure 11. The location of overstressed regions above the 2nd floor transfer beams corresponds well with visual observations of cracks in CMU walls.

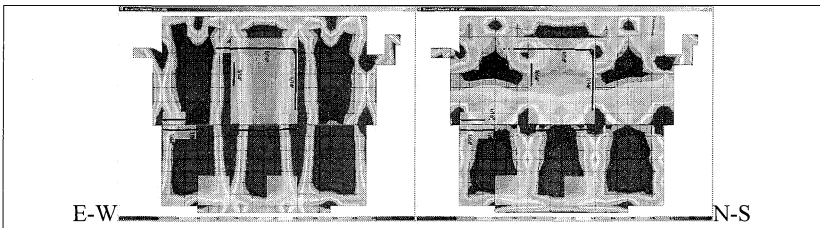
Figure 12. Overlay of crack map and E-W, N-S normal stress plots (Top of 2nd floor slab).

The calculated stresses in the second floor slab from gravity and Northridge earthquake loads along with an overlay of observed cracks are illustrated in Figure 12. The normal stress demands in the plane of the slab in the East-West and North-South directions are shown in Figure 12. The red (dark) colored regions along the gridlines correspond to stress levels that exceed the tensile capacity of the grout joints between the hollow-core planks. These regions correlate well with the areas in the building where cracking was observed as shown in the crack maps overlaying the stress plots in Figure 12. Crack maps in Figure 12 are located in areas where damage survey was conducted. Figure 12 illustrates the excellent correlation obtained from the field data and computer model results.

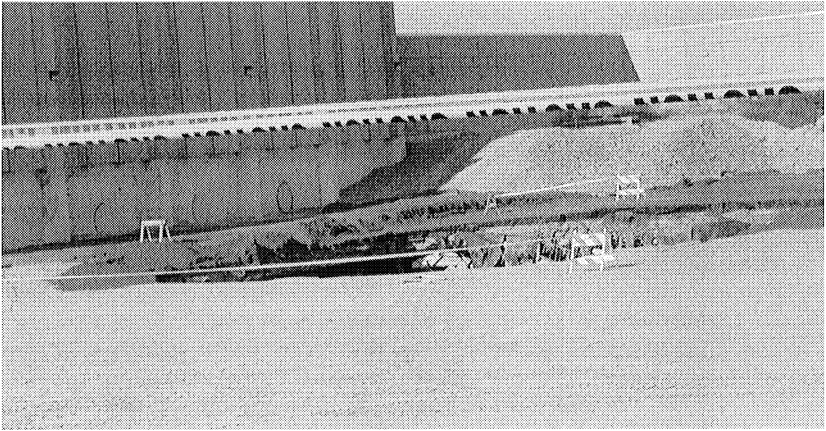
Figure 1. View of collapsed roof section

Improvements to the clear wells and the high lift suction well were designed in 1995. The construction of the improvements began in 1997. The collapse of a portion of the South Clear Well roof occurred at approximately 2:00 p.m. (EDT) on June 22, 1999 during final topsoil placement operations on the roof of the clear well. No persons were injured or construction equipment damaged by the failure.

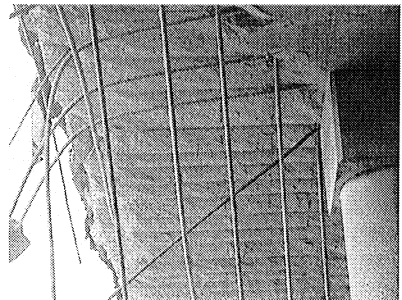
Fig 4. Roof slab steel stripped

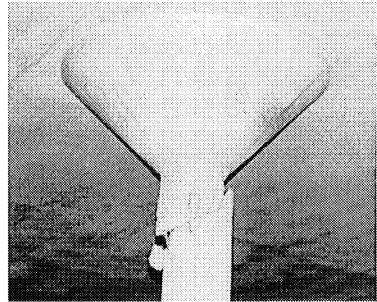
Figure 5. Failed Column

- A single failed column (6f-Qq) was noted southeast of the access hatch located in the northwest corner of the clear well with similar damage to the group of four columns described in the previous bullet.

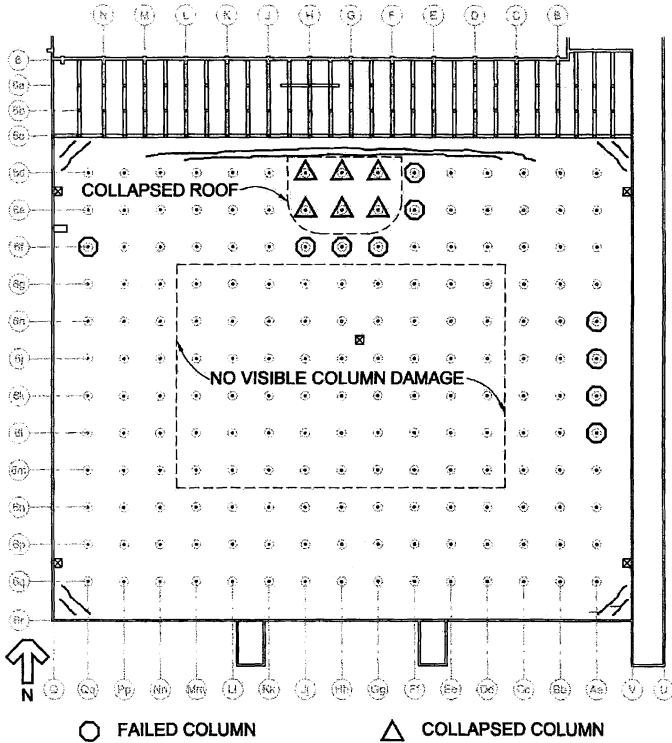
Figure 6. Plan view of clear well roof slab with damaged column notation

- “Undamaged” columns have no structural defects that can be detected by the naked eye. These 54 columns are located within the center of the clear well indicated by the dashed line on Figure 6.
- “Damaged” columns have spalled concrete at base column/pedestal interface oriented towards the center of the clear well, spalled concrete at roof column/capital interface oriented towards the exterior of the clear well. At the midpoint of the exterior walls away from the corners, horizontal hairline cracks at both the top and bottom column/capital/pedestal interfaces and diagonal shear cracks immediately below the roof column/capital interface were noted. These 110 columns are located at the perimeter of the clear well on Figure 6.

- “Failed” columns have undergone lateral displacement along the upper shear cracks in addition to the same characteristics as the damaged columns. At these columns, the roof does not appear to be damaged. These ten columns are indicated by a hexagonal symbol on Figure 6.
- “Collapsed” columns are located in the area of the roof collapse. These six columns are indicated by a triangular symbol on Figure 6.

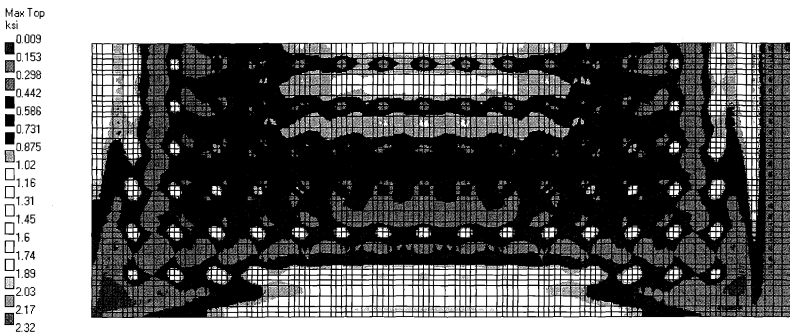
Figure 7. Floor Slab Principal Stress – Uniform Uplift vs. Dead Wt. Plus Topsoil

Structural analysis of the base slab and columns indicate that uplift pressures less than the maximum levels predicted by the hydraulic model and measured in the field are sufficient to cause the generally symmetrical damage noted in the clear well. The actual severity of floor and column damage varies with the general position in the clear well, the specific end conditions (i.e., the stiffness of the walls, adjacent beam and post system, or the filtered water conduit), the specific material properties of the concrete and steel at each column or floor section, and the ability of the under drain system to deliver the uplift pressure to an area of the floor slab. The pattern of failed columns, however, is not consistent with the general pattern of damage. Therefore, a source of additional loading was required to bring specific areas to failure. A review of the construction sequence indicates the collapsed columns and the scattered failed columns have two factors in common. First, the columns are located adjacent to the perimeter of the clear well where the moments in the floor and columns are largest. Second, the failed columns are all in areas where topsoil fill had been placed. The area of the roof collapse was the offloading point for the topsoil and underwent the highest traffic loading.

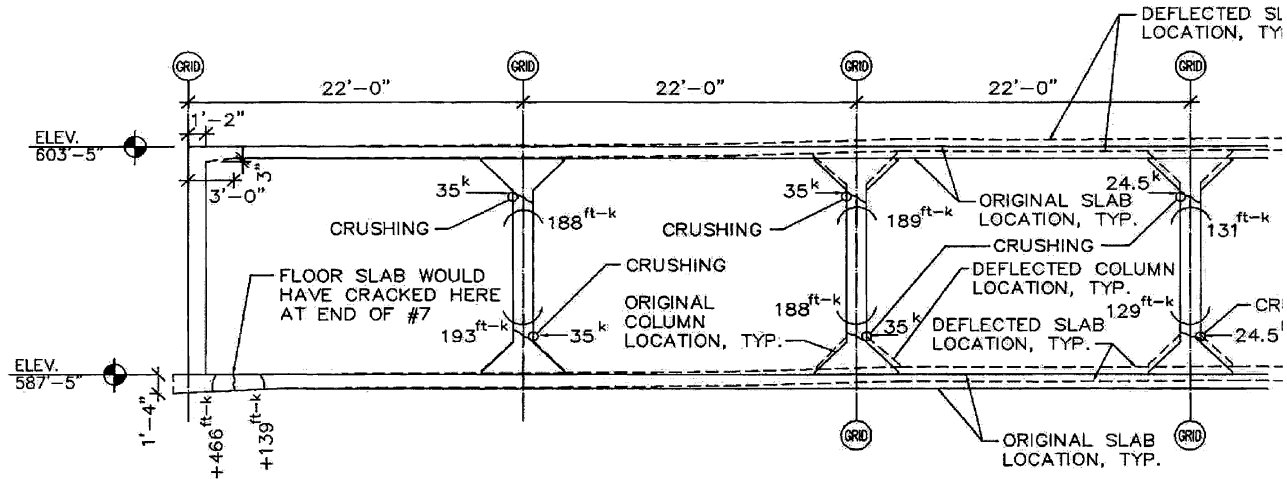
1. ULTIMATE CAPACITY OF COLUMN @ P_u 147^k $M = 101^{ft-k} < 188^{ft-k}$,
 189^{ft-k} , 131^{ft-k} @ HEAD OF 7'-1"
2. COLUMNS HAVE EXCEEDED ULTIMATE CAPACITY
3. THE SHEAR FORCES HAVE EXCEEDED THE ULTIMATE
 MAXIMUM SHEAR 28.7^k FOR THE FIRST TWO COLUMNS
4. CONCRETE & STEEL STRENGTH OF EA. INDIVIDUAL COLUMN
 WILL HAVE AN EFFECT ON THE MAGNITUDE OF FAILURE

Figure 8. Deflected Slab Shape and Resultant Shear Forces and Moments

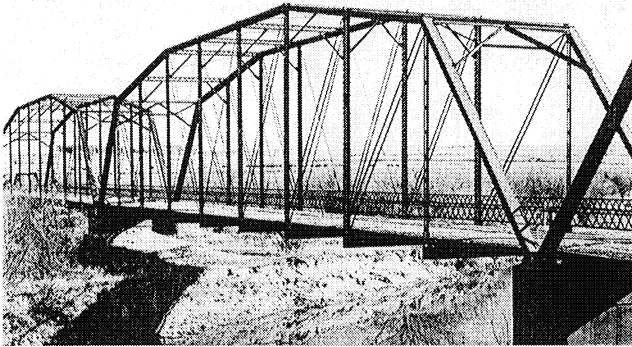
Figure 1. Prowers Bridge over the Arkansas River, near Lamar, Colorado. This bridge consists of one five panel Pratt pony truss built in 1921, three nine panel Camelback Pratt through trusses built in 1909, two six panel Pratt through truss built in 1902 and 1906. The 49-meter (160-feet) Camelback Pratt through truss span, seen in this photo, was instrumented because it received the greatest wind exposure. It has steel floor beams with steel stringers and asphalt filled corrugated steel deck. It has steel bottom chord eyebars and diagonals with steel rod counterbracing. The railing is a steel lattice with single angle top and bottom rails. Virtually all paint has weathered away. It survived a major flood of the Arkansas River in 1921 and served as a highway bridge until its abandonment in 1994 when a replacement bridge was constructed nearby.

To aid preservation efforts, real bridges were examined with non-traditional structural analysis and on-site field wind data. This paper focuses on the Prowers Bridge shown in Figures 1 and 2. The bridge is a pin connected Camelback Pratt through-truss. It has moment-resisting end post member at the portals and horizontal trusses consisting of rod X-bracing intended to resist lateral loads.

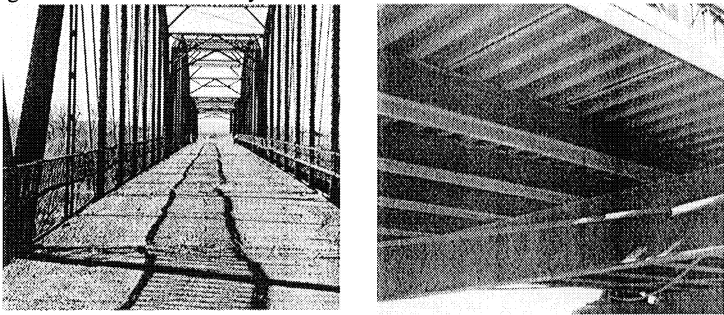
Figure 2. Prowers Bridge Deck. The steel stringers are riveted to the floor beams. Asphalt pavement, now significantly weathered, was installed over a corrugated bridge deck.

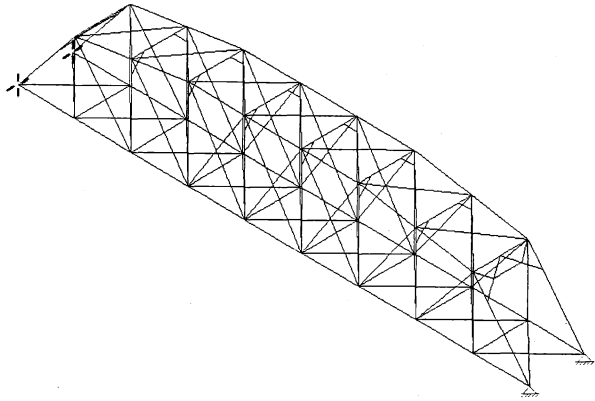
Figure 3. Prowers Bridge. Illustration of the traditional skeleton method of modeling based on the steel members only.

Figures 3 through 6 for Prowers Bridge illustrate the modeling technique used for Prowers Bridge with the RISA-3D software (RISA 2002).

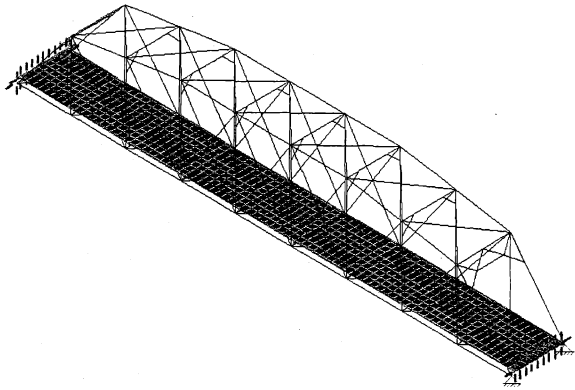
Figure 4. Prowers Bridge. Skeleton model with stringers and deck.

The Prowers deck model was based on a skeleton model plus 810 plate elements with steel stringers, as shown in Figure 4 through Figure 6. The corrugated deck was represented as a thin plate. The corrugated steel deck has one stiffness in the corrugated direction and a different stiffness in the non-corrugated direction. The RISA 3-D model is not capable of defining stiffnesses of orthogonal plates/shells. The method used here was to model a range of deck stiffnesses for the corrugated steel deck, treating the deck as if it were isotropic. Table 1 shows axial forces of the windward bottom chord eyebars from the original timber deck skeleton model, the existing deck skeleton model, two models with different deck stiffnesses for the corrugated steel deck models, and the deck modeled as a rigid diaphragm. The wind pressure criteria was based on the AASHTO wind pressure of 3.59 kPa (75 psf), perpendicular to the bridge.

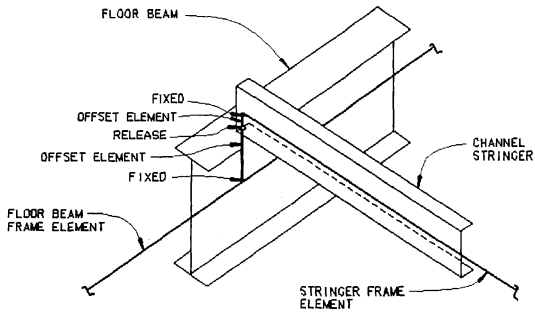
Figure 5. Prowers Bridge. Offset members and release locations

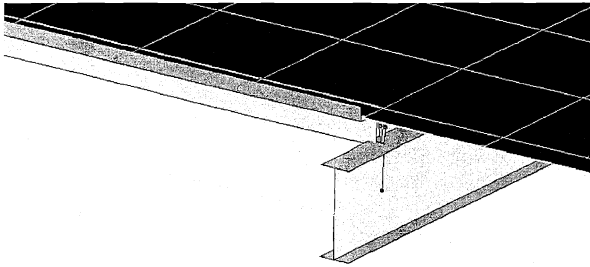
Figure 6. Prowers Bridge. Rendering of equivalent corrugated steel deck with deck edge angle on steel stringers on steel floor beam. The deck was modeled as an equivalent solid.

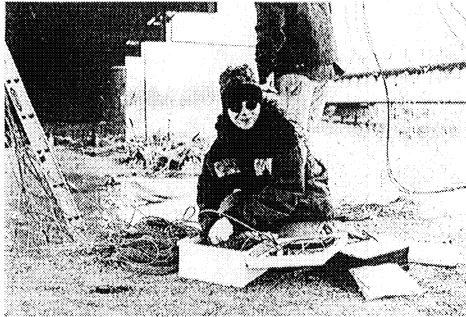
Figure 7. Strain transducer and wind sensors cables installation to the data logger prior to placing into service.

A Campbell Scientific CR5000 Data Logger (Campbell Scientific 2001) with remote data downloading capability collected all Prowers Bridge field data. Figure 7 shows the field installation of the strain transducer and wind sensors cables to the CR5000 Data Logger. Remote downloading capability was provided through the use of a program downloaded to the data logger, a digital cellular modem, and an antenna. Figure 8 shows the digital cellular modem and antenna used during the Prowers test.

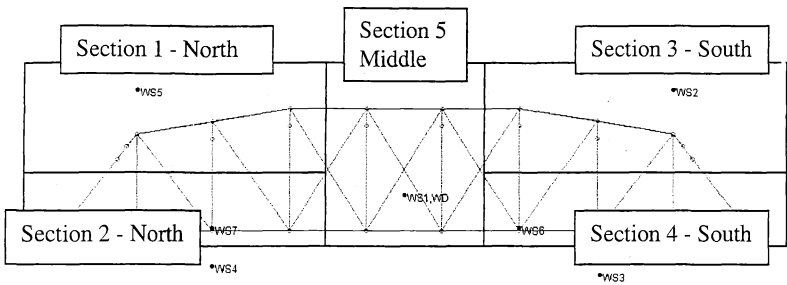
Figure 10. Diagram of Prowers Bridge illustrating the locations of the anemometers (WS1-WS7) and wind direction sensor (WD) and sections subjected to different uniformly distributed wind pressures in the verification analysis. North is to the left. WS1 was positioned directly upwind of the centroid of the wind intercept area. WS2 and WS5 were located 3 meters (approximately 10 feet) above the top of the end post members in the portals. WS3 was positioned 3 meters (approximately 10 feet) below the bridge deck, at an elevations mid-height between the bridge deck and the water surface below. WS4 was positioned 2.5 meters (approximately 8 feet) below the bridge deck, at an elevations mid-height between the bridge deck and the existing ground below. WS6 and WS7 were positioned approximately at the deck elevation. Wind pressure on Section 1 was determined from a weighted average from the velocities measured at WS5 and WS1. Wind pressures at the other sections were similarly determined except for Section 5, which was determined from WS1 only.

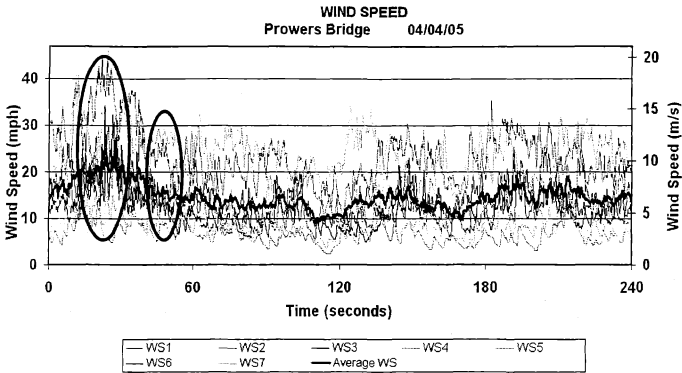
Figure 11. Prowers Bridge. Illustrating the wind speed as measured by the seven anemometers. The bold line shows the average of all seven anemometers. The circle areas were the "high" spike event and "low" spike event.

The wind pressure is really the variable of interest and wind pressure varies with the square of velocity. Therefore, the wind velocities from the anemometers were converted into wind pressures at each location based on the Bernoulli's theorem (Weidner and Sells 1966) incorporating drag coefficients. The field velocity data from the seven anemometers are shown in Figure 11 and field wind direction data is shown in Figure 12.
