Forensic Engineering

Proceedings of the
Fourth Congress

FORENSIC ENGINEERING

October 6–9, 2006
Cleveland, Ohio

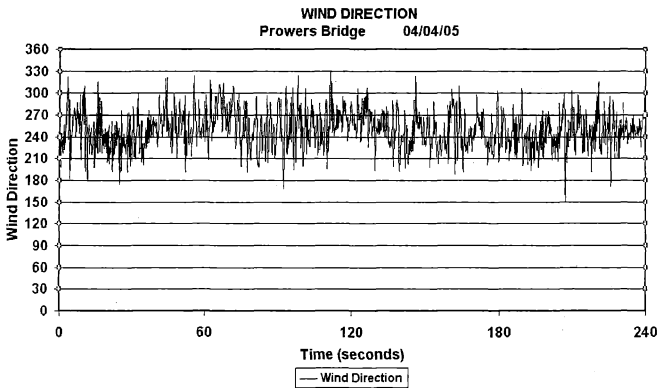
Figure 12. Prowers Bridge. Wind direction as measured during the test.

The wind pressure is really the variable of interest and wind pressure varies with the square of velocity. Therefore, the wind velocities from the anemometers were converted into wind pressures at each location based on the Bernoulli's theorem (Weidner and Sells 1966) incorporating drag coefficients. The field velocity data from the seven anemometers are shown in Figure 11 and field wind direction data is shown in Figure 12.

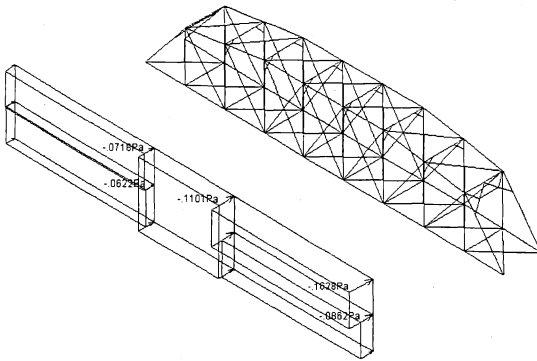
Figure 13. Measured field wind pressure applied to the five sections for analysis. North is to the left.

The data from the seven anemometer revealed that the instantaneous wind speeds are not the same at different parts of the bridge. Therefore, the wind pressures are not uniform along the bridge. The bridge model was divided up into five sections to account for the different pressure at different areas of the structure as shown in Figures 10 and 13. Each set of the values were averaged to remove some of the local fluctuation out of the results. Table 2 shows the measured field pressures used on the Prowers Bridge model.

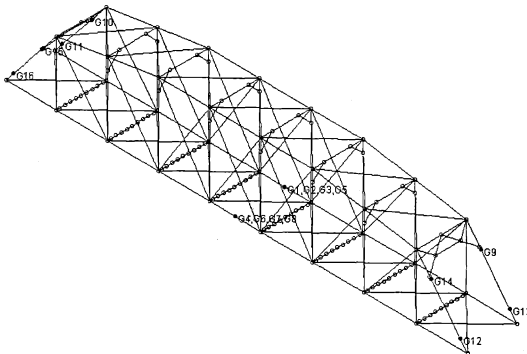
Figure 14. Diagram of Prowers Bridge. Illustrating the locations of the strain transducers. North is to the left. The wind direction was from the west, orthogonal to the bridge. Strain transducer numbers, G1-G3, G5 were clamped to the leeward bottom chord eyebars. G4, G6-G8 were clamped to the windward bottom chord eyebars. G9, G12-G14 were clamped to the end post at the south portal. G10-G11, G15-G16 were clamped to the end post at the north portal. See Figure 15 for actual field location of transducers on the bottom chord eyebars.

Figure 14 shows the location of the clamp-on modular strain transducers on the Prowers Bridge. Each bottom chord member consists of two pin-connected eyebars. At the mid-span of the bridge, a location where wind-induced strains were expected to be the maximum, a strain transducer was clamped to each side of each eyebar. Figure 15 shows the clamp-on strain transducers installed on the eyebars on the Prowers Bridge.

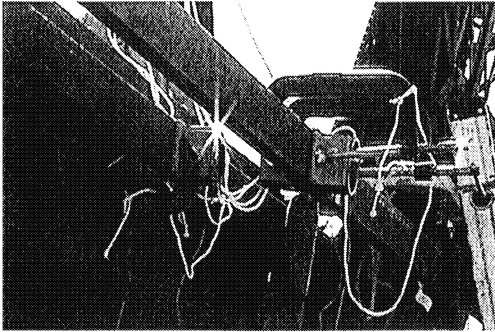
Figure 15. Strain transducers (G4 & G6 – G8) installed on the bottom-chord eyebars on the west side at Prowers Bridge. Each device has a safety string attached to the bridge as a precaution against falling off the bridge during installation.

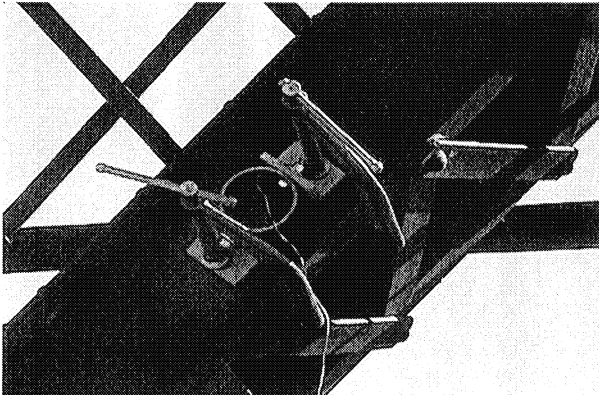
Figure 16. Strain Transducer installed on the outside face of the north end post (portal) at Prowers Bridge. It is located 1.5 meters (2 feet) above the lower pin.

The clamp-on modular strain transducers were mounted at the location of the knee brace near the top of the end post and above the pin location at the bottom of the end post of the portal frame. These locations were selected due to anticipated high moments from lateral (wind) loading. Figure 16 shows one of clamp-on strain transducers on the lower end post member.

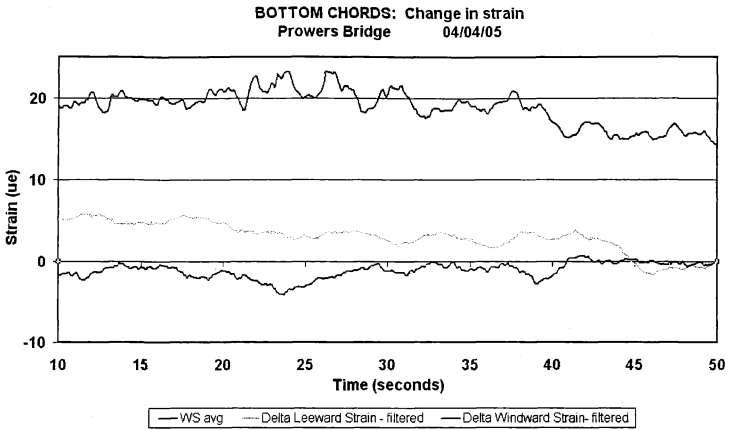
Figure 17. Prowers Bridge. Enlargement of the traces for windward (bottom line) and leeward (middle line) bottom chord eyebars measured strains. Both are traces of the filtered data. Thus, they represent the change in measured strain starting from the same point in time as the corresponding change in wind velocity. The wind velocity (top line) is shown for reference to an arbitrary scale.

A local "low" spike of a 3-second interval was averaged at the bottom of the event and a local "high" spike of a 3-second was averaged at the top of the event to obtain a strain difference (delta strain) to eliminate any residual strain from the strain gage. A 2-second rolling average was performed to filter out electrical noise from the raw data on the bottom chords as shown in Figure 17. It also was performed on raw data for the end posts members (portal) as shown in Figure 18.

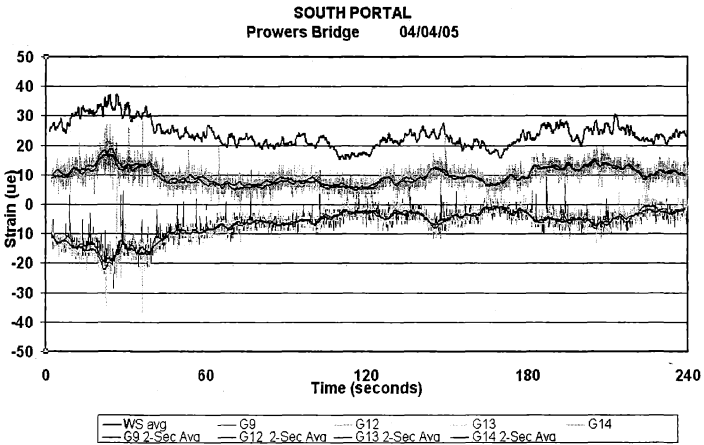
Figure 18. Prowers Bridge. Illustrating the strains measured at the south end post. Note how the strain response correlates with changes in the wind velocity, shown at the top to an arbitrary scale.

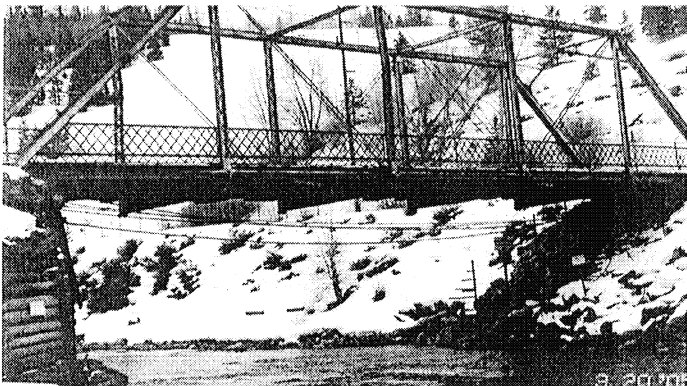
Figure 1. Blue River Bridge over Blue River.

The Blue River Bridge is a steel Pratt truss bridge that has an 80 feet span with five 16 feet bays as shown in Figure 1. The bridge road width is 16 feet and the truss height is also 16 feet. The bridge truss consists of double channel lattice posts, top chords, and portals. The bottom chords are double eye bars and the diagonal members are either rods or double plates. The top and bottom chord x-braces are also rods. The deck consists of longitudinal and transverse timbers on steel stringers that bear on the floor beams. The bridge bearings are buried.

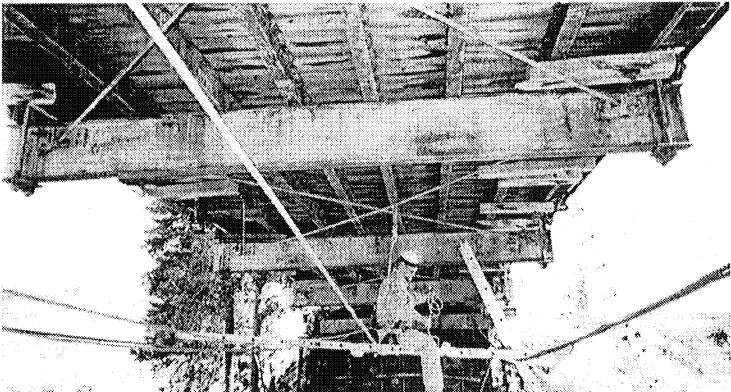
Figure 2. Blue River Bridge. Strain Transducer Installation.

The university research team utilized several instruments to obtain measurements of wind speed, wind direction, and strains from selected members during windy conditions. A total of five anemometers were used to obtain wind speed data. Wind direction was determined by a wind direction sensor with respect to the bridge orientation. Wind direction was expected to be consistent over the bridge span. A total of sixteen strain transducers were installed at different members to obtain the strain data. These members were selected because of relatively high axial forces or moments due to lateral load. For the Blue River Bridge, eight strain transducers were installed back to back on each eyebar at mid-span. Four transducers were installed on end stringers at mid-span and four on top and bottom of the south end posts. Figures 2 and 3 show the test set-up for the Blue River Bridge.

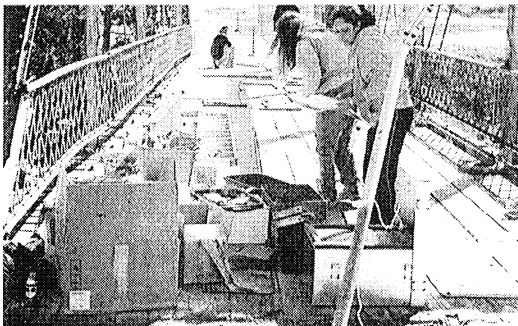
Figure 3. Blue River Test set-up in progress. The deck consists of longitudinal "running boards" on transverse timbers on steel stringers. The orthogonal criss-crossing of running boards and deck timbers creates a much more continuous deck than that at Fruita Bridge. The steel stringers bear on and are mechanically attached to the steel floor beams.

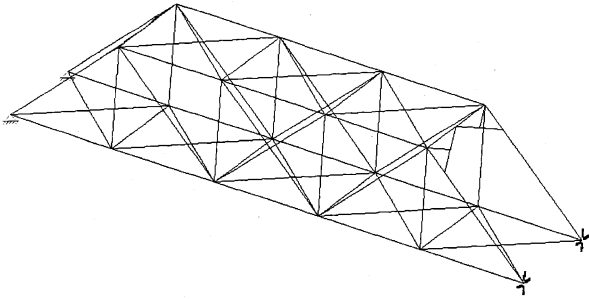
Figure 4. Blue River Bridge: Illustrating the traditional skeleton based on the primary members only.

The Blue River Bridge was first modeled as a skeleton structure as shown in Figures 4 through 8 and then modeled with a deck shown in Figures 9 through 11. The choice for boundary conditions for both configurations was pinned joints at one end and roller joints at the other. The roller joints were restrained from lateral translation but free to translate in the longitudinal direction the bridge. All internal member connections were assumed to be pinned, that is released to rotate.

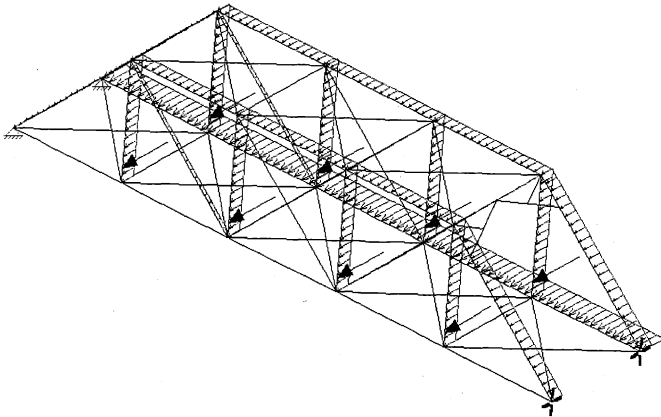
Figure 5. Blue River Bridge: Lateral wind pressure on the bridge.

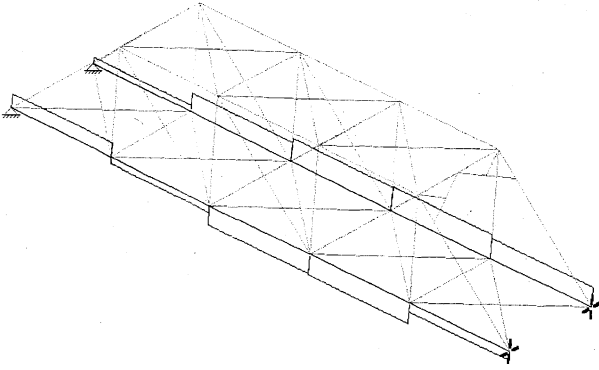
Figure 6. Blue River Bridge: Graphical representation of axial forces in the bottom chord eyebars due to wind on the skeleton structure.

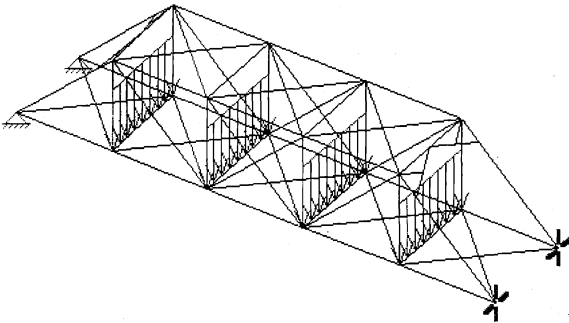
Figure7. Blue River Bridge: Representation of superimposed gravity loads.

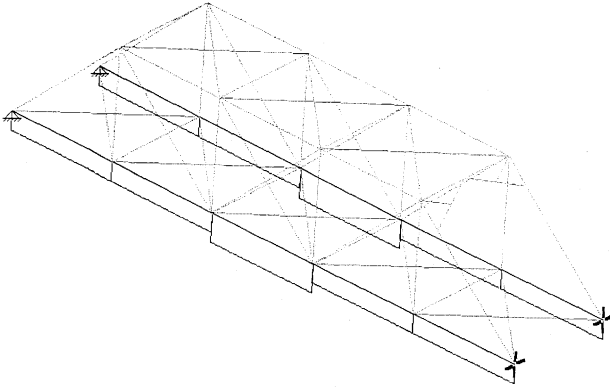
Figure 8. Blue River Bridge: Relative axial forces in the bottom chord eyebars due to gravity loads on the skeleton structure.

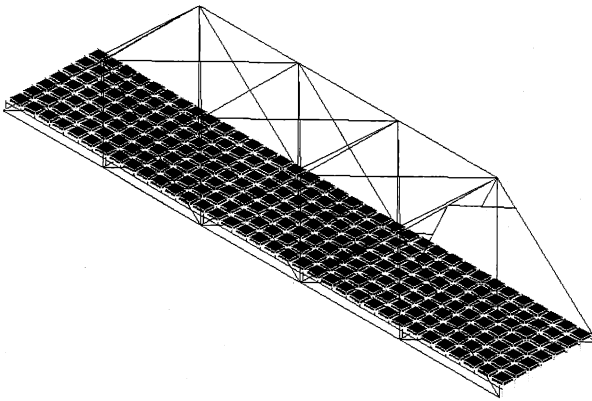
Figure 9. Blue River Bridge: Skeleton model with stringers and deck.

As it is shown in Figures 9-11 the transverse deck boards and the longitudinal running boards oriented perpendicular to them were treated as a solid instead of as individual boards. This was because the two mutually perpendicular layers, well spiked together, were believed to act similar to a single solid material. As such, this timber deck had considerably stiffness in the lateral direction. This can be validated by comparing the deck model to the diaphragm model, discussed below. Table 1 shows the results for bottom chord eyebars in three different cases.

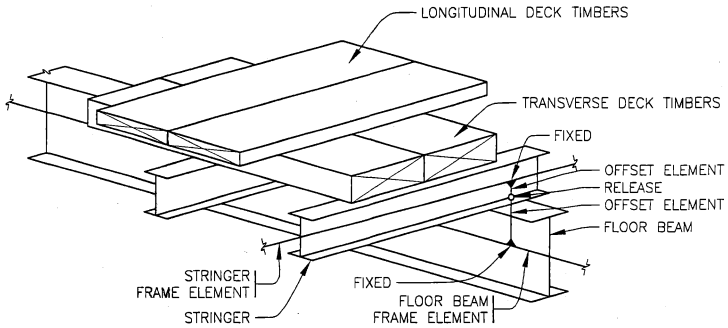
Figure 10. Blue River Bridge. Offset members and release locations.

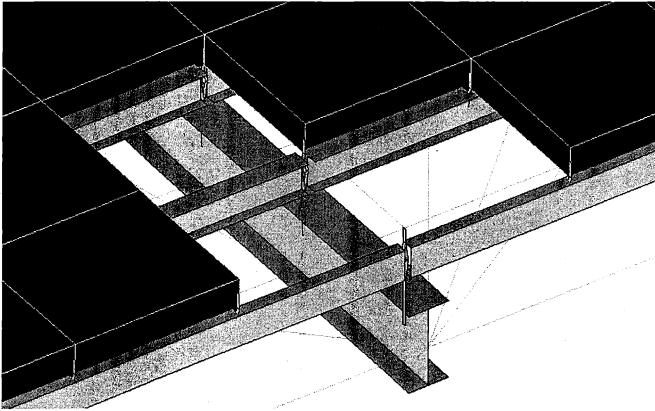
Figure 11. Blue River Bridge: Rendering of deck timber deck on steel stringers on steel floor beam. The mutually orthogonally deck timbers have been treated as a single monolithic solid.

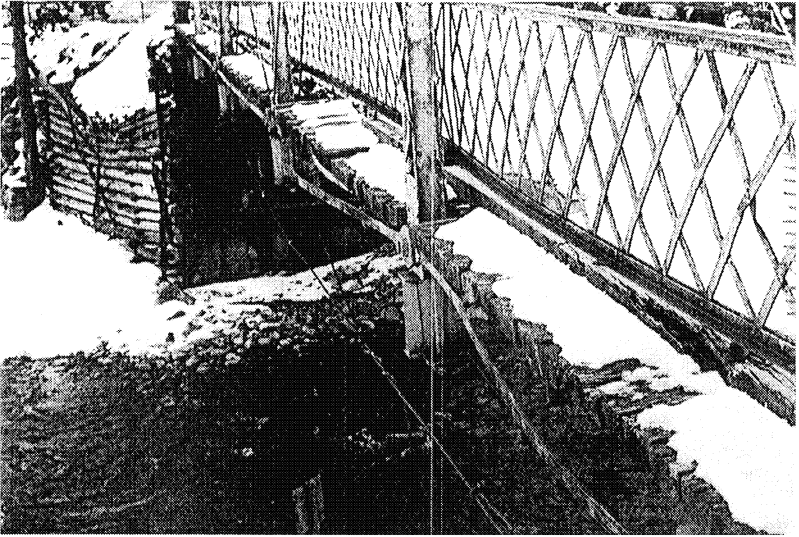
Figure 12. Buckled eyebars in the Blue River Bridge.

As it is shown in Figure 12 the eye bars were buckled significantly under the applied loads. This condition was assumed to be a result of the abutment failure. Because the abutment wall shown in Figure 13 had failed, soil pressure was apparently causing a net compressive force down the longitudinal axis of the bridge which caused buckling in the bottom chord eye bars. Despite the eye bar buckling, the bridge was still functional for pedestrian use. The stiff deck can carry some tensile force caused by gravity and lateral loads. In addition arching can occur and compressive forces can go to the end posts. Gravity load tests compared very well with analytical results suggesting the buckled condition of the eyebars was not significant to the members response (Hamedian, 2006)

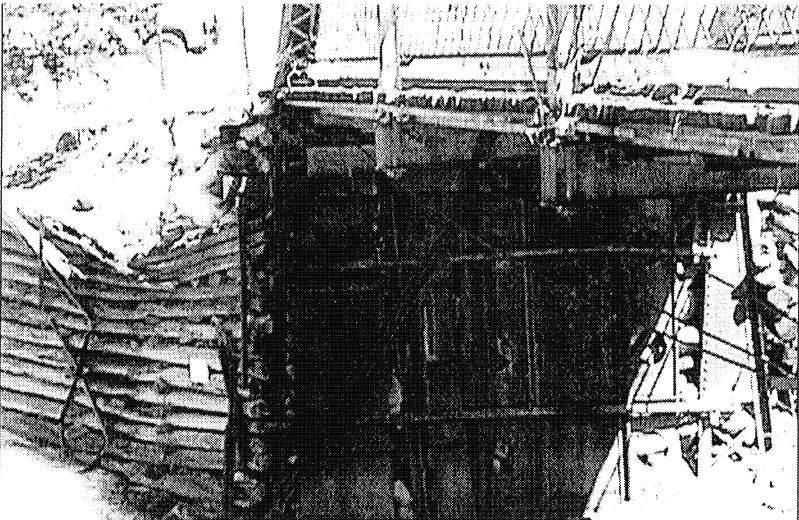
Figure 13. Abutment failure in the Blue River Bridge.

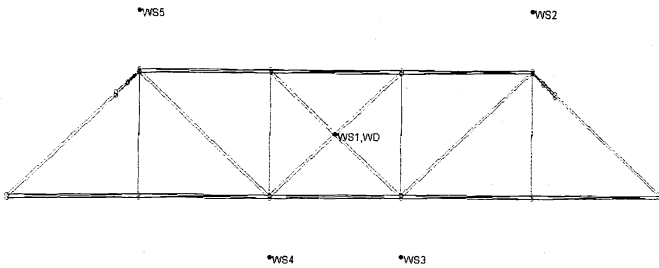
Figure 14. Diagram of Blue River Bridge, illustrating the locations of anemometers (WS1-WS5) and wind direction sensor (WD). North is to the left. WS1 was positioned at the approximate center of the wind intercept area. WS2 and WS5 were located above the end diagonal in the portals. WS3 and WS5 were located below the bridge at the elevation mid-height between the bridge deck and the water surface below.

Figures 14 through 19 and Table 2 show the location of instruments such as strain transducers, wind sensors, and general results for the Blue River Bridge.

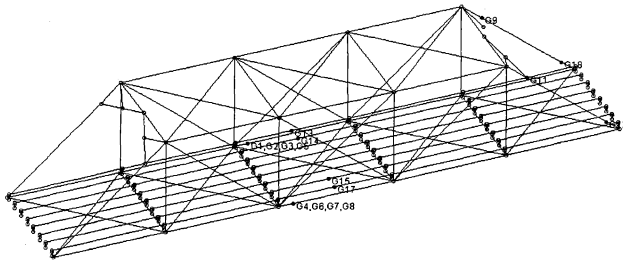
Figure 15. Diagram of Blue River Bridge, illustrating the locations of the strain transducers. North is to the left. The wind direction was from east to west, orthogonal to the bridge. Strain transducers G1, G2, G3 and G5 were clamped to the windward bottom chord eyebars. G4, G6, G7 and G8 were clamped to the leeward bottom chord eyebars. G9 and G11 were clamped to the top of the south portals. G12 and G18 were clamped to the bottom of the south portals. G13 and G14 were clamped to the east stringers in the middle bay and G15 and G17 were clamped to the west stringers.

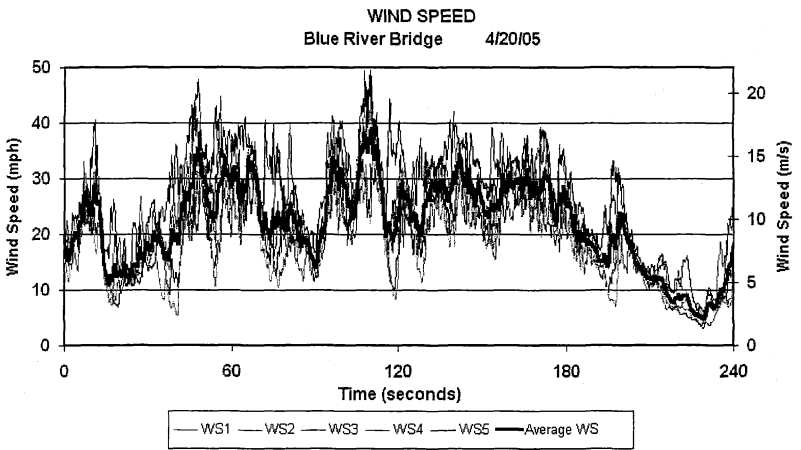
Figure 17. Blue River Bridge: Wind Speed as measured by the five anemometers. The average of all five anemometers is shown by the bold line.

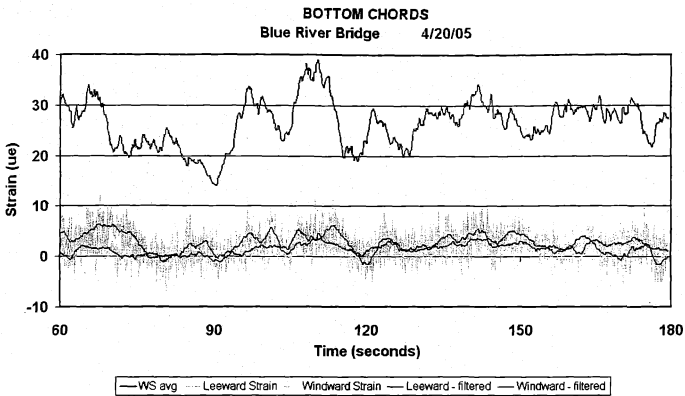
Figure 18. Blue River Bridge. Strain measurements for the windward and leeward bottom chord eyebars. The average wind speed, to an arbitrary scale, is also shown as the bold line at the top. Strain in the leeward eyebar is shown above strain in the windward eyebar. Both the raw data and a filtered line that removes much of the signal noise are shown.

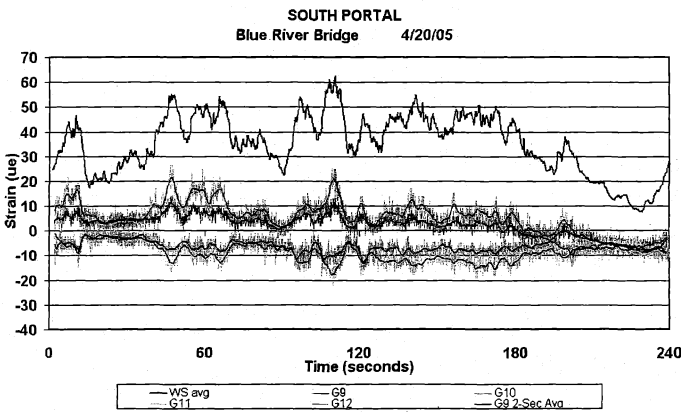
Figure 19. Blue River Bridge. Measured strains at the south end posts are shown.

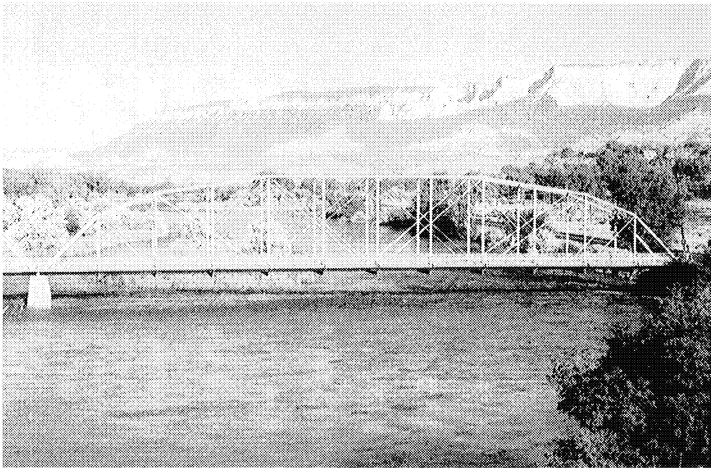
Figure 1. Rifle Bridge over the Colorado River at Rifle, Colorado. This 73 meter (240-foot) span Pennsylvania truss comprises the longer of two different spans at that location. It has steel floor beams with steel stringers, covered by a corrugated metal deck with asphalt pavement. It has steel eyebar bottom chords and diagonals and steel rod counterbracing. The railing is a steel lattice with double angle top and bottom rails. It has been abandoned since the late 1960's, when a replacement bridge was constructed upstream.

It is believed that to be of the greatest practical value in aiding preservation efforts that real bridges be examined. This paper focuses on the Rifle bridge shown in Figures 1 and 2.

The structure is a 240 ft span Pennsylvania truss, built in 1909 and in service until the late 1960's. The Rifle bridge is unique in that it has the longest span of those studied, which results in a span to width ratio of 12. Additionally, it was retrofitted with a deck covering heavier than the original construction. This had the effect of maintaining tensile forces in the slender bottom chords that would have otherwise reversed stress direction resulting in a compressive stress condition for higher wind load events.

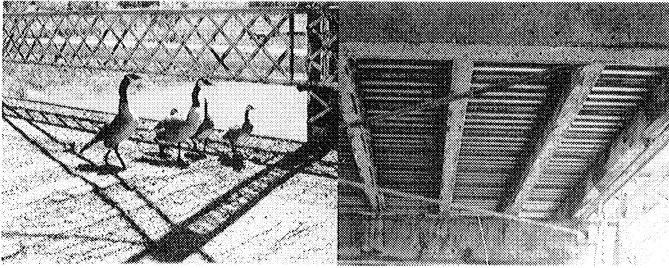
Figure 2. Rifle Bridge deck. The deck of (weathered) asphalt pavement on a corrugated metal bridge deck on of steel stringers was modeled.

The modeled representation of the deck shown in Figure 7 represents the actual deck shown in Figure 2. The 2.25" x 0.125" corrugated metal bridge deck is topped with an average of 1" of asphalt pavement, all of which was modeled as approximately square plate elements. This analysis included the asphalt as a contributing factor to the stiffness. This was accomplished by calculating a composite stiffness by using a transformed modulus composed of both steel deck and asphalt

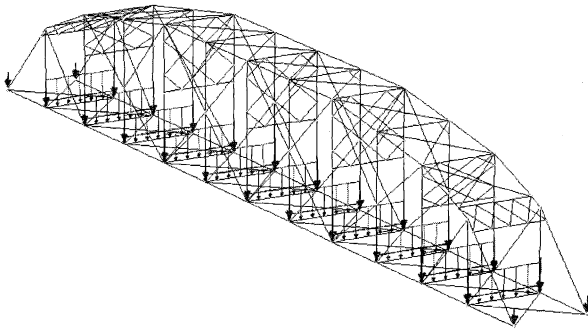
Figure 3. 3D model of bridge, illustrating the traditional skeleton based on the steel members only, using the software RAM Advanse. Representation of superimposed gravity loads (D + L) is shown.

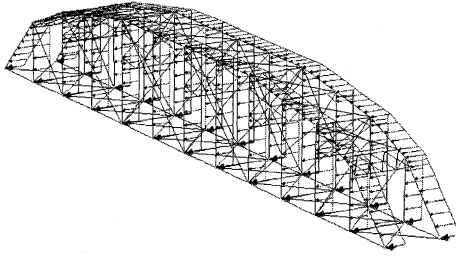
Figure 4. Representation of transverse wind pressure on the bridge. The wind load event studied was skewed, and therefore included a longitudinal component (not shown).

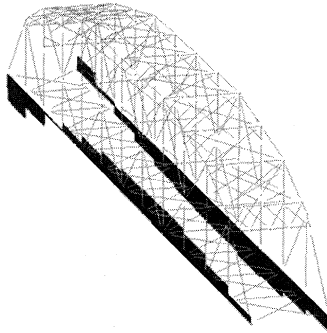
Figure 5. Graphical representation of axial forces in the bottom chord eyebars due to wind for the skeleton structure.

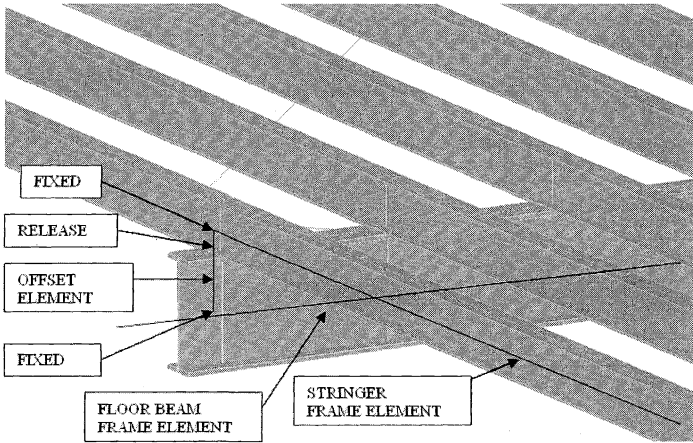
Figure 6. Rendering of stringers on a steel floor beam for the deck model. The rendering was produced by RAM Advanse 3D. The dummy offset elements used to connect the floor beam and stringer have a rotational release at the beam-to-stringer interface.

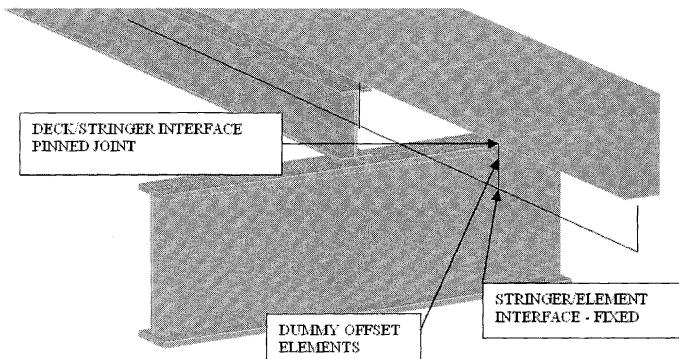
Figure 7. Rendering of the 1" asphalt paving over 2.25" steel deck planks on steel floor beam. For clarity, near stringers are not shown. Offset elements, from the beam centerline to the beam/stringer intersection to the stringer centerline to the deck/stringer interface were used.

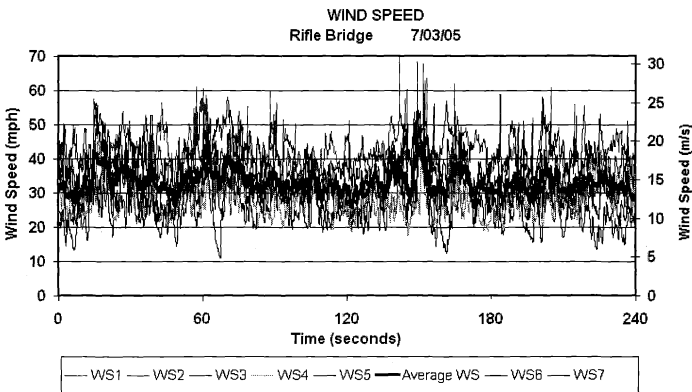
Figure 11. Wind speed data from seven anemometers. The heavy trace is the average of all seven, and will be used as a reference in the subsequent graph.

Transducer measurements indicated each region was subjected to a different wind pressure. Pressures used in analysis were averaged from adjacent regions. Wind velocities varied from 1.5 m/s to 14.9 m/s at the different anemometer locations; although it is the difference in the maximum and minimum velocity at a location for the period of time studied that was used to establish pressure on the model.

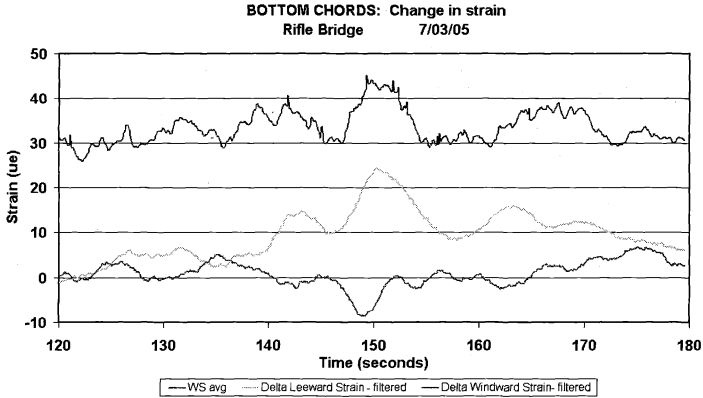
Figure 12. Enlargement of the traces for windward and leeward bottom chord eyebar measured strains. Both are baseline traces of the filtered data. Thus, they represent the change in measured strain starting from the same point in time as the corresponding change in wind velocity. The wind velocity is shown for reference at the top. The spike in the strain at 150 seconds correlates to the spike in the wind velocity used for this study.

Figure 12 portrays the effects of the wind event used for the Verification study. Note at Time 150 seconds the spike in the wind velocity and the subsequent spike in the measured strains at the same time. The strains were applied to the properties of the bottom chord eyebars to develop measured forces. Tables 2 and 3 show a comparison of calculated and measured forces for the Rifle Bridge.

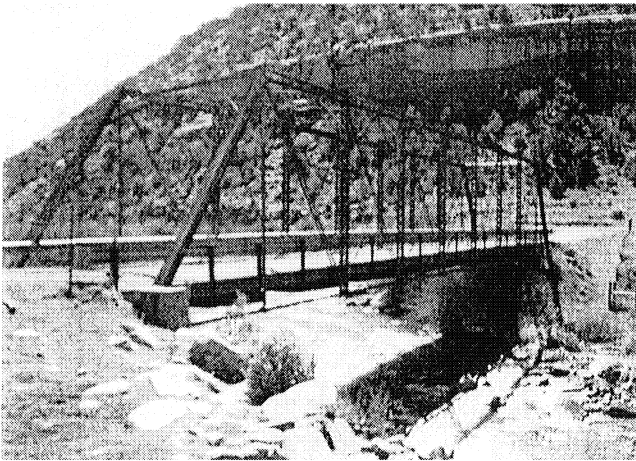
Figure 1. San Miguel Bridge over San Miguel River near Uravan, Colorado.

It was believed that to be of the greatest practical value in aiding preservation efforts that real bridges be examined. This paper focuses on the San Miguel Bridge, shown in Figure 1.

The 43-meter (142-foot) Pratt truss was built by the Phoenix Bridge Company in 1886 and used wrought iron as the primary structural material. The bridge was part of a five-span Fifth Street Bridge over the Grand (now Colorado) River at Grand Junction, Colorado, shown in Figure 2. One span was relocated to the San Miguel River location in the 1930s. It has a roadway of gravel on an unusual system of semi-circular lengths of corrugated metal pipe set between steel stringers. It has wrought iron eyebar bottom chords and diagonals and wrought iron rod counterbracing. A steel vehicular rail has replaced the original railing. It served the mining industry in western Colorado until the 1980s. Abandoned since 1990, it remains the oldest bridge originally built in Colorado.

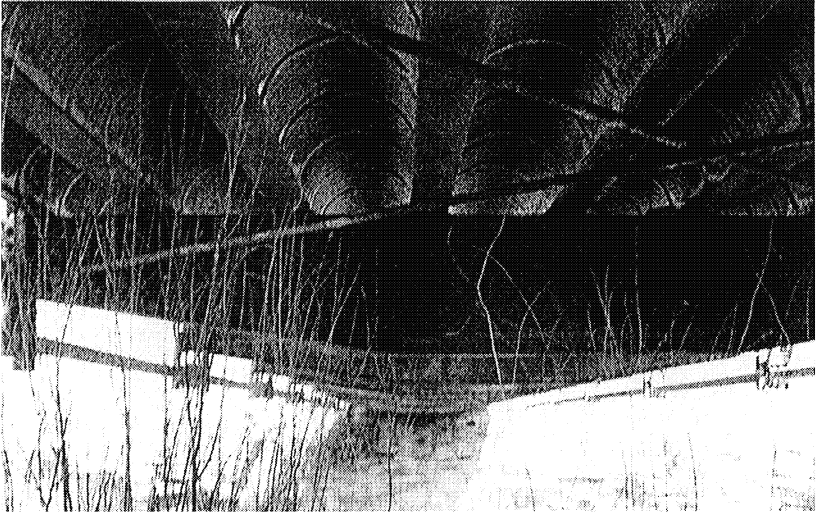
Figure 3. San Miguel Bridge deck as it appears today near Uravan, Colorado.

The deck shown in Figure 3, believed to have been installed in 1964, consists of semi-circular corrugated metal pipe segments which bear on the bottom flanges of steel stringers. The metal pipe has been replaced with timber blocks in a few places where the corrugated metal pipe has rusted away. The semi-circular corrugated metal pipe segments are topped with a gravel roadbase.

This deck is much heavier than its original timber deck. The gravel roadbase produces a heavy dead load of approximately 3.54 kPa (74 psf), much higher than the original timber deck, and estimated at approximately 0.62 kPa (13 psf).

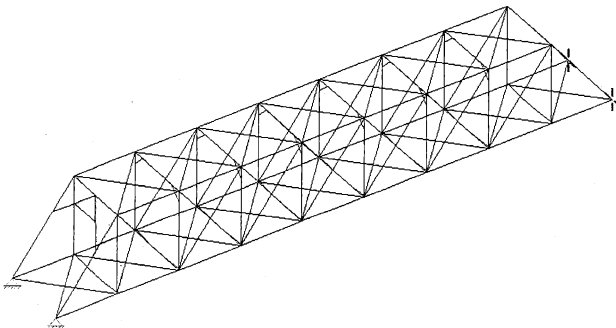
Figure 4. Illustration of the traditional of skeleton structure based on steel members only.

The pin connected skeleton frames, shown in Figures 4 through 6, were analyzed under AASHTO loads for pedestrian bridges. This analysis was compared to the deck model, shown in Figure 7, subject to the same loads. As-built dimensions and section properties from San Miguel Bridge were used. Because it was desired to investigate the problem using software tools that were readily available to practicing engineers, RISA-3D software (RISA 2002) was used for both analyses. RISA-3D is exemplary of readily available software that includes both frame elements and plate/shell elements.

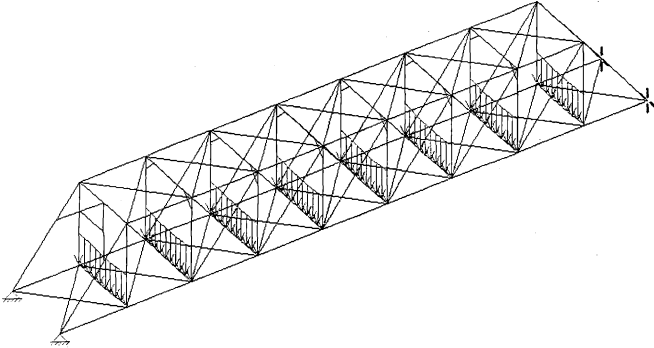
Figure 5. Gravity loads applied to skeleton structure.

The San Miguel Bridge boundary conditions were pinned at one end and rollers at the other end as indicated in Figure 5. The rollers are restrained from translation in the lateral direction.

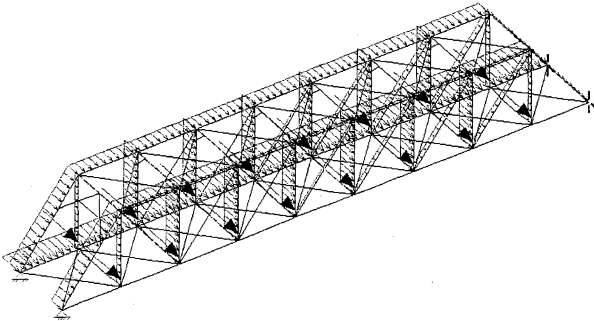
Figure 6. Wind load applied to skeleton structure. The wind load shown is based on the AASHTO criteria of 3.59 kPa (75psf).

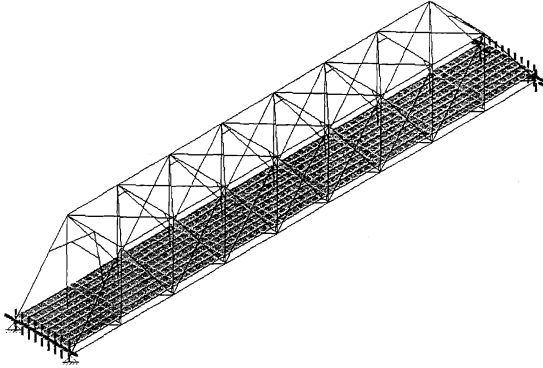
Figure 7. San Miguel Bridge: Skeleton model with stringers and deck.

The interior stringers shown in Figures 7-9, are 12 inch deep wide flange beams while the outer stringer is a 15 inch deep channel, all of which is intended to model the floor system that was installed in 1964.

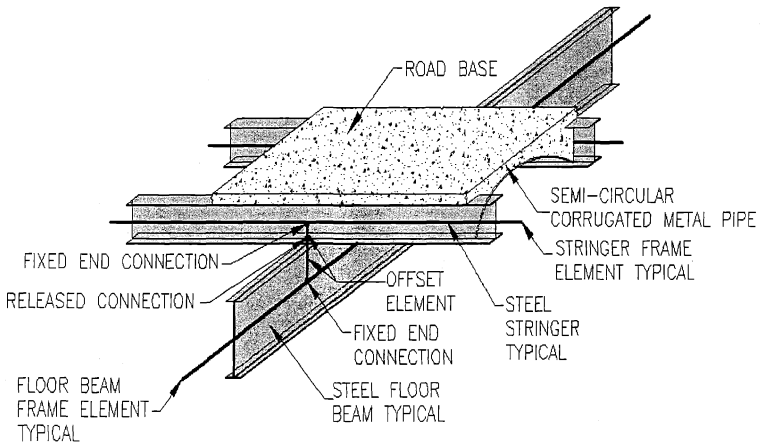
Figure 8. Offset members and release locations.

The deck was modeled using RISA 3D and interconnected plate elements were used to represent the gravel roadbase. Offset elements, shown in Figure 8, were modeled such that the deck elements were at the same elevation as the stringer top flanges, but otherwise similar to Figure 8. This was done for modeling simplicity.

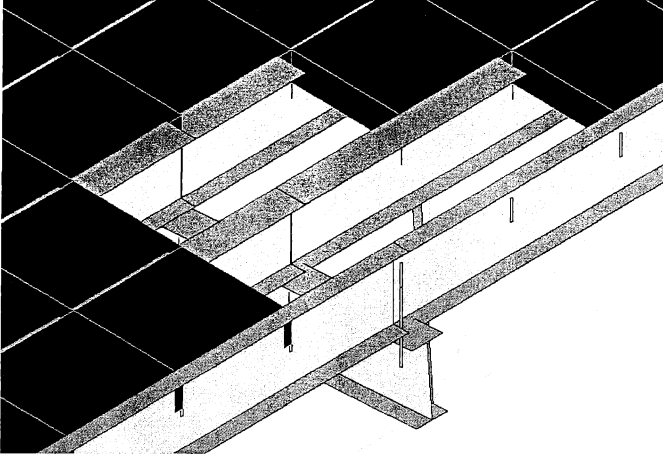
Figure 9. Rendering of floor beam, stringers, and deck. Note that the deck is represented as centered on the top flange of the stringers, intended to approximate the actual roadbase material, which envelops the stringer top flanges.

Studying the bridge and deck in Figures 1-3 and utilizing RISA 3D software in Figures 4 through 9 was used to construct the skeleton model with the applied gravity and wind loading. The deck was modeled as an elastic solid that enveloped the top flange of the stringers, as shown in Figure 9. The San Miguel Bridge deck, with its large amount of gravel roadbase, has a relatively heavy dead load. Table 1 shows axial forces of the windward bottom chord eyebars.

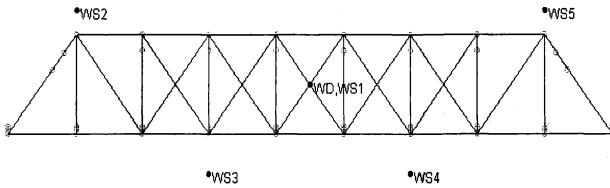
Figure 11. Diagram illustrating the locations of anemometers (WS1 – WS5) and wind direction sensor (WD). North is to the left. WS1 was positioned directly upwind of the approximate center of the wind intercept area. WS2 and WS5 were located 1.5 meters (approximately 5 feet) above the top of the end diagonal members in the end post. WS3 and WS4 were positioned 2 meters (approximately 7 feet) below the bridge deck, at an elevation mid-height between the bridge deck and the water surface below.

Figure 10 is a topographic map of the vicinity of San Miguel Bridge. Figures 11 through 18 and Table 2 show the location of instruments and results for the San Miguel Bridge.

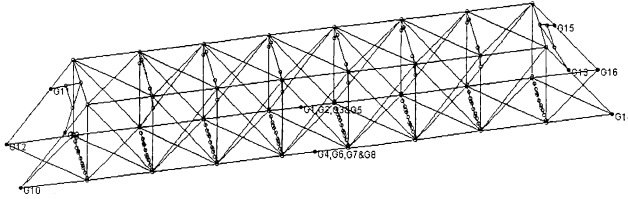
Figure 12. Diagram illustrating the locations of the strain transducers. North is to the left. The wind direction was from the west, orthogonal to the bridge. Strain transducer numbers G1, G2, G3 & G5 were clamped to the leeward bottom chord eyebars. G4, G6, G7 & G8 were clamped to the windward bottom chord eyebars. G9 – G12 were clamped to the end diagonals at the north end post. G13 – G16 were clamped to the end diagonals at the south end post.

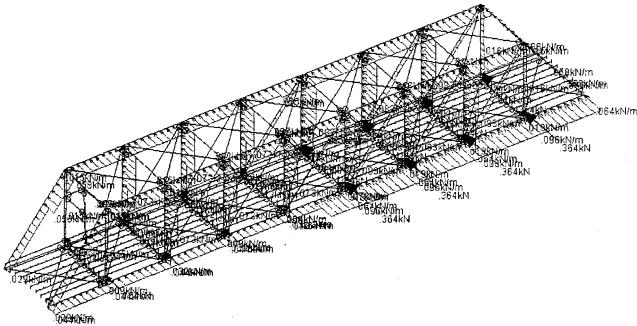
Figure 13. Wind Pressure applied to the four quadrants for analysis. North is to the left. Adding another component of wind pressure from the south (not shown here) to simulate the measured wind direction from the southwest was also investigated but the result was inconclusive.

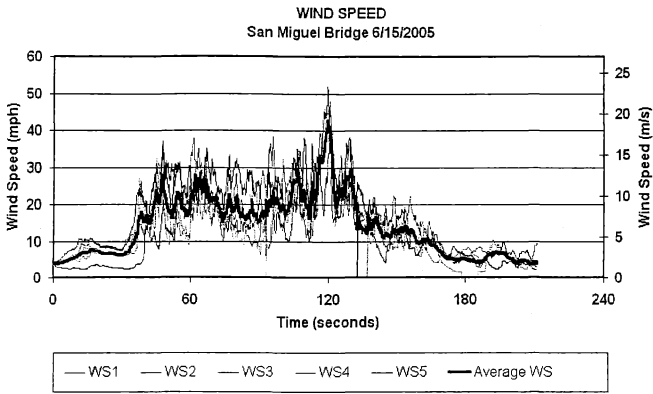
Figure 14. Wind Speed as measured by the five anemometers. The bold line shows the average of all five anemometers.

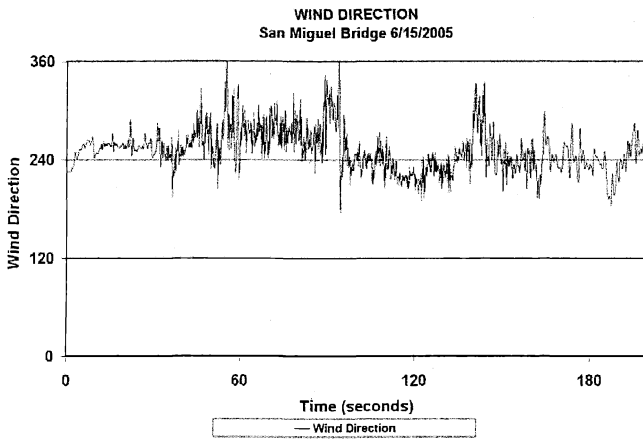
Figure 15. Wind direction as measured during the test.

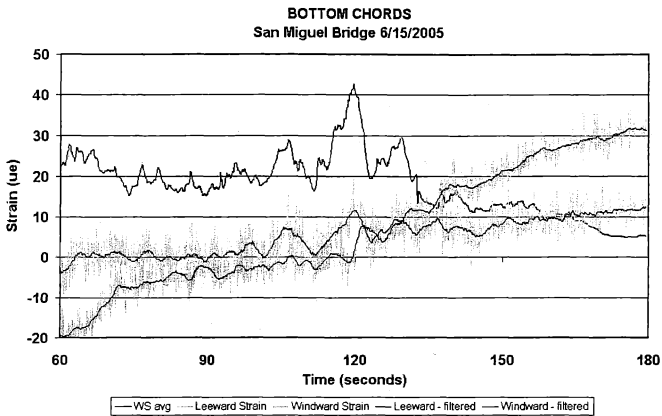
Figure 16. Strain measurements for the windward and leeward bottom chord eyebars.

The bold trace at the top of Figure 16 is the average wind speed, to an arbitrary scale. Measured strain for both leeward and windward bottom chords is shown. Both the raw data and a filtered line that removes much of the signal noise are shown. (Note: The increase in the strain value beyond 120 second time is most likely due to some signal drift – it does not appear to be due to mechanically-induced strain because the wind pressure is diminishing in this range)

The drift affecting the reading at time of collecting data as shown in Figure 16 and Figure 18 for the strain measurements at bottom chords and south end post could be explained by the following reasons:

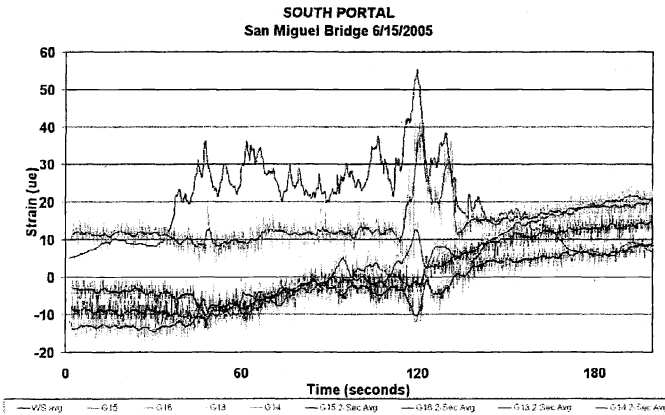
Figure 17. Measured strains at the south end post are shown.

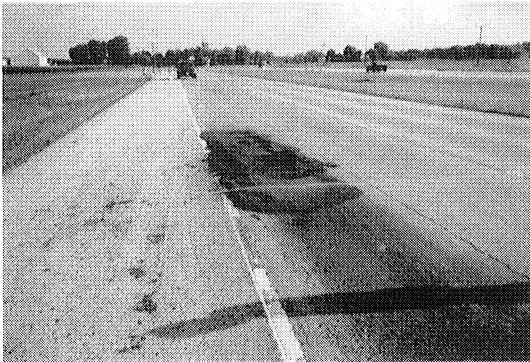
**Figure 1 Severe Distress, Section 390103**

Section 390103 showed the worst overall distress with high levels of rutting and longitudinal cracking. The longitudinal cracking was present in the center of the lane for the entire length of this section, with a mean crack width of about 12.7 mm. Also, longitudinal cracking of the same magnitude was noted along the inside edge of both wheel paths. Cold patch had been used to repair this distress (Figure 1) but had deteriorated to high severity. Fatigue cracking was present in approximately 25% of the right and left wheel paths and could be classified as moderate in severity. Some alligator cracking was also noticed in the wheel path and on the shoulder.

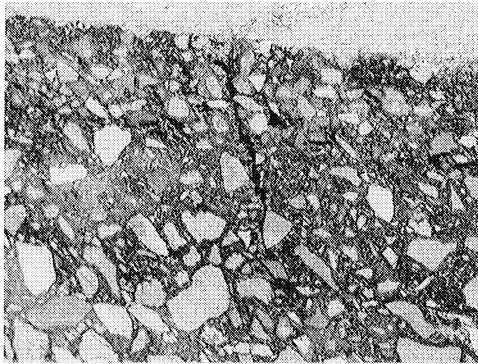
Figure 2 Close-up of Longitudinal Crack

Longitudinal cracking observed in all four sections during trench excavation, initiated on the pavement surface and was considered to be top-down with low to moderate severity as shown in Figure 2. The longitudinal crack consistently occurred in the center of the lane in all four sections and did not stray from a straight line path. The longitudinal wheel path cracking occurred on the edge of the wheel path and also followed a straight line. The wheel path cracks were shallower than the center line cracks and none of the longitudinal cracks extended all the way to the base, and most were within the top 10 cm.

Similar observations were made during a recent Colorado top-down crack study⁽⁷⁾. Of twenty-five longitudinal crack sites in Colorado, 72% were top-down cracking and 67% of the top-down cracking associated with visual segregation at the bottom of the surface layer. Figure 2 shows the segregation, where a relatively large portion of coarse aggregates is distributed in the bottom half of the surface layer. The Colorado study further identified the source of the segregation and it was attributed to the edges of the slat conveyors located at the center point of certain models of pavers, thus explaining the straight line longitudinal cracks.

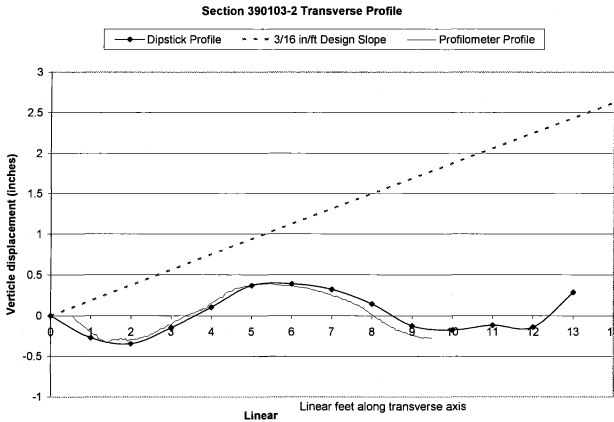
Figure 3 Transverse Profile 2 of Section 390103 (1 in =2.54 cm, 1 ft =0.3048 m)

Transverse profiles from Section 390103 for the profilometer and dipstick, shown in Figures 3, illustrate significant variations from the proposed original design. This section exhibited the greatest rutting of all. It should be noted that the profiles measured with the dipstick and the profilometer were very similar with the differences between the two attributed to each instrument starting at a slightly different reference point on the pavement.

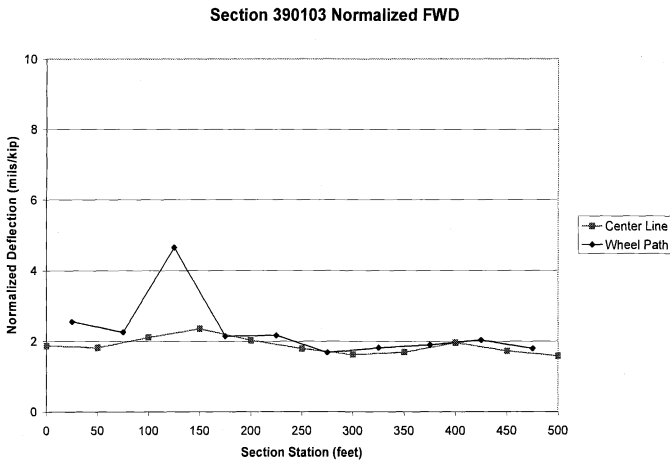
Figure 4 Normalized FWD Plot of Section 390103 (1 ft=0.305m; 1mil/kip=5.71 nm/N)

FWD tests were also conducted during the initial construction of these sections. In order to compare the two sets of data, the FWD data taken at the time of the forensic study was normalized to a load of 4.45 kN (1 kip). Examining the normalized FWD data at the time of the forensic study for Section 390103 (Figure 4) a large deflection spike is observed, while FWD deflection plots obtained at the time of construction do not show spikes in the AC or ATB layers. Therefore the distress occurring in the pavement at that location can not be attributed to any flaw during construction in the pavement base layers including the subgrade.

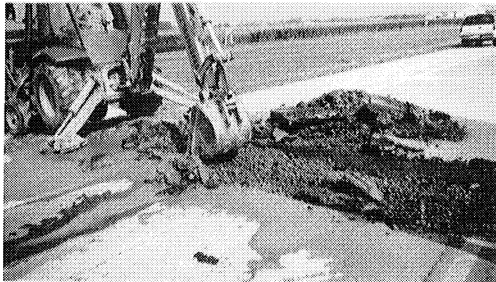
Figure 5 Trench Excavation

Lateral trenches approximately 1.5 m wide and 1.2 m deep were excavated (Figure 5) at locations within each section exhibiting various levels of distress. Three trenches were excavated in Sections 390103 and 390110, and two in Sections 390108 and 390109. Approximate section stations and levels of distress noted at the trench locations are shown in Table 3.

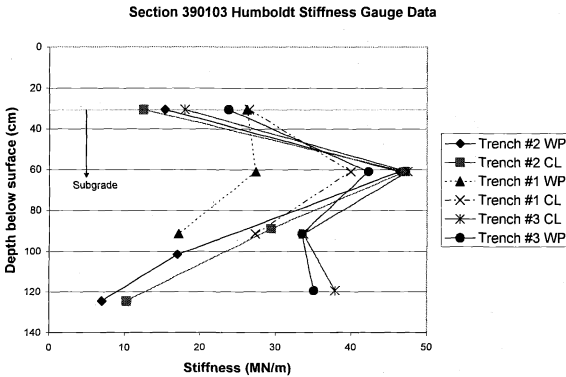
Figure 6 Humboldt Stiffness Gauge Plot of Section 390103

In-situ subgrade stiffness was measured at different depths within the trenches using a Humboldt Stiffness Gauge with typical data shown in Figure 6. Measurements were taken at 15 and 30 centimeter intervals at the same transverse location where the trenches were excavated. As shown in this figure, the data showed considerable variability in stiffness with depth in each section. Section 390103 revealed a significant increase in stiffness at a depth of 60 centimeters below the surface. This trend was present in all sections in at least one trench.

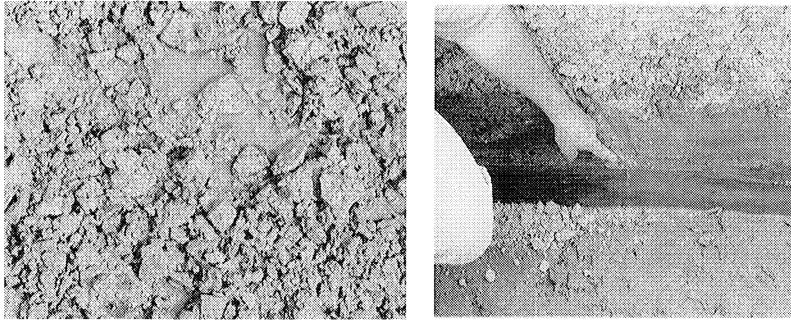
Figure7 Water Seeping from Interface Layer

Free water was observed between layers in the subgrade, between the asphalt concrete pavement and the base layers, and also water could be seen “seeping” from the subgrade (Figure 7). This indicated a lack of adequate drainage in the four pavement structures, even though Sections 390108, 390109, and 390110 were constructed with edge drains.

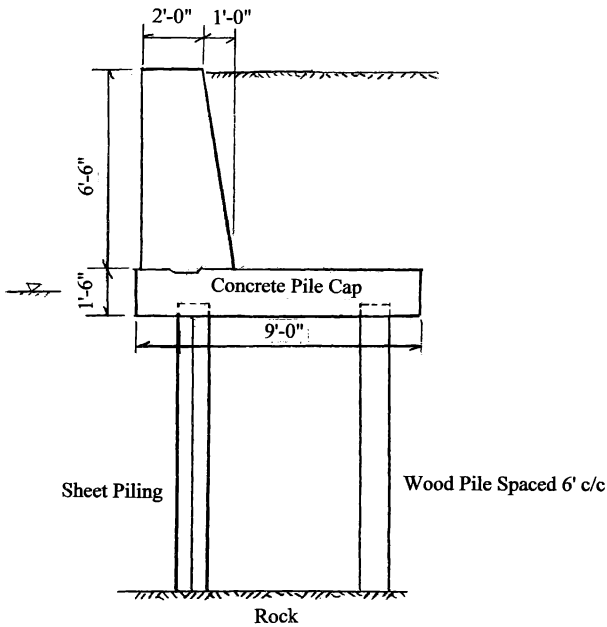
Figure 2
WALL CROSS-SECTION

The inner harbor lake wall consists of 34 mass concrete sections each 65 feet long. The cross section of the wall is a trapezoid with a 6'-6" foot tall vertical front face, a two foot wide top, a tapered back, and a 3 foot base (Figure 2). The sections have a keyway between them. This is set on a 1'-6" foot thick deck slab which extends about one inch beyond the toe of the wall and itself is founded on a sheet pile about 1'-3" back of the front face and wood piling about 7 feet back of the front face. The deck slab is a total of 9 feet wide. Drawings show a counter weight 35 feet behind the slab, but the presence of the counter weight and the wood piling could not be verified in the field. The drawings also show a keyway between the wall and the slab. The wall was anchored to the slab by 5/8 inch bars 18 inches on center at the toe and heel of the wall. The earth back fill comes to the top of the wall. There are no structures

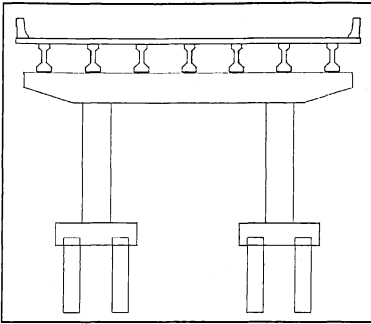
Figure 1: Model Bridge Cross-Section

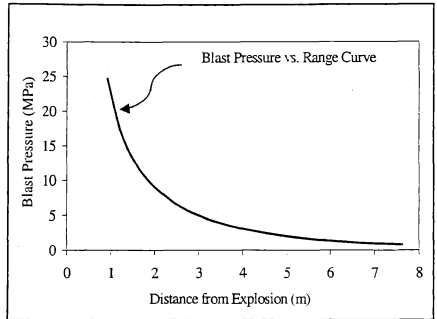
Figure 2: Variation of Blast Pressure with Distance.

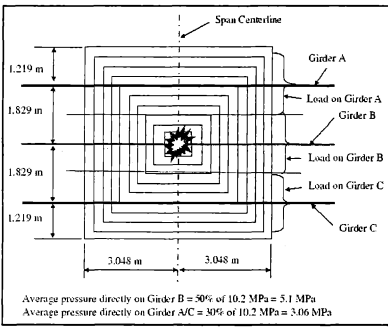
Figure 3: Blast Pressure Distribution on Bridge Deck.

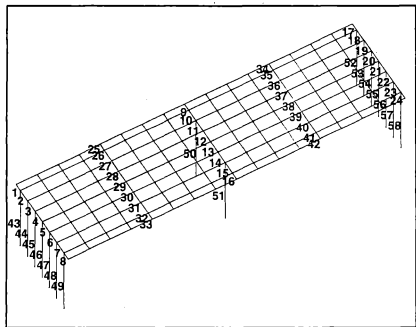
Figure 4: Model Bridge in STAAD.Pro

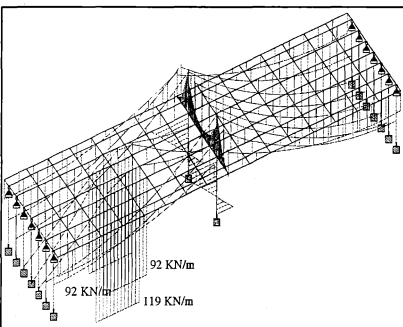
(a) Load Case 1

(b) Load Case 2

Figure 5: Load and Moment Diagrams for Girder Capacity.

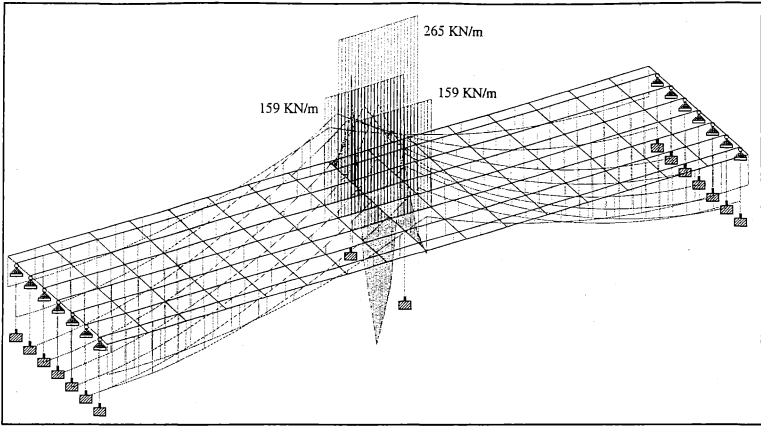
Load Case 3

Figure 6: Load and Moment Diagrams for Pier Cap Capacity.
