Forensic Engineering

Proceedings of the
Fourth Congress

FORENSIC ENGINEERING

October 6–9, 2006
Cleveland, Ohio

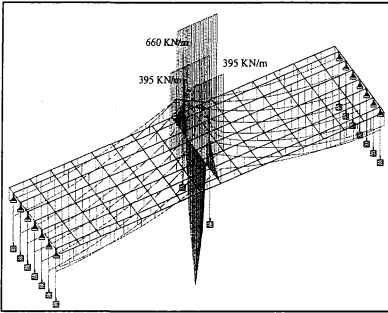
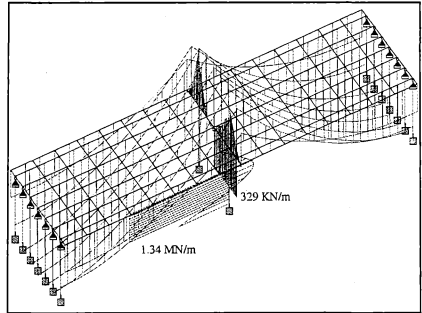
(a) Load Case 3

(b) Load Case 5

Figure 7: Load and Moment Diagrams for Column Capacity.

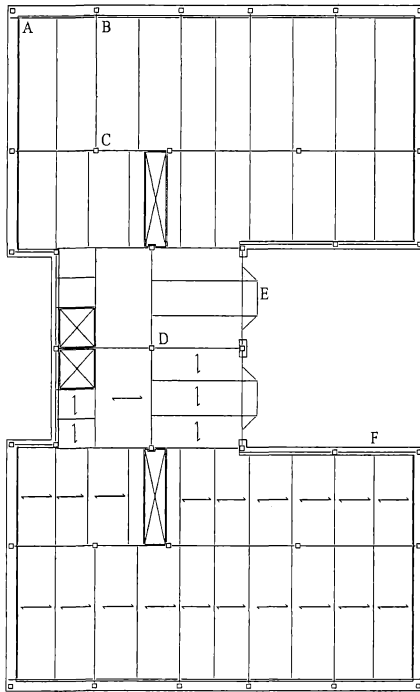
Figure 1: "A" indicates a column eccentrically loaded in both axes, "B" is a column eccentrically loaded around one axis, "C" is an interior column

possibly loaded eccentrically, "D" is a concentrically loaded column, "E" is a metal-clad bay window, and "F" is typical exterior wall.

The building, located in midtown Manhattan at 59 West 46th Street, was to have twelve typical stories with a smaller, set-back penthouse. The general plan was 55 feet by 90 feet overall, in a broad "U" around a light court. (Figure 1) The full height was to be 148 feet, with 10'-10" typical floor-to-floor spacing. Neville & Bagge, the architects of record, had designed many smaller apartment houses, tenements, and row-houses. The general contracting firm, Pole & Schwandtner, was also the engineer of record.

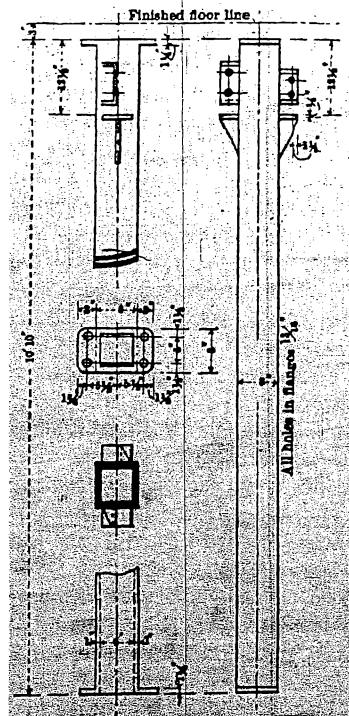
Figure 2: Column connections

Even though the frame did not support the exterior wall, the spandrel columns were completely enclosed within the wall. This was an intentional part of the design: as the wall was intended to resist wind loads, it was necessary for the frame supporting the interior gravity loads and the wall to be structurally linked. Enclosing the columns within solid masonry provided a mechanism for force transfer between the frame and wall. This design meant that all spandrel columns were eccentrically loaded, with offsets between beam and column centerlines as great as 12 inches.

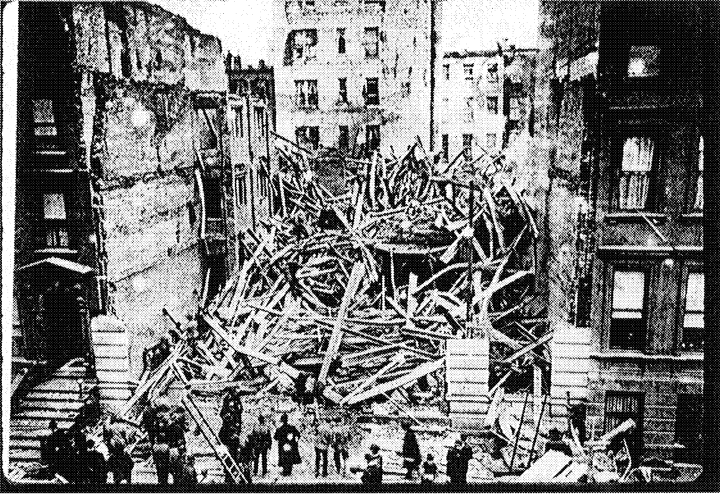
Figure 3: View from the south after collapse. A portion of the west side wall is visible at left, adjacent to the row house.

The collapse destroyed the building, leaving portions of the side walls, bent steel beams, and cast-iron columns broken in pieces. (Figure 3) Witnesses observed the upper floors of the frame swaying in various directions but then collapsing inward toward the center of the site. ("The Collapse of the Darlington...," 1904) In the following weeks, the collapse was examined and discussed by various engineers, city officials, and the press.

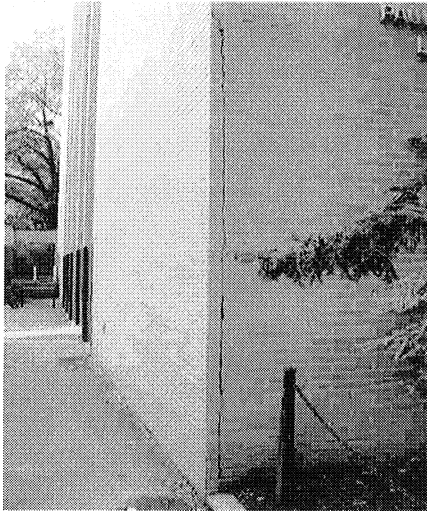
This vertical crack near a building corner was identified by student campus surveys.

Exploring campus by the students has led to the discovery of several cavity wall facades that are lacking the proper number and/or size of movement joints resulting in cracking and damage to the masonry. Figure 1 is a photograph of a student identified example of this type from a building that contains few movement joints overall, and none near the building corners.

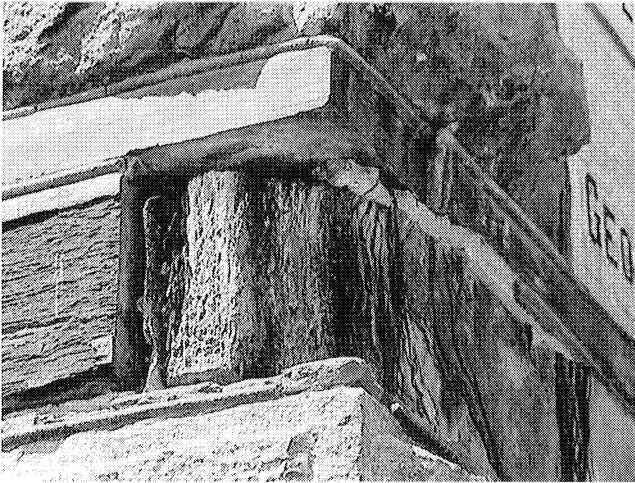
Figure 3

The Photograph above is a close up of one segment of the Obelisk. Students are alerted to different weathering patterns of the stones relative to type of stone, exposure and bedding placement.

Older buildings on campus are also frequently used to point out conditions related to historic preservation issues such as the proper repair and maintenance of masonry, slate roofs and other period materials. Students are shown that observations of historic structures can also provide clues as to how even newer materials will weather and perform over time. One excellent example on campus used for the class is the Penn State Obelisk (Figure 2). Constructed in 1896, this mass masonry monument-like structure contains 281 stones arranged in natural geologic order. The Obelisk was originally erected to demonstrate the weathering properties and subsequent value of Pennsylvania stones. While some of the mortar has been repaired, the stones have continued to weather and the obelisk is still being used in Building Failures and several other classes for demonstrating the long term impacts of weathering on building stones, including variations due to orientation and bedding (Figure 3).

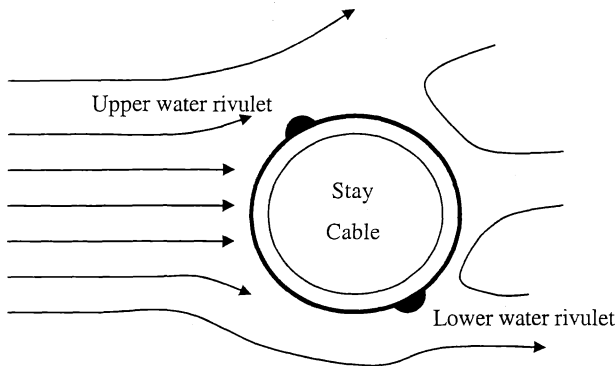
Figure 1. Aerodynamics of rain-wind induced vibration

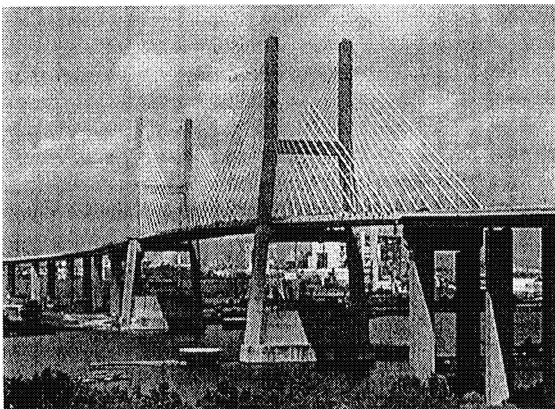
Figure 2. South elevation of the Cochrane Bridge

The Cochrane Bridge majestically crosses the Mobile River in Mobile, Alabama, as shown in Figure 2. The two semi-harped arrangements of cables on H-shaped pylons complement the vast flat landscape of the area. The structure carries US Routes 90 and 31, and spans a total of 460 meters over the Mobile River. The main center span is 240 meters with two flanking spans of 110 meters. The total length of the bridge including all approach spans is approximately 2200 meters in length. The bridge was completed in 1991 at a cost of \$70,000,000.

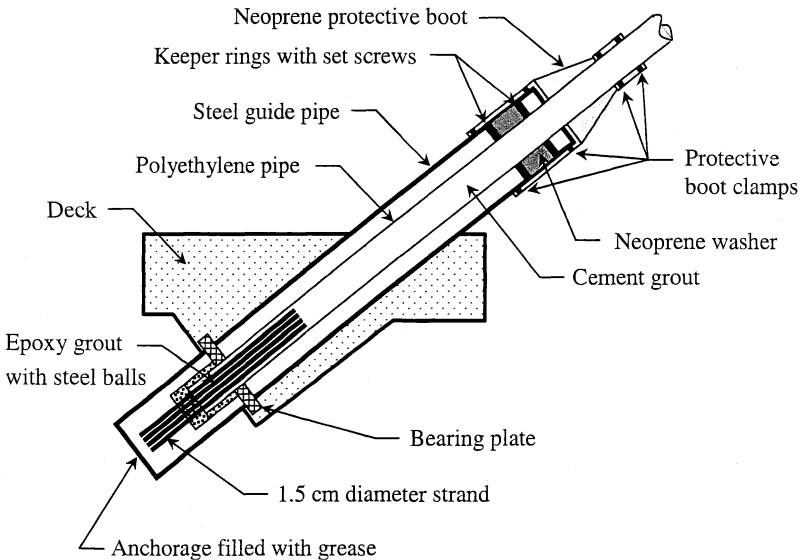
Figure 3. Guide pipe and washer connection at the anchorage

The cable stayed spans carry two 12 meter wide roadways on a 28 meter wide by 2.3 meter deep prestressed concrete deck. The deck consists of longitudinally and transversely post-tensioned and segmentally constructed twin cast-in-place single cell trapezoidal concrete box girders supported along each side by 48 cable stays in a semi-harped arrangement. The cable stays consist of a varying number of 1.5 centimeter diameter parallel seven wire high strength strands encased in polyethylene pipes. The strands, which vary from 26 on the short cables to 72 on the long cables, are embedded in a cement grout within the polyethylene pipe. At the anchorage, the stay cable passes through a steel guide pipe, and a neoprene washer is provided in the annular space between the polyethylene pipe and the steel guide pipe, as shown in Figure 3.

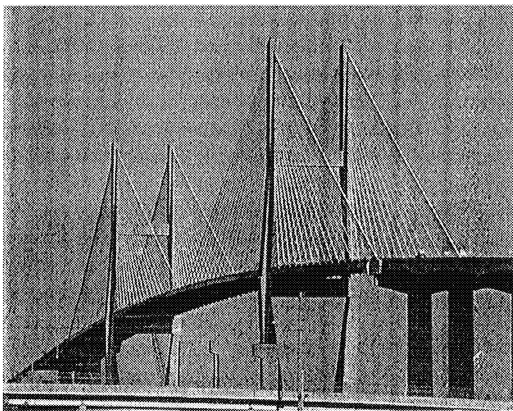
Figure 4. West elevation of the Talmadge Memorial Bridge

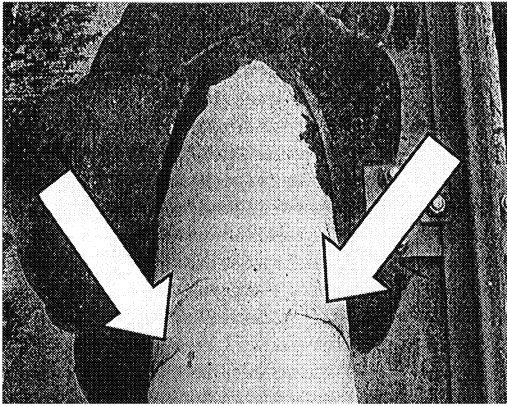
Figure 5. Fractured steel guide pipe

During construction, movement of the cables occurred (Liles 1999). In 1998, excessive cable vibrations were reported by maintenance workers, and one (1) of the guide pipes had fractured (due to excessive movement of the cable stay). Soon thereafter, an inspection by the Georgia Department of Transportation (GADOT) and Federal Highway Administration (FHWA) was performed, and a number of problems associated with cable vibrations were reported, including: (1) partial fracture of three additional guide pipes (see Figure 5), (2) missing dampers or misaligned cables at the guide pipe entrance, and (3) further spalling and cracking at the guide pipe/bridge

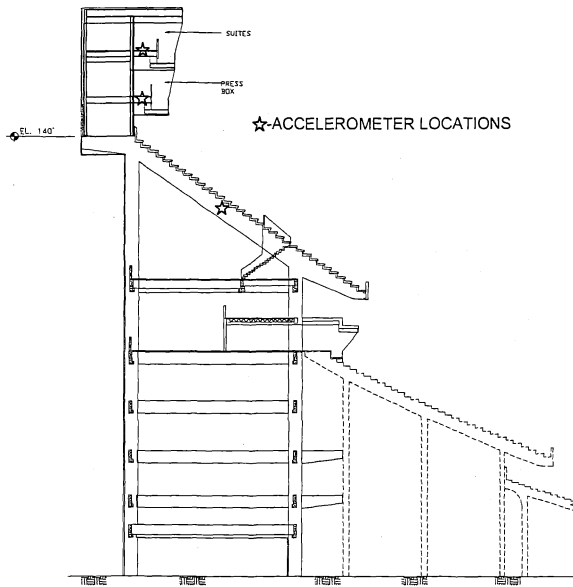
Figure 1. Cross Section of the Stadium Stand

The stadium stand of interest consists of three concrete deck levels with a pre-engineered steel box on top of the third deck housing the press box and suite levels. The stadium stand structure consisted of typical concrete column elements, concrete raker beams, and precast seating risers. Figure 1 show a cross section of the stadium stand of interest. A schematic layout of the stadium is shown in Figure 2.

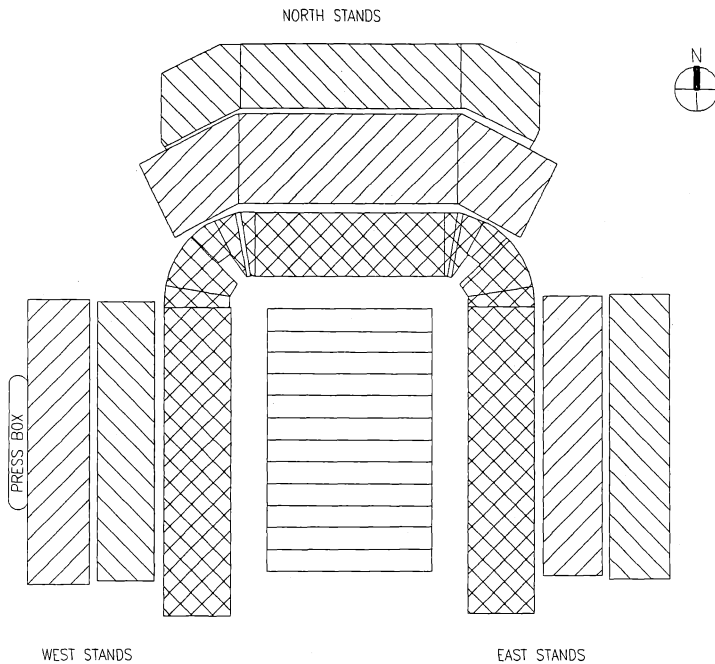
Figure 2. Schematic Layout of the Stadium

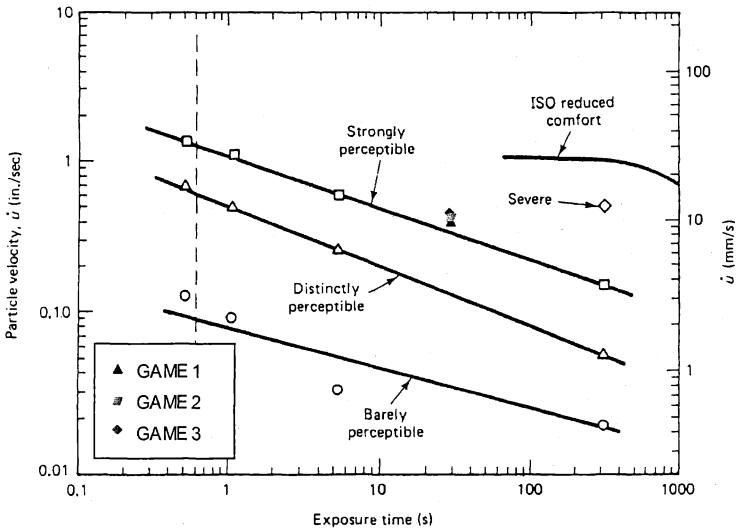
Figure 3. Human Response to Transient Pulses of Varying Durations After Wiss and Parmelee (1974) As Replotted by Siskind et al. (Extracted From Construction Vibrations by C.H. Dowding)

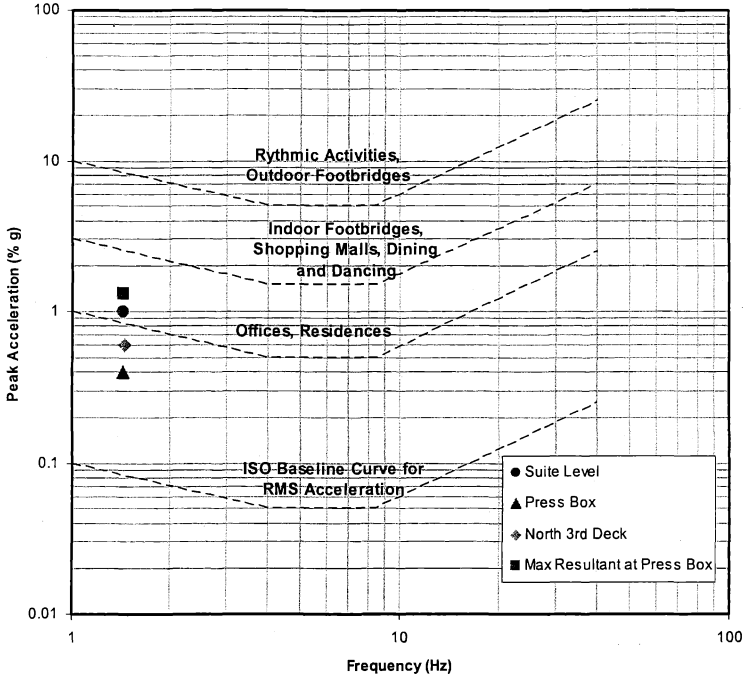
Figure 4. Vibration Response of the Stadium On Game 1

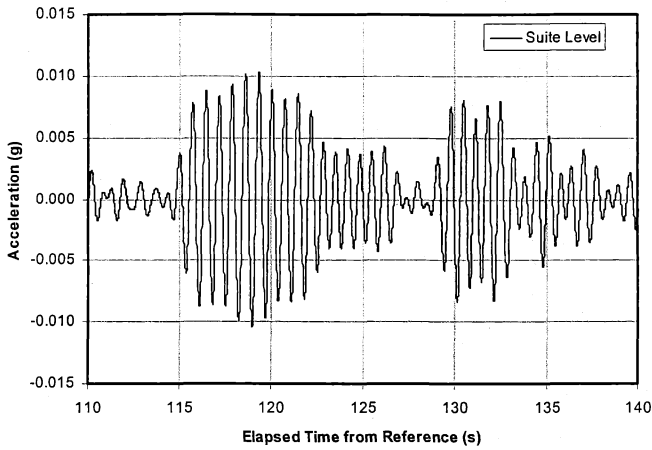
Figure 5. Lateral Acceleration at Suite Level on Game 1

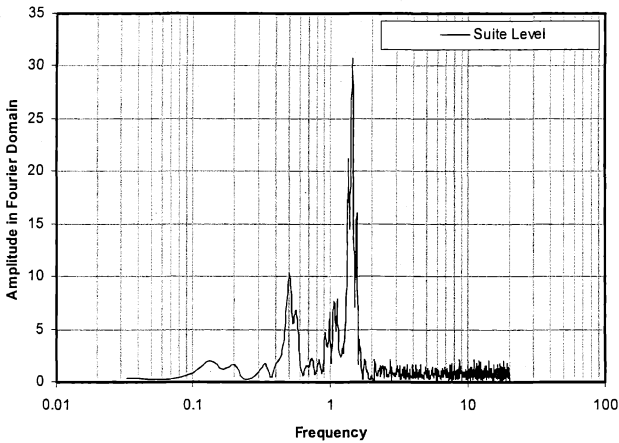
Figure 6. Fourier Spectrum of Lateral Acceleration at Suite Level on Game 1

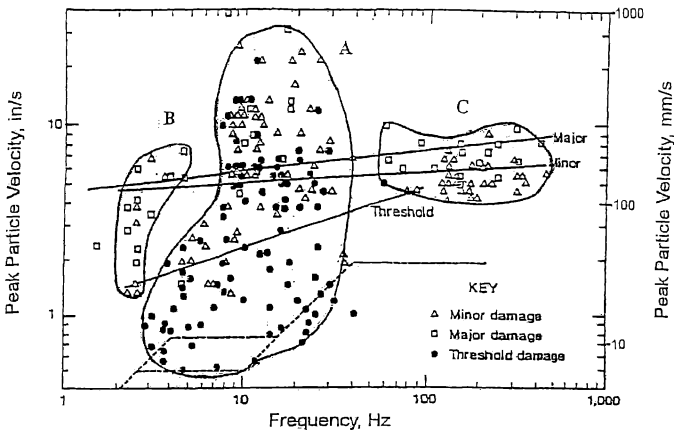
Figure 1. Three zones with closely grouped structure responses and damage summary from ground vibrations generated by blasting, and USBM recommended safe limits-dashed lines. Data were modified from Siskind (2000)

The USBM accumulated results of structural damage from ground vibrations generated by surface mine and quarry blasting are shown in Figure 1 which was modified from Siskind (2000). The data were obtained from 718 blasts and 233 documented observations of threshold, minor and major damage. Non-damaging blasts are not shown, although some of them produced relatively high levels of ground vibrations even exceeding 51 mm/s (2 in./s), the maximum allowable limit of ground vibrations. Analysis of these data indicates different vibration effects on structures depending on the dominant frequency and the peak particle velocity of ground vibrations, Svinkin (2004a, 2005a).

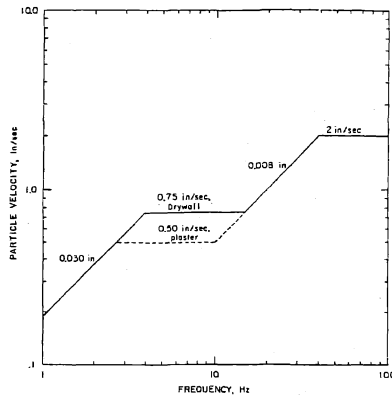
Figure 2. USBM safe levels of blasting vibrations for houses using a combination of velocity and displacement, after Siskind et al. (1980)

For 1-2 story houses surrounding surface mining facilities of coal industry, the USBM has developed the frequency-based safe limits of cosmetic cracking threshold shown in Figure 2, Siskind et al. (1980). It was a great achievement that provided safety of low-rise residential structures from vibrations generated by mining blasting. The Office of Surface Mining (OSM) included the derivative version of the USBM safe limits as the Chart Option into the OSM surface coal mine federal regulations, OSM (1983). In several years later, the USBM safe limits also received a status of federal regulations, NFGA 495 (2001).

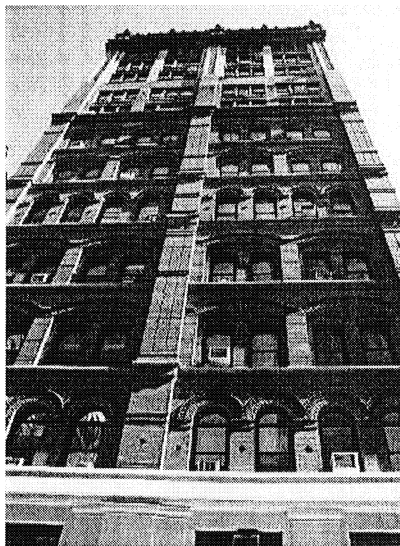
Figure 3. Masonry arch windows on south elevation of Building 1.

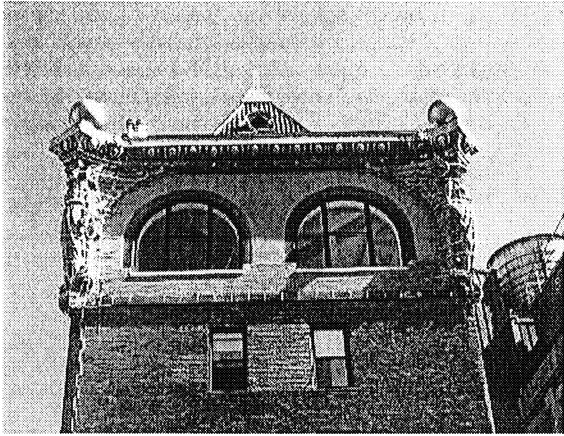
Figure 4. Terra cotta caryatids in the form of winged angels at penthouse corners

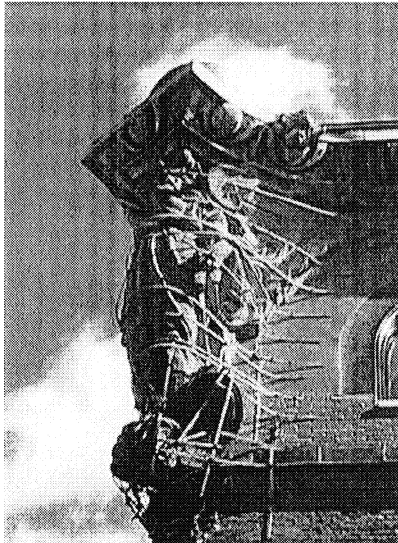
Figure 5. Straps used to support caryatids

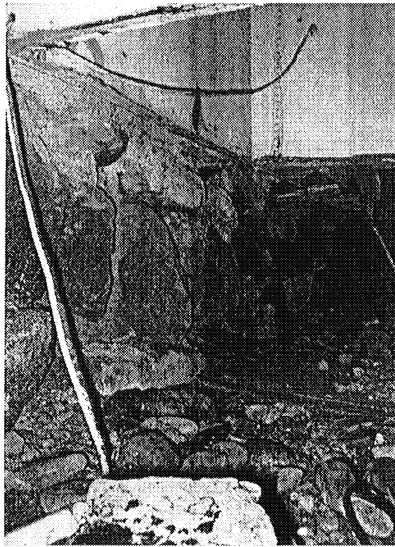
Figure 7. Rubble foundation in basement of historic district building.

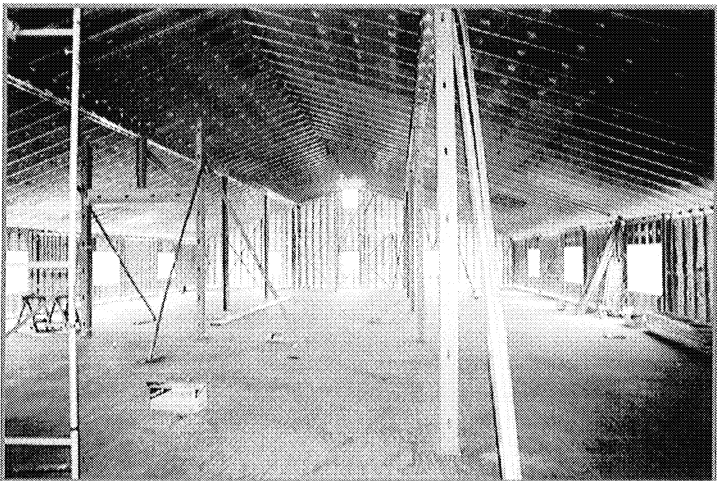
Figure 1. Overall configuration of the 2nd floor-to-roof columns.

- 1) The 2nd floor to roof columns were originally designed as built-up members consisting of (4) 600S162-54 light gauge steel structural studs configured as two pairs of back-to-back structural studs wrapped (continuous from top of floor to underside of roof beams) on two sides (across the stud flanges) with (2) 800-T-100-54 light gauge steel track sections; (1) on each side. The original design recognized the columns to be unbraced from the top of the second floor to the elevation of the roof beams in the columns' weak direction (oriented left-to-right or side-to-side in the building) and unbraced from the top of the second floor to the elevation of the roof rafters in the columns' strong direction (oriented front-to-back in the building). It appears to be for this reason that the steel track sections were required. From the photographs (taken both during construction and after failure), it was evident that the as-built construction omitted the track sections and substituted (3) 2" steel straps screwed across the structural stud flanges (see figures 1 and 2 taken during construction). Three straps were located at roughly 6 feet, or greater, on centers, with one located near the top of the second floor, one near mid-height, and one near the underside of the beam framing into the column.

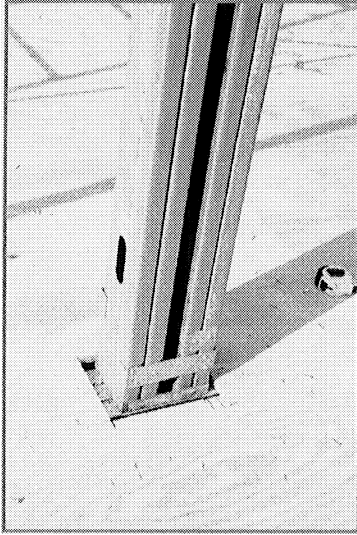
Figure 2. Close-up photograph documenting the omission of the continuous track sections intended to be fastened across the outside flanges of the built-up columns. This was important objective evidence of a critical departure from the intended structural design. This was also confirmed in the photos taken after the failure.

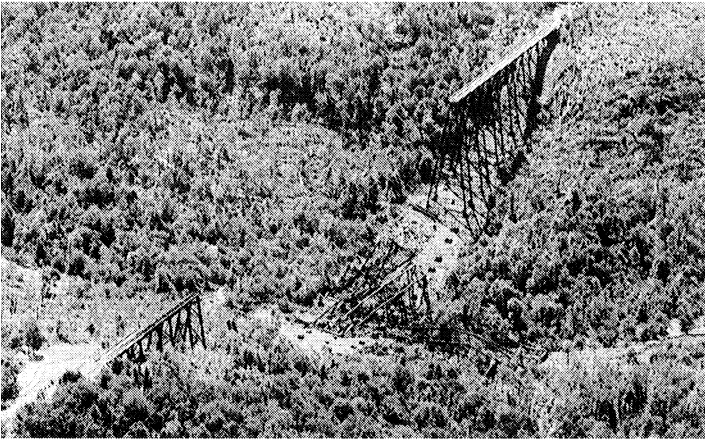
Photo 1 - Kinzua Viaduct, Mt. Jewett, PA, July 2003 – looking southeast

The spectacular collapse of twenty-three of the structure's forty-one spans resulted. (Photo 1) The *Board of Inquiry* investigation ultimately concluded that due to a specific hidden deterioration within the anchorage system, the structure was especially vulnerable from high winds attacking from an easterly direction. (Leech et al. 2003)

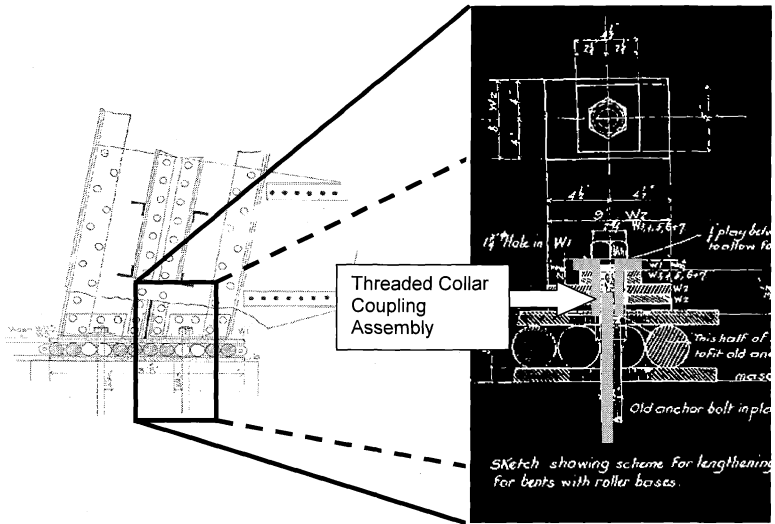
Figure 1 – Wrought Iron Anchor Bolt Extension via Threaded Collar Coupling Assembly

with roller expansion bearings so that the structure could expand laterally in response to temperature. Because the existing wrought iron anchor bolts were too short to accommodate the fitted expansion bearings used in the new design, the wrought iron anchor bolts were spliced to steel anchor bolt extensions by means of threaded, steel collar coupling assemblies. (Grimm 1901) The collar coupling assemblies were encapsulated by large diameter circular washers, and were consequently obstructed from view prior to the collapse. (Figure 1)

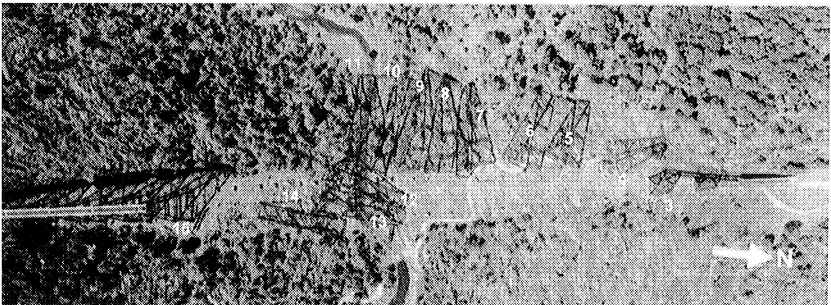
Photograph 2 – High Resolution Aerial Photograph – tower numbers indicated

Strict protocols were established to support the field and analytical phases of the investigation. These protocols were established within 24 hours of the incident and set in motion a rapid chain of events. Within one week of the collapse, [1] a team of specialists, skilled in forensics, meteorology, and fracture interpretation were assembled and placed under contract to the Pennsylvania Department of Conservation and Environmental Resources, [2] all arrangements were made to conduct a one day field investigation including all logistical support necessary to freely transport all investigative personnel over the rugged terrain, and [3] high resolution aerial photography of the 1200 m (4000 ft) wind impacted area was obtained by the Commonwealth of Pennsylvania, Department of Transportation. (Photograph 2)

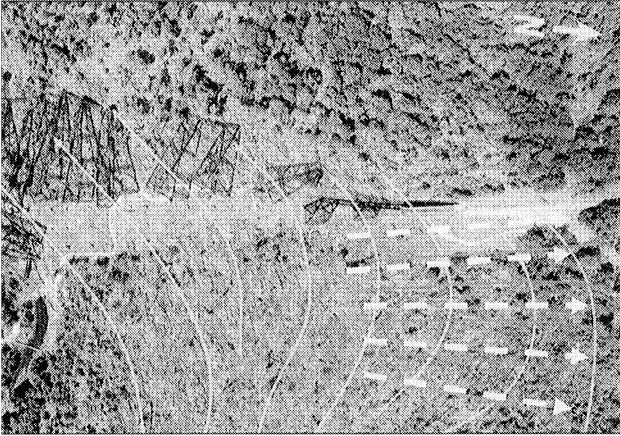
Figure 2 – Depiction of Wind Streamlines (Directional Markers) with “leading edge” wind streamlines – directed westward; and “inflow” wind streamlines – directed northward

Directional markers – including both the direction of fallen trees and collapsed towers. (Figure 2) Directional markers were evident through high resolution photography and revealed wind directed in two orthogonal directions (initially from the east, then from the south). The observation of these markers confirmed the sequence of collapse as well as the contribution of both “vortex leading edge” (easterly) winds accompanied by “inflow” (southerly) winds occurring in rapid sequence in this extreme weather event.

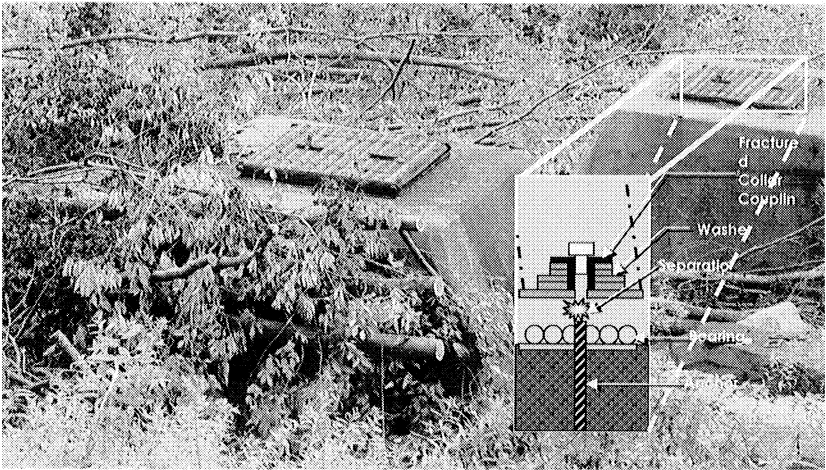
Separation markers – including all evidences of “clean” breaks. (Figure 3) During the field investigative phase, it was apparent to the investigative team that the initiation of failure occurred at boundary between superstructure (of trestle bent configuration) and substructure, most likely at the specific boundary of the 1882 (original construction) and the 1901 (reconstruction).

Figure 3 – Illustration of separation failure at substructure/superstructure interface

At this boundary, the original wrought iron anchor bolts and masonry were preserved in the reconstruction. Fractures were observed within certain wrought iron anchor bolts (1882 construction) and a majority of expansion bearing, steel collar coupling assemblies (1901 construction), that provided connectivity between the original masonry and reconstructed superstructure. Consistently “clean breaks” were observed at the interface of the 1882 and 1901 construction. The separation markers were observed during the field inspection. The separation markers evidenced distinctive separation of the superstructure from its roller bearing assembly at the base of the superstructure for all eleven collapsed towers.

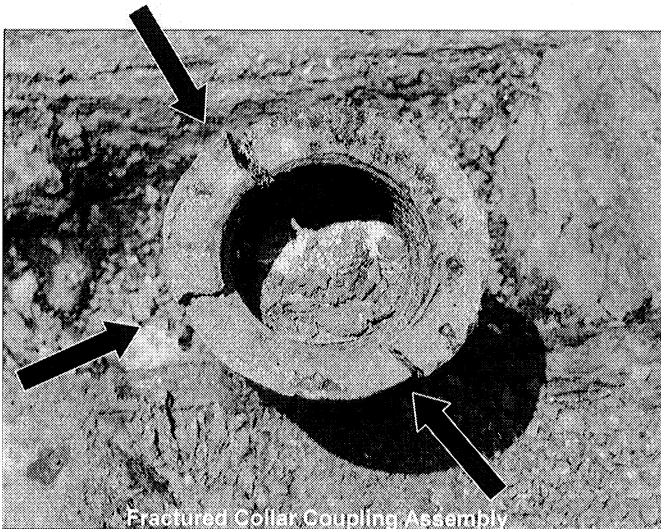
Fracture markers – including steel evidence of consistent patterns of small sub-critical fractures within members. (Photograph 3) Consistently, small sub-critical fractures were observed in the steel collar couplings connecting the 1882 construction and the 1901 construction on the windward side of the towers. Subsequent fractographic examination using a light microscope and microscopic examination using a scanning electron microscope, revealed evidence of long term fatigue crack propagation. The visual appearance of the fractures was characteristic of fatigue fracture with a flat, smooth surface without any evidence of plastic deformation in the fracture region. Microscopically, the fracture morphology also appeared fatigue-like with smooth featureless regions, typically found in high sulfur steels. (Photograph 4) No evidence of fatigue beach marks or striations were observed in these regions, however, the absence of evidence of brittle fracture by a cleavage mechanism or ductile fracture mechanism by dimple fracture suggested that the flat regions were most likely the result of stable crack propagation by a fatigue mechanism.

Photograph 3 – Delineating Through-Wall Cracking

Based on the four forensic markers and subsequent analysis, the *Board of Inquiry* investigation concluded that failure initiated at the “weak-link” of the system – the anchor bolt system on the eastern faces, which was initially installed in the 1882 construction and subsequently modified in the 1901 construction. The 1901 construction provided a collar coupling assembly which included a series of washers that surrounded the anchor bolts and couplings. Consequently, the through wall-cracking of the collar couplings was hidden from view during routine condition inspections.

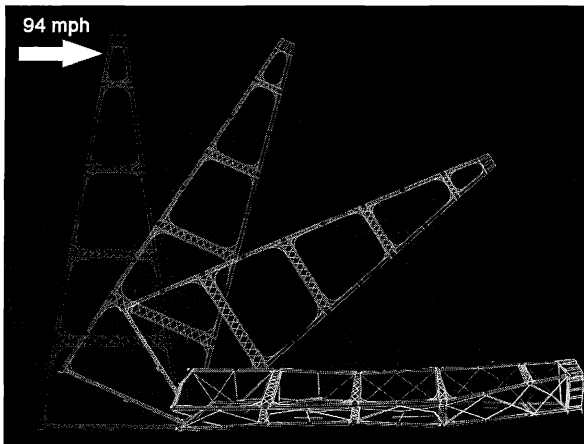
Figure 4 – Illustration of Rotational Failure Mechanism

All eleven collapsed towers were fitted in the 1901 reconstruction with expansion bearings secured to the existing masonry via (1882) wrought iron bolts and (1902) collar coupling assemblies. Based on site observation that for the majority of these locations, three out of four of the anchor bolt assemblies at each tower leg displayed complete separation of the superstructure from the substructure at the collar coupling connection, the immediate failure at the expansion bearings may be characterized as a separation failure. As this separation failure resulted in a rotational failure of each tower about the fixed (or opposite) tower bearings, a back calculation of the force effects necessary to overturn the structure became the basis for prediction of the limiting wind velocity. (Figure 4) This back calculation derived uplift capacity based on the fracture of one anchor bolt out of four (with no strength attributed to the remaining three anchor bolts within a typical four bolt tower location) and utilized limit strengths derived from specimen samples. This back calculation subsequently derived an applied wind velocity of 42 m/s (94 mph) accompanied by a wind pressure of 1.9 kPa (39 psf) and recognized two distinct modes of failure of the anchor bolt system.

Failure Mode 1 – Coupling Failure at the Boundary of 1882 and 1901 Construction – Expansion Bearing Anchor Bolt Collar Coupling. This mode accounts for approximately 3/4 of observed separation failures. All collar couplings observed at the site exhibited a radial cracking pattern, along with multiple longitudinal “splits” within the anchorages. The equiangular “splits” completely penetrated the collar couplings. The collar couplings found throughout the debris field exhibited similar fracture indications. Coupling failures showed evidence of fatigue fracture with secondary fractures occurring by overload presumably during the collapse. (Photograph 4) The *Board of Inquiry* investigation concluded that the couplings, which separated from the bearing assemblies and which were strewn within the debris field, experienced long term fatigue crack propagation prior to the time of the collapse incident. Because the cracks propagated through the entire thickness of the coupling, these collar couplings were judged to be ineffective for the transmission of uplift forces to the substructure. (Kaufmann and Connor 2003)

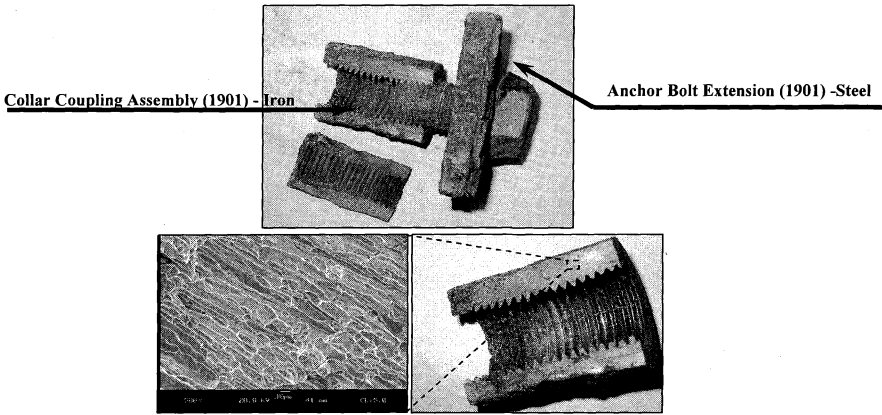
Photograph 4 – Laboratory Investigation of Through-Wall Cracking (demonstrating long term fatigue crack propagation)

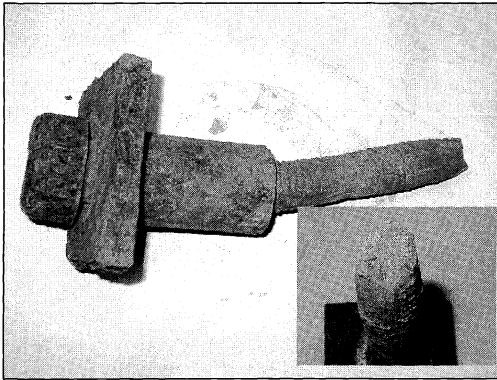
Mode 2 – Ductile Failure within the existing 1882 anchor bolts – Expansion Anchor Bolts. (Photograph 5) This mode accounts for approximately 1/4 of observed failures. Fractographic examination of fractured original 1882 anchor bolts showed that the fracture resulted from tensile overload and was a fully ductile fracture. (Kaufmann and Connor 2003) The estimated tensile capacity of a single (1882), 31.75 mm (1-1/4 in) anchor bolt at failure, considering a 20% corrosion loss, was determined to be 13 kN (30 tons) based on Brinell Hardness evaluation. Based on the observed, 3:1 ratio of collar coupling failure to ductile anchor bolt failures, an uplift capacity of 13 kN (30 tons) was attributed to each tower. This capacity established a lower bound, critical wind speed of 42 m/s (94 mph), which was sufficient to initiate failure. (Leech et al. 2003) The failure was sudden and catastrophic.

Photograph 5 – Wrought Iron Anchor Bolt – Ductile Fracture

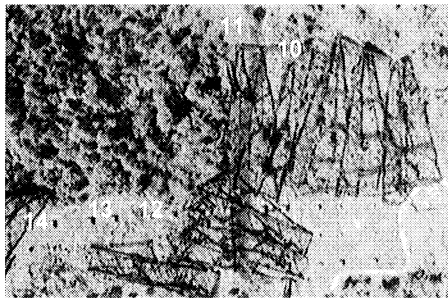
1. Tornado touched down – easterly (or “vortex leading edge”) winds grew rapidly – local wind speeds (from the east) exceeded 40 m/s (90 mph) – as wind speeds grew, the towers oscillated laterally in response to their natural frequency.
2. “Separation” failures occurred within the “expansion” anchor bolt system of Towers 10, 11, 12, 13 and 14.
3. Rotational failure accompanied by collapse of Towers 10 and 11 and adjoining spans occurred.
4. Towers 12, 13 and 14 initially become airborne and “jumped” a small distance north and westward. Towers 12, 13 & 14 momentarily came to rest in the upright position on the ground, not initially collapsing. The rails and wooden decking for a brief period of time remained affixed to several spans and held the three towers in a vertical position, initially preventing immediate catastrophic collapse.

Photograph 6 - Debris Field – Episode 1 – tower numbers indicated

The following occurred in Episode 1 in the sequence indicated. (Photograph 6)

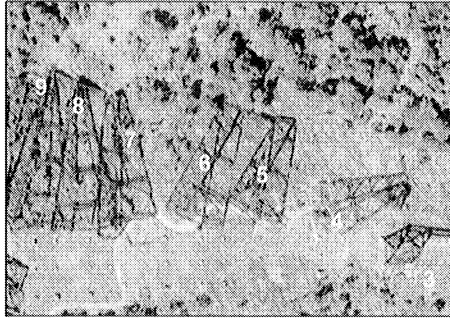
1. Tornado moved northward – easterly (“vortex leading edge”) winds grew rapidly – local wind speeds (from the east) exceeded 40 m/s (90 mph). As wind speeds grew, all towers oscillated laterally in response to their respective natural lateral frequencies.
2. Wooden decking and rails (spans 1 – 18) separated from the structure.
3. “Separation” failure occurred in sequence within the “expansion” bearings of Towers 9, 8, 7, 6, 5 and 4.
4. In sequence, rotational failure of Tower 9 occurred, shortly, followed by rotational failure of Towers 8, 7, 6, and 5. Collapse was progressive from South to North.
5. Tower 4 was initially restrained by Tower 3 and the connecting girder span. However, after elongation of the girder span’s connection to Tower 3, rapid collapse and clockwise twist of the tower occurred. Tower 3, although standing, was visibly distorted.

Photograph 7 - Debris Field – Episode 2 – tower numbers indicated

The following occurred in Episode 2 in the sequence indicated. (Photograph 7)

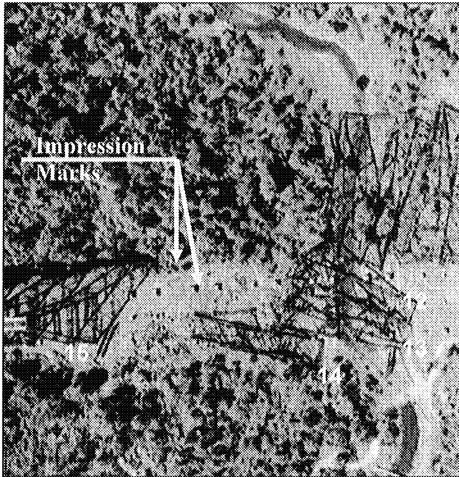
1. Tornado moved northward – rapid and confined southerly (“inflow”) winds attack from the south.
2. The wooden decking and rails, momentarily connected to Towers 12, 13 and 14 during Episode 1, separated from the structure.
3. Towers 12, 13 and 14 and adjoining girder spans, having separated from the bearings during Episode 1, twisted and subsequently collapsed in a southerly direction.
4. The final remaining girder span, momentarily affixed to Tower 15, oscillated laterally several times at the Tower 15 connection, eventually separating and rotating upside down before impact. The rails remained attached and “hung” from Tower 15.

Photograph 8 - Debris Field – Episode 3 – tower numbers indicated

The following occurred in Episode 3 in the sequence indicated. (Photograph 8)

From a forensic perspective, the most puzzling aspect of the debris field at the time of field investigation was the location and orientation of Towers 12, 13 & 14 after collapse. The towers clearly were affected by the winds during Episode 1, but were positioned on top of all Episode 1 debris and were oriented in a direction opposing all other structure debris. Interpretation of the debris clearly indicates the effects of “inflow” wind throughout the collapse cycle. Examination of impression marks on the ground surface displayed on the high resolution photography depicted evidence of initial motion westward during Episode 1, attributable to easterly (“inflow”) winds. Evidence of the effects of southerly (“inflow”) winds included the overall southerly vector orientation of a significant region of the debris field.

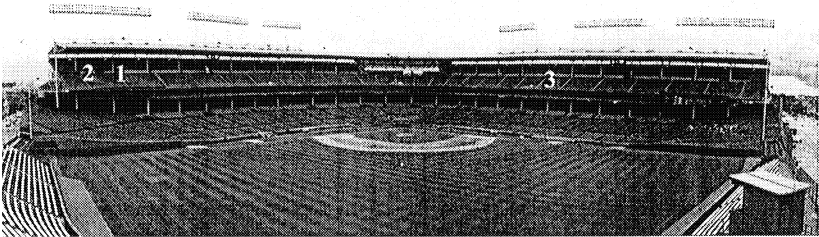
During the 2004 baseball season, three separate incidences when a small piece of concrete fell from the underside of the upper stands (locations indicated with white markers in Figure 1) generated a flurry of local and national media coverage. Each incident was investigated by structural engineers retained by the Cubs, and protective netting was hung above public areas to catch any new spalls that might occur during the remainder of the season.

Figure 1. Main grandstands of historic Wrigley Field, Chicago, Illinois, showing approximate locations of spalled concrete during 2004 season

Close-up examinations. The authors carried out close-up examinations of the precast concrete at each of the three reported spalls, the general locations of each noted on Figure 1. At Location No. 1, a piece of concrete had spalled from the lower corner at the end of a precast tread-and-riser section, as shown in Figure 4. The spall was shallow (maximum depth of about 1/2 inch) and had a total length of about 12 inches. The piece that fell was likely only a small portion of this spall. A heavily corroded reinforcing bar was exposed along the length of the spall. Concrete clear cover over this bar was 1/4 to 1/2 inch. On the top side of the precast tread at this location, there was a crack in the tread parallel to the joint at the end of the precast section. A few inches away from the end of the precast section, the concrete was sound. The spall location is largely obscured from view from below, because it is directly above the top flange of the upper deck truss top chord.

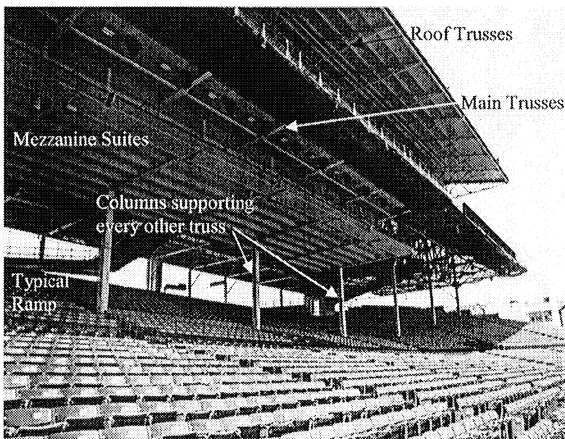
Structural framing for the lower stands consists of cast-in-place concrete tread-and-riser sections that span between radially-oriented lines of raker beams and columns. Near the playing field, the raker beams and columns are cast-in-place reinforced concrete. Elsewhere, the raker beams and columns are built-up structural steel sections. The stadium columns are reportedly founded on spread footings. The concourse floors at grade level are typically concrete slabs or brick pavers supported on-grade. Figure 2 shows a portion of the main grandstand framing along the third base line.

Figure 2. View of main stands and mezzanine suites along third base line

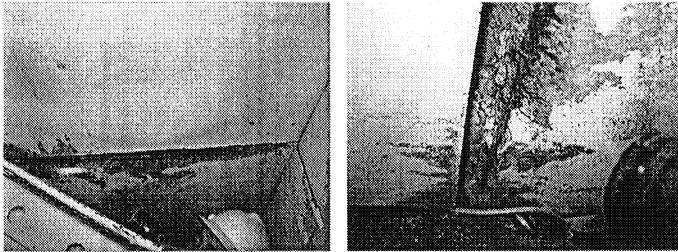
Figure 4. Precast concrete distress at Location No. 1

- The distress at Location No. 1 where concrete fell was attributed to chloride-induced corrosion of embedded reinforcement with shallow cover.
- The cracking in the sample removed from Location No. 2 was judged to be the result of horizontal bearing stress on the edge of the spalled surface (from unintended concrete-to-concrete contact with the next riser).

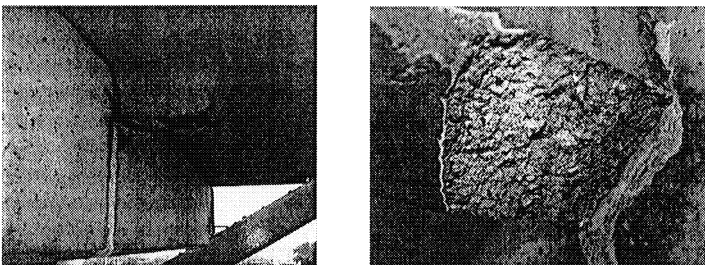
At Location No. 2, a thin piece of concrete, approximately 1/8-inch thick by 4 inches square, had spalled from the underside of a precast tread-and-riser alignment bracket. The spalled area is shown in Figure 5. The remaining portion of the alignment bracket was sound, though heavy water staining was present on and immediately surrounding the alignment bracket. Also, the face of the alignment bracket was in contact with the back side of the next precast riser. Typically, there is a gap between the alignment bracket and adjacent riser. No reinforcing steel or corrosion staining was exposed at the surface of the spall.

Figure 5. Precast concrete distress at Location No. 2

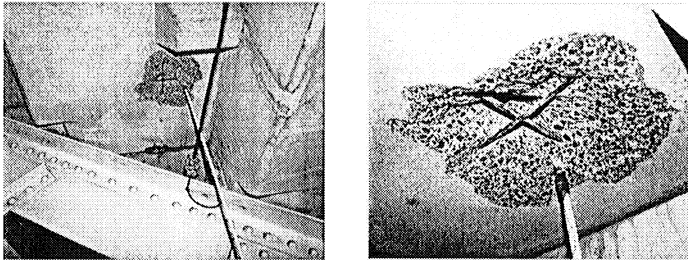
At Location No. 3, a small piece of concrete had spalled around a threaded rod that was anchored into the underside of a precast concrete tread. The threaded rod subsuspended a plumbing pipe below. At the time of the authors' inspection, the concrete at this location had been excavated much deeper than the spall in order to expose the embedded reinforcing steel in preparation for a concrete patch. The condition of this location is shown in Figure 6.

Figure 6. Precast concrete distress at Location No. 3

- Analysis of the samples removed from Location No. 3 indicated that the concrete had been damaged to some degree when a power-driven anchor for suspending a pipe was originally installed at this location. Also, the anchor had been driven a

slight angle to the suspended load, such that vertical loading on the anchor induced lateral forces on the concrete at the anchorage. The damage went undetected, and eventually a small piece of the concrete around the anchor spalled.

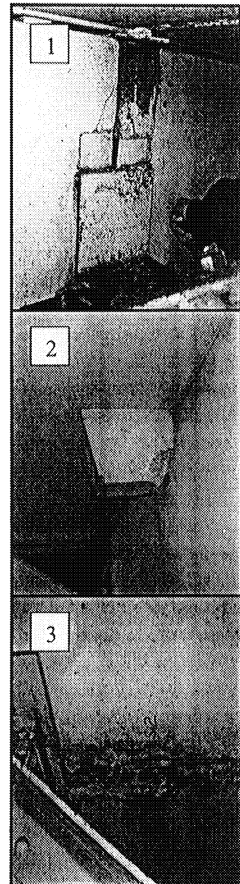
Category 1 - Cracks above embedded steel plates at bearing connections. The distress is caused by volume change movement of the concrete (shrinkage and thermal expansion/contraction), which is restrained by the embedded plates and welded connections at both ends of the members.

Category 2 - Distress at alignment brackets. A gap is typically present between the bracket and the face of the adjacent riser. However, where the gap was tight, the unintended concrete-to-concrete contact had often caused bearing failure of the unreinforced bracket.

Category 3 - Distress at end joints. Leakage through the joints over time has resulted in corrosion of embedded steel elements at the panel ends, including reinforcing steel with shallow cover and steel inserts presumably used for lifting during erection. Corrosion

Figure 7. Examples of typical precast distress

of the embedded steel has led to cracking and spalling of the bottom corners of some of the precast members.

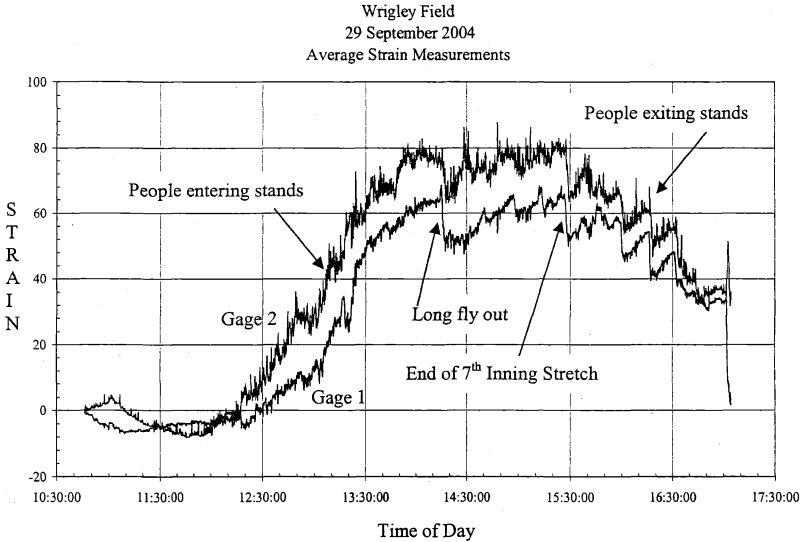
Figure 8. Average strain measurements at top chord of upper deck cantilever

Vibration and Dynamic Strain Measurements. In order to better understand the structural behavior of the main stands, a typical grandstand frame was instrumented and continuously monitored during a nearly sold-out home game during the 2004 pennant race. Seven strain gages and three accelerometers were installed on the upper deck steel trusses and a supporting steel column along the third base line. This portion of the structure was also subsequently analyzed with a finite element computer program. Strain gages were 1/4 inch long, bondable foil gages with high strain sensitivity. The accelerometers measured the crowd-induced dynamic response

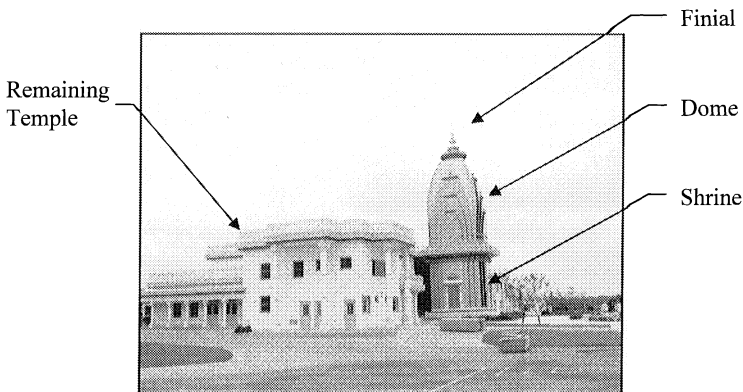
For discussion purposes, this dome structure is considered a part of the temple, but will be indicated as "dome" within the context of this paper. The dome portion of the temple was designed by an architect based in India and a structural engineer based in Texas. The contractors were based in Texas, and the fabricator of the granite was based in Italy. The dome was built in stages with separate contractors for the shell of the dome structure, the granite cladding, and for decorative accents at localized areas of the dome. No architect or other design professional was involved during the construction of the separate stages of the dome construction. Figure 1 shows an elevation view of the dome, shrine, and remaining temple structure.

Figure 1. General elevation view.

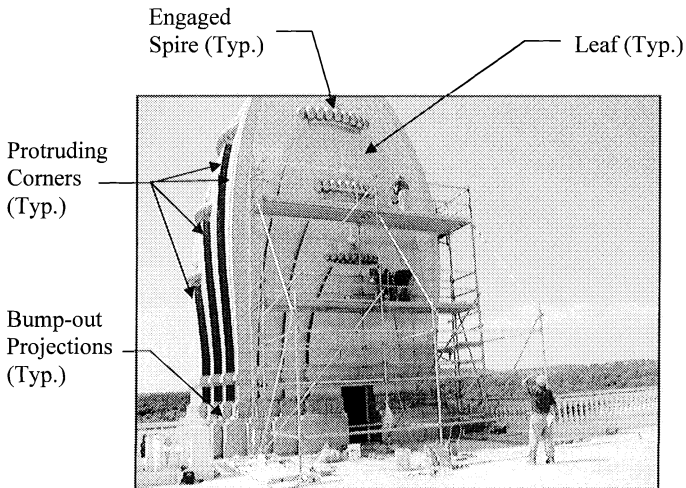
Figure 2. Dome exterior.

The dome was constructed as a gunitite reinforced concrete shell structure that extended approximately 43 feet above the top of the shrine and roof of the temple. Thus, the dome is more than 70 feet above the finished floor of the temple. The dome is a curved structure having two intermediate ring beams between the base and the top. The top of the dome is flat with an opening in the middle. The drawings indicate the dome to have a 1'-5" wall thickness at the base of the dome (above the shrine roof); it tapers to a wider thickness between the base and the first ring beam, and then tapers down in thickness at the first ring beam elevation. The wall thickness between the first ring beam and the top is indicated as 8". The dome walls are supported on a thickened structural two-way slab that makes up its floor. Four main cast-in-place columns that bear on straight-shafted piers support the floor slab. Three step-like projections, or "leaves," that follow the curved shape of the dome and are located above the temple roof level on each of the four (4) faces of the dome and were constructed monolithically with the dome walls. An elastomeric coating was specified to cover the entire exterior of the gunitite dome. After the curved gunitite dome was completed, projections at the base of the dome were constructed out of brick and CMU block (neither of which were indicated on the drawings). Figures 2 and 3 show the exterior and the interior of the dome, respectively.

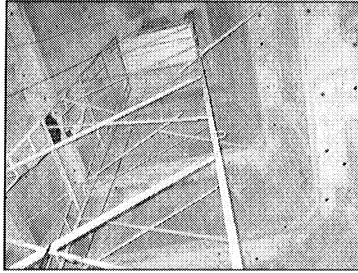
Figure 3. Dome interior (looking up).

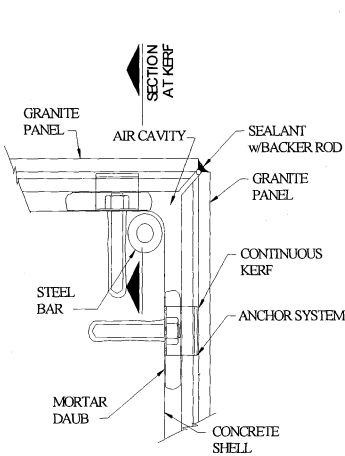
The cladding on the dome as well as the temple soffits and fascia consists of 1 1/4" thick granite of varying widths and lengths with 1/4" wide by 1" deep continuous kerfs (slots at edges of granite pieces). Stainless steel anchors set (anchored) into the exterior side of the concrete shell of the dome are utilized to independently support the individual granite pieces. Mortar daubs at each anchor location were used during granite installation to facilitate construction of the veneer. The granite joints are comprised of sealant with backer rods used as the joint backing material. Figures 4 and 5 show typical plan and section details of the granite support at the protruding corners of the dome.

Figure 4. As-built plan at protruding corner.

block and at least two different types of brick masonry. Additionally, steel hollow sections (bar/tube) were noted at the edges of the protruding corners of the dome shell (Figures 4-5). There was no indication on the structural drawings that steel hollow sections (bar/tube) were to be installed. The horizontal blue and pink beaded stone bands were built after the granite was installed (Figures 7-9). No indication of this type of installation and construction was noted in the shop drawings or in the architectural schematic drawings. Details and/or specifications for the horizontal bands were not prepared. Therefore, the contractor installed the horizontal beaded bands under no design supervision, did not conduct the work based on any specific details provided by a design professional, and was not aware of the necessity of allowing the cavity wall to weep excess water. Furthermore, the structural drawings indicated that the dome shell was squared off and open at the top. Observations indicated that the top of the dome consisted of an additional concrete shell, above the specified opening, that was not indicated on the structural drawings.
