Forensic Engineering

Proceedings of the
Fourth Congress

FORENSIC ENGINEERING

October 6–9, 2006
Cleveland, Ohio

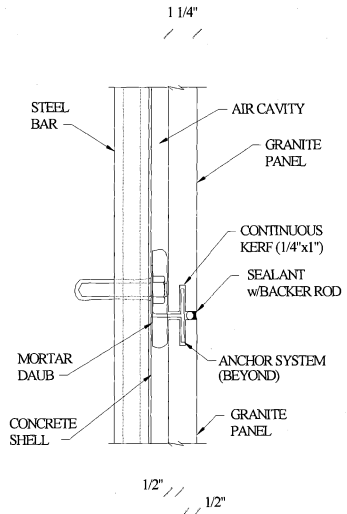
The cladding on the dome as well as the temple soffits and fascia consists of 1 1/4" thick granite of varying widths and lengths with 1/4" wide by 1" deep continuous kerfs (slots at edges of granite pieces). Stainless steel anchors set (anchored) into the exterior side of the concrete shell of the dome are utilized to independently support the individual granite pieces. Mortar daubs at each anchor location were used during granite installation to facilitate construction of the veneer. The granite joints are comprised of sealant with backer rods used as the joint backing material. Figures 4 and 5 show typical plan and section details of the granite support at the protruding corners of the dome.

Figure 5. Section at kerf.

block and at least two different types of brick masonry. Additionally, steel hollow sections (bar/tube) were noted at the edges of the protruding corners of the dome shell (Figures 4-5). There was no indication on the structural drawings that steel hollow sections (bar/tube) were to be installed. The horizontal blue and pink beaded stone bands were built after the granite was installed (Figures 7-9). No indication of this type of installation and construction was noted in the shop drawings or in the architectural schematic drawings. Details and/or specifications for the horizontal bands were not prepared. Therefore, the contractor installed the horizontal beaded bands under no design supervision, did not conduct the work based on any specific details provided by a design professional, and was not aware of the necessity of allowing the cavity wall to weep excess water. Furthermore, the structural drawings indicated that the dome shell was squared off and open at the top. Observations indicated that the top of the dome consisted of an additional concrete shell, above the specified opening, that was not indicated on the structural drawings.

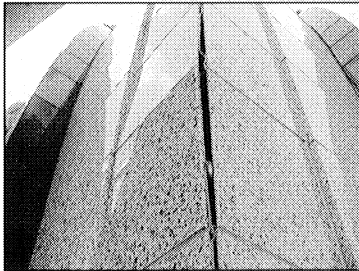
Dome: An initial visual walk-through of the site confirmed that most of the damage was indeed located at the dome with little distress observed at the remaining portions of the temple. Most of the distress was noted at the protruding corners of the dome. The granite pieces at these corner joints were displaced outward on each side of the joint. Figures 6 and 7 show separations at the protruding corners.

Figure 6. Separation at protruding corner.

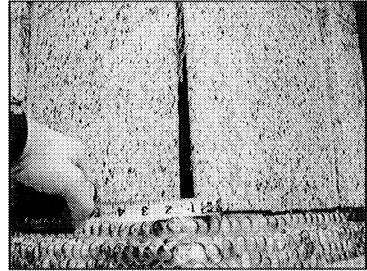
Figure 7. Separation at protruding corner near projection.

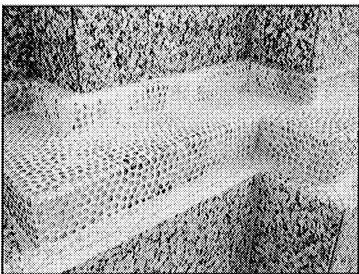
Additionally, localized areas of granite developed fractures in the pieces themselves. Evidence of accumulated and excess moisture including staining, efflorescence, and spalled glass beads at the horizontal banded trim at the base of the dome were noted. Figures 8 and 9 show typical areas exhibiting distress.

Figure 8. Moisture staining at base projection.

Evidence of the effects of this water intrusion is noticed at the dome exterior especially at the blue beaded stone bands that surround the base of the dome (Figure 8). Additionally, upon removing the granite panels and at locations where the granite had already been removed, bubbling and blistering of the paint/coating that was applied over the CMU block was observed. Additionally, mineral deposits were observed to be leaching through the coating from the bump-out projections/shell locations. The mineral deposits and bubbling/blistering is a typical affect of water transpiring from the shell and/or CMU block through the applied paint/coating. Rust streaks and corrosion of the embedded steel hollow sections were observed at the protruding corners of the shell. Corrosion and the effects thereof are discussed in detail in the following section.

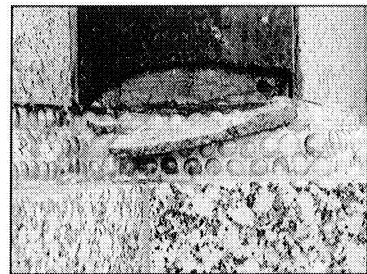
Figure 9. Granite fracture.

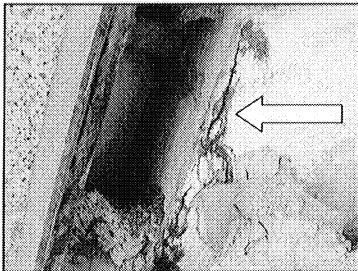
Water and oxygen are essential for corrosion to occur. The lack of any cover at these protruding corners in conjunction with the abundance of water affecting the exterior of the shell, allowed corrosion to develop and affect these metal bars/tubes. Unhydrated ferric oxide (Fe_2O_3), or rust, when fully dense has a volume of about two times that of the steel it replaces. Broomfield (Broomfield, 2003) reports that when ferric oxide gets hydrated it swells even more and becomes porous. Hydrated ferric oxide ($\text{Fe}_2\text{O}_3 \cdot \text{H}_2\text{O} + 2\text{H}_2\text{O}$) is approximately two to ten times the volume of original steel. Kaminetzky (Kaminetzky, 1991), reports that the increase in volume of rusted embedded steel (typically reinforcing bars) produces internal pressures in the concrete that split the concrete in the path of least resistance. Figures 10 and 11 are typical views of the effects of the corrosion at the protruding corners of the shell.

Figure 10. Corrosion at protruding corner of dome shell.

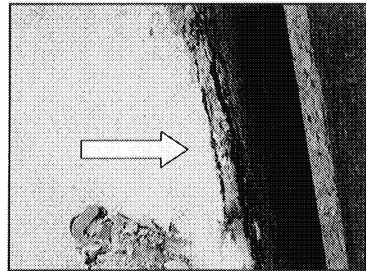
Figure 11. Similar as Figure 10 at another location.

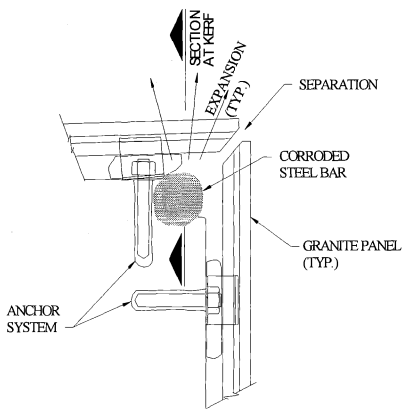
Furthermore, fractures at some of the granite panels (black in color) located at the sides of the leaves, correlates with the area of the stainless steel anchor attachment. As discussed above, the stainless steel anchors were attached to the shell, proximate to the corroding steel bar. The expansion creating by the corroded bar led to outward pressure at the anchor. This resulted in the split-tail portion of the anchor, which was attached to the granite panel, to induce an outward force on the sides of the kerf located at the center of the granite panel. Figures 12 and 13 show how the corroded bar affected the granite.

Figure 12. Plan at protruding corner after corroded bar expansion.

The panel is 1 1/4" thick with a 1/4" wide kerf. The granite thickness on each side of the kerf is approximately 1/2" thick. The section at the exterior face of the kerf is less than half the thickness of the panel (approximately 1/2") and is weakest at this location. The outward movement of the anchor creates a localized bending and shear at the exterior face of the granite panel. Where the capacity of the granite panel has been exceeded, it is exhibiting fractures.

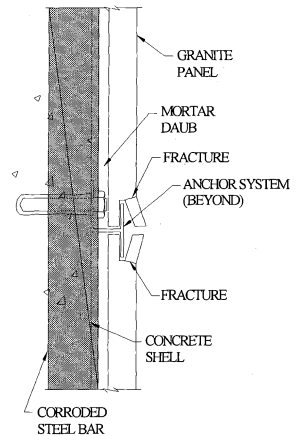
Figure 13. Section at kerf after corroded bar expansion.

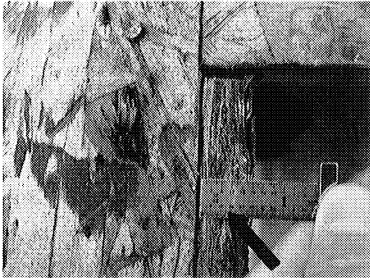
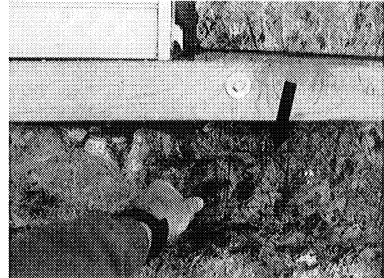
phenolic resin adhesive or equivalent waterproof binder. Like most manufactured wood products, its primary challenge is dimensional stability; that is, the OSB swells irreversibly, especially near the edges, when it gets wet. The swelling of the panels can cause uneven and partially laminated conditions. In addition, the fasteners (nails) can appear to be overdriven due to the increased thickness of the panel from swelling (APA, 2002).

Figure 1. Swollen and deteriorated OSB. Figure 2. Location of OSB sample #6.

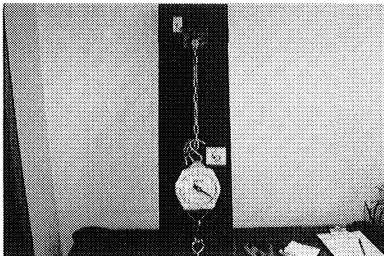
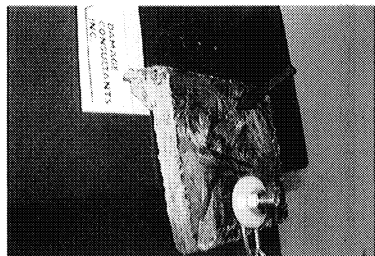
Figure 3. Sample #6 in testing apparatus. Figure 4. Close-up view of OSB sample #6 fastened with 8d nail.

The testing apparatus consisted of a wood frame with a metal nailing plate at the top where one of the 8-penny sheathing nails retrieved from the site was inserted into the OSB sample, approximately 3/4” from the edge. The bottom portion of the OSB was fastened with 3/8” diameter bolts and a washer that was connected to a chain to a spring loaded mechanical scale that was connected to an eyebolt at the base of the frame. As the nut on the eyebolt was tightened, tension would be applied to the sample and subsequently be recorded on the scale. Testing was ceased at approximately 90 pounds which was the minimum lateral strength requirement set forth by the Department of Commerce Voluntary Performance Standard PS2-04 authored by the APA-engineered Wood Association (Performance, 2004). The samples were not tested to failure in order to preserve and present the samples at settlement conferences and to use the samples for further independent testing should the results be disputed. Only one sample (#29) did not meet the requirement. This sample would no longer accept additional load at 75 pounds where the 8-penny nail failed at an existing nail hole. It should be noted that this 75-pound load exceeded the 1991 UBC 63 pound lateral load capacity for an 8-penny nail (International, 1991). The results of the lateral load tests are shown in Table 1.

In order to determine if the stained and deteriorated portions of OSB panels met the criteria set forth by the applicable codes, 36 samples approximately 4” square each were removed from the building at areas that were stained and deteriorated. The OSB varied in thickness between approximately 1/2” and 5/8” thick (refer to Figure 1). Four of the 36 OSB sample locations and their subsequent testing are shown in Figures 2 through 14.

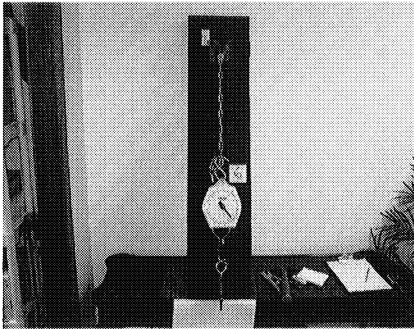
Figure 5. 90 pound tension force applied to OSB sample #6.

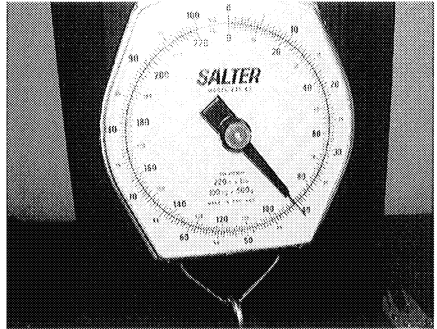
Figure 6. Close-up view of scale face.

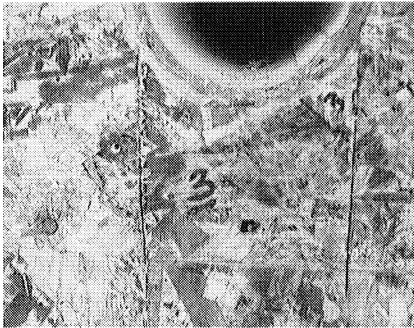
Figure 7. Stained, partially deteriorated OSB sample #3 beneath environmental exhaust vent.

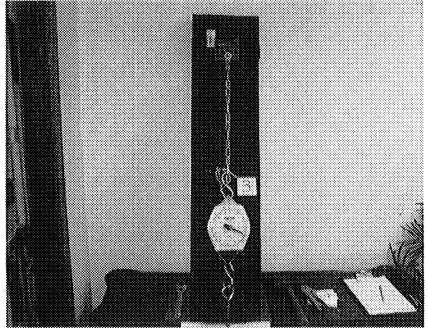
Figure 8. Sample #3 in test apparatus with partial loading.

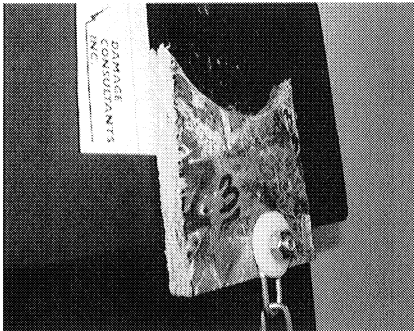
Figure 9. Close-up view of OSB sample #3 fastened to testing apparatus.

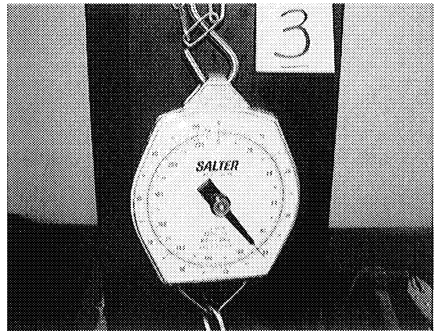
Figure 10. Close-up view of scale at conclusion of testing OSB sample #3.

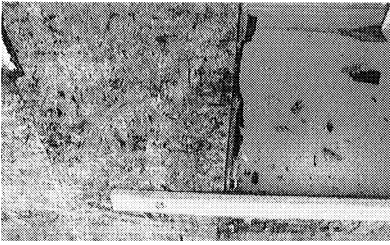
Figure 11. Location of stained and deteriorated OSB sample #12.

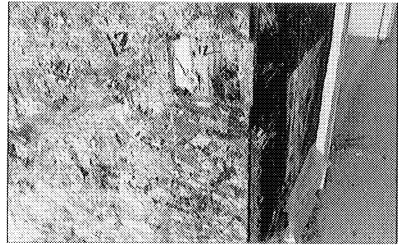
Figure 12. OSB sample removed revealing 1" of decay at 2 x 6 corner stud.

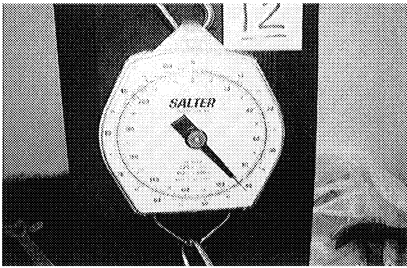
Figure 13. A close-up view of scale when testing of OSB sample #12 was completed.

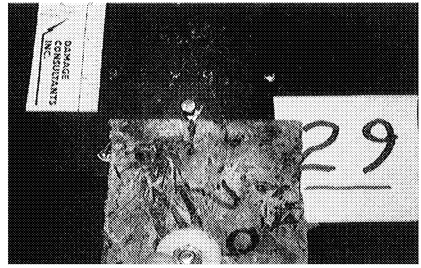
Figure 14. Failure at 75 pounds of an existing nail hole in OSB sample #29.

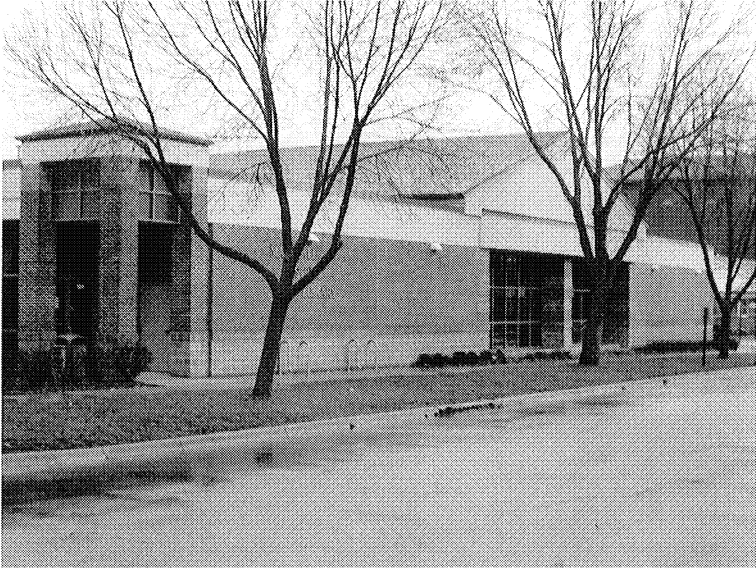
Figure 1. Overall view of library building and newer sloped roof feature.

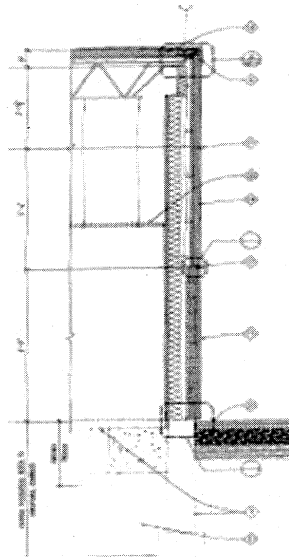
Figure 2 – Excerpt wall section from construction drawings with unfilled reference bubbles.

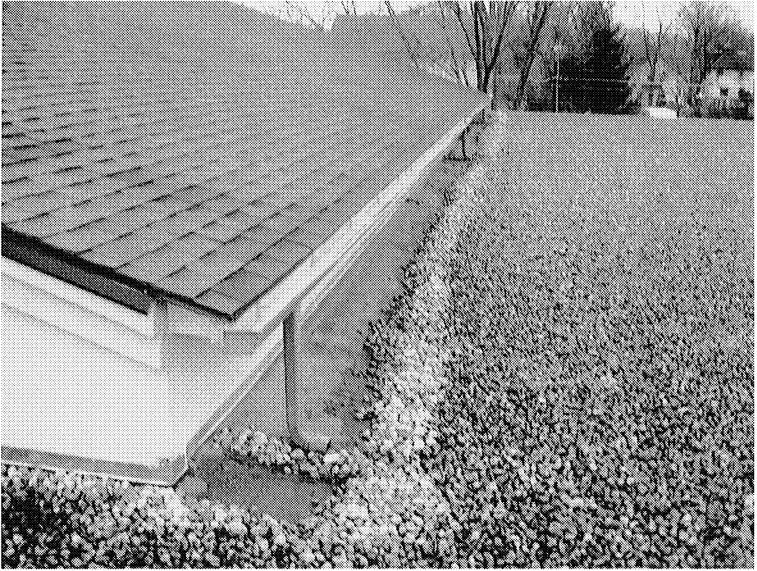
Figure 3. Overall view of sloped roof feature on library building.

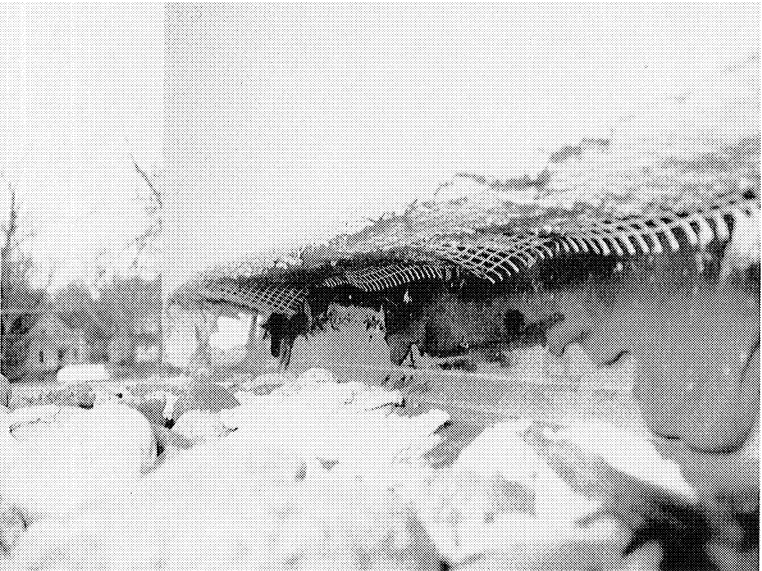
Figure 4. EIFS system is improperly terminated without backwrapping.

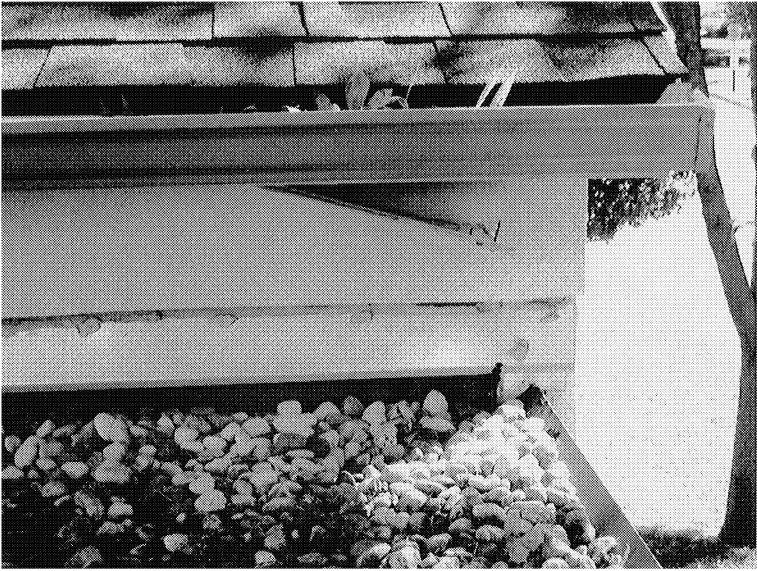
Figure 5. Pullout failure and fallen soffit materials at sloped roof eave.

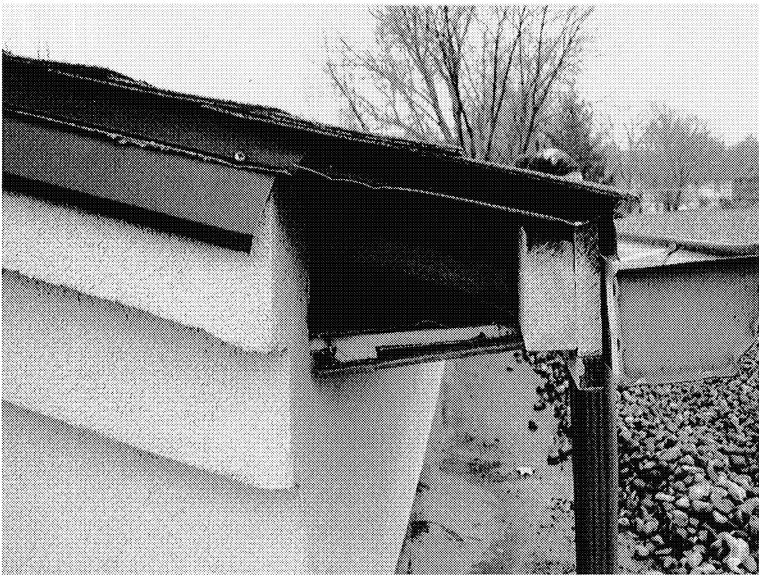
Figure 6 – Open end of soffit at gable eave for sloped roof. The poorly executed fascia extension is also seen at the raked edge of the slope roof.

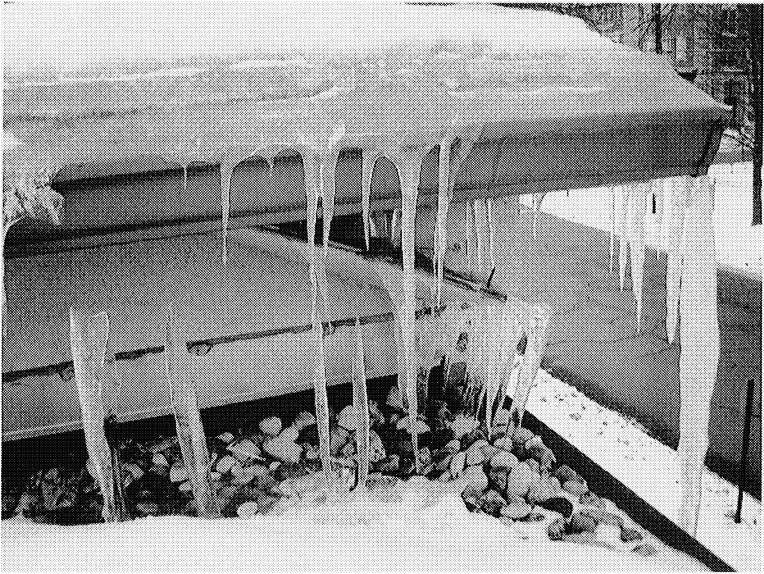
Figure 7. Ice damming at the sloped roof eave.

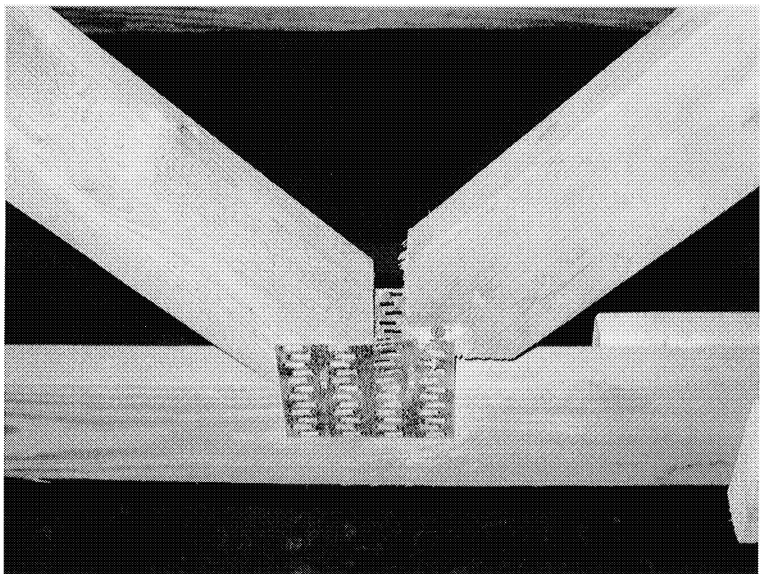
Figure 8 – Disengaged web diagonal at damaged roof truss.

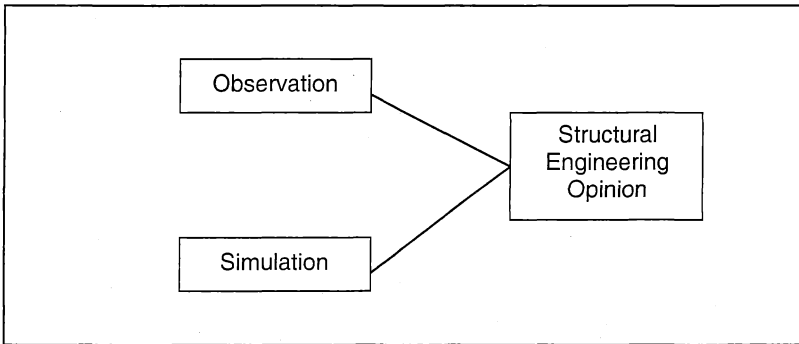
In general, there are two components a structural engineer uses to form an opinion: Observation and Simulation, as illustrated in Figure 1. In the case of an earthquake damage evaluation, the Observation component refers to the field investigation performed in order to document and measure damage to the building in question. The Simulation component refers to the structural analysis that is performed in order to estimate the effects of ground shaking on a building model, created according to details obtained about the building. The confidence in the opinion of the damage is a function of the completeness and competence of the work in each of these two primary sources of information, which can be viewed as branches on an information tree. The variation of scope within each branch is important because it offers a spectrum of tasks that can be performed to meet the required service for the project under consideration. It is possible to obtain a professional estimate of damage using information from any one of these information sources alone but the confidence the structural engineer has in an opinion rises with an increase in the scope of services that are performed.

Figure 1. Information tree of forming a Structural Engineering Opinion.

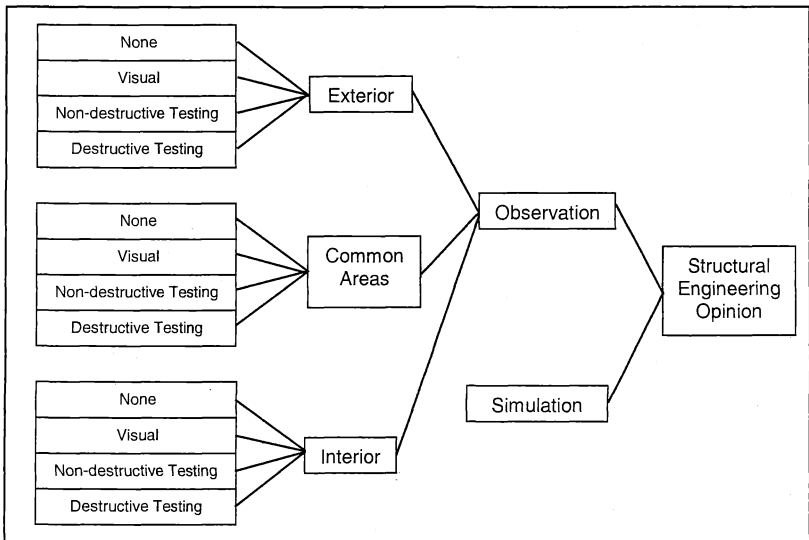
Consider the Observation branch, which may be comprised of a field investigation of the exterior, interior, and/or common areas of the building. In addition, for each of these areas, the scope may range from none to destructive testing, as shown in Figure 2. For each path on the information tree for the Observation branch, a confidence is

Figure 2. Information tree with expanded branch for Observation.

assigned, based on the scope of the field investigation and the information in Table 1. For example, we may state, "If the field investigation consisted of destructive testing an all three areas of the building, I am Almost Certain [90%] that the statements made in the damage evaluation report are correct." This initial confidence, based on the scope alone, is designated as F_{obs} .

Continuing with the Observation branch, in the next step, the field investigation of the three areas (exterior, interior, and common areas) is evaluated to assign a detail/completeness (d) and quality/competence (q) score to each area. These scores are used to quantify, in terms of a confidence level, the thoroughness of the investigation (d) and how well it was carried out (q). The d and q scores are combined and used to update, in a Bayesian Decision Making-type process, the initial confidence value (F_{obs}) to produce a new confidence for the Observation branch (F_{obs}').

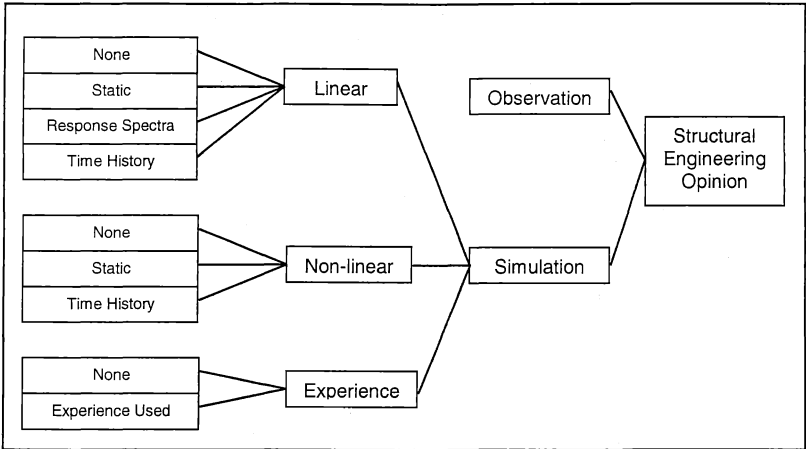
For the Simulation branch of the information tree, the procedure is essentially the same as for the Observation branch. The initial or prior confidence value in this main component of a structural engineering opinion is termed F_{sim} and is based only on the scope of a Simulation or analysis. Figure 3 shows how the Simulation branch of the information tree can be expanded to comprise linear and non-linear analysis as well as engineering judgment.

Figure 3. Information tree with expanded branch for Simulation.

Similar to the Observation branch, each analysis type is assigned a detail/completeness (d) and quality/competence (q) score. These scores are used to update the initial Simulation branch confidence value (F_{sim}) to produce a new confidence value (F_{sim}') that incorporates the new information on how complete the simulation component is and how well it was carried out.

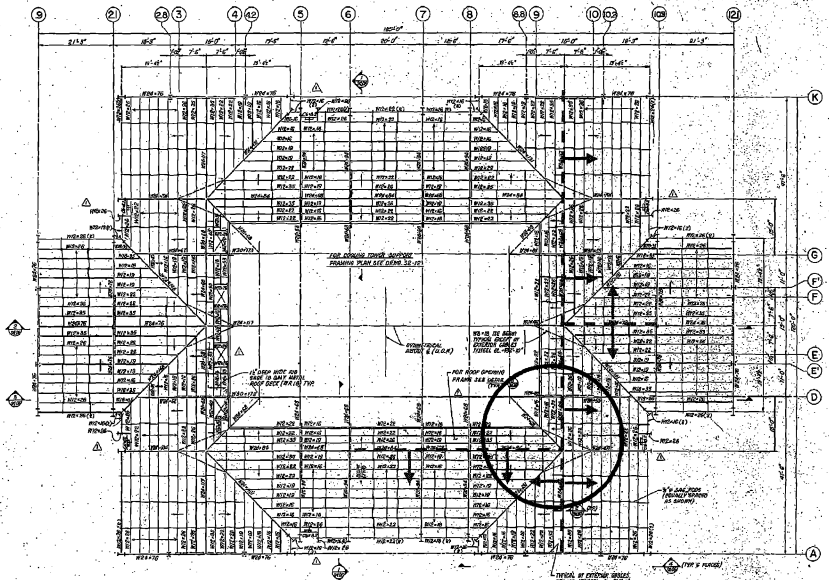
**Figure 1 - Roof Plan (CBM 1985) (North to Right)
Arrows Indicate Roof Slope, Area of Distress Circled**

On July 1, 2005, structural engineers visited the site to investigate the disturbance and the broken bolt (Bast 2005). Closer inspection of the mechanical space on the 42nd floor revealed four additional bolt halves lying on top of a mechanical duct. These bolts were found beneath the connection between column lines 9-10 and A-D, as located in Figure 1 and shown with greater detail in Figure 2. A small “pin-hole” of light was observed at the gabled peak near this connection.

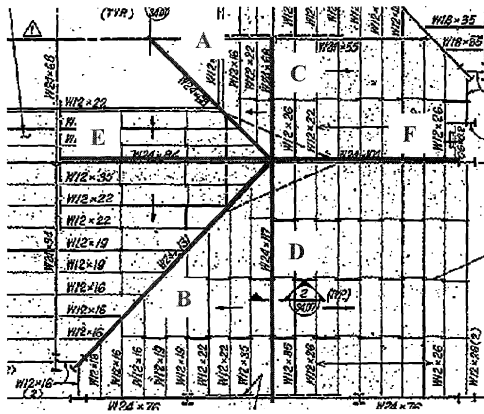
Figure 2 - Roof Partial Plan (CBM 1985) (North to Right)

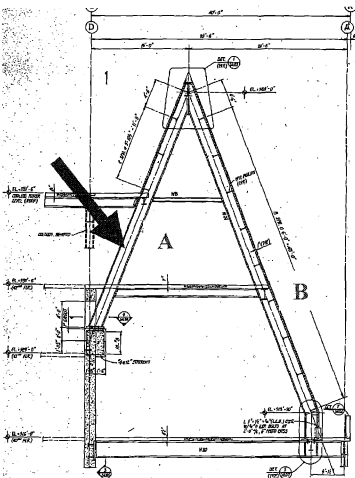
Figure 3 - Gable Detail (CBM 1985)
Arrow Indicates Beam Framing into Shear Wall

Following removal of additional fire proofing from the steel framing, the structural engineers located a beam connection missing five bolts. The connecting W24x68 beam (noted "A") spanned diagonally upward from the core wall of the 42nd floor to the peak of the northeast corner of the room. The upper end of the beam framed into a connection with five other steel beams ("B" to "F"). The lower end rested on top of a corbel attached to the concrete core wall, as illustrated below (Figures 3 and 4).

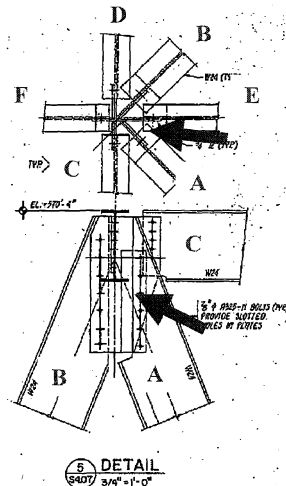
Figure 4 - Detail of Connection (CBM 1985)
Arrow Indicates Distressed Connection

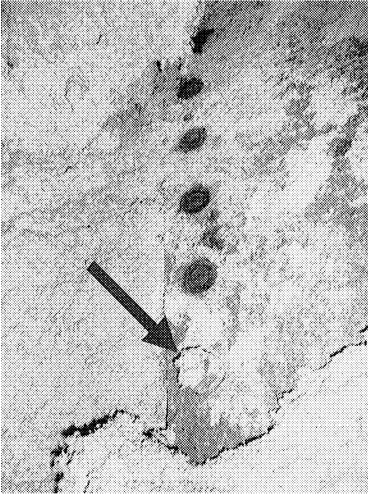
**Figure 5 - Failed Connection
Arrow Indicates Unsheared Bolt**

Figure 5 is a photograph of the connection missing five of the six bolts. In this photo, the holes of the backing plate are not visible. Observed scrape marks on the backing plate, visible through the bolt holes and the interface between the fireproofing and connection plate (Figure 6), indicate some longitudinal movement at the top of the connection.

The bolts were marked as type A325 and measured 7/8 in. (22mm) in diameter. All discovered bolts were sheared across the shank, not the threads. No sheared bolts were discovered at similar locations in the other quadrants of the symmetric roof system.

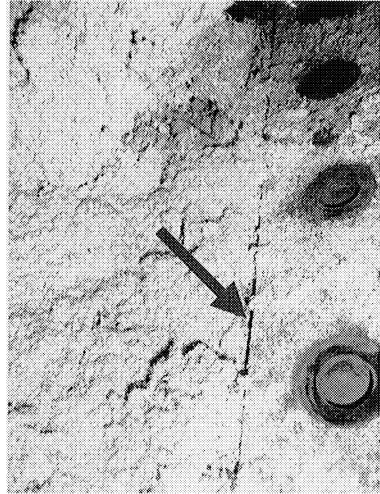
**Figure 6 - View of Fireproofing at
Connection
Arrow Indicates Edge of Connection
Plate**

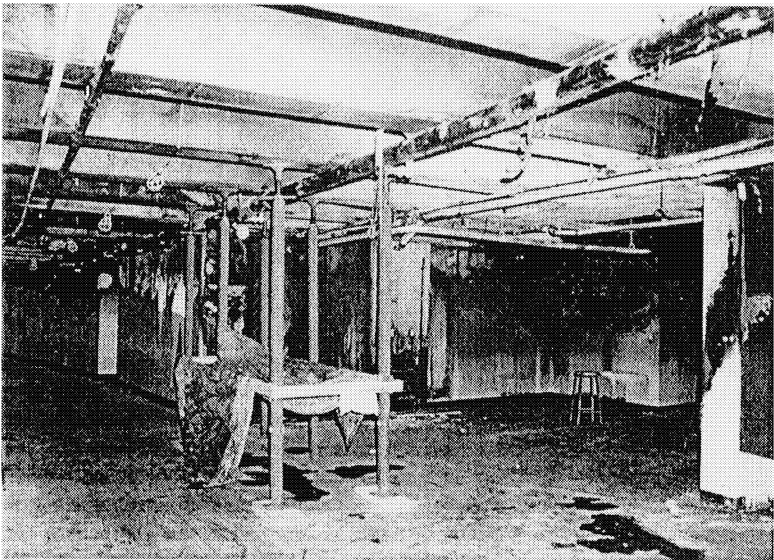
Figure 1 Overall view of fire damaged area.

Prugar Consulting, Inc. (Prugar) was contacted in February 1994 by an insurance company to evaluate the extent of fire damage to the concrete structure of a local high school. The high school had been constructed in the late 1960's with a cast-in-place concrete frame comprised of joists, beams, columns, and a floor slab (Figure 1). The concrete slab was 4 inches thick. The joists, which were spaced at approximately 5 feet, measured 30 inches deep by 15 inches wide. The beams measured 30 inches deep and approximately 48 inches wide. The joists, beams, columns, and the underside of the floor slab were exposed and painted in many areas of the school, including the area that was damaged. The joists were designed and constructed with a two span condition. The spans were not equal with one being 56 feet and the other 42 feet. The joists in the 42 foot span were observed to be sagged on both sides of an intermediate concrete block wall. Thus, the joists in the 42 foot span were inadvertently supported by the intermediate partition wall.

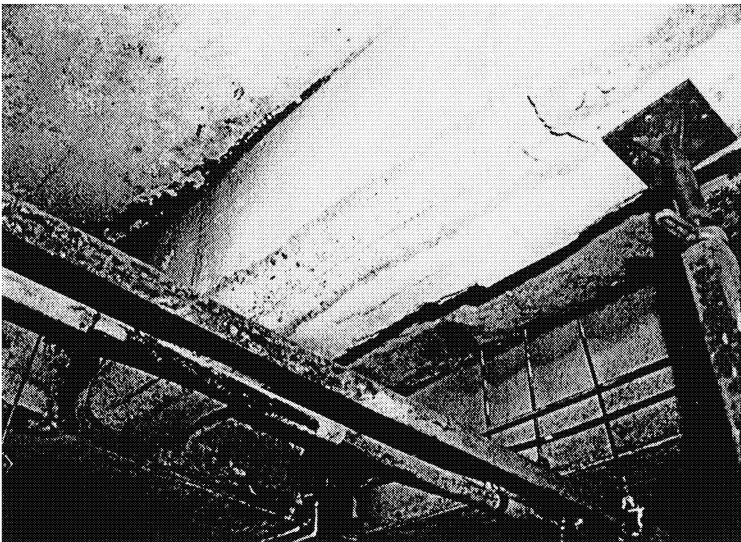
Figure 2 Fire damage at bottom of joist.

Examination disclosed smoke damage that extended throughout most of the lower level of the school. A portion of the concrete in the area of the reported fire exhibited a pink hue. A large area of the concrete material on three of the joists exhibited a dull thud when sounded with a carpenter's hammer. Some of the concrete was easily dislodged from the joists and a corner of a column when struck by a moderate blow with a hammer. The longitudinal bottom reinforcing was exposed where some of the concrete had been dislodged from the joists (Figure 2). Cracking was observed along the length of the longitudinal reinforcing bars at the bottom of the joists: the cracking extended from one end of the joists to near the midspan. One of the bottom bars was elongated and buckled out near the support of one joist. Three of the joists exhibited diagonal cracking within 4 feet of their support. The diagonal cracking extended from the bottom of the joist to the bottom of the slab and along the intersection between the joist web and the slab. All of the cracking on these three

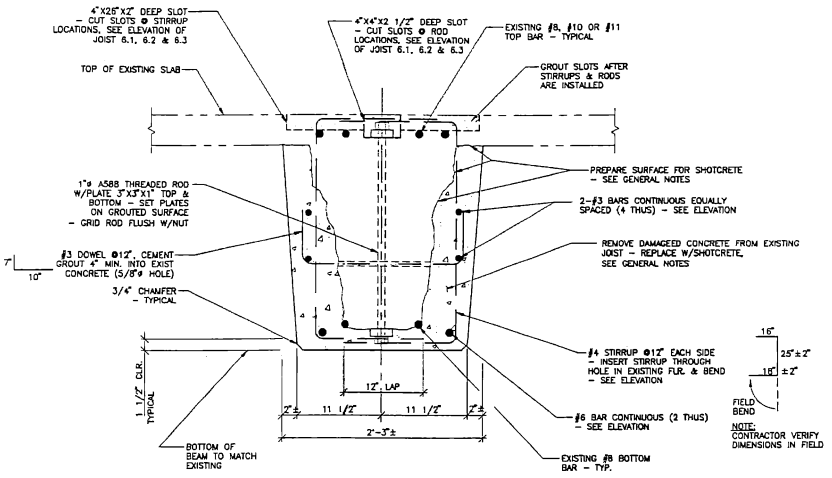
Figure 3 Cross section through joist showing repairs.

The diagonal shear cracking indicated that the concrete joists had failed in shear and were resisting shear by shear friction and the dowel action of the longitudinal bottom reinforcing steel. The shear strength resulting from shear friction was calculated and considered. It was decided to include the shear friction in the shear capacity of the joists. To include the shear friction, the two separated sections of the joist needed to be held together. It was decided that pretensioned threaded rods would be installed to hold the cracked sections of the joists together. See Figures 3 and 4.

L-shaped dowels were also grouted into holes drilled into the sides of the joists to provide a mechanical means of holding the shotcrete to the joists. Longitudinal steel was installed in the new portion of the joists for additional bending strength and to reduce shrinkage cracking on the sides. See Figures 3 and 7.

Since the joists were supporting the additional weight of the repair, additional bending strength was required. Additional bending strength was obtained by adding longitudinal steel reinforcing bars at the bottom of the new shotcrete. See Figure 3.

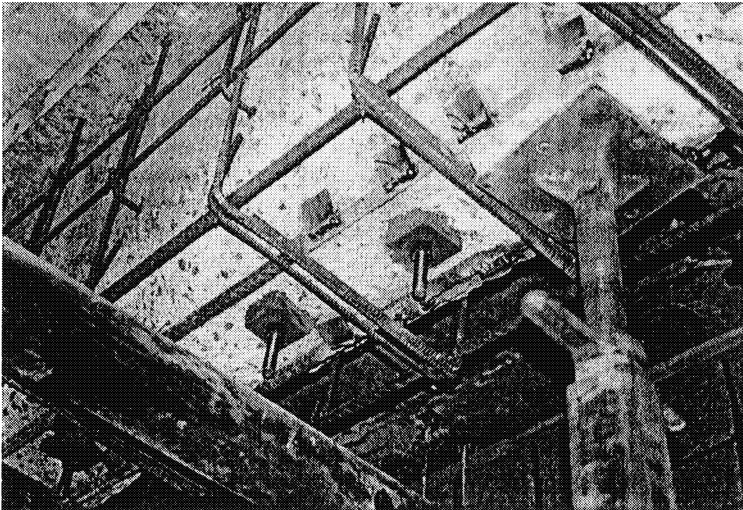
Figure 4 Bearing plates for clamping rods set in a grout bed.

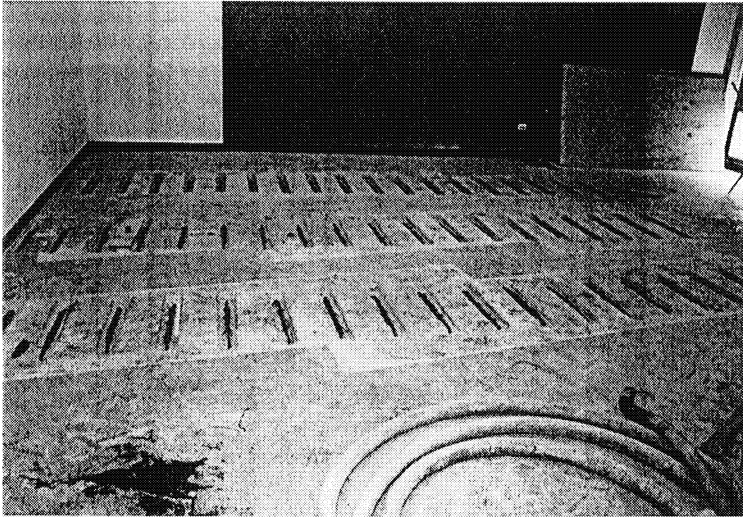
Figure 5 Floor above with slots for joist ties.

Due to installation limitations, it was thought that the new stirrups would be lapped on the sides of the joists. However, ESO suggested that they could field bend the stirrups across the top the joist. Prugar observed their bending method and the condition of the bar at the bend. The diameter of the bend was such that the steel was not kinked. Thus, new L-shaped stirrups were installed from below and the vertical legs bent over the top of the joists and the bottom legs of the L-shaped stirrups were lapped at the bottom. The top legs of the stirrups were concealed in a slot cut in the top of the slab. See Figures 5 through 8.

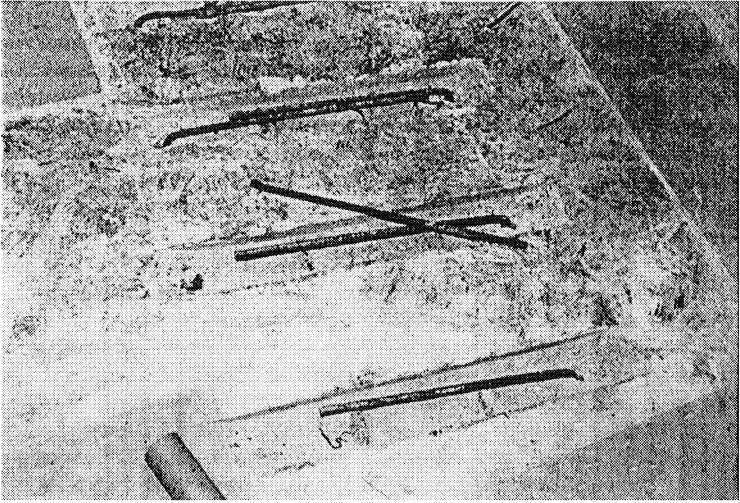
Figure 6 Joist ties bent over into slot.

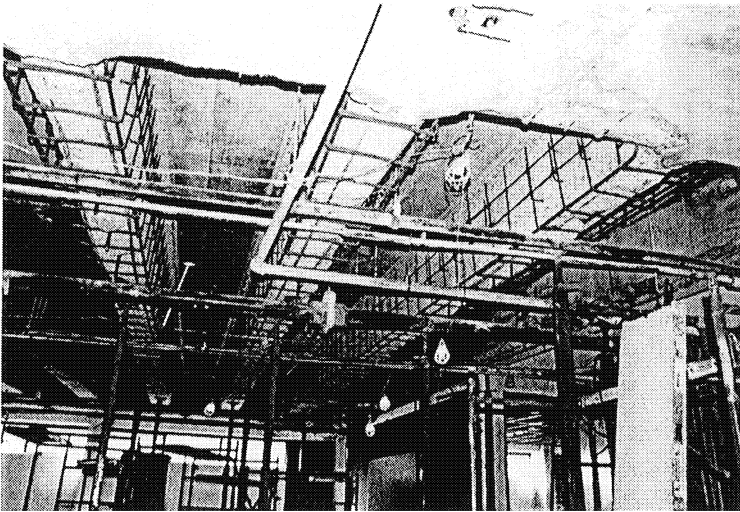
Figure 7 Joist ties viewed from below.

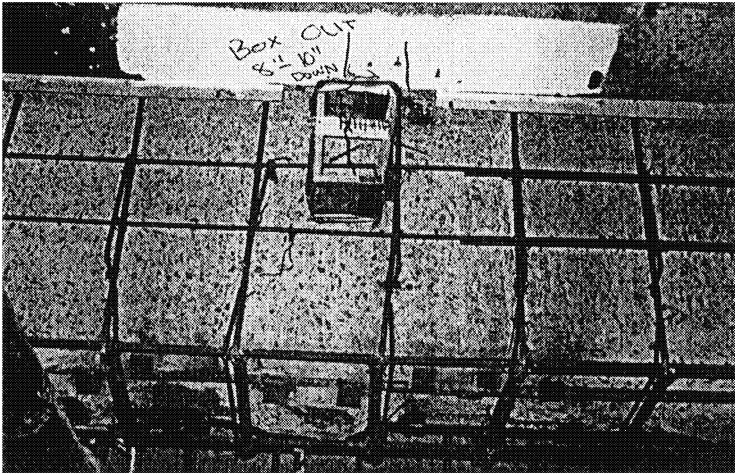
Figure 8 Side of joist exhibits ties. Bottom exhibits welding plates for longitudinal bars.

The buckling of the longitudinal steel reinforcing in one of the joists caused it to lose a significant portion of its development length. The longitudinal bar was re-secured to the joist by welding plates to the side of the bar: the plate had studs which were embedded and grouted into the side of the joist. See Figures 8 and 9.

Prugar checked the extent of the loose and damaged concrete removal by sounding the excavated areas with a hammer. Areas that needed more removal were marked by Prugar. Little additional concrete required marking for removal. Removal of the damaged concrete exposed additional longitudinal bars. The development length of these were re-established using the methods discussed previously and shown in Figures 8 and 9.

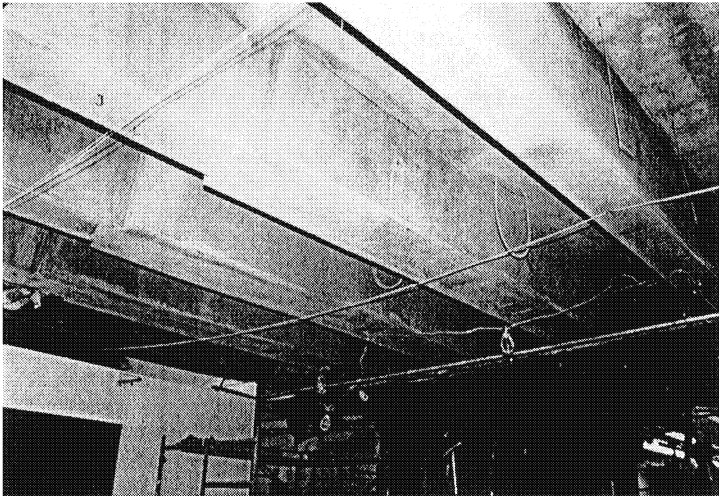
Figure 10 Finished joists.

The new reinforcing was set in place and the shotcrete was applied to the joists. The surface of the shotcrete was cut to a smooth finish to match the existing joists. It gave the appearance of formed joists. See Figure 10.

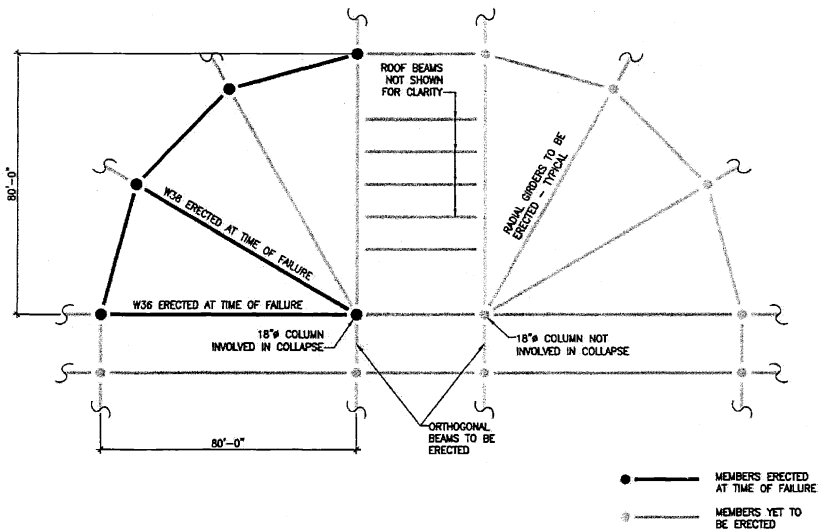
Figure 2: Partial Plan of Roof Structure at Collapsed Area (Taken from structural plans)

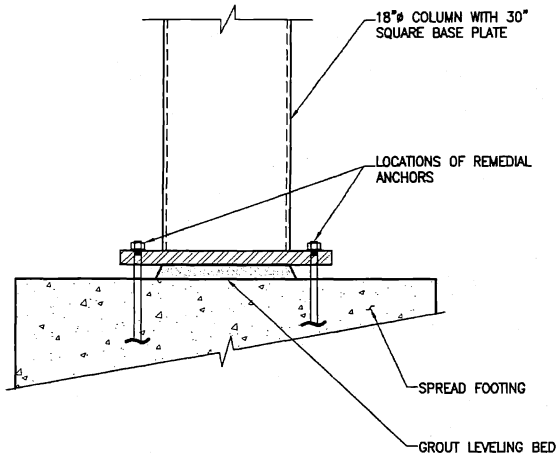
Figure 3: As-built Column Base Condition

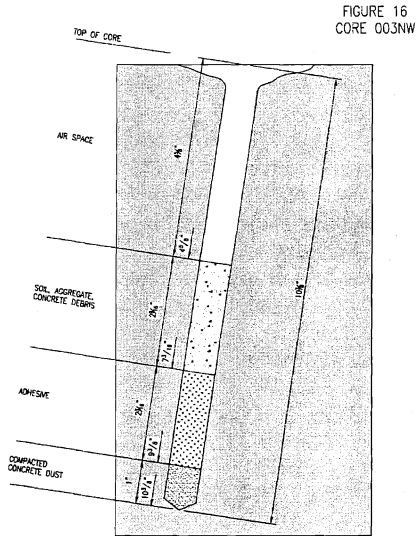
Figure 4: Materials Found in Core 003NW

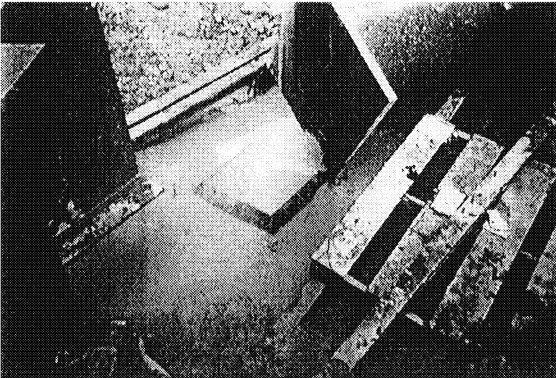
Photo 2: Column Base After Collapse (Source: General Contractor)

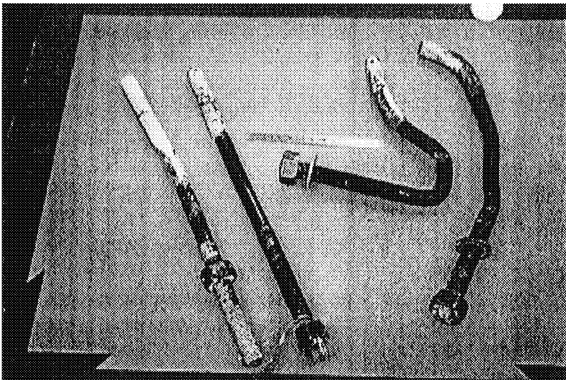
Photo 3: Anchor Bolts Of Collapsed Column (Source: Adhesive Manufacturer)

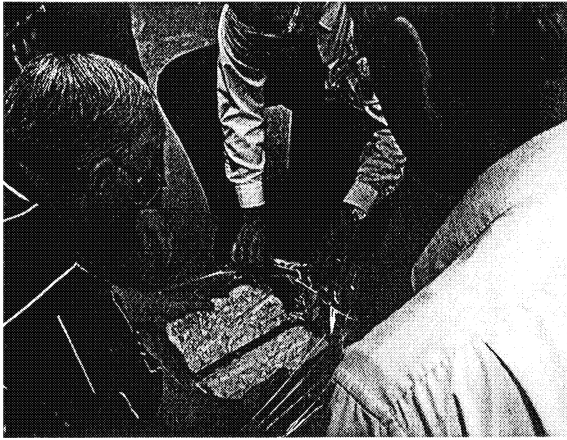
Photo 4: Splitting of Concrete Core Specimen
(Source: Simpson Gumpertz & Heger Inc.)

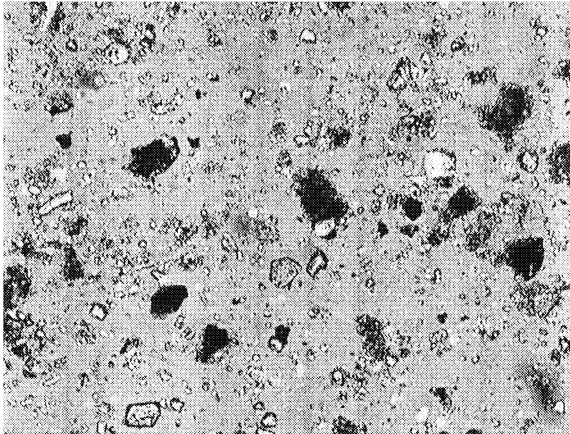
Photo 5: Example of White Material from Anchor Bolt Thread Showing Predominately Hydrated Cement Paste, Aggregate Particles, and Minor Amounts of Soil.
(Source: Simpson Gumpertz & Heger Inc.)

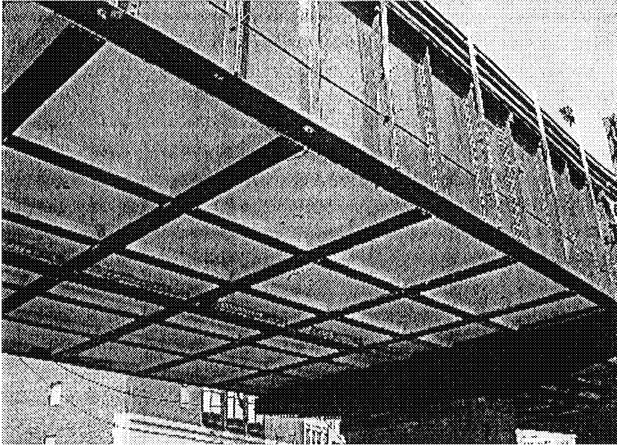
Photo 1. Overview of train viaduct.

Case 1 - Train Viaduct. The multi-span elevated train viaduct was constructed circa 1912 using lightly-reinforced concrete panels placed into a grid of built-up steel floor beams and main support girders (Photo 1).

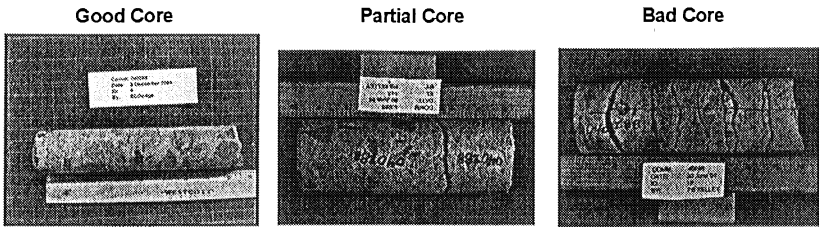
Photo 2. Classification of concrete core samples.

Following these attempts to define the extent of concrete deterioration for repairs using coring, IR tests were performed on each concrete panel to better define the extent of deterioration so that a comprehensive rehabilitation program could be developed. The IR test used a grid of test points beginning approximately 6 inches (15 cm) from the edges and spaced at approximately 1 foot (30 cm) on center in the middle of the panels. The core samples were classified as “good”, “partial”, and “bad” based on observations during the drilling process and on visual inspections in the laboratory (Photo 2), for comparison to the IR test results.

The “good” cores showed no signs of ASR and were removed intact. The “partial” cores showed some signs of internal cracking and were removed in 1 or 2 sections with little evidence of fracture planes in the drilled holes. The “bad” cores were removed in multiple sections and showed significant signs of ASR and fracture planes in the drilled holes. The “partial” cores typically were most clearly indicated by the average mobility values, the “bad” cores were typically most clearly indicated by the mobility slope values. All of the core conditions were closely indicated by the mathematical product of the average mobility and the mobility slope parameters (“mobility times slope”) in Figure 1.

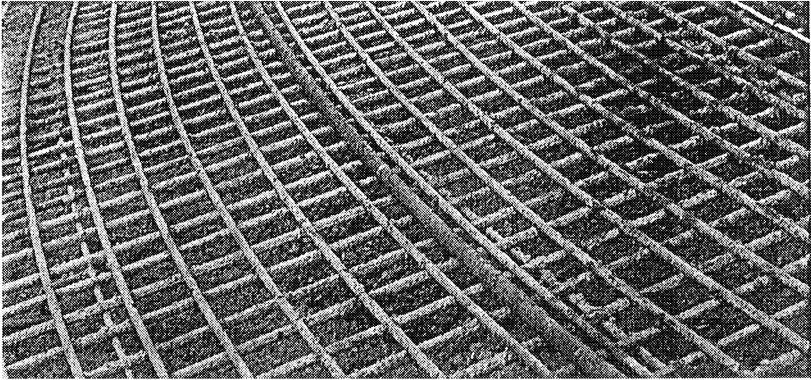
Photo 3. Variable elevation hardened lower lift of concrete.

Case 2 - Poor Consolidation Between Concrete Lifts. A circular structural concrete roof slab was constructed with up to a 10-hour delay between concrete lifts. The roof slab is heavily reinforced, approximately 2-ft-thick (0.6m), and is cast integrally with several mechanical structures. The upper concrete lift was placed directly onto the hardened lower lifts of varying elevation (Photo 3).

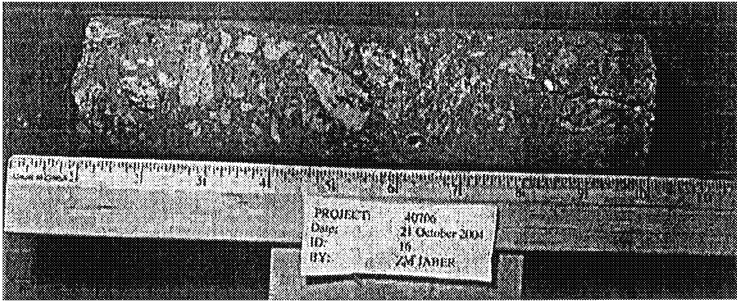
Photo 4. Concrete core classified as “good”.

Document review and conversations with involved parties regarding the construction of the structure revealed that there were three potential concrete conditions that required investigation: sound concrete, areas with potential defects, and areas with likely internal defects. The initial investigation used IR tests spaced at 2 feet on center over approximately 60% of the slab surface selected to cover the range of expected concrete conditions. Based on a preliminary interpretation of the IR data, we selected 18 core locations to correlate the existing condition to the range of observed IR values. The core samples were classified as “good”, “partial”, and “poor” based on observations during the drilling process and visual inspections in the laboratory. A “good” core showed no signs of voiding or cold joints (Photo 4).

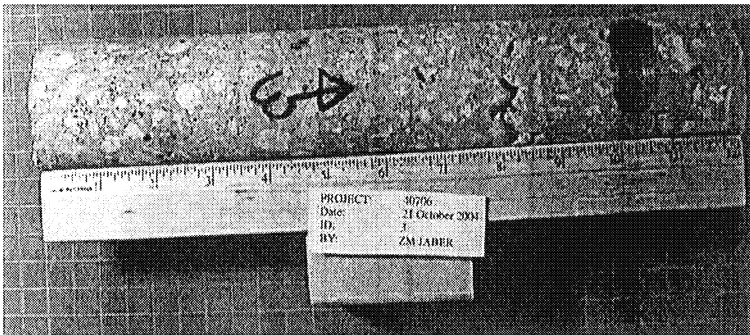
Photo 5. Concrete core classified as “partial”.

A “partial” core showed minor voids through a low percentage of the core cross-section and no cold joints (Photo 5).

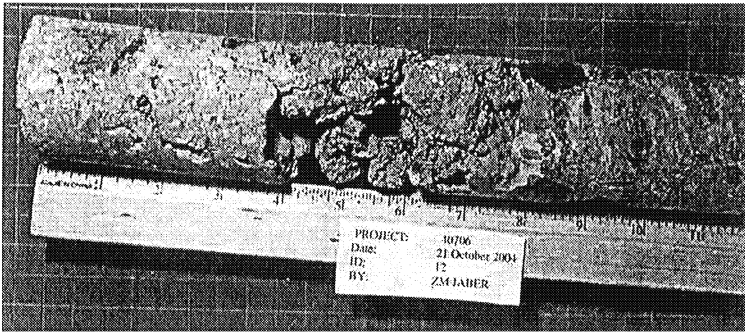
Photo 6. Concrete core classified as “poor”.

A “poor” core showed large voids over the majority of the core cross-section or cold joints (Photo 6).

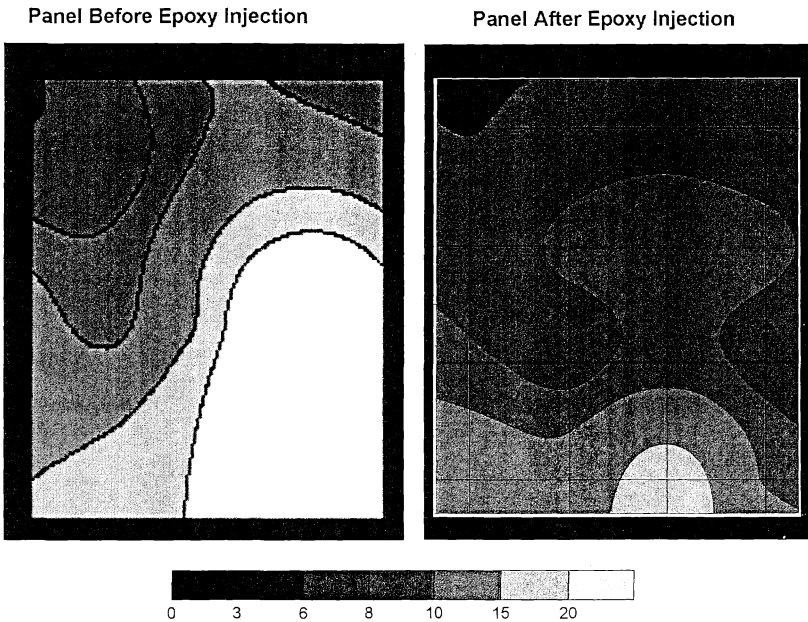
Figure 3. Comparison of mobility times slope values.

The areas with a “mobility times slope” values greater than 10 allowed for effective epoxy penetration in approximately 30% of the areas as shown by a comparison of the pre- and post-injection IR testing (Figure 3) and by post-injection coring.
