Forensic Engineering

Proceedings of the
Fourth Congress

FORENSIC ENGINEERING

October 6–9, 2006
Cleveland, Ohio

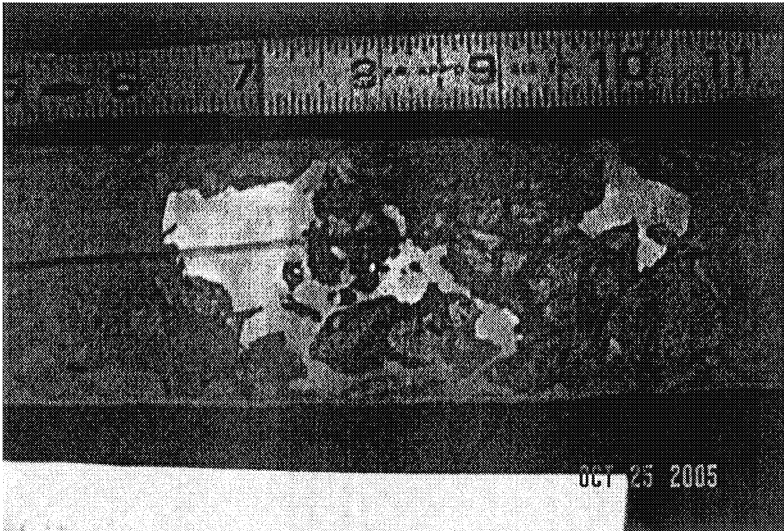
Photo 7. Epoxy penetration into poorly-consolidated areas.

The IR test results show that the average mobility values are significantly lower after the anchor installations and epoxy injections (Figure 4). Even after successful repair, the slab-epoxy composite structure responds differently than solid concrete as evidenced by areas of the elevated average mobility values that have adequate epoxy filling of poorly consolidated zones (Photo 7).

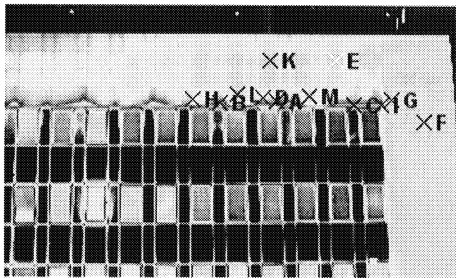
Fig. 1, Office building, thermogram of eastern facade (thermal range - 4°C/3.5°C)

The investigation allowed to survey all the heating loss on the Southern and Eastern facades. Major thermal anomalies resulted at the last level, between the windows and the stone slabs. The comparison between average temperature on sound areas (for example, lateral bands) and defects allowed to quantify thermal gradients. Fewer thermal anomalies resulted on Southern façade. Inside, the higher thermal loss is around the windowframes, and it is about 2°C .

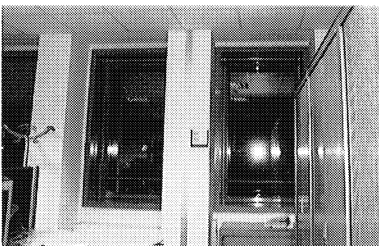
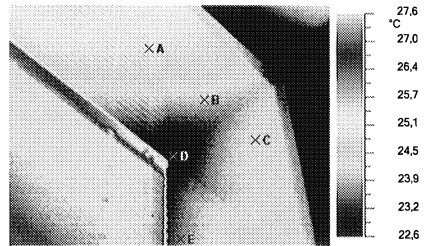
Fig. 2, Office Building, windows in room n 4025; fig. 3, thermogram of the right window in room 4025

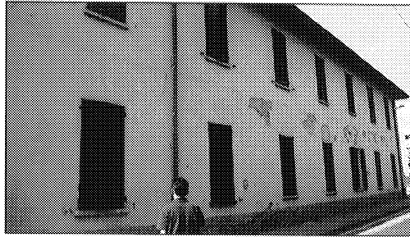
**Fig. 3. Bovisio Masciago, BV1 buildings, Eastern elevation**

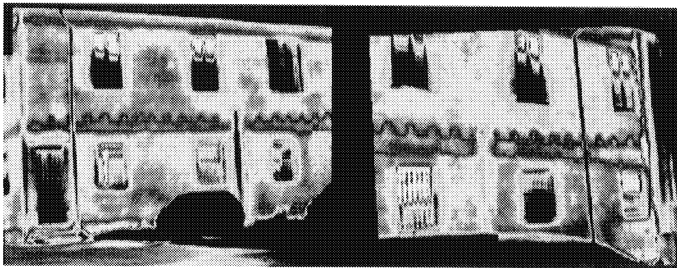
**Fig. 4. Bovisio Masciago, thermograms of Eastern elevation (thermal range 17.7-22.5°C)**

IRT and gravimetric tests were performed after some weeks of rain, in order to measure the maximum of water content inside the structures. A preliminary thermography scanning on the whole envelope of the buildings allowed to locate the major thermal anomalies (fig. 4). According to their location, geometry and connection with the damage, operators collected some samples from the surface and inside the masonry, by drilling. Results of gravimetric tests indicated water content for each sample. This procedure joins map of humid surfaces on the whole extension of the plaster, and the quantitative measurements of water content, without disrupting and wasting materials. In fact the number of samples is very reduced, because results of only few samples are significative of the part of surface at the same temperature. Inside, in the apartments at ground floor, microclimatic monitoring pointed out a high RH (connected with the damage) where the boundary wall joins the ceiling.

Moreover, investigation results showed the paths of water coming in to the structures (pipes leakages). A further step of analysis consisted on the investigation of the building techniques by fiberscope. IRT showed large thermal bridge where the exterior damage was most spread (at first floor). Fiberscope results showed that the long horizontal thermal discontinuity is due to the presence of a concrete beam, without insulation, directly plastered with stucco.

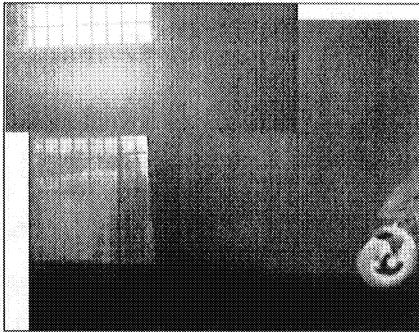
Fig. 6. Istituto Donizetti, thermograms of Southern and northern elevations, thermal range 7,2°-11,5°C;

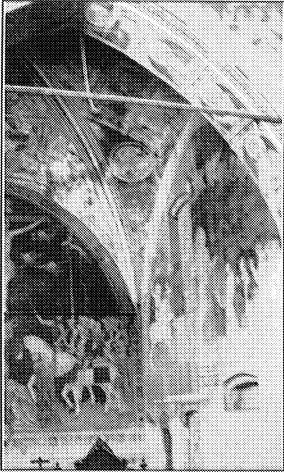
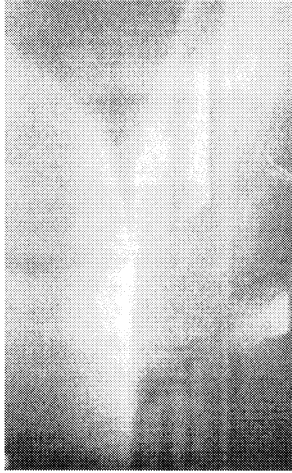
Fig. 8, Southern wall of the apse; fig. 9, mosaic of thermograms of the Southern wall of the apse (thermal range 8.1-12.3°C). Consider that the higher thermal gradient resulted on the eastern corner, due to sun irradiation

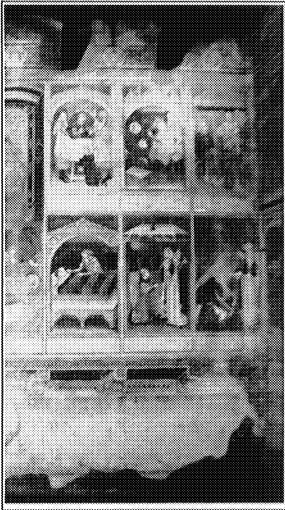
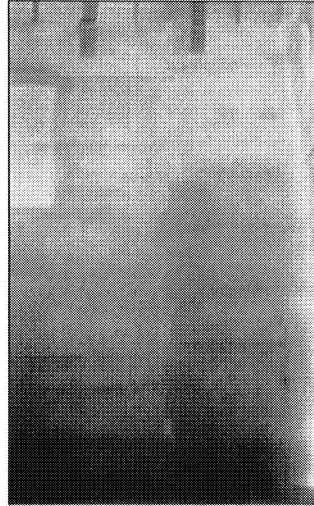
Fig. 10, nave, Southern elevation; fig. 11, mosaic of thermograms (thermal range 8.1-12.3°C)

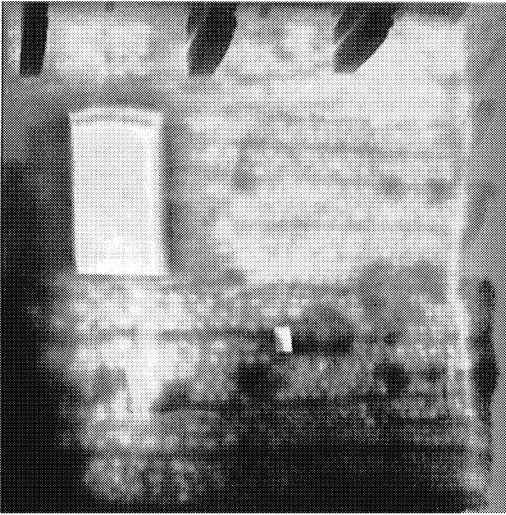
Fig. 12. Mosaic of thermograms of the Southern elevation in the nave, during the heating of the adjunct building

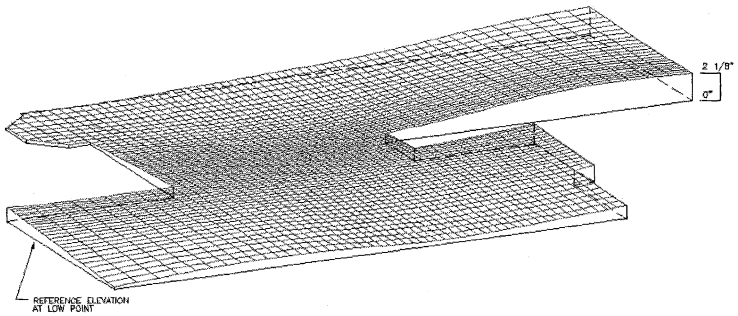
Date of Design	02/24/98
Total Number of Beam Tendons	28 Tendons
Total Out-of-Levelness	2 1/8"

Figure 1. Three Dimensional Representation of Total Out-of-Levelness Floor Plan A (28 Total Beam Tendons)

The relative elevation survey of the foundation systems for these Floor Plan A plans indicated more out-of-levelness in the foundations as the number of beam tendons decreased. The out-of-levelness for the foundations with 28 total beam tendons, 23 total beam tendons, and 20 total beam tendons was measured to be 2 1/8", 3 3/8", and 4 3/8", respectively. Representations of the change in out-of-levelness in Floor Plan A are provided in the following Figures 1, 2, and 3:

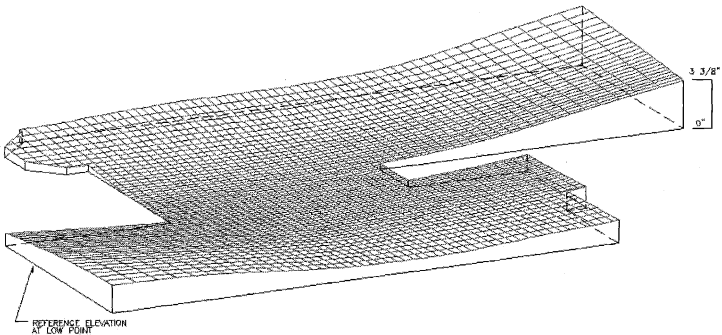
Date of Design	06/12/98
Total Number of Beam Tendons	23 Tendons
Total Out-of-Levelness	3 3/8"

Figure 2. Three Dimensional Representation of Total Out-of-Levelness Floor Plan A (23 Total Beam Tendons)

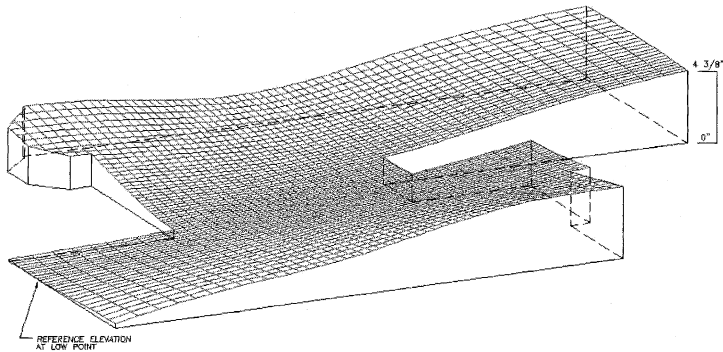
Date of Design	06/20/98
Total Number of Beam Tendons	20 Tendons
Total Out-of-Levelness	4 3/8"

Figure 3. Three Dimensional Representation of Total Out-of-Levelness Floor Plan A (20 Total Beam Tendons)

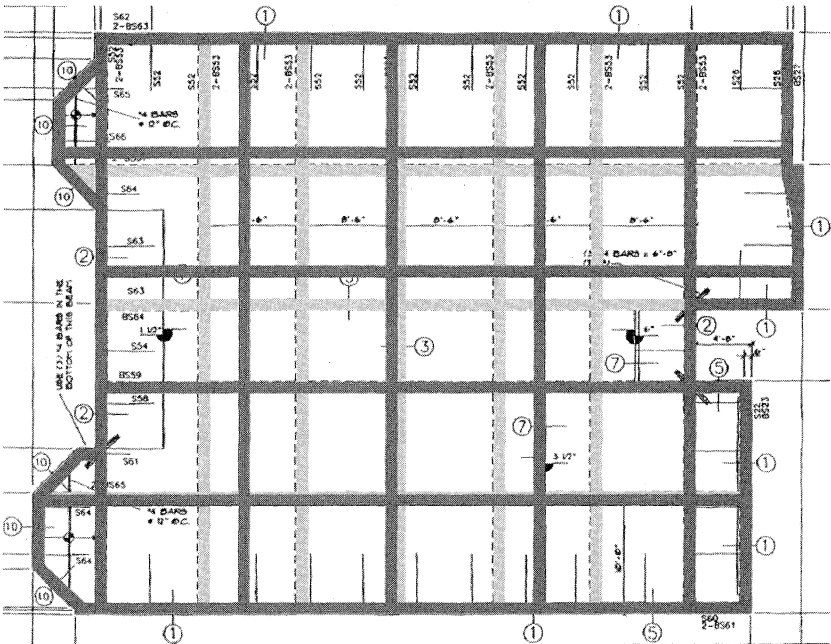
Figure 4. Beam Layouts from Foundation Designs for Floor Plan B

A graphic presentation has been prepared to demonstrate the differences in beam layout between Engineers Alpha and Beta. The grade beam locations were highlighted in a floor plan used by both engineers (Floor Plan B), and the highlighted grade beam locations from the plan designed by Engineer Beta was overlain on top of the highlighted beam locations from the design by Engineer Alpha. The graphic presentation is provided in Figure 4; the darker beams are representative of the design by Engineer Beta. Note that there are fewer short direction grade beams in the design by Engineer Beta.

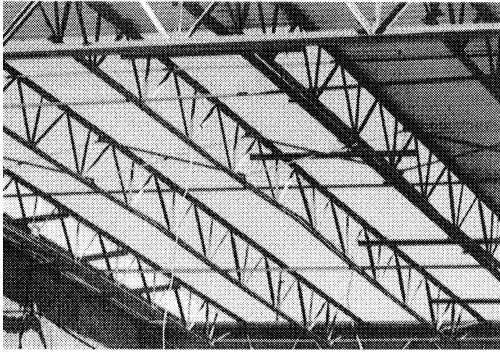
Figure 1. Buckling at joist bottom chord (Photo courtesy of Roof Technical Services, Inc.).

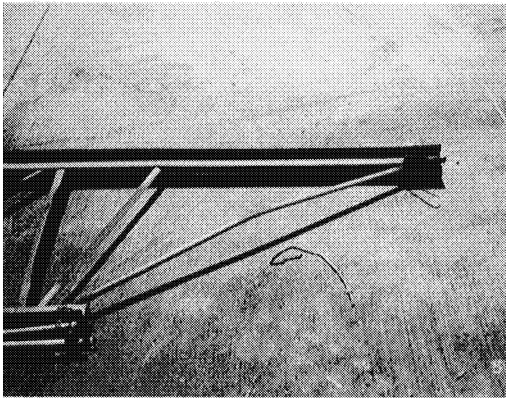
Figure 2. Buckling failure at end web (Photo courtesy of Roof Technical Services, Inc.).

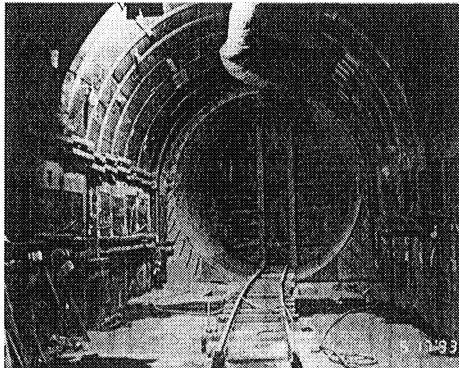
Figure 2. Hand-mined starter adit at Barnsdall shaft.

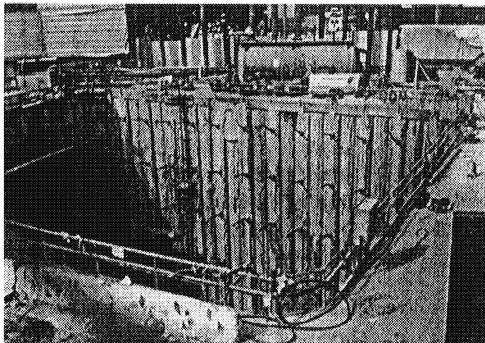
Figure 3. Barnsdall shaft supported by concrete tangent piles.

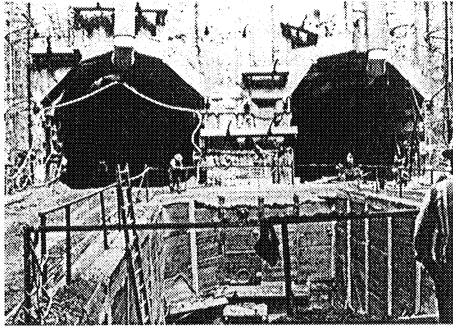
Figure 4. Reinforcement of failed pillar at Barnsdall shaft, west wall.

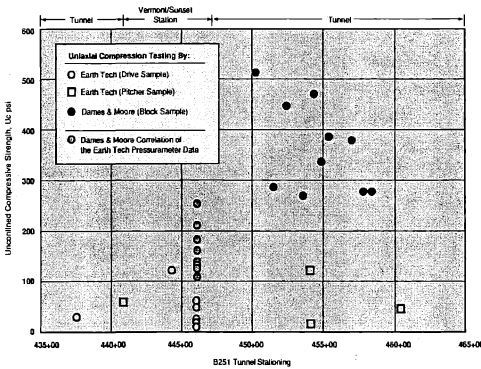
Figure 5. Unconfined compressive strength of siltstone - open symbols are lab-test data listed in the GDSR; full symbols represent test data from block samples taken during tunneling.

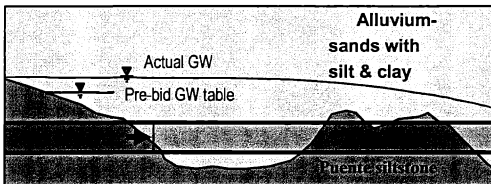
Figure 6. Subsurface conditions near Edgemont Avenue (not to scale); the black arrow marks the collapsed tunnel face.

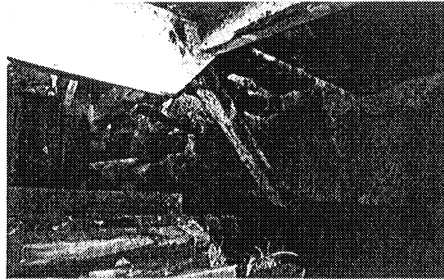
Figure 7. Boarded up tunnel face following the collapse due to running ground at Edgemont Ave.

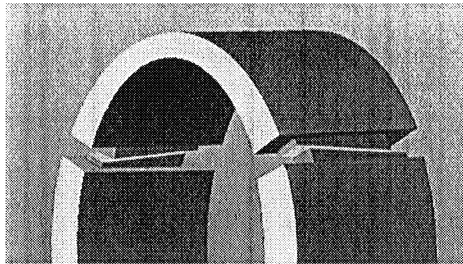
Figure 8. Hardwood wedges in the 10- and 2-o'clock positions of the expanded pre-cast concrete liner.

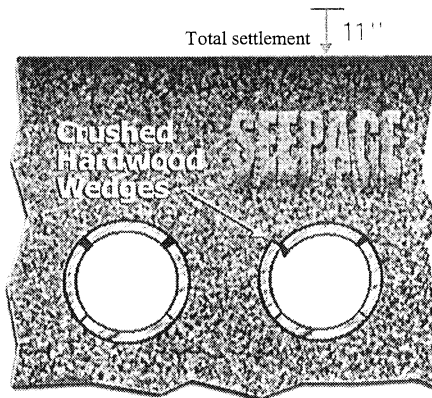
Figure 9. The hardwood wedges in the 10-o'clock position of the outbound tunnel crushed when the trailing shield passed.

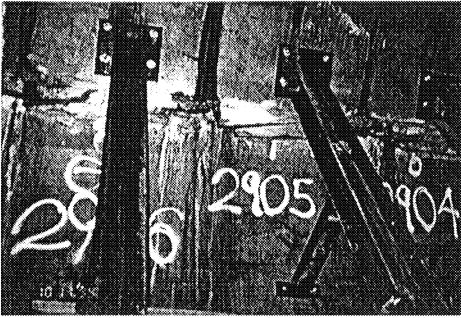
Figure 10. Steel posts supporting the failed temporary liner.

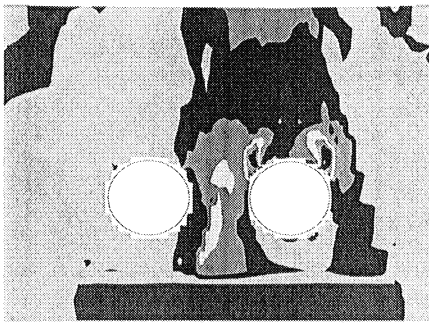
Figure 11. Volumetric-strain contours showing pattern of wetting-induced hydro-compaction as predicted by the numerical model; darker areas indicate more compaction.

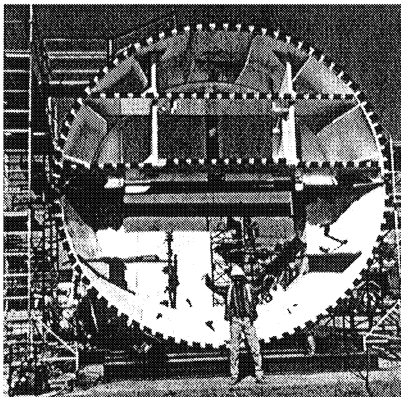
Figure 12. Digger shield with 2 breasting tables, used for Lankershim Blvd tunnels.

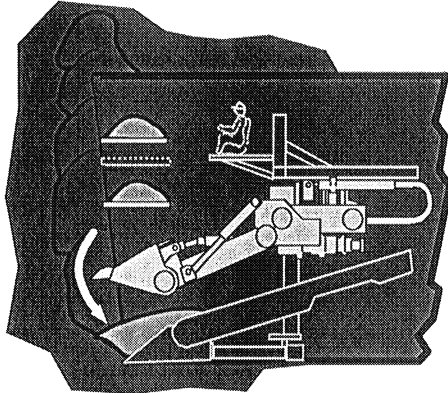
Figure 13. Caving below the breasting tables resulted in the development of chimneys above the crown.

As soon as the first shield left a short break-out zone stabilized by chemical grouting, the contractor encountered difficulties with caving of the tunnel face below the lower breasting table. Sand and gravel lenses encountered at this elevation tended to stand vertically at first, but then suddenly collapsed in the form of 1- to 2-foot thick, near-vertical slabs separating and falling away from the face. Caving then advanced upward to the crown and above, ahead of the cutting edge of the shield (Fig. 13).

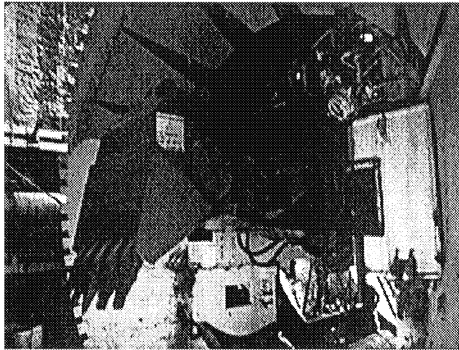
Figure 14. The over-sized digger could not be retracted inside the cutting edge of the shield.

The problem was caused by the oversized digger (Fig. 14), which could not be fully retracted and, hence, tended to undermine the face below the breasting tables. Concerns about this digger had been voiced even before the machines were installed underground. The contractor, however, opted to leave the diggers unchanged and add fixed hoods instead. This measure turned out to be ineffective, and caving continued to advance above the crown.

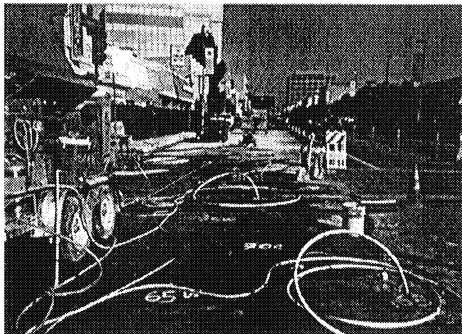
Figure 15. Grouting from the surface along Lankershim Blvd.

After periodic shut downs and directions given to the contractor to improve his means and methods, it came to a total impasse. The contractor requested a change order for implementing ground improvement, but this request was denied. In the interest of proceeding with the project, the owner finally directed the contractor to stabilize the entire alignment by chemical grouting from the surface (Fig. 15).

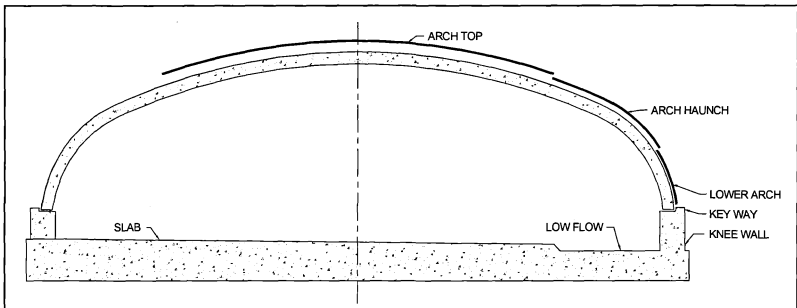
Figure 2: The Duck Creek culvert typical section. The precast concrete arch elements are placed on top of the knee walls, which were cast monolithically as part of the cast-in-place base slab.

The Corps of Engineers designed the cast-in-place base slab and knee walls upon which the precast culvert elements were to be placed, using design loads from Con/Span®. BridgeTek fabricated the 161 arch segments, each 49'-8" wide, 11-inches thick and approximately seven feet long, at their Milton, Kentucky outdoor precasting facility. A typical cross-section of the culvert is shown in Figure 2.

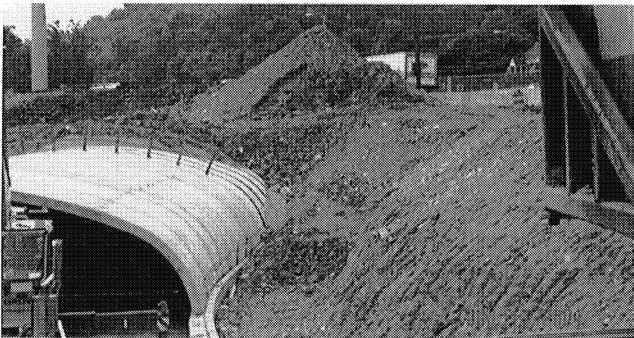
Figure 3: One of several distinct overburden stockpiles placed over the culvert.

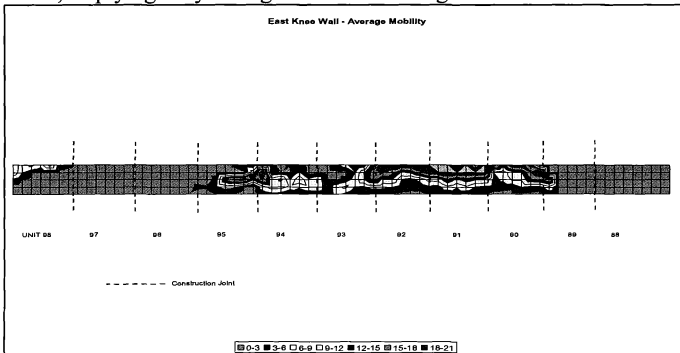
Figure 5: Sample Impulse Response data from the east Knee Wall.

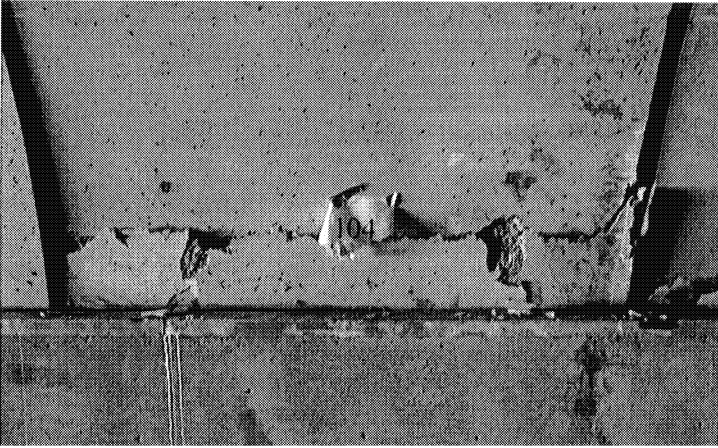
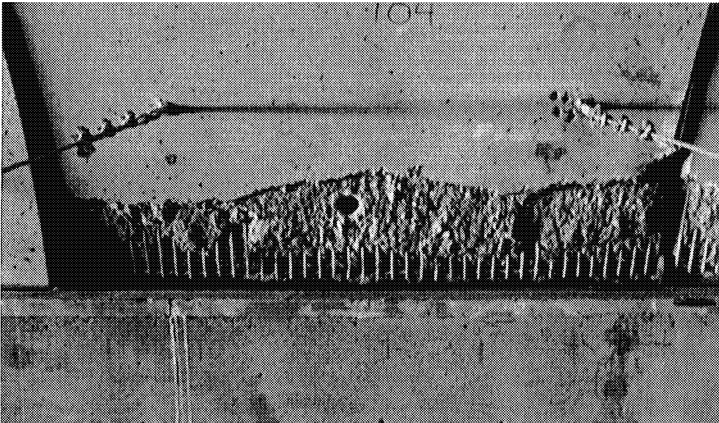
Figure 6: Damage to unit 104 at the interior surface of the east base with and without spalled concrete removed (exploratory core hole also visible).

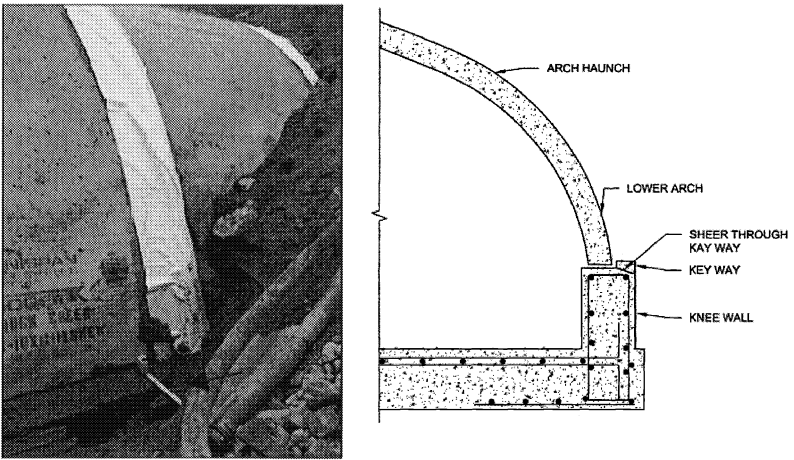
Figure 7: Keyway failure.

4. Knee Wall: Separation between the arch units and the interior grout pack of the knee wall was documented in units 98 through 112. This implied a failure of the key (Figure 7). Cores at units 92 and 94, visual observations and the IR data indicated complete failure of the knee wall in units 90 to 95 and 98 to 100 (Figure 8). All other units within the ranges 90 through 112 had key way or transitional damage due to displacement of the arch base (based on visual observations).

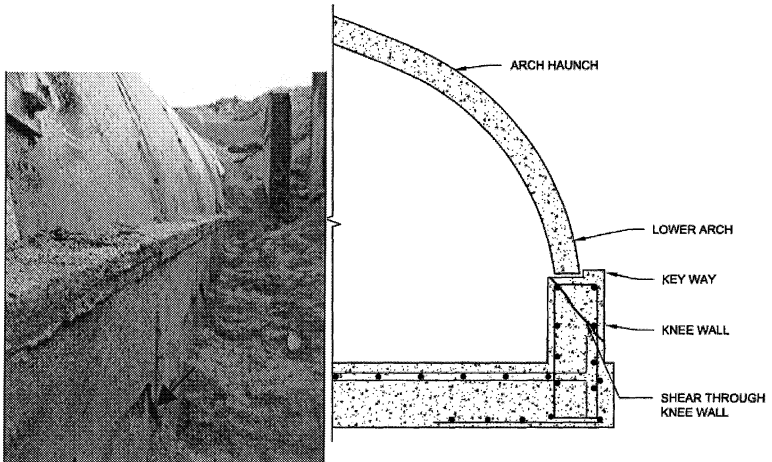
Figure 8: Knee wall shear failure.

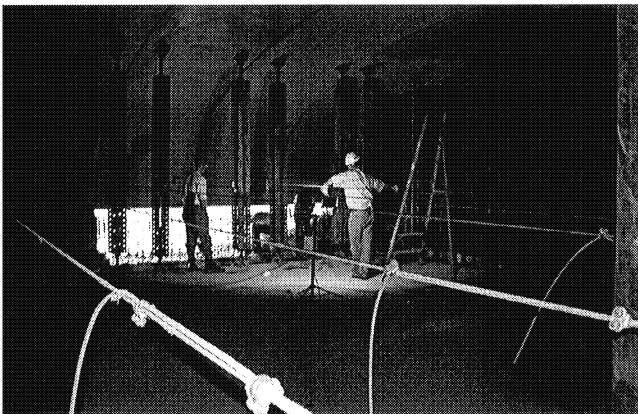
Figure 9: The arch units were shored up vertically and cable ties were installed to keep the legs from spreading due to loss of support from the side fill. This photo shows where a damaged section of the knee wall has been removed.

The first step at each location was to provide the temporary shoring (sheeting) required to maintain traffic on the temporary road. The arch units were then shored up vertically and cable ties were installed (Figure 9) to keep the legs from spreading due to loss of support from the side fill. Earth fill was then removed evenly on each side of the precast arch units to minimize any unbalanced loading. The required concrete removals were then made based on the extent of damage and the required repair (Figure 10). The arch unit span was then adjusted by a combination of jacking the arch units up to bring the leg in and by tensioning the cable ties to get the arch back as close to the original span of 48ft-10in as possible. The knee wall repairs were then completed with the arch segments in place (Figure 11).

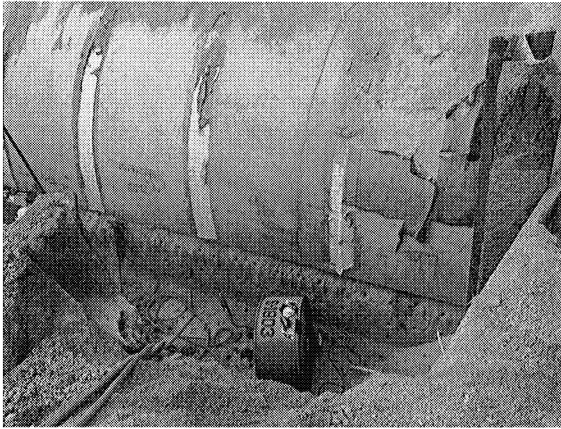
Figure 10: After the backfill was removed, demolition and replacement of the damaged portions of the kneewall proceeded. The contractor drilled holes and used hydraulic splitters and jackhammers to demolish the existing concrete. Splitter holes are shown.

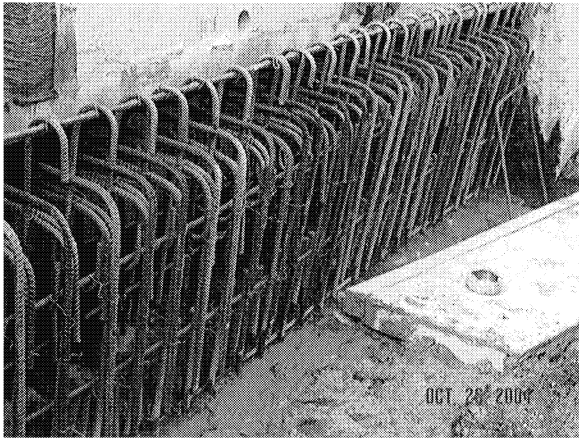
Figure 11: New reinforcement was added in the knee walls and especially in the keyway to provided added shear resistance in locations where the arch segments spread.

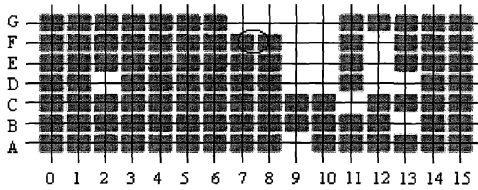
FIGURE 3b Deteriorated areas obtained from Test Area 2 using RP and IE methods.

The same grid setup shown in Figure 1 was used for these test methods as well. IE data analysis and interpretation used signal processing software, which transformed the time domain signal (waveform) into the frequency domain. In time domain, it is possible to exclude an invalid waveform (caused by loss of transducer contact with the surface), from the valid one as shown in Figures 2a and 2b, respectively. Waveforms obtained from Test Areas 1 and 2, as shown in Figures 2c and 2e, indicated delaminations. Although these waveforms looked similar to those obtained from the solid section, they possessed different dominant frequencies. In Figures 2d and 2f, frequencies of 6.35 kHz and 6.84 kHz indicate delaminations at test grid point F5 in Test Area 1 and at test grid point D10 in Test Area 2, respectively. These values were compared to the solid (thickness) frequencies of 5.86 kHz and 6.36 kHz with allowable error of 6%, which can be calculated using Eq.(1), for solid sections in Test Areas 1 and 2 respectively. The rest of the field waveforms were analyzed and interpreted and their results are presented in Figure 3.

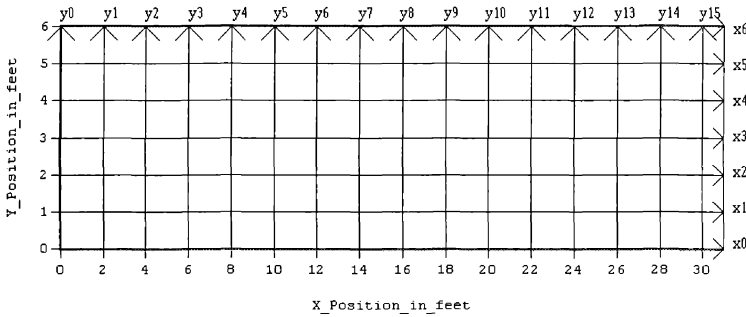
FIGURE 5 GPR survey lines used for collecting data from Test Areas 1 and 2 (1 ft. = 305 mm).

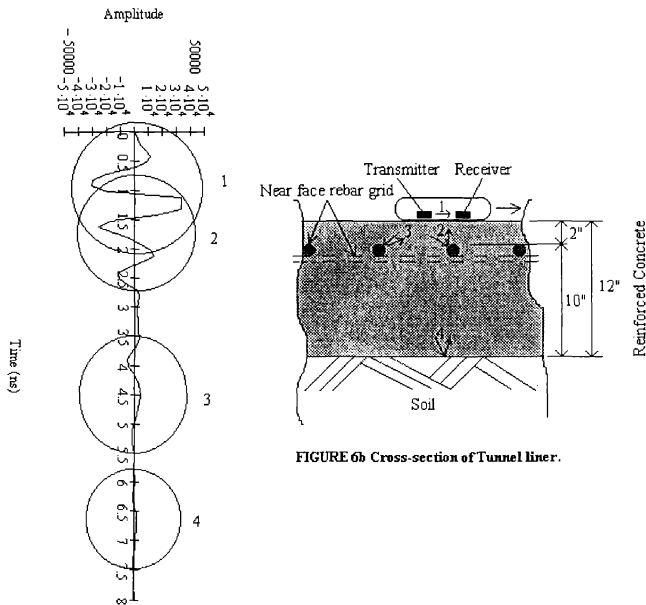
FIGURE 6b Cross-section of Tunnel liner.

FIGURE 6a Waveform obtained using ground-coupled radar system.

FIGURE 6 An example of GPR waveform obtained using ground-coupled radar system and cross section of tunnel liner (1 inch = 25 mm).

An example of radar waveform obtained using a ground-coupled radar system is shown in Figure 6a. This waveform consists of four exponentially decaying echoes, which were from direct air wave and surface echo, rebar, and concrete/soil interface as shown in Figure 6b. The transmitted pulse is not an ideal pulse. Instead, it is a two or three cycle oscillatory pulse having a duration time of about 2 ns. The near face rebar grid with concrete cover less than 76 mm (3 inches), in general, causes overlapping of early time echoes and a multiple reflection or ringing phenomenon.

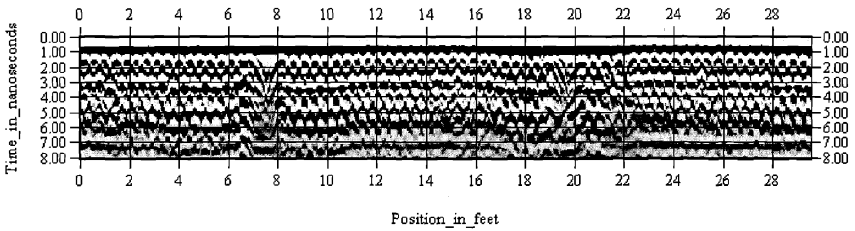
FIGURE 7a Post-processed and reconstructed subsurface profile from survey Line_x3 of Test Area 1 using Auto Gain.

Examples of post-processed data from Test Area 1 are shown in Figure 7. Unless structural information was provided, it became difficult to indicate the location of the concrete/soil interface because echoes from unexpected reinforcing steel appeared in many locations in the subsurface profiles as shown in Figures 7a and 7c. The image of a thick dark layer, appeared at 6.0 ns in Figure 7a and between 6.0 – 7.0 ns in Figure 7c. Locations of near face rebar can be determined from Figures 7b and 7d, whereas those of far face rebar can be determined from Figures 7a and 7c. Surface cracks, between 1.8 – 2.4 m (6 – 8 feet) and 5.5 – 7.3 m (18 – 24 feet), are marked in Figure 7b using three solid circles. Another variation, marked by the second solid circle from left, indicates a possible deteriorated area beneath the surface.

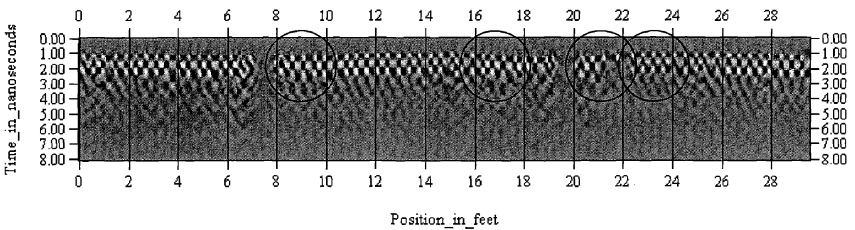
FIGURE 7b Post-processed and reconstructed subsurface profile from survey Line_x3 of Test Area 1 using No Gain, Migration, and Background Subtraction.

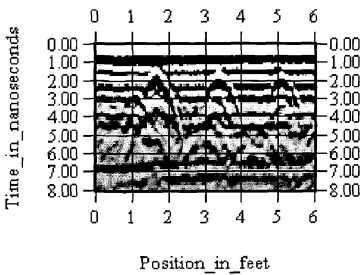
FIGURE 7c Post-processed and reconstructed subsurface profile from survey Line_y7 of Test Area 1 using Auto Gain, Migration, and

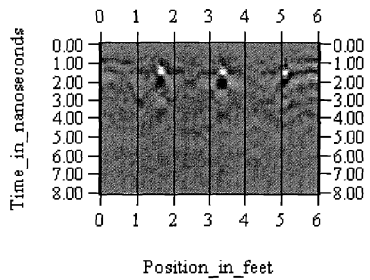
FIGURE 7d Post-processed and reconstructed subsurface profile from survey Line_y7 of Test Area 1 using No Gain, Migration, and Background Subtraction.

FIGURE 7 Examples of post-processed and reconstructed subsurface profiles obtained from Test Area 1 (1 ft. = 305 mm).

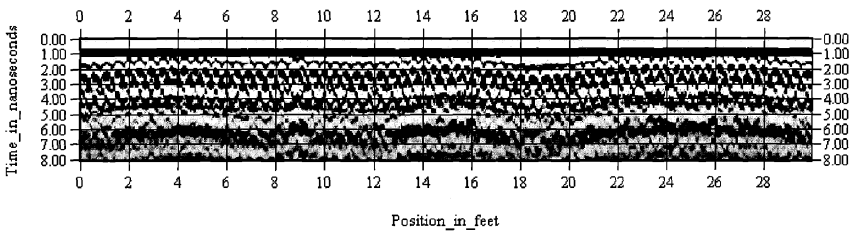
FIGURE 8a Post-processed and reconstructed subsurface profile from survey Line_x3 of Test Area 2 using Auto Gain.

Analysis and interpretation of data obtained from Test Area 2 was similar. The location of concrete/soil interface is between 6.0 – 7.0 ns as shown in Figures 8a and 8c. No flaws were found in this test area. There are two likely false indicators, which may cause misinterpretation of post-processed data image. The first one is the arch located at 9 feet and 6.5 nanoseconds in Figure 8a. Rather than being a deeper lying rebar, it may simply be a reflection from the closely-spaced rebar layer located above. The other is that the varying location of the near face transverse rebar locations, marked using a solid ellipse in Figure 8b, may be due to a varying surface moisture content of the concrete at that location, which affects the signal wave speed, rather than a variance in the actual rebar depth. Figure 8d shows locations of the near face longitudinal rebar locations as well as near face transverse rebar, which is indicated by a dark layer at about 2.0 ns.

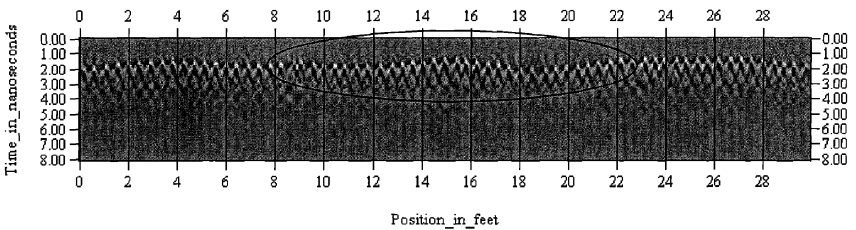
FIGURE 8b Post-processed and reconstructed subsurface profile from survey Line_x3 of Test Area 2 using No Gain, Migration, and Background Subtraction.

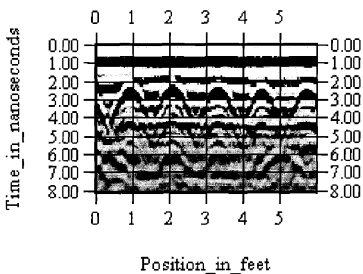
FIGURE 8c Post-processed and reconstructed subsurface profile from survey Line_y7 of Test Area 2 using Auto Gain, Migration, and

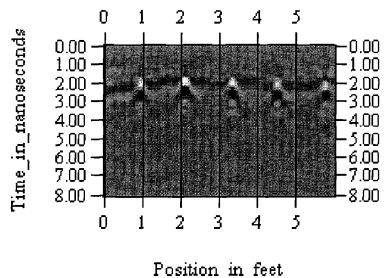
FIGURE 8d Post-processed and reconstructed subsurface profile from survey Test Area 2 using No Gain, Background Subtraction.

FIGURE 8 Examples of post-processed and reconstructed subsurface profiles obtained from Test Area 2 (1 ft. = 305 mm).

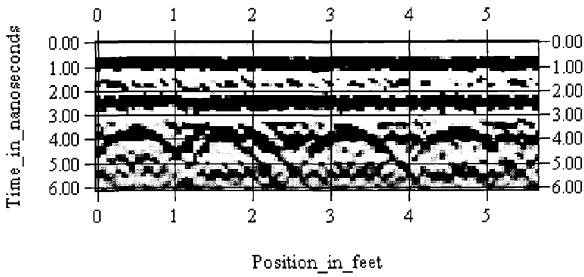
FIGURE 9a Post-processed and reconstructed subsurface profile from longitudinal survey line at center of Test Area 3 using Auto Gain.

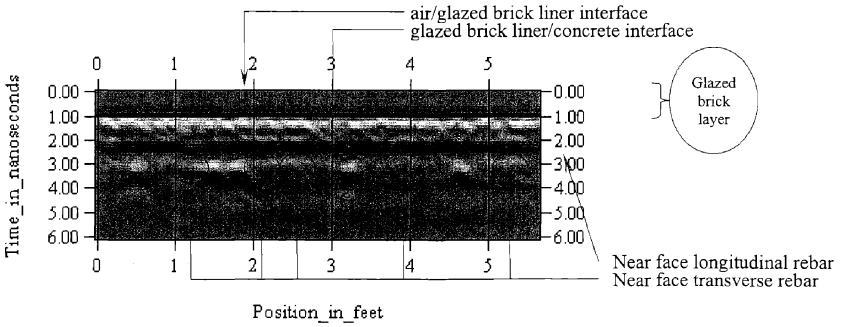
FIGURE 9b Post-processed and reconstructed subsurface profile from longitudinal survey line at center of Test Area 3 using No Gain and Migration.

FIGURE 9 Examples of post-processed and reconstructed subsurface profiles obtained from Test Area 3 (1 ft. = 305 mm).
