GEOTECHNICAL PRACTICE PUBLICATION NO. 7

GEOCHALLENGES

RISING TO THE GEOTECHNICAL CHALLENGES OF COLORADO

PROCEEDINGS OF THE 2012 BIENNIAL GEOTECHNICAL SEMINAR

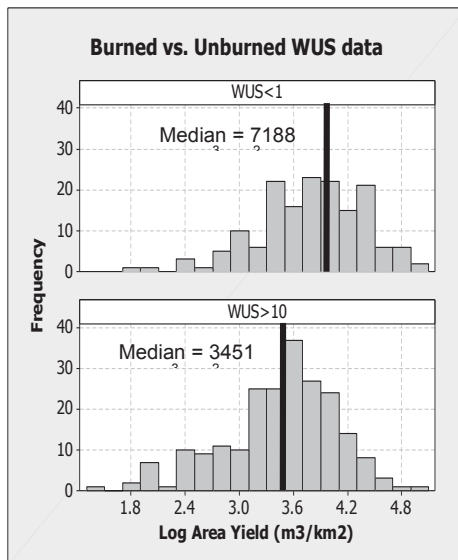
FIG. 1. Comparison of debris-flow area yield rates (volume of debris per unit area of drainage basin) for burned (WUS < 1) and unburned (WUS > 10) sites in the Western U.S. (Santi and Morandi, in review)

Debris flows in burned areas are larger than flows in the same areas before the burn or after recovery. For example, Figure 1 shows data from 276 sites in the Western U.S., compiled by Santi and Morandi (in review), where the median yield rate (volume of debris per unit area of drainage basin) for burned areas is over twice the rate for unburned areas. Debris flows can be triggered by much lower rainfall amounts and intensity in burned areas than in unburned areas, as shown in Figure 2 (Cannon and DeGraff, 2009).

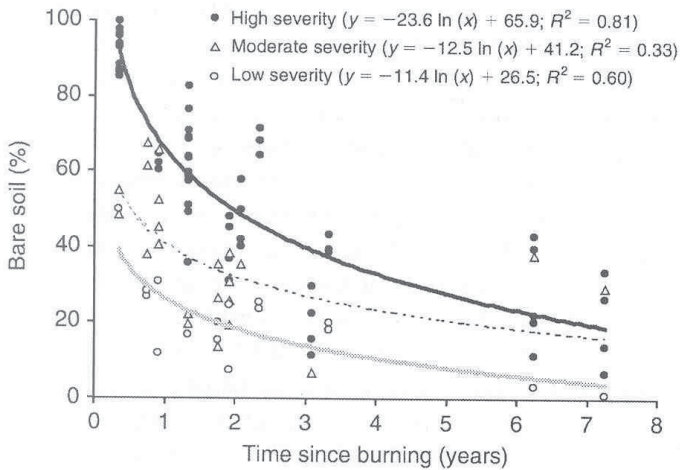
FIG. 3. Percentage of bare soil following a burn, as related to burn severity. Recovery to pre-burn conditions (70 to 80% vegetated) takes approximately 3 years (Benavides-Solario and MacDonald, 2005)

After wildfire, vegetation often recovers to pre-fire conditions in one to three years. For example, Figure 3 plots data showing vegetation represented as decreasing bare soil exposed for different burn severities (from Benavides-Solario and MacDonald, 2005). Assuming that typical Colorado mountain regions have a range of up to 20 to 30 percent bare soil, vegetative recovery appears to take approximately three years. As plant regrowth will reduce hillslope sediment erosion, researchers have shown that the sediment delivery returns to pre-fire rates within 2 to 4 years in the Rockies (Martin and Moody, 2001; Legleiter et al., 2003). Extending this concept further, Santi and Morandi (in review), found that debris flow volumes return to their pre-fire magnitudes in approximately 3 to 5 years (Figure 4).

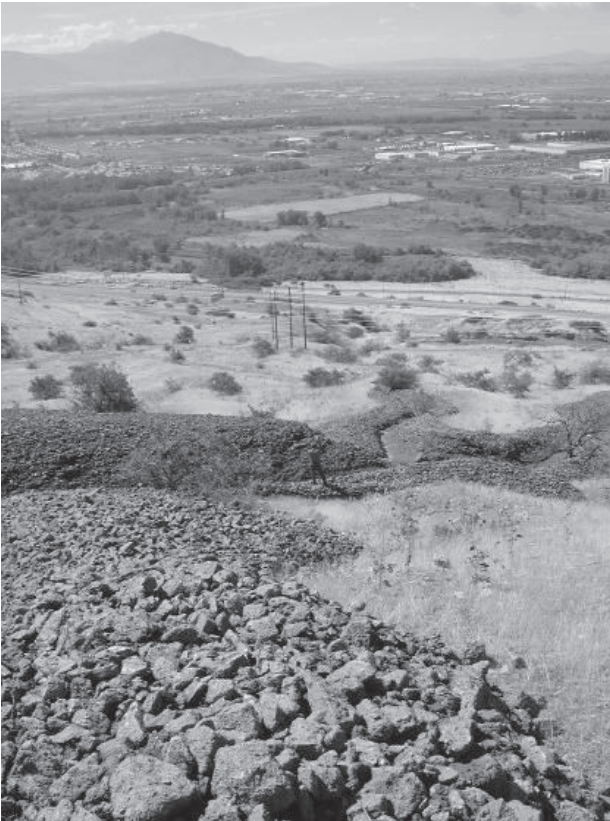
FIG. 5. Branching debris-flow deposit on open slope near Springville, Utah (photo by Rich Giraud, Utah Geological Survey)

The propensity of debris flows to move in pulses and to create and rupture dams of material enhances the distributary nature of deposits on open slopes, where the flow has overflowed or travelled beyond a confined channel. This results in lobate deposits, even for a single debris-flow event, that spread over a debris fan into unanticipated areas. For example, Figure 5 shows two lobes of a branching debris-

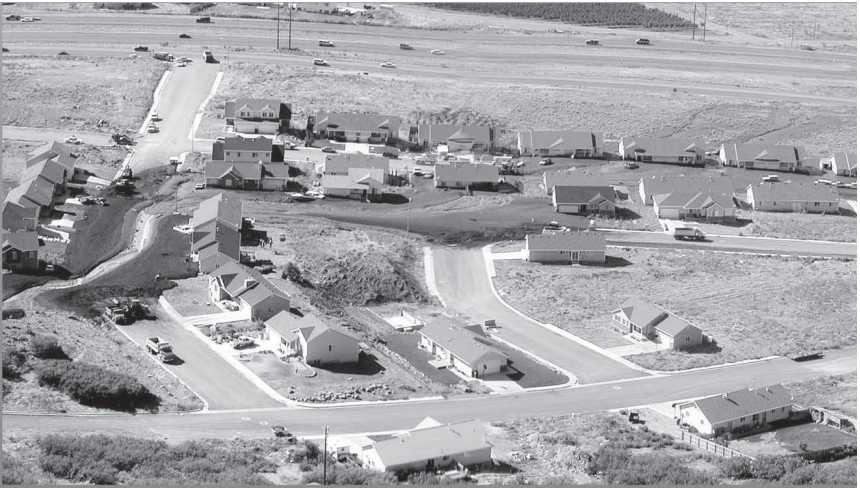
FIG. 6. Random sharp turn in an open-slope debris flow in Santaquin, Utah in 2002 (photo by Date Deiter, USFS, originally published in Giraud, 2005)

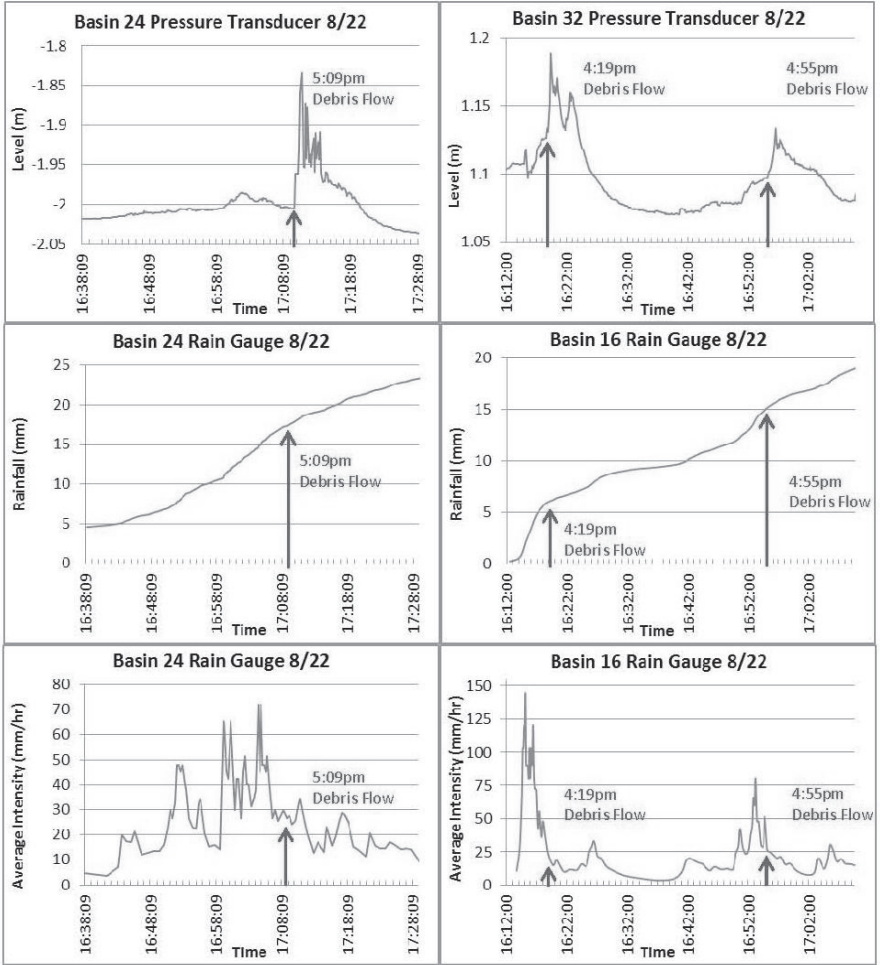
FIG. 7. Recordings of rain gauges and pressure transducers, at Medano Fire burn area, Great Sand Dunes National Park and Preserve, Colorado. Upper graphs show debris flow passage over in-channel pressure transducers. Middle graphs show cumulative rainfall and lower graphs show instantaneous rainfall intensity (Friedman, 2012)

The importance and magnitude of rainfall intensity spikes to initiate debris flows has been shown by McCoy et al. (2010), McCoy et al. (2011), Friedman and Santi (2011), and Friedman (2012), who used field instrumentation to record rainfall intensity and timing of debris flows. An example of these data is shown on Figure 7, where the time lag between rainfall intensity bursts and debris flow pulses is less than four minutes. Both Friedman (2012) and Kean et al. (in press) found that short periods of intense rainfall (typically 5-minute intensity) were responsible for debris-flow initiation. Similarly, Figure 2 shows the typical shorter and lower intensity threshold

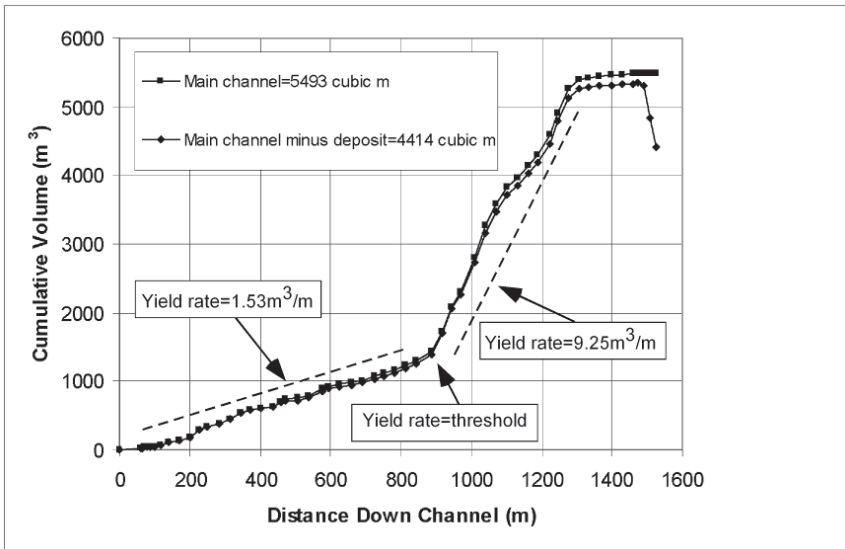
FIG. 8. Example graph showing cumulative debris-flow volume from Elkhorn Canyon near Durango, Colorado, following the 2002 Missionary Ridge Fire (Santi, 2008). Yield rate is calculated as the slope of the cumulative volume line

2003b; Berti and Simoni, 2005; Hungr et al., 2005; Stock and Dietrich, 2006). Figure 8 shows an example of the third mechanism, where incremental debris-flow volumes were measured by increments of channel erosion calculated from a series of channel cross-sections. In this example, the channel yield rate, measured in incremental added volume per unit channel length shows a dramatic increase partway down the channel. Santi et al. (2008) showed that these jumps in yield rate occurred in 87 percent of the 46 debris flows they measured, indicating that it is a very common phenomenon. They also noted that 52 percent of the flows had debris input from side channels that fed into the main channel, and that these side channels contributed an average of 23 percent of the total debris-flow volume. Therefore, about half of debris flows can be expected to have a branching source area and mitigation measures should take this into account.

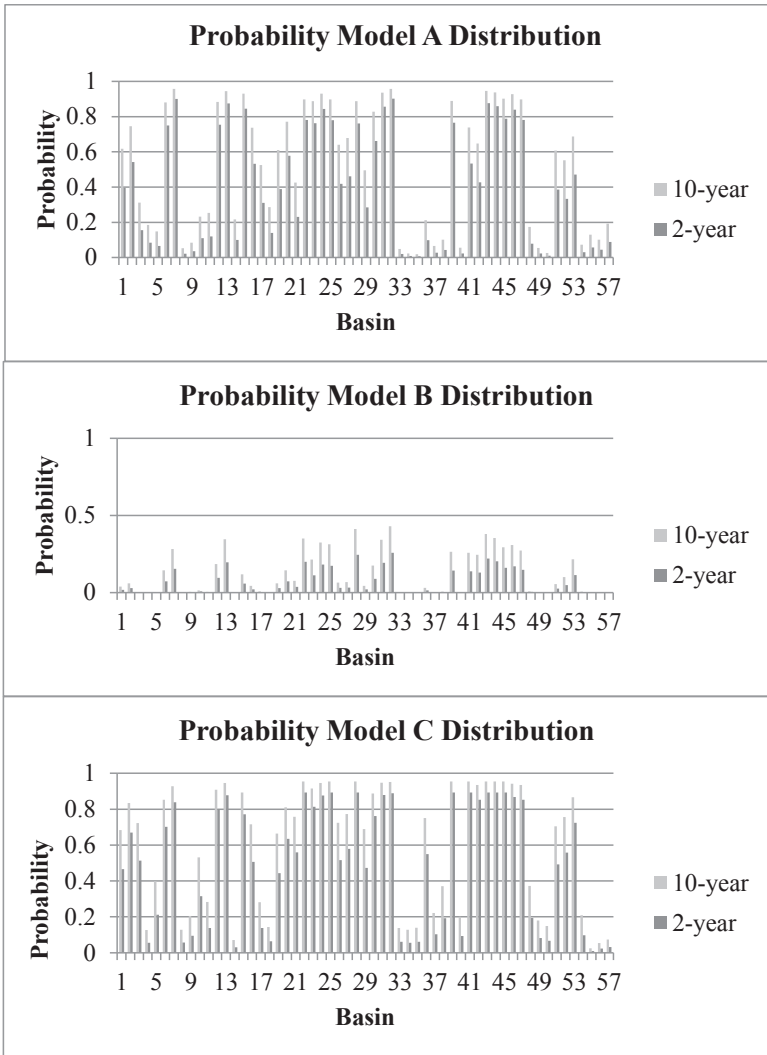
FIG. 2. Bar graphs showing distributions of probability values from models A, B, and C, respectively, for all basins in response to the 2-year and 10-year return interval storms

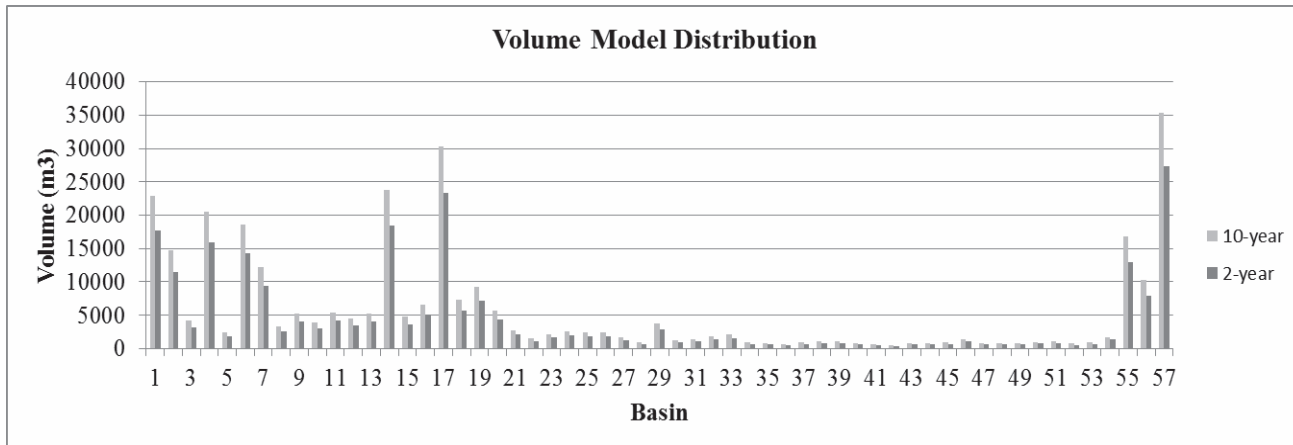
FIG. 3. Bar graph showing the distribution of values from the volume model for all basins in response to 1-hour, 2-year and 10-year return interval storms

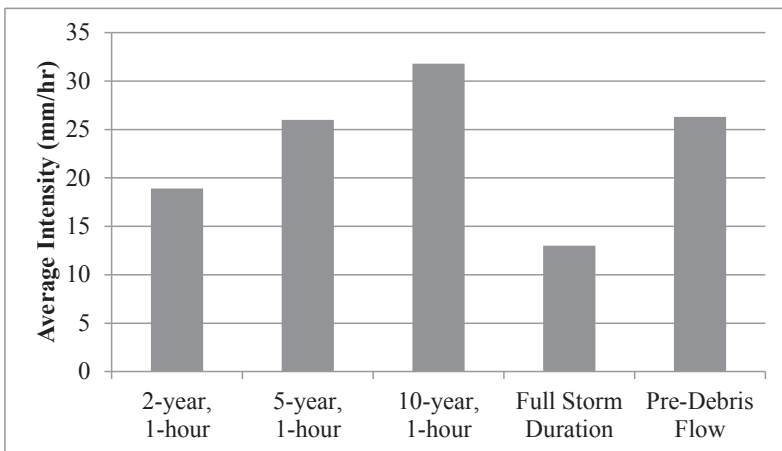
FIG. 7. Average intensity of rainfall for 1-hour, 2-year, 5-year, and 10-year design storms, and means of recorded average intensity values for storms that triggered debris flow

In order to validate the models, actual rainfall conditions that resulted in debris flow occurrence recorded at the site during the monitoring period are input into debris-flow probability and volume models and compared to the observed basin responses. The timing of debris-flow events on August 22, 2011 is known from pressure transducer records in basins 24 and 32, as is the rainfall intensity throughout the storm from rain gauges in basins 16 and 24 nearby. This enables calculation of average intensity values up to the time of debris-flow initiation in these basins, which were between 19.7 mm/hr to 54.8 mm/hr. The timing of debris flows during the August 28, 2011 event is unknown, but the average storm intensities recorded on rain gauges in close proximity to debris flows (gauges in basins 7 and 24) were 15.6 and 20.5 mm/hr, respectively. Since both of these storms delivered high intensity rainfall to extensive areas throughout the watershed, and true intensity values are not known for the majority of the burned basins, the calculated mean of the recorded intensity values (26.3 mm/hr) from the debris flow triggering storms described above is used for probability model validation. For comparison, the mean of average storm intensity values for the full duration of all rain events that triggered debris flows (13.0 mm/hr), recorded on rain gauges in close proximity (in basins 7, 16, and 24) to debris flows is also used for model validation. The large difference between these two mean values can be attributed to the fact that the full duration of the August 22 storm event was significantly greater than the duration of rainfall before the debris flows occurred. Figure 7 shows the relationship between the recorded values for these two measures of average intensity, and those of the 1-hour, 2-year, 5-year, and 10-year design storms.

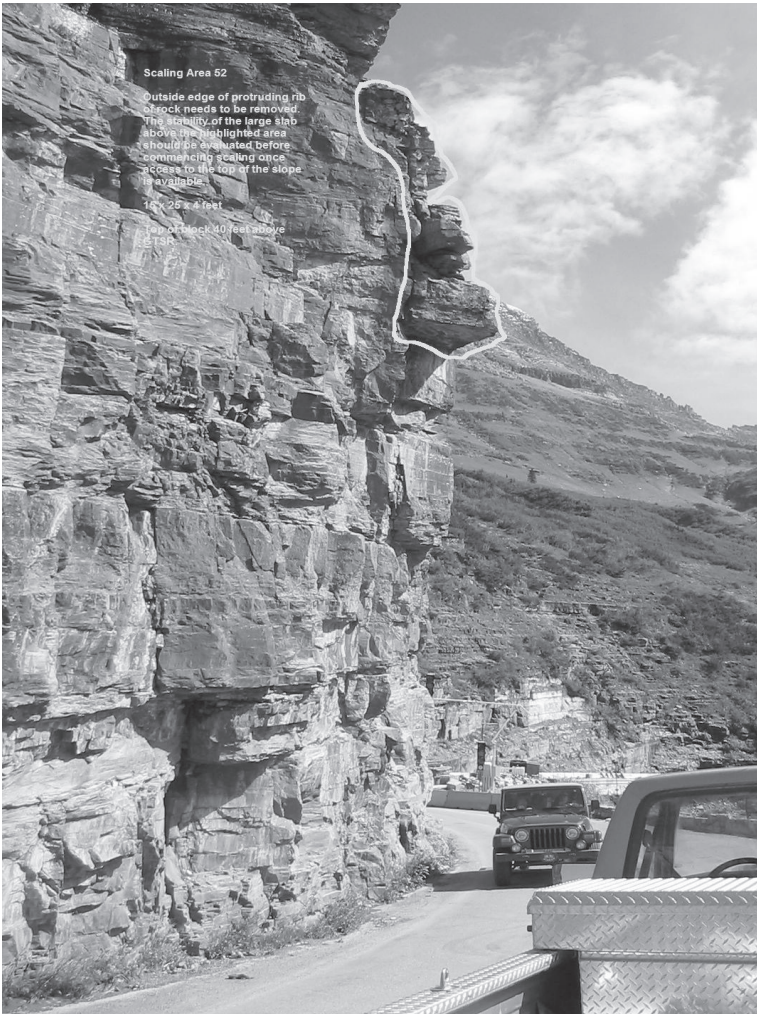
FIG 1. Rock slope at Glacier National Park where rockfall is expected to reach the travel lanes of the road (courtesy of Cornforth Consultants, Inc.)

It is not practical to prevent all rocks on slopes (cut or natural) from falling, to prevent all falling rocks from reaching highways, or to immediately remove fallen rocks from highways. Therefore, rocks will impact vehicles, either moving or stopped, and vehicles will impact rocks. Programmatically, a certain low level expectation of this must be tolerated. Furthermore, highways below cut or natural rock slopes will have rock removal and repair as a maintenance need. In other words, it is not a question of “if” rockfall will occur; it is a question of how much is acceptable, or tolerable. One can measure this in terms of hazard or risk. Hazard and risk definitions vary but generally *hazard* is a measure of the likelihood of rockfall occurrence; whereas, *risk* is a measure of likelihood and consequence of occurrence. Figure 1 shows an example where the consequence could be considered high.

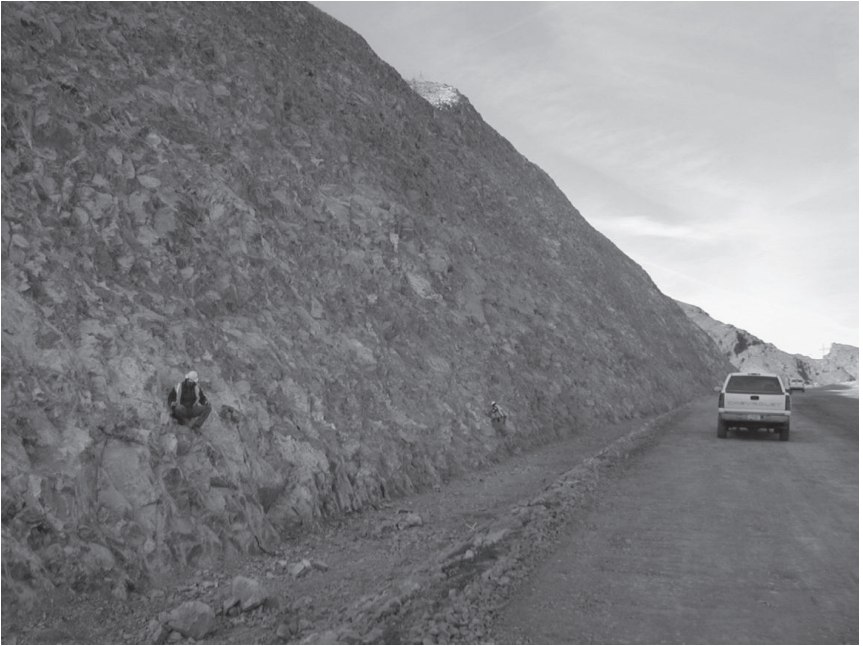
FIG 2. Hand-scaling of a cut after construction to reduce probability of failure (hazard)

Figure 2 shows an example where steps are taken to reduce probability of failure. Figure 3 shows (a) a case where the ditch and run out area is far from the road, and (b) where a barrier is used on the same road to contain rockfall in the ditch. In both cases, the consequence of failure is reduced. With these definitions in mind, the common tools for analysis are described below and reference is made to how they contribute to understanding risk.

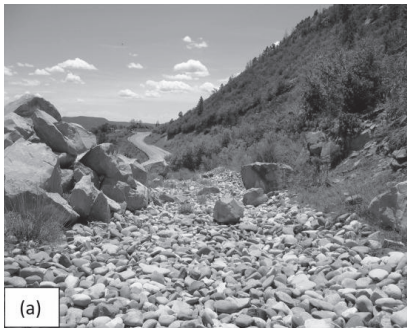
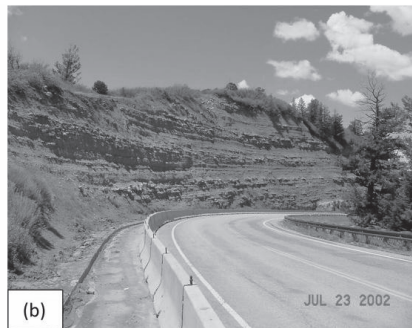
FIG 3. Examples at Mesa Verde National Park where ditch effectiveness and distance from travel lanes effectively confines rockfall to the fallout area, reducing the consequence of failure

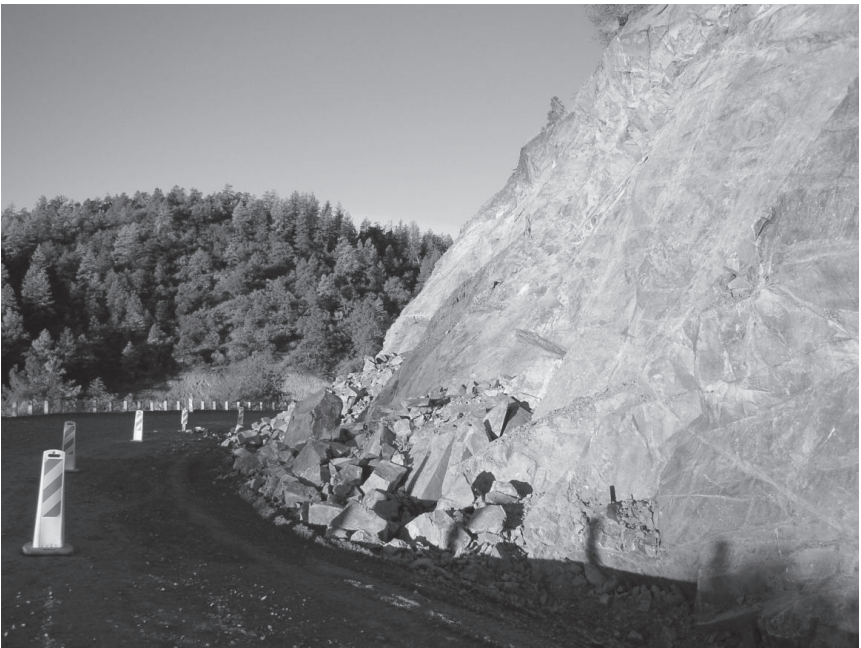
FIG 4. New slope created by widening and straightening to increase roadway capacity and traffic safety

There are two types of “new” slopes often encountered. One is a significant widening or improvement of a cut that currently exists (Figure 4). This often results in an increase in cut size and height. The second type is a new alignment where no current exposure of the rock exists. In either of these cases the design could be developed to result in a level of risk that is set by the owner. The risk could be set to be equivalent to an average level of risk for a corridor or road system or, for example, it could be set to a lower level so that in time the risk posed by rock slopes system-wide would drop. If the risk assessment is quantitative, the risk could also be set with reference to other risks assumed by the owner. This approach is consistent with steps being taken in other parts of highway design where owners are balancing their investments in a corridor to lower risk for the whole corridor, not just for certain elements (e.g., improvements to safety geometrics).

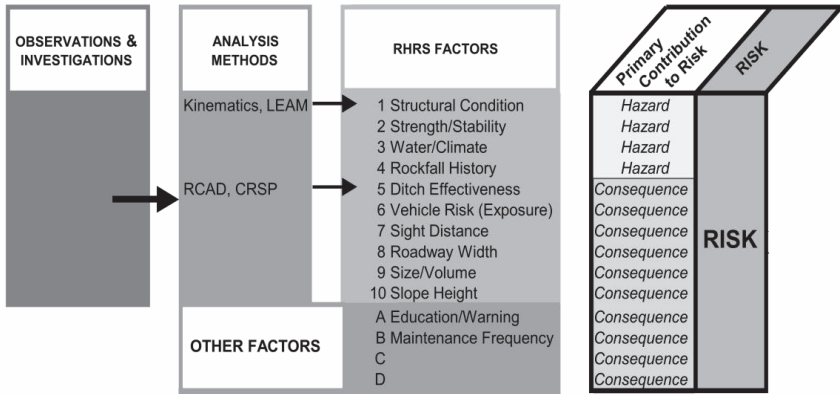
FIG 5. The evaluation of risk through observations, analysis rating system and other factors

In this example, B and C are conditional probabilities and the probability that rockfall and vehicle collide is the product, $A \times B \times C$. From this it is clear that if the ditch was essentially 100 percent effective the risk of a rockfall – vehicle collision is effectively zero. This challenge is most notable for the ditch effectiveness factor but one can envision its impact on other factors as well. Ideally, this challenge would be dealt with by converting the RHRS to a system based on multiplication of factors from one based on summation. Until that can happen it is suggested here that other criteria be used in addition to a RHRS rating to evaluate suitability of a rock slope design. For example, the owner might specify that regardless of the calculated RHRS rating for the slope in design, a certain percent retention from the maximum slope height is required.

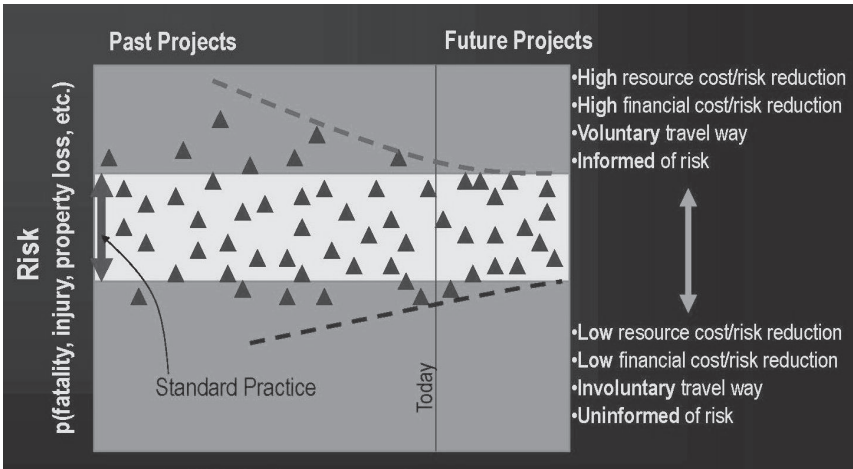
FIG 6. The evolution of a band of standard practice

An established range of practice would be useful for owners and responsible professionals engaged with the owners in setting expectations. Establishing the current range of practice, as well as future targets for slope performance, allows owning agencies to manage internal expectations as well, identifying when competing mission priorities fall within or outside accepted performance levels. The proposed risk-based approach to designing new slopes or mitigating old ones would provide a framework for setting a standard for a particular route or region and in evaluating alternative designs, such as ditch width versus scaling or mesh installation in a rational way. Having a standard for a given project will help the appropriate allocation of resources targeted at route-appropriate performance objectives and avoid “worst-first” management of existing slopes and over-/under-design of new or rehabilitated slopes.

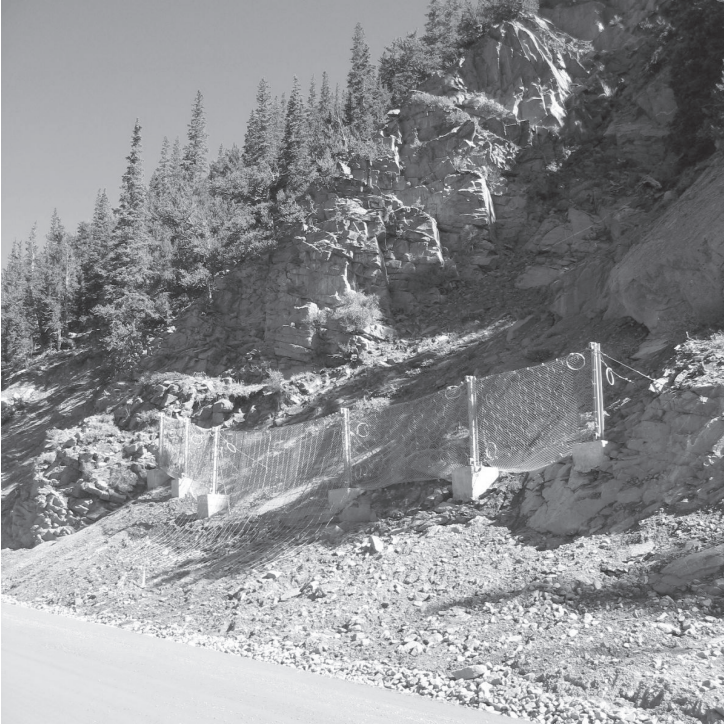
FIG 7. A rockfall fence installed on Guanella Pass Road

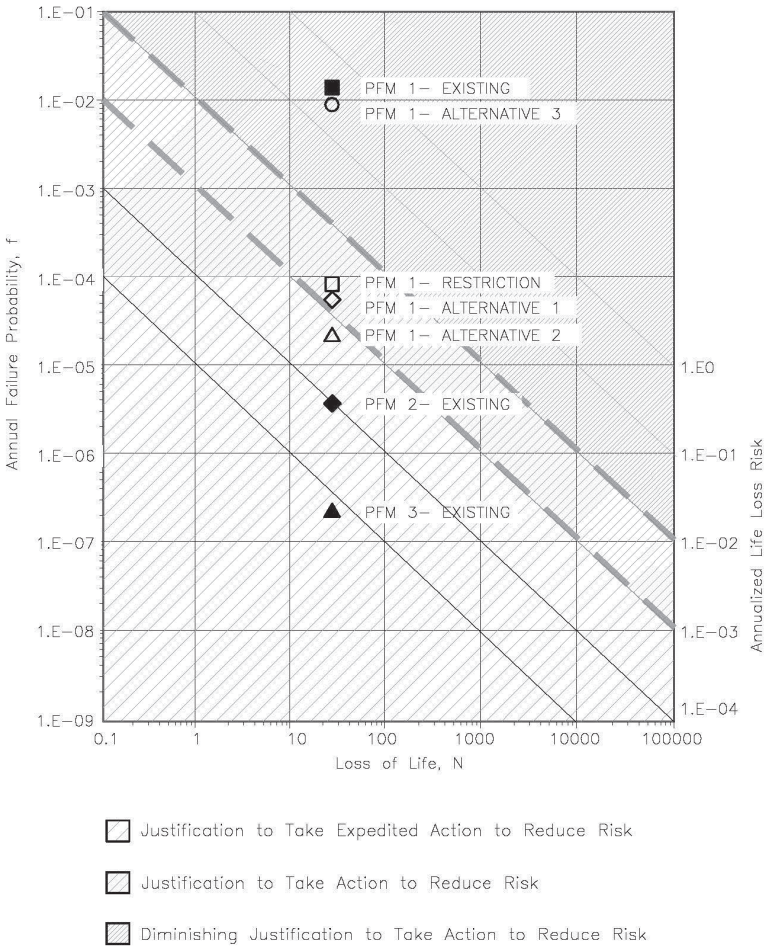
FIG. 6. f - N Plot of Results

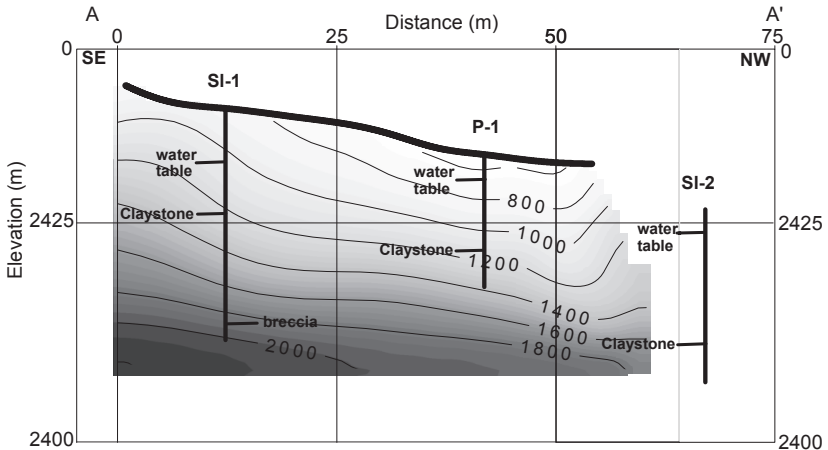
Figure 4. Seismic profile along borehole section A-A' (contour interval equals 200 meters/second, 656 feet/second)

Although it is just one example, the seismic profile extracted from the 3D volume presented on Figure 4 indicates the seismic results correlate well with the depth of the slip plane, as defined by geotechnical data from the two slope indicator (SI) borings. Depth to the slip plane derived from the SI borings (shown on the profile A-A') is about 17.7 m (58') below ground surface. This depth is also coincident with the claystone layer encountered in each boring. It is not clear if the sliding soil mass moved along the top of the soil / claystone interface, or if the materials in the soil sliding mass are also composed of claystone. Several examples of intact claystone blocks can be observed on the landslide as prominent rock-like outcrops with internal sedimentary structure, but very little or no lateral uniformity; therefore, they are considered remnant intact bedrock blocks within the materials translated downslope.

The P-wave velocities obtained in the landslide mass range from very slow (275 m/s – 900 ft/s) to just less than 1220 m/s (4000 ft/s). This range is typical for unconsolidated, non-indurated soils; also, soils which are unsaturated. Although there is considerable P-wave velocity variation laterally and vertically within the landslide mass the velocities, in general, increase gradually with depth to the slip plane. The overall gradual increase can likely be attributed to overburden pressure. 3D velocity variations are very difficult to present using a single 2D profile (Figure 2).

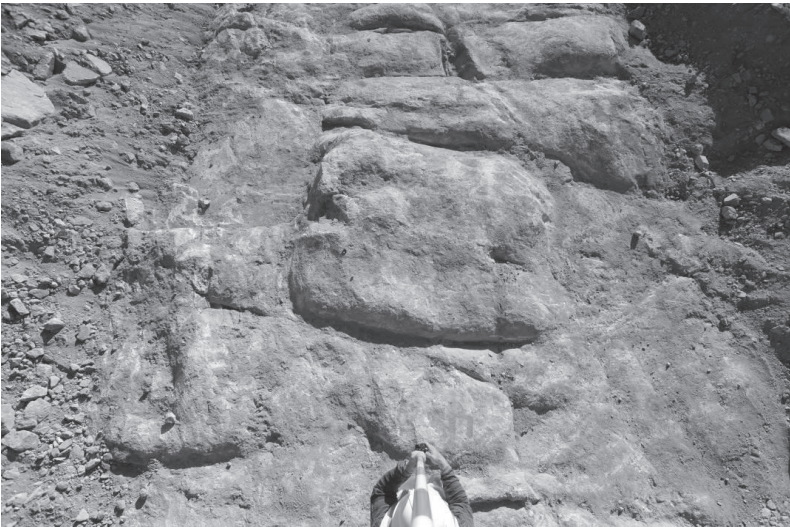
FIG. 1. Photogrammetric image being taken along the spillway foundation

Once geologic mapping on conventional photographs was completed, equipment was set up to capture photogrammetric images of the foundation. An “off-the-shelf” Nikon D700 camera was mounted atop a 12-foot-long survey staff, used in conjunction with a wireless shutter trigger system for collection of field digital images. Photographs were taken along the centerline of the foundation alignment at 5-foot intervals as shown in Figure 1.

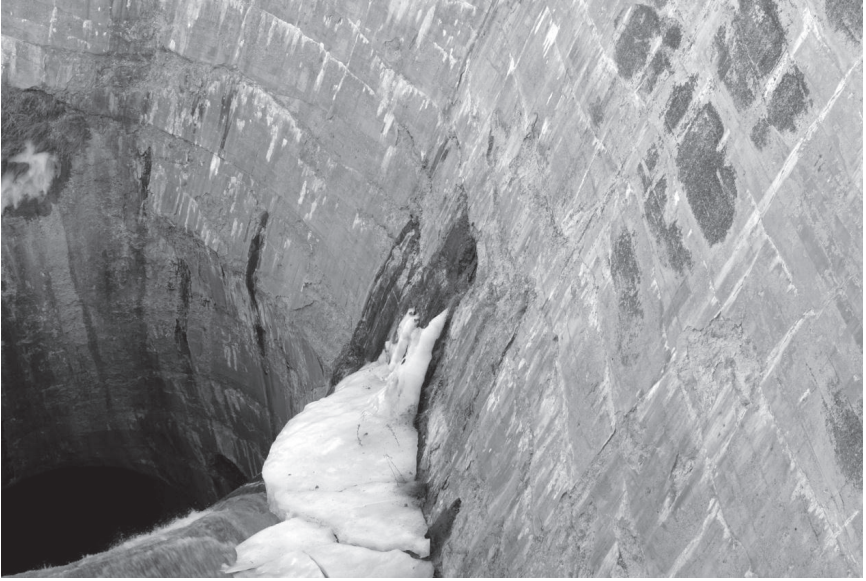
FIG. 2. Freeze thaw damage at the intake

The concrete around the intake structure and in the upstream half of the tunnel has deteriorated over the past 50 years. The concrete spalling is attributed to many years of freeze thaw damage (**Figure 2**). The amount of concrete deterioration and the existing conditions of the concrete are important design and cost considerations for the south spillway modifications.

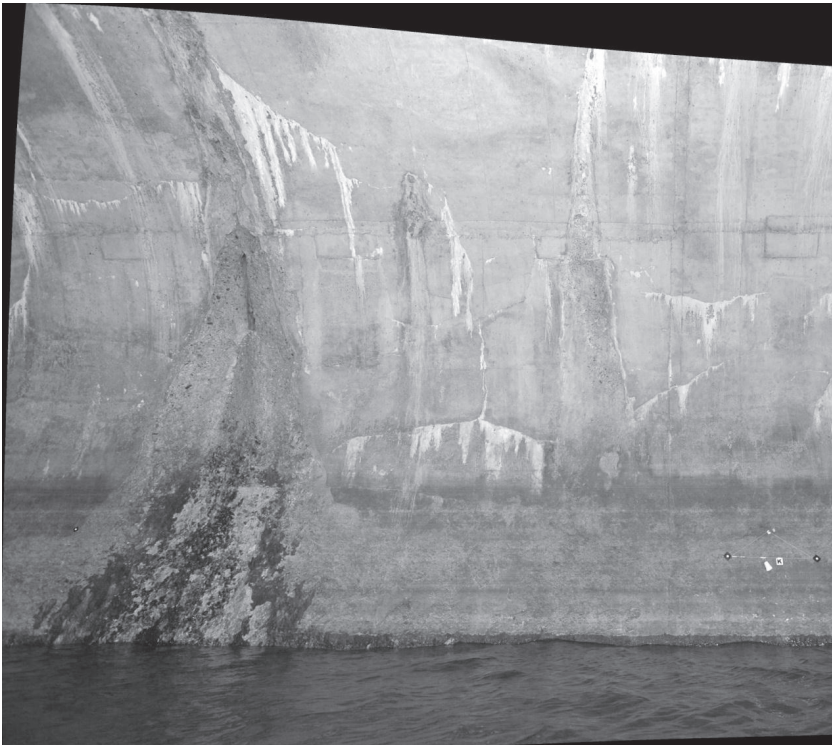
FIG. 3. Epipolar image of tunnel wall with scale bar on the right (above)

Scale bars were needed along the tunnel walls to provide a metric (**Figure 3**). The spillway intake required scale bars and three constant elevation targets on the back wall opposite the spillway gates (**Figure 4 and 5**). Typically, scale bars are provided for every 5th or 6th photograph (every 20 meters along each tunnel wall). However, the wet tunnel walls and boat access limitation made it difficult to attach the scale bars. The boat was not a stable platform for drilling anchors for the targets, and the wet walls prevented the use of glue to mount the scale bars. The scale bars were attached to metal washers by strong magnets. The metal washers were set in place using a ramset to shoot concrete nails into the tunnel lining 1 meter (a few feet) above the waterline.

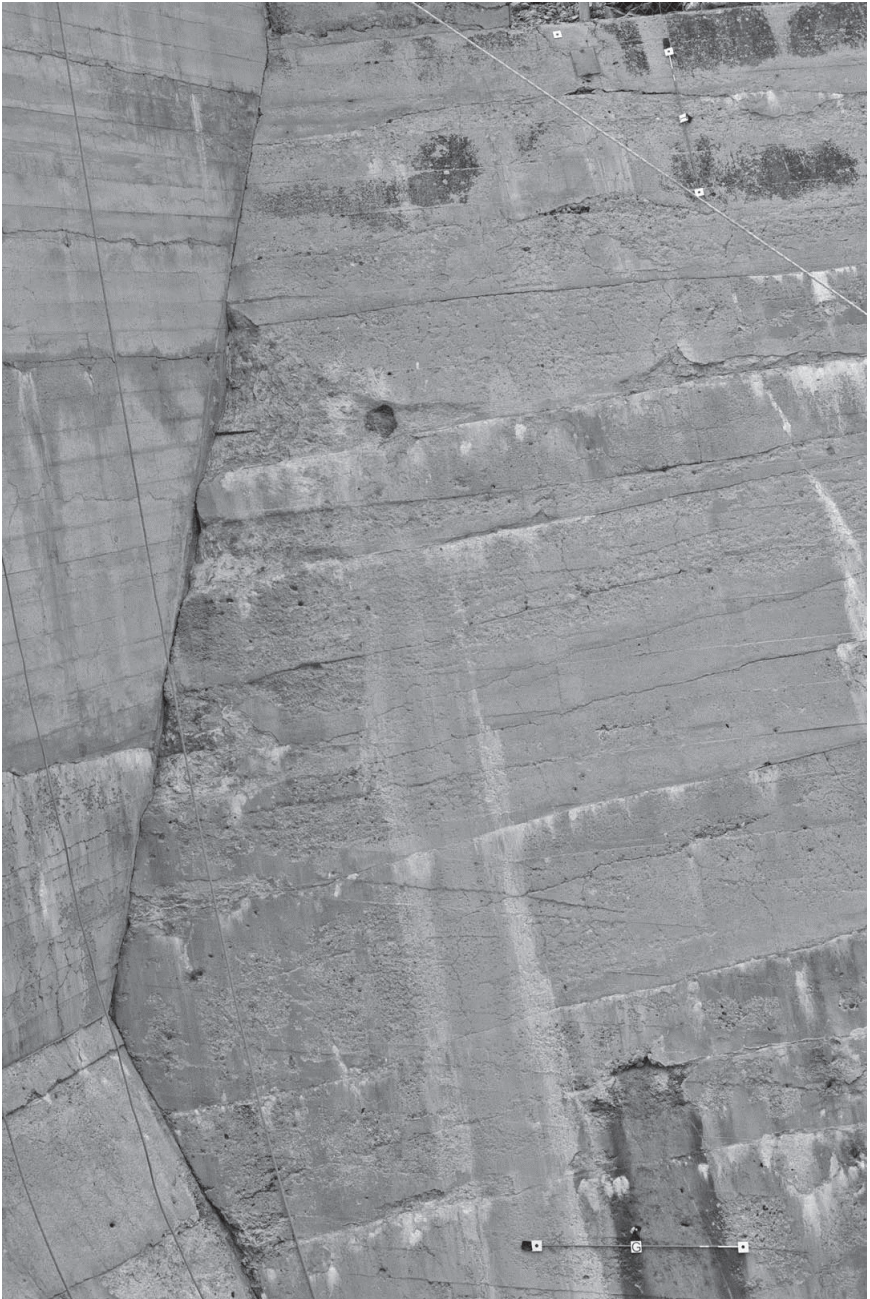
FIG. 4. Scale bars on the intake back wall (right)

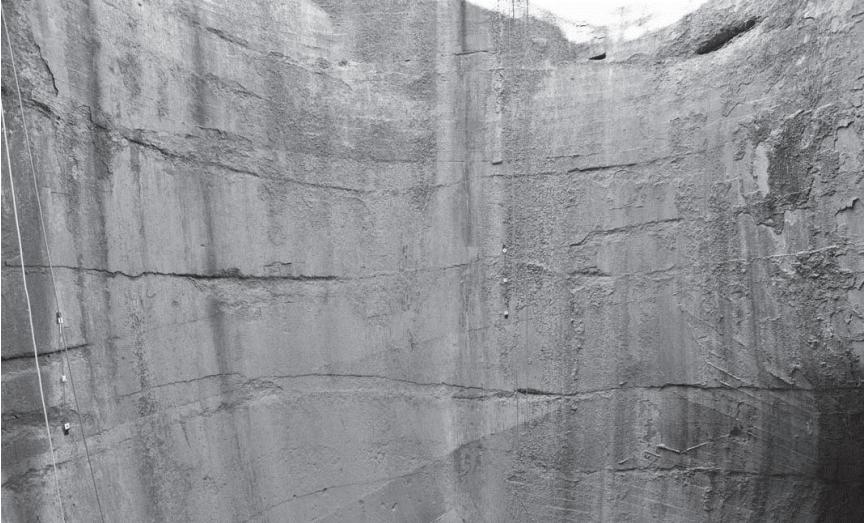
FIG. 5. Scale bars in the shaft (below)

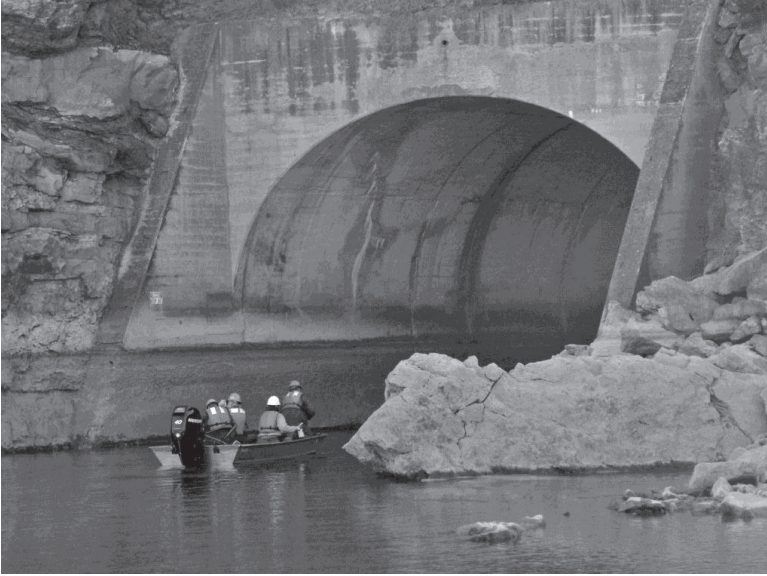
FIG. 6. Boat access at the downstream portal

The tunnel access was limited to a small boat (**Figure 6**) by the tail water condition. The water depth in the tunnel was between 1.5 and 3 meters. The tunnel size and limited boat access precluded reaching the crown to mount scale bars.

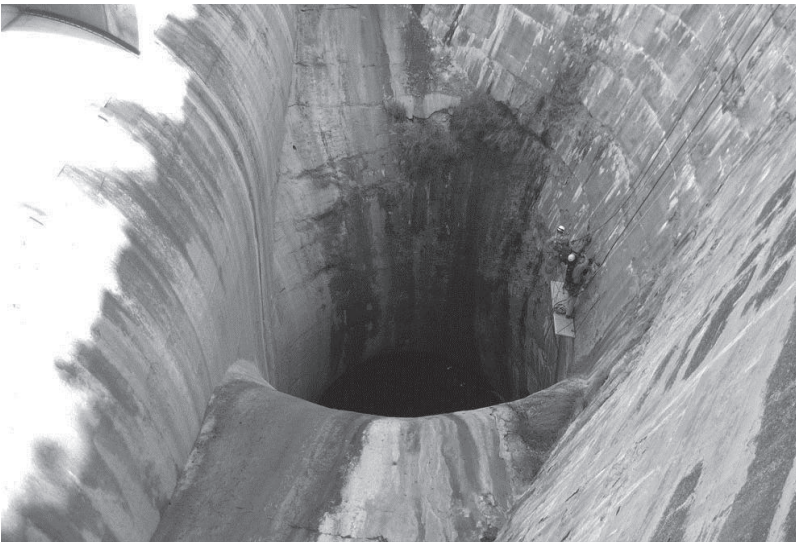
FIG. 7. Rope access work in the intake

The limited access at the intake and the vertical shaft required the photographer to be trained in rope access techniques (**Figure 7**). The support of a three-member rope access team was needed to safely take the photos in the shaft and around the intake.

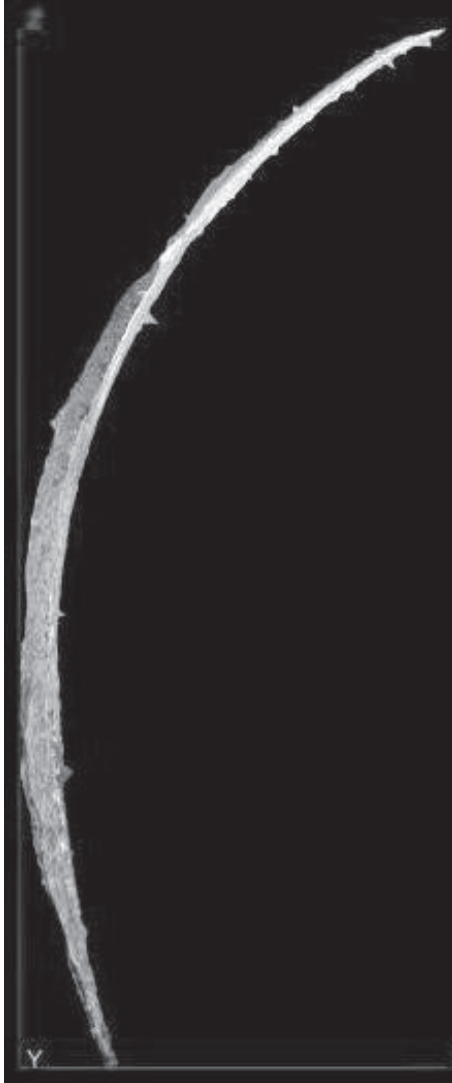
FIG. 11. 3D view of textured DTM looking down the tunnel axis (left)

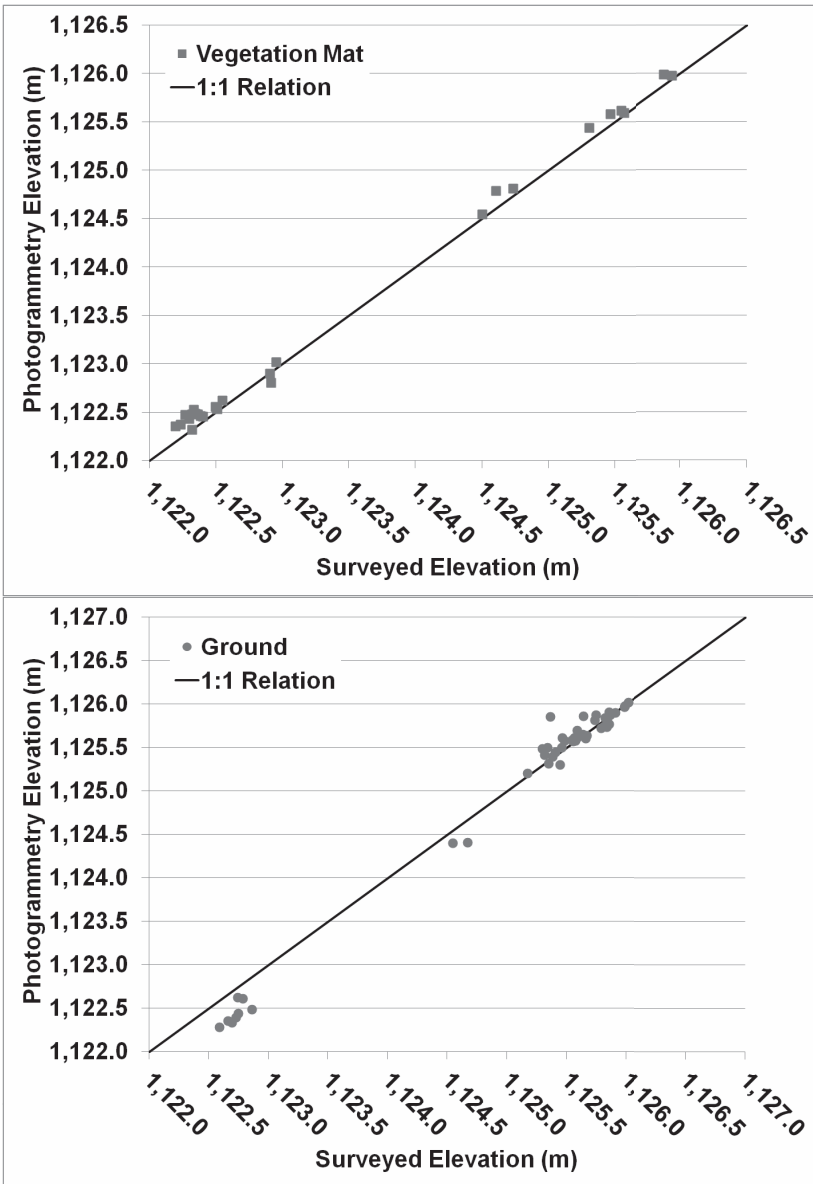
FIG. 8. Comparison of different ground cover survey points and DTM elevations

Photogrammetry produces a very dense set of DTM points (see Figure 4). Figure 8 shows the comparison of the closest surveyed values from each of the ground truth types to the DTM points. To determine if any of the points in the vegetated areas were able to “see” through the vegetation and pick up ground elevations, the minimum elevation was selected from DTM points that were within 0.15 meters (0.5 ft) of the vegetation points. The vegetation plot includes the minimum and closest elevation values. The minimum elevations are still biased higher than the surveyed elevations. Although the minimum elevation does improve the relationship slightly, it is not adequately capturing the ground elevation. Therefore, the DTM points in vegetated areas should not be utilized in other analyses. This should be reevaluated at a different site where the vegetation may be less dense than what was seen on the Beaver to Ragged project. For the wood, vegetation mats, and bare ground DTM points, the average elevation difference (absolute value) is 0.16, 0.09, and 0.12 meters (0.54, 0.30 and 0.38 ft), respectively.

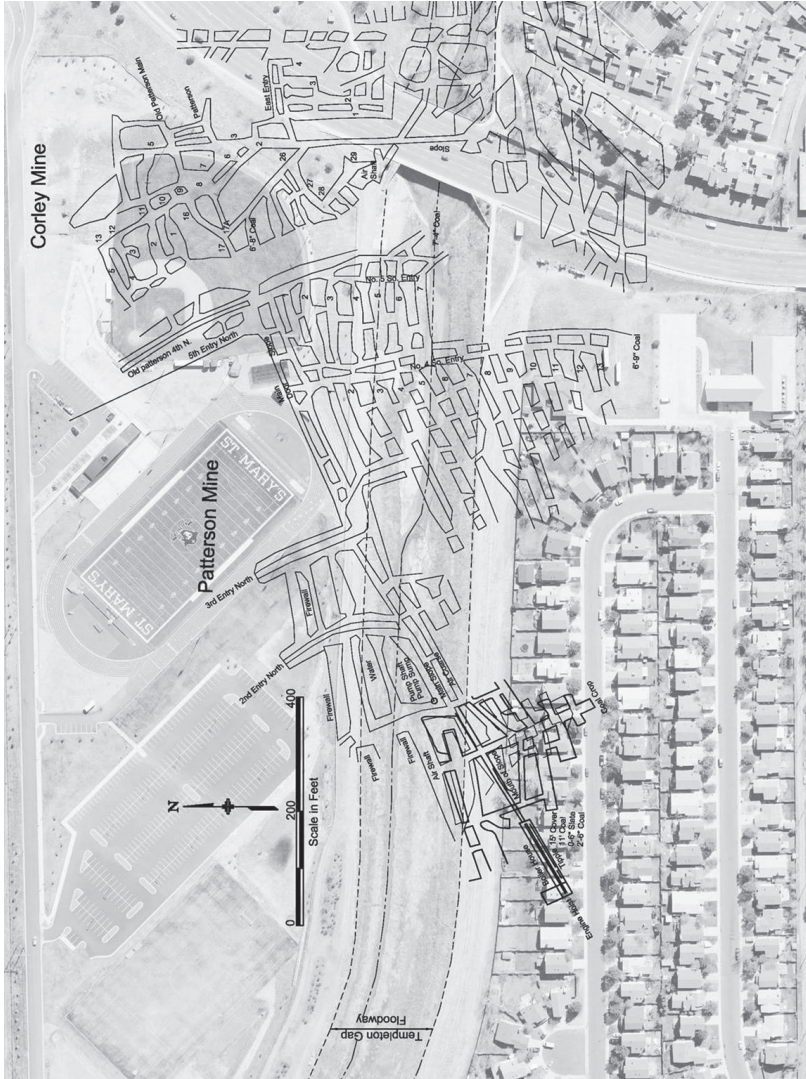
FIG 2. Mine Locations with Respect to the TGL (ZAPATA, 2010)

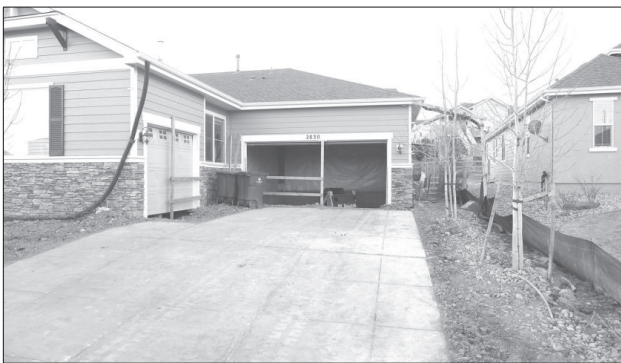
FIG. 2. Vista Ridge, Erie, Colorado. Bobcat excavating under garage slab

Vista Ridge is a relatively new subdivision in the Laramie Formation in the town of Erie, north of State Highway 7. Some of the residential damage due to the swelling soils has been so severe that extensive remedial work has been required. Figure 2 below shows a Bobcat excavating beneath the garage floor slab inside a residence. Several other residences in the immediate area were also receiving similar extensive remedial work. Figure 3 shows the excavation of claystones around the foundation of another house. We have no details on the original construction or mitigation designs. However, the extensive remedial work clearly illustrates the impacts of the swelling properties of the Laramie claystones.

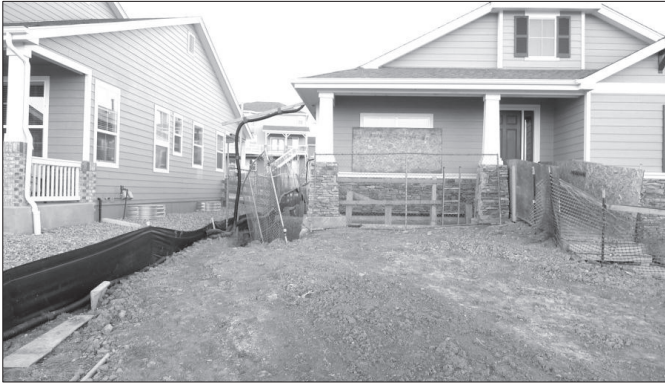
FIG. 3. Vista Ridge, Erie, Colorado. Excavating around house foundation (note the ladder)

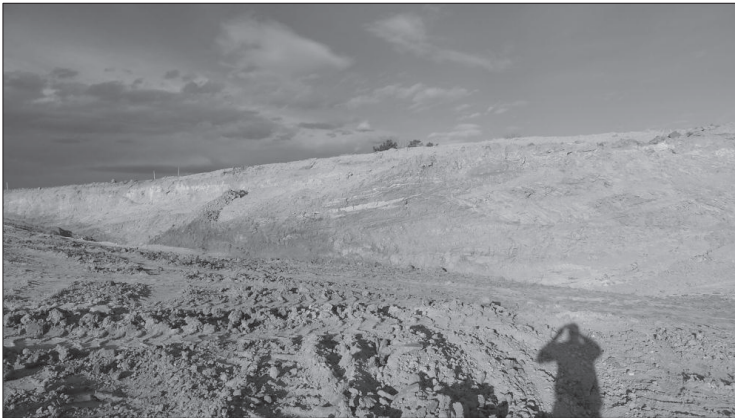
FIG. 4. Silverleaf Subdivision next to the Wildgrass Subdivision, Broomfield, Colorado. Deep excavation of Laramie claystones with sandstone beds and lenses

Builders in another nearby residential development in the city of Broomfield have taken a different approach to residential construction on the Laramie bedrock. Rather than relying on a structural system or design to mitigate the effects of the swelling bedrock, this approach seeks to modify the bedrock behavior. In the Wildgrass and Silverleaf Subdivisions, the entire development area for each lot is being excavated to depths of approximately 6 meters (20 feet). The excavated bedrock is then moisture conditioned to near optimum Proctor moisture content and recompacted on-site. Figure 4 shows the extent of bedrock excavation on one of the sites and the bedrock strata excavated.

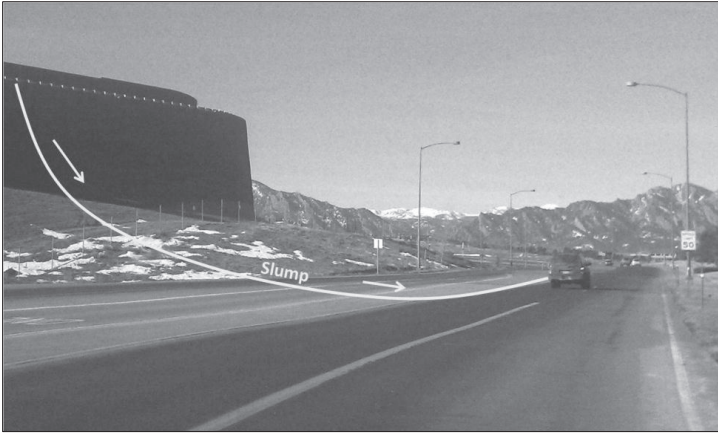
FIG. 5. Rocky Mountain Metropolitan Airport landslide

Figure 5 shows a landslide that occurred in 2011 on a relatively gentle claystone slope above Colorado Highway 128 at Interlocken in Broomfield. The top of the slope was surcharge loaded with a very high reinforced earth (MSE) retaining wall

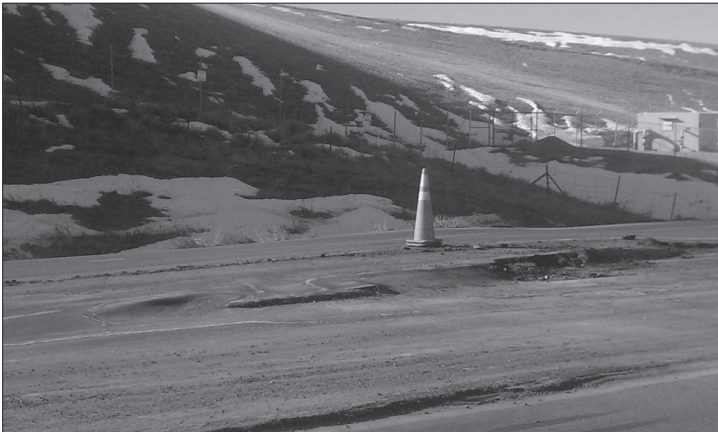
FIG. 6. Toe of Rocky Mountain Airport landslide in State Highway 128

constructed by the FAA to allow extension of the runway at the Rocky Mountain Metropolitan Airport. Under the added load, the slope failed with the toe of the landslide bulging the highway pavement upward as shown on Figure 6. While we are not aware of the design strength parameters used for this project, it is our opinion that the fully softened condition was probably present in the slope bedrock at the time of failure.

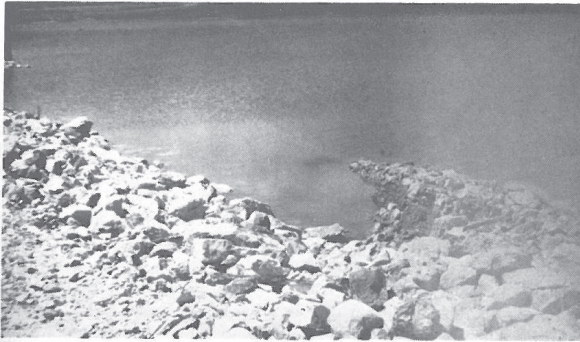
FIG. 7. Great Western Dam slope failure extending to upstream slope

characterized as a deep downstream slide (Sherard, et al., 1963). The landslide included the entire dam crest extending to the upstream slope. The slide parted the low level outlet conduit eliminating the ability to draw down the reservoir with the gravity outlet works. Figure 7 shows the slope failure on the dam. The dam was eventually stabilized with a downstream berm and the water level was safely lowered using a siphon. Analysis of the dam embankment in the 1990s using Laramie claystone residual strengths indicated that the embankment was still only marginally stable and an additional berm was added in 1995 to enhance the stability.
