GEOTECHNICAL PRACTICE PUBLICATION NO. 7

GEOCHALLENGES

RISING TO THE GEOTECHNICAL CHALLENGES OF COLORADO

PROCEEDINGS OF THE 2012 BIENNIAL GEOTECHNICAL SEMINAR

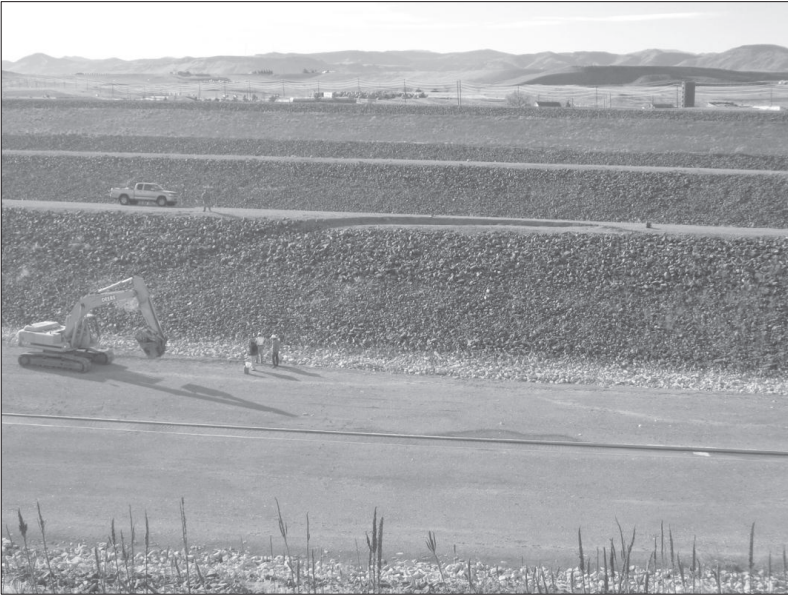
FIG. 9. Laramie claystone landslide on internal dike

In the late fall of 2011, a large slump occurred in one of the internal dikes. The location of the failure is shown on Figure 8. At the location of the failure, most of the separation dike consists mainly of undisturbed Laramie claystones. Figure 9 shows the landslide.

The original stability analysis for the design used an effective friction angle of 21 degrees and an effective cohesion of 123 kg/m^2 (600 psf). Back calculation of the failed slope with the factor of safety set equal to 1, using the groundwater conditions from a nearby monitoring well, gave an effective friction angle of 21 degrees with an effective cohesion equal to zero.

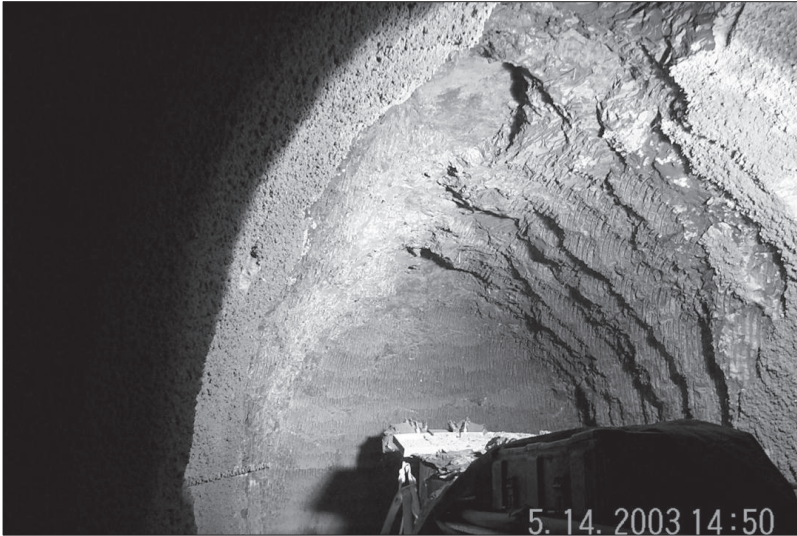
FIG. 10. Standley Lake Tunnel (note slickenside and overbreak of claystone in crown)

Figure 10 shows the bare claystones with a slickenside and overbreak in the crown over the roadheader.

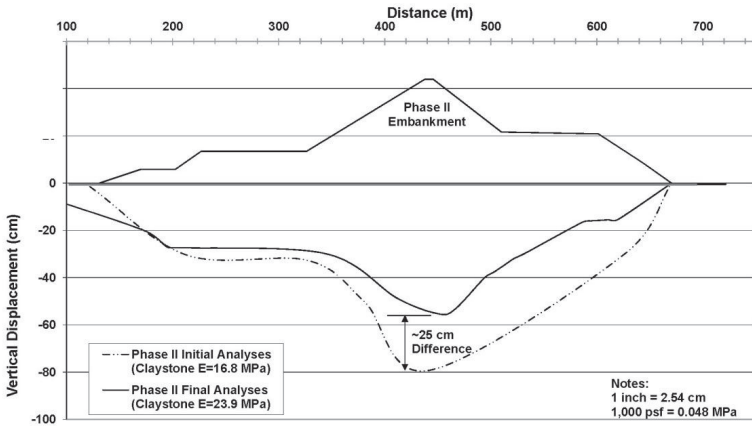
Final deformation analyses were completed using the adjusted elastic modulus of 23.9 MPa (5.0×10^5 lb/ft²) to support design of the Phase II dam and outlet works conduit, and to confirm the adequacy of the outlet works components constructed during Phase I. The computed maximum deformations for the Phase II dam below the maximum section of the embankment and along the outlet works conduit for both the initial analyses and the final analyses are presented on Figures 9 and 10, respectively.

FIG 9. Predicted Phase II Embankment Deformation

The revised deformations in the bedrock for the Phase II dam, using the calibrated elastic modulus values, are generally about 25 percent less than originally predicted. The predicted deformations were used to: a) compute the forces in the conduit to confirm that the previously constructed components were adequate for the applied loads, b) to design the additional Phase II components of the outlet works, and c) to design the Phase II embankment camber.

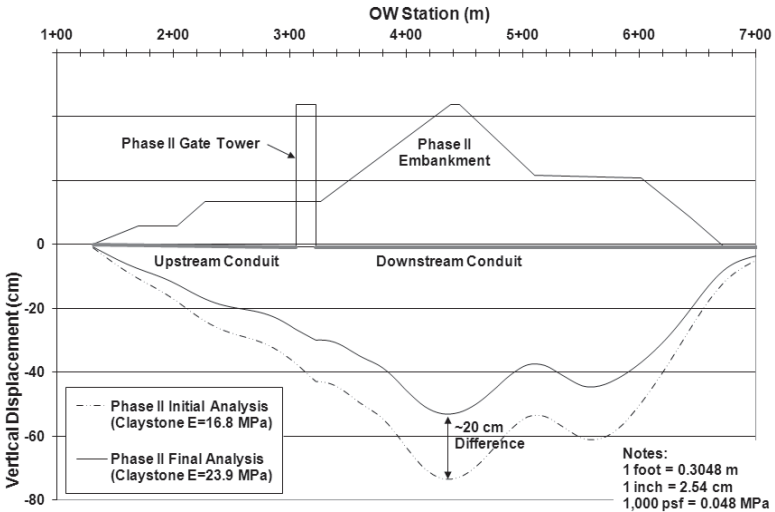
FIG 10. Predicted Phase II Outlet Works Conduit Deformation

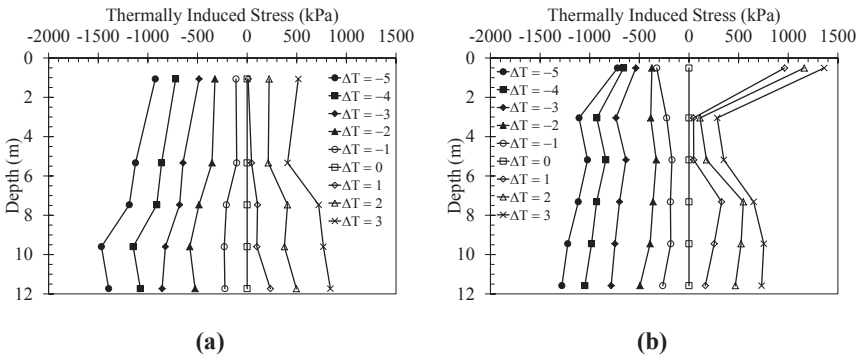
where E is the Young's modulus of reinforced concrete which is assumed to be 30 MPa (4.35 ksi), ε_T is the measured thermal strain after correction, and $\alpha_c \Delta T$ is the free expansion strain of the reinforced concrete. The thermal stress profiles calculated from the data in Figure 9 are shown in Figures 11(a) and 11(b) for Foundations A and B, respectively. The locations of the smallest strain in the energy foundation correspond to the locations of the maximum thermal stress. Compressive (positive) thermal stresses occur during heating when the axial expansion of the foundation is restrained by the overlying building, underlying bedrock, or the side shear resistance of the soil surrounding the foundation. With the exception of the high thermal stresses noted at the top of Foundation B during heating, which are likely due to the higher ambient temperature at this time, the stress profiles indicate that the highest stresses are at the bottoms of both foundations. The decrease in compressive stress with height is due to resistance from side shear stresses during thermal contraction or expansion. It is also possible that the smaller stresses noted in Foundation B between depths of 2 and 6 meters may have occurred due to residual stresses encountered during cooling of the foundation, which deserves further study.

FIG. 11. Thermal axial stress profiles: (a) Foundation A; (b) Foundation B

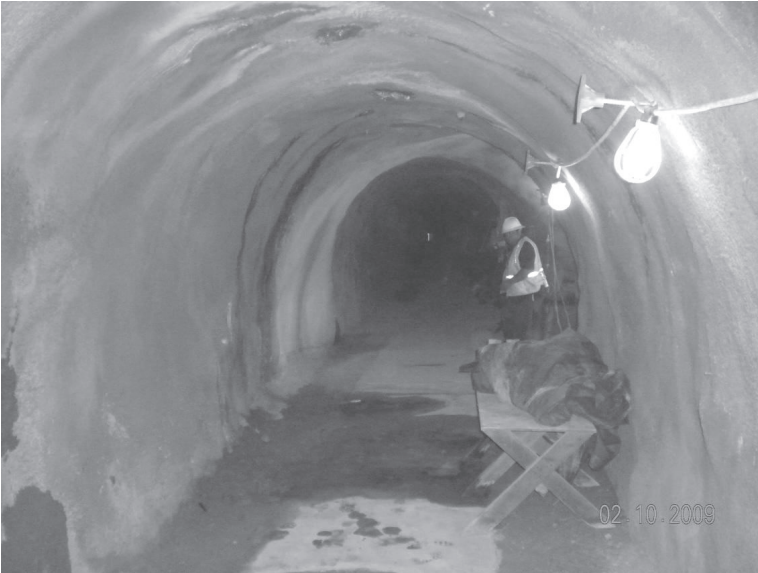
FIG. 4. Completed Emergency Tunnel Repair

A photograph of the completed emergency repair is given in Figure 4.
