**Structural appraisal
of iron-framed textile
mills**

ICE design and practice guides

Tom Swailes and Joe Marsh

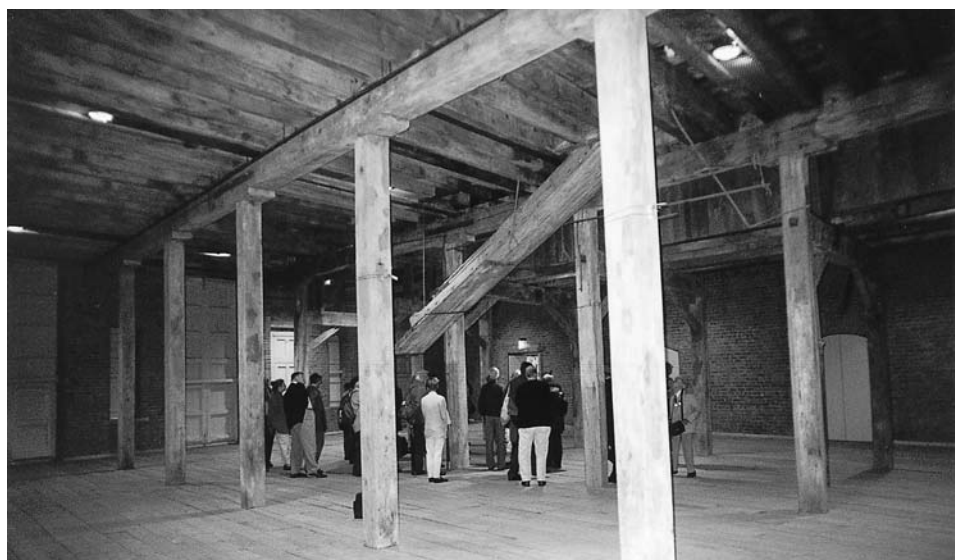
Figure 2.1 Liverpool Road Railway Station warehouse, Manchester. Built in 1830 and now a grade I listed building.

Prior to the industrial revolution, most manufacturing took place either in the home or out in the open. Almost the only large scale industrial buildings were storage warehouses, maltings and breweries. Brick or stone load-bearing walls supported timber floors with intermediate timber stanchions supporting the floor joists in the wider buildings. Warehouses could be subject to very high floor loads and timbers of up to 18-in. square section were not uncommon (Figure 2.1).

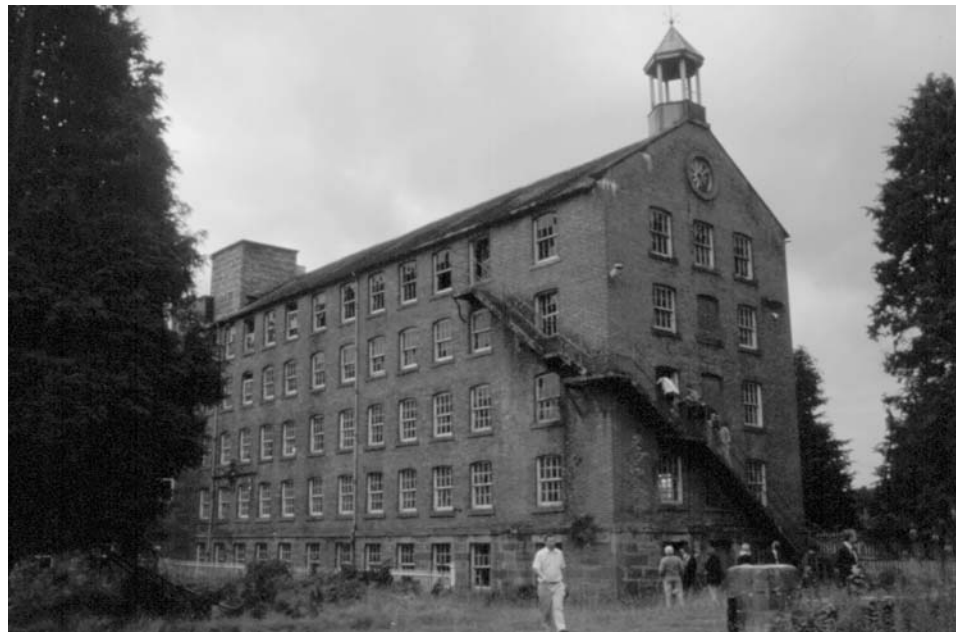
Figure 2.2 Bell Mill, Stanley, near Perth. Built c. 1787, a brick-built mill that exemplifies the long narrow floor plan of early Arkwright-type mills.

The central development during the industrial revolution was that of the factory system. The invention of spinning machinery led to the movement of the textile industry out of the home into mass production factories that became known as textile mills (Figures 2.2 and 2.3). In the early multi-storey spinning mills, power generated by a waterwheel was distributed to large numbers of relatively lightweight machines (Figure 2.4, [26]). Mechanization of the several stages in the conversion of the raw material to yarn came early but efficient machines for weaving the yarn came much later, in the 1820s. The classic handweaver's cottage had a third storey lit by long windows but sometimes weaving would be carried out under supervision in purpose-built loomshops on several floors. The later heavy power looms were often housed in separate single-storey weaving sheds lit via roof glazing.

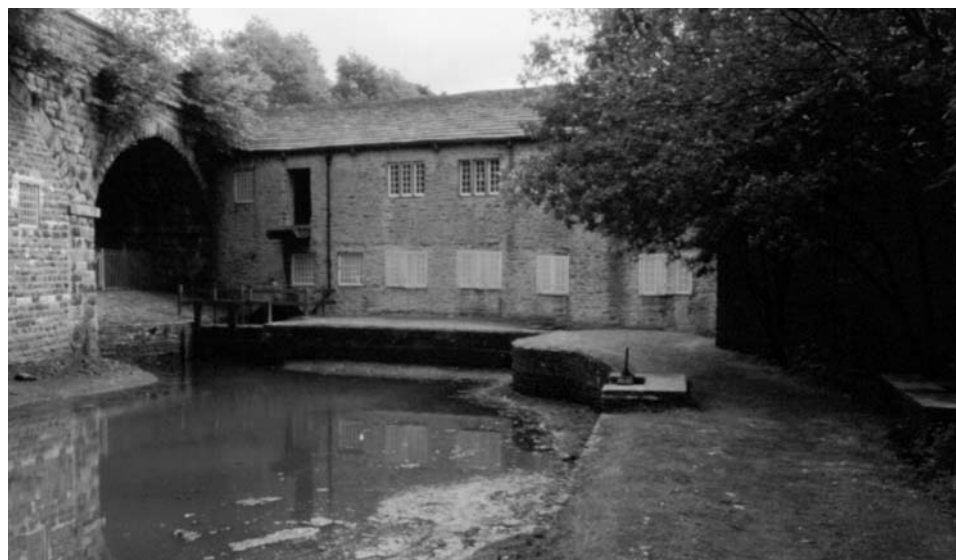
Figure 2.3 Higher Mill, Helmshore. Although built in 1790, the stone exterior, small windows and low rise of this mill are typical of pre industrial revolution water-powered mills.

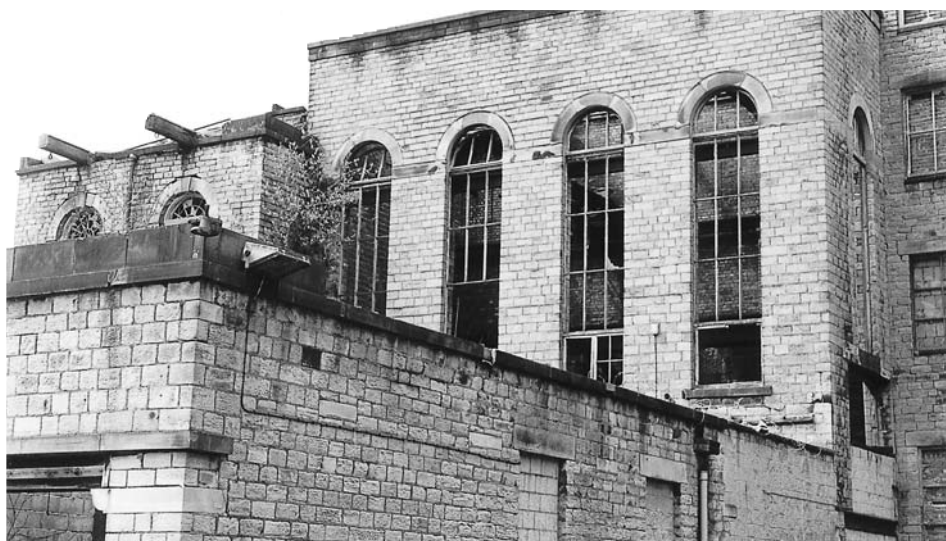
Figure 2.8 Wren's Nest Mill, Glossop. Development of the site began in 1815 or earlier and the first steam engine was installed in 1829.

engines that provided their power. Tall, semicircular arch-headed windows, rising through two storeys, provide external evidence of an early engine house (Figure 2.8). Cast-iron and brick floors, in an otherwise timber-framed mill, are further evidence of the use of early steam engines.

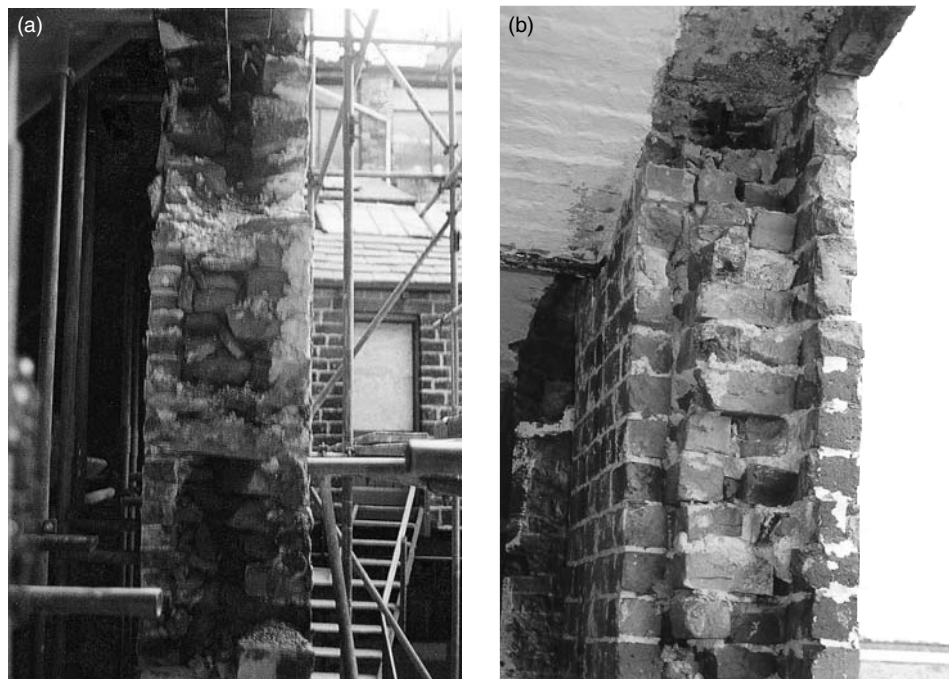
Figure 2.10 (a) Stone wall section, built c. 1791. Greenup's Worsted Mill, Sowerby Bridge Mills, is five storeys high with internal timber framing. (b) Brick wall section. (Stuart Millns)

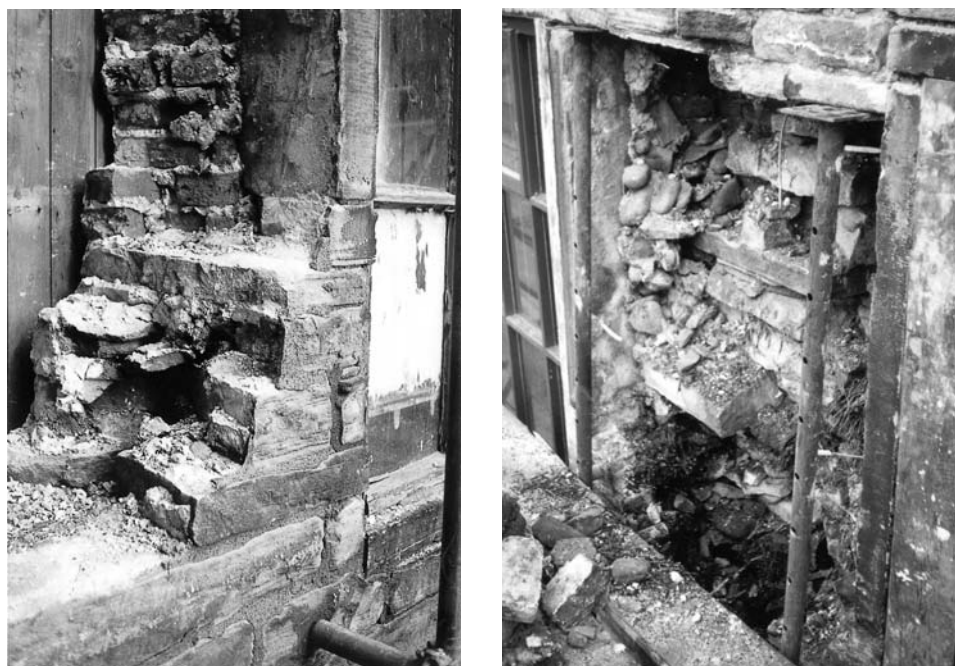
Figure 2.11 Cavity wall with rubble infill. Greenup's Worsted Mill, as previous figure. Cavity wall construction and window elongation. Note through-stones and part throughs with loose cavity rubble. Single leaf internal brickwork returns to stone jambs at window reveals. (Stuart Millns)

Foundations and walls followed previous local practice in warehouse construction. The use of stone was common in the Yorkshire Pennines, for example, whereas brick was common elsewhere. In the brick-built mills, handmade bricks were gradually replaced by bricks made by machine in the second half of the nineteenth century. The best stone-built mills used good quality stone for both inner and outer leaves and for the through-stones joining them together, with stone offcuts and poorer quality stone for the infill (Figure 2.10). In stone-built mills constructed with a low budget, the stone inner leaf was replaced by brick and the built infill replaced by rubble (Figure 2.11).

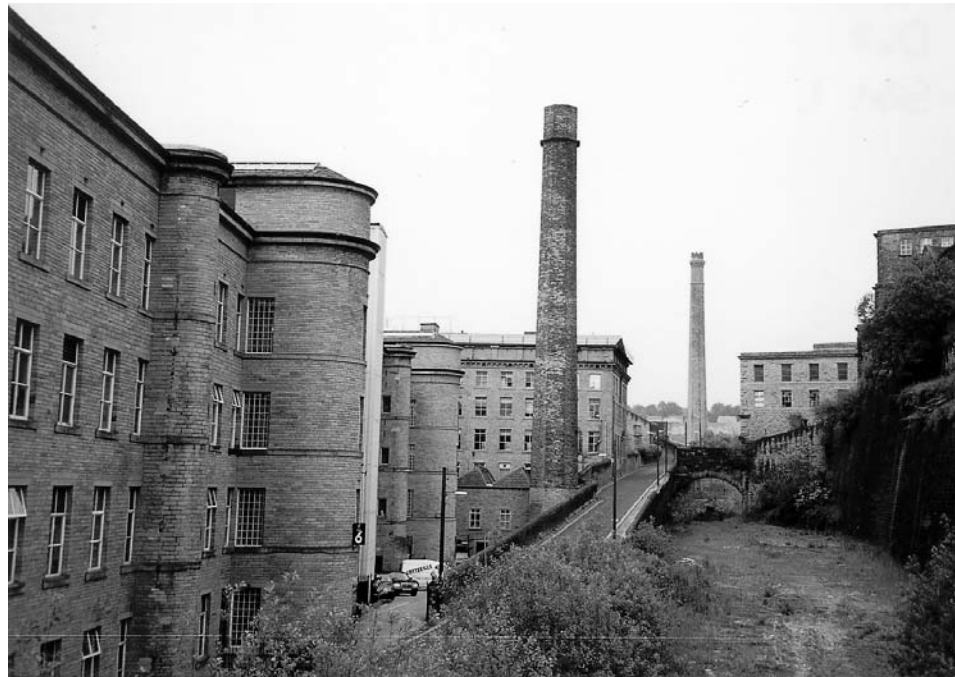
Figure 2.12 A Yorkshire industrial landscape – Dean Clough, Halifax. In the foreground is Bowling Mill, built c. 1840. The external stair and toilet towers maximize the floor space available for spinning machinery. Note the double stone lintels and good quality Yorkshire sandstone. (Stuart Milns)

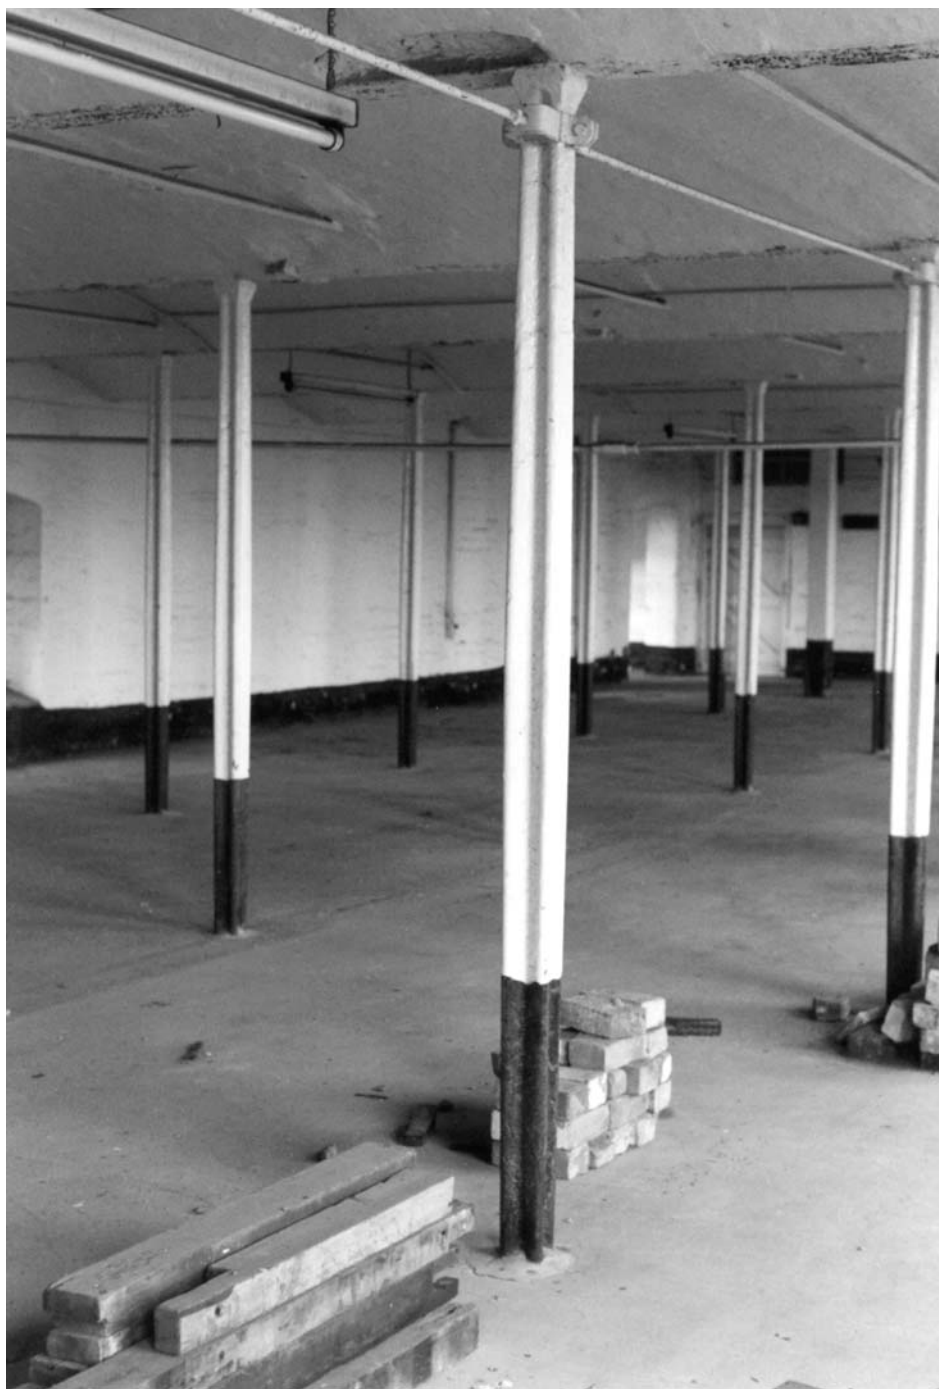
Figure 2.13 Cruciform column. in the 1797 Marshall, Benyon & Bage Flax Mill, Shrewsbury.

The first textile mills were similar to warehouse buildings with load-bearing walls supporting timber floors. With typical internal widths of 24–28 ft, large timber beams could span from wall to wall. Solid cruciform-section cast-iron ‘storey posts’ provided intermediate support in the wider buildings. These replaced the large timber stanchions of heavier warehouse construction. Initially, these iron posts were relatively slender and the same size from top to bottom of the building (Figure 2.13). Sometimes solid or thick walled circular-section columns, and even solid hexagonal-section columns, were used in place of the cruciform sections.

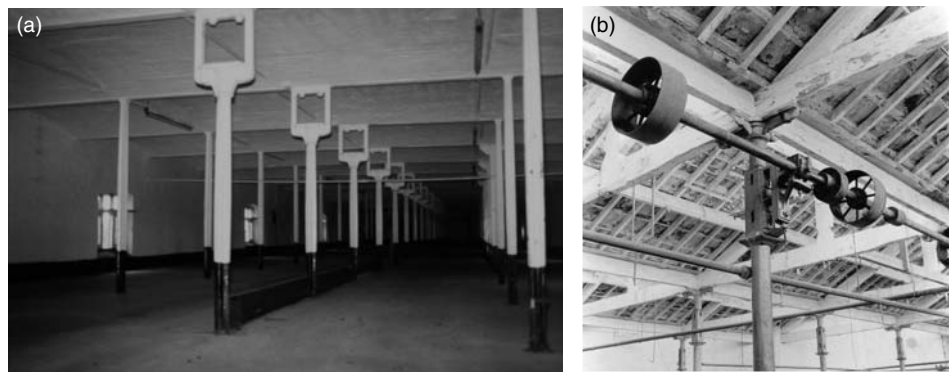
Figure 2.14 (a) Provisions for line shaft support – modified cruciform columns in the 1797 Marshall, Benyon & Bage Flax Mill, Shrewsbury. (b) Line shaft support brackets fixed to bolting faces on a hollow circular cast-iron column. James Walker blanket mill, Mirfield. (Ron Fitzgerald)

are a characteristic feature of hollow circular textile mill columns. Occasionally, the local framing arrangements for shaft bearing supports on the column are more elaborate (Figure 2.14). In some cases, line shafting was suspended from the beam soffits via brackets, either bolted or clamped to the bottom flange.

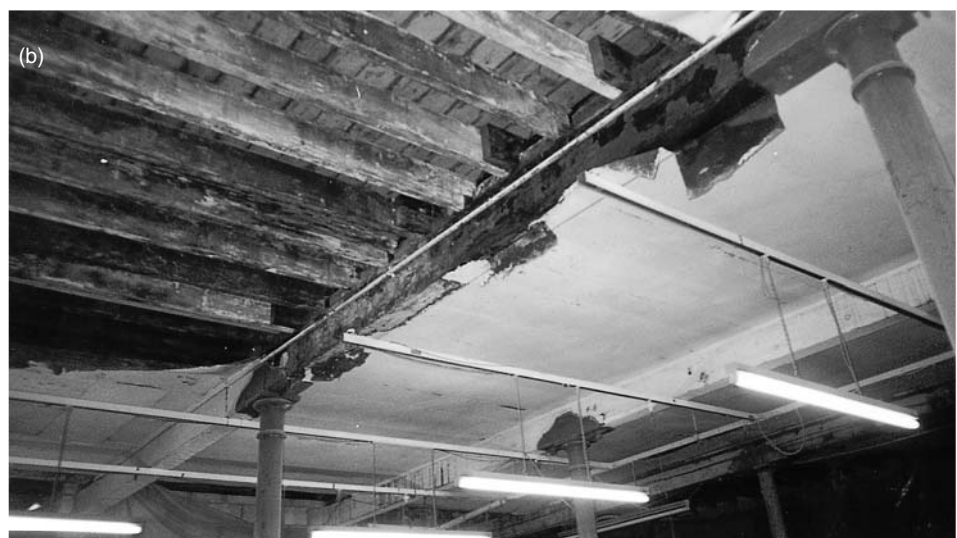
Figure 2.16 (a) Wrought-iron tongues between thick floorboards (e.g. Havelock Silk Mill, Manchester, c. 1830). (b) Wrought iron sheet fire protection to a timber beam and joist floor in the 1855 Canal Mill, Botany Bay, Chorley.

Fireproofing of timber floors took a variety of forms. Early on, while large section timber was still relatively cheap, 4-in. thick floorboards were fixed directly over the principal timber beams. The thickness of the boards themselves provided some delay to the spread of fire and this delay was increased by the insertion of continuous wrought-iron tongues between the boards (Figure 2.16a). A domestic-style lath and plaster ceiling fixed to ceiling joists at the soffit of the main beams further improved fire resistance but at high cost. As an alternative to lath and plaster, rolled sheet wrought iron was used to cover and protect beams and the underside of floors (Figure 2.16b). This system continued to be used well into the twentieth century.

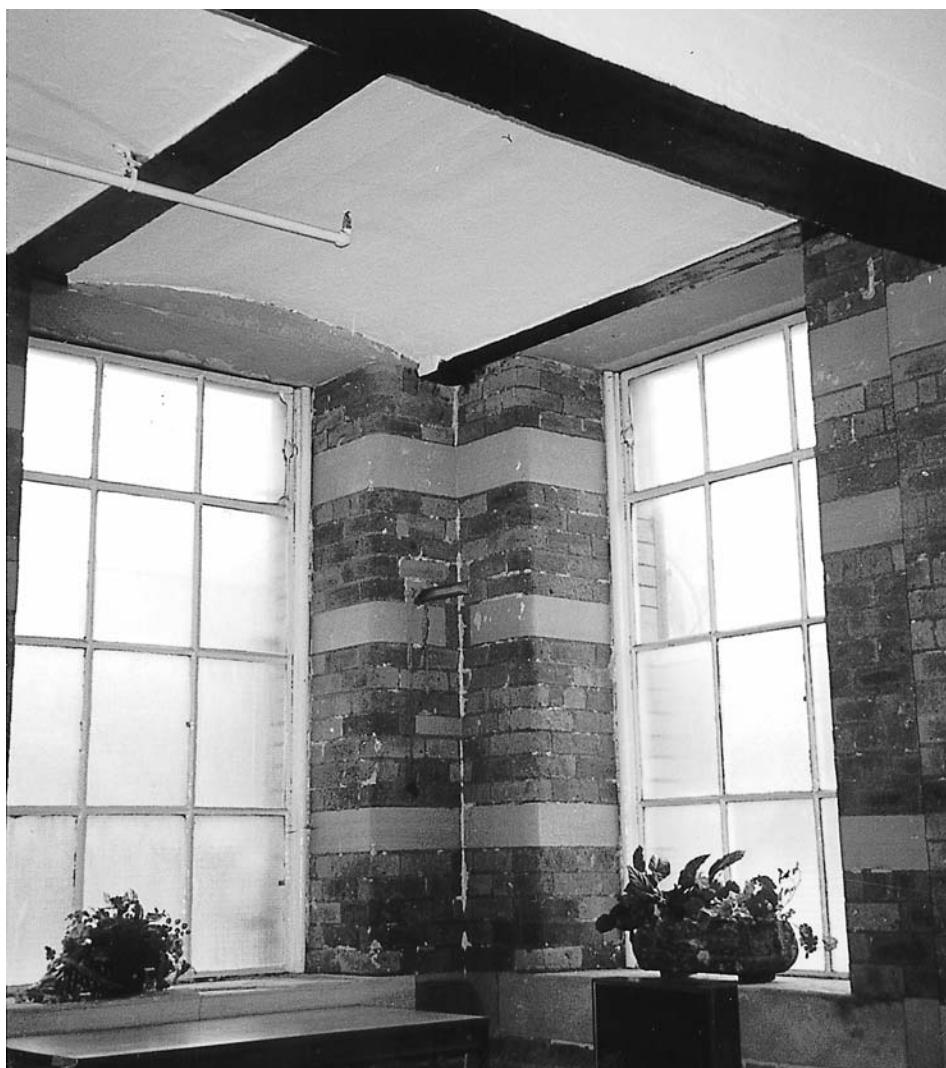
Figure 2.19 Manningham Mills, Bradford (1871). End bay showing change of direction to cast-iron beam and jack arch floor. Note the good quality of the through stones, lintels, cills and padstone into backing brickwork. (Stuart Millns)

A second disadvantage of the arch floor system is that the gable walls must withstand the weight of the end arch thrusts. This problem could be solved to a certain extent by replacing the last arch with a series of transverse arches carried on secondary beams between the primary beam and the end wall (Figure 2.19). This system of carrying arches on secondary beams was further developed in the mid-nineteenth century, the reduced floor weight making greater spans possible.

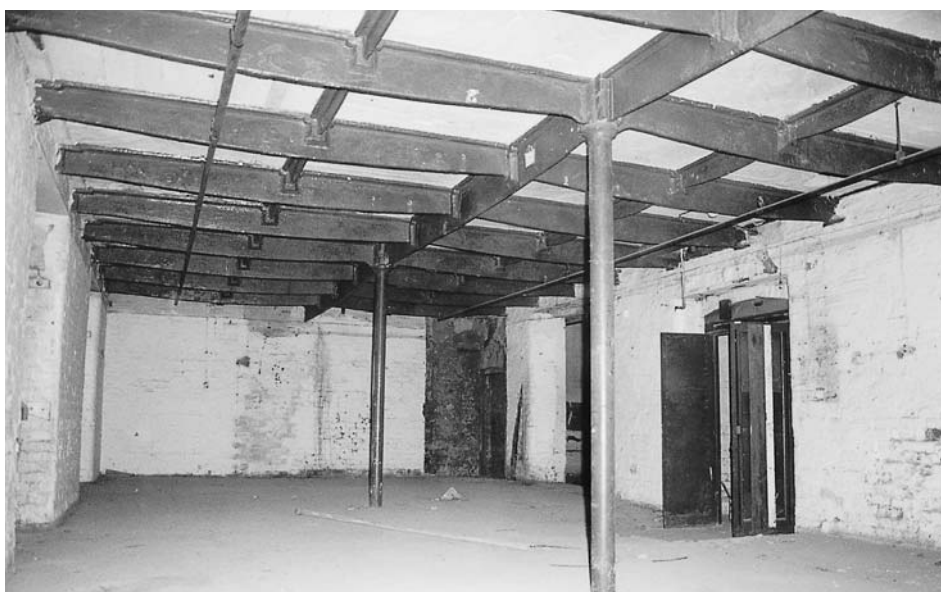
Figure 2.20 Beehive Mill, Manchester, 1824. Stone slab floor on cast-iron framing.

(Figures 2.20 and 2.21). The system was vulnerable to fire because the whole of the ironwork in the grid was exposed. It was therefore only used in small sections of buildings, such as over boiler rooms.

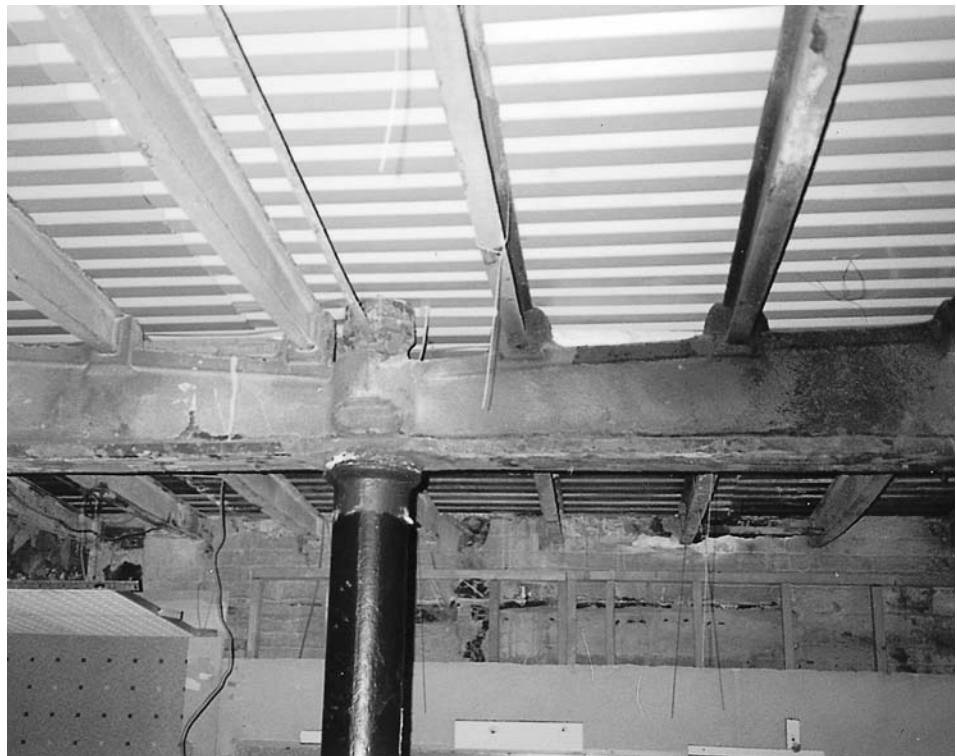
Figure 2.21 Bowling Mill, Dean Clough, Halifax (c. 1840). Hog-backed cast-iron beams and fish-bellied cast-iron joists which formerly supported stone slabs over the boiler house. (Stuart Millns)

In both cast-iron floor systems the increased bending moment at centre span was recognized by designing the beams with an increased web depth at centre span. This gave the inverted beams a 'hog back' and the upright beams a 'fish belly'. The early T-section beams gave way to I-sections during the 1820s. Experiments by William Fairbairn and then Eaton Hodgkinson in Manchester established 'the best form of beam', with larger bottom flanges the norm in mills from the 1830s onwards (Figure 2.22). Both top and bottom flanges were often narrower towards the beam ends and wider at mid-span. The ideal theoretical proportion of the cross-sectional area of the lower to upper flange was determined by Hodgkinson as six to one but, in practice, for beams in buildings, a lower ratio was often adopted. From the 1830s Fairbairn pioneered the use of the improved form of beam for spans of up to 25 ft, enabling a width of 50 ft to be interrupted by only a single line of columns.

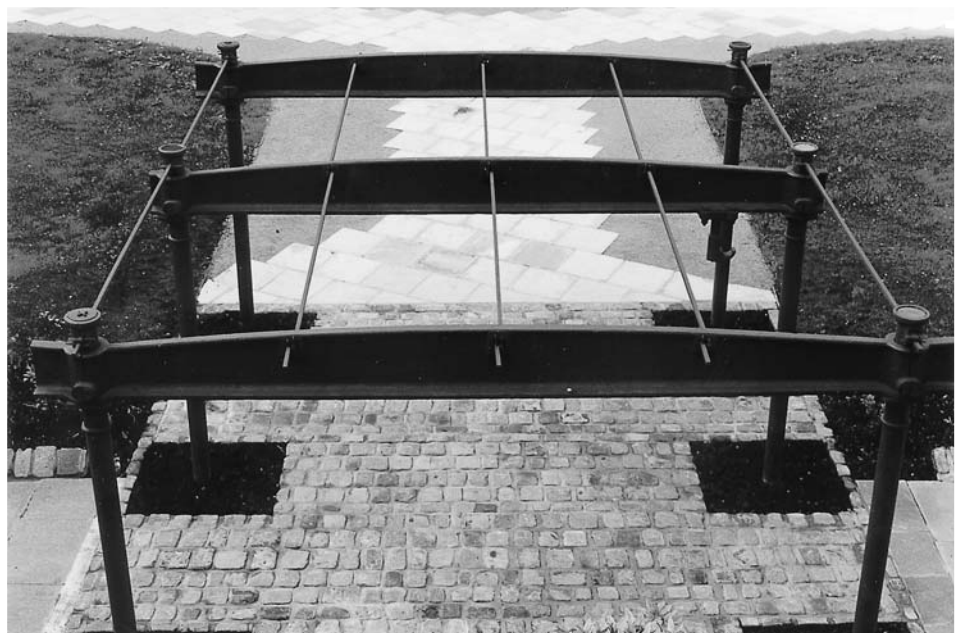
Figure 2.22 Havelock Cotton Mill iron framing (1845). As re-erected on the UMIST campus in 1997.

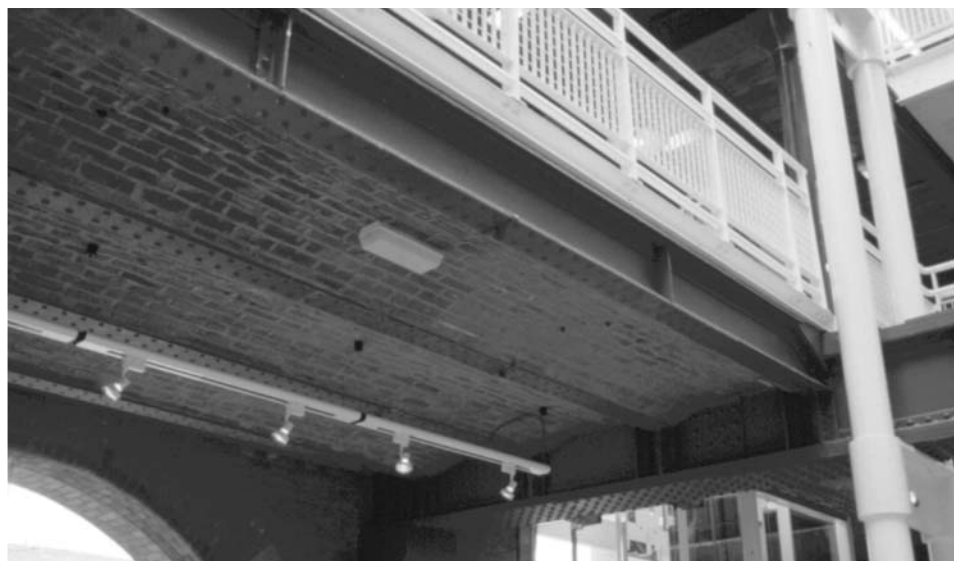
Figure 2.25 Lower Byrom Street warehouse, Museum of Science and Industry, Manchester.

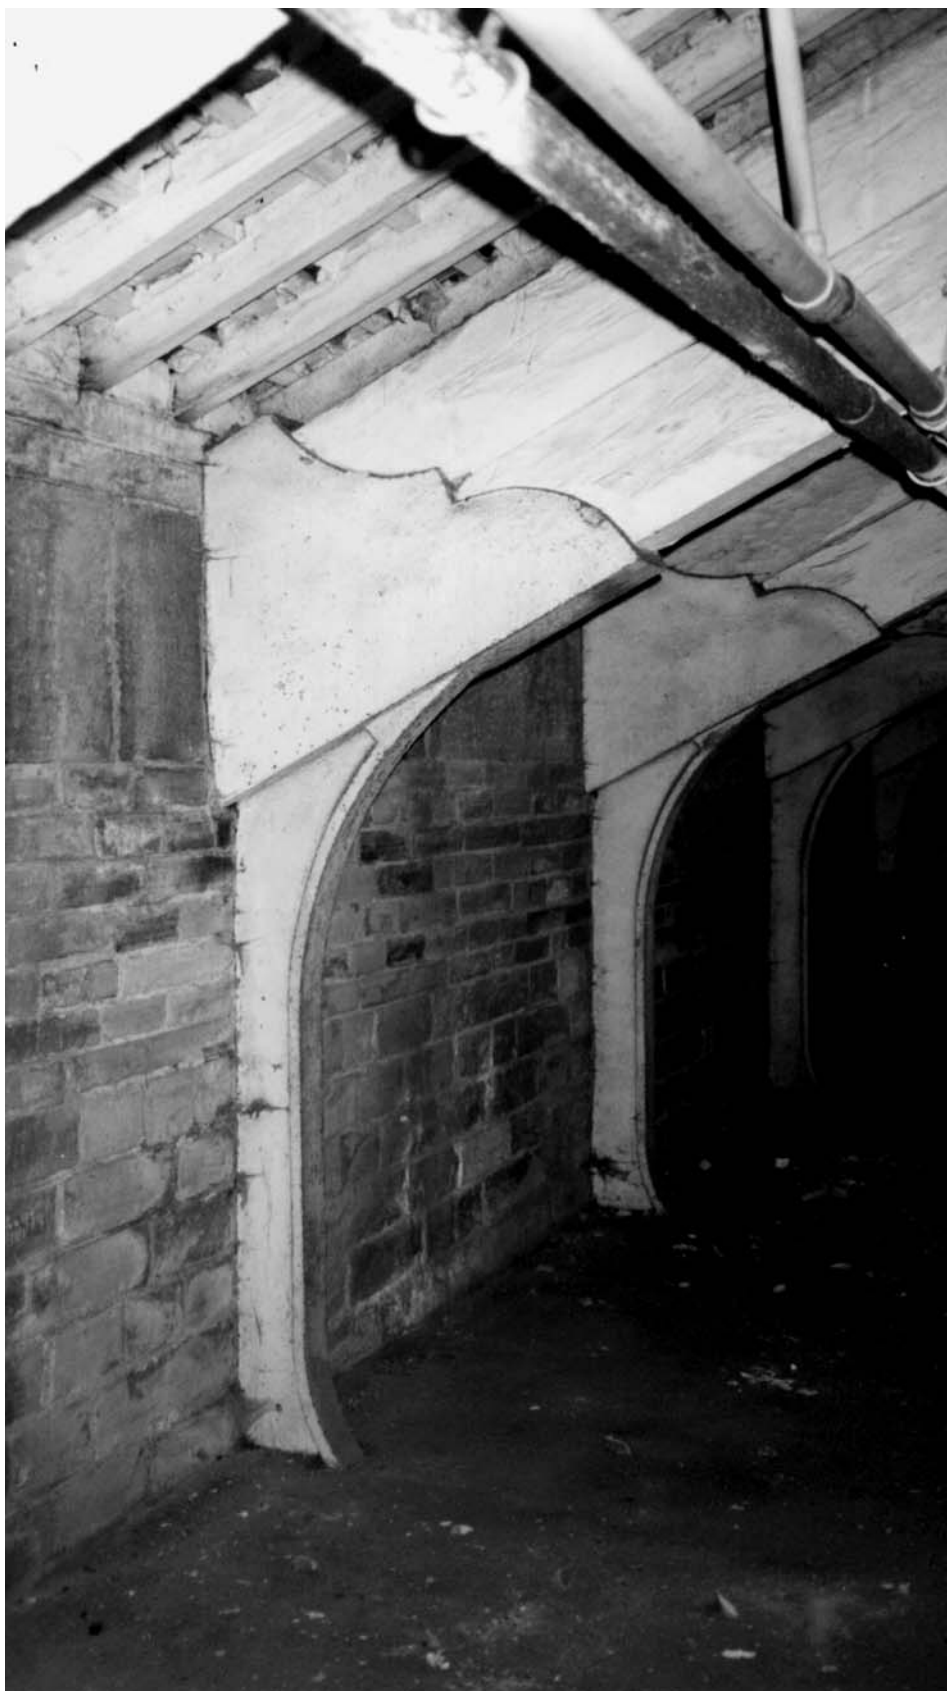
Figure 2.28 Timber roof with cast-iron knee braces. Garden Street Mill, Halifax (c. 1860). The brackets are fixed to the cast-iron floor beams and have a second leg within the wall. In this case there was no evidence of roof spread. (Stuart Millns)

In the first half of the nineteenth century, mill roof spaces were used as working spaces with varying degrees of success. Traditional slate-clad pitched roofs using queen post timber trusses gave some working or storage space. Sometimes cast-iron members were substituted for some of the timber members of trusses. One solution involved the use of cast-iron knee braces to raise the ends of the principal rafters clear of the floor (Figure 2.28). In some cases, segmental cast-iron arches with their feet tied by the floor/ceiling beams, replaced the trusses entirely. This 'ironbridge-like' solution to providing useful roof space can look quite elegant (Figure 2.29). In a few later mills, laminated timber arches were used instead of iron (Figure 2.30).

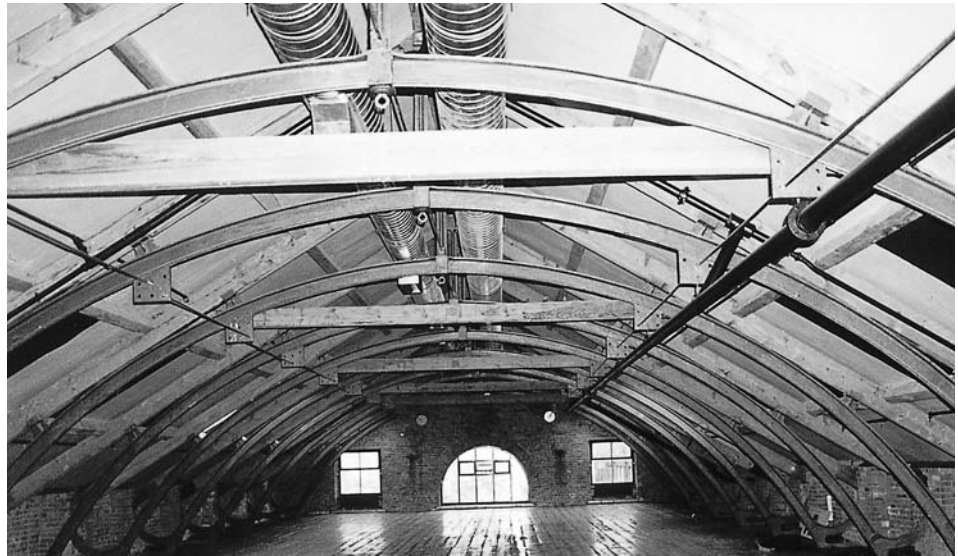
Figure 2.30 (a) Laminated timber roof arches with cast-iron wall brackets. Lumb Lane Mills, Bradford (1856). Up to six timber planks were screwed together with through-bolted truss connections (Stuart Millns). (b) Similar timber arches and floors seen during demolition of a mill. (Ron Fitzgerald)

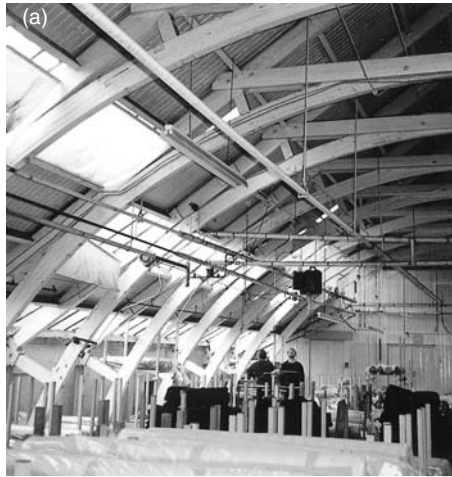
Figure 2.31 Trussed iron roof to part of Beehive Mill, Manchester (1824).

Other solutions to the roof problem developed around the use of wrought iron (Figure 2.31). Often, the use of iron was not confined to the building frame and some of the earliest iron trusses support mill roofs. Well-engineered examples from early in the nineteenth century betray the influence of firms such as Boulton & Watt on the structural design of the mill buildings that were to be powered by their steam engines. High double-pitched roofs gave way to much lower multi-bay roofs with networks of wrought-iron tension rods and wrought-iron angle sections supporting ridges and valleys. These boarded and slated roofs with north facing roof lights were early space frames, requiring the minimum of intermediate support. For longer span building roofs in the second half of the nineteenth century, development was driven, for the most part, by the needs of railway stations and station-type roofs are to be found over some mills.

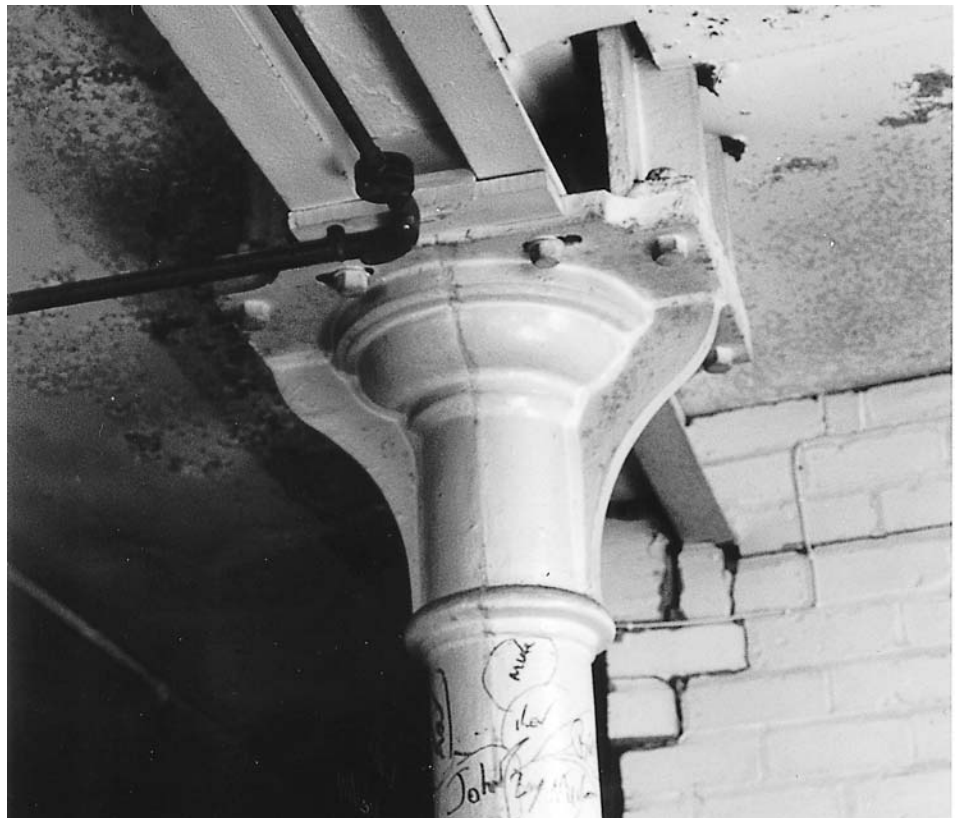
Figure 2.34 Floor supports in Murray's New Mill, Manchester. Built in c. 1804, with two lines of cruciform columns to continuous timber beams, the building was modified c. 1900. The original columns were replaced with a single line of hollow circular cast-iron columns and the floors supported by channels placed either side of the original timber beams.

stantial hollow circular columns at wider spacings (Figure 2.34). Individual columns or rows of columns may have been moved or removed without much consideration of the wider structural implications (Figure 2.35–2.37 [28]). On occasion, complete floors have been taken out (Figure 2.38).

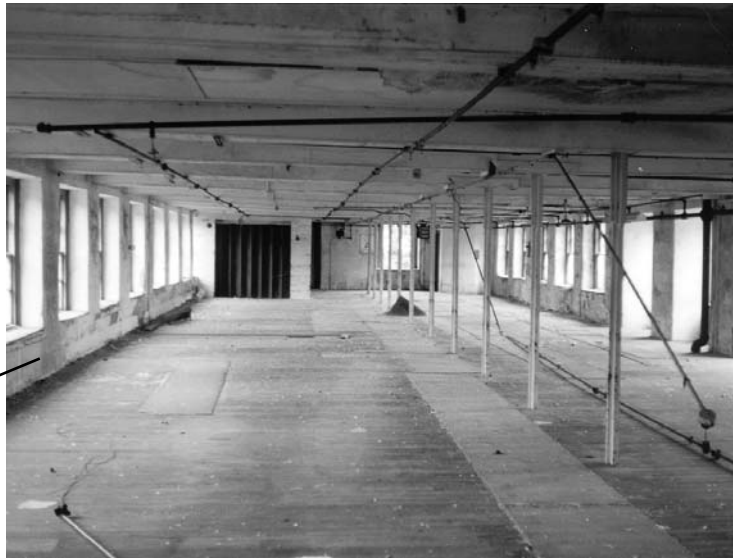
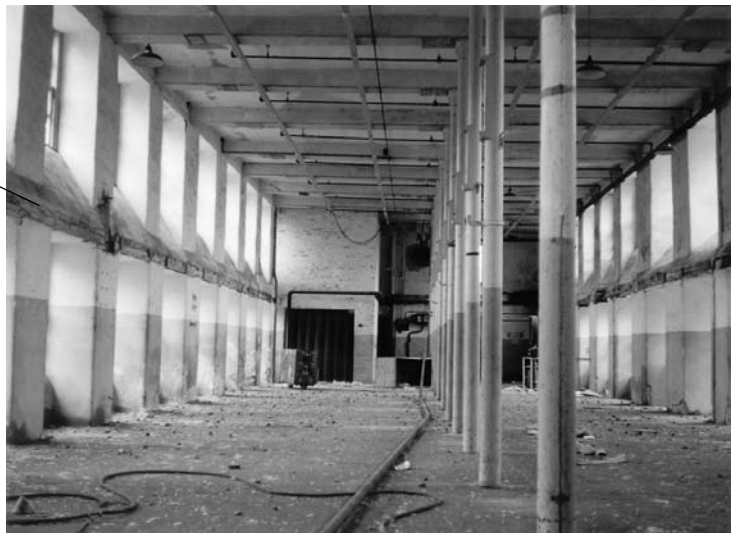
Figure 2.38 Floor removal in Bell Mill, Stanley, near Perth. Built in c. 1787 a complete floor removed about 100 years later.

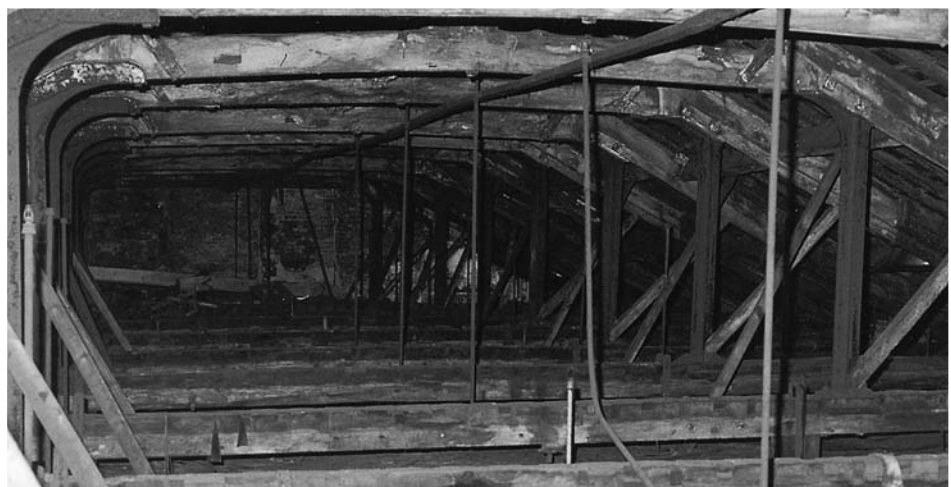
Figure 2.39 Murray's New Mill, Manchester (1804). Cast-iron queenposts inserted as a modification to the original all-timber truss.

Roofs are areas where extensive modification can be expected. Many mills have had upper storeys removed. In others, heavy single-pitched roofs have been replaced by lighter structures. In yet others, heavy timber sections were replaced by special cast-and wrought-iron sections (Figure 2.39).

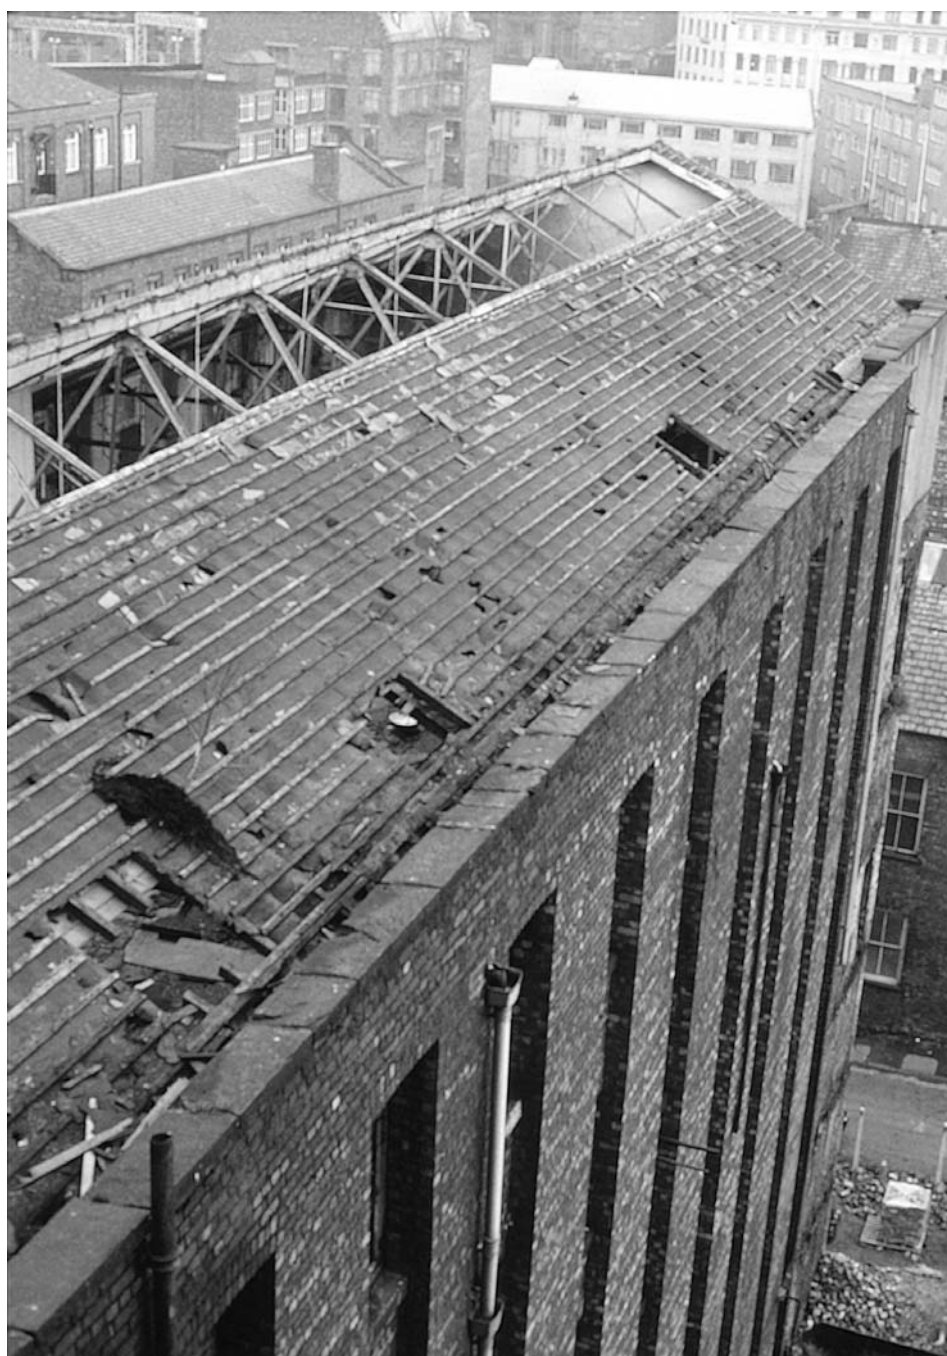
Figure 2.40 Chorlton Mills, Manchester. Built in c. 1803, the outer leaf to the mill is probably a late nineteenth-century addition.

Exterior structural walls are unlikely to have suffered significant alteration although some new window and door spaces will have been opened in many buildings. A Manchester mill had an additional complete outer leaf added sometime after the original construction, but that treatment was exceptional (Figure 2.40).

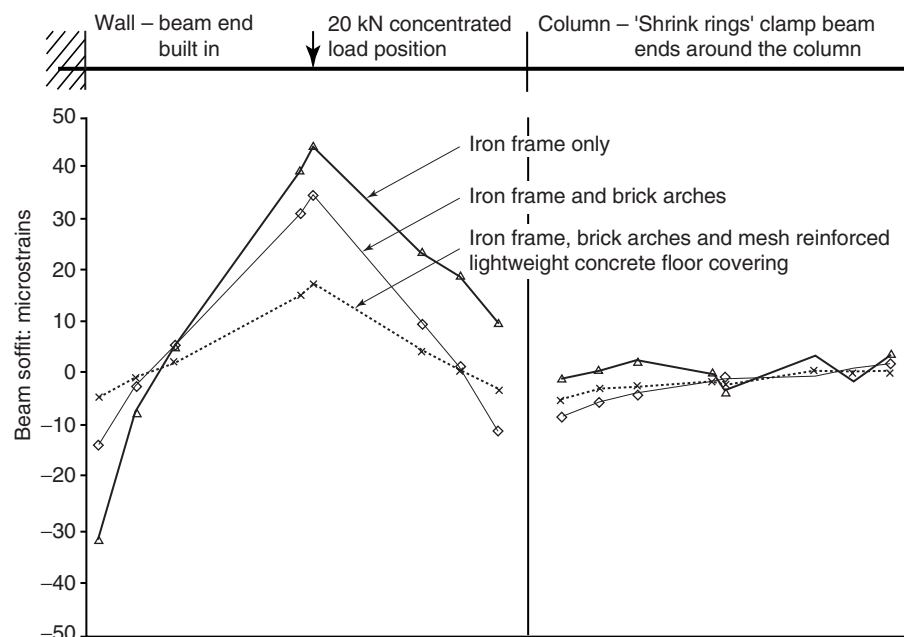
Figure 3.1 Beam concentrated load tests.

Beam ends in iron-framed textile mill buildings were commonly set well into the external wall piers so as to provide greater lateral stability. Recent site tests in three different buildings have demonstrated that such beam ends may be considered 'partially fixed' (Figure 3.1) [31]. For beam strength calculations, a simple support assumed at the inner face of the wall pier is a little bit conservative.

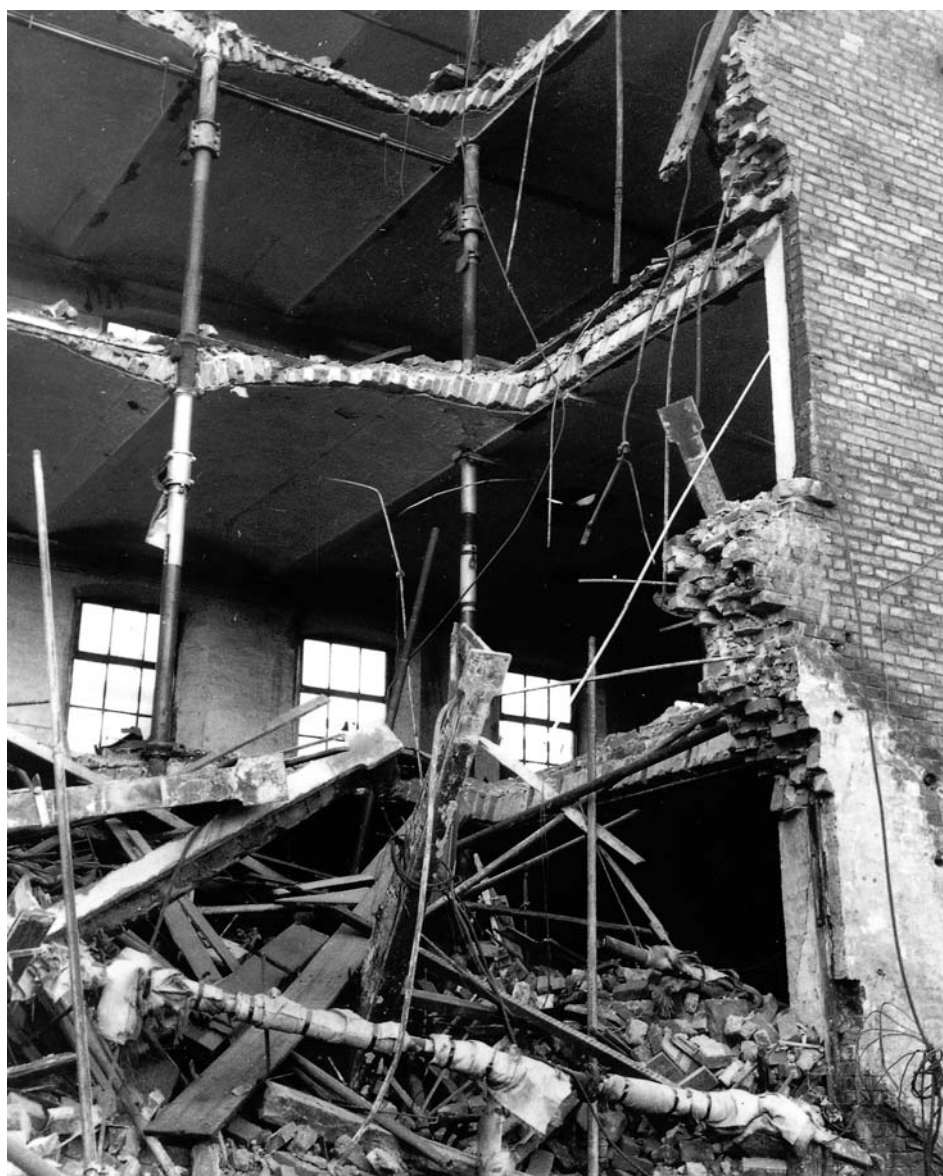
Figure 3.7 An iron-framed building during demolition in 1970. Fairbairn's block at Bean Ing Mill, Leeds (1823-4). (John Goodchild, reproduced with permission)

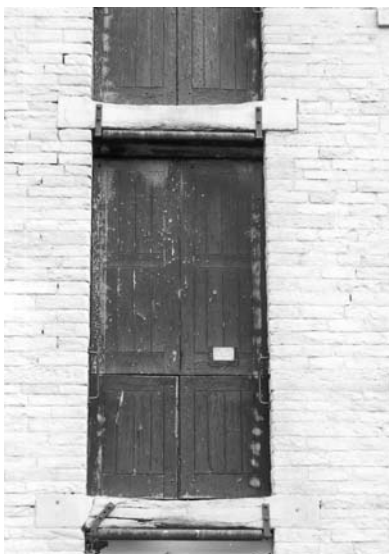
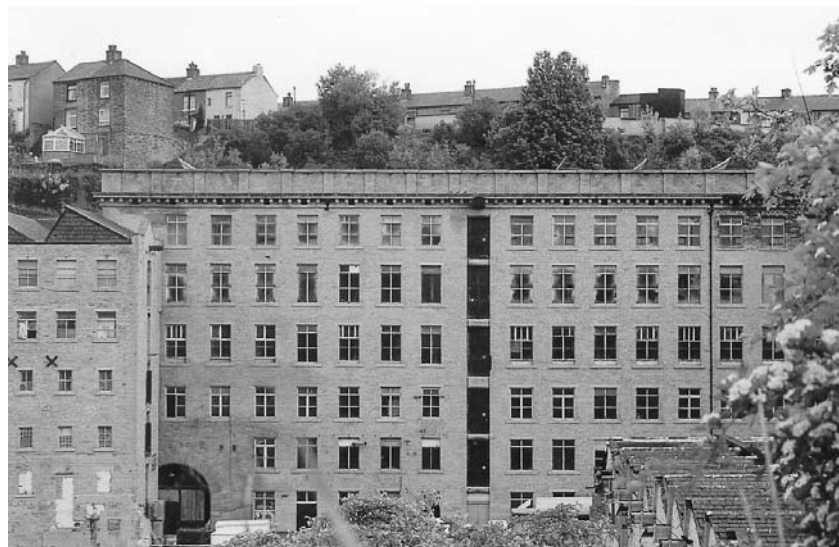
Figure 4.1 F Mill, Dean Clough, Halifax, 1858. Differential settlement to the front elevation is apparent in the form of cracks to the stone lintels across the full height loading bay doors. Note also the damage caused by the corrosion and expansion of iron fixings. (Stuart Millns)

As well as a visual inspection, verticality checks are made easily by plumb line or theodolite. Wall thickness usually reduces at the inner face from the lower to the upper storeys. Taking levels or measuring the slopes of floors and cills is useful in evaluating distortions due to possible foundation movement. Significant movement may have occurred with little cracking of the masonry. Damage due to foundation settlement may only be apparent where there is an obvious structural discontinuity, such as a series of loading bay doors over the height of the building (Figure 4.1).

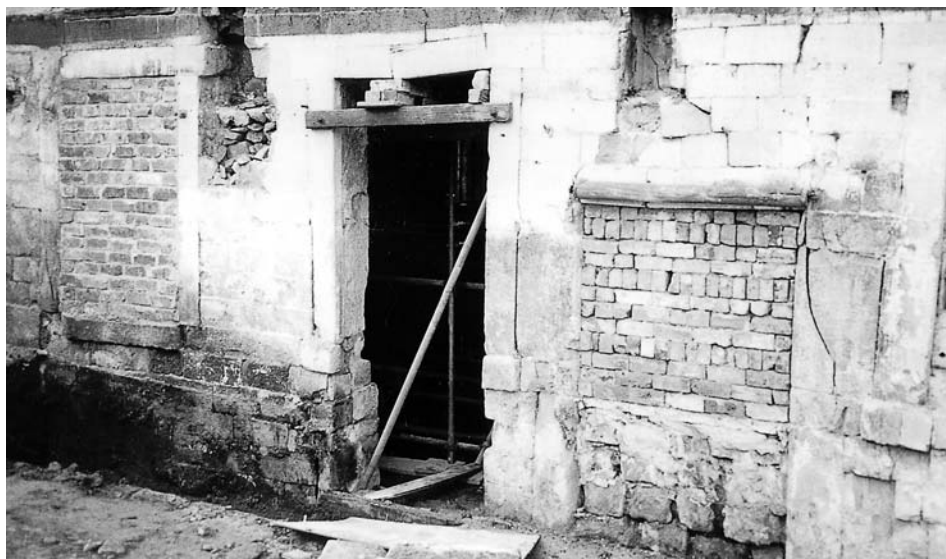
Figure 4.2 Poorly carried out structural alterations to a wall. Bricking up of openings prevented early collapse of this 1830s mill with cast-iron columns and timber floors. Complete rebuilding of the wall was required. (Stuart Millns)

Where bulging or separation of masonry leaves has occurred, opening up works may be needed to determine the quality and bonding of the wall or pier construction (Figure 4.2). In stone masonry, it may well be possible to identify a pattern of through-stones which tie together the inner and outer leaves for each bay. Good practice in West Yorkshire, for example, was to build through-stones into solid walls at staggered centres of 3 ft horizontally and 3 ft vertically. Full width stone lintels and cills are common too. In the event of inadequate connection between inner and outer leaves, the basic options are to partially rebuild or to drill through and fix suitable ties (Figure 4.3).
