**Structural appraisal
of iron-framed textile
mills**

ICE design and practice guides

Tom Swailes and Joe Marsh

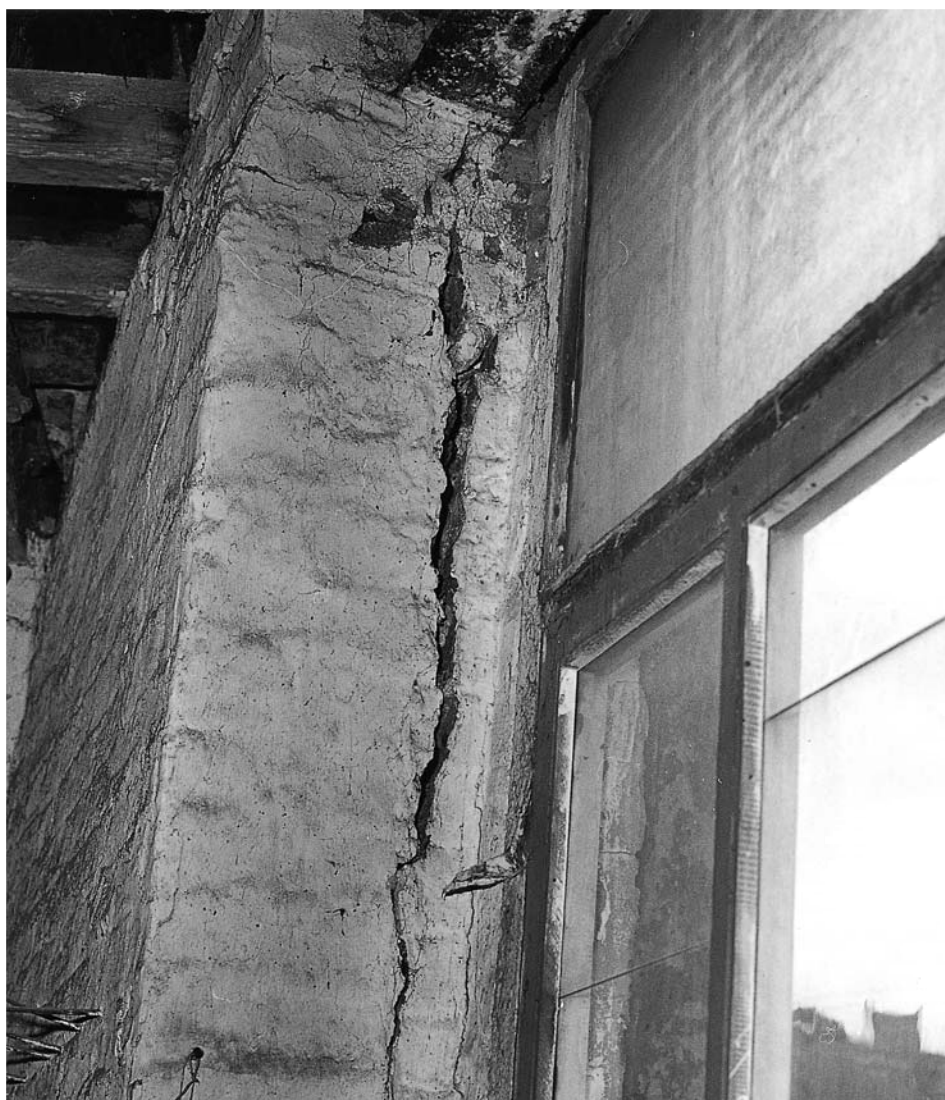
Figure 4.3 Separation of inner leaf brickwork from outer leaf stonework, due to the combined effects of low strength brickwork, poor bonding and settlement. (Stuart Millns)

Where bulging or separation of masonry leaves has occurred, opening up works may be needed to determine the quality and bonding of the wall or pier construction (Figure 4.2). In stone masonry, it may well be possible to identify a pattern of through-stones which tie together the inner and outer leaves for each bay. Good practice in West Yorkshire, for example, was to build through-stones into solid walls at staggered centres of 3 ft horizontally and 3 ft vertically. Full width stone lintels and cills are common too. In the event of inadequate connection between inner and outer leaves, the basic options are to partially rebuild or to drill through and fix suitable ties (Figure 4.3).

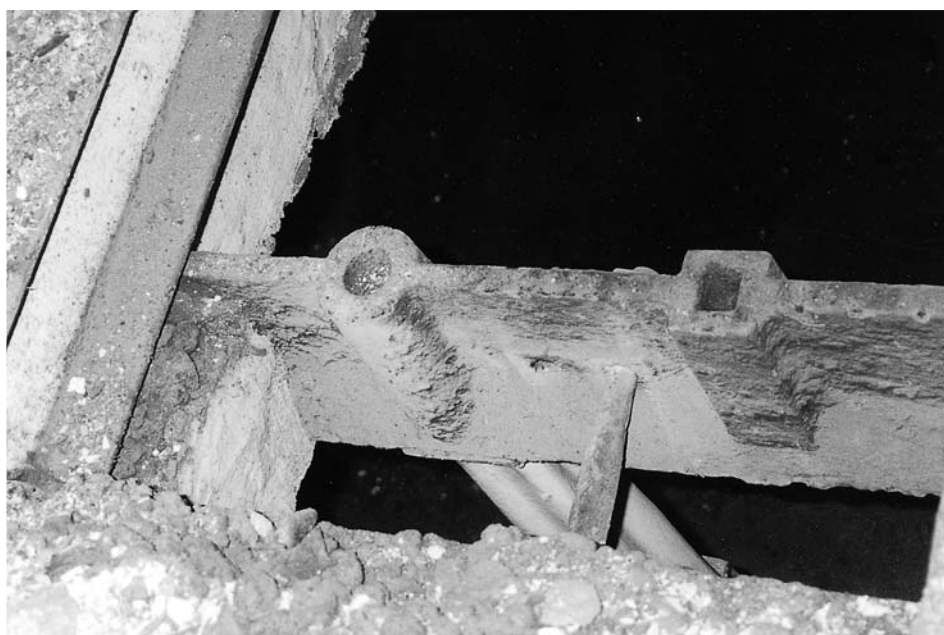
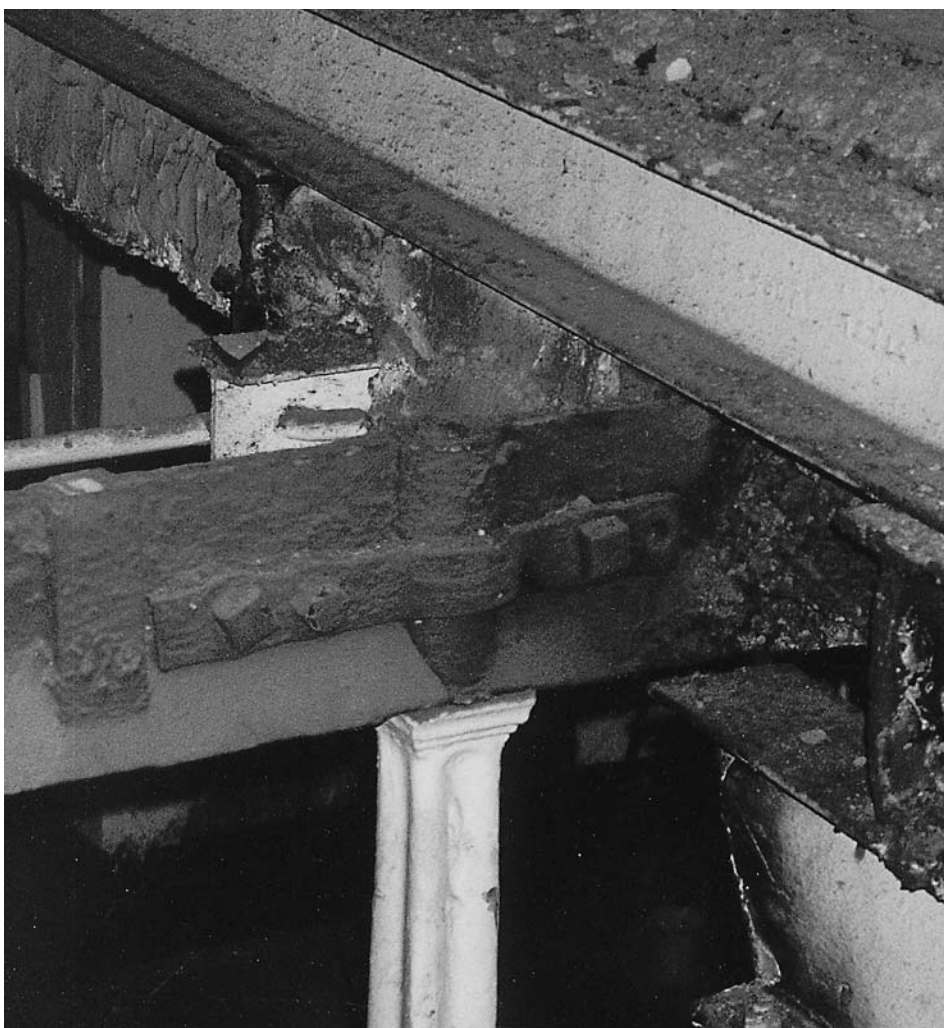
Figure 4.5 Inverted T-section cast-iron beams. As exposed in the 1797 Marshall, Benyon & Bage Flax Mill in Shrewsbury. Some beams are cracked where continuous over an intermediate column and a splice repair has been made using bolted wrought-iron straps. (Stuart Millns)

More serious is the far less common contamination of a casting with large detached pieces of mould or the presence of a cold joint due to an interruption in casting (Figure 4.4). These gross internal defects are rarely apparent from a visual inspection and are difficult to detect by other means, making the use of a large factor of safety necessary. However, the safety factor does not remove the need for inspection of surfaces for more serious flaws such as fractures, an operation best carried out after removal of paint and with good lighting. In the unlikely event that a gross casting flaw is found, or if a beam has suffered severe mechanical damage, a visually intrusive repair may be unavoidable. An iron frame is intolerant of differential settlement, which in extreme cases may cause beam ends to fracture over or near to a support (Figure 4.5).

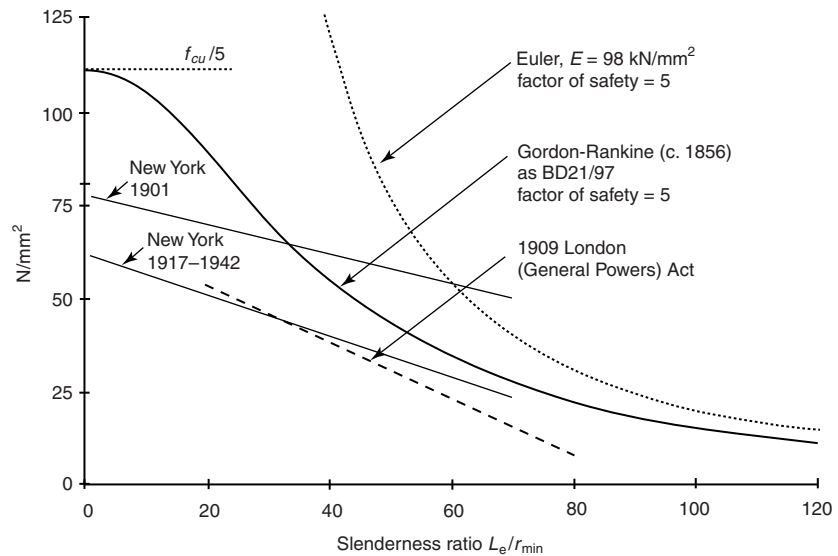
Figure 4.8 Cast-iron column design capacity curves.

No significant testing of real cast-iron columns, complete with casting defects and with a variety of end conditions, has ever been carried out. The Gordon–Rankine formula provides the basis for the most enduring of the capacity checking methods. It is a semi-empirical fit to a very extensive series of tests by Eaton Hodgkinson in the 1830s on relatively small column and strut sections. Straight line formulae have been popular in the United States, used with large safety factors after the Darlington Apartment collapse, and based on a small number of rather inconclusive tests carried out for the New York Building Department. A wide range of answers may be obtained from the different capacity checking methods available (Figure 4.8, [39]). It is

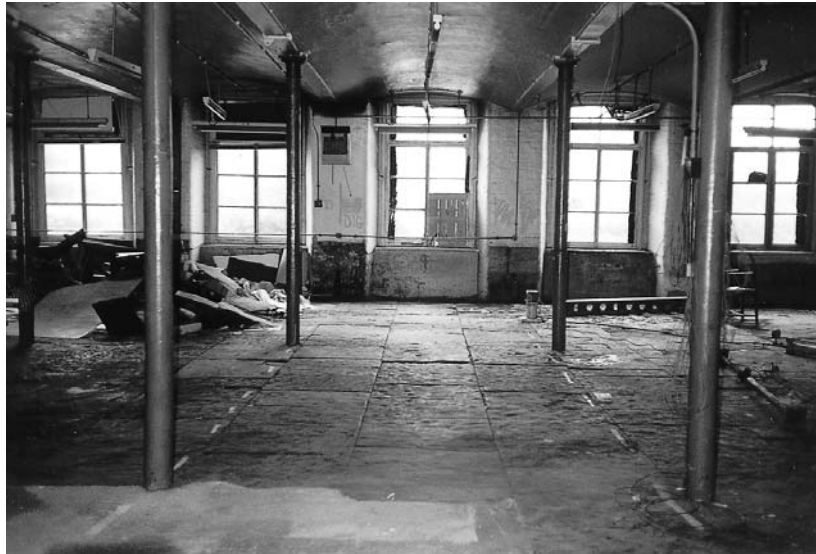
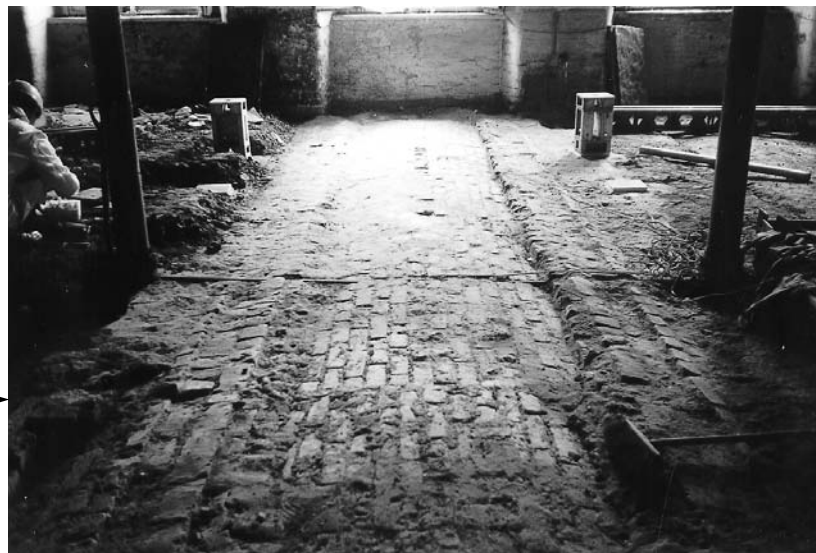
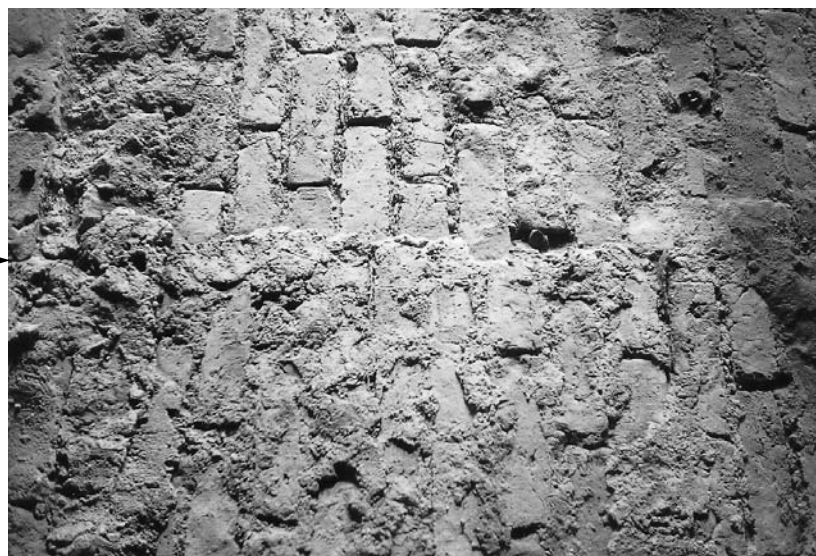
No ties below arch soffit

Shrink rings to beam-column connections within arch brickwork

Flags and ash fill removed

Ties between columns visible

Joint between arch sections, tie bar within

Detail at arch crown

Figure 4.9 Havelock Cotton Mill, Manchester (1845), floor details.

The safety of undisturbed jack arch floors should rarely be a cause for concern, as the example calculation in the next section shows. In textile mills, however, with a span of 9 or 10 ft and span-to-rise ratio of around 10, the shallow arch exerts a considerable thrust and is sensitive to disturbance. The arch soffit profile is invariably a circular arc and the brickwork, though thick at the springing, usually reduces to the thickness of a brick on its edge at the crown (Figure 4.9).

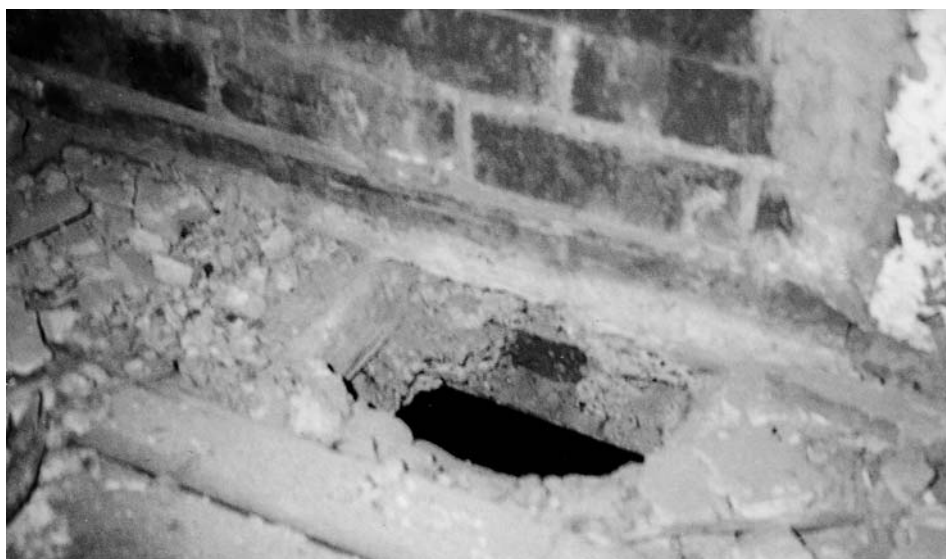
Figure 4.10 A 4 m brick wall built directly off a filler joist floor in the c. 1908 Rugby Mill, Chadderton, Oldham. The continuous wall arches between the primary steel beams.

Filler joist construction became the most common form of fireproof floor towards the end of the nineteenth century (Figure 4.10). Most common in textile mills are wrought-iron filler joists of 3- or 4-in deep and spaced at around 16 in in a slab of about twice their depth. Corrosion within damp masonry walls is a common problem and local opening up to expose joist ends in vulnerable positions is recommended. Rust staining at soffit level may sometimes be seen. The concrete encasing the joists is usually weak, with aggregate of broken brick, cinders, etc. In some cases, the wheels of fork-lift trucks or warehouse trolleys have been reported to punch through between joists.

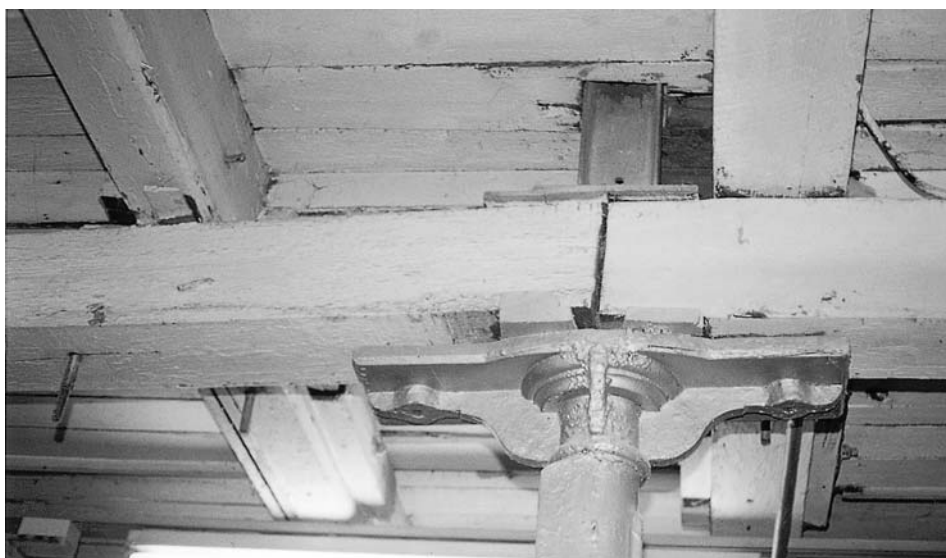
Figure 4.11 A structural alteration to a mid-nineteenth century warehouse and workshop showing gross lack of fixity. Note the absence of any bolts or coach screws and the very poor packing between the column end plates and the beam ends.

The filler joists are usually placed in the bottom of the slab and are at least partially effective as reinforcement in the composite section. Tests carried out at the National Physical Laboratory in the early 1920s indicated that, under certain circumstances, the safe working load for a composite floor of this type might be twice that obtained by considering the strength of the joists alone [40]. The strength increases with the concrete cover over the joist. Guidance on the assessment of filler joist floors is contained in the obsolete permissible stress codes for structural steelwork. Instrumented proof-testing has been used with success to confirm the adequacy of a floor of this type for a specified imposed load where it was not possible to do so by calculation [39]. As for arches and ties, other examples of bad floor construction practice will be found (Figures 4.11 and 4.12)

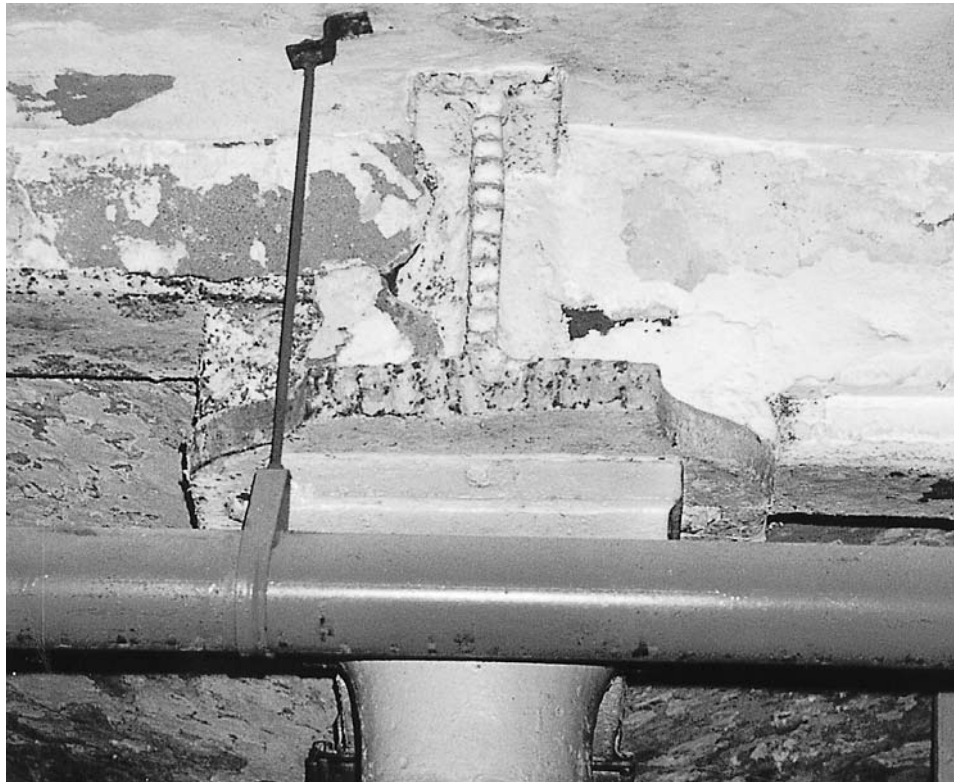
Figure 4.12 Replacement floor details. An arch floor removed and cast iron beam cut away at Manningham Mills, Bradford, and replaced with a reinforced concrete slab. Note the unsymmetrical cross-section of the beam and the means of cutting by a series of drilled holes. (Stuart Millns)

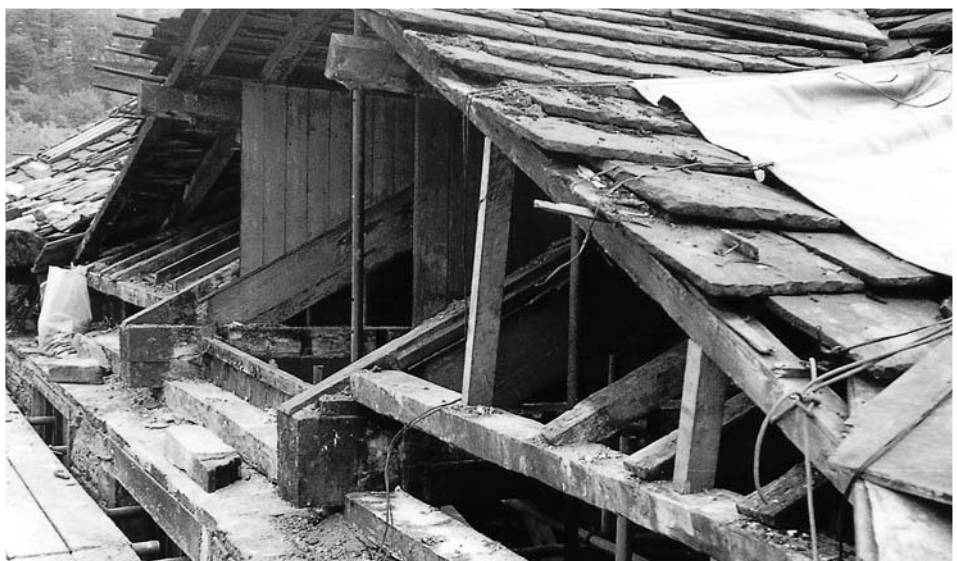
Figure 4.13 Remedial work to timber roof in progress. The roof to Greenup's Worsted Mill, c1791, Sowerby Bridge Mills. Lack of maintenance to gutters and eaves masonry often leads to rapid deterioration of mortar, requiring rebuilding of masonry, replacement of timber wall plates and remedial work to timber truss bearings. (Stuart Millns)

Mill roofs will not be considered in detail here as they have few features that are not found in the roofs of other old buildings. Roof spread is quite common, particularly where a knee braced roof has been provided to maximize the useable space. Where a roof is recovered or the rafters underdrawn and insulation provided, either an increase or decrease in dead weight may need to be allowed for. Timber roof member ends bearing in damp masonry or in the vicinity of defective gutters are particularly prone to wet rot (Figure 4.13).
