Masanori Hamada

Engineering for Earthquake Disaster Mitigation

Masanori Hamada
Waseda University
Tokyo, Japan

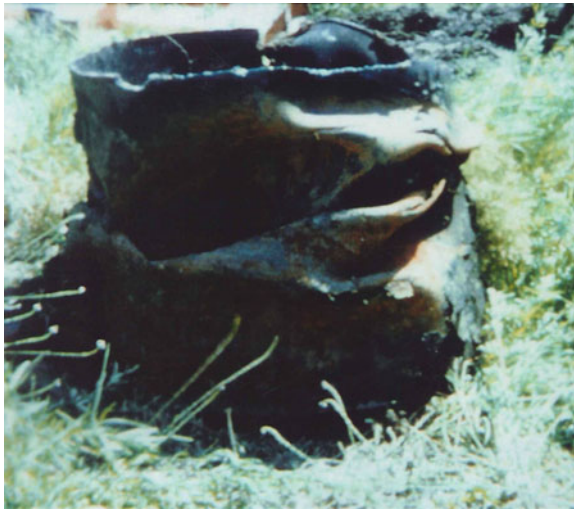
A bridge over a highway at Arifiye, constructed with pre-stressed concrete girders, collapsed due to fault offset. Figure 1.8 shows that the earthquake fault crossed the bridge axis at a 70-degree angle as the span expanded. The lateral offset of the fault was about 4 m. Water and gas pipes crossing earthquake faults were buckled and ruptured, as shown in Fig. 1.9.

Fig. 1.9 Buckling of buried pipe due to earthquake fault offset (1999 Kocaeli earthquake, Turkey, at Arifiye)

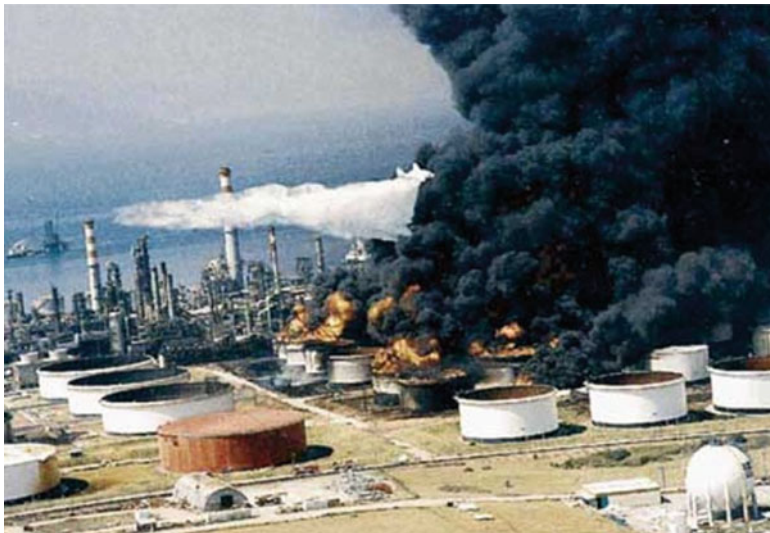
The Tüpraş petroleum refinery on the southern coast of the Gulf of Izmit in Kocaeli produces $270,000\text{ m}^3$ oil, which is about one third of Turkey's annual oil production. Four tanks of 20–25 m diameter and two of 10 m diameter were destroyed by earthquake-induced fire (Fig. 1.11). All these tanks had floating

roofs, and the fire was caused by sloshing vibration of the oil, due to the long-period component of earthquake ground motion. The natural period of sloshing vibration of a 20–25 m diameter tank is about 4–6 s. These periods were consistent with the dominant periods of the ground motion observed at Izmit. Buckling occurred on the sidewalls of fixed-roof tanks; there was no serious damage. It was reported that spherical tanks were undamaged.

Fig. 1.11 Fire of tanks by long-period component of earthquake ground motion (1999 Kocaeli earthquake, Turkey, at Tüpraş oil refinery)

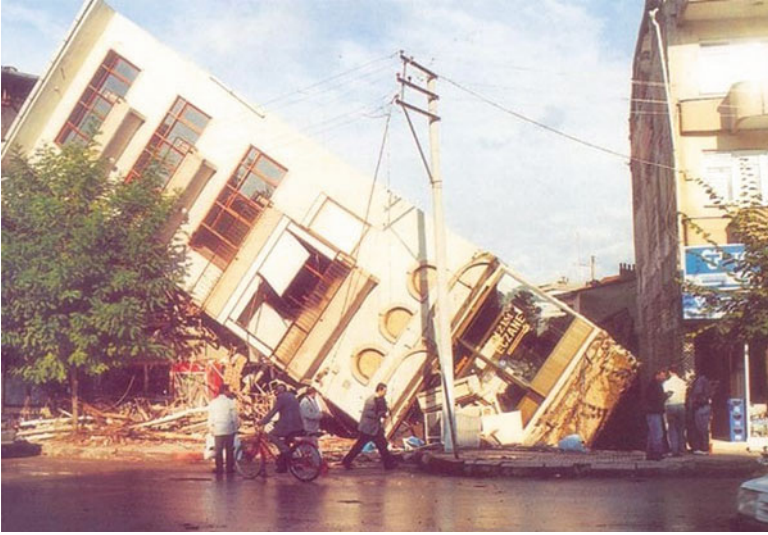
Damage from soil liquefaction at Adapazarı was the most serious. About 1,000 buildings and houses were inclined and subsided. As one of examples, Fig. 1.12

Fig. 1.12 Collapse of a building due to soil liquefaction (1999 Kocaeli earthquake, Turkey, at Adapazarı)

shows collapse of a six story building. Furthermore, soil liquefaction extensively damaged buried lifeline pipes.

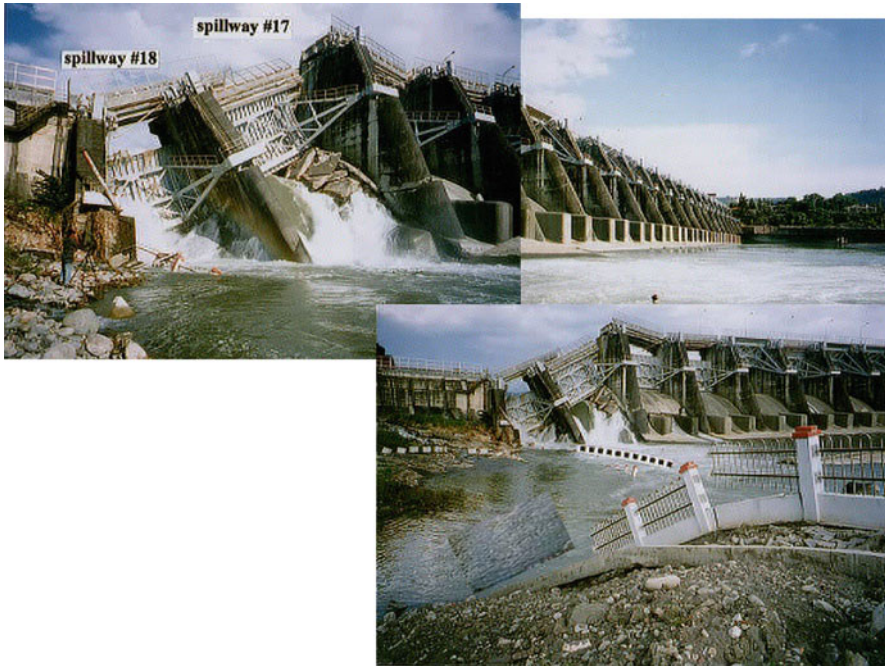
Many earthquake faults emerged at the ground surface. Figure 1.15 shows that Shin-Kang Dam was destroyed by a reverse fault. The dam was a concrete gravity-type of 25 m height and 357 m crest length, constructed in 1997 about 15 km north of Taichung for water supply. According to the Water Resources Agency of Taiwan, the dam was destroyed by a vertical differential displacement of 10 m, caused by the reverse fault. The left side of the dam was lifted 11 m and the right

Fig. 1.15 Destruction of Shin-Kang dam caused by the earthquake fault (1999 Chi-Chi earthquake, Taiwan)

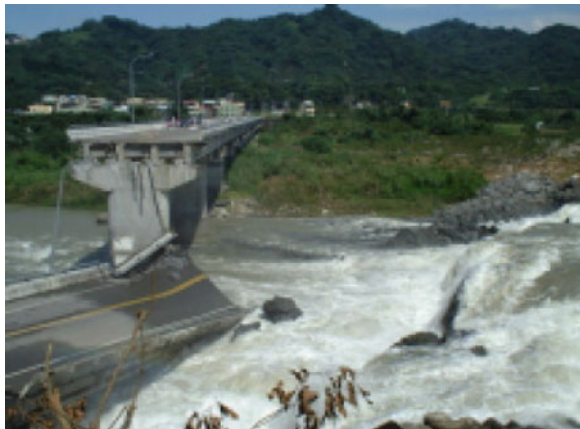
Fig. 1.17 Collapse of a bridge and water fall by earthquake fault offset (1999 Chi-Chi earthquake, Taiwan)

Figure 1.17 shows a reverse fault emergence in the river and collapse of a concrete bridge. The fault offset formed a new waterfall in the river. Yi-Jiang Bridge in Fig. 1.18 is another example of a concrete bridge collapsed by fault movement. It was reported that vertical offset of the fault reached over 4 m at this location.

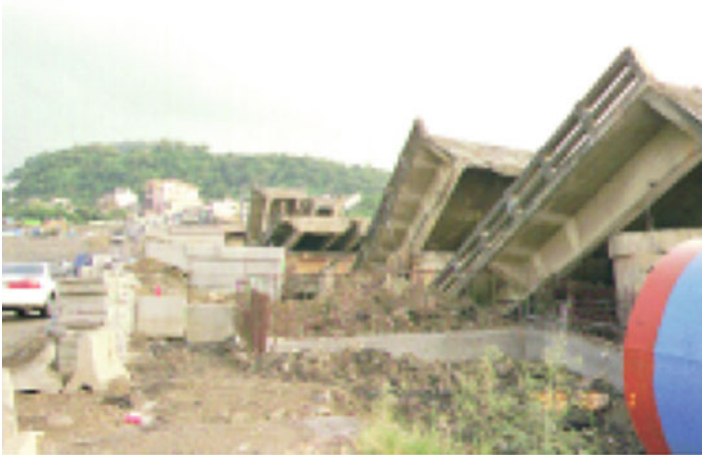
Fig. 1.18 Collapse of Yi-Jiang bridge crossing earthquake fault (1999 Chi-Chi earthquake, Taiwan)

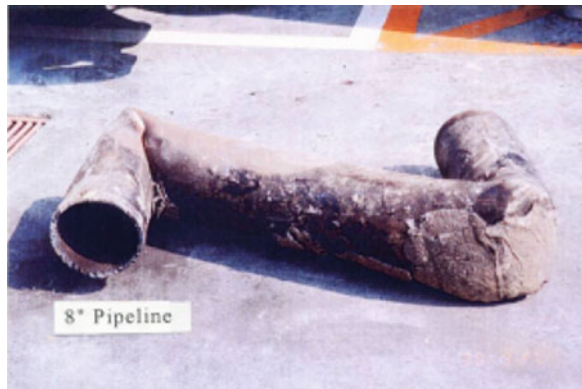
Fig. 1.19 Buckling of a gas pipe by earthquake fault offset (1999 Chi-Chi earthquake, Taiwan)

Figure 1.19 shows buckling of a gas pipe with diameter 20.4 cm due to fault crossing, and Fig. 1.20 shows the destruction of air circuit breakers at an electric substation by strong earthquake motion and offset displacement of earthquake fault.

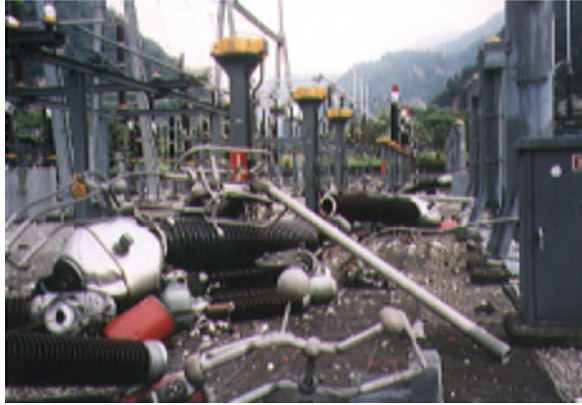
Fig. 1.20 Collapse of air circuit breakers by strong ground motion and earthquake fault offset (1999 Chi-Chi earthquake, Taiwan)

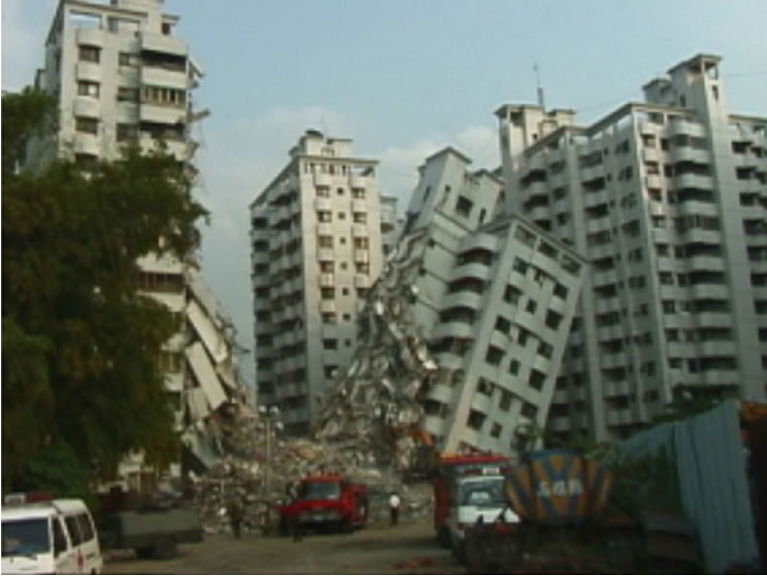
Fig. 1.22 Collapse of reinforced concrete buildings caused by strong ground motion (1999 Chi-Chi earthquake, Taiwan)

Figure 1.22 shows an example of damaged buildings caused by shear failure of RC columns.

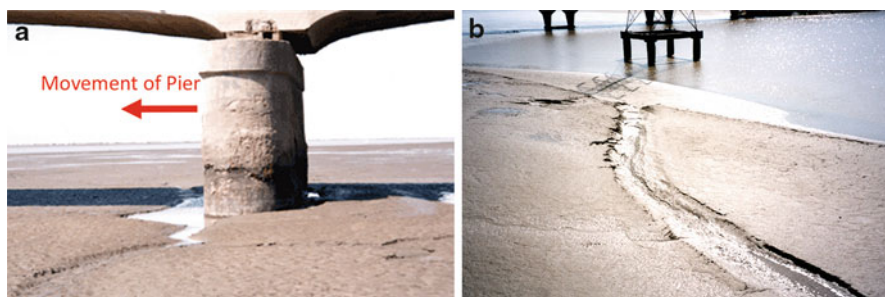
Fig. 1.26 Movement of bridge pier due to liquefied ground displacement (2001 Gujarat-Kachchh earthquake, India, at Hadakia bridge). (a) Movement of pier. (b) Soil liquefaction and surface break

Figure 1.26a shows the concrete pier of a bridge with total length 1,171 m and 30 spans crossing the Hadakia River, about 50 km from the epicenter. Due to horizontal displacement of liquefied ground in the river reservation, the foundations of bridge piers moved toward the river center. Ground surface break due to ground displacements was observed in a river channel, as shown in Fig. 1.26b. Horizontal movements of foundations and piers from liquefied ground flow were also reported in the 2003 Boumerdès earthquake, Algeria (Fig. 1.31).

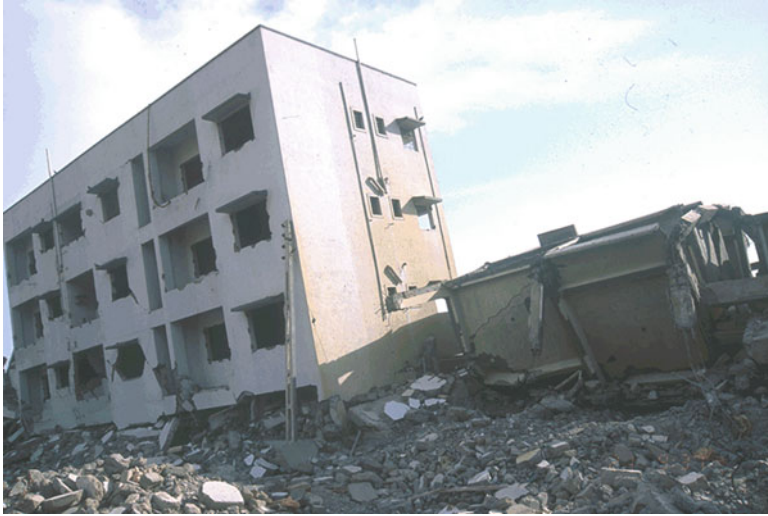
Fig. 1.27 Collapse of Piloti-type concrete building (2001 Gujarat-Kachchh earthquake, India, at Ahmadabad)

Many piloti-type buildings were severely damaged. Figure 1.27 shows a damaged concrete building in Ahmadabad. It was reported that the subsurface layer largely amplified earthquake motion, and the natural periods of the building coincided with the dominant period of ground motion. Power generation plants, oil refineries, and port facilities were also damaged.

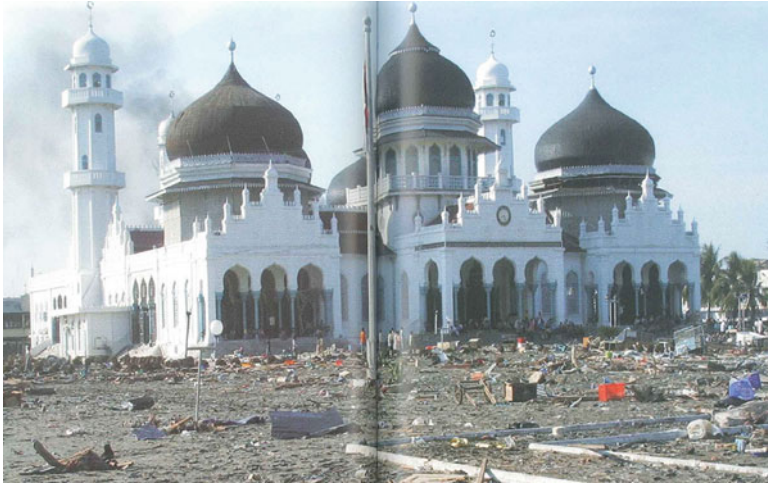
However, Fig. 1.35 shows that some mosques near the coast survived from the tsunami without any structural damage. Because mosques in Islamic societies are the most important buildings, it was presumed that these were constructed with high strength. The tsunami passed through the prayer hall on the first floor of a piloti-type structure.

Fig. 1.35 Mosque survived from the tsunami (2004 Sumatra offshore earthquake and tsunami, at Banda Aceh)

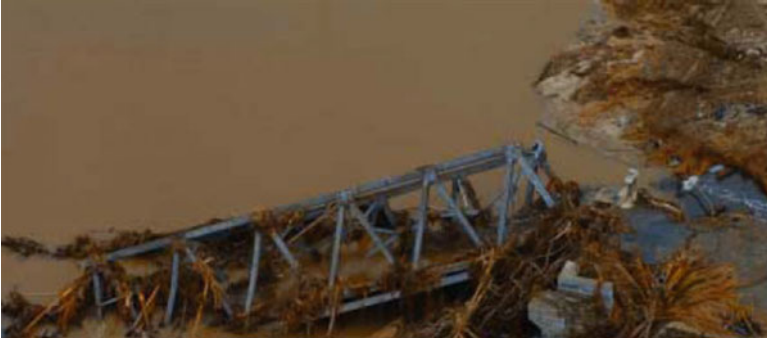
Fig. 1.37 Steel truss bridge washed down by the tsunami (2004 Sumatra offshore earthquake and tsunami, on the west coast of Sumatra)

reconstruction. Along this stretch, about 80 bridges were swept away; most were of a steel-truss type (Fig. 1.37). Embankments behind bridge abutments were washed away by the tsunami. It was assumed that the soft foundation ground was scoured by the tsunami.

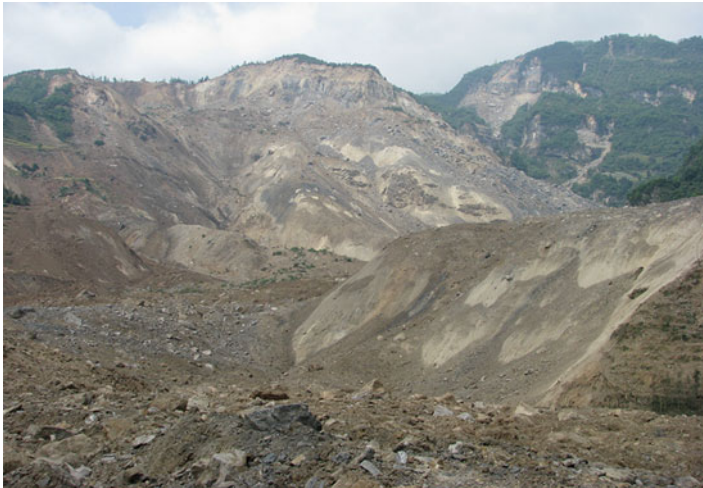
Fig. 1.49 A large slope failure and buried villages (2008 Wenchuan earthquake, China, at Donghekou)

Figure 1.49 displays the long travel landslide at Donghekou in Qingchuan Prefecture, about 250 km from the epicenter. A large amount of soil of a million cubic meters collapsed from a 550-m-high mountaintop, spreading several kilometers. Four villages were buried by this landslide.

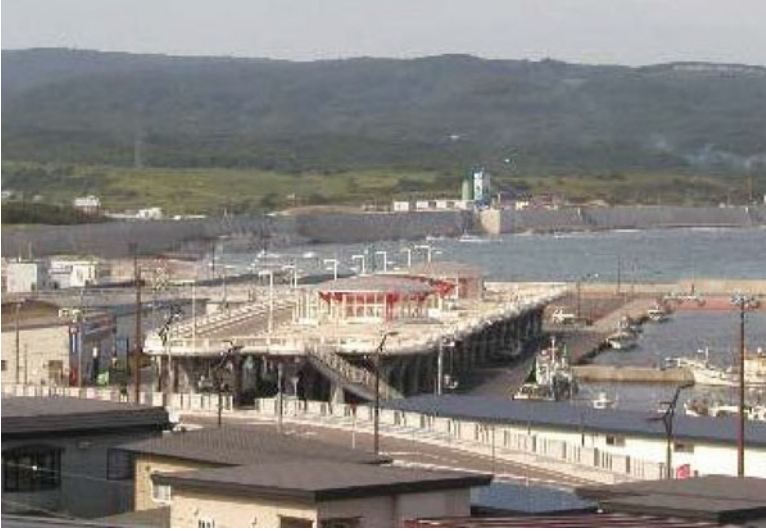
Fig. 1.53 Shelter terrace constructed after the tsunami

In the most severely damaged area of Okushiri Island, embankments of 3–5 m height were constructed behind the existing tide barrier wall after the tsunami. In addition, the area near the coast was made into a park and non-residential area, and residents were relocated to higher ground. Figure 1.53 shows a terrace for the tsunami evacuation shelter that was constructed nearby the coastline.

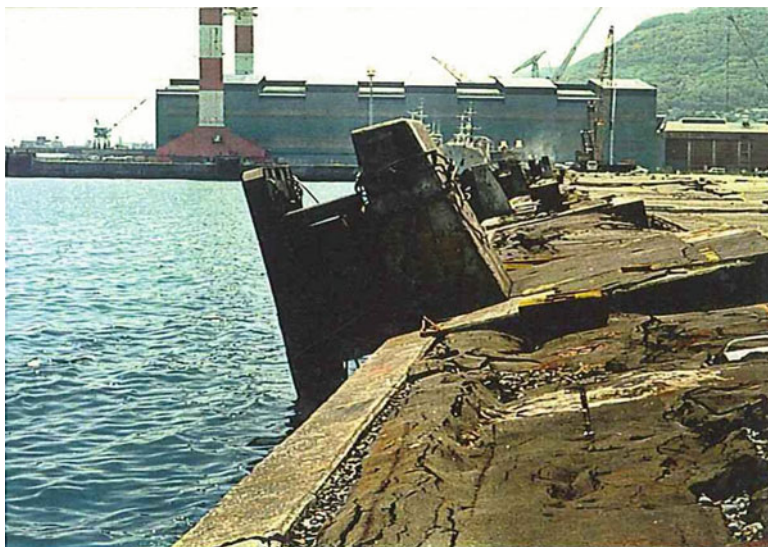
In the Hakodate port area with seismic intensity 4 (JMAI), liquefaction caused inclinations and horizontal displacements of coastal revetments, and subsidence of the pavement behind the revetment (Fig. 1.54). However, the quay wall in the western part of the port was not damaged by soil liquefaction, because the ground had been improved by a sand compaction pile method.

Fig. 1.54 Deformation and inclination of quay wall by steel sheet piles at Hakodate port (1993 Southwest Hokkaido offshore earthquake)

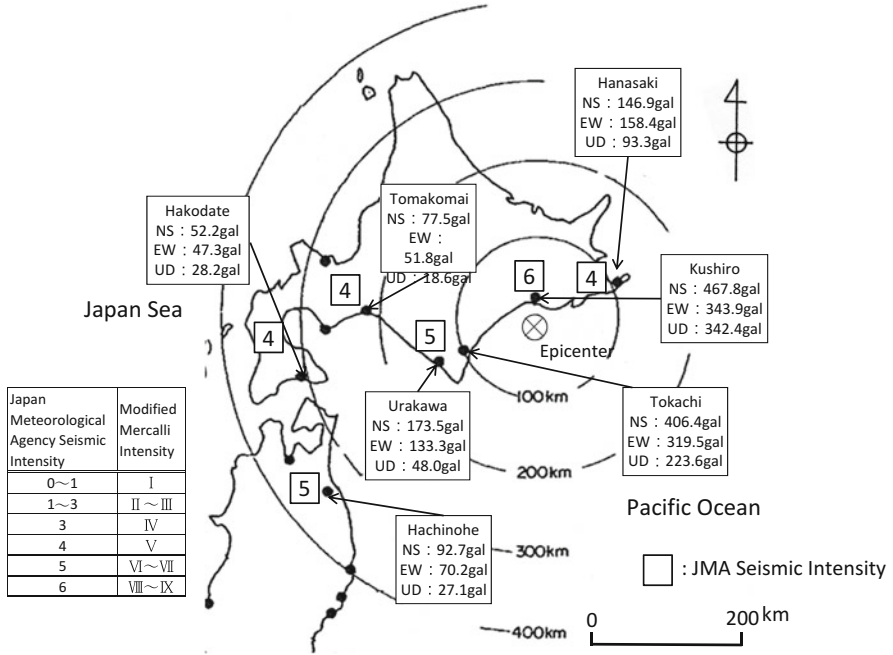
Figure 1.55 shows seismic intensities and maximum accelerations at ground surface in southern Hokkaido and the northern Tohoku region. Seismic intensity was 6 (JMAI), and maximum acceleration at the ground surface was 467 cm/s^2 in port of Kushiro. However, at the Kushiro Meteorological Observatory building, about 16 km from the epicenter, maximum acceleration reached 920 cm/s^2 .

Fig. 1.55 1993 Kushiro offshore earthquake, seismic intensity and ground surface acceleration (cm/s^2)

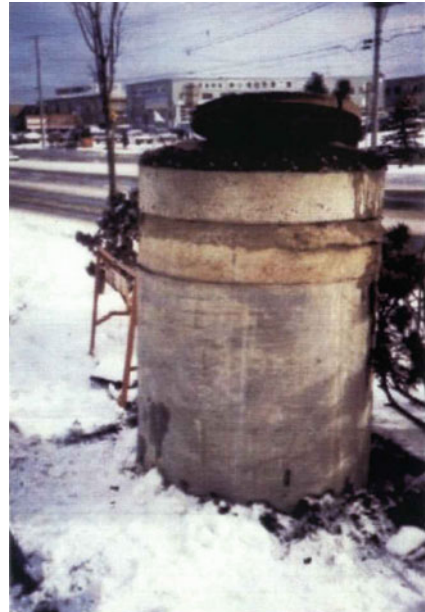
Soil liquefaction caused the uplift of manholes, subsidence and inclination of houses, ruptures of buried pipes, and others. Figure 1.56 shows a lifted sewage manhole caused by buoyancy of the liquefied soil. It was reported that sandy soil was used for backfill material after excavation and that the ground water level was high.

Fig. 1.56 Uplift of a manhole by soil liquefaction (1993 Kushiro offshore earthquake)

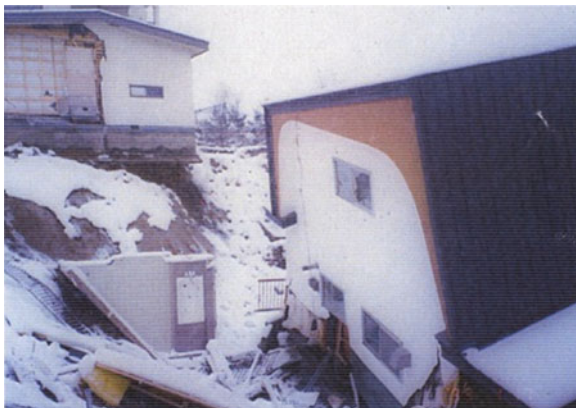
Fig. 1.57 Slope failure in residential area (1993 Kushiro offshore earthquake)

Because the Kushiro earthquake was in January, the ground was frozen to about 1-m depth. The damage to buried pipes and buildings from liquefaction was likely reduced because of decreased displacement and acceleration at the frozen surface. Nevertheless, damage to residential houses was produced by landslides in hilly and mountainous areas (Fig. 1.57).

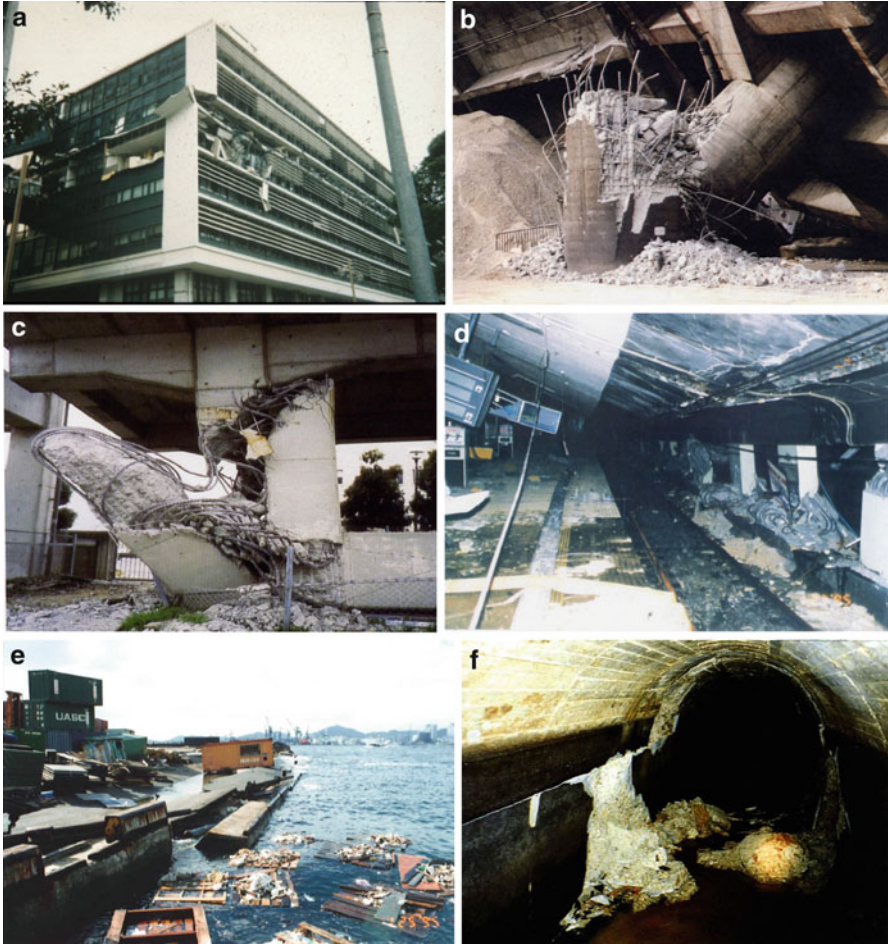
Fig. 1.61 Damage to building, road, railway, subway and tunnel (1995 Kobe earthquake, Japan). (a) Collapse of a building. (b) Shear failure of concrete pier of road bridge. (c) Shear failure of concrete column of railway bridge. (d) Shear failure of columns of subway. (e) Large inclination of quay wall. (f) Damage to a tunnel for water transmission

The Kobe earthquake raised the following issues for disaster prevention in highly urbanized areas, against earthquakes caused by nearby inland faults. The earthquake was caused by an approximately 40 km-long inland faults. Strong ground motion caused by these faults destroyed a number of buildings, infrastructures and lifelines in the urban area within 5–10 km from the faults. According to response spectra shown in Fig 1.60b, the response acceleration reached 2,000 cm/s^2 between 0.3–0.8 s. This was largely beyond the acceleration of 1000 cm/s^2 used in the design of road bridges and railway structures before the earthquake. The ground motion caused tremendous damage to buildings, roads, railways, subways, quay walls and tunnels (Fig. 1.61).

For water supply to Kobe, Nishinomiya and Ashiya cities, it took about 70 days to recover from damage to purification plants, distribution and transmission pipes, and others. Most notably, the city water works office in Kobe, on the 5th floor of the city hall, collapsed by the earthquake (Fig. 1.61a). Thus, documents regarding facilities and buried pipes were unusable, greatly hindering restoration work.

The water conveyance tunnel in Ashiya (Fig. 1.61f) was damaged. This may be attributed to strong earthquake ground motion near the active fault and shallow depth of the tunnel.

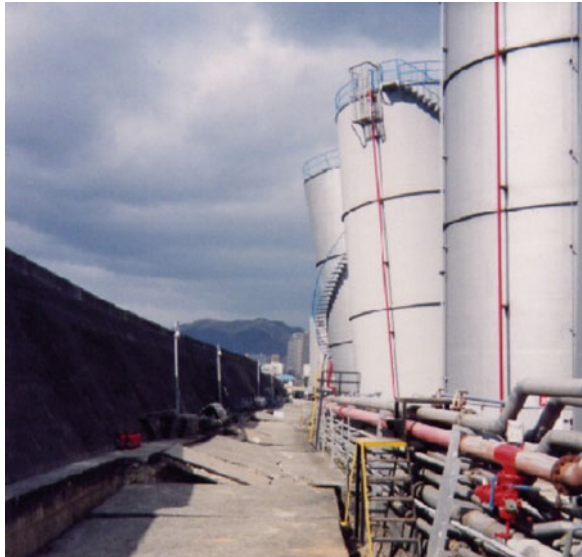
Fig. 1.63 Inclination and subsidence of tanks of petro-chemical products (1995 Kobe earthquake)

The second hidden disaster was that the earthquake did not trigger large fires in storage tanks of oil, petrochemical products and hazardous material in industrial complexes on artificial islands reclaimed from the sea. Figure 1.63 shows inclination of tank due to soil liquefaction in a reclaimed land of Kobe, but there was no collapse. The main reason of no serious damage was the short duration of ground motion of the earthquake, only 10–15 s. A longer duration of several 10 s–1 min would have caused greater inclination and possible collapse, resulting in a much more severe disaster. Oil spilled from collapsed tanks could have induced a large fire on the sea. The large inclination and subsidence of the tanks caused by soil liquefaction during the Kobe earthquake showed the importance of enhancement of earthquake resistance for industrial complexes in reclaimed areas around big cities such as Tokyo, Nagoya and Osaka.

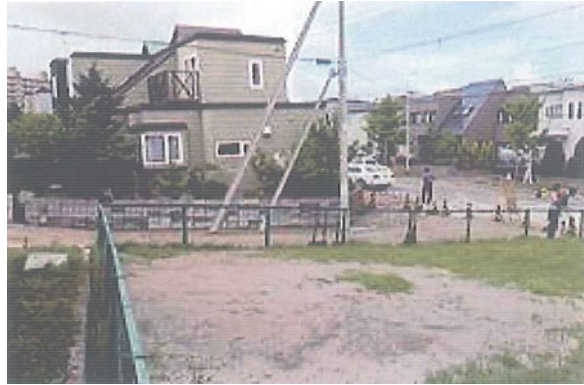
Fig. 1.65 Sand boiling by soil liquefaction and an inclined house (2003 Tokachi offshore earthquake, at Sapporo)

There was extensive soil liquefaction across a wide area of southern Hokkaido, from Sapporo to Kushiro. Liquefaction heavily damaged port facilities, embankments, buried pipes, and residential houses. Figure 1.65 illustrates sand boiling and an inclined house at Kiyota in Sapporo, about 300 km from the epicenter. This residential area was constructed on ground by reclamation from a valley.

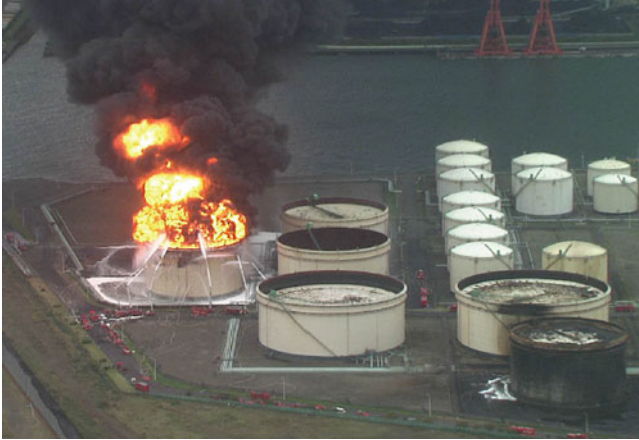
Fig. 1.67 Fire of oil tanks (2003 Tokachi offshore earthquake, at Tomakomai, after Kyodo Tsushin)

Two floating roof-type tanks of diameter about 40 m burnt down at an oil refinery in Tomakomai (Fig. 1.67). Long-period ground motions caused sloshing vibration of the contents of floating type of tank, which triggered the fires. Figure 1.68 shows accelerations at the ground surface and their velocity response spectra, which were recorded at Tomakomai and Hiroo. The epicenter was off

The 2003 Tokachi offshore earthquake caused fires of crude oil and naphtha tanks of an oil refinery in Tomakomai (Fig. 1.67). Long-period earthquake ground motion triggered sloshing vibration of the contents of floating roof-type tanks. It is also assumed that fire broke out from collision of metal fragments of the tanks. Tank fires by long-period component of earthquake motions have been caused in earthquakes greater than mid-scale, such as the 1964 Niigata and 1999 Kocaeli (Turkey) earthquakes. A large number of floating-roof type tanks have been constructed in oil and chemical industrial complexes in Japan. Around Tokyo Bay, the number of such tanks exceeds 600. Several methods to suppress the sloshing vibration of tank contents have been proposed, but none have been practically used to control vibration of content in tanks with diameters of several tens of meters. Moreover, for tanks that have already been constructed, it is difficult to install devices to suppress the sloshing vibration.

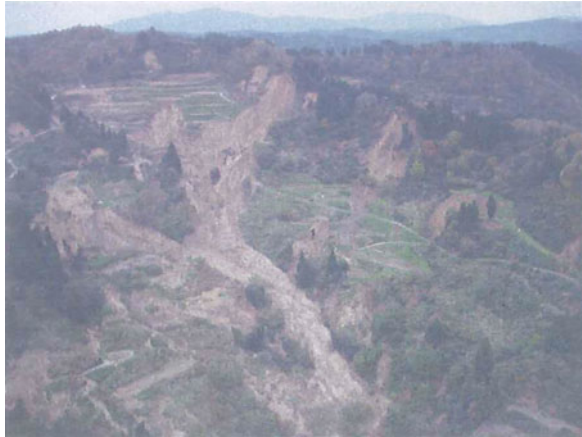
Fig. 1.72 Failures of weathered rock slope (2004 Niigata-Chuetsu earthquake)

Landslides were a major characteristic of the Niigata-Chuetsu earthquake. Areas impacted by the earthquake were in an active fold zone compressed by oceanic plate movement. Mountain slopes were weathered and vulnerable because of abundant groundwater. Strong ground motion caused many landslides. According to a report from the Ministry of Land, Infrastructure, Transport and Tourism, there were approximately 1,662 landslides totally with 70 million m^3 of debris, which dammed rivers and formed many lakes (Fig. 1.72). Imo River were blocked at 38 locations and maximum water volume of the quake lake reached 2.5 million m^3 (Fig. 1.73).

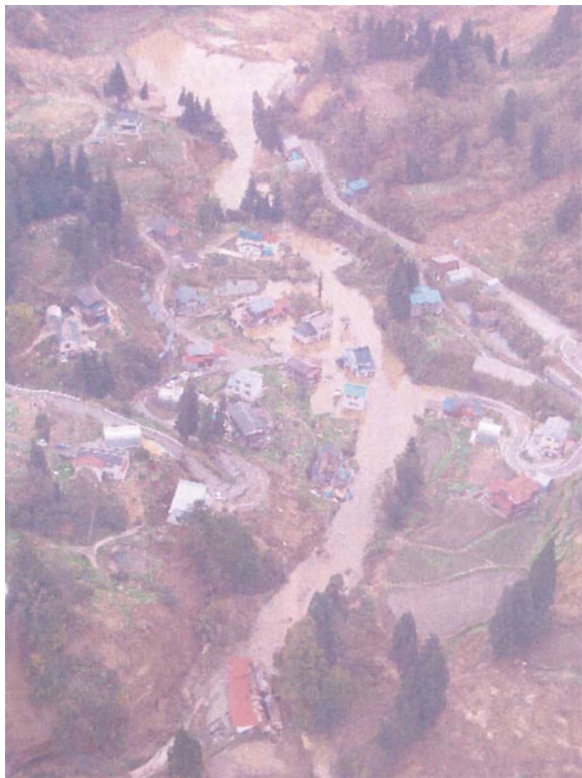
Fig. 1.73 A quake lake by slope failures (2004 Niigata-Chuetsu earthquake)

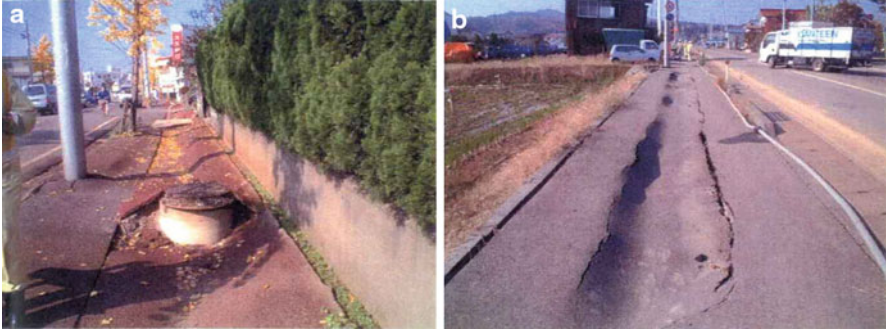
Fig. 1.74 Damage to buried sewage pipes (2004 Niigata-Chuetsu earthquake). (a) Uplift of a manhole by liquefaction of backfilling soil (at Nagaoko). (b) Subsidence of ground surface by liquefaction of backfilling soil (at Ojiya)

Another feature of this earthquake was that numerous manholes were lifted by soil liquefaction (Fig. 1.74a). Over 1,400 manholes were lifted in Ojiya, Nagaoka,

and other areas. Figure 1.74b shows subsidence of the ground surface along sewage pipes, caused by liquefaction of backfilling soil.

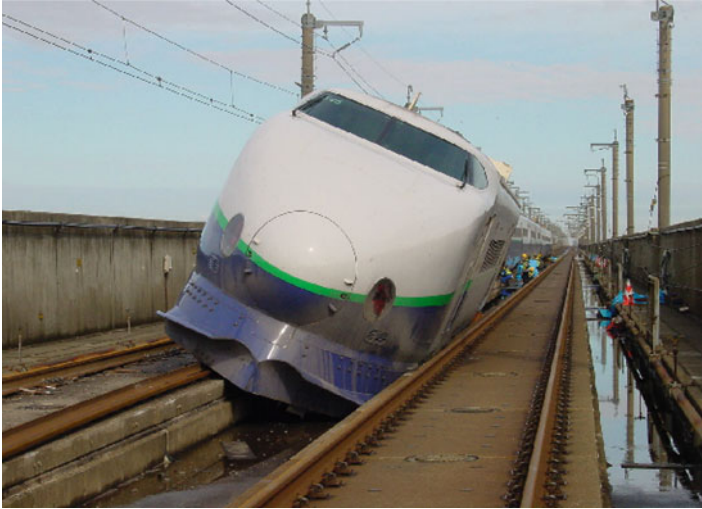
Fig. 1.78 Derailement of Shinkansen due to strong ground motion (2004 Niigata-Chuetsu earthquake)

Other notable damage was derailment of the Shinkansen (bullet train) (Fig. 1.78). The Shinkansen No. 325 from Tokyo to Niigata was derailed between Urasa and Nagaoka by strong earthquake motion. Fortunately, there were no deaths or injuries among the 151 passengers. The train was running on a viaduct of 8.82 m height. The viaduct was constructed on river terraces and alluvial lowlands. The earthquake motion was greatly amplified by the surface soil and viaduct. Seismic intensity at the ground surface in the area was 6 lower, JMAI (6 in Fig. 1.70). However, because of amplification of earthquake motion, intensity at the level of the rail increased to 7. As mentioned above, train derailment was also reported during the 1995 Kobe earthquake. Among nine trains in the area of seismic intensity 7, eight trains derailed.

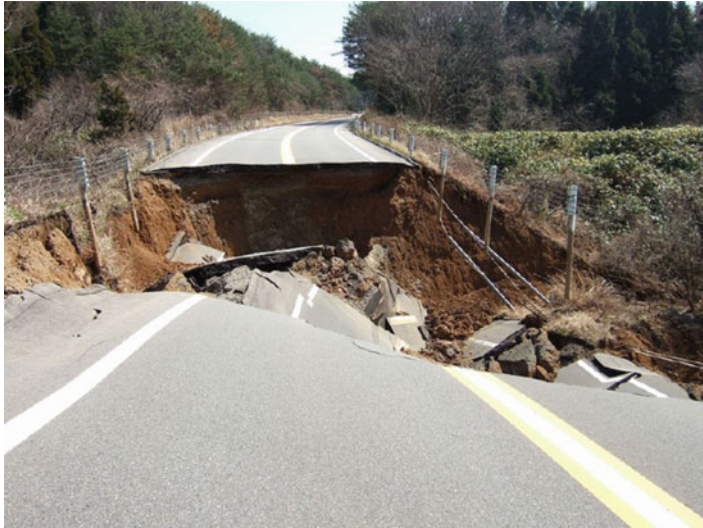
One person was killed and 359 were injured. The numbers of totally collapsed or partially damaged houses and buildings were 638 and 13,553, respectively. This earthquake severely damaged road embankments, quay walls, and buried water and sewage pipes. Figure 1.81 shows a collapse of a highway road embankment crossing a valley.

Fig. 1.81 Failure of embankment of a highway crossing vally (2007 Noto Peninsula earthquake)

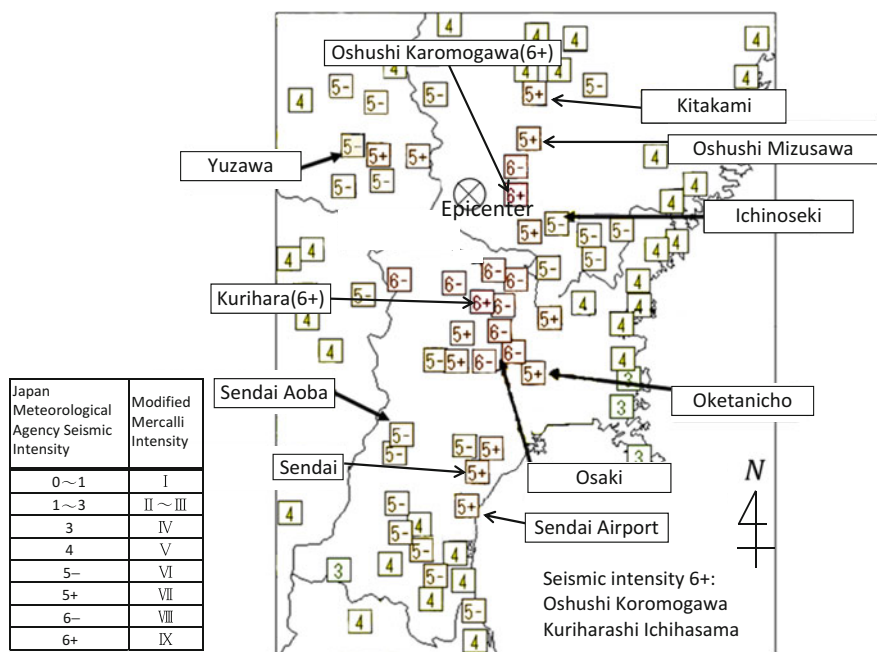
On June 14, 2008, an earthquake of $M_w = 6.9$ occurred in the mountainous region of southern Iwate Prefecture. The epicenter was at $N39^{\circ}01'$ and $E140^{\circ}53'$, with hypocentral depth of 8 km. Figure 1.88 depicts seismic intensities in Iwate, Akita

Fig. 1.88 Seismic intensity by 2008 Iwate-Miyagi inland earthquake

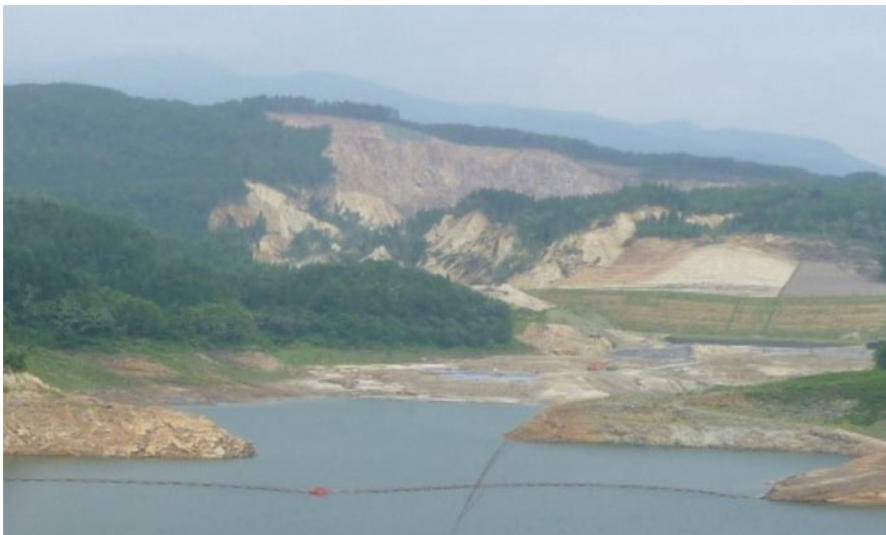
Figure 1.91 shows a huge slope sliding around Aratosawa reservoir, the largest caused by the earthquake. Total length and width of this sliding were 1,300 m and 900 m, respectively. Approximately 7 million m^3 of soil surged downward about 300 m. A ground surface of volcanic ash caused the large-scale slope slide.

Fig. 1.91 Large slope slide at Aratosawa dam lake, (2008 Iwate-Miyagi inland earthquake length: 1.3 km,width: 900 m, debris volume: $70 \times 10^6 \text{ m}^3$)

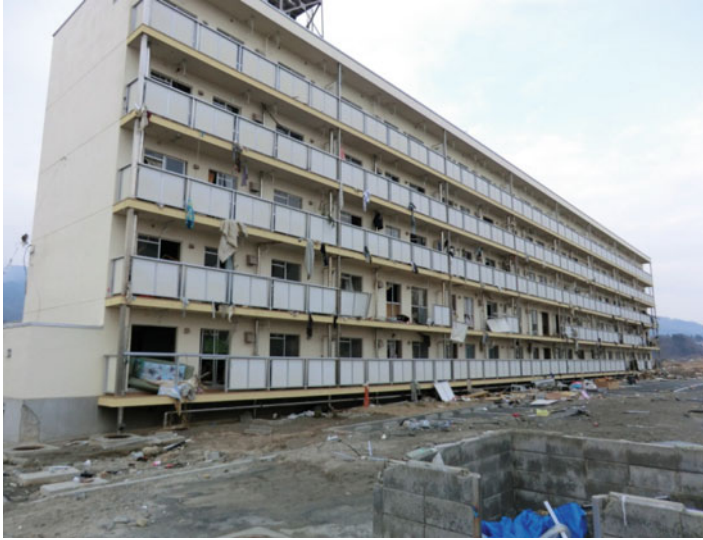
Fig. 1.95 Five story concrete building survived from the tsunami (2011 Tohoku earthquake, at Rikuzen-Takada)

Although many structures and facilities were destroyed by the tsunami, some structures survived. Figure 1.95 shows a survived five-story RC building, which located on the seashore of Rikuzen-Takada. No structural damage was found in the concrete superstructure and on concrete piles. The water level reached the fifth story and the tsunami passed through the building. Figure 1.96 shows survived viaduct for a road along the shore of Kamaishi. The tsunami reached the top of the concrete bridge piers, but no structural damage to the piers was reported.

This concept was suggested based on the investigation of damage to buildings, bridges, and other structures after the 2004 Sumatra and 2011 Tohoku earthquake and tsunami events. As shown in Fig. 1.95 (Sect. 1.3.9 on the Tohoku earthquake), the tsunami was as high as a five-story reinforced concrete apartment building near the coast in Rikuzen-Takata. The tsunami flowed through the entire building but caused no structural damage to it or its concrete foundation piles. Furthermore, as shown in Fig. 1.35 (Sect. 1.2.5 on the Sumatra offshore earthquake and tsunami), a mosque along the coastline in Banda Aceh was structurally unharmed even though the tsunami passed through the prayer hall on its first floor.

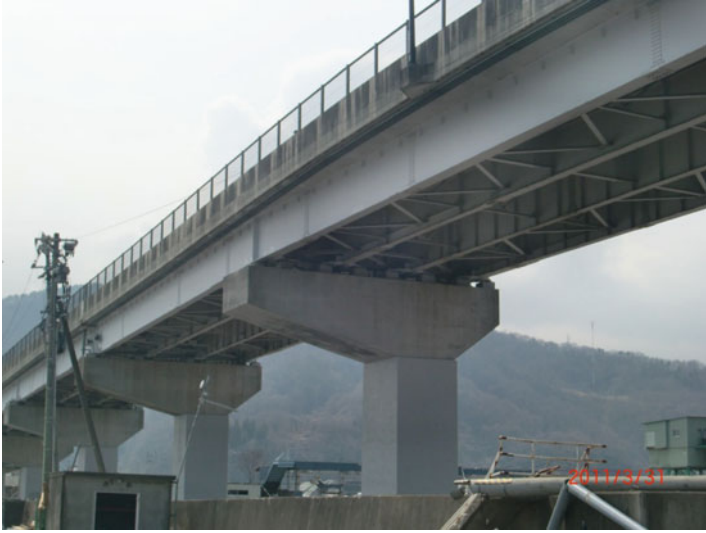
Fig. 1.96 A concrete viaduct for road survived from the tsunami (2011 Tohoku earthquake, at Kamaishi)

In addition, as shown in Fig. 1.96, the tsunami reached the top of a concrete road viaduct constructed on the coastline in Kamaishi, but there was no damage to the concrete pier. The same was reported for a concrete bridge in Banda Aceh.

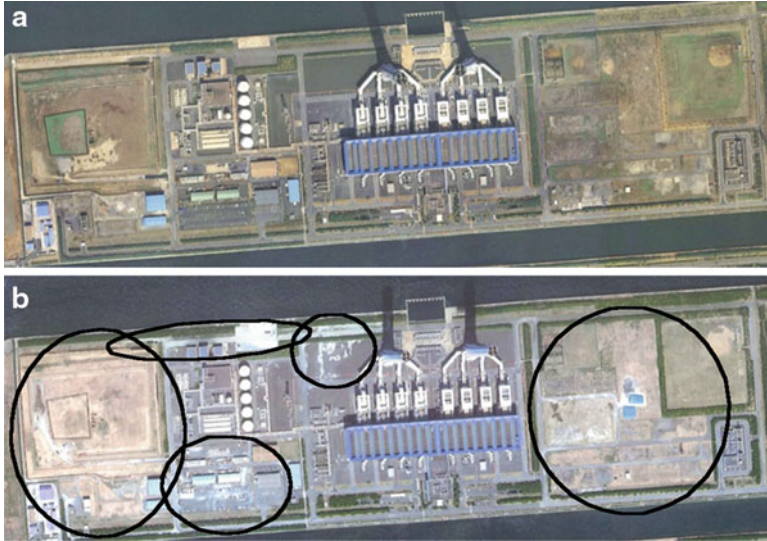
Using satellite and aerial photos of the reclaimed lands around Tokyo Bay taken before and after the earthquake, the author found traces of sand boils and identified locations of soil liquefaction. An example of sand boiling traces is shown in Fig. 1.97. Figure 1.97a is an aerial photo taken half year before the earthquake, and Fig. 1.97b shows the same area 20 days after the earthquake. On the surface within the circles, the traces of sand boiling can be seen. The sites of soil liquefaction surveyed by the aerial photos around the Tokyo Bay are summarized in Fig. 1.98. The result shows that most of the bay areas liquefied. Figure 1.99 shows a lifted sewage manhole in Urayasu, and sand and water boils in reclaimed land of Kawasaki.

Fig. 1.97 Soil liquefaction in power plant around the Tokyo Bay (2011 Tohoku earthquake). (a) Before the earthquake (2009.10.16). (b) After the earthquake (2011.3.31) (identification of liquefaction traces by aerial photographs, circles show the traces of the sand boiling)

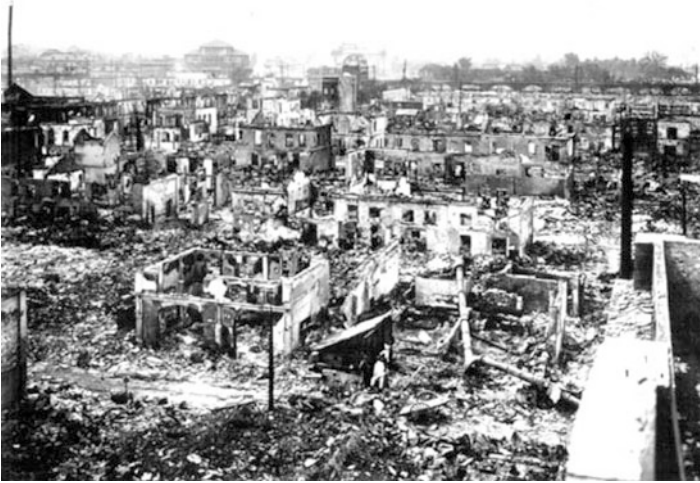
Fig. 2.2 Damage to modernistic buildings by 1923 Kanto earthquake (home page of the National Science Museum)

Attention has been paid to earthquake-resistance of structures such as buildings and bridges, particularly since the 1923 Kanto earthquake (Great Kanto Earthquake Disaster). More than 576,000 houses and buildings were destroyed and burnt by the earthquake. Because of fires after the earthquake, there were more than 140,000 dead and missing. This earthquake has been regarded as the most serious calamity in modern history in Japan. Modernistic buildings constructed by European and American technologies during the Meiji Era (1868–1912) were greatly damaged in this event, as shown by Fig. 2.2.

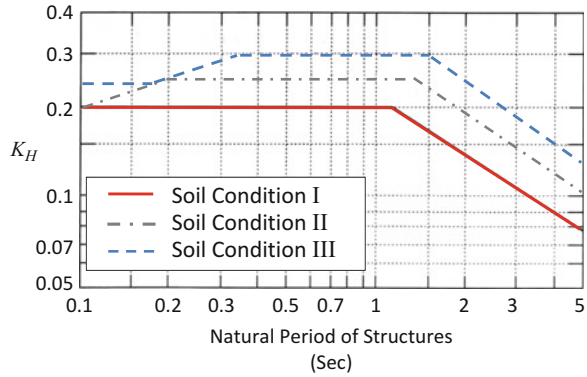
Fig. 2.4 Seismic coefficients K_H for modified seismic coefficient method (Specification for Highway Bridges and Explanation, Part V, Seismic Design [3])

A modified seismic coefficient method is proposed to solve this limitation. Seismic intensity coefficient is required to change with the natural period of structures. Figure 2.4 depicts the K_H in *Specifications for Highway Bridges and*

Explanation Part V, Seismic Design [3]. The horizontal axis indicates the natural period of structures, and K_H is determined by natural periods of structures and soil condition (I to III). The horizontal force H on the structures can be obtained from

where C_z is the regional coefficient; values of 0.8–1.0 were adopted (Fig. 2.5) according to regional seismic activities. Figure 2.4 indicates that K_H is relatively large for periods between 0.3 s and 1.5 s under the soil condition III. This follows from the fact that earthquake ground motions are generally dominant in these periods.

Soil conditions I to III are determined based on the natural period of the surface ground. Type III represents soft soil such as alluvial plain and reclaimed land, whereas type I indicates hard soil such as diluvial ground and bedrock. Type II specifies soil intermediate to types I and III. Figure 2.4 is termed a response spectrum, and is calculated by the method described below.

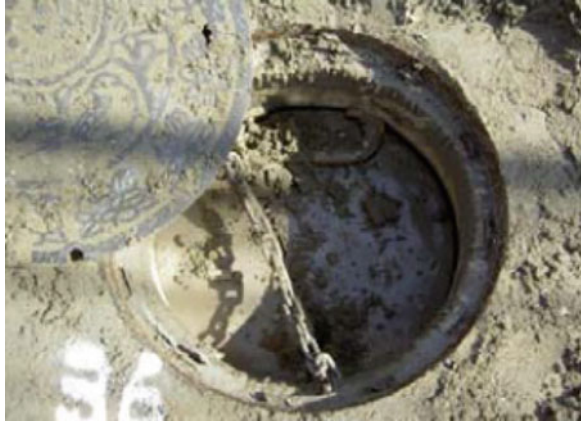
Fig. 2.9 Liquefied soil flow into a manhole (2011 Tohoku earthquake)

Numerous waste water treatment plants and pumping stations were severely damaged by the tsunami of the 2011 Tohoku earthquake. Because of loss of power sources by tsunami inundation, inflow of floating objects to the sedimentation basins, and flowing-out of machineries, sewage treatment functions were stopped for a long period. For this reason, the *Fundamental Concept for Promoting Anti-Tsunami Measures* was established by the “Committee for Anti-Earthquake and Tsunami Measure of Sewage System”. Details are described in Sect. 2.8. Furthermore, there were another kinds of sewage pipelines damage such as horizontal differential displacement of concrete ring elements of manholes, pullout of sewage pipes connecting manholes, and inflow of liquefied soil. An example of liquefied soil flow into a manhole is shown in Fig. 2.9.

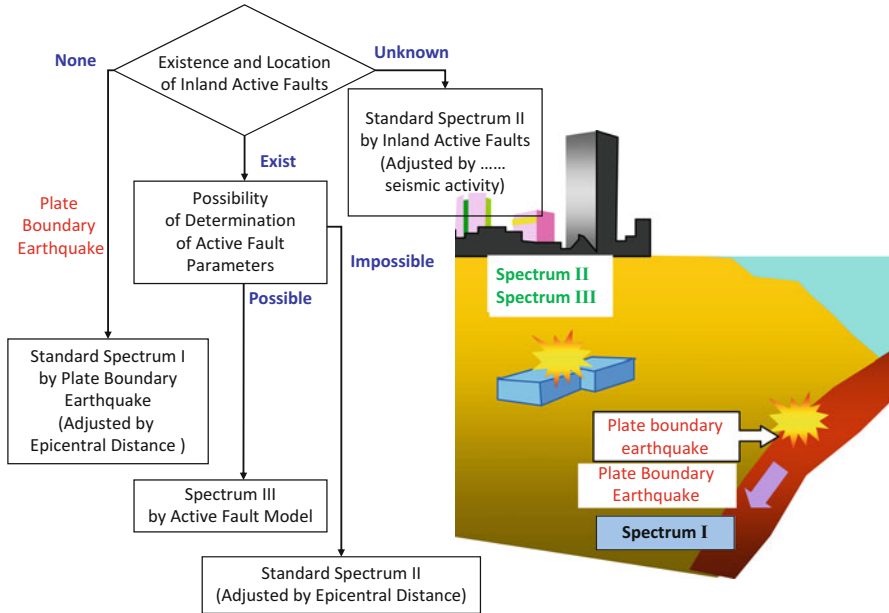
Fig. 2.14 Flow of setting of level-2 earthquake ground motion for railway structures [12]

In the standards of railway structures [11], a flowchart as shown in Fig. 2.14 is recommended for determination of level 2 ground motion. In this flowchart, whether inland active faults existence is firstly investigated. Second, if it is determined that such faults do not exist, the standard spectrum I by plate-boundary earthquakes is used, with adjustment for epicentral distance. If it is ascertained that inland active faults exist and determination of the parameters of fault failure is possible, design ground motion is directly determined by numerical analysis (Spectrum III). When identification of those parameters is impossible, standard spectrum II, which is made based on ground motions observed during past earthquakes caused by inland faults, is adjusted by the regional seismic activity. When the existence and locations of inland faults are unknown, the standard spectrum II is adjusted by the regional seismic activity.

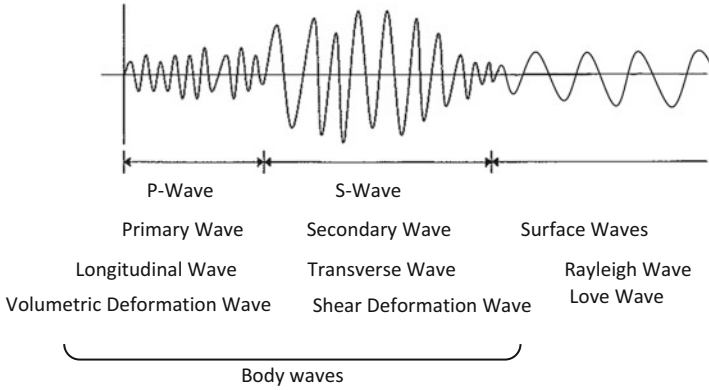
Fig. 2.16 Seismic waves

Seismic waves consist of body waves, which are P (primary) and S (Secondary) waves, and surface waves, which are Rayleigh and Love waves (Fig. 2.16). P and S-waves directly propagate in the earth crust and soil from the fault to the ground surface. The Rayleigh and Love waves, which are generated after the body (P and S) waves reach the surface, propagate along the surface.

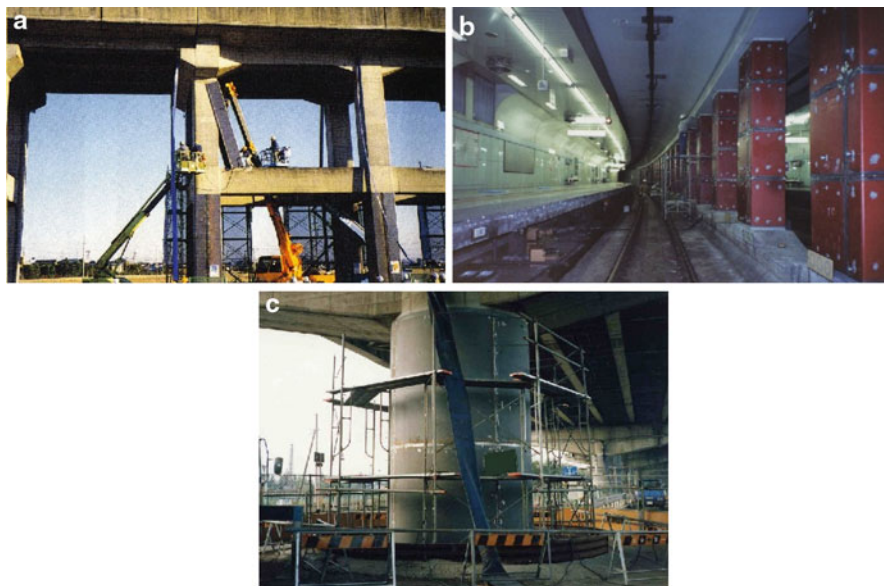
Fig. 2.24 Seismic reinforcement of concrete structures (by steel jacking). (a) Concrete viaduct of shinkansen (*new trunk line*). (b) Center concrete column of subway station. (c) Concrete bridge pier of an express way

concrete casting (Fig. 2.23b). Examples of the reinforcement of viaducts of the Shinkansen (new trunk line), center columns of a subway, and piers of an express highway are shown in Fig. 2.24. Shear failures of subway center columns resulted in total collapse in Kobe. Therefore, about 3,000 concrete subway columns were reinforced in big cities, such as Tokyo and Osaka. In addition to the above-mentioned two methods, reinforcement by aramid and carbon fibers (Fig. 2.23c), and PC steel bars have been adopted. Furthermore, for rigid-frame piers, methods to construct shear walls between the piers and methods using dampers have been developed. The effectiveness of concrete pier reinforcement by steel jacking was examined by model tests. It was confirmed that both strength and ductility of reinforced piers increased.

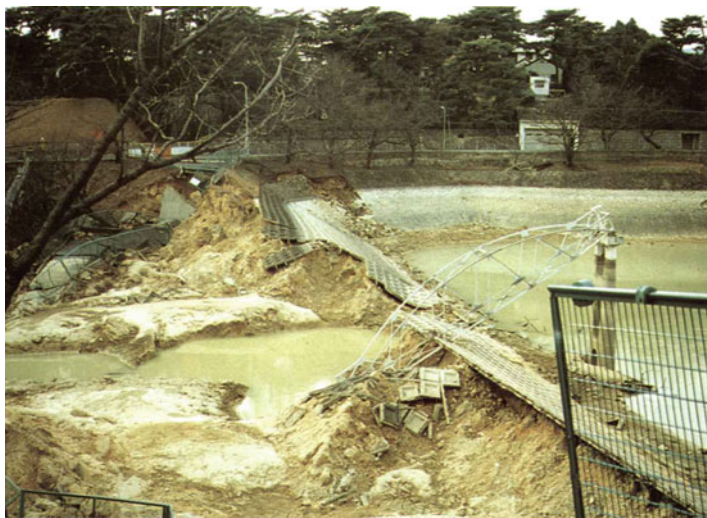
Fig. 2.25 Slide and sinkage of Niteko earth dam (1995 Kobe earthquake)

Niteko Reservoir dam in Nishinomiya slid and sank significantly in the 1995 Kobe earthquake (Fig. 2.25). N-values of the dam body and foundation ground were less than 10, and circular slip was caused by strong earthquake motion near the

active fault. The dam was located in a densely populated area and had height approximately 15 m. Fortunately, the water level of the reservoir at the time of the earthquake was low, so there was no flooding.

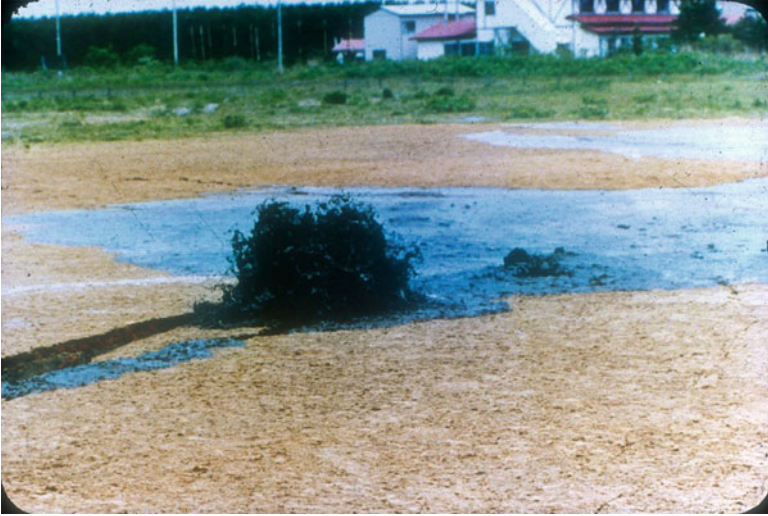
Fig. 3.1 Sand and water boiling due to soil liquefaction (1983 Central Japan Sea earthquake) [1]

Figure 3.1 shows a baseball field in Noshiro of Akita Prefecture just after the 1983 central Japan Sea earthquake, which caused widespread soil liquefaction [1]. The figure captures the moment of the seismically triggered “sand boil.” Figure 3.2, was taken in the suburb of Dagupan after the 1990 Luzon Islands earthquake in the Philippines, showing a sand volcano of several meters in diameter, with sand and
