Masanori Hamada

Engineering for Earthquake Disaster Mitigation

Masanori Hamada
Waseda University
Tokyo, Japan

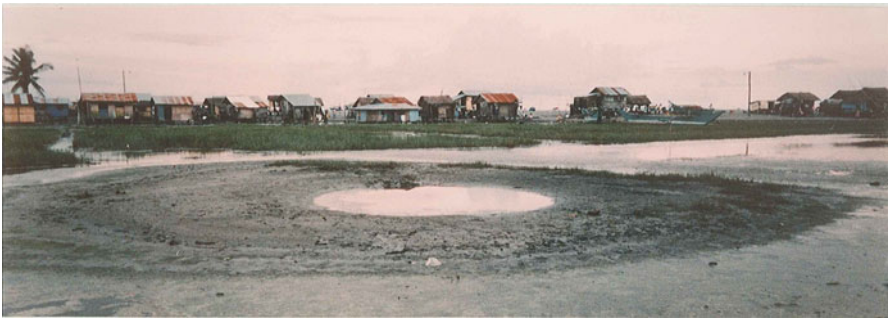
Fig. 3.2 A large sand volcano (1990 Luzon earthquake, Philippines) [2] (the diameter of sand volcano was about 5 m and sand spread about 15 m in radial direction)

Figure 3.1 shows a baseball field in Noshiro of Akita Prefecture just after the 1983 central Japan Sea earthquake, which caused widespread soil liquefaction [1]. The figure captures the moment of the seismically triggered “sand boil.” Figure 3.2, was taken in the suburb of Dagupan after the 1990 Luzon Islands earthquake in the Philippines, showing a sand volcano of several meters in diameter, with sand and

water spreading outward concentrically [2]. According to local residents on the scene, the sand surged as high as the tops of telephone poles. Although this may have been exaggerated because of the state of agitation of these witnesses, the fact that an enormous volume of sand and water boiled out of the ground is indisputable.

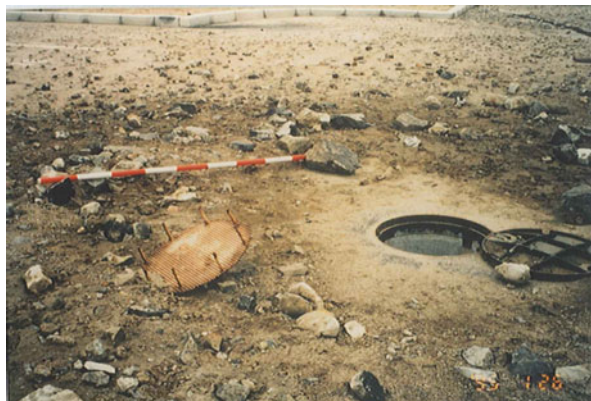
Fig. 3.4 Gravels boiled out of ground due to liquefaction (1995 Kobe earthquake)

Although alluvial fan is included in (C), liquefaction occurred with a mixture of pebbly and decomposed granite soil during the 1995 Kobe earthquake (Fig. 3.4). Thus, the liquefaction potential of alluvial fan must be qualified with consideration of soil contents.

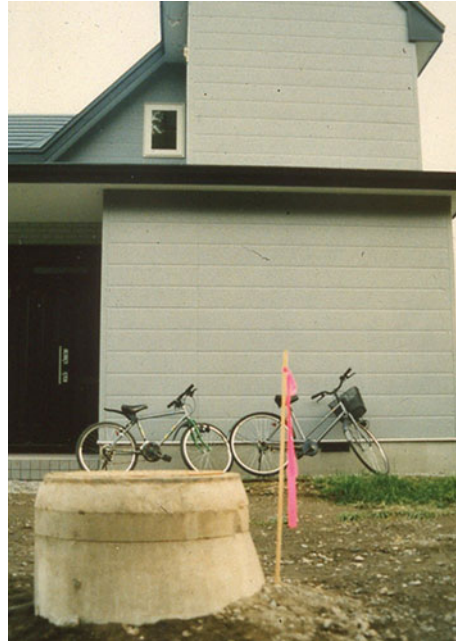
Fig. 3.21 A non-damaged house against soil liquefaction (1993 Tokachi offshore earthquake)

A huge number of houses have suffered subsidence and inclination from soil liquefaction during earthquakes. For residential houses, there is a problem of substantial construction cost for driving long piles into deep firm ground. One method to lessen house damage by liquefaction is the use of concrete spread foundations with gravel layer. Figure 3.21 is a photo taken after the 1993 Kushiro offshore earthquake, which shows a manhole lifted by soil liquefaction next to an undamaged house. Contrarily sand boils were observed in the neighborhood. It was reported that this house had a concrete mat foundation underlain by a gravel layer. It is believed that the gravel layer dissipated pore water pressure and the spread foundation prevented the structural damage of the house.

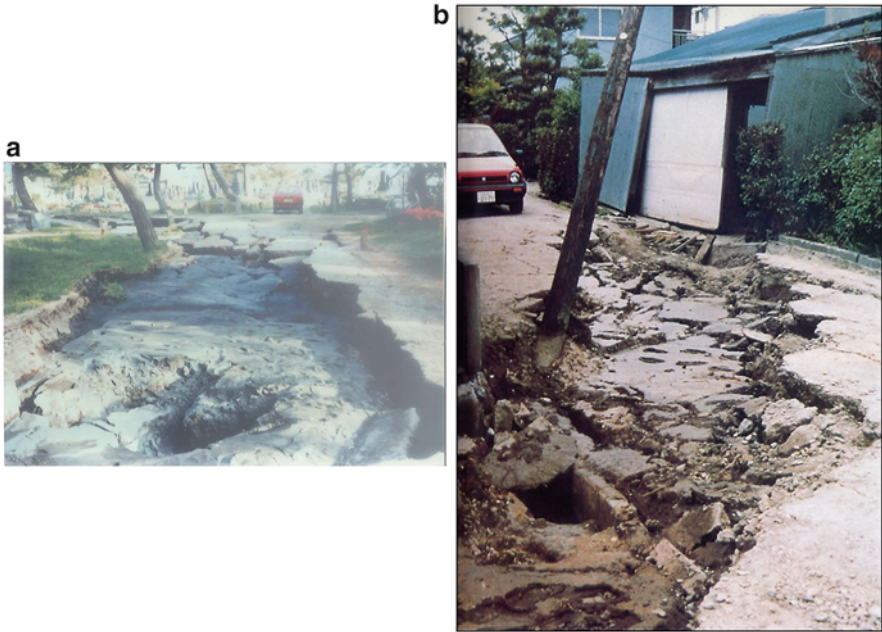
To investigate the cause of these pipe ruptures, ground failures such as fissures and subsidence, and damage to structures such as houses in the liquefied area were surveyed. Figure 4.2 reveals examples of fissures at the ground surface that were observed over a broad area of Noshiro. It was inferred that there were large ground displacements in the horizontal direction. Figure 4.3 illustrates separation of a concrete-brick wall, which also showed a trace of horizontal ground displacements. These ground fissures and brick wall gap suggest that breakage of the pipes was not caused by cyclic ground displacements, but by monotonic ones. The damage to the pipes and traces of horizontal ground movement motivated research on liquefaction-induced ground displacements and their induced damage.

Fig. 4.2 Surface fissures by horizontal ground displacements (1983 Central Japan Sea earthquake). (a) Surface fissure and sand volcano in a park. (b) Surface fissure in a residential area

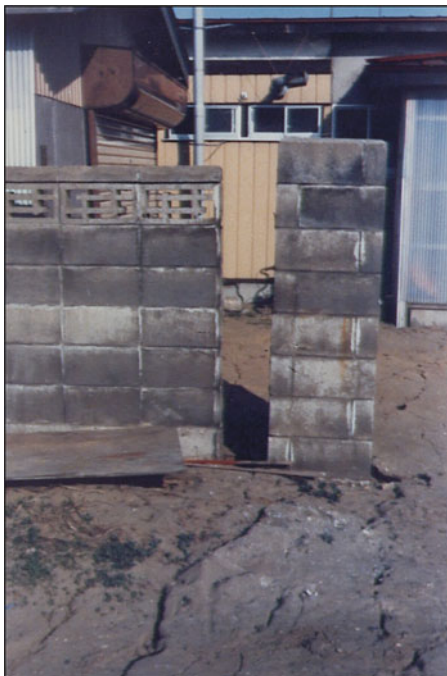
Fig. 4.3 Horizontal separation and vertical gap of a brick wall (1983 Central Japan Sea earthquake)

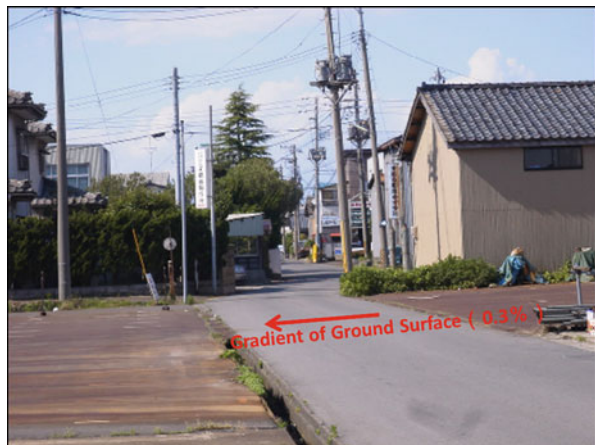
There are many reports that previously straight roads were curved by liquefaction-induced displacements in Niigata. Figure 4.32 was taken from point B in Fig. 4.33. This road had been straight prior to the earthquake, but the ground displaced 3–4 m westward (Fig. 4.33). The gradient of the ground surface was very small, about 0.3 %. From Fig. 4.32, however, it is inferred that the ground surface slightly inclines from right to left in a westerly direction.

Fig. 4.32 Curved road by liquefaction-induced ground displacements (1964 Niigata earthquake)

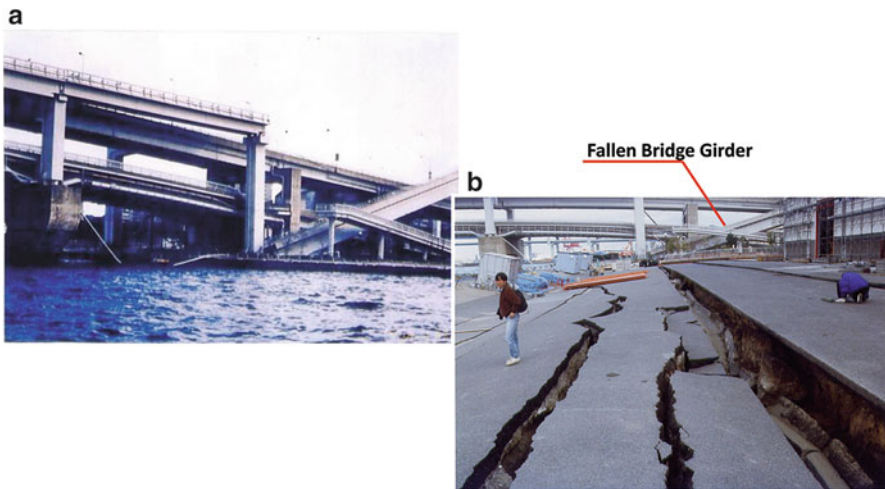
Fig. 4.35 Fall of a bridge girder by liquefaction-induced ground displacements (1995 Kobe earthquake, at Rokko Island). (a) Fall of a bridge girder. (b) Ground fissures, and inclination and subsidence of ground surface

Figure 4.35 shows the fallen bridge girder and post-earthquake situation of the ground surface, which had previously been level. The ground inclined toward the sea, with fissures running parallel to the quay wall. The ground surface along the wall sank more than 2 m, and areas as far as 100 m also sank, by over 1 m (Fig. 4.34). Increased span between neighboring piers as the cause of bridge girder fall during the Kobe earthquake was seen elsewhere. A bridge of the Hanshin Expressway Bayshore Line collapsed, as shown in Fig. 4.36a, due to the movement of the pier foundation with a magnitude of about 1 m in the direction of the sea. As an aerial photo shows, the vicinity of the pier was covered by boiled sand due to soil liquefaction, with fissures opening in the ground behind the quay wall. Figure 4.36b shows an approach ramp to the Kobe Bridge, which also collapsed due to the ground displacements in the seaward direction.

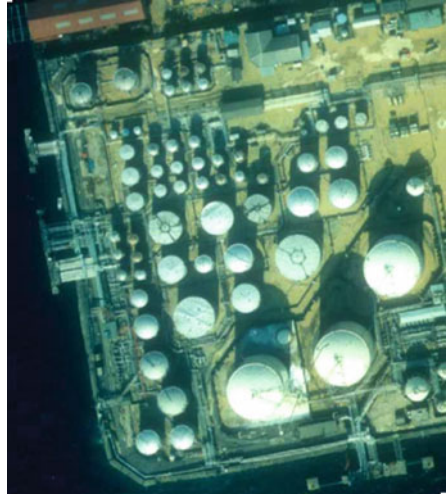
Figure 4.37 is an aerial photo taken over a tank yard in Kobe, 2 days after the earthquake. Boiled sand accumulated all over the yard, indicating that its entire area had liquefied (yellow colored part in the figure). The three large tanks in the photo contained LPG (liquefied propane gas). In the aftermath of the earthquake, a large amount of gas leaked because of rupture of a pipeline valve. The threat of a massive explosion of leaked propane gas forced neighborhood residents to be evacuated for about 24 h.

Fig. 4.37 Soil liquefaction in a tank yard (1995 Kobe earthquake, Mikagehama in Kobe city)

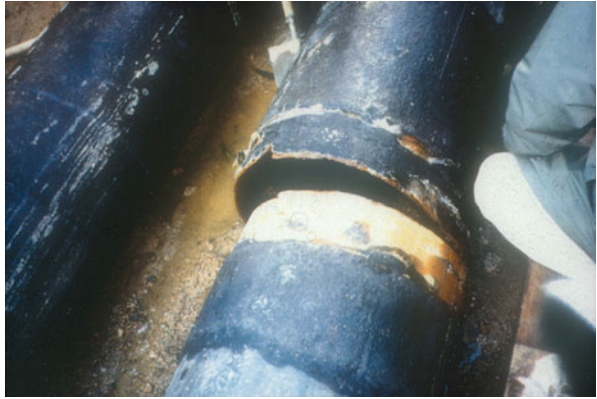
Fig. 4.40 Rupture of buried pipe of water trunk line by liquefaction-induced ground displacements (1995 Kobe earthquake, Port Island)

Figure 4.39 shows horizontal and vertical ground displacements in a park in northern part of the Island. The park is surrounded by the sea on three sides, and the ground expanded seaward in three directions. Maximum horizontal ground displacement in this area reached more than 4 m. Point D in Fig. 4.39 indicates where a buried pipe of a water trunk line was ruptured. The pipe was broken and separated at the welded joint, as shown in Fig. 4.40. From measured displacements, ground strain was estimated to be tensile with magnitude 2.5%.

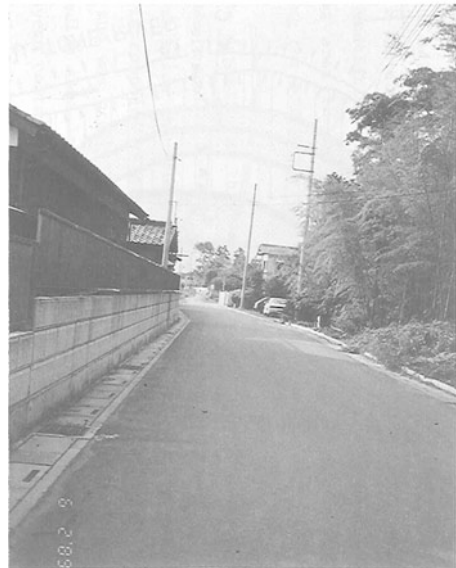
Fig. 4.55 Curved road due to the liquefaction-induced ground displacement (1923 Kanto earthquake at Kawakubo)

72 m displaced a maximum of 1.5 m eastward, toward the old Tone River. A survey by the author confirmed that as seen in Fig. 4.55, the road remains curved. Following the F-F' section of Fig. 4.53, Fig. 4.56 shows the soil condition and estimation of liquefaction under an assumption that ground surface acceleration was 200 cm/s^2 . The present ground surface is 5–7 m above sea level and the mean gradient of the ground surface is 0.7 % toward the Old Tone River. The ground under the riverbank consists of a sand deposit, mostly with fine and medium grain-size sand of 5 m thickness. Maximum thickness of the liquefied soil where there were fissures and

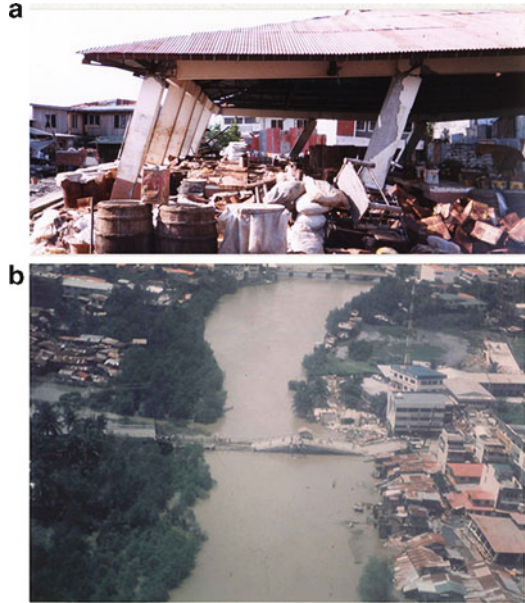
Fig. 4.60 Liquefaction-induced ground displacements (1990 Luzon Island earthquake, Phillipines, at Dugupan).
 (a) Movement of a building towards the river.
 (b) Collapse of the Magsaysay bridge

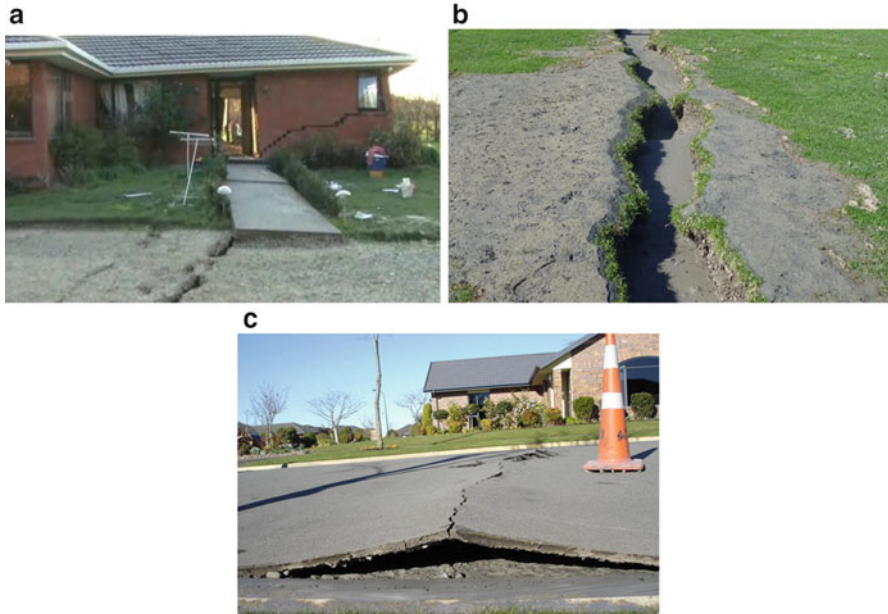
Fig. 4.66 Damage to house, ground fissure and buckling of pavement (2010 Darfield earthquake, New Zealand). (a) A House damaged by ground displacement. (b) Ground fissure and sand boil. (c) Buckling of pavement

An earthquake of moment magnitude $M_w = 7.1$ struck the city of Christchurch on the South Island of New Zealand on September 4, 2010, with an epicenter some 50 km west in Darfield. The earthquake triggered extensive soil liquefaction and ground displacements in residential suburbs of the city, causing severe damage to houses and lifeline systems, including water and sewage services. Ground displacements were measured by aerial photos before and after the earthquake in two Christchurch suburbs, Avon and Kaiapoi (Fig. 4.65). As indicated in Fig. 4.66, a number of houses suffered from liquefaction-induced ground displacements, and ground fissures and pavement buckling were observed.

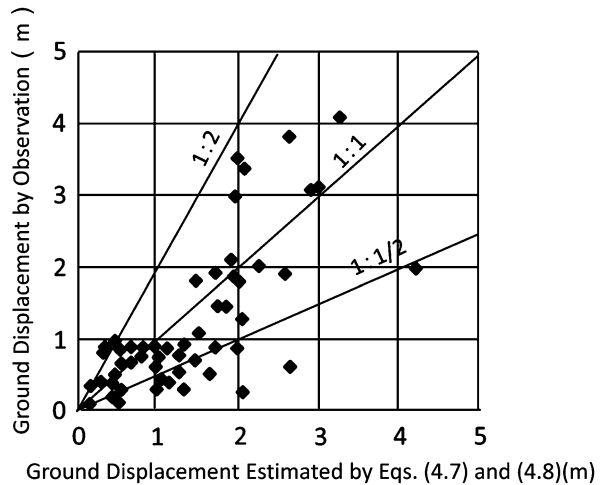
Fig. 4.74 Horizontal ground displacements by observation and Eqs. (4.7) and (4.8)

Figure 4.74 compares ground displacements estimated by Eqs. (4.7) and (4.8) and observed ones. In this case, the estimated displacements also show large scatter, again indicating the difficulty of estimating liquefaction-induced ground displacements with high accuracy.

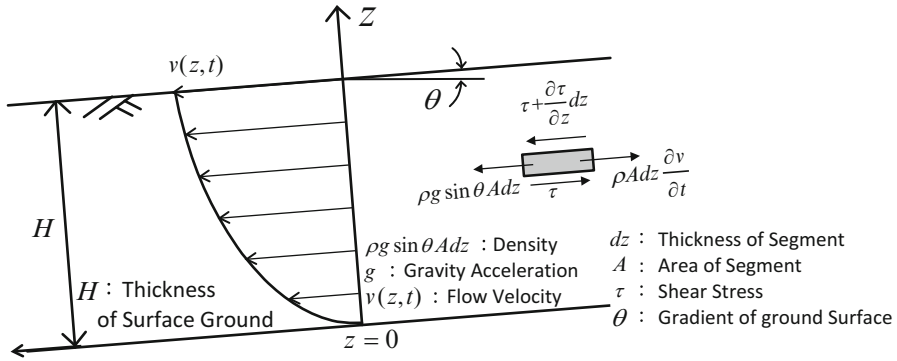
Fig. 4.78 One-dimensional viscous flow

one-dimensional viscous flow at the surface from a stationary condition can be obtained as follows, from the dynamic equilibrium of forces on a small segment of liquefied soil (Fig. 4.78):

Here, μ , ρ , θ , g , H , t are coefficients of viscosity of liquefied soil, density of liquefied soil, ground surface gradient, gravity acceleration (980 cm/s²), thickness of liquefied soil and time, respectively. The experiments were conducted under conditions shown in Table 4.3. The thickness of the model ground was varied from 84 to 151 cm, but the relative density of the model ground was mostly constant, and ground surface gradient, acceleration and frequency of input motion were same. The purpose of this experiment was to examine the effect of thickness of the ground on flow characteristics of liquefied ground.

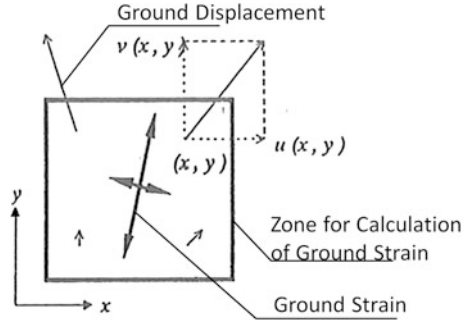
Fig. 4.83 Calculation of ground strains on horizontal plane

- (i) The displacement function in quadrilateral areas with side length about 100 m (Fig. 4.83) is defined by

- (ii) The six coefficients α_1 – γ_2 of the displacement function are determined from measured displacements in quadrilateral areas, by the least mean square method.

(iii) Ground strains on the horizontal (x - y) plane are calculated from the coefficients, as follows:

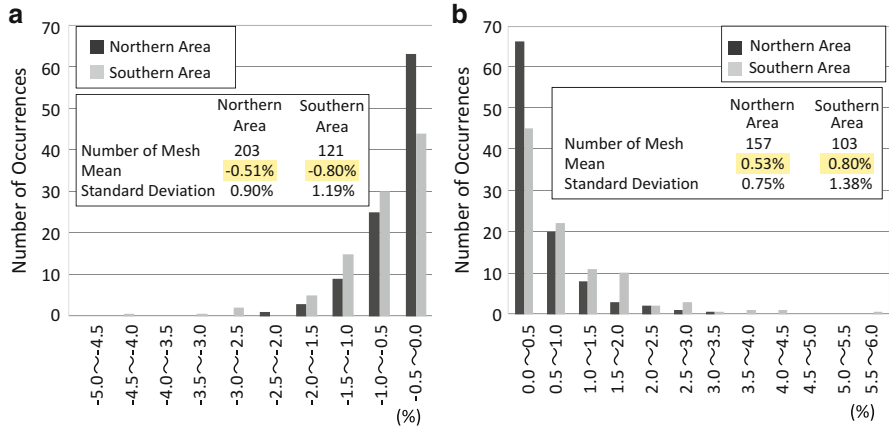
Fig. 4.86 Ground strains due to surface inclination (1983 Central Japan Sea earthquake, ground strain due to type 1 displacement in Fig. 4.70a). (a) Compressive strain (*lower part of slope*). (b) Tensile strain (*upper part of slope*)

An example of ground strains calculated at Port Island in Kobe is shown in Fig. 4.84. Behind the quay walls, there were large tensile strains of more than 2 %. Figure 4.85 shows statistics of compressive and tensile strains in reclaimed land of Kobe, and Fig. 4.86 shows results from sloped ground in Noshiro. According to Fig. 4.85, the mean tensile strain just behind the quay wall (along water in Fig. 4.85) was 0.97 %, which was much larger than that of inland areas at 0.36 %. This large tensile strain was caused by large displacement of the quay wall toward the sea. Similarly, large ground tensile strains were observed behind banks of the Shinano River during the 1964 Niigata earthquake.

According to Fig. 4.86, the magnitudes of tensile strains at the upper part of the sloped ground, and of compressive strains on the lower part, were mostly between 0.5 % and 0.8 %; however, there were some cases of maximum ground strain exceeding 2 %. These results were referenced for ground strain determination during the design of buried water and sewage pipes, as addressed in Sect. 4.3.2.

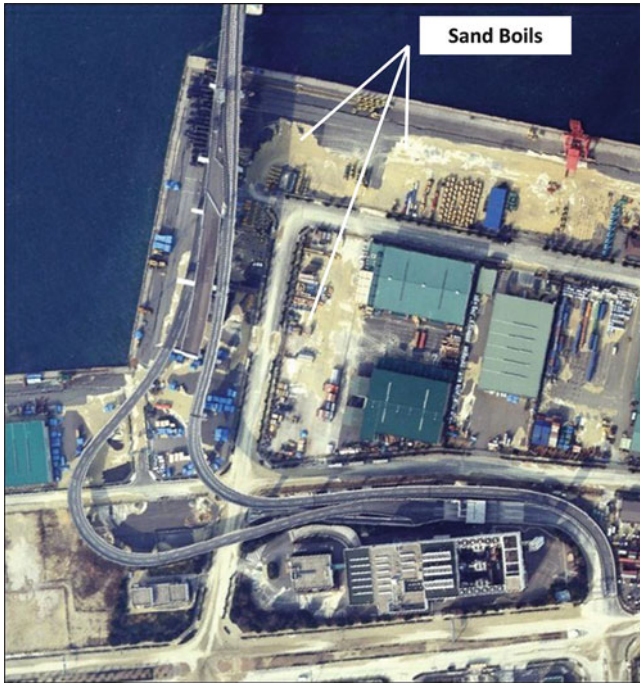
Fig. 4.91 Sand boils around a highway bridge (1995 Kobe earthquake at Rokko island in Kobe)

Figure 4.91 shows an aerial photo of a highway bridge on Rokko Island in Kobe. The yellow colored part on the ground surface indicates sand boils due to soil liquefaction. Figure 4.92 displays horizontal displacements at the ground surface and at the tops of bridge piers, measured by aerial photos before and after the earthquake. The ground surface around the highway displaced 2–3 m seaward, and tops of piers moved a maximum of 90 cm. Based on ground displacement. Through investigation of damage to bridge foundations, the effects of liquefaction-induced ground displacement were taken into the consideration in the revision of earthquake-resistant design of highway bridges and railway bridges after the earthquake. Figure 4.93 illustrates the design method for road bridges (Fig. 4.93a) [4] and railway bridges [32] (Fig. 4.93b). For road bridge design, passive earth pressure from upper non-liquefied soil and earth pressure equivalent to the liquid force generated by liquefied soil flow are considered. The coefficient of equivalent earth pressure from liquefied soil is about 0.3, which was determined by back analyses of the residual deformation of the highway bridge piers after the Kobe earthquake. For the design of

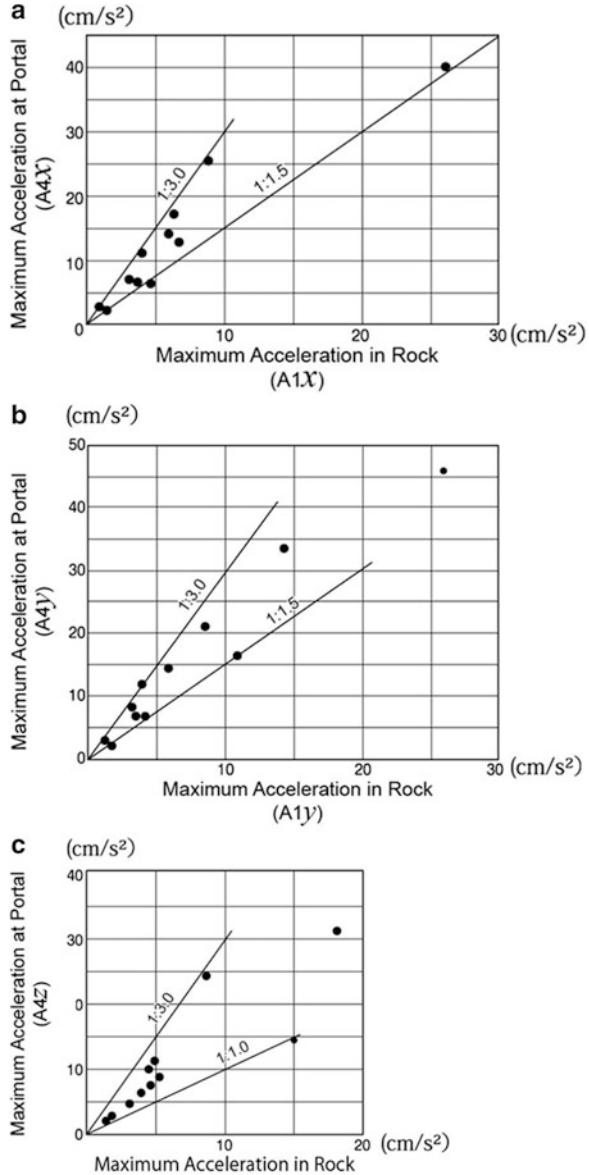
Figure 5.25 shows maximum acceleration at portal (A4) in relation to that at a measurement point in the tunnel (A1). The amplification factor of acceleration at the portal is 1.5–3.0 times in both horizontal directions, and 1.0–3.0 times in the vertical. One reason for this amplification at the portal is the fact that it is a free surface, and another is the fact that the rock surface is covered by talus and topsoil to about 10-m depth.

Fig. 5.25 Amplification of acceleration at portal:
 (a) x direction (axial),
 (b) y direction (lateral),
 and (c) z direction (vertical)

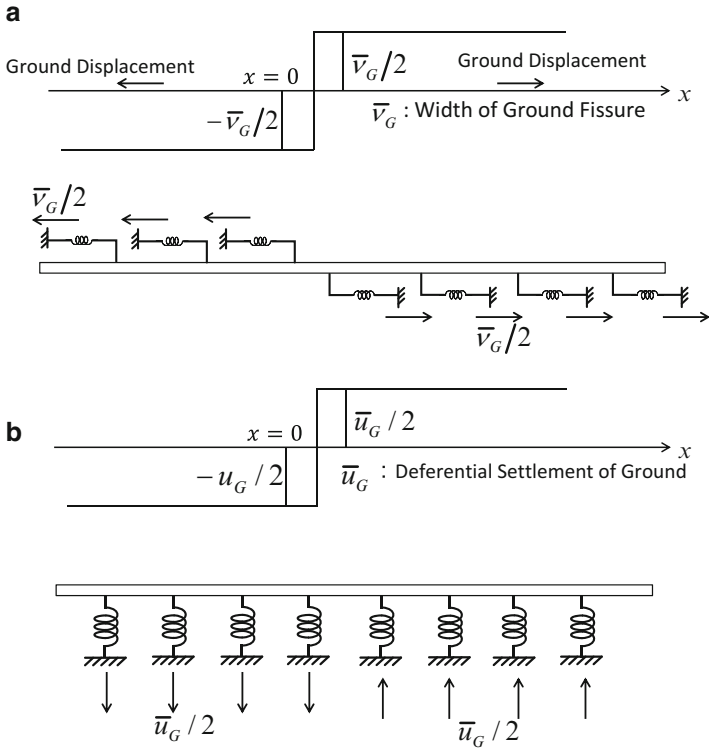
Axial deformation of pipes for horizontal ground fissures of width \bar{v}_G (Fig. 5.35a) was analyzed. The general solution for axial deformation of a buried pipe in such a case is given by Eq. (5.36). The boundary condition is

Fig. 5.35 Deformation of buried pipe caused by ground fissure and differential settlement. (a) Deformation by ground fissure (in axial direction). (b) Deformation by differential settlement (in direction perpendicular to the pipe axis)

Deformation of a buried pipe in the case of differential settlement (Fig. 5.35b) can be obtained using the general solution indicated in Eq. (5.30). The boundary condition in such a case is

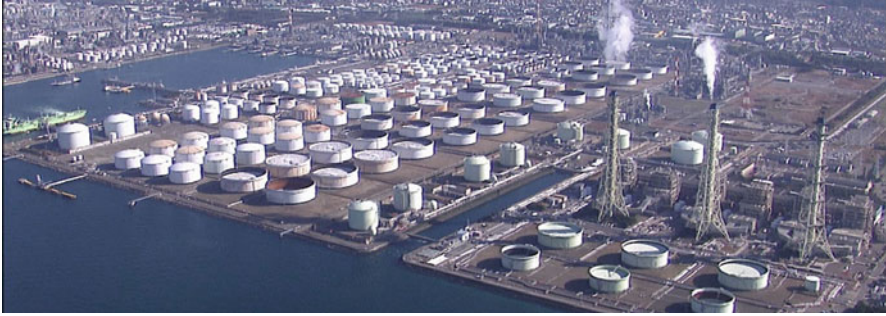
Fig. 6.9 Petro-chemical complexes around the Tokyo Bay

Figure 6.9 shows examples of floating roof-type tanks in an oil industry around Tokyo Bay. It is reported that more than 600 floating-roof-type tanks are on reclaimed land around the bay. These tanks contain crude and heavy oil. Figure 6.10 shows earthquake ground motions and velocity response spectra that have been calculated for coastal areas along the bay, on the assumption of continuous occurrence of Tokai and Tonankai earthquakes. Long-period earthquake ground motions of 9–10 s in the Chiba area and 6–7 s in the Kawasaki area would be predominant. The thickness of sedimentary soil in the Chiba area is about 3 km, larger than 2 km in the Kawasaki area. Based on analysis of sloshing vibration of oil in tanks, it is estimated that the contents of 64 tanks, approximately a tenth of the 600 total, would overflow (Table 6.3). It is expected that some of these incidents would involve fires, as experienced in the Tokachi offshore earthquake. With large ground displacement from the lateral flow of liquefied ground, along with sloshing vibration of tank contents, it is believed that large amounts of crude and heavy oil would spill into Tokyo Bay and become widely diffused on the water. It is certainly possible that this oil could catch fire, causing a large-scale fire on the sea surface. Figure 6.11 shows results of a simulation of the diffusion of crude oil in a case where 12,000 kl of crude oil spills into the ocean from the Kawasaki industrial zone. In the summer season, the crude oil would reach the Chiba area in about 3 days with southwesterly winds of speed 5.0 m/s, drifting and diffusing over a wide area of the bay. In winter, the crude oil would drift toward the mouth of the bay with

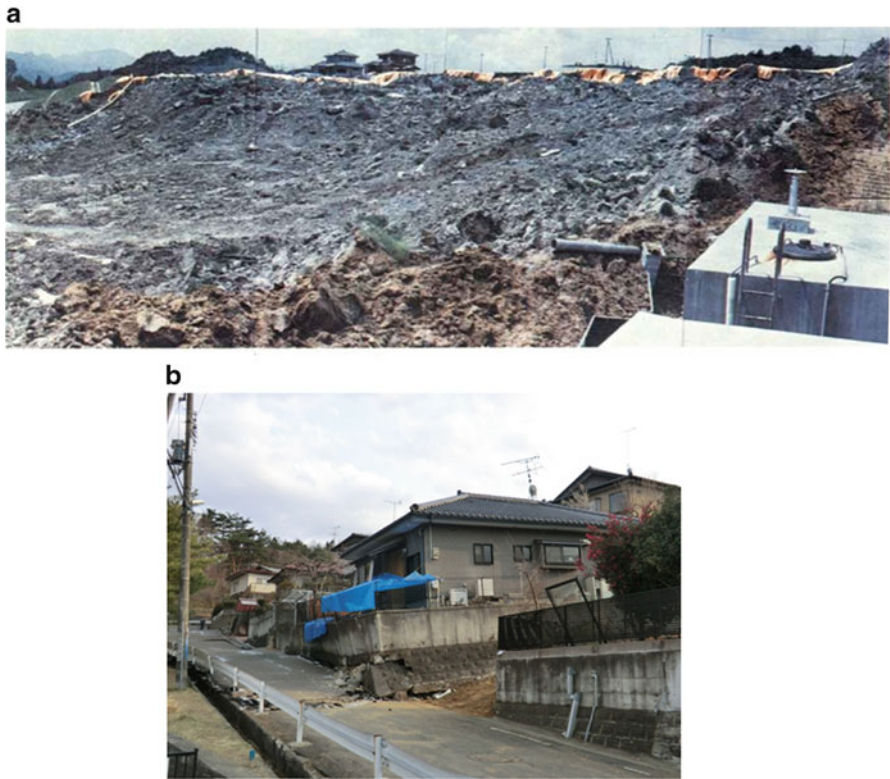
Fig. 6.12 Slope failures of residential areas. (a) 1978 Miyagi prefecture offshore earthquake (Shiroishi city). (b) 2011 Tohoku earthquake (Sendai city)

Given the population growth in Tokyo and other large cities, much hilly suburban land has been excavated and reclaimed for residential use. However, past earthquakes have resulted in sliding and collapse of filled portions of such hilly residential land. Figure 6.12a, b shows examples of slope failures in hilly land reclaimed for residential use from the 1978 Miyagi Prefecture offshore earthquake and the 2011 Tohoku earthquake, respectively. In general, when hills are developed for residential use, ridges are excavated and the resulting soil is used to fill in valleys. This results in balanced amounts of soil for reclamation work. The former Ministry of Construction specified that soil from excavation of ridges must be prepared by removing trees and other foreign matter and then subjected to adequate rolling compaction. However, there are many housing developments where land was reclaimed without thorough compliance with these rules. The damage in residential areas shown in Fig. 6.12 appears to be an example of this problem.

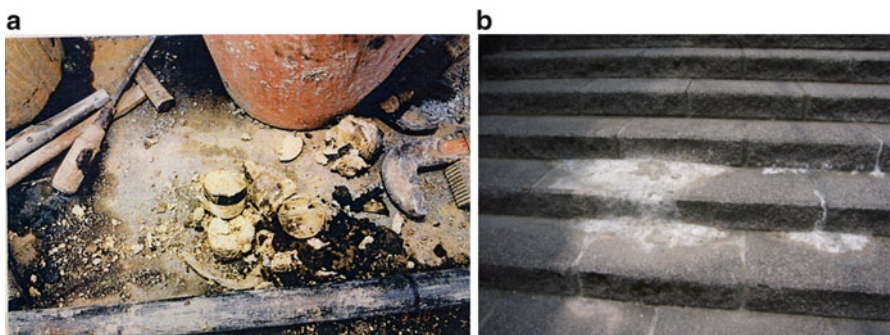
Figure 6.13a shows a boring survey of reclaimed hilly land in Kanagawa Prefecture. When inclination and subsidence caused damage to a house built on land reclaimed by filling in valleys, boring was done for the sake of restoration work, revealing this situation. The boreholes were not dug into soil, but rather revealed timber in a fresh state. This indicated that trees and the like were not removed from the soil before it was used for reclamation in the valleys. Figure 6.13b shows steps built on reclaimed residential land in a valley, with white traces where rainwater had burst through during heavy rainfall. It is thought that rainwater flowed from the ridge into the valley, creating the water flow that emerged from these steps.

Fig. 6.13 Boring test in the residential area and eruption of water due to rain fall. (a) Boring test (wooden fragments were excavated by boring). (b) Traces of water eruption from stairs

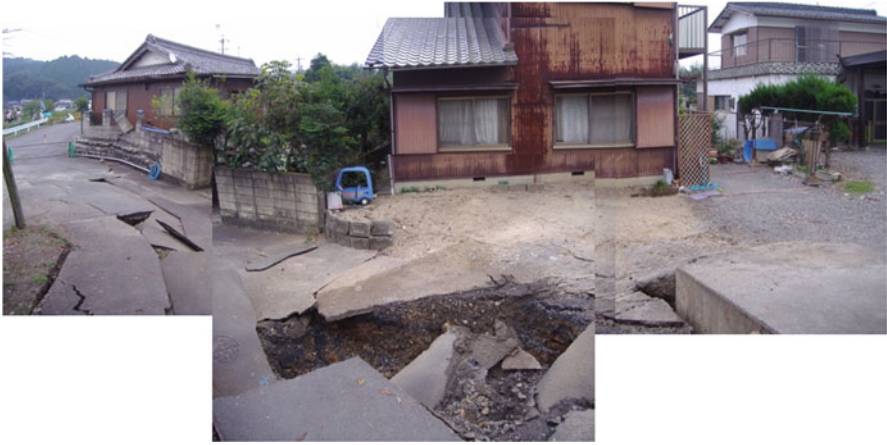
destruction or partial destruction of six homes. Figure 6.16 shows a view of that cave-in. Large-scale cave-ins have occurred repeatedly over the past few years in Mitake. The reason appears to be that the columns and mine ceilings have deteriorated over the period of more than 60 years since the lignite mines were excavated.

Fig. 6.16 Cave-in due to collapse of lignite mine

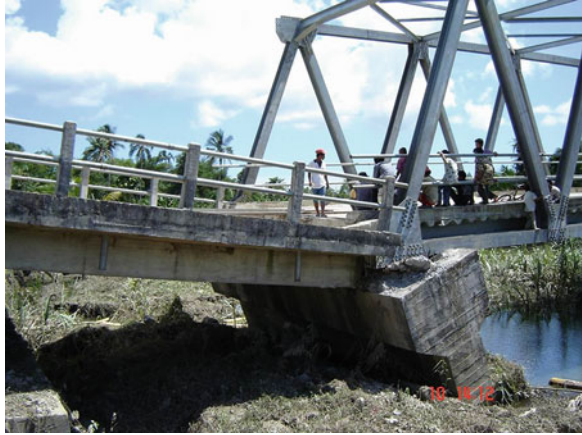
Fig. 6.30 Damage to Muzoi bridge due to soil liquefaction (2005 Nias Island earthquake, Indonesia)

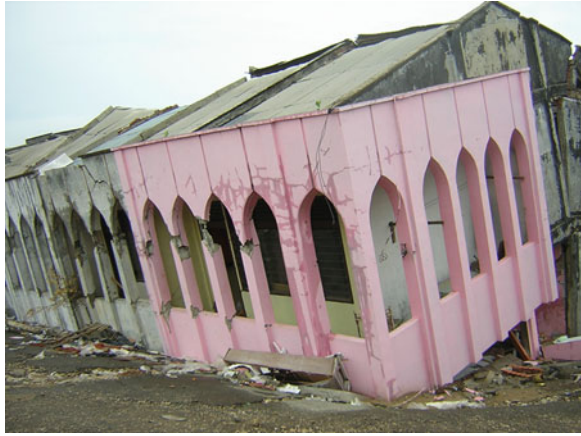
Fig. 6.31 Subsided and Inclined building due to soil liquefaction (2005 Nias Island earthquake, Indonesia)

Nias is an island with a population of approximately 700,000 people, measuring about 150 km from north to south and 50 km from east to west. Significant damage occurred on Nias because part of the ruptured fault was directly under the island. The earthquake caused 847 deaths and 6,279 injuries and damaged buildings, bridges, slopes, port and harbor structures, and others. The piers of Muzoi Bridge in the northern part of the island were tilted and subsided owing to soil liquefaction, as shown in Fig. 6.30. Inclination and subsidence from soil liquefaction also affected many buildings in the capital of Gunung Sitoli, as shown in Fig. 6.31.

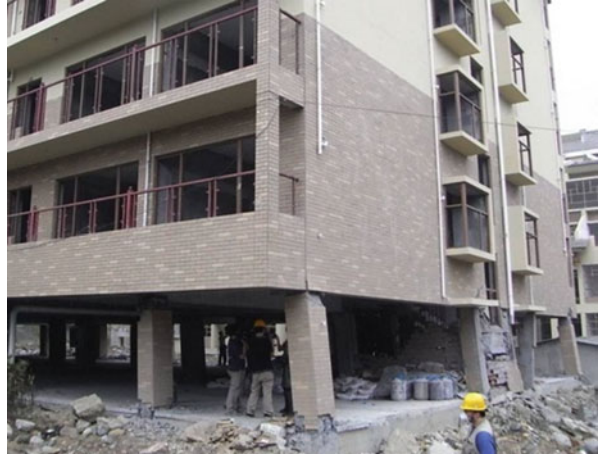
Fig. 6.33 Damage to reinforced concrete building (2008 Wenchuan earthquake in Shichuan province, China)

Figure 6.33 shows a six-story apartment building in Dujiangyan that was damaged by the earthquake. Connections between columns and beams on the first floor were damaged, causing major deformation. In consultation with the local government, the team from the Japanese committee proposed several ways to reinforce the columns. Figure 6.34a illustrates a restoration method used in Japan for seismic retrofitting of buildings and bridges, involving use of steel plates to enclose damaged concrete columns. Figure 6.34b illustrates a method for restoration using earthquake-resistant shear walls that are constructed on the first-floor level, after correcting residual deformation of the building.

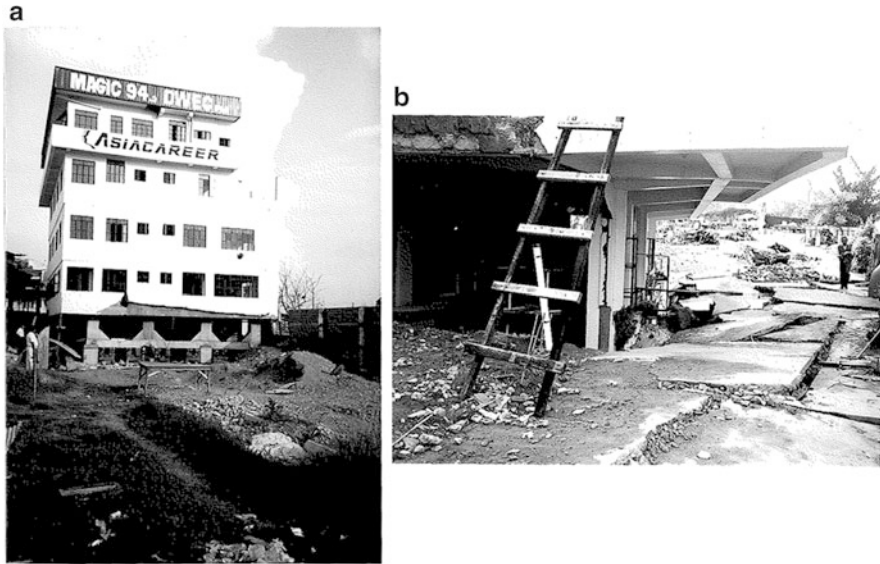
Fig. 6.37 Subsided and inclined concrete building with five stories due to soil liquefaction (1990 Ruzon island earthquake, Phillipines, at Dugupan). (a) Damaged building. (b) Subsidence and inclination (Max. subsidence: 1.5 m, inclination 3°)

As described in Sect. 4.1.9, a magnitude 7.7 earthquake occurred in central Luzon, Philippines on July 16, 1990, causing damage by soil liquefaction and ground flow over a wide area in Dagupan. Liquefaction caused subsidence and inclination of a five-story reinforced concrete building of a private university along the banks of the Pantal River in Dagupan, as shown in Fig. 6.37. The building's maximum subsidence was approximately 1.5 m, and maximum inclination approximately 3° . About 1 month after the earthquake, the JSCE sent a team for an onsite investigation and technical cooperation. University officials had requested technical cooperation regarding building restoration methods. The JSCE sent 20 jacks from Japan and dispatched an engineer specializing in restoration of building inclination, and the building was restored. Local construction engineers
