# STRUCTURAL SURVEYING

S.L.J. Mika

S.C. Desch

Second Edition

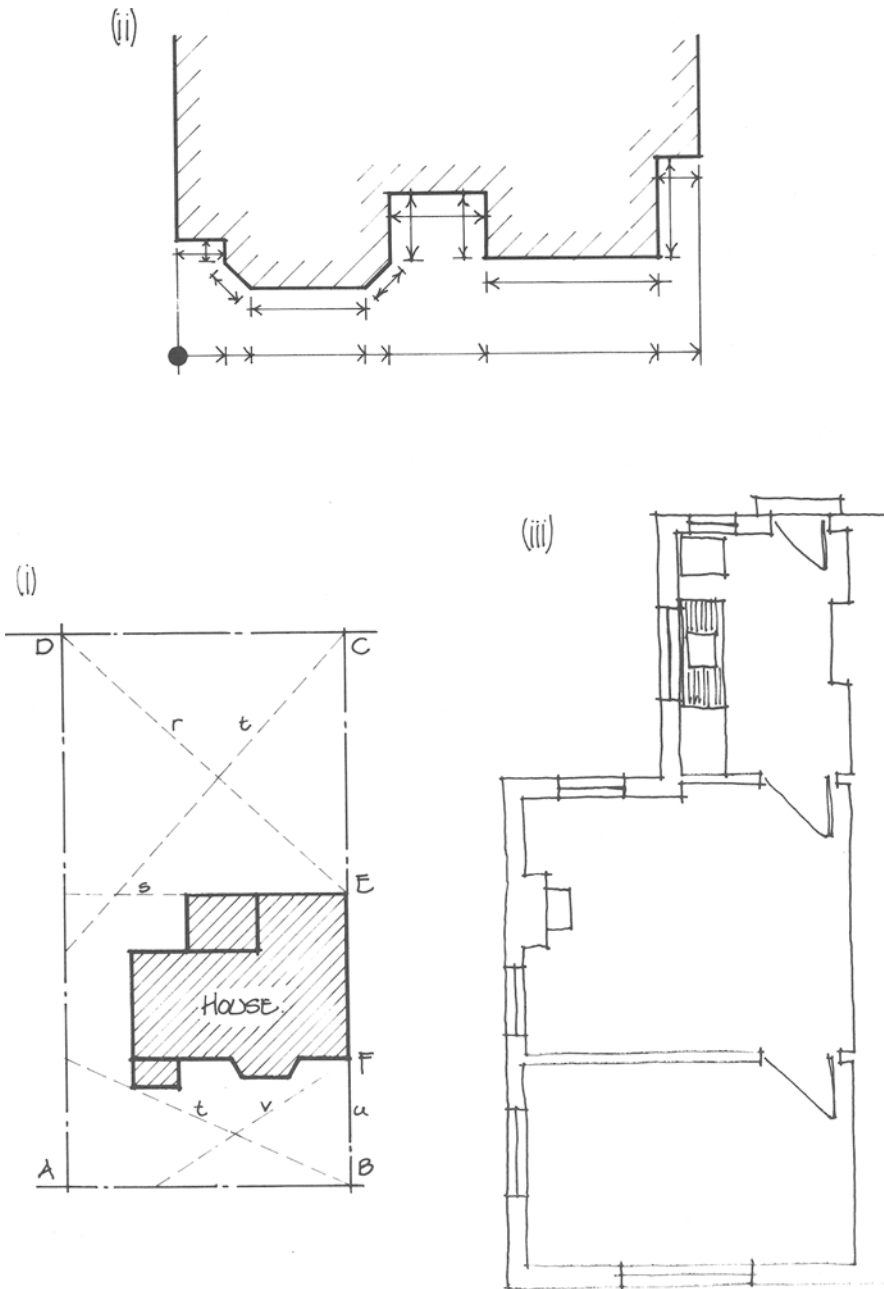
Figure 2 Measuring buildings

Figure 2(i) shows a typical case of a block plan for a semi-detached house. The long western boundary fence 'AD' could be the base line and the corners 'B' and 'C' tied from it by the measurements of the front and back walls and the two ties 't'. The corner 'E' of the house is tied from the base by the measurements 'r' and 's', and the corner 'F' from the front plot boundary by measurements 'u' and 'v'. The principal corners of the house would be fixed by ties or offsets from the most convenient fence lines and the usual detailed measurements of the house taken.

When measuring long walls, broken by details such as doors, windows, bays, porches etc., there are two methods of procedure. One is to take each straight length independently, as shown by the dimension lines recorded close against the building in figure 2(ii), and the other is to take 'running measurements', all read from one position at the zero end of the tape, as shown by the bottom recording. The latter method is the quicker and it avoids the 'cumulative error' which may occur when a number of dimensions are added together. If however, there are big projections from the main face of the building, so that in order to take running measurements it would be necessary to hold the tape at a considerable distance from the main face, the method is not so reliable. A better method is to take separate measurements of each straight length and to check their total at the time of measurement by an overall dimension. When plotting the work the overall dimension should be set out first and then divided into parts from the separate measurements.

The first thing to be done is to go over each floor making a rough sketch plan of the rooms, corridors and staircase, with the walls being shown merely by single lines. No dimensions need be taken at this stage and this will act merely as a key or guide in preparing the more detailed sketch or sketches, on which the dimensions are written, see figure 2(iii).

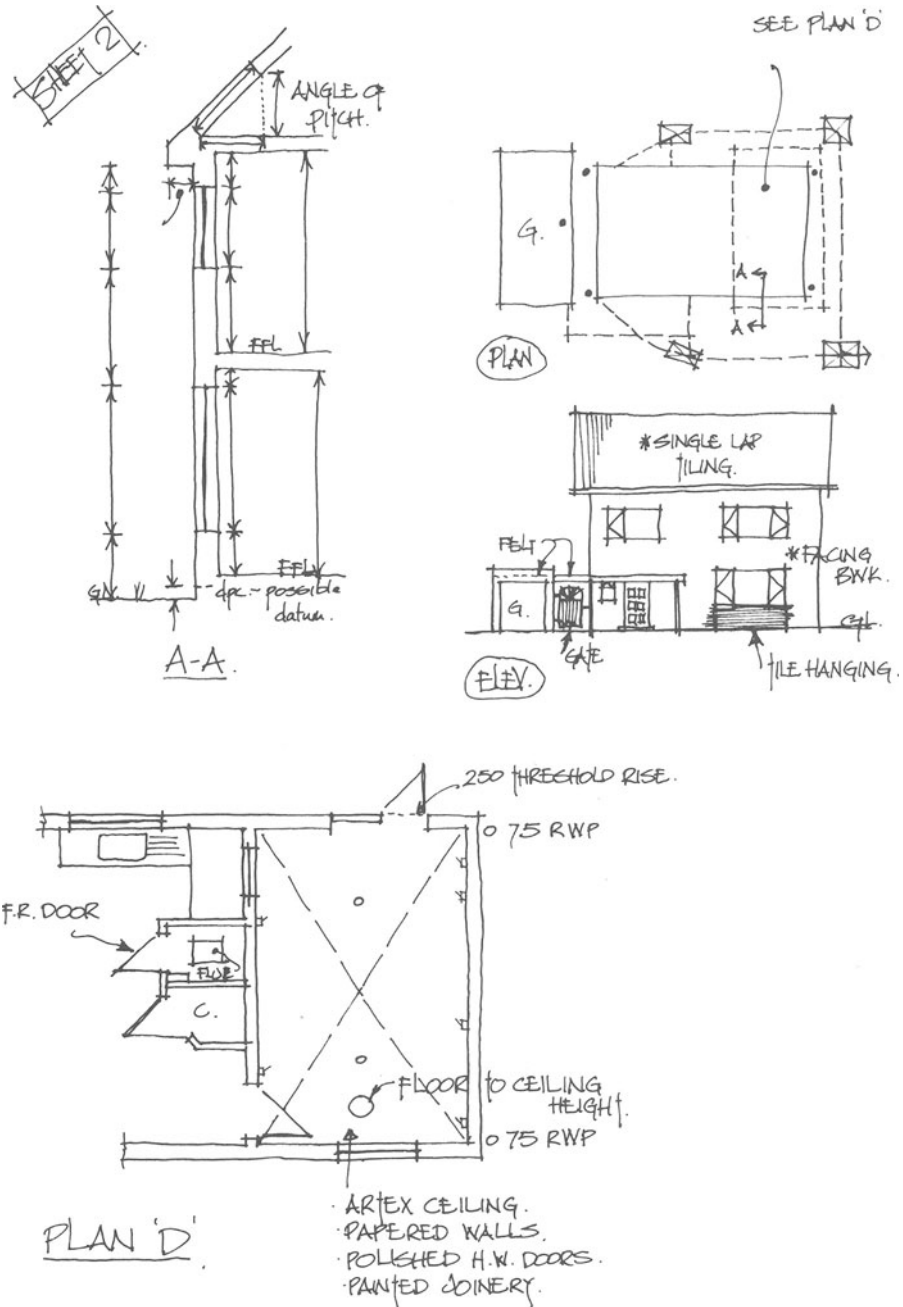
Figure 3 Typical notebook sketches

together. If it is decided to include all the building in one detailed sketch it need not be sketched out immediately. One could start with one long wall and add the rooms one by one as they are measured. A good draughtsman will be able to sketch the whole layout freehand, without using a straight-edge or set-square, and yet manage to get the rooms in good proportion. One less skilled will be wise to rule the walls and sketch the rooms roughly to scale, and probably the most convenient method of achieving this result without loss of time is to do the work on a sketch block with squared paper. The 'scale' can be made any convenient number of squares according to the size of the house and the sketch block.

A surveyor should never be satisfied with only the length and breadth of a room. All four walls and the two diagonals should be measured. If the opposite walls have equal length and the diagonals are also equal, the length of the diagonals need not be recorded, and only one dimension of length and one of breadth need to be noted, for in these circumstances the room is rectangular. If however, the opposite walls or the diagonals are not equal, all these dimensions must be entered, for one diagonal will be needed to enable the room to be plotted and the other to enable the work to be checked.

Some typical notebook sketches are shown in figure 3.

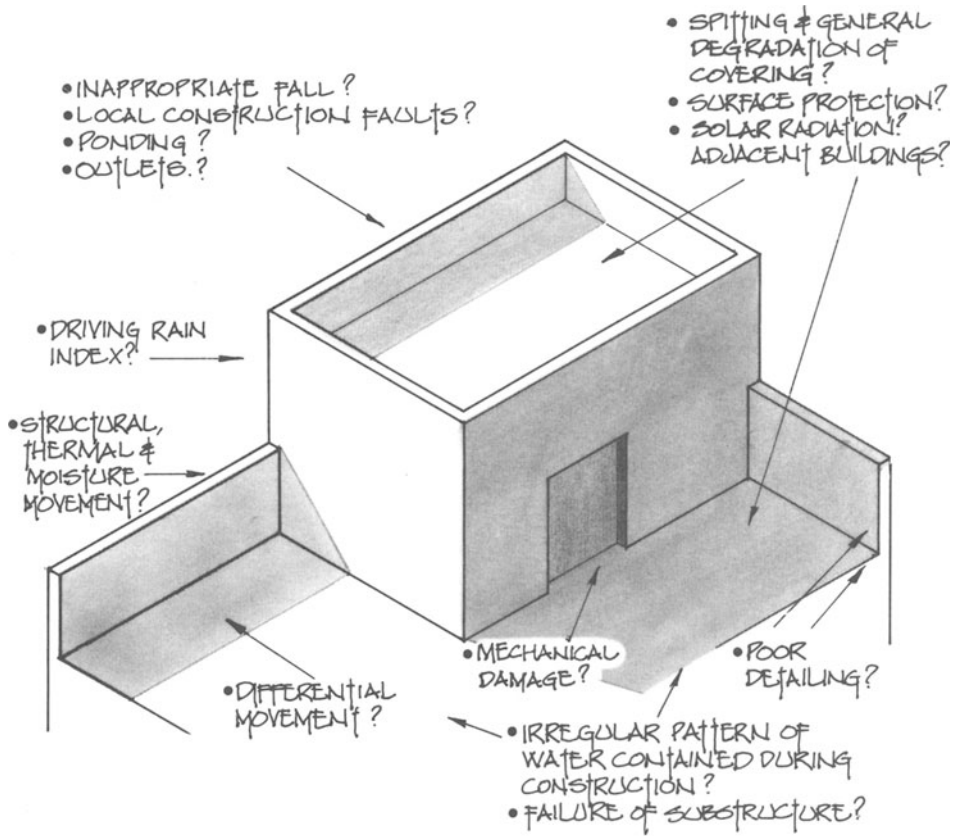
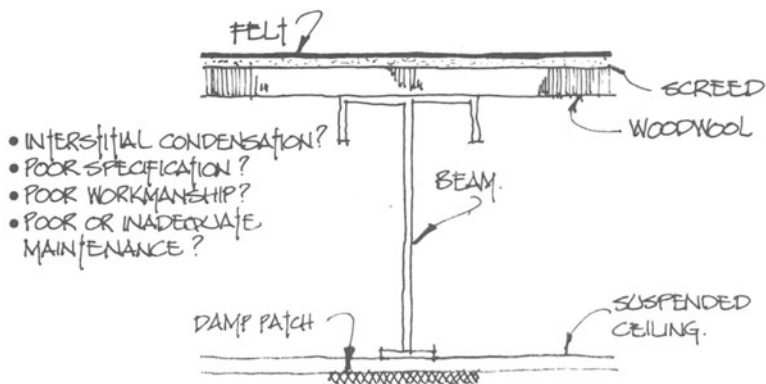
Figure 4 Site sketch of construction

It would be prudent for any building owner to arrange for a programme of testing and inspection to be commenced as soon as building is completed or even during the physical construction, if this is possible. Without this ideal situation, a surveyor has to be something of a detective and must apply testing procedures and performance standards that are appropriate for the particular circumstances. Testing obviously has to be non-destructive when being carried out in an inspection, and may involve elaborate equipment requiring specialists, but often decisions and opinions may be sufficient which are the result of direct visual observation, knowledge and experience. A systematic approach can be developed for all the elements of a building and an association of ideas in this connection is shown in the following list and illustrated in figure 4.

SITUATION BEING EXAMINED.

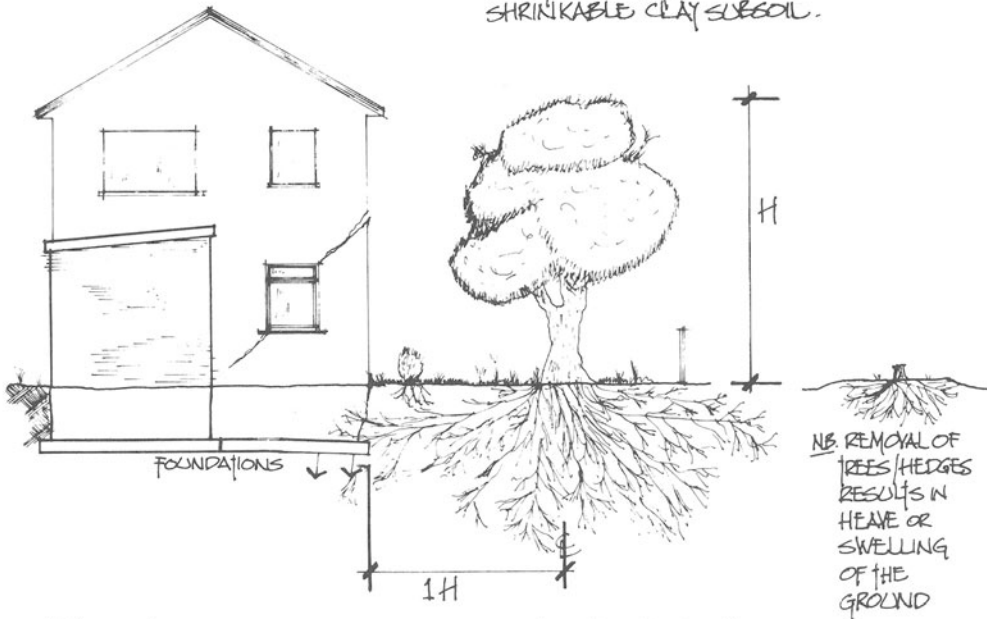
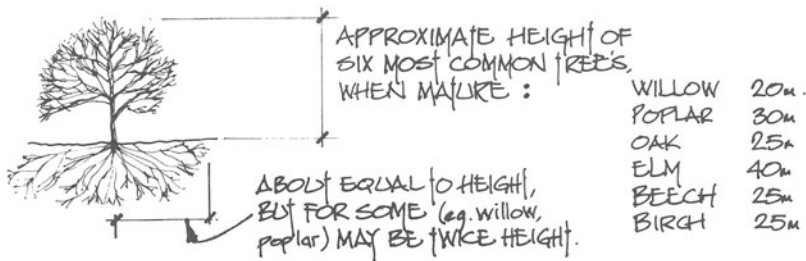
Figure 5 Tree heights and foundations

(i) SINGLE TREE.

\* AREAS PARTICULARLY AFFECTED BY DRYING/WETTING MOVEMENT ARE THOSE WITH SHRINKABLE CLAY SUBSOIL.

(ii) NEW TREE

(iii) TREE TYPES.

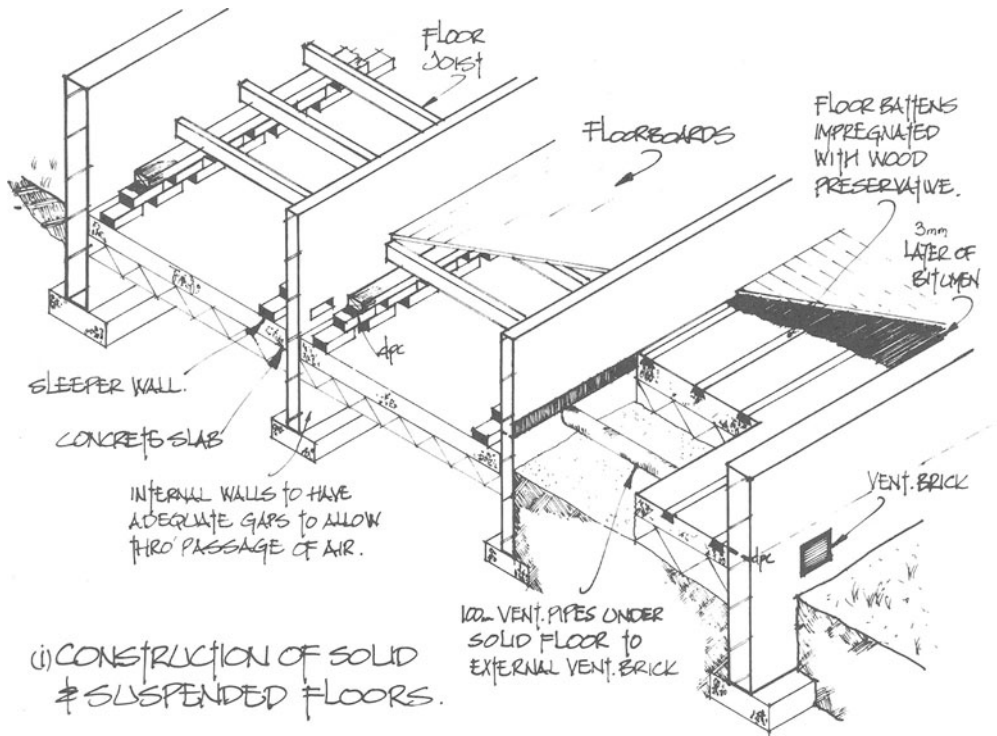
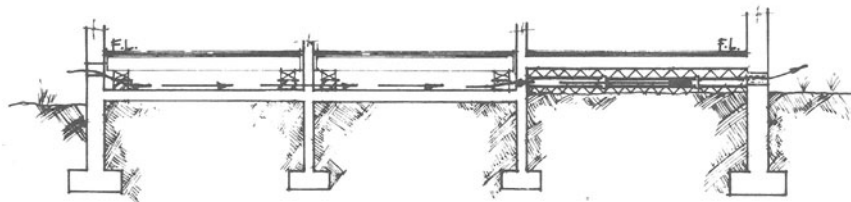
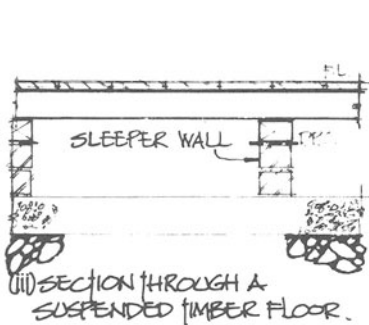
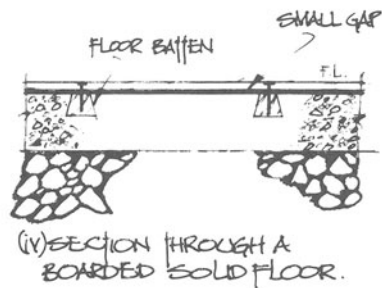
**Figure 6** Solid and suspended floors

(ii) DIAGRAMMATIC SECTION SHOWING UNDER FLOOR AIR FLOW, THROUGH BOTH SUSPENDED & SOLID FLOORS.

under the floor are adequate and that they are not impeded by areas of solid floor and internal partitions taken down to the oversite in solid brickwork. Obviously, in semi-detached houses there will be no cross-ventilation, and the adequacy of ventilation from front to back is all the more important. Checking that air bricks are not obstructed does not, of course, ensure that there is through ventilation under the floor between rooms, as there may be no voids in the partitions that have been taken down to the oversite. Where practicable, floorboards to be taken up should be those against internal partitions and in the recesses between projecting chimney breasts. Figure 6 ((i)–(iii)) reproduced from an early BRE Digest, illustrates the good practice that was advised in the 1950s for suspended timber floors with adjoining solid floors. It also indicates the points to look for when inspecting suspended floors, including the provision of ventilation by means of pipe ducts through the adjoining solid floors.

Figure 6(iv) reproduced from the same Digest shows a typical detail of a solid floor but the surveyor is unlikely to be able to check such details in the course of a reconnaissance survey. The floor finish on solid ground floors most likely to give trouble is the boarded or strip floor on battens. In the older properties the battens will almost certainly not be pressure-treated, and there is unlikely to be an impervious membrane in any position under the boarded floor. There is frequently a small gap between the top of the oversite concrete and the underside of the floorboards, see figure 6(iv), and, with no impervious membrane, such floors have a very uncertain life, particularly if the boards are a non-durable species such as European redwood. High relative humidities can build up under the boards, creating ideal conditions for the development of dry rot. Such solid boarded floors, if of softwood, require very careful scrutiny, including tapping and probing for any signs of decay.

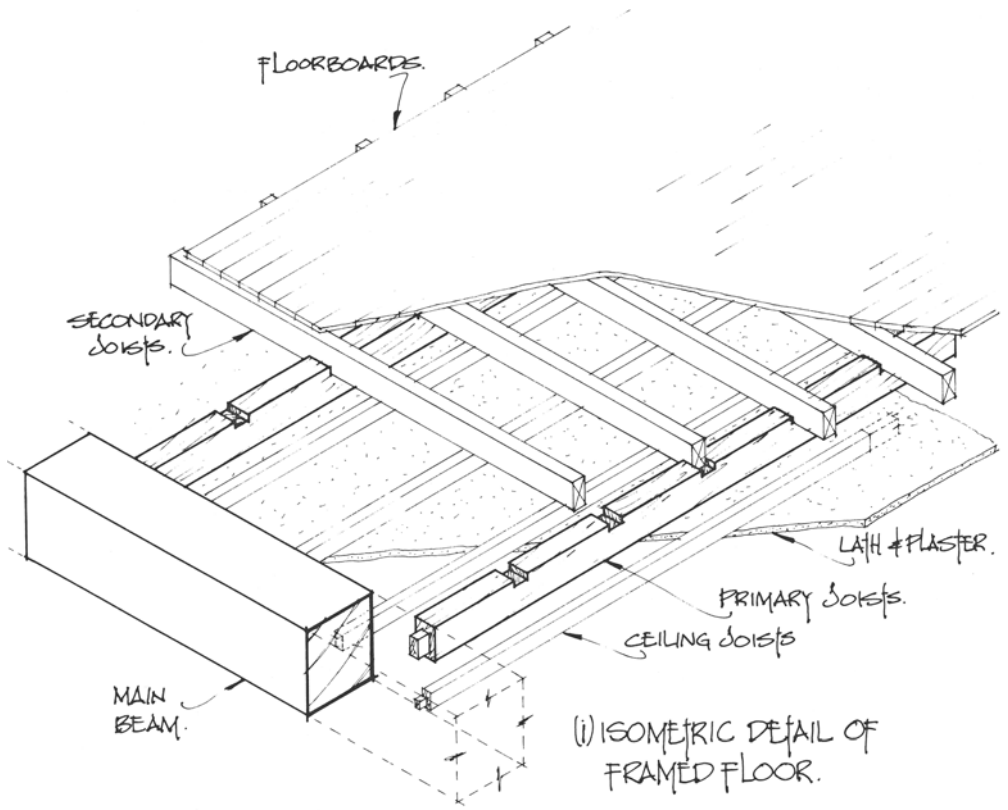
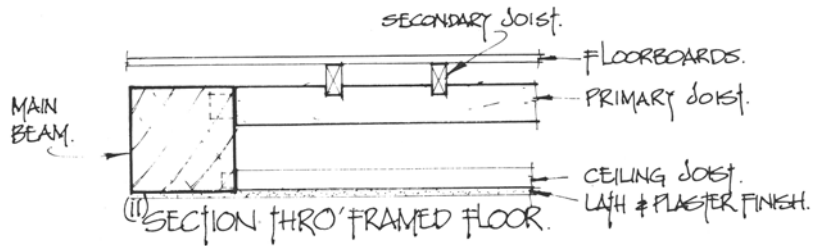
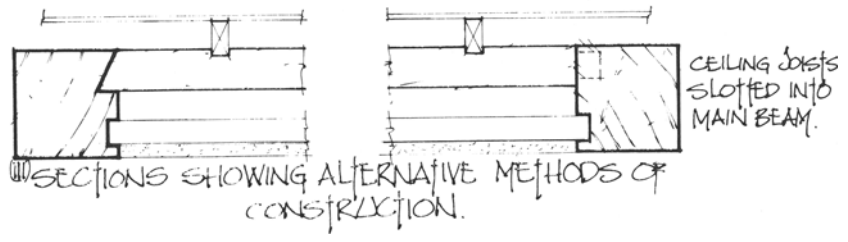
Figure 7 Framed floors

The nature of the housing for the principal joists in the main beam is also likely to vary. In addition to tenons of conventional pattern, others of unusual shape and size may be encountered, or the principal joists may be simply slotted into the main beam as shown in figure 7(ii) and (iii) and figure 9(i)-(iii). The simple slotting of principal joists into the main beam has certain advantages over conventional tenons, in that shrinkage of the main beam does not result in the principal joists becoming dependent only on their tenons, probably no more than one-third of the depth of the joists. Many of the elaborate housings involve huge mortices in the main beam, and, as a result of shrinkage, the fit of one member in the other is no longer tight, reducing the effective cross-sectional area of the supporting beams appreciably.

In older buildings additional services are likely to have been installed from time to time, and plumbers and electricians are given to notching beams with a total disregard for the weakening effect of the notches. As the original main beams in older properties were nearly always of inadequate size, loss of effective sectional area from mortices and notches, coupled with the destruction of sapwood edges by old beetle infestation, can be extremely critical, particularly if deep notches occur in the middle third of the span. It is not unusual to find that the main beam has been still further weakened by a groove cut close to the bottom or top edge of the beam to house the ceiling joists after the main floor structure has been framed up, see figure 7(iii).

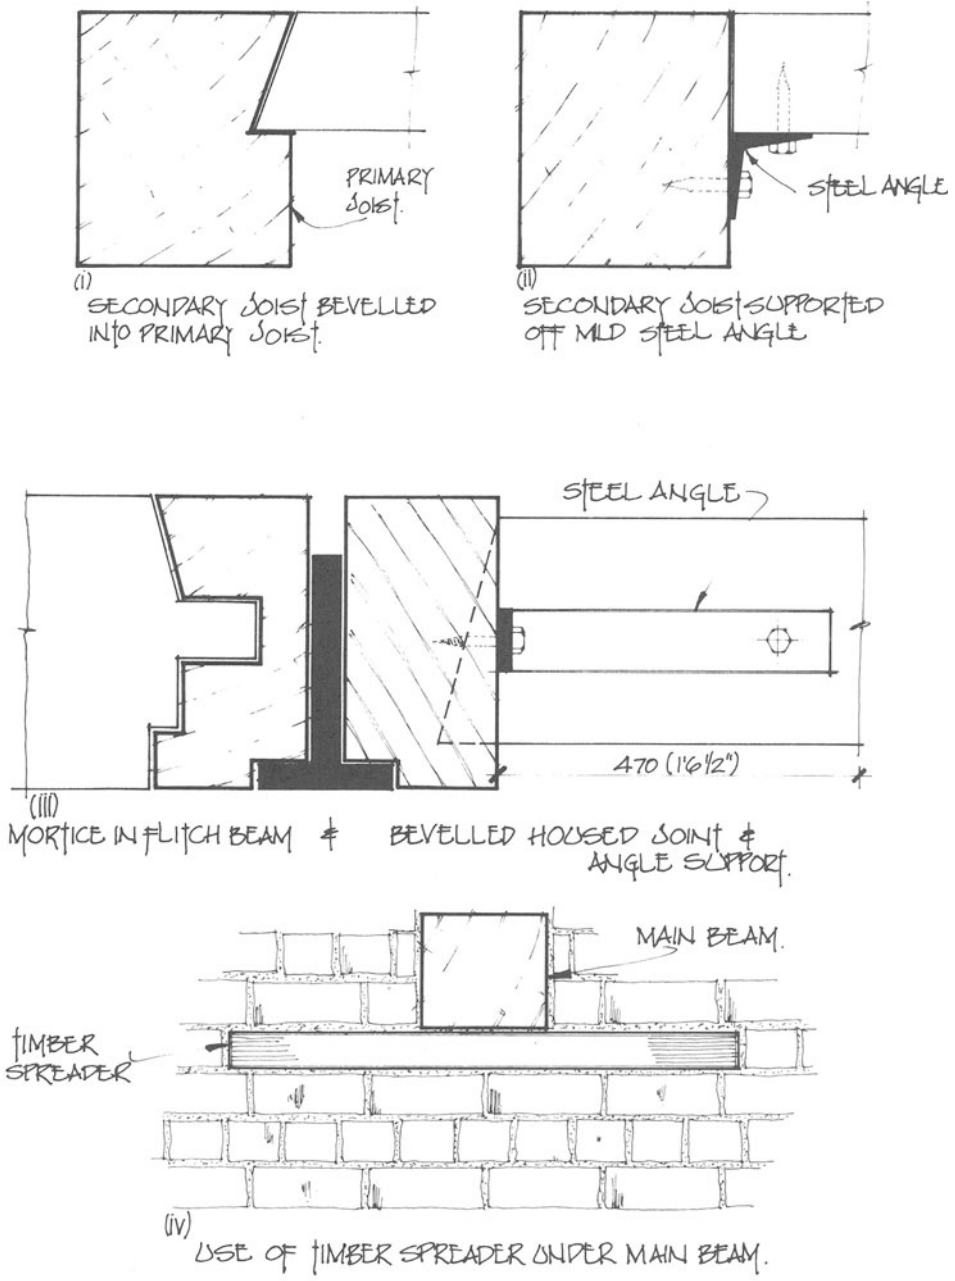
Figure 9 Timber housings and supports

In the course of detailed structural survey it is essential to check the condition of the ends of the main beams housed in external walls. These initially may have had a spreader in the wall under the beam figure, see figure 9(iv), but it is not unusual to find that the spreader has been cut out because of decay, and the void left has been built up in brickwork. In consequence, the beam imposes a point load on the wall, and this can lead to the development of fractures in the wall under the beam. Repairs carried out in the nineteenth century were often indescribably shoddy.

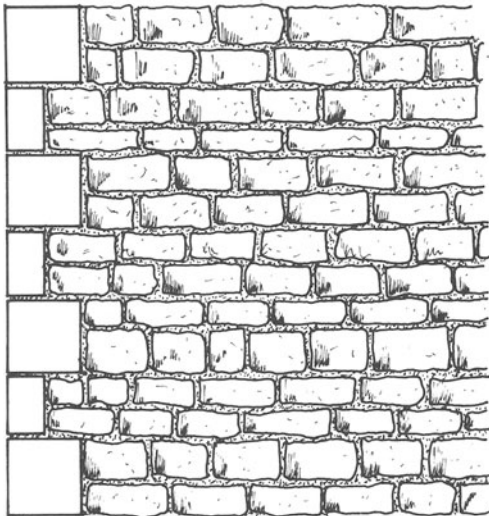
(i)  
 COURSED RUBBLE WALLING SET TO DRESSED STONE QUOINS SELECTED FOR SIZE & ROUGHLY WORKED TO COURSE HEIGHTS, THEN DESCRIBED ACCORDING TO FINISH, ROCK, HAMMERED, PUNCHED, ETC.

Stone walls may be built in courses with all the stones in any one course of the same height but not necessarily of the same length. Also, stones may be in random sizes, either square, rectangular or irregular in shape. It is not unusual to find occasional stones equal in height to two or even three courses—these are called jumpers. The exposed faces may be rock faced, which is the natural surface of the stone as found in the quarry, but freshly fractured, when it is supplied as random rubble. Alternatively, the exposed face may be worked with mason's tools to give a variety of finishes. Stone finished to a smooth surface is known as *ashlar*, whether built in courses or as random work. Some examples of stone walling are shown in figure 10.

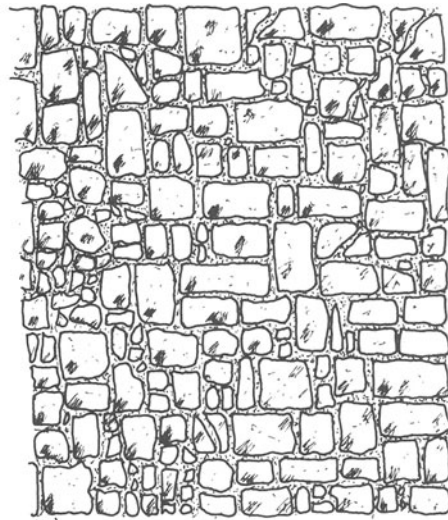
(ii)  
 RANDOM RUBBLE WALLING - STONES BUILT AS QUARRIED, LITTLE CONSIDERATION BEING GIVEN TO HORIZONTAL JOINTS. SOMETIMES ROUGHLY HAMMERED.

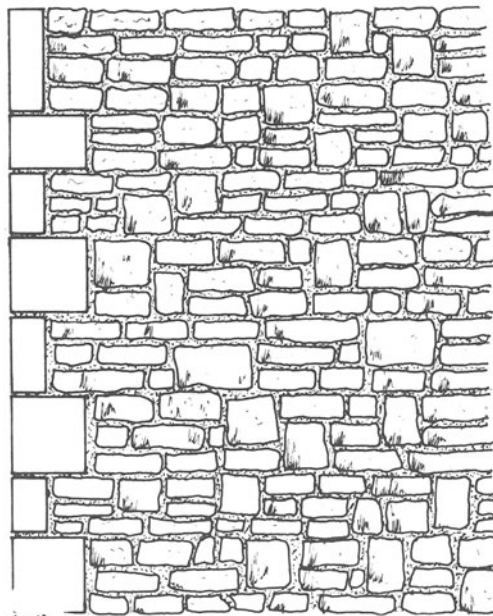
(iii)  
 RANDOM RUBBLE WALLING BUILT TO COURSES. STONES IRREGULAR HEIGHT, COURSING AT INTERVALS.

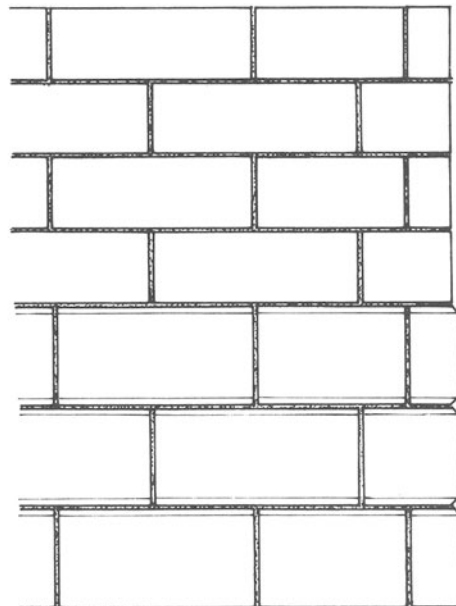
Figure 10 Stone walling

(iv)  
 TWO EXAMPLES OF ASHLAR MASONRY, PLAIN & RUSTICATED.

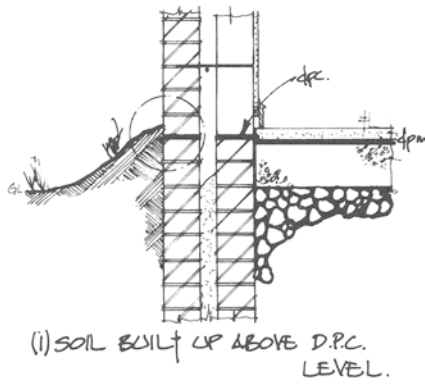
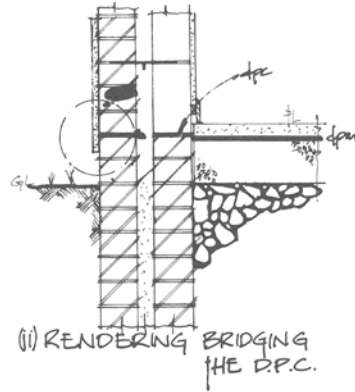
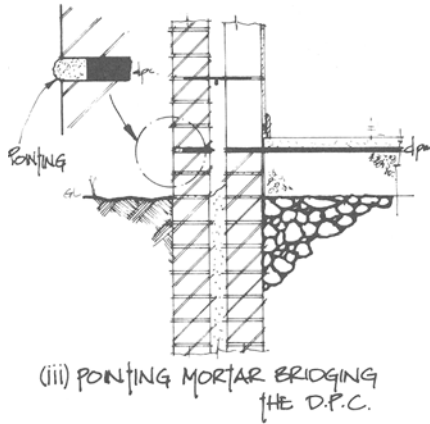
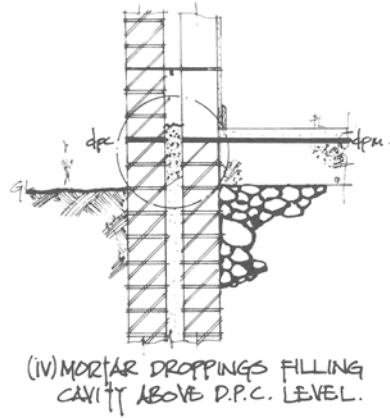
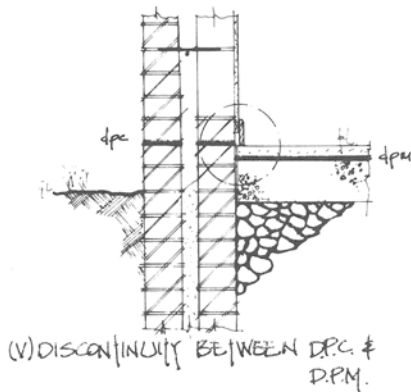
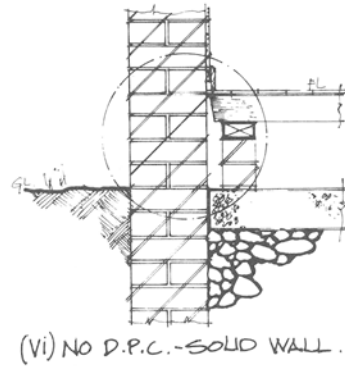
Figure 11 Typical causes of rising damp

Damp-proof courses serve a very necessary function although they are only found in more modern buildings. Many buildings without them are, however, basically sound, although there may be plaster problems in ground floor or basement rooms because of persistent rising damp. This rising soil moisture draws up salts from the soil, which work through to the face of the plaster. Being hygroscopic, the salts deposited on the face of the plaster attract moisture at times of above average humidity, discolouring the decorations. Persistent absorption of moisture by these salts, and subsequent drying out when the humidity falls, cause wallpapers to peel and paint finishes to blister. Rising damp usually

In addition to spoiling decorations, rising moisture can cause decay in skirtings and panelling fixed to the wall, the decay usually being caused by a so-called wet rot rather than dry rot. Attack may spread behind door and window linings to considerably greater heights than moisture will rise in the solid walls. This will be due to the build-up in the relative humidity of the still air behind such linings, providing ideal conditions for fungal growth. Attack may even reach the head of a door opening although moisture in the solid walls has only risen to about 1050 mm (3 ft 6 inches). Figure 11 illustrates typical causes of rising damp.

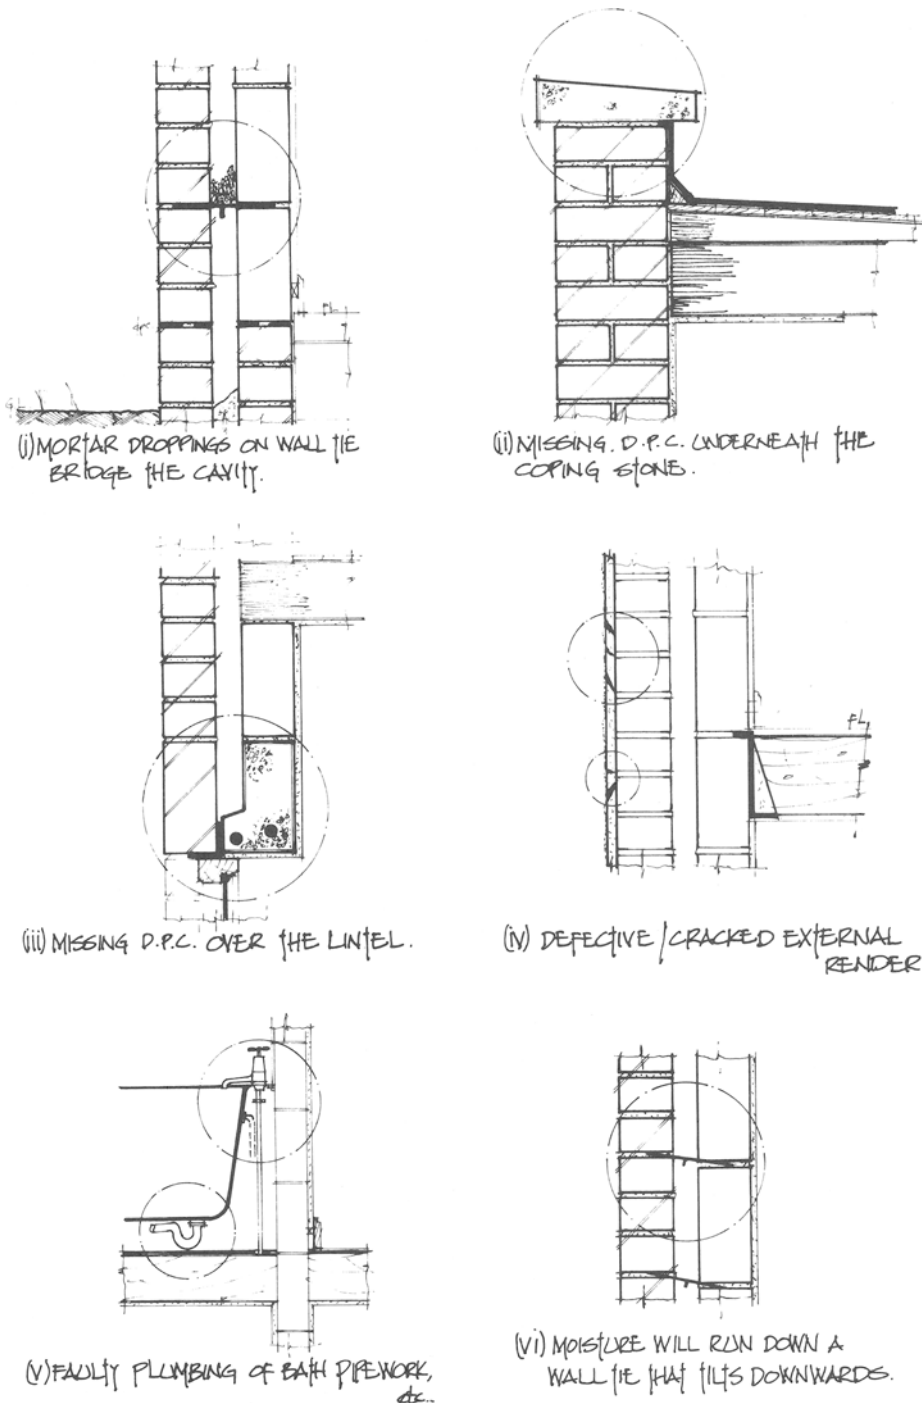
**Figure 12** Typical causes of penetrating damp

The relationship between walls and the ground levels, outside and inside, is particularly important and should be noted on the survey report. If the ground level outside is above floor level inside, then there should be both a vertical and horizontal damp-proof course to provide a continuous barrier to moisture. Ground or basement floors in such cases are unlikely to be adequately ventilated and, unless they are solid, the possibility of appreciable fungal decay in the floor timbers should be suspected. Ground levels outside may have an important bearing on possible flooding, particularly if there are watercourses or streams in the vicinity. It may be necessary to check with Local Authorities or Water Authorities to establish whether or not a risk exists. It is not uncommon for apparently insignificant streams to take very large quantities of water at times of abnormally heavy rain. The danger from flooding is often increased in residential areas if such streams are taken under roads in culverts. Failure to keep these culverts clear can result in the water rushing over the road,

Rain penetration will be established by the type, orientation and condition of the wall and the pattern of internal wetting, for example, following a period of prolonged and heavy rain. Older buildings with solid walls of poor quality (under-fired) bricks are very susceptible to penetrating damp. Poor jointing and pointing will also increase the moisture penetration of brickwork and stonework. Often the cause of penetrating damp will be a combination of a number of such factors which together create the conditions suitable for the defect to occur. Figure 12 illustrates typical causes of penetrating damp.

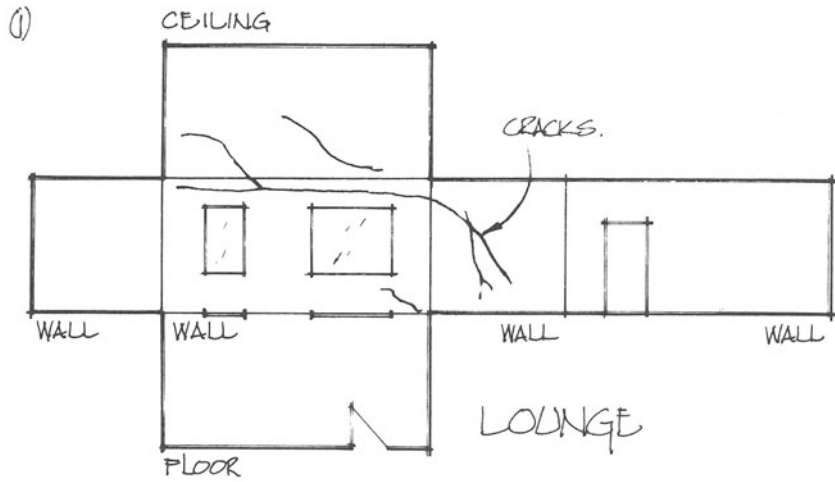
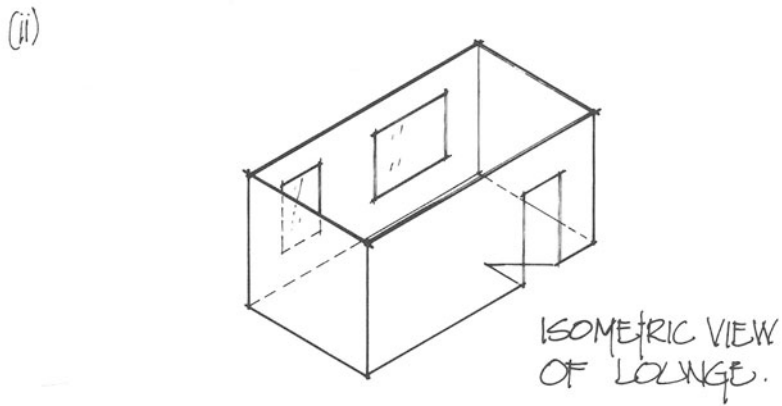
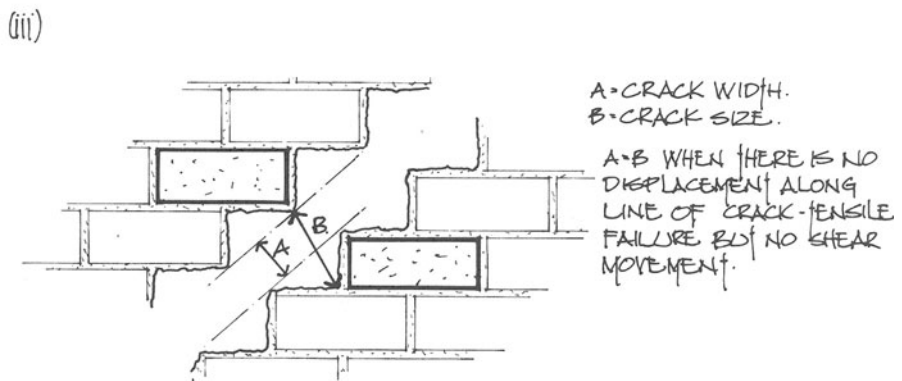
Figure 13 Recording and measuring cracks

In order to understand what is happening to a building which contains cracks, John Pryke recommends a simple method of recording cracks by using a diagram, unfolding every room as shown in figure 13(i) which represents figure 13(ii), the isometric view of the room. By recording cracks in this manner and relating the drawing to a floor plan, it is possible to build up an accurate three-dimensional record of the cracks for further analysis.

From a table published by John Pryke & Partners, which they have kindly given permission to reproduce here, a definition scale of cracking is possible, and this classification is a most important stage in the inspection procedure. However, the whole problem resulting from this defect can be very subjective and consequently the application of the analysis must be tempered by the situation presented at the time. With respect to the table below the definitions of crack width and size are given in figure 13(iii).

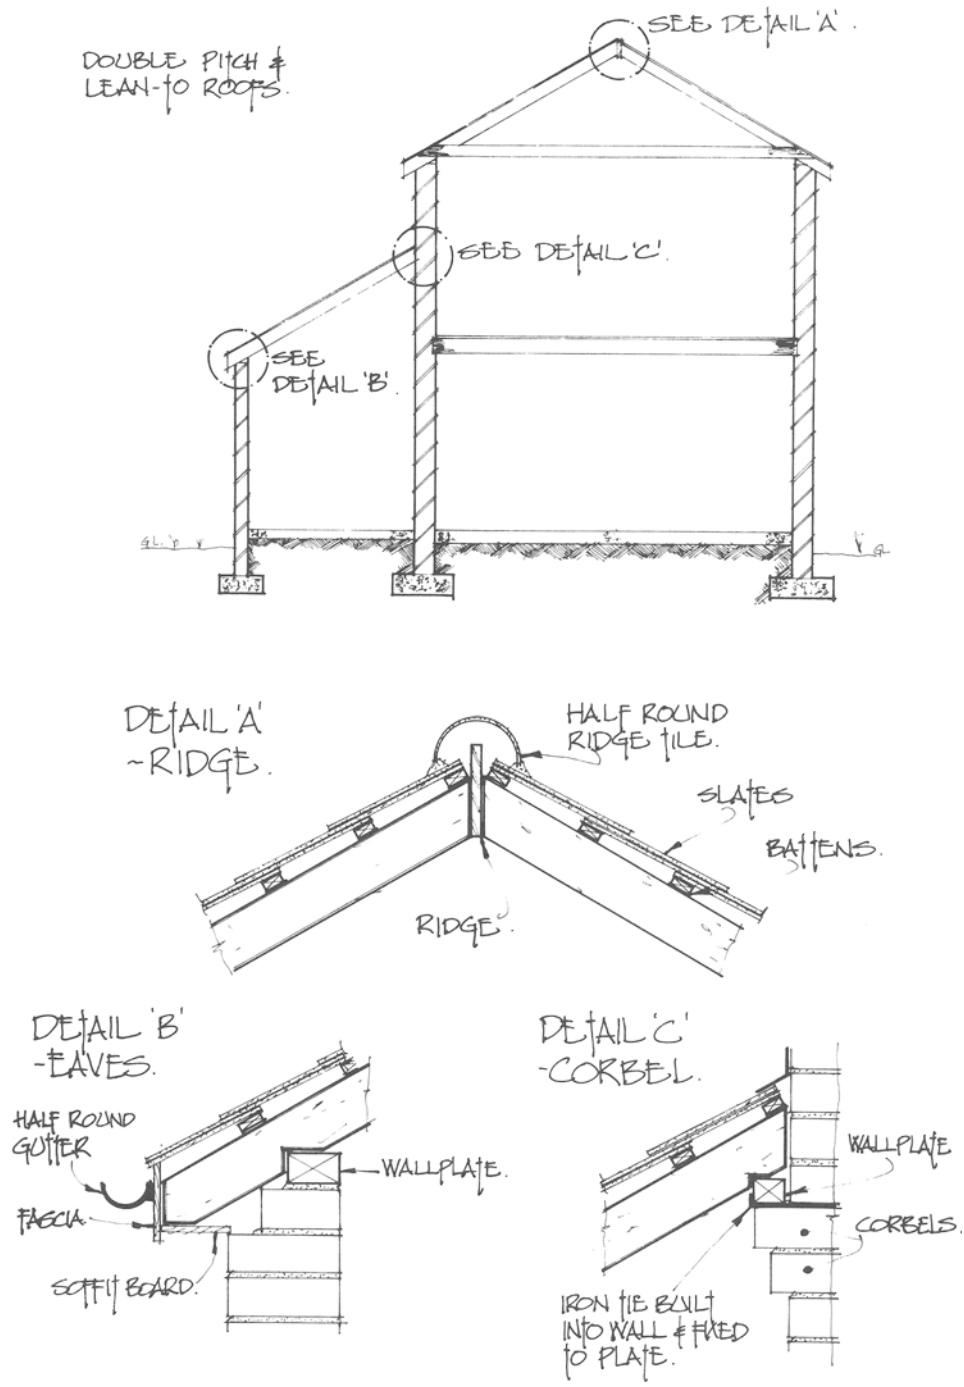
Figure 17 Simple roof form

The simplest form of sloping roof is the mono-pitch or lean-to roof, but the most common form is the double-pitch, the two slopes meeting at the apex in a ridge as shown in figure 17. Such roofs are used both for cottages and large buildings, with spans up to 12 metres (40 ft). They may terminate at both ends in gables, the pitch roof over-sailing the end walls of the building, the last rafters at each end being protected by a fascia board or barge board. Alternatively, the end walls may rise above the roof slopes where they are capped with coping stones or the slopes may be hipped back at both ends.

The simplest form of roof construction consists of wall plates, rafters and a ridge board in the configuration shown in figure 17. As the span increases, collars are introduced to restrain the outward push of the roof, and the nearer the collars are to the feet of the rafters, the more effective they are in preventing this outward thrust. In the simple lean-to (mono-pitch) roof, or in double-pitch roofs for garages and outbuildings, it is not unusual to find collars on only every third pair of rafters when, provided they are of sufficient depth, they can constitute the ceiling joists. In poorly designed speculatively built, older houses, the rooms on the top floor are often partly accommodated in the roof void, with the result that the collars are pushed up nearer to the apex of the roof, progressively reducing their effective function of restraining the outward thrust of the rafters.

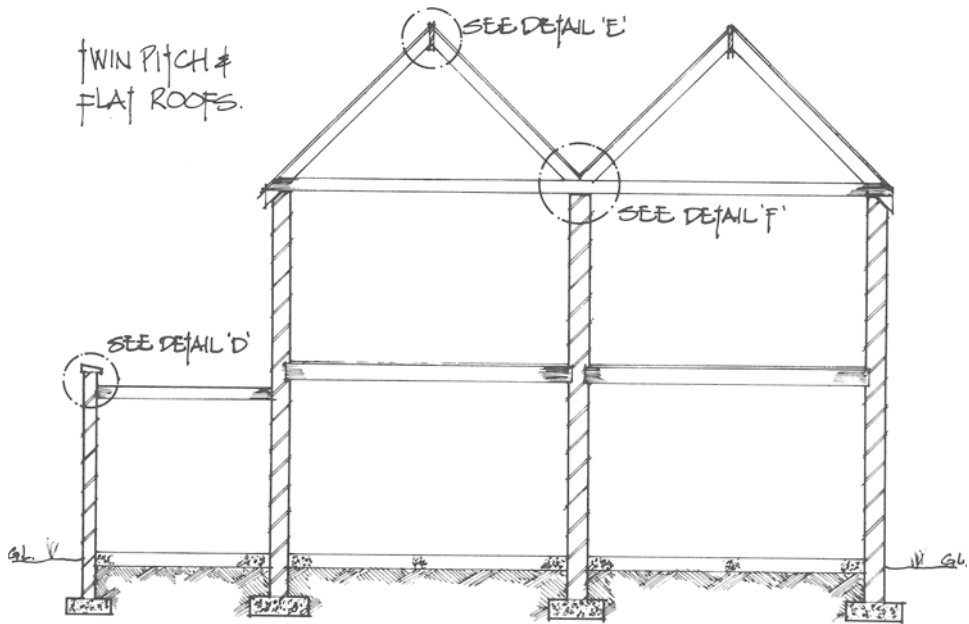
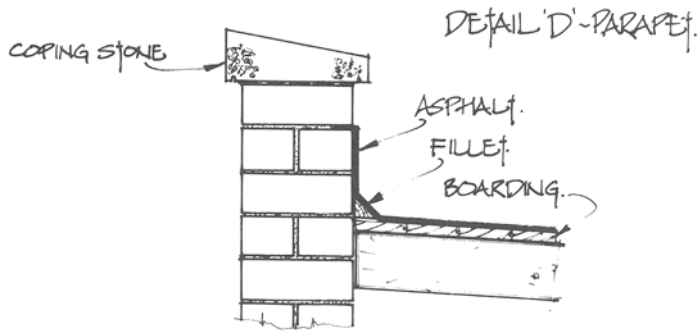
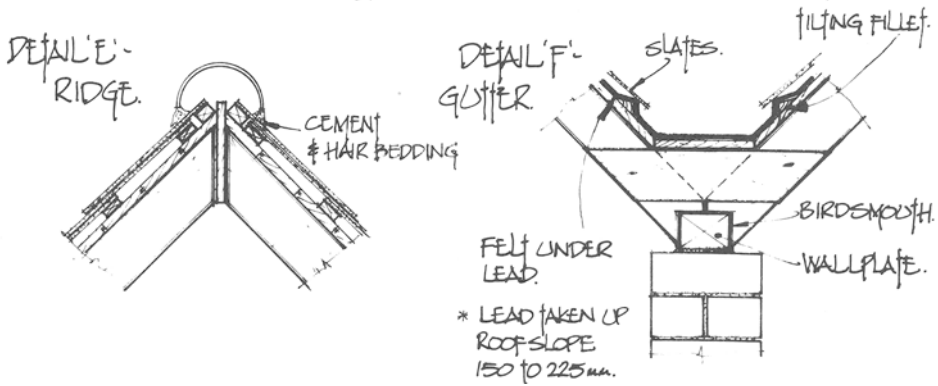
Figure 18 Twin pitch and flat roof forms

For spans of more than 12 metres (40 ft) the double-pitch roof is normally uneconomic because of the excessive height from eaves to ridge, and the complexity of the construction. Therefore, in older domestic work, the problem of spans larger than 12 metres (40 ft) were frequently overcome by using twin double-pitch roofs, with a centre gutter between the two slopes, figure 18. With other than rectangular plans, subsidiary double-pitch roofs at right-angles to the main roof offered a simpler solution, except for the necessity for valleys where two slopes at right-angles meet. The older, larger country house, square in plan, often has a completely internal gutter surrounded by the four internal roof slopes, figure 19(i), or the area between the four external roof slopes may have a slightly domed flat roof.

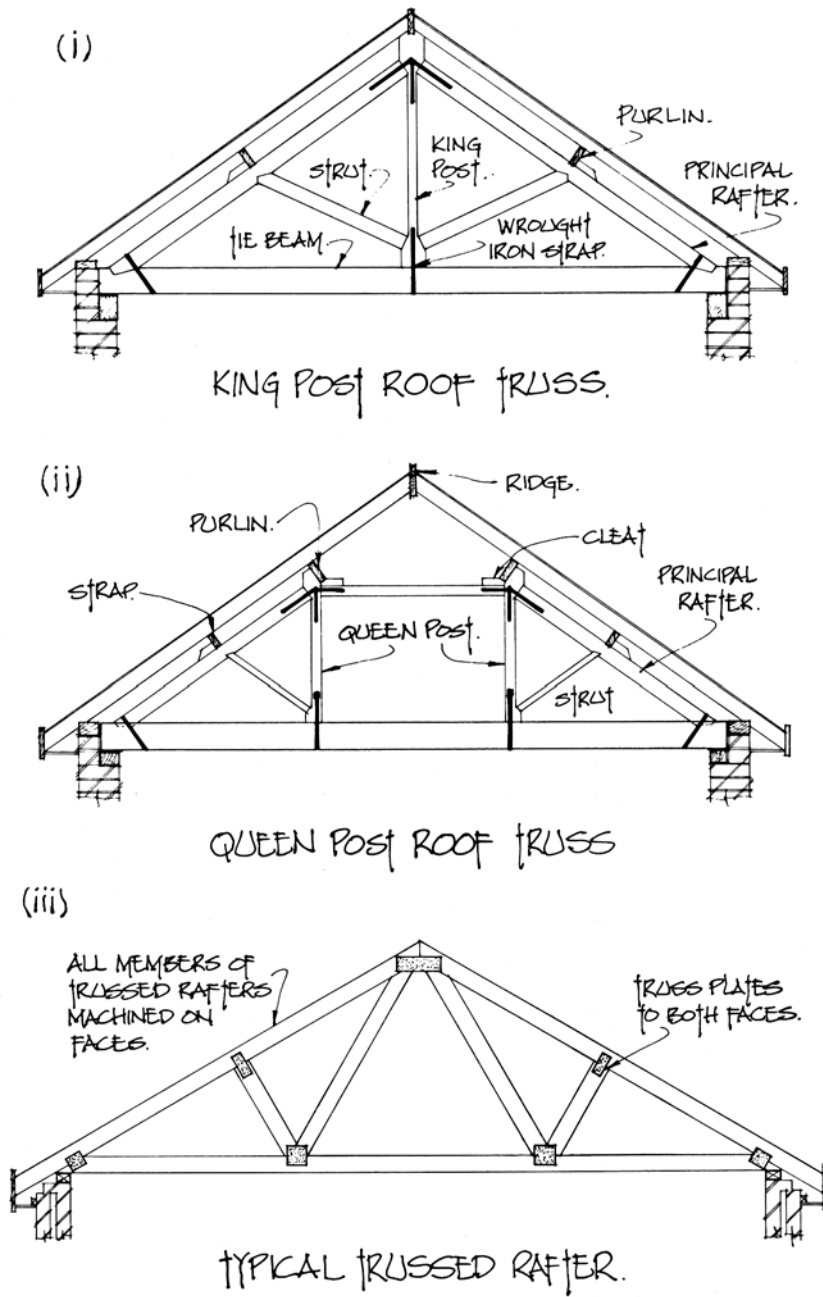
Figure 20 Roof trusses

In buildings sixty years of age or more, it is usual to find some form of roof truss at about 2100 mm (9 ft) centres, with common rafters between the trusses. The commonest types are king-post and queen-post trusses which are used for spans up to 12–15 metres (40–50 ft), see figure 20(i) and (ii). King-post trusses may also be found in the older, much smaller, cottage property. Such trusses called for great skill in manufacture and assembly which was mainly due to the complexity of the carpentry joints. Often the king and queen posts were further secured to the tie beams with iron straps, as were the principal rafters. In earlier examples of such trusses, the different members were tenoned into mortices in adjacent members, the tenons being secured in their mortices with timber dowels. In these older buildings, the condition of the dowels will warrant close inspection for it is likely that the dowels will have been completely eaten away by old beetle infestation. Also, the distance pieces between the inner and outer wall plates are particularly vulnerable to fungal decay, resting as they do on top of a thick wall and often under the sole of a parapet gutter.

Apart from the trusses discussed previously, there are several types of framed trusses known by the names of the original designers, for example, Fink, Pratt and N-trusses. These trusses may be constructed of steel or light metal alloy, as well as of timber. In modern construction the trussed rafter has become commonplace for traditional low-rise housing. Figure 20(iii) illustrates a typical trussed rafter. These factory produced trusses

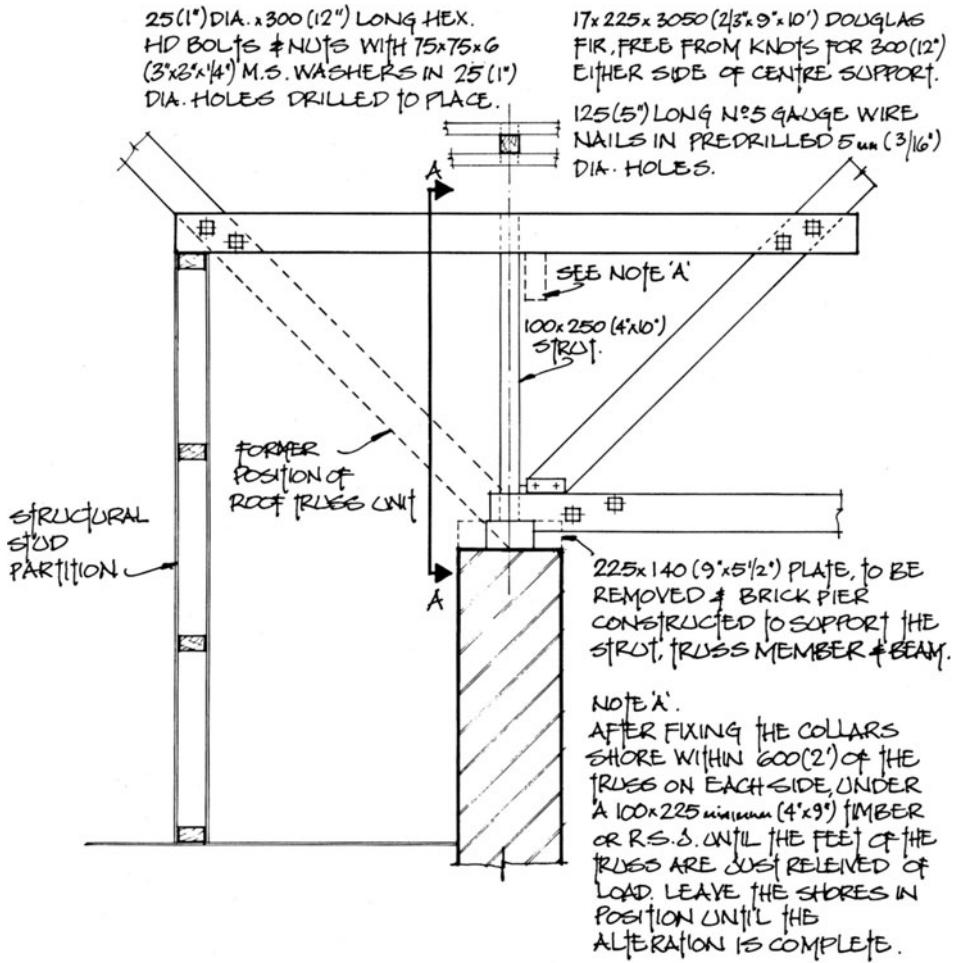
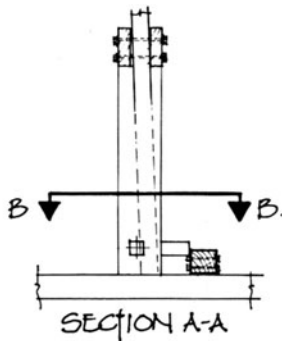
Figure 21 Removal of roof members

Another common failure of nineteenth-century restorers was to cut out lengths of decayed wall plates, building up the voids in brickwork without introducing spreaders, figure 9(iv), under the tie beams. As a result of point loads, there is a tendency for cracks to develop in the re-built brickwork. Another important aspect the surveyor should always have in mind when inspecting period properties, is the possibility that a previous owner in the course of modernising the property may have cut away some vital structural timber without taking steps to re-distribute loads adequately. It is very common to find that a purlin has been cut through to improve access to an attic without carrying out the necessary construction work to prevent the lateral spread of the roof. It is, however, perfectly possible to remove part of a vital structural member such as the lower length of a principal rafter, provided the re-distribution of loads is properly designed and configured with other timber members. Figure 21 illustrates how this was done to provide staircase access to a roof void that was to be converted into a flat. The scheme was designed by a timber engineering consultant and,

from so detailed a drawing, local carpenters had no difficulty in providing the headroom for the new staircase, which was an essential part of the conversion.
