# STRUCTURAL SURVEYING

S.L.J. Mika

S.C. Desch

Second Edition

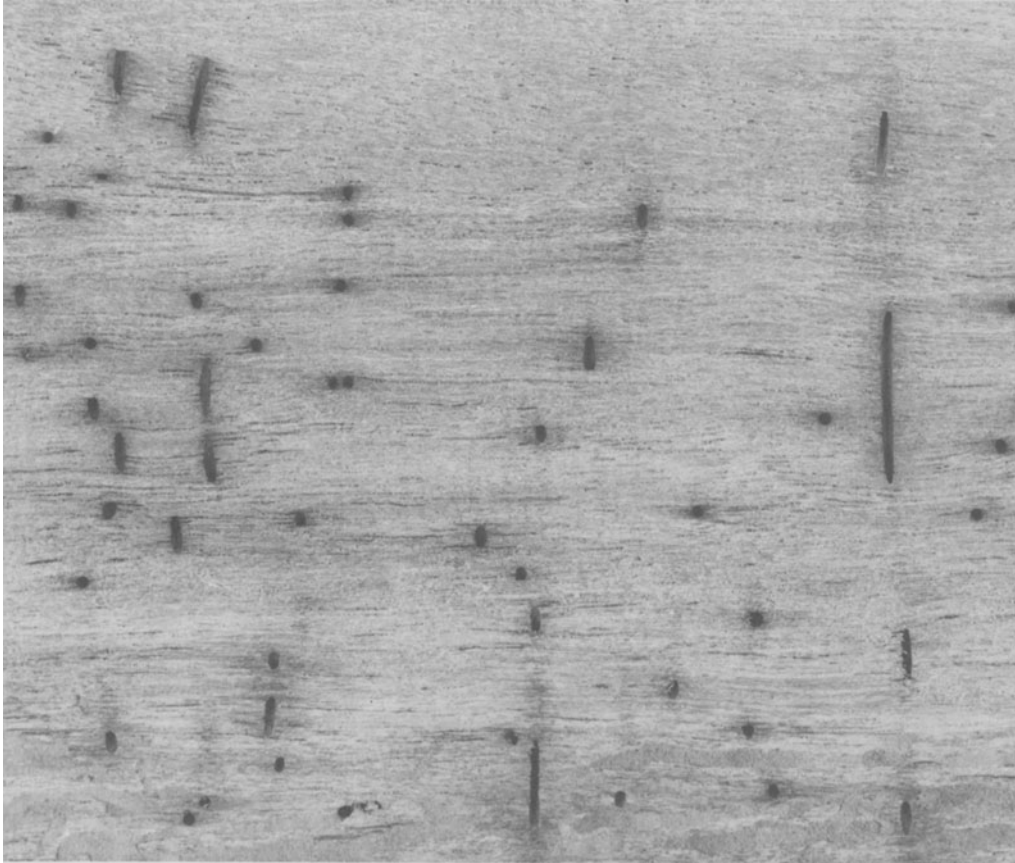
**AMBROSIA BEETLES.** This group does a considerable amount of damage to tropical timbers in particular, although there are a few species in this country that are occasionally found in oak and other hardwoods. The popular names for these beetles is 'pin-hole' or 'shot-hole' borers. The adult beetle tunnels spirally at right-angles to the grain, into living trees and newly felled logs, laying the eggs in specially constructed egg-chambers. At the time of egg-laying, the adult introduces the *Ambrosia fungus* into the galleries, upon which the larvae feed when hatched. Provided the extent of pin-hole and shot-hole borer damage infestation is not excessive, the timber can safely be used as there is no risk of spread of attack and still less risk of infections of other timber in the vicinity. This is because as the converted timber dries, the fungus also dies, and the larvae cannot complete their life-cycle for want of food. It is important to recognise such wormy timber for what it is, since there is no need to apply an insecticidal treatment to timber containing this form of beetle attack, see figure 23. Among carcassing timbers, hemlock is the one species likely to contain pin-worm damage, and since hemlock is quite extensively used in modern estate development, the surveyor should be able to recognise the holes for what they are, so that he can assure his client that the attack is of no practical significance, and calls for no remedial measures.

**Figure 23** Pin-hole damage (*Crown copyright: Reproduced by permission of the BRE Princes Risborough Laboratory*)

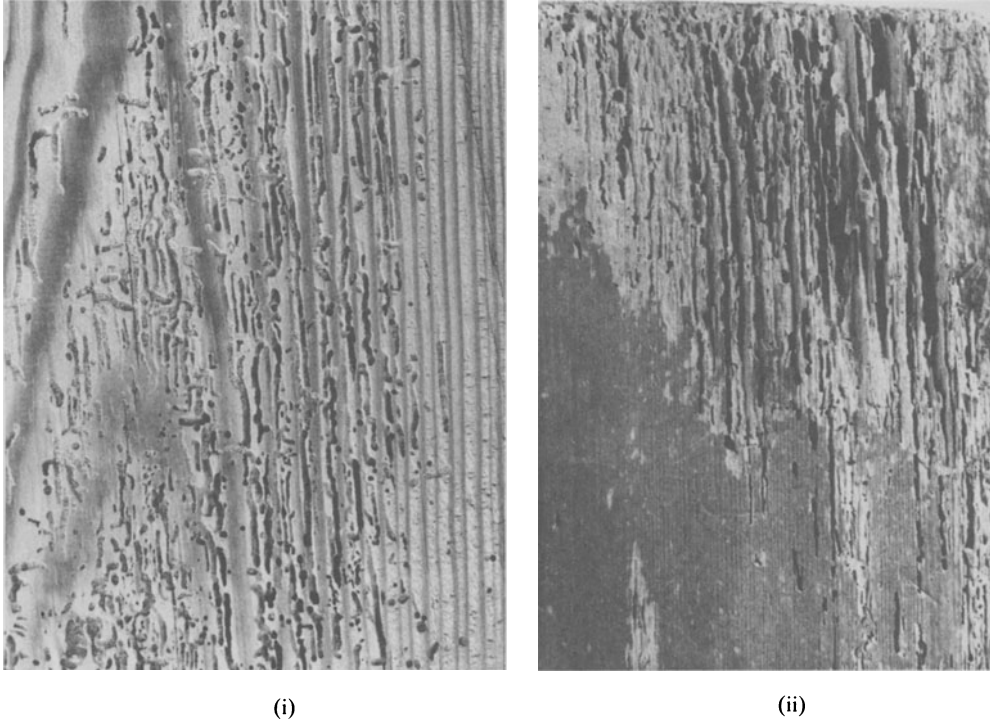
**Figure 27** (i) Common furniture beetle damage and (ii) weevil damage (*Crown copyright: Reproduced by permission of the BRE Princes Risborough Laboratory*)

**WOOD-BORING WEEVILS.** These belong to the genus *Pentarthrum*. Both beetles and larvae bore in timber, causing damage resembling that of the common furniture beetle, but the galleries are rather smaller in diameter and the frass is rather finer in texture than that of the furniture beetle, see figure 29(ii). It is possible to confirm weevil infestation by finding parts of, or whole, beetles with their characteristic snouts, see figure 29(i). Both hardwoods and softwoods are liable to infestation and attack is not necessarily confined to the sapwood. In most cases a prerequisite of attack is the presence of decay, and hence weevil infestation is most likely to be found in basement and poorly ventilated ground-floor floors, where there is no oversite concrete and fungal decay has become established. The measures called for to dispose of the decay hazard will eliminate the weevil without insecticidal treatment. Typical weevil damage is shown in figure 27(ii).

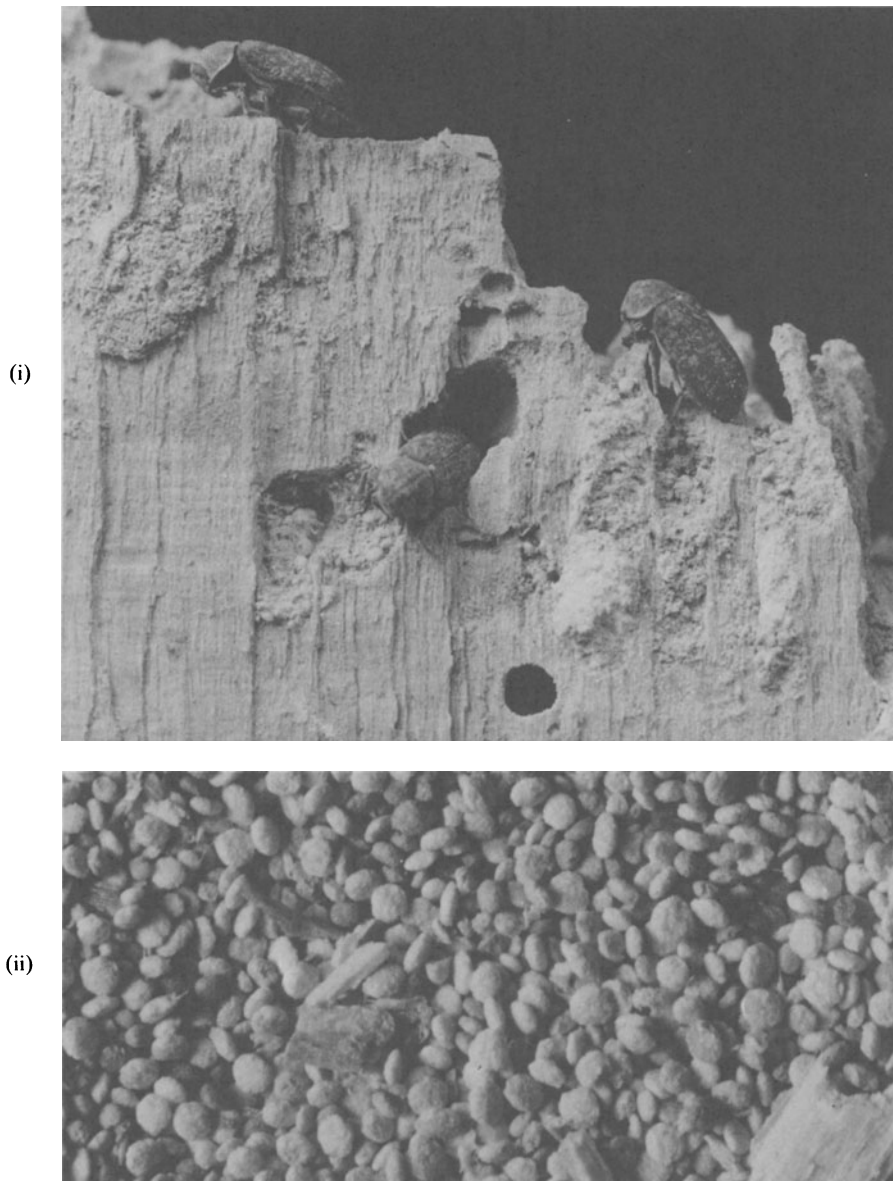
**DEATH WATCH BEETLE, *Xestobium refulvillosum***, lays eggs in crevices, cracks, or old exit holes, and the larvae create the damage by tunnelling and feeding on the wood. Attack is usually confined to old timbers of several species of hardwoods, but it has been known to spread to adjacent softwood timbers or even to be found in a house containing no hardwoods. Attack is not confined to the sapwood, but is more likely to begin in sapwood than in heartwood. Adequate moisture and the presence of fungal decay are conditions favourable for infestation. The galleries made by the larvae are about 3 mm (approximately  $\frac{1}{8}$  inch) in diameter and they are filled with coarse frass, containing bun-shaped pellets, figure 28(ii). Removal of decayed wood and the causes of decay are the first essential steps in eradicating this beetle. Frequently, however, major structural damage will have already occurred, when replacement of the attacked timbers rather than *in-situ* chemical treatments, is the only practicable course. *BRE Information Paper IP 19/86* gives further advice on controlling death watch beetle. Typical death watch beetle damage is illustrated in figure 28(i). The adult beetle is brown or red-brown in colour, and varies from 6 to 8 mm (approximately  $\frac{1}{4}$  to  $\frac{5}{16}$  inch) in length. The thorax is smooth, broad and flanged, and there are patches of short yellow hairs on the wing cases which give the beetle a mottled appearance. Moreover, if the beetle has only recently emerged

**Figure 28** (i) Deathwatch beetle/damage and (ii) frass (*Crown copyright: Reproduced by permission of the BRE Princes Risborough Laboratory*)

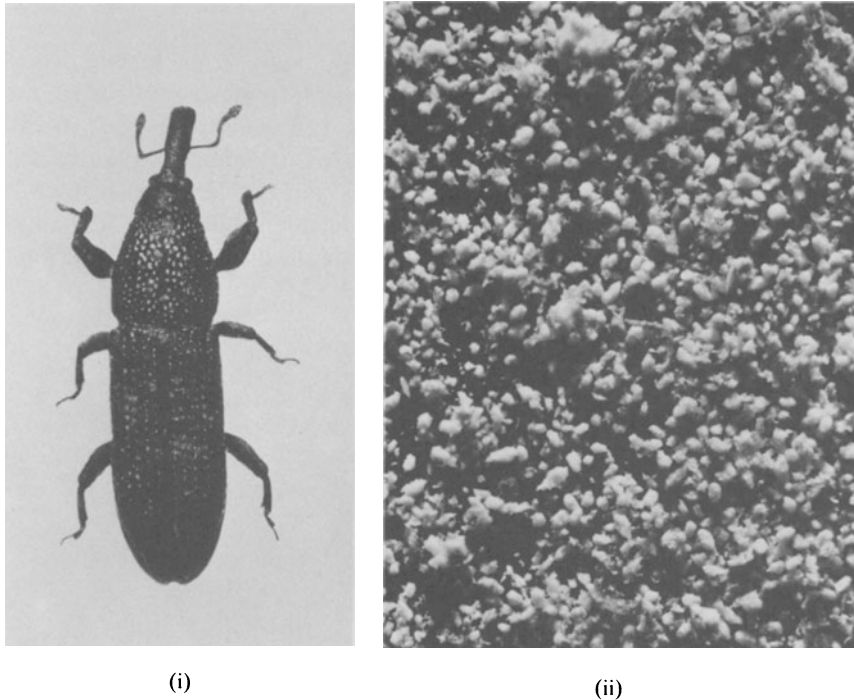
**Figure 29** (i) Wood-boring weevils and (ii) frass (*Crown copyright: Reproduced by permission of the BRE Princes Risborough Laboratory*)

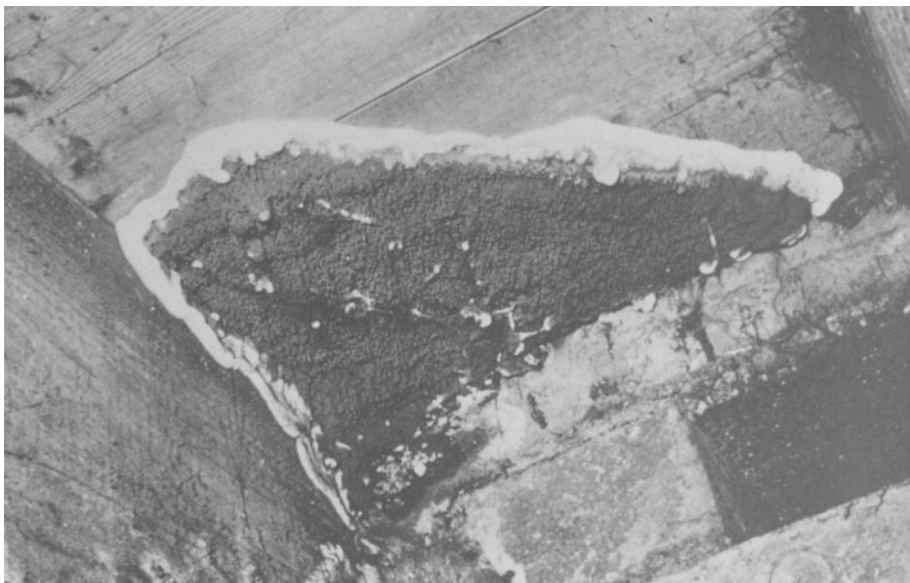
**Figure 30** Dry rot fruiting body (*Crown copyright: Reproduced by permission of the BRE Princes Risborough Laboratory*)

It is essential for surveyors to be able to recognise the few wood-rotting fungi that commonly attack timber in buildings, because, depending on the species, the appropriate remedial measures vary. By far the most important of these fungi is the true dry rot *Serpula lacrymans* which is a brown cubical rot. The appearance, both of the fungus and of the infected wood depends on the stage attack has reached, and on the growth conditions for the fungus. In damp conditions, particularly in still air, it develops as a white, fluffy, cotton-wool-like mass, spreading over the surface of the attacked wood. In drier conditions the *mycelium* forms a grey-white felt over the wood, usually with small patches of bright yellow or lilac. Branching strands may develop from the felt, varying in thickness from coarse threads to strands as thick as a lead pencil. These strands are made up of hyphae that conduct plant nutrient (food materials) and water. They can penetrate loose mortar in a brick wall and cross steelwork and concrete to reach new feeding grounds to attack dry timber. The fruit bodies are soft, fleshy plates with white margins, figure 30. Numerous folds or shallow pores occur on the surface of the fruit bodies which contain the rust-red spores. These are microscopic and so light that they are easily blown about. They are sometimes produced in such quantities that a whole room may be covered with a layer of rust-red spores. The fruit bodies sometimes grow vertically in the form of a thick bracket, when the pore-bearing surfaces become elongated, like small stalactites. Water may be exuded in drops by the fruit bodies and fluffy growths of *mycelium* in still air, hence the name *lacrymans* or 'weeping' for the commoner species of *Serpula*.

The fruit bodies that grow out into the air and light are frequently the first indication of dry rot in a building, but unventilated rooms or shut-up houses that are infected usually have a characteristic musty odour. Slight wavyness on the surface of panelling, skirtings, linings and other joinery items are further indications of possible extensive damage. Wood beneath

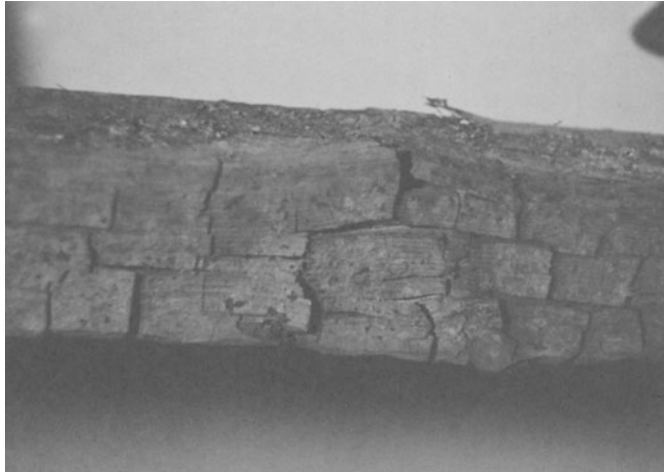
**Figure 31** Dry rot damage (*Courtesy of Cuprinol Limited*)

a coating of *mycelium* is wet and slimy to the touch, but in the final stages of attack it is dry and friable, brown in colour, and breaking up into cube-shaped pieces see figure 31.

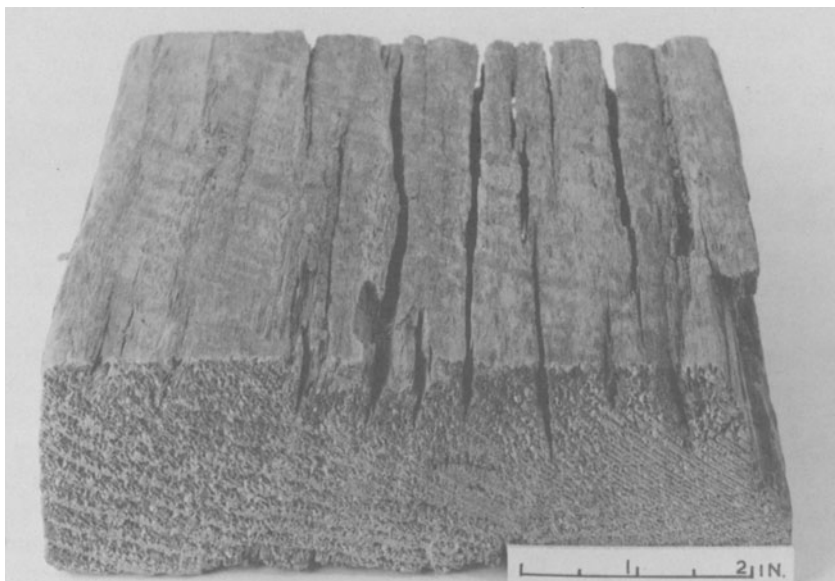
*Coniophora puteana*, commonly called the cellar fungus is also a brown rot, but in the final stages of attack the wood sometimes develops longitudinal splits or cracks, see figure 32, and the decayed timber may break up into cubical pieces. This is virtually indistinguishable from the final stages of *Serpula* attack, except that the wood is not permeated with *mycelium*. The decayed timber is dark in colour and extremely brittle. It is capable of being reduced to powder if rubbed between the fingers. Although *Coniophora* grows most vigorously in the moisture range of 24–28 per cent, initial infection usually occurs in conditions of somewhat higher moisture content, too high for the so-called dry rot. *Coniophora* is particularly liable to occur wherever there is persistent leakage of water or condensation. The *hyphae* are always fine and they rapidly turn brown or almost black. Spreading over the face of the wall the *mycelium* resembles the maiden-hair fern, but without leaves. The fruiting bodies are thin, olive-

**Figure 32** Cellar fungus damage (*Crown copyright: Reproduced by permission of the BRE Princes Risborough Laboratory*)
