Journal of ASTM International
Selected Technical Papers STP 1514
**Durability of Building and Construction
Sealants and Adhesives: 3rd Volume**

JAI Guest Editor:
Andreas T. Wolf

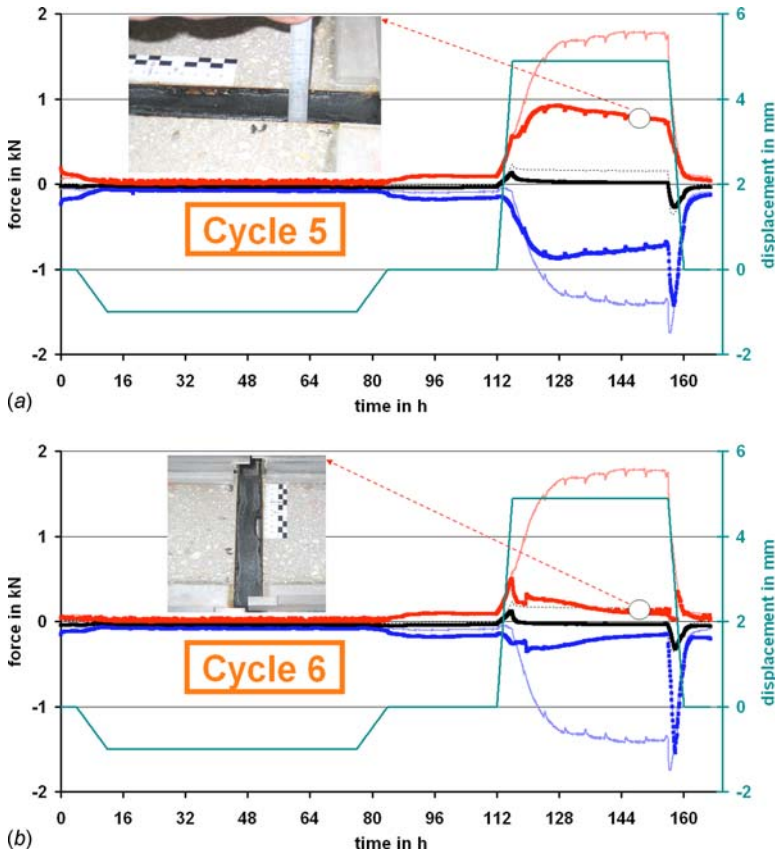
FIG. 14—(a) Typical failure at the end of system's service life (durability) indicated by the beginning of a local loss of the adhesive bond. (b) Nearly complete failure at the end of system's service life (durability).

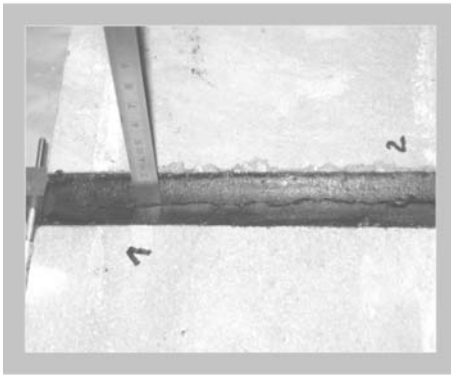
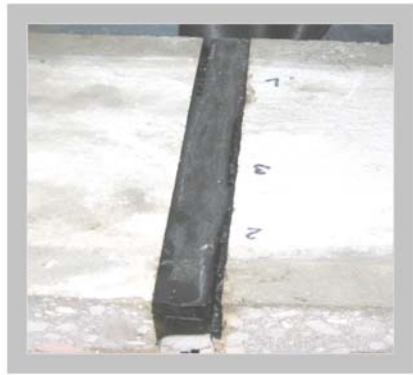
durability of joint sealing systems as derived from the discussion of annual force-deformation graphs, we now would like to introduce a tool for a physical exact characterization of the joint sealing systems that will complete the mechanical system evaluation. This supporting information can be derived from the analysis of the hysteresis curves (shape) for single dynamical deformations (see Fig. 16). From the slope of the curve, k , the stiffness of the system can be deduced. As can be seen from the hysteresis diagram shown in Fig. 16 the joint sealing system type PS 2 shows the highest stiffness. The slope of system PS 2 is approximately 35 times higher than the investigated RS 1 system and the profile system studied and still 3.5 times higher compared to system ES 2, for which the performance and durability behavior has been discussed above. A comparison of the shape and surface areas of the graphs indicates different mechanical behaviors of the various systems, whereas the shape of the hysteresis of system PS 2 indicates even differences between the tension and com-

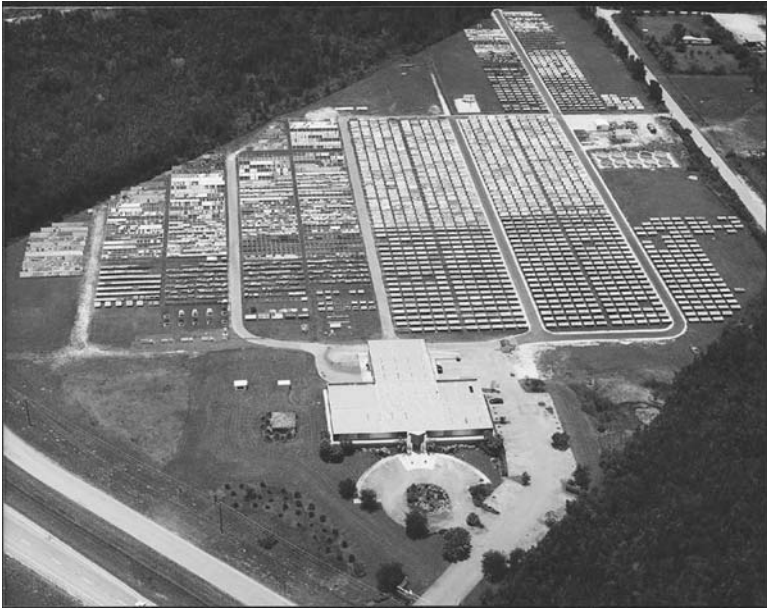
FIG. 1—Test site, aerial view (courtesy of Atlas Materials Testing Technology LLC).

Exposures were conducted in Miami, Florida, USA at an exposure field operated by the Atlas Weathering Services Group—South Florida Test Service (SFTS). The site is located in a rural, unpolluted environment with a general prevailing climate that provides high levels of ultraviolet radiation, humidity, and temperature in a tropical environment (see Fig. 1).

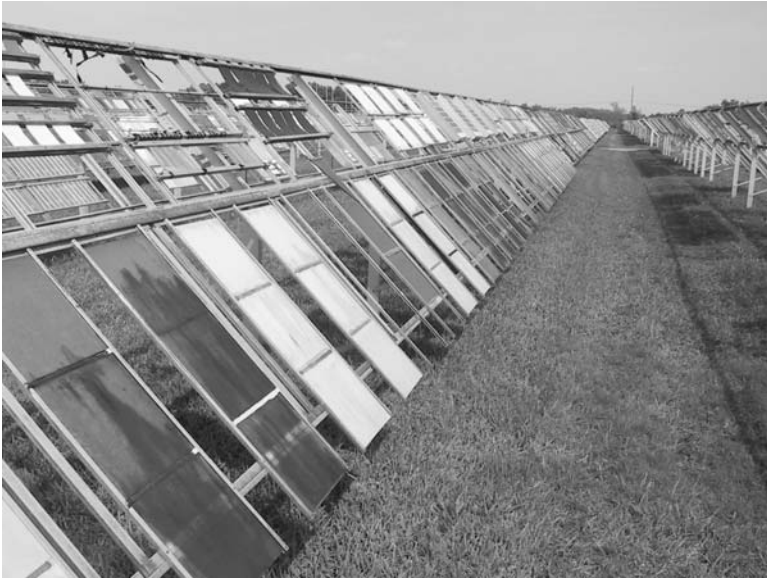
FIG. 3—*Test assembly array at test site location.*

tioned on the racks at a 45° angle to the horizon and facing south. Each test assembly consisted of three glass (or painted aluminum) panels with two horizontal in-plane joints created between the panels (see Fig. 3). Both joints, of each test assembly, were filled with the same sealant product. All joints in all test assemblies were 1.3 cm (1/2 in.) wide and created using small plastic shims placed at the left and right edges of the panels to maintain separation. Glass thickness was 0.64 cm (1/4 in.). Painted aluminum panels used a 90° bend at the edges to provide sufficient surface length [1.91 cm (3/4 in.)] for bonding.

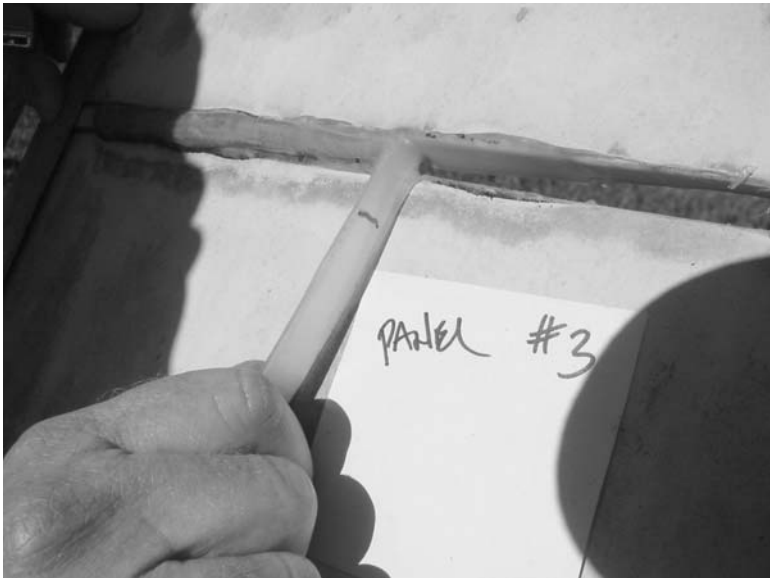
FIG. 5—Adhesion check by hand Pull, during.

Sections of each sealant were physically cut out from each glass and aluminum panel test assembly and at that time the adhesion was qualitatively evaluated by hand pull and visual inspection of the joint bondline for mode of failure (cohesive or adhesive). See Figs. 4 and 5. Adhesion results are shown in Table 5.

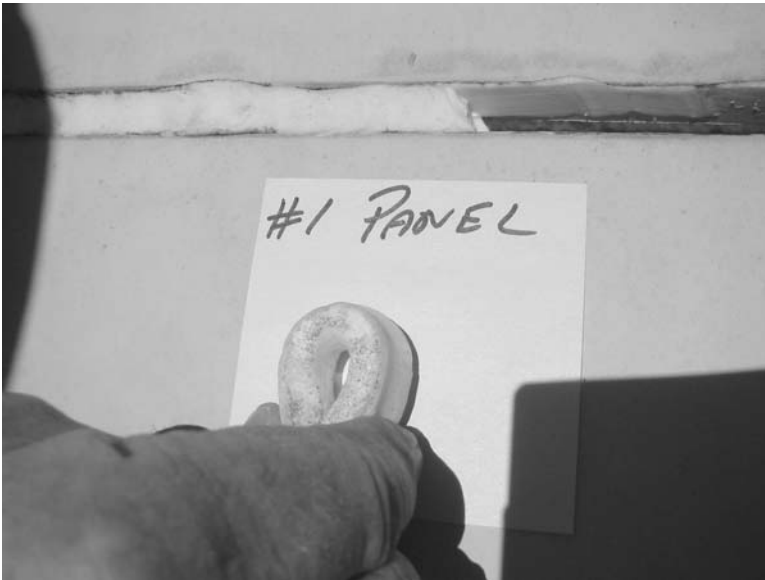
FIG. 6—180° manual bend of sealant (rated *Excellent*).

Immediately after each sealant was manually flexed/bent 180°, the sealant was released and the elastic recovery was noted and photographed. Elastic recovery is defined as the percent recovery to original shape within 5 min of release

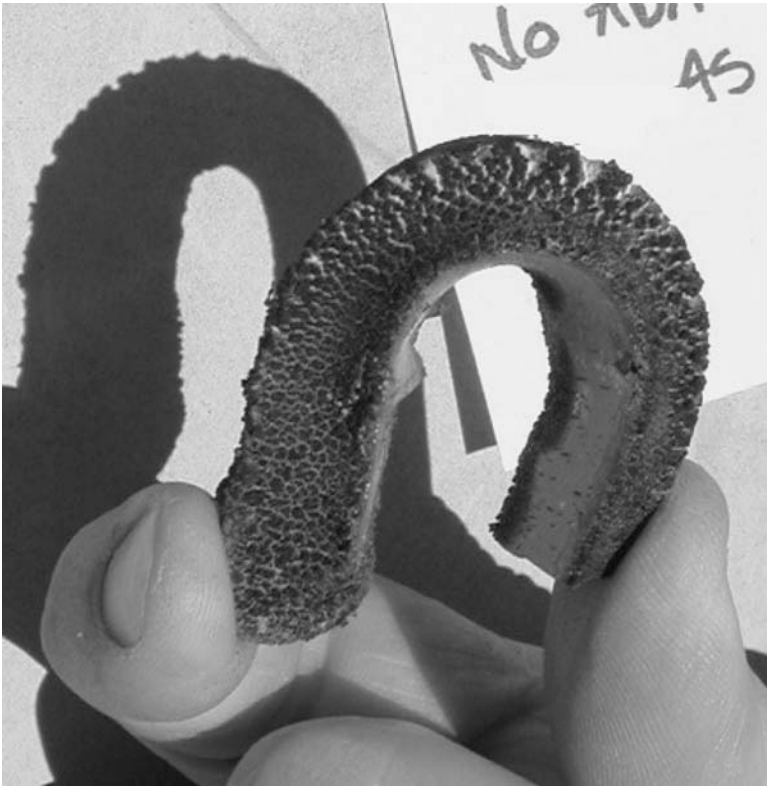
FIG. 7—180° manual bend of sealant (rated Good).

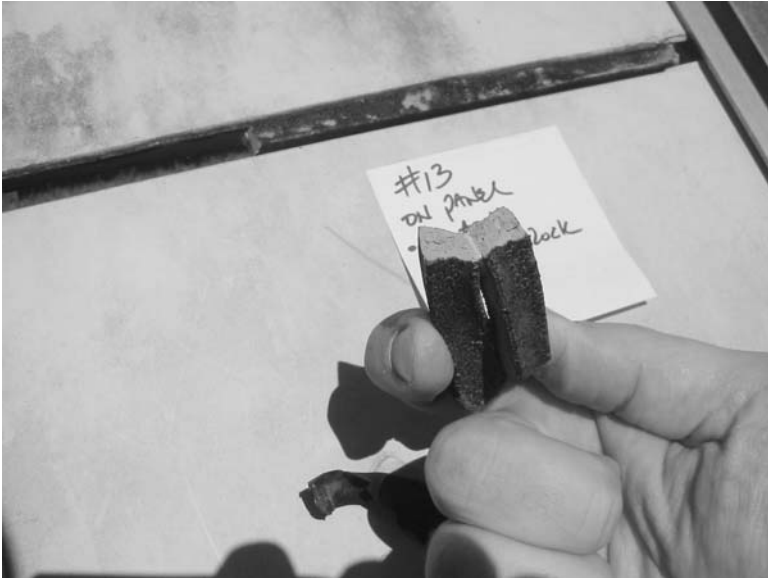
FIG. 8—180° manual bend of sealant (rated Poor).

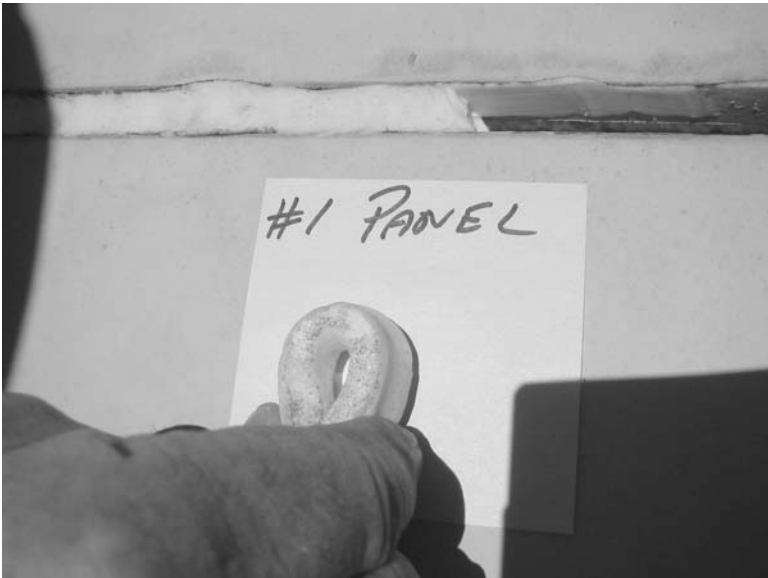
FIG. 9—180° manual bend of sealant.

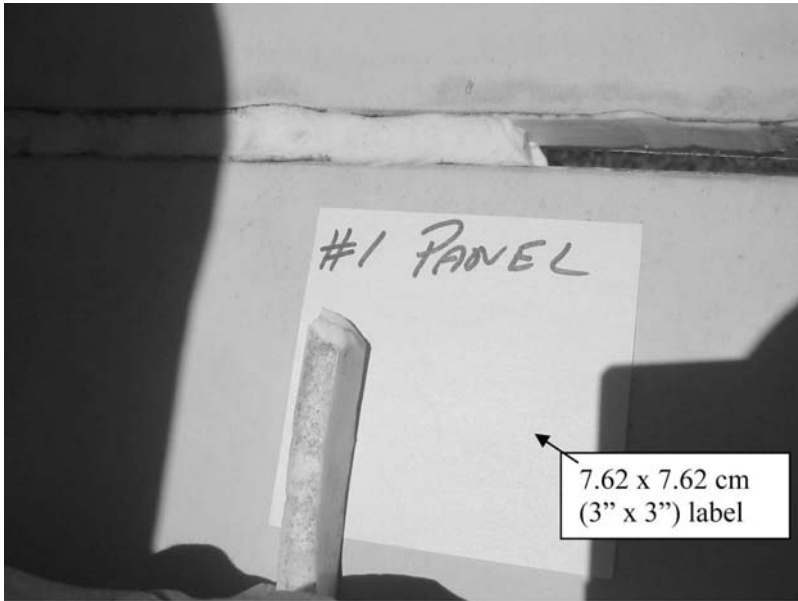
FIG. 10—Sealant immediately after release of 180° manual bend.

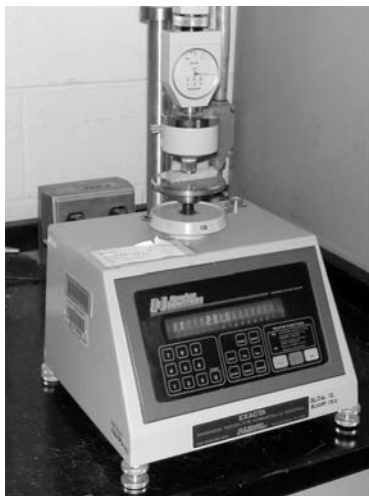
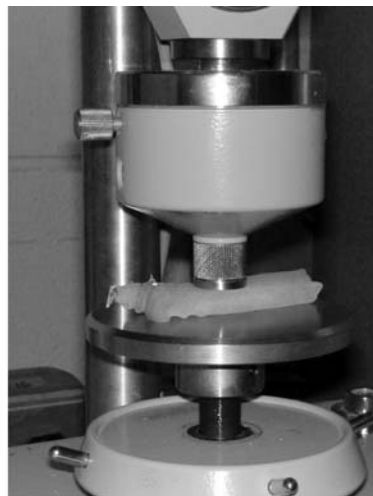
FIG. 11—Hardness tester.

Sections of each sealant were physically cut out from each glass and aluminum panel test assembly. Samples were taken to lab and measured for hardness using an Exacta Model# EX200/300T hardness tester manufactured by Newage Industries, Willow Grove, PA (see Fig. 11). Sealant specimens were cut using a sharp blade to create a suitable flat surface to take readings. For each specimen, a minimum of three readings (instantaneous values) were taken and recorded. Average hardness readings are tabulated in Table 6.

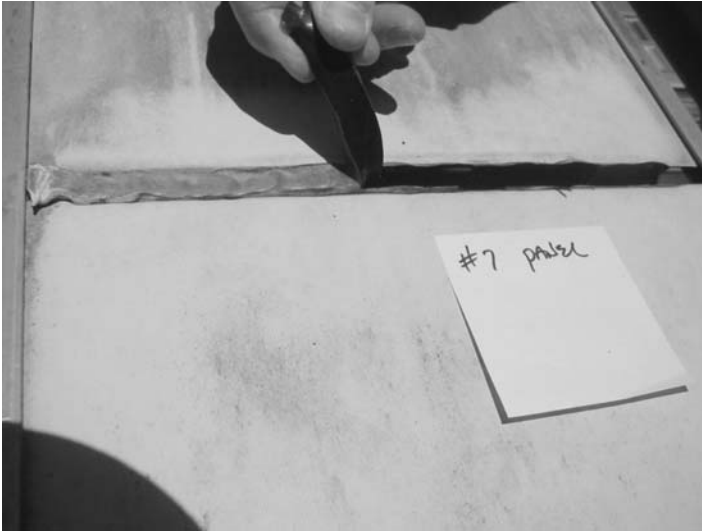
FIG. 23—Silicone sealant #7, after cleaning.

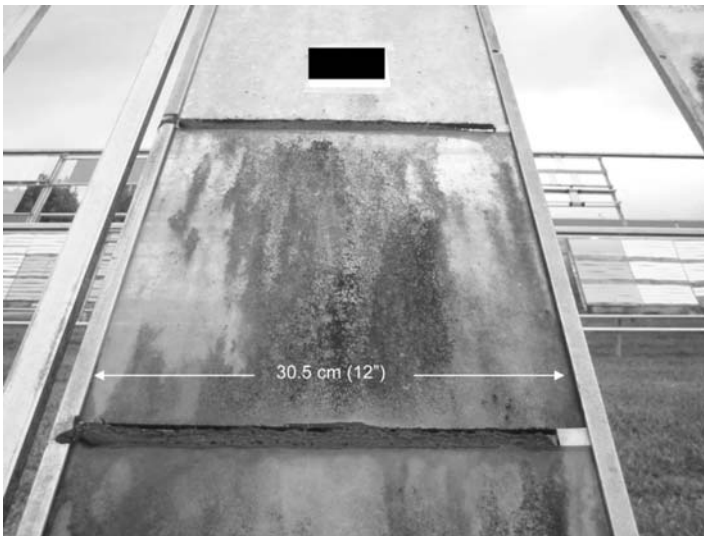
FIG. 30—Acrylic terpolymer sealant #11, before cleaning.

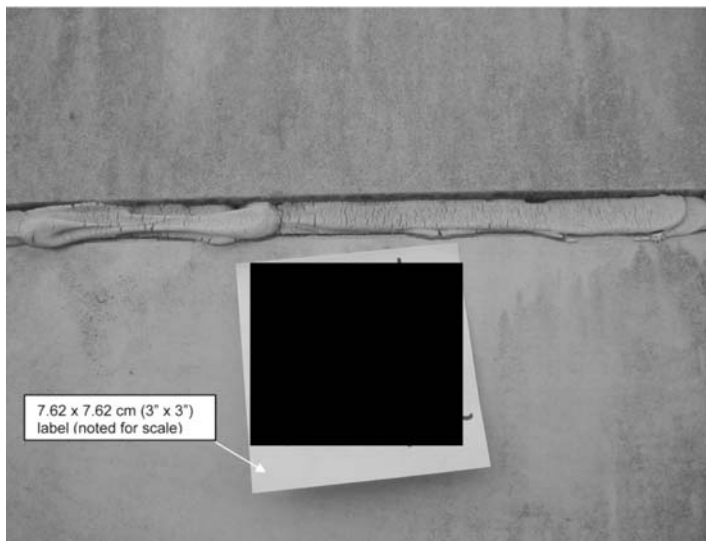
FIG. 32—Polyurethane sealant #12, before cleaning.

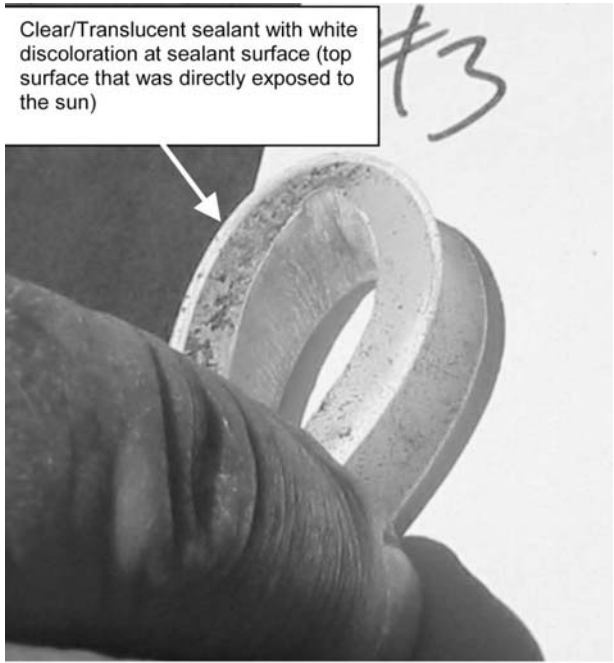
FIG. 35—Silicone sealant #3, surface discoloration.

^aSurface of sample was white (original color was clear/translucent). The white change occurred only on the glass test assembly (i.e., color change did not occur on aluminum panel test assembly) and only on top and bottom surfaces which were exposed to the environment (i.e., color change did not occur on the sealant edges on the bond line). See Fig. 35.

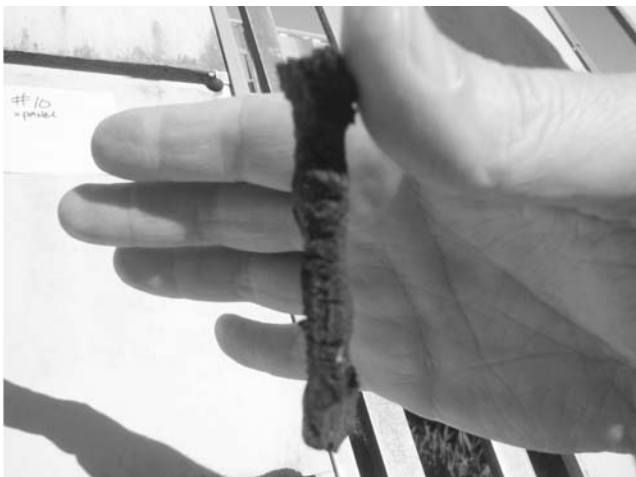
FIG. 42—Polyurethane sealant #10, reversion.

^eSamples were friable in some cases and body mass of some samples exhibited reversion (gummy). See Figs. 41 and 42.

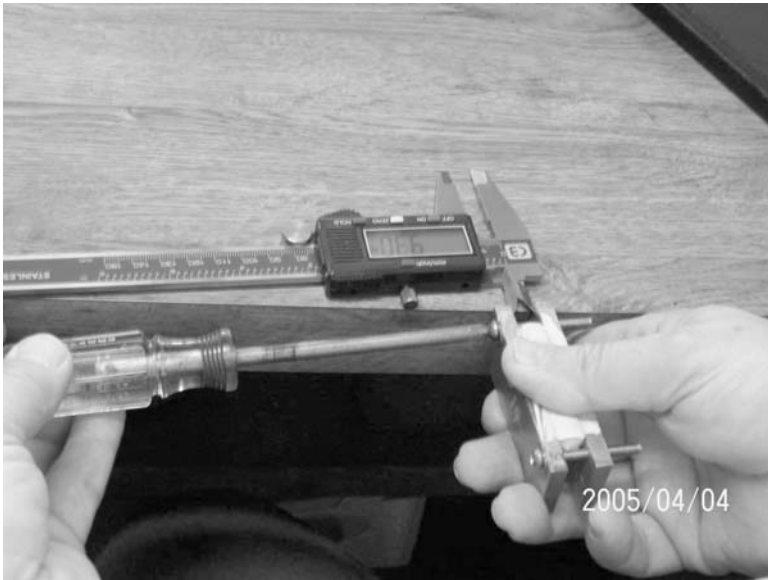
FIG. 3—Setting compression with screw.

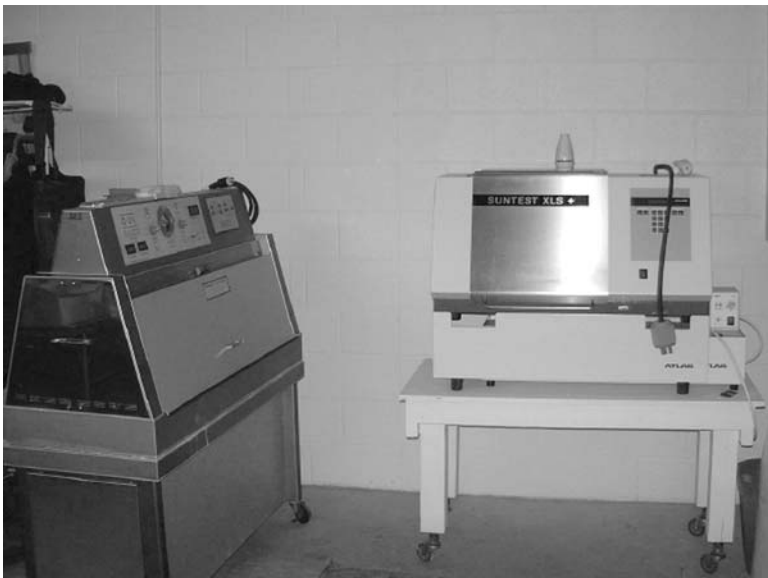
FIG. 4—Two weathering machines.

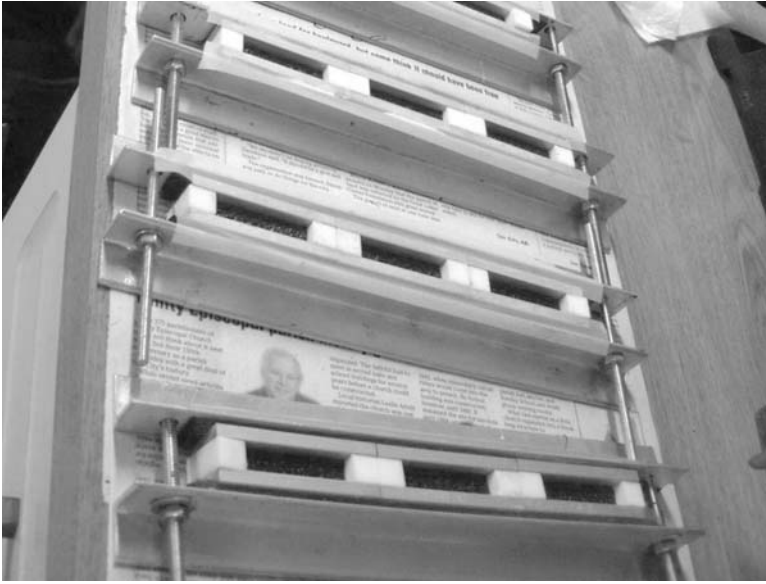
FIG. 5—Polyethylene foam backing.

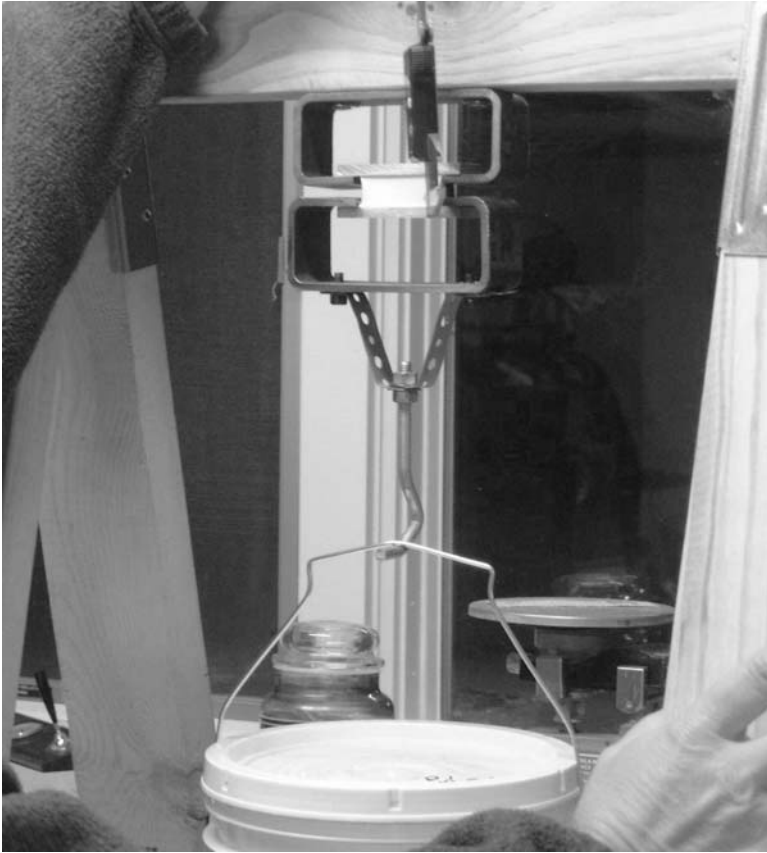
FIG. 6—*Strain testing.*

Displacement at a given load was measured initially and again after each complete weathering/movement cycle. The load (stress) varies with the modulus of the sealant, varying from 0.03 N/mm^2 (3.4 g/cm^2) to 0.20 N/mm^2 (28.5 g/cm^2). The displacement at a given load is easily measured after 30 s in any laboratory with a normal stress and fatigue setup and does not require a machine that measures load at a given displacement. In the end, the tests use conventional low cost weathering machines and simple low cost testing devices.

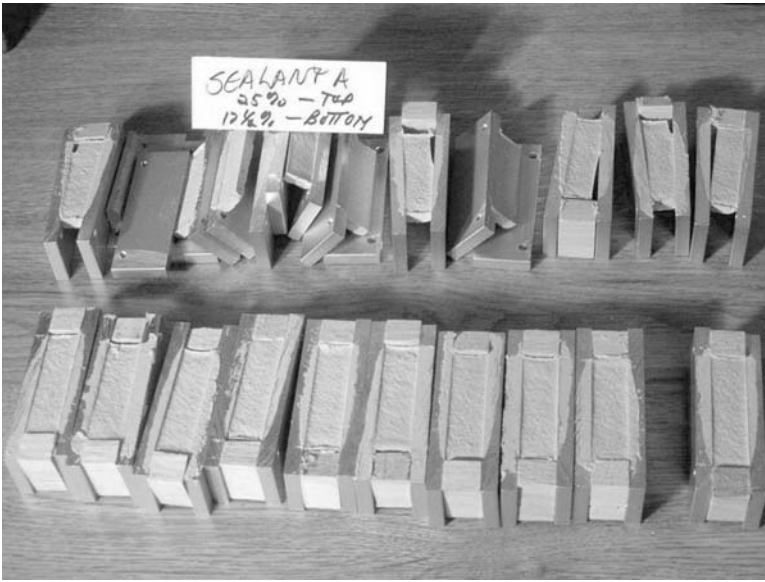
FIG. 7—Failures after the first extension at half the rated movement.

The experimental procedure followed the plan almost perfectly until stressing started. The original plan was to take each of the sealants to their advertised maximum movement ability. However, when the original 21 samples of the first sealant to be placed on the rack were extended, they stood overnight and then

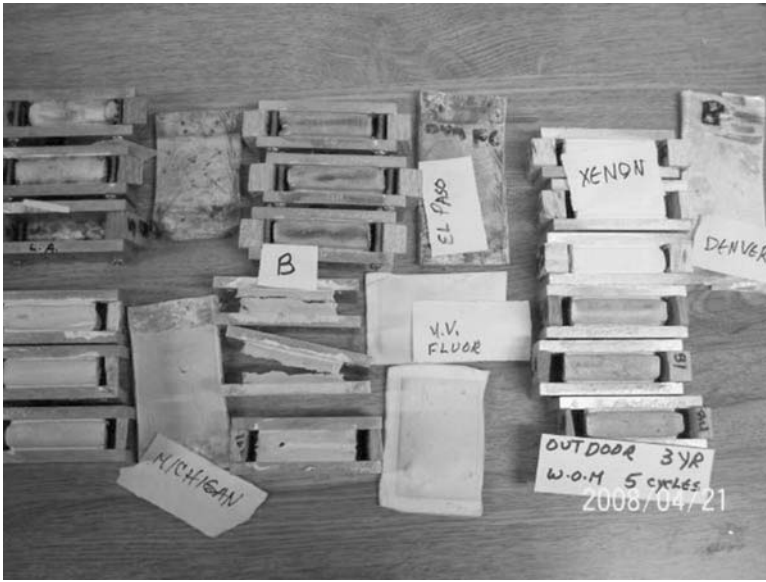
FIG. 9—Sealant B: White urethane one part.

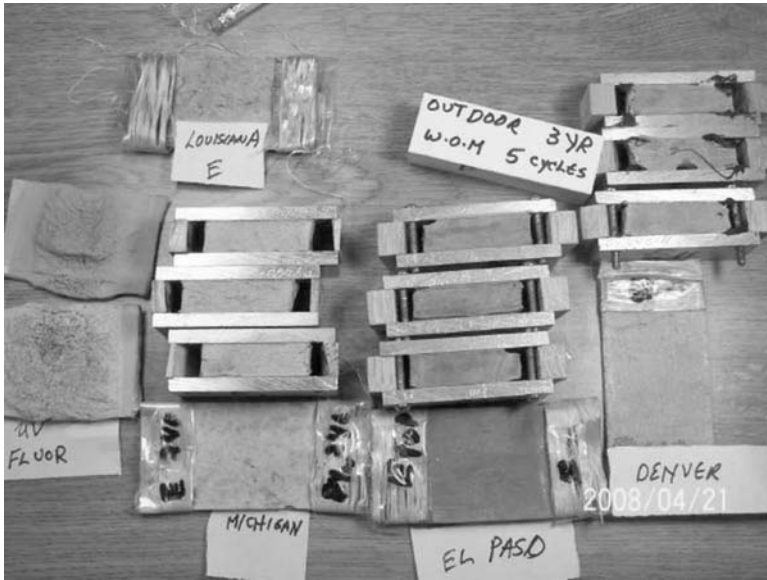
FIG. 12—Sealant E: White urethane two parts.

Sealant E was a white urethane (Fig. 12). Hurricane Katrina affected the results for this sealant, as the Louisiana joint samples were lost after the adhesion failed. The sealant joints in the xenon arc and UVF weathering machines failed in adhesion during the first cycle, though the samples were glued back together in efforts to obtain correlation numbers relative to rubber properties. The Denver samples also failed in adhesion and were glued. All samples, joints, and slabs in all locations showed severe weather cracking and crazing. The surviving joints in Michigan, Denver, and El Paso all had similar rubber changes (softening) and nearly a doubling of strain with a given stress. The outdoor weathering of the unstressed slabs was interesting—the El Paso and Denver

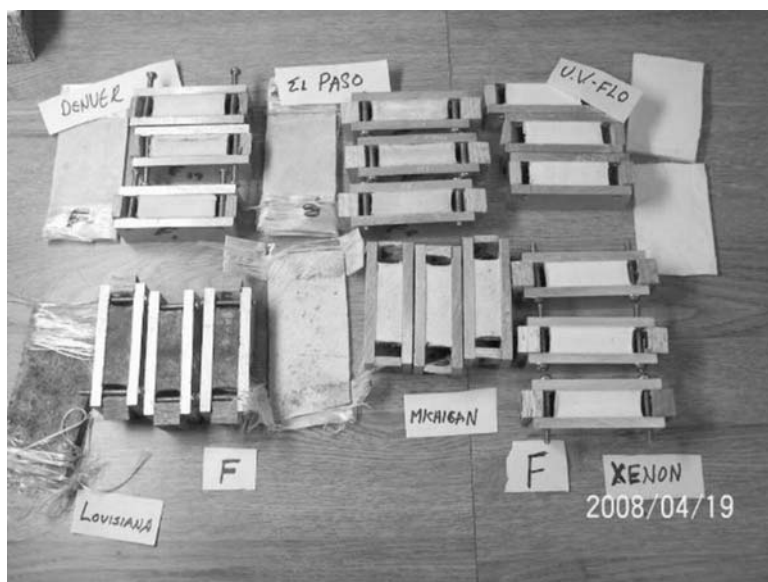
FIG. 13—Sealant F: White silicone one part.

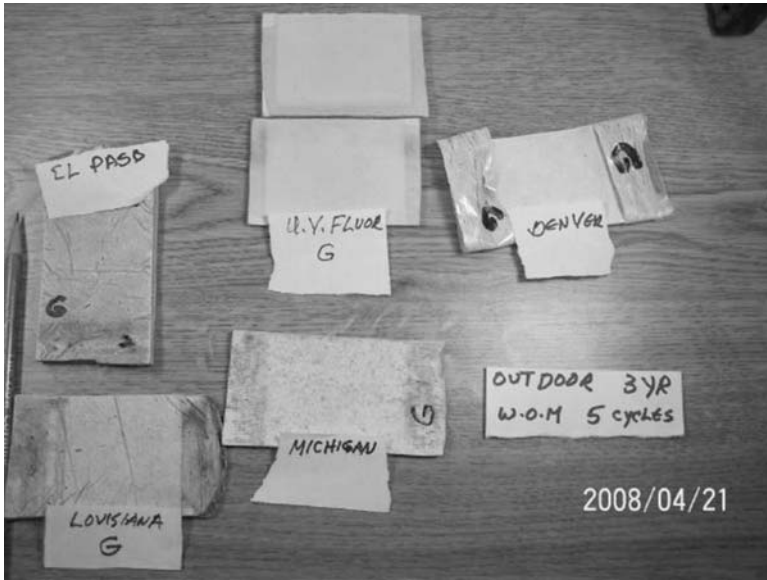
FIG. 14—Sealant G: White urethane two parts.

Sealant G was a white urethane (Fig. 14). Following the manufacturer's recommendation, no primer was used. All joints failed in adhesion in the first machine cycle or the first year of outdoor weathering. None were saved. However, some data was gleaned from the weathered slabs of sealant.

The slab in the UVF became substantially softer in the first cycle and stayed that way through five cycles. The outdoor slabs either remained relatively un-

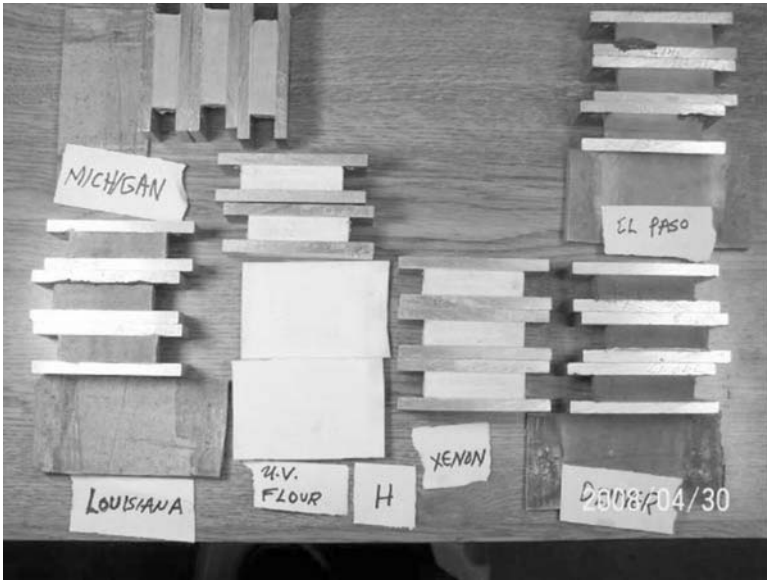
FIG. 15—Sealant H: White silicone one part.

Sealant H was a white silicone (Fig. 15). In all exposures the joint samples first softened then stiffened. Michigan, Denver, and El Paso samples all had minor softening before stiffening. They remain nearly at initial values, and it will be interesting to observe their progress in subsequent years. The Louisiana samples softened more than the others in the first year and have not yet fully recovered. One Louisiana sample lost adhesion.

The xenon arc lamp samples softened to a greater degree, much like the Louisiana samples, and after five cycles have not yet fully returned to original stiffness. Samples across all tests for Sealant H are continuing to harden and have not hit a plateau. If the span of time required for a sealant to return to its

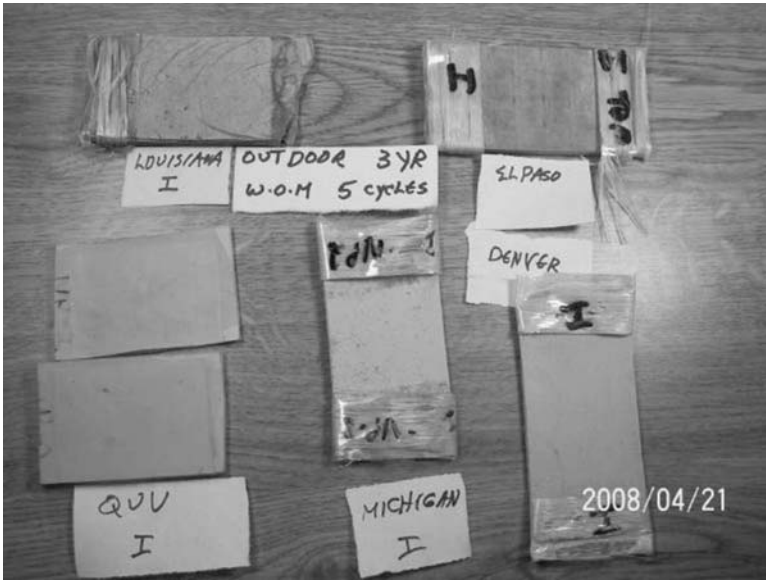
FIG. 16—Sealant I: A two-part beige urethane.

Sealant I was a beige urethane (Fig. 16). All samples lost adhesion early. These were not repaired (as had been attempted with other sealants), but the study continued with the slabs. As before, only Shore A durometer and appearance were studied with the slabs. The Louisiana and El Paso samples showed a slight softening in the initial year. The Denver sample showed almost no change in the first year, and the Michigan sample hardened slightly, as did the UVF sample. However, after the first year the samples remained constant in hardness.

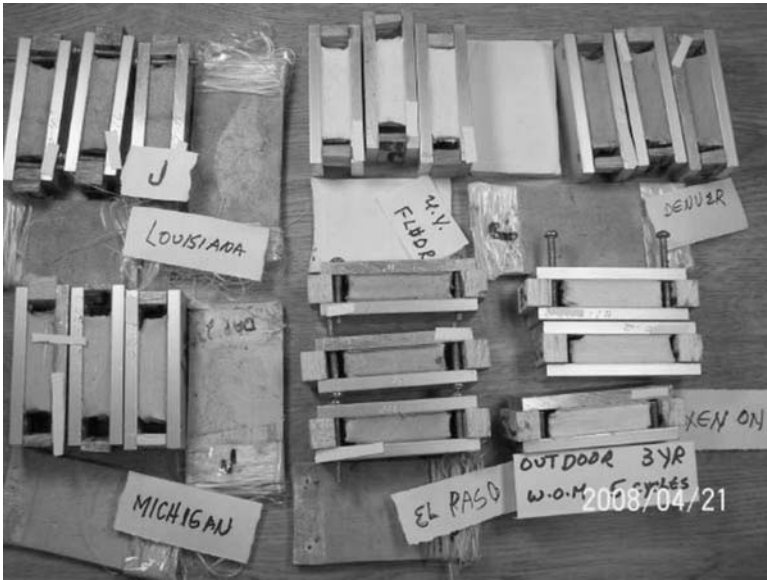
FIG. 17—Sealant J: White acrylic one part.

Sealant J was acrylic latex (Fig. 17). This sealant, like many of the others, lost adhesion quickly after the advertised movement; however, at half of the movement level, it performed quite well. At first touch it seemed hard, and it is, but a stress relaxation followed and the sealant softened somewhat. The overall trend for Sealant J was hardening with time and movement. Joints that opened to between 15 % and 20 % with a given weight after 1 month of cure would then typically open only near 5 % and often less after 1 year or more of outdoor weathering. For this sealant, correlations cannot be made for want of more precise execution in testing.

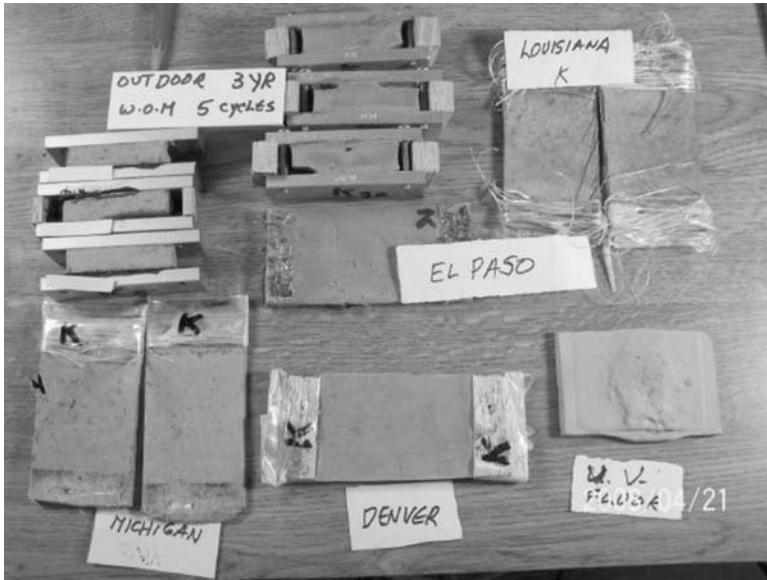
FIG. 18—Sealant K: *Beige urethane two parts.*

Sealant K was a beige urethane (Fig. 18). Of 18 joint samples using this sealant, only one did not lose adhesion and even then only because it had been glued together after failing on the second yearly cycle in the same manner as detailed with other sealants. Thus, no moving joint correlations can be made to the weathering machines. Also as before, further studies require closer work with the manufacturer and a better primer.

The slabs remained in testing and a unique result occurred: The UVF slab started to bubble, near to frothing, at its center. This bubbling is inconsistent with outdoor weathering for all samples. Note, however, that the UVF samples underwent five weathering cycles in the machines, but the slabs underwent only three outdoor cycles. Sealant K could be particularly sensitive to UVA energy, and the cumulative effect of the outdoor exposure had not yet matched that of the machine. It would mean that UVF machines have a very large acceleration factor with this material.

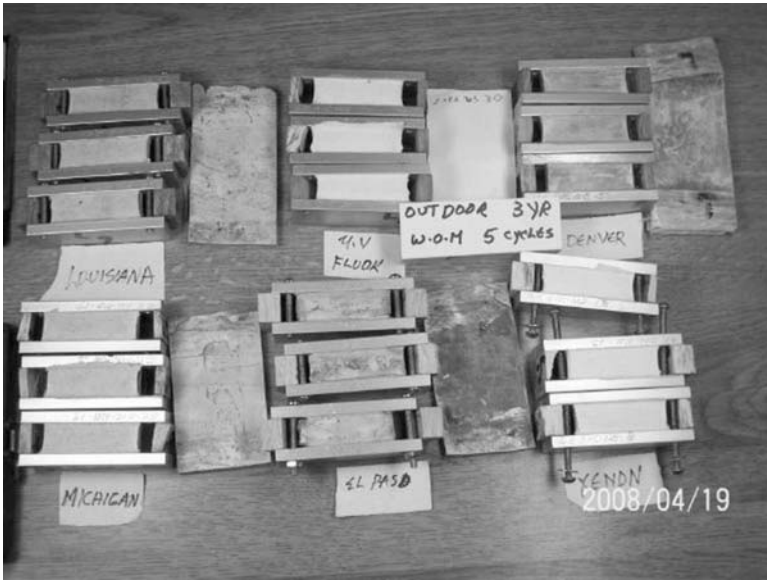
FIG. 19—Sealant L: White silicone one part.

Sealant L was a white silicone (Fig. 19). There was neither adhesion loss nor surface damage. For rubber performance, the modulus softened slightly in all outdoor samples—Louisiana the most and the machine-weathered samples even more so. The machine samples' softening occurred during the first 8 weeks of cycling, with no further change during the other five cycles tested. Until more damage or more change occurs, no correlation can be made.

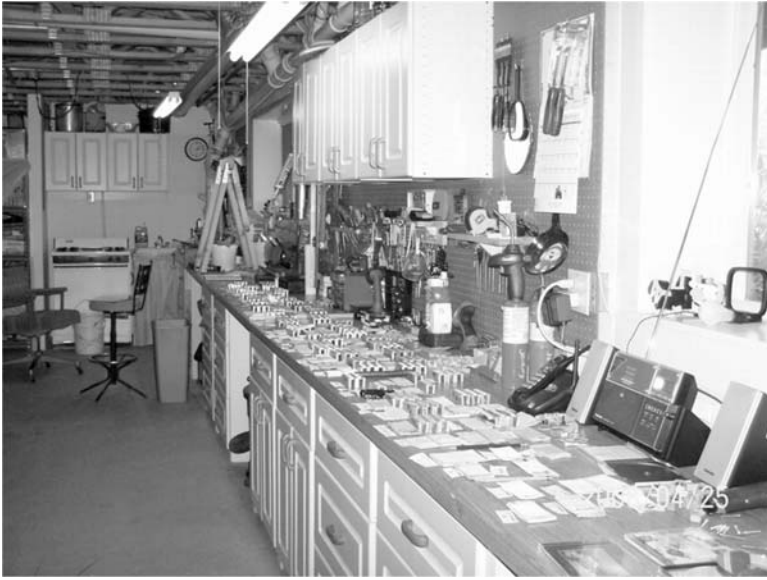
FIG. 21—*Laboratory.*

Among the sealants tested were those, all of the same generic type, that performed well both outdoors and in the machines (Figs. 21 and 22). With sealants like these, correlations between outdoor and accelerated weathering need longer test periods to produce significant damage or more precise testing. On the other hand, others showed major deterioration despite the relatively short duration of the study given their intended purposes. However, some of the same generic class were still performing adequately throughout this study. This study emphasizes that there are no possible generic generalizations relative to durability, adhesion, or esthetics of a urethane. It could also be true of silicons, but longer exposures are needed for such a conclusion. It seems that generalizations in generic types relative to durability in given climates are difficult, near impossible, where the stability of a sealant depends on the concentration or types of additives, as is the case with the urethanes. Thus with such

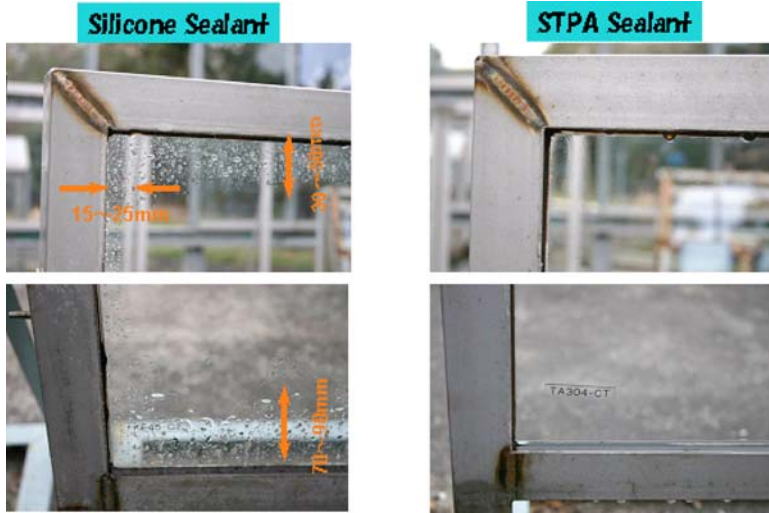
The hydrophobic contamination test of SCG with silicone and STPA sealants was carried out by using specimens shaped like an actual window [16]. The test results after 812 days of outdoor exposure are shown in Fig. 14. The photos were taken after spraying the glass surface with water so that hydrophilicity or

FIG. 14—Contamination test results on window shaped specimens (outdoor exposure for 812 days; photos taken after spraying the surface with water).

hydrophobicity of the glass surface could be observed easily. The silicone sealant specimen showed a hydrophobic contamination area along the sealant joint with a width of 15–90 mm, while the STPA sealant specimen showed no contamination at all with the whole specimen remaining hydrophilic.

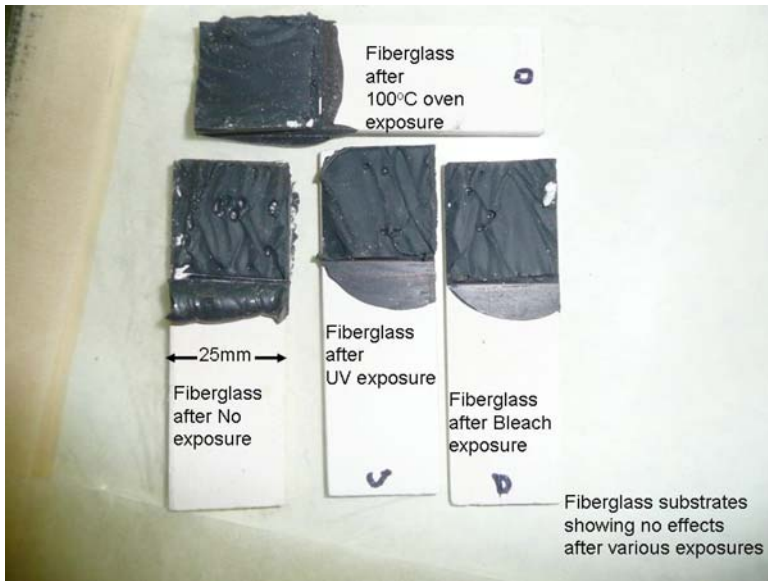
The fiberglass substrate showed excellent adhesion and strength in all but the water immersion after bleach exposure and degradation of the surface was not noted in any case. Figure 13 shows fiberglass substrate unaffected by the various conditions. When reviewing Fig. 9 to the controls noted on Fig. 2, the lap shear strength was a bit lower than the overall average and the one condition of water immersion after bleach exposure had an impact on the ultimate strength. The fiberglass substrate showed no visible effects of color change or dimensional changes through these exposures.

FIG. 13—Fiberglass specimens after UV, oven, and bleach exposures and control.

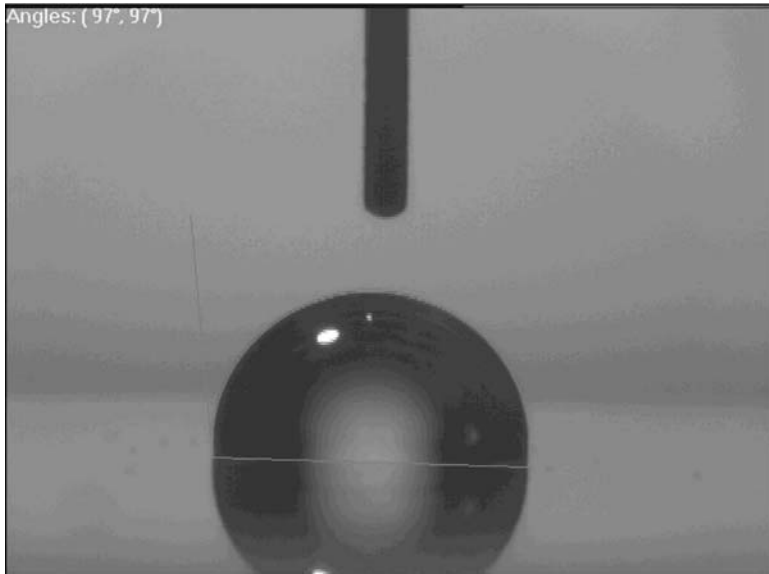
FIG. 1—The tangent angle of a bead of water on an oily surface at the point of contact of the water and the oily surface is typically between 90° and 110° . This angle is called the contact angle.

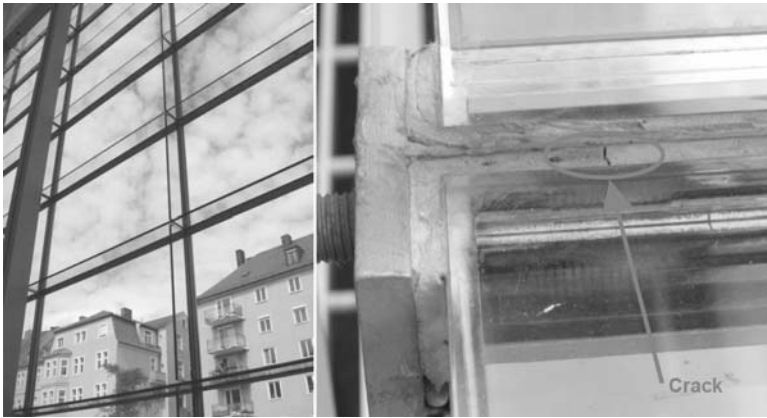
FIG. 3—Glass façade in the year 2008.

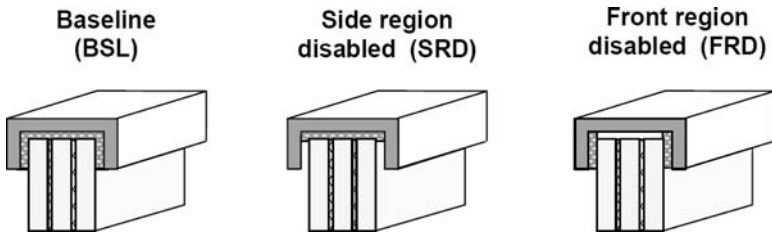
FIG. 11—U-type bonding test configurations.

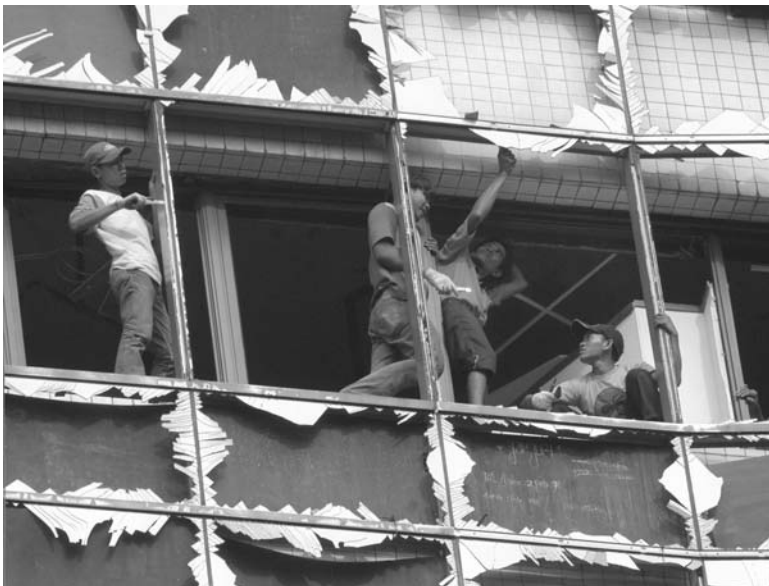
FIG. 1—Glazed curtainwall damaged by bomb blast (note the remaining shards of glass) (Source: Associated Press).

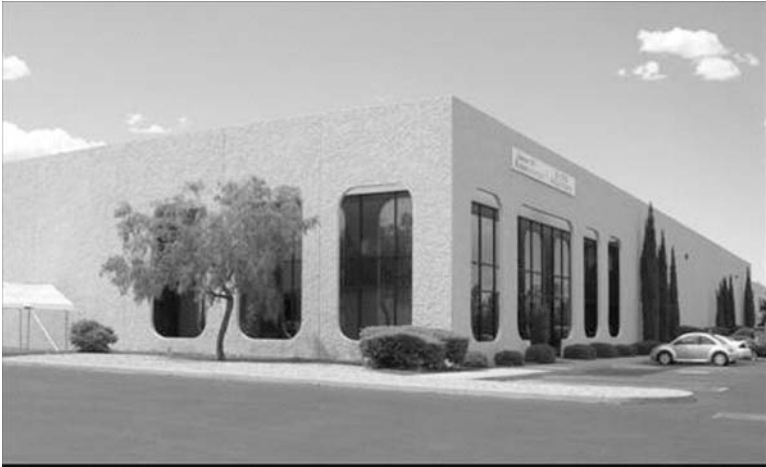
The warehouse was constructed of concrete tilt-up panels with a decorative aggregate surface finish (Figs. 1 and 2). The aggregate finish is made up of a large aggregate embedded in a soft friable concrete mortar. Because of the size of the aggregate, the aggregate layer is roughly 3/4 in. (19 mm) deep. Although it would have been preferable, from an adhesion point of view, to install the sealants against the underlying concrete panels, it was not possible to do so

FIG. 1—El Paso, TX, tilt-up warehouse used for exposure of high performance acrylic and polyurethane sealants.

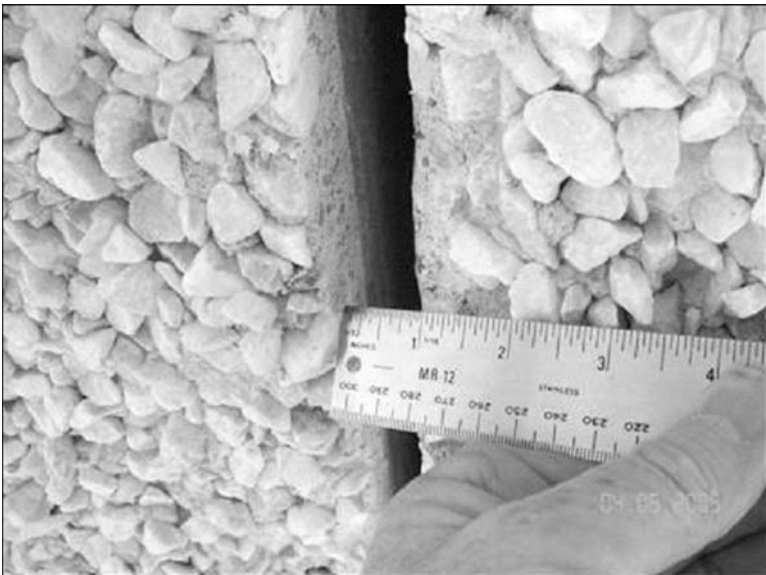
FIG. 2—Example of a prepared joint 1 in. (25 mm) wide. The underlying concrete slab and exposed aggregate surface layer are readily visible.

because of the depth of the aggregate layer. In both the original installation and in the retrofit described below, the sealants were installed flush with the building exterior and against the aggregate layer.

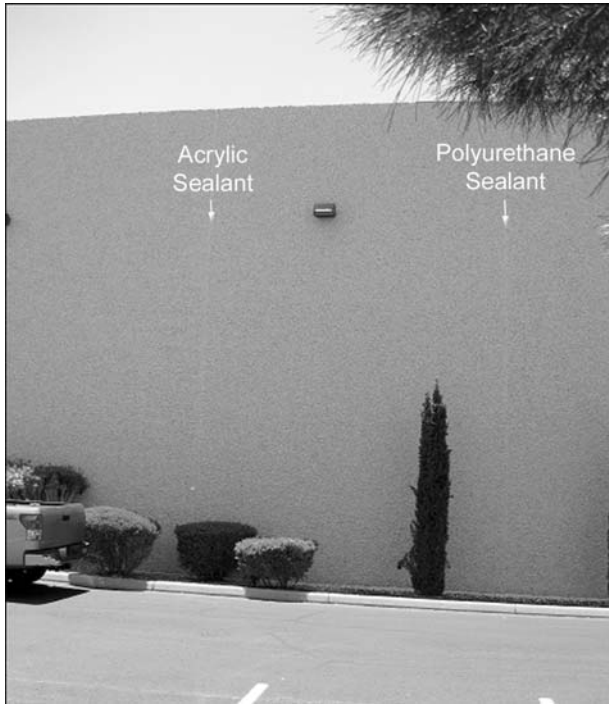
FIG. 3—View of the east elevation of the El Paso warehouse with an acrylic sealant joint on the left and a polyurethane sealant joint on the right.

Longer Term Observations—As determined visually and in comparative photographs, the dirt pickup of the two sealants after 1, 2, and 3 years is comparable. Dirt pickup, as might be expected, varies from elevation to elevation. However, from a distance, and from any elevation, the acrylic and polyurethane sealants look similar. After 3 years and at a distance of 20 ft (6 m), the acrylic and polyurethane sealants on the east side of the building (Fig. 3) are indistinguishable. Closer views of the two sealants on the north side of the building (Fig. 4) also reveal a similarity in overall appearance. On more detailed inspection, however, differences between the two sealants become apparent. A close-up comparison of the two sealants on the east elevation of the warehouse (Fig. 5) reveals considerable crazing of the surface of the polyurethane sealant but no apparent crazing of the acrylic sealant. This is a trend seen throughout the warehouse exposure—after 3 years of exposure, the polyurethane sealant exhibits considerable crazing in all vertical joints in all elevations. The acrylic sealant, in contrast, exhibits no visible crazing on any of the vertical joints.
