Corrosion protection of reinforcing steels

Technical report prepared by

Task Group 9.7

February 2009

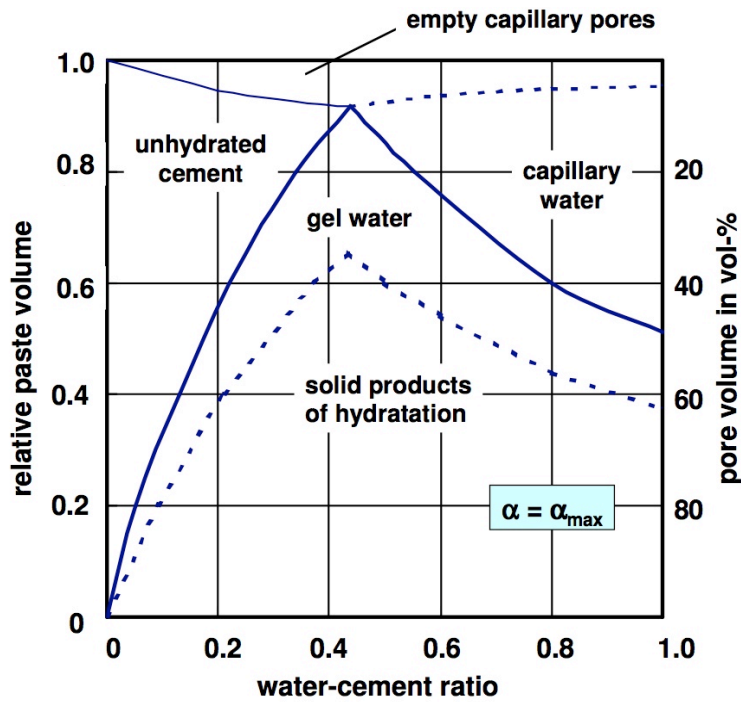
Fig. 2.1: Composition of hydrated cement paste and the final stage of hydration [6]
 α = degree of hydration

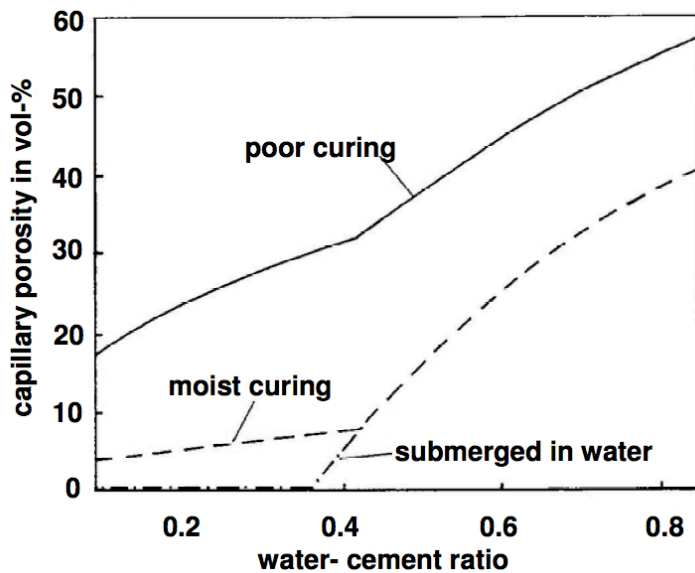
Fig. 2.2: Composition of hydrated cement paste at partial hydration

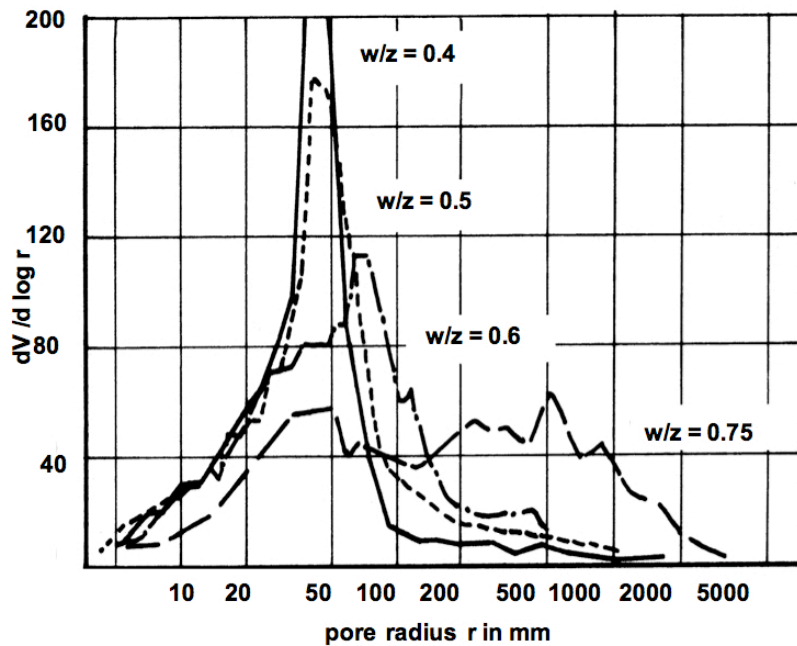
Fig. 2.3: Pore size distribution as a function of water/cement ratio [8]

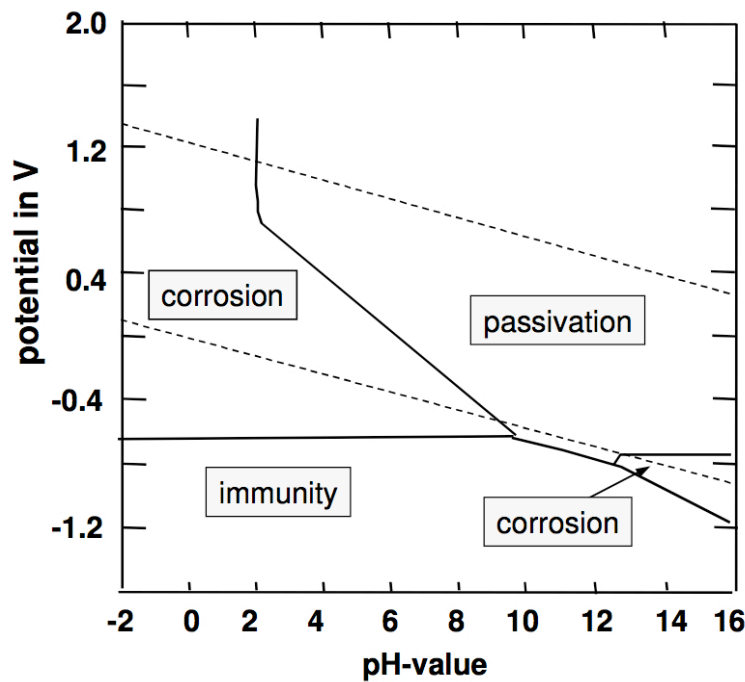
Fig. 2.4: Pourbaix diagram of iron in aqueous solution [9]

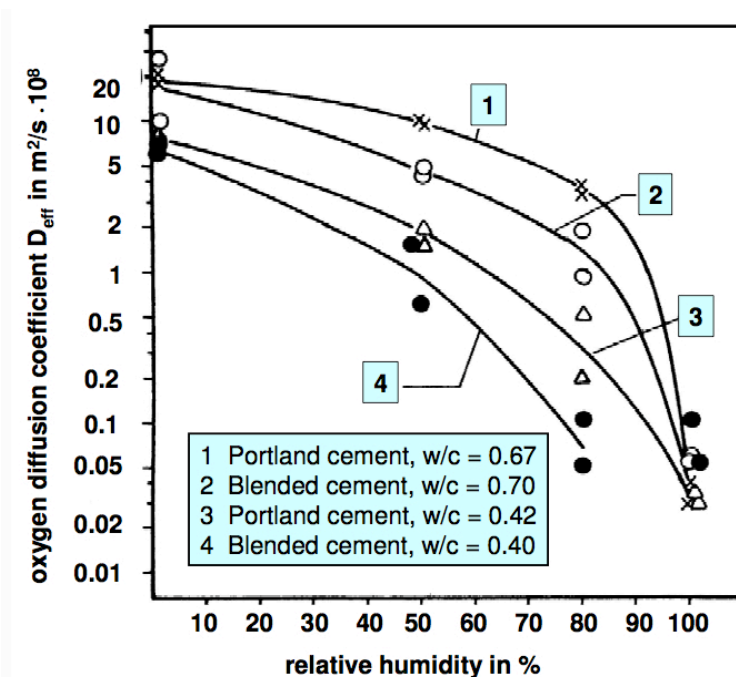
Fig. 2.5: Effective oxygen diffusion coefficient of Portland cement and slag cement concrete [10]

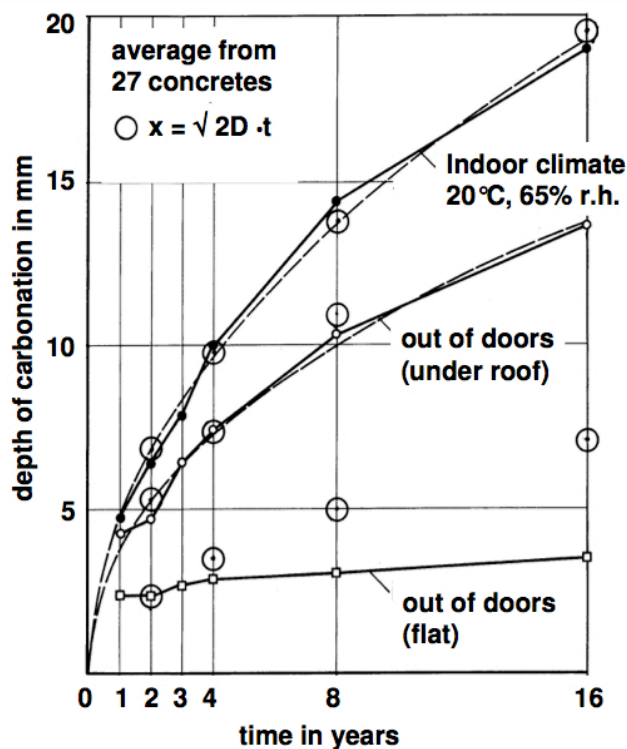
Fig. 2.6: Carbonation depth as function of time and environment [12]

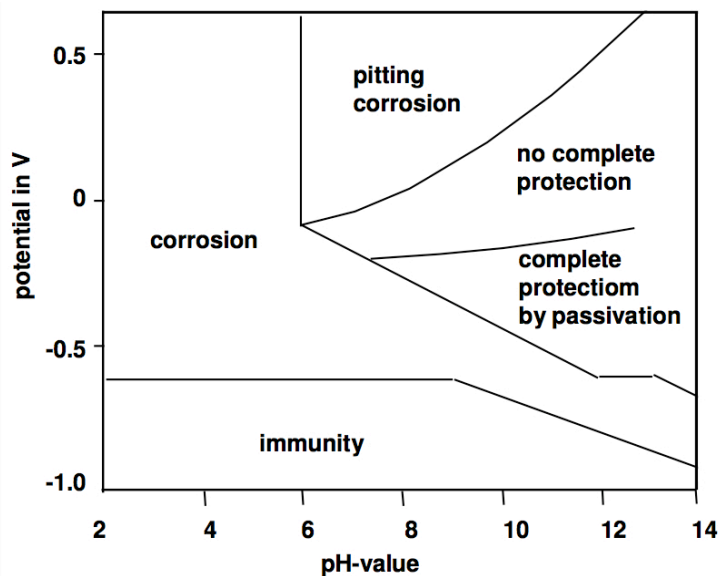
Fig. 2.7: Pourbaix diagram for iron in chloride solution [9]

Chlorides are either chemically bound in the hydrated cement paste or free. The bound chloride amounts to about 0.4% of the mass of cement. However, in carbonated concrete this number drops to almost zero. The free chlorides in the pore solution can penetrate the passivation layer and cause corrosion. This can be explained by Fig. 2.7.

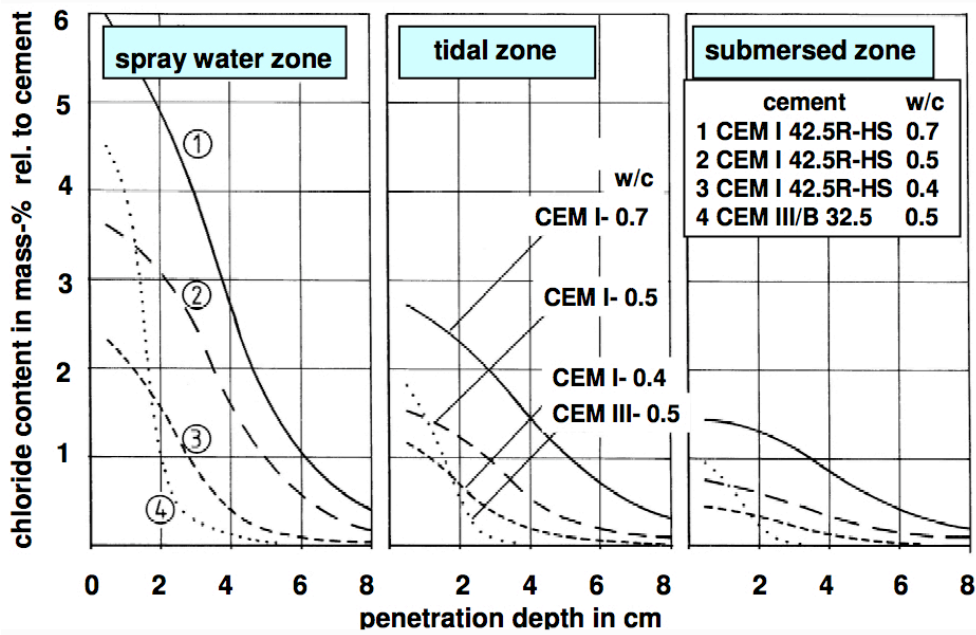
Fig. 2.8: Chloride concentration in various concretes [16]

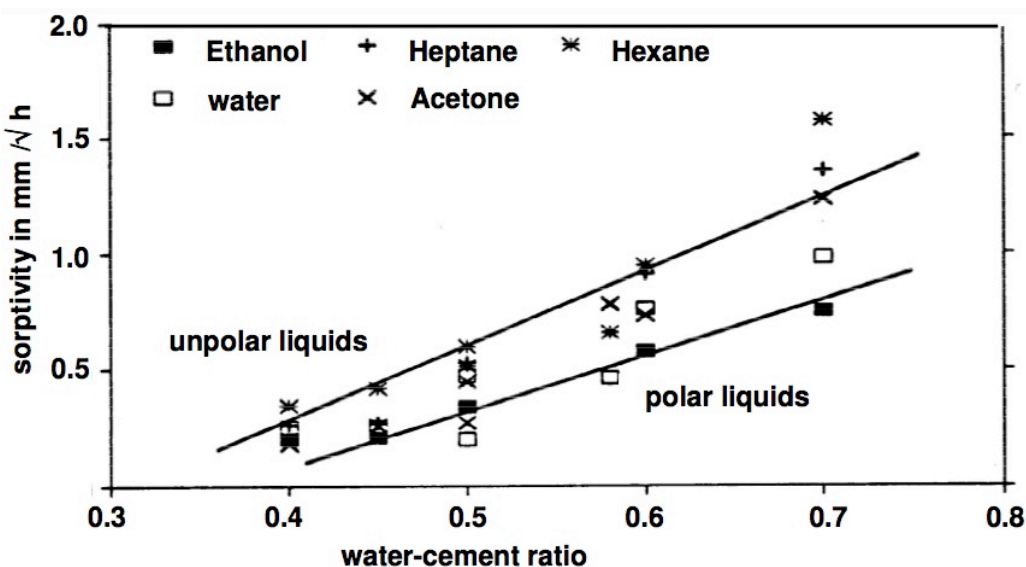
Fig. 2.9: Sorptivity vs. water/cement ratio for five fluids [15]

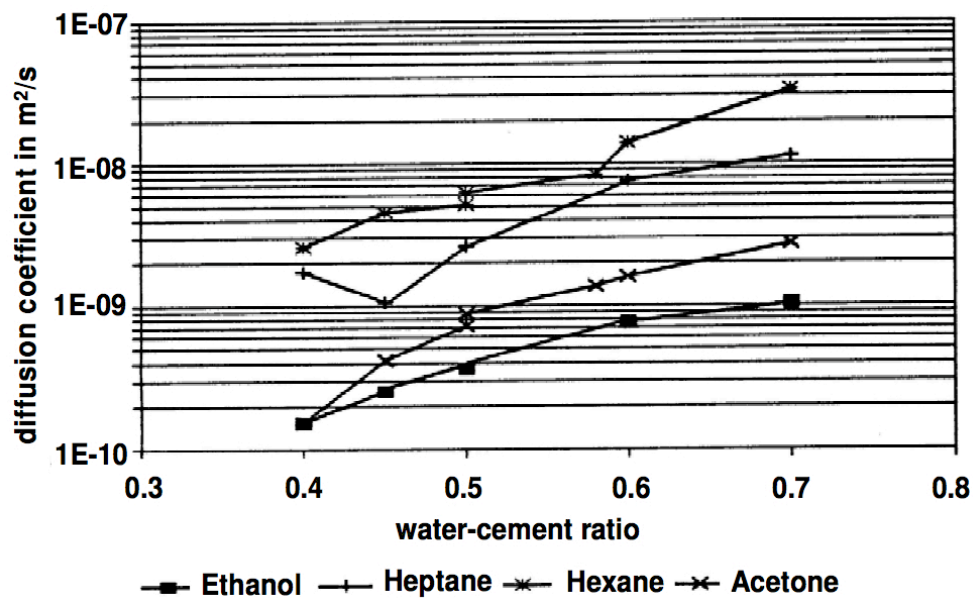
Fig. 2.10: Diffusion coefficient vs. water/cement ratio for four vapours [19]

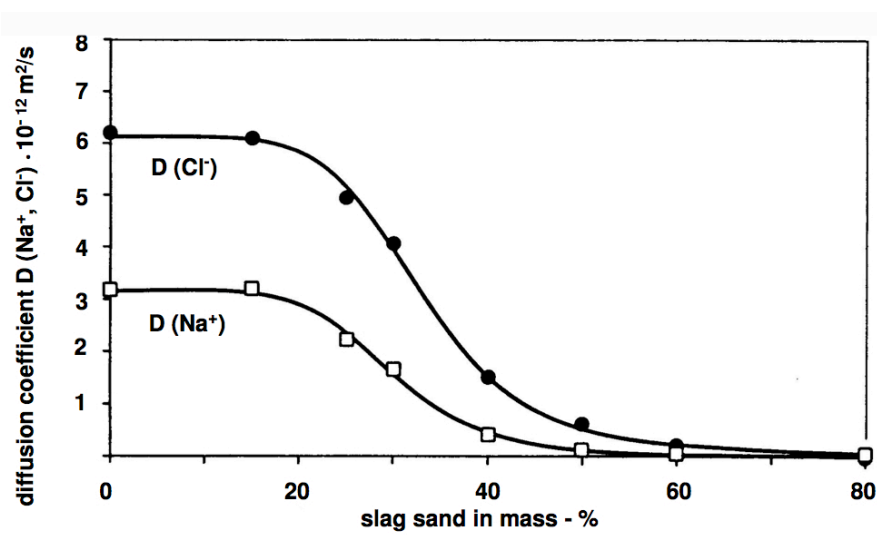
Fig. 2.11: Influence of ground granulated blast furnace slag on diffusion coefficient of sodium- and chloride-ions [20]

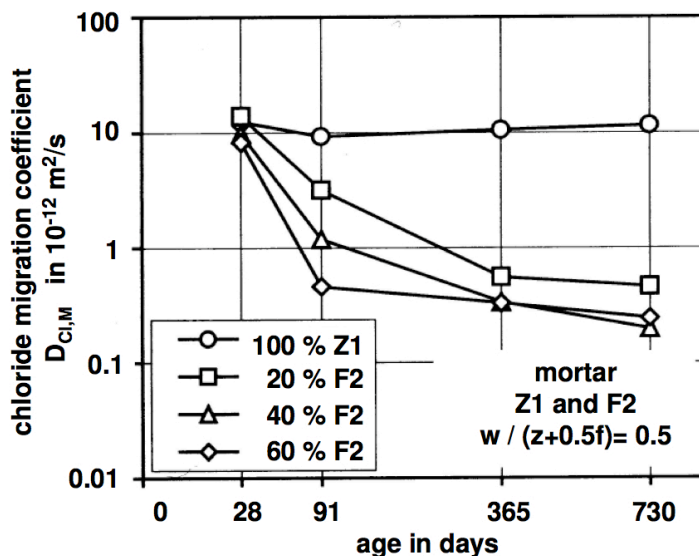
Fig. 2.12: Chloride migration coefficient as function of age and fly ash content [23]

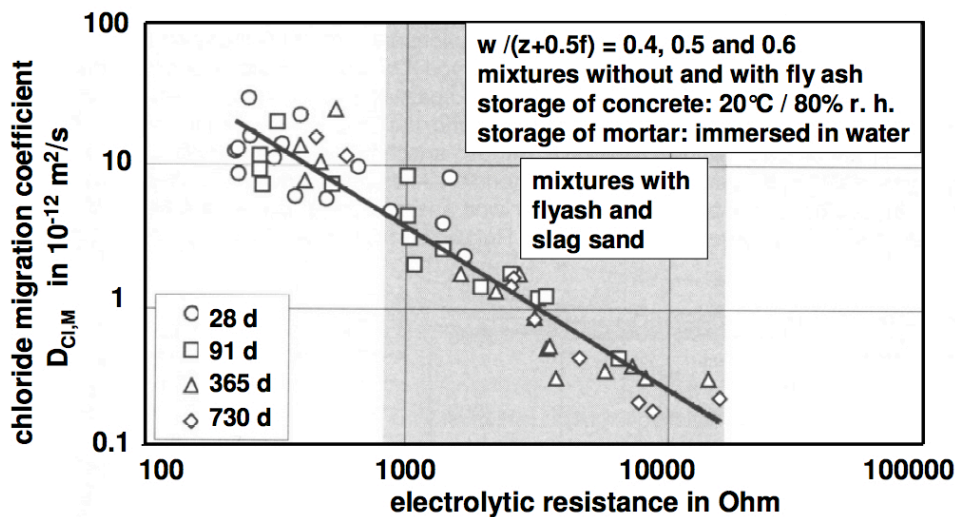
Fig. 2.13: Chloride migration coefficient vs. electrolytic resistance [23]

If the migration coefficient drops, the electrolytic resistance increases as described in Fig. 2.13 shows. This holds for mixtures with fly ash or ground granulated blast furnace slag, as indicated by the shaded area. The addition of silica fume has a positive effect on the tightness of concrete by reducing the porosity and the size of the pores. Since silica fume is mainly used in high-performance concrete, the effect is discussed in the next chapter.

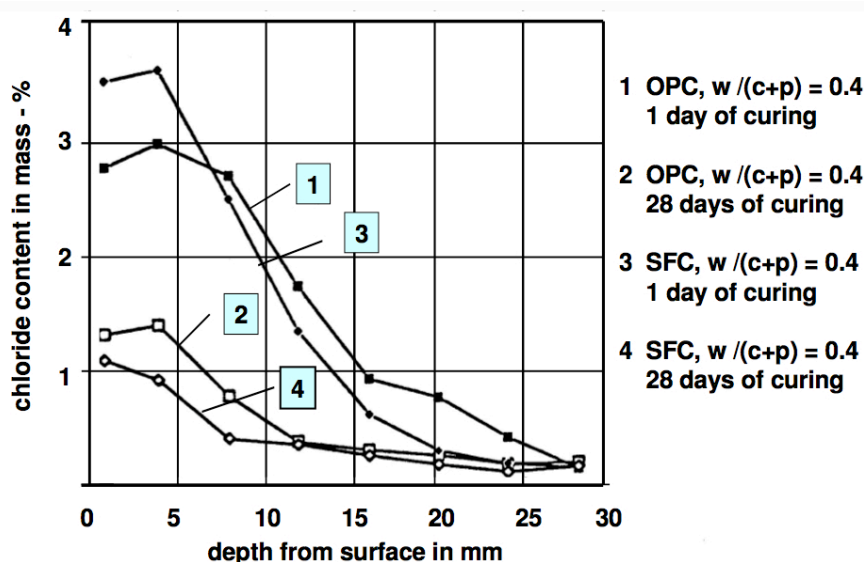
Fig. 2.14: Chloride distribution in concrete with and without silica fume [27]

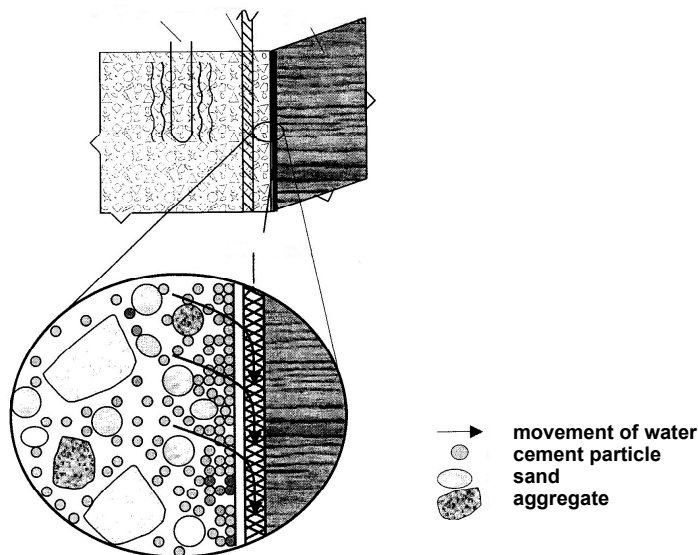
Fig. 2.15: Schematic of CFP effect [30]

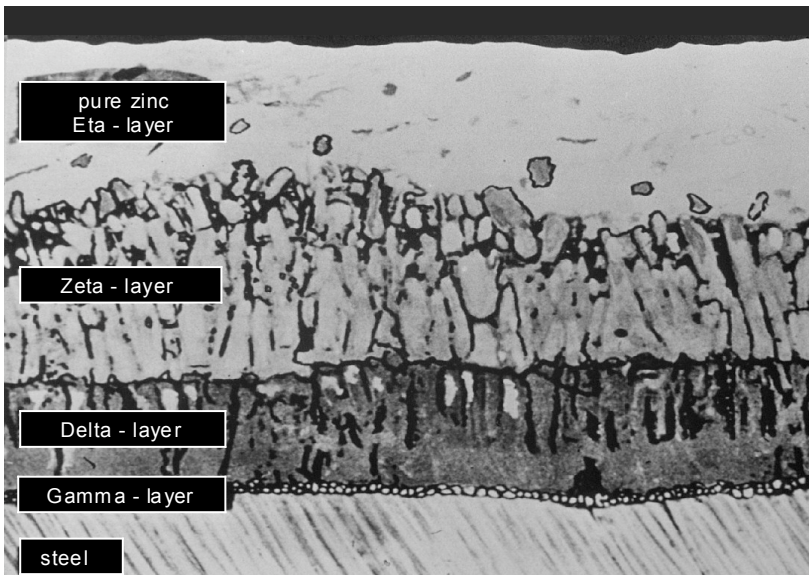
Fig. 3.1: Structure of the coating of a hot dip galvanized steel

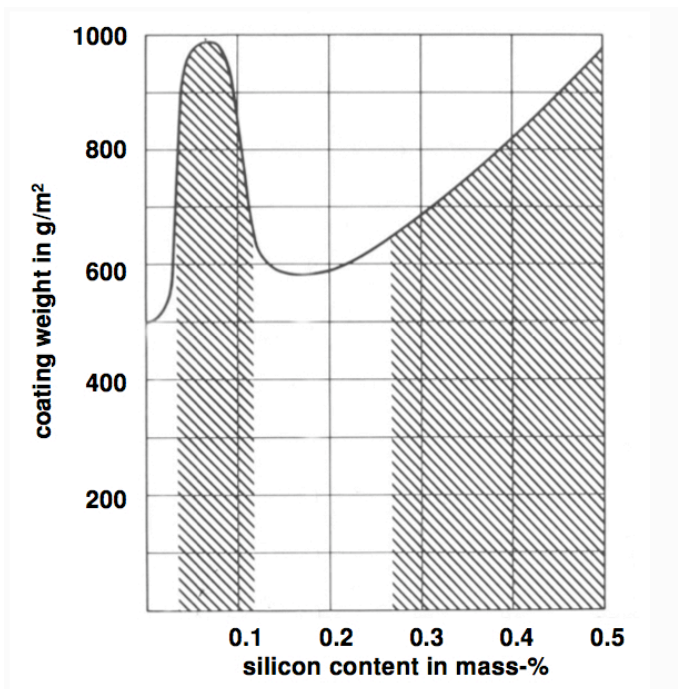
Fig. 3.2: Influence of silicon content in steels on zinc deposition

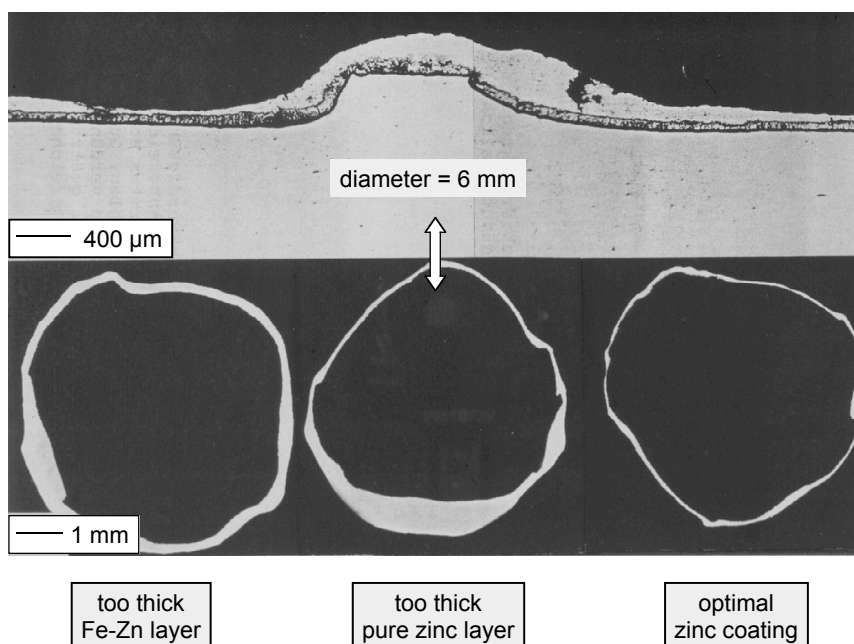
Fig. 3.3: Thick coating in the rib area of a small diameter reinforcing steel (DPN = Diamond Pyramid Number)

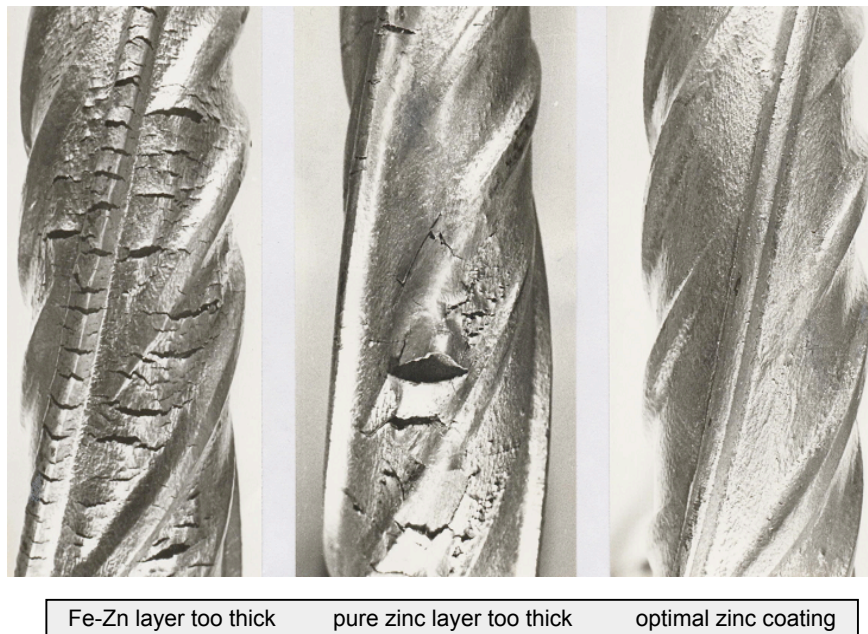
Fig. 3.4: Behaviour of coatings during bending around a smaller mandrel [8]

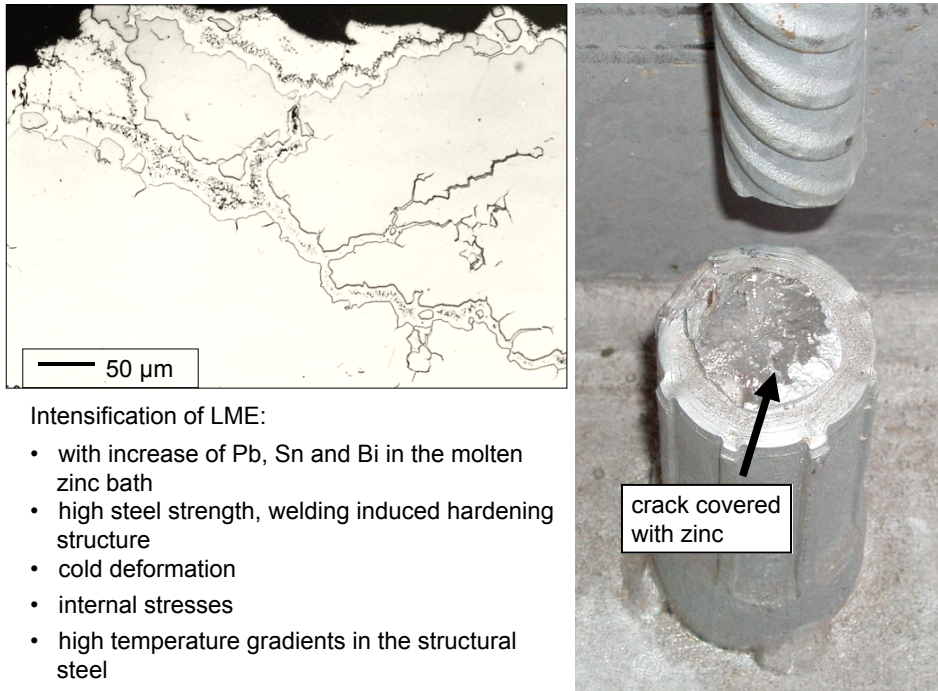
Fig. 3.5: Clamp joint between steel plate and galvanized reinforcement; steel fracture because of liquid metal induced embrittlement (LME) of galvanized steel. Cracks: zinc enriched with tin (Sn) and lead (Pb)

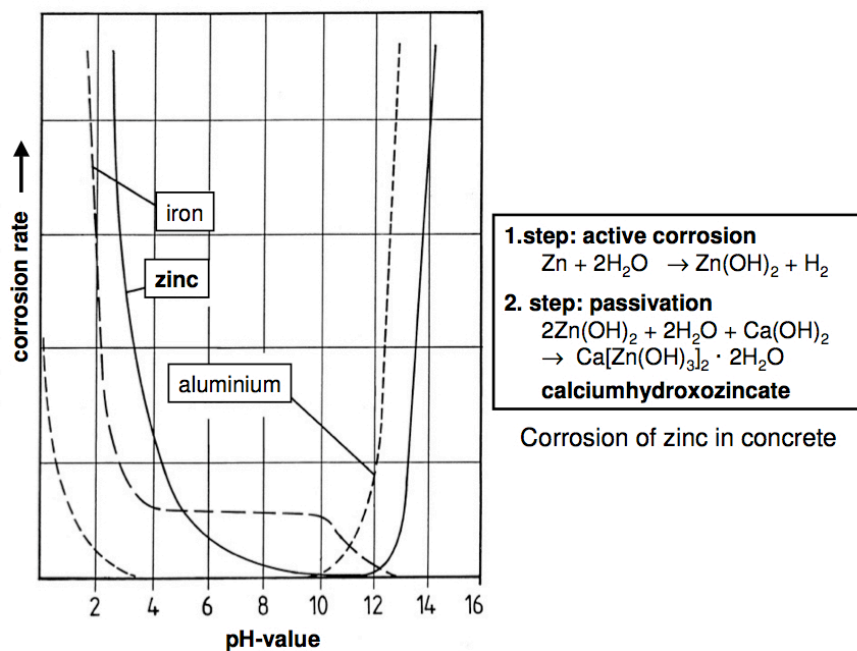
Fig. 3.6: Corrosion rate of metals in aqueous solutions as function of the pH value and corrosion of steel in fresh concrete

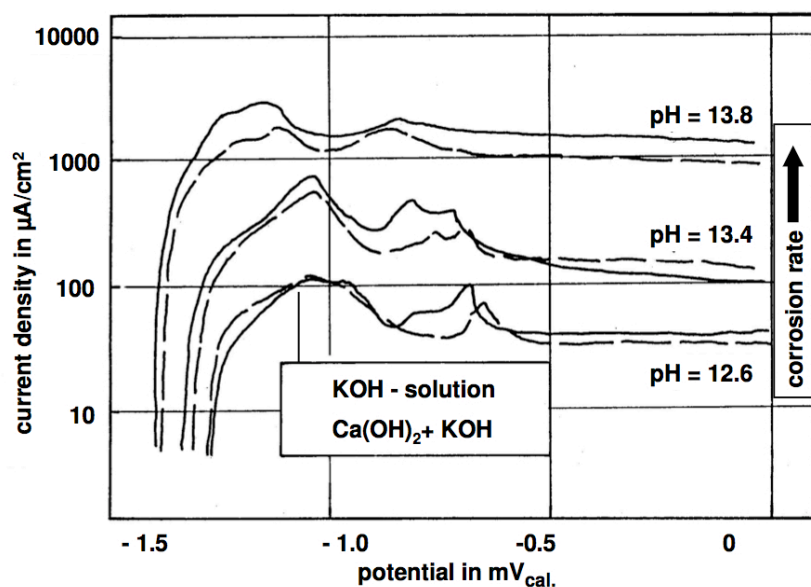
Fig. 3.7: Zinc corrosion in high alkaline aqueous solutions [24]

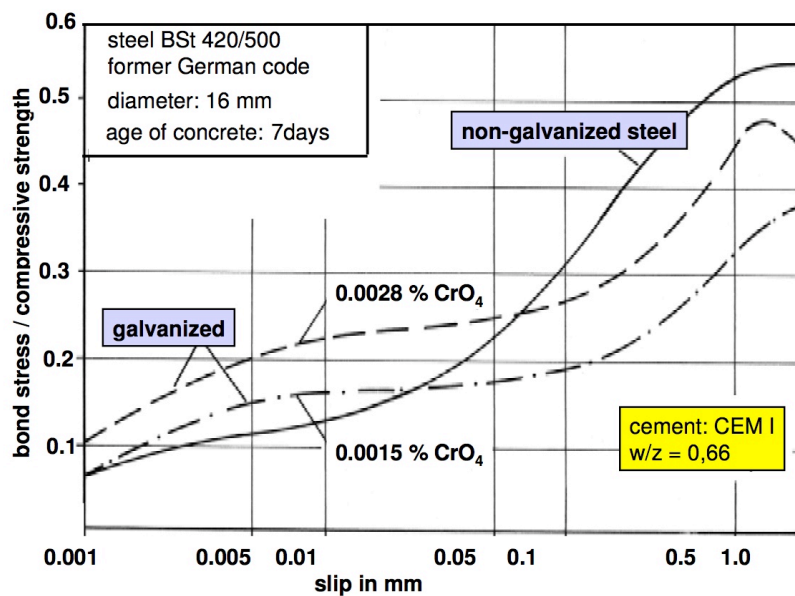
Fig. 3.9: Bond of non-galvanized and galvanized ribbed reinforcing steel after 7 days [13]

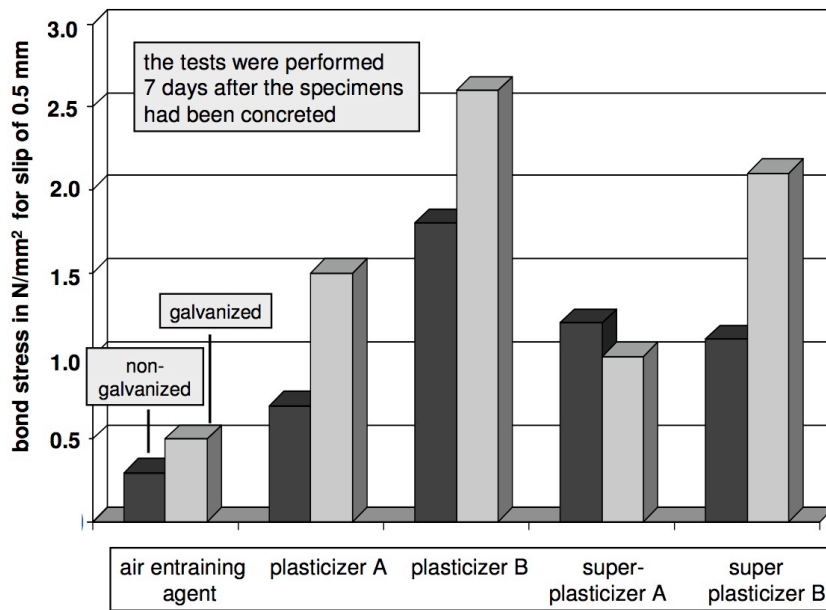
Fig. 3.10: Results of pull-out tests of smooth non-galvanized and galvanized bars, $d=20$ mm, specimens concreted with different admixtures, cement with low chromate content of 3 ppm [33]

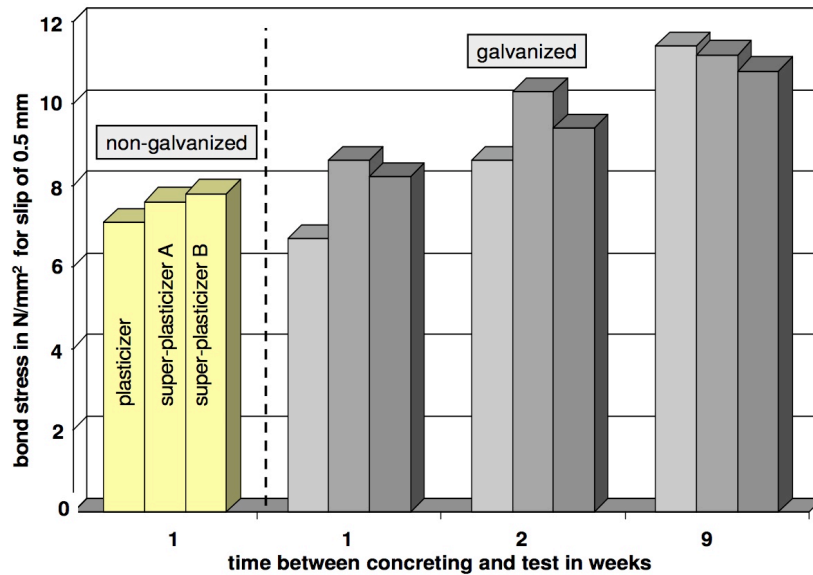
Fig. 3.11: Results of pull-out tests of smooth non-galvanized and galvanized bars, $d = 20$ mm, specimens concreted with different admixtures, cement with low chromate content of 3 ppm [33]

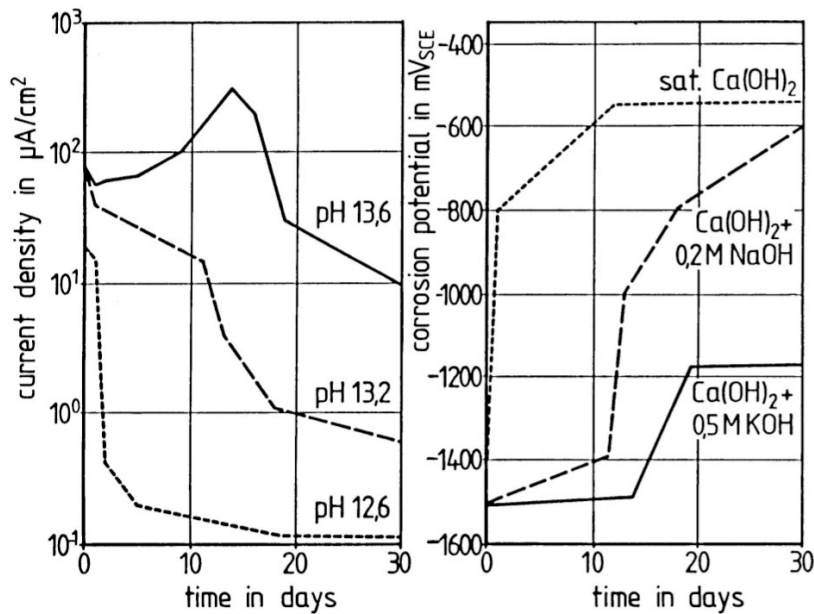
Fig. 3.12: Corrosion current density and -potential of galvanized reinforcing steel in alkaline solutions with pH 12.6, 13.2 and 13.6 [41]

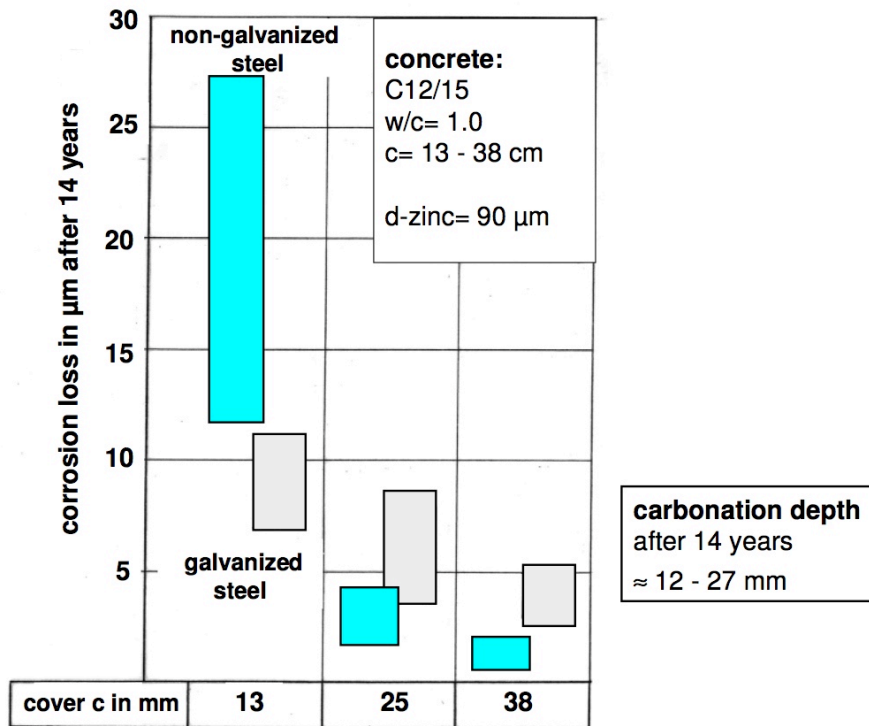
Fig. 3.13: Metal wastage of non-galvanized and galvanized reinforcing steel in lightweight concrete after exposure [44]

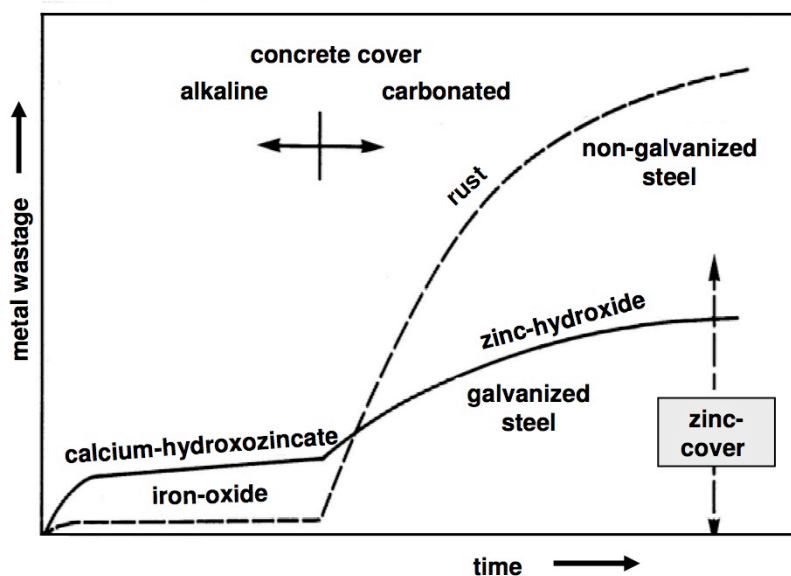
Fig. 3.14: Corrosion performance of non-galvanized and galvanized steel in concrete [3]

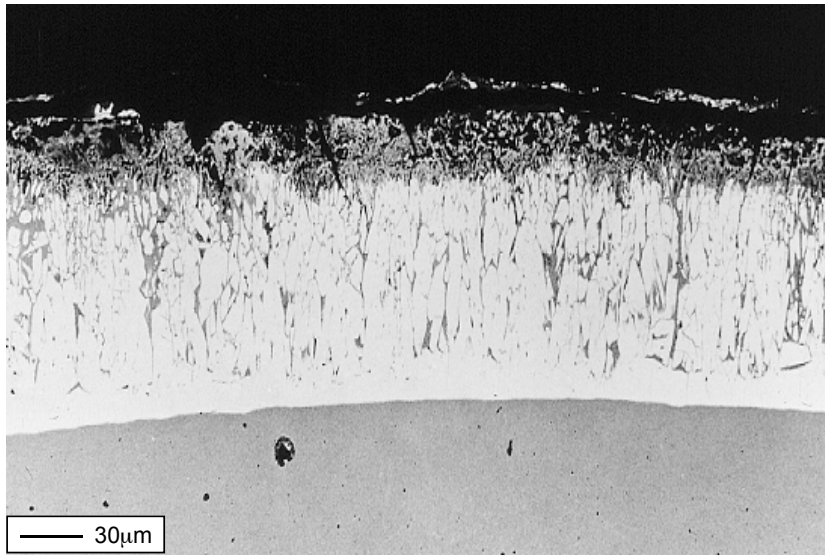
Fig. 3.15: Uniform corrosion of galvanized steel in carbonated concrete [3]

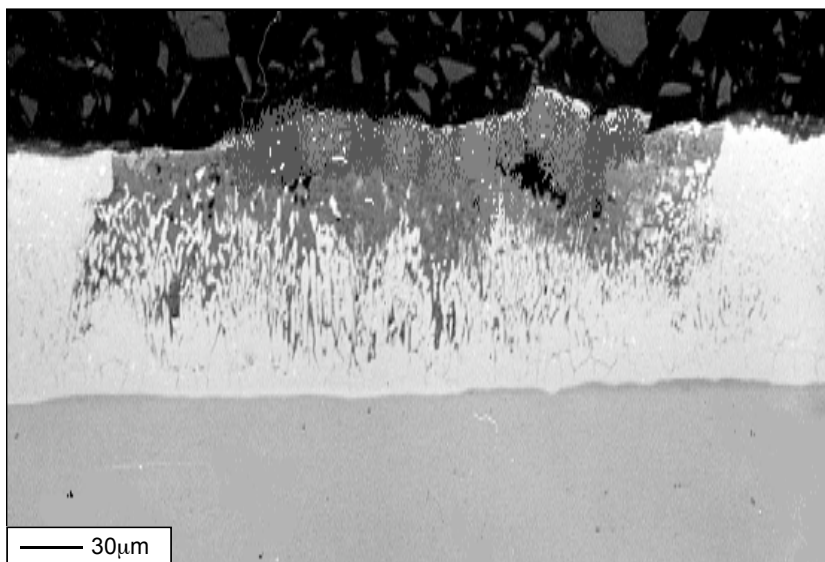
Fig.3.16: Pitting corrosion of galvanized steel in chloride containing concrete [3]

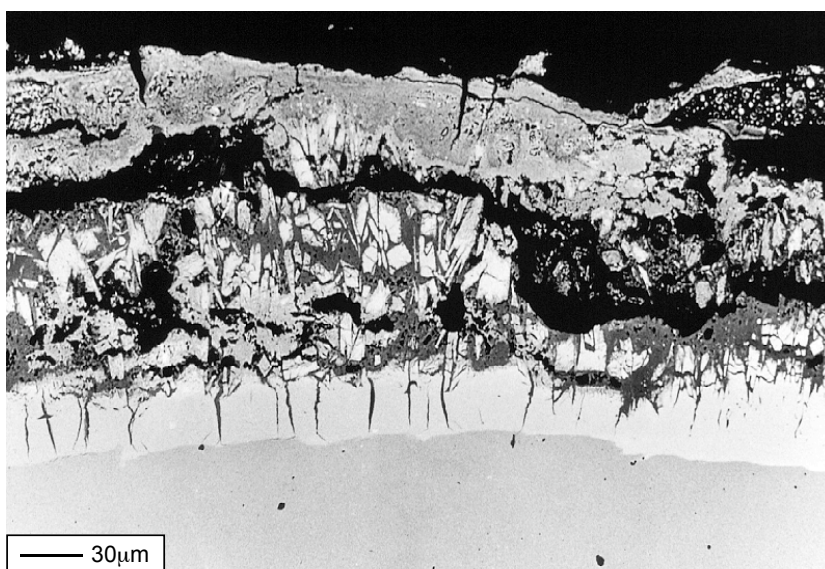
Fig. 3.17: Zinc-corrosion in heavily chloride-contaminated concrete [3]

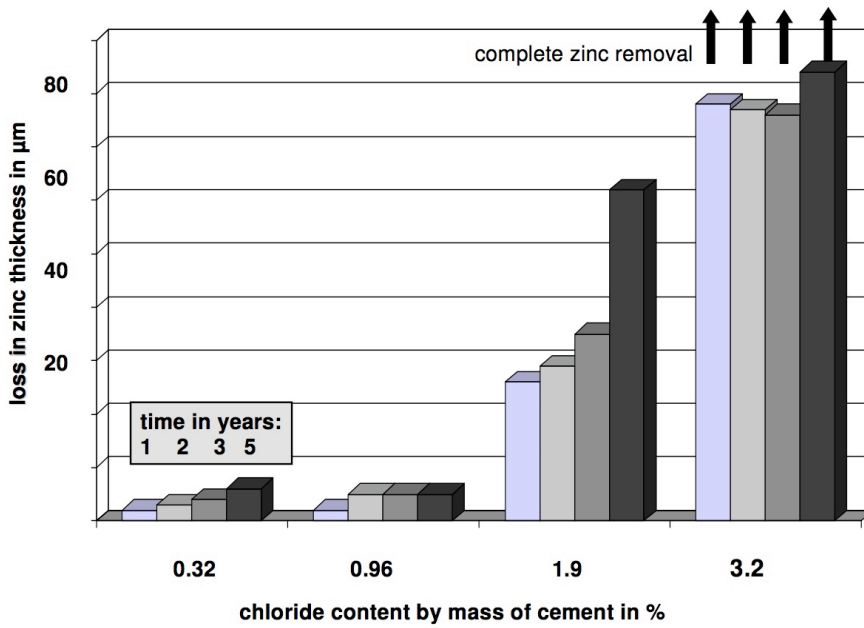
Fig. 3.18: Influence of the chloride content on the corrosion of galvanized reinforcing steel stored in concrete in the open air [44]

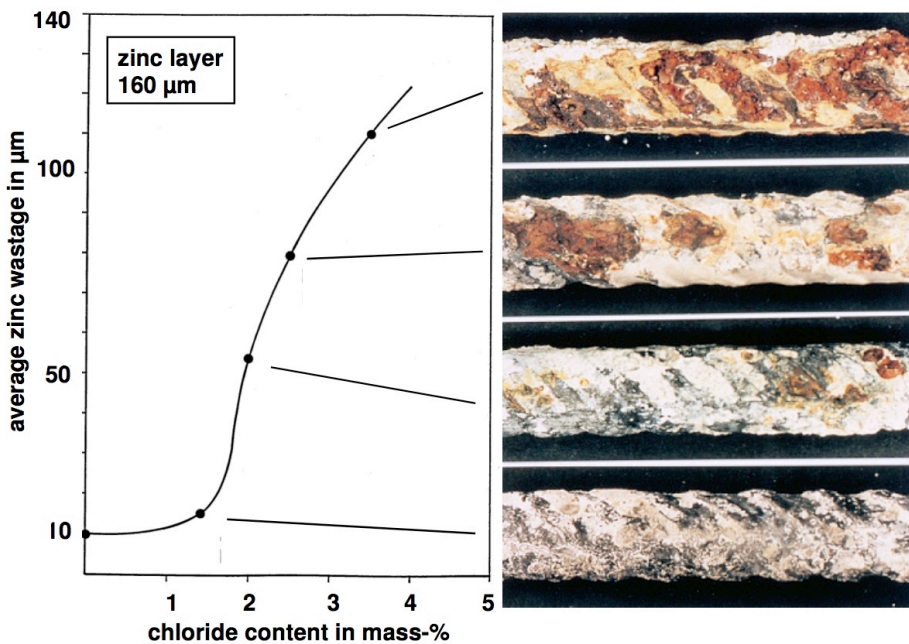
Fig. 3.19: Zinc wastage of galvanized reinforcing steels after 2.5 years embedded normal-weight concrete as a function of chloride content after seawater exposure (concrete cover 15 and 25 mm) [47]

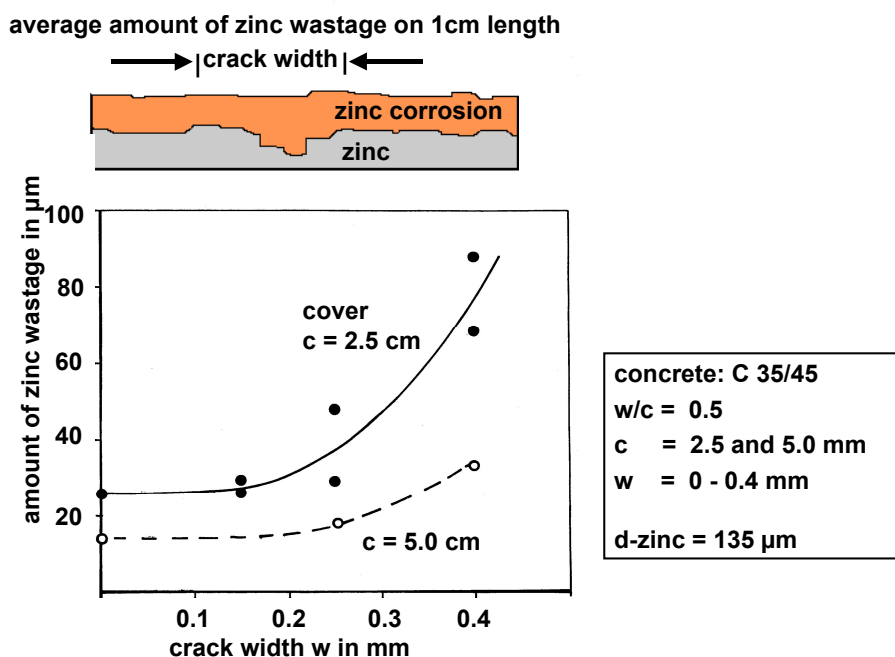
Fig. 3.20: Corrosion of galvanized reinforcing steels in cracks of concrete under condition of seawater splash zone [47]

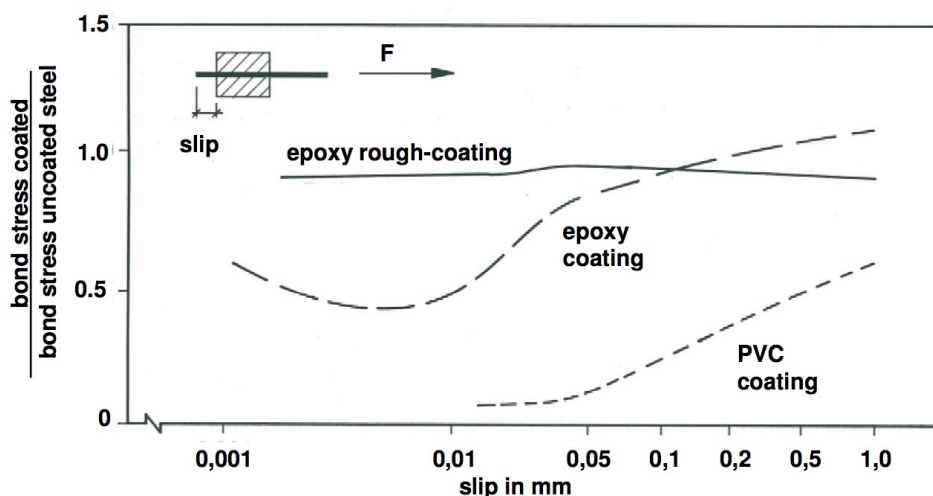
Fig. 4.1: Comparison of the bond behaviour of coated and non-coated bars [13]

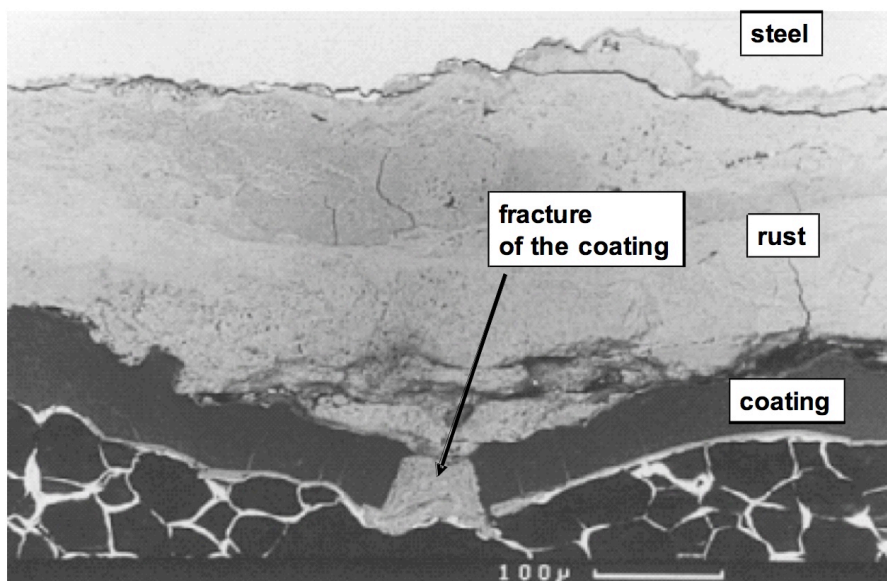
Fig 4.2: Under-rusting of a PVC-coating starting from local defects

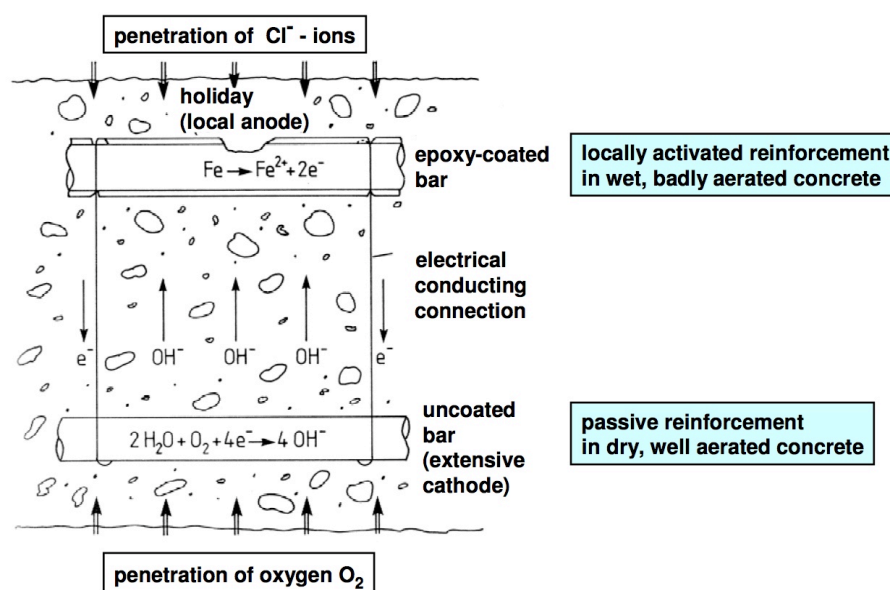
Fig. 4.3: Corrosion cell between epoxy-coated bar and uncoated reinforcement (e.g. parking decks) [1]

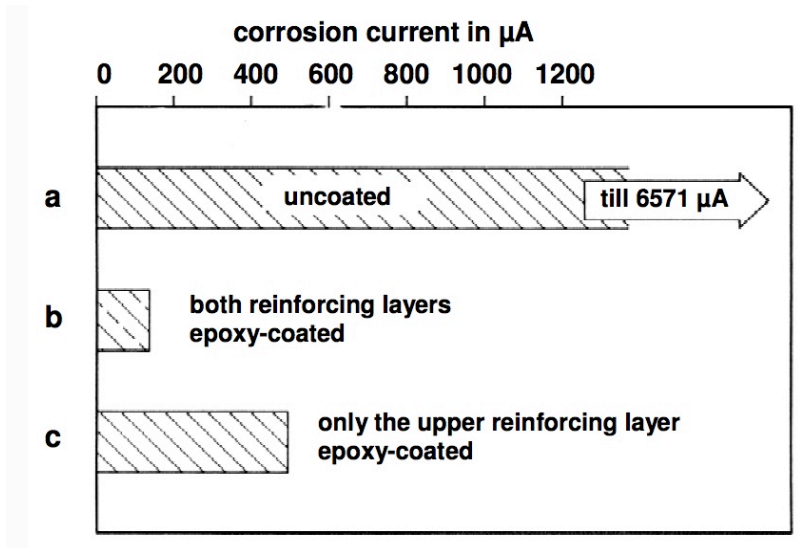
Fig. 4.4: Corrosion currents depending on the state of coating (FHWA)

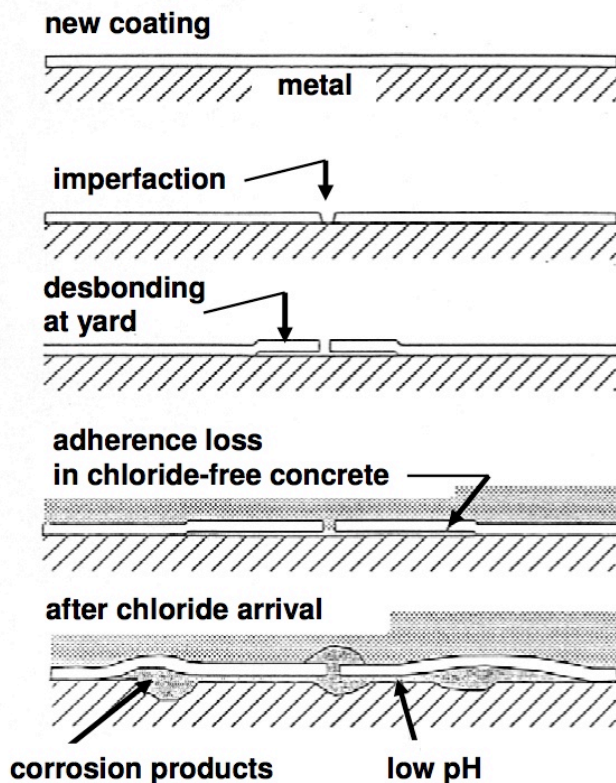
Fig. 4.5: Stages in the development of corrosion of epoxy-coated rebar in concrete [35]

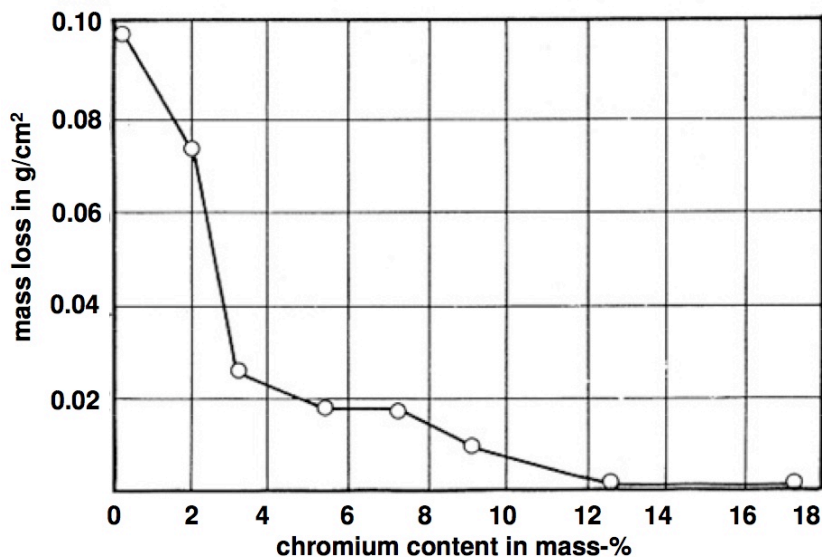
Fig. 5.1: Corrosion of chromium steels in industrial air (Binder and Brown in [3])

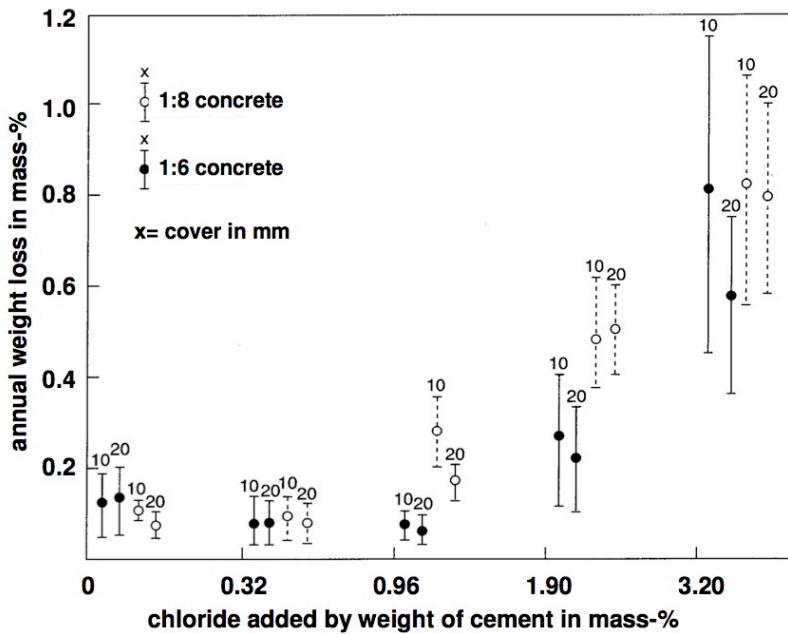
Fig. 5.2.a: Weight loss of shot-blasted unalloyed steel with respect to chloride content of concrete

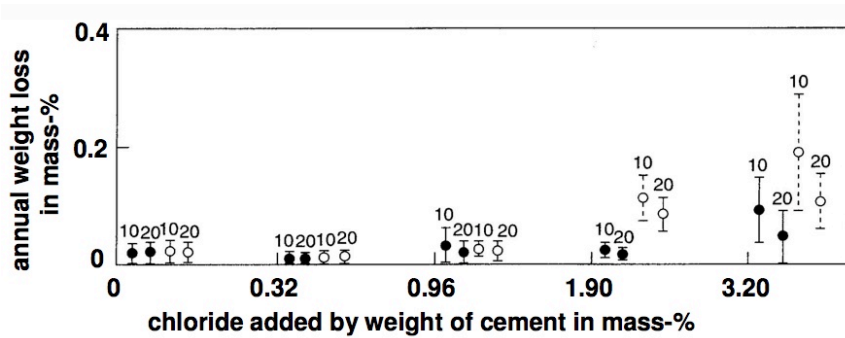
Fig. 5.2.b: Weight loss of type 430 ferritic steel with respect to chloride content concrete

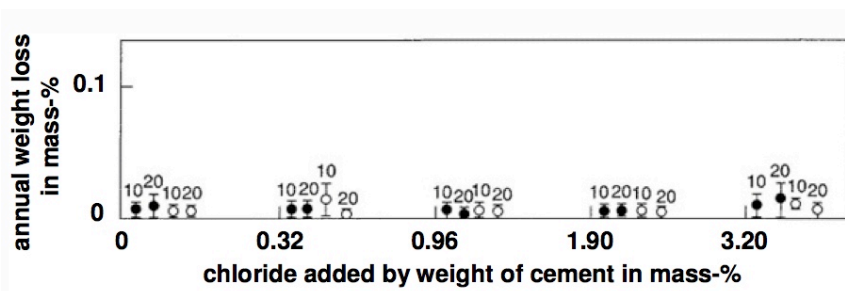
Fig. 5.2.c: Weight loss of type 316 austenitic steel with respect to chloride content of concrete

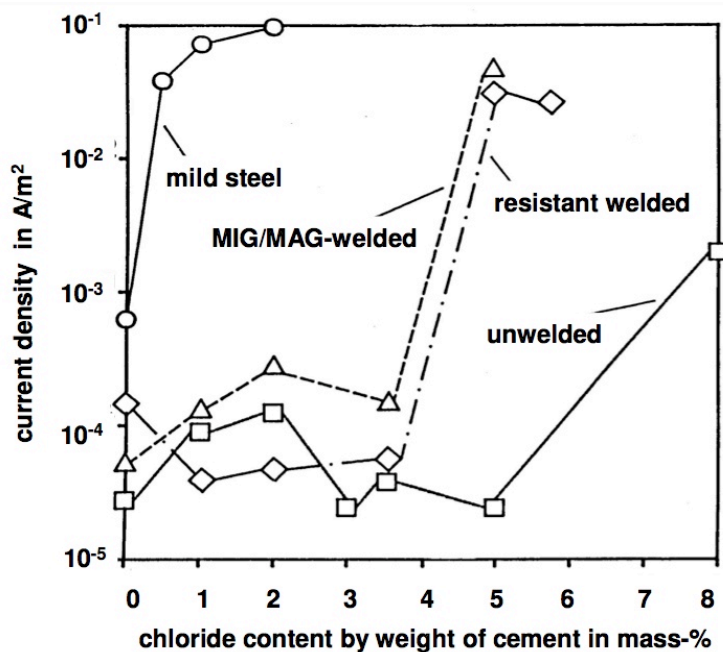
Fig. 5.3: Corrosion current density of steel type 1.4301 versus content of mixed-in chloride 0 mV
