Corrosion protection of reinforcing steels

Technical report prepared by

Task Group 9.7

February 2009

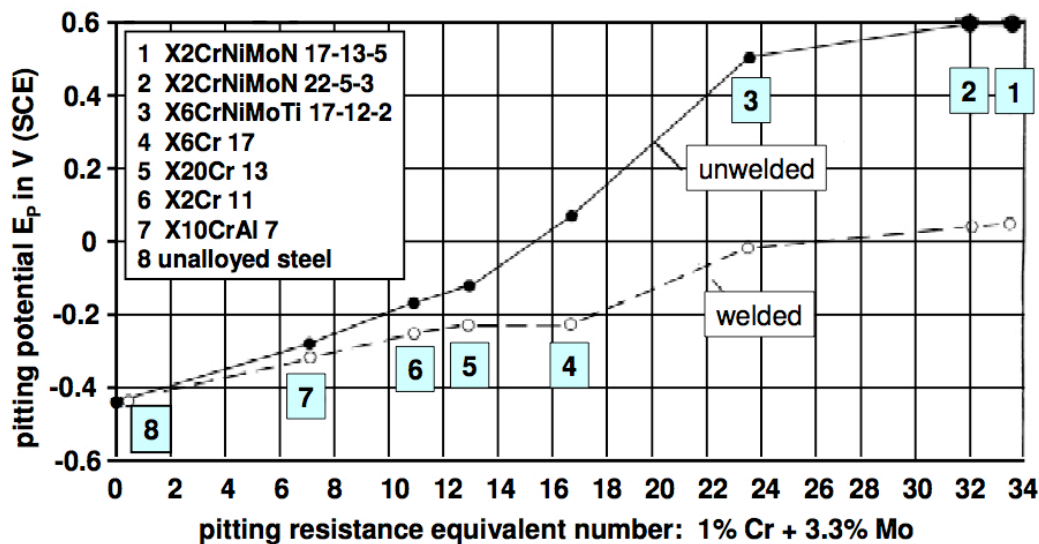
Fig. 5.4: Pitting potential of steel specimens with plain surface in saturated $Ca(OH)_2$ - solution with 5 M.-% chloride (potentiokinetic tests)

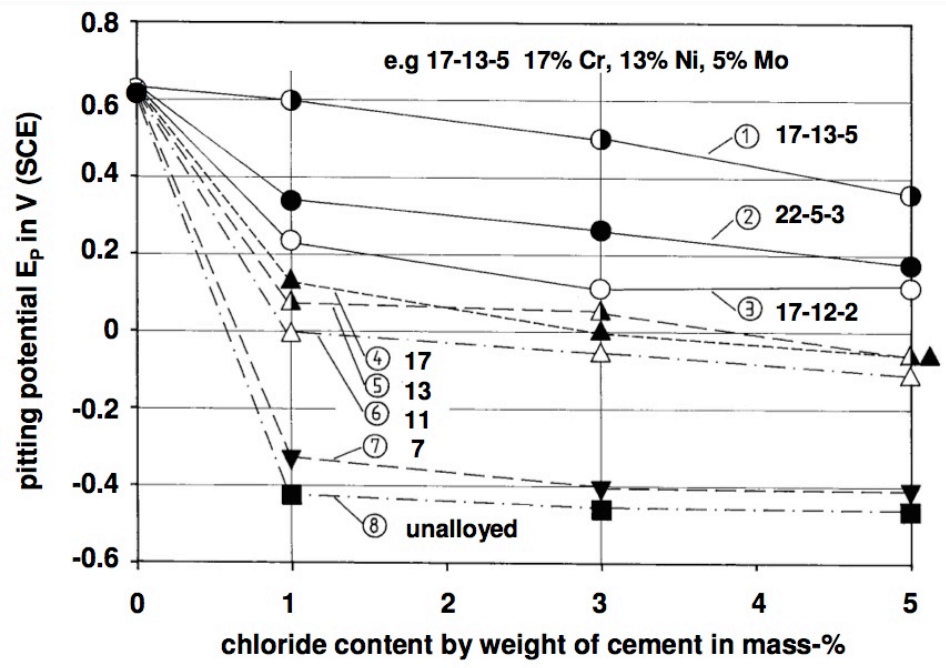
Fig. 5.5: Pitting potential E_p of plain welded steel specimens in PC-mortar-electrodes depending on the steel type and chloride content; potentiostatic test (oxygen evolution potential $E = +600 \text{ mV}_{SCE}$)

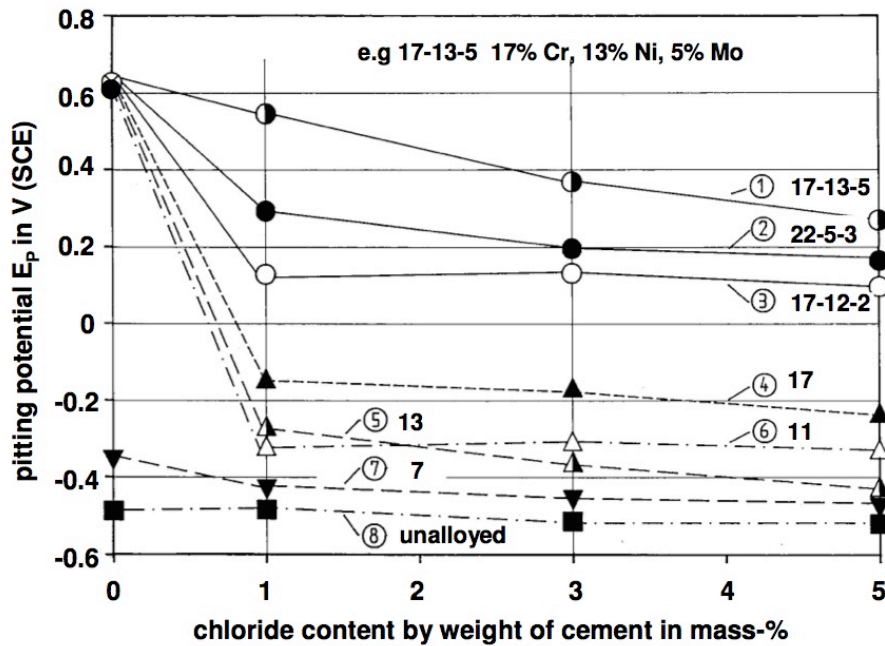
Fig. 5.6: Pitting potential E_p of plain welded steel specimens in carbonates PC-mortar- electrodes depending on the steel type and chloride content; potentiostatic test ($t = 24$ h), oxygen evolution potential $E = +600\text{mV}_{\text{SCE}}$

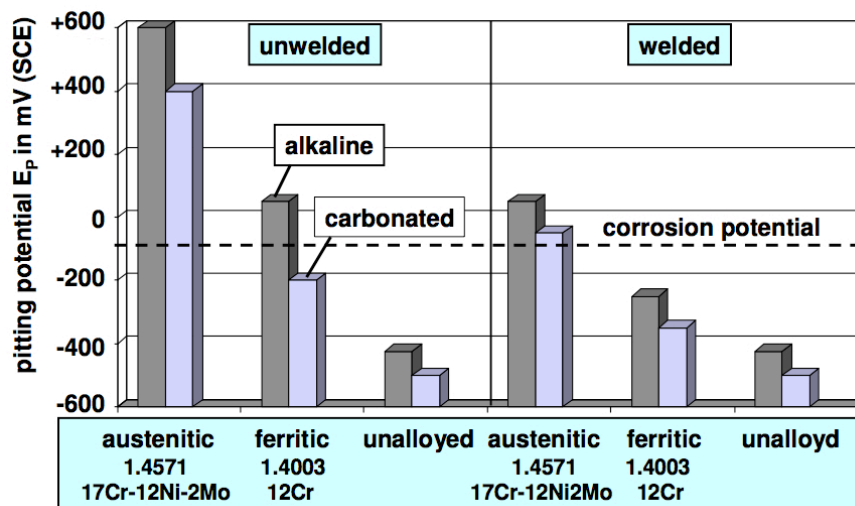
Fig. 5.7: Pitting potential E_p of deformed steel specimens in mortar-electrodes with 3 mass-% chloride depending on the steel type, the presence of welds and carbonation; potentiostatic test (oxygen evolution potential $E = +600$ mV_{SCE})

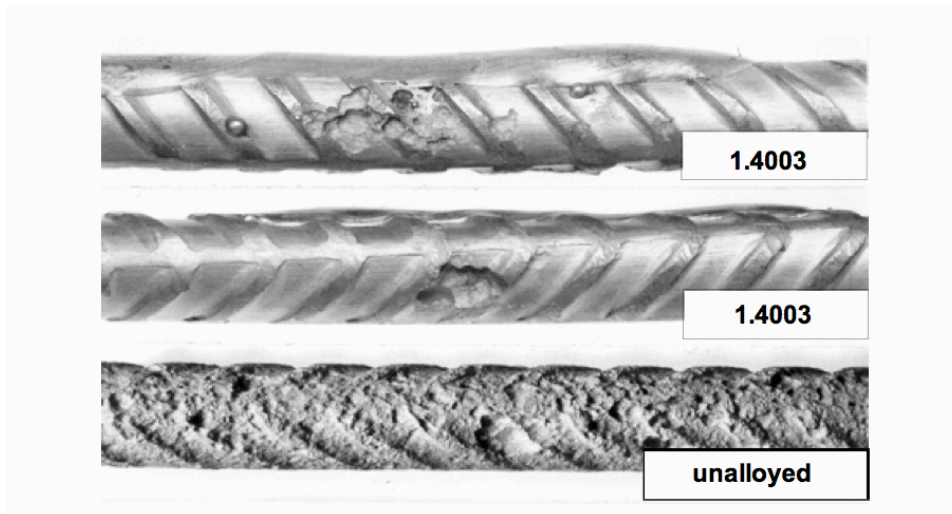
Fig. 5.9: Corrosion of deformed reinforcing bars in concrete (2 years; 2.5 mass-% Cl⁻)

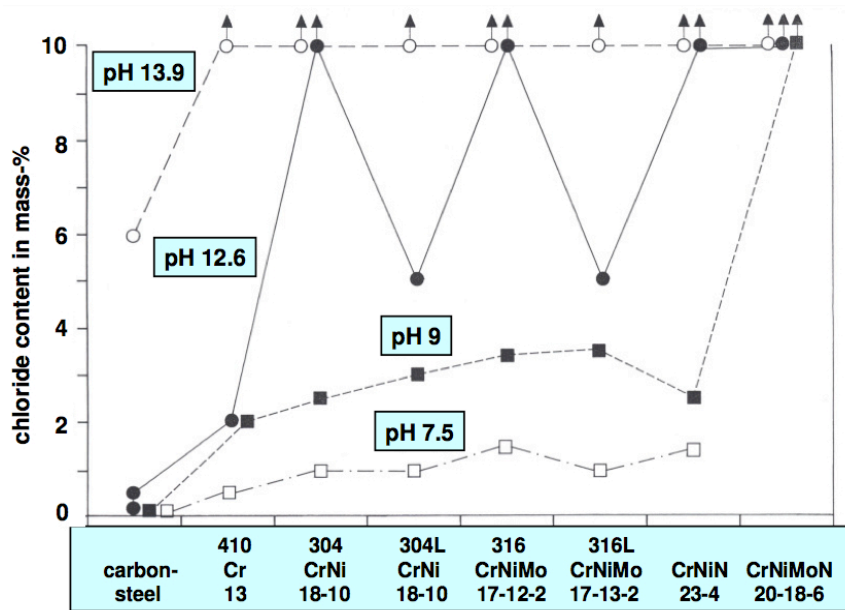
Fig. 5.10 Critical chloride content in pH 7.5 - 13.9 solutions at 20 °C during potentiostatic tests at +200 mV vs SCE

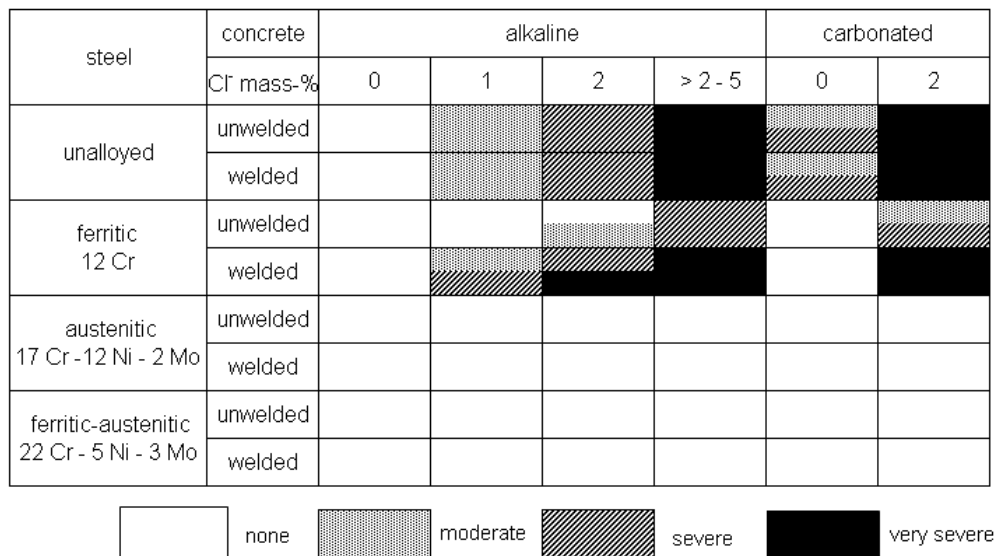
Fig. 5.11: Corrosion behaviour of steel in concrete (survey)

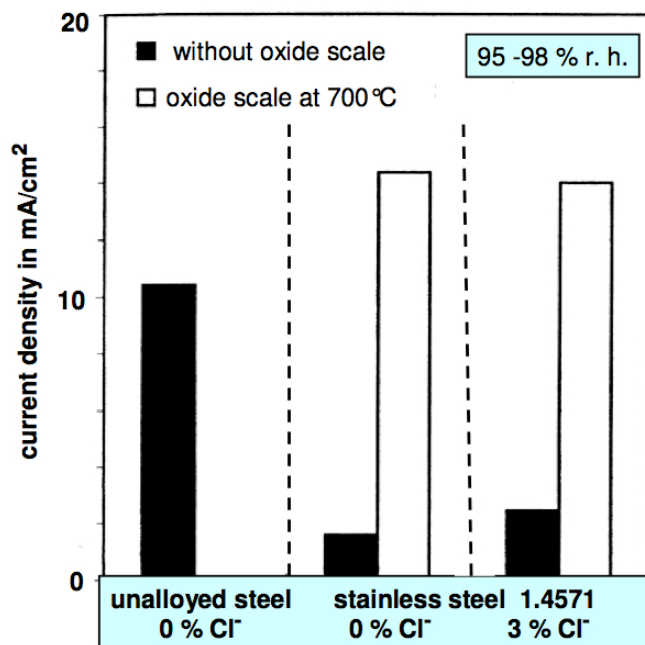
Fig. 5.12: Macrocouple current density in a corroding bar of carbon steel in 3 % chloride contaminated concrete when it was coupled with
 - a passive bar of unalloyed steel in chloride free concrete,
 - bars of 1.4571 stainless steel in chloride free concrete,
 - bars of 1.4571 stainless steel in 3 % chloride contaminated concrete.
 Results on stainless steel bars also with the surface covered with oxide scale produced by heating at 700 °C in order to simulate a welding scale [11].
